# RCRA Compliance Inspection Report

## AkzoNobel Coatings

Salem, Oregon

July 18, 2023 – July 19, 2023

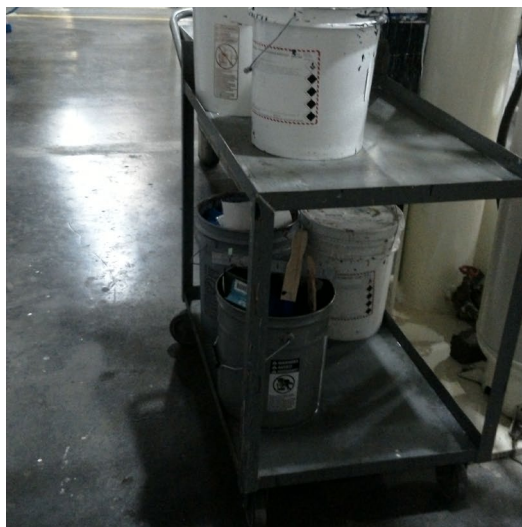
{Photograph 4, Attachment 05}

The inspection team observed a 5-gallon bucket with an open lid that contained waste PPE, rags, and stir sticks. The bucket was in good condition and was not labeled with a hazardous waste label. The bucket was an empty raw material pail from the batch process. Mr. Tanaka observed a maximum concentration of 3,609 ppm from this bucket, while the background concentration was 12.5 ppm. A photo of this bucket was taken as shown in Photo 4 in Attachment 05.

1. A maximum concentration of 3,609 ppm was observed using the TVA 2020 coming from the 5-gallon bucket in the front of the bottom of the cart from the perspective of the photo below.

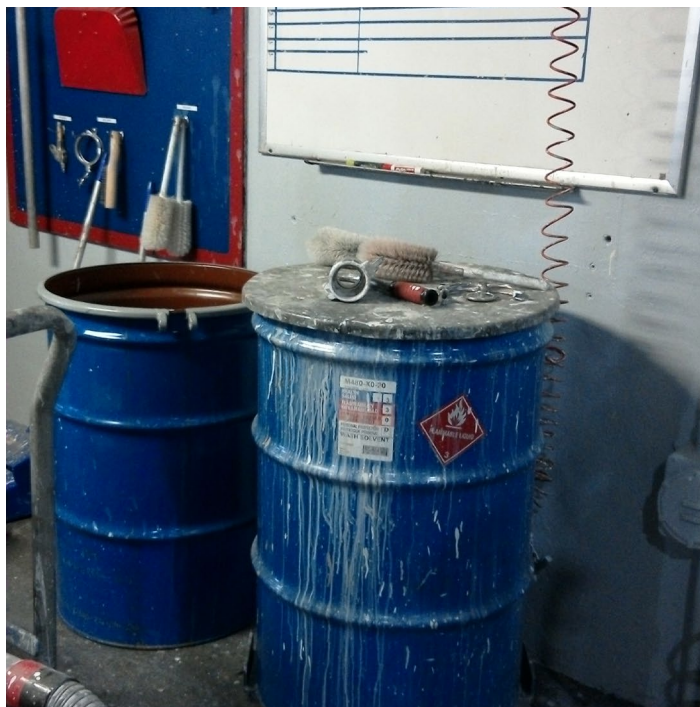
{Photograph 6, Attachment 05}

Next to the fill station, the inspection team observed a wash solvent drum in Area A with a loose metal lid without drum locking rings. The drum was in good condition and clearly labeled with a hazardous waste and flammable label, identifying the hazards. Mr. Tanaka observed a maximum concentration of 9,770 ppm from this bucket, while the background concentration was 11.1 ppm. A photo of this wash solvent drum was taken as shown in Photo 6 in Attachment 05.

2. A maximum concentration of 9,770 ppm was observed with the TVA 2020 coming from the wash solvent drum in the foreground of the photo below.

In response to the area of concern regarding wash solvent drums that were in use having loose lids and detectable emissions (area of concern #7), Mr. Oates explained in Attachment 15 that all wash solvent drums now have a sealed lid.

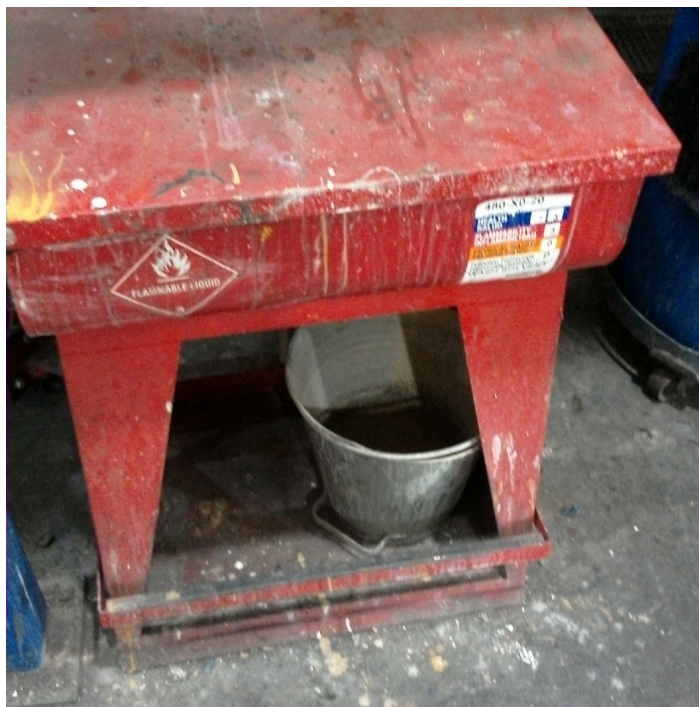
{Photograph 7, Attachment 05}

The inspection team then moved to Area B at approximately 10:00. They viewed the facility's UV tank. A nearby SAA drum of UV solid wastes included a hazardous waste label and the hazard was identified as flammable. The drum was in good condition, and it was closed. The inspection team also observed wash solvent drums and a staging area for portable diaphragm pumps. ANC had a color-coding system for different product types for these pumps. The inspection team observed two fill off stations (for loading product containers) near Area B's letdown tanks with one being a manual gravity feed and the other being pumped. There was an SAA closer to the letdown tanks adjacent to a parts washer, which was used for waste solids. An unlabeled open bucket under the parts washer was about 1/4 full of liquid. The bucket was in good condition. The parts washer was not actively draining or being used at the time of the inspection. The parts washer was clearly labelled as hazardous and flammable. ANC personnel indicated that they dump the solvent from this bucket into a 55-gallon SAA when the parts washer is dirty. Mr. Tanaka observed a maximum concentration of 984 ppm from this bucket, while the background reading was 15 ppm. A photo of this bucket and the parts washer was taken as shown in Photo 7 in Attachment 05.

3. A maximum concentration of 984 ppm was observed with the TVA 2020 coming from the bucket in the foreground of the photo below.

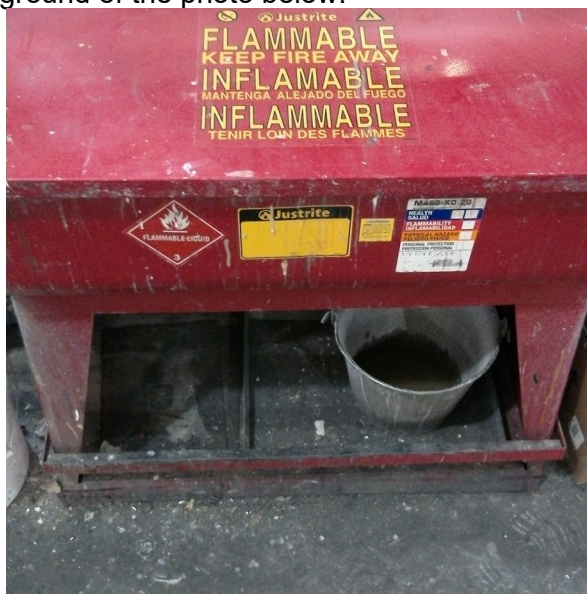
{Photograph 11, Attachment 05}

The inspection team observed the Renzmann pot washer. The current Renzmann pot washer schematics are included as Attachment 07. The inspection team observed two SAA drums adjacent to the Renzmann washer, one being used for wash solvent and the other for UV wash. Both of these drums were in good condition, closed, and they included hazardous waste labels identifying the hazards. ANC personnel indicated that the wash solvent SAA drum adjacent to the Renzmann washer accepts parts washer solvent from throughout the facility as well as residual products. A photo of these SAA drums was taken as shown in Photo 10 in Attachment 05. Mr. Tanaka monitored an open bucket under the Renzmann parts washer that contained residual fluid and observed a concentration of 1683 ppm. The bucket was not labelled and was in good condition. The parts washer was not actively draining or being used at the time of the

inspection. The parts washer was clearly labelled as hazardous and flammable. A photo of this bucket and the Renzmann parts washer was taken as shown in Photo 11 in Attachment 05.

4. A maximum concentration of 1,683 ppm was observed with the TVA 2020 coming from the bucket in the foreground of the photo below.

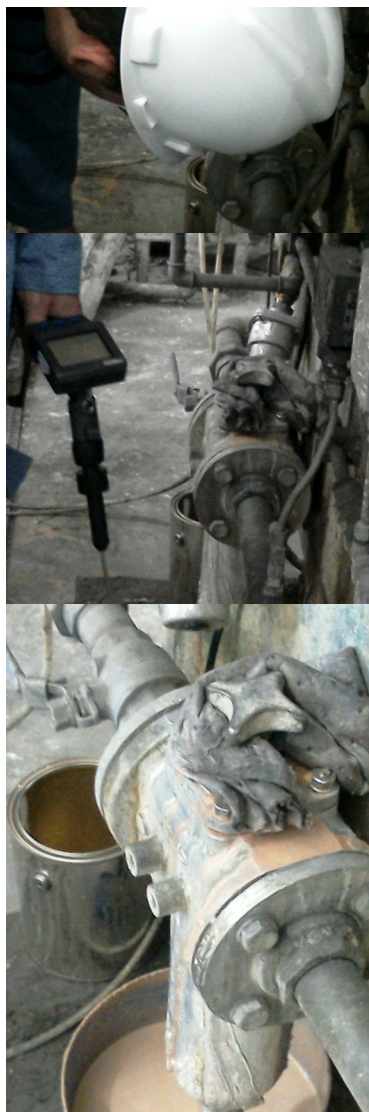
{Photographs 13-15, Attachment 05}

The inspection team also observed an open pan with liquid in it next to the Renzmann equipment. The liquid in the pan appeared to be drained from the Renzmann dirty solvent tank. Mr. Tanaka monitored this drip pan and observed a concentration of 30,000 ppm (3.0%), with a background concentration of 28 ppm. Three photos of this drip pan for the Renzmann filter were taken as shown in Photos 13-15 in Attachment 05.

5. A maximum concentration of 30,000 ppm was observed with the TVA 2020 coming from the drip pan in the photos below. The photo on the left shows Mr. Tanaka taking the measurement with the TVA 2020 and the other two photos show the drip pan.

Mr. Young observed material dripping from the filter at the outlet of the Renzmann dirty solvent tank and asked the ANC personnel what the cause of the leak was. Mr. Brunkal said that there was a leaking part and he explained that he had ordered a replacement for this part.

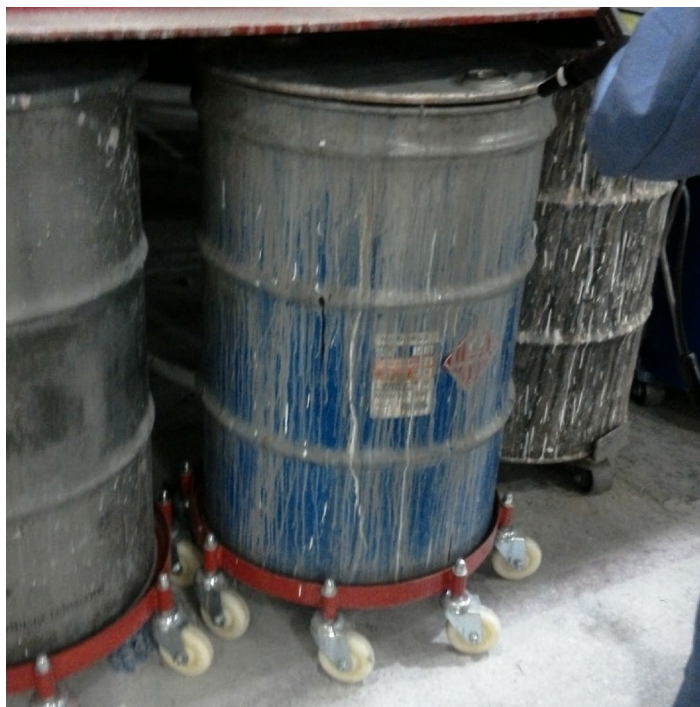
{Photograph 16, Attachment 05}

The inspection team moved on to Area C of the ANC facility. They observed tanks for latex and a wash solvent drum under the latex tank platform. The drum was labelled as hazardous waste and flammable and in decent condition. The wash solvent drum had a loose lid and Mr. Tanaka observed a concentration of 16,000 ppm (1.6%) coming from this drum, with a background concentration under 50 ppm. This drum is shown in Photo 16 in Attachment 05.

6. A maximum concentration of 16,000 ppm was observed with the TVA 2020 coming from the drum in the photo below.

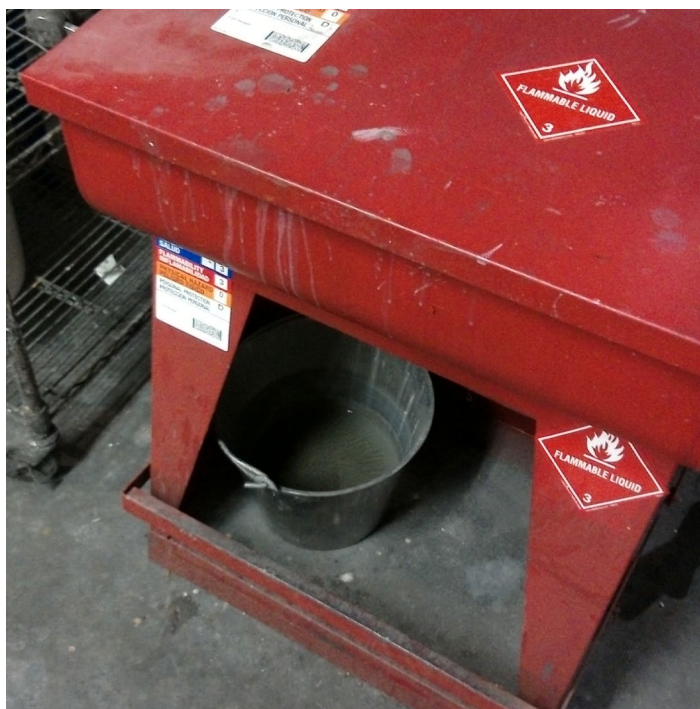
{Photograph 17, Attachment 05}

In Area D, the team inspected ANC's West 2000 Tank and their West 1000 Tank for solvent primer. Mr. Oates explained that Ryan Warnock (Team Lead) said that ANC had not been flushing or cleaning the tanks between batches. He indicated that if they were to flush the tanks, the flushed material would be emptied into pails or totes then recycled into the next batch. The inspection team observed a parts washer under the mezzanine in Area D with an unlabeled open bucket underneath it that was approximately 1/3 full. The bucket was in good condition. The parts washer was not actively draining or being used at the time of the inspection. The parts washer was clearly labelled as hazardous and flammable. Mr. Tanaka observed a concentration of 6,800 ppm from this bucket, with a background concentration of 40 ppm. This bucket is shown in Photo 17 in Attachment 05.

7. A maximum concentration of 6,800 ppm was observed with the TVA 2020 coming from the bucket in the photo below.

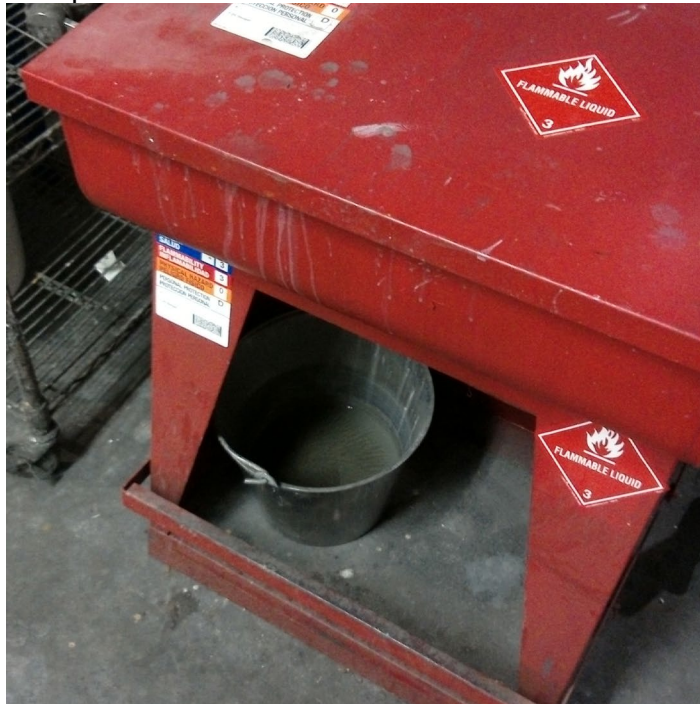
{Photograph 17, Attachment 05}

A maximum concentration of 6,800 ppm was observed with the TVA 2020 coming from the bucket in the photo below.

In response to the area of concern regarding the facility's parts washers having open buckets holding hazardous waste under them that resulted in high concentrations measured by the TVA 2020 (area of concern #3), the same word document addressing area of concern #1, included as Attachment 15, explained that since the inspection, their SOP for solvent parts washer waste management has been updated. This SOP is included as Attachment 04. According to Mr. Oates, all wash stations have been updated to the new standard, the updated SOP is in place, and labeled, sealed, and empty new buckets under the parts washers are in place as of July 28, 2023.

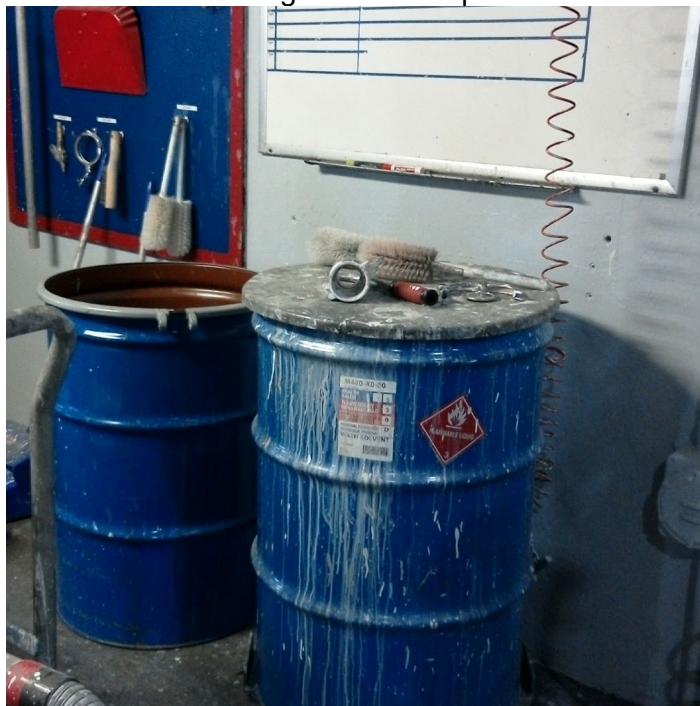
{Photograph 6, Attachment 05}

7. Wash solvent drums that were in use had loose lids without drum locking rings and detectable emissions in several areas, such as in Area A below the mezzanine, as shown below. Other instances of this issue are described in more detail in the inspection summary.

A maximum concentration of 9,770 ppm was observed with the TVA 2020 coming from the wash solvent drum in the foreground of the photo below.

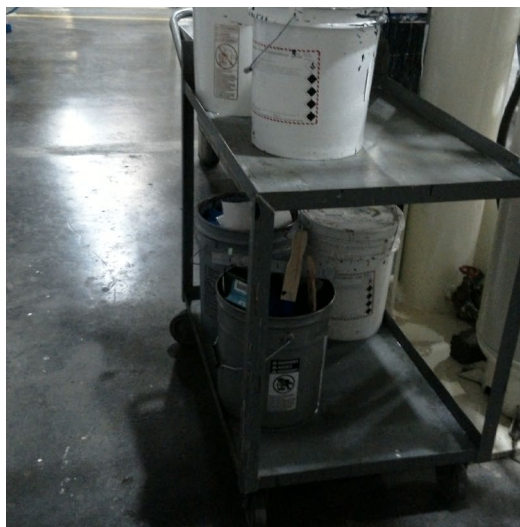
{Photograph 4, Attachment 05}

Aa maximum concentration of 3,609 ppm was observed using the TVA 2020 coming from the 5-gallon bucket in the front of the bottom of the cart from the perspective of the photo below.
