**Region 6 - Enforcement & Compliance Assurance Division**  
**INSPECTION REPORT**

| Inspection Date(s): | 06/27/2023 | |
| Facility Name: | <b>Arkadelphia Waterworks</b> | |

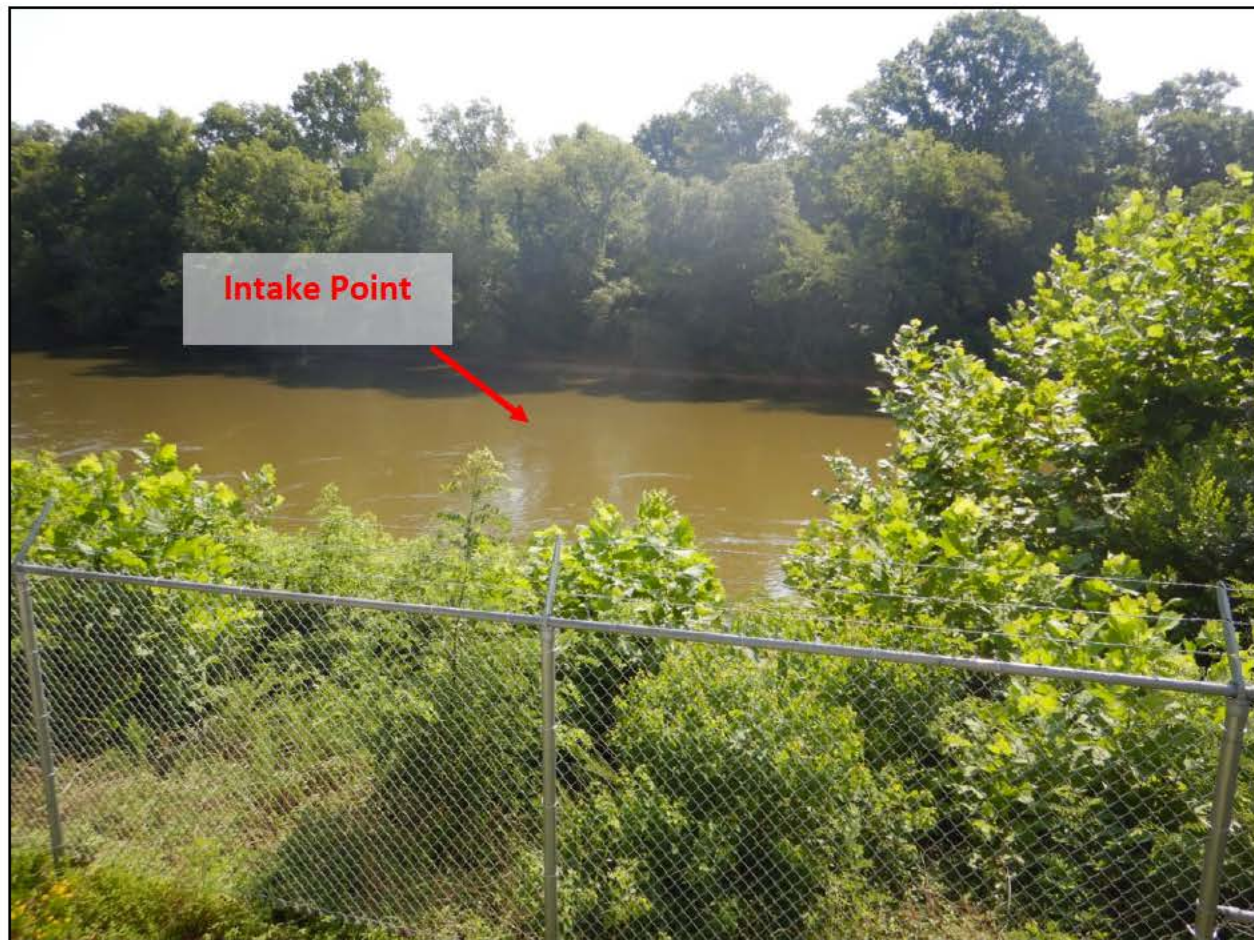
The WTP intake was located in the Ouachita River (refer to [Appendix 2, Photograph 3](#)). There was no buoy or marker indicating the intake point in the river. System representatives stated that the intake was screened. There were four raw water pumps positioned next to the river (refer to [Appendix 2, Photograph 4](#)). Following the intake, a chemical addition manhole was observed (refer to [Appendix 2, Photograph 5](#)). The manhole led to the influent line, and System representatives stated that coagulant and sodium permanganate were added at this point.

**Photograph 3. Raw Water Intake, WTP #01** View of the raw water intake point for WTP #01 within the Ouachita River. There were no markers or buoys to identify the intake point.

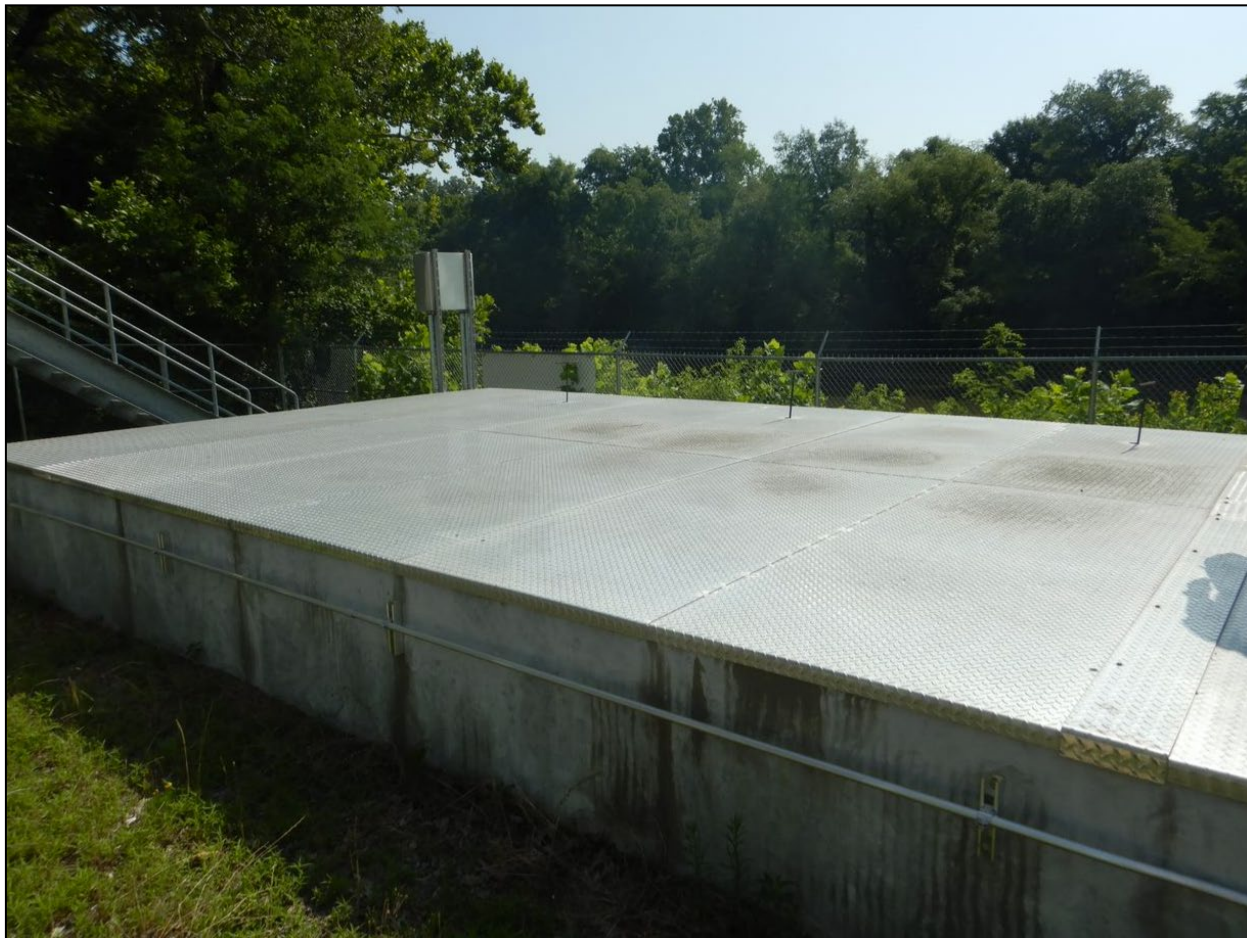
**Photograph 4. Raw Water Intake Pumps, WTP #01** View of the vault containing the four, raw water intake pumps next to the Ouachita River at WTP #01.

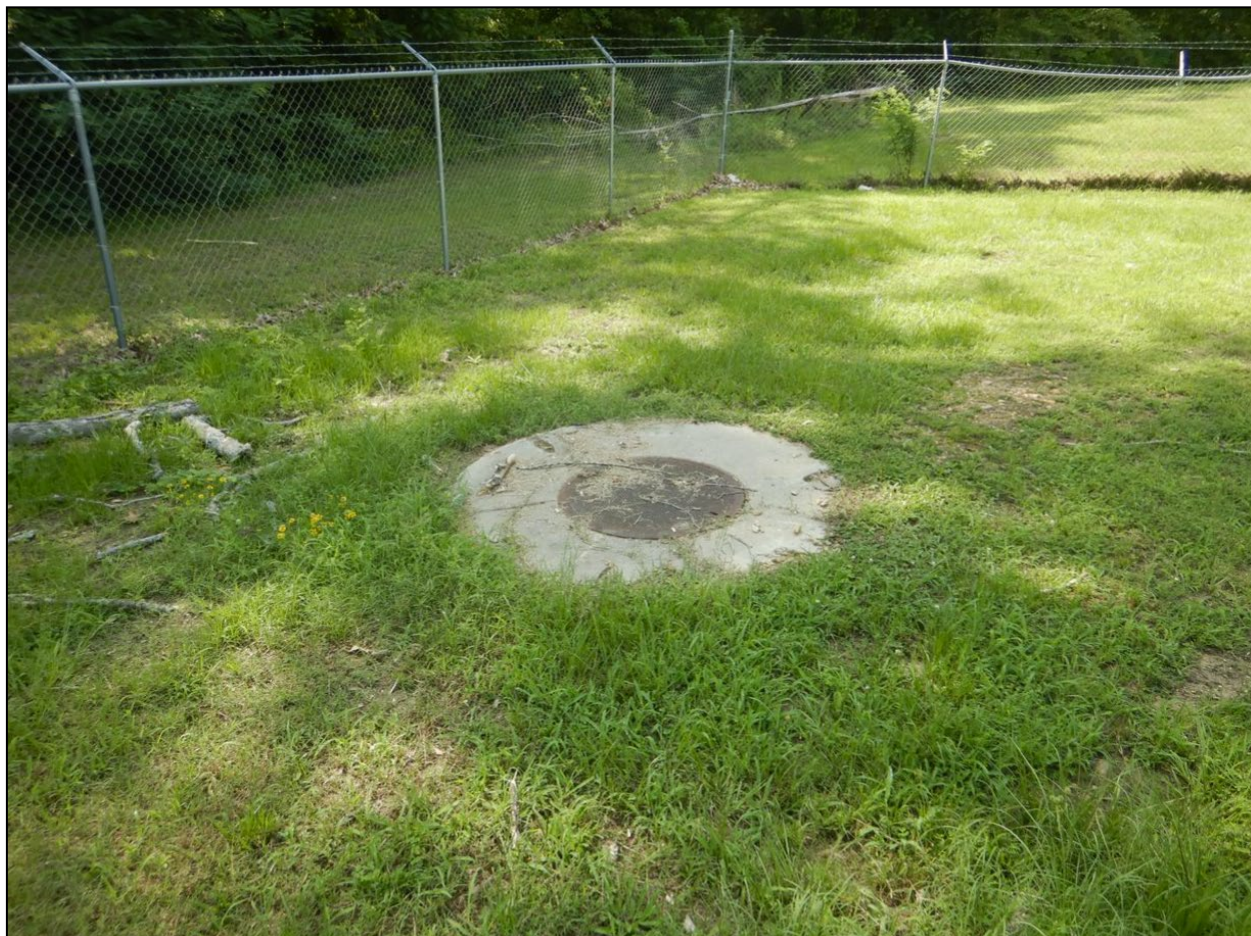
**Photograph 5. Chemical Addition Manhole, WTP #01** View of the chemical addition manhole located outside of WTP #1. The manhole leads to the raw water influent pump line. The System Manager stated that coagulant and sodium permanganate were added at this point.

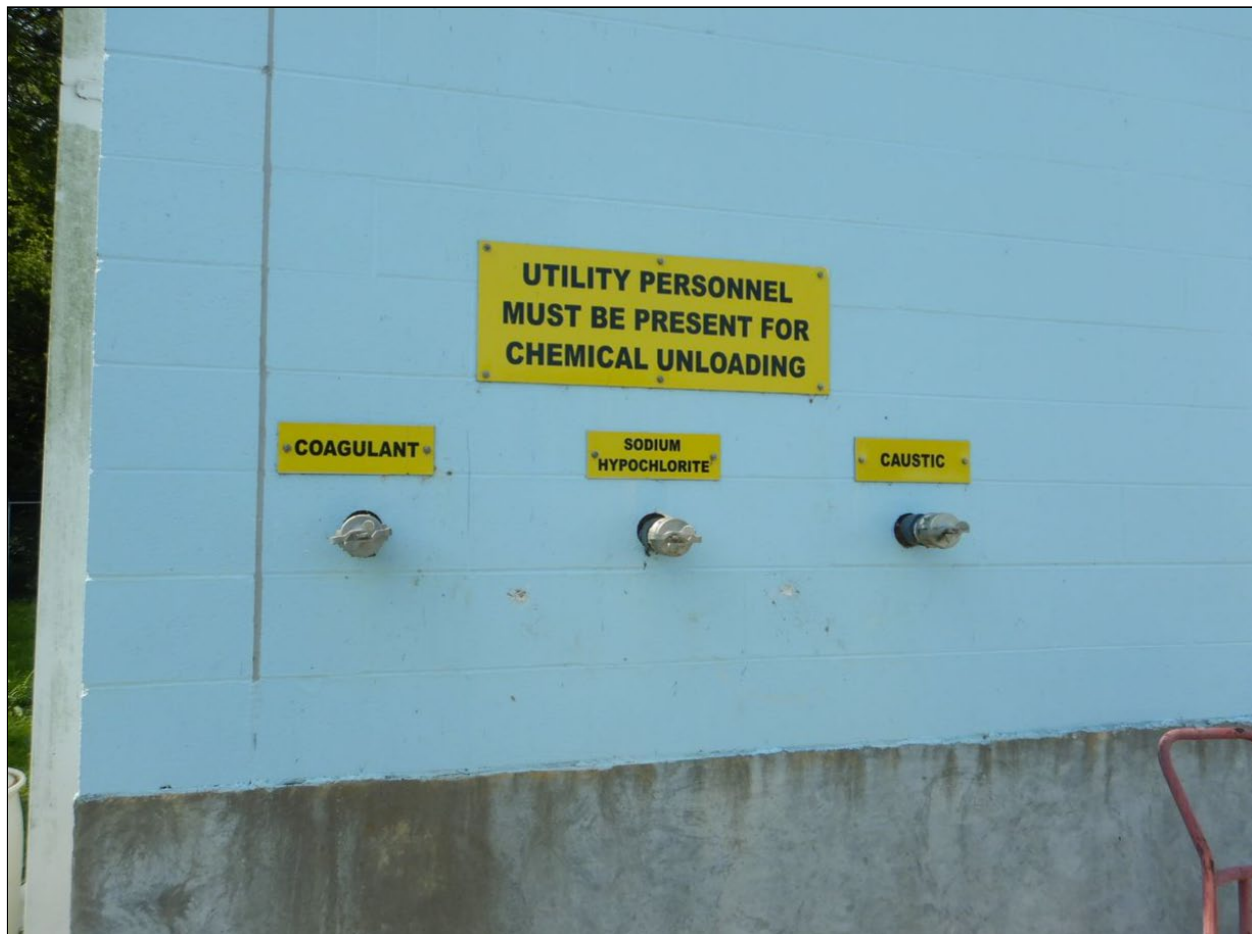
The chemical delivery ports into the WTP were observed outside of the chemical storage area (refer to [Appendix 2, Photograph 6](#)). The ports were labeled, and System representatives stated that chemicals were sampled prior to being unloaded. The chemical ports were positioned over a drainage grate (refer to [Appendix 2, Photograph 7](#)). The System Manager stated that if a chemical spill occurred there, the chemicals would drain to the backwash pond located adjacent to the WTP. It is unknown if this chemical drainage presents a concern for the plant's National Pollutant Elimination System-permitted (NPDES-permitted) discharge.

**Photograph 6. Chemical Delivery Ports, WTP #01** View of the chemical delivery ports for coagulant, sodium hypochlorite, and caustic located on the exterior of the chemical storage area at WTP #01. System representatives stated that chemicals were sampled prior to being unloaded.

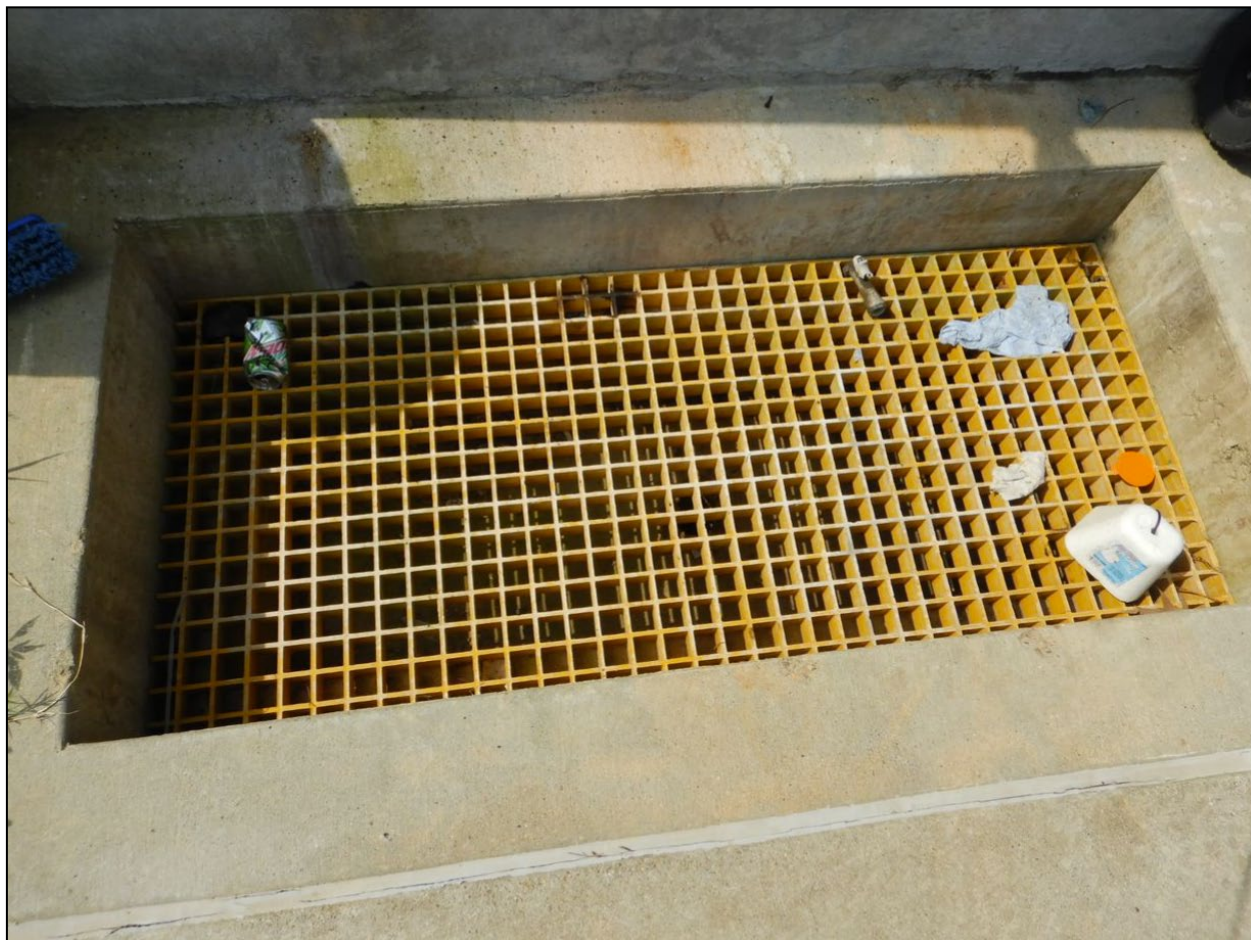
**Photograph 7. Chemical Delivery Port Drain, WTP #01** View of the drain positioned below the chemical delivery ports at WTP #01. The System Manager stated that the drain led to an onsite backwash pond. It is unclear if this presents a concern for the plant's NPDES permit.

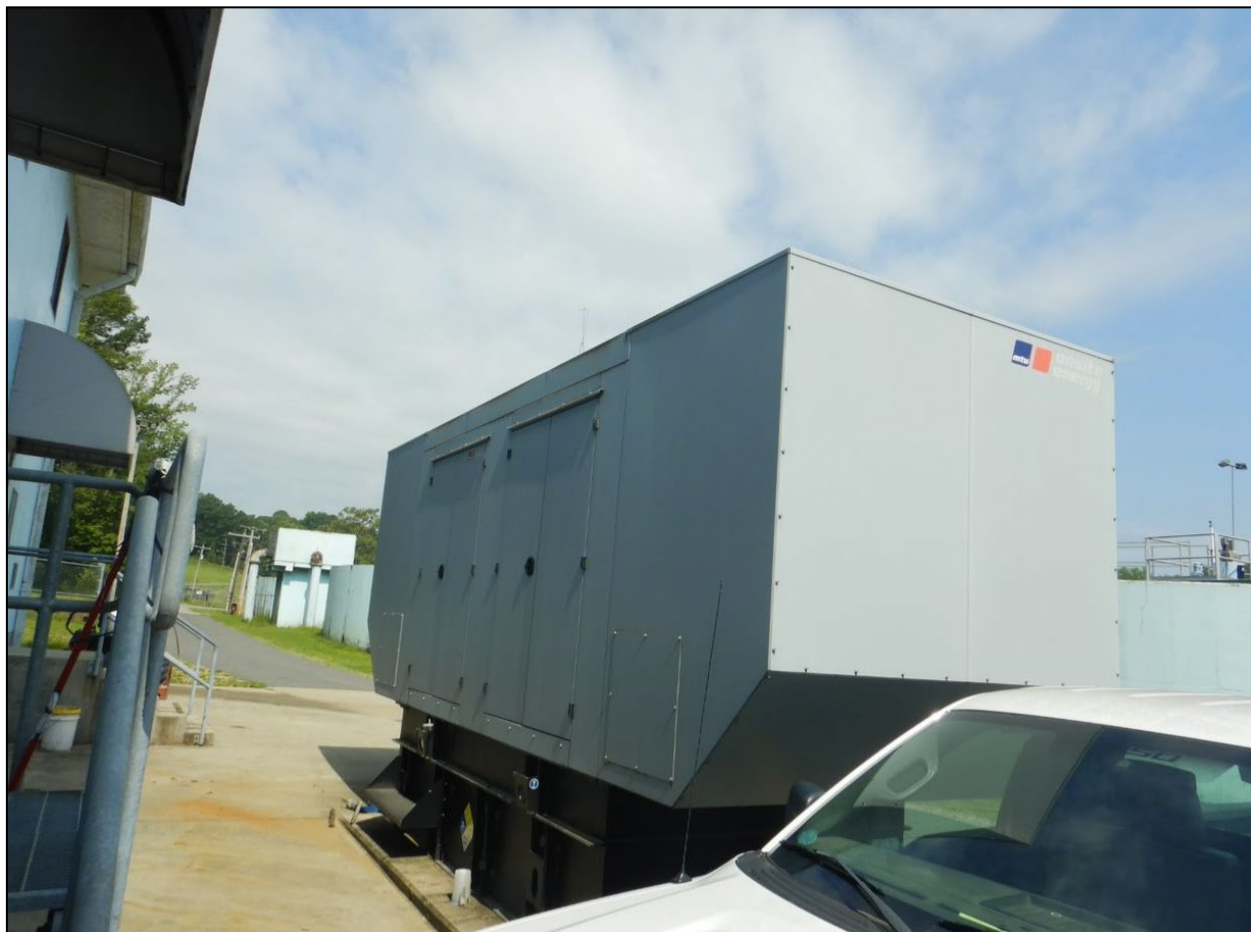
**Photograph 8. Mounted Generator, WTP #01** View of one of three mounted backup generators at WTP #01. The System Manager stated that this was the only generator that would turn on in the event of a power outage.

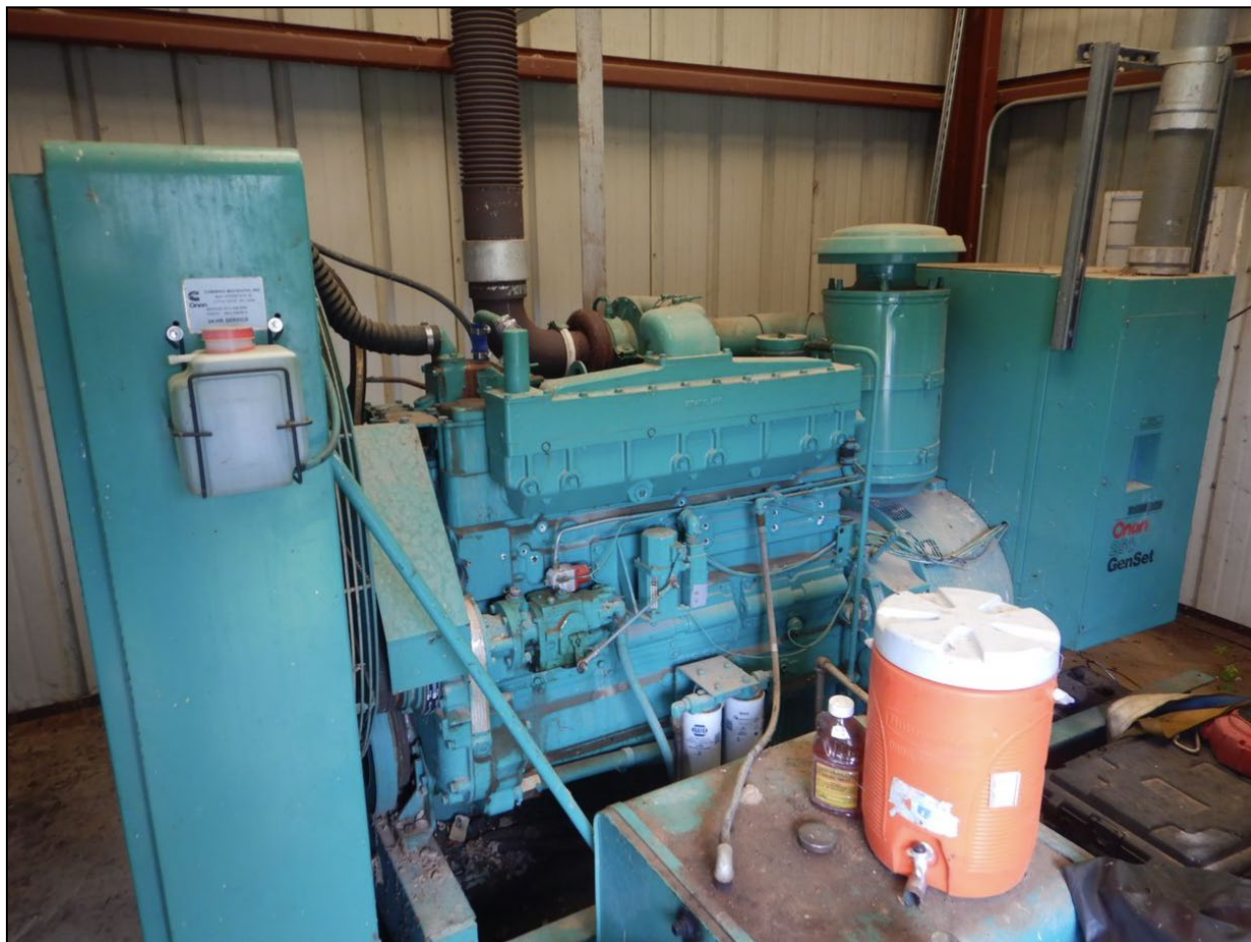
**Photograph 9. Mounted Generator, WTP #01** View of one of the three onsite mounted generators at WTP #01. This was one of two generators that need to be turned on manually in the event of a power outage.

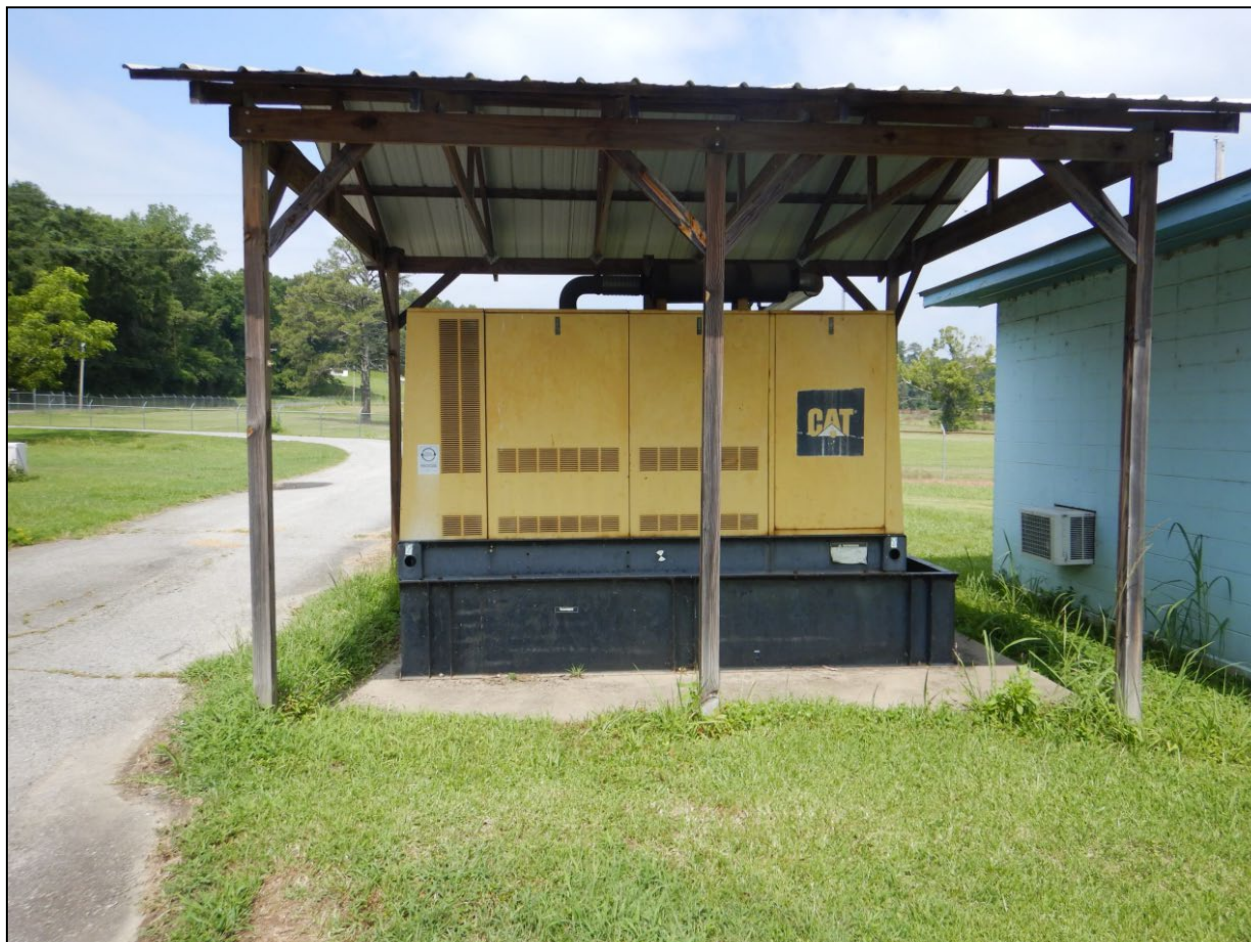
**Photograph 10. Mounted Generator, WTP #01** View of one of the three onsite mounted generators at WTP #01. This was one of two generators that need to be turned on manually in the event of a power outage.

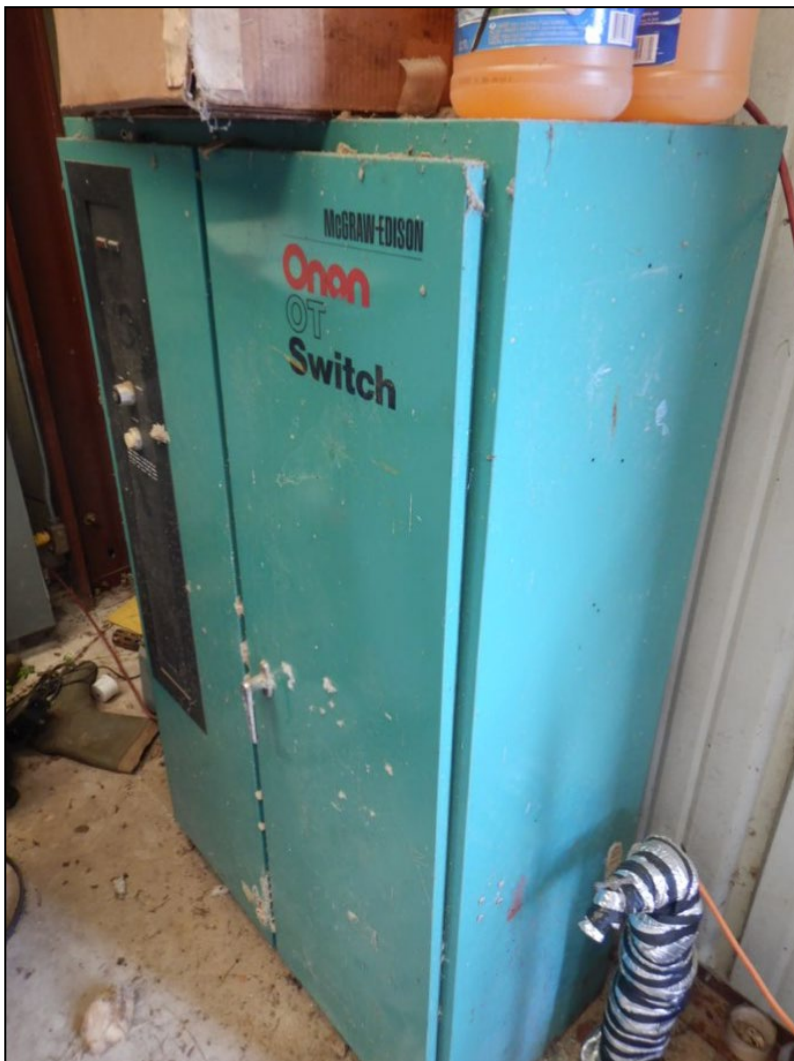
**Photograph 11. Switch Gear Box** View of an offline switch gear box associated with one of the two manual start up generators. The System Manager stated that this was not in use, but if it was functional could be used to turn on the backup generator automatically in the event of a power outage.

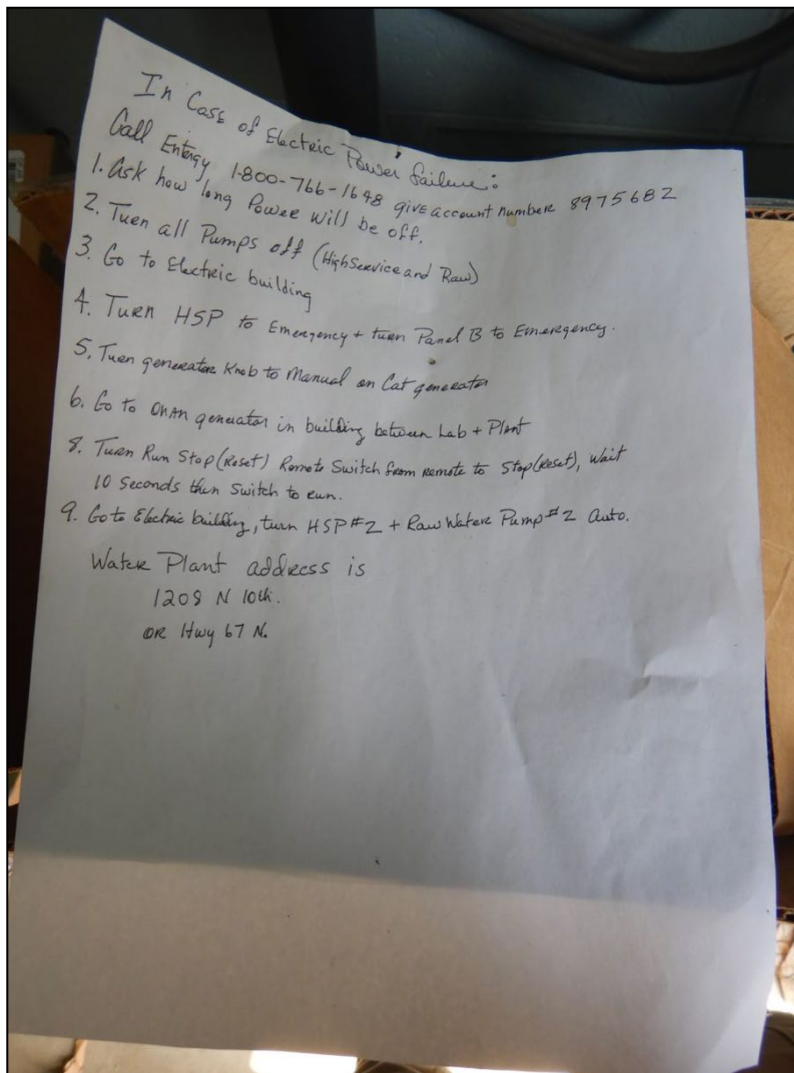
inform operators of the steps needed to turn on the generator (refer to [Appendix 2, Photograph 12](#)). In addition to these mounted generators, the System Manager stated that they had access to a portable generator that could be used in the event of a power outage in the distribution system.

**Photograph 12. SOP, Manual Generator** View of an SOP for manually turning on the backup generators onsite at WTP #01. The SOP was positioned next to one of the manual generators.

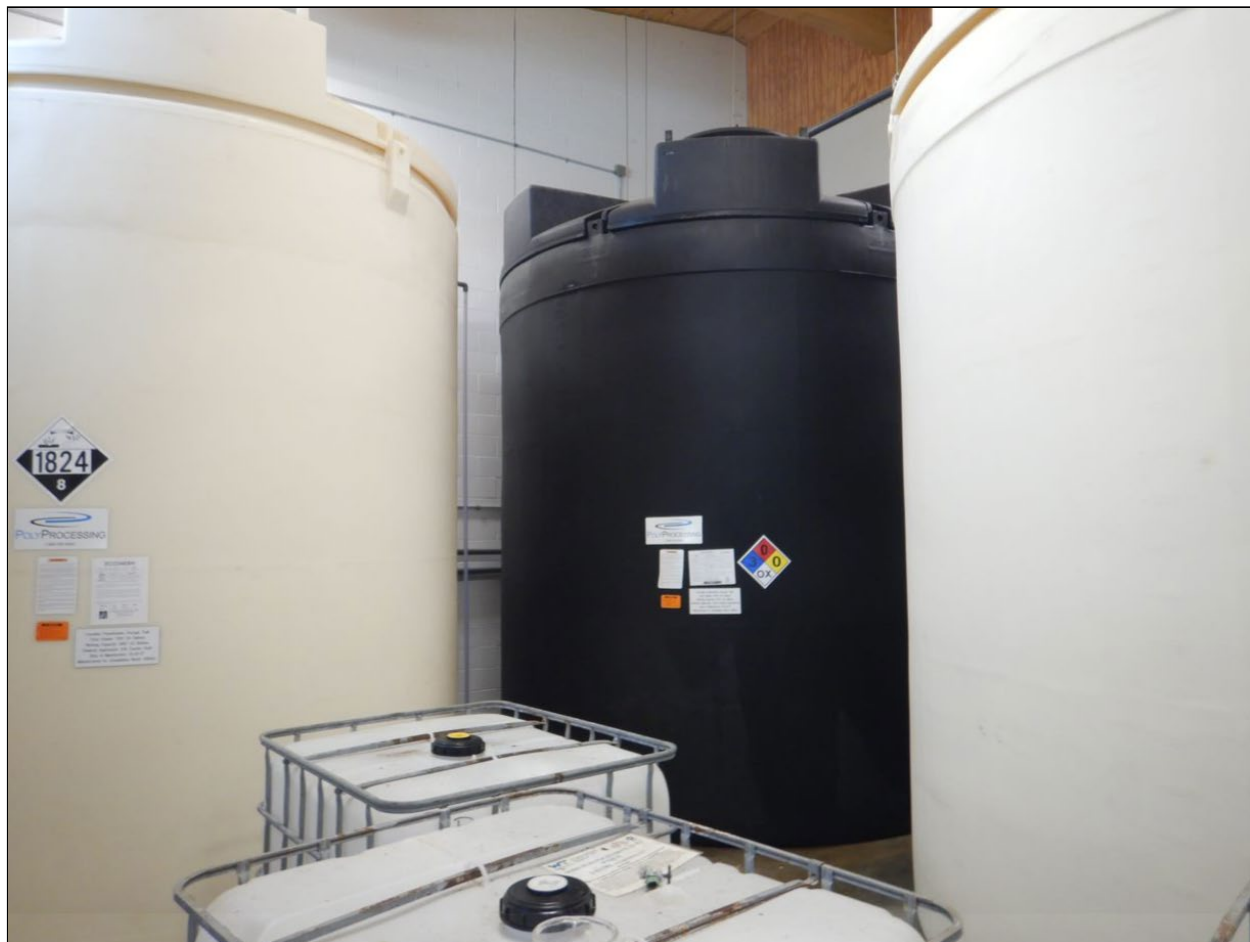
Inside the treatment plant, the chemical storage area was observed. There was a caustic tank, a sodium hypochlorite tank, and a coagulant tank in the storage area (refer to [Appendix 2, Photograph 13](#)). The line leading to the caustic tank was experiencing a leak and there was crystallized caustic on the ground surrounding the line (refer to [Appendix 2, Photograph 14](#)). The System Manager stated that this happened often, and vinegar was poured on the leak to neutralize it.

**Photograph 13. Chemical Storage Tanks, WTP #01** View of the caustic tank, a sodium hypochlorite tank, and a coagulant tank in the storage area at WTP #01. The tanks were labeled.

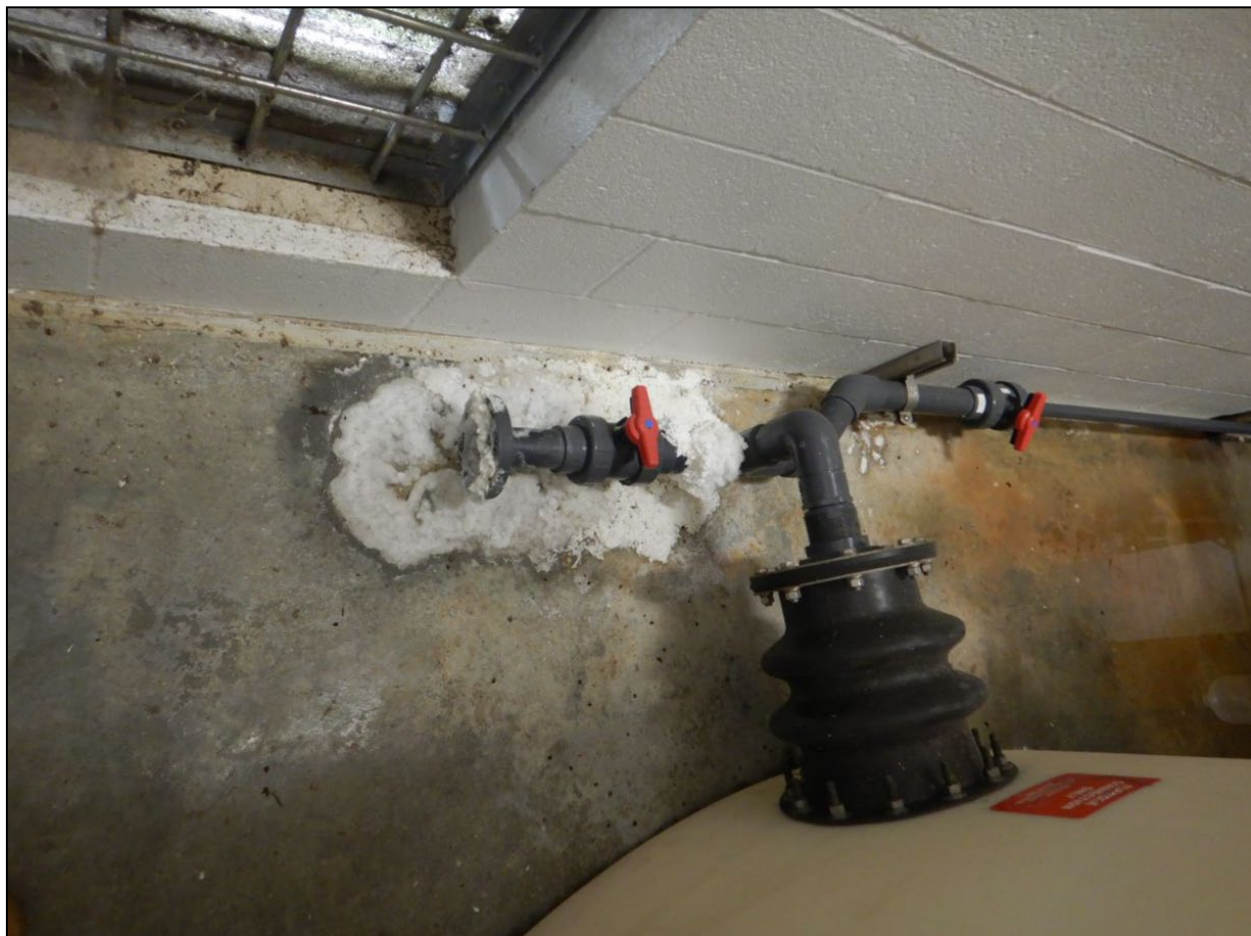
**Observation 15.** A line leading to the caustic tank inside of the treatment building at WTP #01 had experienced a leak, causing crystalized caustic to be on the line and on the floor surrounding the line (refer to [Appendix 2, Photograph 14](#)). The System Manager stated that this was a frequent occurrence, and that he had poured vinegar on the caustic to neutralize it.

**Photograph 14. Caustic Line, WTP #01** View of the line leading to the caustic tank. The line was experiencing a leak and there was crystallized caustic on the ground surrounding the line. The System Manager stated that this happened often, and vinegar was poured on the leak to neutralize it.

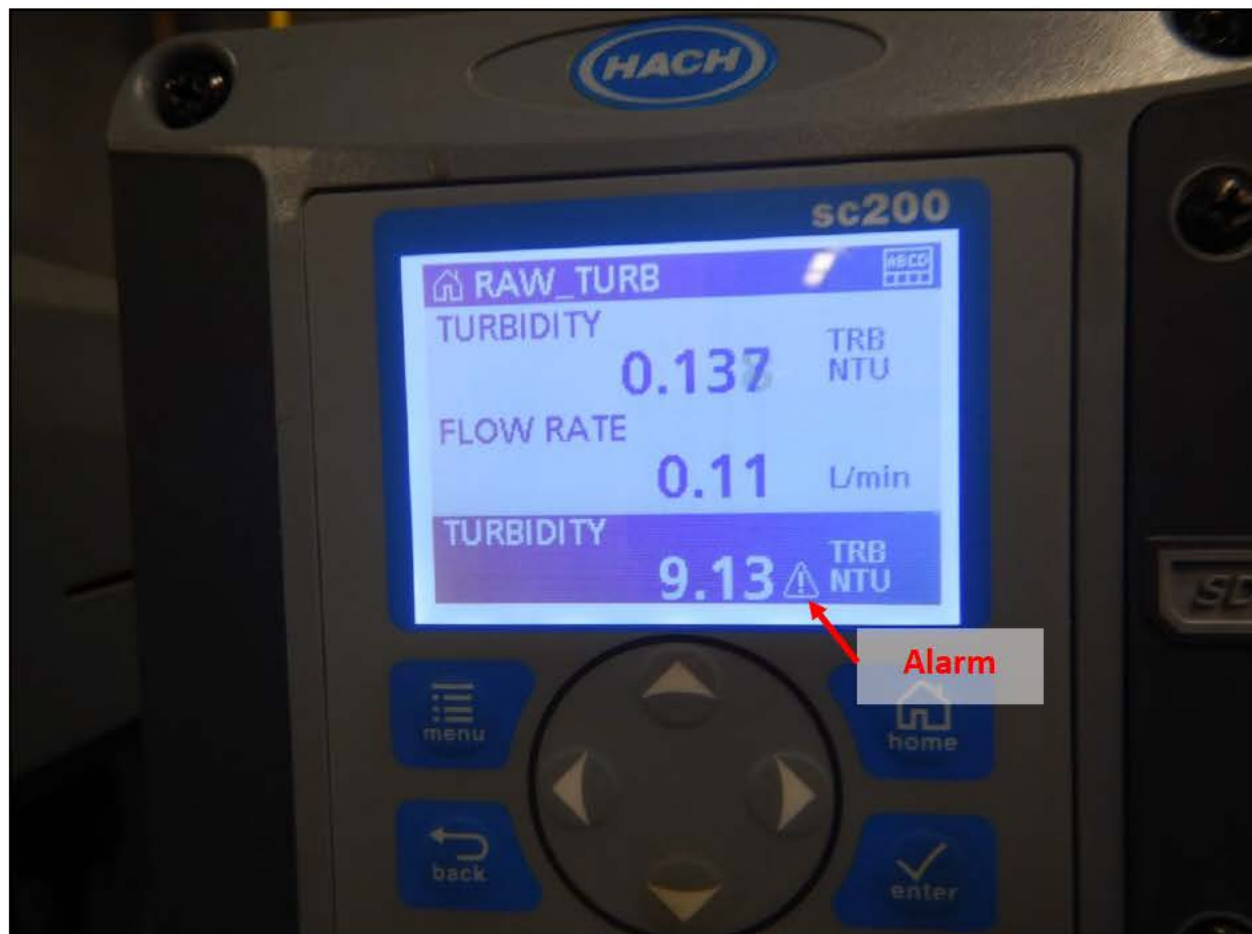
**Photograph 15. Turbidity Meter, WTP #01** View of the raw water turbidimeter reading that was displaying 9.13 NTU with an alarm during the inspection. System representatives were unsure what was causing the alarm, but they assumed that the alarm was a result of a clogged raw water line leading to the turbidimeter.

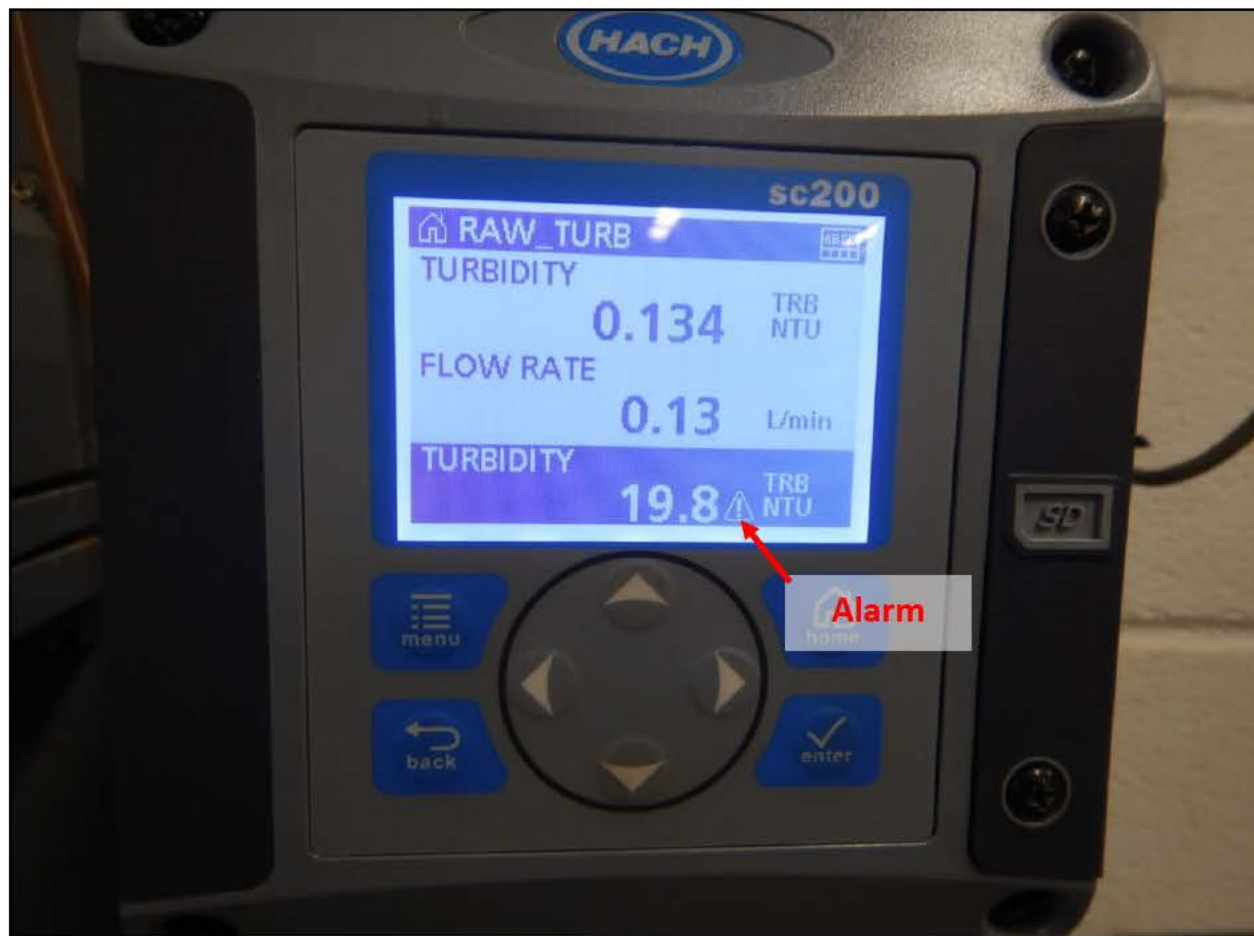
The chemical day tanks were also observed. The System Manager stated that the chemical drains in the day tank room also led to the onsite backwash pond. The raw water turbidity meter was present in the day tank room. At the time of the inspection, the raw water turbidimeter was reading 9.13 NTU, and an alarm was on (refer to [Appendix 2, Photograph 15](#)). System representatives were unsure what was causing the alarm, but they assumed that the alarm was a result of a clogged raw water line leading to the turbidimeter. To attempt to deactivate the alarm, a System representative pulled the line out of the turbidimeter and reattached it. This caused the raw water turbidity to rise to 19.8 NTU, and the alarm continued (refer to [Appendix 2, Photograph 16](#)).

**Photograph 16. Turbidity Meter, WTP #01** View of the raw water turbidimeter after the System Manager tried to fix the influent raw water line. The meter was reading 19.8 NTU, and an alarm was still being displayed.

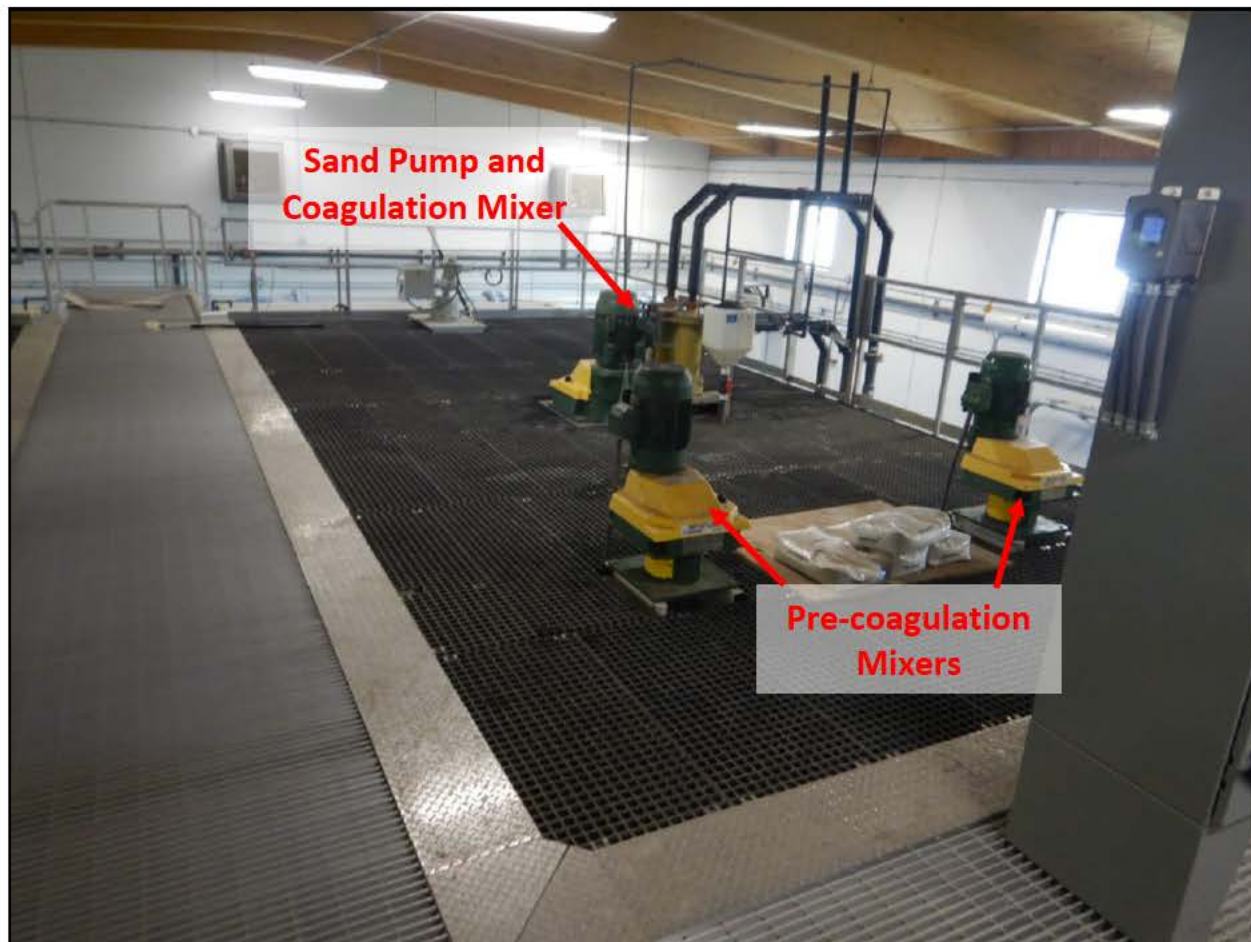
**Photograph 17. Treatment Train, WTP #01** View of one of the two parallel treatment trains at WTP #01. Visible in this image are the pre-coagulation mixers, the sand pump, and the coagulation mixers.

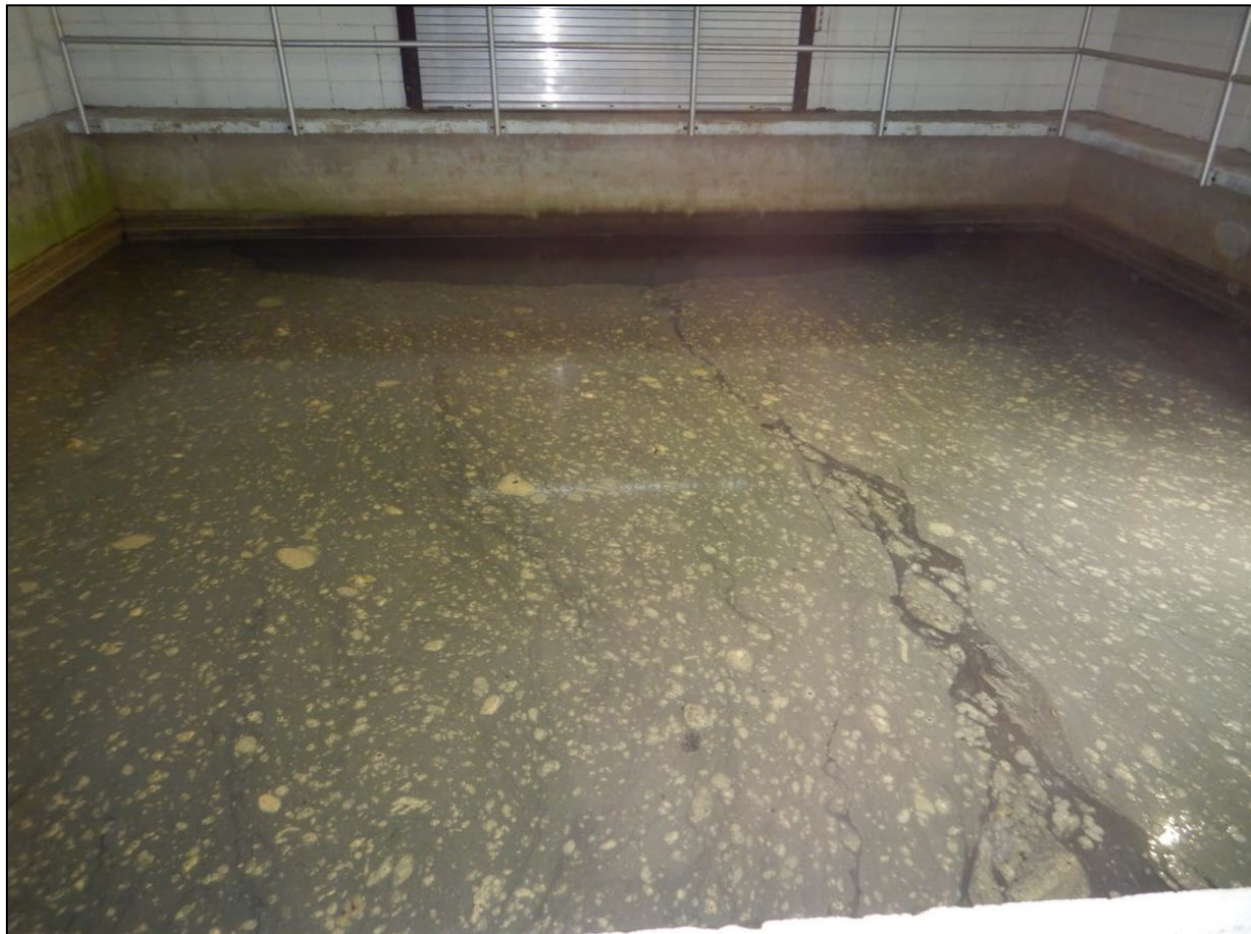
**Photograph 18. Filter No. 1, WTP #01** View of the surface of the water in Filter No. 1 at WTP #01. There was a buildup of foam on the surface of the water, and System representatives stated that they may have been over feeding coagulant.

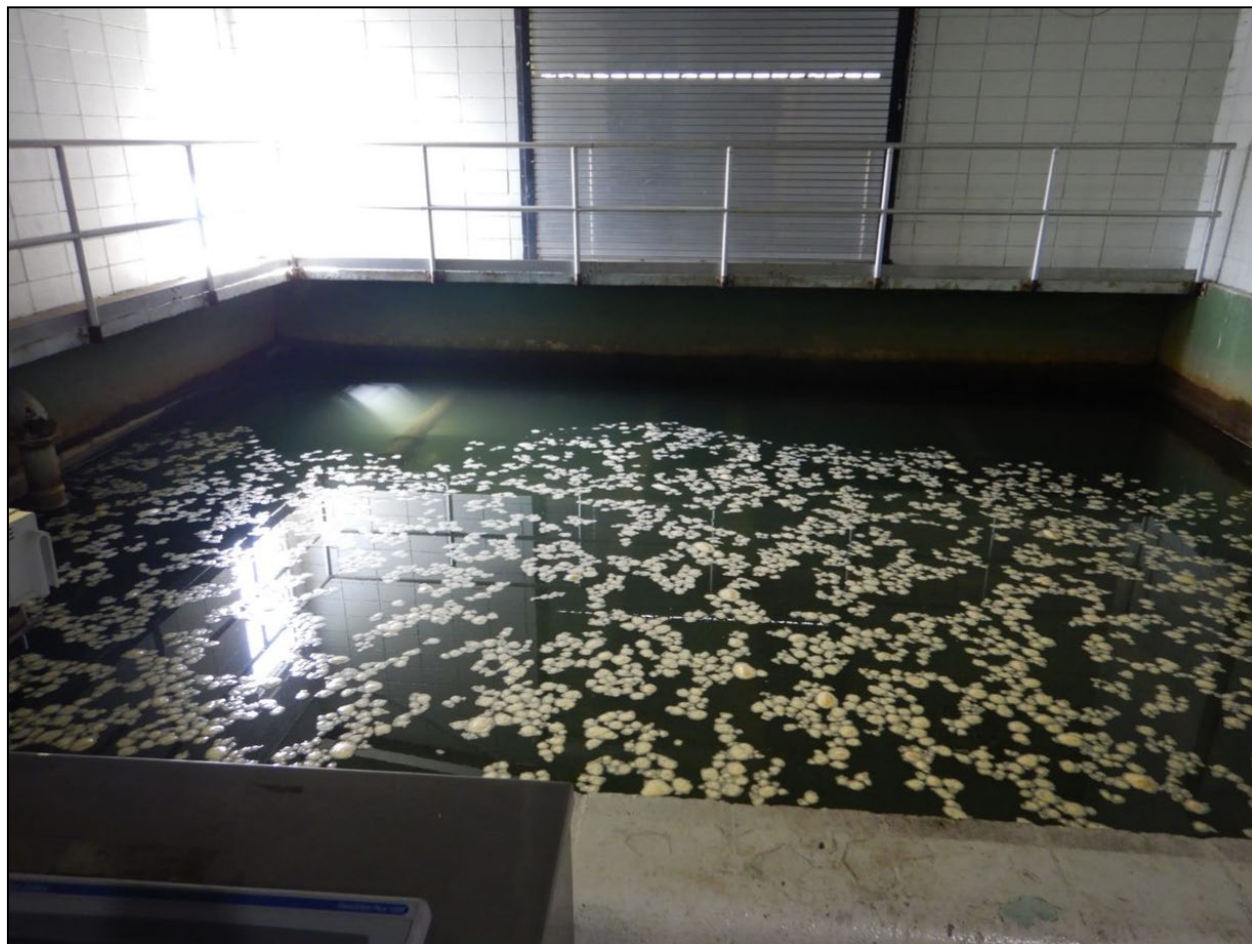
**Photograph 19. Filter No. 2, WTP #01** View of the surface of the water in Filter No. 2 at WTP #01. There was a buildup of foam on the surface of the water, and System representatives stated that they may have been over feeding coagulant.

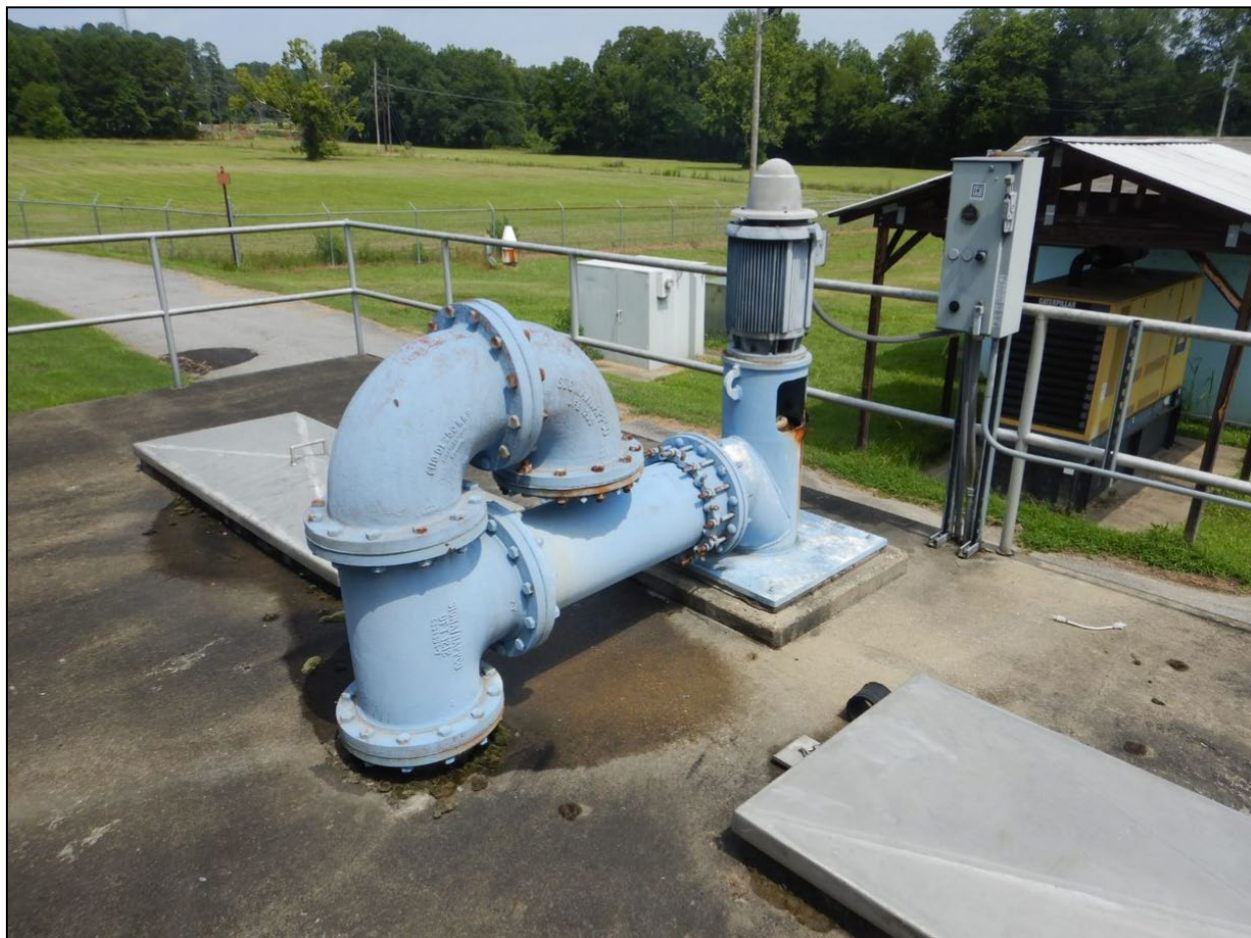
Outside of the treatment building, the backwash water holding tank and backwash pump for Filters Nos. 3, 4, 5, and 6 were observed (refer to [Appendix 2, Photograph 20](#)). The System Manager stated that the water used for backwashing Filter Nos. 3-6 was filtered but not chlorinated. He stated that when the level in the backwash holding tank became too high, the extra water was chlorinated and sent to one of the onsite clearwells as treated water. A separate backwash pump was used for Filter Nos. 1 and 2, and it was located next to the WTP high service pumps (refer to [Appendix 2, Photograph 22](#)). The System Manager stated that backwash water from Filter Nos. 1 and 2 was taken from one of the clearwells.

**Photograph 20. Backwash Pump, WTP #01** View of the backwash pump and backwash holding tank that is used to send filtered (but not chlorinated) water through Filter Nos. 3-6. A separate backwash pump is used to send finished water from an onsite clear well through Filter Nos. 1 and 2.
