**Region 6 - Enforcement & Compliance Assurance Division**  
**INSPECTION REPORT**

| Inspection Date(s): | 06/27/2023 | |
| Facility Name: | <b>Arkadelphia Waterworks</b> | |

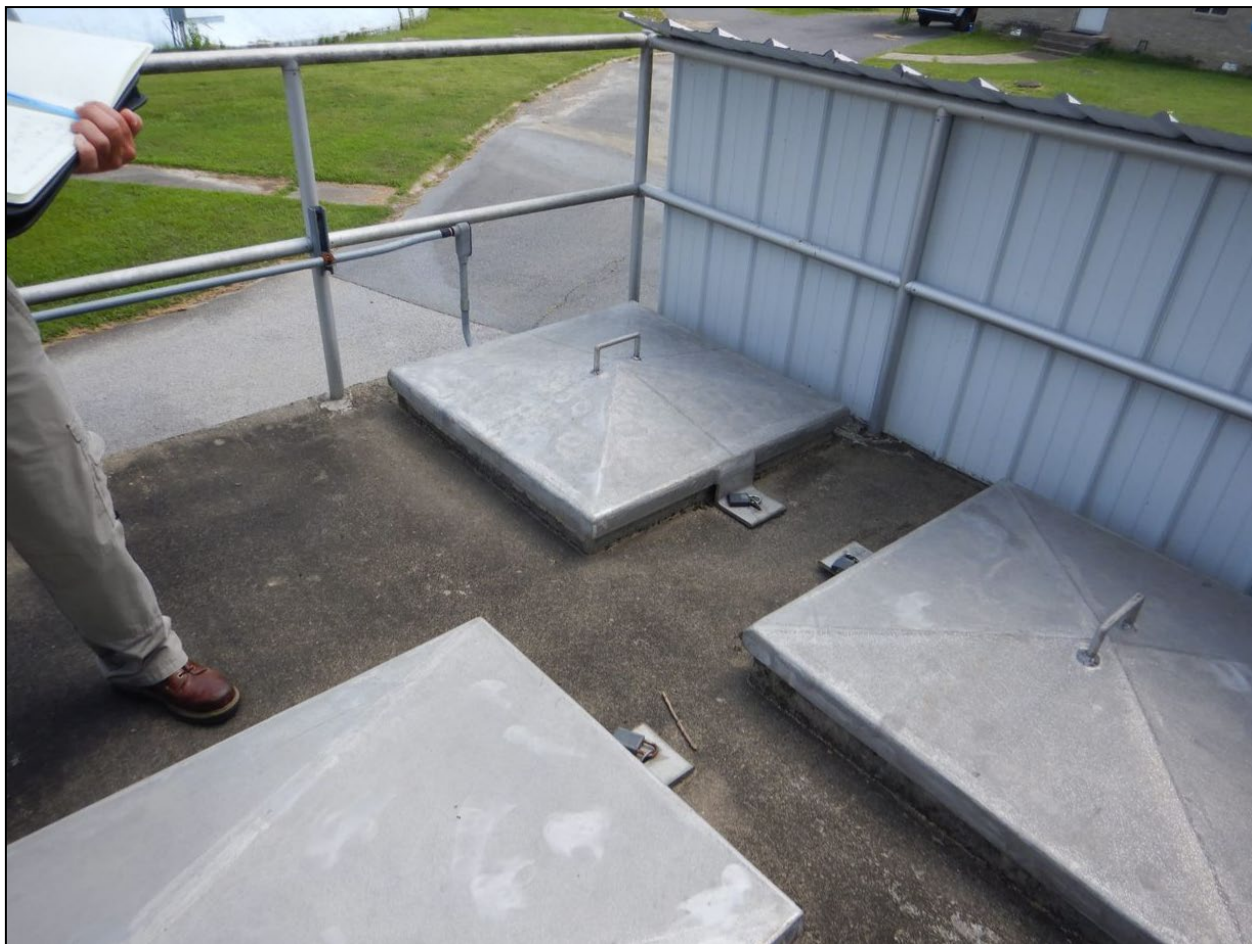
**Observation 18.** There were hatchways with lids to the backwash water holding tank (refer to Appendix 2, Photograph 21). The lids were loosely fitted over the hatchways, and there were no gaskets around the rims of the hatches.

**Photograph 21. Backwash Water Holding Tank, WTP #01** View of the hatchways and lids leading to the backwash water holding tank. This tank stores water that is filtered but not chlorinated, and the water is used for backwashing Filter Nos. 3-6. The lids were loosely fitted over the hatchways, and there were no gaskets in the hatchways.

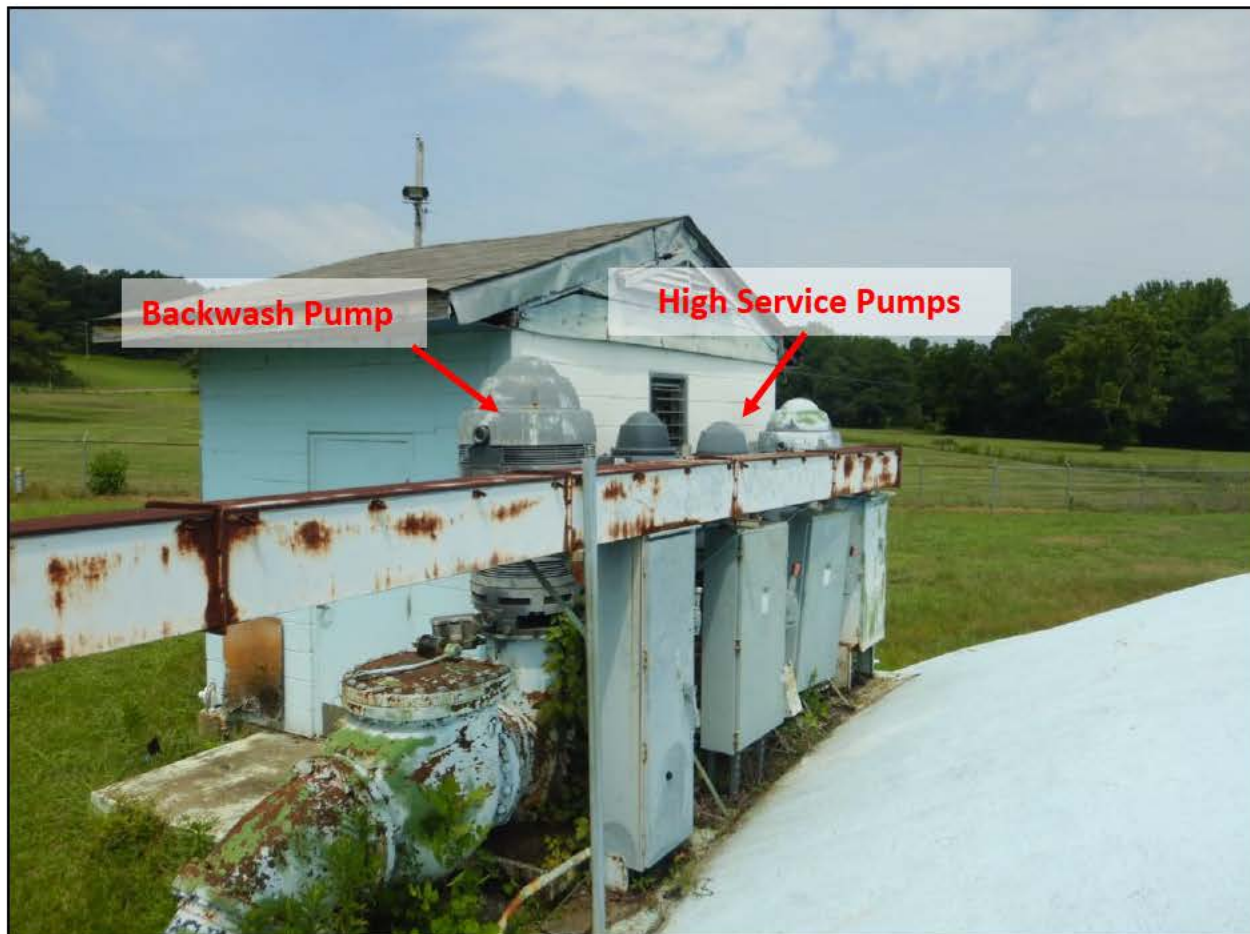
**Photograph 22. Backwash Pump and High Service Pumps, WTP #01** View of the backwash pump used to send water from the clear well through Filter Nos. 1 and 2 during a backwash. Also visible are the three high service pumps used to send finished water into the distribution system.

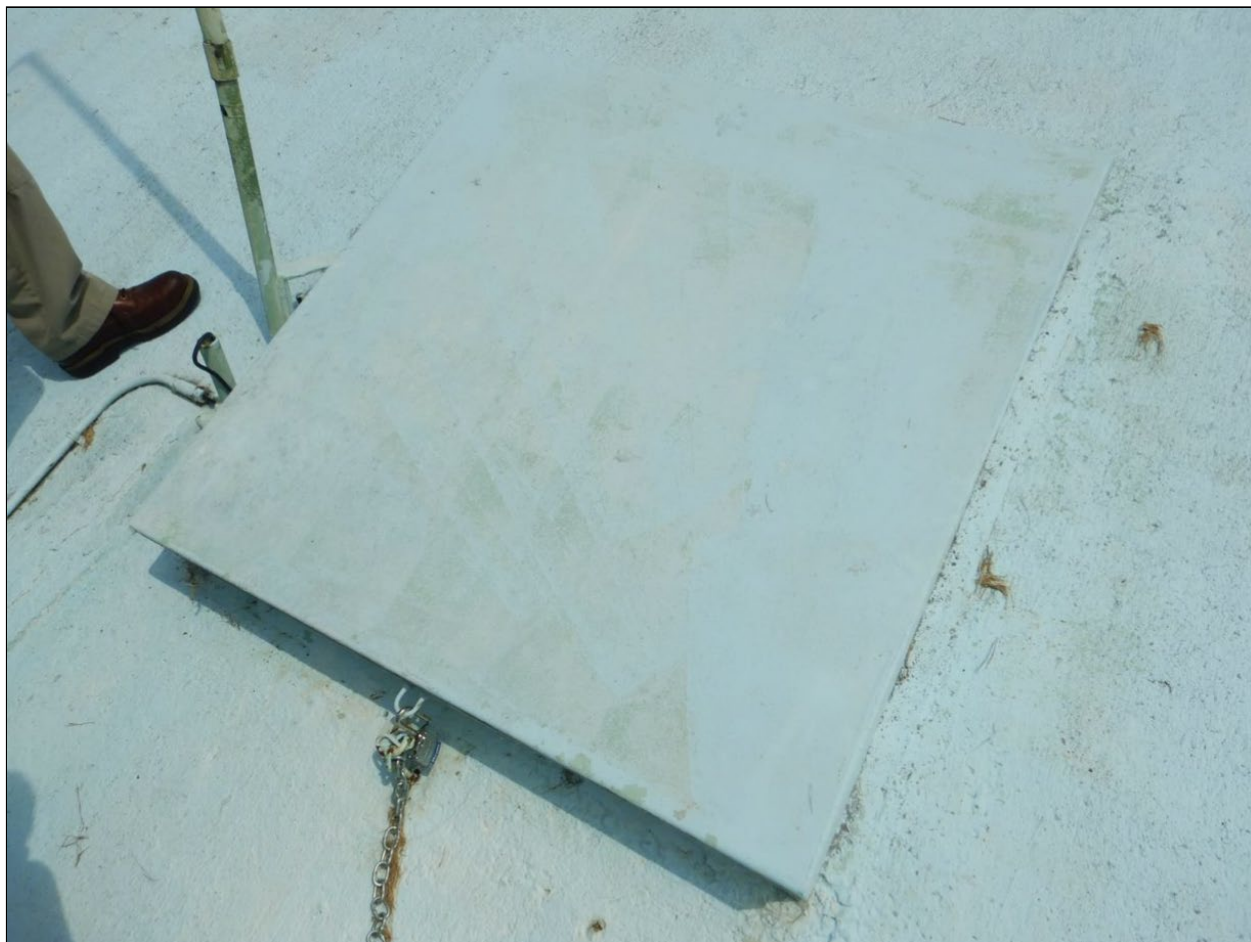
**Photograph 23. Front Clearwell, WTP #01** View of the hatchway and lid on top of the Front clear well at WTP #01. The hatchway was locked when the EPA Inspection Team arrived, and this picture was taken after the operator unlocked the lid.

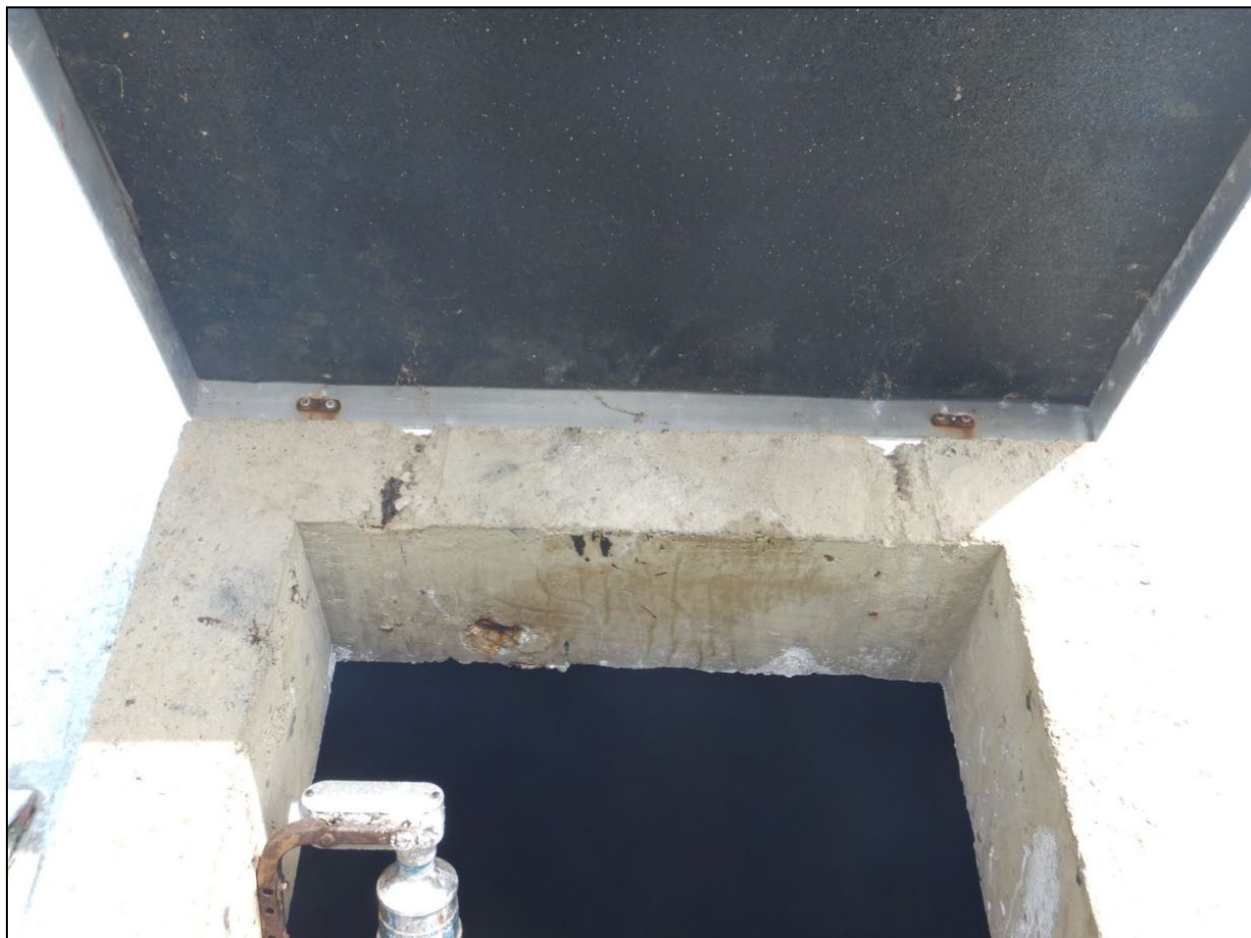
**Photograph 24. Front Clearwell, WTP #01** View of inside of the hatchway on top of the Front clear well. The hatchway opening was elevated, and the lid was a shoebox lid which fit around the outside of the hatch.

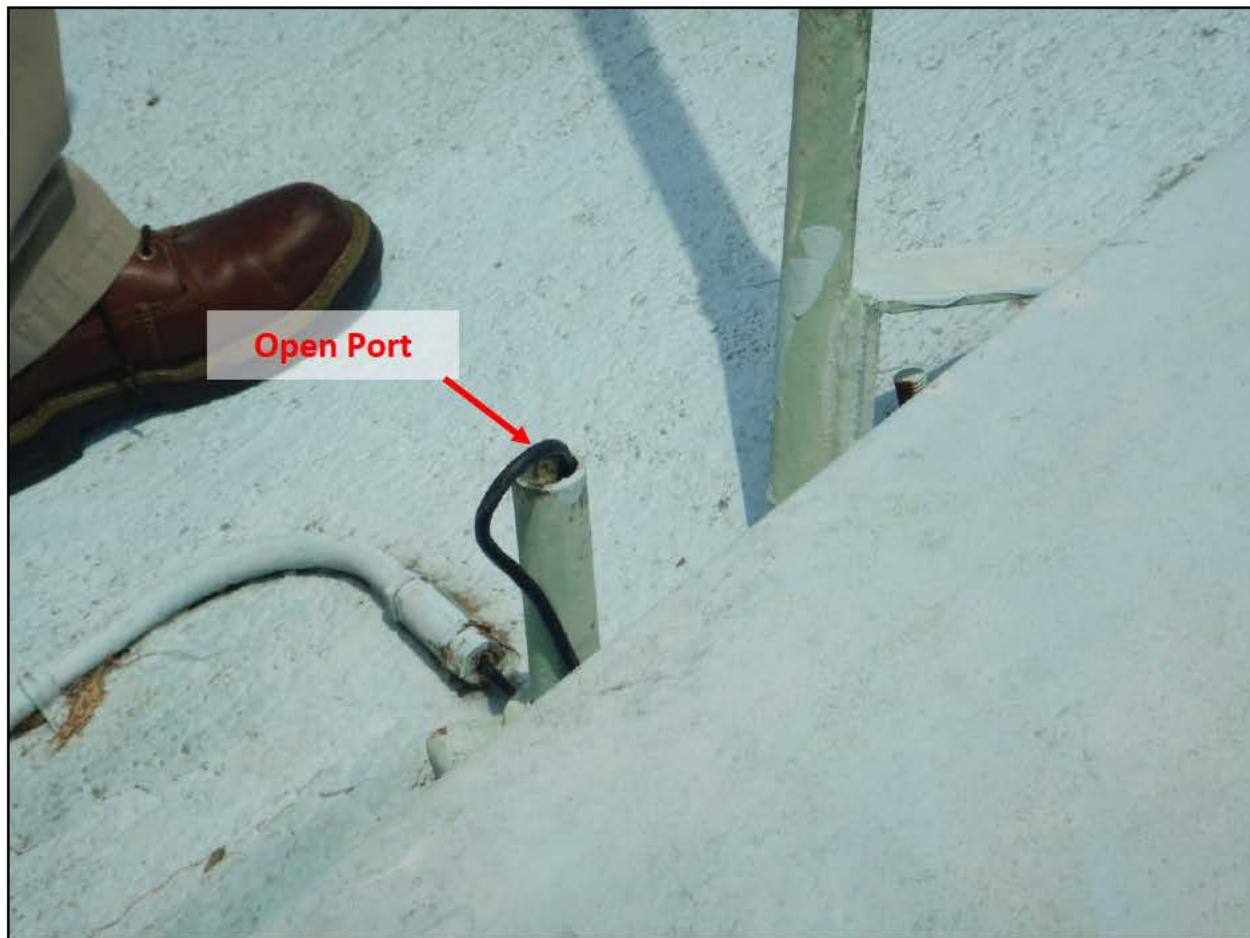
**Photograph 25. Front Clearwell, WTP #1** View of an open port used for a level transducer wire. The opening of the port was not screened, providing open access into the Front clear well.

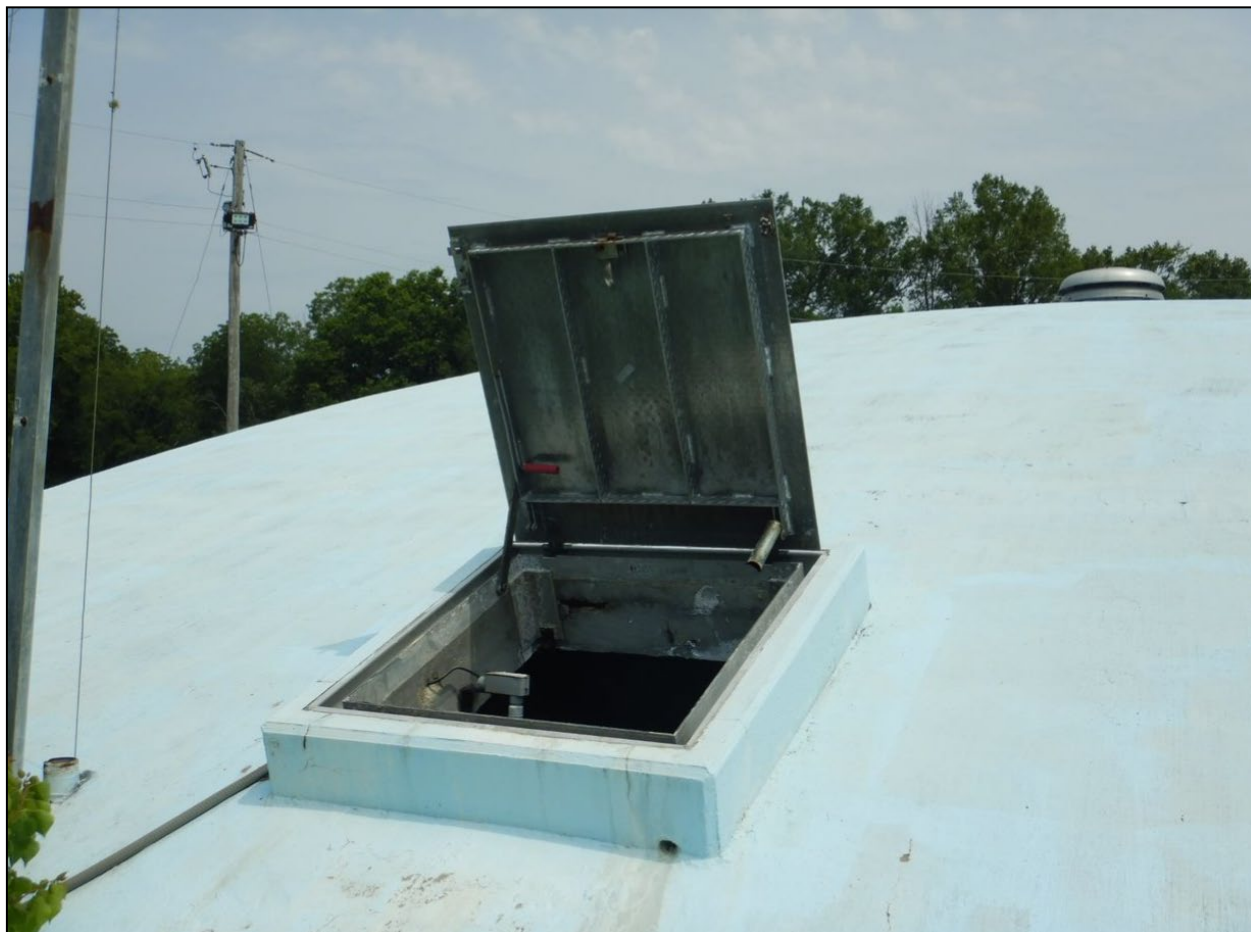
contained drainage (refer to [Appendix 2, Photograph 26](#)). There was a line extending from the Back clear well that went below grade. The System Manager stated that the line could be used to empty the Back clear well and fill the Front clear well.

**Photograph 26. Back Clearwell, WTP #1** View of the hatchway leading to the Back clear well. The hatchway was elevated, and the rim beneath the lid contained drainage.

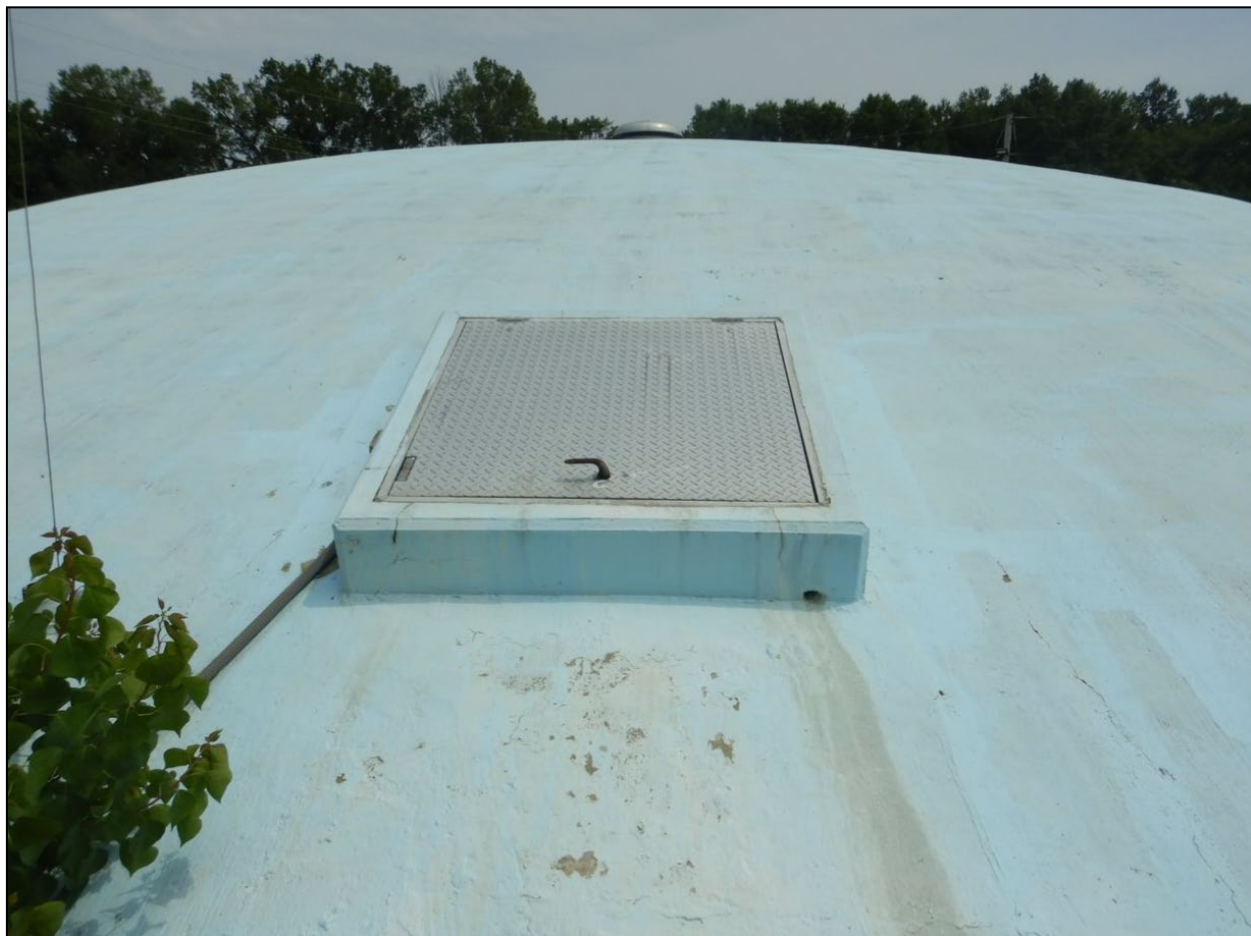
**Photograph 27. Back Clearwell, WTP #1** View of the closed hatchway leading to the Back clear well.

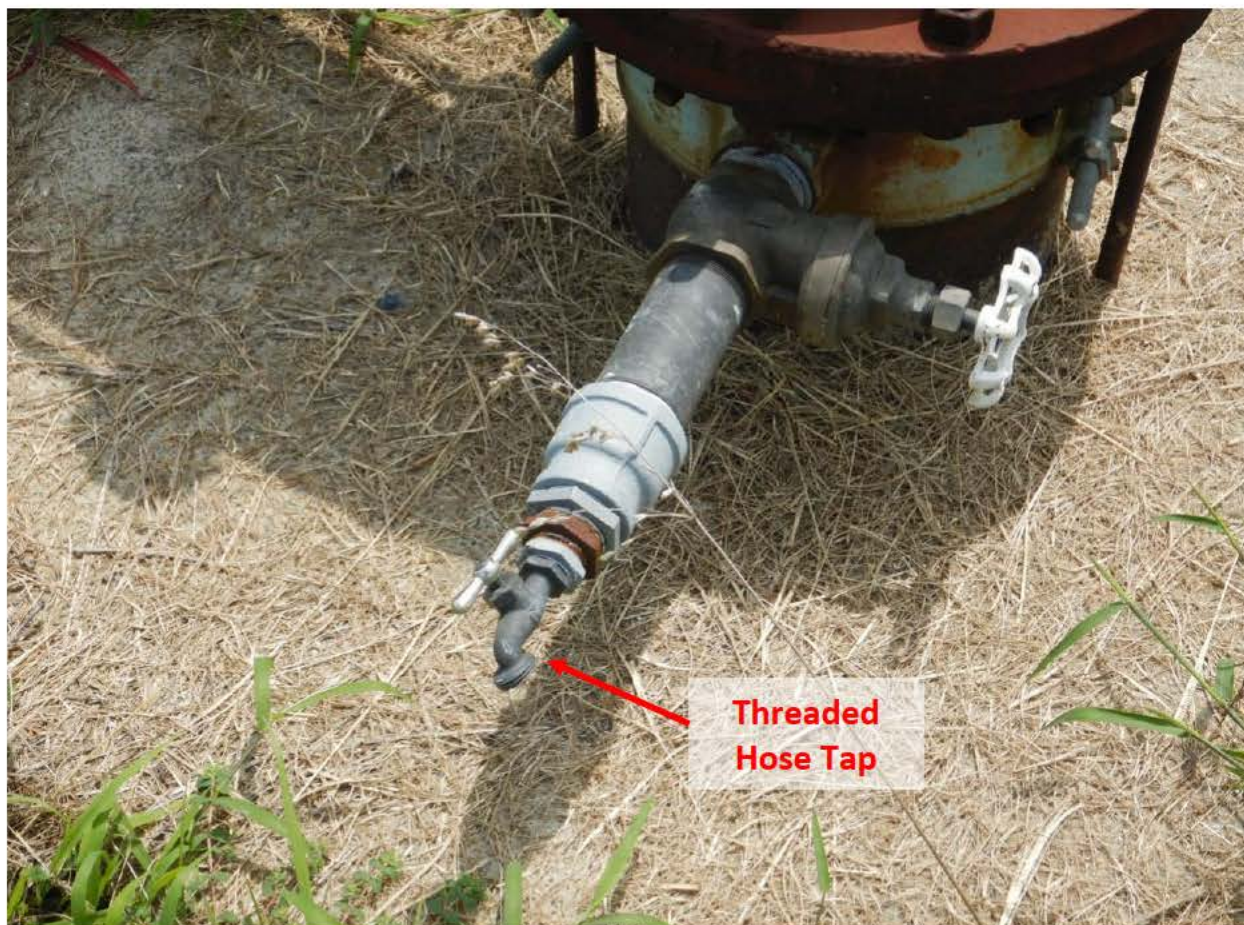
**Photograph 28. Threaded Hose Tap, Clearwell Line** View of a threaded hose tap that came off of a line extending from the Back clear well to the Front clear well. The System Manager stated that the line was used to empty one clear well and fill the other. The hose tap did not have backflow prevention.

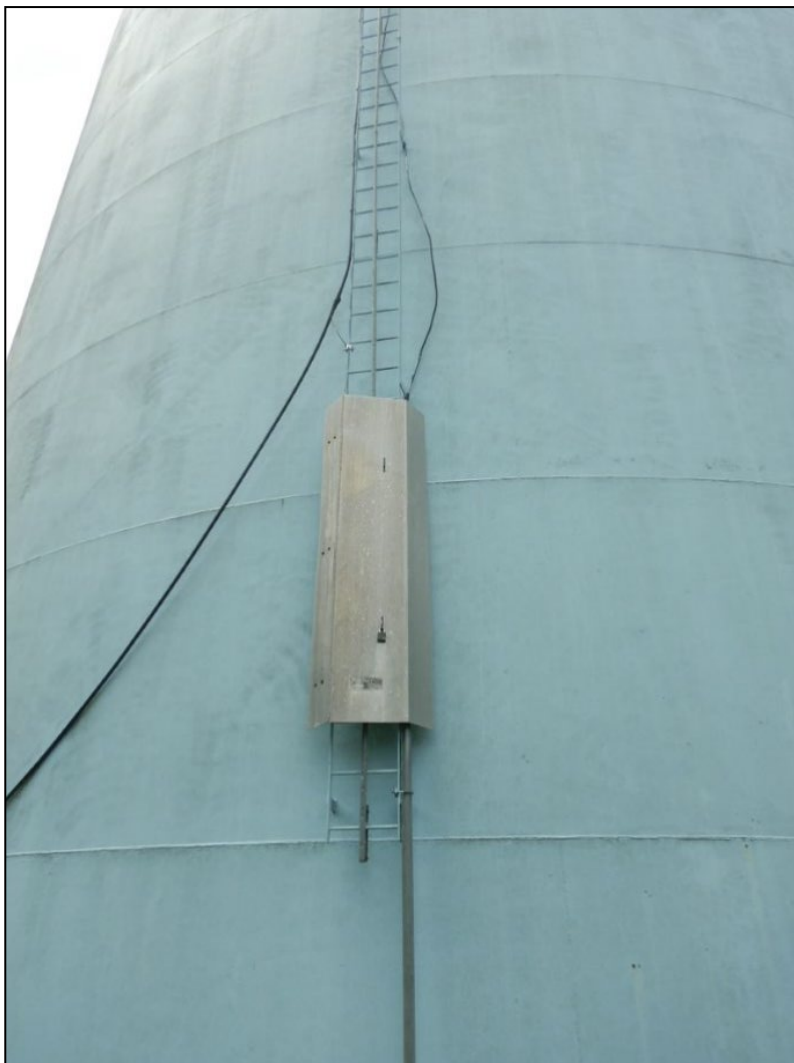
**Photograph 32. 26<sup>th</sup> St. Water Storage Tank** View of the 1,000,000-gallon 26<sup>th</sup> St. Water Storage Tank. The bottom rungs of the tank ladder were removed, and there was a locked security shield covering the lower rungs.

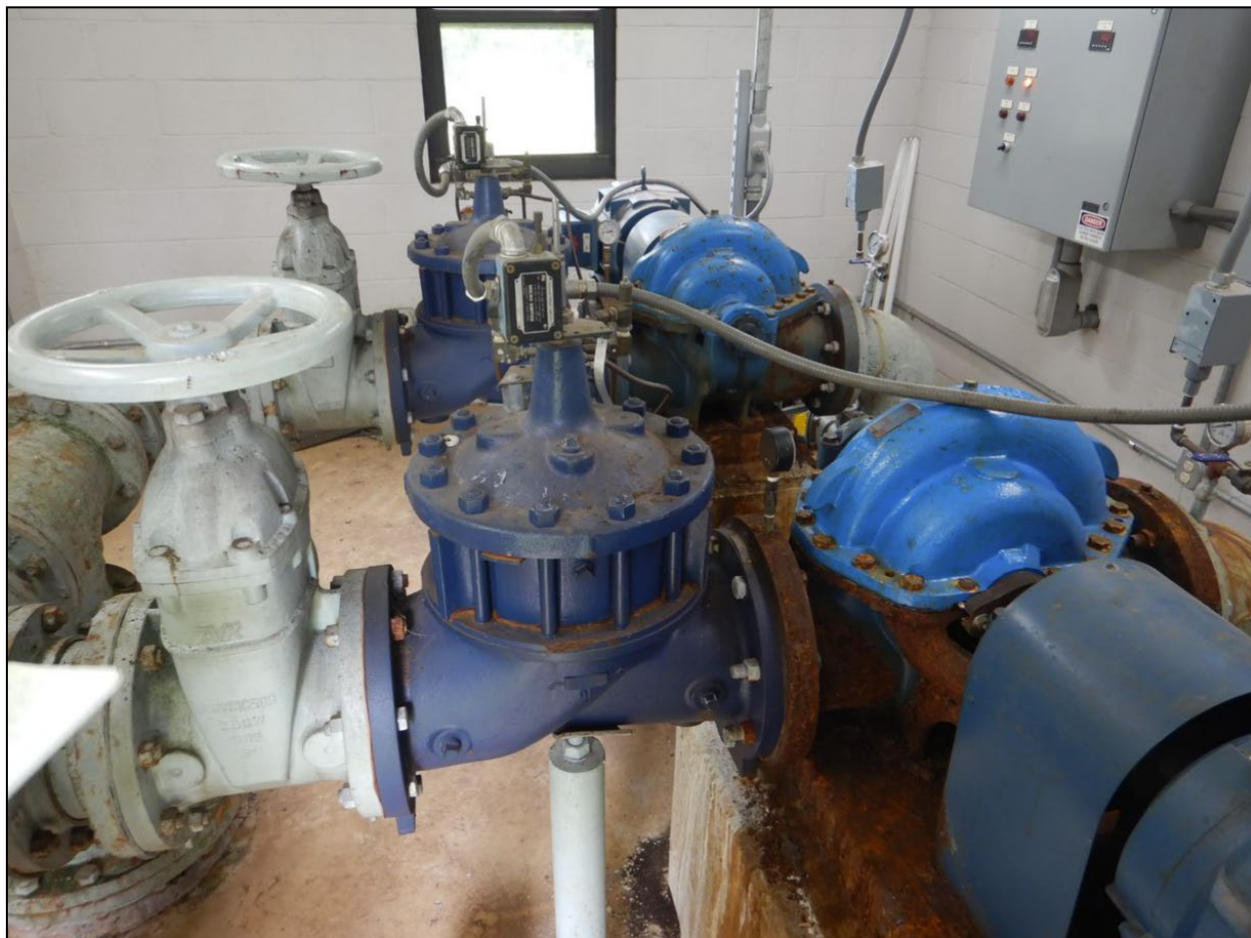
**Photograph 33. 26<sup>th</sup> St. Pump Station** View of the inside of the 26<sup>th</sup> St. Pump Station. The System Manager stated that the 26<sup>th</sup> St. Water Storage Tank was filled by gravity, and that this pump station was used to send water to the Malone Water Storage Tank.

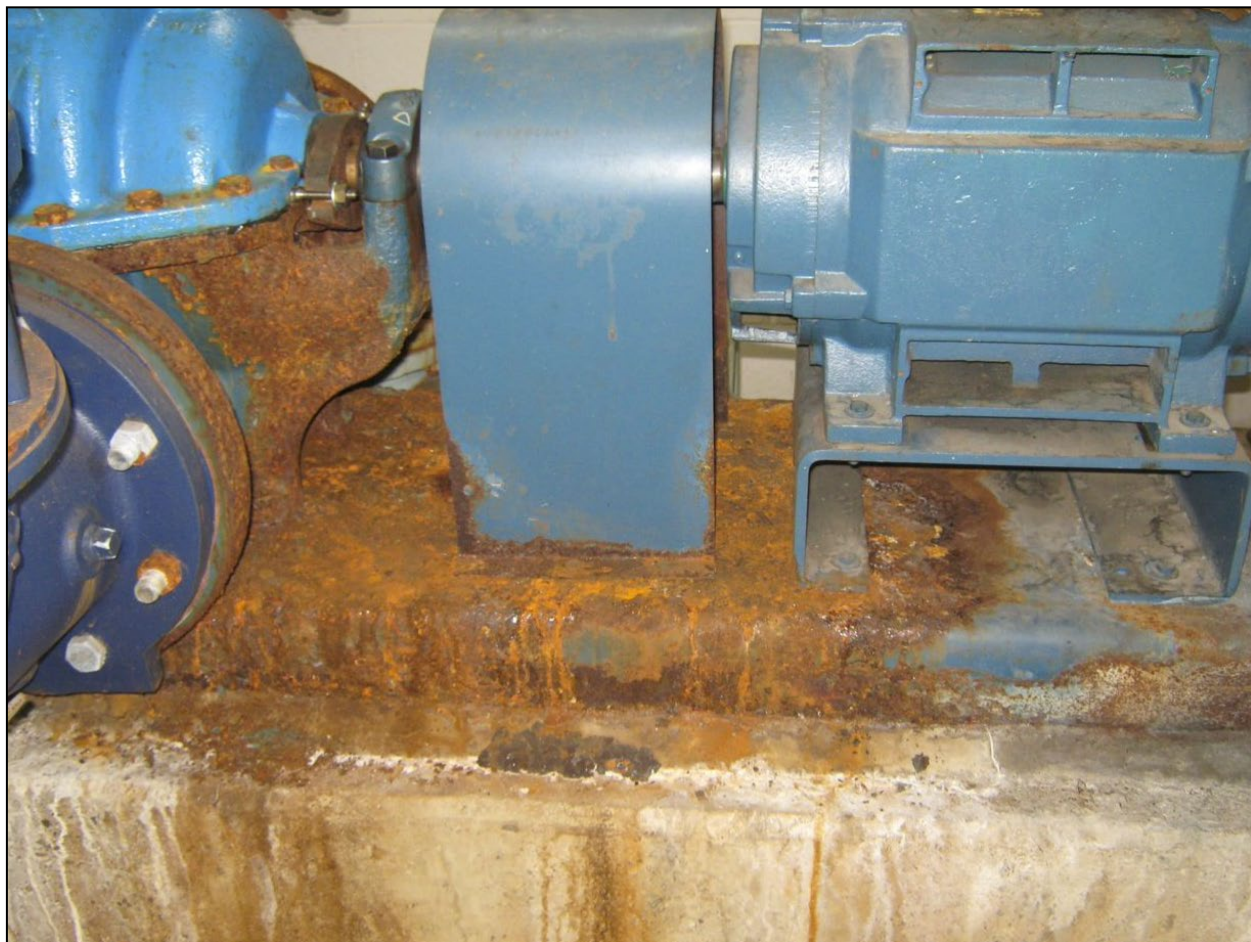
The 26<sup>th</sup> St. Pump Station was also observed inside fence line (refer to [Appendix 2, Photograph 33](#)). The System Manager stated that the 26<sup>th</sup> St. Water Storage Tank was filled by gravity, and that this pump station was used to send water to the Malone Water Storage Tank. He also explained that the System portable generator could be quickly connected at this pump station in the event of a power outage. There was some rust/corrosion on the pump infrastructure at the pump station (refer to [Appendix 2, Photograph 34](#)).

**Photograph 34. 26<sup>th</sup> St. Pump Station** View of one of the pump mounts inside of the 26<sup>th</sup> St. Pump Station that was experiencing corrosion/metal loss.

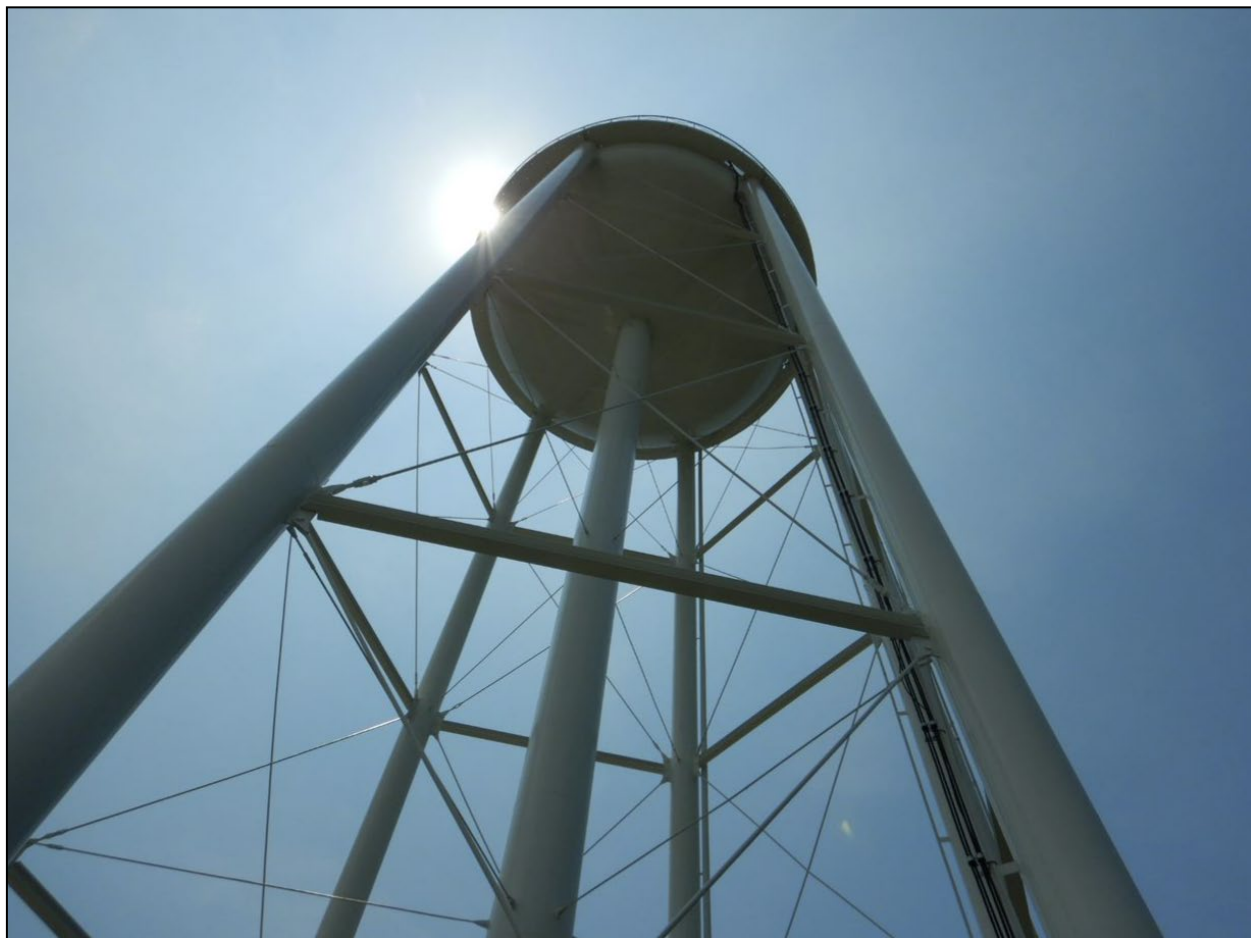
Next, the 300,000 gallon elevated 16<sup>th</sup> St. Water Storage Tank was observed (refer to [Appendix 2, Photograph 35](#)). The tank was surrounded by a locked perimeter fence, and the area inside fence line was shared with other Arkadelphia Waterworks buildings, as well as multiple telecommunication buildings. [REDACTED]

**Photograph 35. 16<sup>th</sup> St. Water Storage Tank** View of the 300,000-gallon elevated 16<sup>th</sup> St. Water Storage Tank.

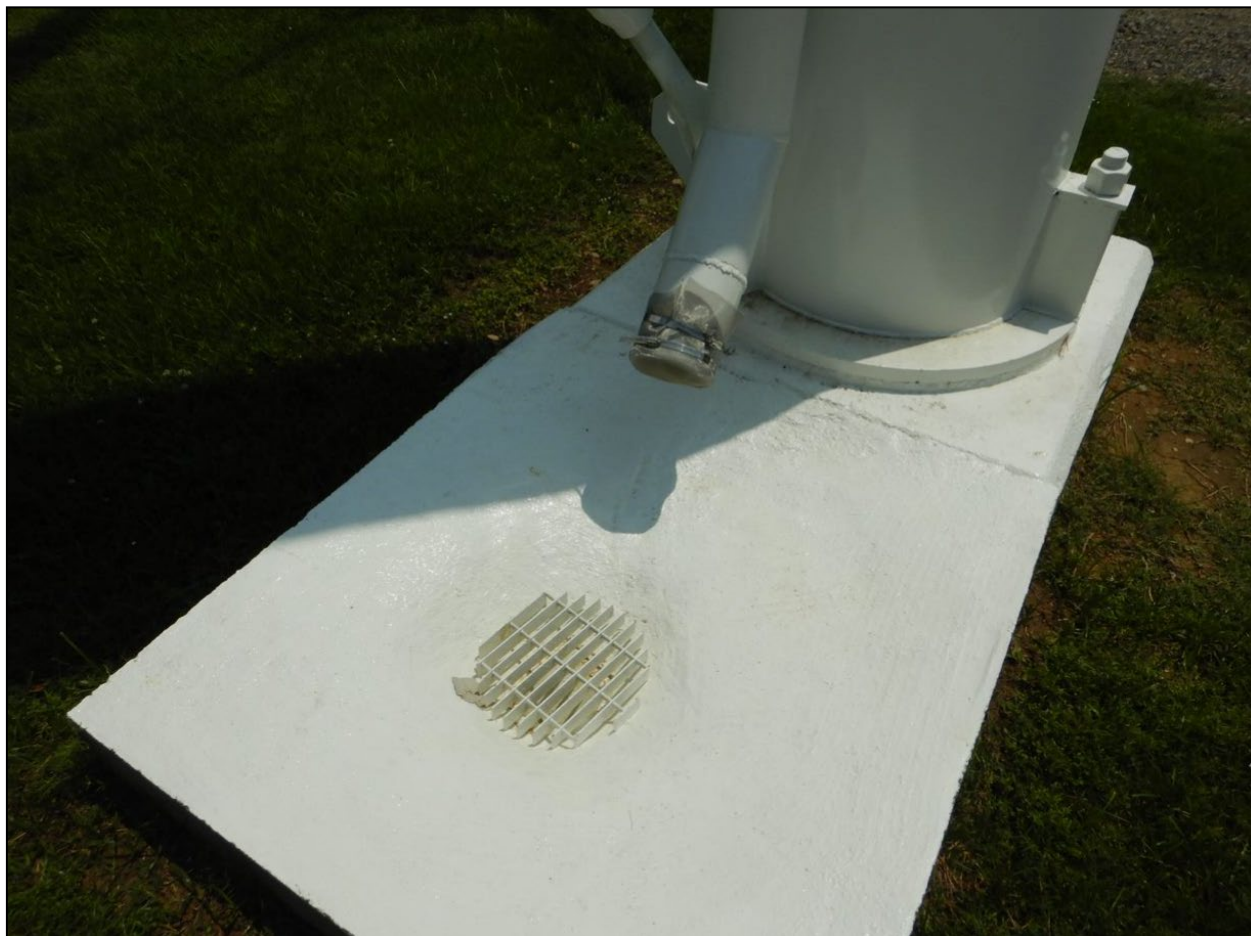
**Photograph 37. Overflow Pipe, 16<sup>th</sup> St. Water Storage Tank** View of the 16<sup>th</sup> St. Water Storage Tank overflow pipe. The overflow pipe terminated approximately nine inches above a concrete pad, which appeared to be less than double the pipe diameter.

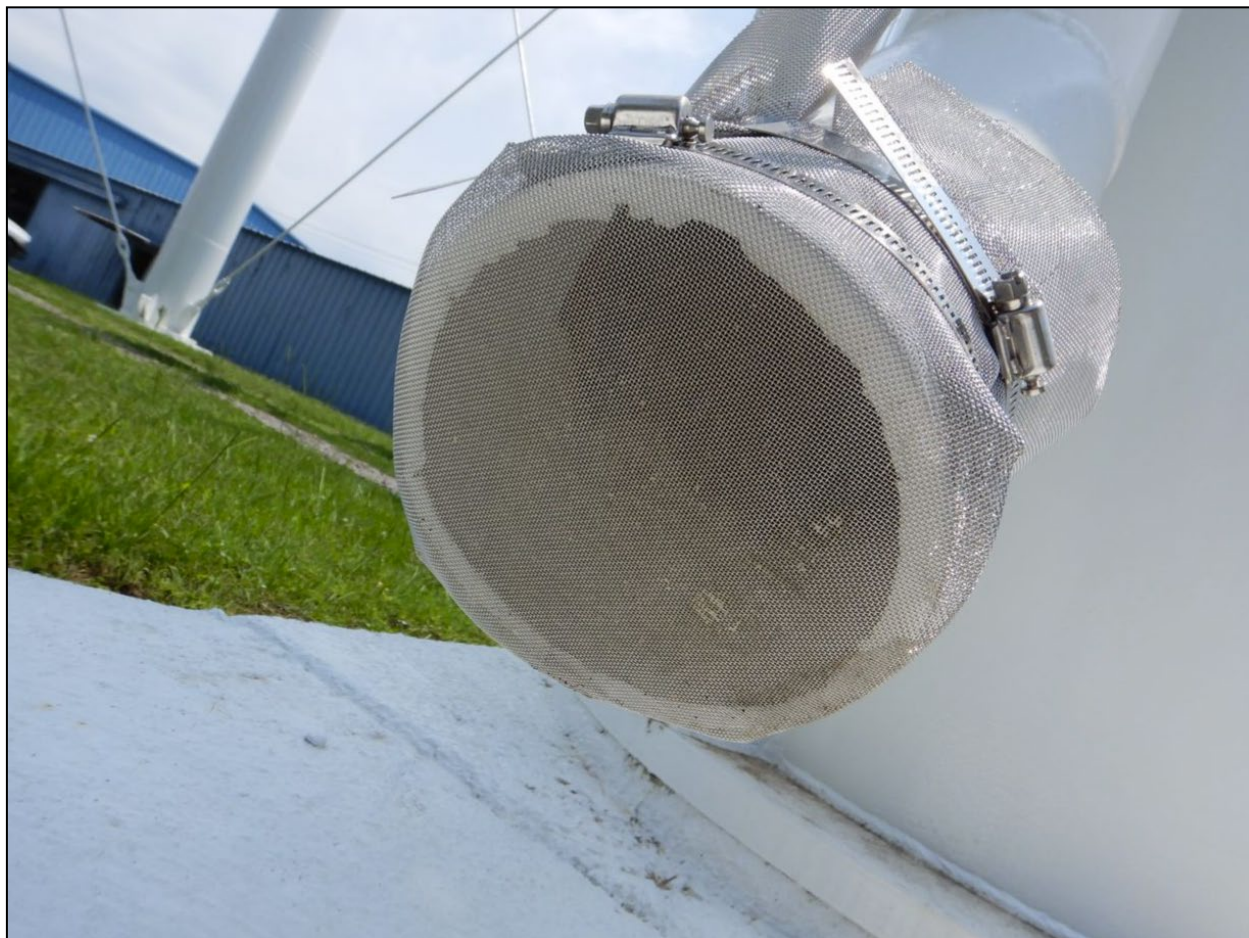
**Photograph 38. Overflow Pipe, 16<sup>th</sup> St. Water Storage Tank** View of the end of the 16<sup>th</sup> St. Water Storage Tank overflow pipe. The opening was covered by a mesh screen.
