**Region 6 Compliance Assurance and Enforcement Division  
INSPECTION REPORT**

| Inspection Date(s): | 05/22/2018 | | |
| Company Name: | <b>Wolf Energy, Inc.</b> | | |
| Facility Name: | <b>Marmaduke Lease</b> | | |

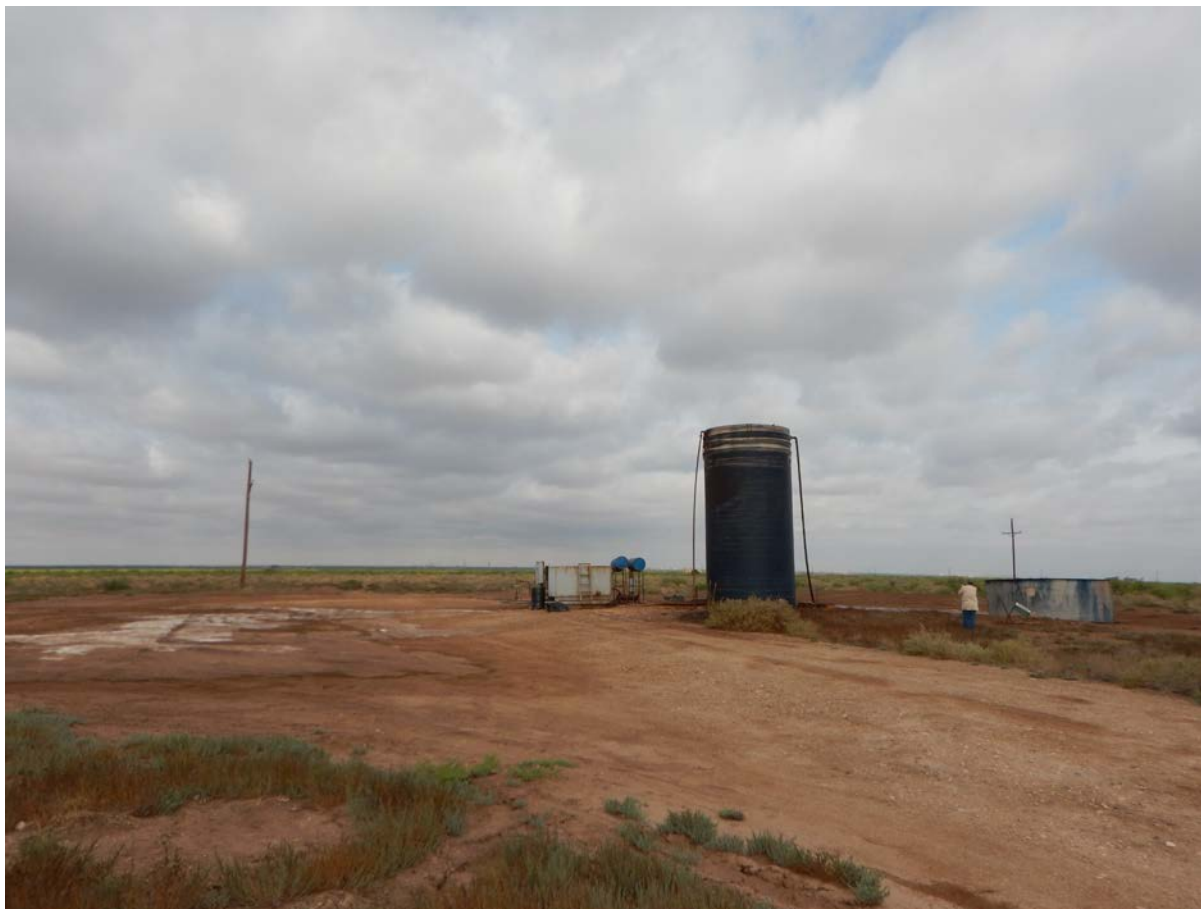
Photograph File Name: DSCN3477.JPG  
Date of Photograph: 05/22/2018  
Latitude: 31.681495 N  
Longitude: -103.640833 W  
Orientation: W  
Map Datum: WGS-84  
Time of Photo: 09:27 AM  
Photographer: Carol Johnson  
Description: This image shows the Wolf Energy, Inc. / Marmaduke Lease, which consists of an oil and gas storage facility that has two storage tanks, an injection well and associated oil field production equipment. An open line coming from the north side of the tallest storage tank was the line that was leaking actively during the inspection.

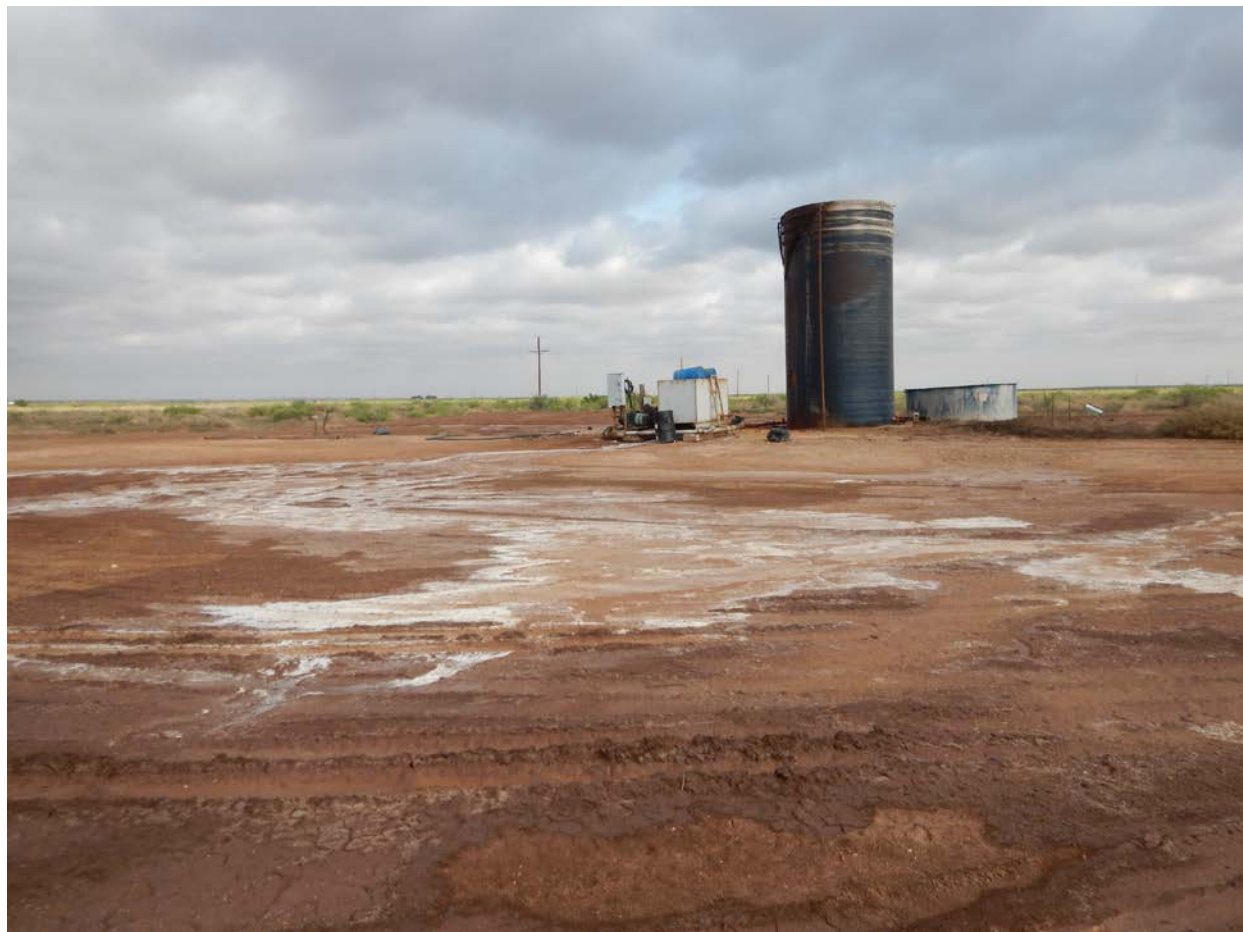
Photograph File Name: DSCN3499.JPG

Description: This image shows the Wolf Energy, Inc. / Marmaduke Lease, which consists of an oil and gas storage facility that has two storage tanks, an injection well and associated oil field production equipment. We observed salt crystals on the surface in multiple areas around the storage tanks and equipment and the surface had not vegetation away from the storage tank area. Additionally, the tanks did not have secondary containment areas and were heavily corroded.

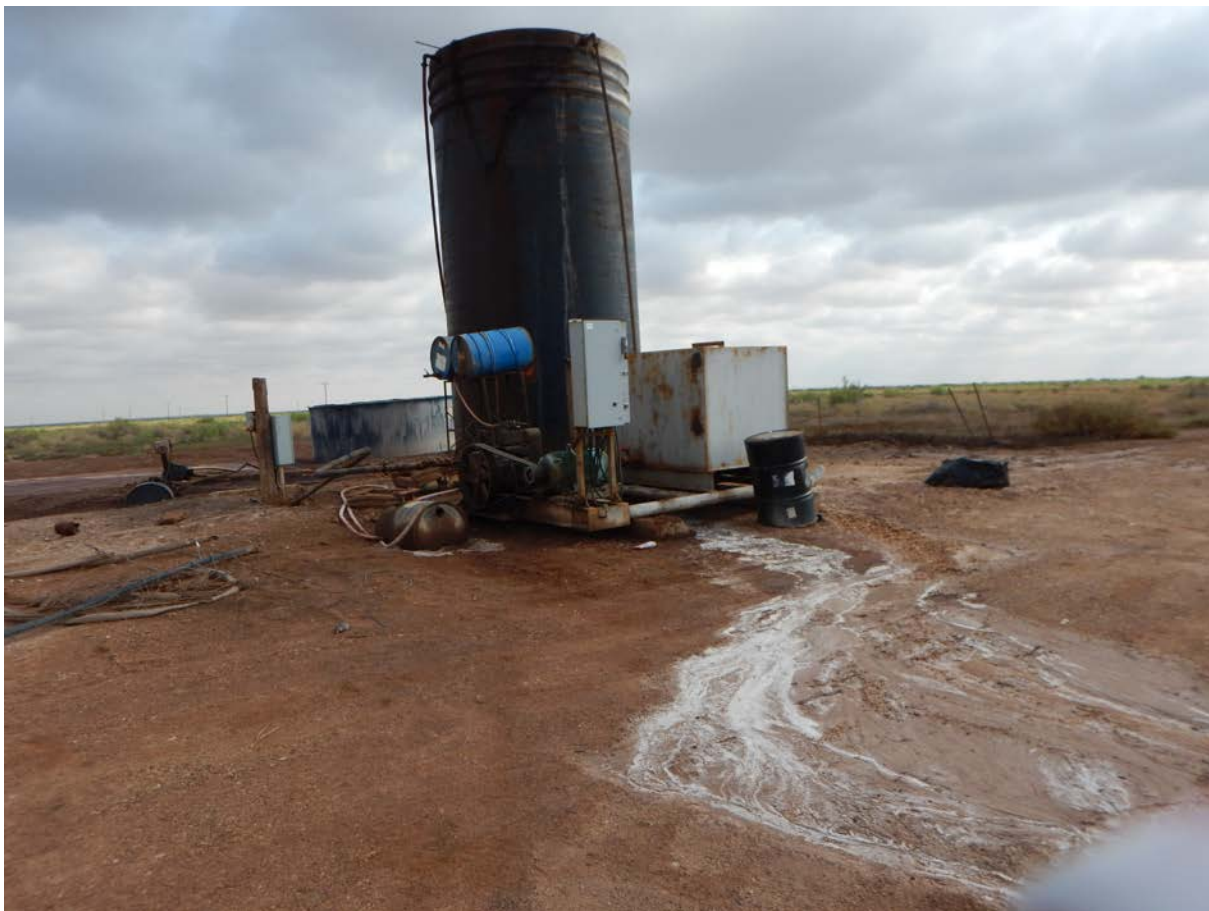
This image shows the Wolf Energy, Inc. / Marmaduke Lease, which consists of an oil and gas storage facility that has two storage tanks, an injection well and associated oil field production equipment. We observed salt crystals on the surface, no vegetation, no secondary containment, and heavily corroded tanks. Also, there were some drums on site with unknown labeling and no containment area.

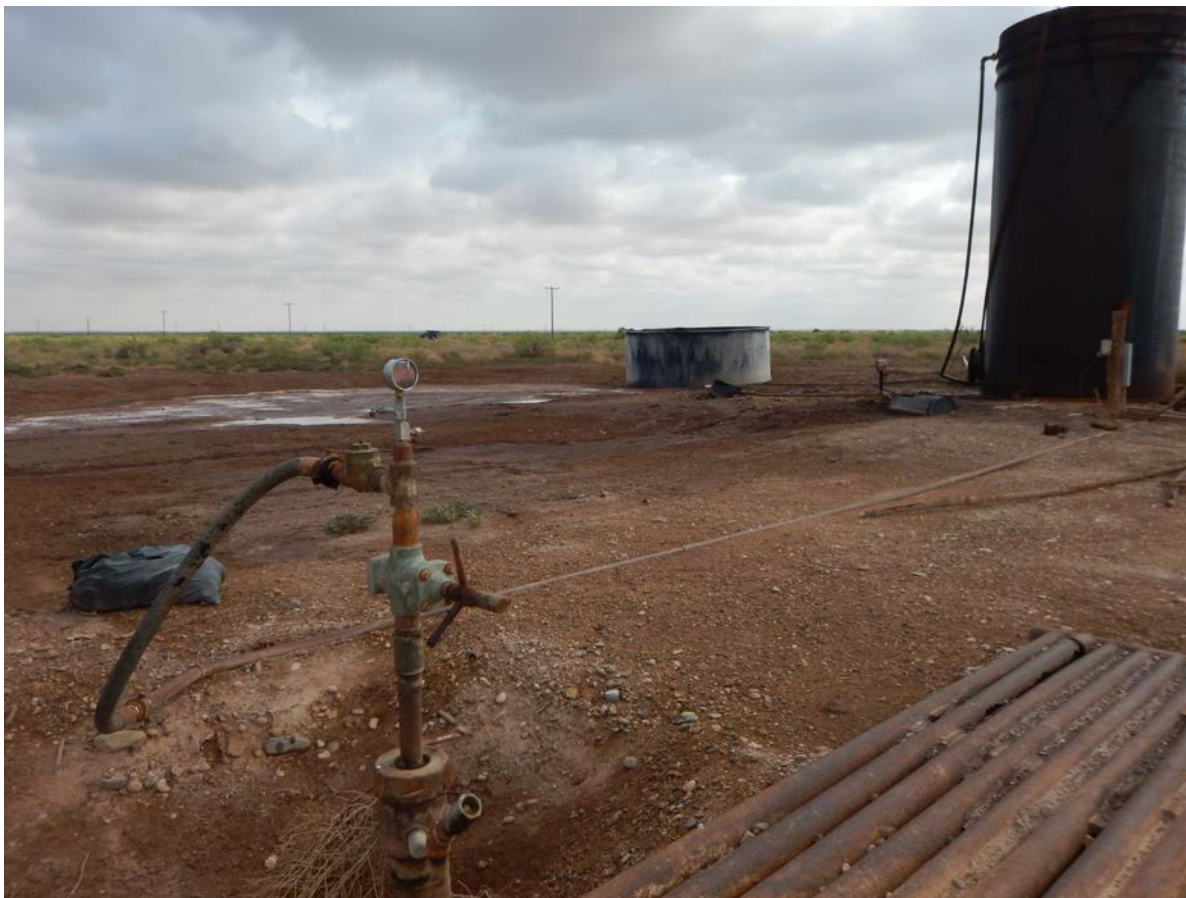
Photograph File Name: DSCN3503.JPG

Description: This image shows the injection well on site near the storage tanks. The area around the injection well was cratered and a metal grate (like a cattle guard) was being used as a walkway across the crater to see the pressure gauge at the wellhead. The flow path from the active leak can be seen in the background of this photo to the north.

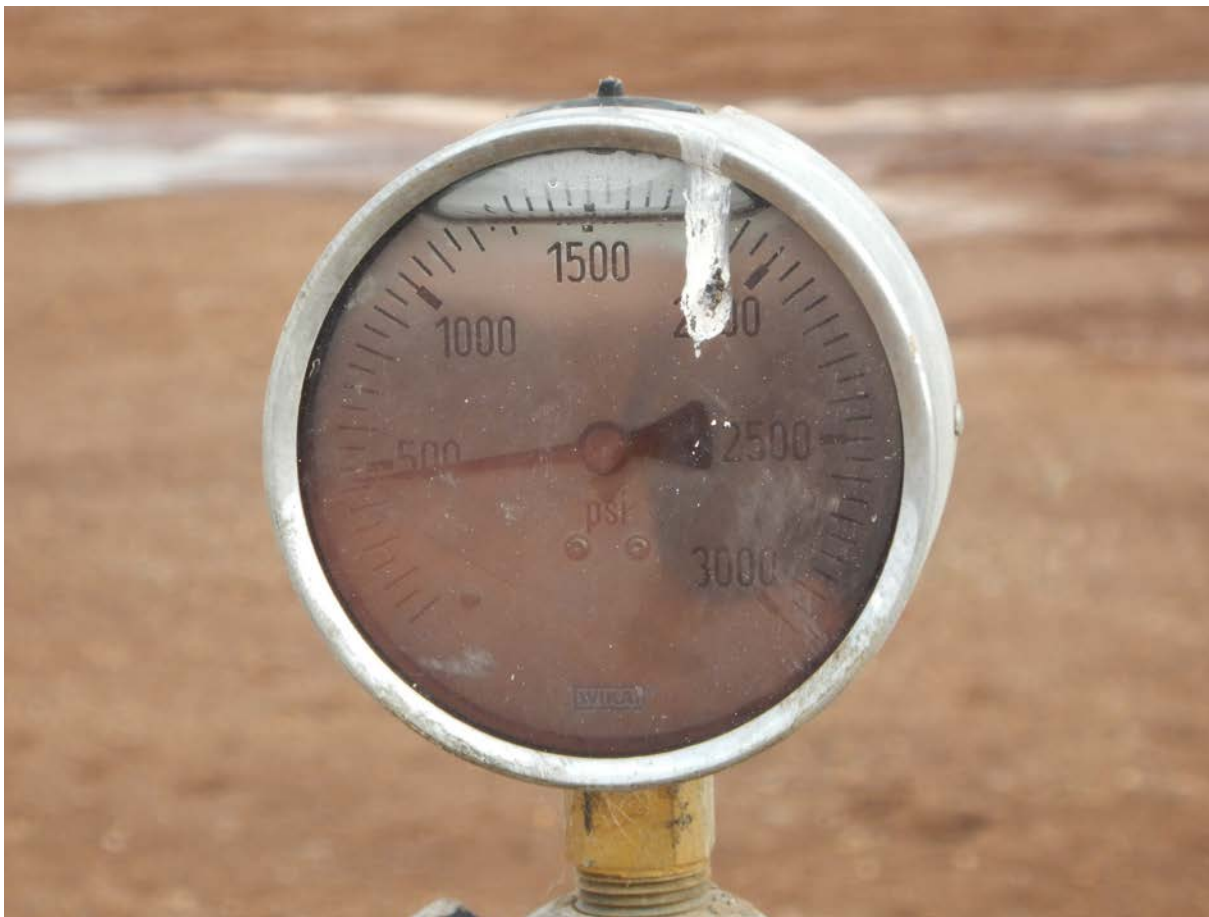
This image shows the injection well pressure gauge at the well head. At the time of the inspection the pressure gauge read between 450 psi and 500 psi.

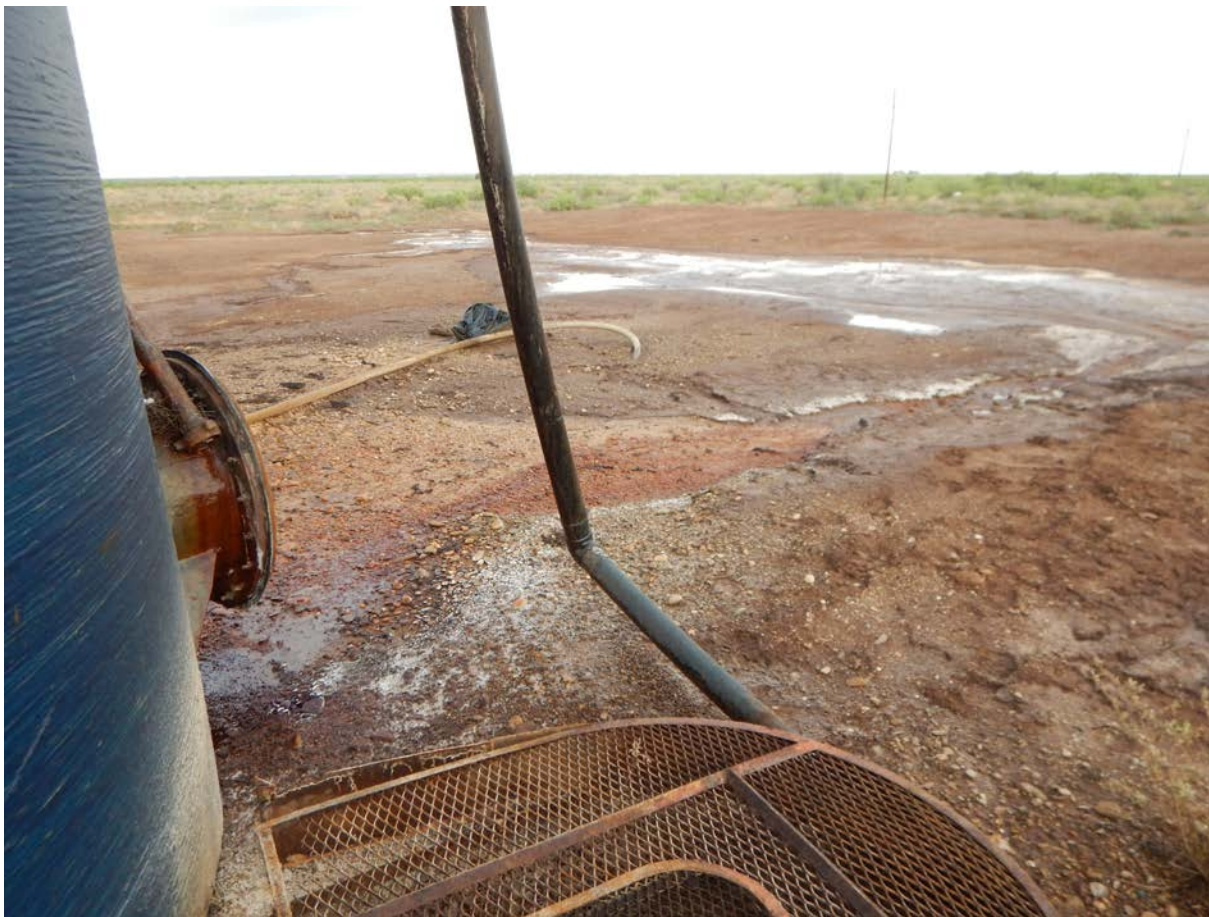
This image shows the point of discharge at the Marmaduke Lease. The line resting on the top portion of the bolted inspection door on the storage tank was leaking during the inspection. We observed a thick and wide spread amount of salts on the surface that occurred along the flow path and on the site. There was no vegetation and the surface was completely saturated during the inspection. There was equipment on site that was not in use and laying around the facility inactive.

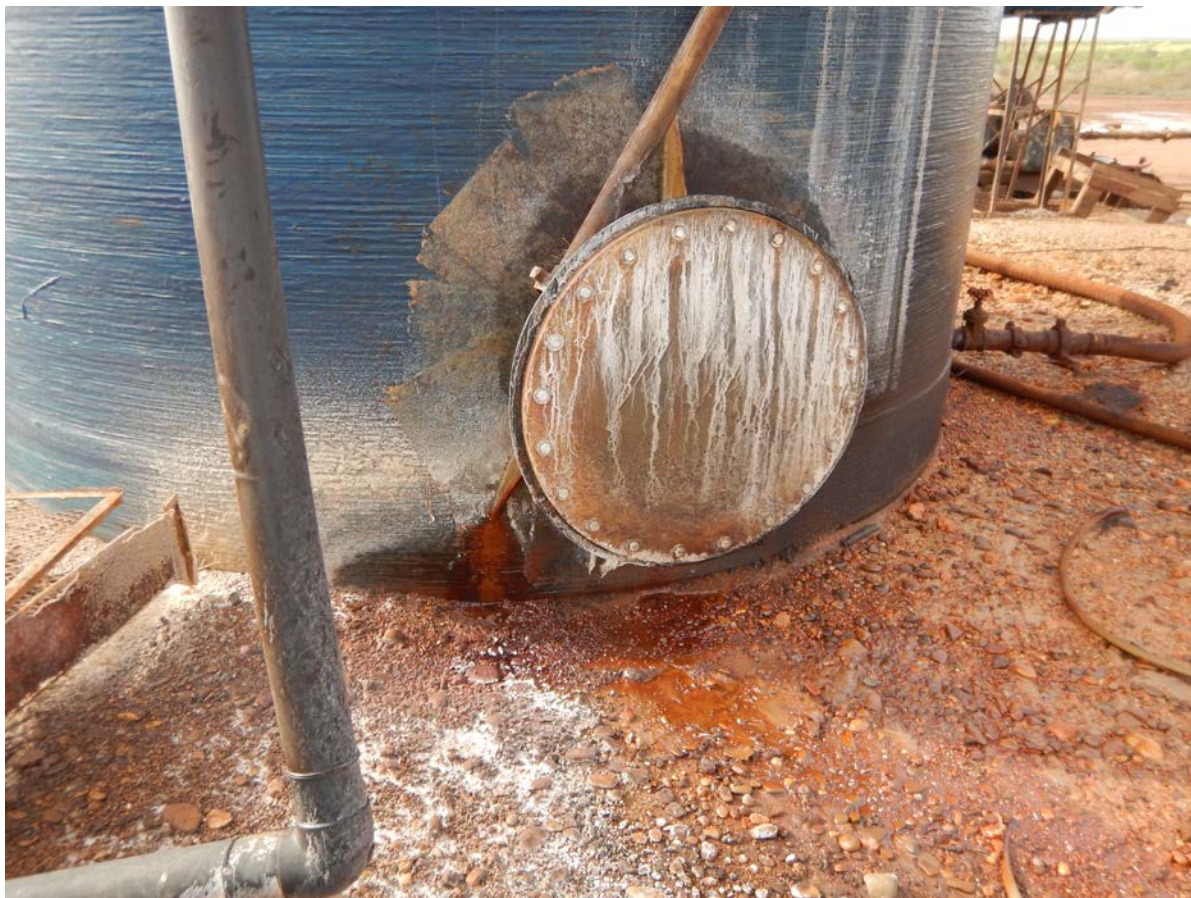
This image shows the point of discharge at the Marmaduke Lease. The line resting on the top portion of the bolted inspection door on the storage tank was leaking during the inspection. We observed visible salt crystals on the flow path. The tank had heavy corrosion on the inspection port area, and salts were dripping off from the tank indicating that this leak has been ongoing for a long period of time. Other parts and equipment around this leak were heavily corroded and the area was completely saturated.

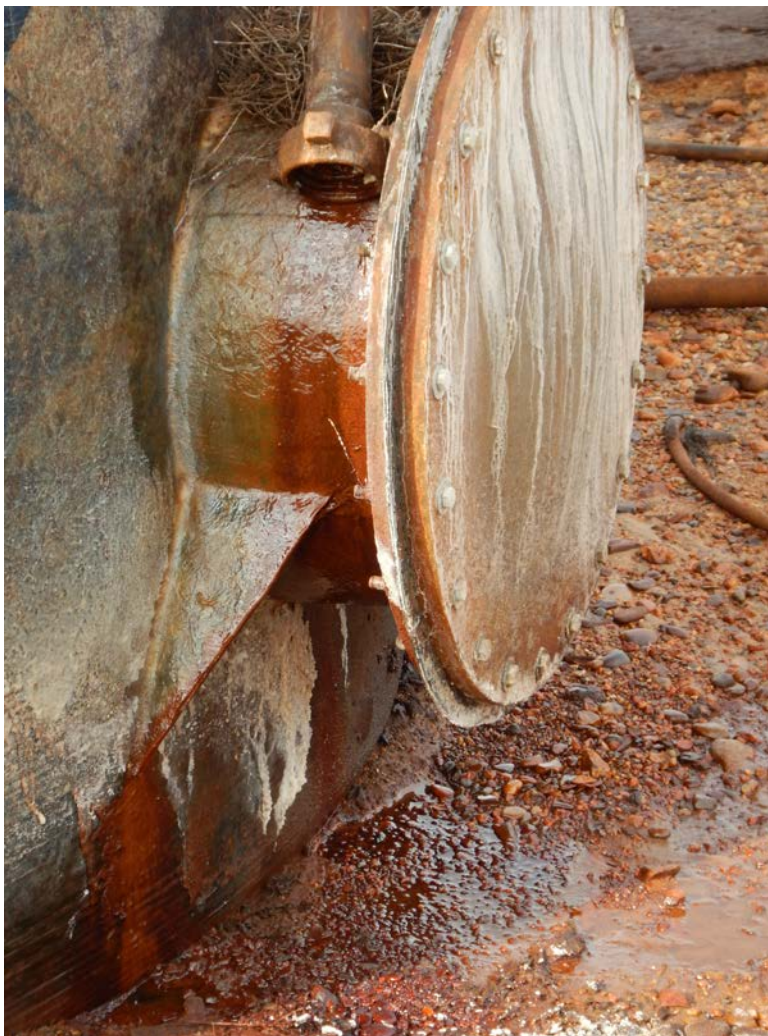
This image shows the point of discharge at the Marmaduke Lease. The line resting on the top portion of the bolted inspection door on the storage tank was leaking during the inspection. The tank had heavy corrosion on the inspection port area. Other parts and equipment around this leak were heavily corroded and the area was completely saturated.

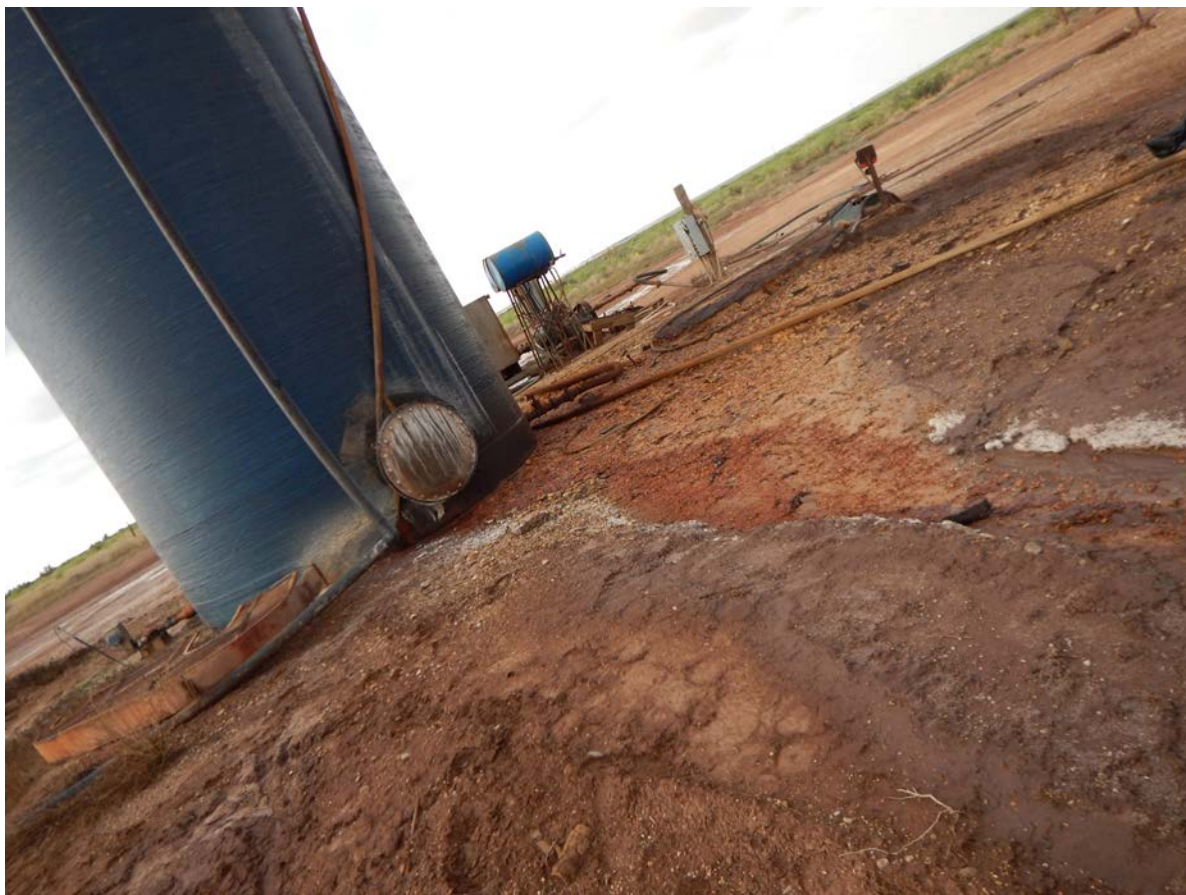
Photograph File Name: DSCN3482.JPG

Description: This image shows the point of discharge at the Marmaduke Lease. The line resting on the top portion of the bolted inspection door on the storage tank was leaking during the inspection. We observed a thick and wide spread amount of salts on the surface that occurred along the flow path and on the site. There was no vegetation and the surface was completely saturated during the inspection. There was equipment on site that was not in use and laying around the facility inactive. The flow path can be seen flowing north in this photo from the point of discharge.

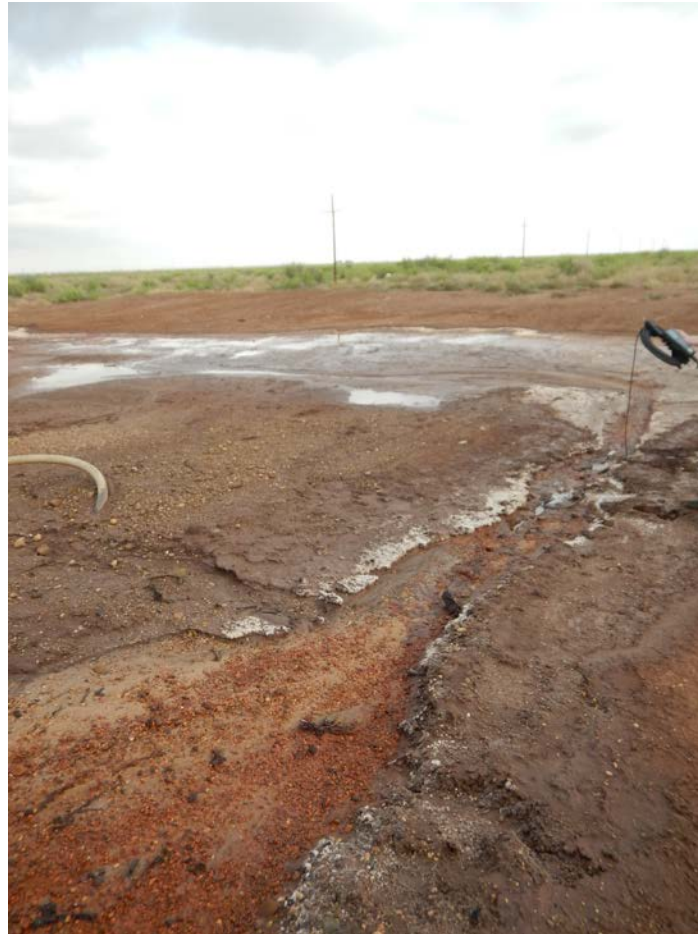
This image shows the flow path just north of the point of discharge. The flow path had erosion, visible salt crystals that were white and thick along the flow path. There was no vegetation and the surface was completely saturated during the inspection. There were some small ponded areas with fluids in them along the flow path.

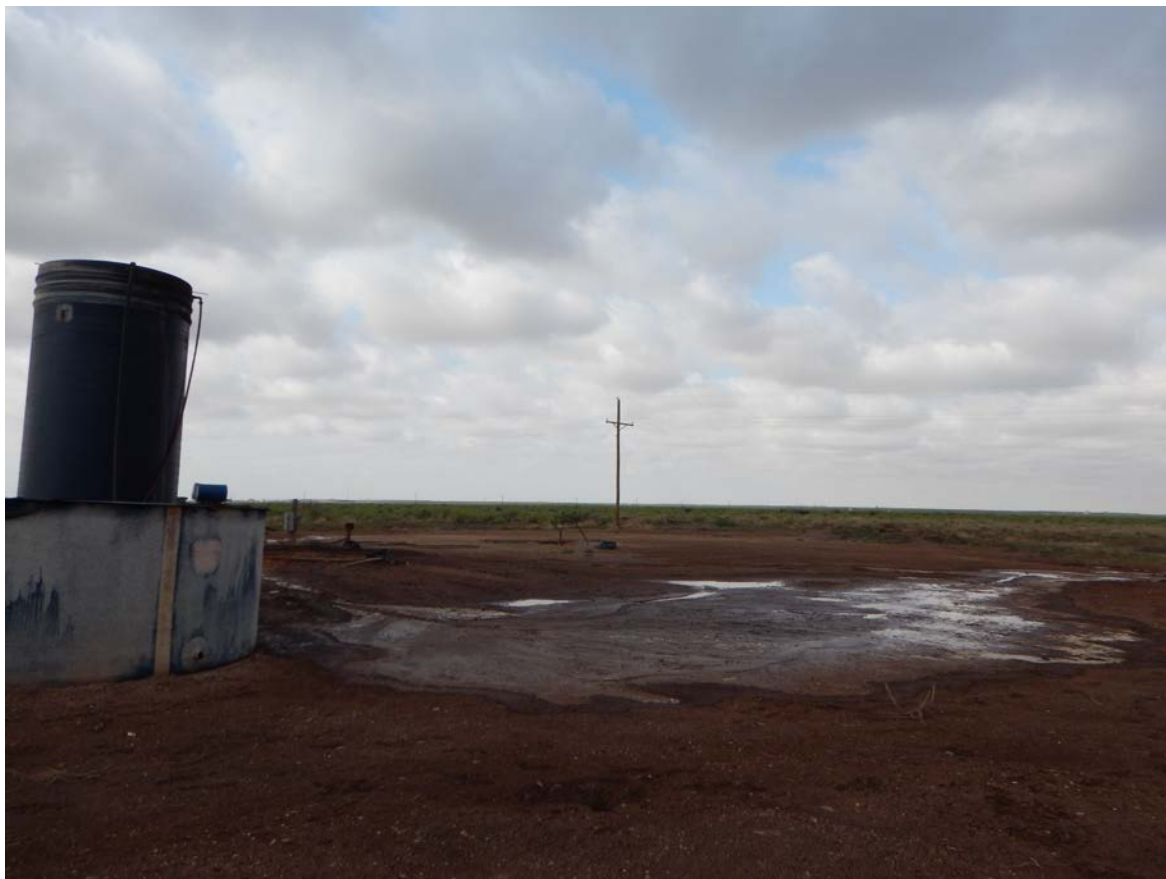
This image shows the flow path that flows north from the point of discharge and then west towards Horseshoe Draw. The entire flow path was saturated and we observed no vegetation along the flow path. We observed a thick amount of salt crystals along the flow path and erosion, which indicated that this leak had been ongoing for a long-time period.

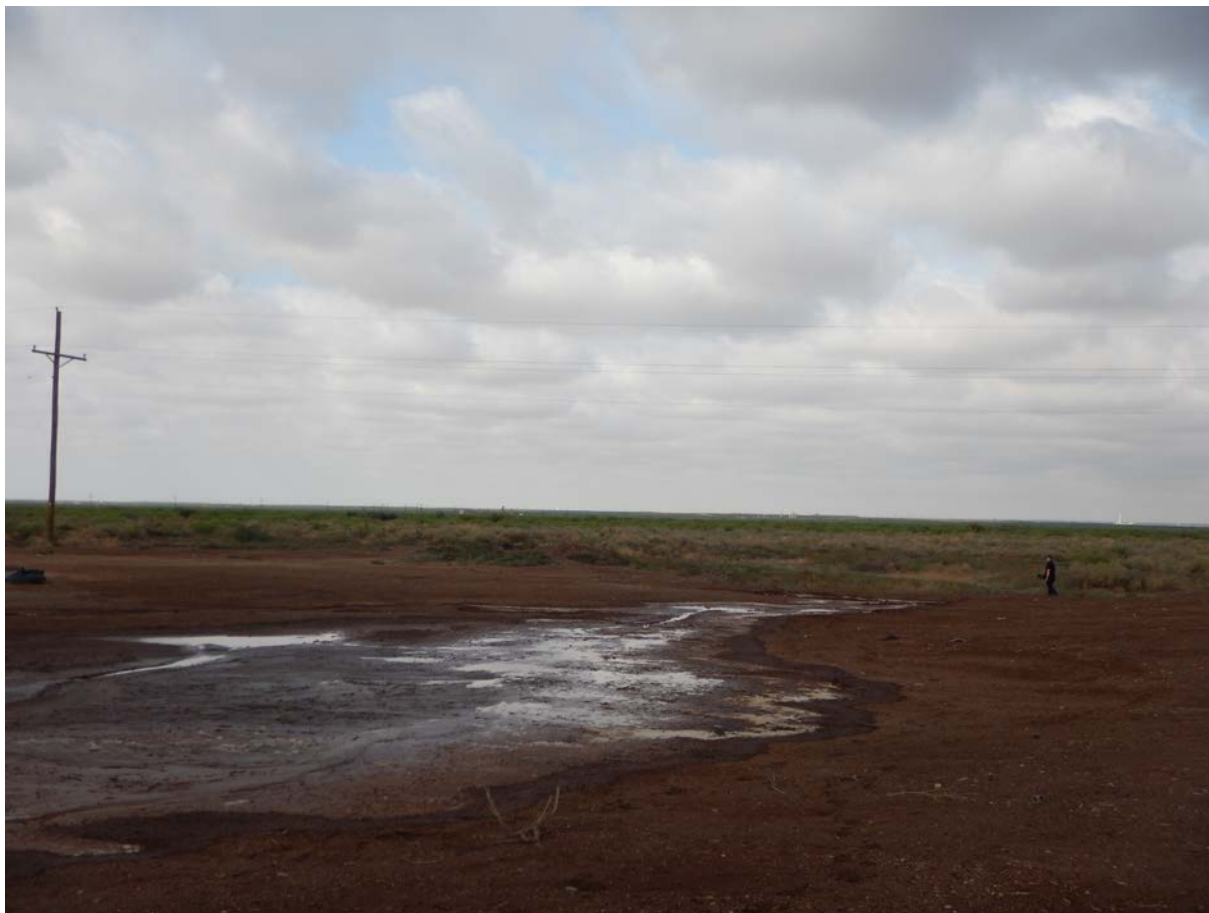
This image shows the flow path that is going west and flowing towards Horseshoe Draw. We observed that the flow path was saturated and there were large areas along the path that had salt crystals. We observed a large dead area in the surface with no vegetation. We observed the soil was so saturated that we were sinking while walking near the flow path during the inspection. This is indicative that this leak has been ongoing for a long time.

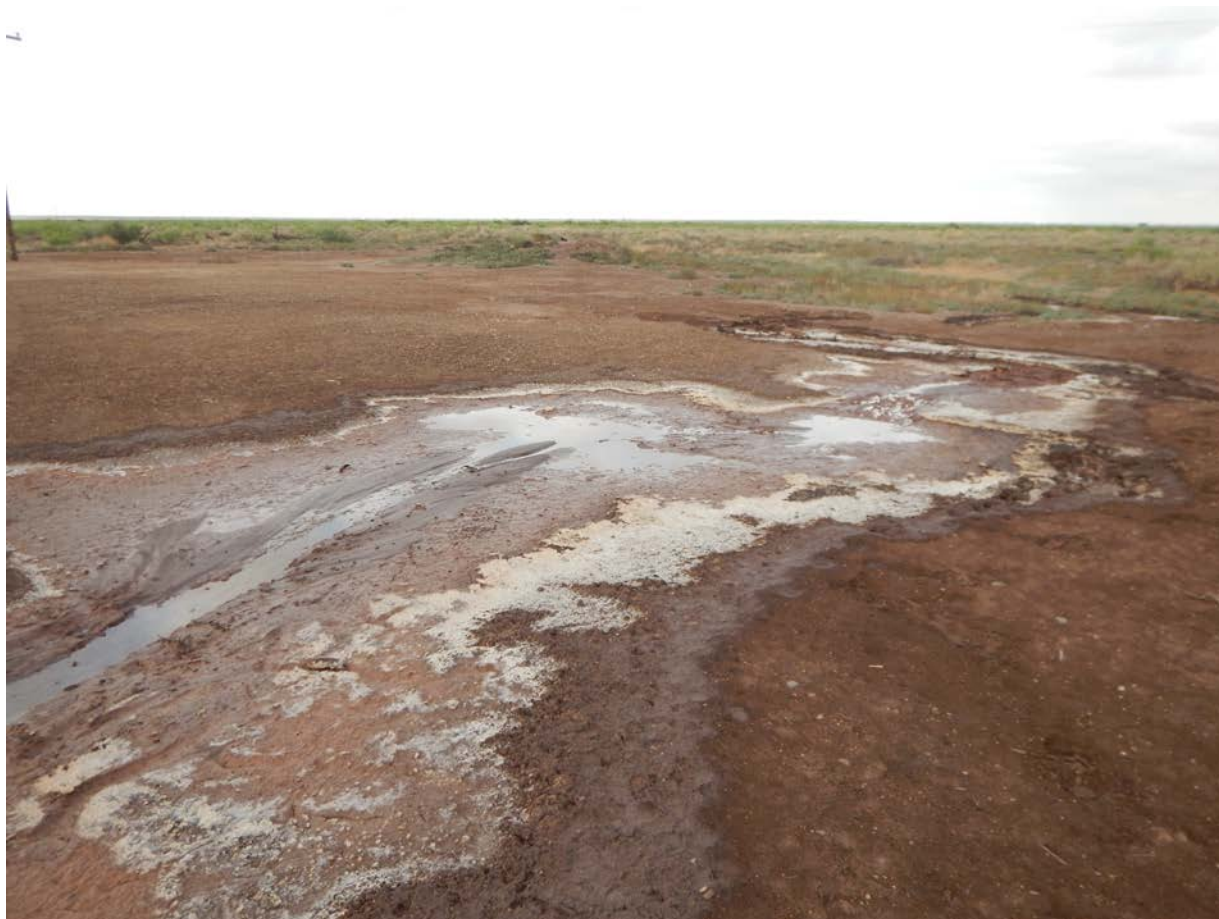
This image shows the flow path that is going west and flowing towards Horseshoe Draw. We observed that the flow path was saturated and there were large areas along the path that had salt crystals. We observed a large dead area in the surface with no vegetation. We observed active flow along the flow path.

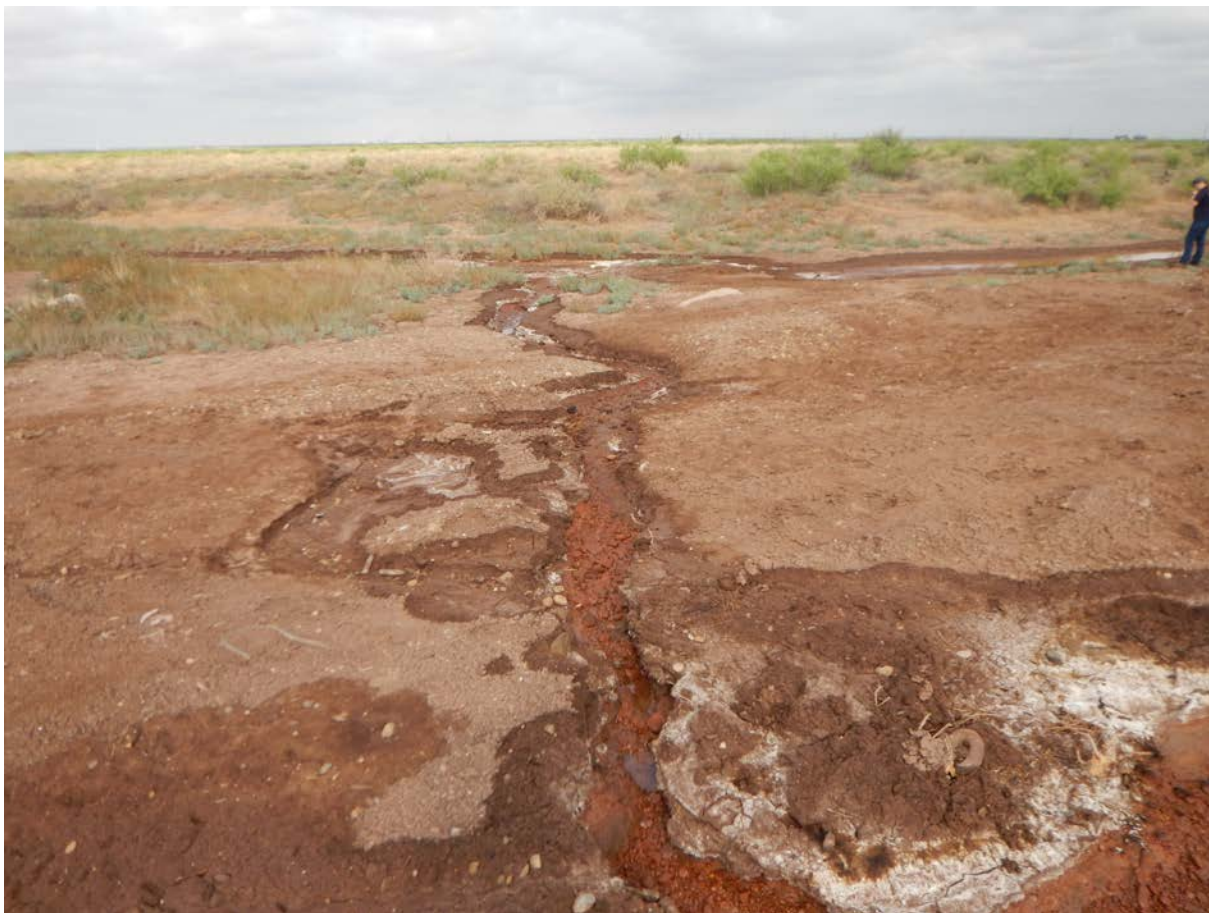
Photograph File Name: DSCN3506.JPG

Description: This image shows the flow path that is going west and flowing towards Horseshoe Draw. We observed that the flow path was saturated and there were large areas along the path that had salt crystals. We observed a large dead area in the surface with no vegetation. We observed active flow along the flow path.

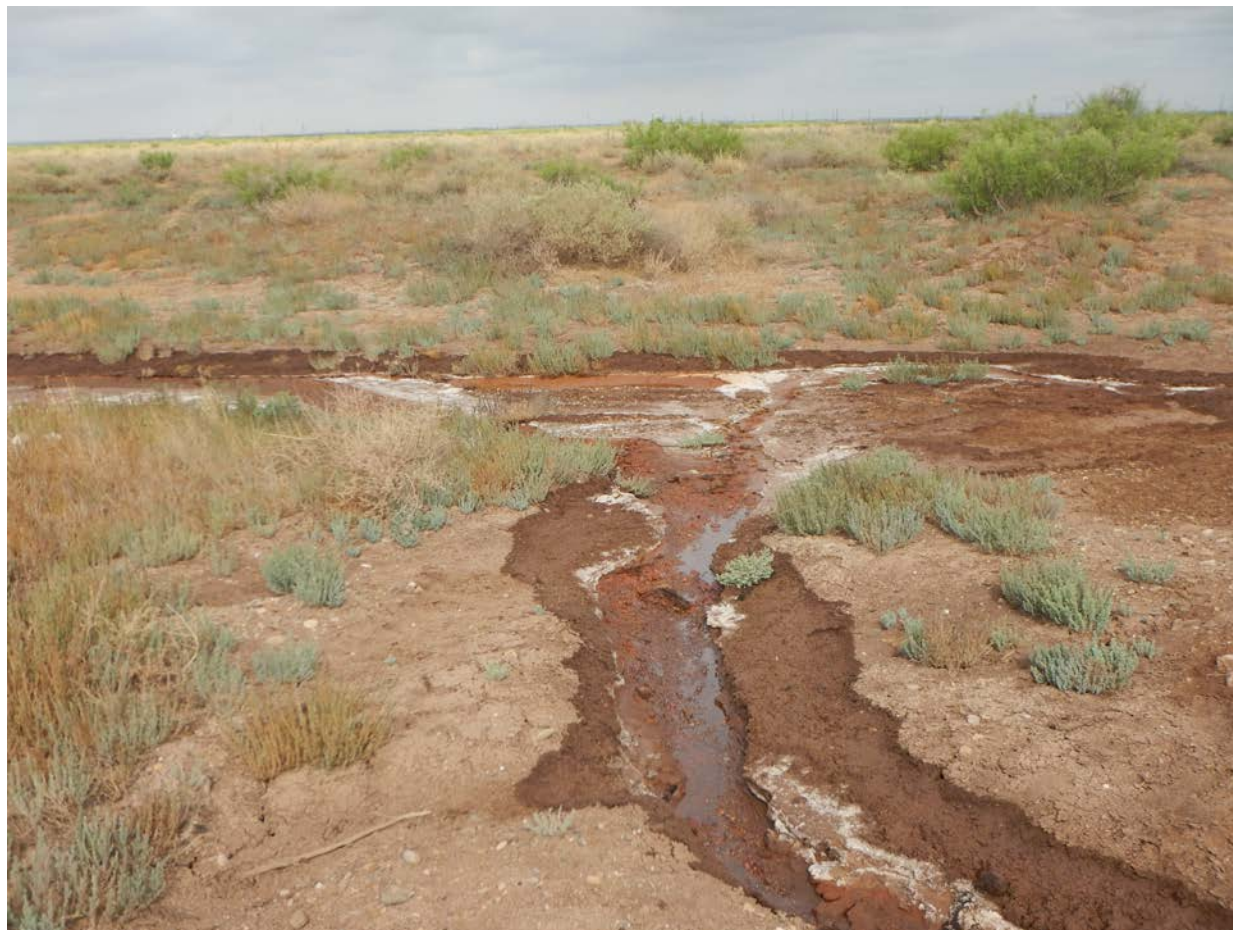
Photograph File Name: DSCN3507.JPG

Description: This image shows the flow path that is going west and flowing towards Horseshoe Draw. We observed that the flow path was saturated and there were large areas along the path that had salt crystals. The flow path was active and this photo shows the point of entry into Horseshoe Draw.

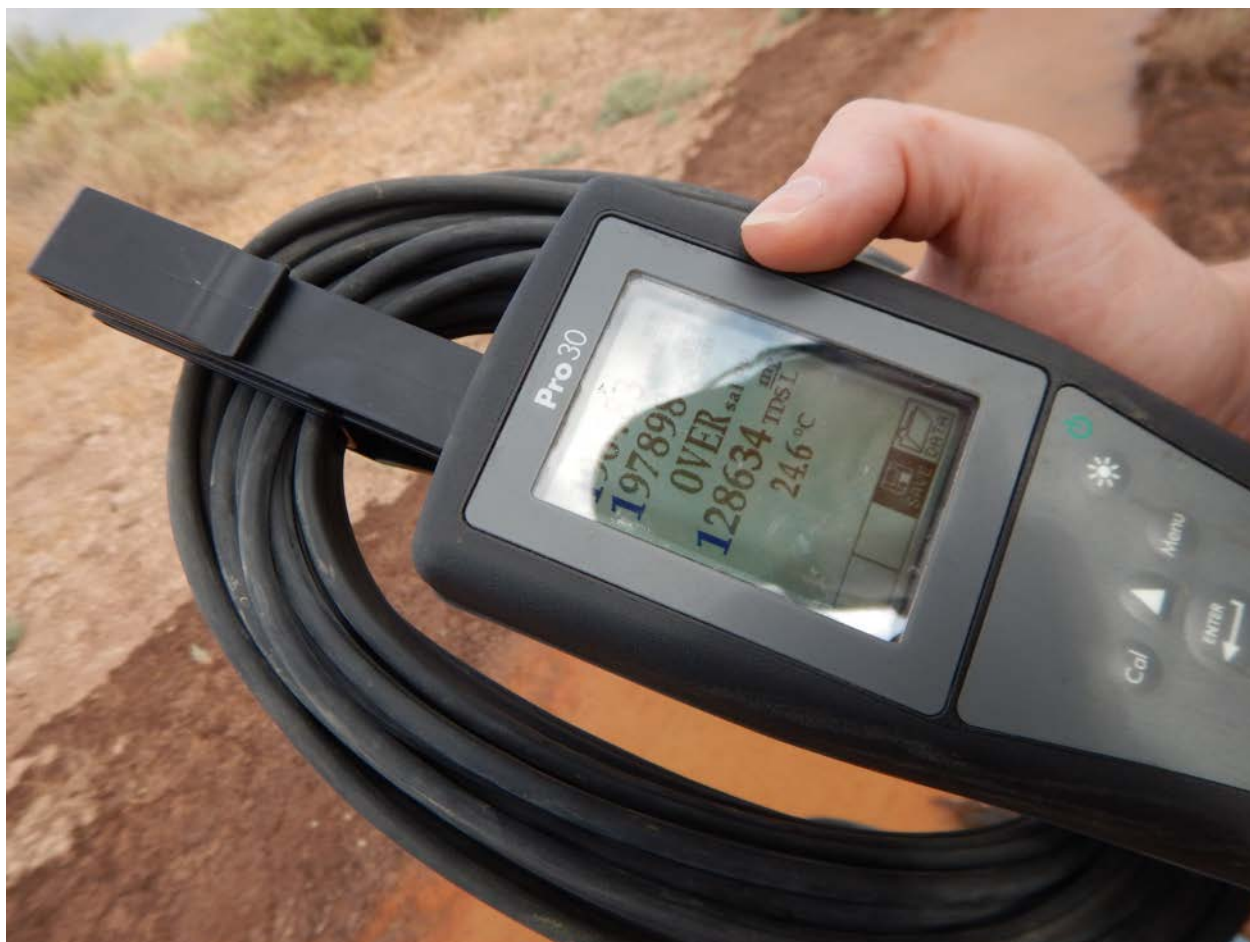
Description: This image shows at the point of entry from the active flow path into Horseshoe Draw. A reading of 128,634 mg/L TDS was taken at this location. We observed that the fluids were a rusty discoloration and had some oil sludge in the bottom of the draw. Vegetation at the point of entry was dead. No aquatic life was observed.

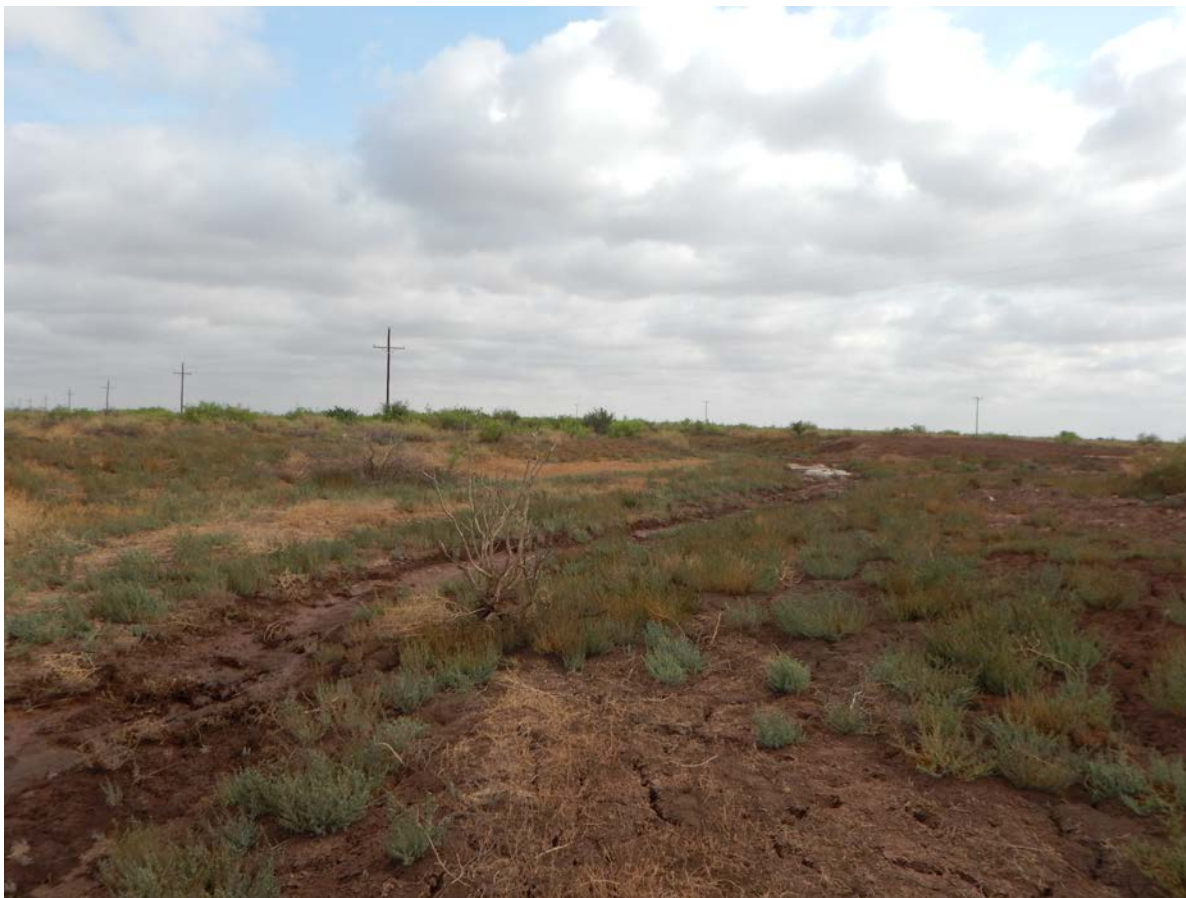
This image shows approximately 175 feet downstream along Horseshoe Draw from the point of entry of produced water into the draw. This photo shows upstream along the draw and fluids from the active leak have contaminated the draw and saturated the soil along the draw. There were fluids in Horseshoe Draw during the inspection. We observed dead vegetation as well at this location.

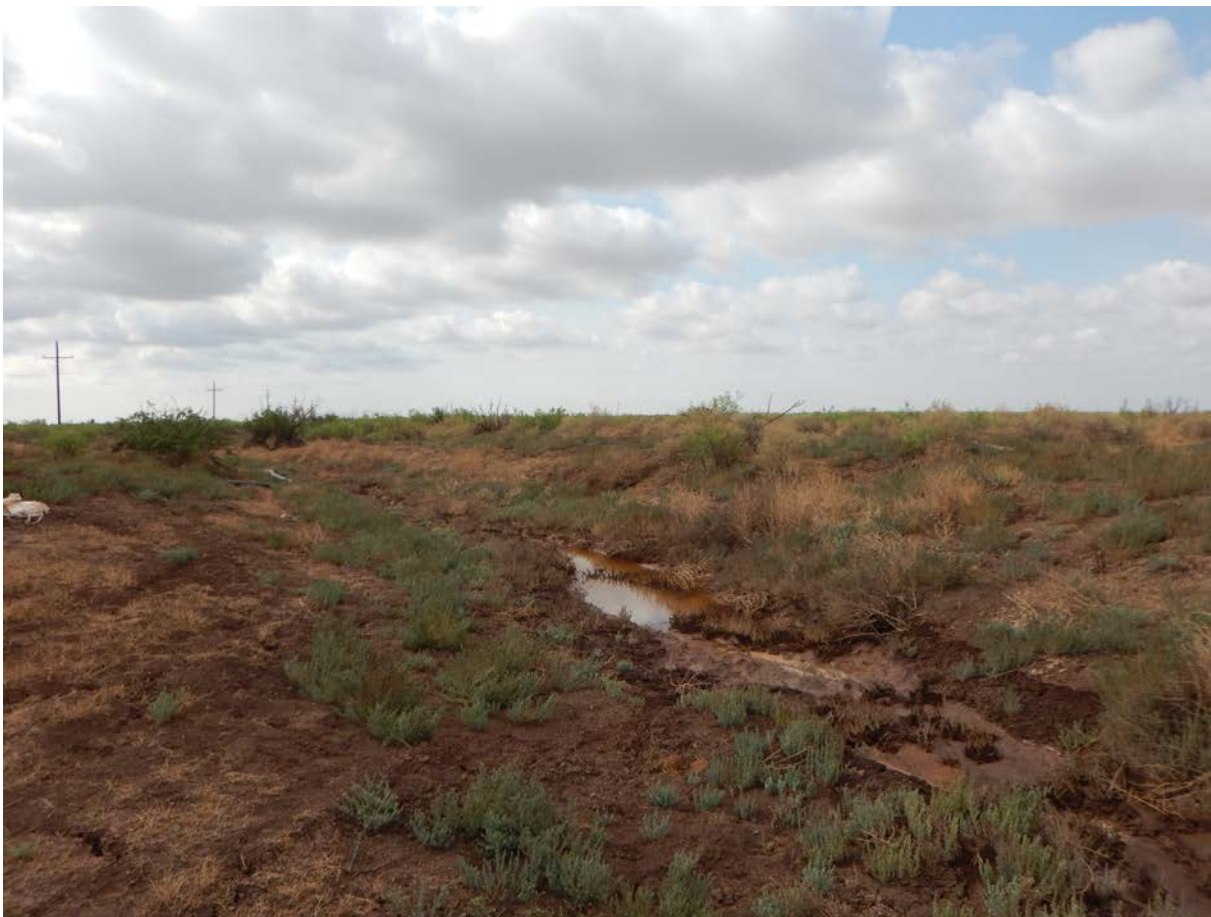
This image shows approximately 175 feet downstream along Horseshoe Draw from the point of entry of produced water into the draw. This photo shows downstream along the draw and fluids from the active leak contaminated the draw and saturated the soil along the draw. There were fluids in Horseshoe Draw during the inspection at this location. We observed dead vegetation and oil sludge as well at this location.

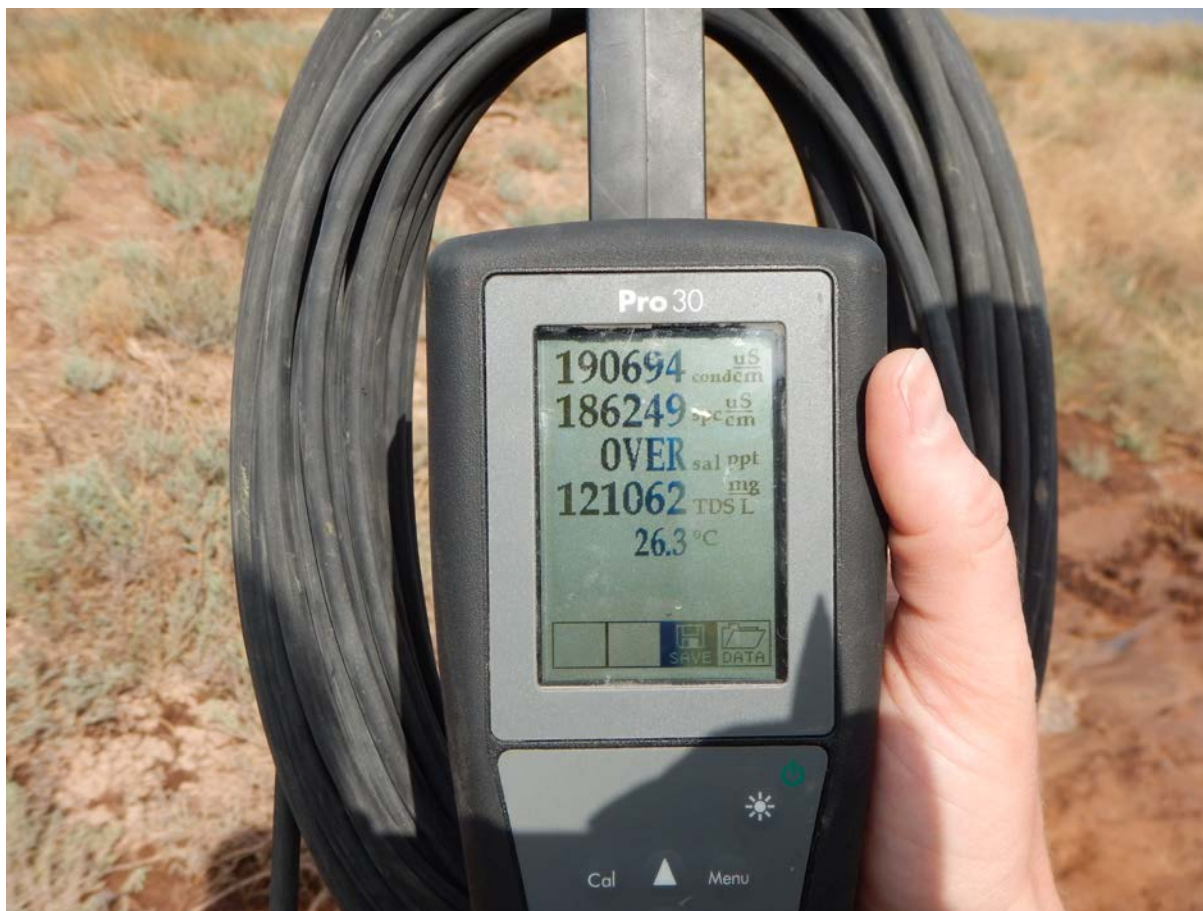
Photograph File Name: DSCN3516.JPG  
Date of Photograph: 05/22/2018  
Latitude: 31.681056 N  
Longitude: -103.641550 W  
Orientation: W  
Map Datum: WGS-84  
Time of Photo: 09:56 AM  
Photographer: Carol Johnson  
Description: This image shows approximately 175 feet downstream along Horseshoe Draw from the point of entry of produced water into the draw. A TDS reading of 121,062 mg/L was taken at this location in Horseshoe Draw.
