**Region 6 Compliance Assurance and Enforcement Division  
INSPECTION REPORT**

| Inspection Date(s): | 05/22/2018 | | |
| Company Name: | <b>Wolf Energy, Inc.</b> | | |
| Facility Name: | <b>Marmaduke Lease</b> | | |

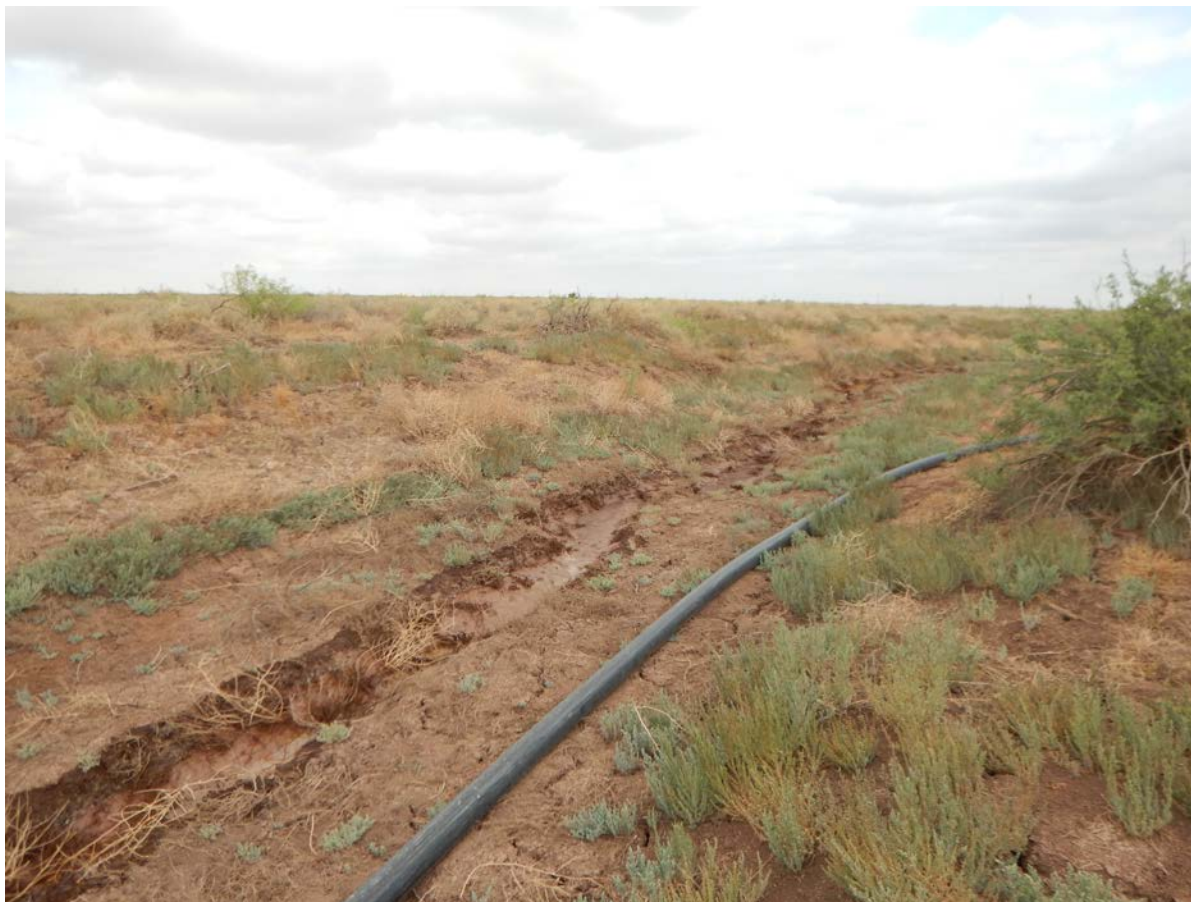
Photograph File Name: DSCN3518.JPG  
Date of Photograph: 05/22/2018  
Latitude: 31.680856 N  
Longitude: -103.641342 W  
Orientation: W  
Map Datum: WGS-84  
Time of Photo: 09:59 AM  
Photographer: Carol Johnson  
Description: This image shows approximately 250 feet downstream along Horseshoe Draw from the point of entry of produced water into the draw. We observed dead vegetation, oil sludge and brine in the draw at this location. Also, a flow line was near the draw here associated with the Marmaduke Lease.

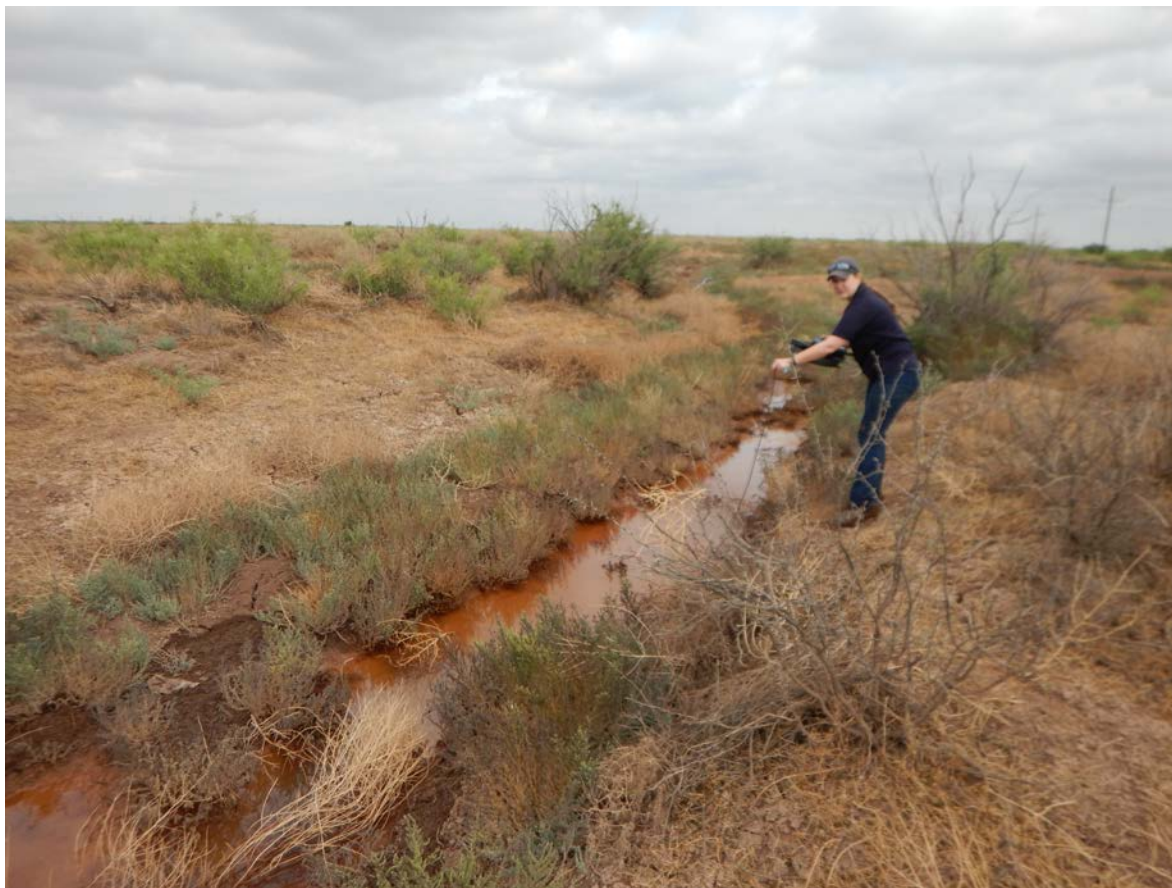
Photograph File Name: DSCN3520.JPG

Description: This image shows approximately 350 feet downstream along Horseshoe Draw from the point of entry of produced water into the draw. We observed dead vegetation, settled oil sludge and brine in the draw at this location. The fluids in the draw were a rusty discoloration.

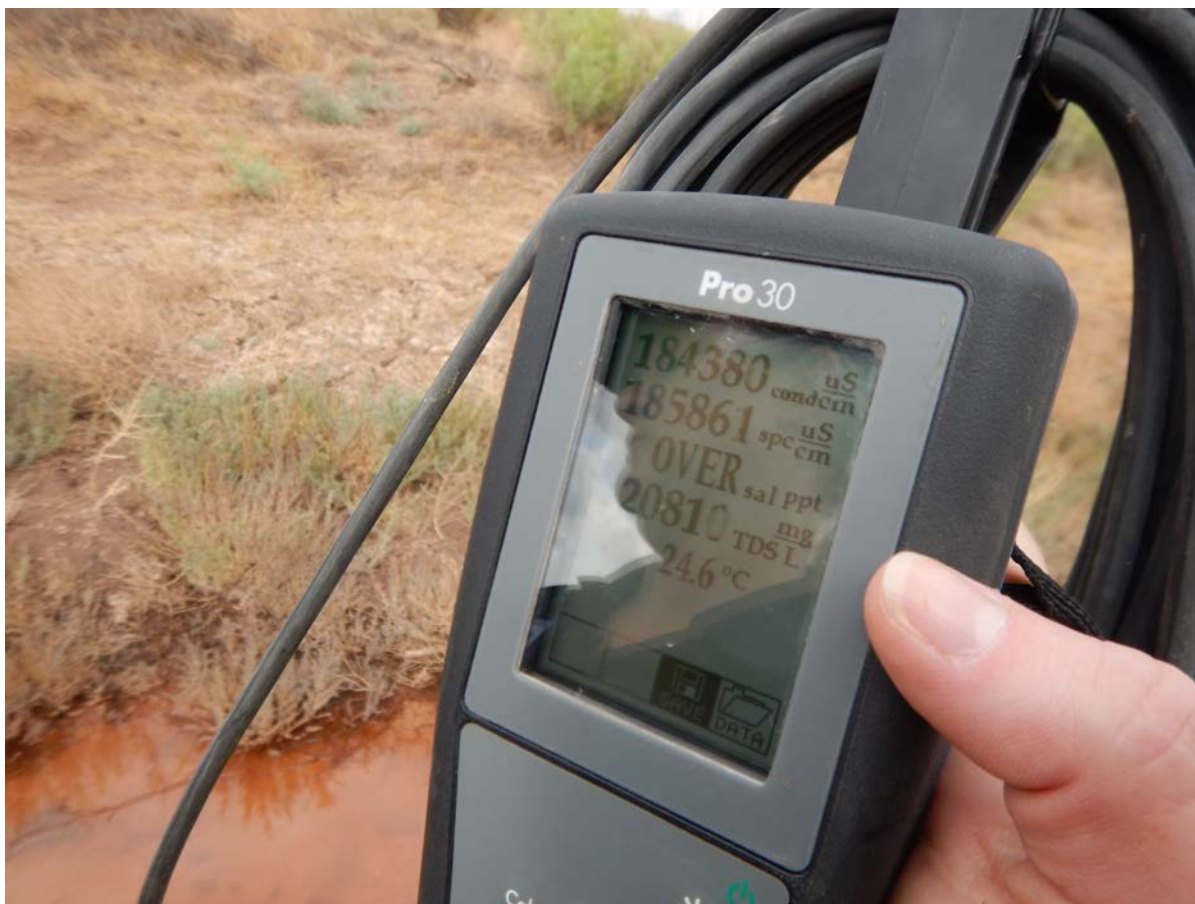
Photograph File Name: DSCN3521.JPG  
Date of Photograph: 05/22/2018  
Latitude: 31.680677 N  
Longitude: -103.641104 W  
Orientation: NW  
Map Datum: WGS-84  
Time of Photo: 10:02 AM  
Photographer: Carol Johnson  
Description: This image shows approximately 350 feet downstream along Horseshoe Draw from the point of entry of produced water into the draw. A reading of 120,810 mg/L TDS was taken at this location in Horseshoe Draw.

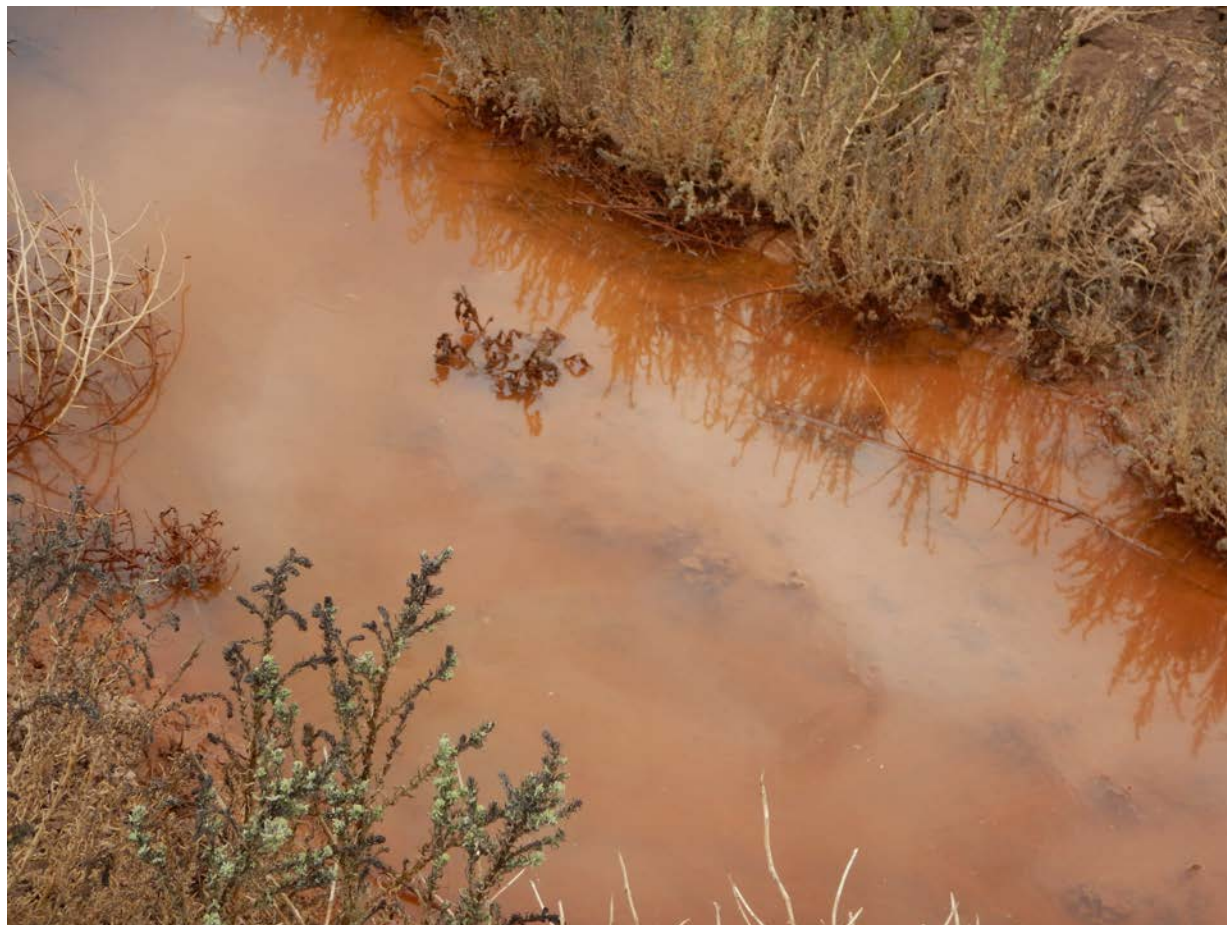
Photograph File Name: DSCN3522.JPG

Description: This image shows approximately 350 feet downstream along Horseshoe Draw from the point of entry of produced water into the draw. We observed a rusty discolored water in the draw that had a sheen on the surface. Evidence of oil sludge in the draw was apparent at this location by visual observation.

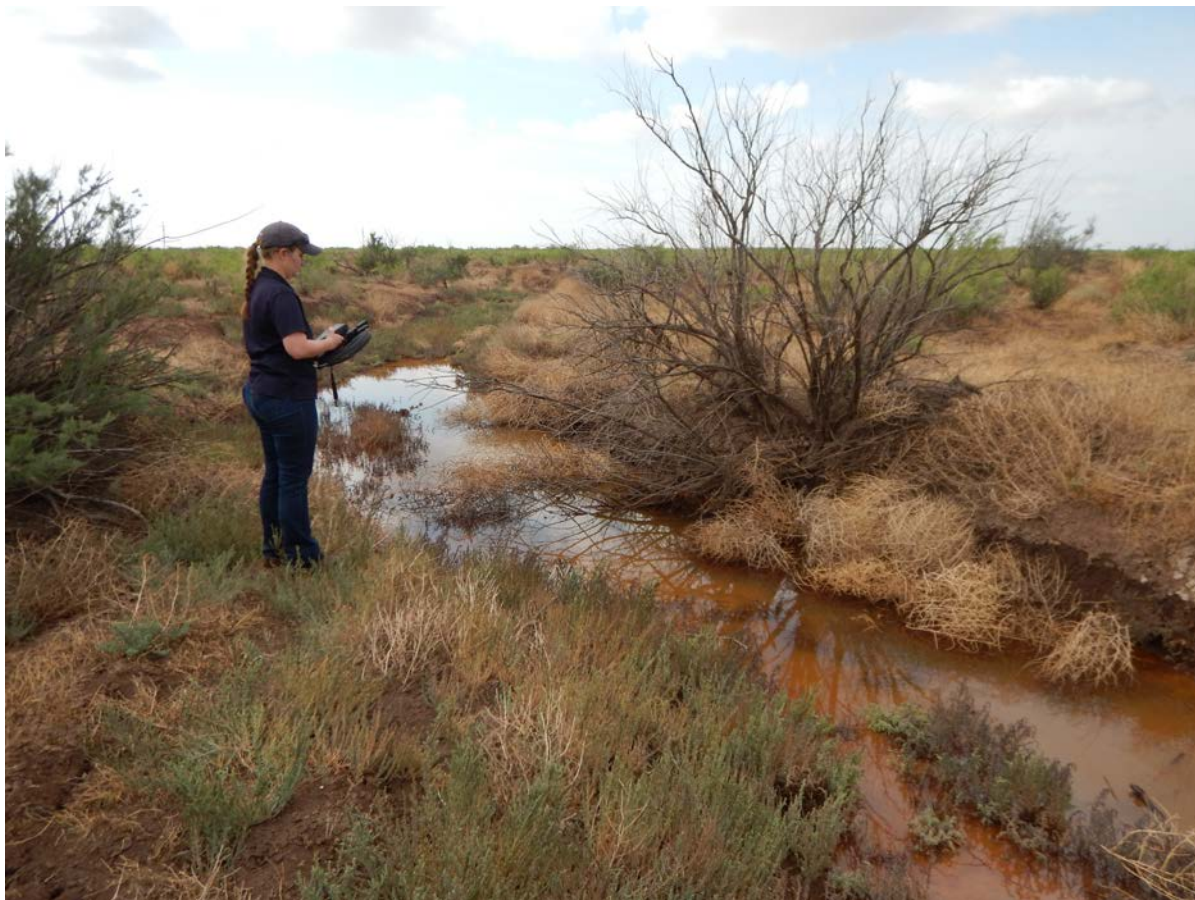
Photograph File Name: DSCN3527.JPG

Description: This image shows approximately 540 feet downstream along Horseshoe Draw from the point of entry of produced water into the draw. We observed some dead vegetation here. We observed clear bed and bank in the draw here as well with some riparian vegetation. The draw had fluids in it and had a rusty discoloration with oil sludge.

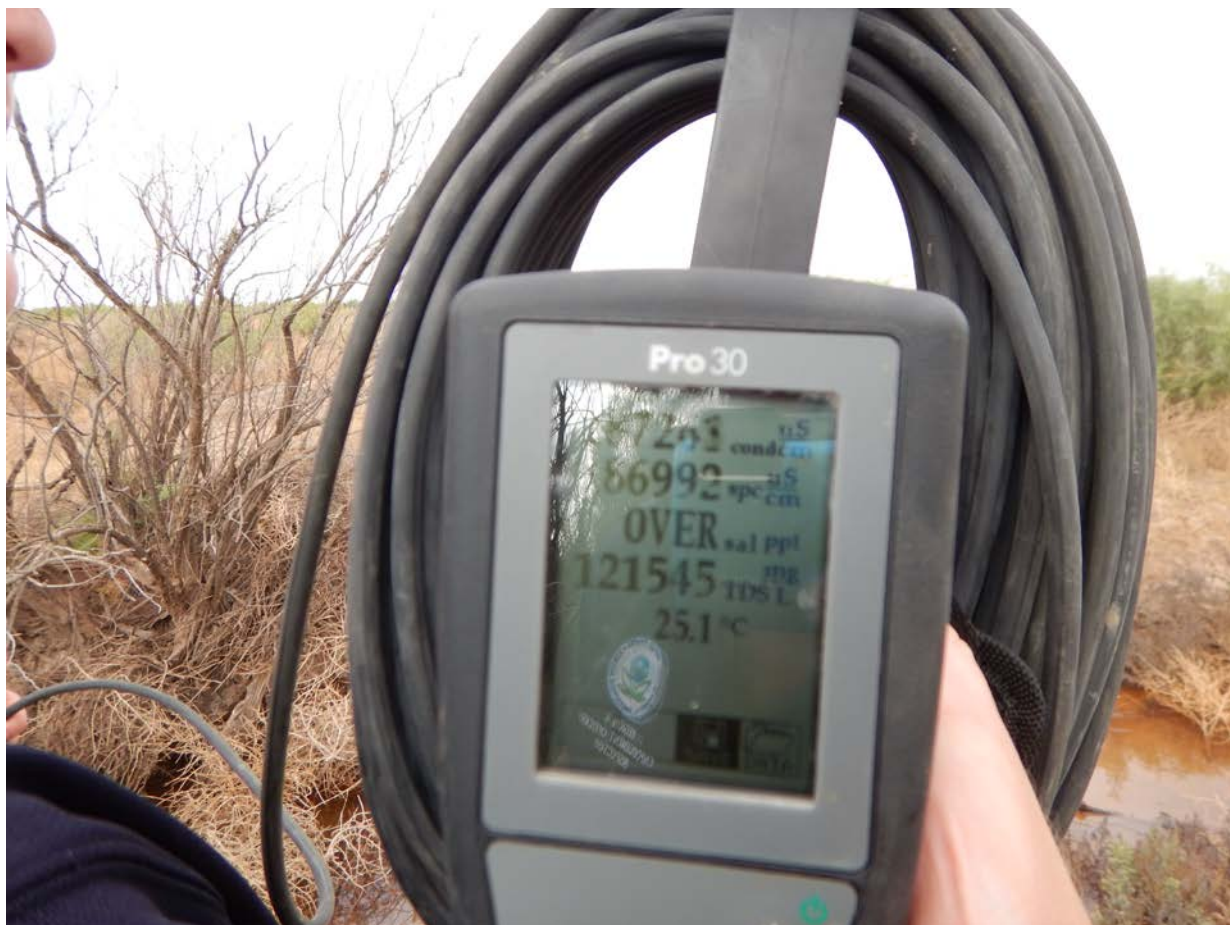
Photograph File Name: DSCN3528.JPG  
Date of Photograph: 05/22/2018  
Latitude: 31.680214 N  
Longitude: -103.640843 W  
Orientation: SW  
Map Datum: WGS-84  
Time of Photo: 10:09 AM  
Photographer: Carol Johnson  
Description: This image shows approximately 540 feet downstream along Horseshoe Draw from the point of entry of produced water into the draw. A TDS reading of 121,545 m/L was taken at this location.

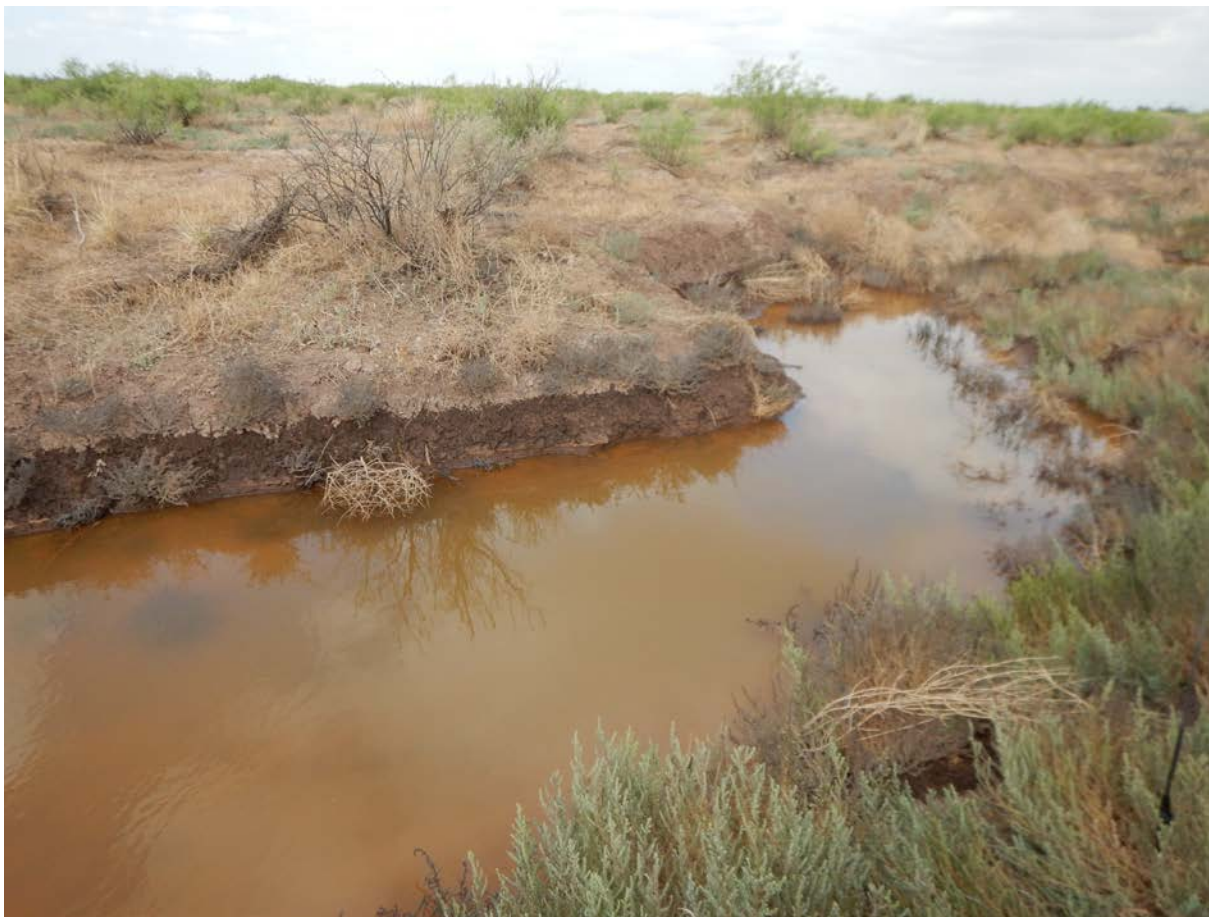
This image shows approximately 750 feet downstream along Horseshoe Draw from the point of entry of produced water into the draw. We observed some dead vegetation here. We observed clear bed and bank in the draw here as well with some riparian vegetation. The draw had fluids in it and had a rusty discoloration with oil sludge.

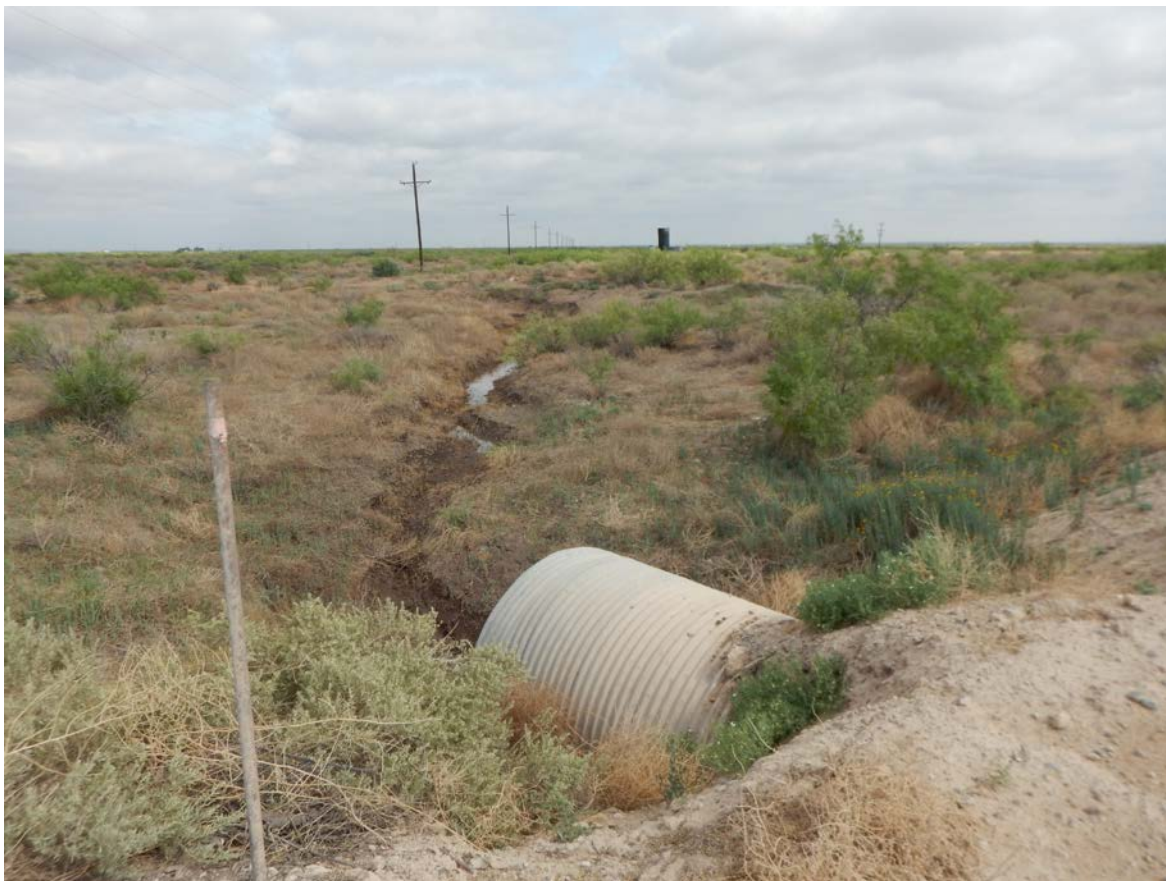
Photograph File Name: DSCN3539.JPG

Description: This image shows approximately 0.23 miles downstream along Horseshoe Draw from the point of entry of produced water into the draw. We observed bed, bank, and riparian vegetation. The fluids in the draw were discolored and had oil sludge in them throughout the draw to this point downstream from the point of entry. The tank battery area can be seen in the background of this photo.

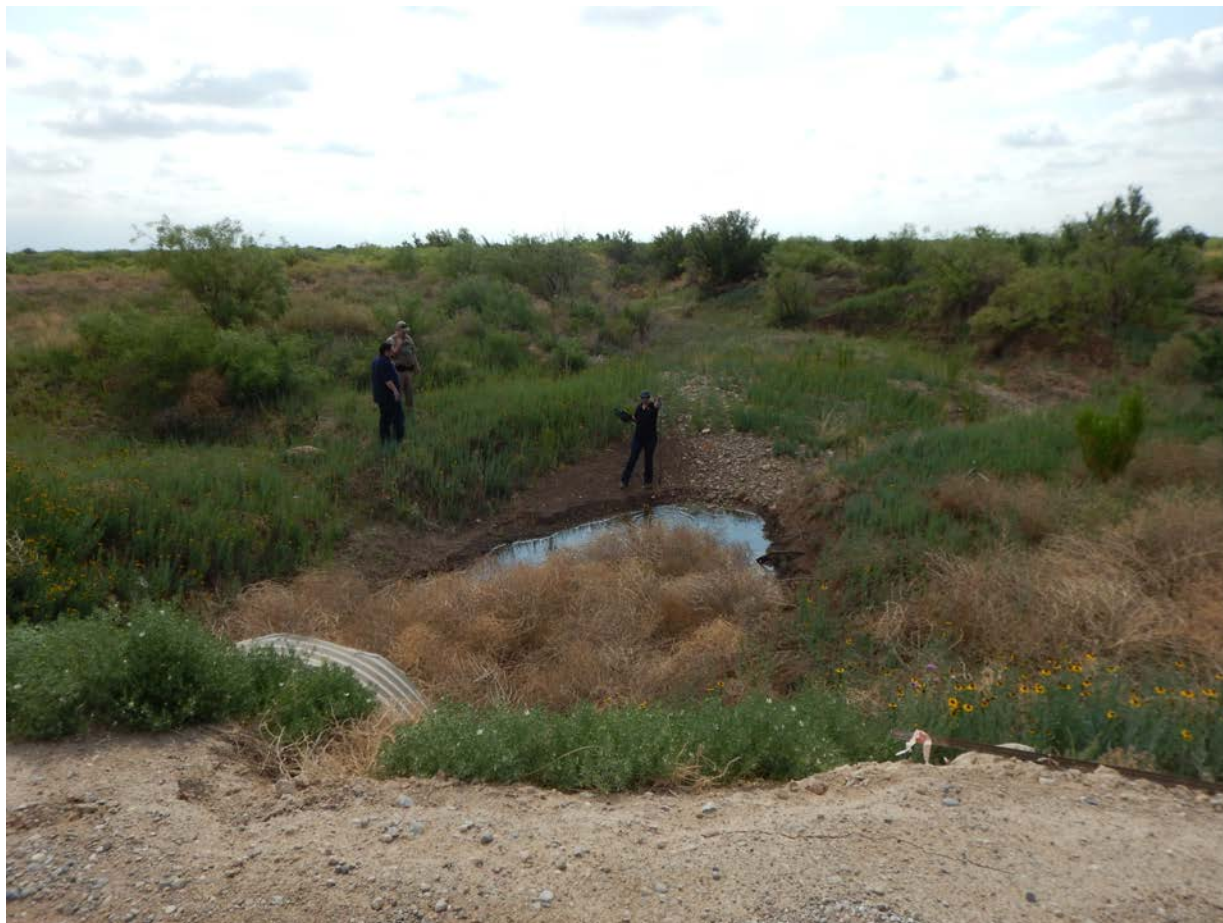
Description: This image shows approximately 0.23 miles downstream along Horseshoe Draw from the point of entry of produced water into the draw. We observed bed, bank, and riparian vegetation. The fluids in the draw were discolored and had oil sludge in them throughout the draw to this point downstream from the point of entry. This photo shows the downstream view from this location in the draw.

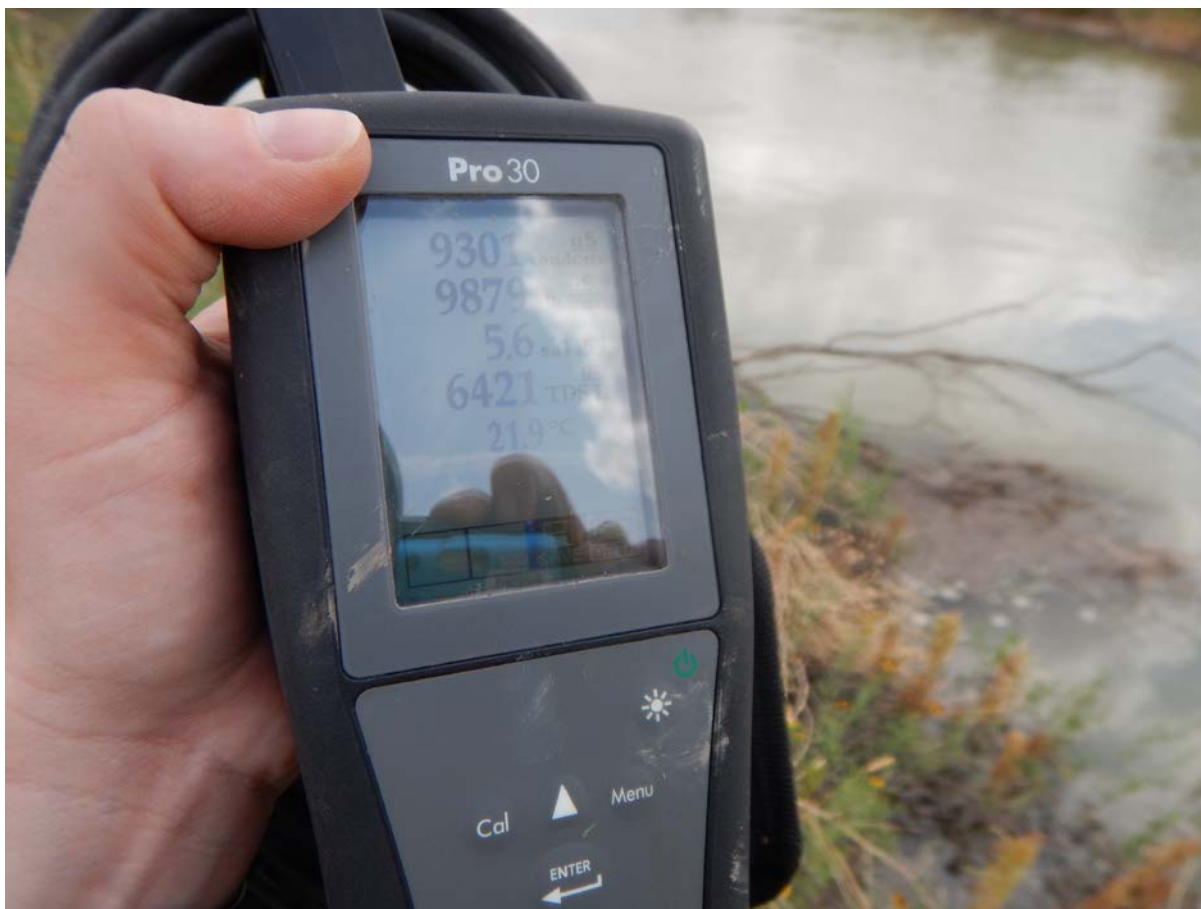
Photograph File Name: DSCN3561.JPG  
Date of Photograph: 05/22/2018  
Latitude: 31.678117 N  
Longitude: -103.634058 W  
Orientation: NE  
Map Datum: WGS-84  
Time of Photo: 10:56 AM  
Photographer: Jeanne Eckhart  
Description: This image shows approximately 0.67 miles downstream along Horseshoe Draw from the point of entry of produced water into the draw. At this location Horseshoe Draw merges with the Pecos River. A TDS reading of 6,421 mg/L was taken at the confluence.
