**U.S. Environmental Protection Agency
Region 5**

Purpose: Clean Water Act National Pollutant Discharge Elimination System (NPDES)
Compliance Evaluation Inspection

Facility: Village of Mifflin WWTP
17 Maine Street
Mifflin, Ohio 44805

Inspection Date: May 3, 2022

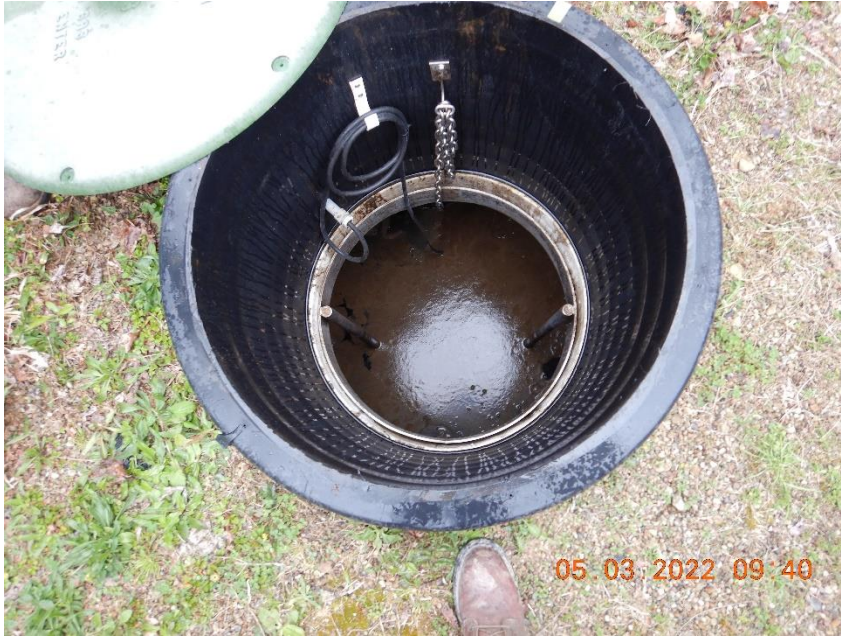
2: DSCN3842

Description: EPA observed that the west floating decanter (second decantor) in the sequencing batch reactor tank was off its guide rails at the time of inspection. Plant operators began realigning the decantor back on the guide rails immediately after the issue was observed during the facility walk-through.

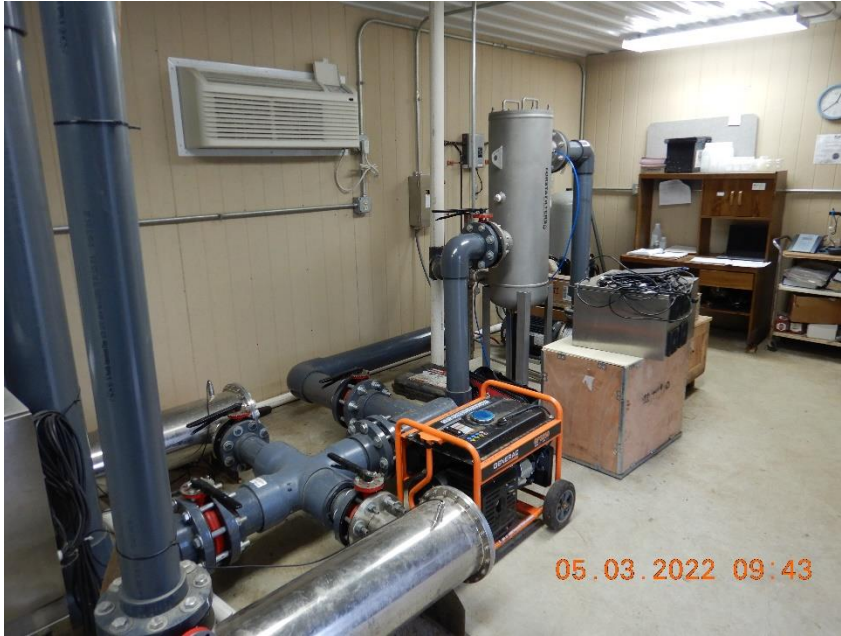
6: DSCN3846

At the time of inspection, only one of the two ultraviolet (UV) disinfection system units were operational. One UV system was damaged due to a lightning strike in the summer of 2020, according to Mr. Abraham. The UV unit was not grounded when it was first installed. It took over a year to receive all the replacement parts including a new panel, bulbs, and wiring. All the parts have been received and the damaged UV system will be repaired in the coming weeks after the inspection and grounded appropriately to avoid future damage due to lightning strikes.

6. During the inspection, only one of the two UV light disinfection units was operational. The second UV disinfection unit had been damaged in a lightning strike in the summer of 2020, due to the unit not being grounded properly in the original installation. Replacement parts took over a year to procure due to supply chain and shipping issues, according to Mr. Abraham. At the time of inspection, the replacement parts were on-site and expected to be installed in the coming weeks.

Description: Interior of facility control building. The Forsta Filter unit (vertical cylinder) and two UV treatment units (horizontal cylinders (lower left corner of photograph) are visible in the photograph. Only one UV tube is operational due to a lightening strike that damaged the unit. Replacement parts for repairs are on site to be installed.

- One of two UV disinfection units was not operating at the time of inspection. The replacement parts for the damaged UV disinfection unit were on site and expected to be installed in the coming weeks. According to Part III., Item 3.A. of the NPDES permit for this facility, “At all times, the permittee shall maintain in good working order and operate as efficiently as possible all treatment or control facilities or systems installed or used by the permittee necessary to achieve compliance with the terms and conditions of this permit.”

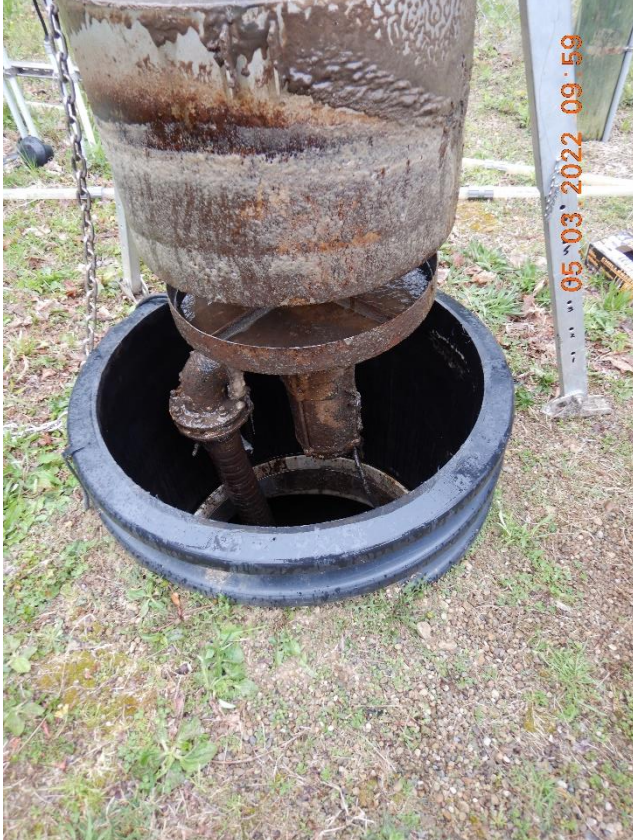
7: DSCN3847

7. Mr. Abraham stated during the inspection that the pan installed on the lower end of each of the floating decanters in the SBR need to be removed or have holes drilled in the pans to allow the sludge to drain out of the pans before the decanting sequence begins. During the mixing sequence, sludge solids settle in these pans. When the pumps turn on to begin the decanting sequence, and the pans are below the liquid level in the SBR, the solids settled in the pans are decanted off with the decanted liquid from the SBR.

Description: West floating decanter removed from sequencing batch reactor for reattachment to guide rails. During mixing sequences, sludge solids settle in the pans. Due to the design, the pans on the lower ends of the decanters do not drain. When the pans are below the liquid level in the tank and the decanting sequence begins, these solids are decanted off with the decanted liquid.

Mr. Abraham stated during the inspection that the pan installed on the lower end of each of the floating decanters in the SBR need to be removed or have holes drilled in the pans to allow the sludge to drain out of the pans before the decanting sequence begins. As described later in this report under the subsection "Sewage Sludge Management," during the mixing sequence, sludge solids settle in these pans. When the pumps turn on to begin the decanting sequence, and the pans are below the liquid level in the SBR, the solids settled in the pans are then decanted off with the decanted liquid from the SBR. Mr. Abraham stated that the pans either need to be removed or have holes drilled in the pans to allow the sludge to drain out of the pans to alleviate this problem of decanting sludge with the effluent.

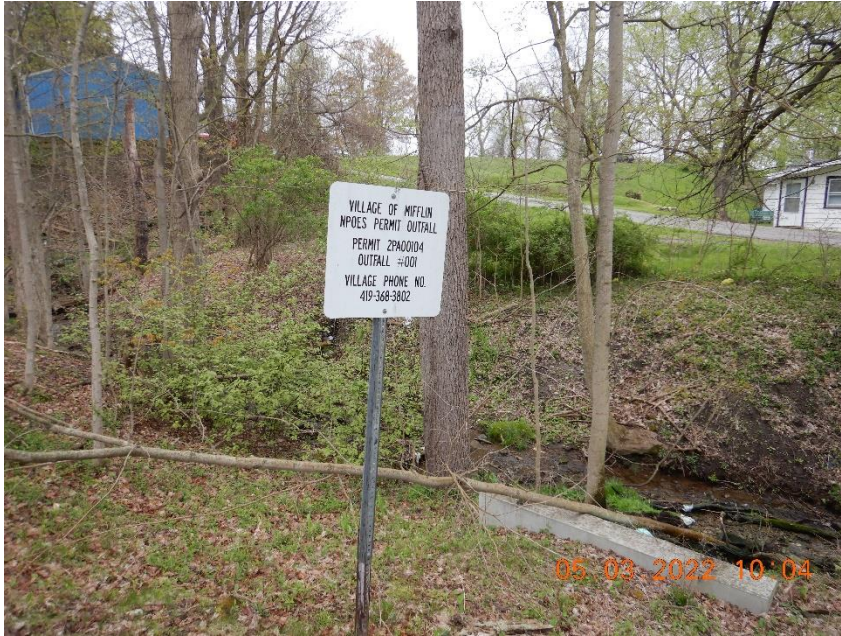
9: DSCN3849

EPA observed a permanent sign installed on the streambank at the outfall discharge. The sign is positioned such that the wording faces north towards Maine Street and would not be visible to persons viewing the outfall from the unnamed tributary unless they were standing in the creek at the outfall on the east side of the stream. To anyone observing the outfall from the west bank of the creek, the sign would not be readable from all vantage points. Refer to photograph 9 of the photograph log.

Description: Outfall signage at Outfall 001 did not appear to meet the minimum permit requirement of 2 feet by 2 feet. The sign is positioned such that it would not be readable from the opposite bank across from the outfall.

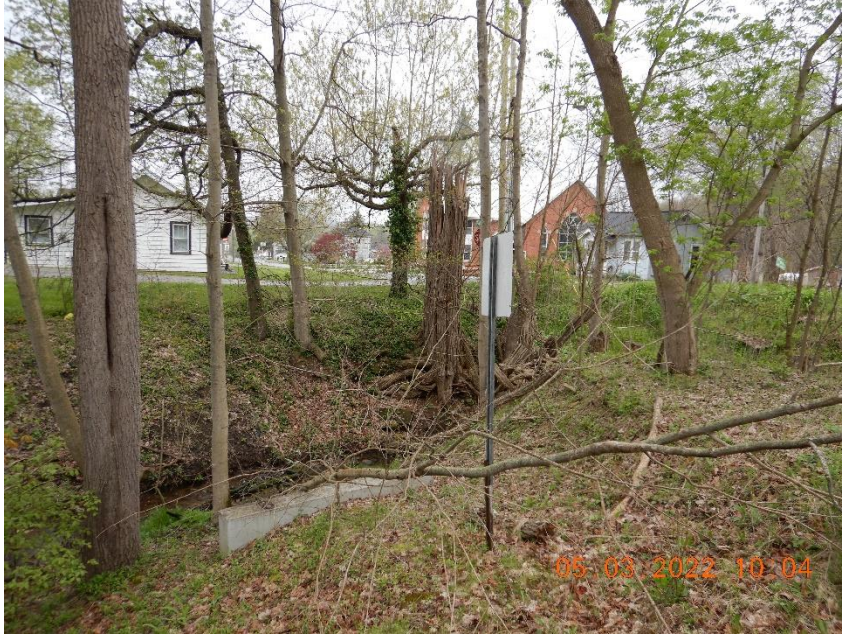
10: DSCN3850

Description: View looking towards Outfall 001 and the backside of the Outfall 001 signage. The concrete bulkhead for Outfall 001 is visible in the lower left of the photograph. The surface waterbody flows from the lower left corner of the photograph towards the center right of the photograph.

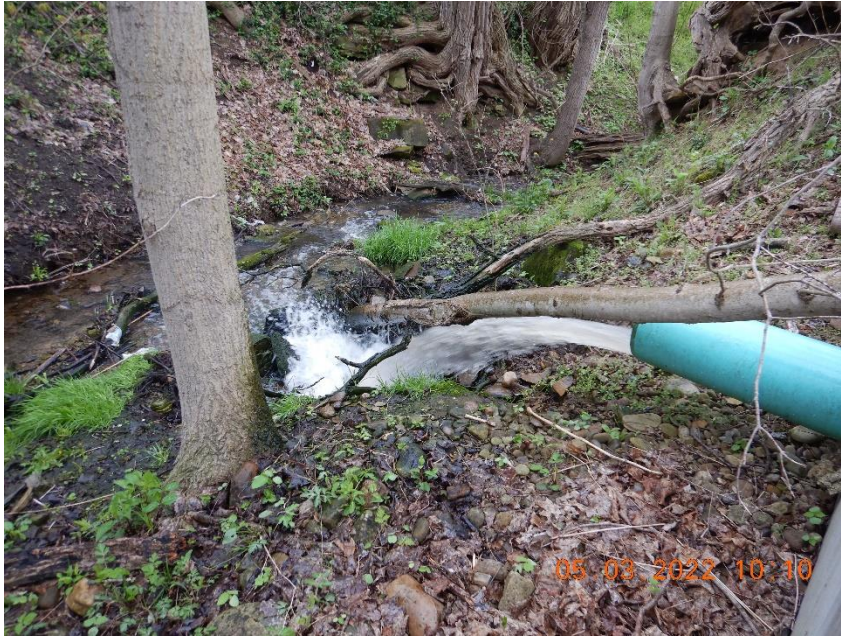
11: DSCN3851

There were no observable oil sheen, color, foam, or recognizable plumes in the receiving waters (Photographs 10 and 11) observed by EPA. Inspector Vincent observed two pieces of small white cloth or plastic trapped on debris adjacent to the outfall; however, it could not be determined if the cloth/plastic was from the outfall or general litter from the adjacent roadway area (Photographs 9, 11, and 12). The receiving waters are accurately described in the permit. During the inspection, the one of the plant operators activated the sequencing batch reactor pumps so that EPA could observe the effluent discharge at Outfall 001. EPA did not observe any oil sheen, floating solids, or abnormal color in the effluent discharging into the unnamed tributary (Photographs 11 and 12).

Description: Being a batch system, the operators activated the pumps so that EPA could observe effluent flow at the outfall. Operators estimate that the effluent flow at the outfall is approximately 210 gallons per minute.

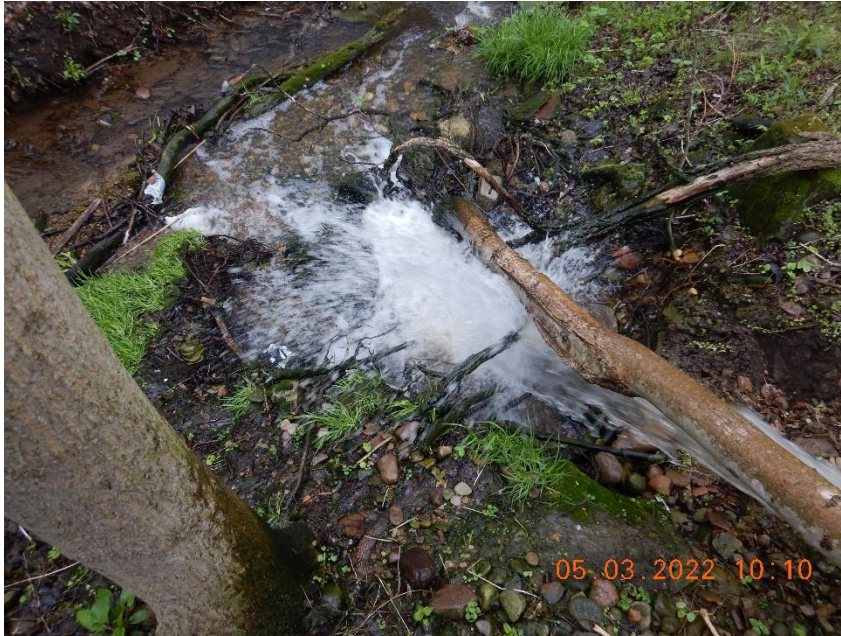
12: DSCN3852

Description: Close-up photograph of Outfall 001 effluent.

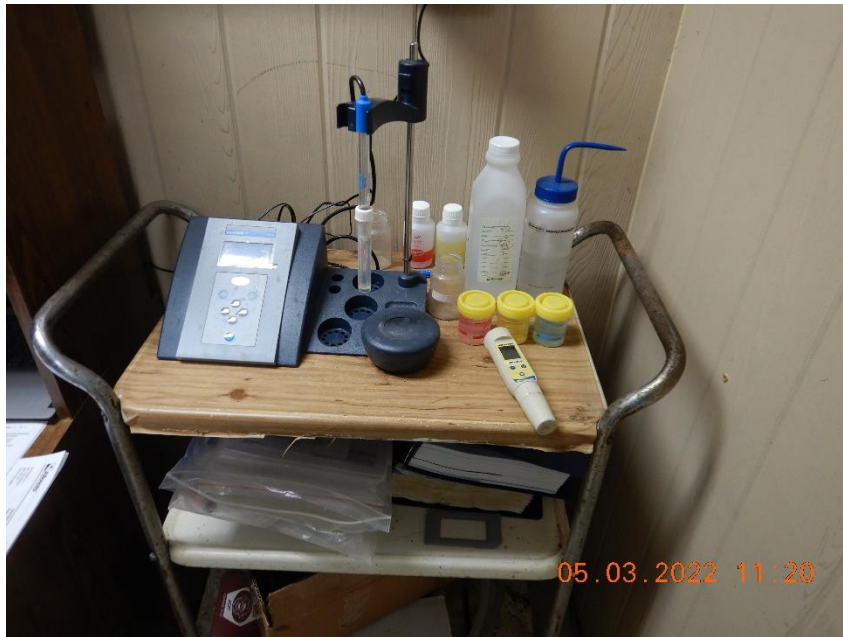
15: DSCN3855

Description: Monitoring bench for DO and pH within the facility control building. The Hach pH meter (left side of bench) does not calibrate appropriately, therefore, the operators are using the Oakton pHTestr 30 pH meter (right side of bench).

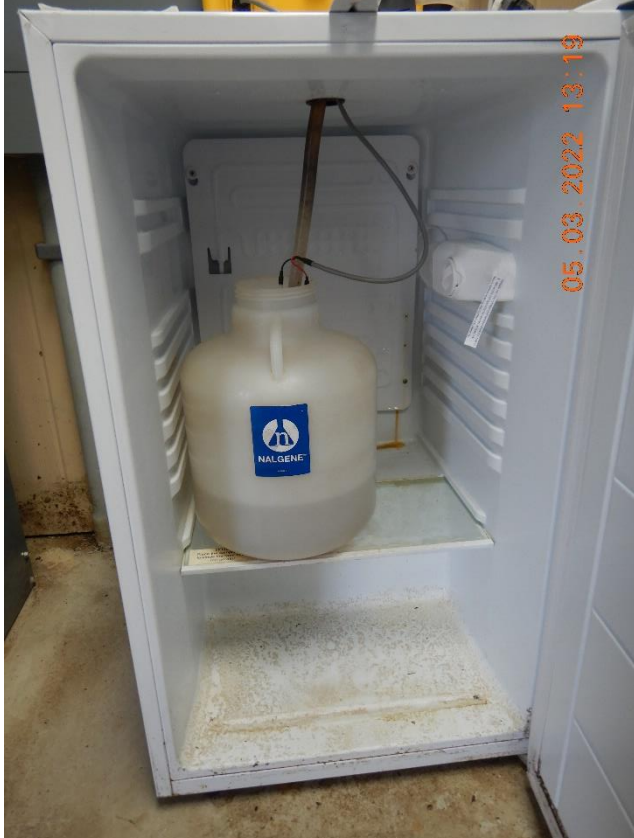
19: DSCN3859

Inspector Vincent observed the automatic sampler refrigerated compartment. There was no thermometer present to monitor and verify the temperature of the composite sample. Composite sampler tubing appeared to be free of debris and loops.

Description: Refrigerator unit for the composite sample jug from the automatic sampler. No thermometer present to verify temperature.

- Although there is a current plan in place to add a sludge holding tank for wasted sludge and a trash trap to the WWTP in order to improve the effectiveness of the system, there are still ongoing effluent violations resulting in self-reported noncompliance.
- USEPA noted that there was no visible thermometer in the automatic sampler refrigerated compartment to verify the temperature.
