RCRA Compliance Branch
INSPECTION REPORT

| Inspection Date(s): | 2/1/2024 | Inspection Announced: No |
| Facility or Site Name: | Jersey Cooperage Co. Inc. | |

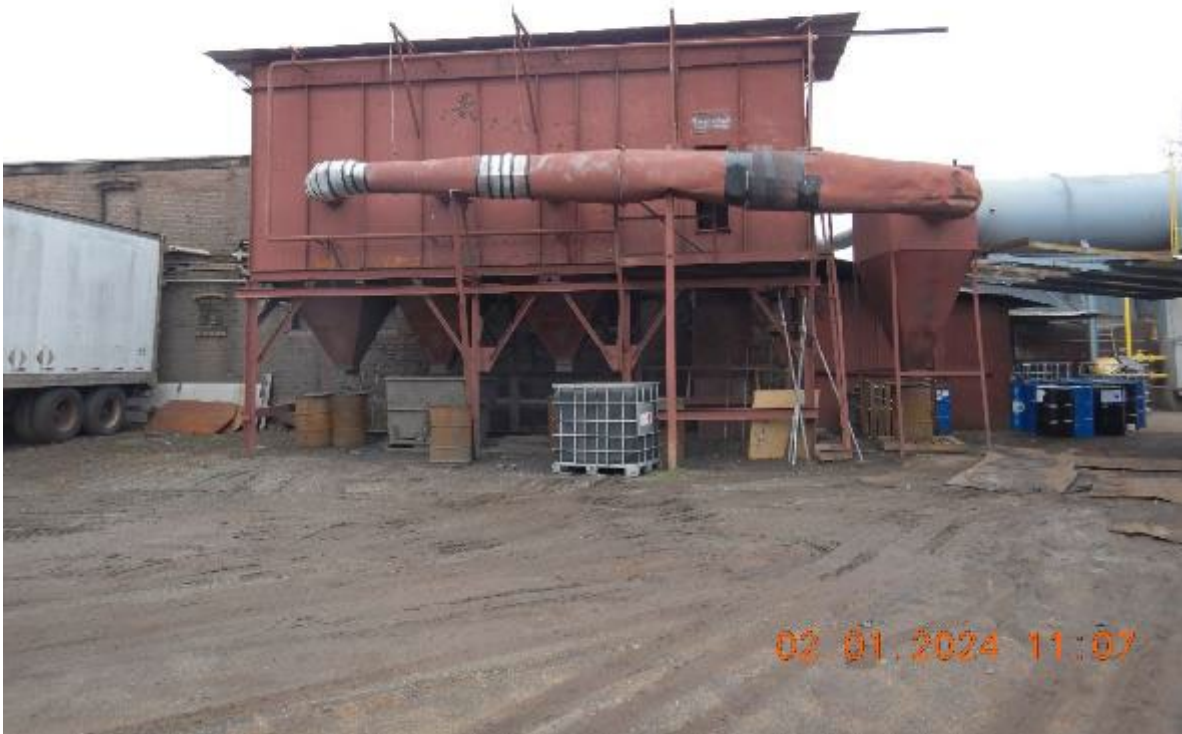
{Photograph 25, Attachment 1}

The inspection team observed two shot blast units that are located inside the facility building and used to surface prep and remove any remaining paint or oxidized material on the drums prior to painting. The facility uses a steel shot blast media. Spent shot blast media and other fines generated from the process are collected via a baghouse system and emptied into an open top container or 55-gallon drums, as shown in Photograph 25 and 27. The spent shot blast media and other fines are combined in the incinerator ash roll-off container for off-site disposal as non-hazardous waste.

View of the baghouse system connected to the shot blast units, which are inside the building. Spent media and fines are collected in 55-gallon drums and other open-top containers.

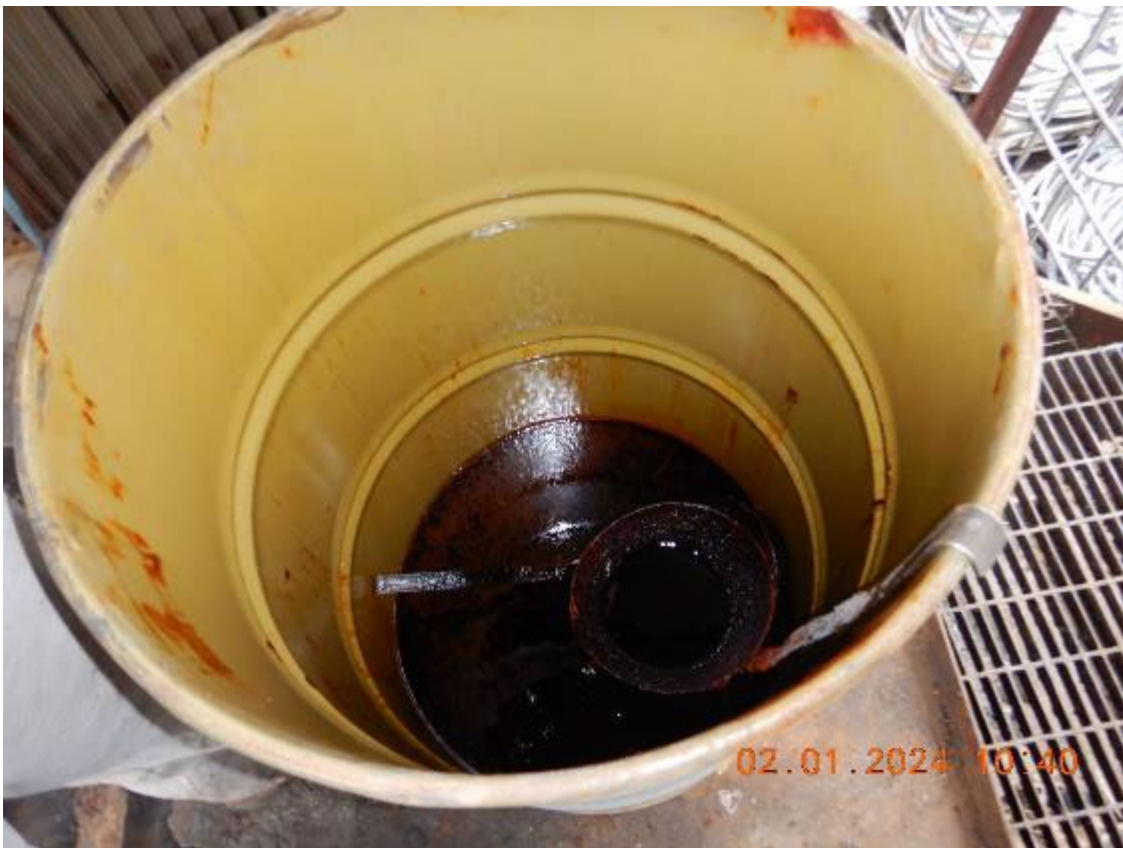
{Photograph 3, Attachment 1}

The inspection team observed the incinerator and drum loading area, where 55-gallon drums are received on site and placed on a conveyor into the incinerator. A 55-gallon drum was present at the point that containers are loaded onto the conveyor, which contained a liquid material and a ladle (see Photographs 2 and 3). Mr. Foglia and Mr. Vega explained that if any residual material is present in the drums received on-site, it will be drained into this drum. Additionally, if a drum is completely dry, a small amount of the collected material will be ladled into the drums prior to loading onto the conveyor, to improve the efficiency of the incineration operation. Mr. Vega stated that the facility does not accept drums that have more than one inch of residual material present. The EPA inspection team did not observe drums received at the facility for processing that had any readily observable residual material.

View inside the 55-gallon drum where residual material from drums received on-site is collected, and then ladled back into containers to improve incineration operations. Located adjacent to the conveyor line into the incinerator.

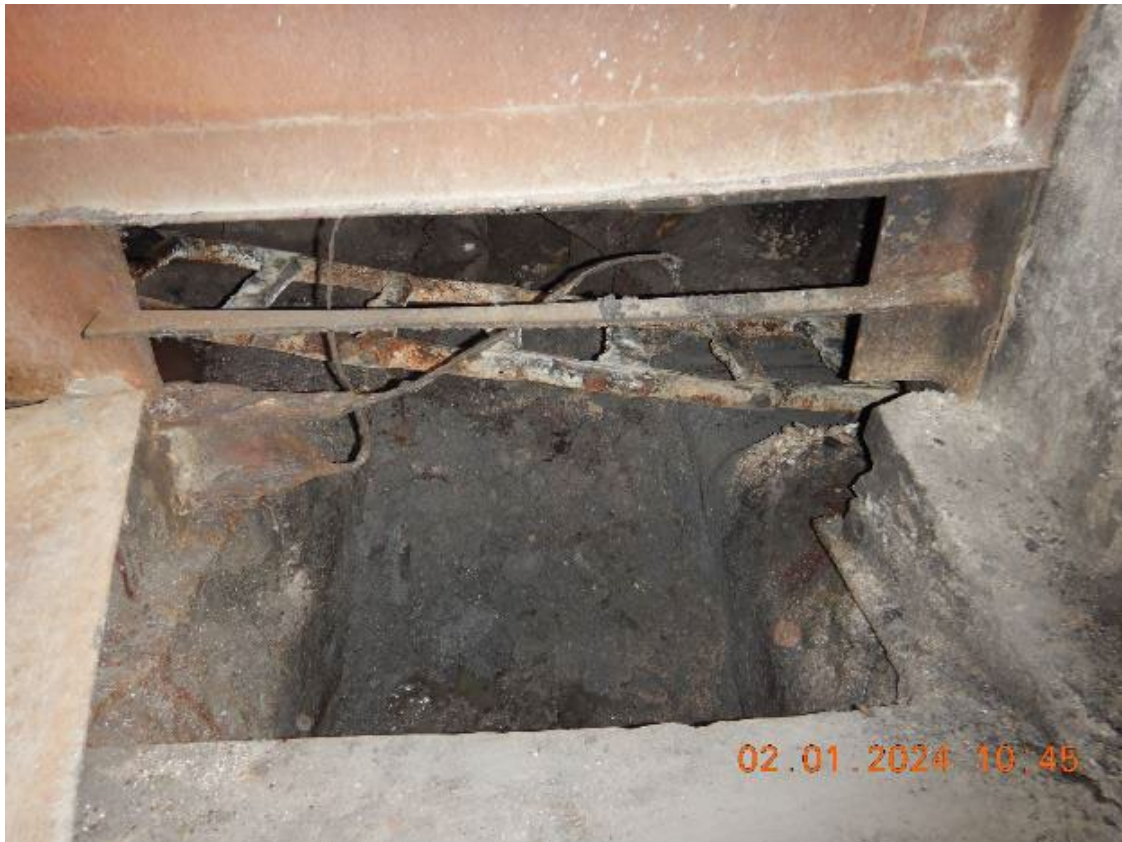
{Photograph 6, Attachment 1}

Under the conveyor and combustion chamber associated with the incinerator, the inspection team observed a pit where incinerator ash and residual materials from the drums could be collected (see Photographs 5 and 6). It appeared that the pits were concrete lined. The pits are

reportedly cleaned at a certain frequency, placed into 55-gallon drums and ultimately emptied into the incinerator ash roll-off container for off-site disposal as non-hazardous waste.

View of one of the pits located beneath the conveyor and combustion chamber of the incinerator. Ash and other residual material may drop into these pits and they are emptied at certain intervals.

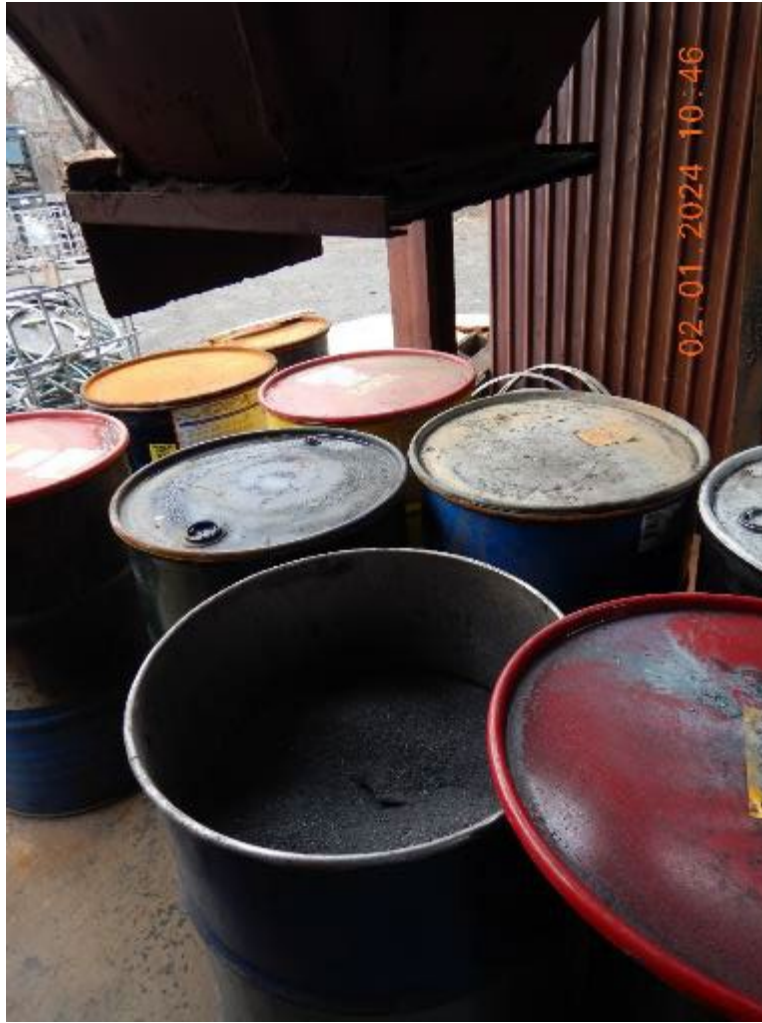
{Photograph 7, Attachment 1}

Incinerator ash fines that are captured after the thermal oxidizer in a baghouse are collected in 55-gallon drums (see Photograph 7). The 55-gallon drums are then emptied into the incinerator ash roll-off container for off-site disposal as non-hazardous waste. A number of drums were observed in this area, some of which contained incinerator ash from the baghouse, and some that were generated from clean-outs of the pits beneath the incinerator. Mr. Pilco stated that the equipment they use to empty the drums into the roll-off container was currently broken, otherwise they would not have so many 55-gallon drums of the incinerator-related wastes stored at one time. None of the drums were labeled as to their contents.

View of one of the pits located beneath the conveyor and combustion chamber of the incinerator. Ash and other residual material may drop into these pits and they are emptied at certain intervals.

1. At the time of the inspection, several 55-gallon drums were observed throughout the facility without labels, including non-hazardous waste containers. The facility confirmed that none of these drums contained hazardous waste, however, Jersey Cooperage should consider, as a best management practice, marking or labeling its non-hazardous waste containers, as well, to avoid confusion regarding their contents.

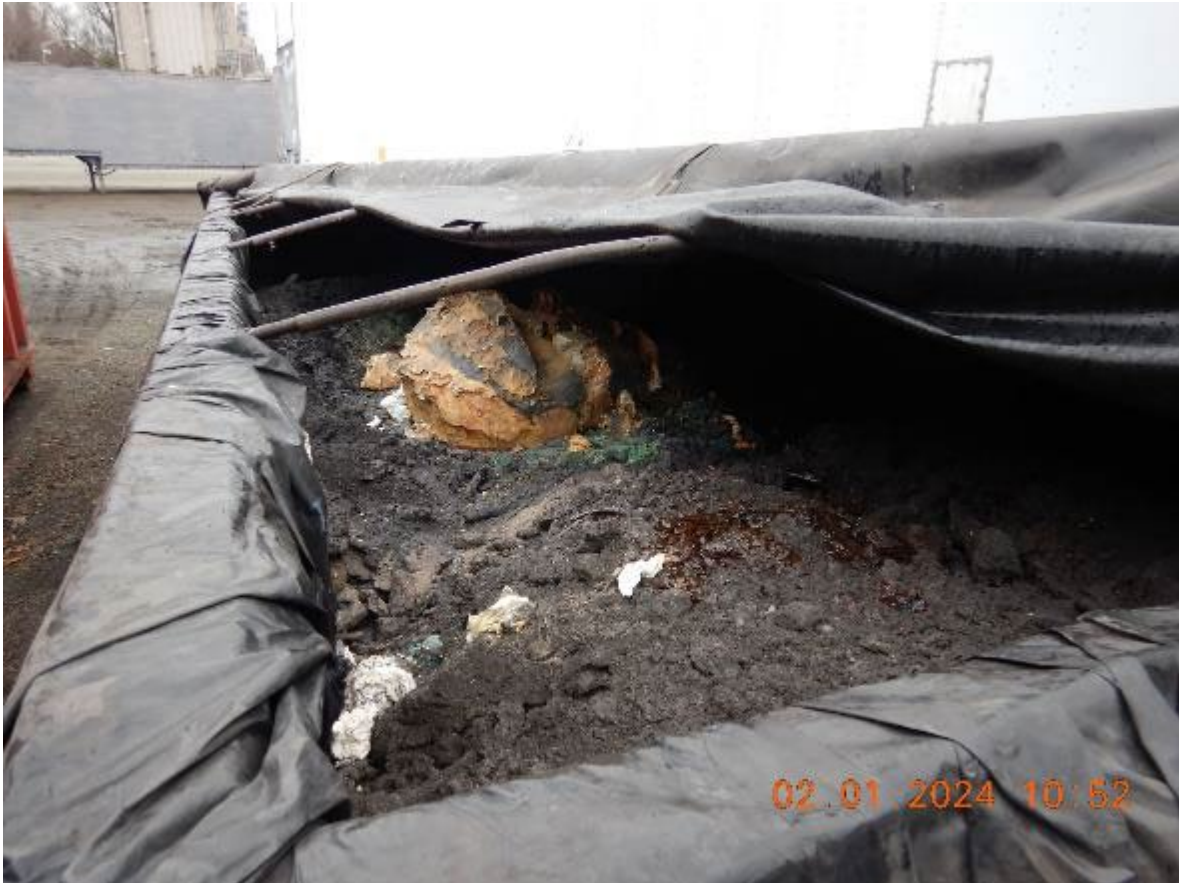
{Photograph 12, Attachment 1}

The inspection team observed the roll-off container where incinerator ash collected from the baghouse, incinerator ash and residual from the incinerator pits, and spent shotblast media and fines are emptied. The roll-off is covered with a plastic tarp when material is not actively being added. Mr. Pilco pulled back the tarp on the roll-off so that the material could be observed. When the tarp was removed, a notable odor was observed by the inspection team.

View inside the roll-off container that contains the incinerator ash and other mixed wastes. A noticeable odor was observed when the cover was removed.
