## **PURPOSE OF INSPECTION**

The purpose of the inspection by the U.S. Environmental Protection Agency (USEPA) at the Tilden Mining Company L.C. mine (Tilden) of the Cleveland-Cliffs Inc. facility (Cliffs or Facility) in Ishpeming, Michigan was to describe, evaluate, and document compliance with the Clean Water Act (CWA) and their National Pollutant Discharge Elimination System (NPDES) permit.

**Cleveland Cliffs Inc. – Tilden and Empire Mine**  
**EPA Inspection 9/13/2022 – 9/15/2022**  
**Photomap Overview**

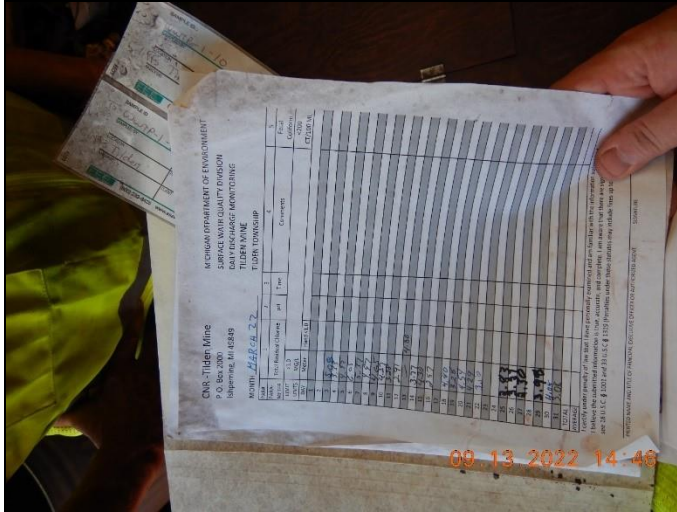
1: DSCN0960.JPG

Description: Residual chlorine bench sheet from the sewage treatment system at Tilden.

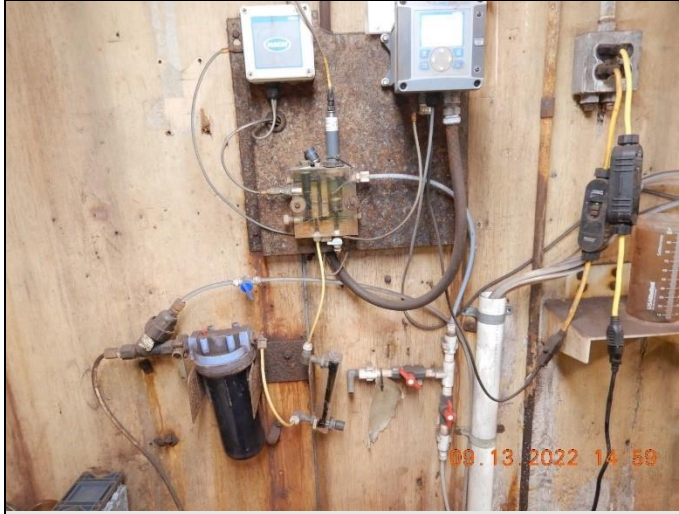
3: DSCN0962.JPG

- Chlorine measurements for compliance purposes at the Tilden wastewater treatment plant are collected with a continuous chlorine analyzer, which was equipped with a free chlorine reagent that would not provide a total chlorine residual value.

Description: Continuous chlorine analyzer at the Tilden sewage treatment system. The chlorine probe was labeled for free chlorine analysis.

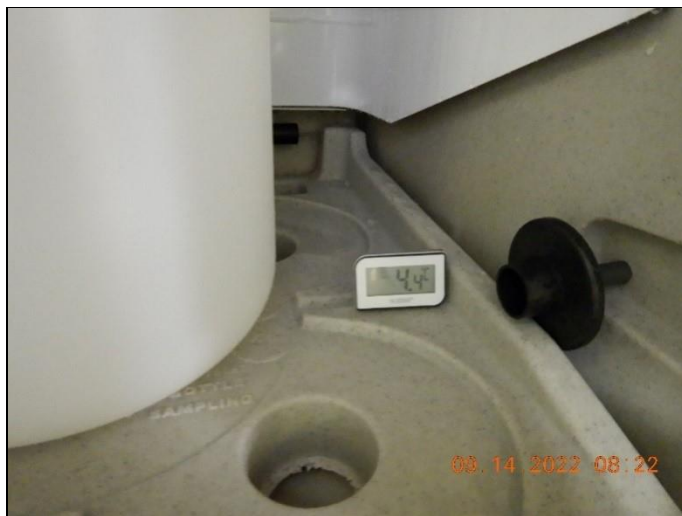
9: DSCN0968.JPG

Description: Non-NIST traceable thermometer at the location shown in photo 8.

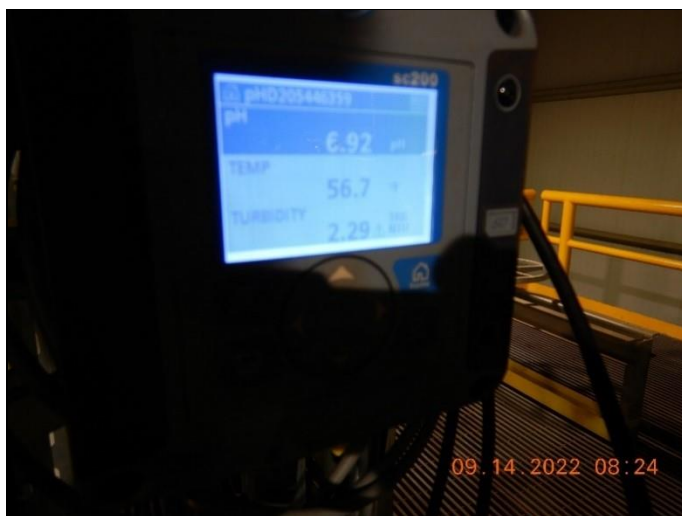
11: DSCN0970.JPG

Description: pH, temperature and turbidity measurements on train #2 at the treatment facility for the Tilden tailings basin discharge. Per Michael Korvela, these continuous measurements are for operational purposes only. At the time of the inspection, the turbidity measurement had an active alarm.

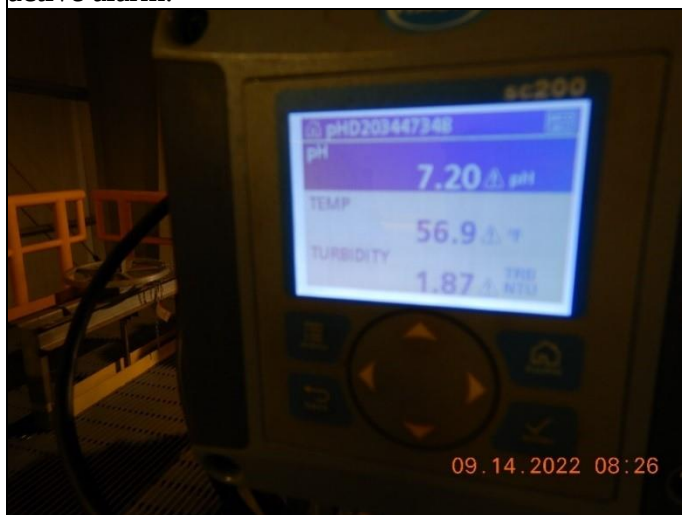
12: DSCN0971.JPG

Description: pH, Temperature and Turbidity measurements on train #1 at the treatment facility for the Tilden tailings basin discharge. Per Michael Korvela, these continuous measurements are for operational purposes only. At the time of the inspection, pH, temperature, and turbidity all had active alarms.

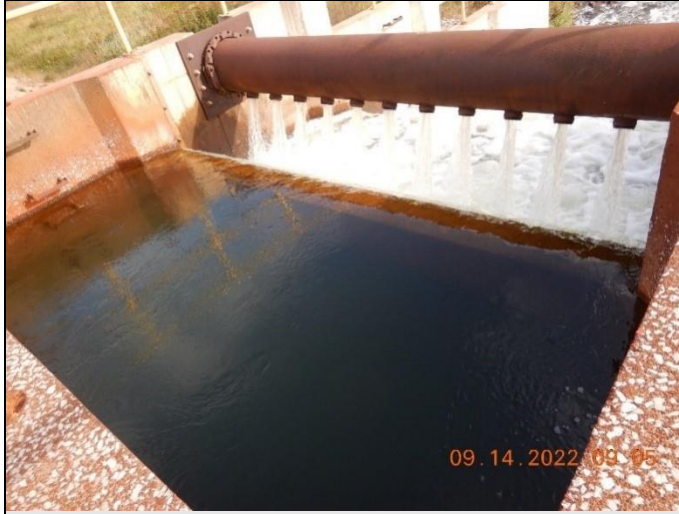
14: DSCN0978.JPG

Description: Discharge structure at the Tilden tailings basin treatment facility. This is where monitoring for Outfall 002A and 002B is collected. The diffuser structure brings in replenishment water for augmenting the discharge to meet the water quality based effluent limits. Location of monitoring point 01.

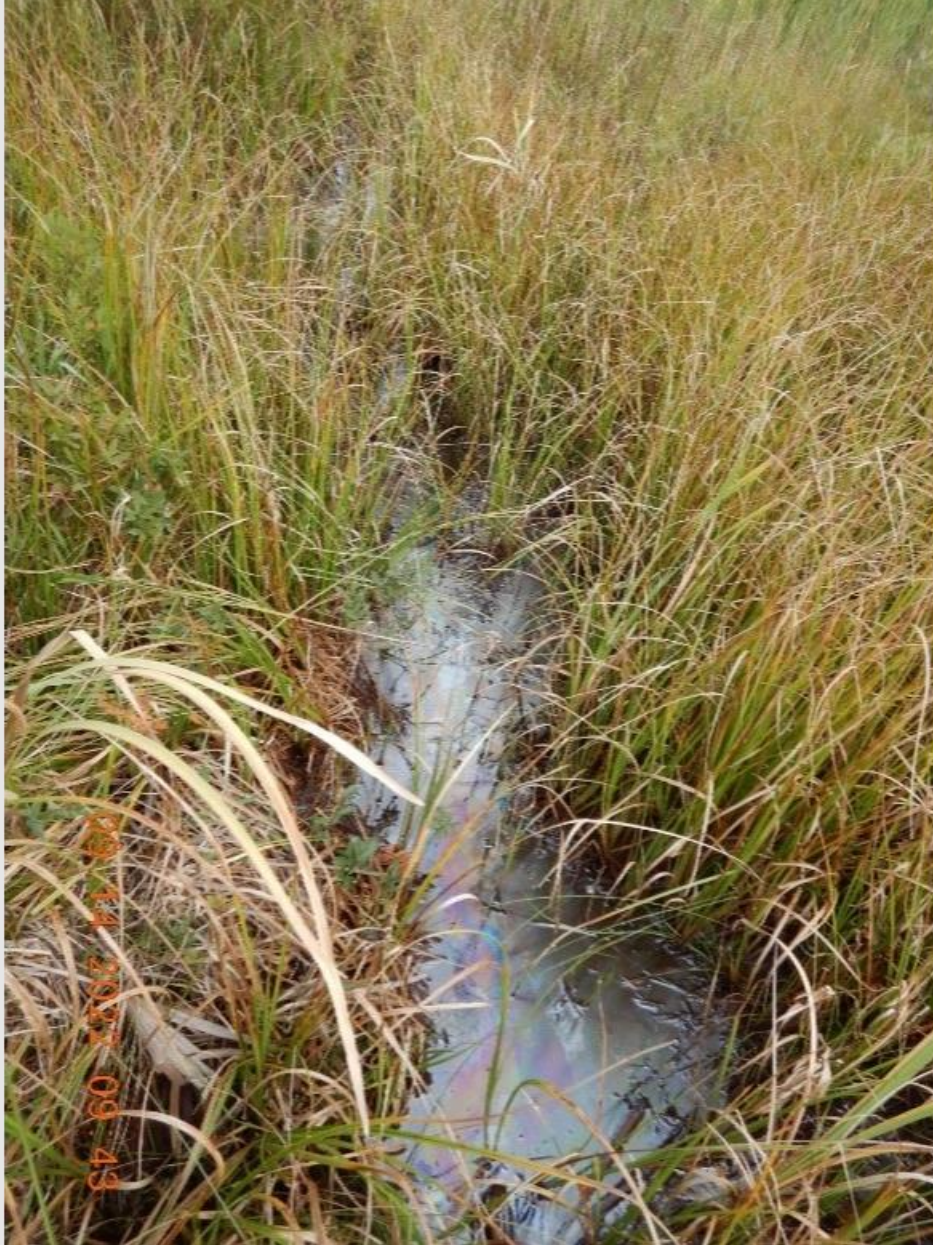
- USEPA observed and conducted field monitoring on flowing water originating from a location near the toe of the outslope of the east side of the Tilden tailings basin, at a location north of the Gribben Clarification Facility. The waterway is shown in photos 19 through 24, including a video of the flowing water. This location is a possible daylighted seep, which is not monitored as an NPDES outfall, stormwater monitoring location, nor an SSMP location. USEPA field monitoring at this location showed a conductivity of greater than 1,000  $\mu\text{S}/\text{cm}$ , which is above the background values.

Description: Location of possible daylighted seep at the east side of the tailings basin. Flow was visible The water had an iridescent sheen.

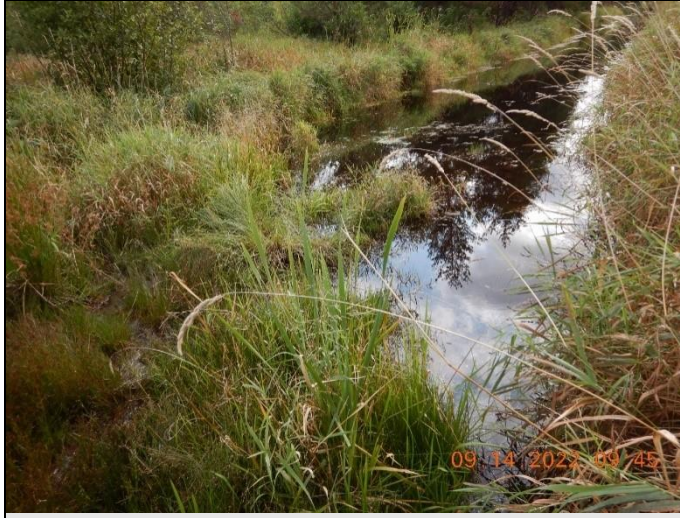
21: DSCN0985.JPG

| Monitoring Point | Description | Photo Number | Date Time | Temperature (°C) | pH (SU) | Specific Conductivity (µS/cm) | DO Concentration (mg/L) |
|---|---|---|---|---|---|---|---|
| 04 | Possible location of daylighted seep at a location east of the Tilden tailings basin and north of the tailings basin treatment building. | 21 | 9/14/2022 10:51 | 11.69 | 6.99 | 1054.69 | 5.24 |

Description: Location of possible daylighted seep at the east side of the tailings basin. Camera is facing downstream. Location of monitoring point 04.

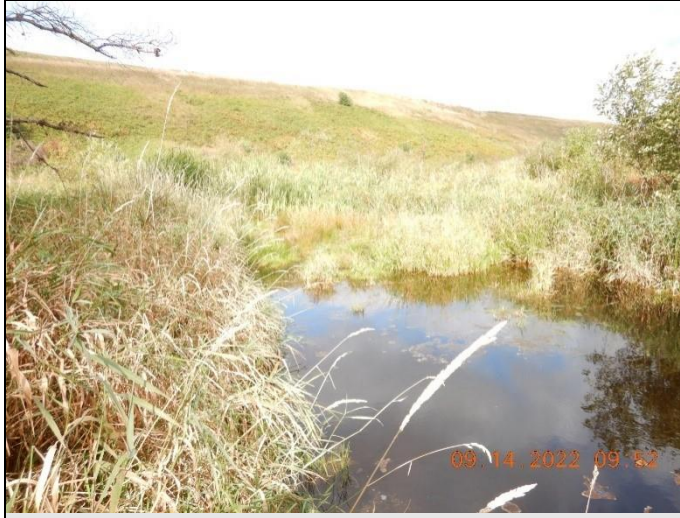
23: DSCN0987.JPG

Description: Location of possible daylighted seep at the east side of the tailings basin. The water had an iridescent sheen. Camera is looking upstream at the outslope of the tailings basin.

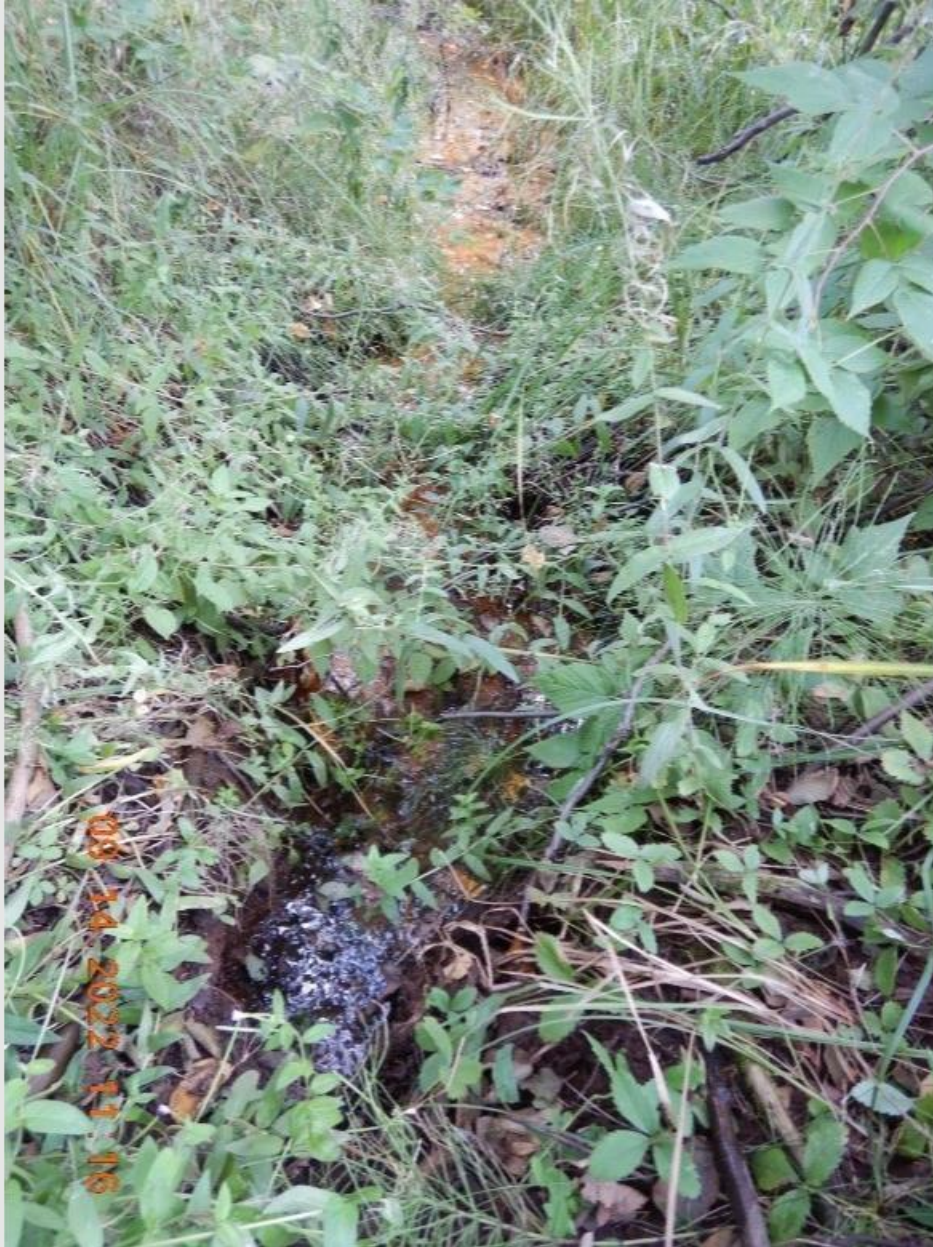
- USEPA observed and conducted field monitoring of flowing water originating near Hoover Pond impoundment of process water. Water flowing from inside culvert connected to impoundment was originating from an unspecified source. Northeast of the culvert is a possible daylighted seep and EPA field monitoring at this location showed a conductivity of greater than 900  $\mu\text{S}/\text{cm}$ , which is above the background values. The waterway, culvert, and possible daylight seep are depicted in photos 29 through 32.

Description: Northeast of the location of the downstream end of the culvert shown in photo 29. Possible location of a daylighted seep. At the time of the inspection the water shown in this photo was flowing and had a red/orange discoloration.

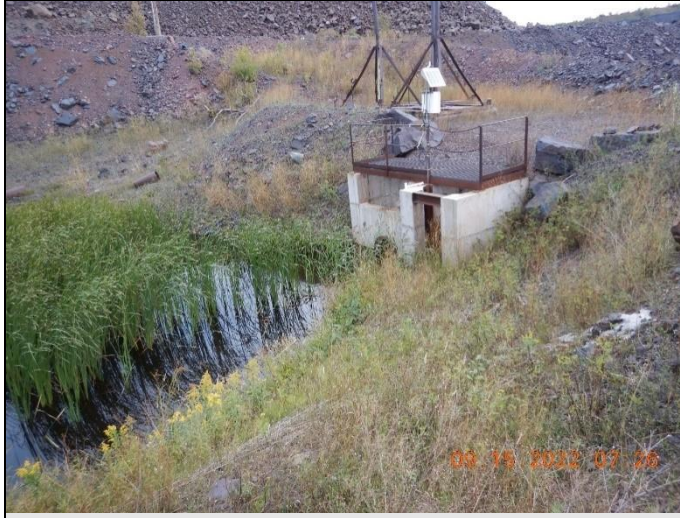
37: DSCN1001.JPG

- During the inspection, USEPA observed waste material from mining operations adjacent to a waterway known as Partridge Creek. Runoff from the slopes of the waste material would drain into a waterway flowing through a historic outfall 003. This is shown in Photos 37 through 42. The Facility representatives stated that NPDES compliance monitoring was no longer being conducted at this location because the discharge was not considered a wastewater. A copy of a cover letter from Michigan Department of Environmental Quality (now EGLE) on June 29, 2017, transmitting the compliance evaluation inspection notes from an April 27, 2017, visit at the Empire Mine (MI0000094) was given to EPA. The June 29, 2017, cover letter was provided as the record of the approval from EGLE. The June 29, 2017, letter references a low selenium concentration and no active mine pit dewatering as justification for changing the NPDES permit, which had expired in 2016.

Description: Historic Empire outfall 003. At the time of the inspection, water flowing from this location was

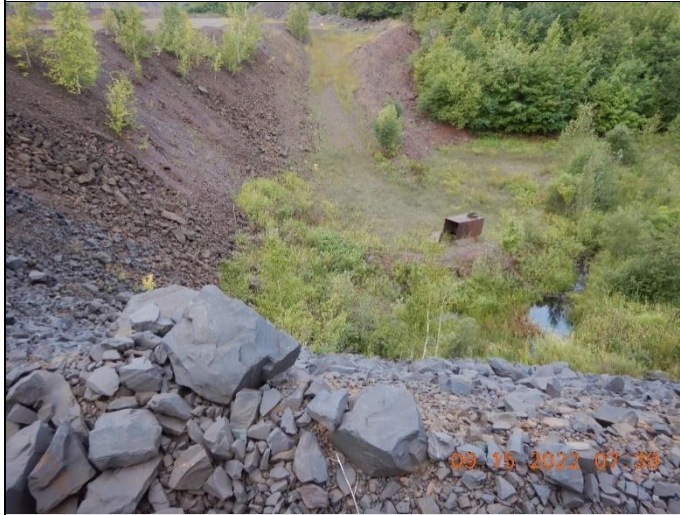
42: DSCN1006.JPG

Description: Area tributary to Partridge Creek. Runoff from this area is tributary to the control structure shown in photos 37 through 41.

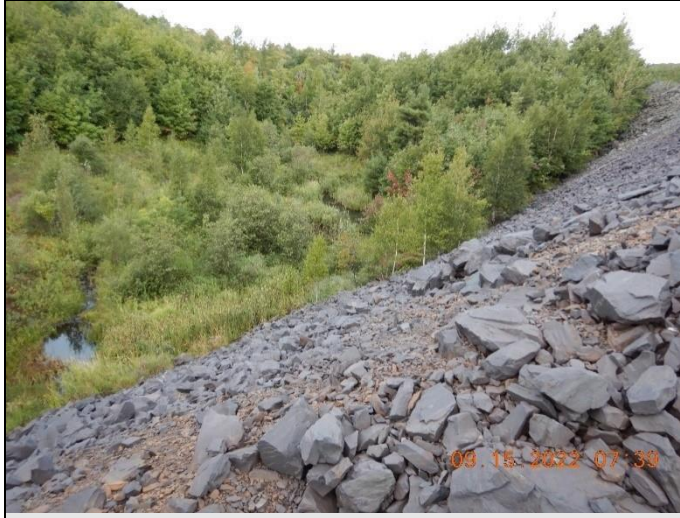
43: DSCN1007.JPG

Description: Area tributary to Partridge Creek. Area tributary to Partridge Creek. Runoff from this area is tributary to the control structure shown in photos 37 through 41.

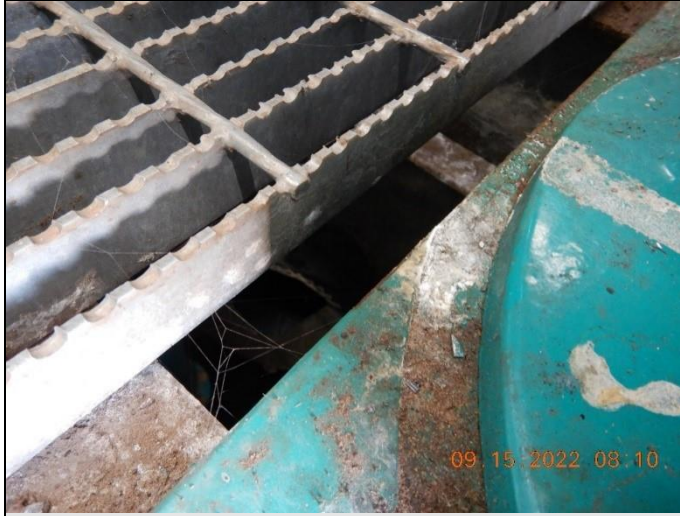
49: DSCN1013.JPG

Description: An overflow weir could be seen under the grating in the pump house for location CC-95. The water level in the wet well for this pump station was below the overflow weir elevation. If the water level in the wet well exceeds the weir it will discharge out the structure shown in photo 45.

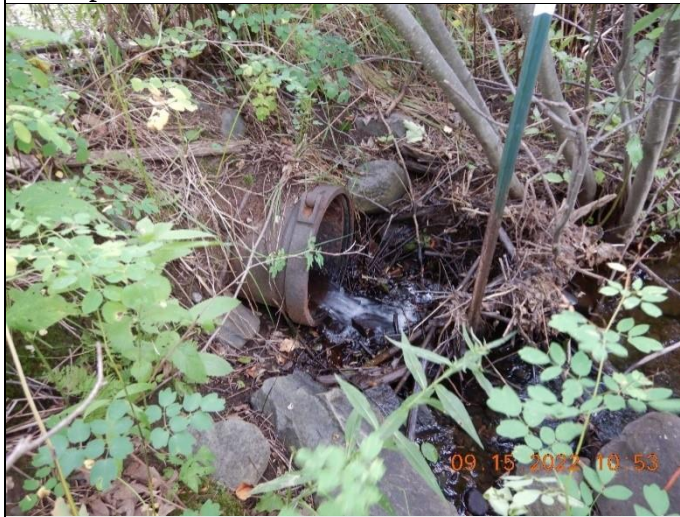
59: DSCN1023.JPG

- Stormwater monitoring location 'M' or CC-93: the SWPPP shows that the rock stockpiles are a source of exposure in the tributary to this location. Field monitoring conducted by USEPA showed a conductivity of 585  $\mu\text{S}/\text{cm}$ , which is above the background values. At the time of the inspection, this stormwater monitoring location was flowing despite dry weather conditions.

Description: At the location of the stormwater monitoring location 'M' or CC-93.

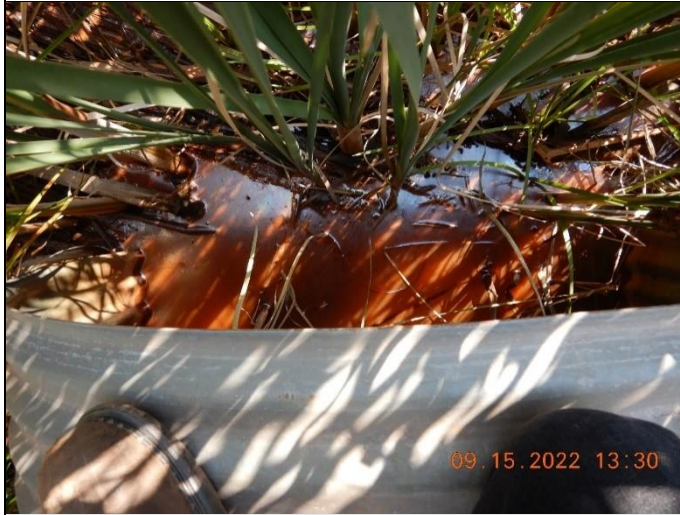
63: DSCN1027.JPG

- Locations CC-291 and CC-292 were not in the current version of the SWPPP available during the inspection, and are not associated with an NPDES outfall. USEPA field monitoring during the inspection showed a specific conductivity of 623  $\mu\text{S}/\text{cm}$  and 439  $\mu\text{S}/\text{cm}$  respectively. At the time of the inspection, these monitoring locations were flowing despite dry weather conditions.
- During the inspection, USEPA observed unvegetated rock piles in the tributary for the water flowing to the control structure for the historic Empire outfall E003.
- Several on-site water bodies present with dark orange coloring, suggesting high levels of iron and conductivity within the water.
  - Stormwater monitoring location '13' or CC-179, was visited during the inspection. The water at this location had an unnatural red color and is shown in photo 63.

Description: At the location of the stormwater monitoring location '13' or CC-179. This was the upstream end of a culvert under the County Road 476. At the time of the inspection, the water in this culvert had an unnatural red color. EPA monitoring location 18.
