**UNITED STATES ENVIRONMENTAL PROTECTION AGENCY**  
**REGION 5**  
**77 WEST JACKSON BOULEVARD**  
**CHICAGO, ILLINOIS 60604**

**SUBJECT:** CLEAN WATER ACT INSPECTION REPORT  
*Suburban Acres Mobile Home Park, Warsaw, Indiana*

**Facility Name:** Suburban Acres Mobile Home Park

**Date(s) of Inspection:** April 2, 2025

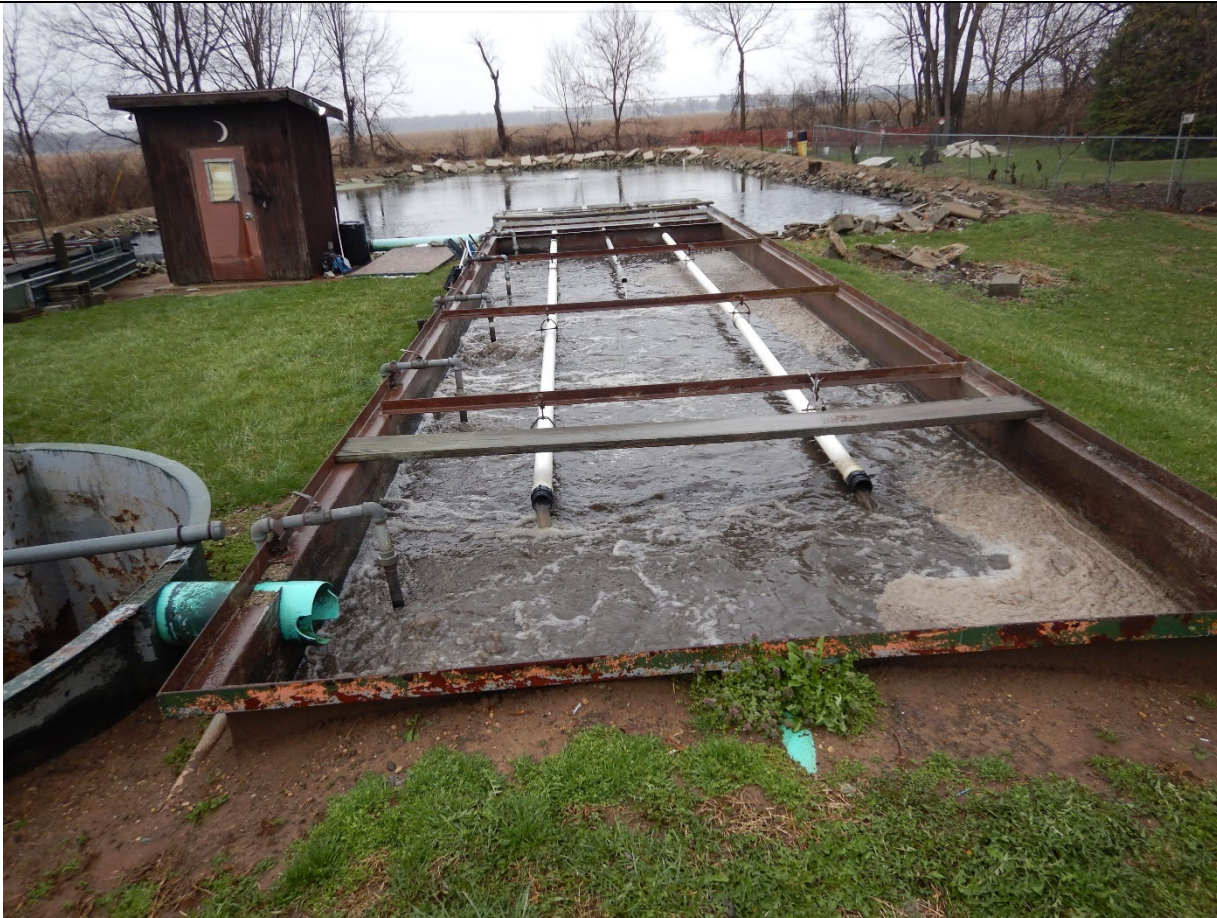
**5: DSCN2450.JPG**

The plant has two aeration basins, east and west. At the time of the inspection the east basin had brown foam on the surface (Photos 5, 25, and 26). The clarifier on the east basin had scum accumulating on the surface (photos 6, 7, and 8).

- The west aeration basin had brown foam on the surface (photos 5, 25 and 26),
- There was scum on the surface of the west aeration basin clarifier (photos 6, 7, and 8)
- The east aeration basin clarifier had flocs moving up toward the surface indicative of high flows or disruptions in the clarifier flow (Photo 14 and videos 15 and 16),
- The flocs in the east aeration basin were visible flowing over effluent weir (photos 10, 11, 14 and video 12),
- Excessive black solids material was present in the southern end of the polishing pond (photos 30 and 31),
- Excessive algae growth was present at the north end of the polishing pond (photo 36),
- An electrical pole and tree stumps were present on the inside edge of the berm surrounding the pond (photos 36 and 37).

Description: East aeration basin at the sewage treatment plant. Brown foam was on the surface of the aeration basin.

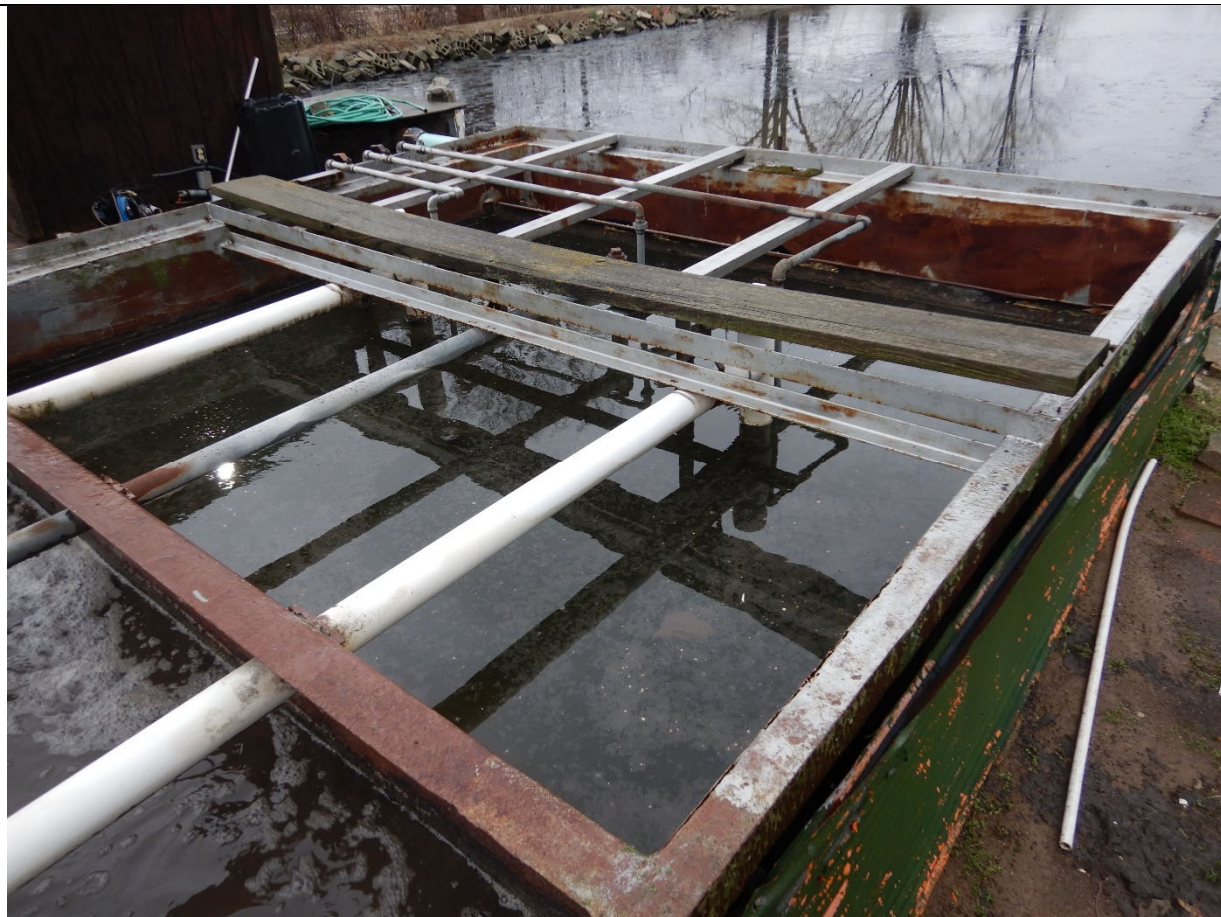
**6: DSCN2451.JPG**

Description: The east aeration basin, at the time of the inspection there was solid material floating on the surface of the clarifier.

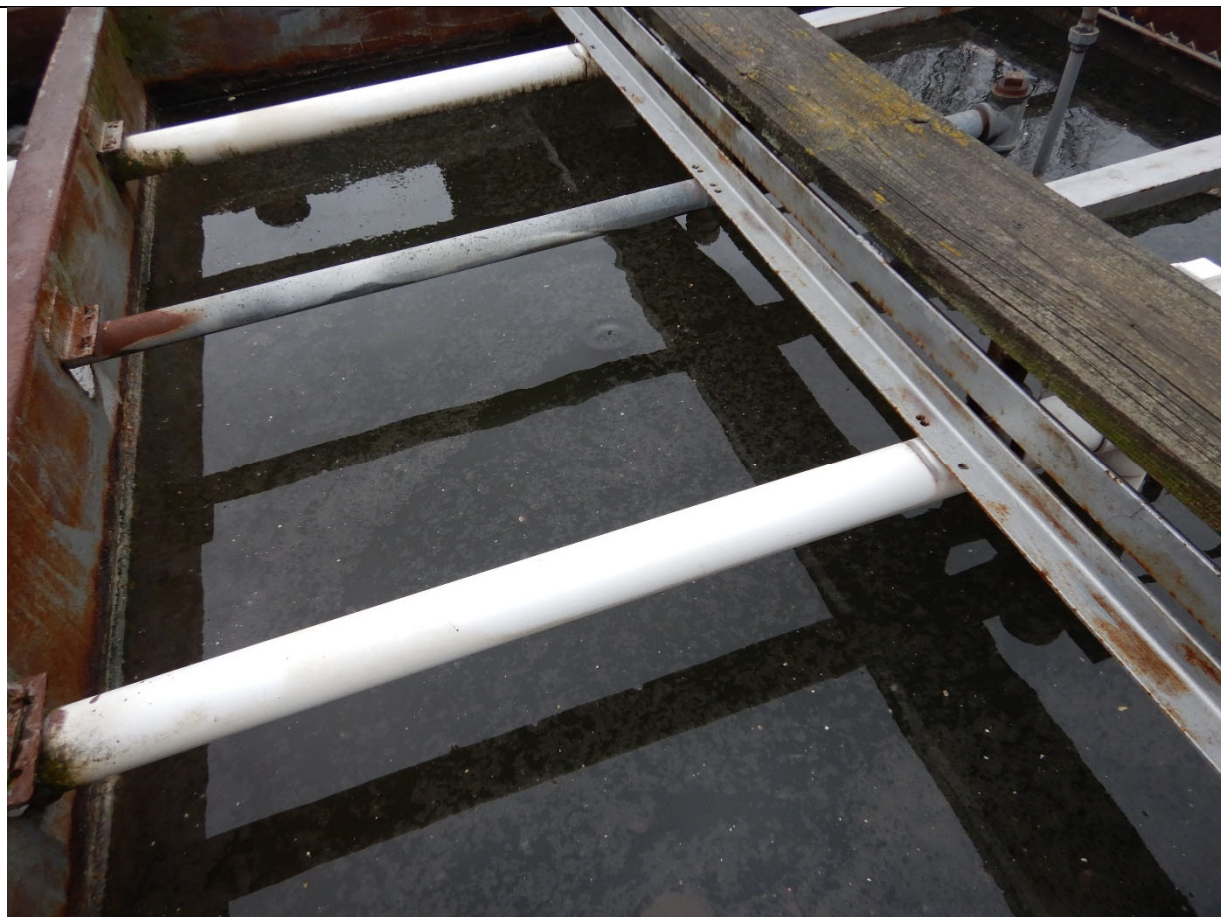
**7: DSCN2452.JPG**

Description: The east aeration basin, at the time of the inspection there was solid material, scum, floating on the surface of the clarifier.

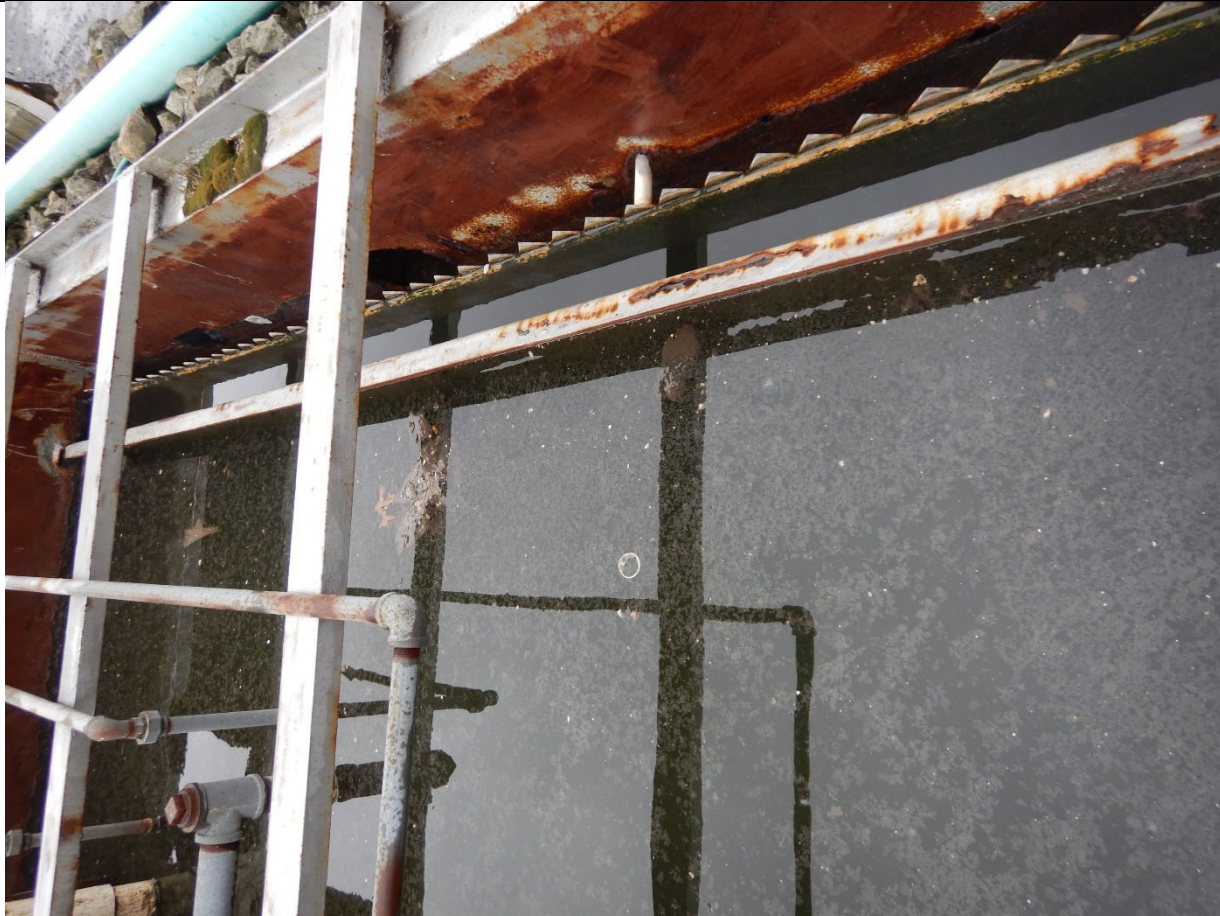
**8: DSCN2453.JPG**

Description: The east aeration basin, at the time of the inspection there was solid material floating on the surface of the clarifier.

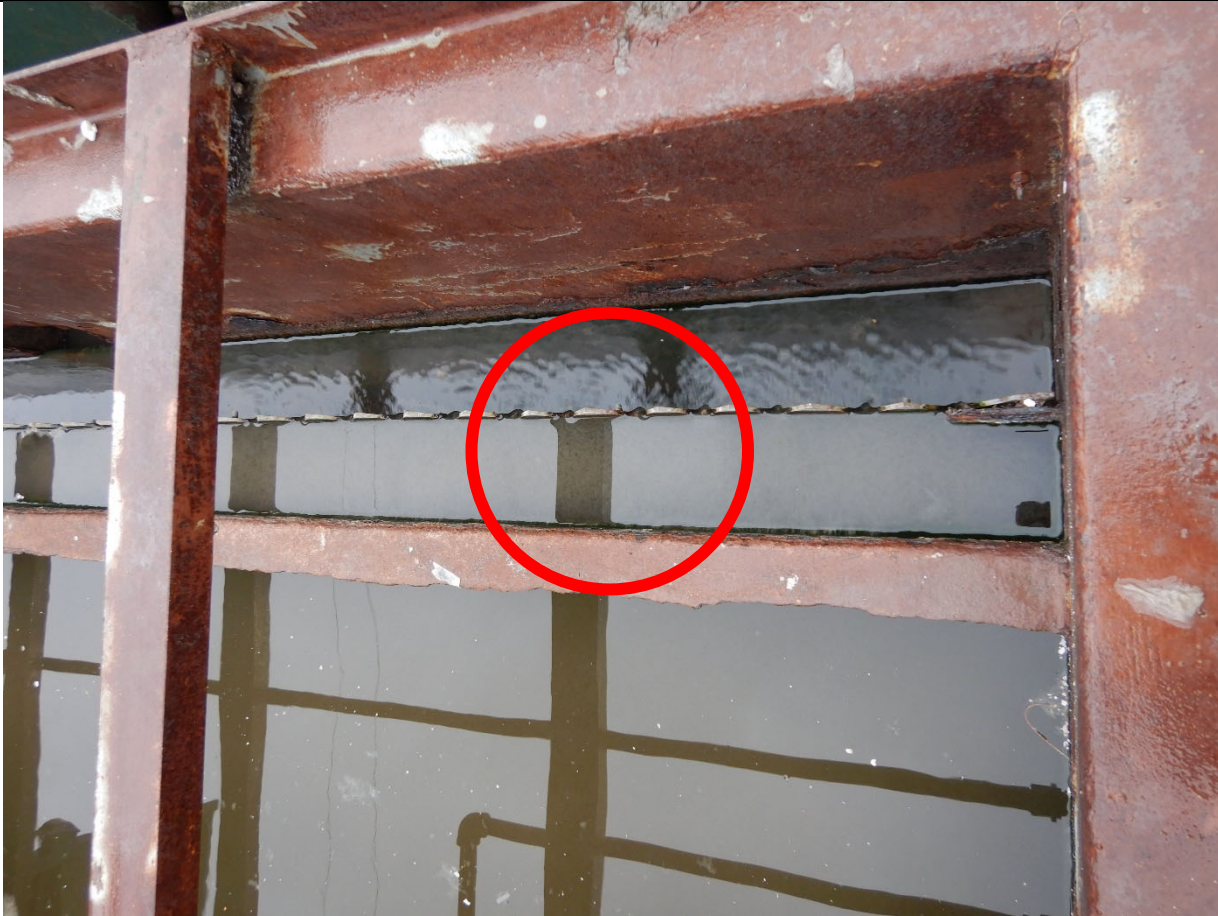
**10: DSCN2455.JPG**

The west aeration basin clarifier had flocs flowing up toward the surface and over the weir (Photos 10, 11, 13, 14 and videos 12, 15, and 16). The splitter box at the headworks was prioritizing flows to the east aeration basin, and away from the west basin (Photo 40).

Description: At the west clarifier, at the time of the inspection, flocs were visible near the surface, and were observed flowing over the weir and out the clarifier. The circle shows a location where the flocs were visible flowing over the weir.

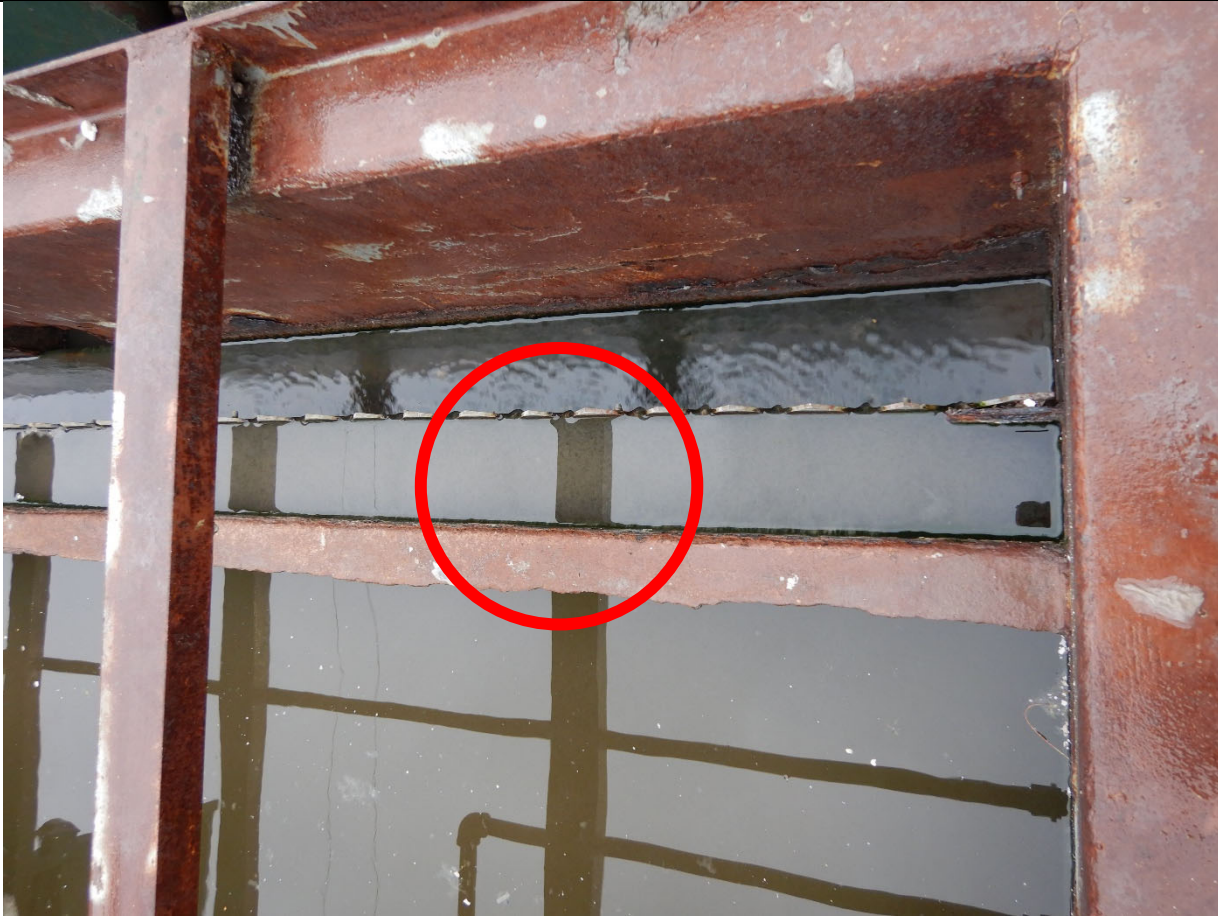
**11: DSCN2456.JPG**

Description: At the west clarifier, at the time of the inspection, flocs were visible near the surface, and were observed flowing over the weir and out the clarifier. The circle shows a location where the flocs were visible flowing over the weir.

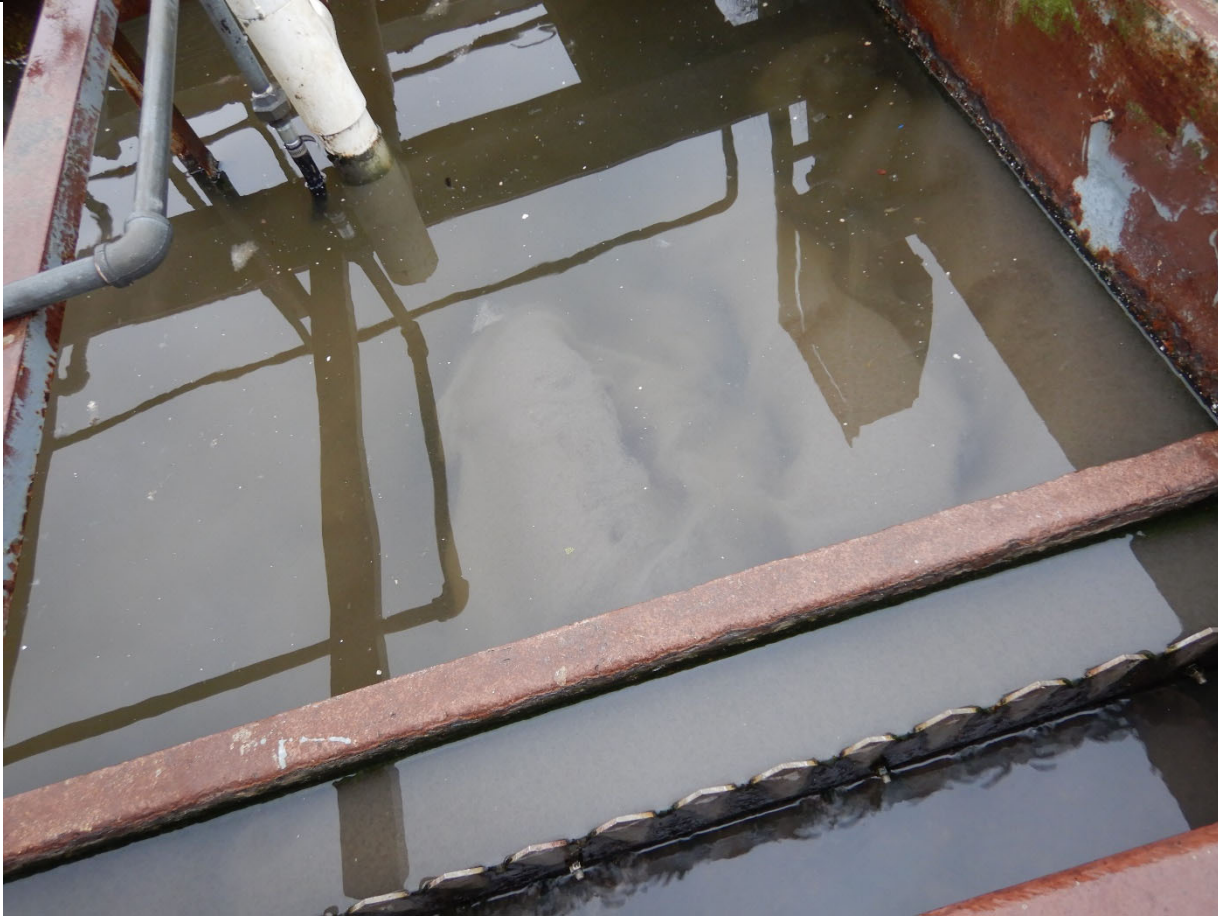
**14: DSCN2459.JPG**

Description: At the west clarifier, flocs were observed rising and swirling near the surface.

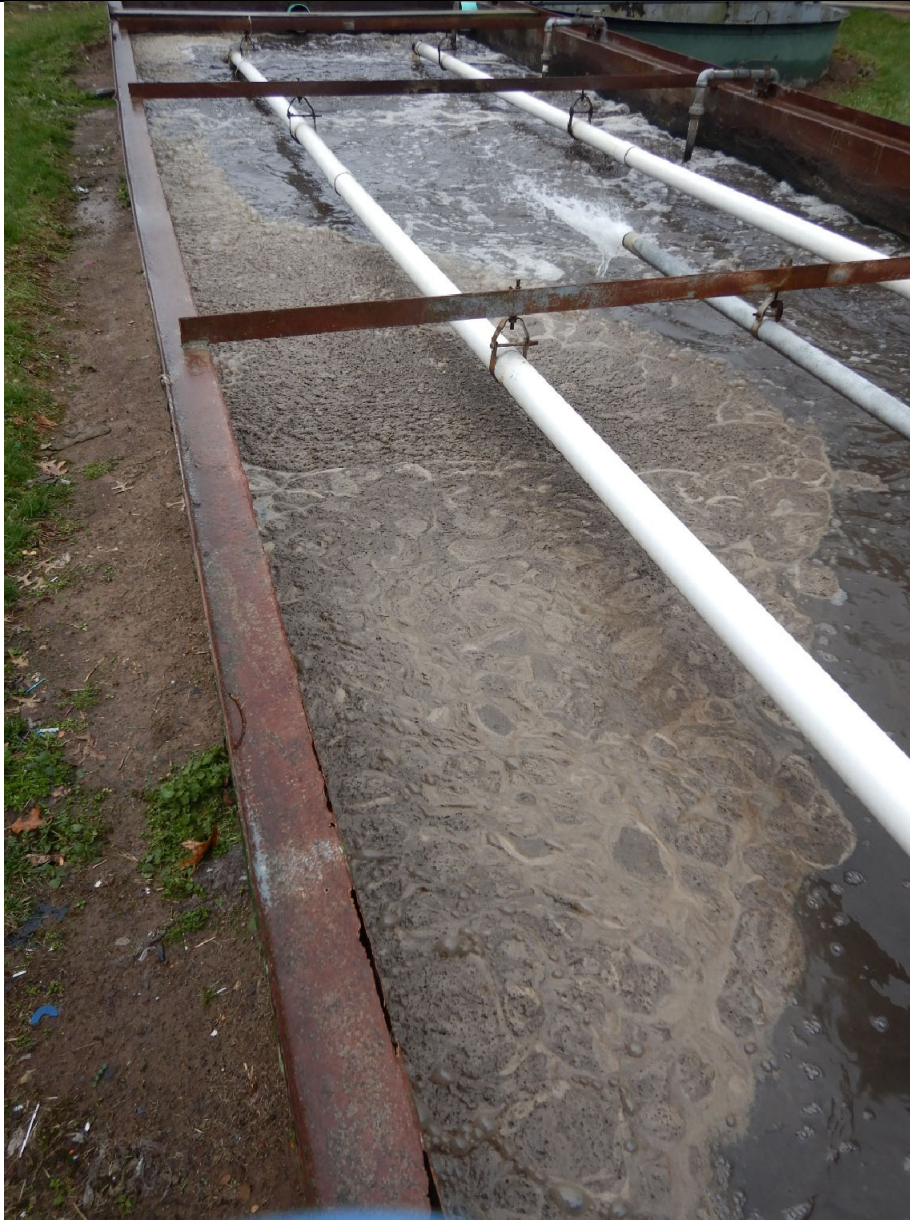
**26: DSCN2471.JPG**

Location: Suburban Acres MHP  
Photographer: Jonathan Moody  
Date/Time: 4/2/2025 10:38 AM  
Camera Direction: South  
Description: East aeration basin, foam on the surface near the north end.

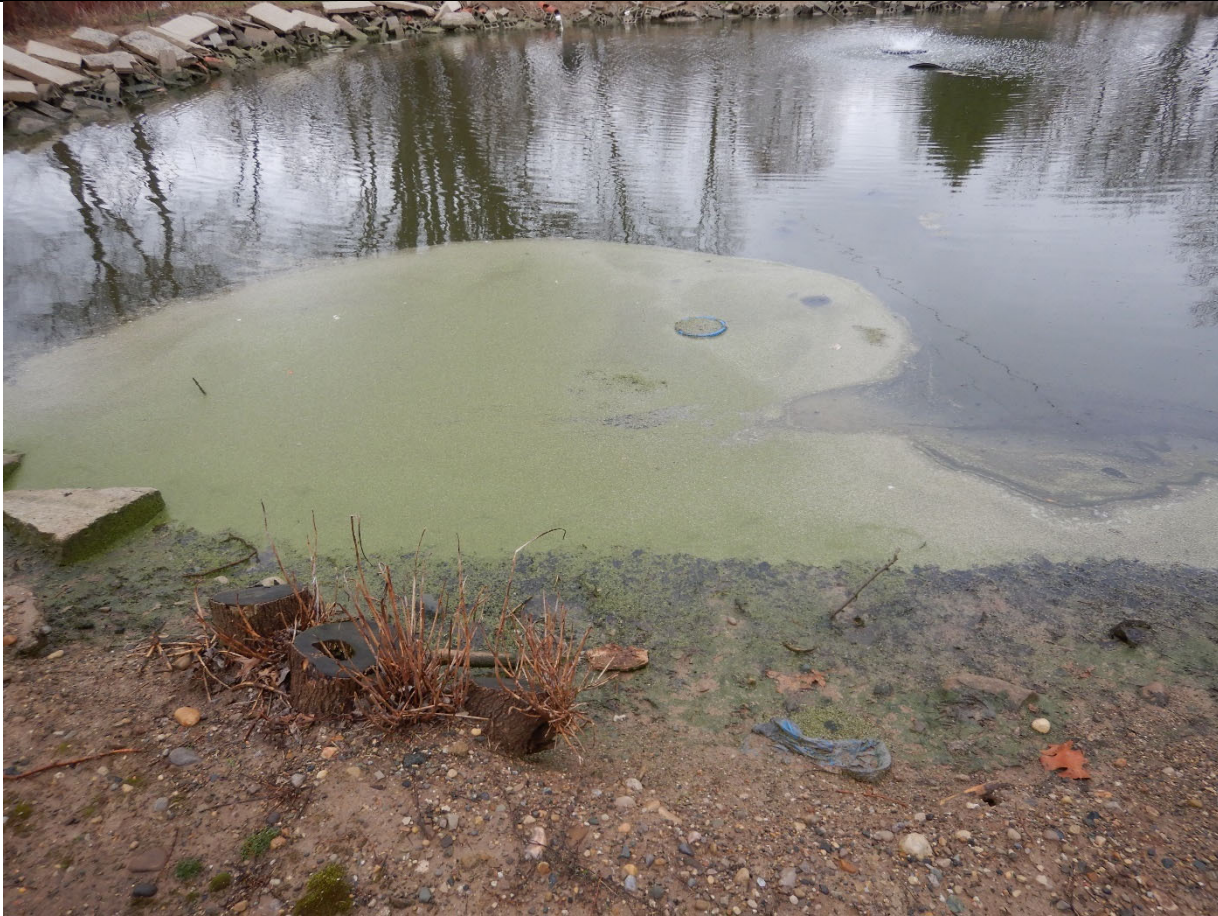
**36: DSCN2481.JPG**

algae near the north end of the pond as shown in Photo 36. An electrical pole and tree stumps were located on the inside of the embankment forming the pond (Photos 36 and 37).

Description: North end of the polishing pond. There were stumps remaining from trees on the interior side of the berm, and algae at this location.
