INSPECTION REPORT

| Type of Inspection | Industrial Stormwater Inspection (ISI) | |
| Permittee Name | United States Postal Service (USPS) – Green Bay Vehicle Maintenance Facility (VMF) | |
| Facility/Site Physical Address | 300 Packerland Drive | |

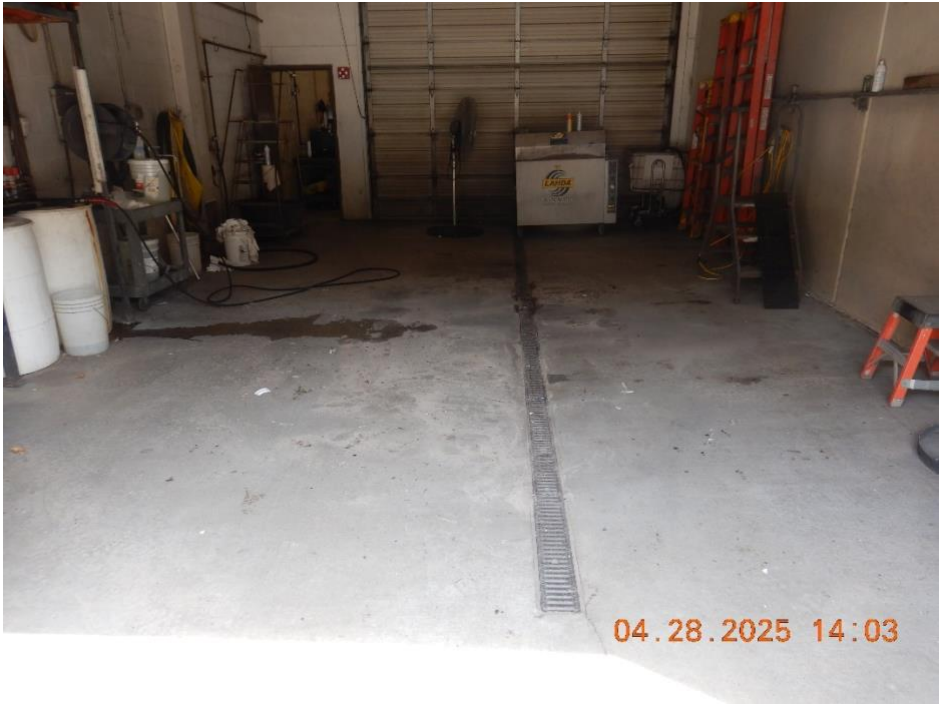
| VMF – Vehicle Wash Bay | | | DSCN1049.JPG |

| <p>EPA observed the following during the walkthrough of the indoor area:</p> <ul style="list-style-type: none"><li>• In the vehicle wash bay, a drain was observed and Mr. Nguyen inquired where the washwater drains. Mr. Dallas stated the washwater drains to a concrete oil/water separator that is separate from the oil/water separator used in the auto body shop. A third party contractor (Safety Kleen) cleans out the wash bay drains and all other inside drains quarterly.</li><li>• Mr. Nguyen observed the auto body repair and paint shop. He observed a drain on the floor and asked if the drain stops inside the bay. Mr. Dewolfe stated the auto body shop has its own oil/water separator and is also cleaned out quarterly by Safety Kleen.</li><li>• Mr. Nguyen observed containers in the fluid storage room on secondary containment. There was a floor drain observed inside the room that was stated to also go to the concrete oil/water separator.</li><li>• Mr. Nguyen observed used battery storage with secondary containment in the storage room.</li><li>• In the vehicle maintenance area, Mr. Nguyen observed an oil filter crusher/press and a sink drain used for transfer of used oil to the outside oil storage tank.</li></ul> | | |

| Indoor drainage in the vehicle wash bay | | | |

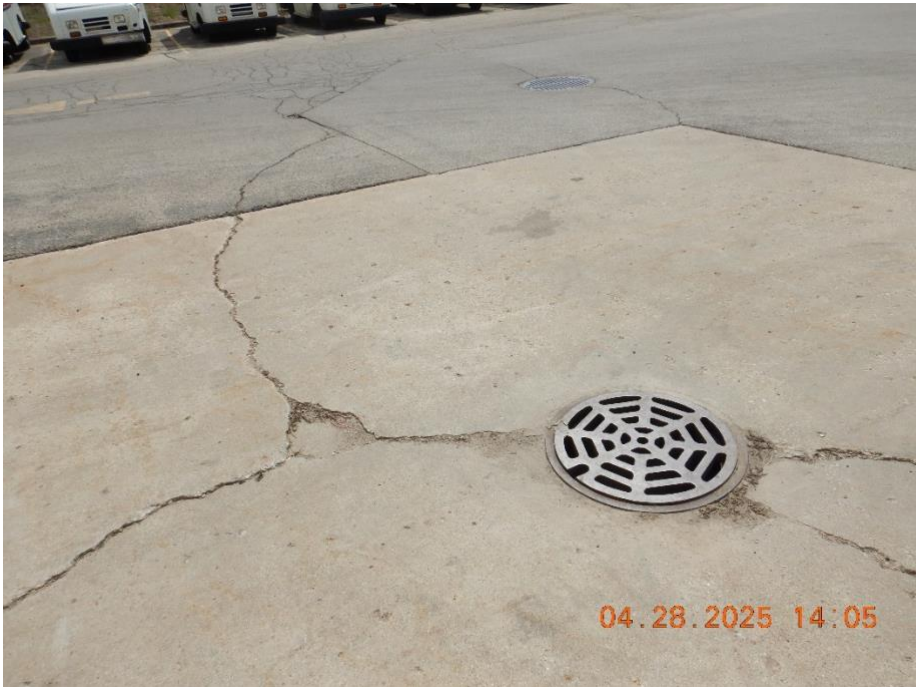
| VMF – Discharge point 002 | | | DSCN1050.JPG |

| Discharge point 002 drain just outside vehicle wash bay | | | |

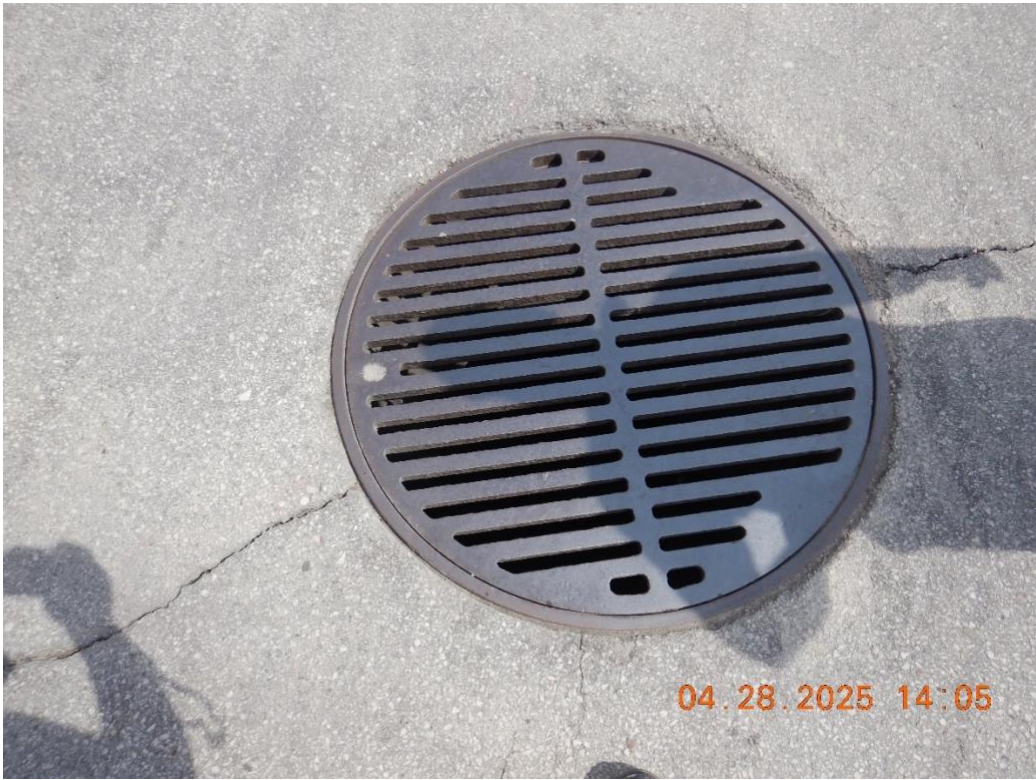
| VMF – Discharge point 002 | | | DSCN1051.JPG |

| <p>EPA observed the following during the walkthrough of the outdoor area:</p> <ul style="list-style-type: none"><li>At discharge point 002 drain on the southeast side of the property, Mr. Nguyen observed an underground pipe flowing into the drain from the south. Facility representatives did not know where the pipe source was from or if it flowed from the adjacent property south of property boundary.</li><li>On the west side of the property, Mr. Nguyen observed some old broken and degraded vehicle chocks on the ground west of discharge point 002.</li><li>At the covered storage area, Mr. Nguyen observed used tires stored on wheeled carts and old equipment. Some of the used tires and old equipment were observed to be exposed and not under cover.</li><li>Starting outside on the north side of the VMF, Mr. Nguyen observed two 275-gallon oil storage tanks. Mr. Dallas stated the tanks were double walled. One tank held new oil and the other tank held used oil.</li><li>On the northeast side of the VMF building and southwest of the main USPS building, Mr. Nguyen observed the discharge point 001 drain.</li><li>On the east side of the VMF building and southwest of the main USPS building, Mr. Nguyen observed discharge point 003 drain. Mr. Nguyen observed pallets, trash roll-off bin, and an outside covered storage area just outside the main USPS building. Mr. Dallas stated the storage area is managed by separate personnel at the main USPS building.</li></ul> | | |

| Close up of discharge point 002 drain with piping from south | | | |

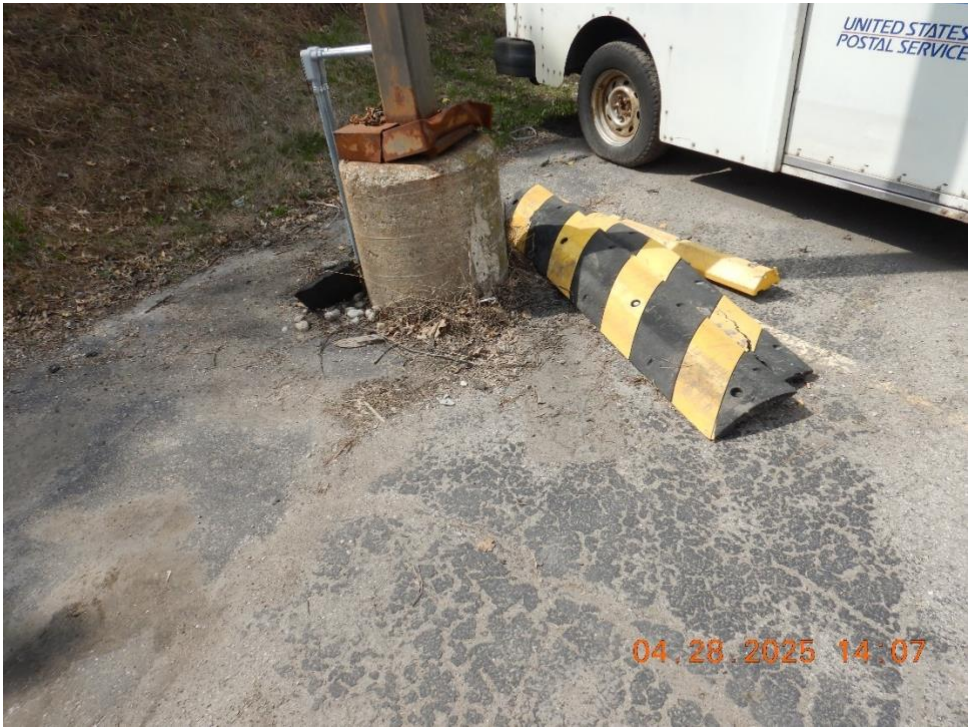
| VMF – Outside Area | | | DSCN1052.JPG |

| <b>AOC:</b> <ul style="list-style-type: none"> <li>On the west side of the property, Mr. Nguyen observed some old broken and degraded vehicle chocks on the ground west of discharge point 002.</li> <li>At the covered storage area, Mr. Nguyen observed used tires stored on wheeled carts and old equipment. Some of the used tires and old equipment were observed to be exposed and not under cover.</li> </ul> | |

| Old vehicle chocks on the ground west of discharge point 002 drain | | | |

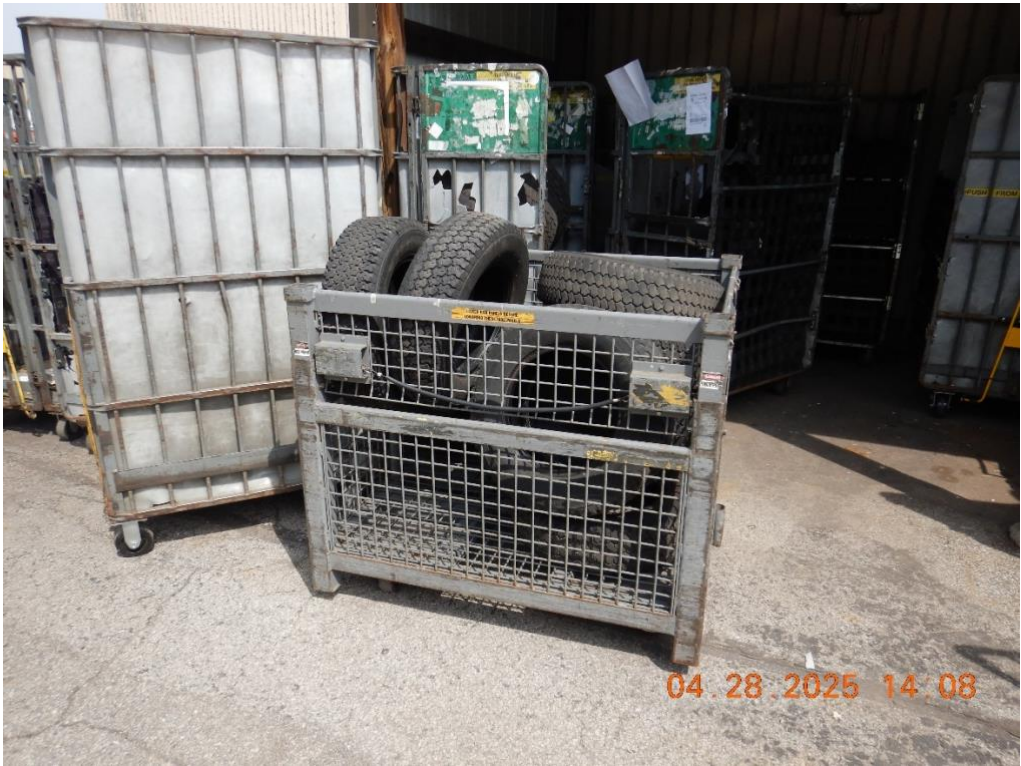
| VMF – Outside Area | | | DSCN1053.JPG |

| Outdoor covered storage with old tires and equipment | | | |

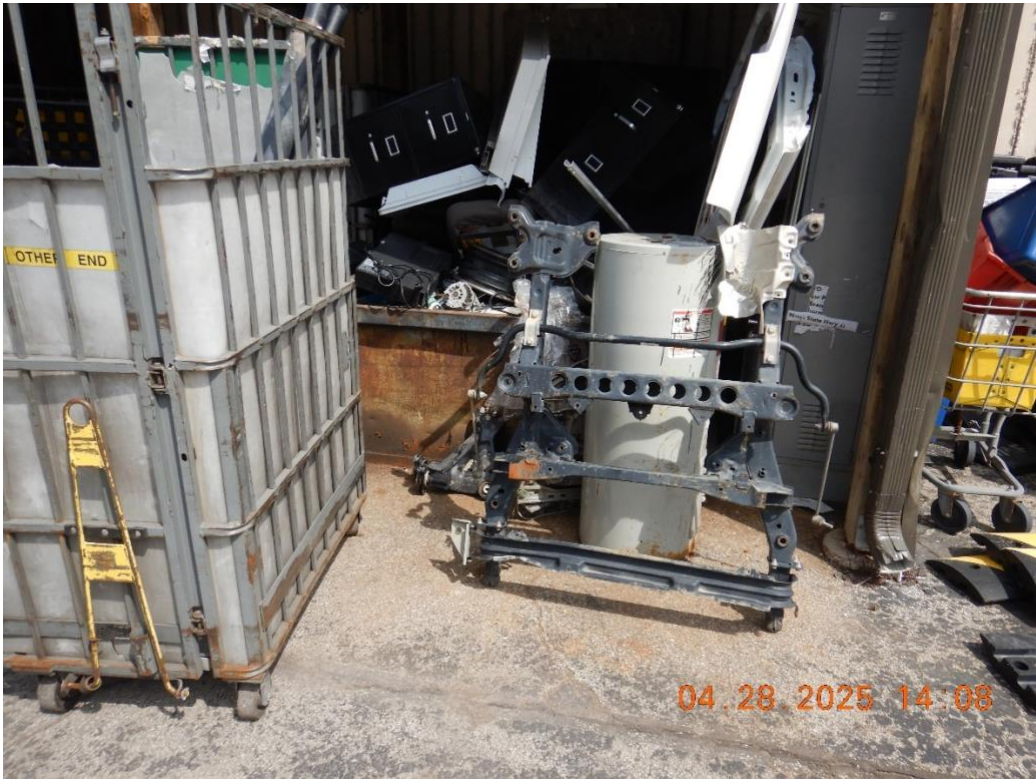
| VMF – Outside Area | | | DSCN1054.JPG |

| Outdoor covered storage with old tires and equipment | | | |

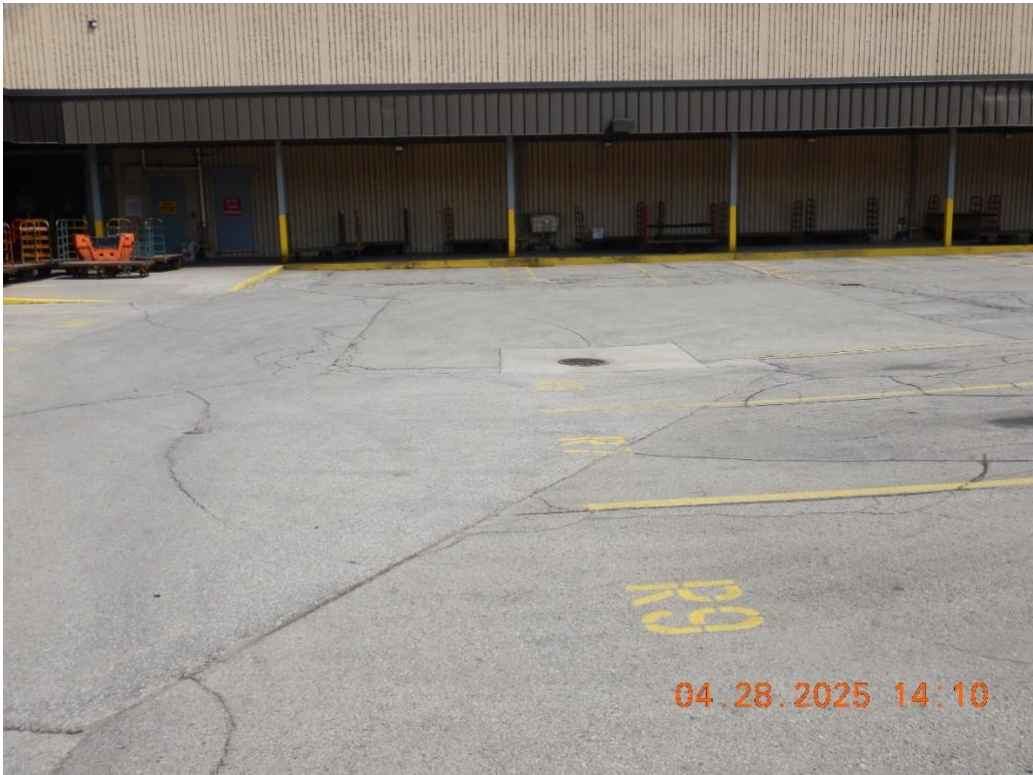
| VMF – Outside Area | | | DSCN1055.JPG |

| Discharge point 001 drain west of main USPS building | | | |

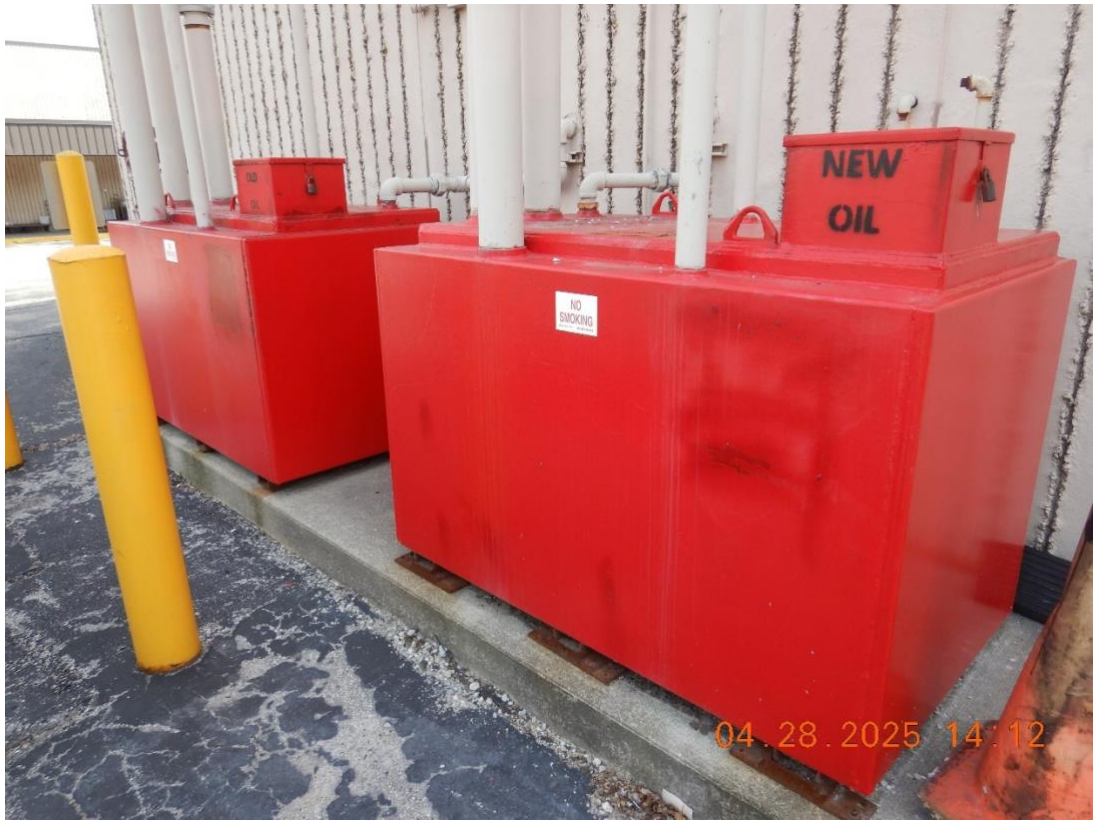
| VMF – Outside Area | | | DSCN1056.JPG |

| Outside oil storage tanks piped into the VMF facility | | | |

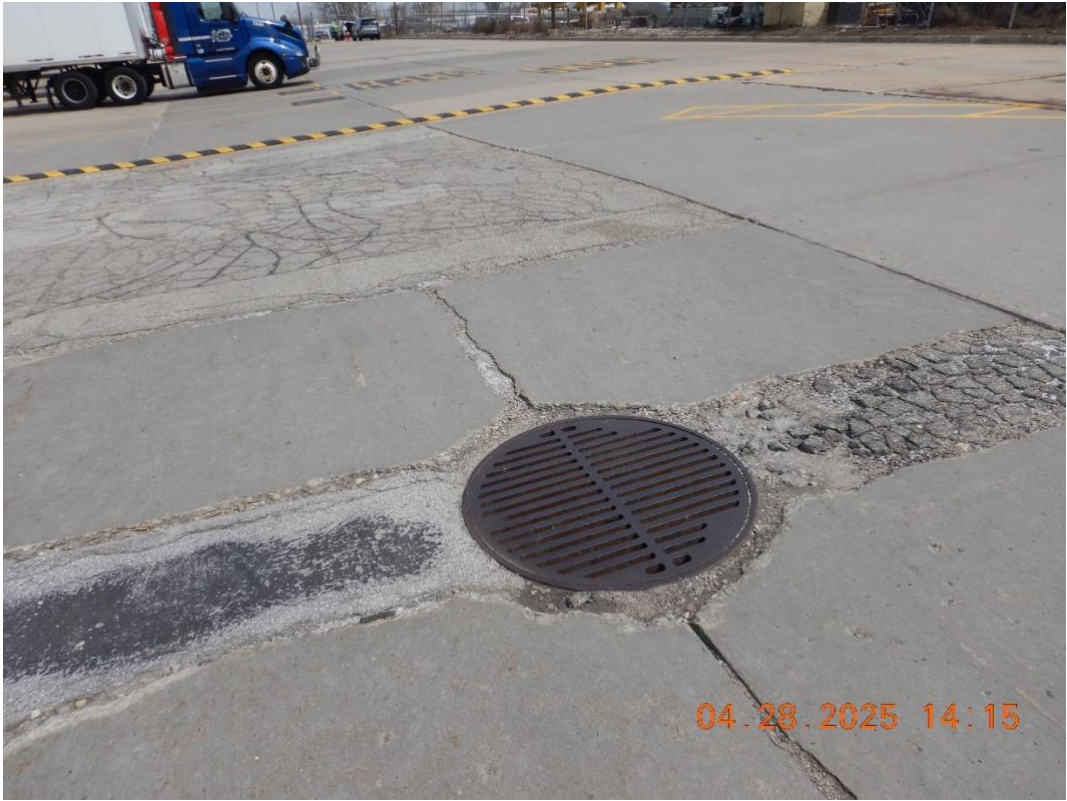
| VMF – Outside Area | | | DSCN1057.JPG |

| Discharge point 002 drain | | | |

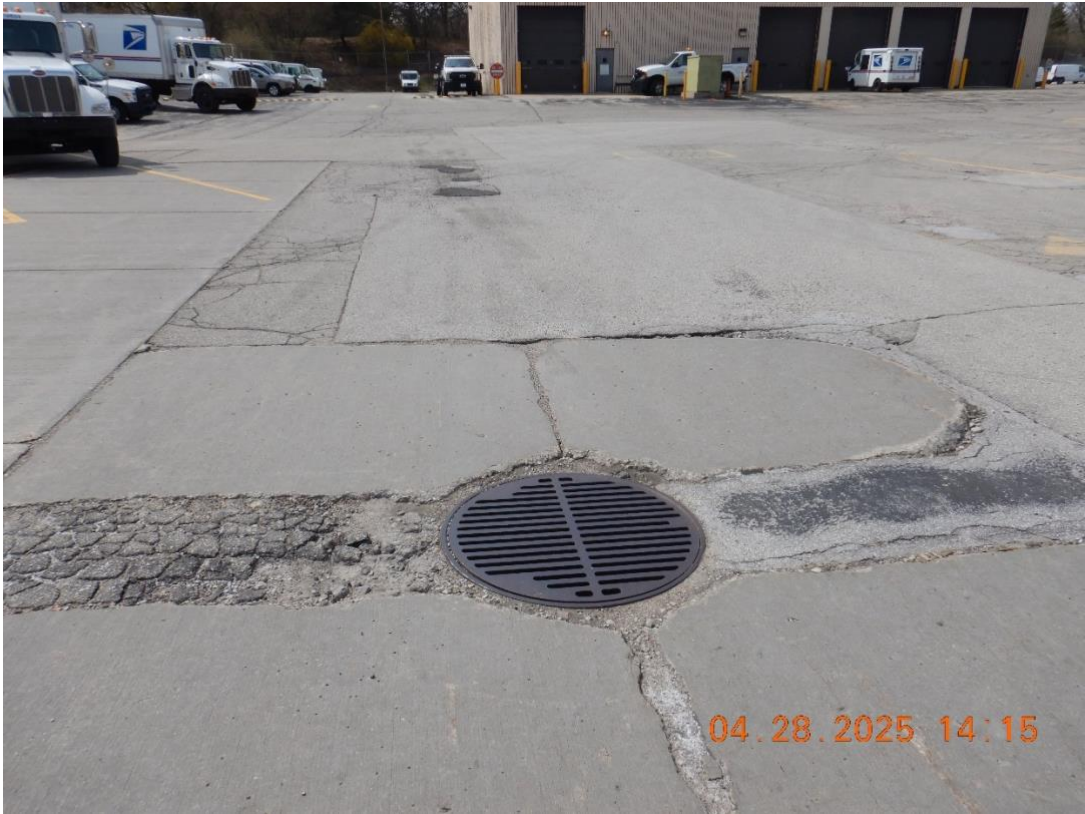
| VMF – Outside Area | | | DSCN1058.JPG |

| Discharge point 002 drain | | | |

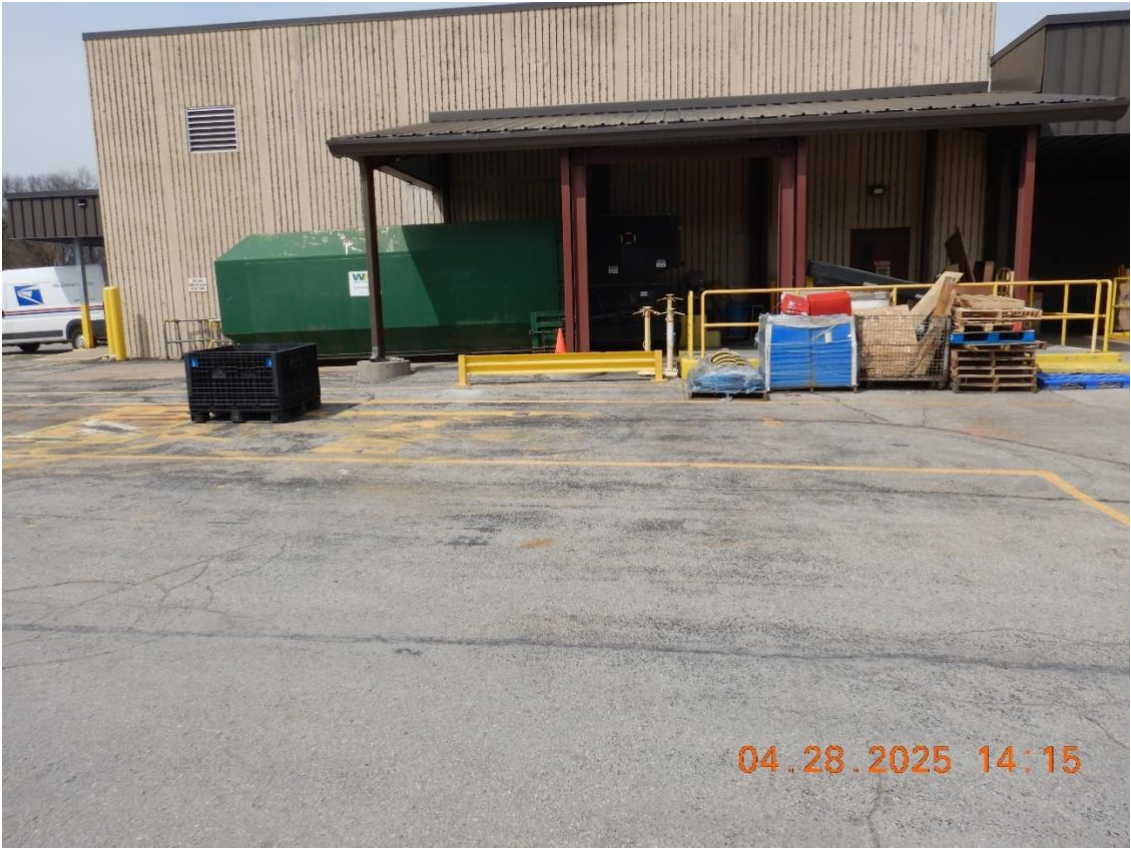
| VMF – Outside Area | | | DSCN1059.JPG |

| Outdoor storage area from main USPS building | | | |

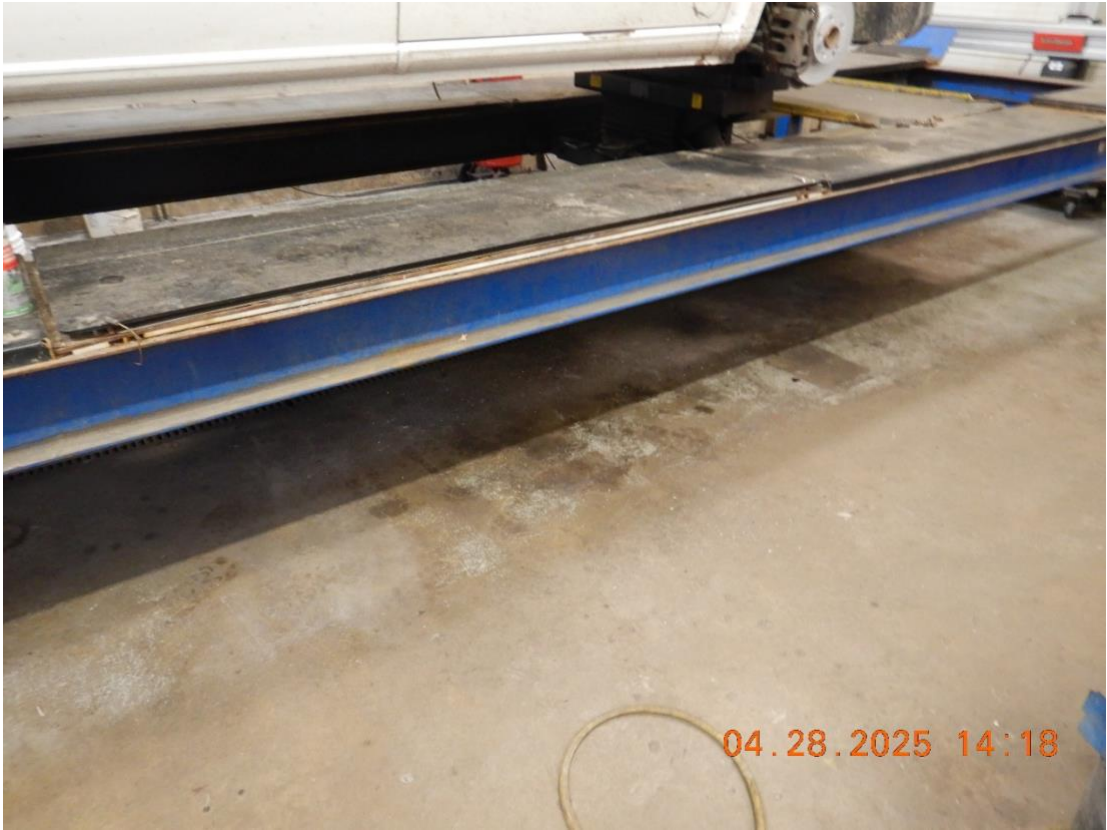
| VMF – Inside Area | | | DSCN1060.JPG |

| Auto repair and paint shop area | | | |

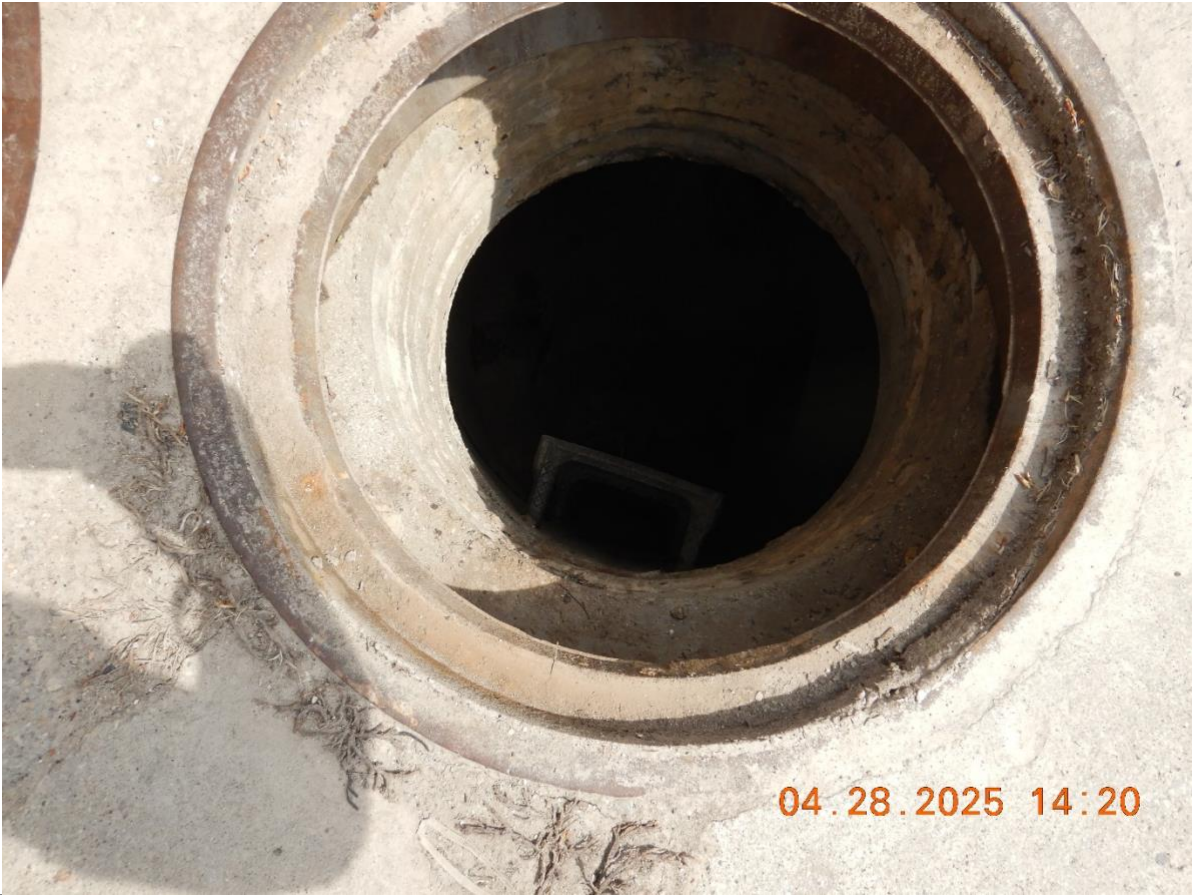
| VMF – Outside Area | | | DSCN1061.JPG |

| Opened discharge point 002 drain with underground pipe from south | | | |

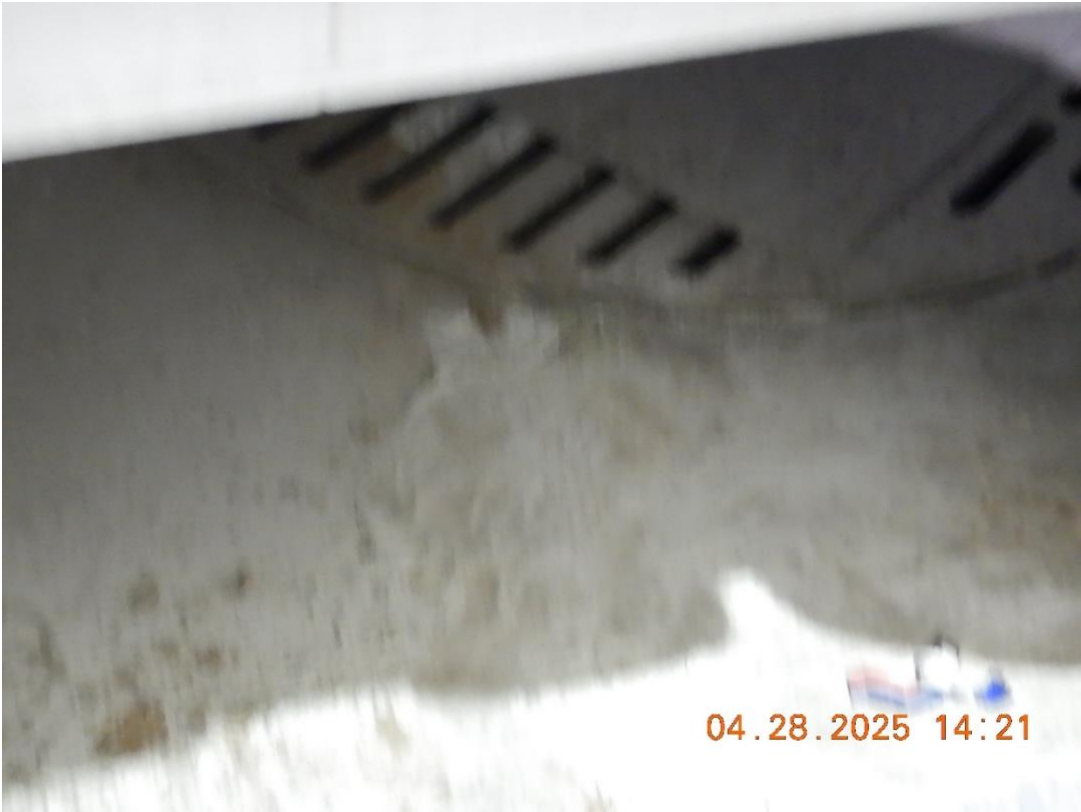
| VMF – Inside Area | | | DSCN1063.JPG |

| Body repair and paint shop drain | | | |

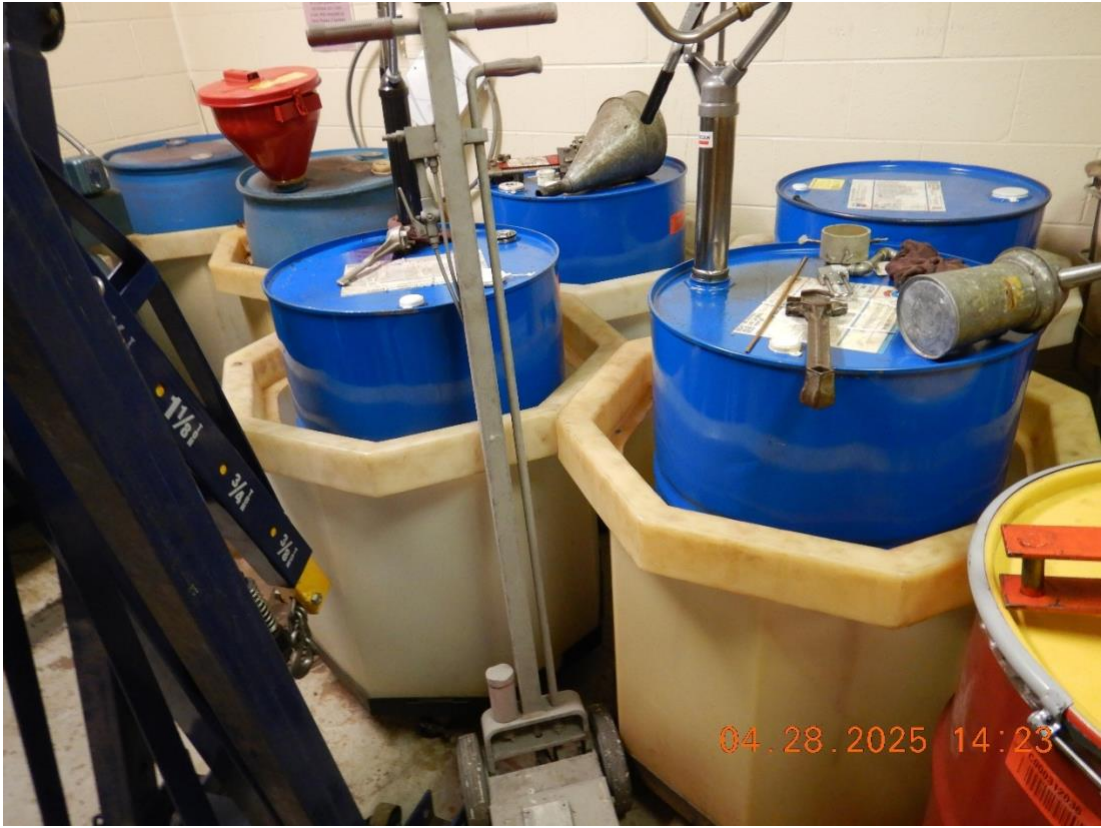
| VMF – Inside Area | | | DSCN1064.JPG |

| Fluid Storage Room | | | |

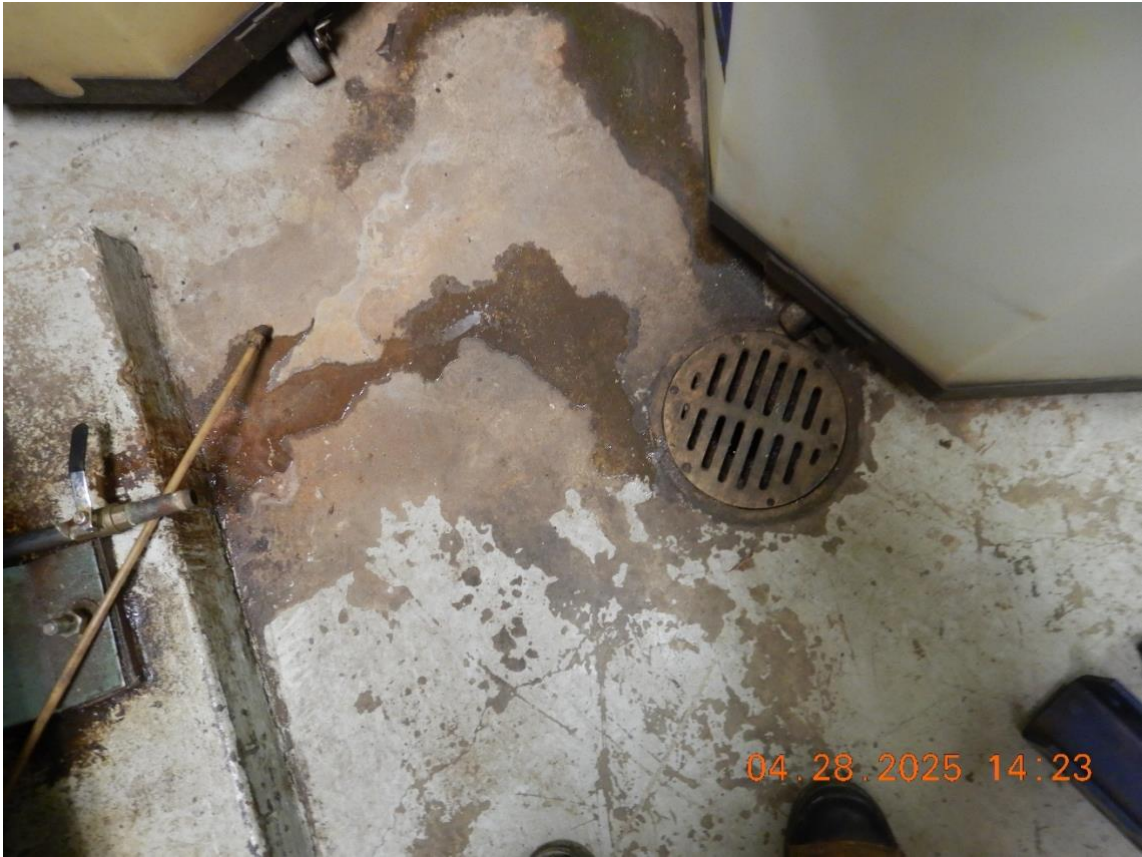
| VMF – Inside Area | | | DSCN1065.JPG |

| Fluid Storage Room drain goes to oil/water separator | | | |

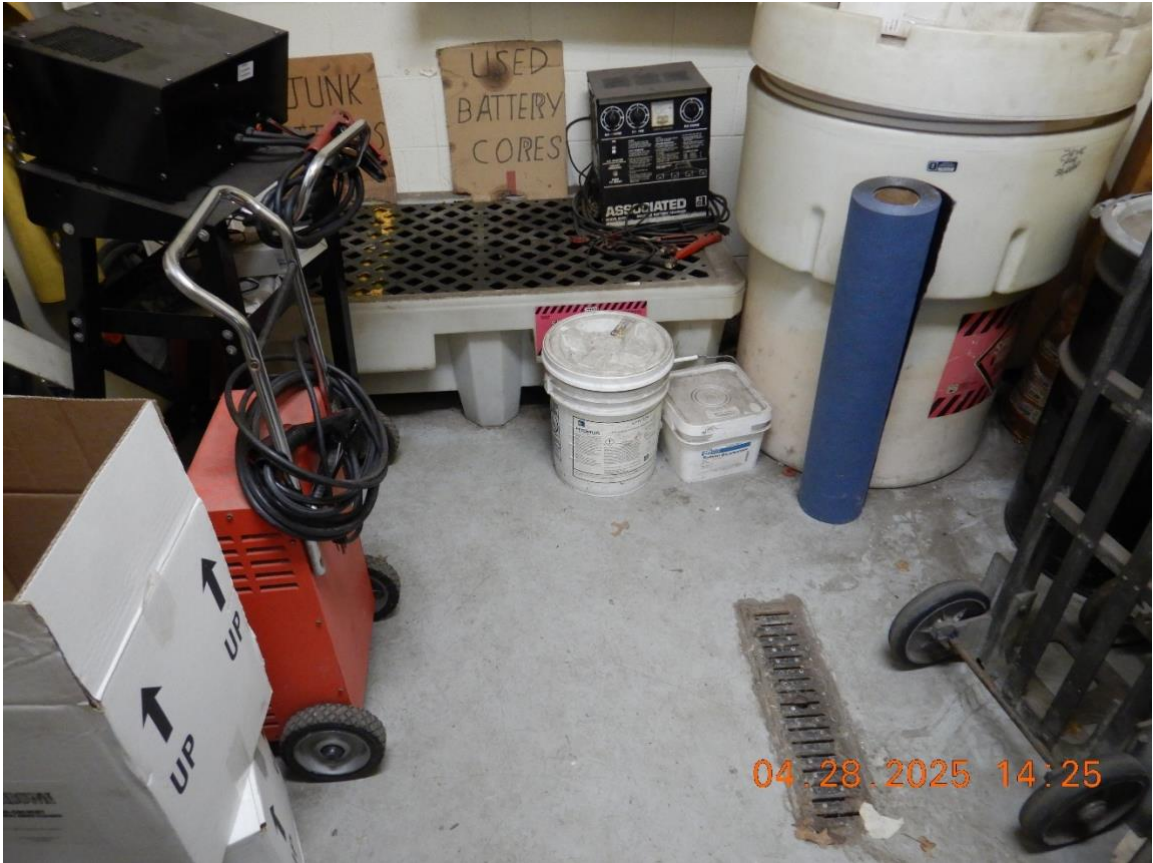
| VMF – Inside Area | | | DSCN1066.JPG |

| Used batteries and equipment storage room | | | |

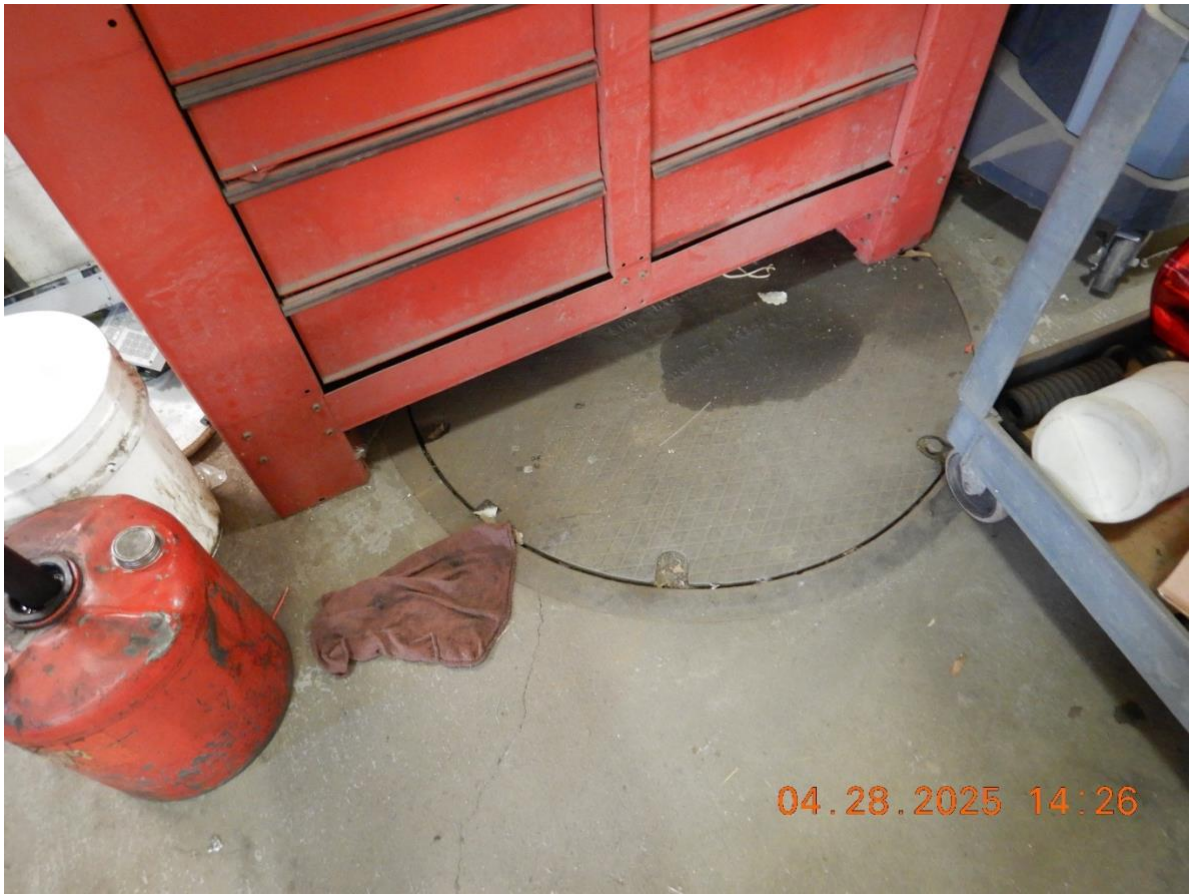
| VMF – Inside Area | | | DSCN1067.JPG |

| Oil/water separator in vehicle maintenance area | | | |

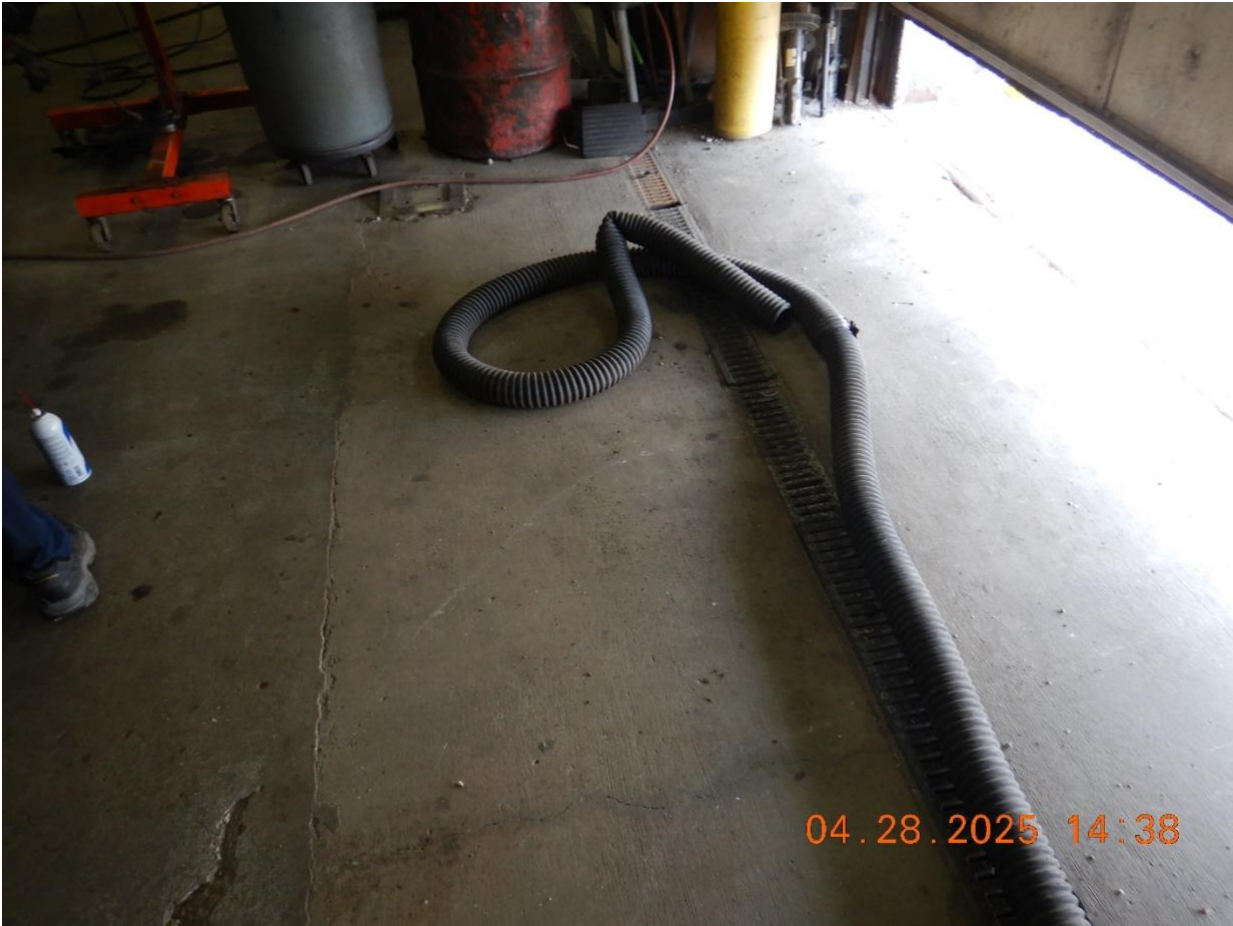
| VMF – Inside Area | | | DSCN1068.JPG |

| Maintenance area drain | | | |

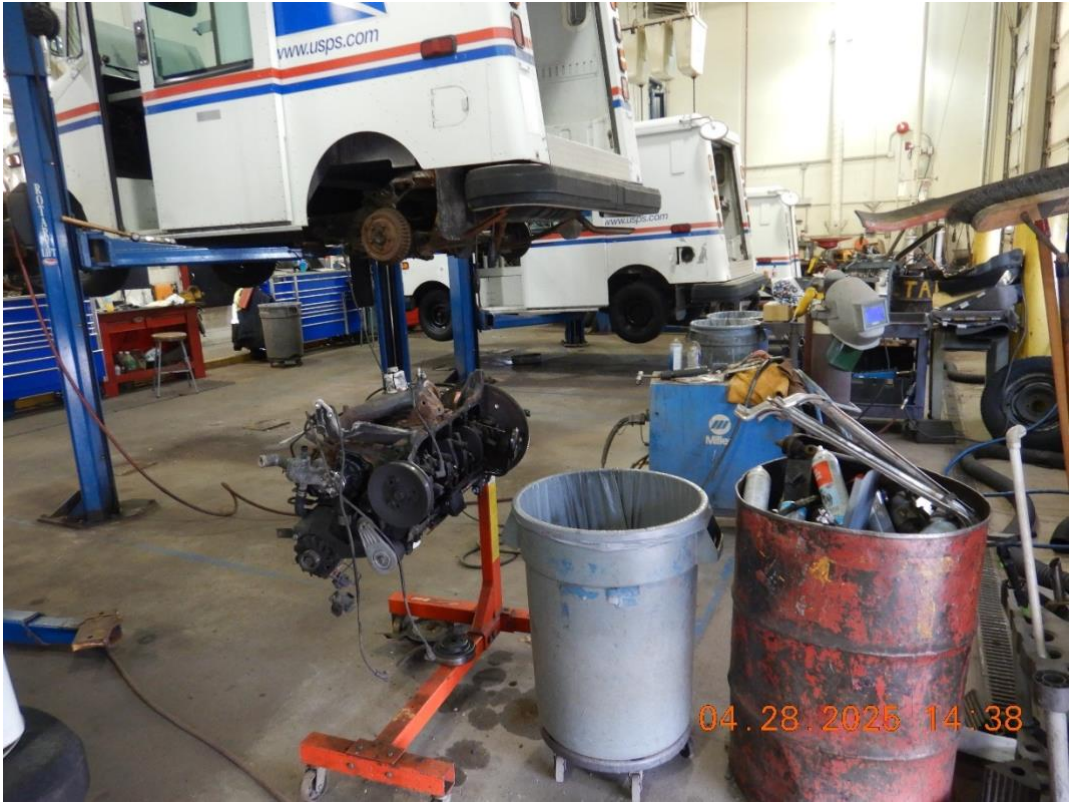
| VMF – Inside Area | | | DSCN1069.JPG |

| Main vehicle maintenance area | | | |

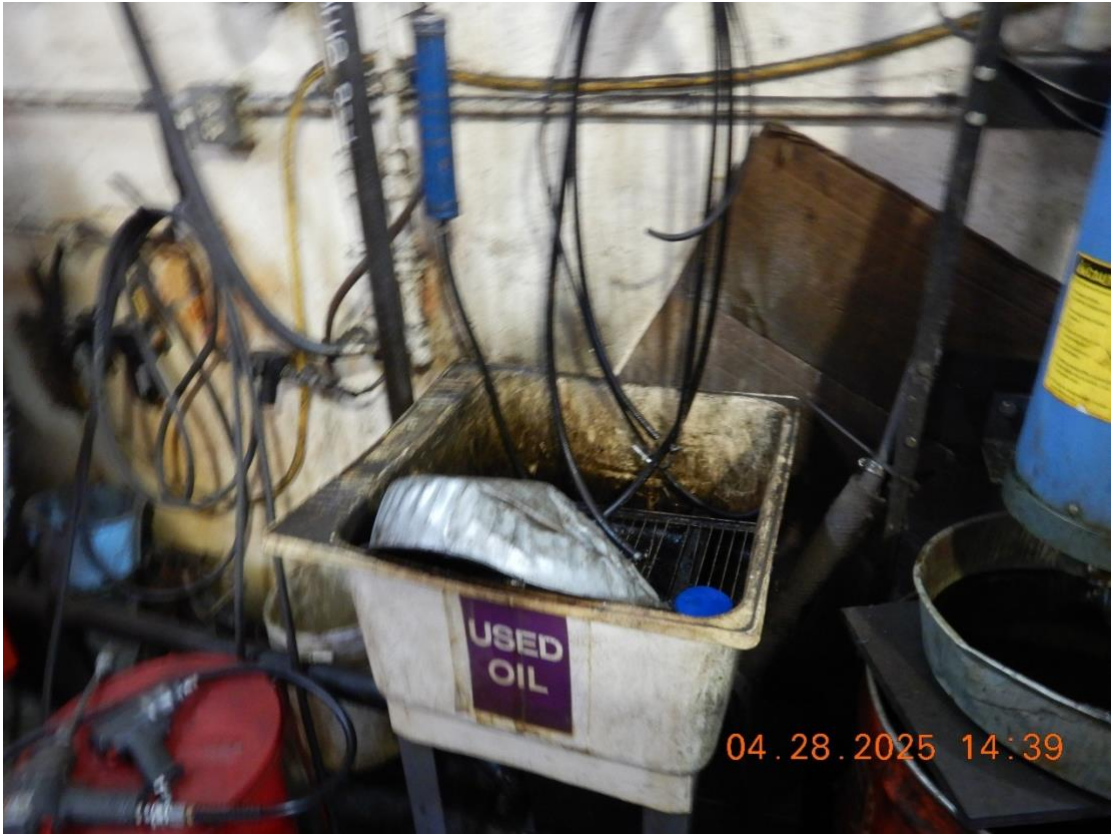
| VMF – Inside Area | | | DSCN1070.JPG |

| Used oil sink drain that goes into the outside used oil storage tank | | | |

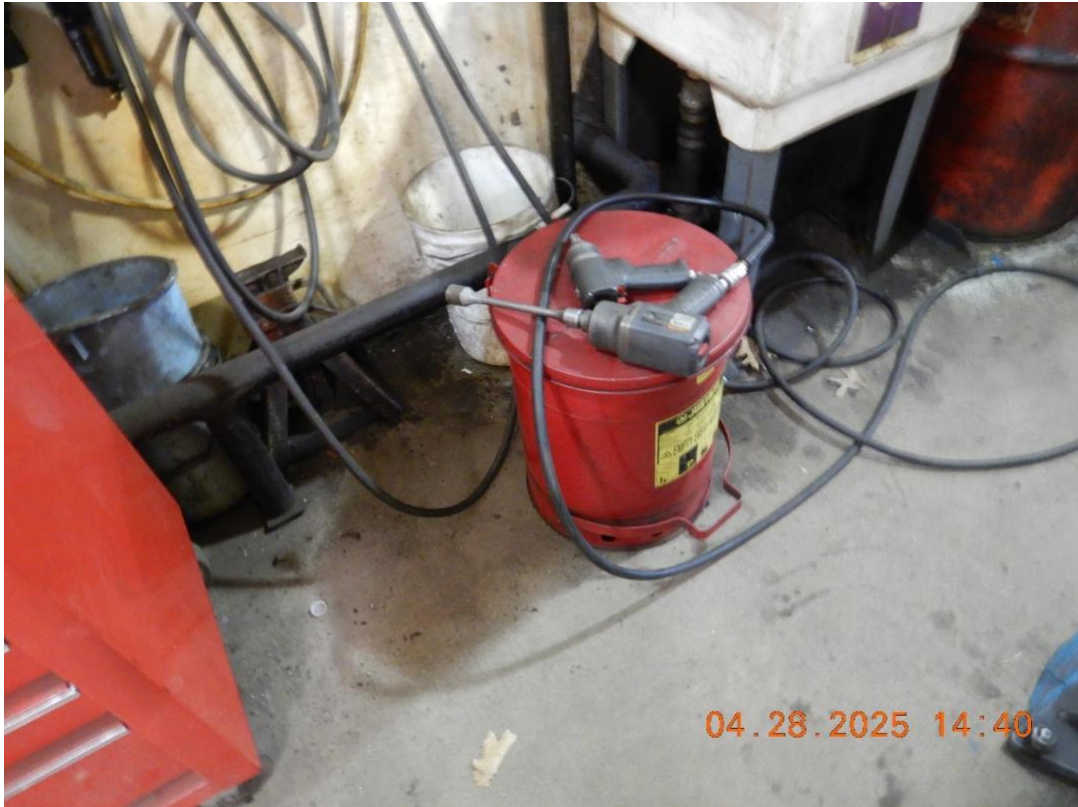
| VMF – Inside Area | | | DSCN1071.JPG |

| Main vehicle maintenance area | | | |

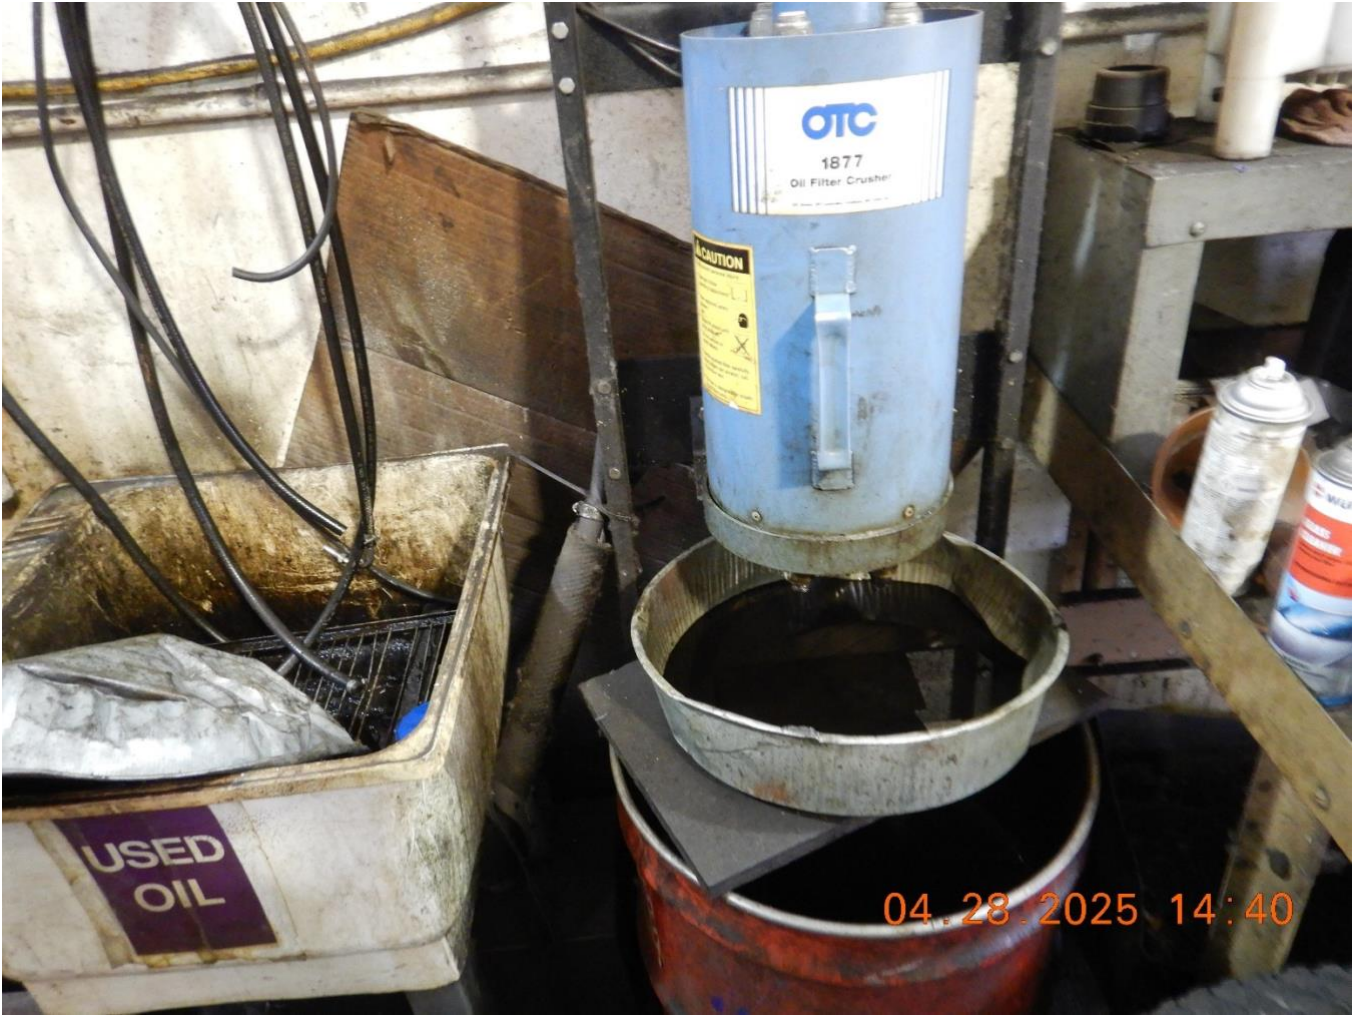
| VMF – Inside Area | | | DSCN1072.JPG |

| Oil filter crusher and press | | | |
