## Region 6 - Enforcement & Compliance Assurance Division

### INSPECTION REPORT

| Company Name: | <b>T2 Operating Corporation</b> | |
| Facility Name: | <b>Buckner #D-5 SWD</b> | |

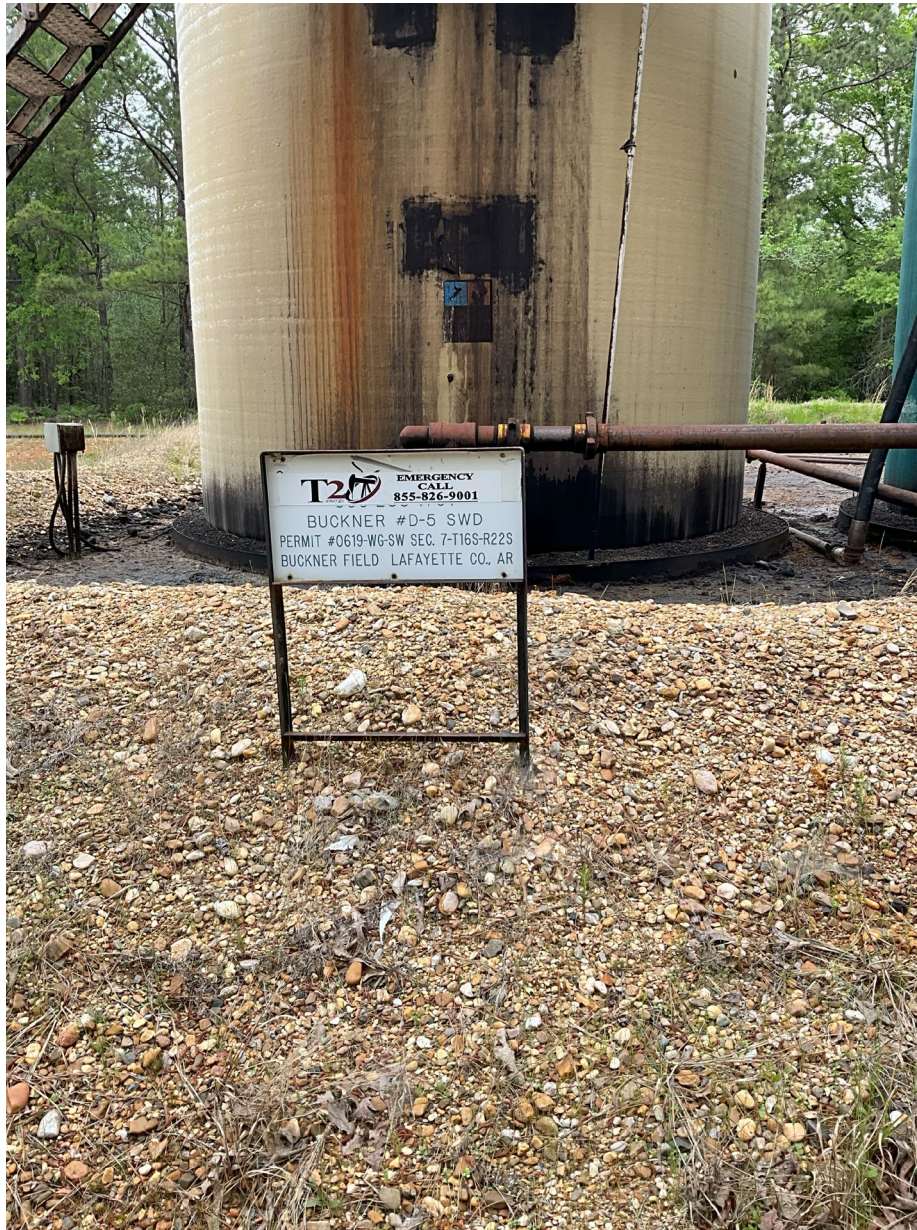
Photo No. 1

**Description:** Looking north, this photo shows the sign at the facility.

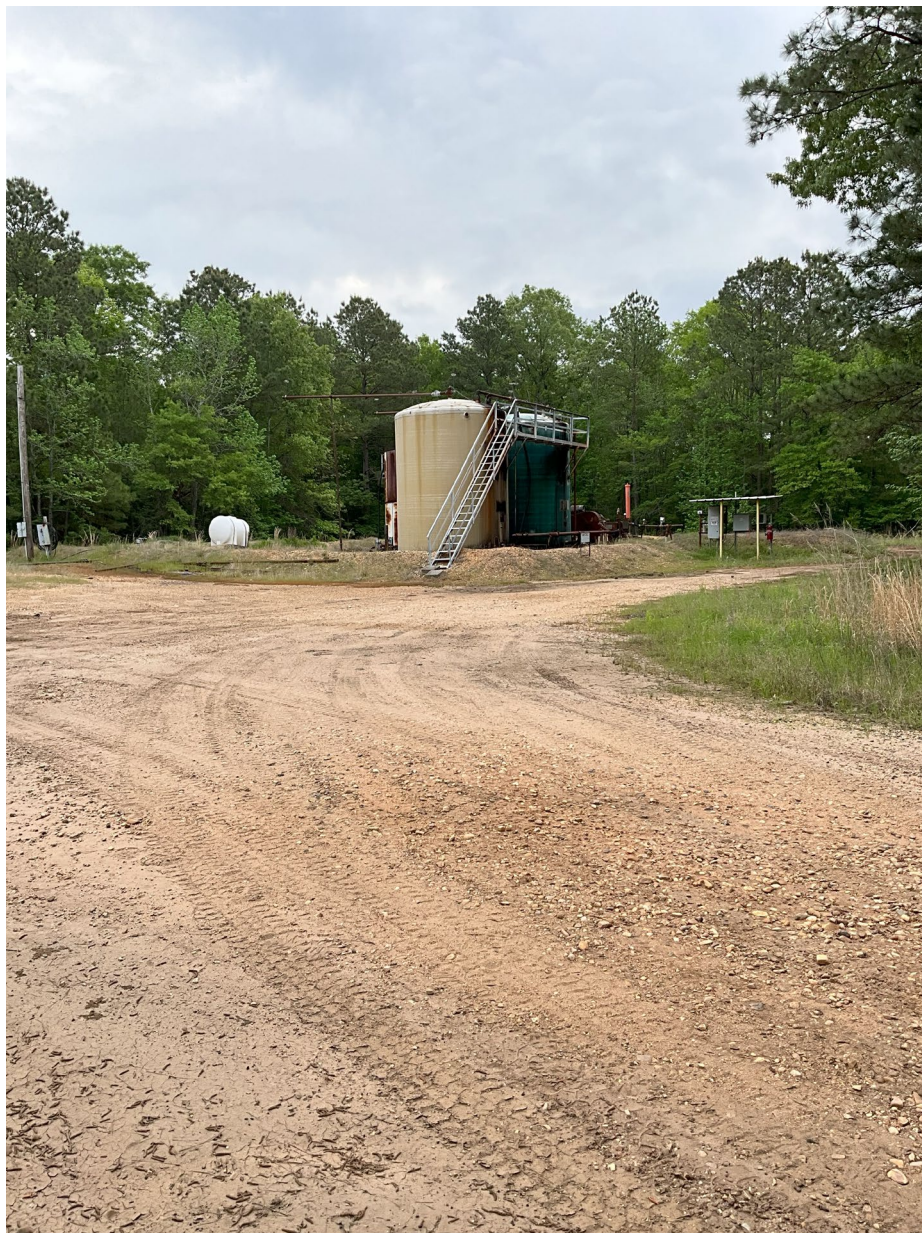
Photo No. 2

**Description:** Looking east, this photo shows an overview of the facility.

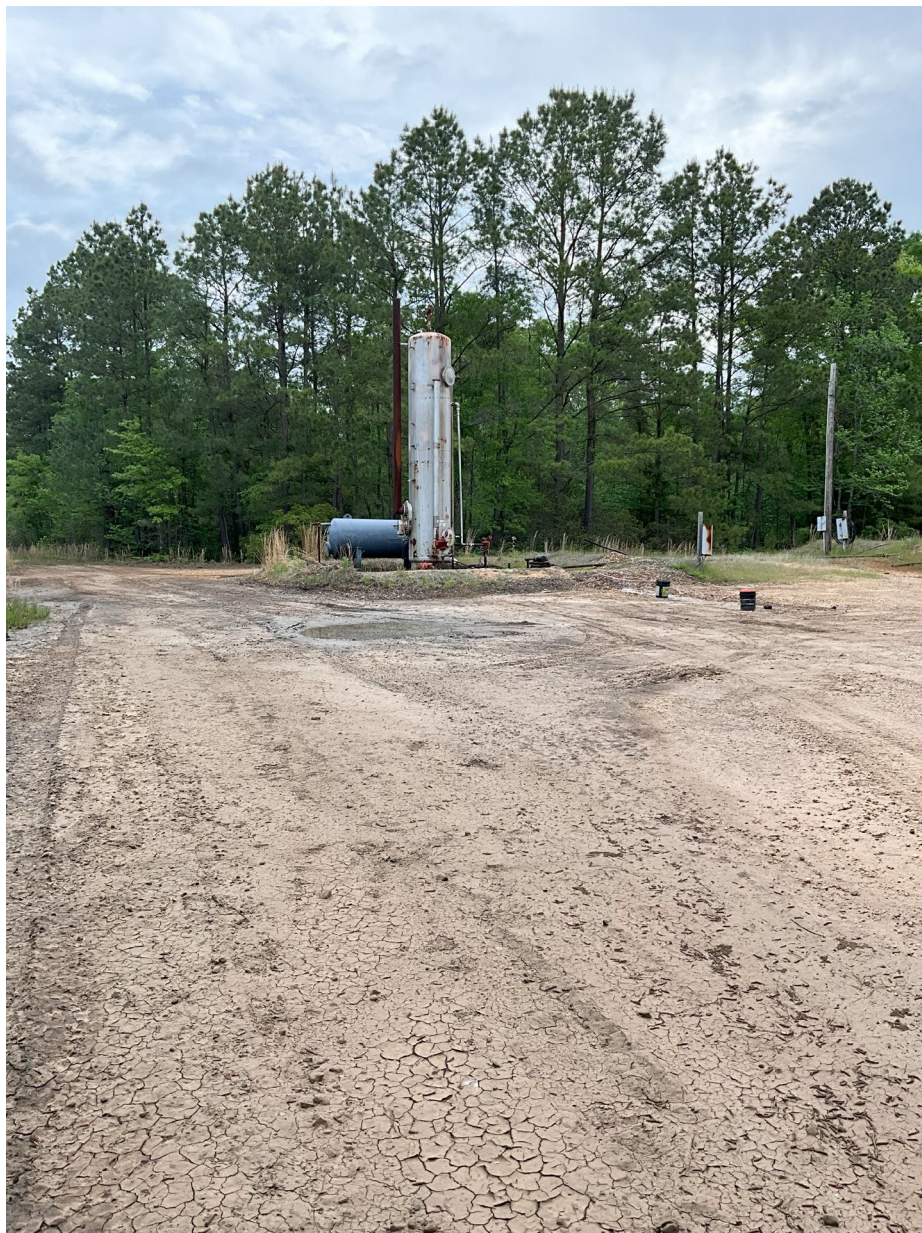
Photo No. 3

**Description:** Looking northeast, this photo shows an overview of the facility.

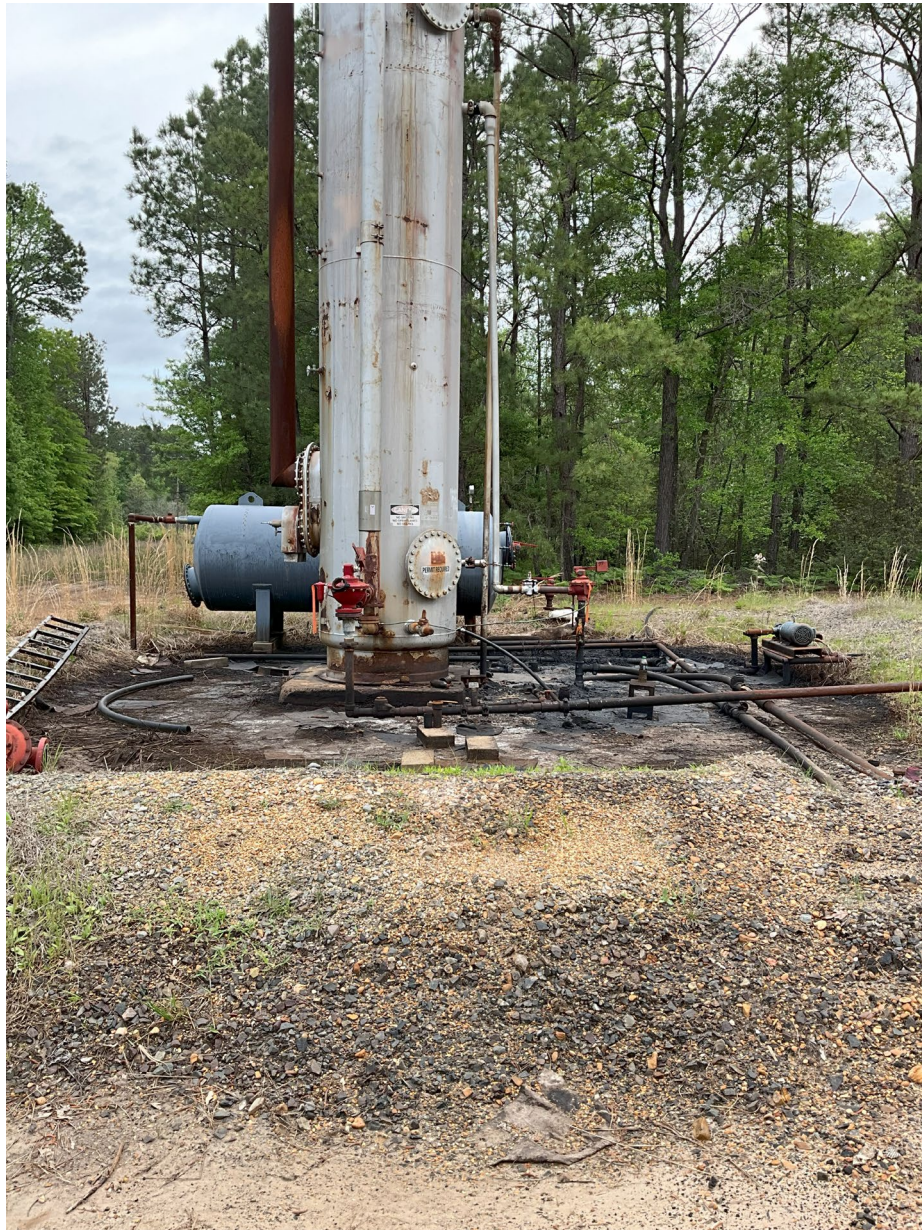
Photo No. 4

I observed loose oil inside secondary containment for the separators, see Photo No. 4. I also observed loose oil inside secondary containment for the storage tanks and pump, see Photo No. 5 through No. 7.

**Description:** Looking north, this photo shows loose oil inside secondary containment for the separator.

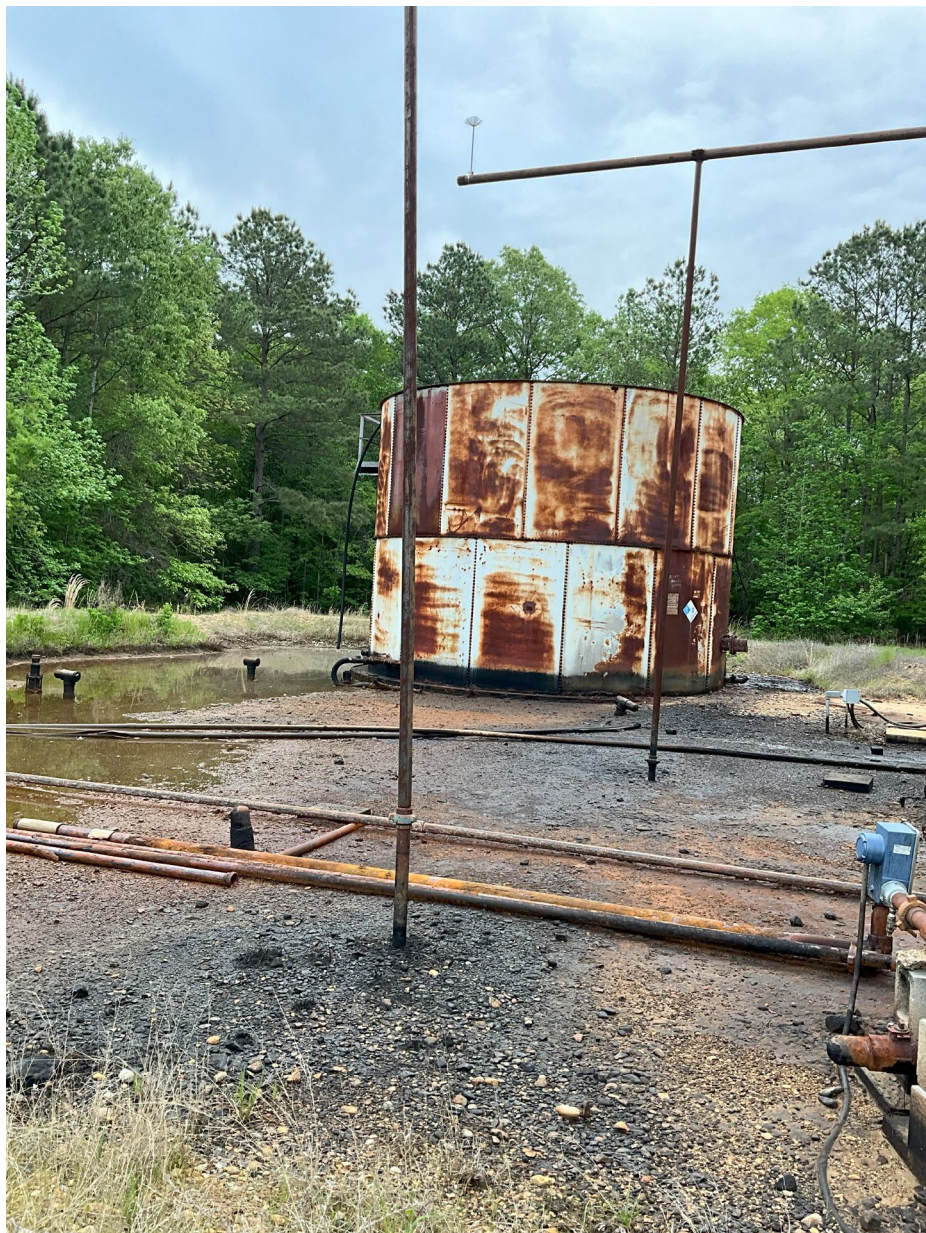
Photo No. 5

**Description:** Looking northeast, this photo shows loose oil inside secondary containment for the tanks.

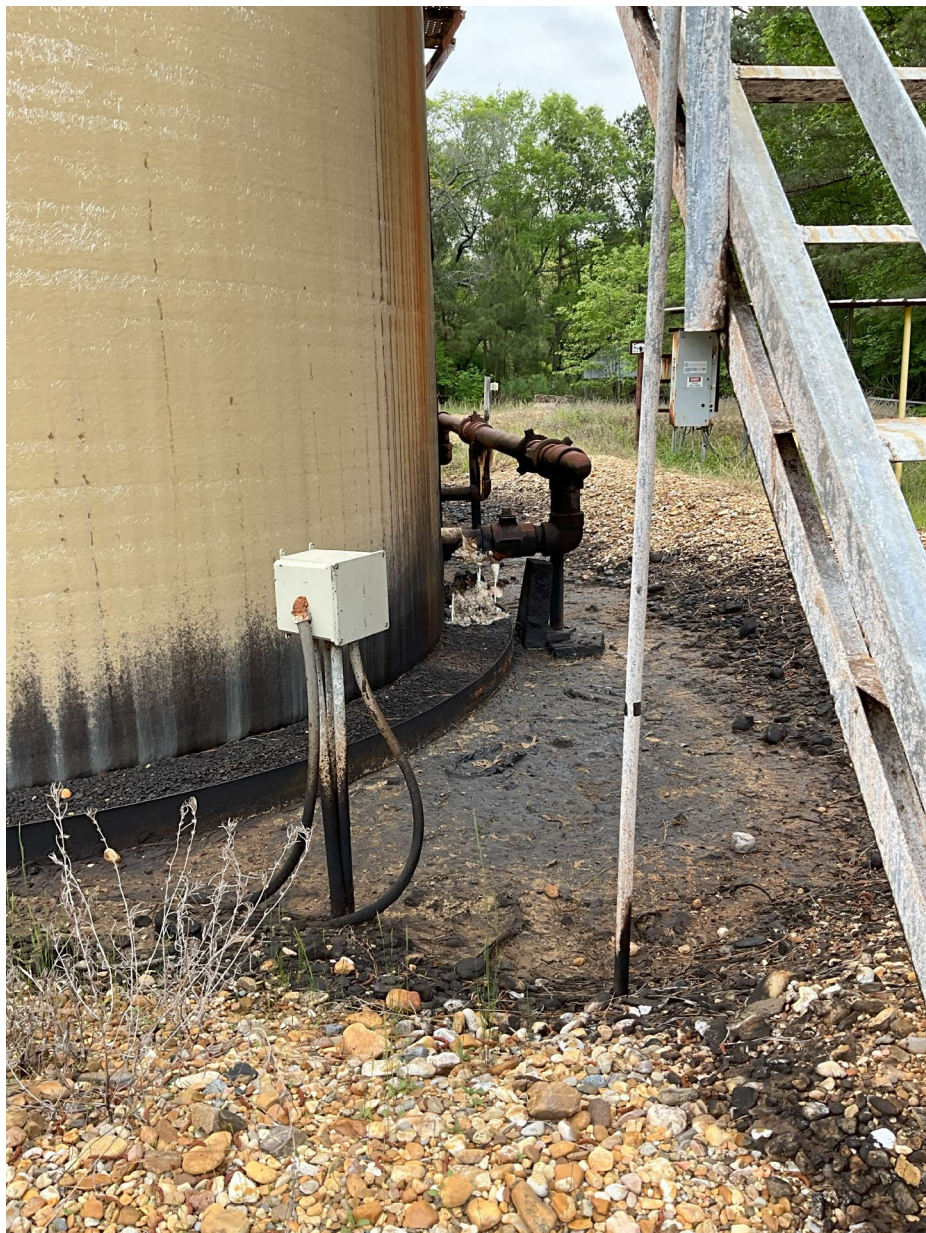
I observed two (2) leaking pipes or valves connected to the storage tank battery, see Photo No. 6 and No. 7.

**Description:** Looking east, this photo shows loose oil inside secondary containment for the tanks and a leaking pipe.

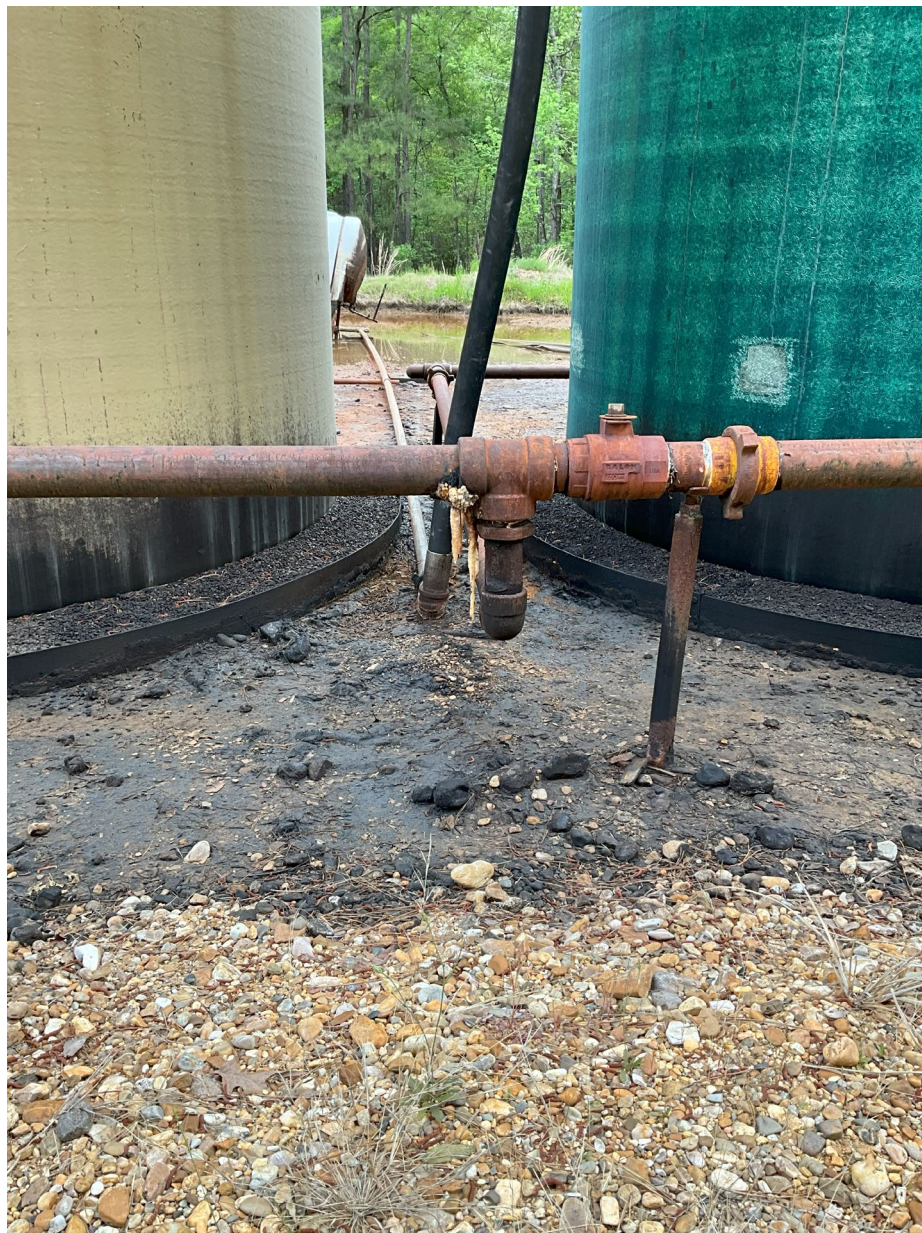
Photo No. 7

**Description:** Looking north, this photo shows loose oil inside secondary containment for the tanks and a leaking pipe.
