PURPOSE OF INSPECTION

The purpose of the inspection by the U.S. Environmental Protection Agency (USEPA) at Zekelman Industries, Inc. – Atlas Tube Division (Atlas Tube or Facility) was to describe, evaluate, and document compliance with the Clean Water Act (CWA) and their National Pollutant Discharge Elimination System (NPDES) permit.

Zekelman Industries, Inc. – Atlas Tube Division
EPA Inspection 8/15/2022
All photos taken by Jake Berger, Physical Scientist, U.S. EPA
Camera: Olympus TG-6

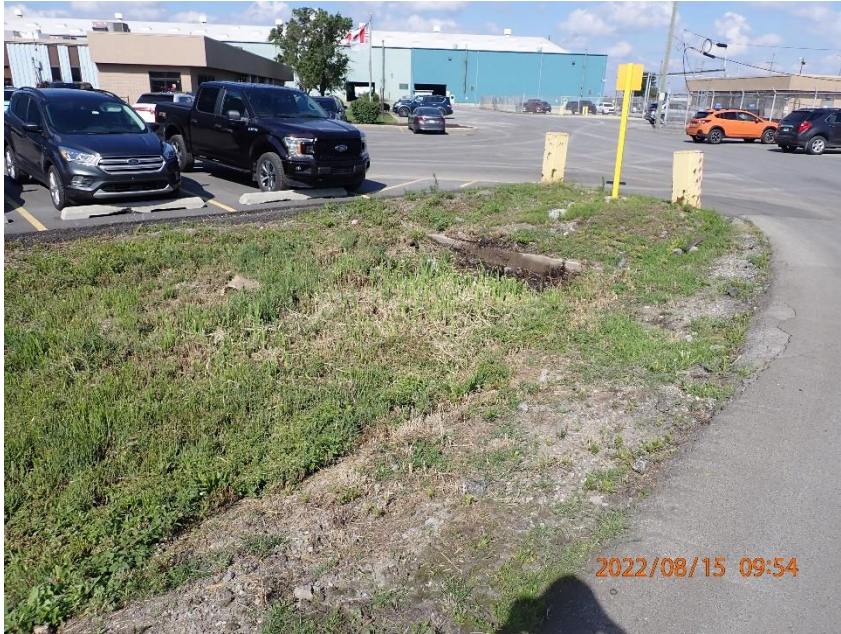
1: P8150001

Description: Starting location of storm water swale

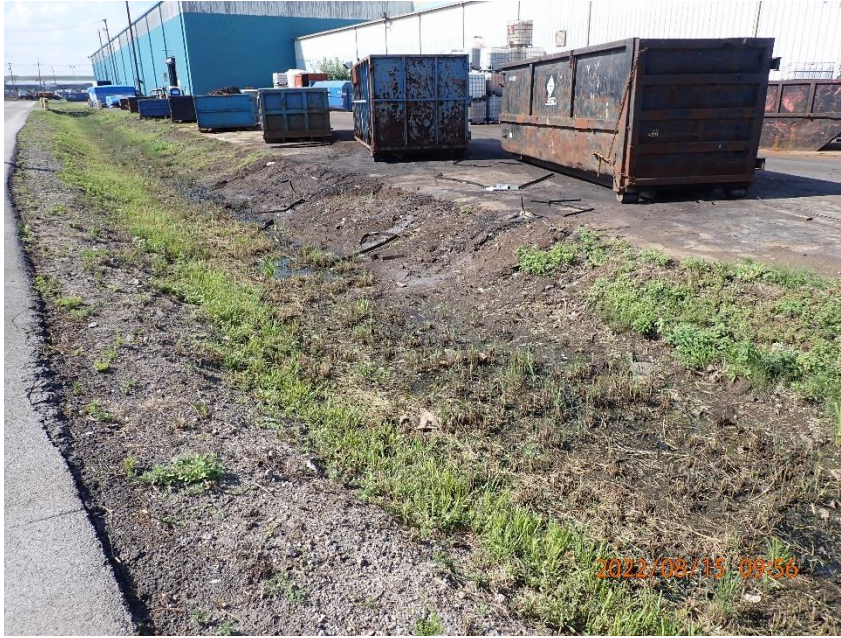
2: P8150002

- As shown in Photo 2 and Photo 3, sections of the banks of the storm water swale have little to no vegetation and are showing signs of erosion.
- As shown in Photo 3, sections of the storm water swale contain underground pipes that are clogged with trash and debris.
- As shown in Photo 4, totes containing a mixture of oil and water are stored outside and lack secondary containment.

Description: Storm water swale, open dumpsters, leachate in swale

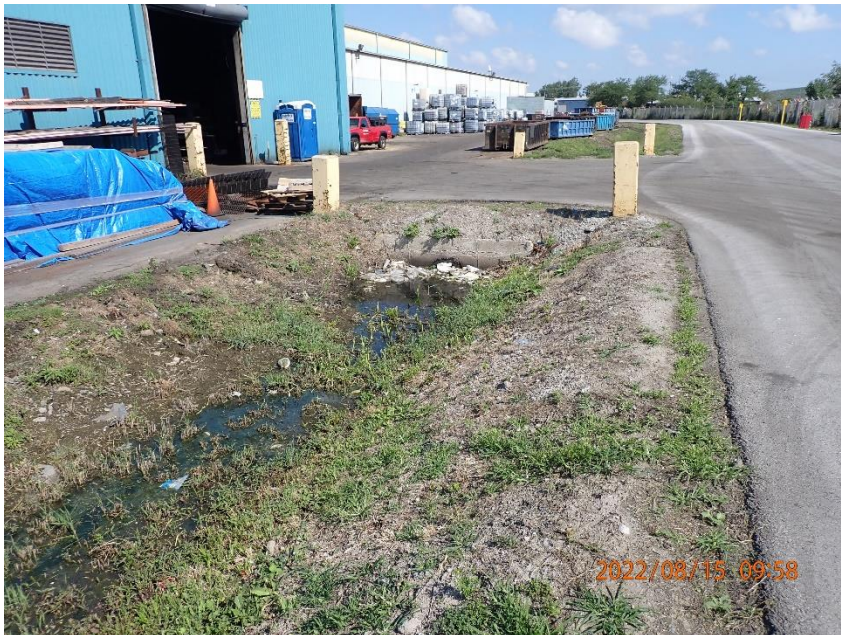
3: P8150003

Description: Storm water swale containing build up of trash and debris

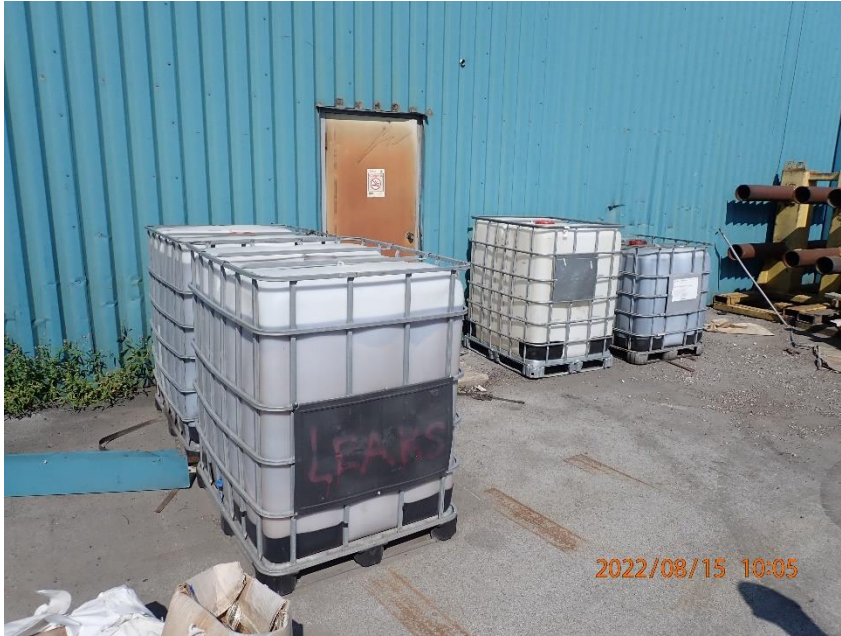
4: P8150004

Description: Totes containing a mixture of oil and water

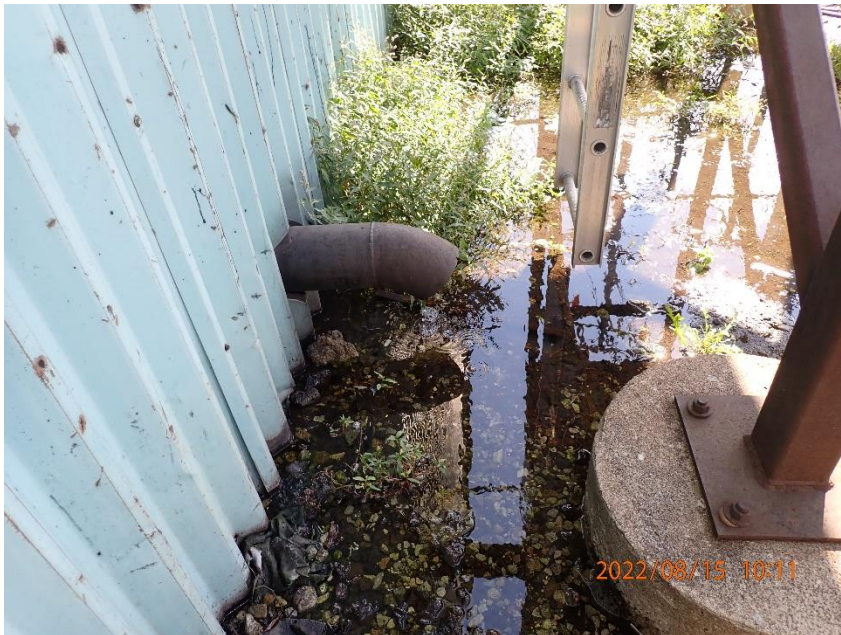
5: P8150005

Description: Discharge of non-contact cooling water, drains to storm water swale

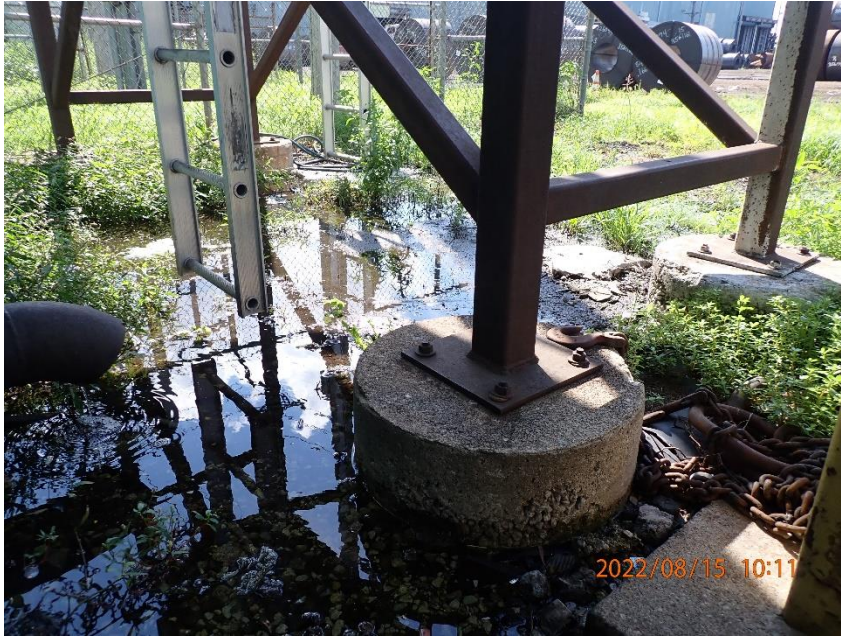
6: P8150006

Description: Discharge of non-contact cooling water, drains to storm water swale

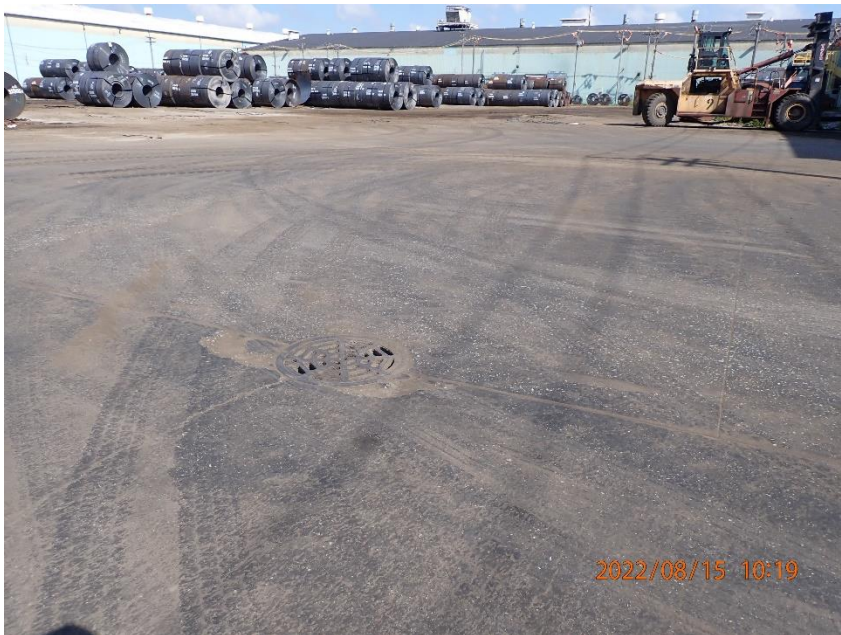
7: P8150007

Description: Storm water inlets and laydown yard

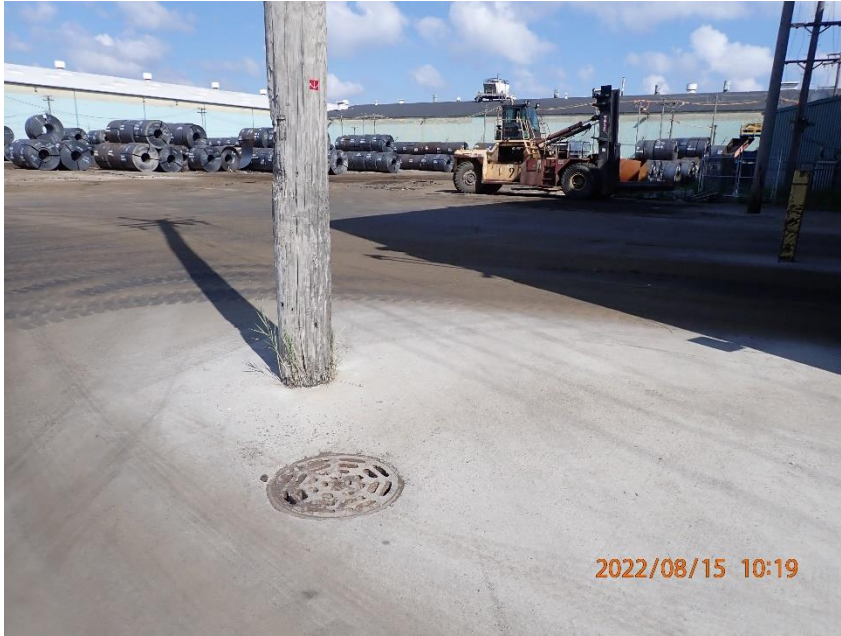
8: P8150008

Description: Storm water inlets and laydown yard

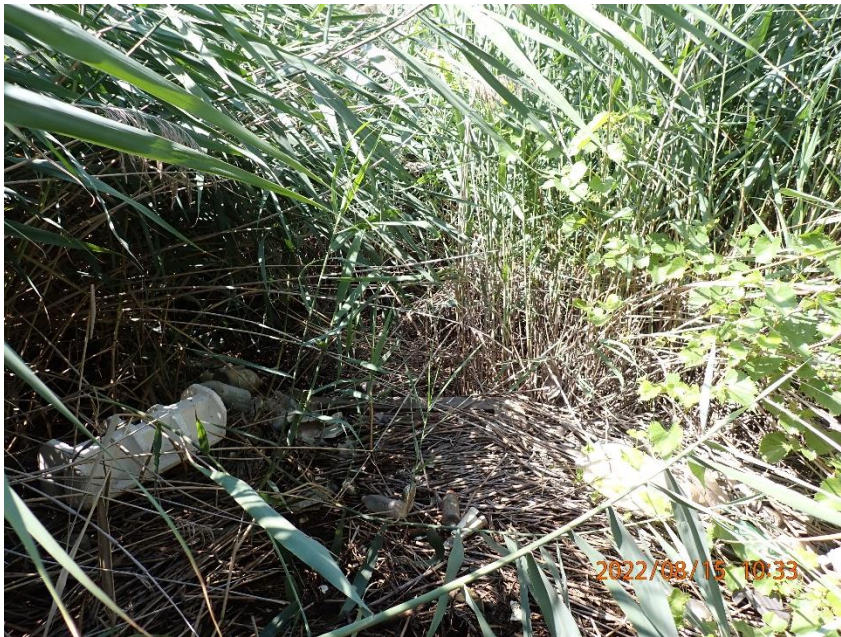
9: P8150009

Description: Storm water swale near where outfall pipe leaves the property, facing upstream

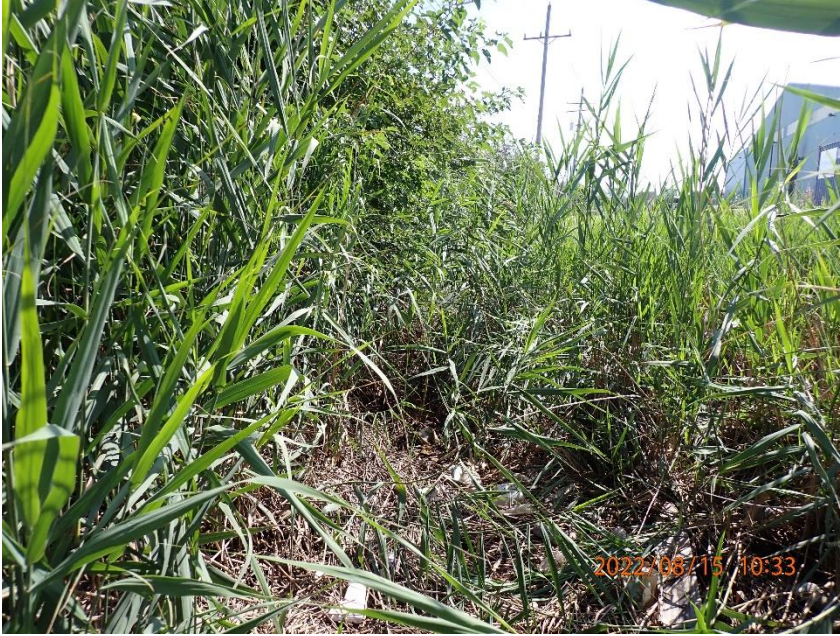
10: P8150010

Description: Storm water swale near where outfall pipe leaves the property, facing downstream

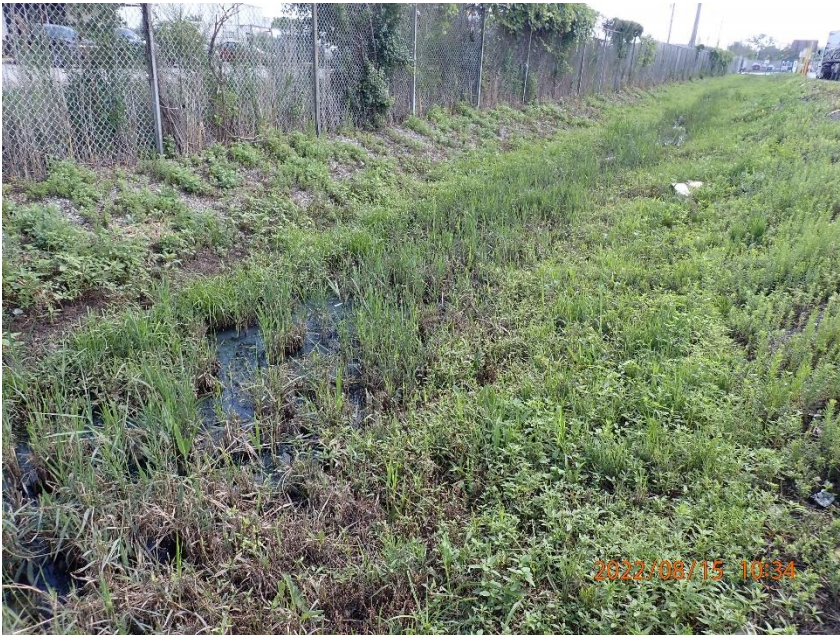
11: P8150011

Description: Upstream view of storm water swale on north end of site

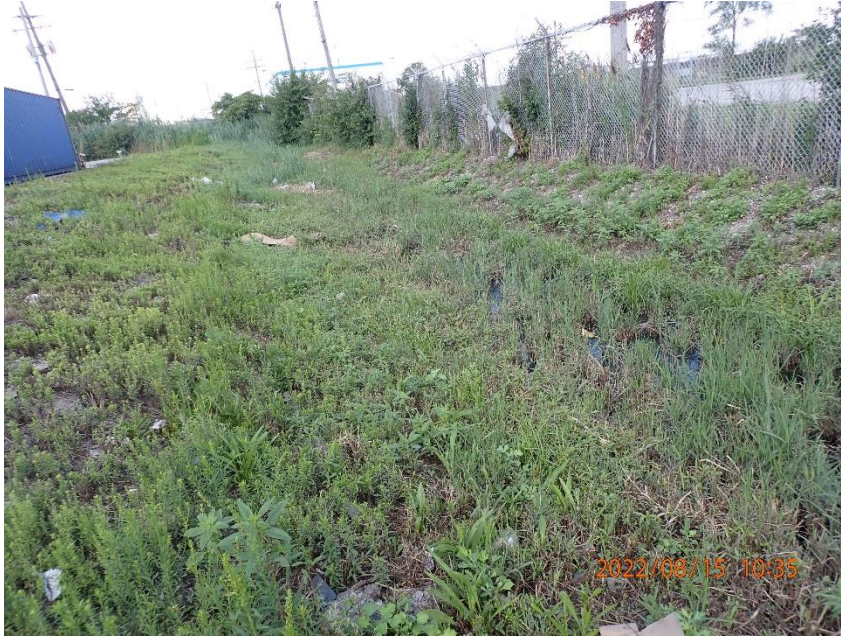
12: P8150012

Description: Downstream view of storm water swale on north end of site
