**CWA COMPLIANCE EVALUATION INSPECTION REPORT  
U.S. ENVIRONMENTAL PROTECTION AGENCY, REGION 5**

Compliance Evaluation Inspection (Clean Water Act portion of a Multi Media Inspection)

Scott Air Force Base  
501 Hangar Road, Building 531  
Scott Air Force Base, Illinois, 62225  
St. Clair County

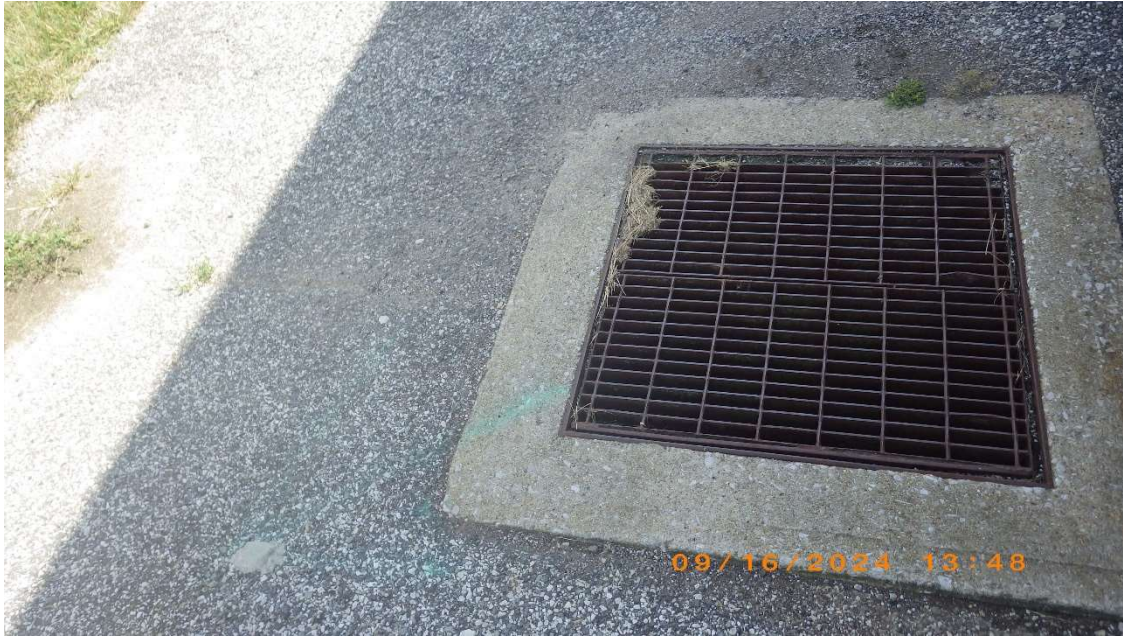
6: RIMG0006

Description: Stormdrain outside door to headworks building. SAFB personel stated that this stormwater drain flowed into the headworks.

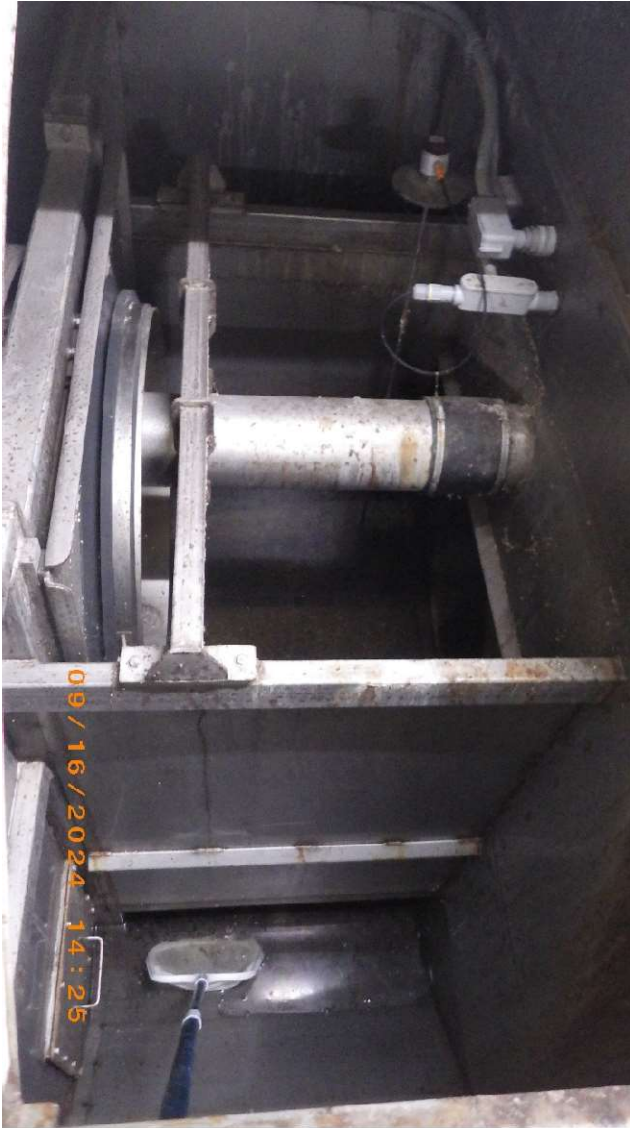
19: RIMG0019

Description: Non-operational disk filter. SAFB personel stated that the disk filters were non-operational due to snail shells in the effluent that immediately clogged the filter spray nozzles. SAFB personel stated that multiple solutions had unsuccessfully been attempted to return the disk filters to service and that the plant was considering alternative replacements.

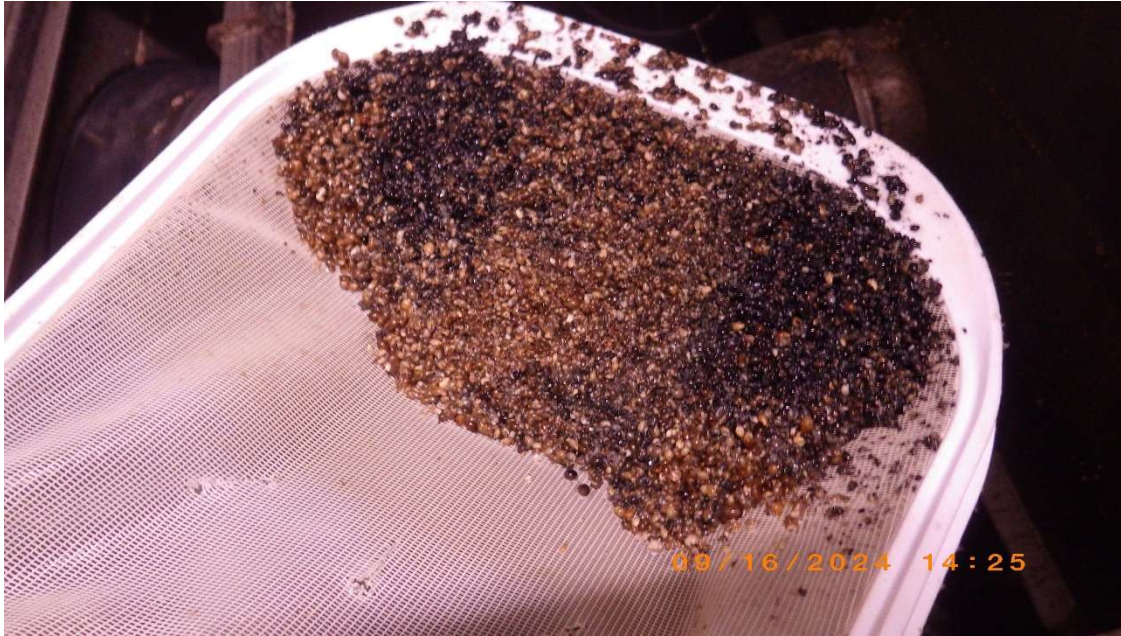
20: RIMG0020

Description: Snail shells in the disk filter.

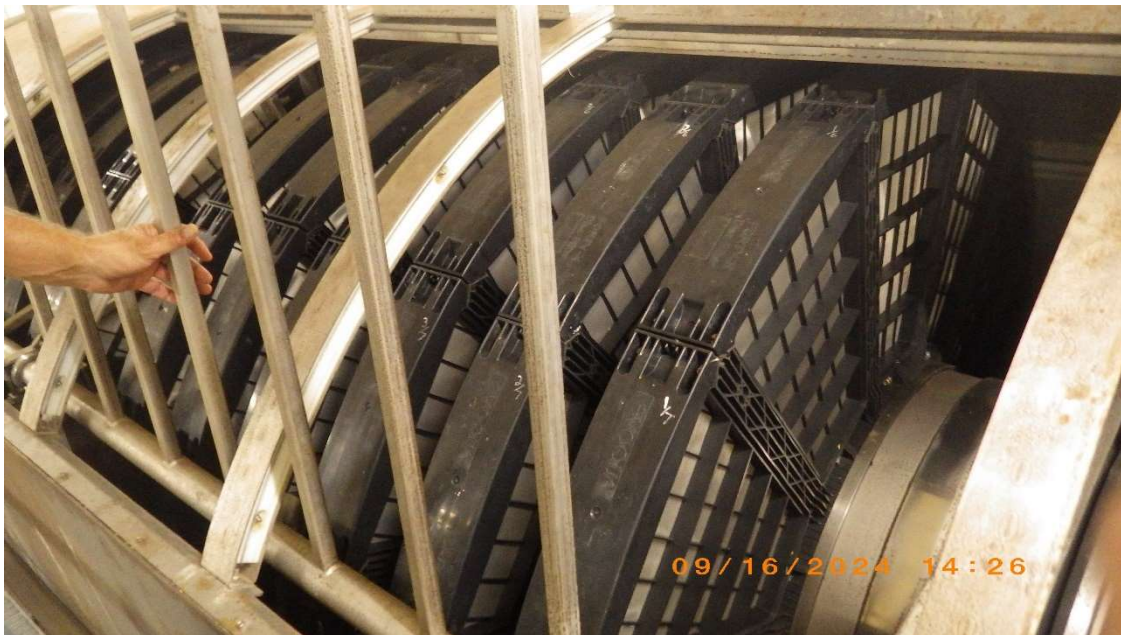
21: RIMG0021

Description: Non-operational disk filter. SAFB personnel stated that the disk filters were non-operational due to snail shells in the effluent that immediately clogged the filter spray nozzles. SAFB personnel stated that multiple solutions had unsuccessfully been attempted to return the disk filters to service and that the plant was considering alternative replacements.

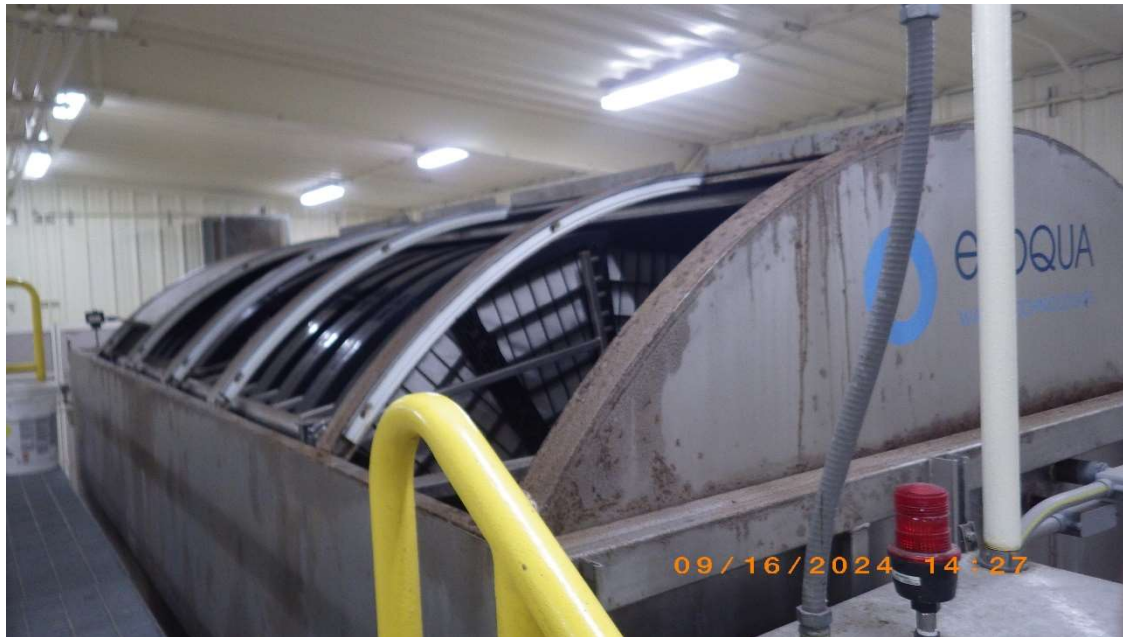
22: RIMG0022

Description: Non-operational disk filter. SAFB personel stated that the disk filters were non-operational due to snail shells in the effluent that immediately clogged the filter spray nozzles. SAFB personel stated that multiple solutions had unsucessfully been attempted to return the disk filters to service and that the plant was considering alternative replacements.

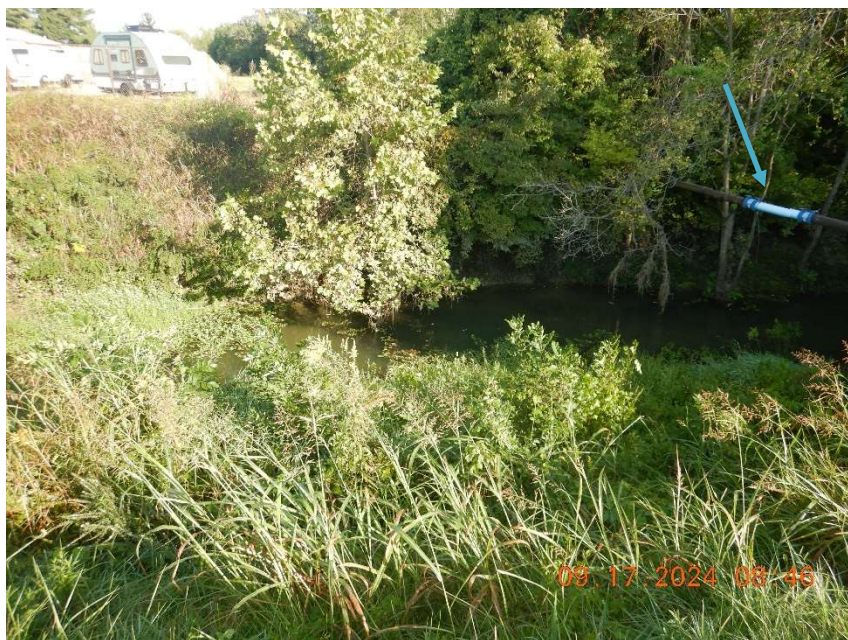
1: DSCN0001

Description: Looking northwest at the industrial stormwater “OUTFALL 2” also called “O-SD1”. Note pipe with repair patch going over the waterway. (blue arrow) SAFB personnel stated that this pipe conveyed effluent from the wastewater treatment plant to the golf course pond.

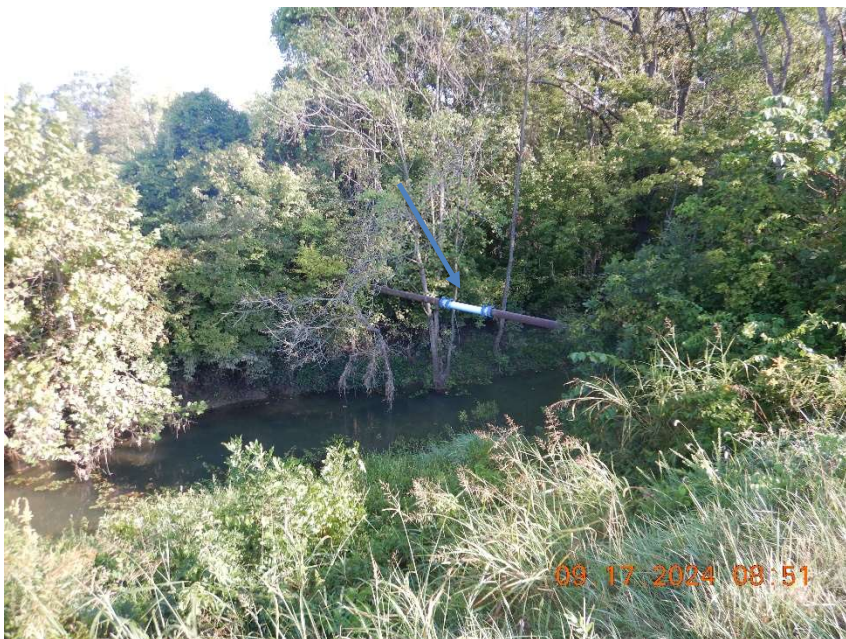
2: DSCN4231

Description: Looking northwest at the industrial stormwater “OUTFALL 2”. Note pipe with repair patch going over the waterway. (blue arrow) SAFB personnel stated that this pipe conveyed effluent from the wastewater treatment plant to the golf course pond.

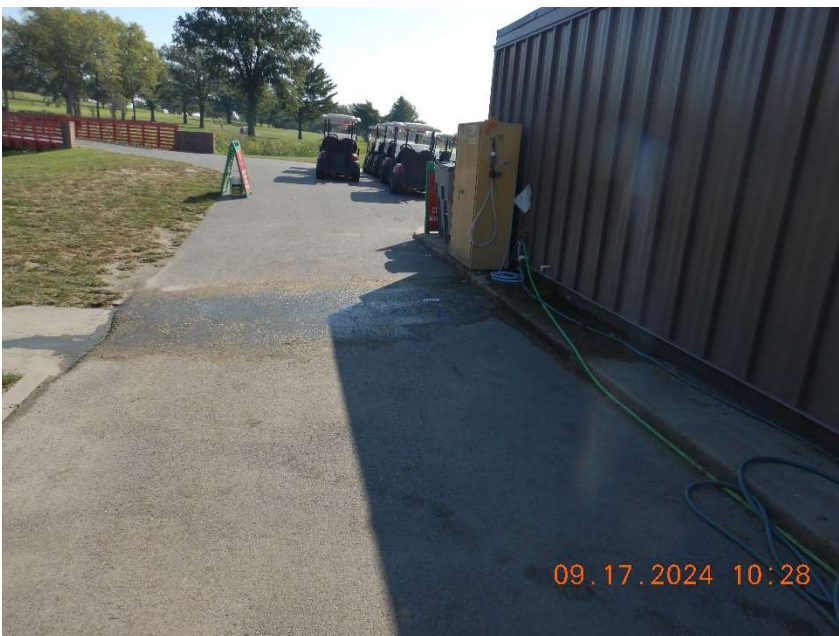
17: DSCN4246

The inspectors then proceeded to view “OUTFALL 7” (O-SL1), the Golf Course Pond, and then “INFLOW 1” (I-CC1). At “INFLOW 1”, EPA observed a leaking hose contributing runoff to “Cardinal Creek” (photos 13-21). Mr. Busch was unaware of what the hose was used for, if this was from the cart wash area, or if any cleaners were being utilized.

Description: Looking east along the north side of the golf cart hut. Note hoses leaking liquid which is flowing north to a concrete swale down to the unnamed tributary.

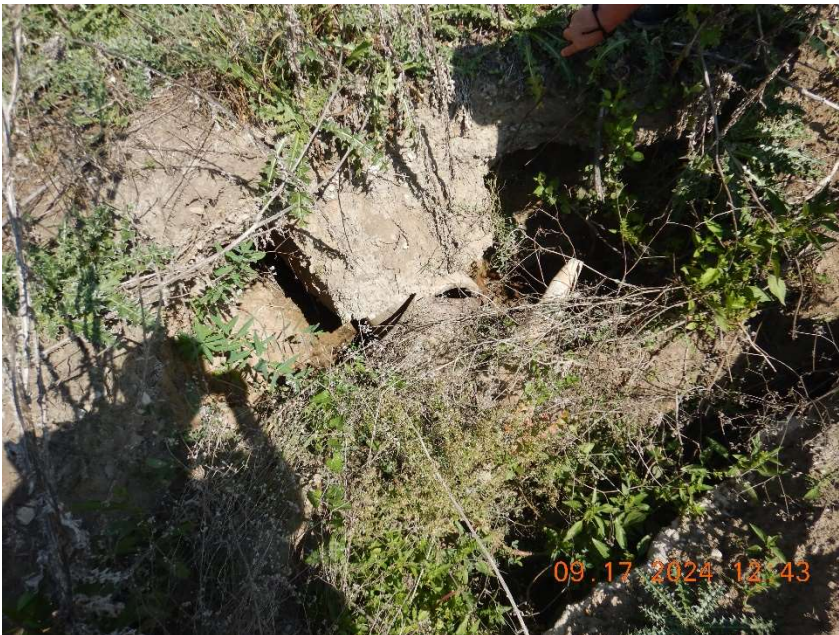
33: DSCN4262

Description: An eroded hole with fragments of a broken pipe in it.

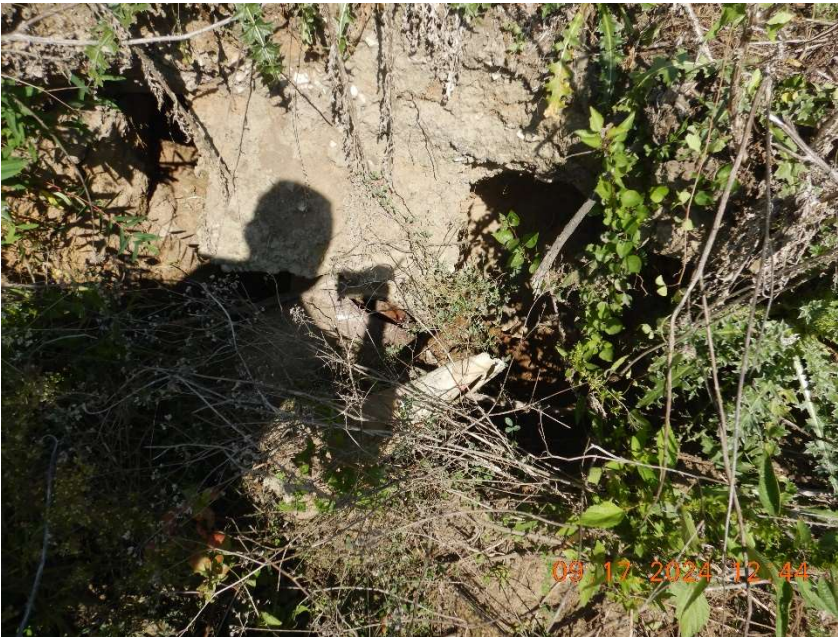
34: DSCN4263

Description: An eroded hole with fragments of a broken pipe in it.

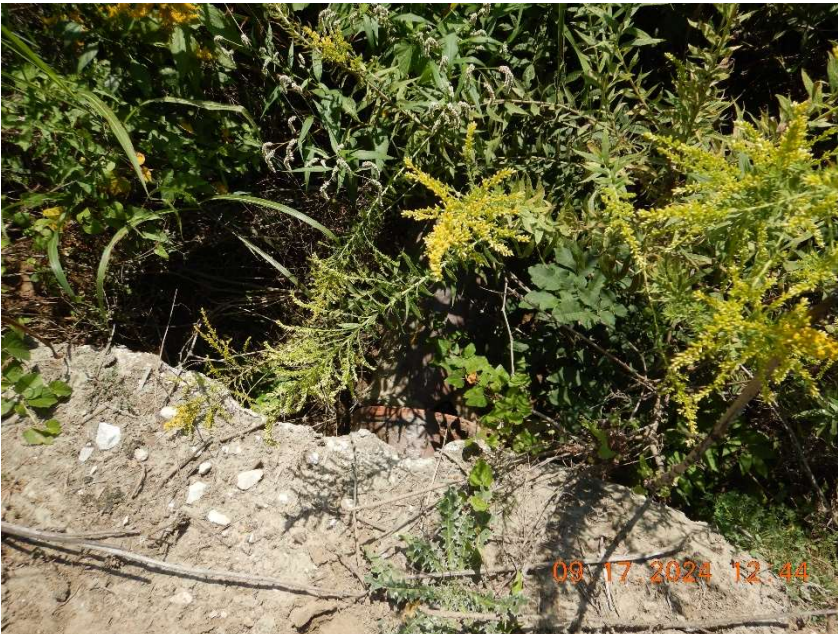
35: DSCN4264

Description: An eroded hole with fragments of a broken pipe in it.

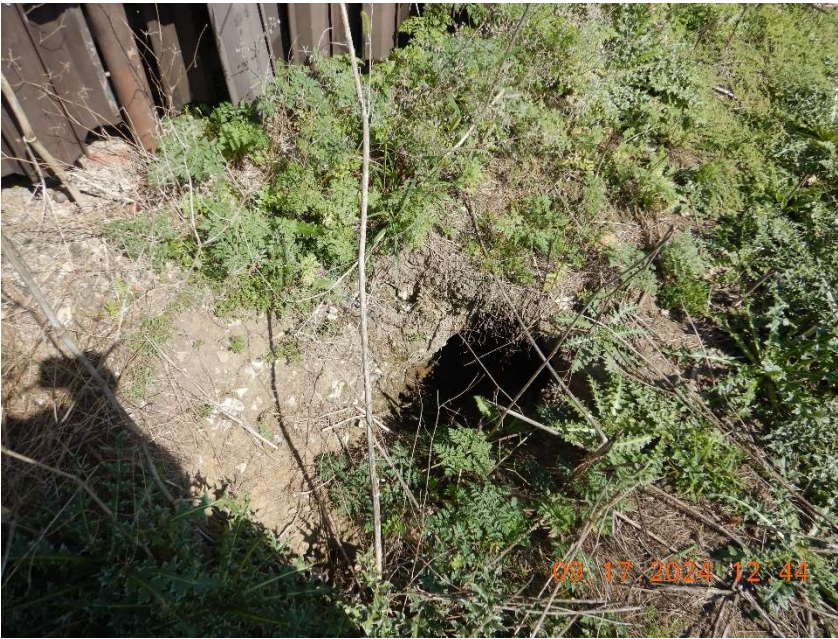
36: DSCN4265

Description: An eroded hole with fragments of a broken pipe in it.

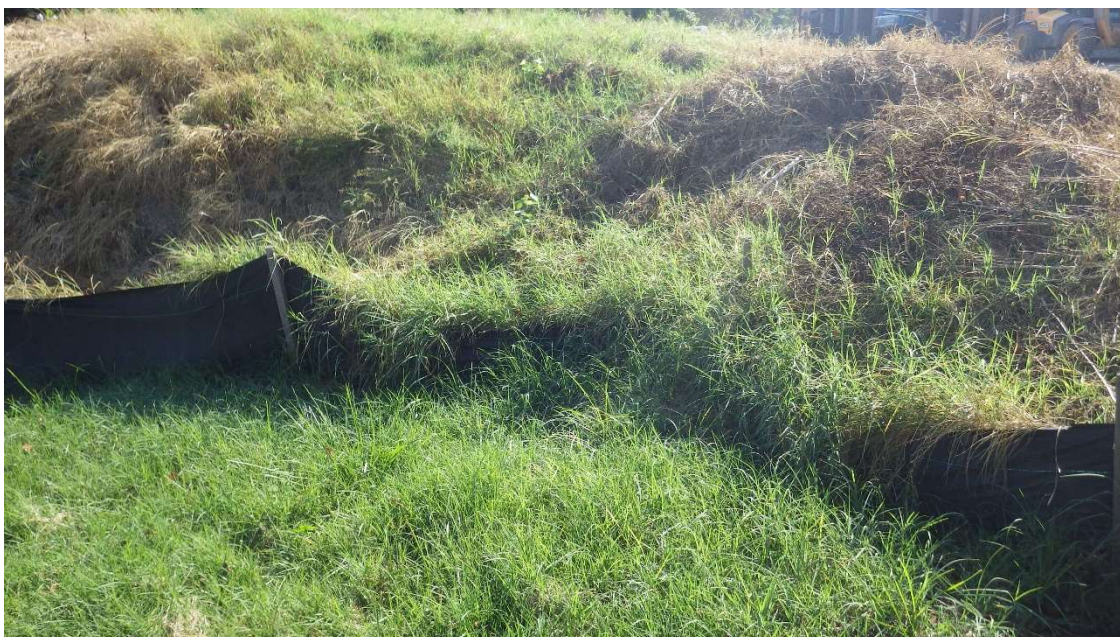
11: RIMG0011

3. As shown in photos 11, 12, and 23 of photo log 2, EPA observed several locations where the silt fence was in need of repair.
4. NPDES Permit No. ILR002659 Part III. A. 3. states “The following non-storm water discharges are prohibited by this permit: concrete and wastewater from washout of concrete (unless managed by an appropriate control)”. As shown in Photo 22 of Photo Log 2, it appears that wastewater from the concrete washout had reached a storm drain.

Description: Silt fence being pushed down by vegetation around stabilized dirt pile.

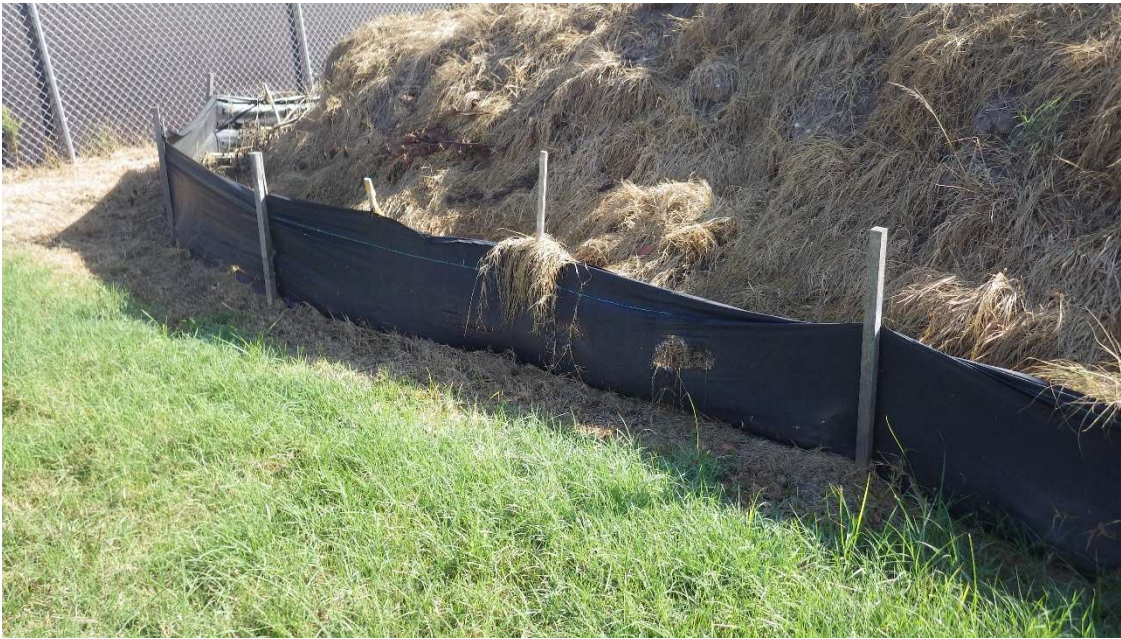
12: RIMG0012

Description: Silt fence with holes in need of maintenance.

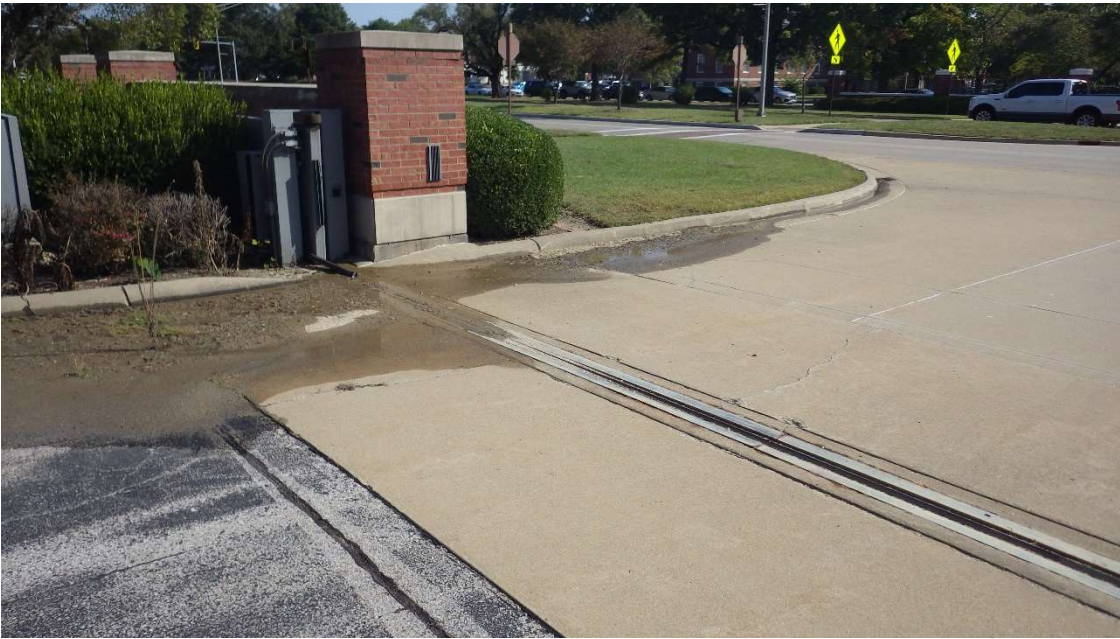
14: RIMG0014

EPA observed a discharge from a red hose to a storm drain (photos 14-18 of Photolog 2) which SAFB personnel identified as dewatering from an elevator shaft. The SWPPP did not identify appropriate pollution prevention measures for this non-storm water discharge.

Description: Water flowing east off the construction site to a storm drain.

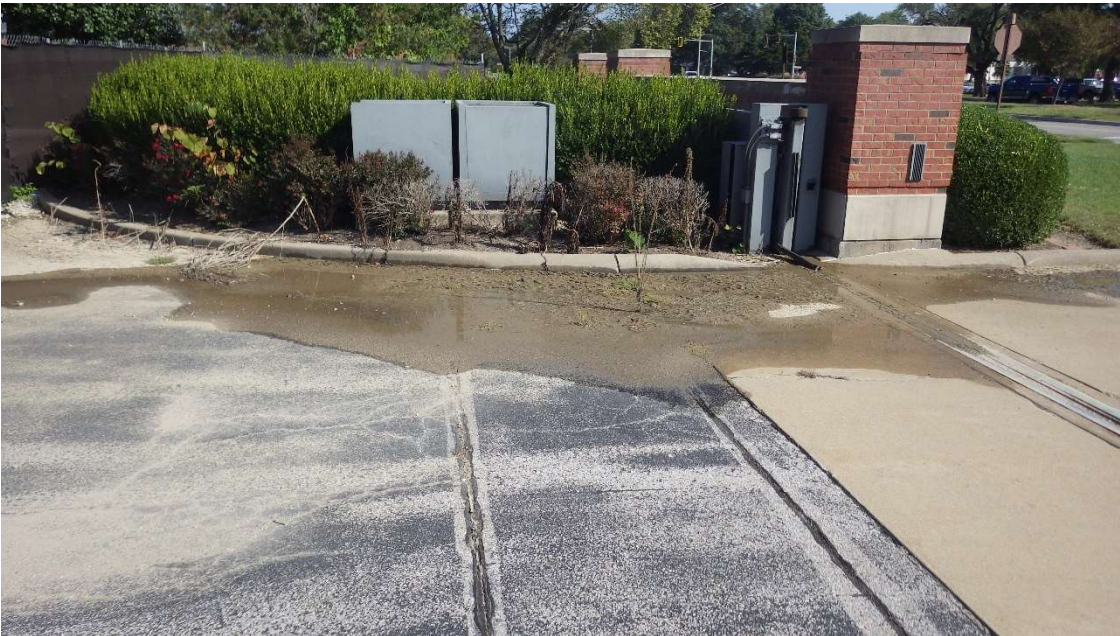
15: RIMG0015

Description: Water flowing east off the construction site to a storm drain. Note sediment in flow path of water.

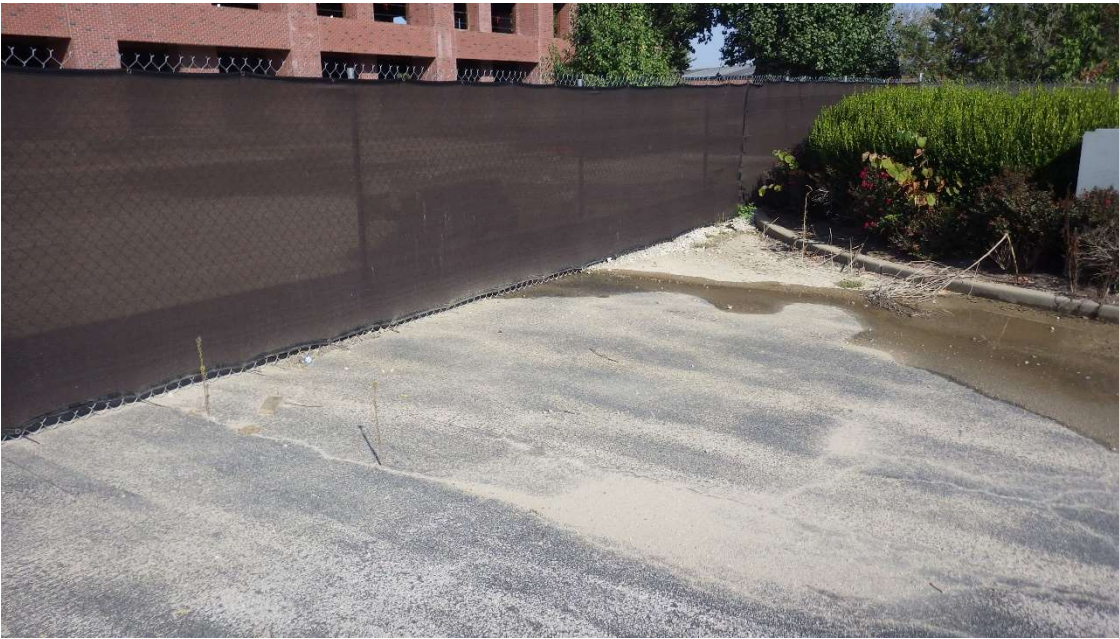
16: RIMG0016

Description: Water flowing east off the construction site to a storm drain. Note sediment in flow path of water.

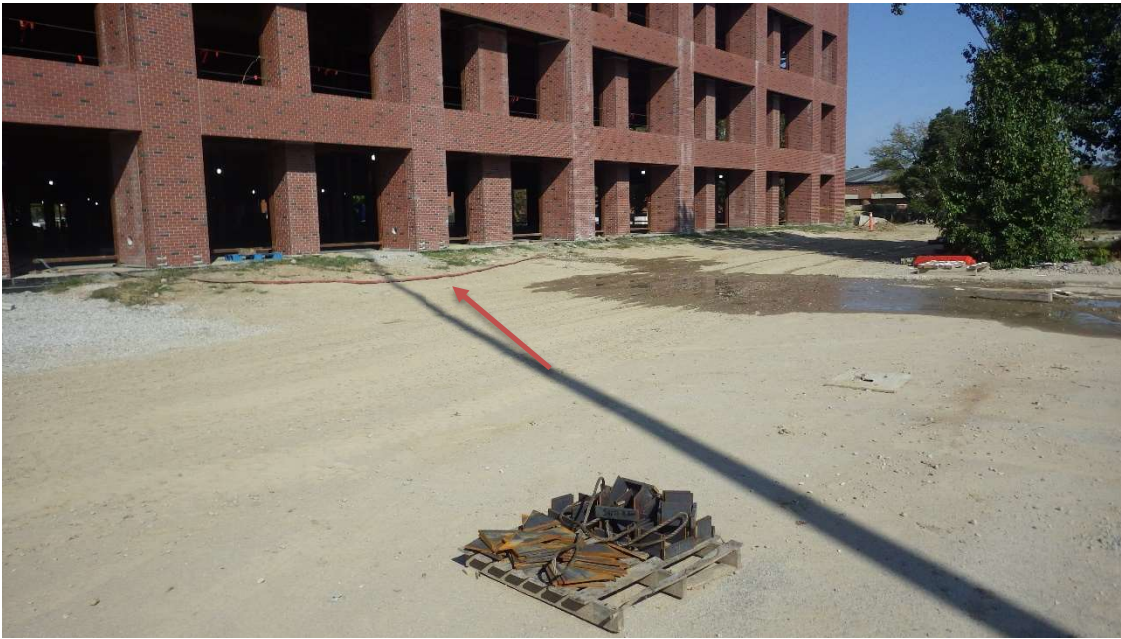
18: RIMG0018

Description: Water flowing east off the construction site to a storm drain. Note sediment in flow path of water. Note red hose which is the source of the water (red arrow). SAFB personnel stated that the hose was attached to a pump that had been used to dewater an elevator shaft and that site personnel had been instructed to ensure that future dewatering activities discharged to areas of the site that would allow for filtering and infiltration.

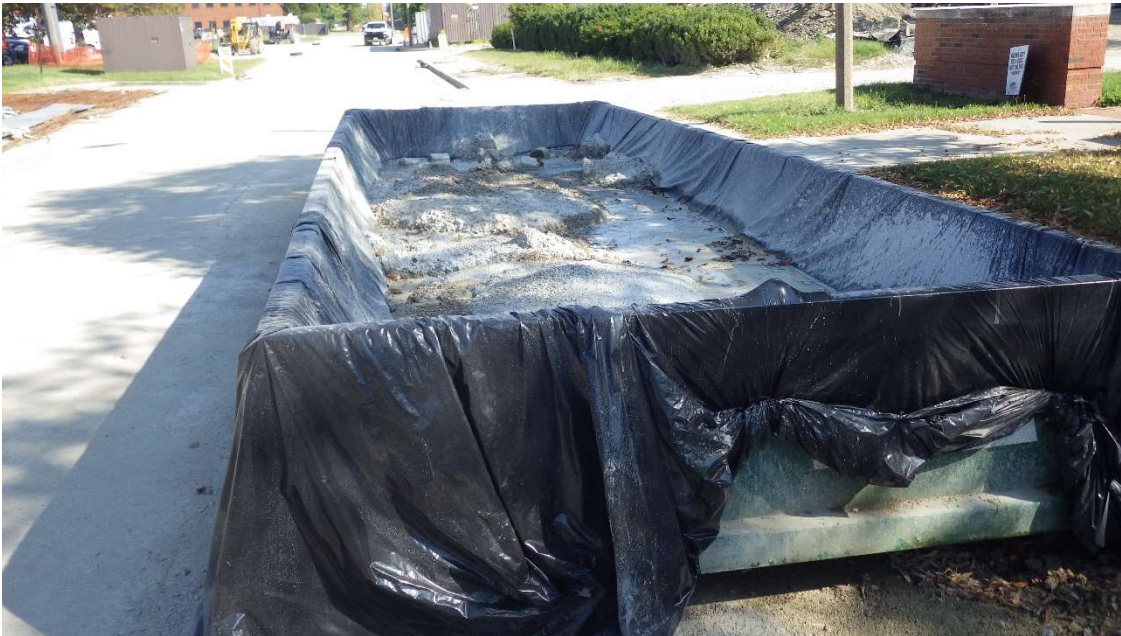
21: RIMG0021

2. EPA noted the following inconsistencies between the SWPPP and practices on-site:
  - a. Silt fence was not installed as indicated on sheet C-501.
  - b. The concrete washout was not constructed as indicated on sheet C-502 including not meeting set-back distance from storm water drains.

Description: Dumpster being utilized as concrete washout.

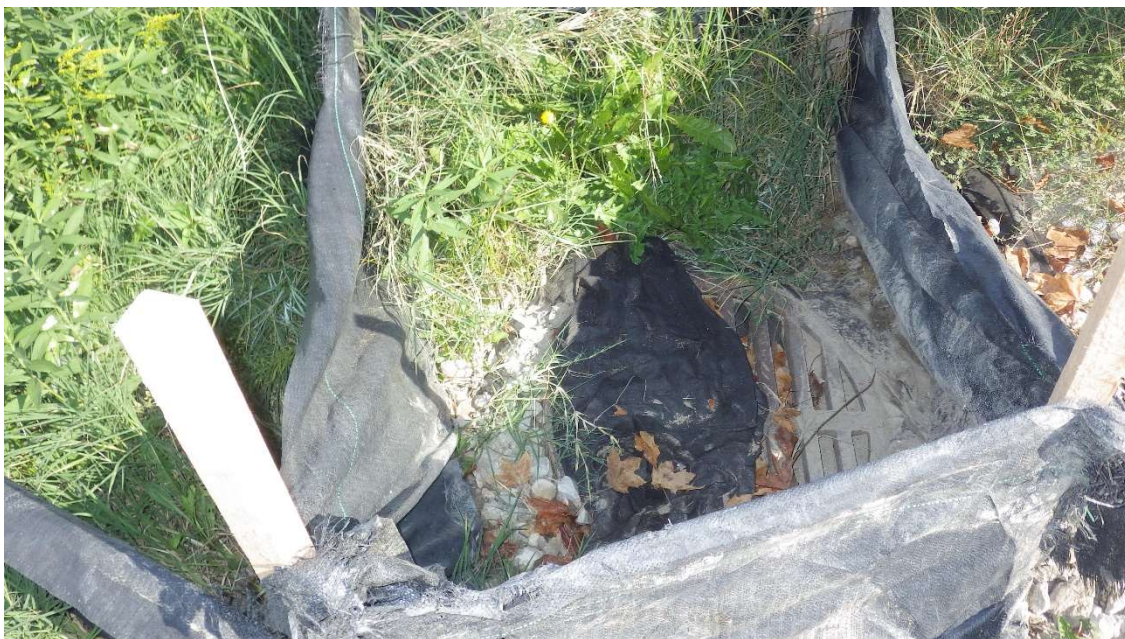
22: RIMG0022

EPA walked around the southeast corner of the site and observed a storm water drain and curb drain that were not called out on the site plan. Both drains were observed to have sediment protection installed around them (photos 19 and 20). EPA continued to walk west along the south side of the site to the west side. EPA observed a plastic lined dumpster that appeared to be the site's concrete washout (photo 21). EPA also observed a storm drain inlet adjacent to the concrete washout that was not called out on the site plan. The drain was observed to have a silt fence around it; however, EPA observed white deposits on the storm drain (photo 22).

Description: Filter fabric around and under storm water drain inlet adjacent to concrete washout. Note white deposits on the inside of the filter fabric.

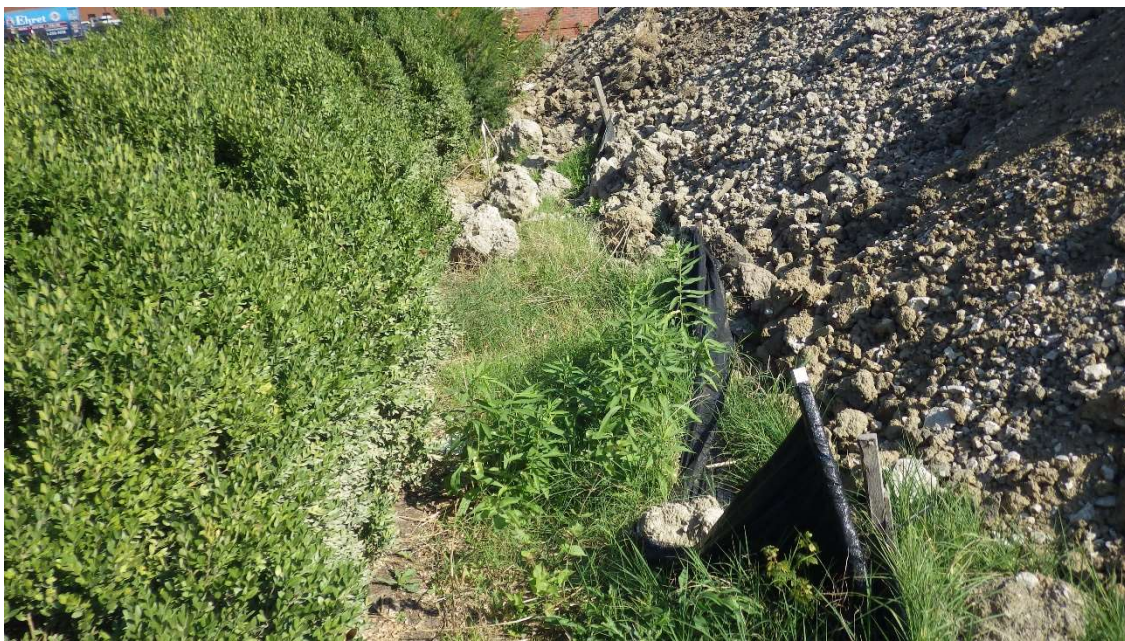
23: RIMG0023

Description: Silt fence on the west side of the building 1600 construction site that has been knocked down by dirt pile.

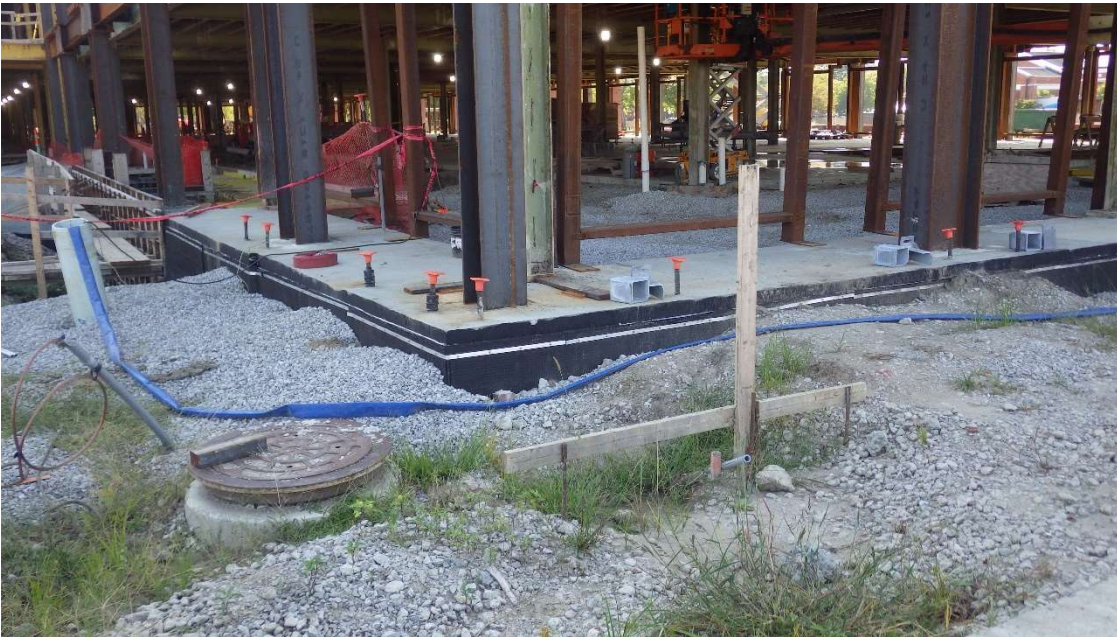
24: RIMG0024  
 Description: Blue hose from white vertical pipe (left) to ajar manhole (right).  
 Location: West side of building 1600 construction site.  
 Camera Direction: Northeast Date/Time: 09/18/2024 10:14 AM

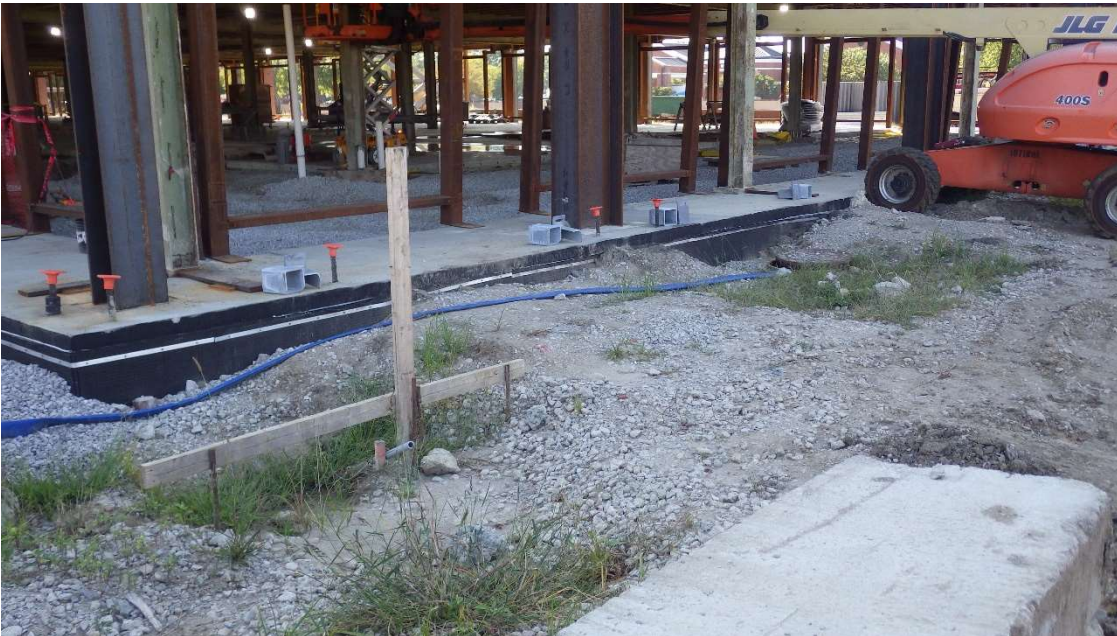
25: RIMG0025  
 Description: Blue hose from white vertical pipe (left) to ajar manhole (right).  
 Location: West side of building 1600 construction site.  
 Camera Direction: Northeast Date/Time: 09/18/2024 10:14 AM
