INSPECTION REPORT

| Type of Inspection | Focused Compliance Inspection (FCI) | | | |
| Facility or Site Name | SSA Marine | | | |
| Facility/Site Physical Address | 1355 Wallace St. | | | |

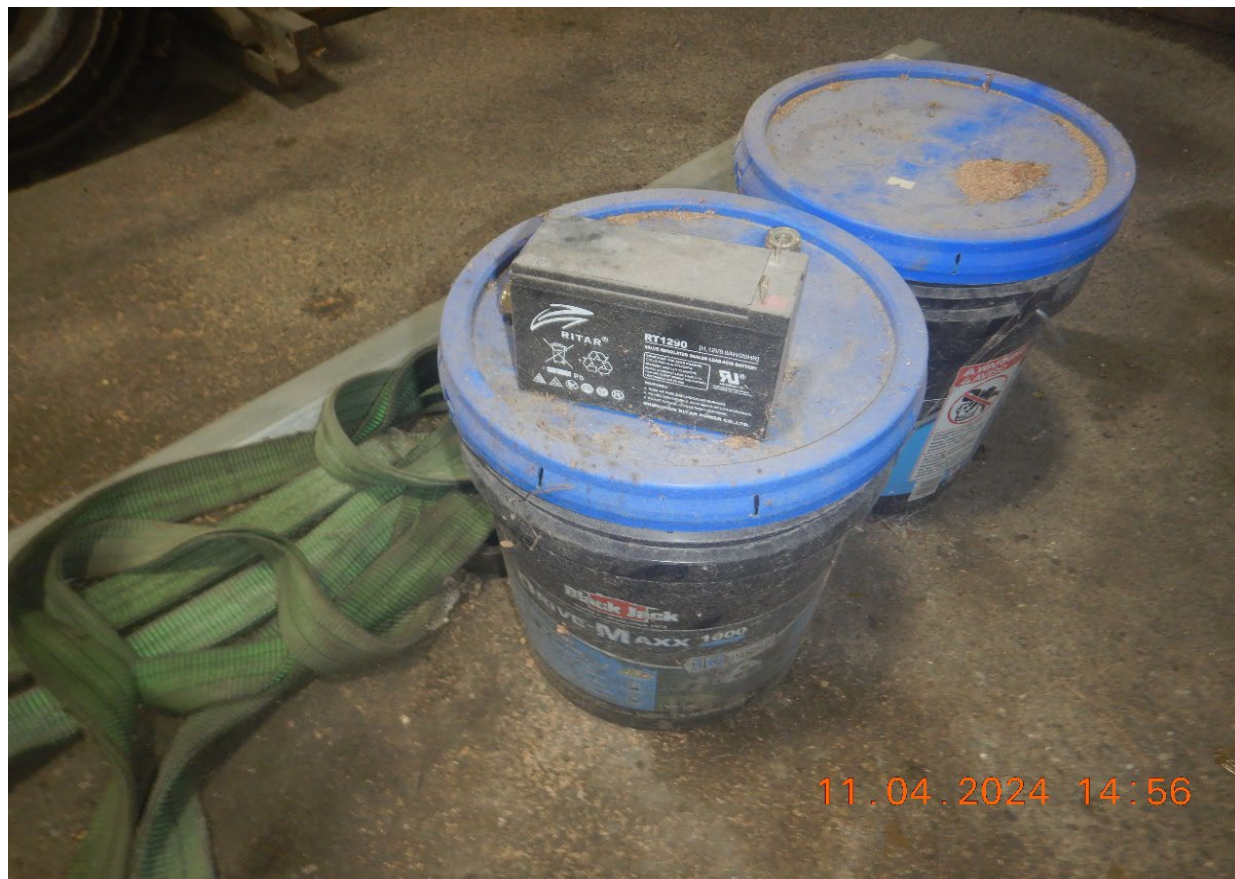
Photo No. 1

Following the opening conference, the inspection team conducted a visual inspection of SSA’s Maintenance Garage where SSA repairs their trucks and forklifts and stores equipment. The inspection team first observed two used lead-acid batteries (see Appendix 1 – Photos 1 to 2). The batteries were not labeled as universal waste. The inspection team asked Jana Watson if they knew the accumulation start date of the used batteries. Ms. Watson was not sure but said a vendor swaps the batteries out several times throughout a year; no BOLs or receipts were provided following the inspection [ **AOC #1** – *SSA did not label batteries being managed as universal waste properly or store the batteries in a properly labeled container – 40 CFR 273.14(a)*]. Next, the inspection team observed a 55-gallon drum of used antifreeze in the back corner of the maintenance garage that was approximately half full (see Appendix 1 – Photos 3 and 4). Ms. Watson stated the used antifreeze is sent for recycling at Action Oil once SSA fills the drum. The inspection team noticed the funnel on top of the drum was not plugged and suggested the drum of antifreeze should remain closed when not in use to minimize the potential for a release. The inspection team walked through the storage yard and did not observe any other areas of concern (AOCs).

| Tenant: SSA Marine | | |
|---|---|---|
| <b>AOC #1</b> – SSA did not label batteries being managed as universal waste or store the batteries in a container labeled as “Universal Waste—Battery(ies), “Waste Battery(ies),” or “Used Battery(ies).” | <b>Citation:</b> 40 CFR 273.14(a) | Section: 2.1 |

Description: An unlabeled lead-acid battery was found on top of a 5-gal container inside the Maintenance Garage.

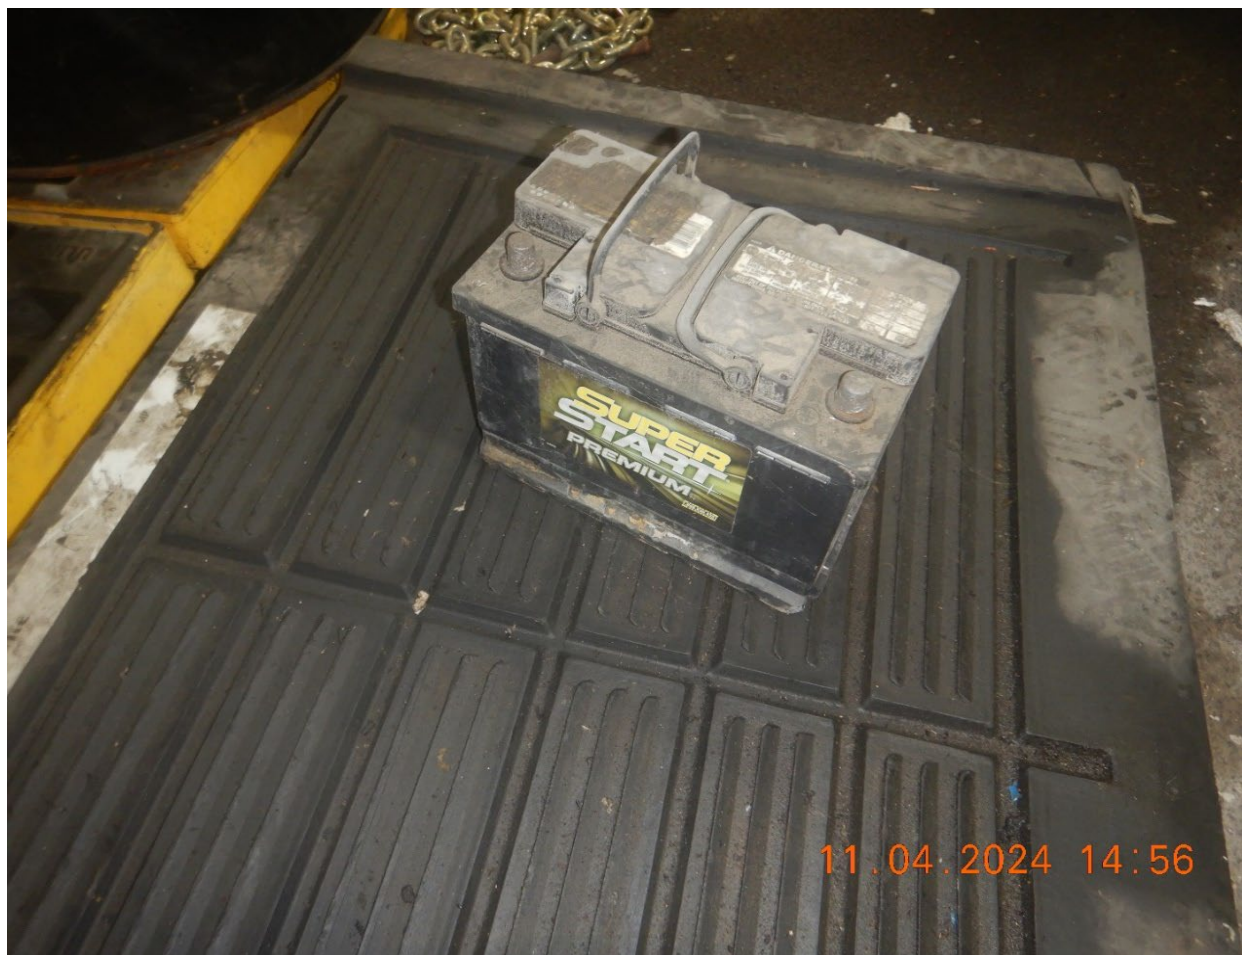
Photo No. 2

Description: An unlabeled lead-acid battery was found on top of a plastic drip pad inside the Maintenance Garage.

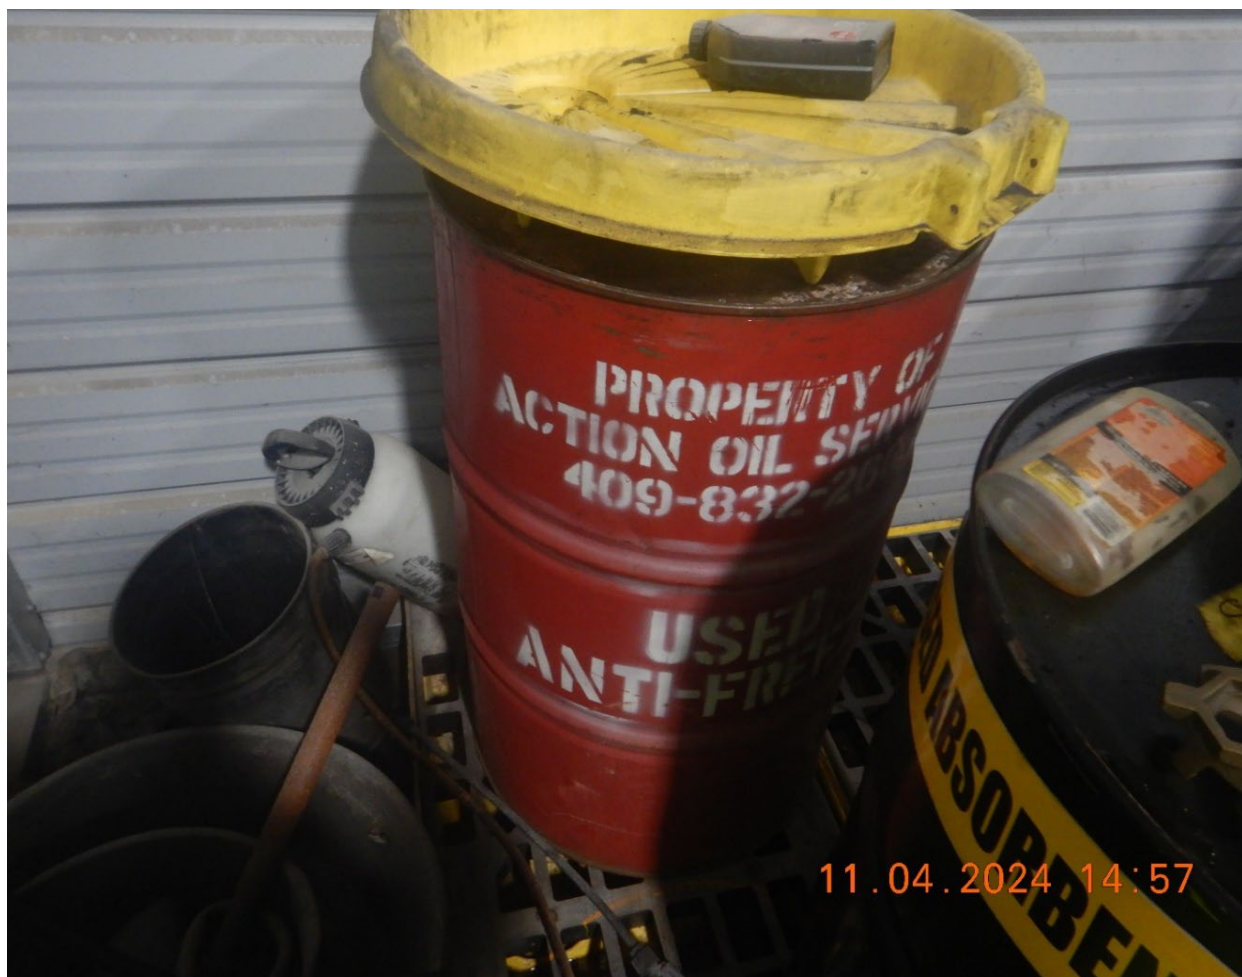
Photo No. 3

Description: View of a 55-gal drum containing used antifreeze that was approximately half full inside the Maintenance Garage.

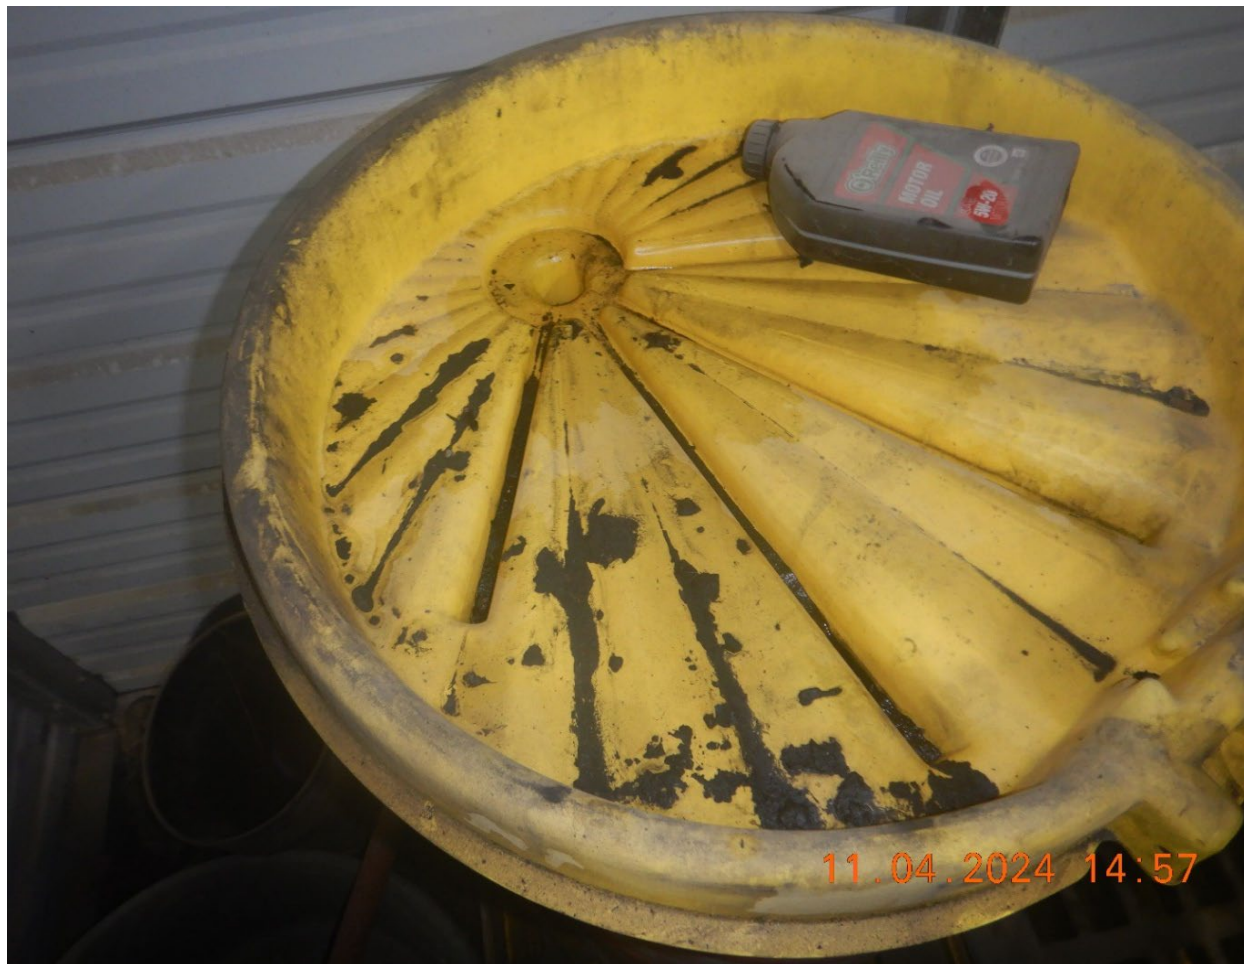
Photo No. 4

Description: View of the funnel on the 55-gal used anti-freeze container that was not plugged or closed.
