**Well Inspection**  
**Osage DNR / Environmental Protection Agency**  
**1201 Elm Street, Suite 500**  
**Dallas, Texas 75270**

| | | <b>Lease Name</b> | NRU | | |
| | | <b>Well ID</b> | 03-02W | | |
| <b>Location</b> | SW 10 24N 07E | <b>Status</b> | Inactive | <b>Well Type</b> | Enhanced Recovery |

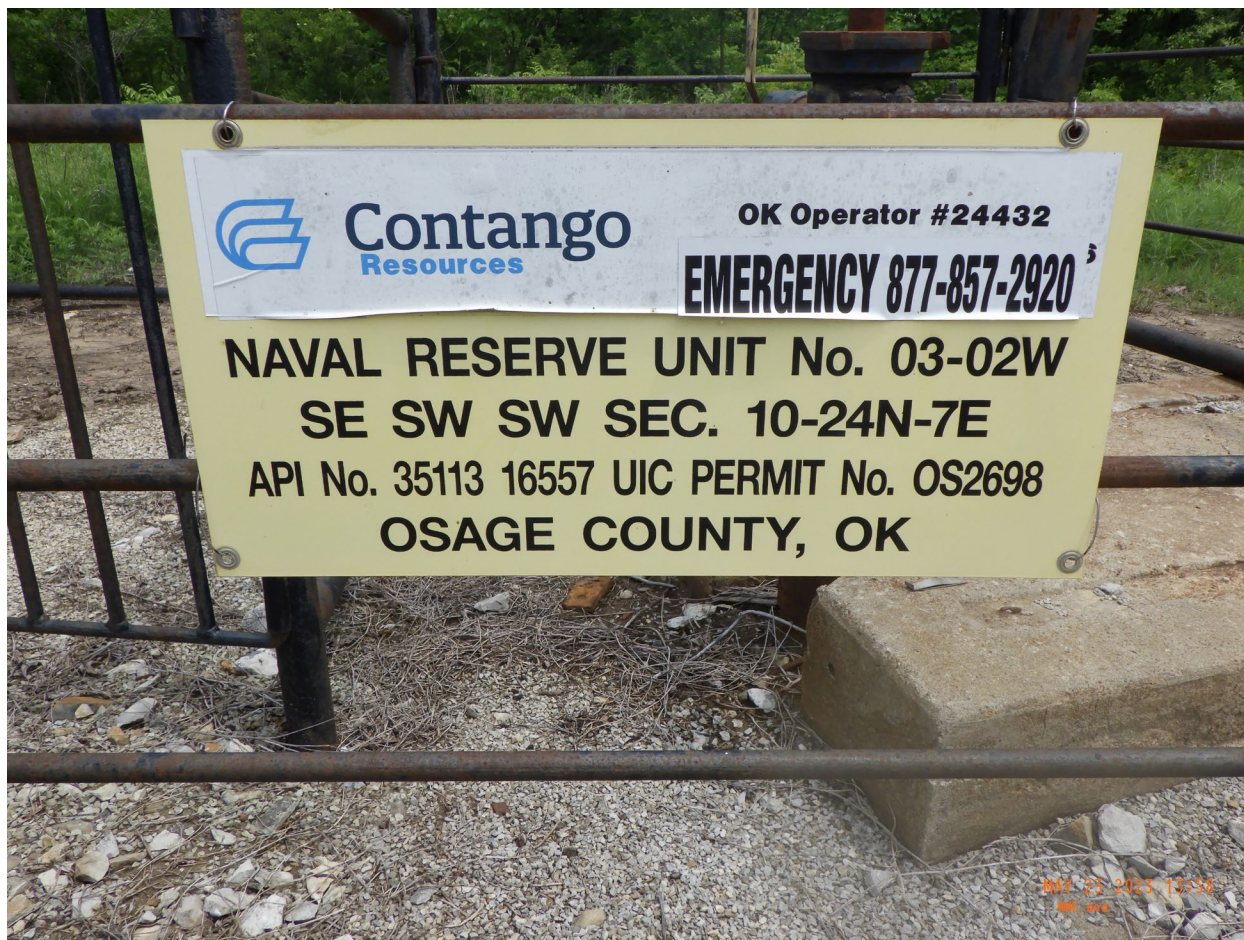
Photo No. 1

Description: This was the injection well OS2698000 sign at the time of the inspection.

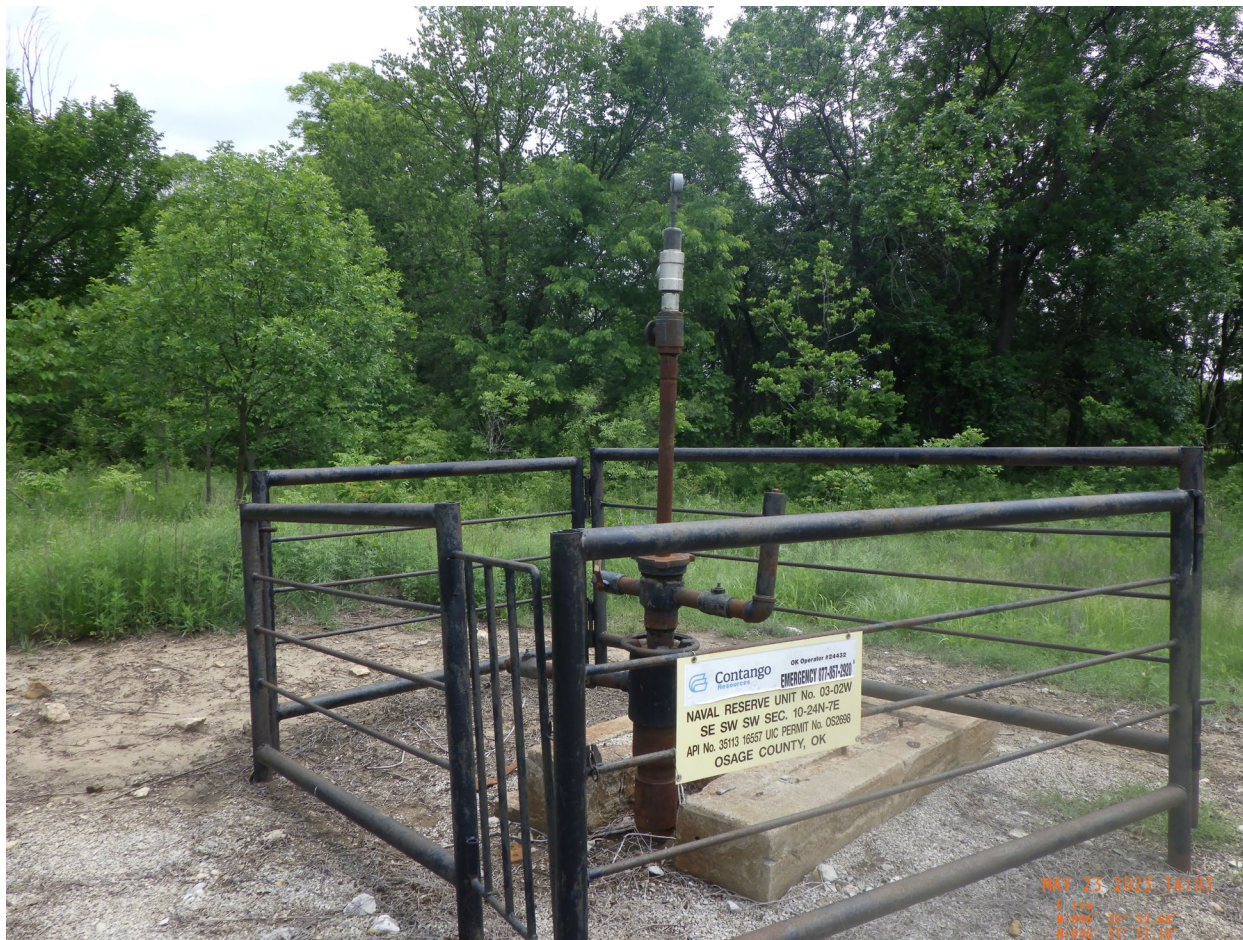
Photo No. 2

| <b>Inspection Comments</b> | A fluid level was taken with a properly calibrated EPA Echometer. The fluid level taken during the inspection was 584 feet deep. This well was not connected during the inspection. The casing size was approximately 3.5". Two photographs were taken during this inspection and can be seen in the Inspection Photo Log. | | | | |

**Description:** This was the injection well OS2698000 at the time of the inspection. It was not connected. I observed multiple liners in this well during the inspection and estimated the casing size with on site representative to be ~3.5".
