## NPDES Inspection Report – Wastewater Treatment Facility

| Facility Location Information | |
|---|---|
| Site/Facility Name & Location:<br>Pine Ridge Community Wastewater Treatment Facility<br>Lat/Long: 43° 0'44.00"N, 102°35'18.00"W (lagoon)<br>Red Top Ave., Pine Ridge, SD 57770 | Email Report to:<br>Ernie Abold, Director, Oglala Sioux Tribe (OST) Water & Sewer<br><a href="mailto:h2osewer@gwtc.net">h2osewer@gwtc.net</a> |

**Facility Name:** Pioneer Metal Finishing (UTR000007062)

**Date of Inspection:** June 4, 2024

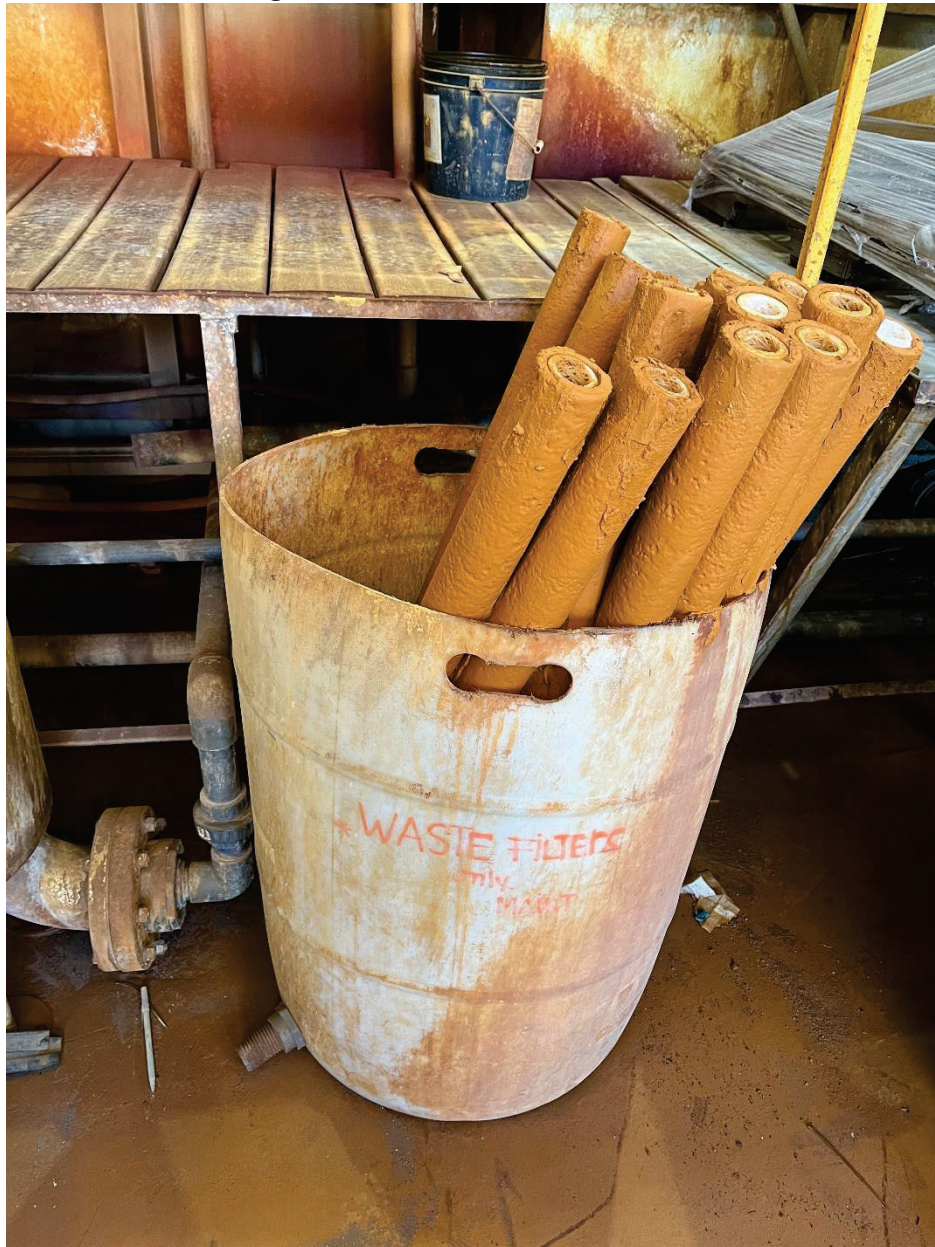
Photo 1: IMG\_0003.jpg – photo of spent filters stored in the powder coat pretreat area located in Building 1. Following the inspection, these filters were determined to be hazardous waste. Potential spillage that is the same color as the material on the filters is visible in the photo on the floor surrounding the drum.

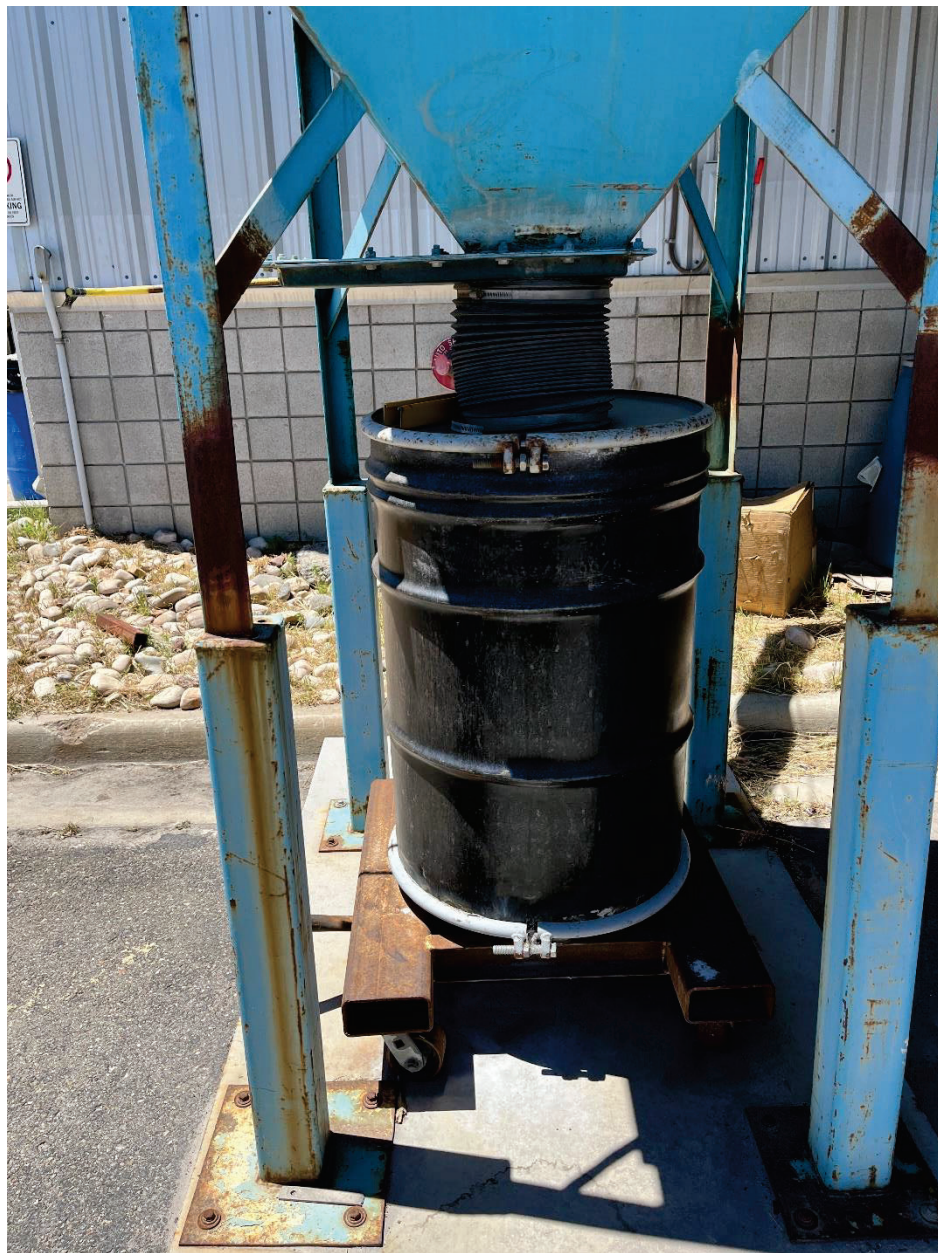
Photo 2: IMG\_0004.jpg – photo of “hand sand blast” baghouse collection drum.

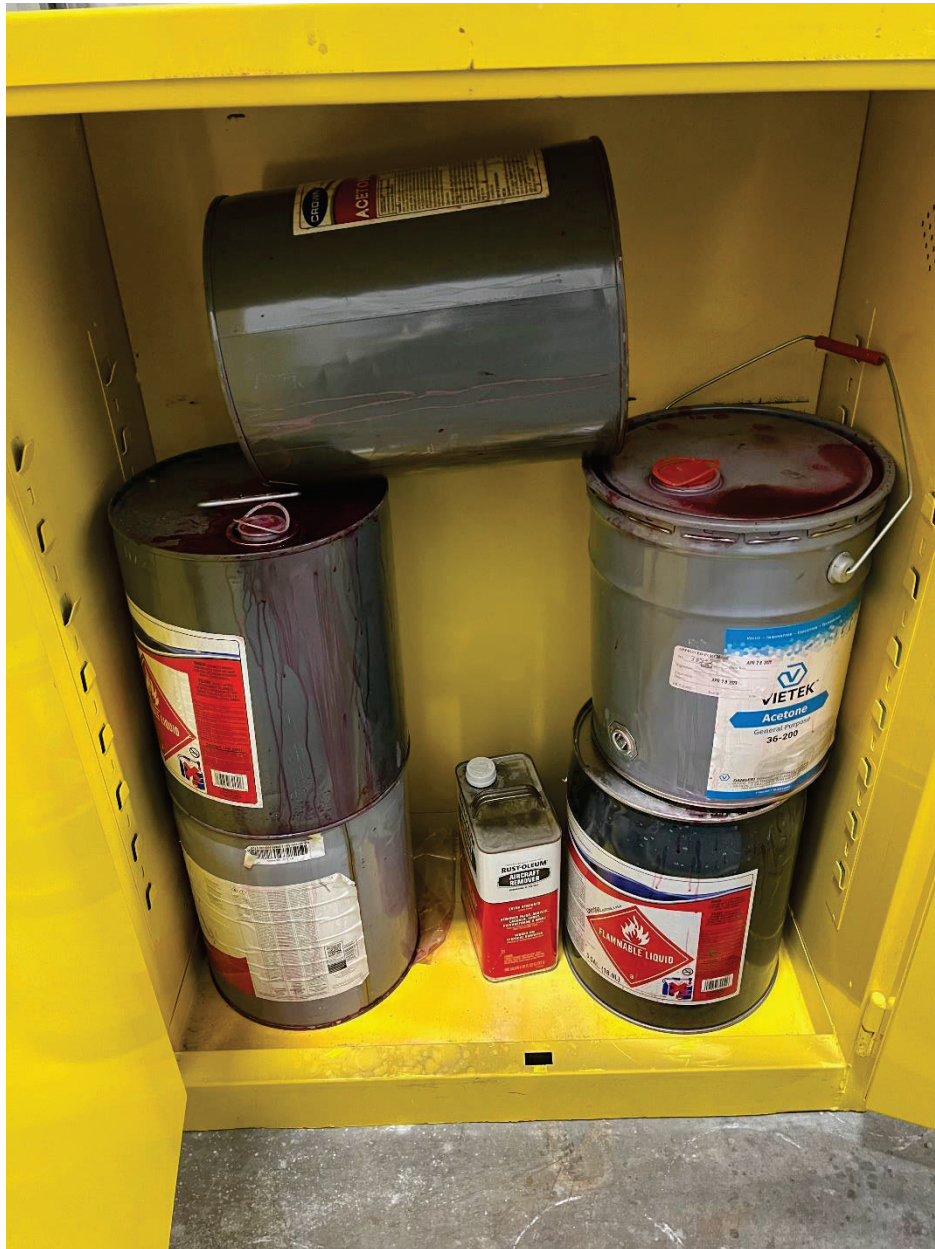
Photo 3: IMG\_0005.jpg – photo of containers in a flammable material storage cabinet in the Wet Coat East hallway immediately adjacent to a 55-gallon drum of hazardous waste Lacquer Thinner.

The Flammable cabinets were moved closer to where the waste stream is being created and grounded. The five gallon containers were relabeled and two were decommissioned. The expectation from our team members is that they will be emptying the cans at the end of each shift.

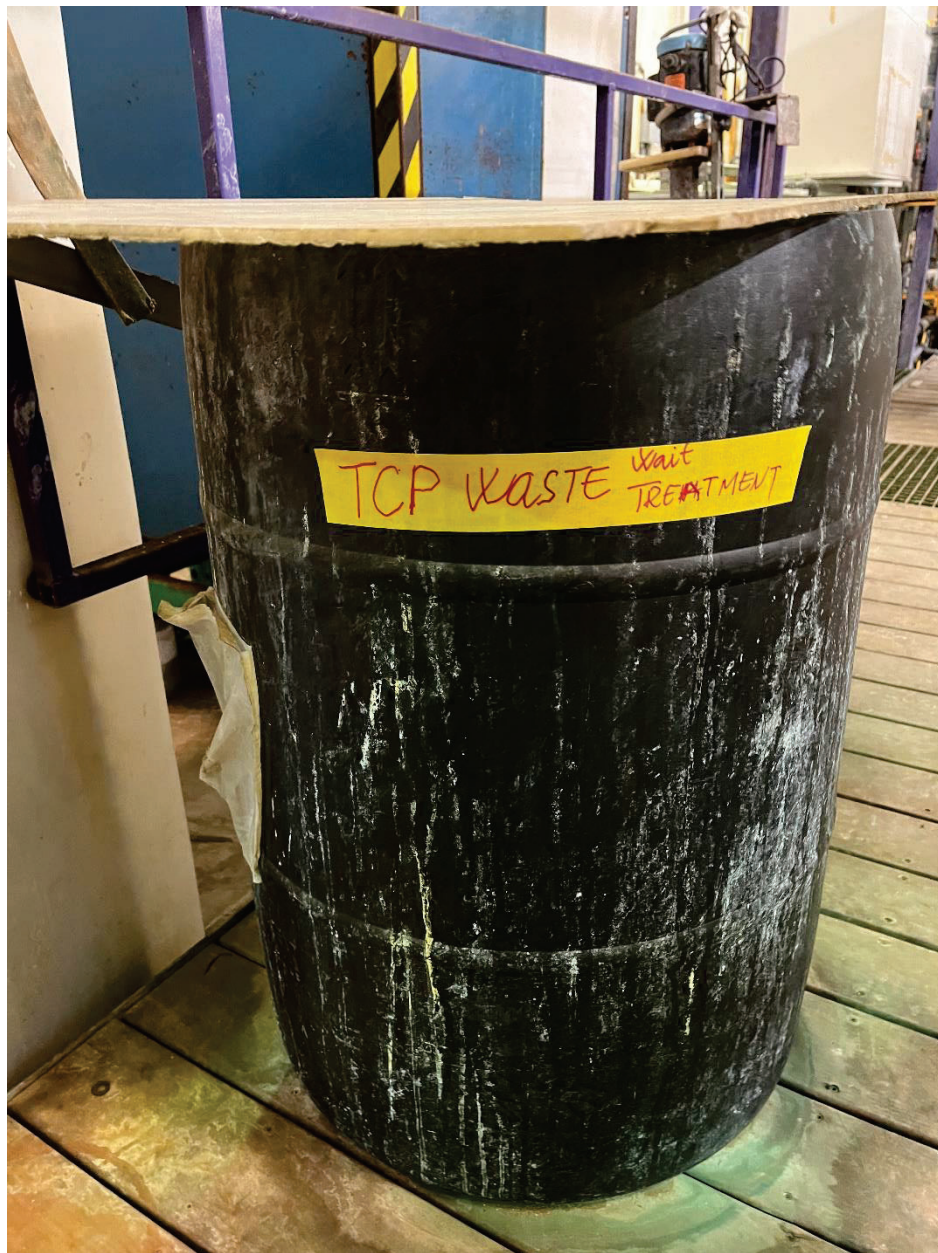
Photo 4: IMG\_0006.jpg – photo of hazardous waste labeled “TCP Waste” located near the wastewater treatment and filter press area.

This drum has replaced the TCP drum we were using during the time of the inspection. It has been added to our facility map and the weekly RCRA inspection form.

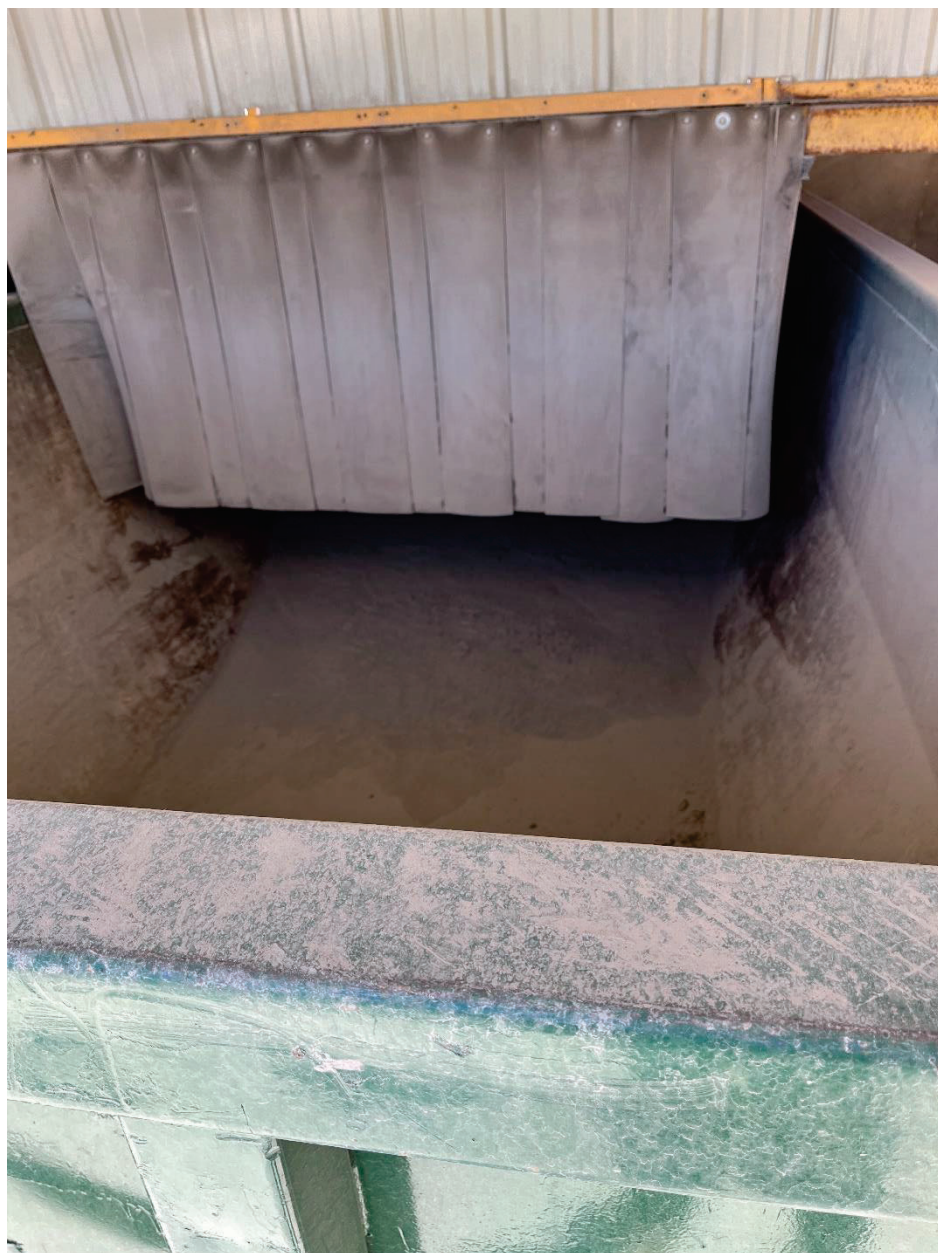
Photo 5: IMG\_0007.jpg – photo of spent sandblast waste in a roll off container.

The sand blast media is currently undergoing the RCRA 8 metals test and we will respond accordingly once those results have been received.

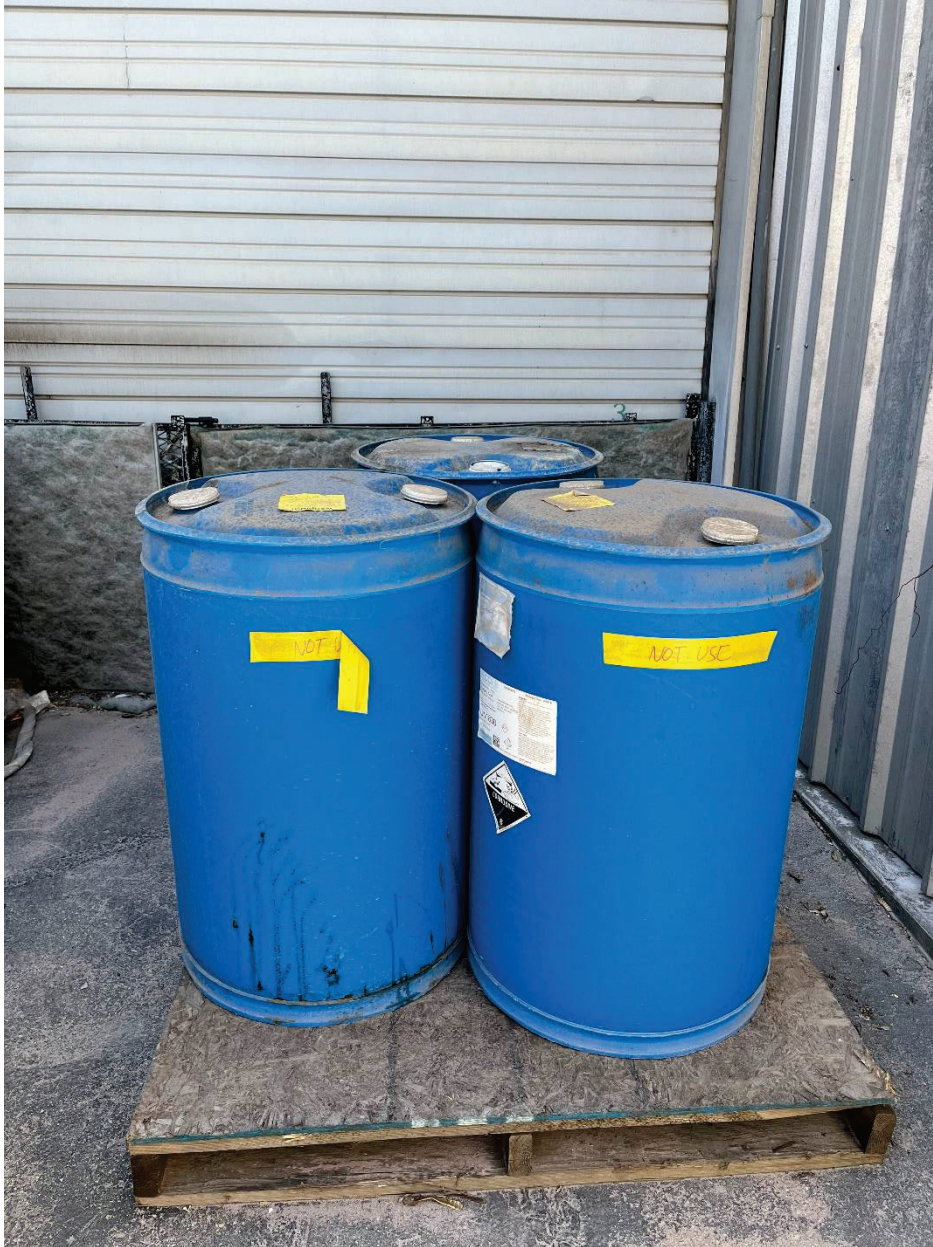
Photo 6: IMG\_0008.jpg – photo of three drums of sulfuric acid hazardous waste located in the empty drum storage area.

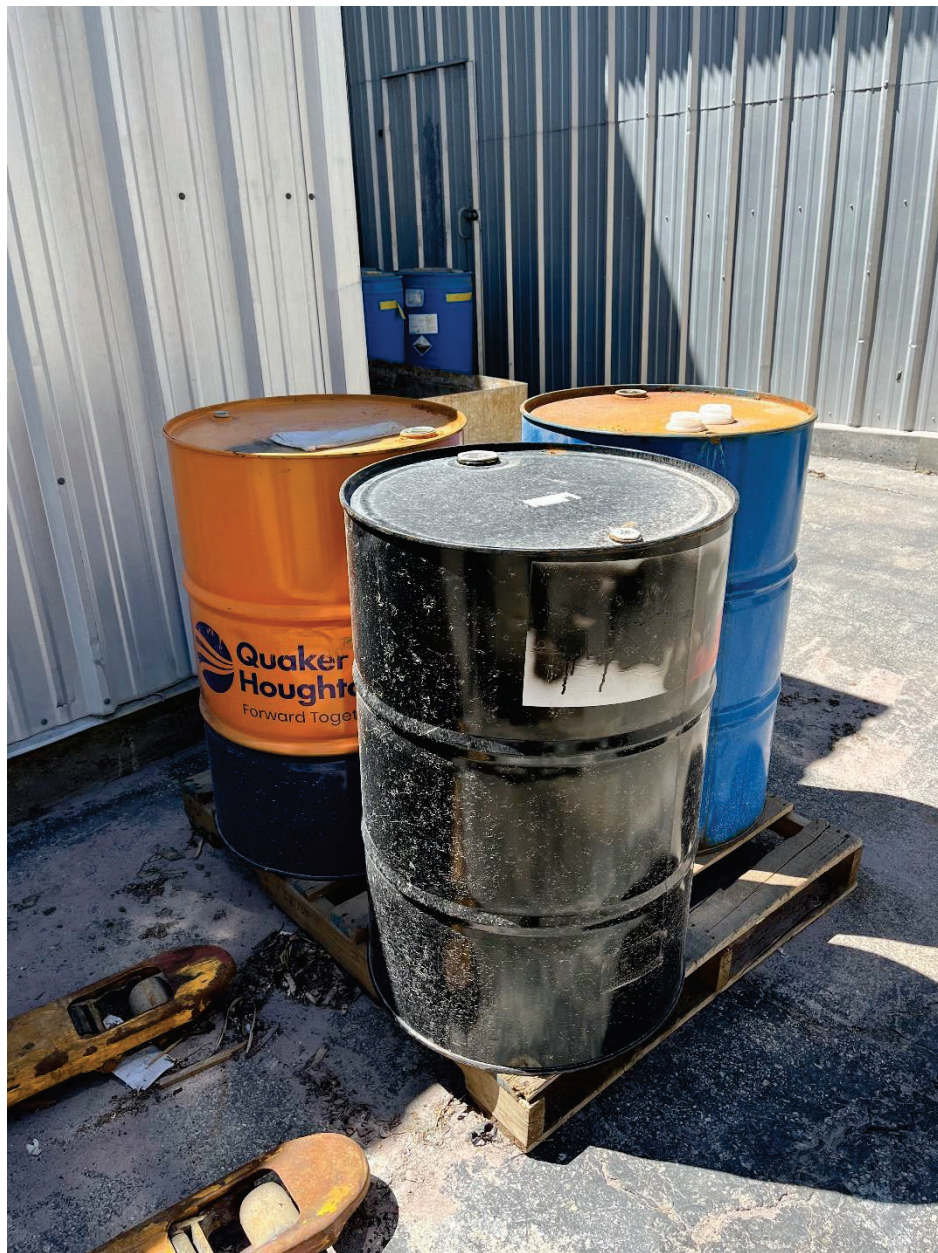
Photo 7: IMG\_0009.jpg – photo of three drums located in the empty drum storage area near the drums shown in photo 6.

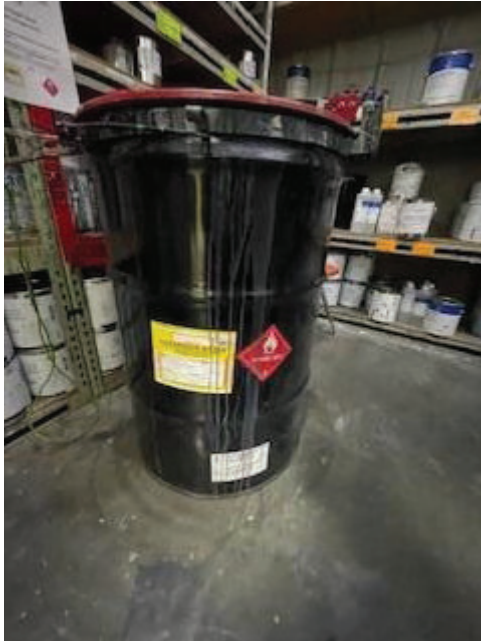
Inside the Wet Coat West paint storage area, I observed a 55-gallon drum SAA that was closed and properly labeled (see Attachment 3, photos 1-2). I also observed a shelf of expired chemicals in storage. Mr. Renner stated that they were in the process of going through the chemicals to determine whether they could be used or would need to be disposed. The accumulation of expired chemicals appeared to be well organized.

Photo 1: Photo of a hazardous waste SAA container located in the Wet Coat West paint storage area.

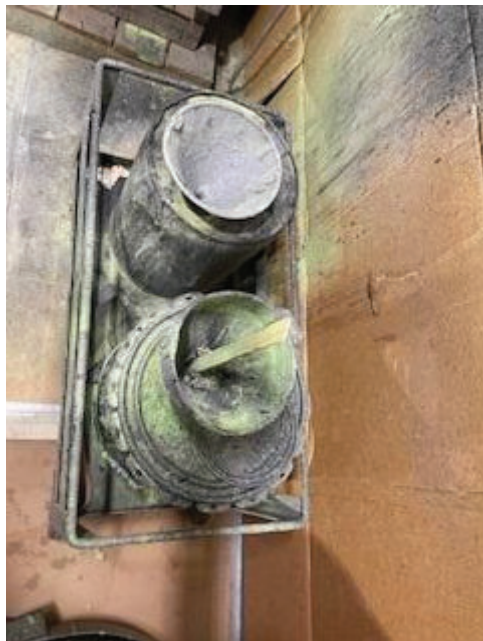
Photo 5: 5-gallon buckets used by painters to accumulate solvents after rinsing their paint guns.

The five gallon buckets have been removed from the process altogether. We have moved the 55 gallon drums to the mixing stations and have attached a locking funnel. The funnel for wet coat west is still in transport and should arrive on 6/13/2024. So currently all painters are cleaning their guns in wet coat east.

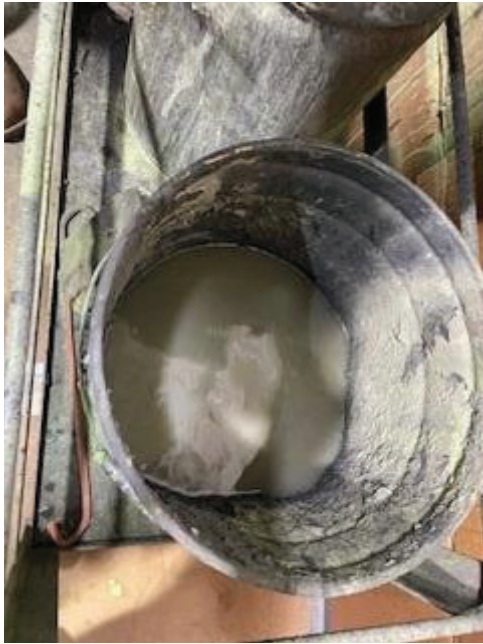
Photo 6: Photo of the contents of one of the two cans shown in photo 5 after facility personnel removed the lid to show the contents.

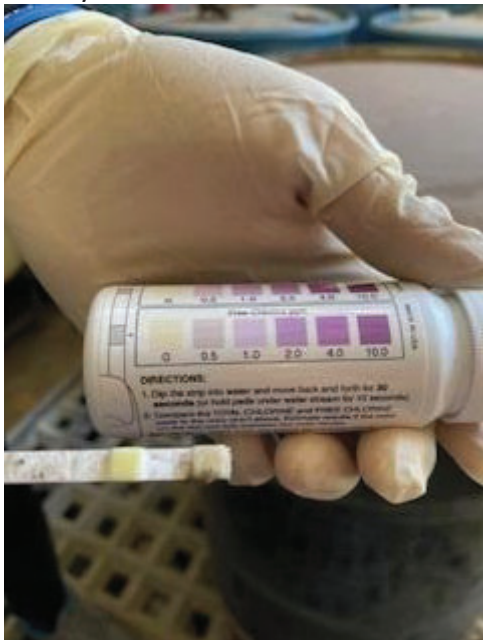
Photo 7: Photo of test strip used to assess a spill into secondary containment in the Building 1 90-day central accumulation area.

It was determined that the reason the pH tested at zero was due to the incorrect testing strip to be used. The test used the day of the audit measures total chlorine and when we tested with the proper pH strip is was in the 5-6 range.

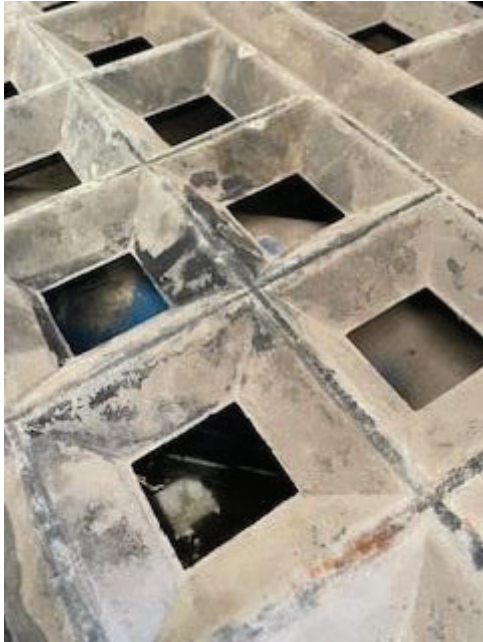
Photo 8: Photo of the spill into secondary containment referenced in the photo 7 description.

The spill pallet was rinsed into our waste water treatment collection area and allowed to dry before returning to it's original location. An Annual secondary containment house keeping task was created for this task to be carried out by the Lab.

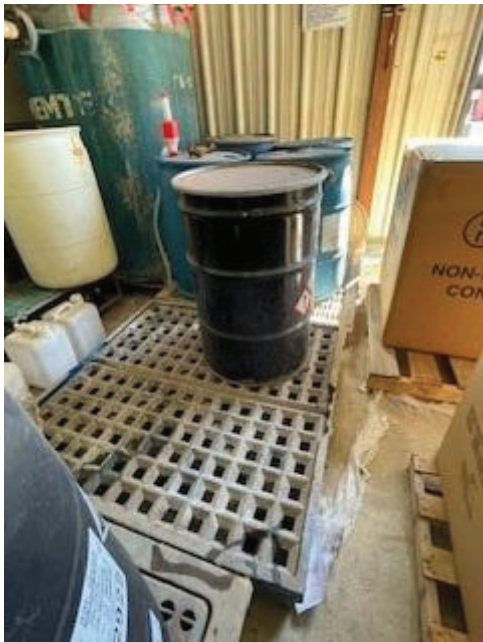
Photo 9: Photo of a drum of GardoStrip Q4599 on the secondary containment shown in photo 8.

**Action Item 7:** Label Gardostrip drum with hazardous waste label and add accumulation date.

The contents of the original Gardostrip drum were transferred to a poly drum due to its corrosive nature.

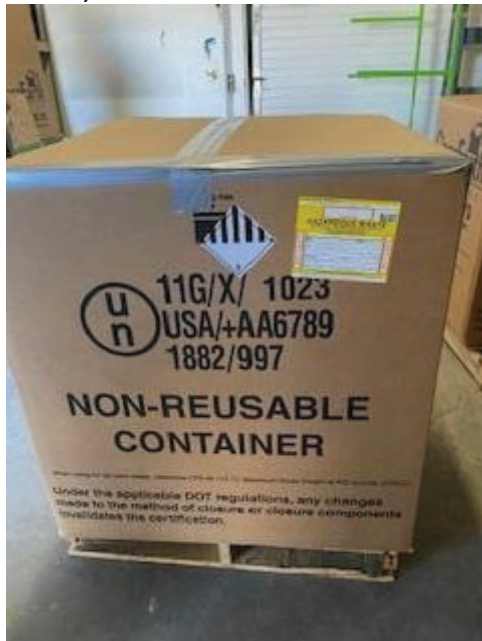
Photo 12: Photo of a cubic yard box of hazardous waste located in the Building 2 Wet Coat East 90-day central accumulation area.

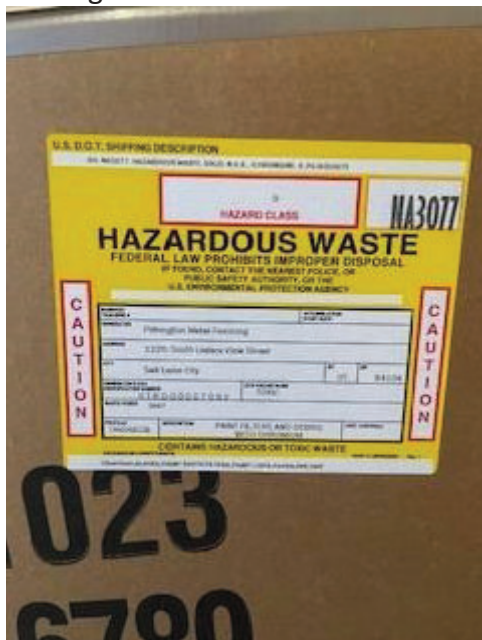
Photo 13: Close-up of the label on the container shown in photo 12, showing that the label was missing an accumulation start date.

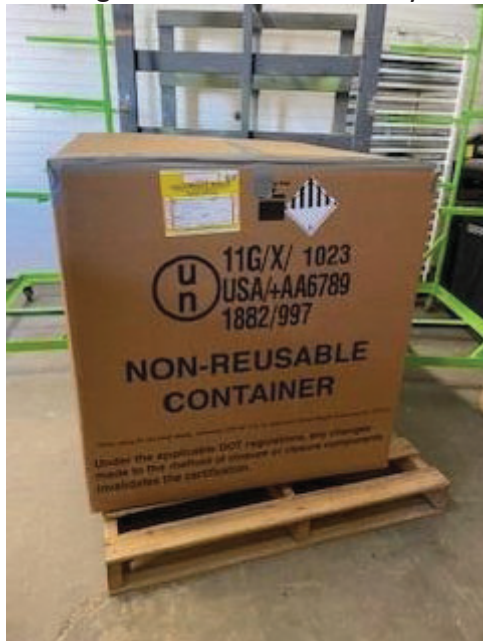
Photo 14: Photo of an additional cubic yard box containing hazardous waste located in the Building 2 Wet Coat East 90-day central accumulation area.

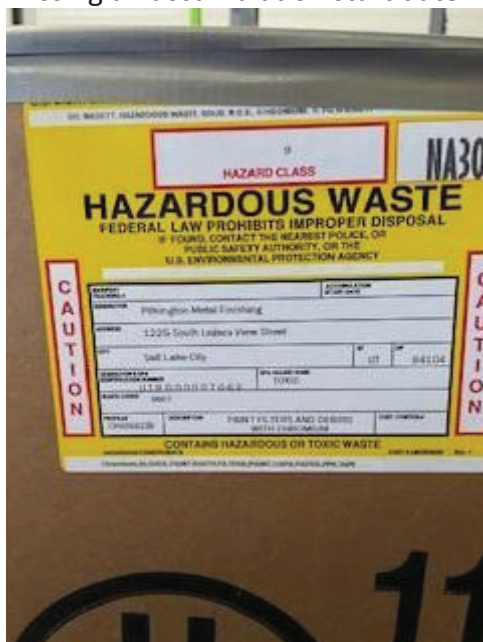
Photo 15: Close-up of the label on the container shown in photo 14, showing that the label is missing an accumulation start date.

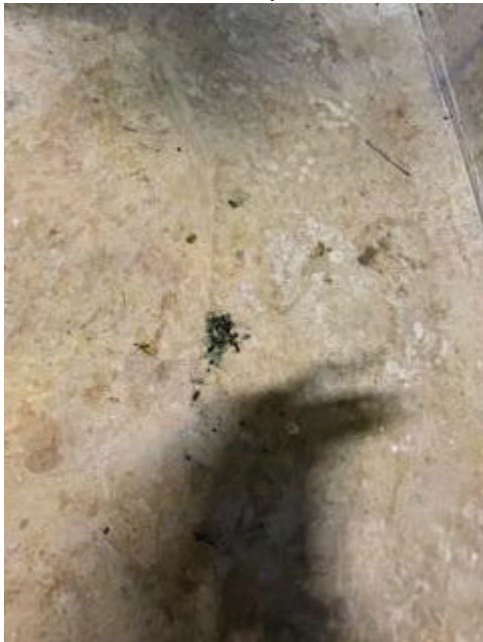
Photo 19: Photo of spilled filter cake on the floor in the area shown in photo 18.

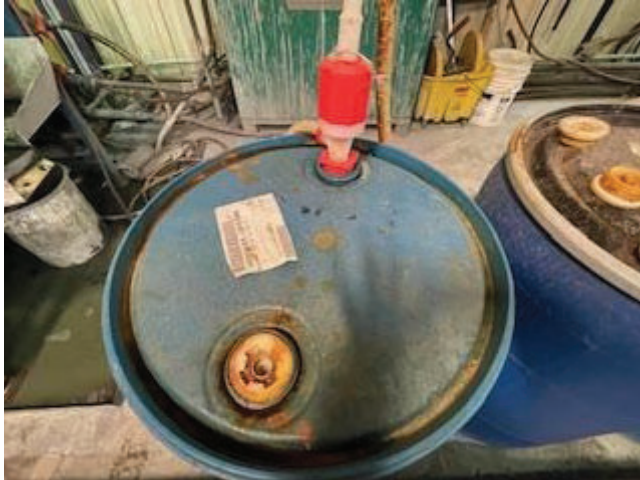
Photo 20: Photo of additional pieces of filter cake on the drum in the foreground in the area shown in photo 18. Also visible at left in a containment pan is water containing filter cake and filter press drippings.

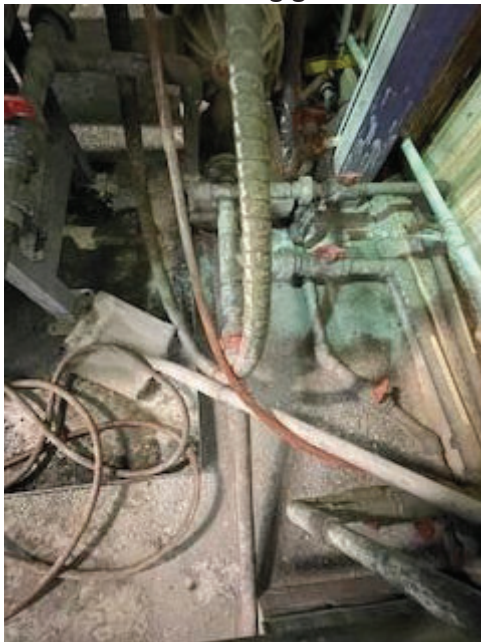
Photo 21: Photo of spilled filter cake on the floor west of the filter press, and potential chromium-containing green residue in the area of the filter press.

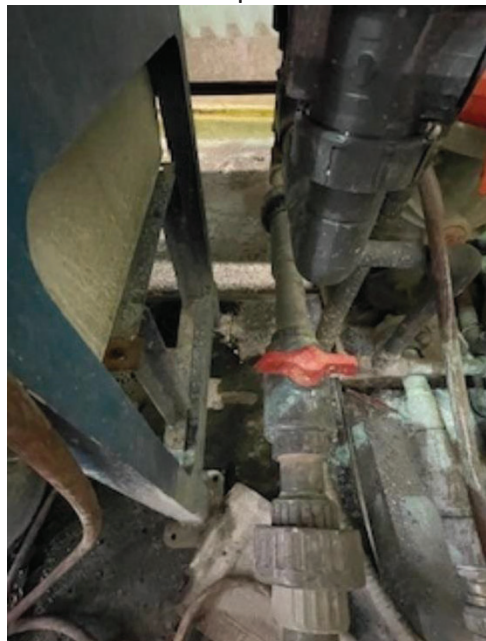
Photo 22: Close-up of the area shown in photo 21.

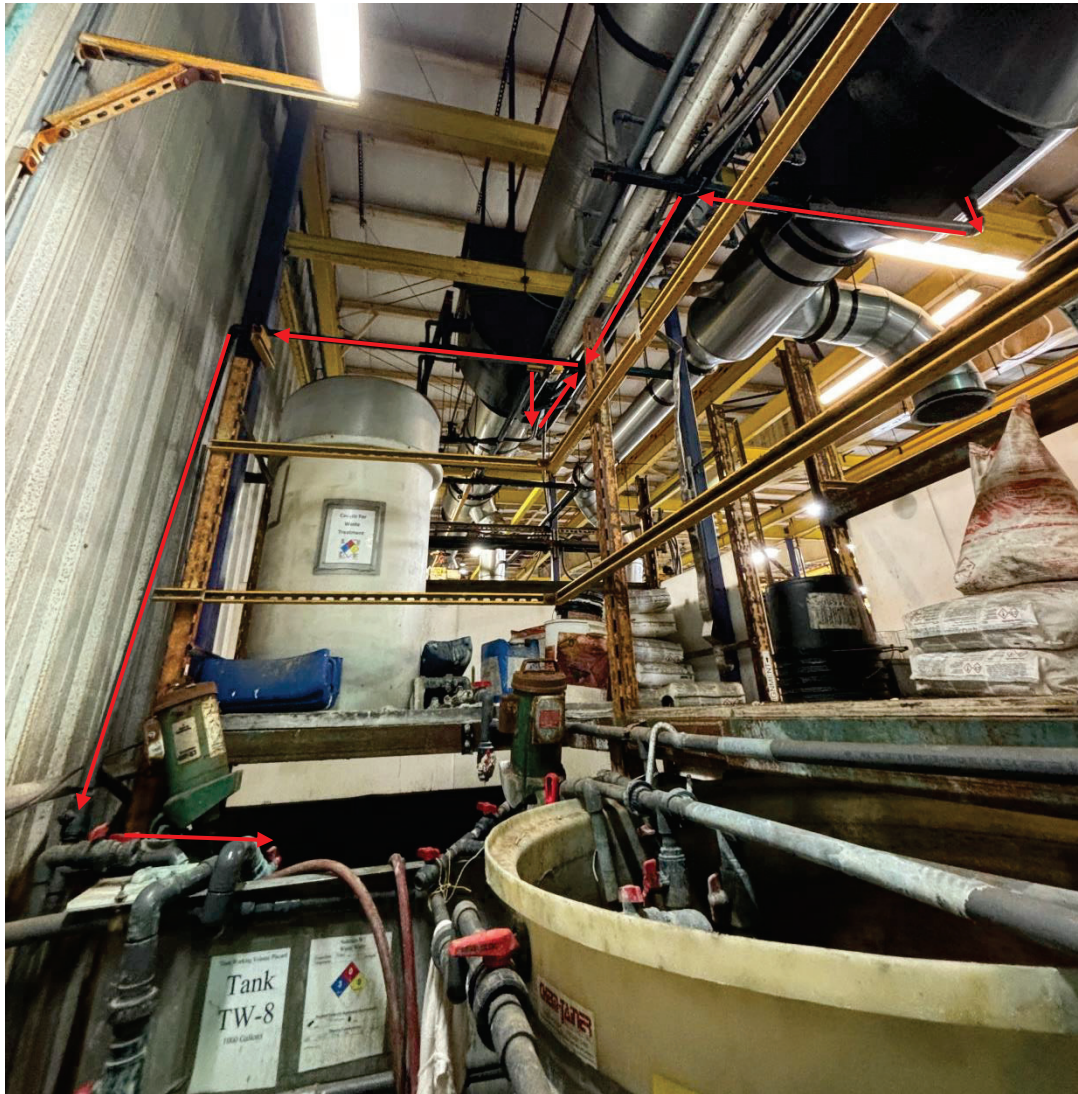
**Action Item 11: EP and Chromic Scrubber**

The scrubbers that service the EP and Chromic lines utilize a water drip filtration system. The water from those scrubbers is then directly run into our waste water treatment process. Routine maintenance is performed every ten years to clean and evaluate the internal system.

The arrows in the below picture indicate the path that the waste water takes to enter the treatment tank.

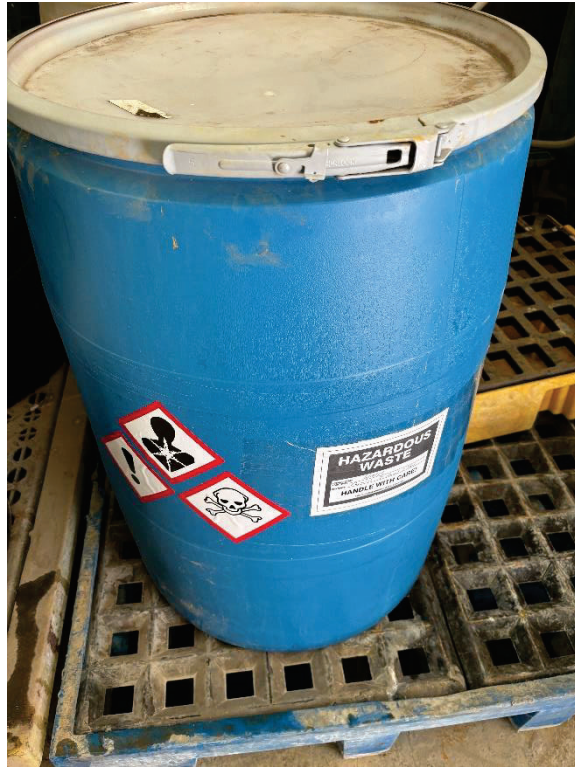
**Action Item 12:** TCLP for Used filters and Sand Blast Media

The used filters were deemed hazardous from the RCRA 8 Metals TCLP; D004(arsenic), D007(Chromium), D008(lead). A profile is in development with Clean Harbors and the contents of that drum have been transferred to a closed poly drum labeled hazardous waste.
