**Region 6 - Enforcement & Compliance Assurance Division**  
**INSPECTION REPORT**

| Inspection Date(s): | 11/06/2019 | |
| Company Name: | <b>Jamie Oil, Inc.</b> | |
| Facility Name: | <b>Gulf Lease</b> | |

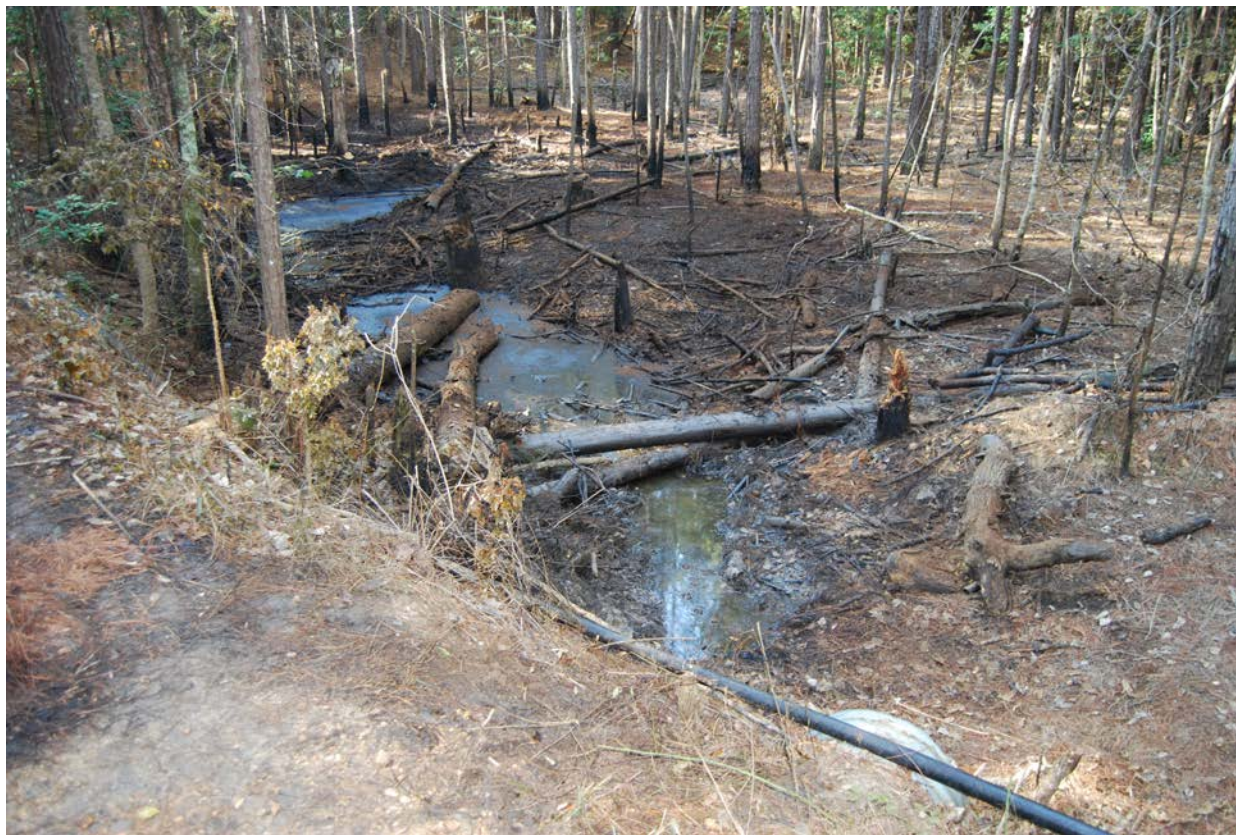
Photo No. 1

Description: I observed a discharge of produced water, or brine, had occurred in this drainage ditch in the woods south of North Creek. A potential flow line failure was the evident source of the point of discharge of brine. I observed oil and brine fluids here and along the flow path downstream, towards North Creek from this location.

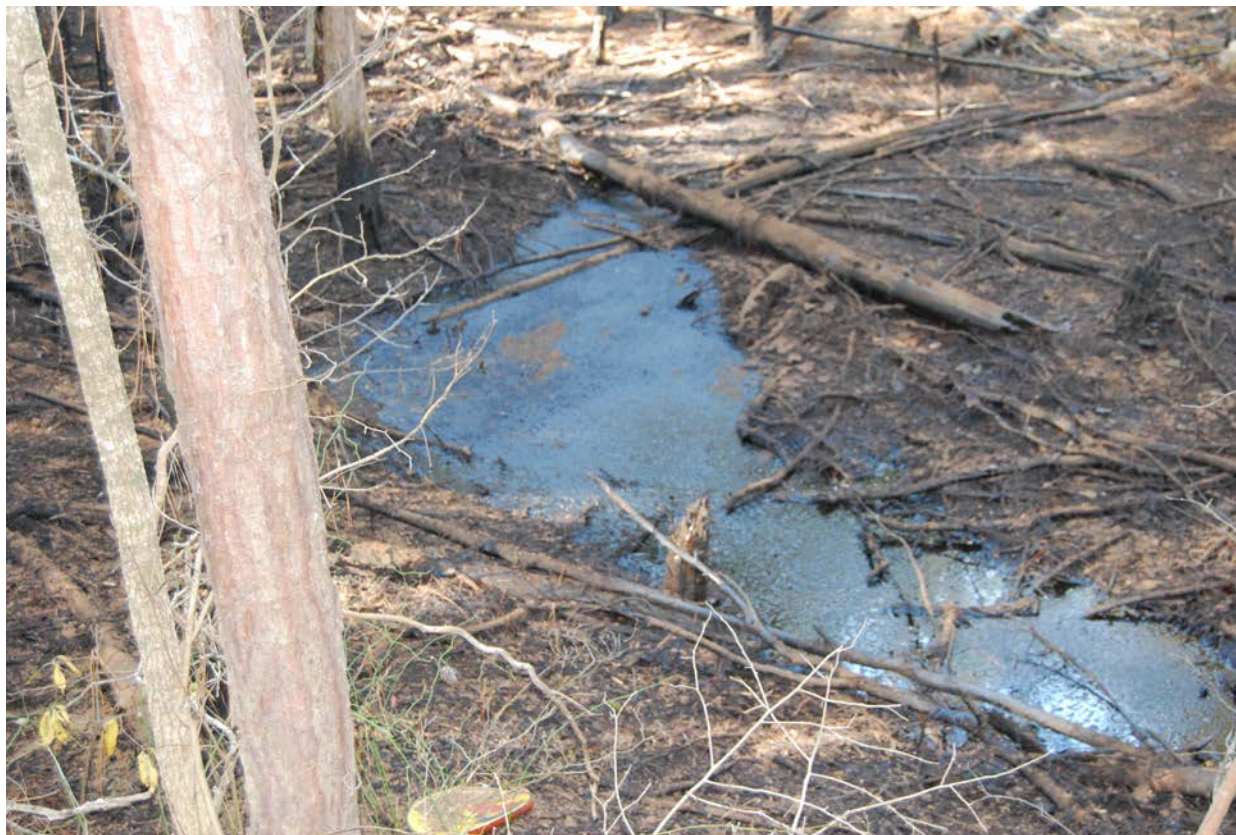
Photo No. 2

Description: I observed brine and oil fluids pooled up here, along the flow path towards North Creek. There was dead vegetation observed at this location as well.

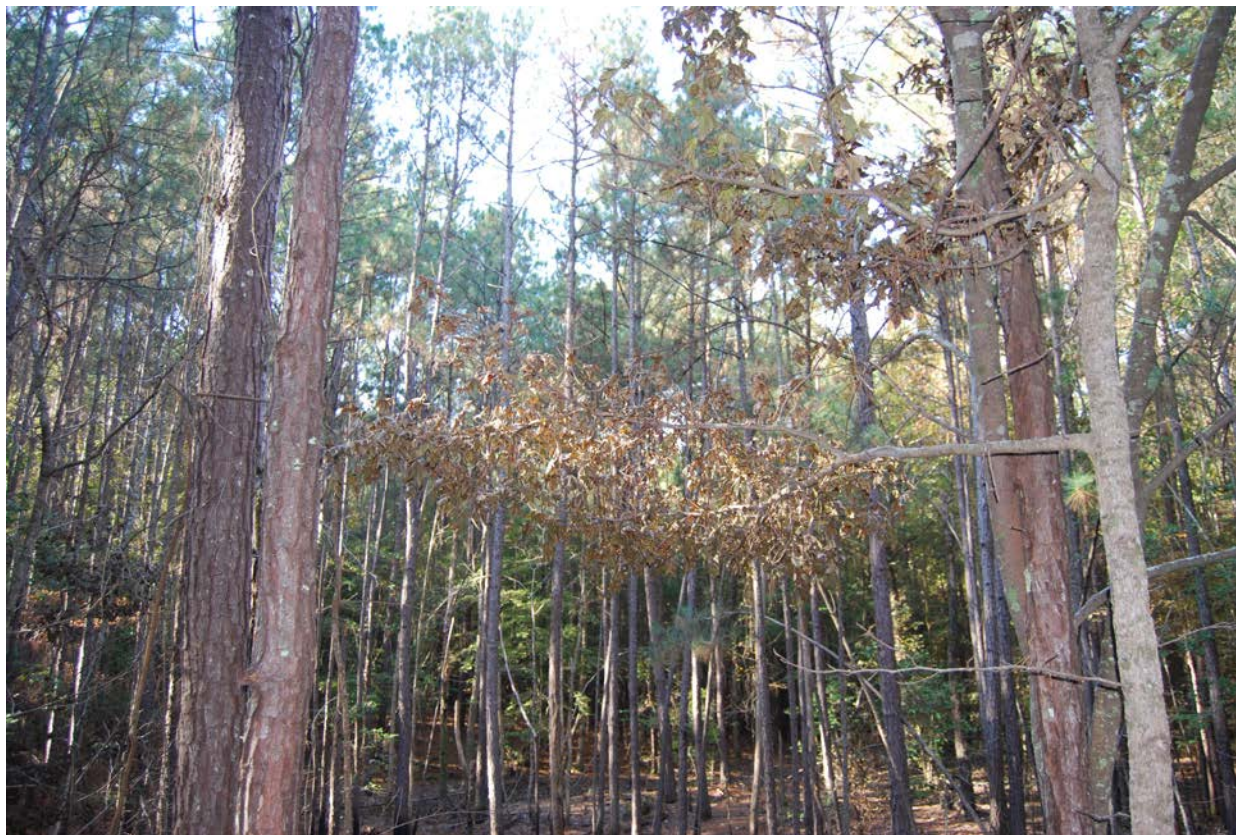
Photo No. 3

Description: There were dead and dying trees after exposure to brine along the flow path, where elevated brine levels were measured.

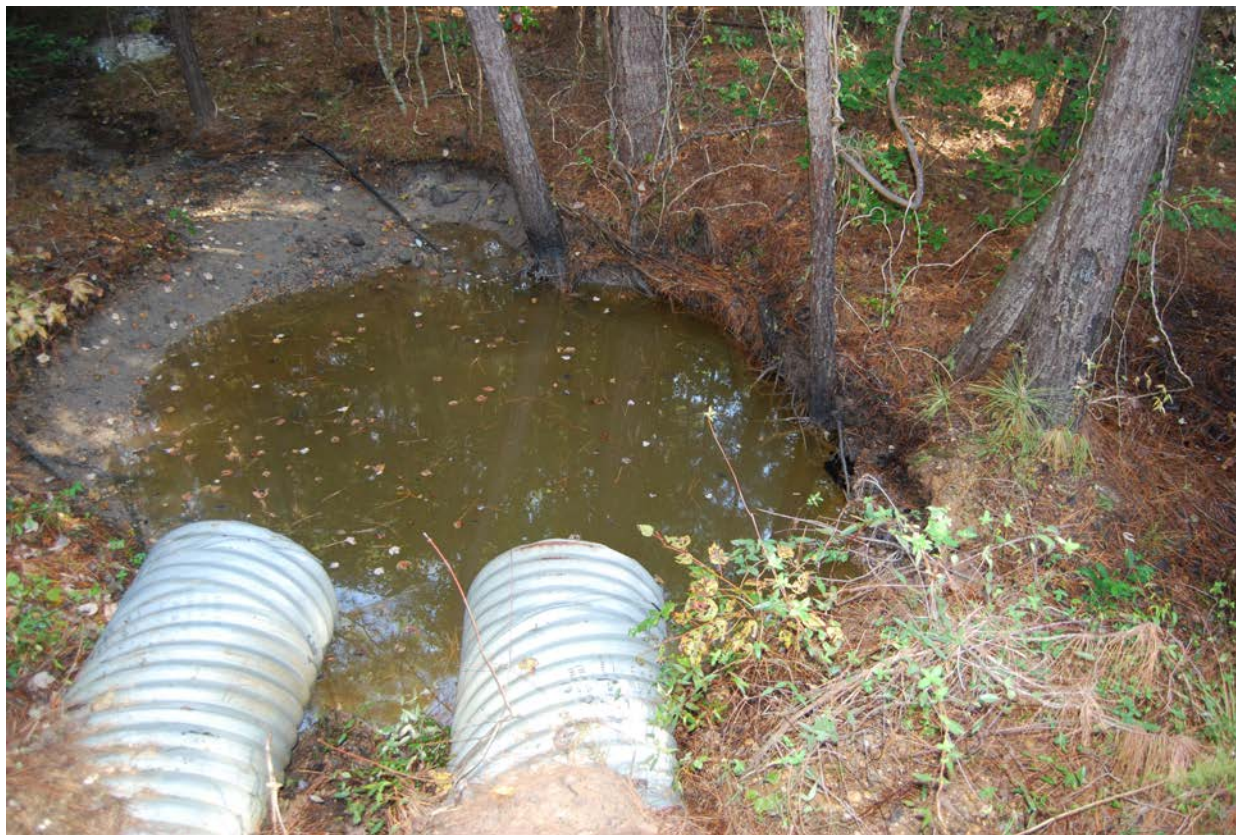
Photo No. 4

Description: I observed fluids, including brine pooled up downstream of the discharge point and lease road crossing. This location was on the flow path toward North Creek.

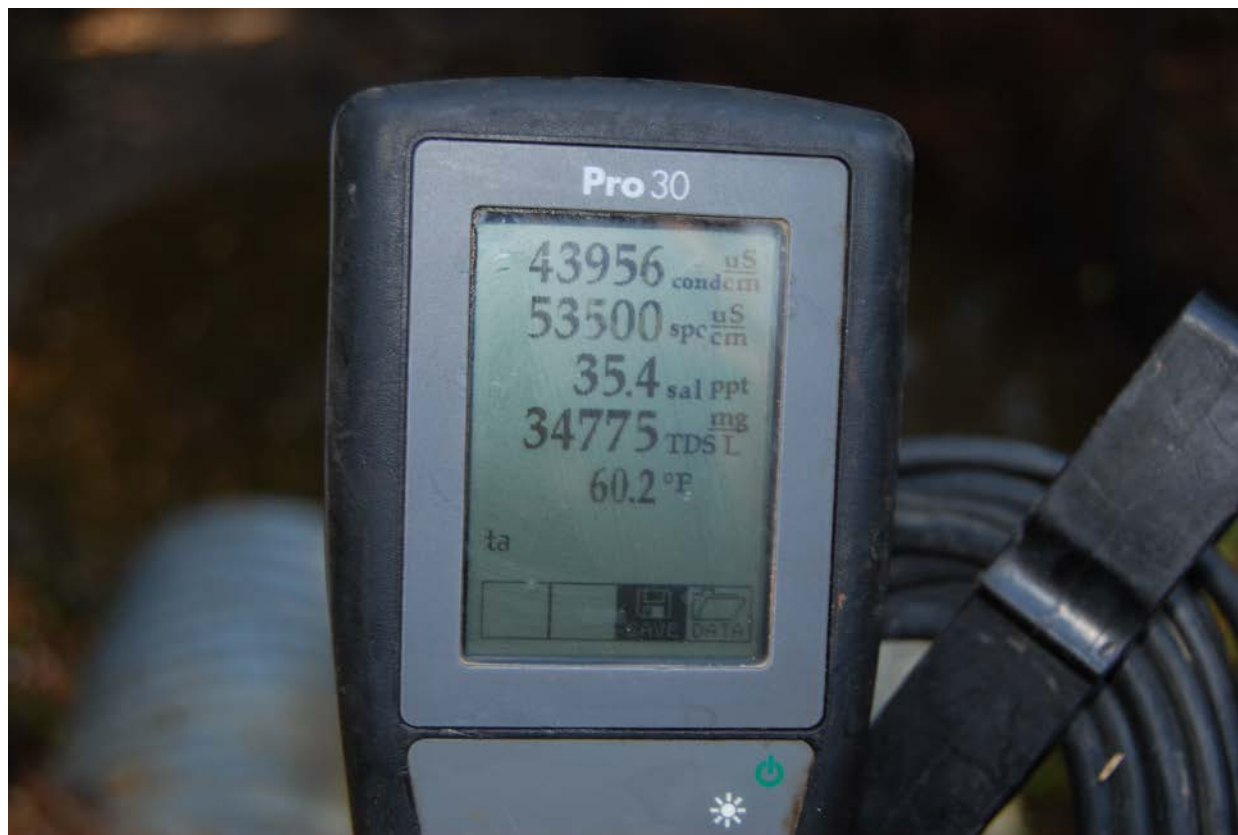
Photo No. 5

Description: With a calibrated YSI Pro 30 Conductivity Meter, I took a Total Dissolved Solids (TDS) reading of the pool shown in Photo 4 and it measured 34,775 milligrams per liter (mg/L).

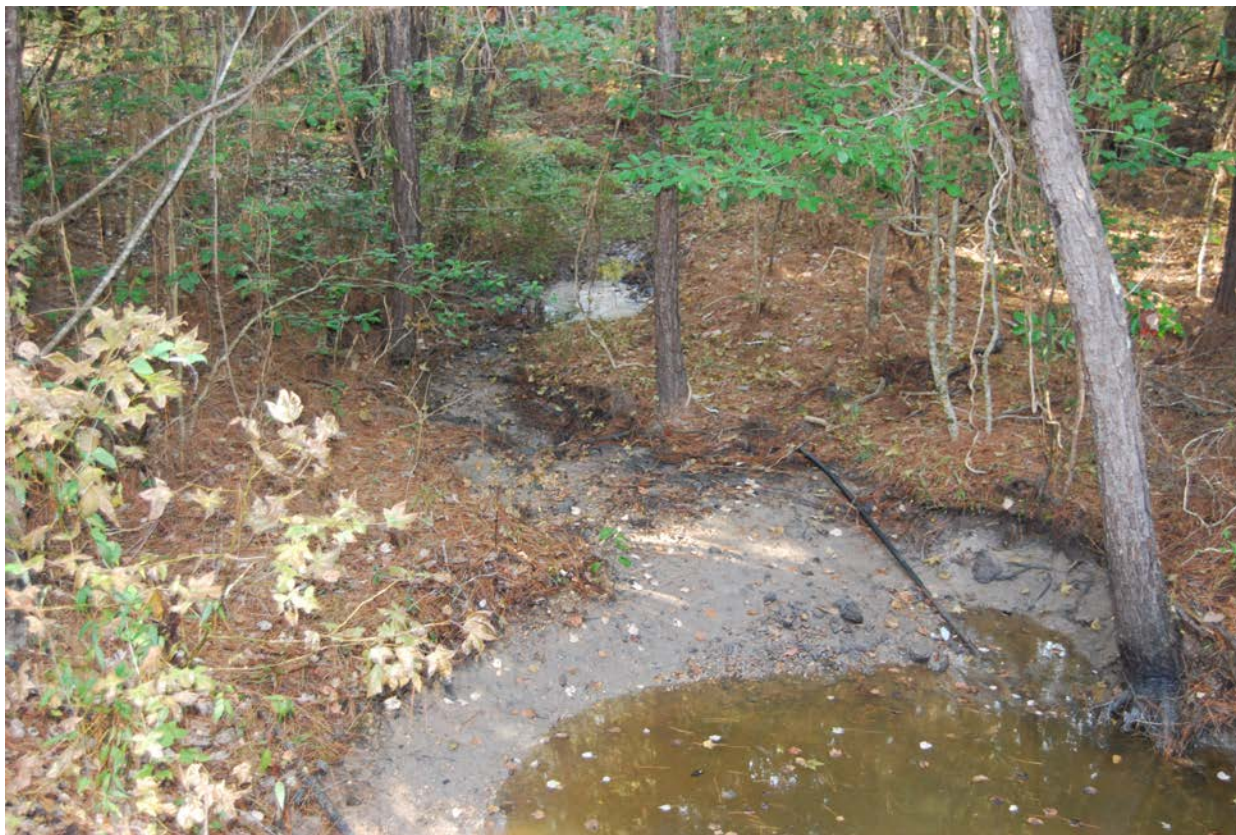
Photo No. 6

Description: The trail of the brine discharge flowed north toward the point of entry to North Creek. I observed intermittent holes of brine along the flow path between here and North Creek.

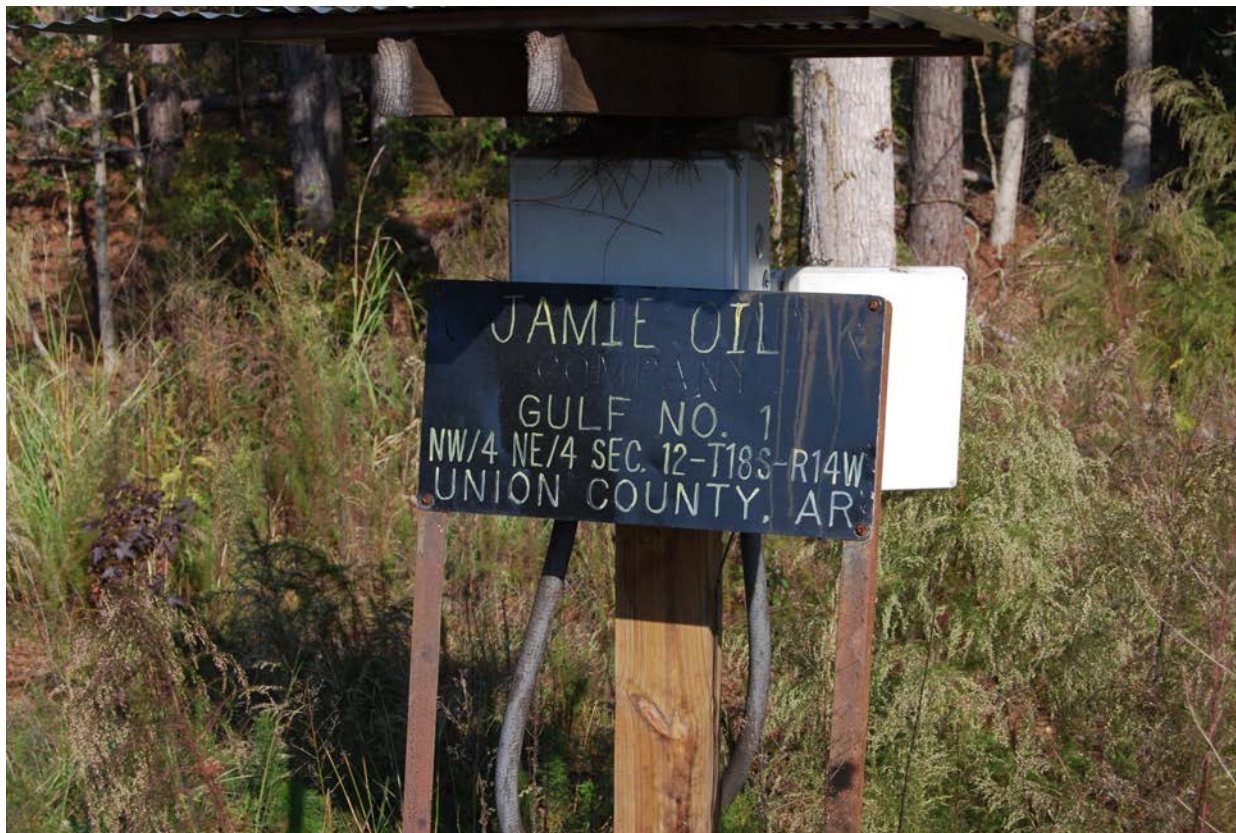
Photo No. 7

Description: This was a producing well located near the point of entry to North Creek.

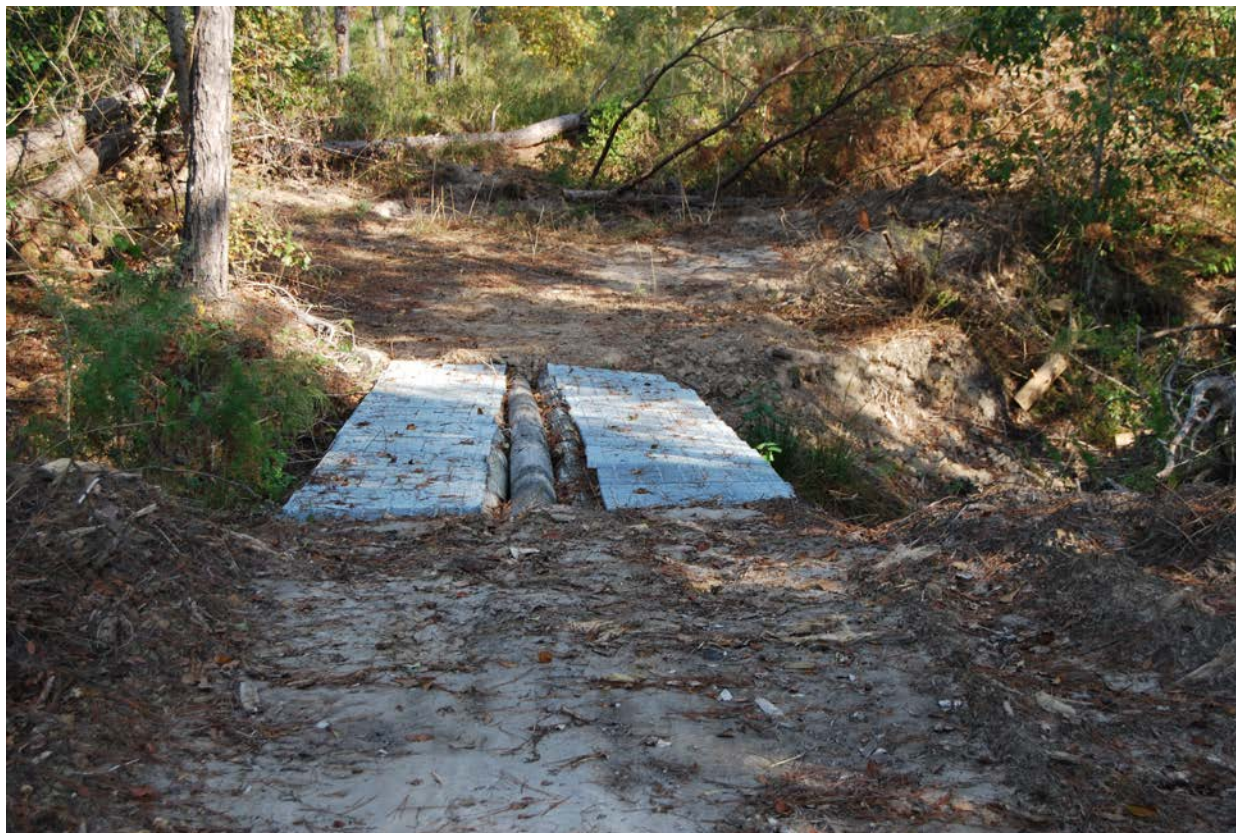
Photo No. 8

Description: A bridge crossing near the point of entry to North Creek was observed here.

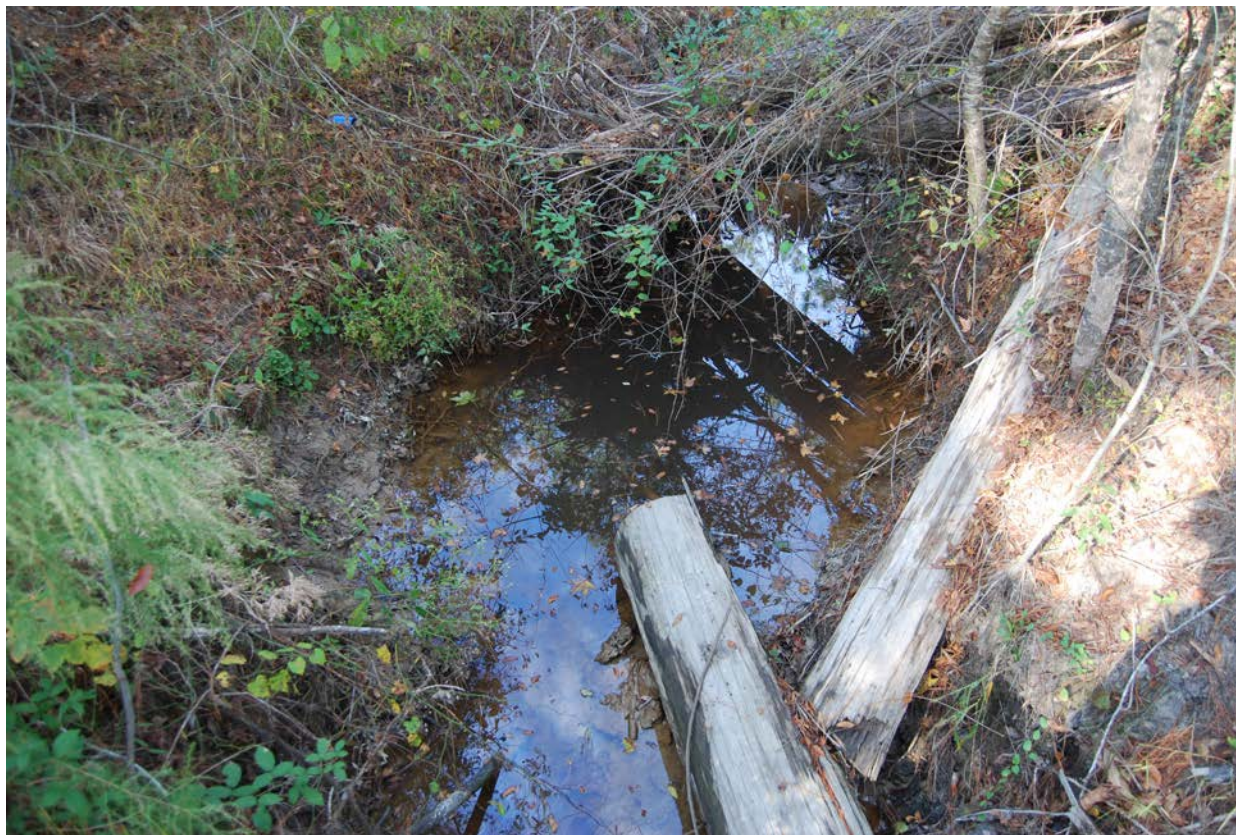
Photo No. 9

Description: I observed the point of entry to North Creek here. The creek was flowing north during the inspection.

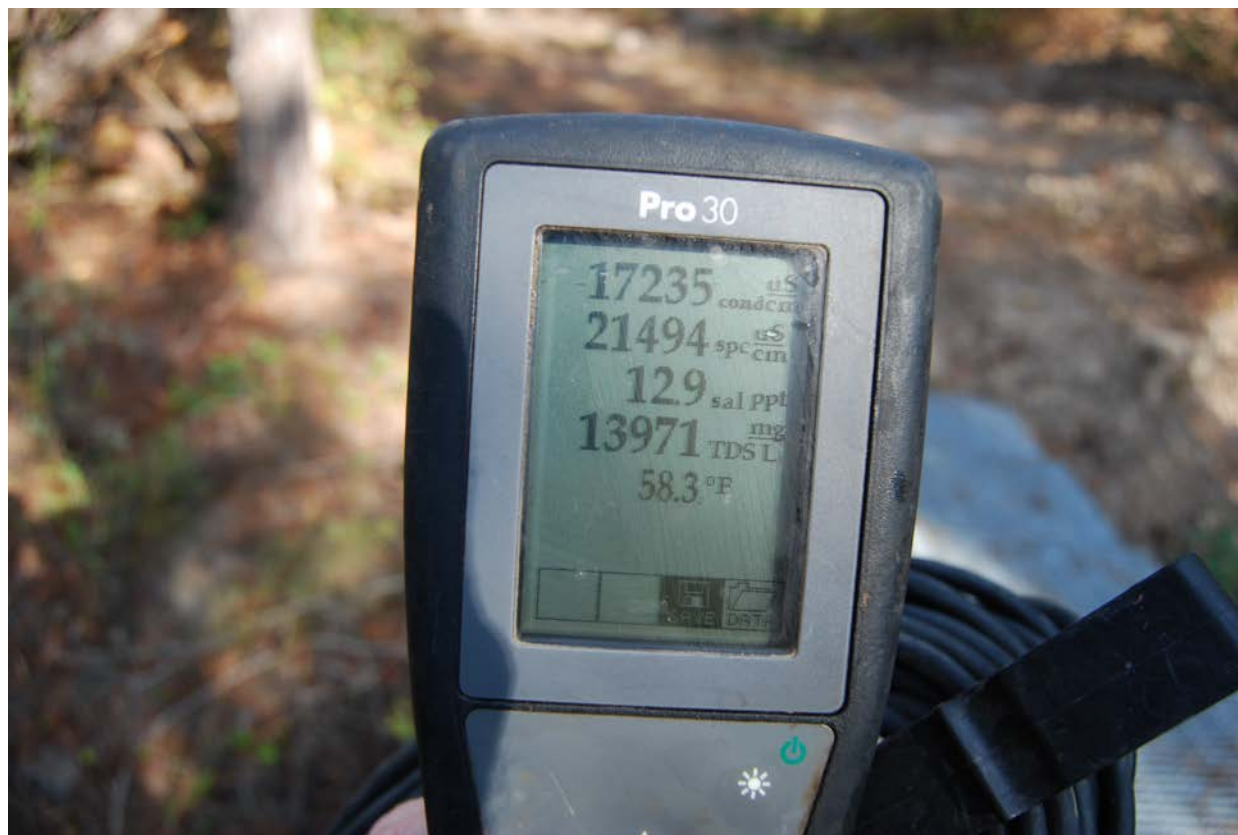
Photo No. 10

Description: The TDS at the point of entry measured 13,971 mg/L.

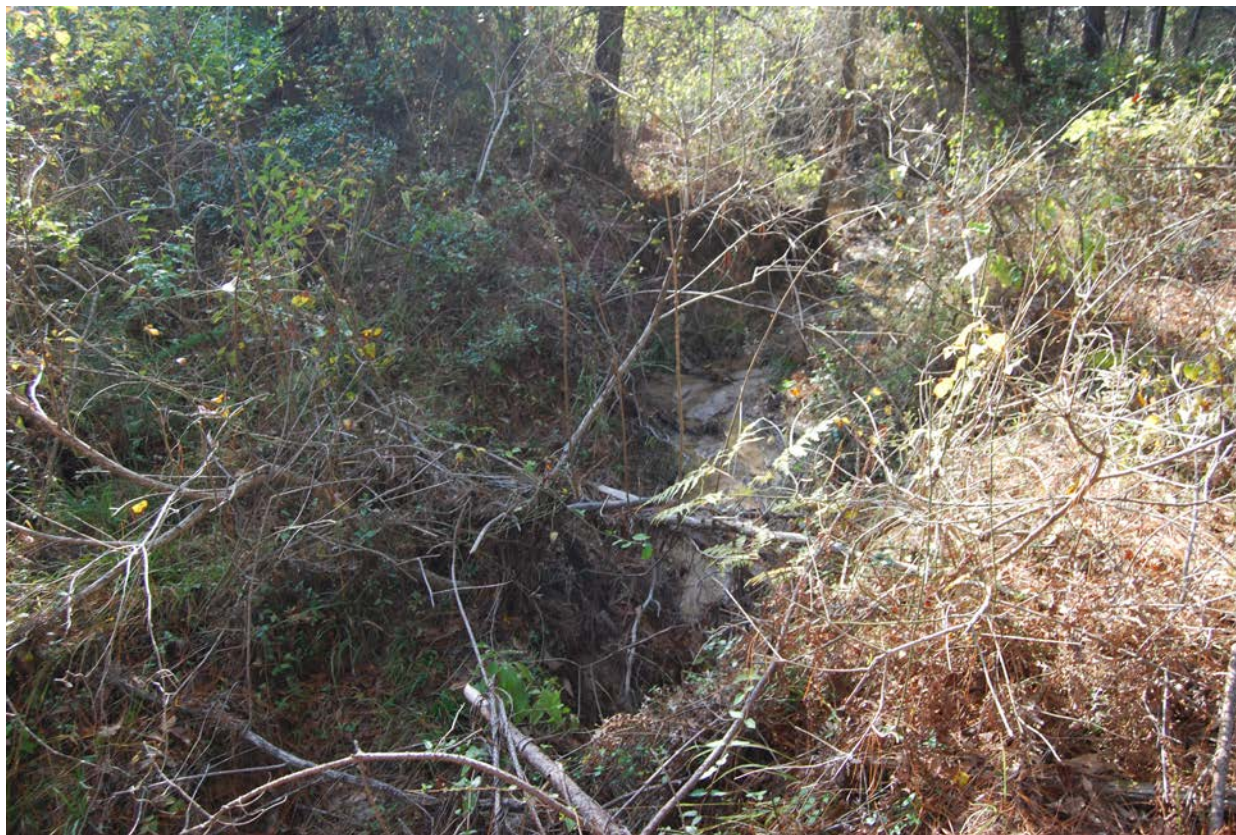
Photo No. 11

Description: This was a view of another small drainage, or tributary, coming from the east, and entered North Creek near the main point of entry of the brine. It was not affected by the spill.

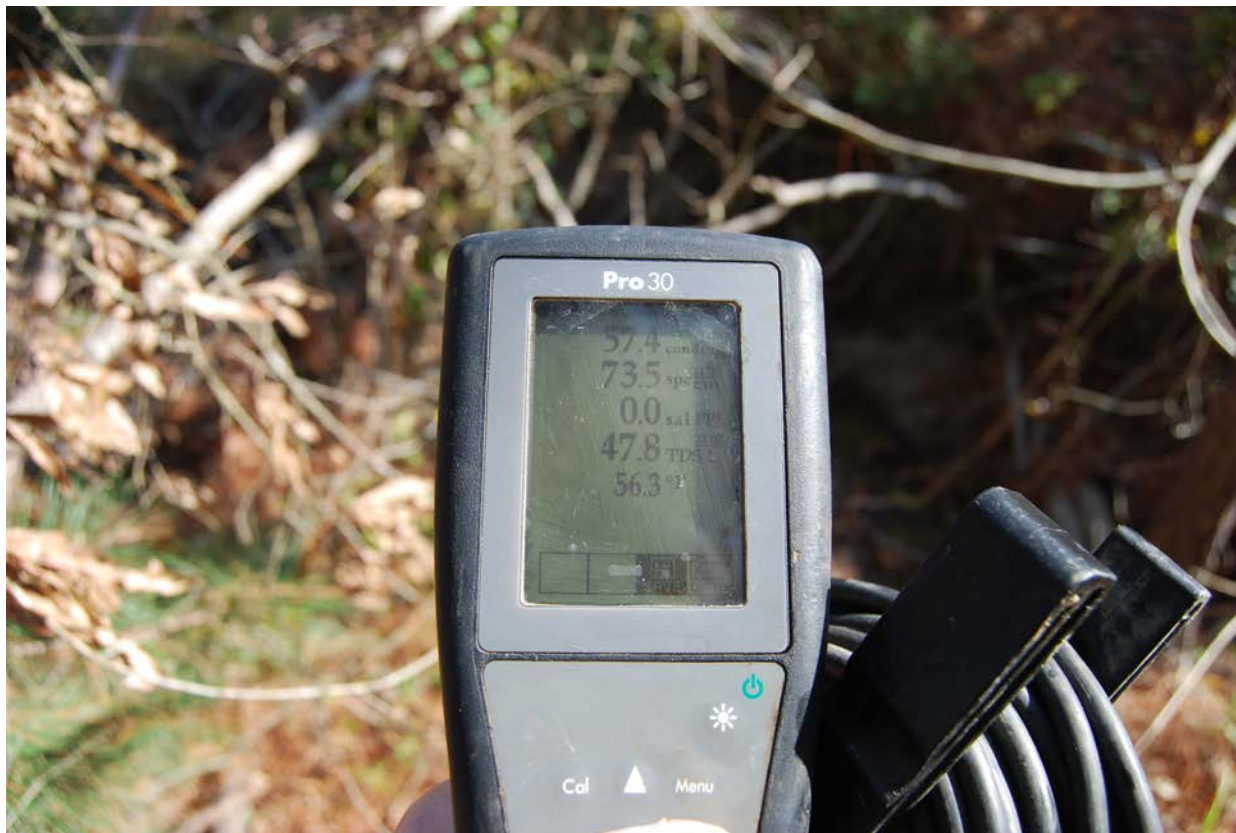
Photo No. 12

Description: The TDS of background water, or the unaffected tributary entering the upstream from the point of entry of brine on North Creek measured 47.8 mg/L.

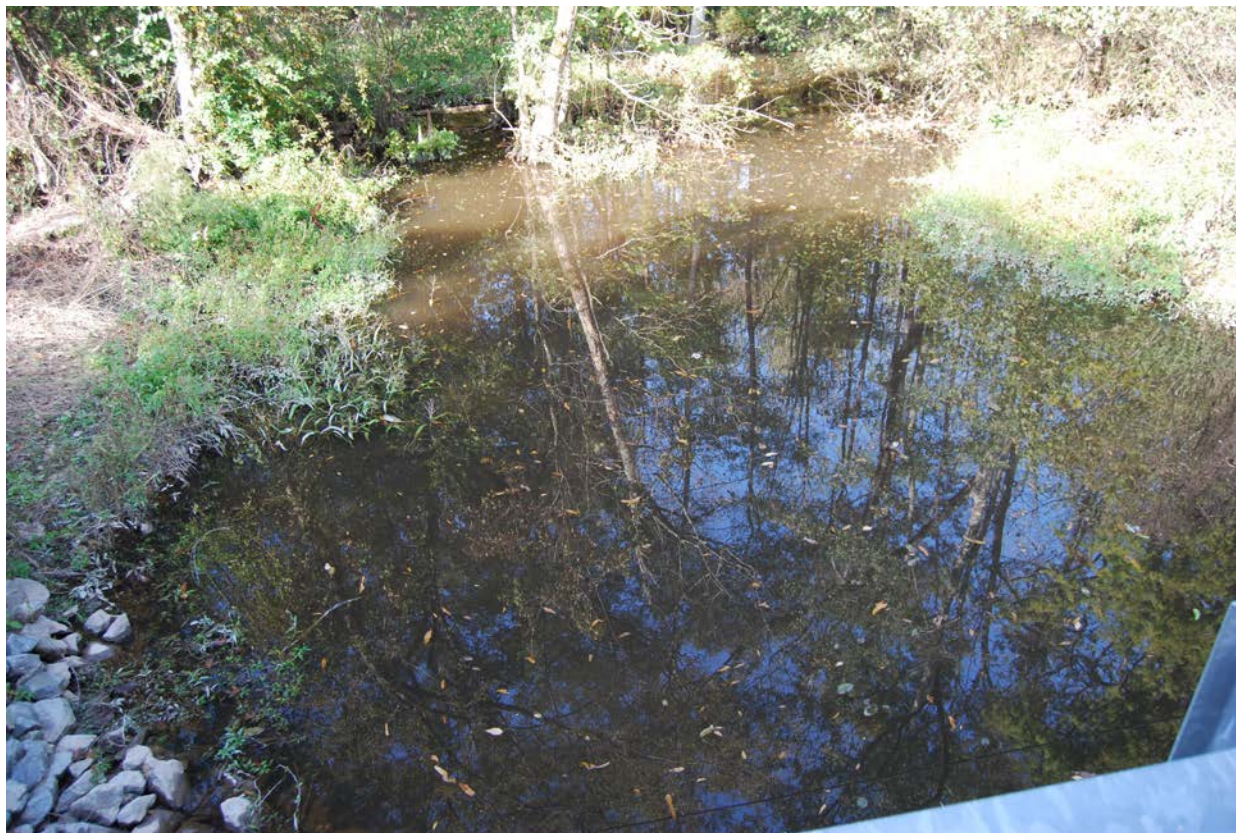
Photo No. 13

Description: This was North Creek several miles downstream from the point of entry of brine into North Creek. I observed that the creek at this location was large and the TDS at this location indicated the water did not have elevated TDS levels in it.

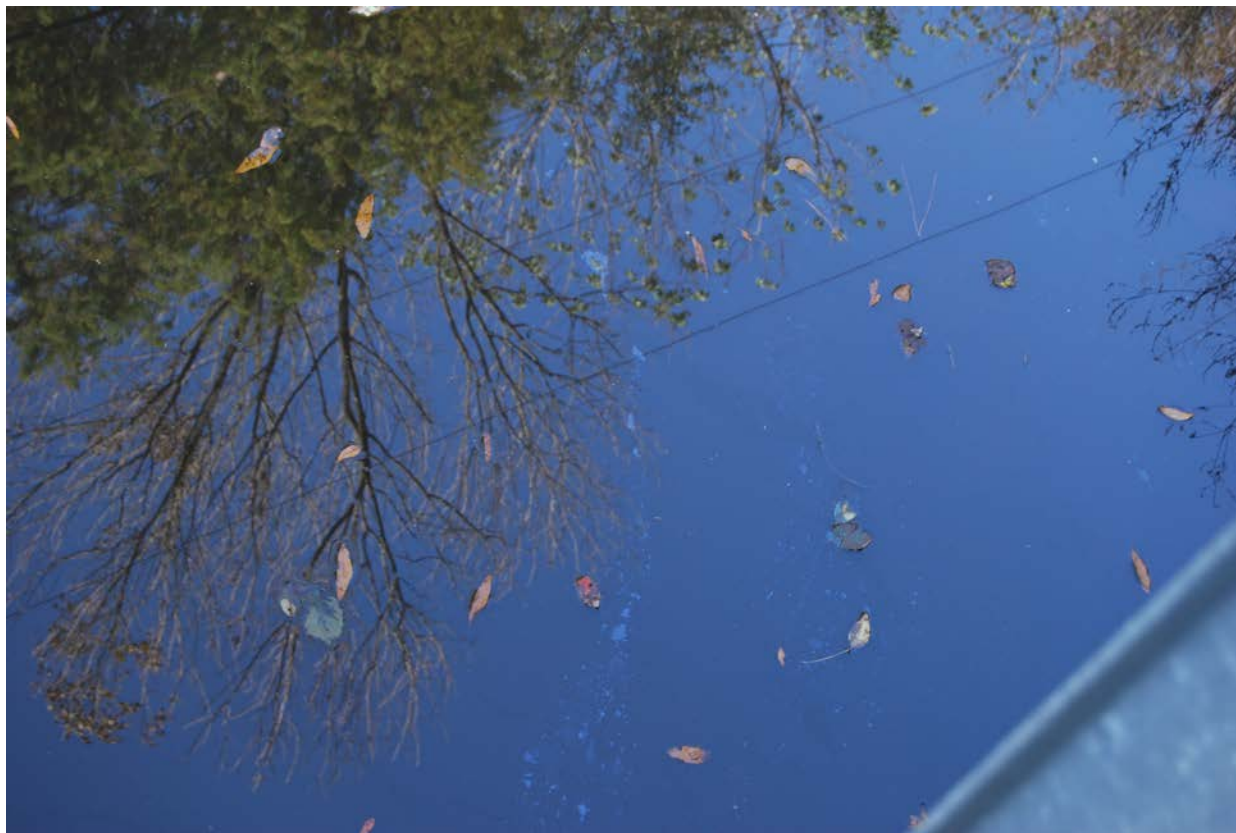
Photo No. 14

Description: This photo was the same location on North Creek as shown in Photo 13. I observed a slight oil sheen on North Creek at this location.
