## U.S. EPA Region 8 NPDES Inspection Report

| Site/Facility Location Information | |
|---|---|
| Site/Facility Name & Location:<br><b>Barnes Gravel Pit</b><br><b>45.667436, -107.665306</b><br><b>Big Horn County, Montana</b> | Send Report to:<br><b>Craig DeBuff, Project Engineer</b><br><b>KLE Construction LLC</b><br><b>craigd@kleconstruction.net</b><br><b>see mailing addresses in cover letter</b> |

## Inspection Narrative and Site Description

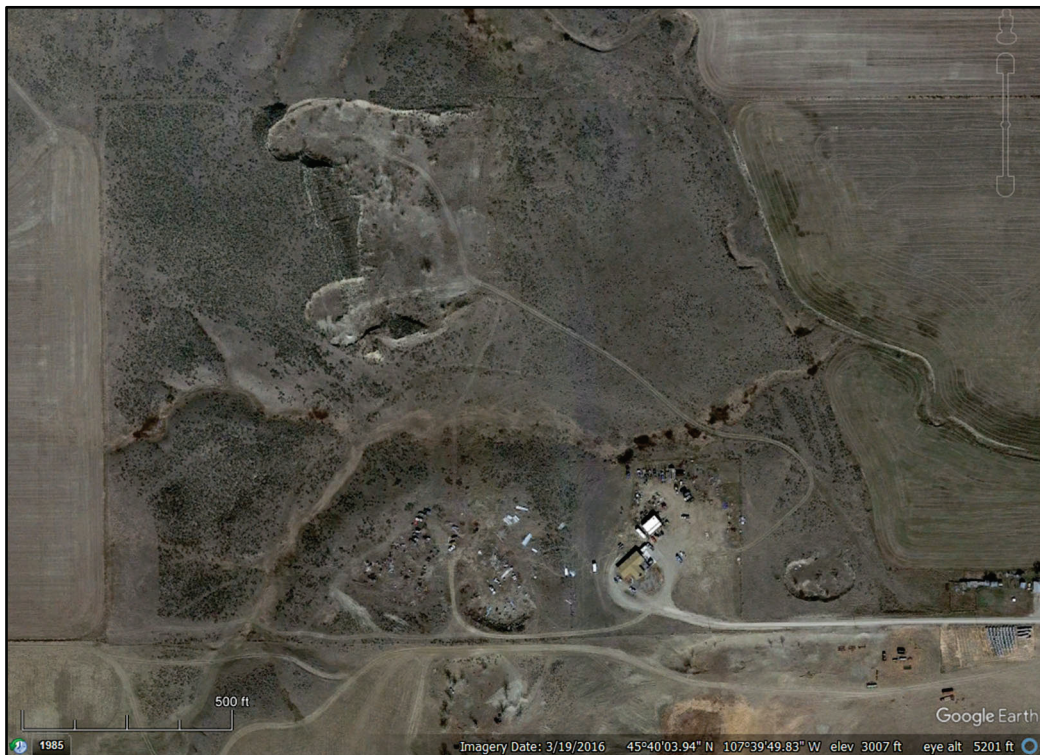
As shown in Figure 1, the site was generally undeveloped prior to the commencement of KLE’s mining activities, excepting an approximately 5-acre area in the north-central portion of the site where, according to information provided by Ruth Barnes, historical sand and gravel mining activities occurred several decades prior. Historical mining activities on the property were not evaluated during the inspection.

Figure 1. Aerial image of the site and surroundings, pre-mining  
Imagery Date: March 19, 2016  
Source: Google Earth Pro

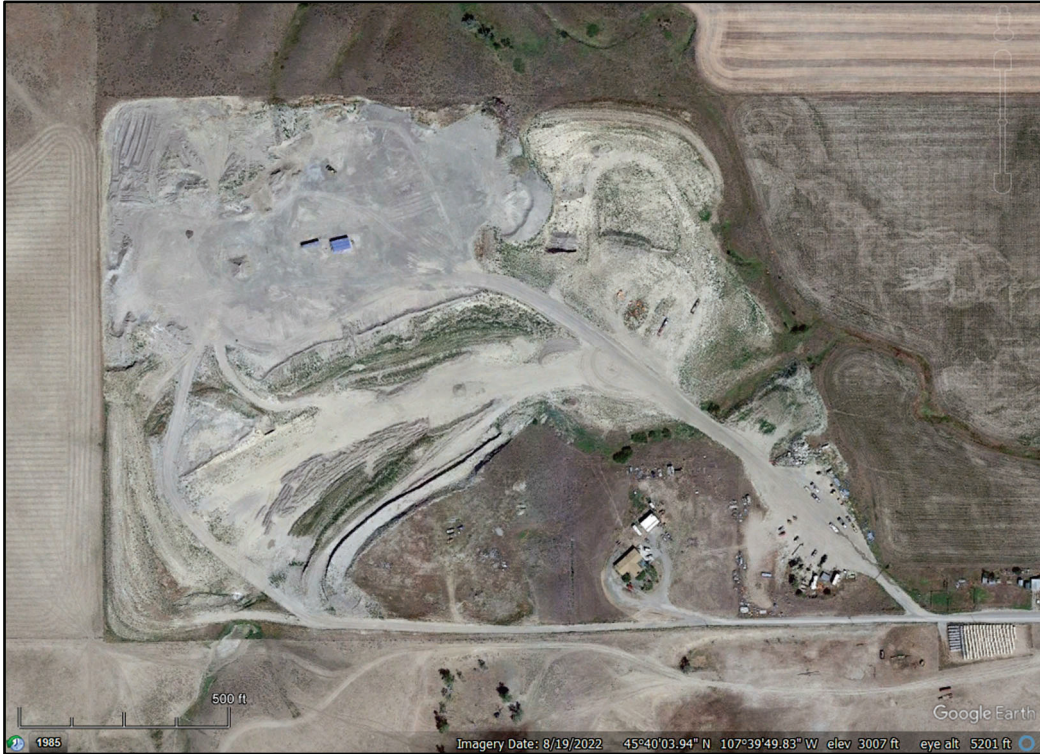
According to Ruth Barnes, mining activities at the site began in spring 2021 and continued for around 2 years. Figure 2 shows an aerial image of the site during this timeframe (August 19, 2022). Based on information provided by Ruth Barnes, mining activities comprised typical construction sand and gravel mining and support activities, including excavating, crushing, staging, and road building. Ruth Barnes indicated she was not aware of any batch plants operating at the site. The EPA has not evaluated whether any dewatering activities may have occurred at the site.

Figure 2. Aerial image of the site and surroundings, presumably during mining  
Imagery Date: August 19, 2022  
Source: Google Earth Pro

The eastern portion of the site comprised a generally eastern-facing slope. One access road entered the site from the southeast and continued northwest until leveling out in the north-central portion of the site. Aerial imagery suggests two other access roads entered the site in the western portion of the southern site boundary (seen in Figure 2), but these roads were not observed in-detail during the inspection.

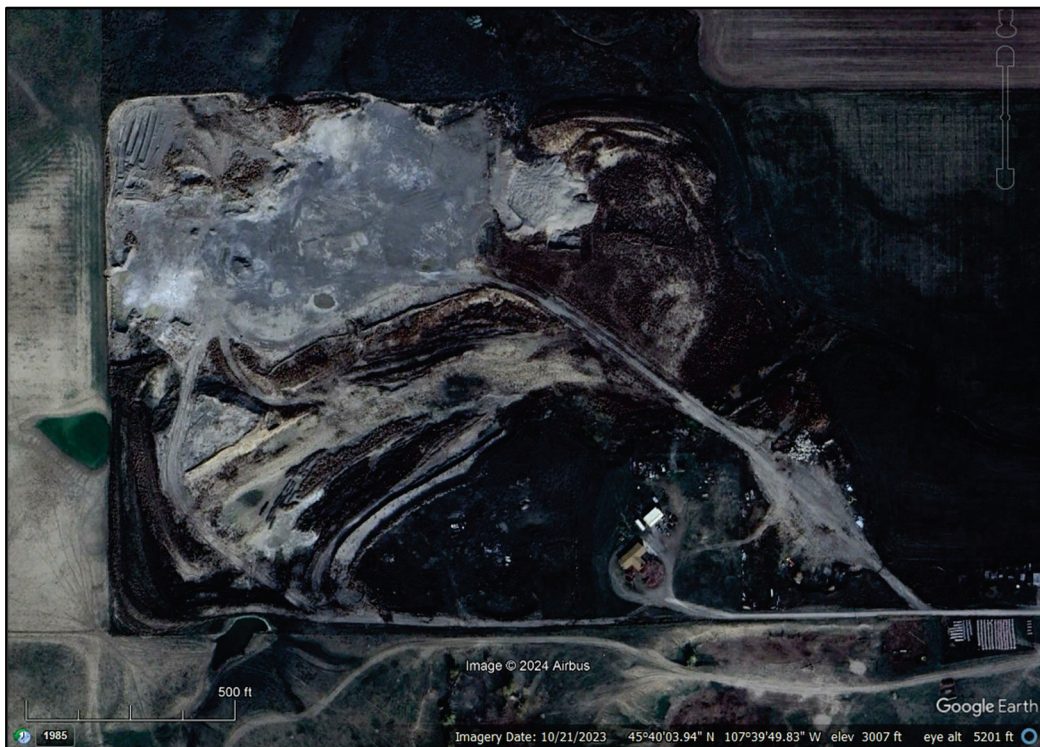
Ruth Barnes indicated, beginning January 2024, she had been allowing another construction contractor, Grizzly Construction, to purchase and haul away some of the stockpiled materials present at the site, but no additional mining, excavation, or earth disturbance had occurred since KLE's departure from the site. Figure 3 comprises an aerial image of the site after KLE's occupancy had ceased (October 21, 2023).

Figure 3. Aerial image of the site and surroundings, post-mining  
Imagery Date: October 21, 2023  
Source: Google Earth Pro
