# NPDES Compliance Inspection Report

## Ron and Leo's Welding Services

**NPDES Permit Tracking Number  
# WAU000665**

**Inspection Date: 01/18/2023**

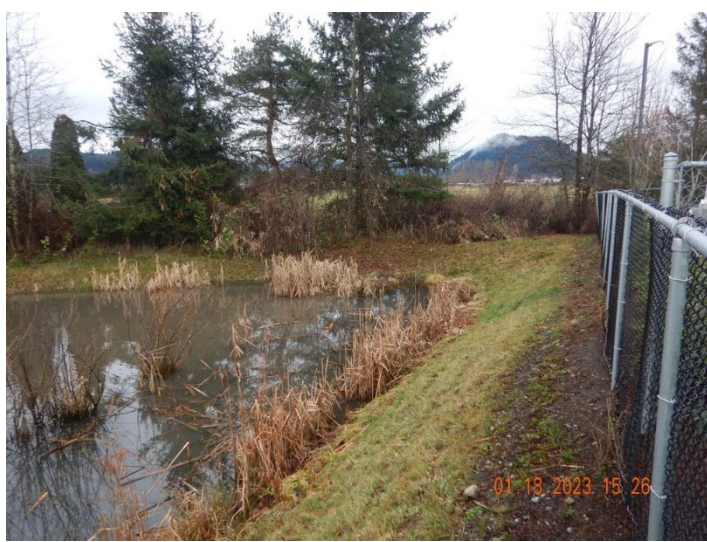
This was an unannounced inspection. Before we arrived on-site, we inspected a nearby City of Enumclaw stormwater pond (**Photo 1**, also **Attachment B**). We could see where drainage from the area fed into the pond (**Photo 3**), where the pond would flow out (**Photo 2**) into waters of the state, eventually reaching Drainage Ditch 5 (**Photo 4**), and Newaukum Creek (**Attachment B**). Upon arriving on-site, Inspector Quarterman and I introduced ourselves to Mr. Hardersen. I explained I was conducting unannounced stormwater inspections in the area that day.

| Photo Log – Ron and Leo’s Welding Services | |
|---|---|
| <p>Photo #: 01 (DSCN0528)<br/>Description: Facing south, photo of stormwater pond south of Battersby Avenue, looking towards receiving inlet.</p> | <p>Photo #:02 (DSCN0529)<br/>Description: Facing east, photo of stormwater pond south of Battersby Avenue, showing outfall crossing the street into Drainage District 5 lateral.</p> |

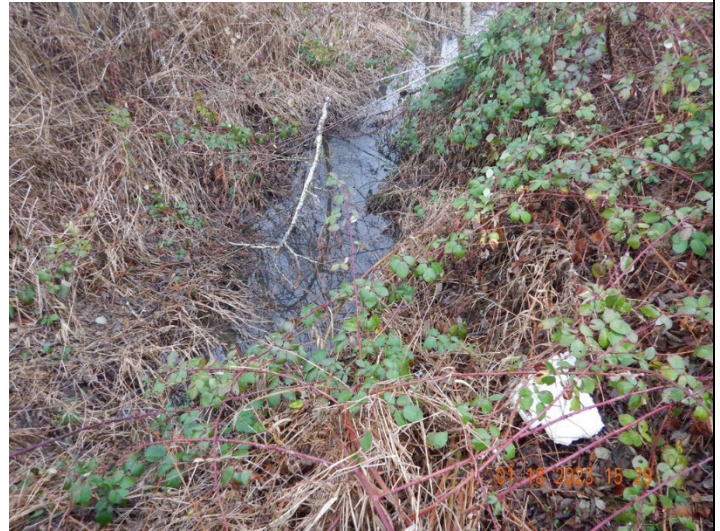
Photo #: 04 (DSCN0531)  
Description: Facing north, photo of drainage ditch receiving water from the pond south of Battersby Avenue.

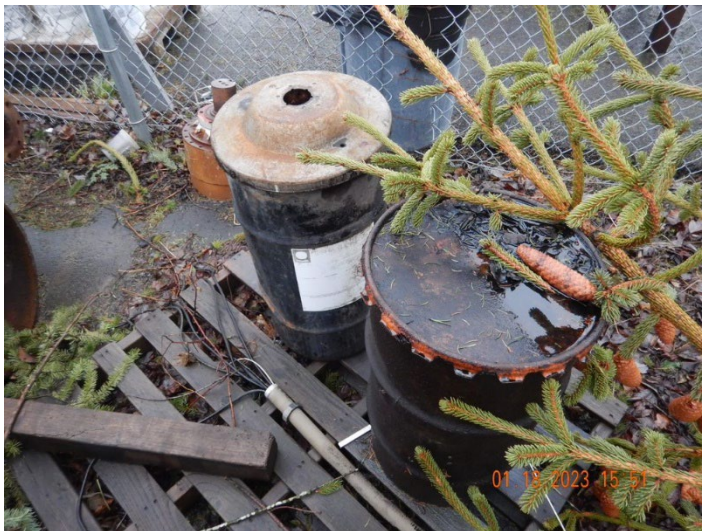
We moved outside the main shop and started at the northeast corner of the Facility, working our way south. We saw two approximately 15-gallon drums, one with a hole in the center of its lid (**Photos 5-6**). Mr. Hardersen told us these drums appeared at the Facility overnight a few weeks prior to our inspection. He said he was unsure who abandoned them, though he understood his obligation to dispose of them. He told us he thought they contained grease, and that he planned to take them to a free hazardous waste disposal event hosted by the county.

During the inspection I observed two approximately 15-gallon drums stored outside without cover (**Photos 5-6**). The Facility also stores numerous containers of fuel and oil outside with inadequate cover and spill containment (**Photos 17-19**). Mr. Hardersen told us the drums were abandoned at the Facility.

Photo #: 05 (DSCN0532)  
Description: Facing north, inside the Facility's fenceline, showing two approximately 15-gallon drums. Mr. Hardersen told us he found the drums abandoned at the Facility within the past month.

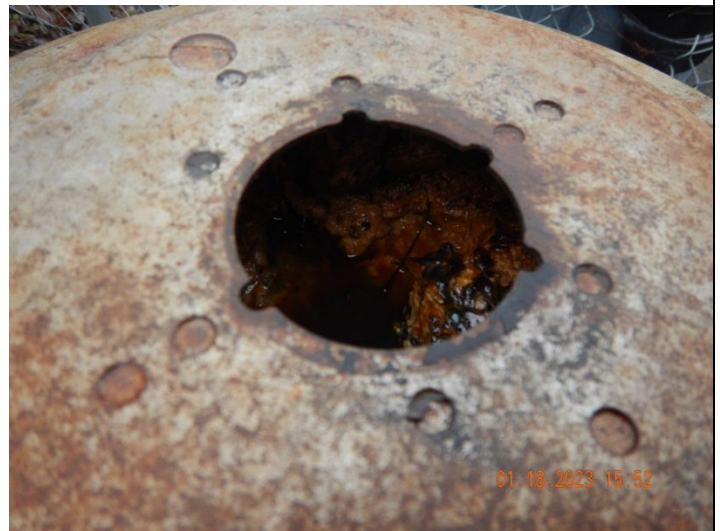
Photo #: 06 (DSC0533)  
Description: Close-up of the open drum in Photo 5, showing an apparent oily/water mixture. Mr. Hardersen told us he thought both drums contained grease.

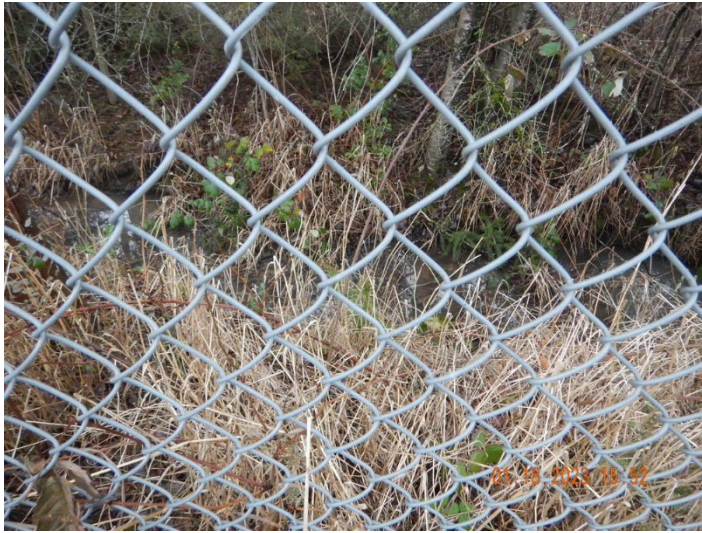
Photo #: 07 (DSCN0534)

As we moved south, we looked at the Facility's eastern fenceline. We saw a drainage ditch with water flowing north, towards Battersby Avenue (**Photo 7**). In the distance we also saw the municipal stormwater pond appearing to receive the flow from the ditch (**Photo 8**). Near the fence, we saw an approximately 20-foot-long roll-off container holding a variety of scrap metal (**Photos 10-11**). The roll-off lacked a lid entirely. Rust colored water pooled under the roll-off (**Photo 9**) and flowed into a nearby catch basin (**Photos 12-13**). We continued south observing a large amount of metal stored without cover (**Photo 14**), and small parts laying on the ground as debris (**Photo 15**).

Description: Facing east, photo of a drainage ditch with flow just outside the Facility's fenceline. The water appeared to flow north, towards Battersby Avenue.

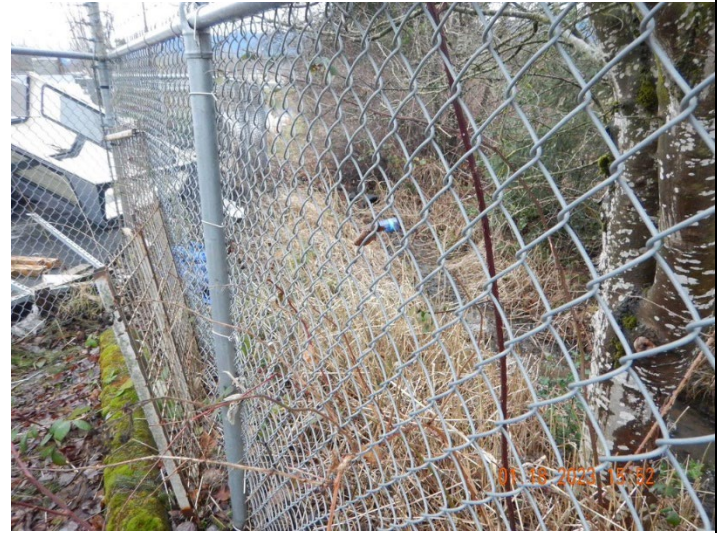
Photo #: 08 (DSCN0535)

Description: Facing northeast, photo of the ditch outside the Facility's fenceline, flowing north to municipal stormwater pond south of Battersby Avenue.

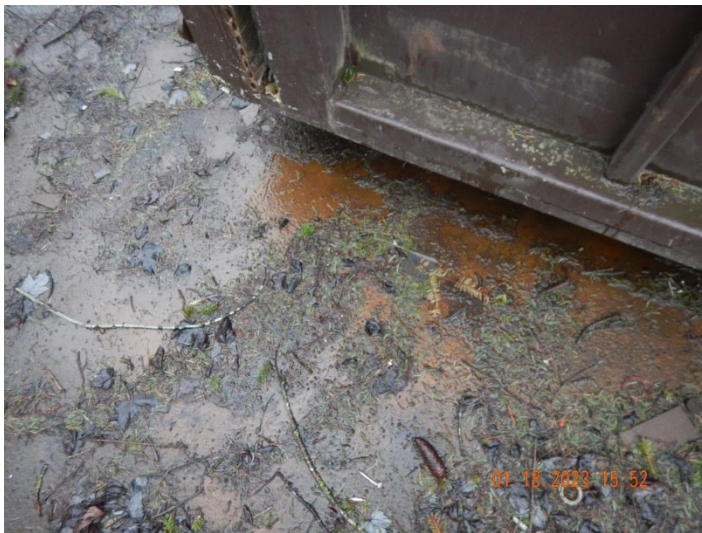
Photo #: 09 (DSCN0536)

Description: Facing southeast, photo of stormwater and debris beneath open roll-off container holding scrap metal.

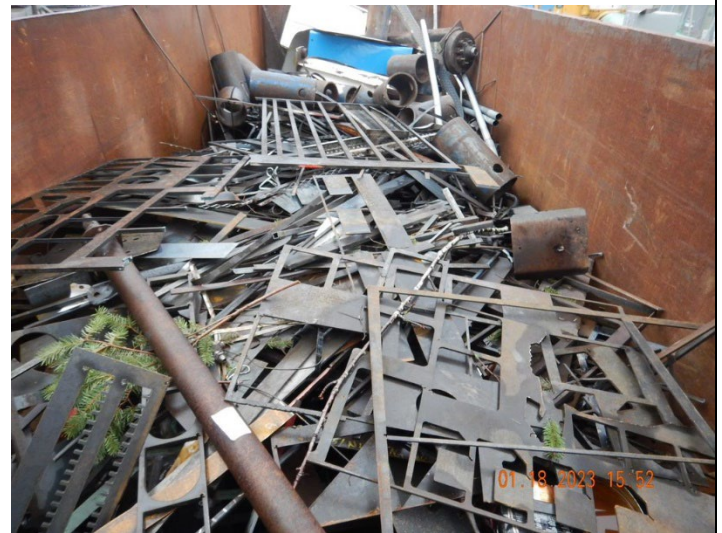
Photo #: 10 (DSC0536)

During the inspection I observed an approximately 20-foot-long roll-off container holding scrap metal without a lid (**Photos 10-11**).

Description: Facing southeast, photo of the contents of the open roll-off container shown in Photo 9.

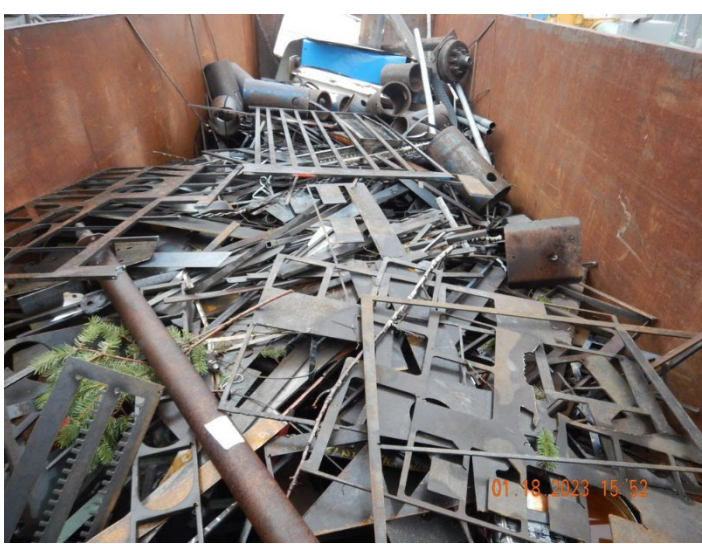
Photo #: 11 (DSCN0537)  
Description: Facing southeast, open roll-off container in Photo 10, slightly zoomed in.

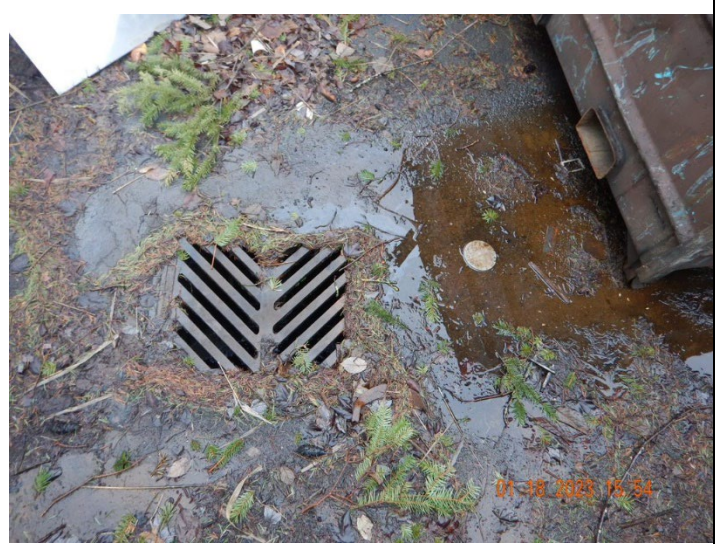
Photo #:12 (DSCN0538)  
Description: Facing east, photo of a catch basin next to the open roll-off in previous photos.

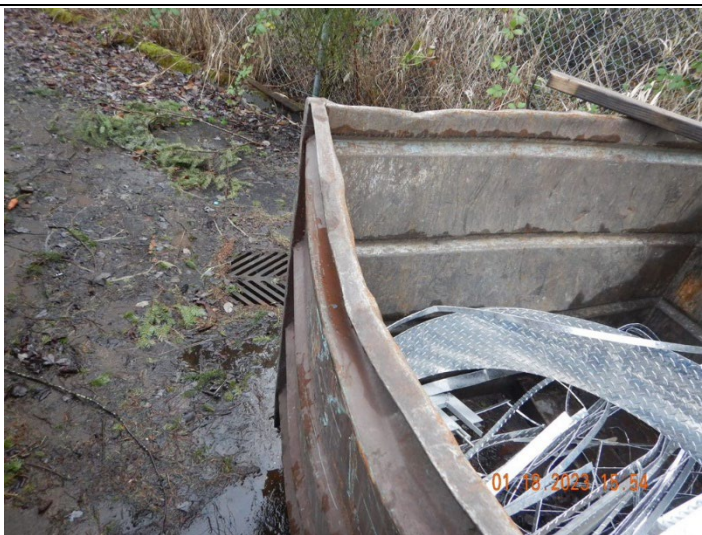
Photo #: 13 (DSCN0539)  
Description: Facing east, photo of catch basin in proximity to open roll-off.

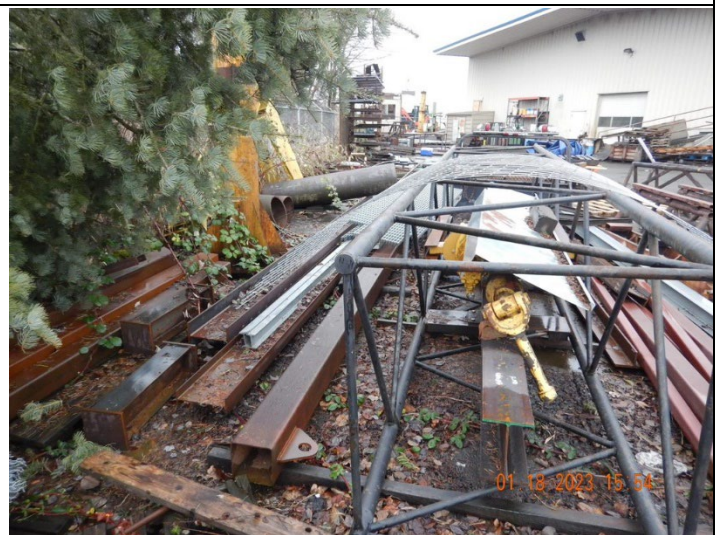
Photo #: 14 (DSC0540)  
Description: Facing southwest, overview photo of the outside of the Facility, largely used as storage with scrap metal in foreground.

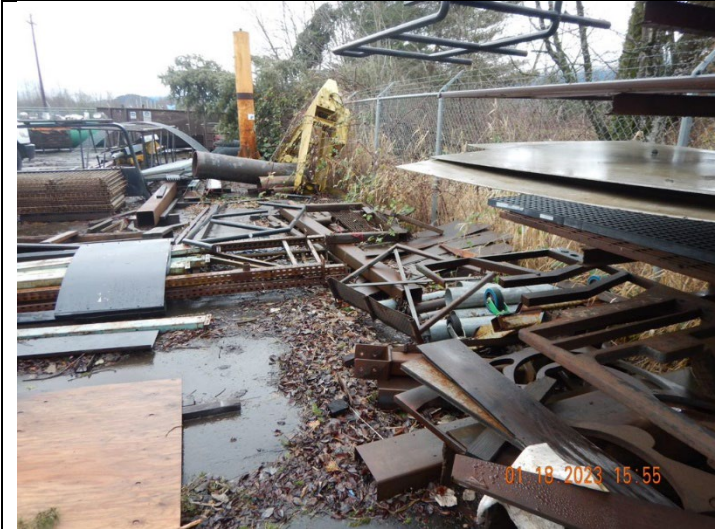
Photo #: 15 (DSC0541)  
 Description: Facing northwest, overview photo of the outside of the Facility, largely used as storage with a mixture of scrap metal and debris on the ground.

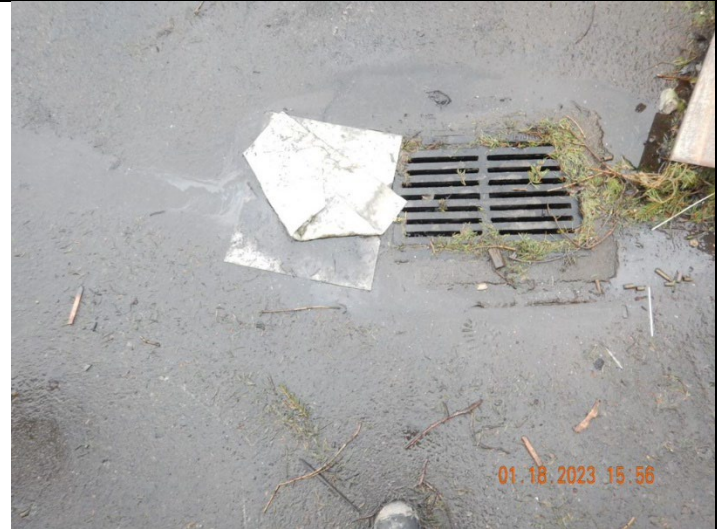
Towards the southeast portion of the Facility, we observed a second catch basin receiving stormwater (**Photo 16**). Two absorbent pads lay between the catch basin and the flow. We noted an obvious sheen in the stormwater heading into the catch basin. Nearby,

We expressed our concern with Mr. Hardersen at such a large amount of oil stored outside with limited cover and spill response capacity. Mr. Hardersen agreed the Facility could improve its storage, though he told us they had not had a significant spill. I pointed out the oily sheen flowing towards the catch basin and highlighted the opportunity to improve stormwater management with a more robust spill response.

Photo #: 16 (DSC0542)  
 Description: Facing east, a second catch basin with absorbent pads placed to the side. Stormwater flowing towards catch basin contained a sheen.

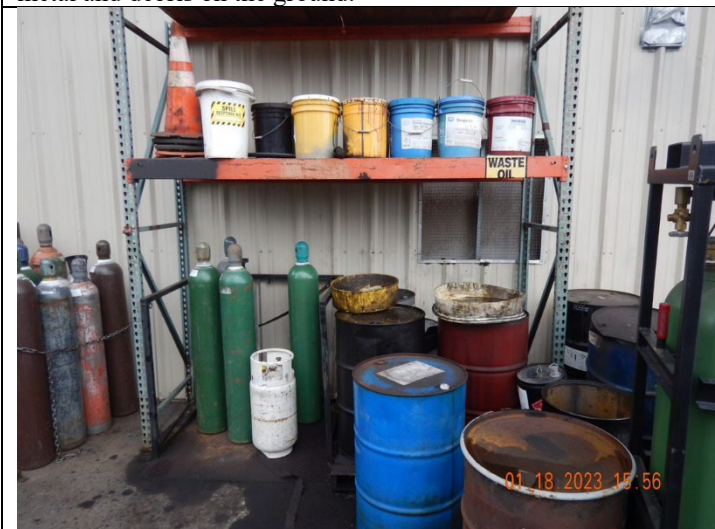
against the outer wall of the Facility, we saw an oil and compressed gas cylinder storage area (**Photo 17**). We counted approximately six 5-gallon pails, one approximately 20-gallon drum, and seven 55-gallon drums. Mr. Hardersen told us about half the drums sat empty. A small portion of cover sat over the shelving; rainwater appeared to accumulate on the containers evidenced with the rusting of lids, and the visible standing water in drains designed to screw into the bungs of the drums (**Photo 19**). Immediately south of the shelving we saw a small outbuilding, additional compressed gas cylinders, and approximately five 5-gallon containers holding fuel and oil (**Photo 18**). Mr. Hardersen told us the outbuilding housed the Facility's compressor.

Photo #: 17 (DSC0543)  
 Description: Facing east, exterior shelving holding a variety of both product oils and greases, and "waste oil," also approximately 12 compressed gas cylinders, some chained.

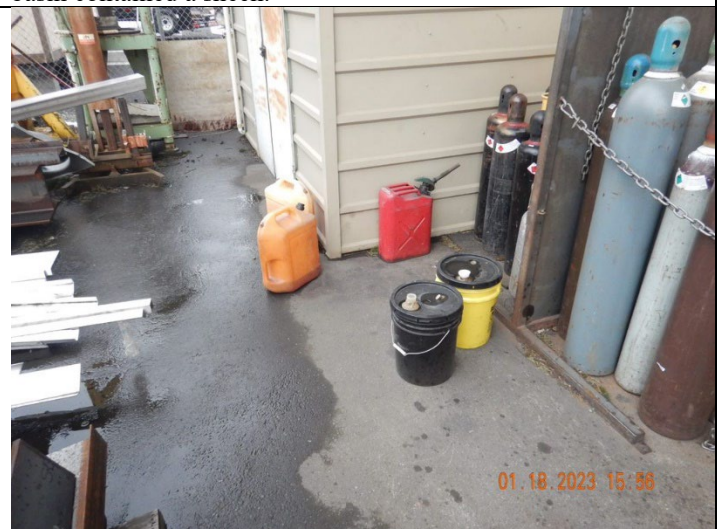
Photo #: 18 (DSC0544)  
 Description: Facing south, exterior storage compartment housing a large compressor. Also, two 5-gallon buckets of oil, and three approximately 5-gallon fuel cans sitting outside and exposed.

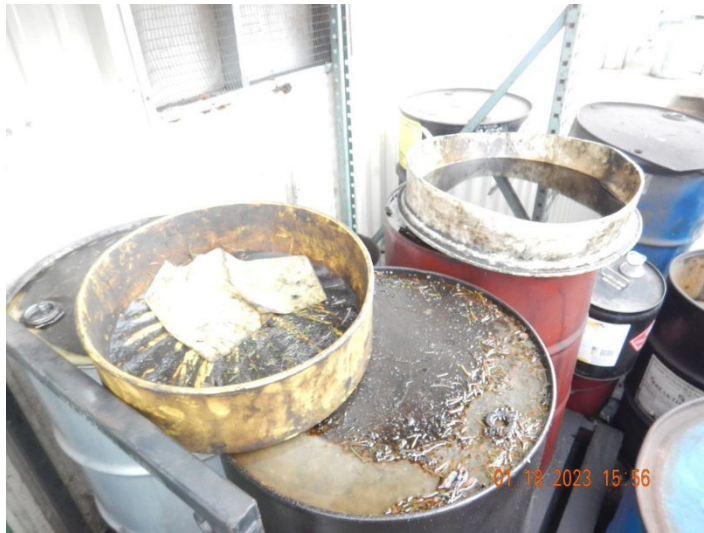
Photo #: 19 (DSCN0545)

Description: Facing west, close-up of Photo 17 showing 5 approximately 55-gallon drums of oil. Mr. Hardersen characterized two of the drums as holding used oil. The drums all appeared wet on top.
