**Region 6 - Enforcement & Compliance Assurance Division**  
**INSPECTION REPORT**

| Inspection Date(s): | 1/29/2025 | |
| Company Name: | <b>Beebe Exploration Company, LLC</b> | |
| Facility Name: | <b>McHenry Tank Battery</b> | |

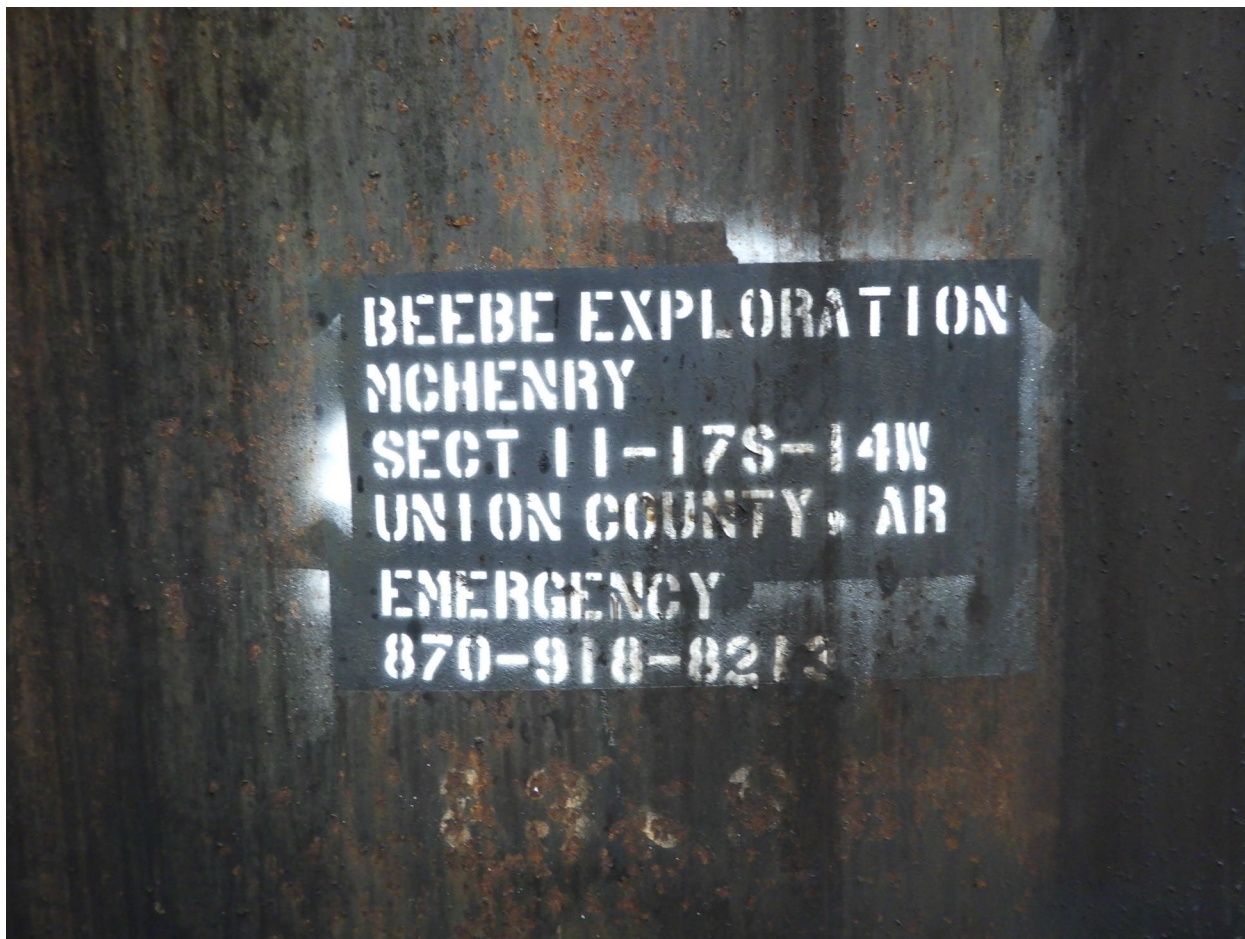
Photo No. 1

**Description:** This photo was taken looking north and shows the facility sign.

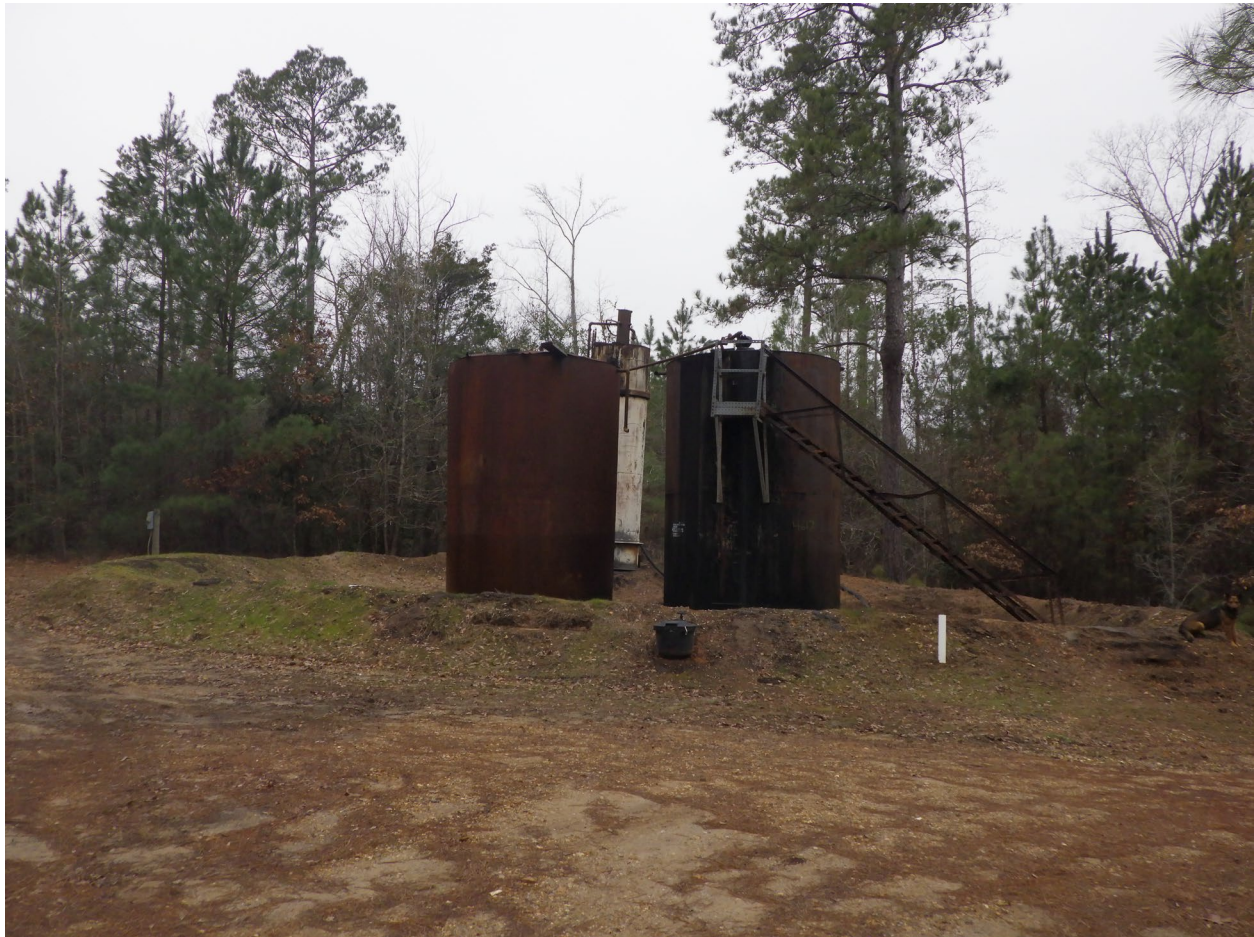
Photo No. 2

**Description:** This photo was taken looking north and shows an overview of the facility.

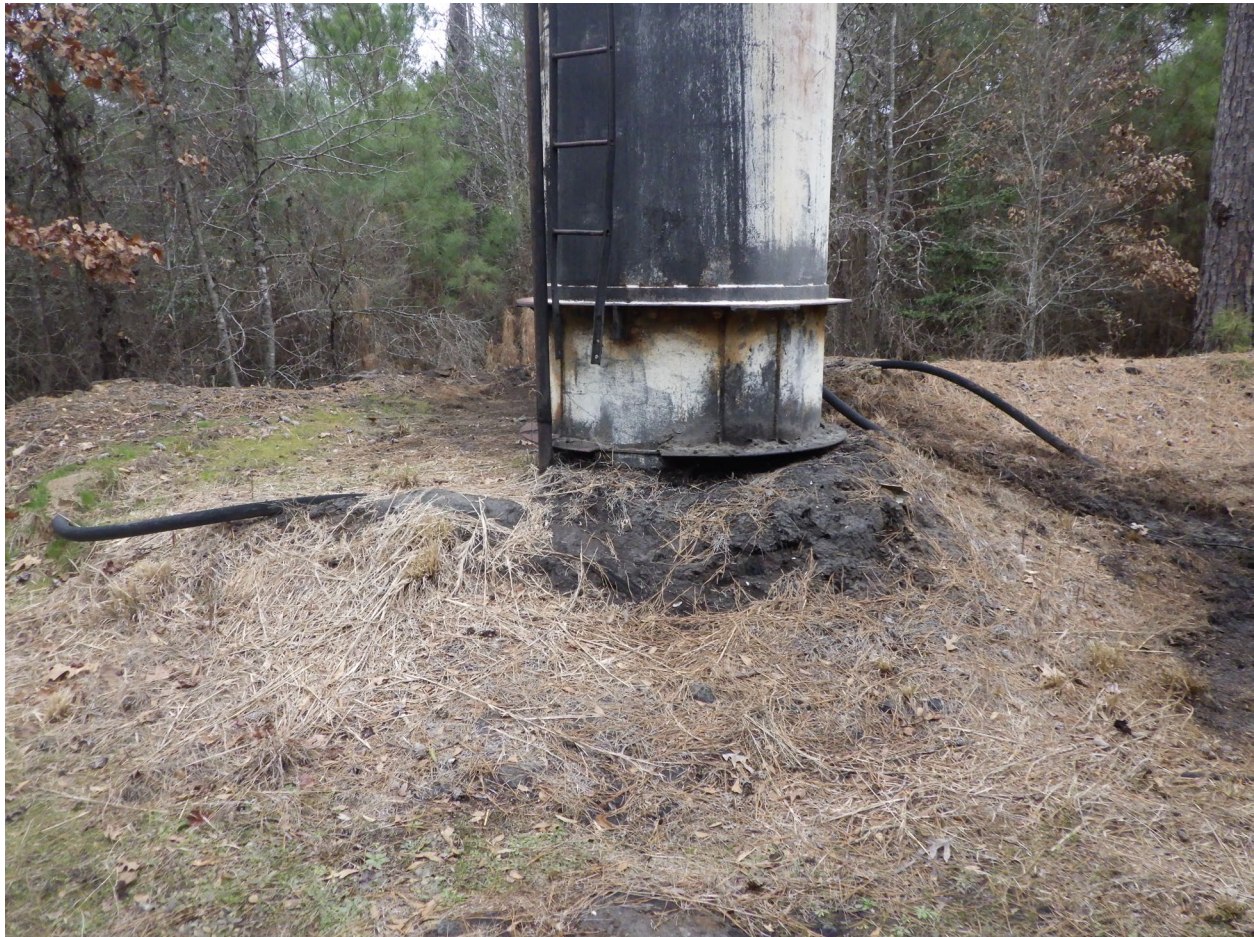
Photo No. 3

I observed a gap under the separator, see photo No. 3.

No closing conference was held due to no Beebe Exploration Company, LLC staff being present during the inspection. Areas of concern at the time of the inspection include gapping under the separator, leaking secondary containments discharge pipe, and large woods vegetation growing into the secondary containment berm.

**Description:** This photo was taken looking west and shows a gap under the separator.

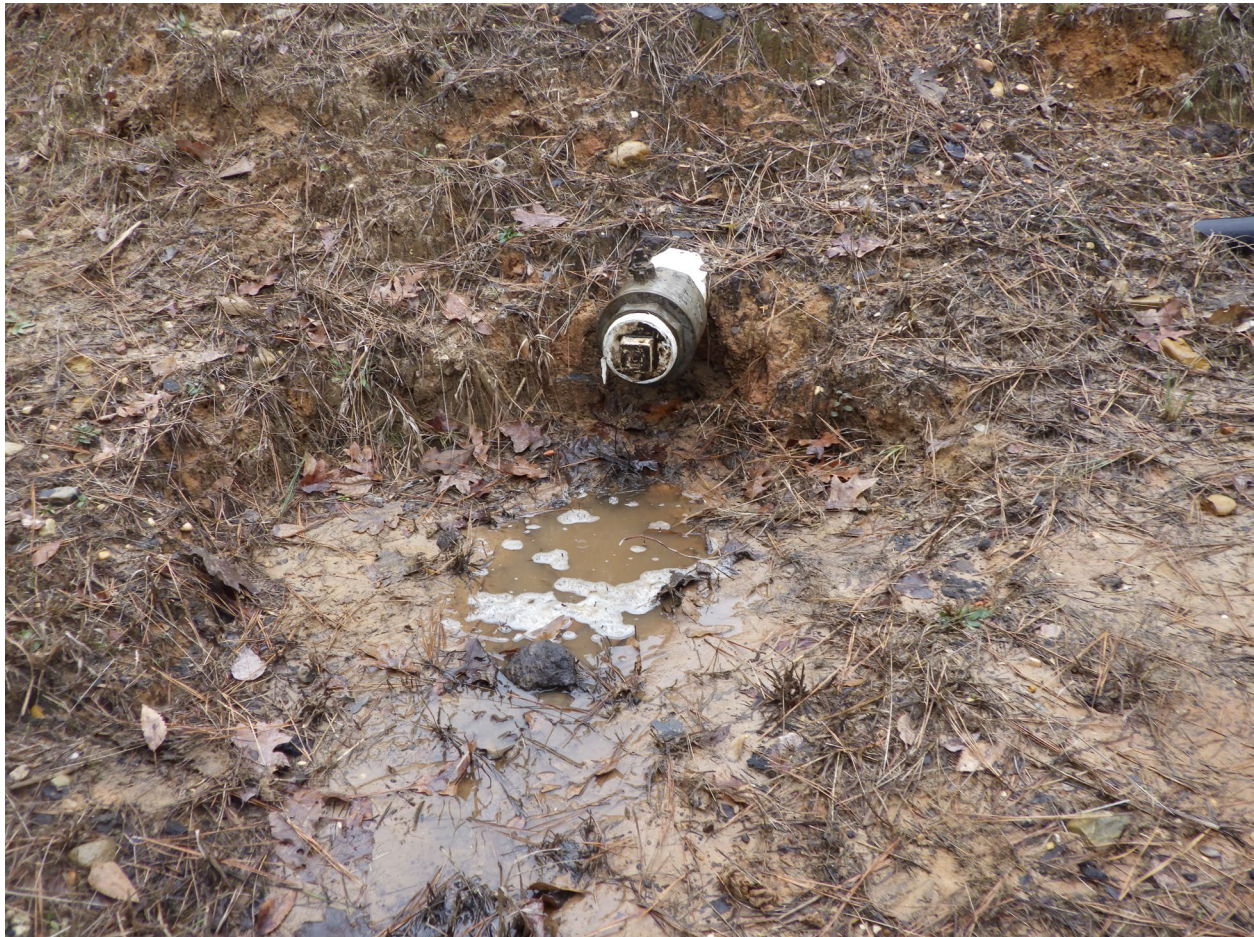
Photo No. 4

I observed an active leak from the secondary containment discharge pipe outside of secondary containment, see photo No. 4.

**Description:** This photo was taken looking W and shows the secondary containment discharge valve actively leaking.

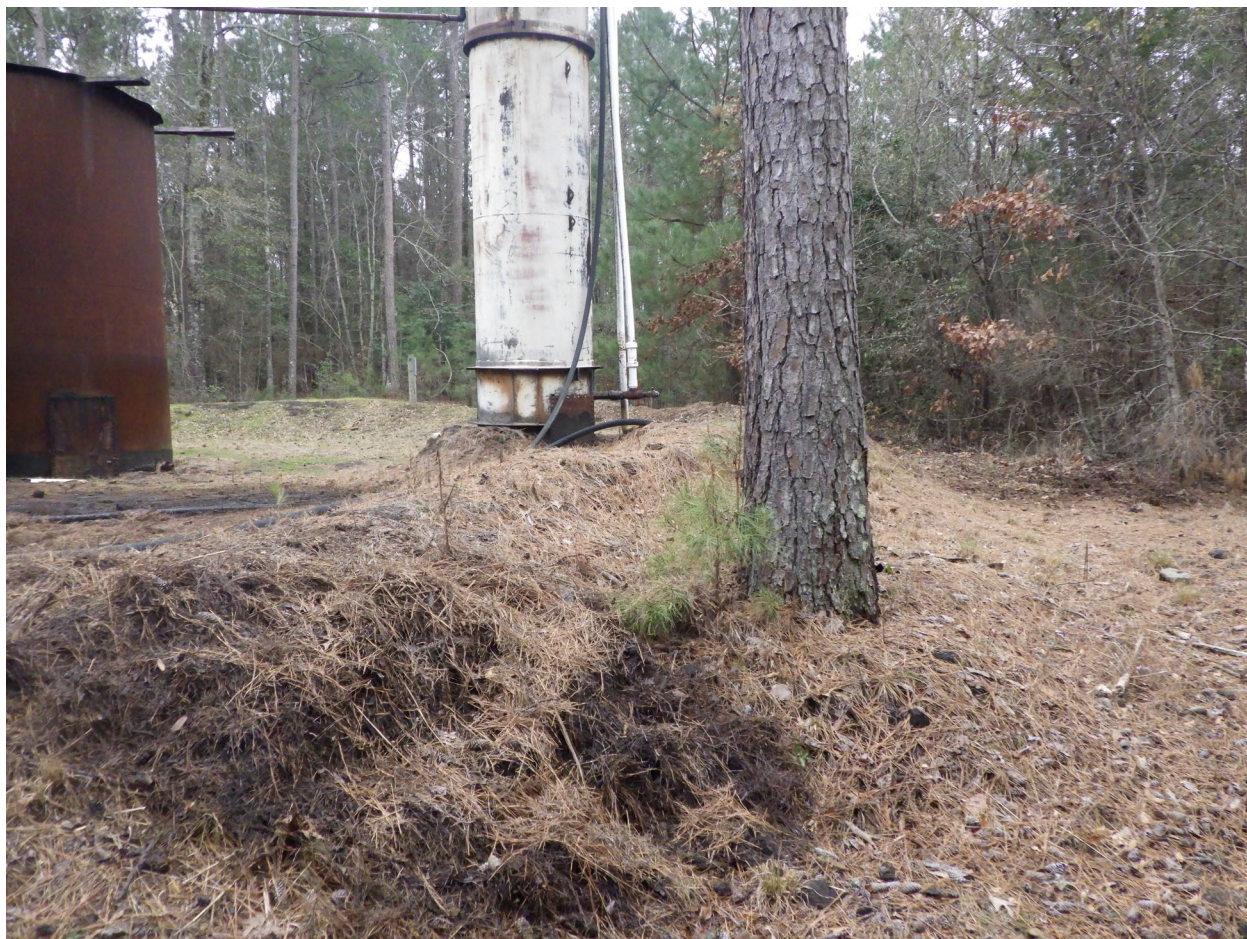
Photo No. 5

I observed a pine tree growing into the secondary containment berm, see photo No. 5.

**Description:** This photo was taken looking southwest and shows a pine tree growing into the secondary containment berm.
