**UNITED STATES ENVIRONMENTAL PROTECTION AGENCY**

**Subj:** Inspection Report  
Clean Water Act - National Pollutant Discharge Elimination  
System ("NPDES")  
Epping WWTF

Epping WWTF  
40 Lagoon Road, Epping, NH  
CWA NPDES Inspection  
July 19, 2023

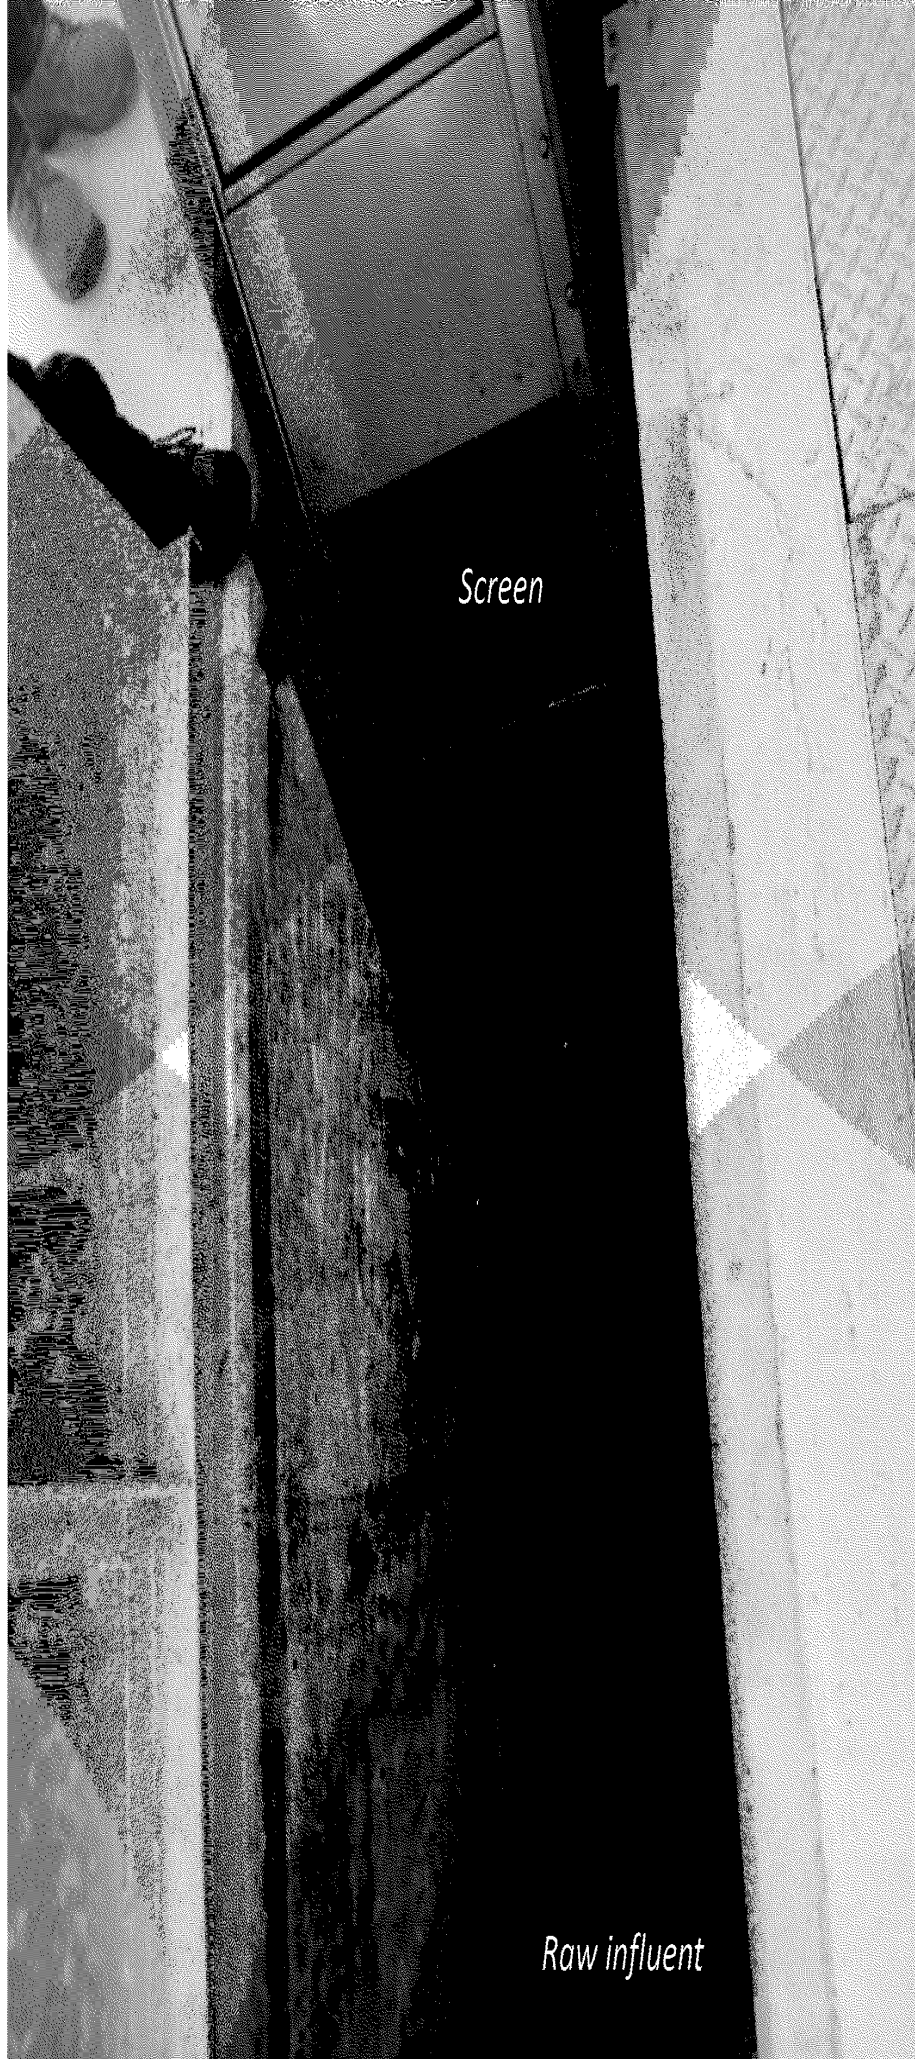
Mr. Anthony Shea and Mr. Mercier lead the inspectors through a walk of the treatment plant starting at the headworks. The group enter the headworks building, where the fine screen and grit removal are located (slides 2-3). Inside a channel, the Town has the influent flow ultrasonic meter (slide 4).

Screen

Raw influent

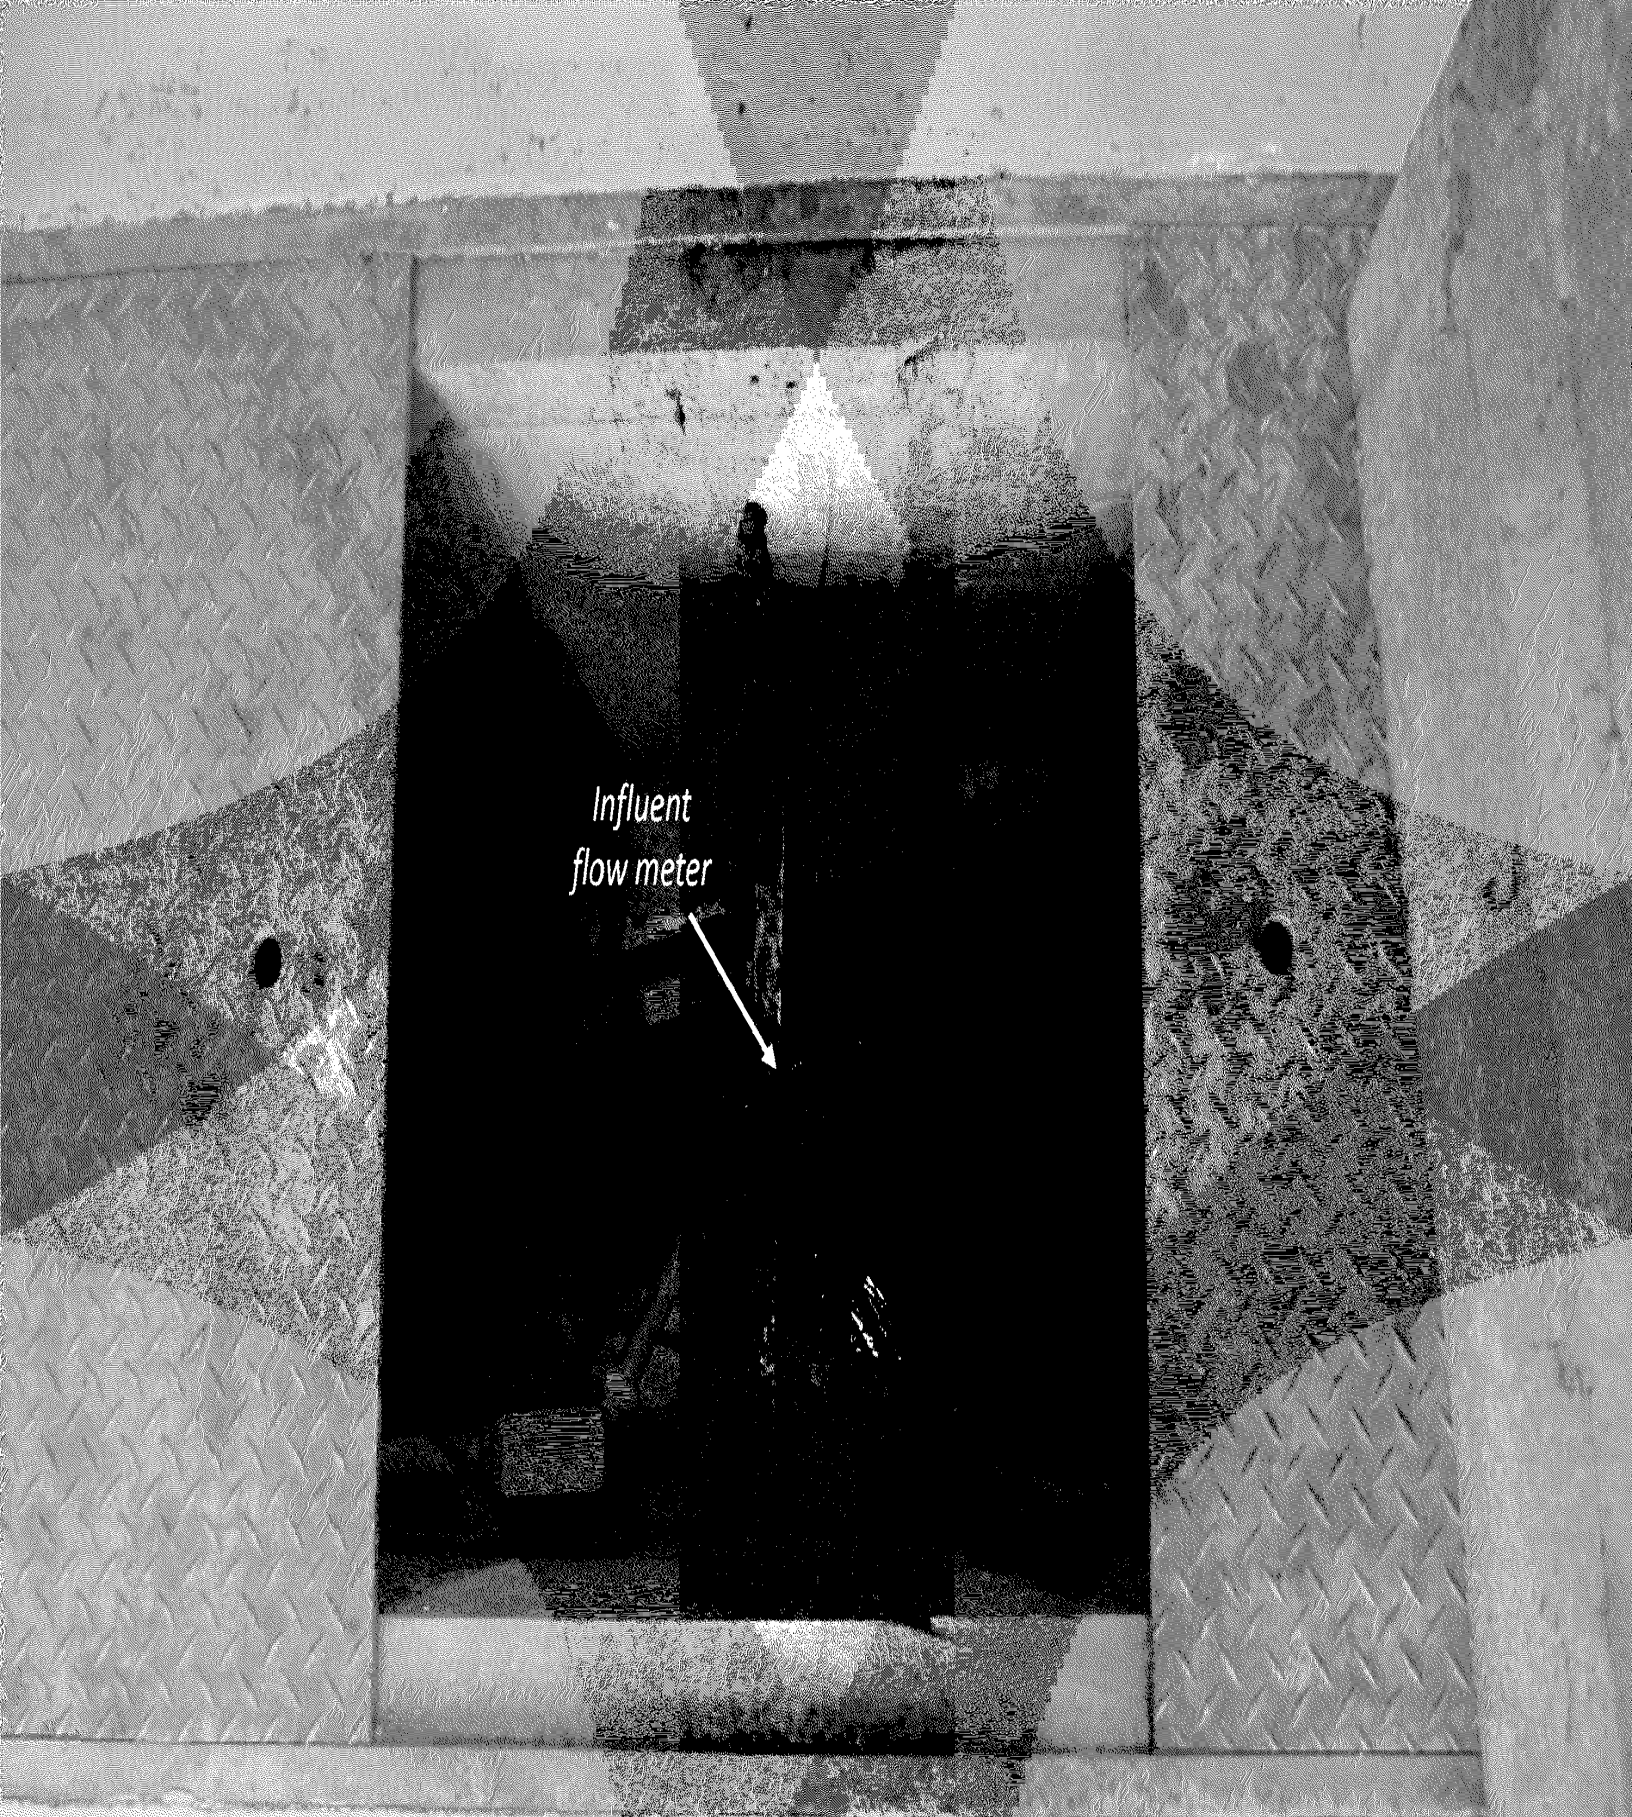
Influent  
flow meter

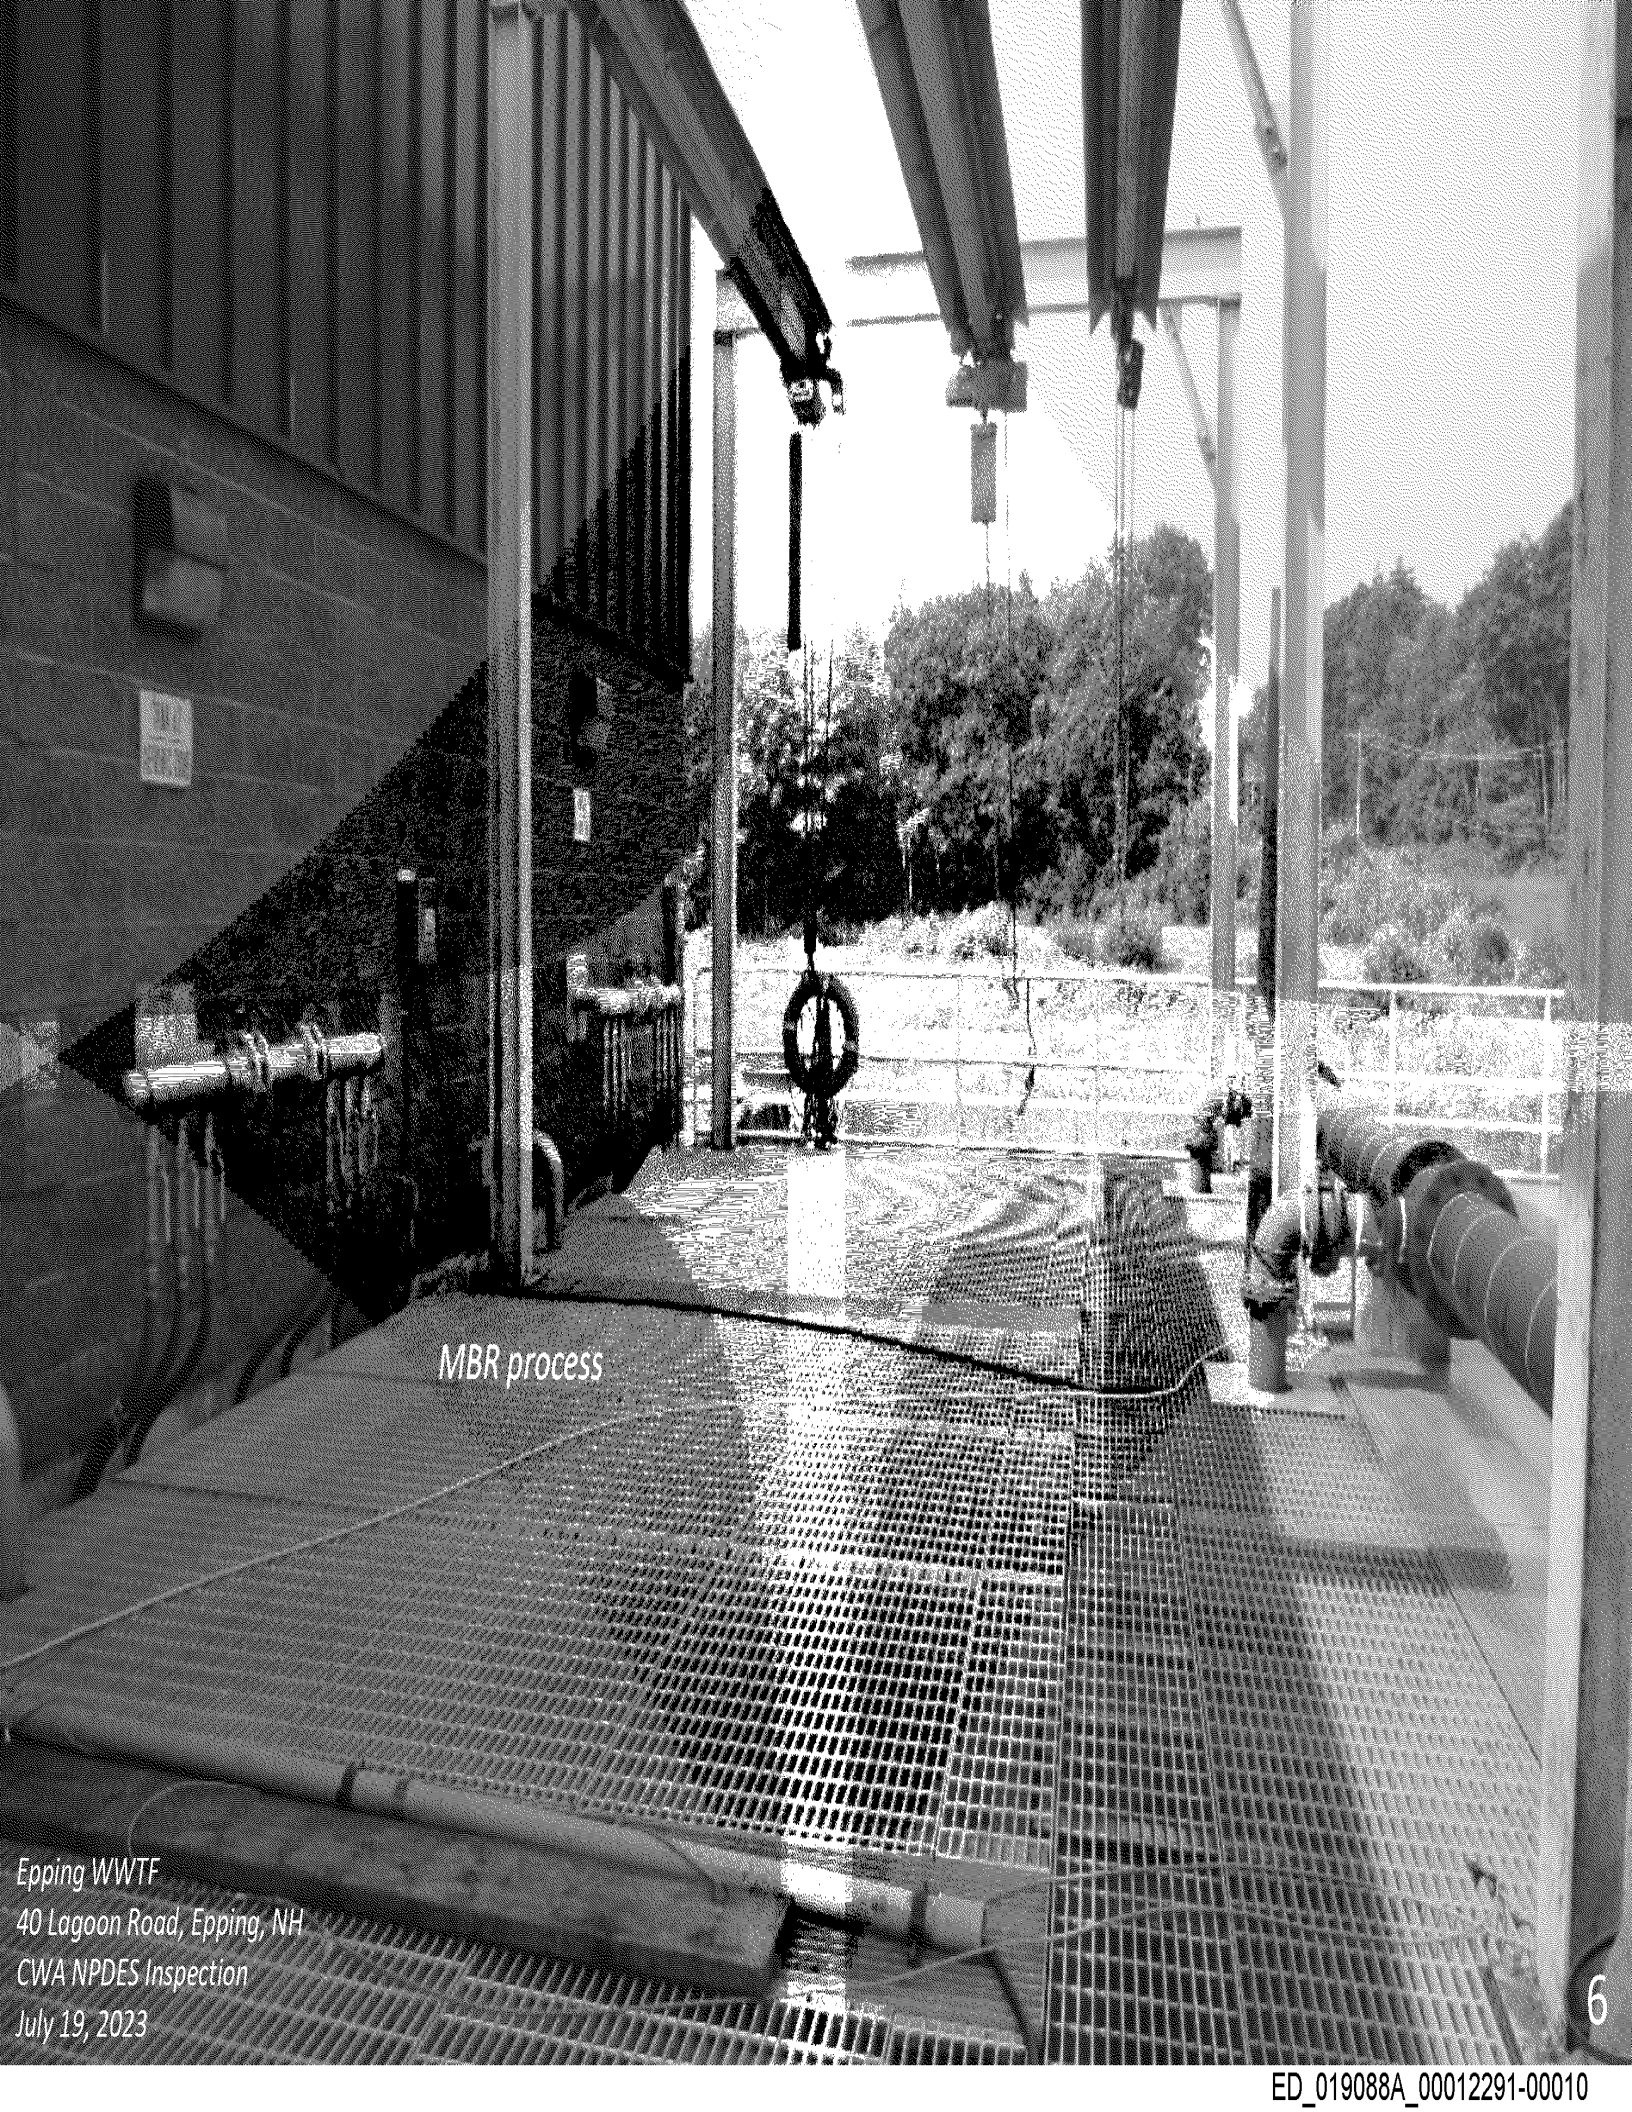
The influent then flows through the lift stations (slide 5). From there the wastewater flows through the MBR process (slides 6-7). The group walked over the grates above the MBRs and observed the crane system above them (slide 8). The cranes are used to lift the membrane from their enclosures and to move them into the designated cleaning area. Mr. Mercier indicated that the heated enclosure building required by the in the AO, needs to be big enough to contain the crane system within.

MBR process

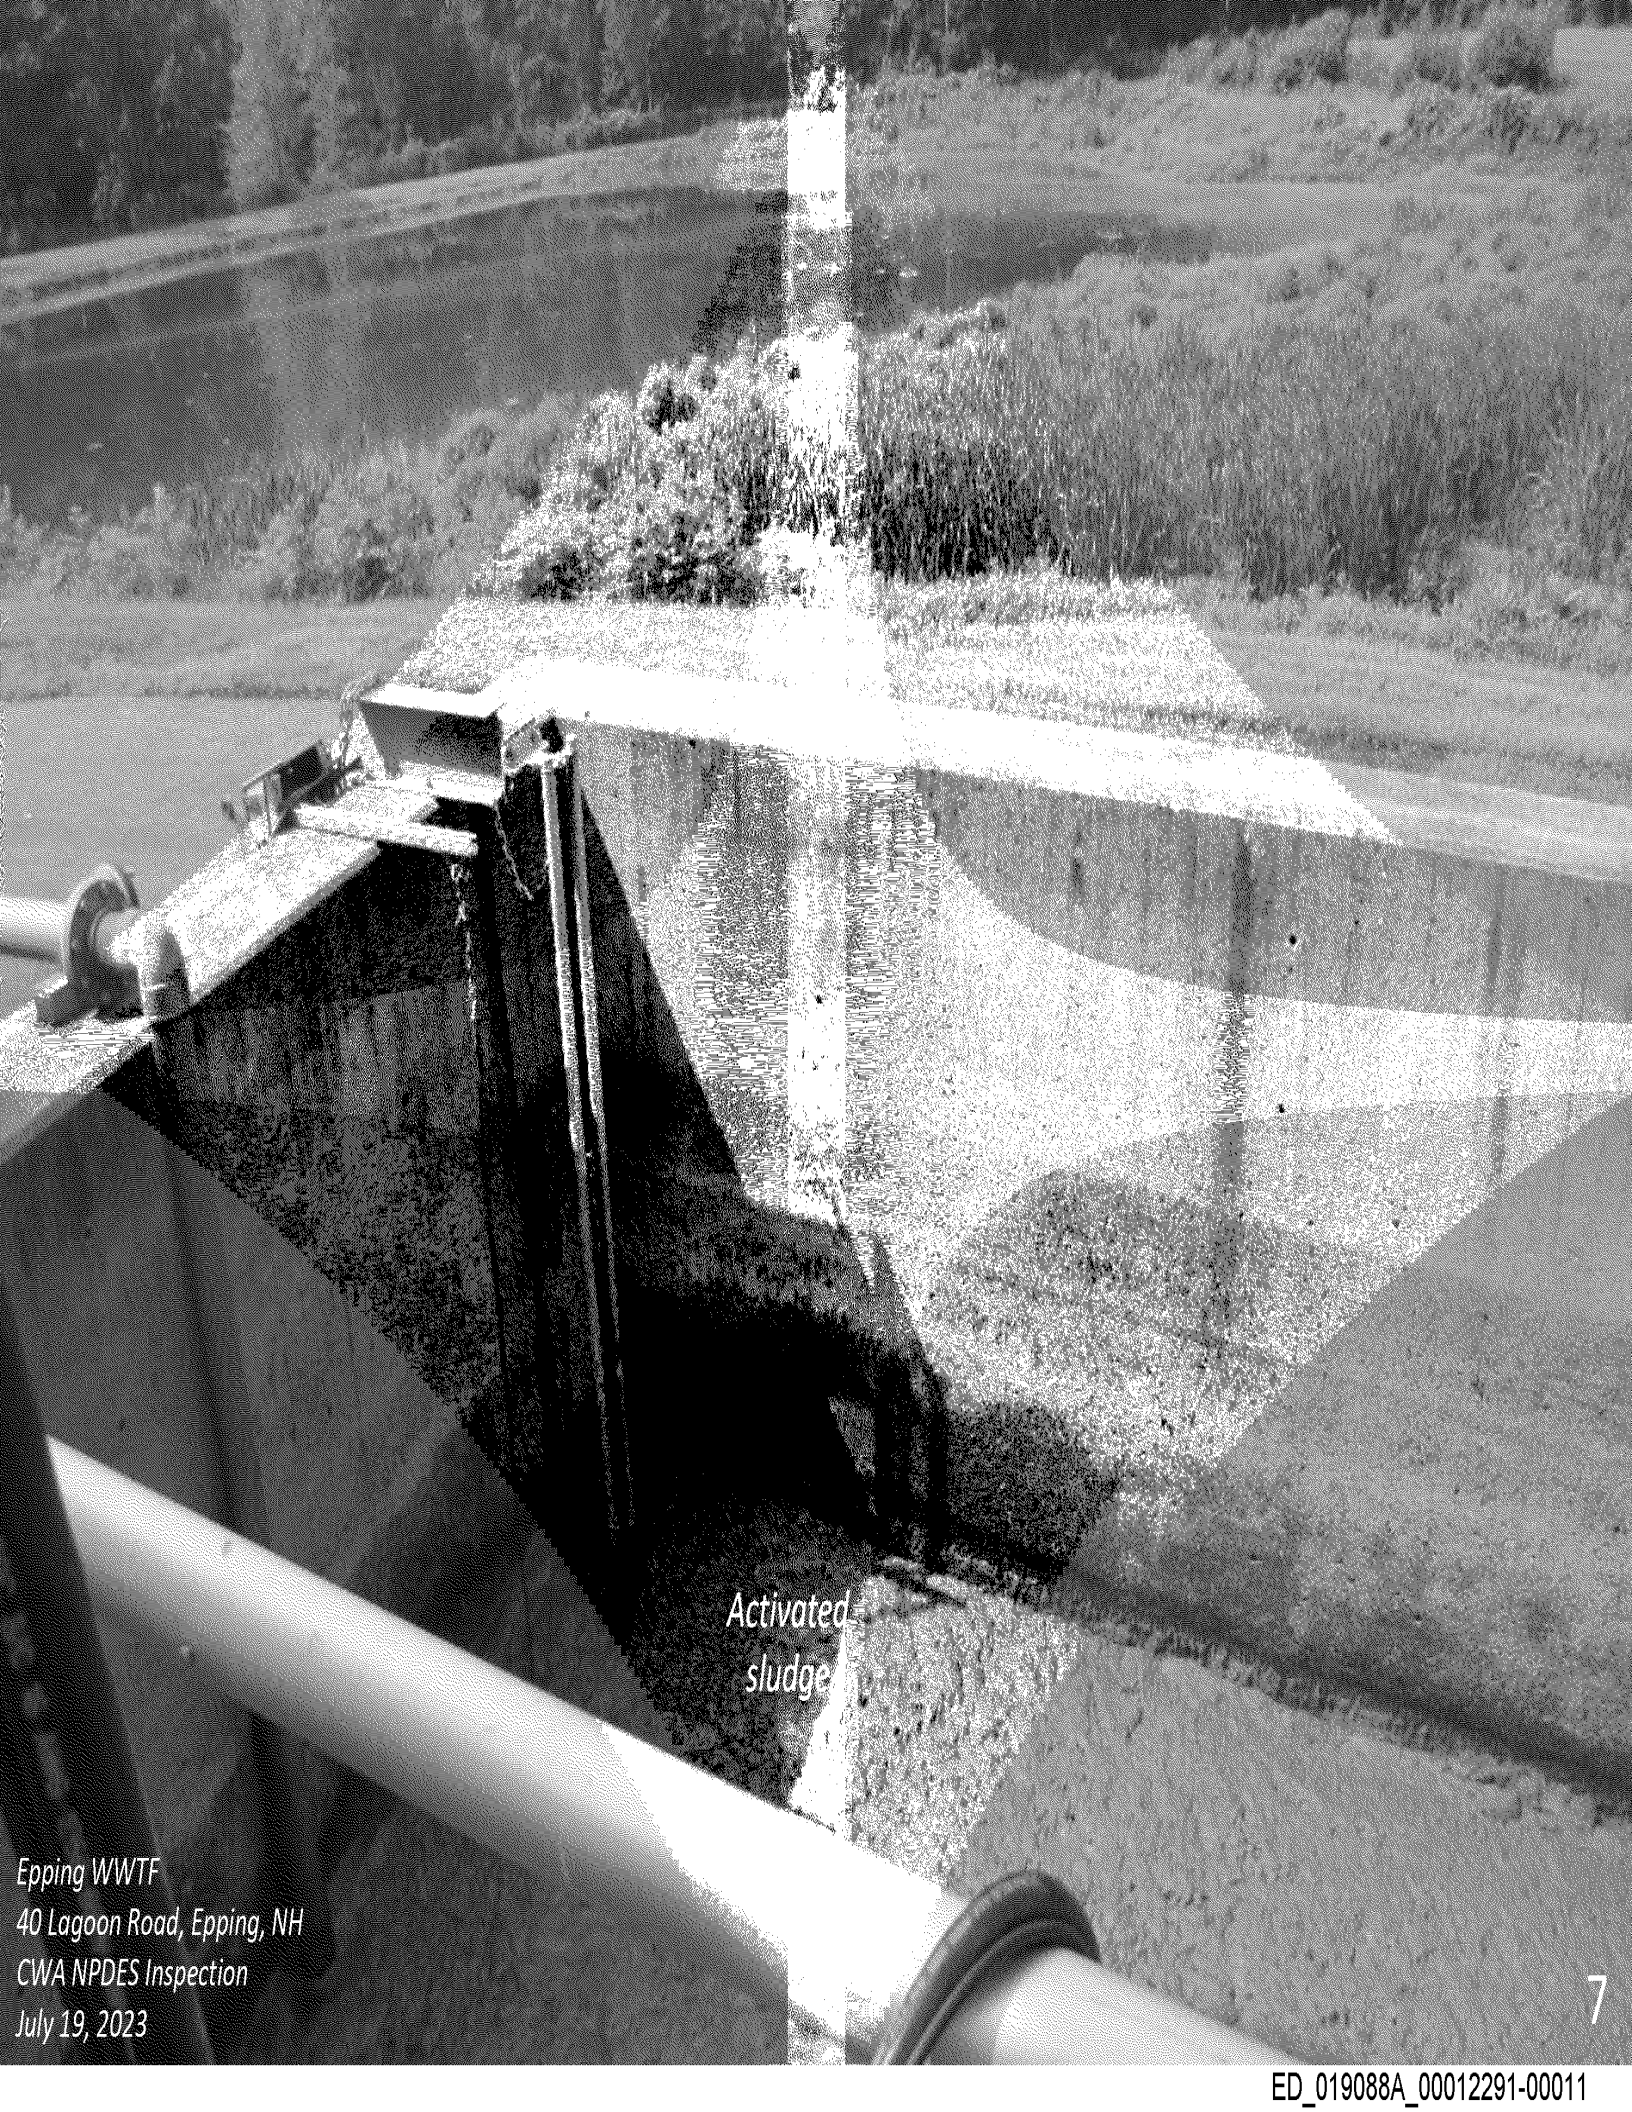
Activated  
sludge

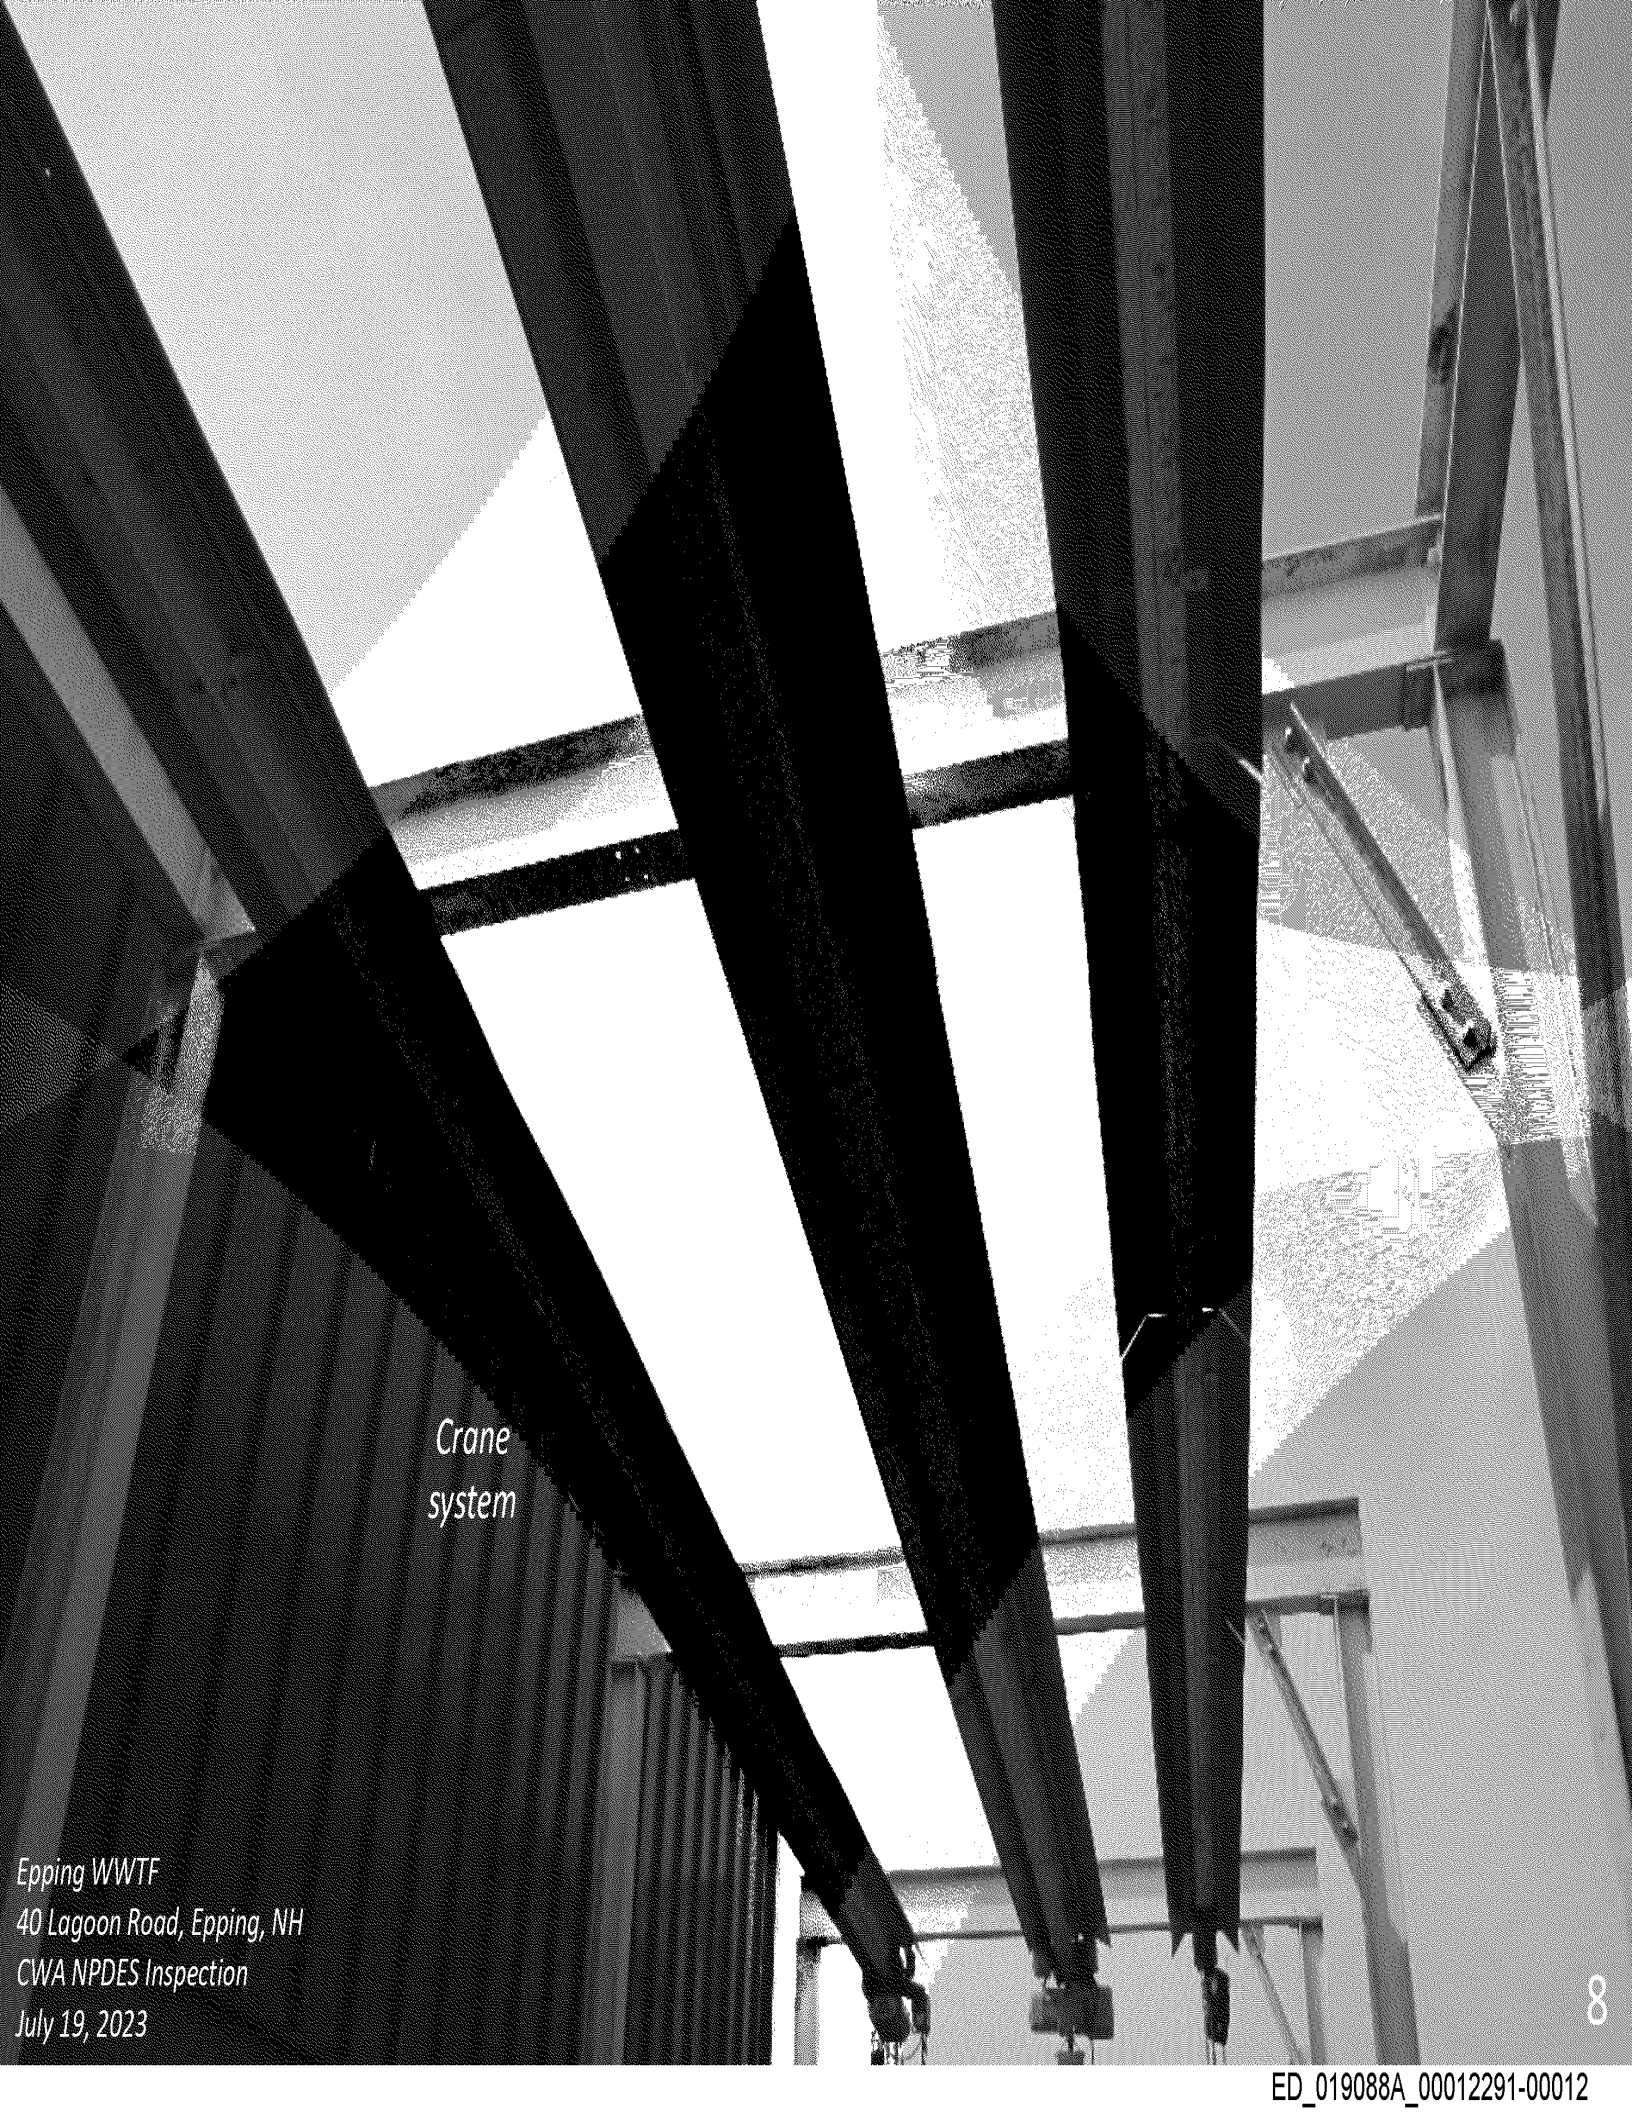
Crane  
system

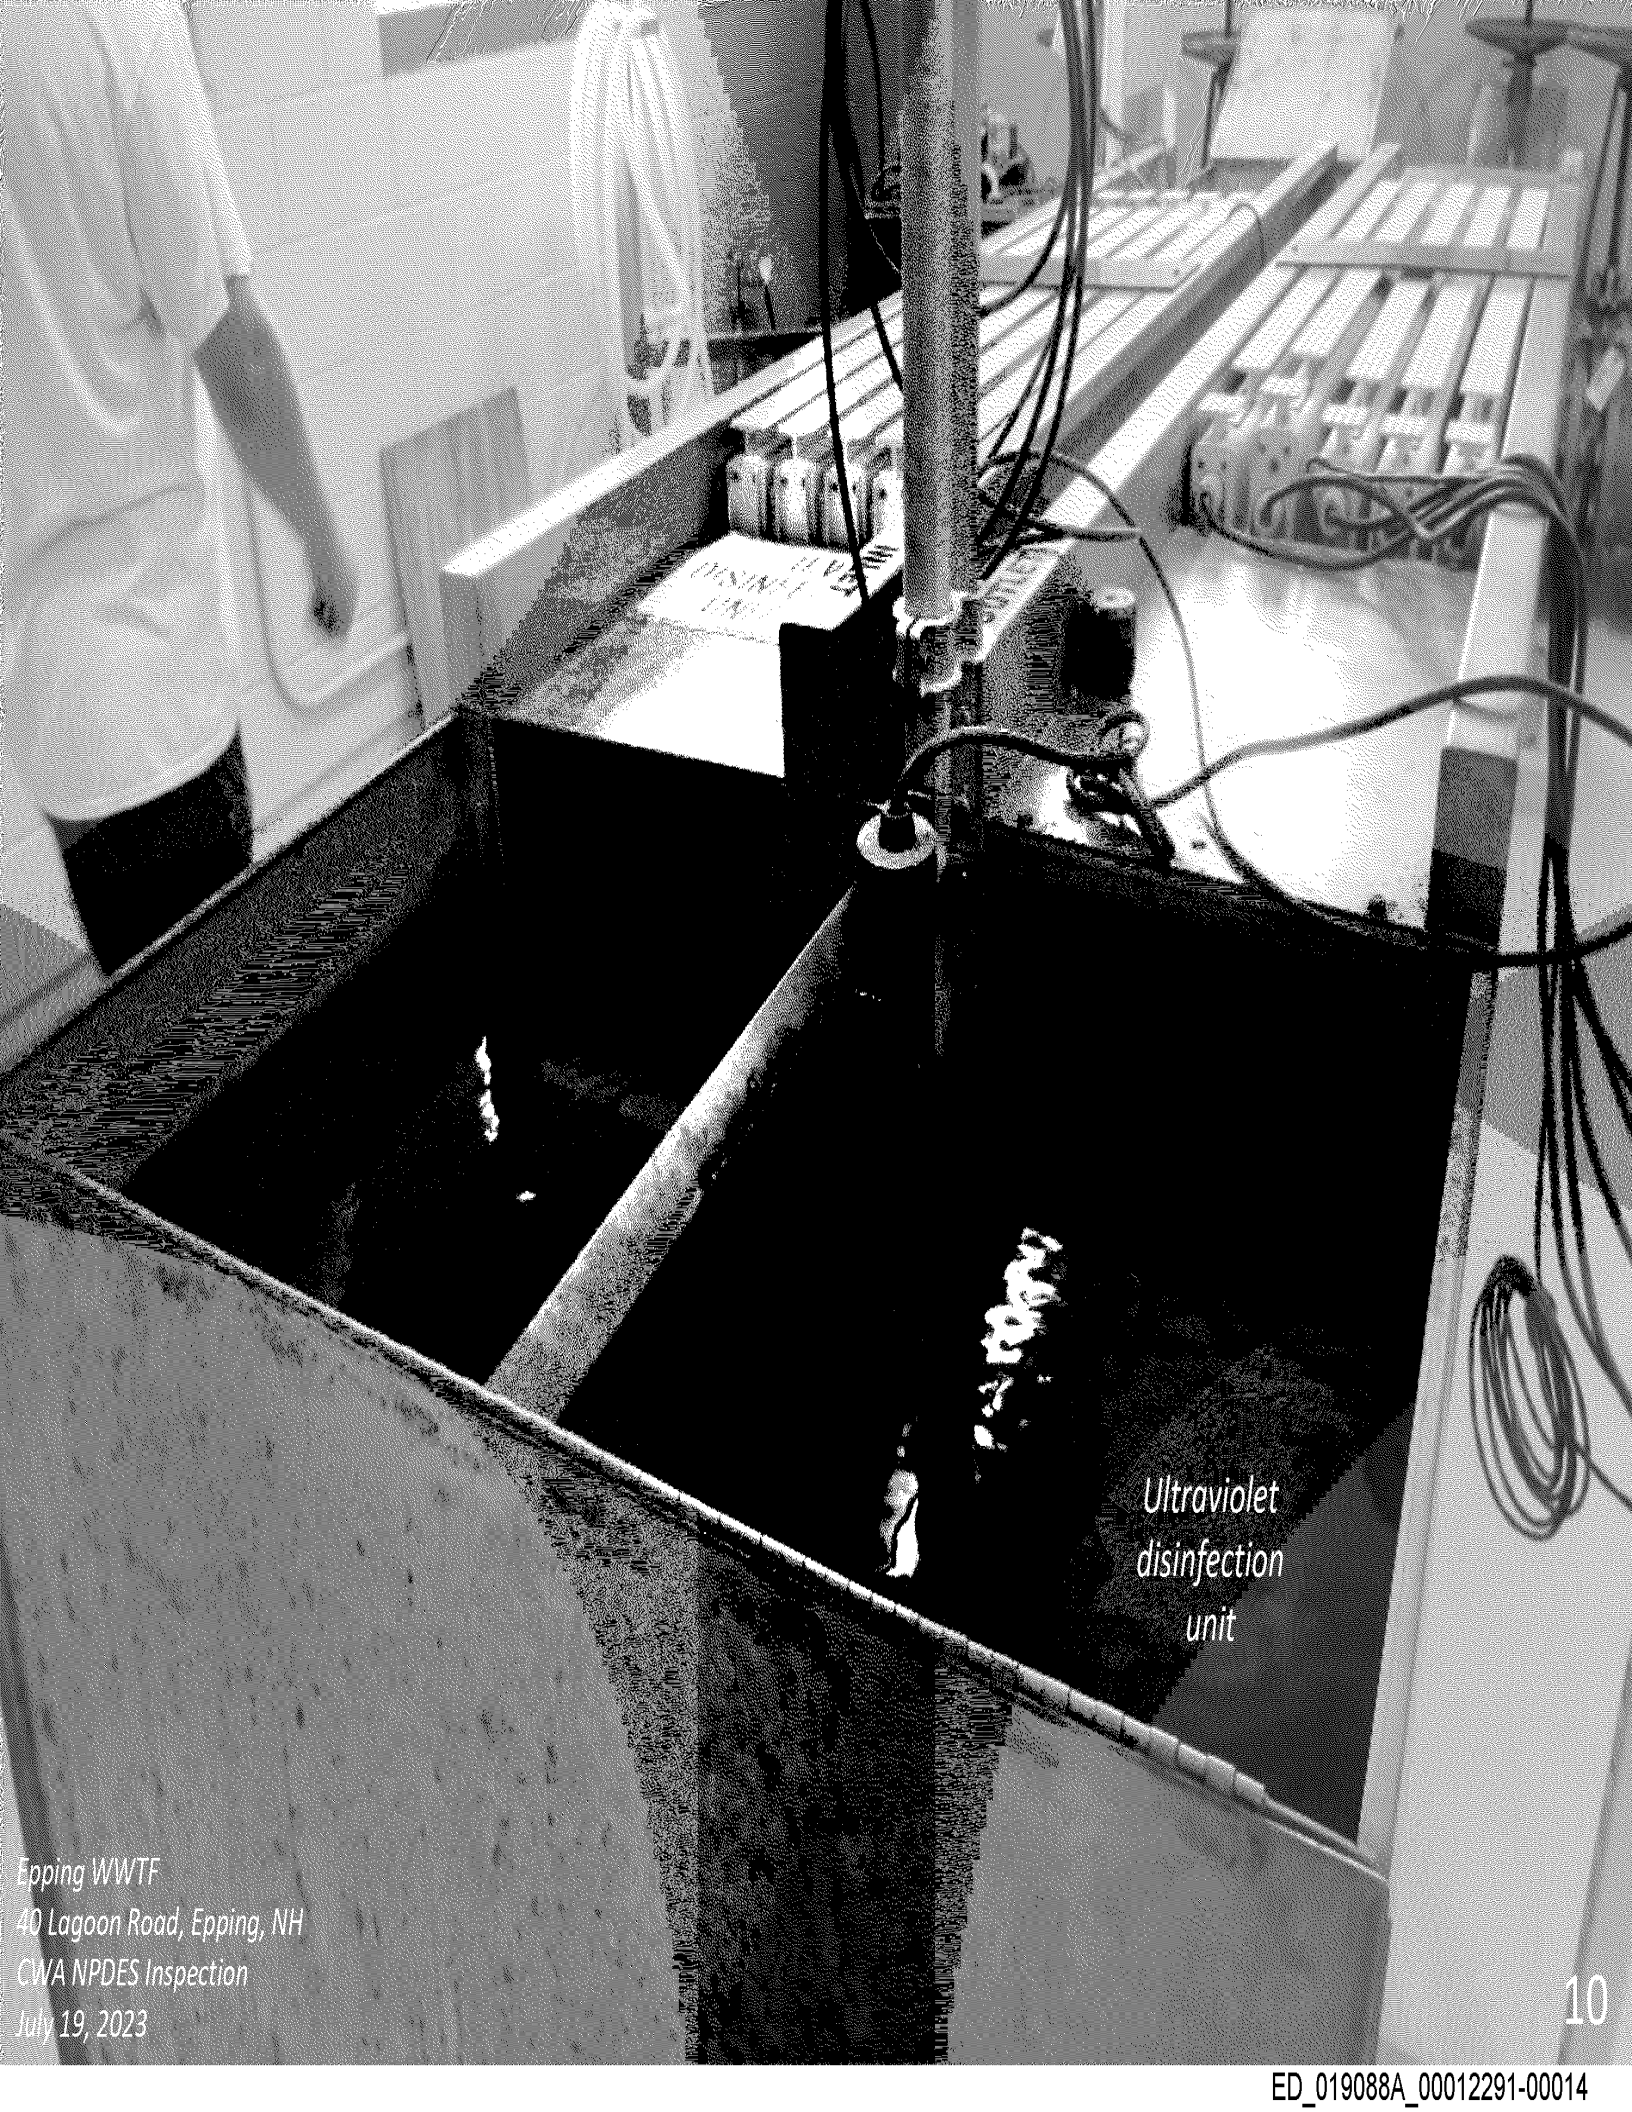
The group then moved to the Process Building. Chemicals and tanks used for pH control are housed in here (slide 9). Inside the building, the UV disinfection unit, the effluent composite sampler, and the effluent flow meter were observed (slides 10-12).

Ultraviolet  
disinfection  
unit

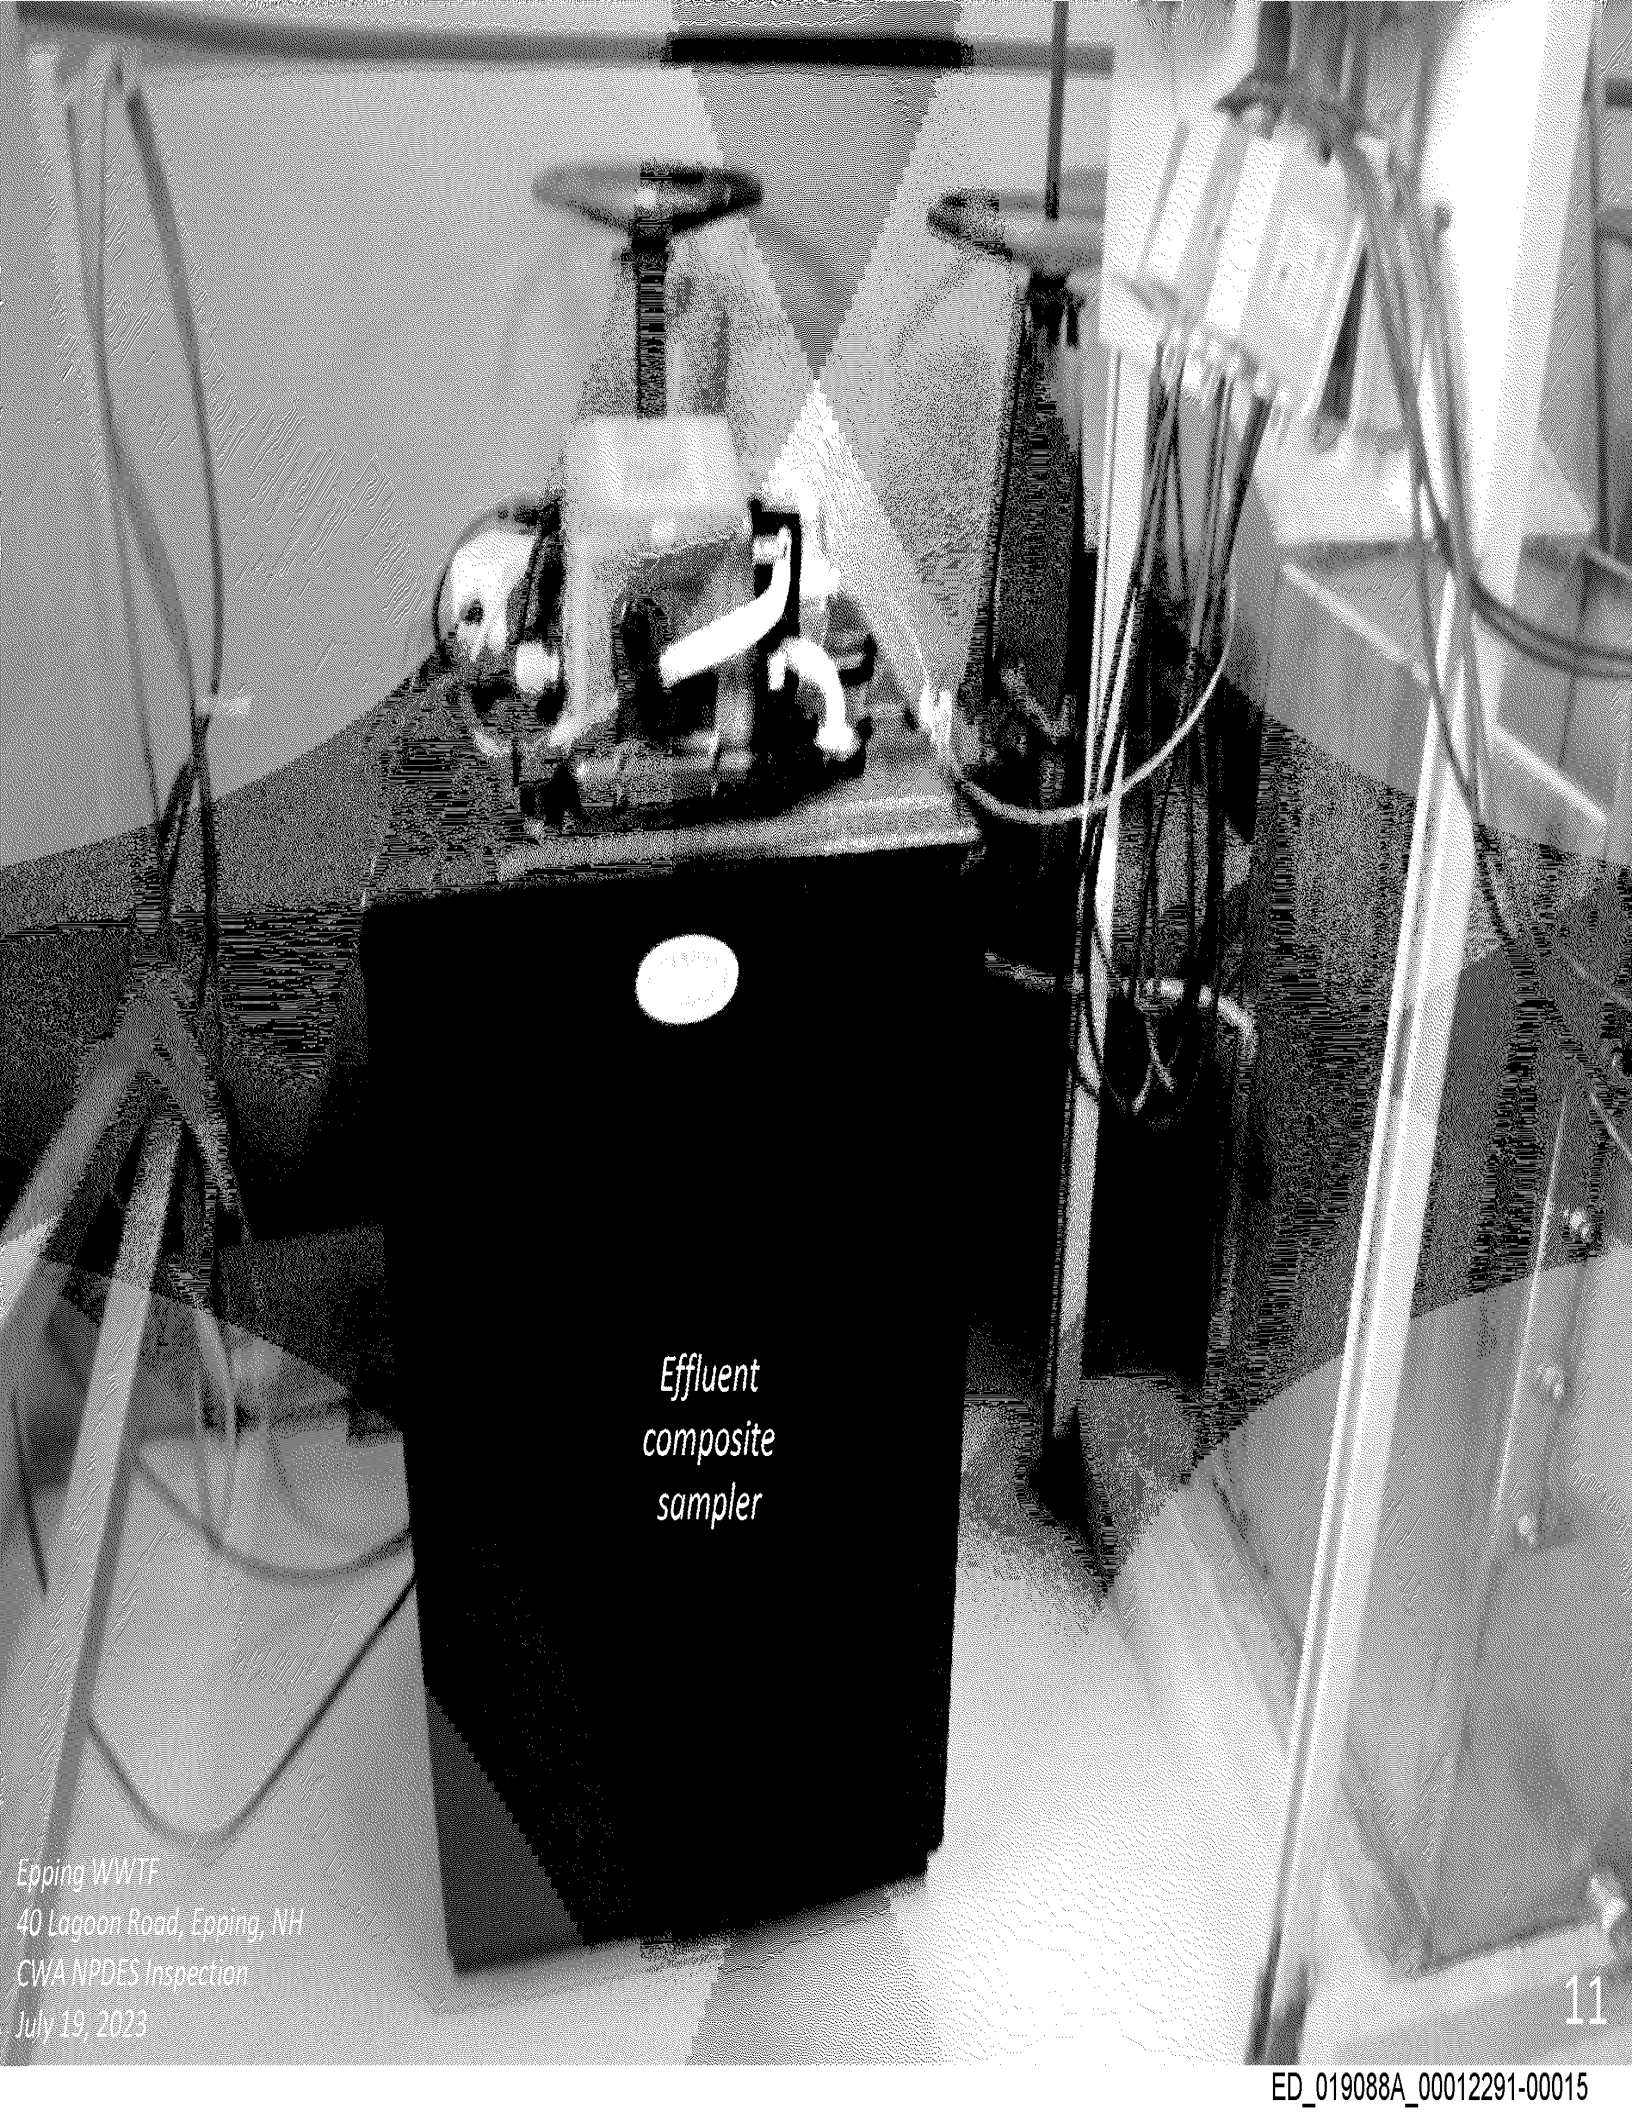
*Effluent  
composite  
sampler*
