**UNITED STATES ENVIRONMENTAL PROTECTION AGENCY**

**Subj:** Inspection Report  
Clean Water Act - National Pollutant Discharge Elimination  
System ("NPDES")  
Epping WWTF

Epping WWTF  
40 Lagoon Road, Epping, NH  
CWA NPDES Inspection  
July 19, 2023

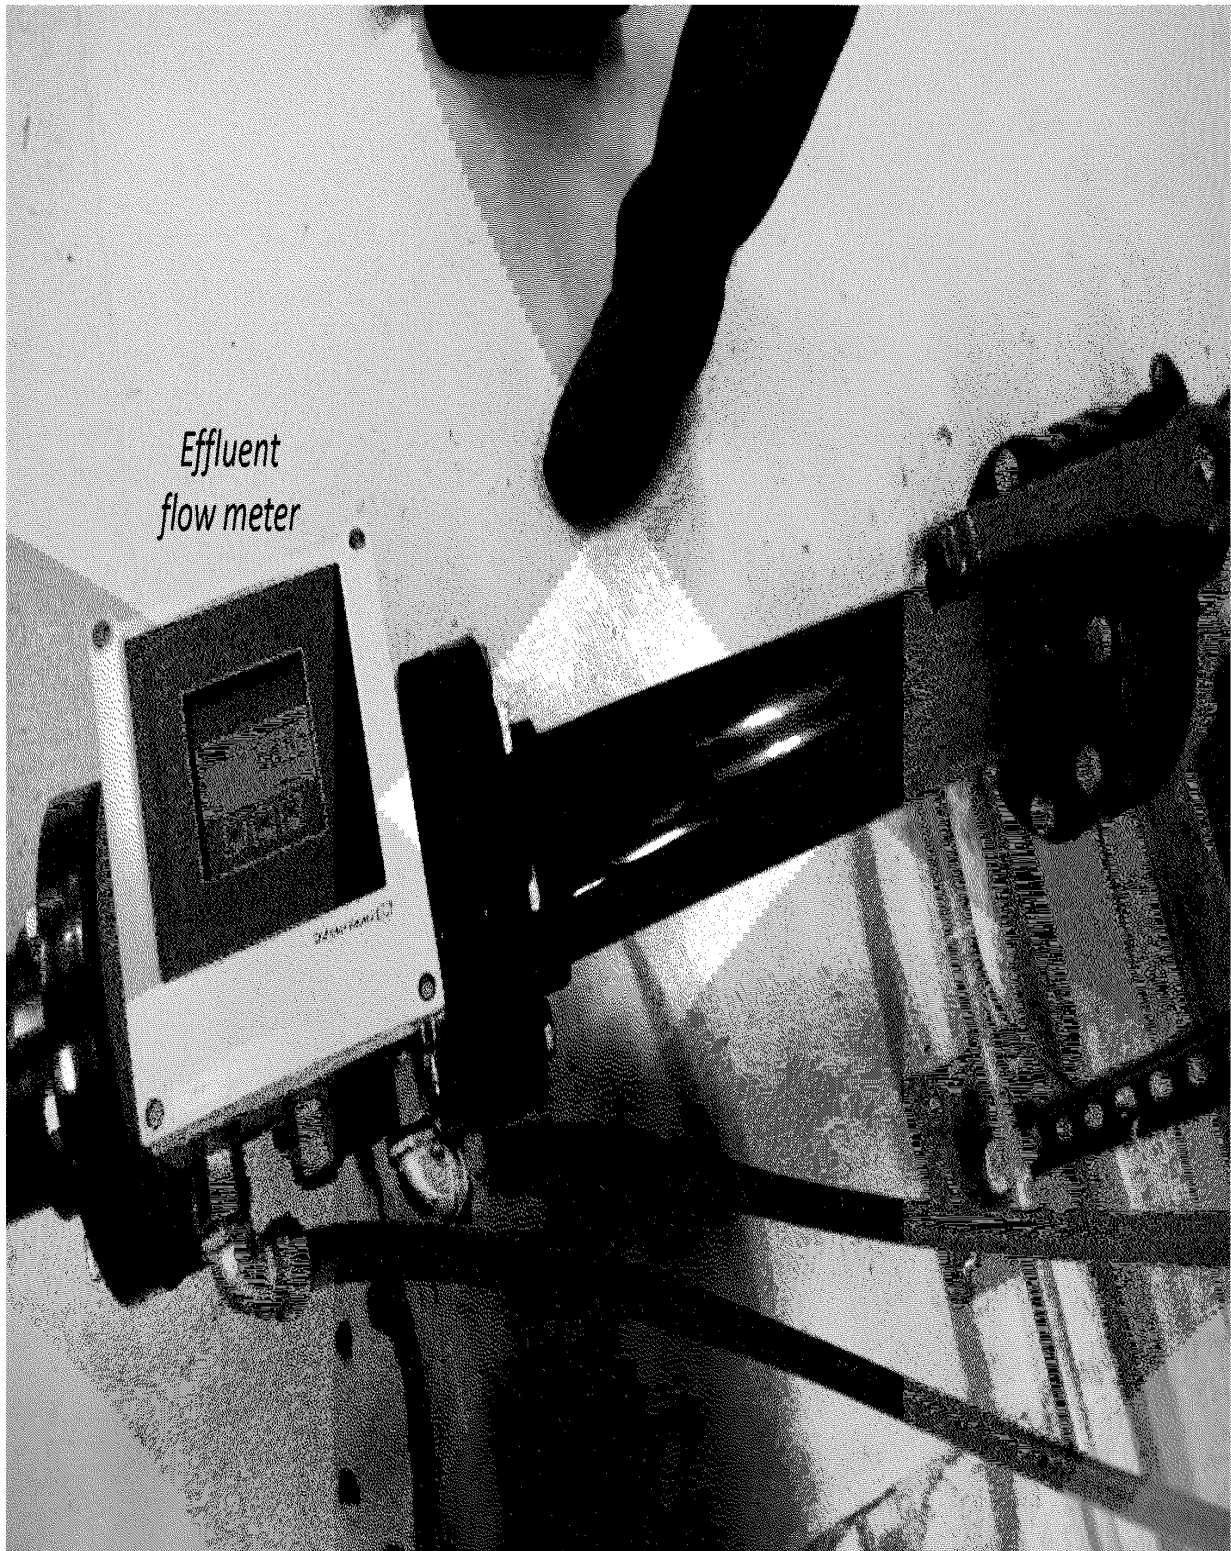
*Effluent  
flow meter*

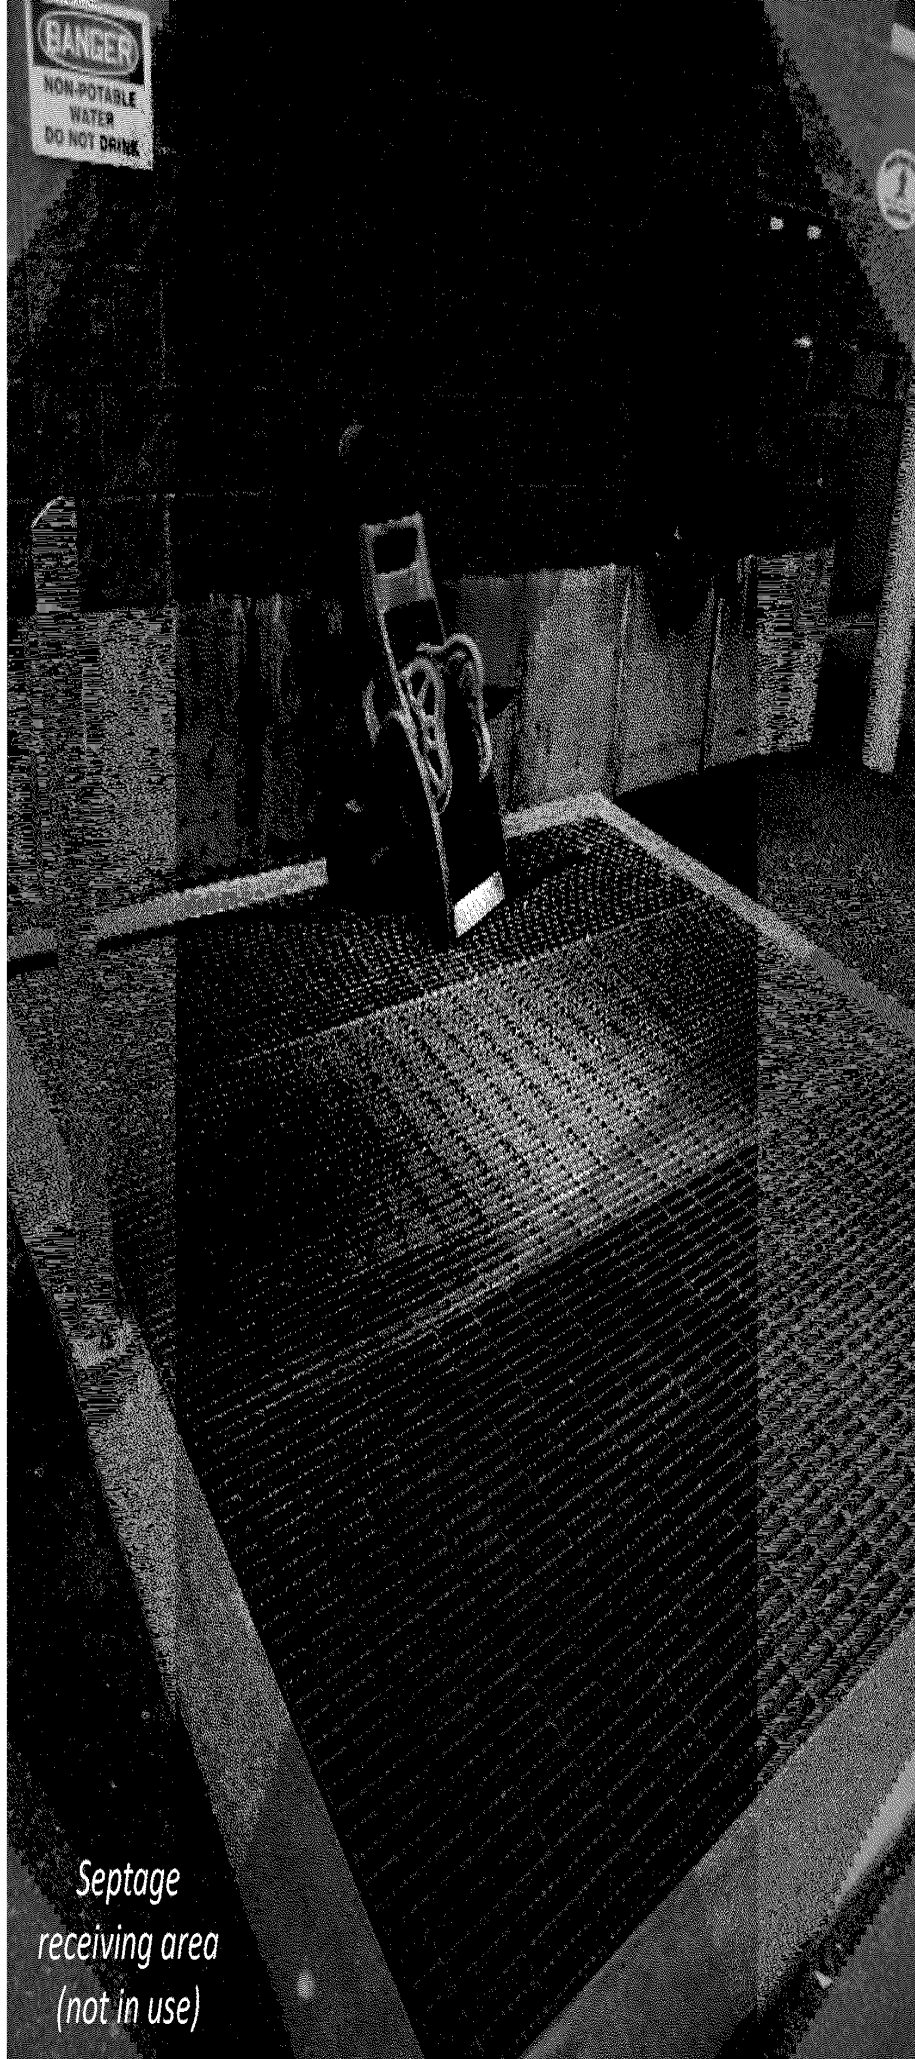
The group then moved toward the septage receiving building (slide 13). Mr. Mercier indicated that the building and equipment housed in there were bought and/or completed in late 2018. The area was observed to be clean and free of any debris.

*Septage  
receiving area  
(not in use)*

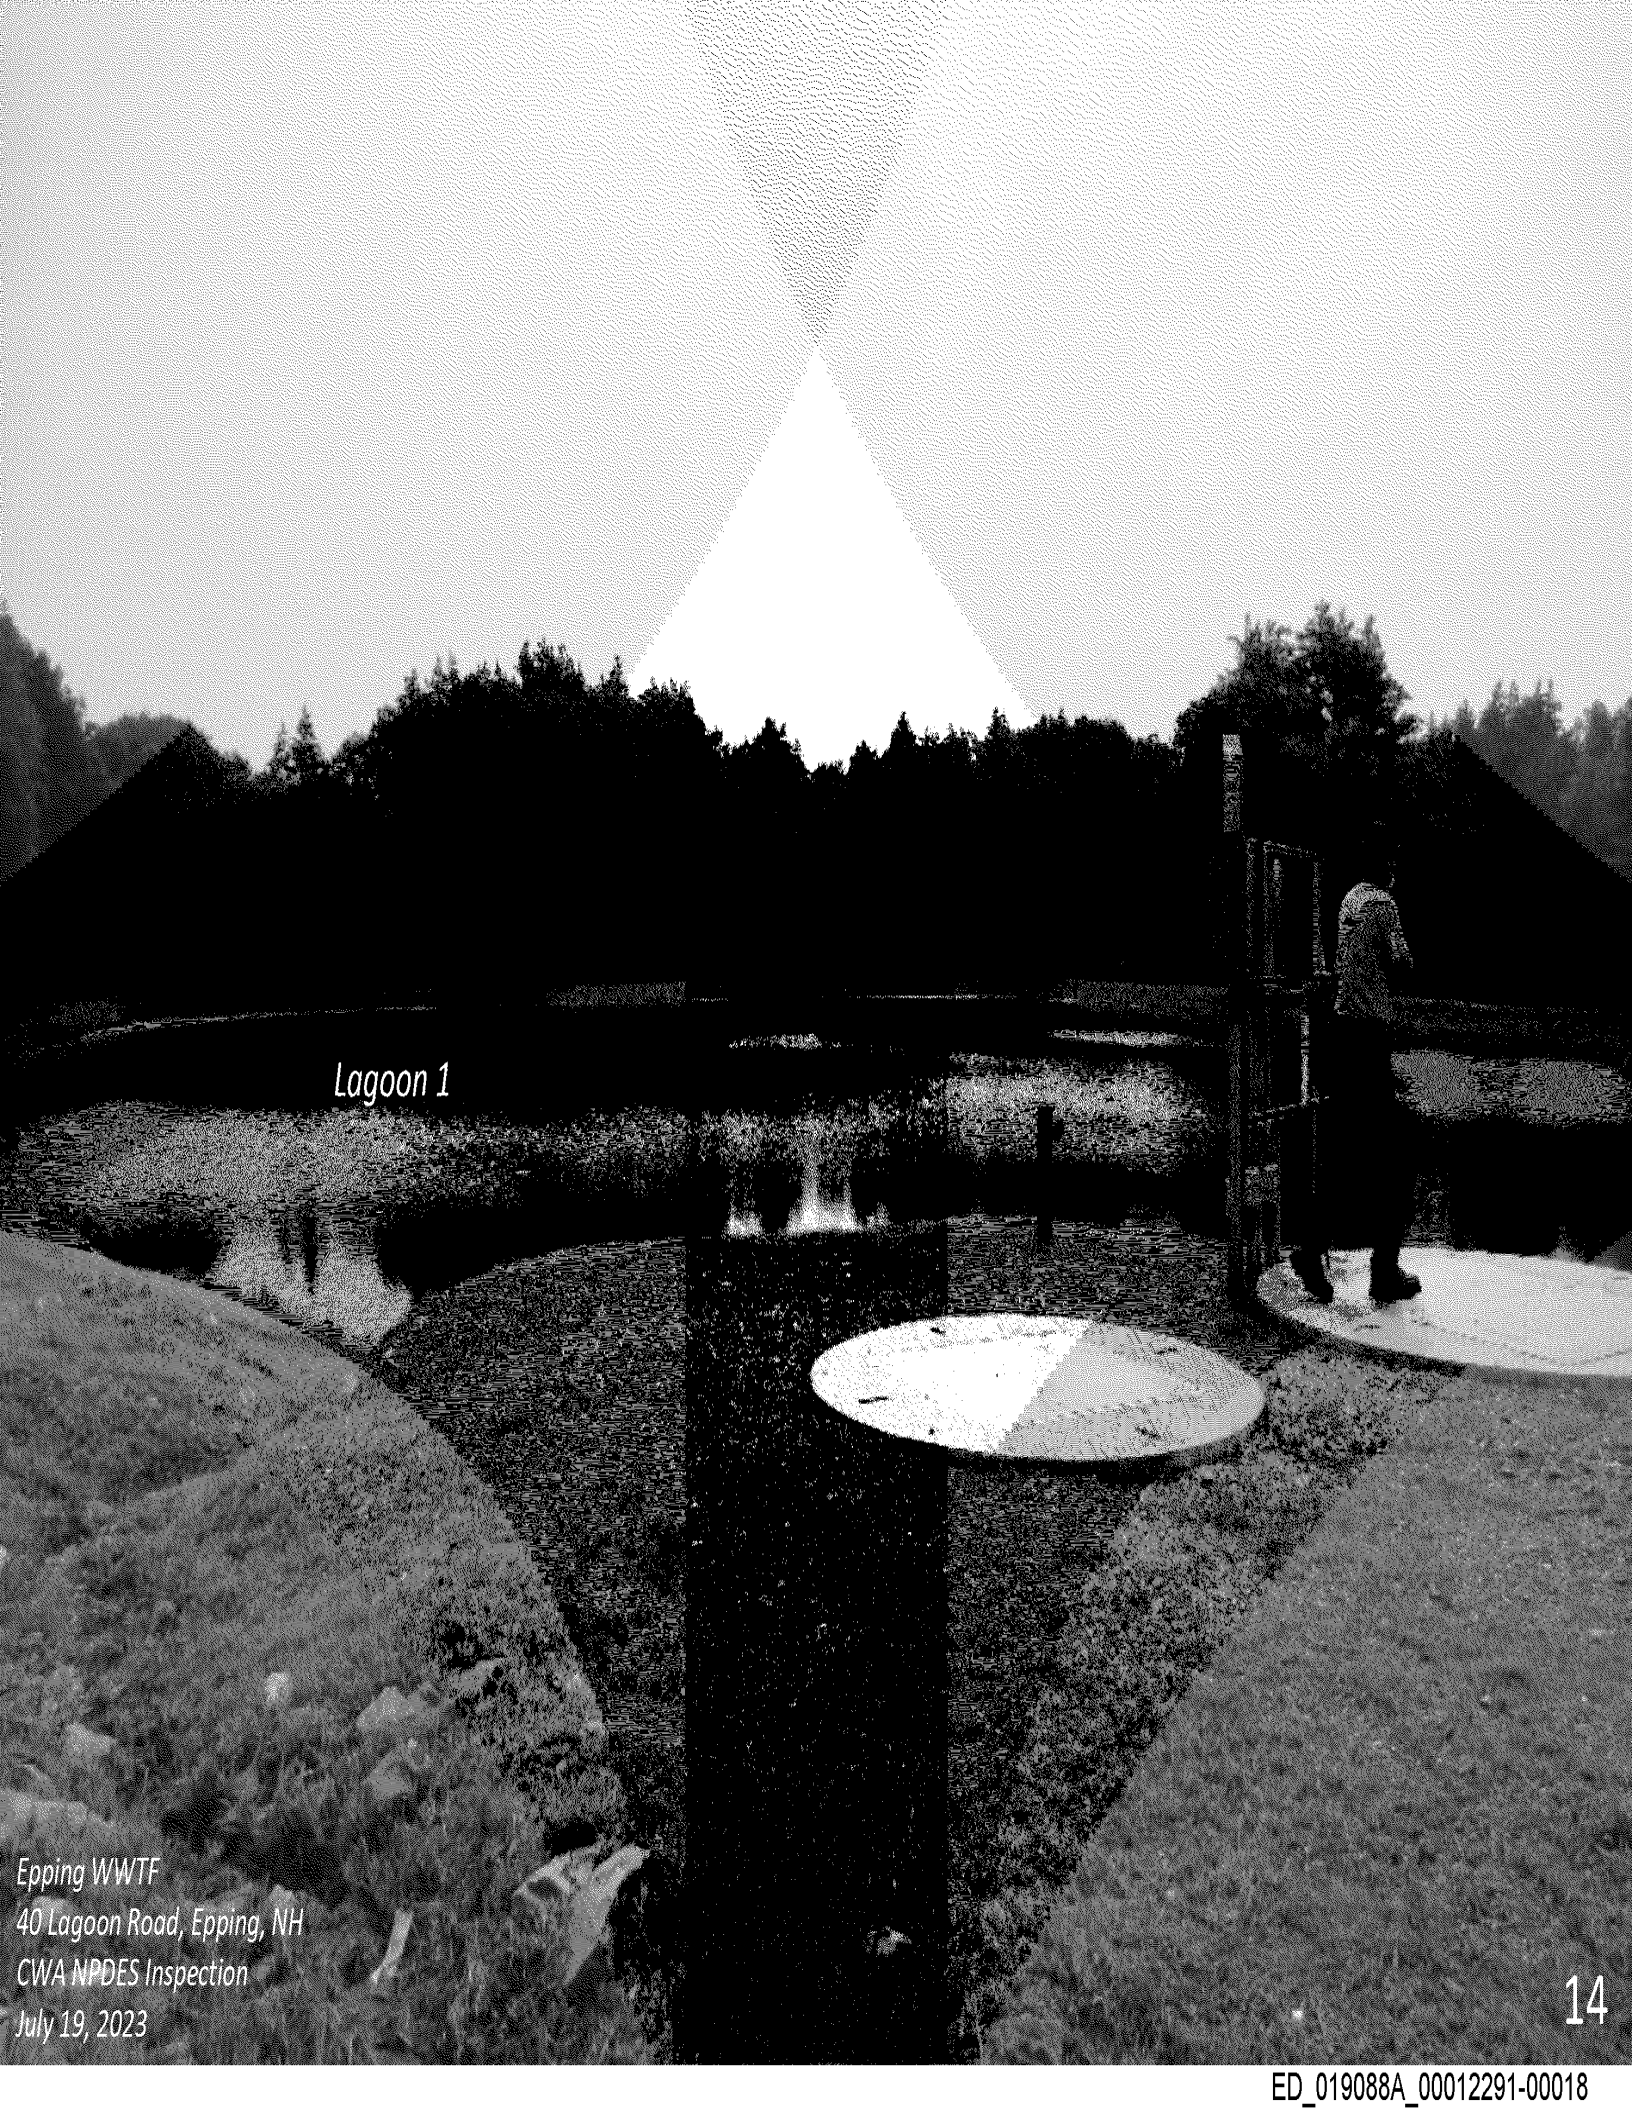
Lagoon 1

Epping currently has two lagoons which are currently used for storage and partial treatment (slides 14-16). Inside Lagoon 2, the Inspector observed a submersible pump (slide 17). The submersible pump was currently offline. The group indicated that wastewater pumped from the lagoon would go into the EBTS system, which was not in used (slides 18-19). The EBTS system is composed by two yellow frac tanks. Near the EBTS, a shed was observed. The Inspectors were told that inside the shed, the Facility stored and controlled the use of bisulfate and polymers for the EBTS system. Partially treated effluent from the EBTS is then discharged into the effluent channel through a white pipe outside of Frac Tank 2 (slide 20).

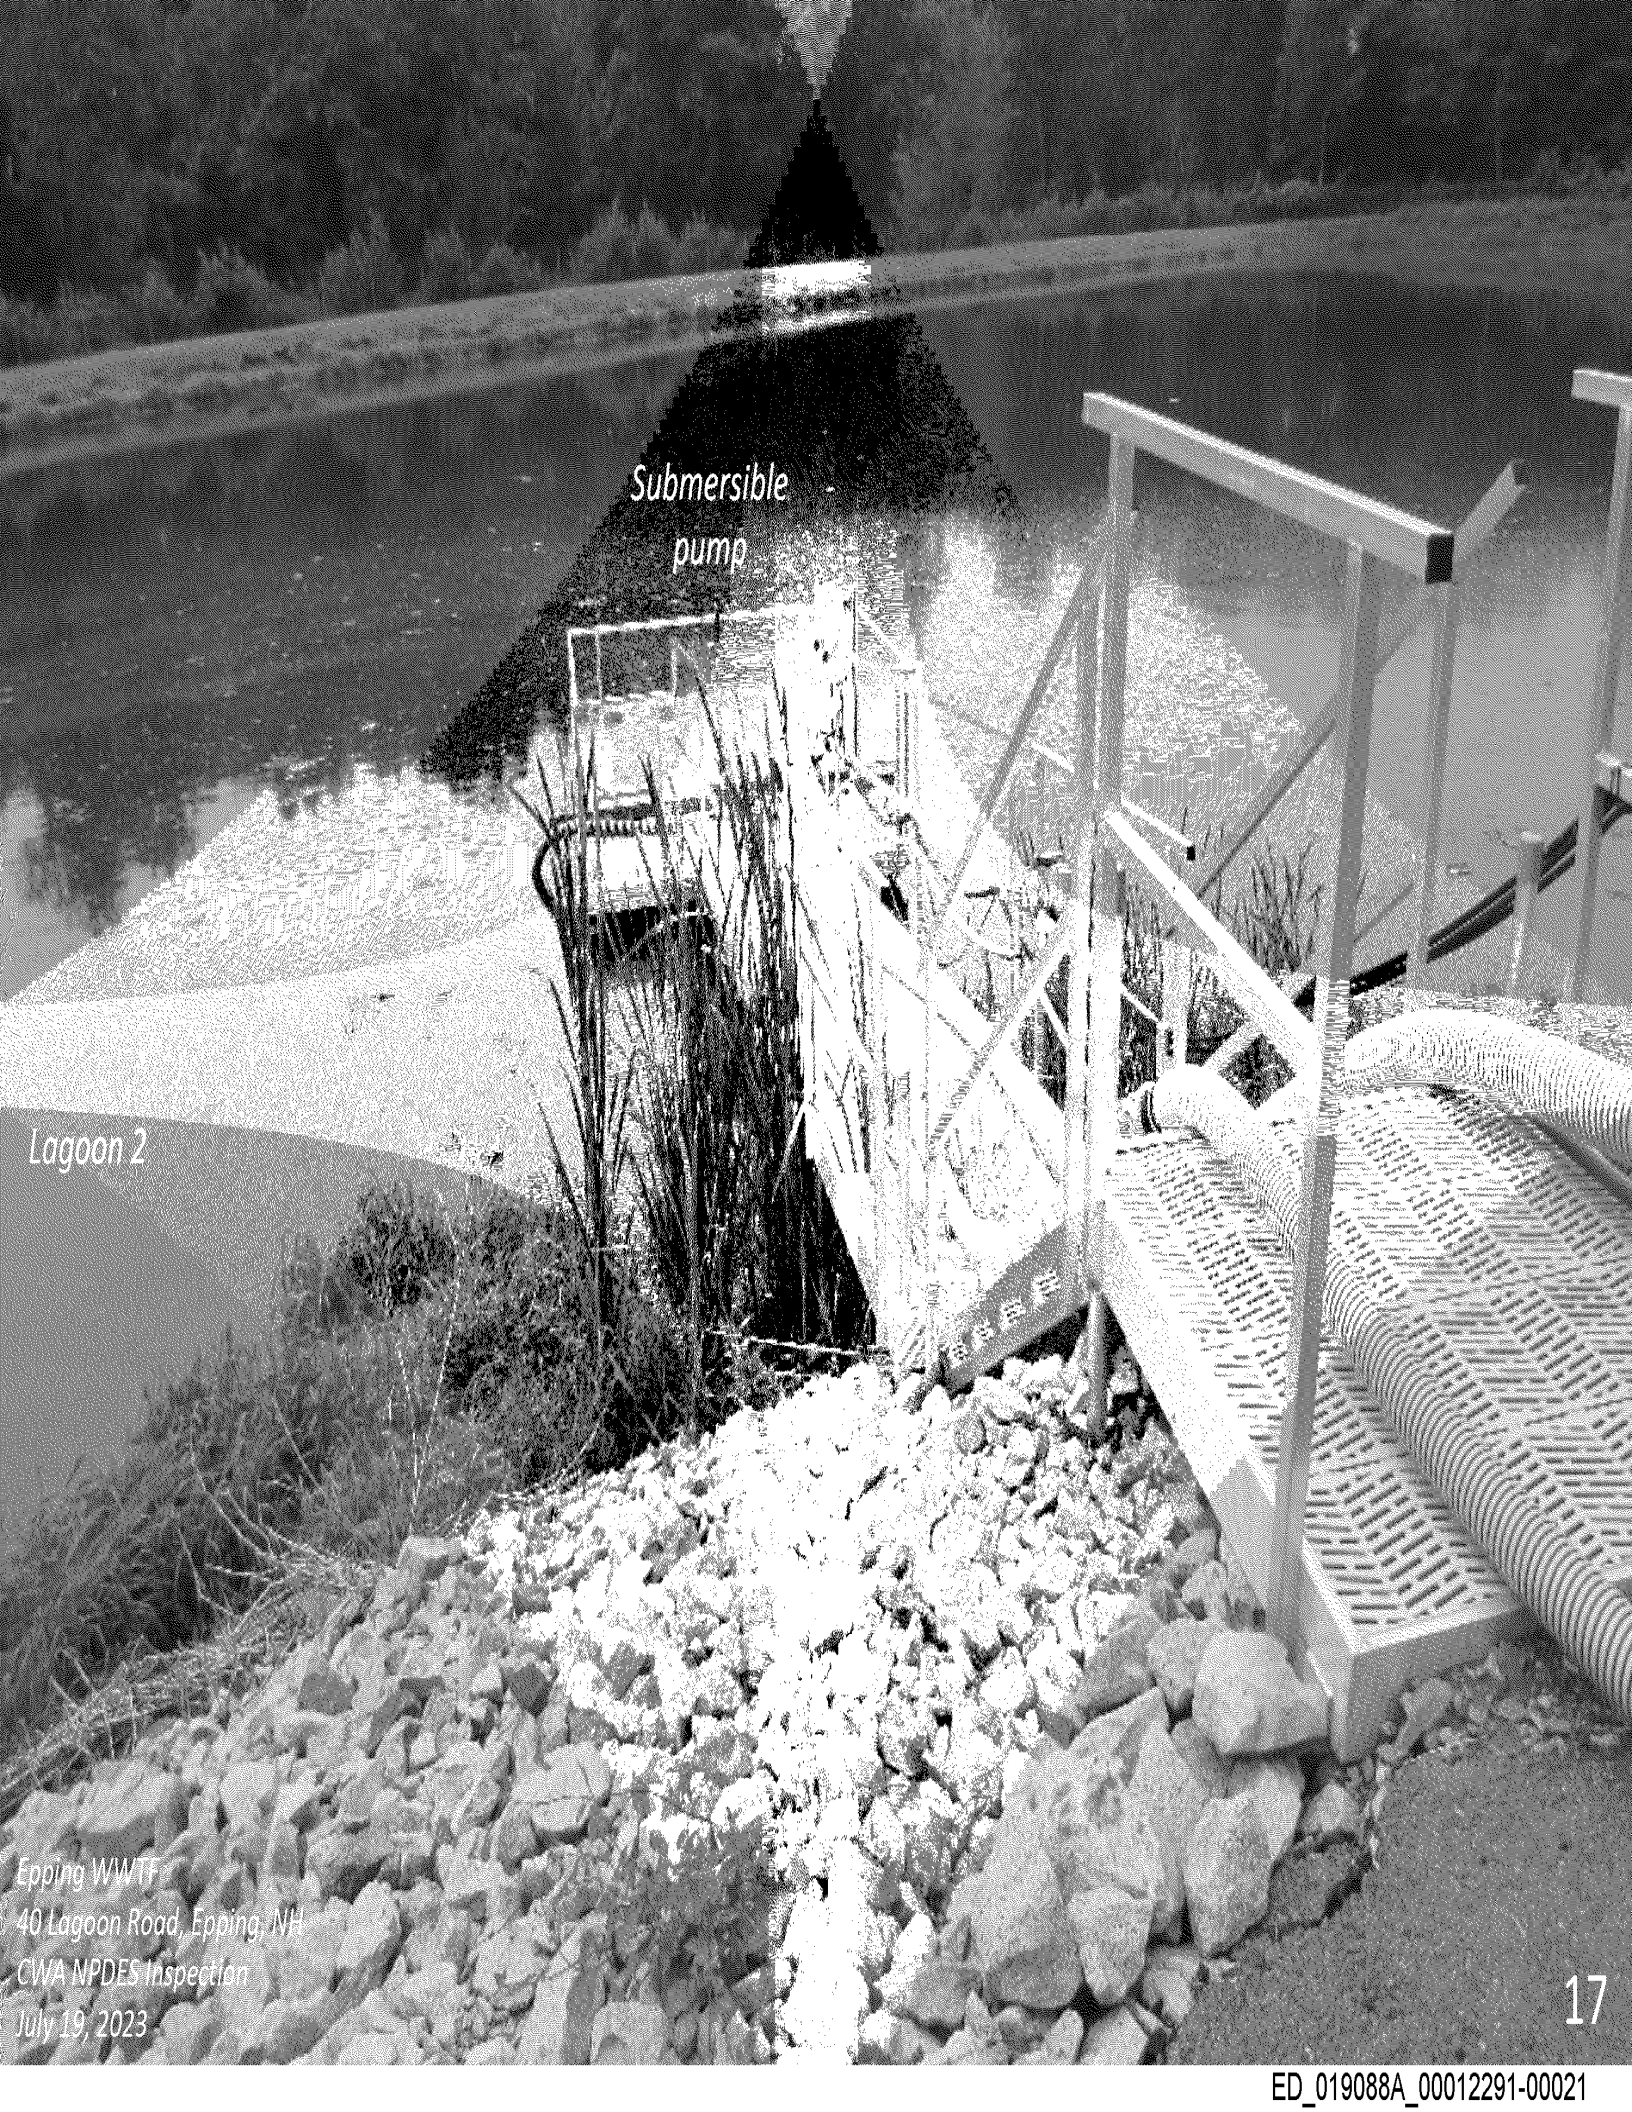
Submersible  
pump

Lagoon 2

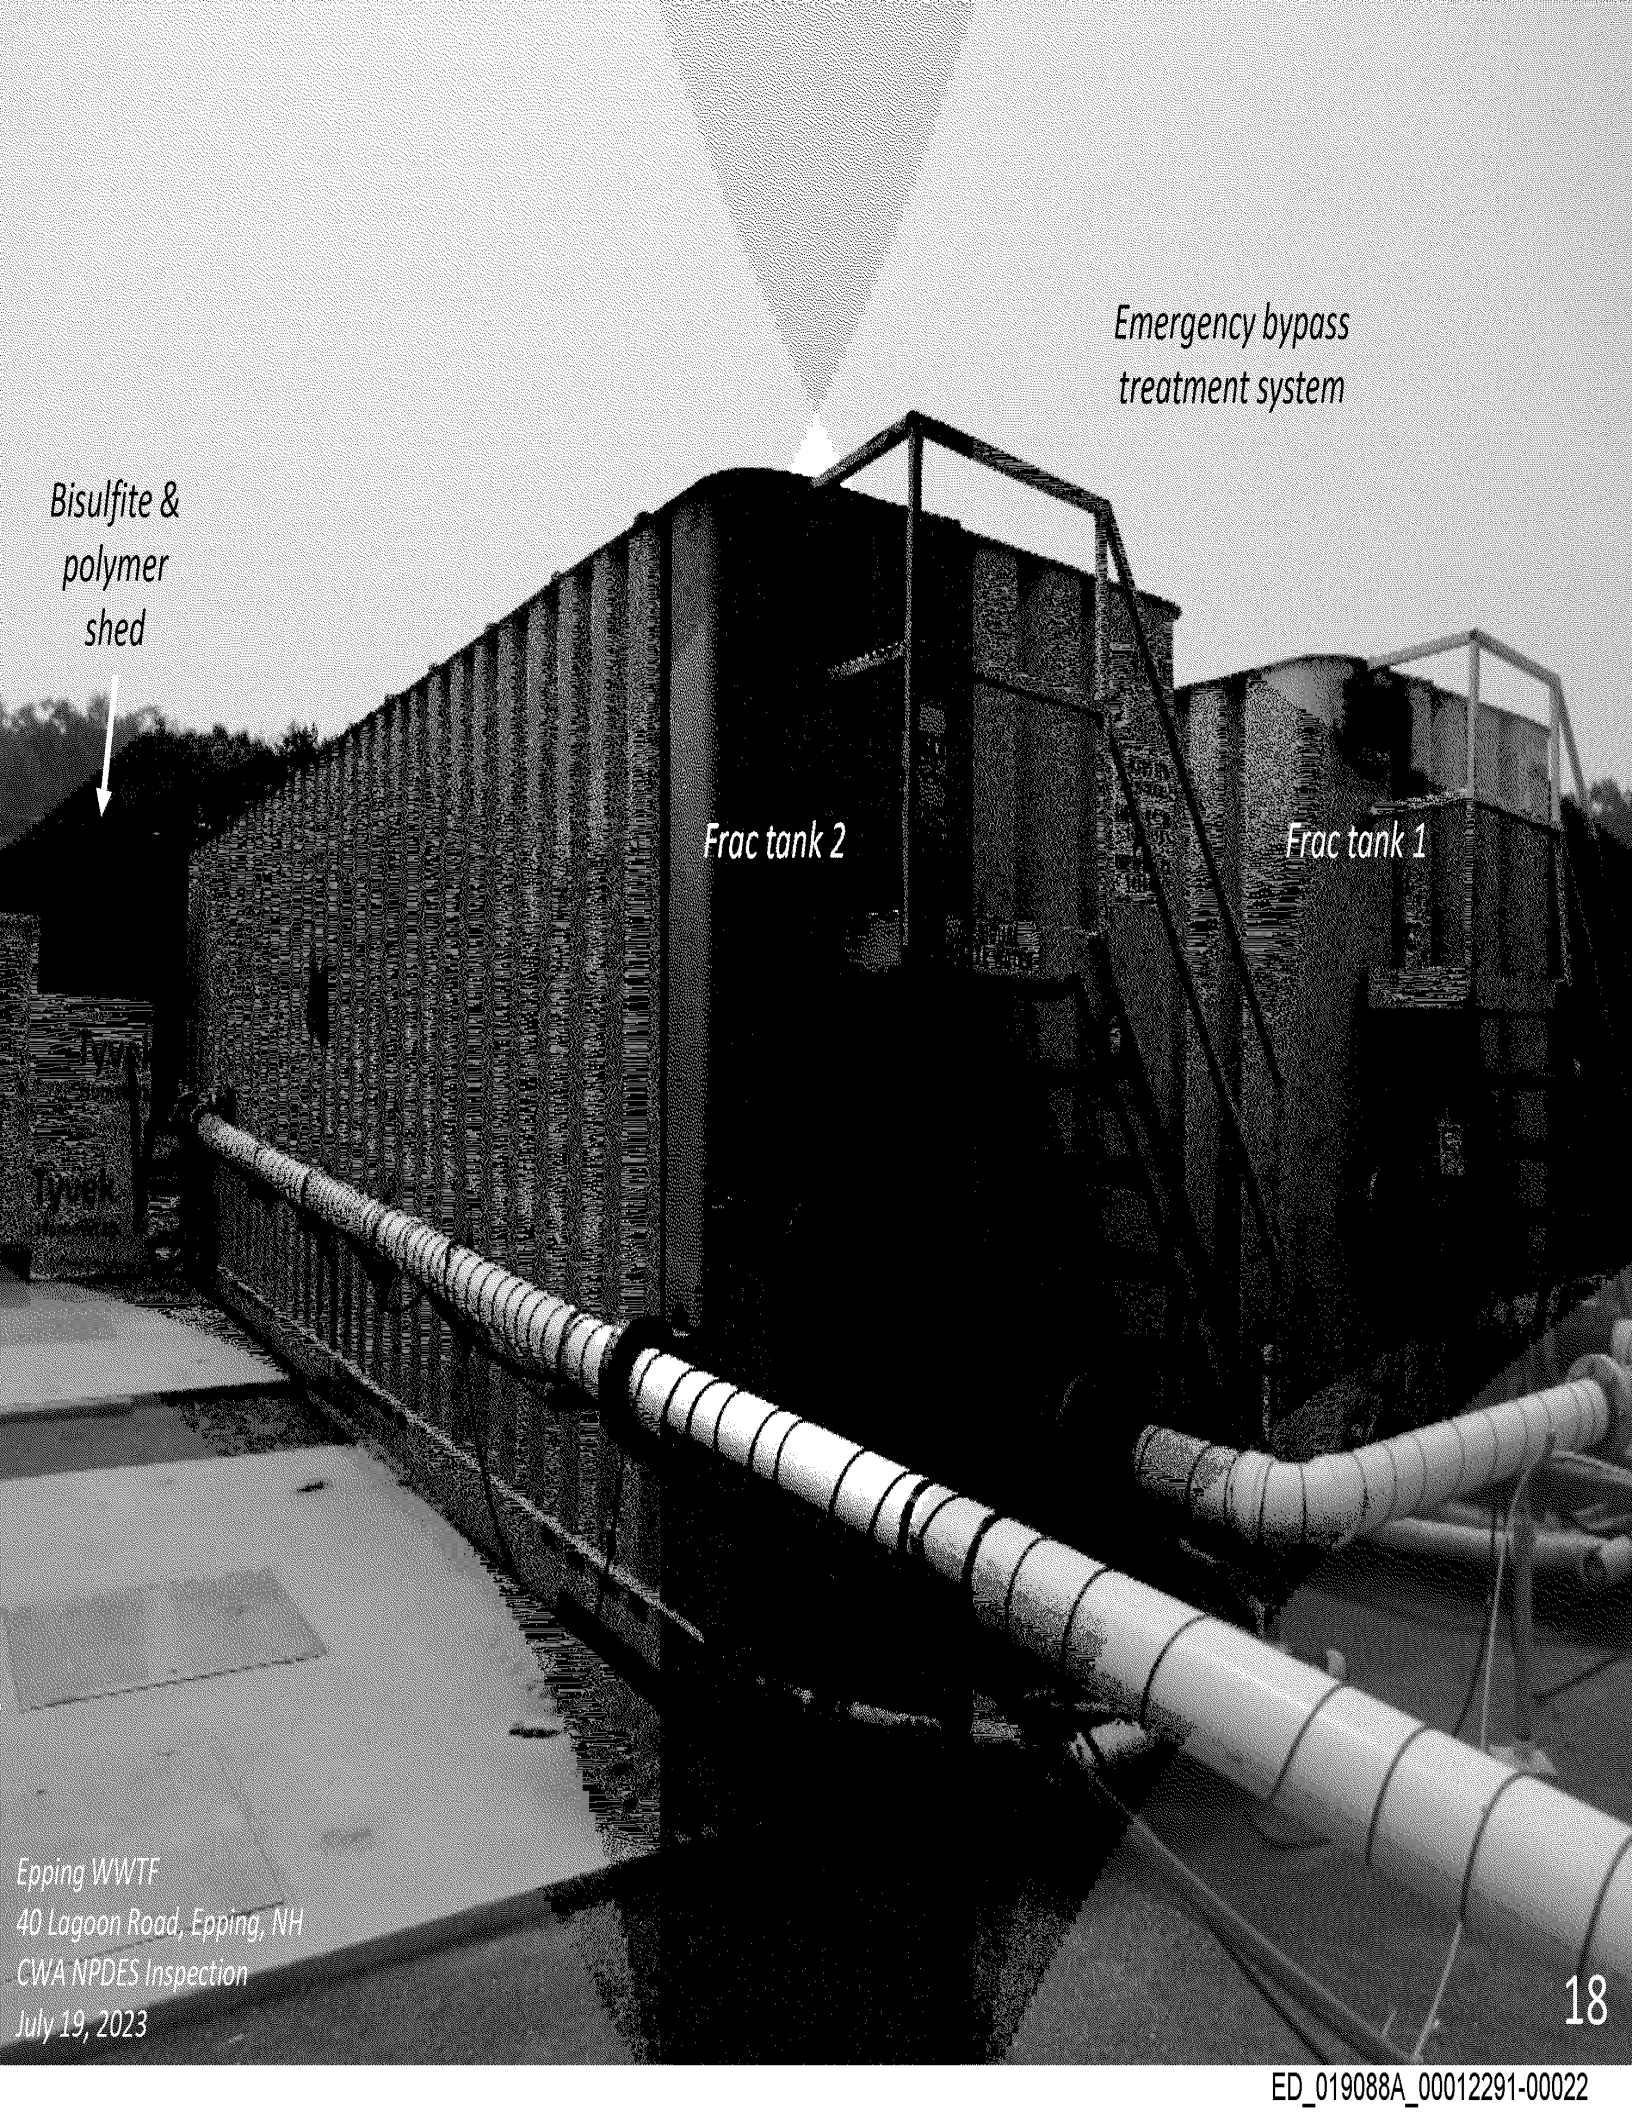
Emergency bypass  
treatment system

Bisulfite &  
polymer  
shed

Frac tank 2

Frac tank 1

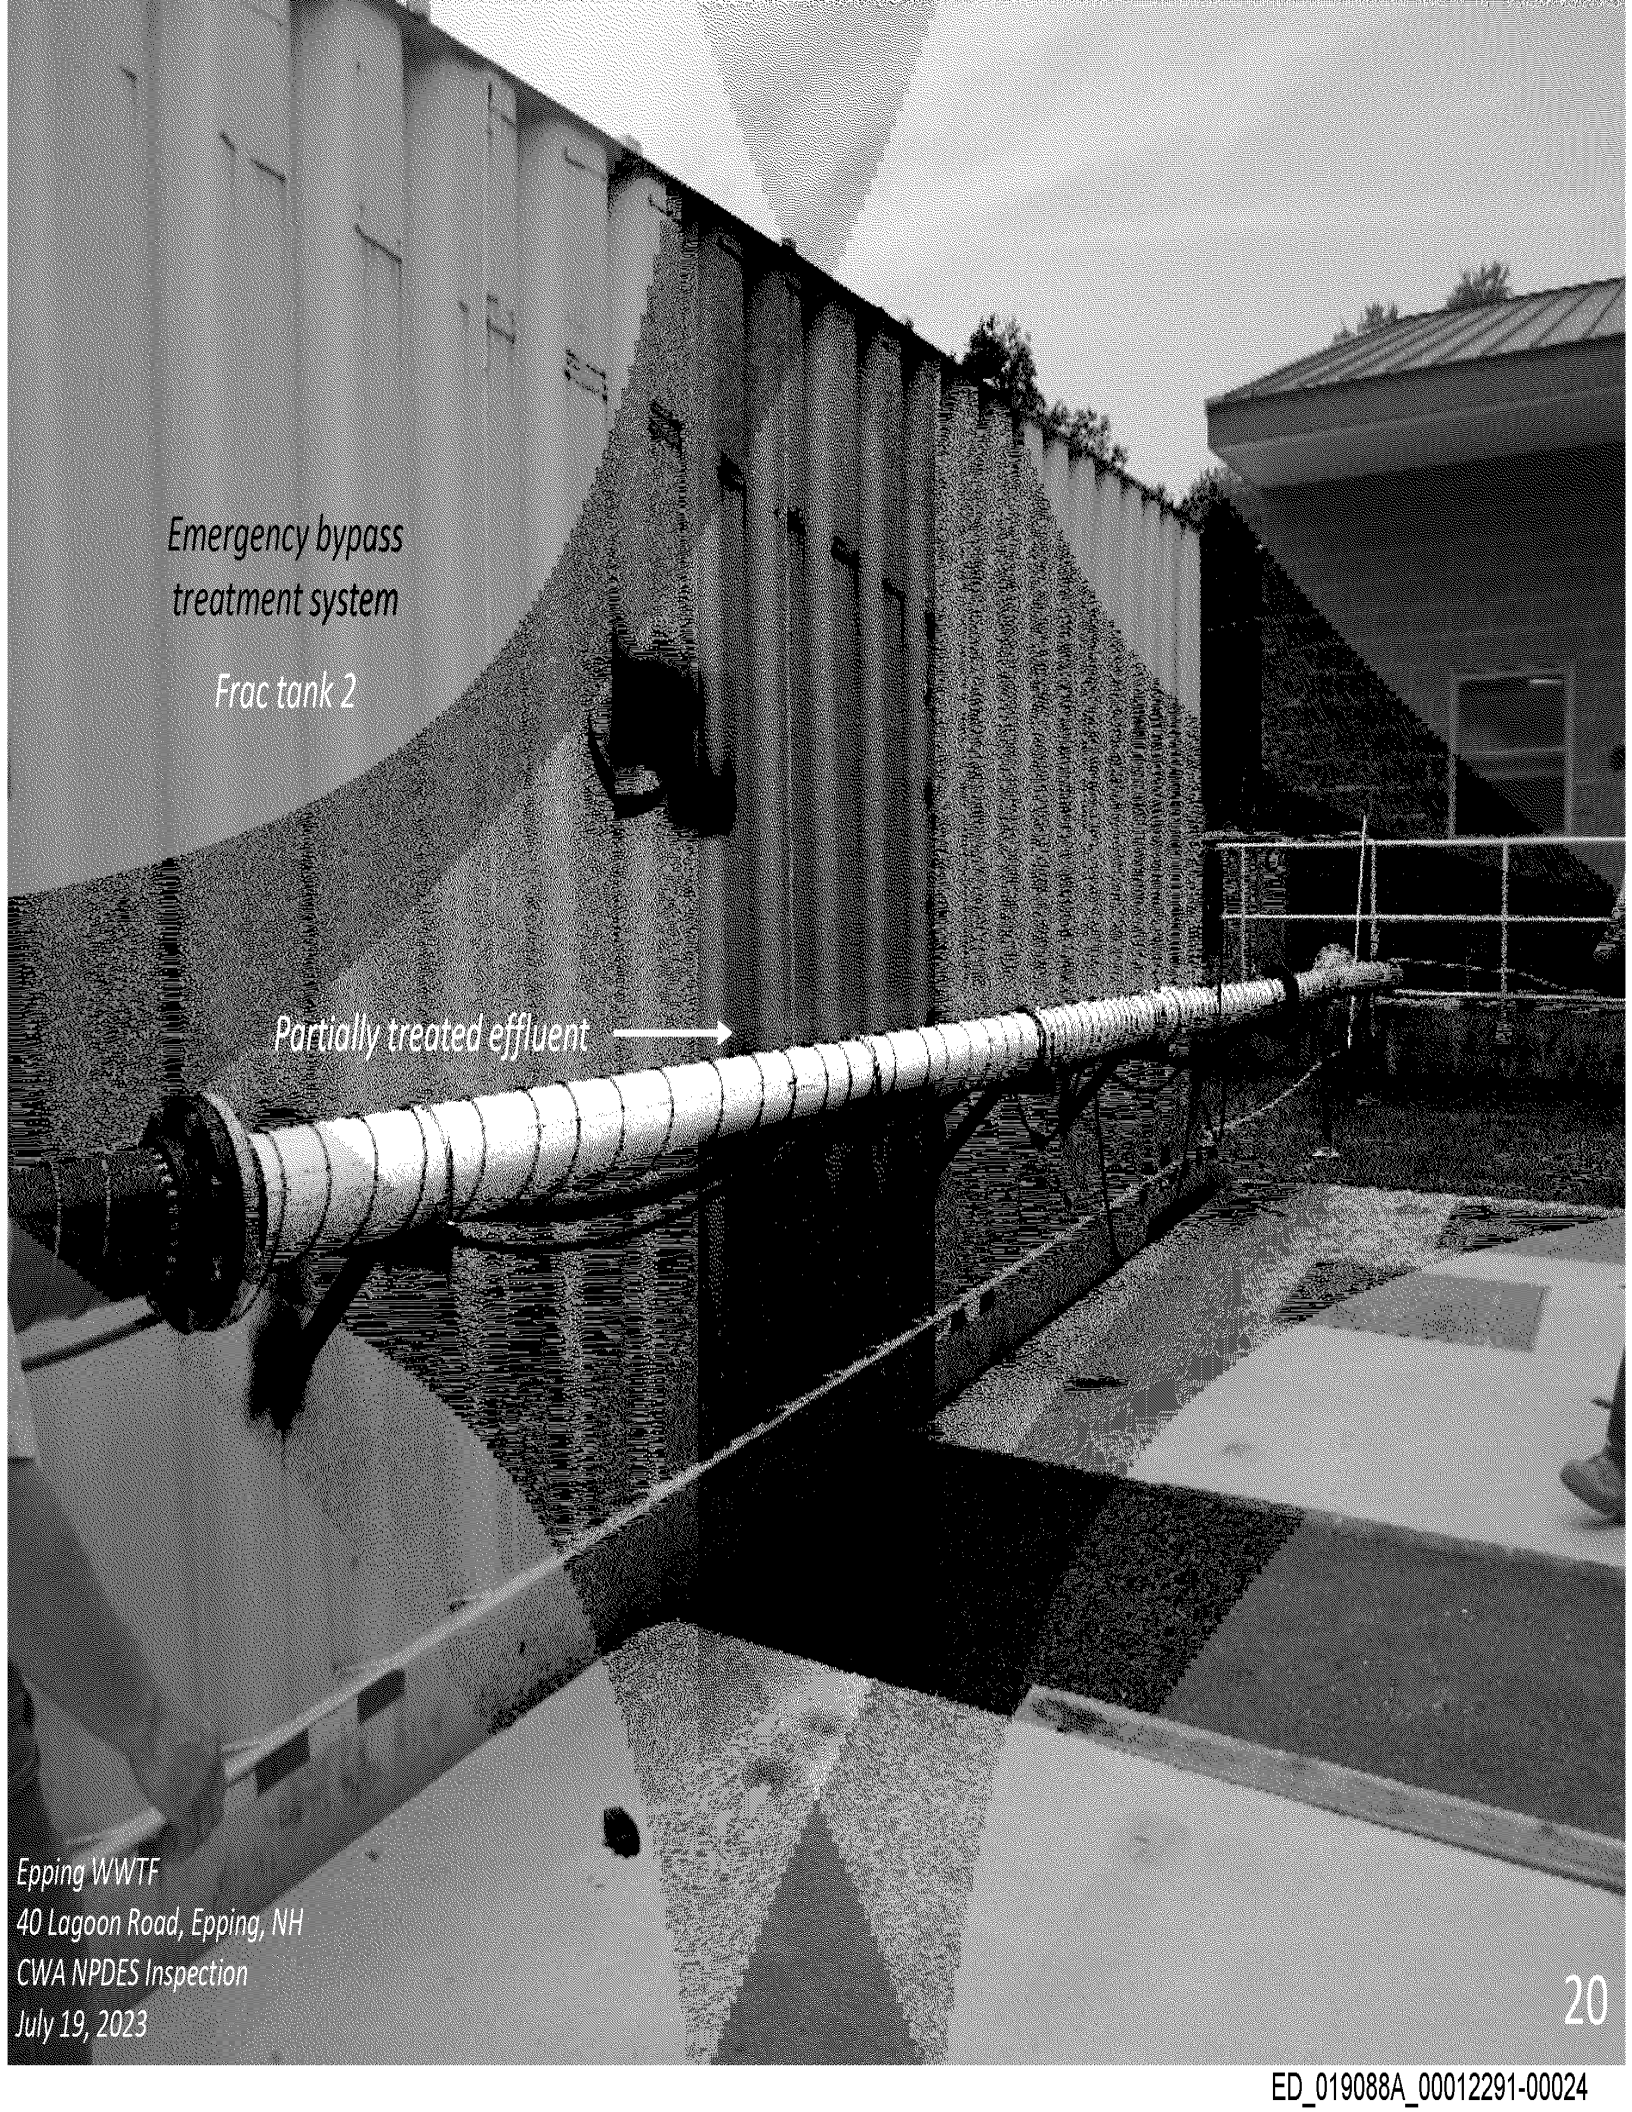
Emergency bypass  
treatment system

Frac tank 2

Partially treated effluent →

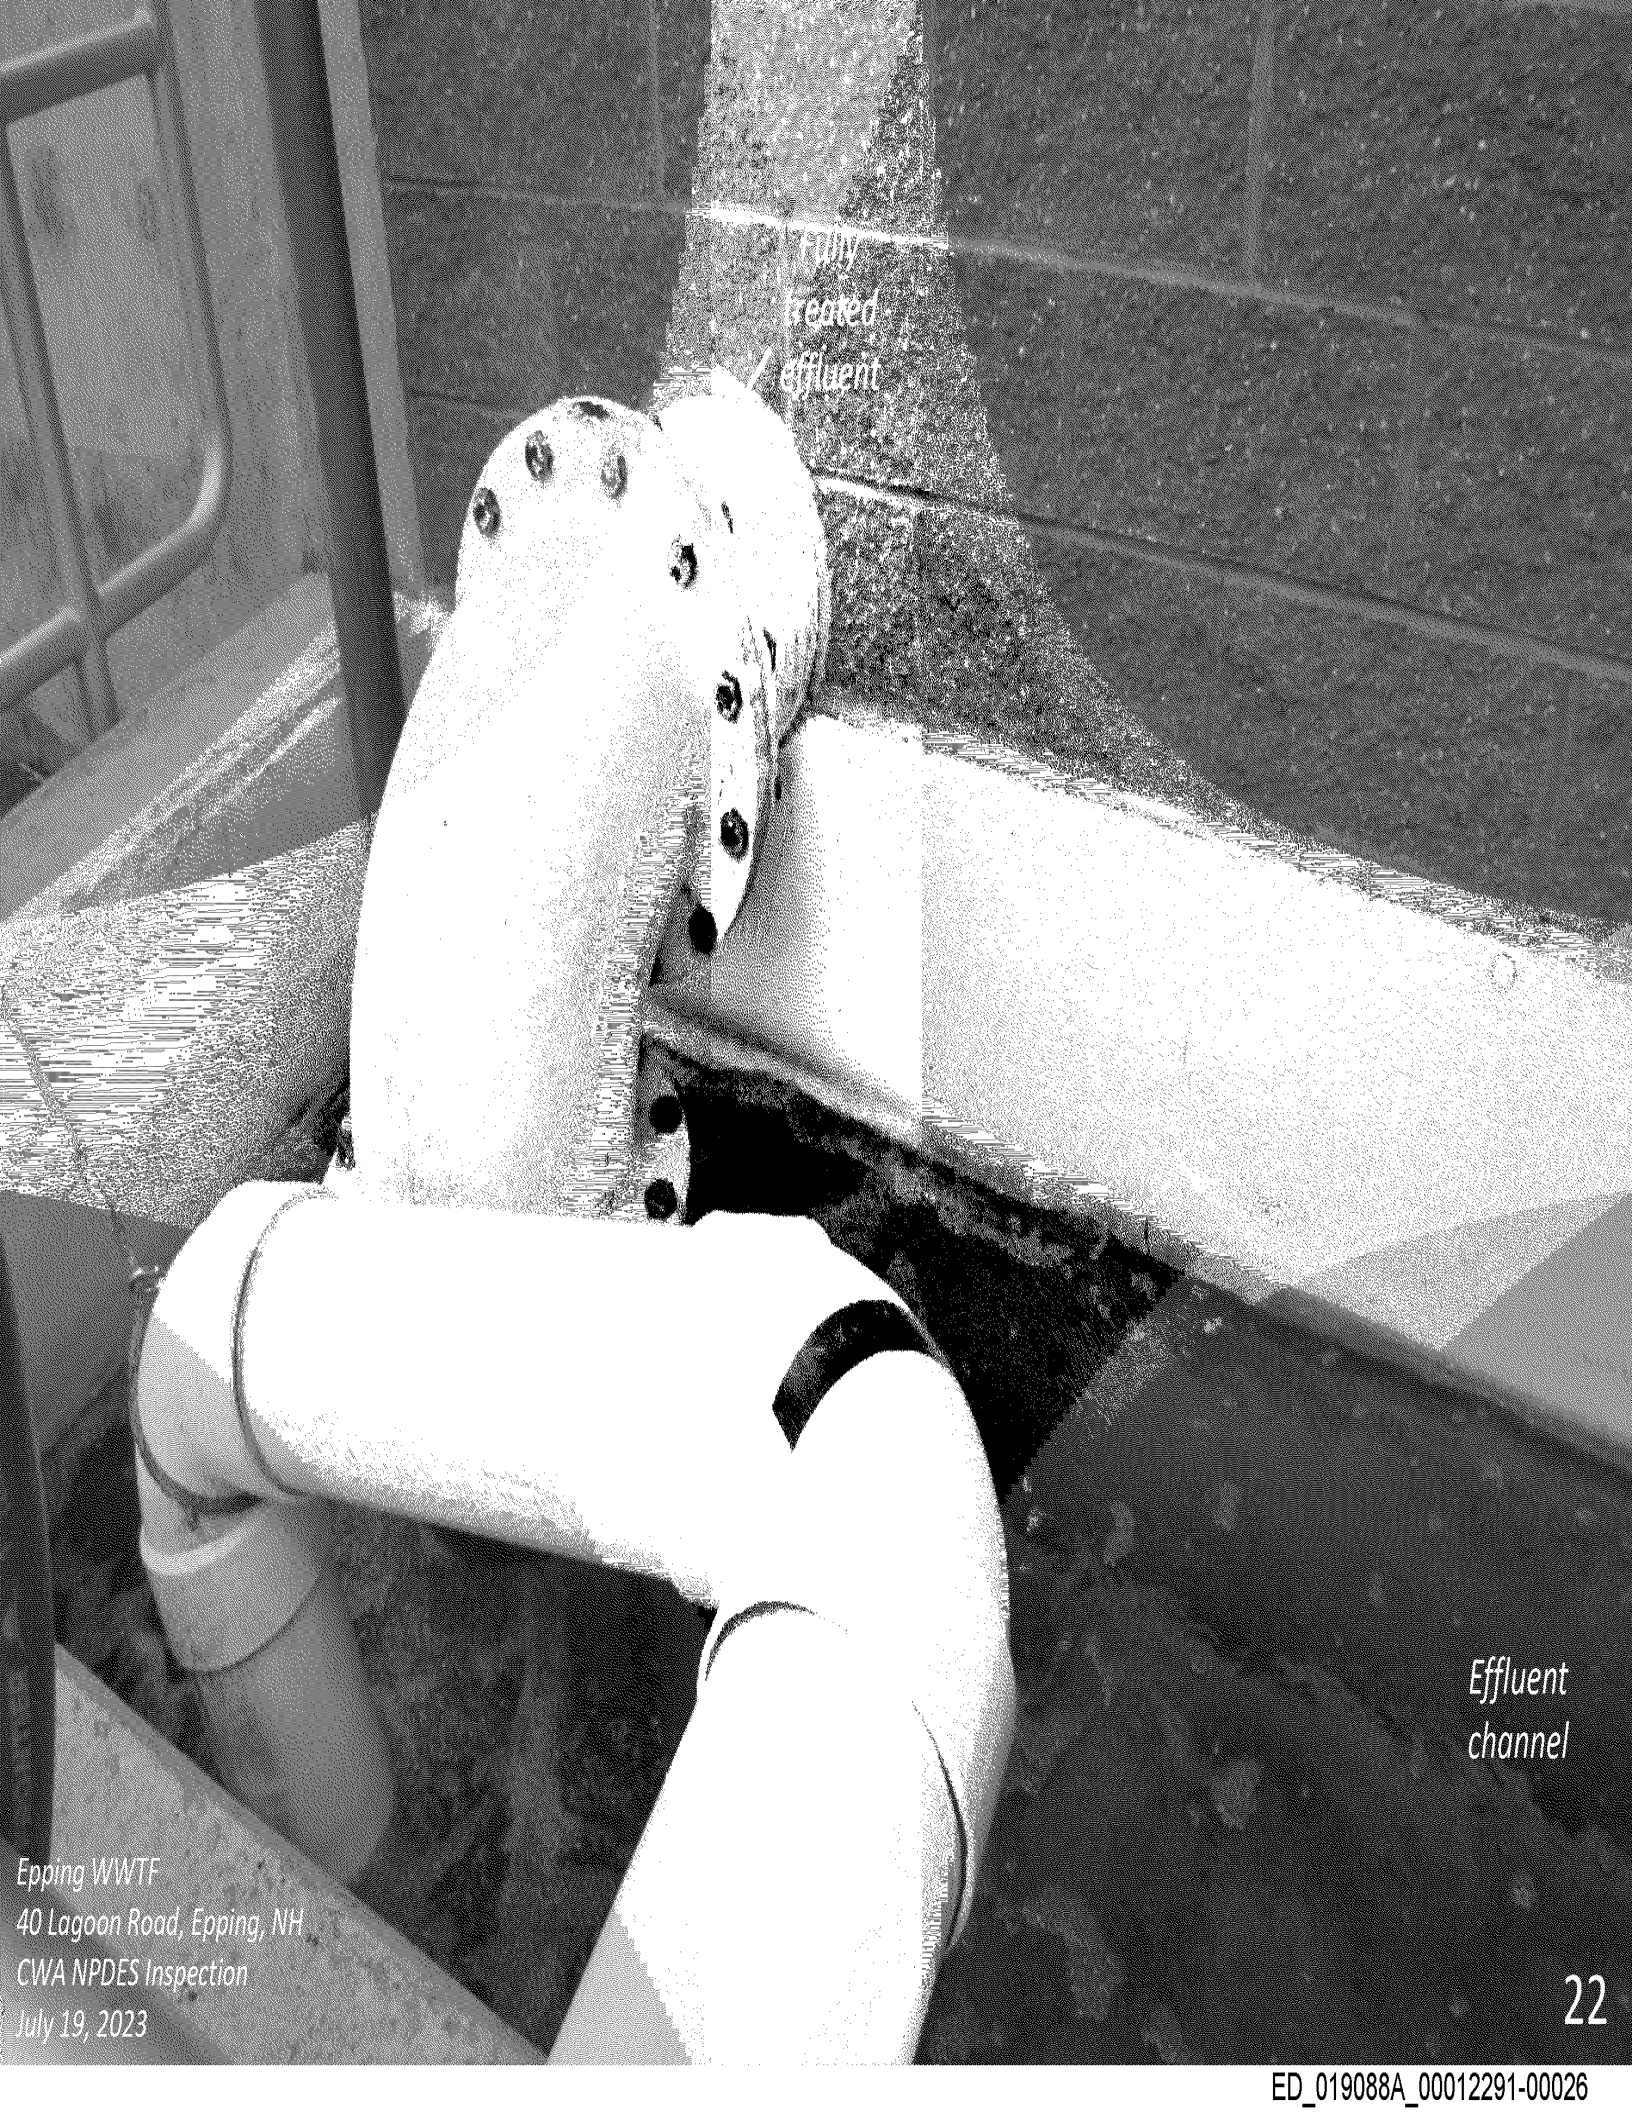
At the effluent channel (slides 21-22), fully treated effluent and partially treated effluent is combined. Effluent is then discharged into the Lamprey River. The effluent flow meter was observed at the effluent channel (slide 23).

Fully  
treated  
effluent

Effluent  
channel
