**UNITED STATES ENVIRONMENTAL PROTECTION AGENCY**

**Subj:** Inspection Report  
Clean Water Act - National Pollutant Discharge Elimination  
System ("NPDES")  
Epping WWTF

Epping WWTF  
40 Lagoon Road, Epping, NH  
CWA NPDES Inspection  
July 19, 2023

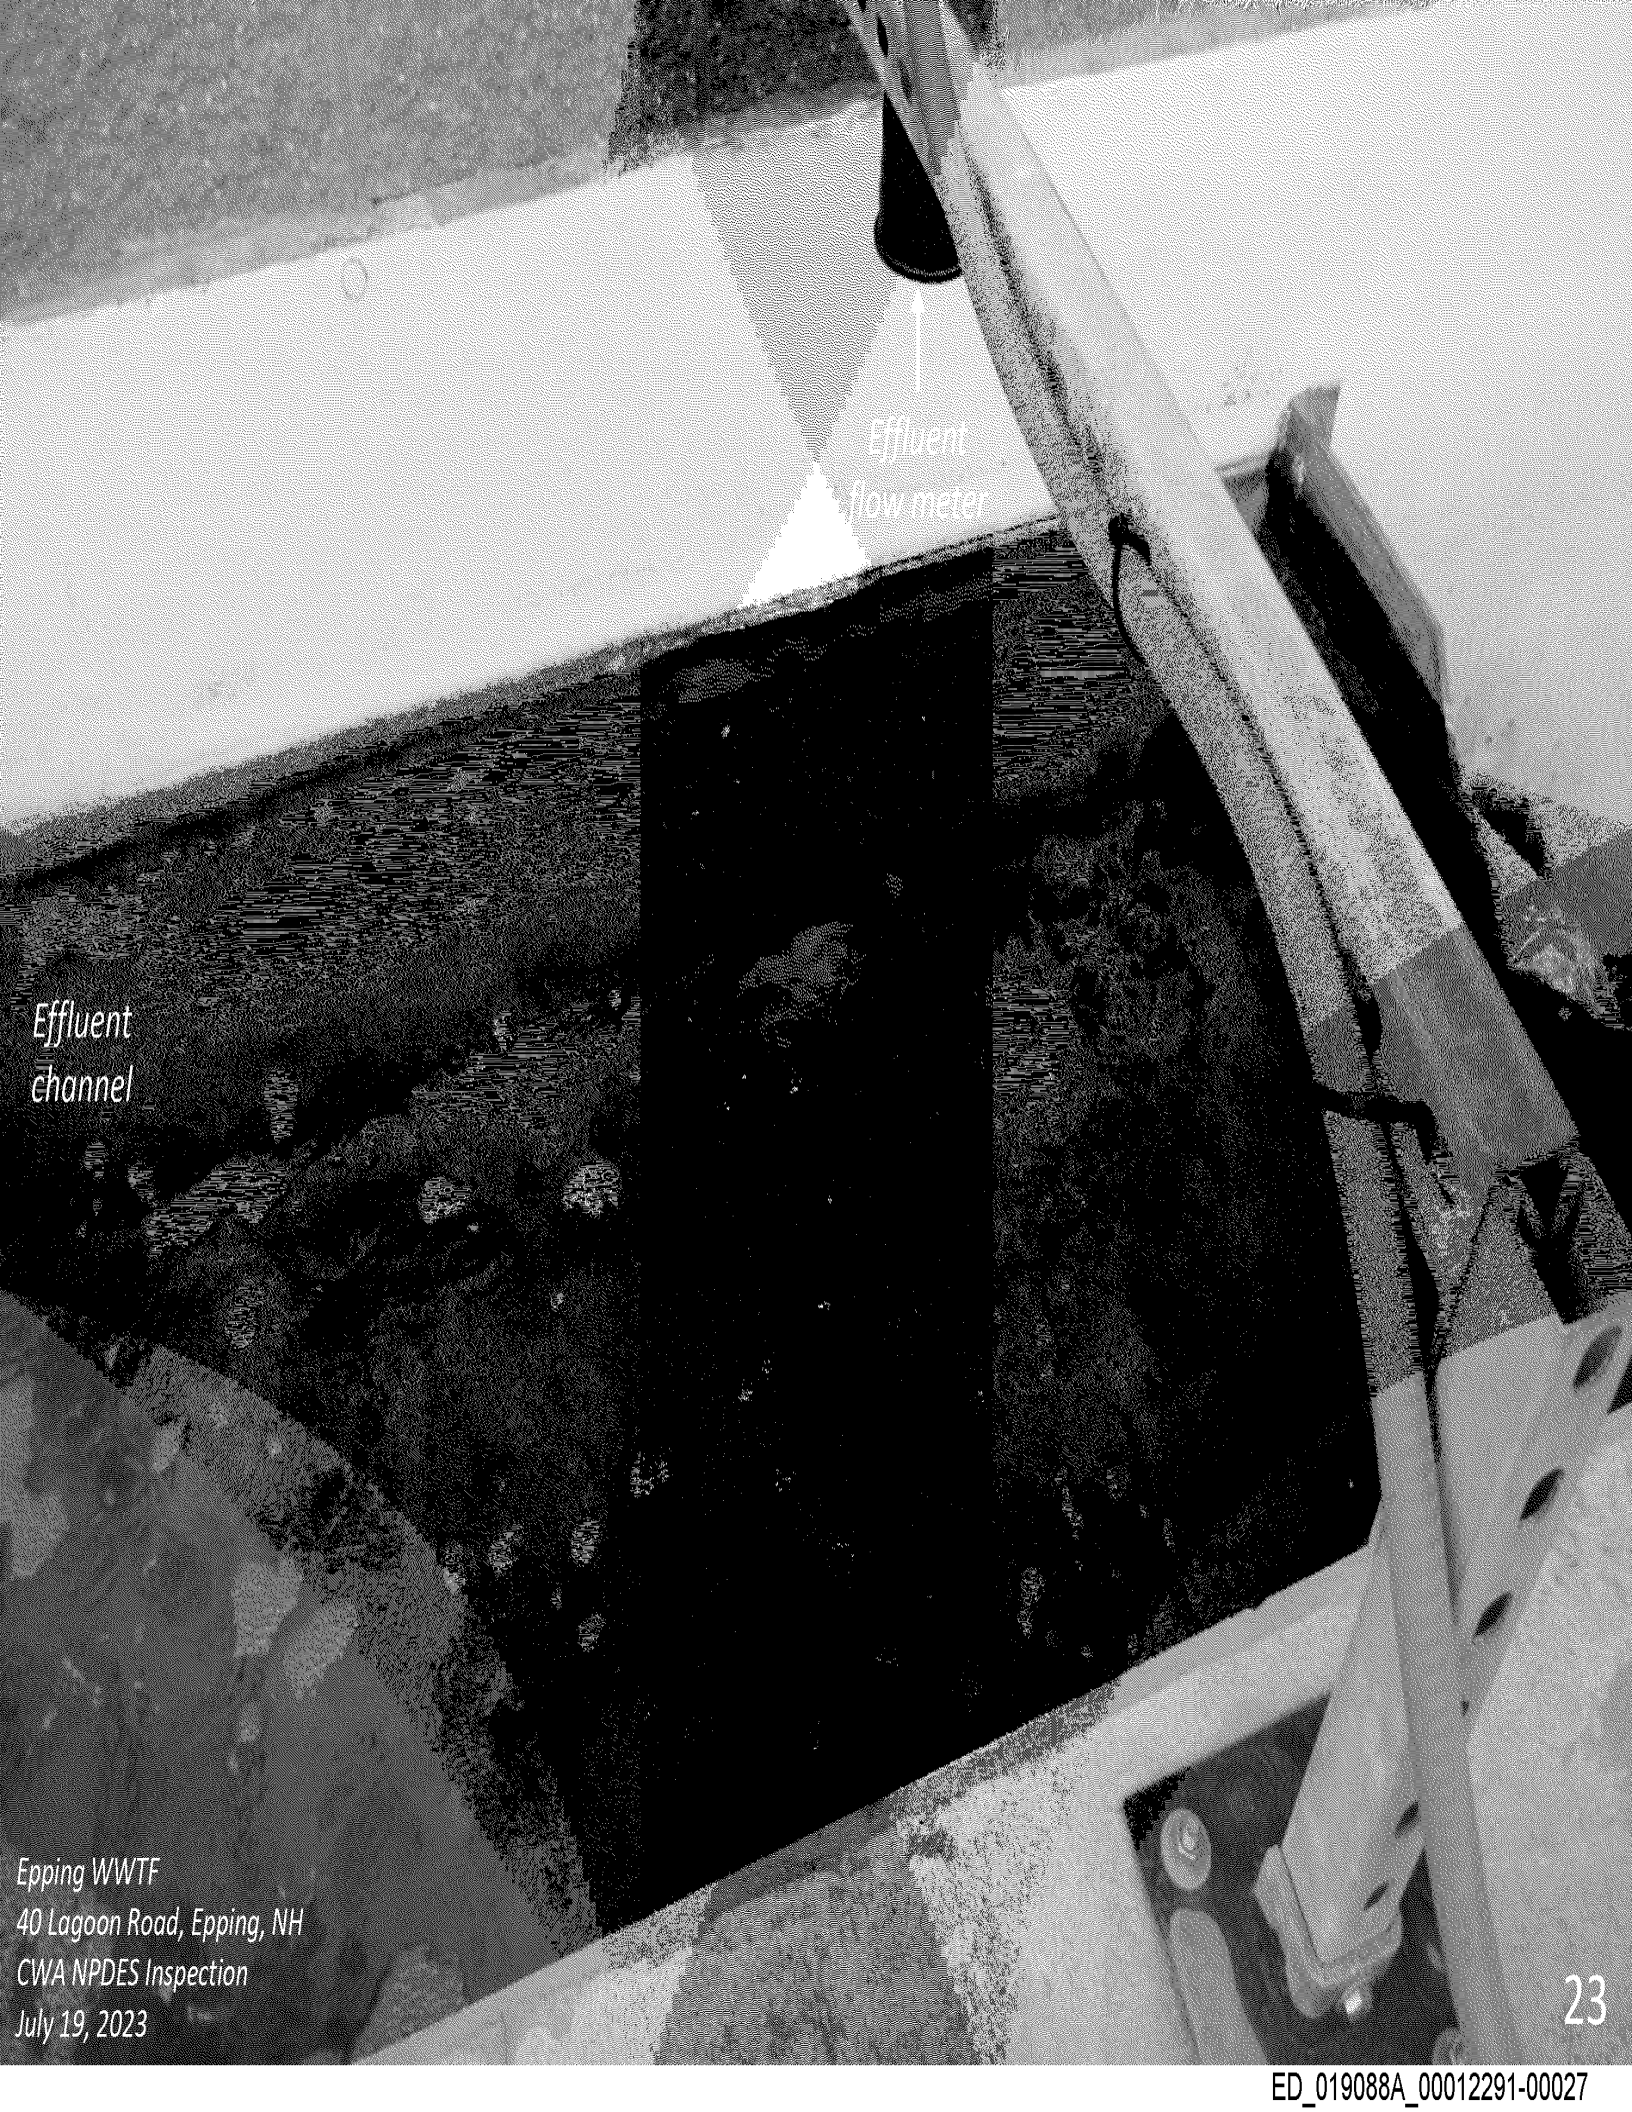
At the effluent channel (slides 21-22), fully treated effluent and partially treated effluent is combined. Effluent is then discharged into the Lamprey River. The effluent flow meter was observed at the effluent channel (slide 23).

Effluent  
flow meter

Effluent  
channel

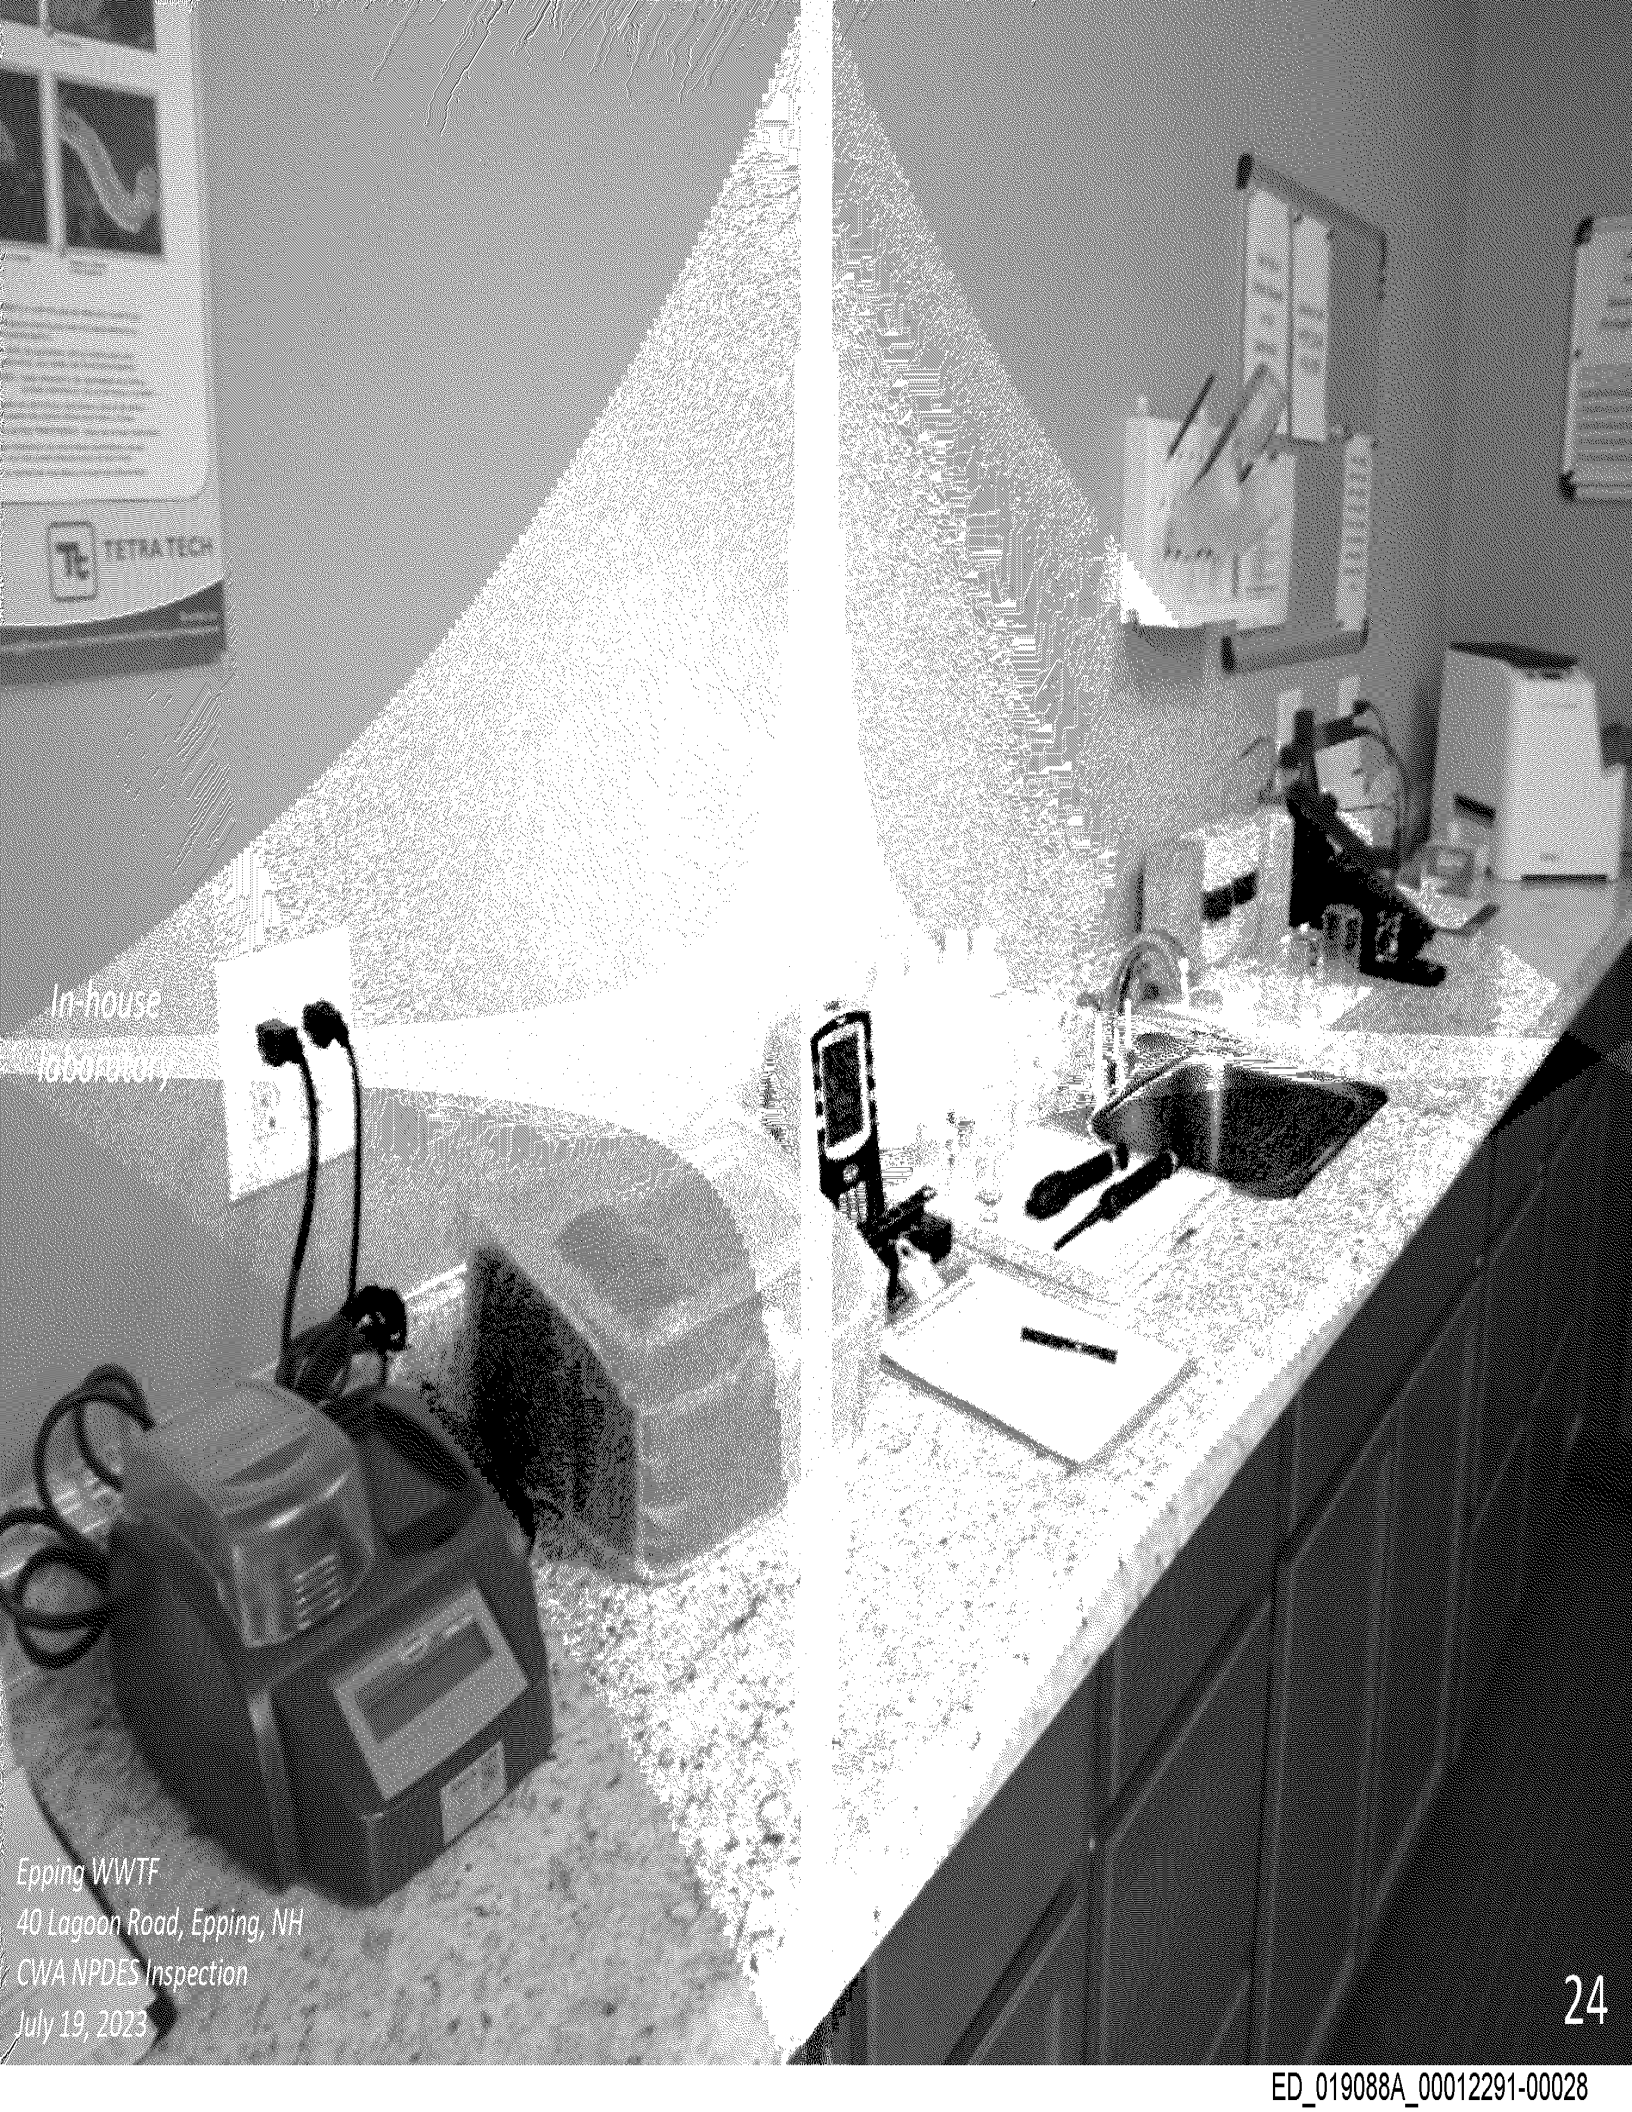
Mr. Shea then proceeded to show the inspector the in-house laboratory (slide 22).

In-house  
laboratory
