Purpose: Commonfields of Cahokia – SSO Recon Inspection Trip Report

Facility: Commonfields of Cahokia Sewer District

Date of Inspection: January 26, 2021

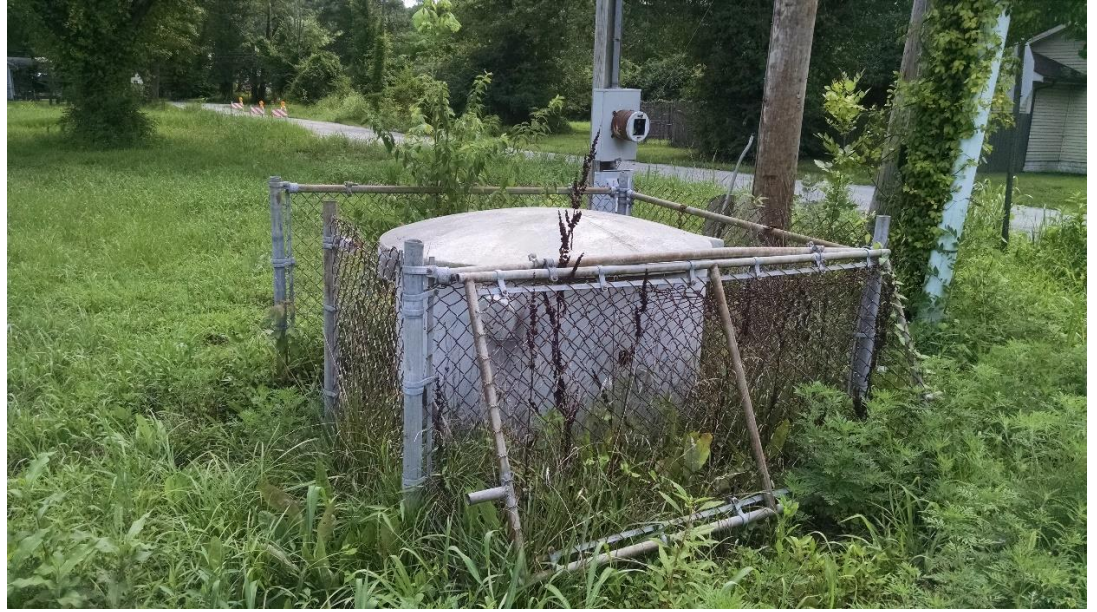
Photo # 001
Date: August 5, 2020
Time: 1:25 p.m.
Taken By: Joe Stitely,DWPC/FOS
Facility: Village of Centerville
Location: Adjacent to Lift Station
Notes: This is a photograph of the lift station near the intersection of N. 82nd street and Bluff Street. The pump station is inoperable, and no bypass pumping has been provided.

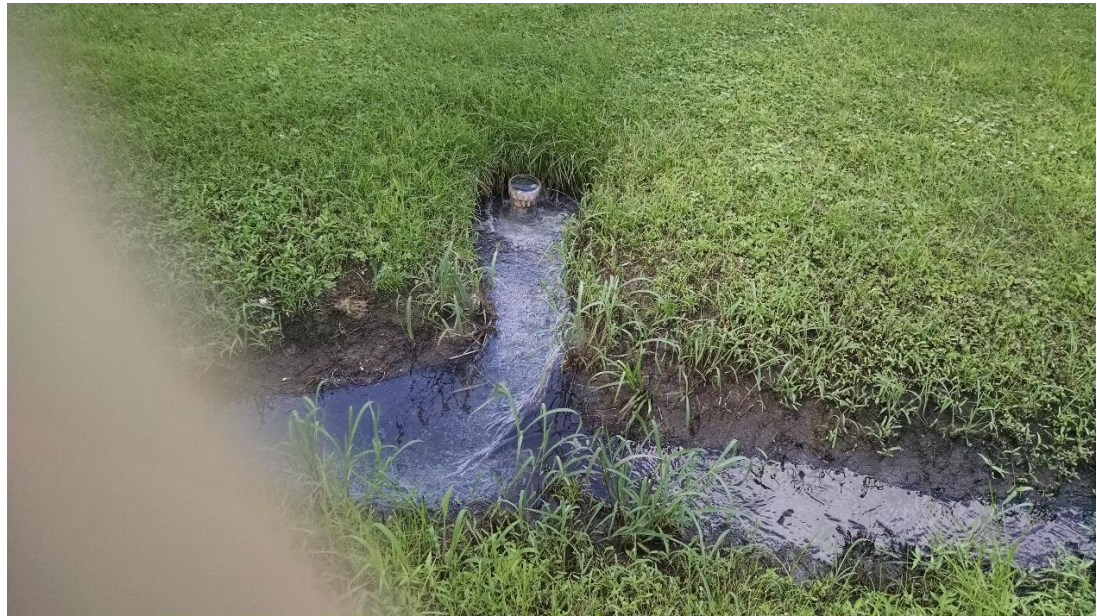
Photo #: 002
Date: August 5, 2020
Time: 1:29 p.m.
Taken By: Joe Stitely,DWPC/FOS
Facility: Village of Centerville
Location: Adjacent to Clean Out
Notes: This is a photograph of the removed clean out cap on the service line at 219 N. 82nd Street. Note the raw sewage discharging from the clean out.

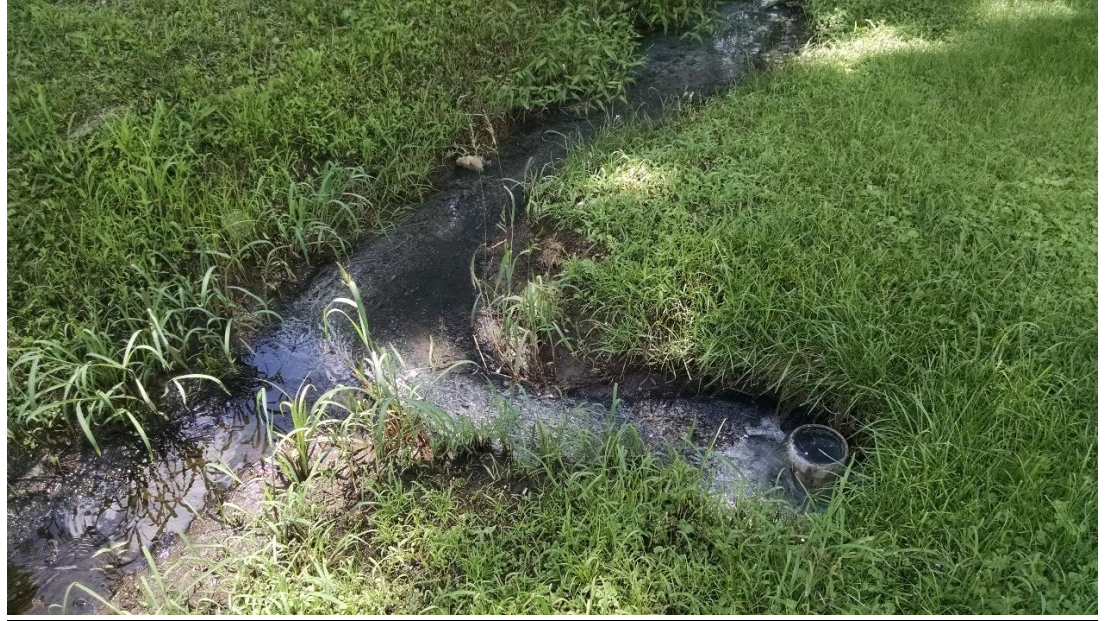
Photo # 003
Date: August 5, 2020
Time: 1:37 p.m.
Taken By: Joe Stitely,DWPC/FOS
Facility: Village of Centerville
Location: Adjacent to Clean Out
Notes: This is another photograph of the removed clean out cap on the service line at 219 N. 82nd Street. Again, note the raw sewage discharging from the clean out.

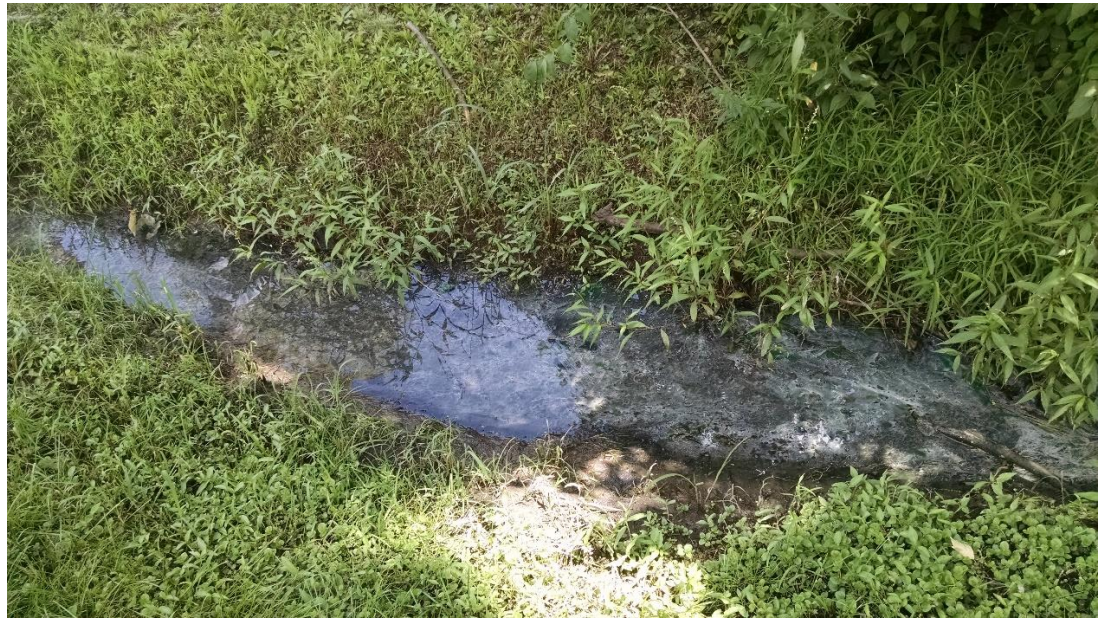
Photo #: 004
Date: August 5, 2020
Time: 1:38 p.m.
Taken By: Joe Stitely,DWPC/FOS
Facility: Village of Centerville
Location: Adjacent to Clean Out
Notes: This is a photograph of the roadside ditch immediately downstream of the removed clean out cap.

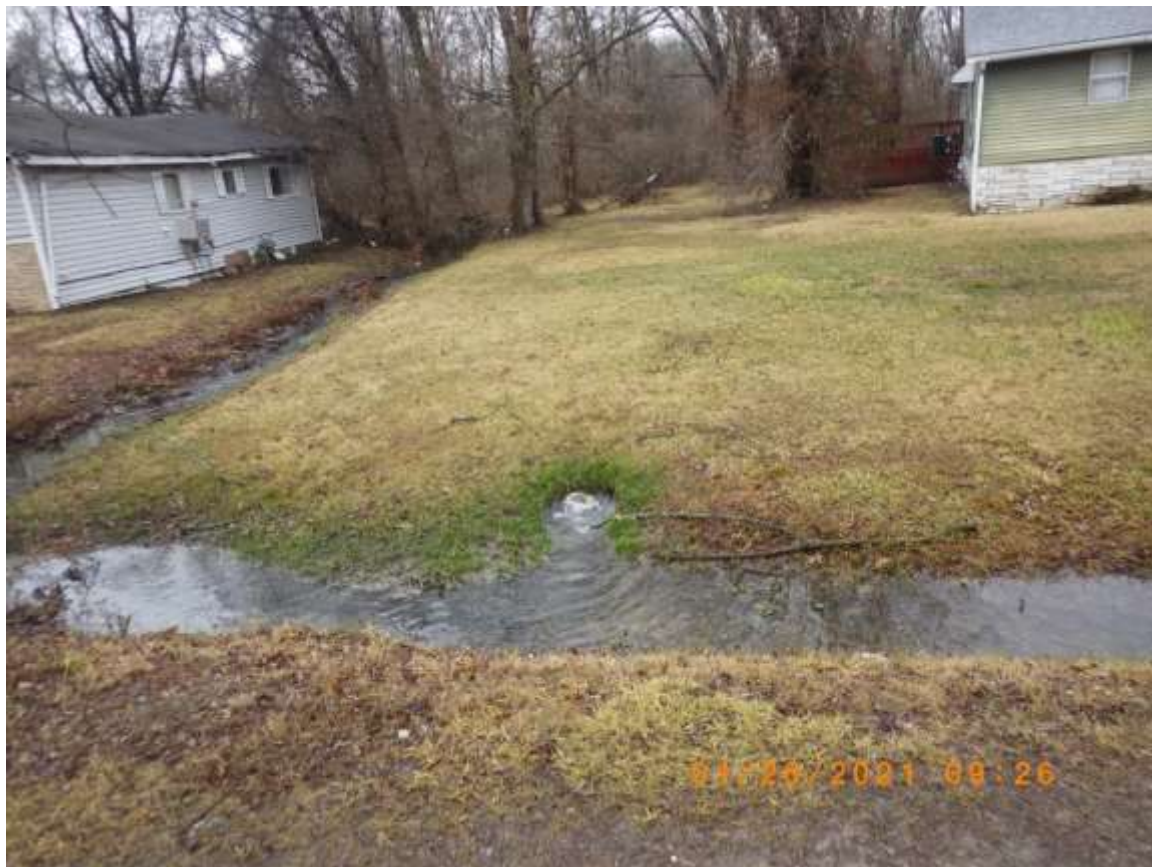
1: COMF0001

I observed raw sewage flowing from a cleanout located in the front yard of the residence at 219 N. 82nd St. in what is referred to the "Ping-pong area" in Centreville (photographs COMF0001, COMF0002, COMF0003). I noted toilet paper debris in the ditch receiving the sewage and a strong sewage odor. I observed the sewage discharging to the ditch running along the front of the residence and then west toward the residence's backyard continuing to the twin culverts under N 80th Street (photograph COMF0004 and COMF0005). The twin culverts discharge to perennial Canal #1 (photograph COMF0020), which flows into Harding Ditch, a perennial stream, which flows to Prairie du Pont Creek, a perennial stream and tributary to the Mississippi River.

Description: Sewage observed flowing from cleanout in front yard of home. Sewage drains west in ditch between homes toward backyard and to culverts discharging to Canal #1.

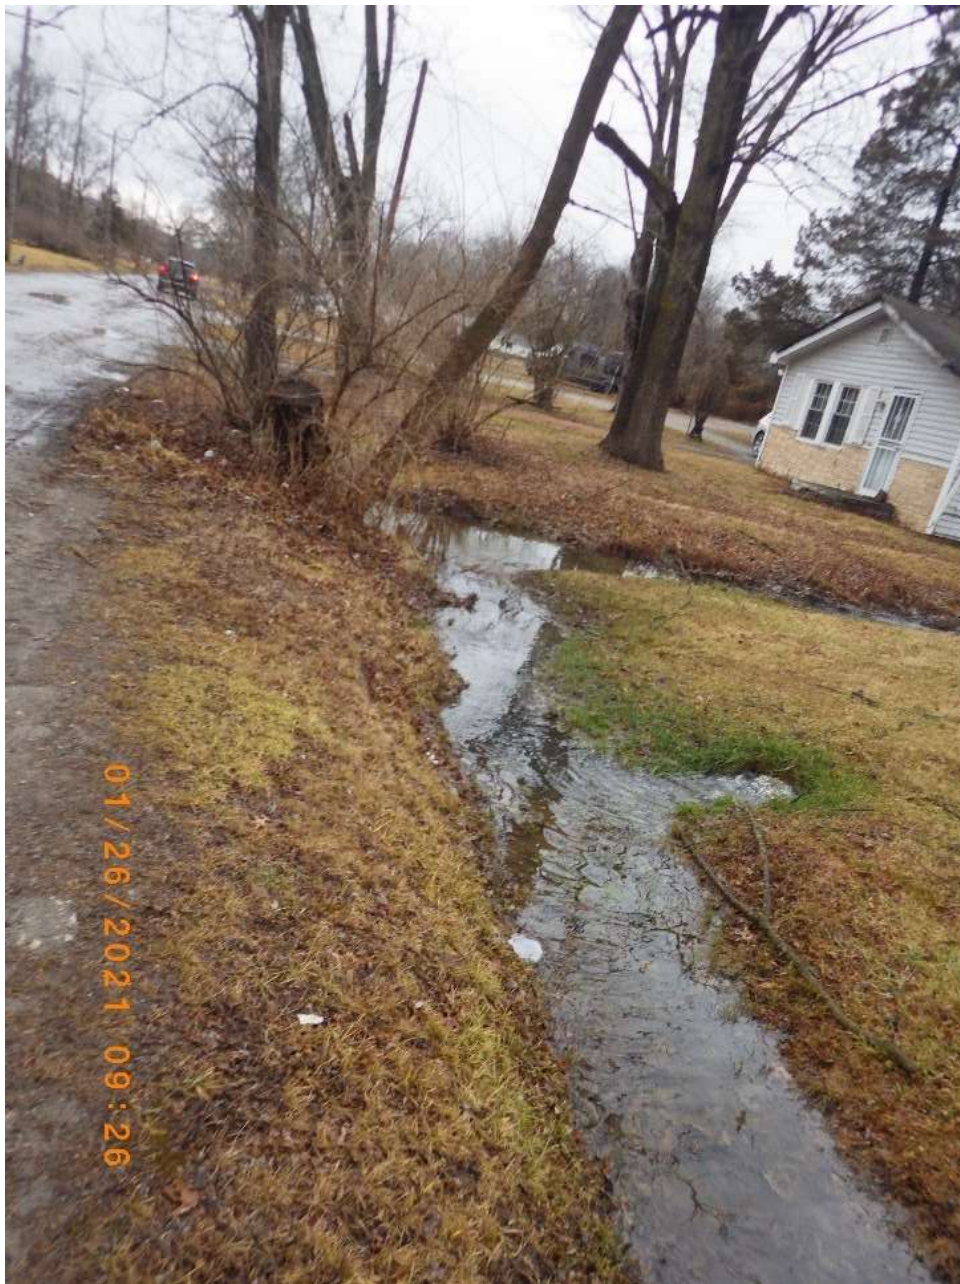
2: COMF0002

Description: Sewage observed flowing from cleanout in front yard of home.

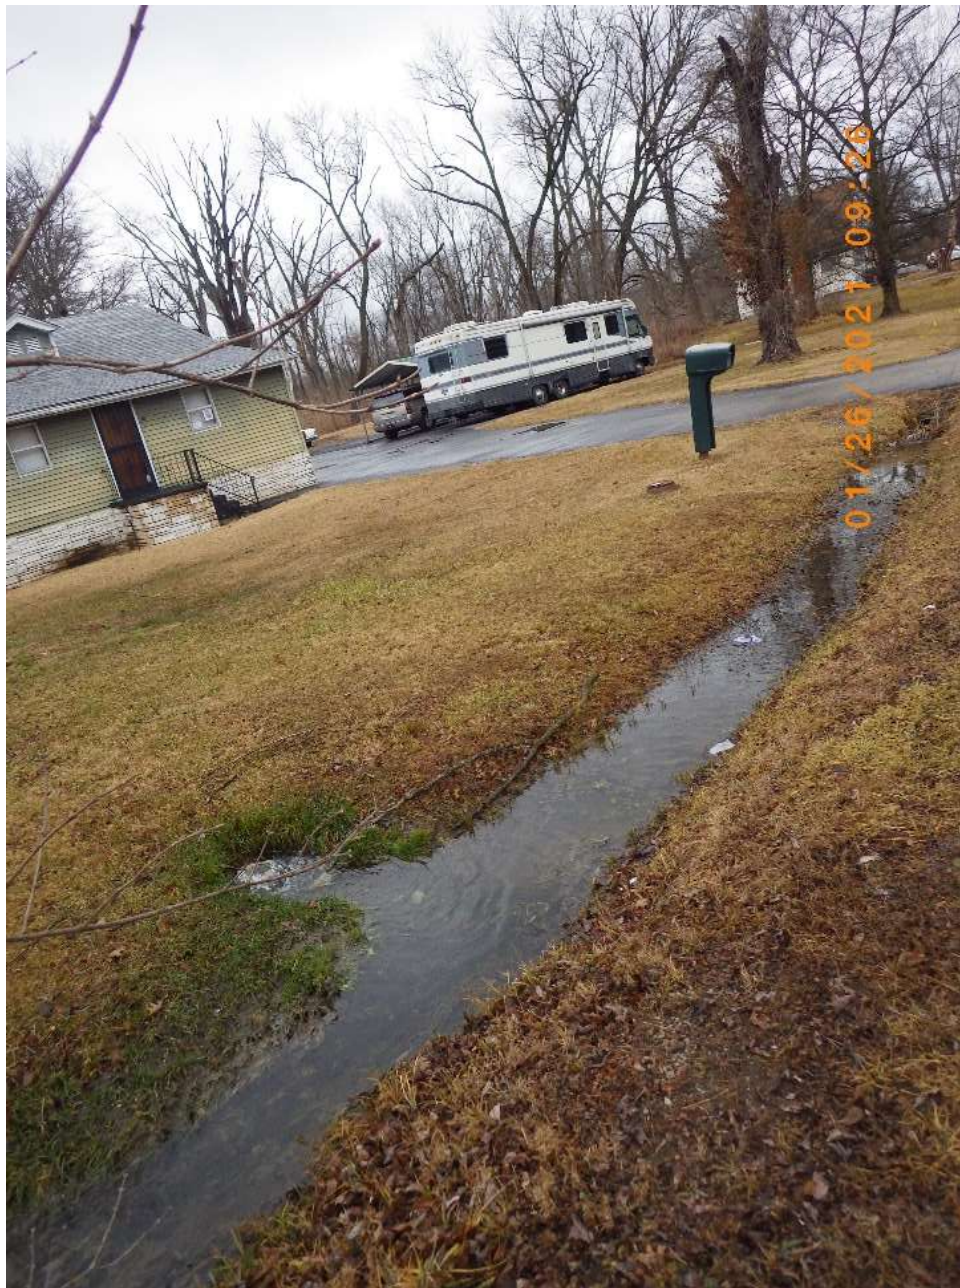
3: COMF0003

Description: Sewage observed flowing from cleanout in front yard of home.

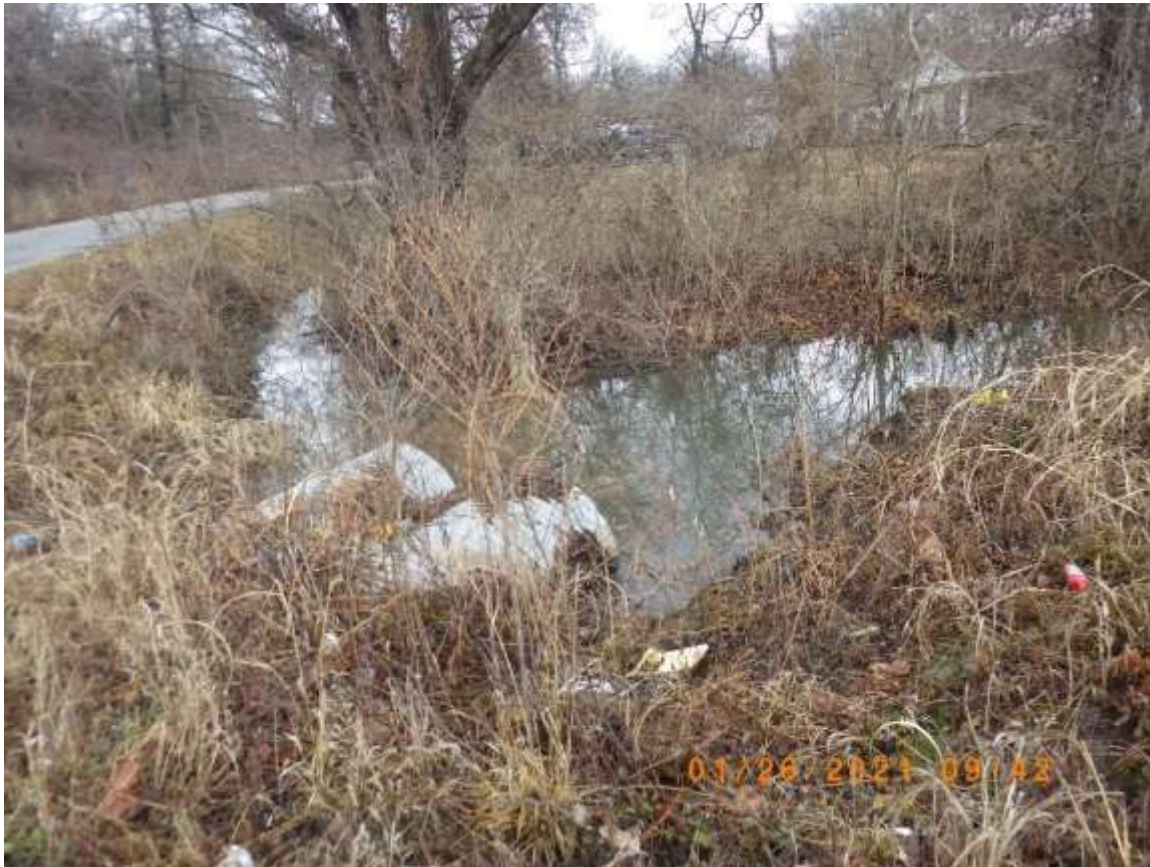
4: COMF0004

Description: Culverts draining "Ping-Pong" area between N 82nd and N 80th Sts. to Canal #1 which flows to Harding Ditch.

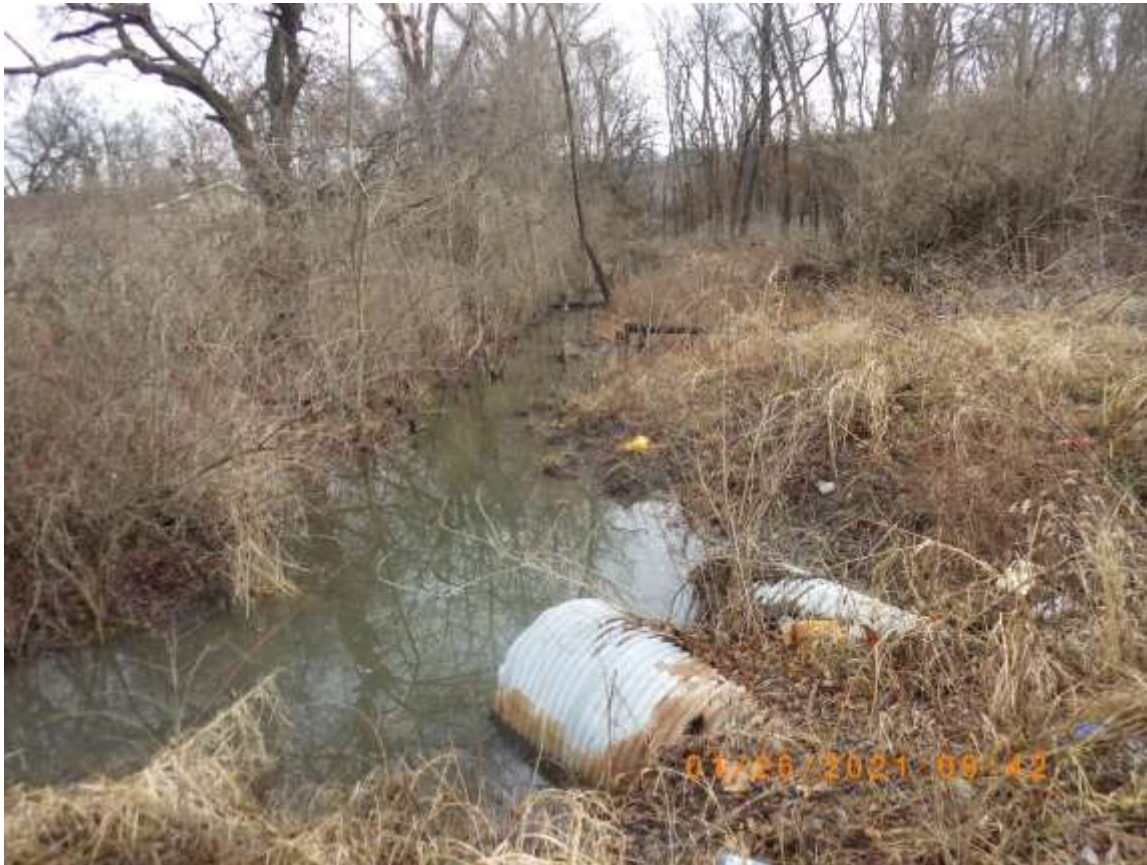
5: COMF0005

Description: Culverts draining "Ping-Pong" area between N 82nd and N 80th Sts. to Canal #1 which flows to Harding Ditch.

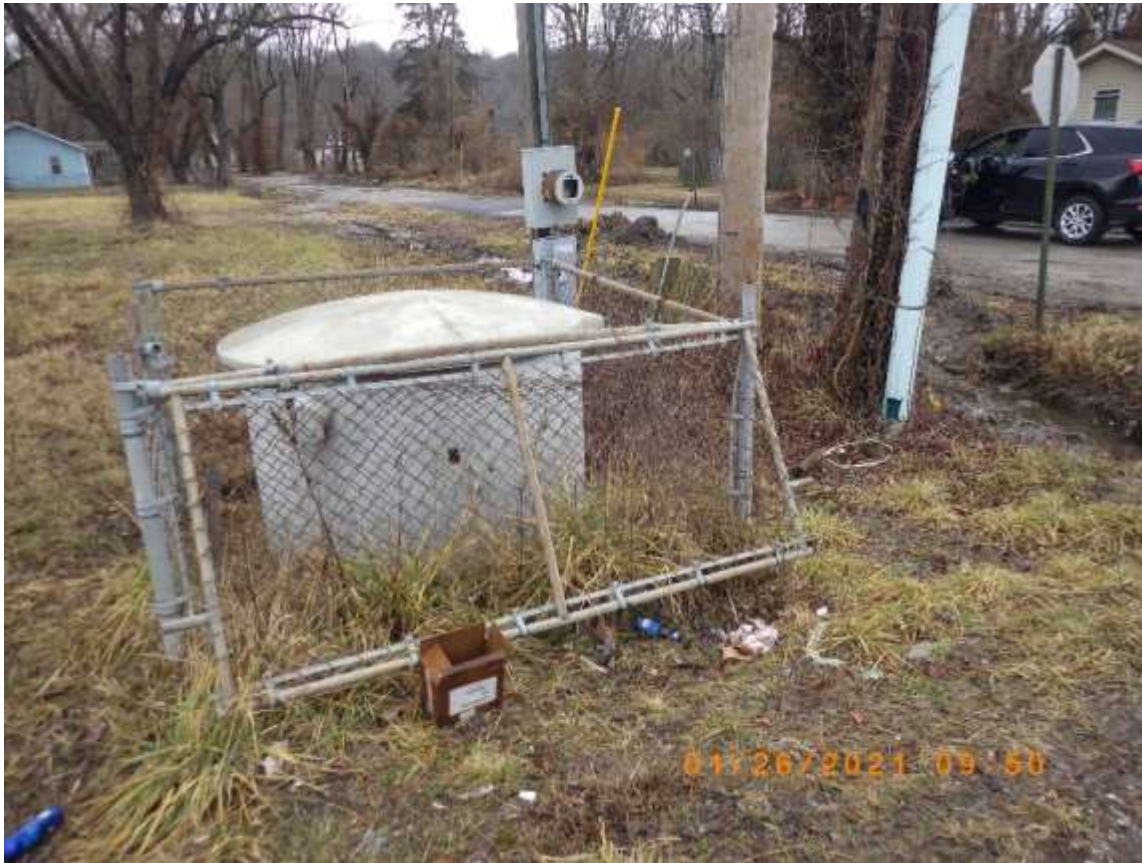
6: COMF0006

Description: Lift station #11

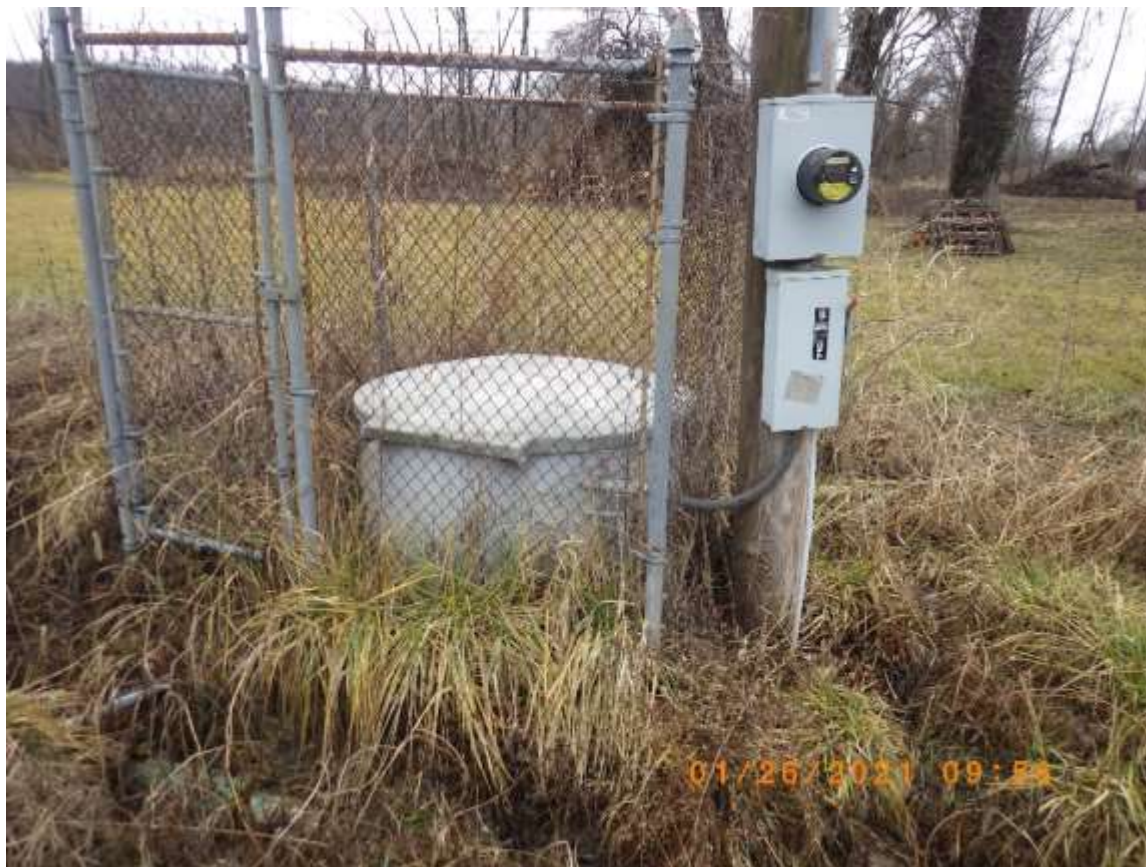
7: COMF0007

Description: Lift station #10. High flows in adjacent manhole but no discharges to surface observed.

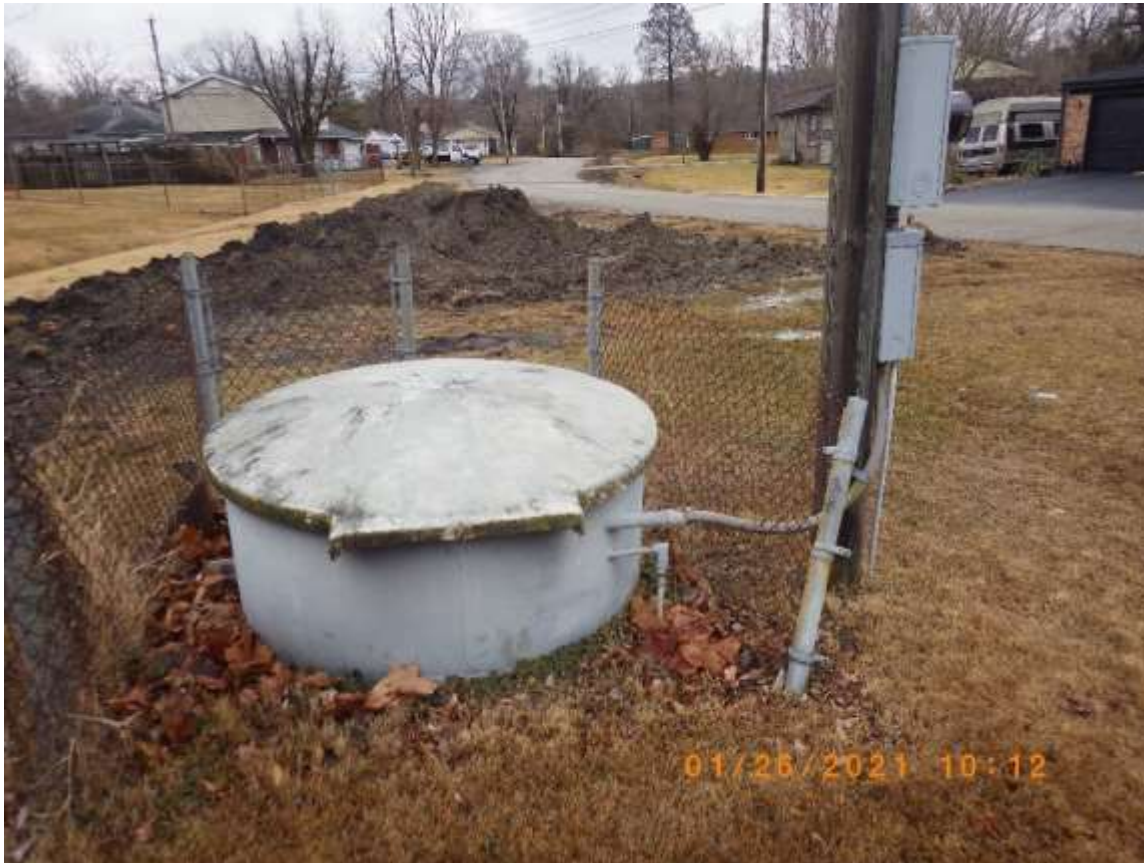
8: COMF0008

Description: Lift station #9. Recent construction adjacent to LS.

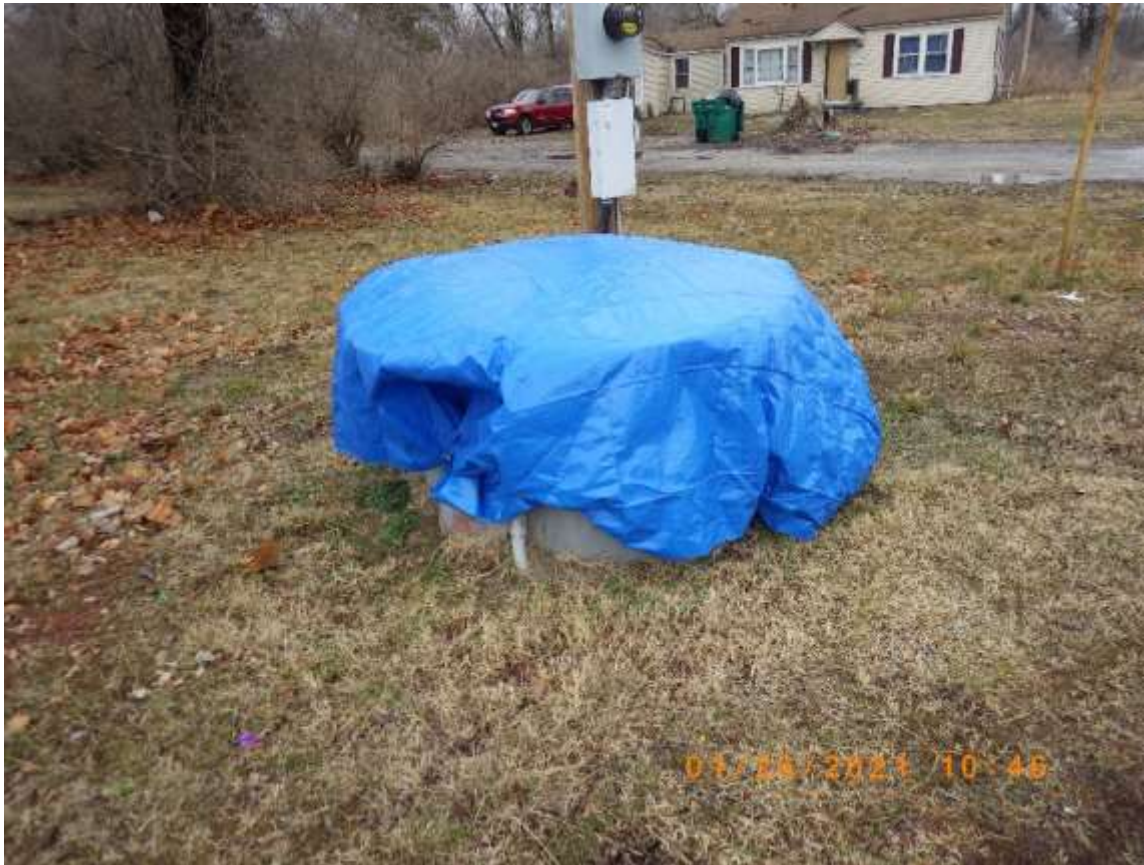
11: COMF0011

Description: Lift station #4. Note lift station covered with blue tarp.

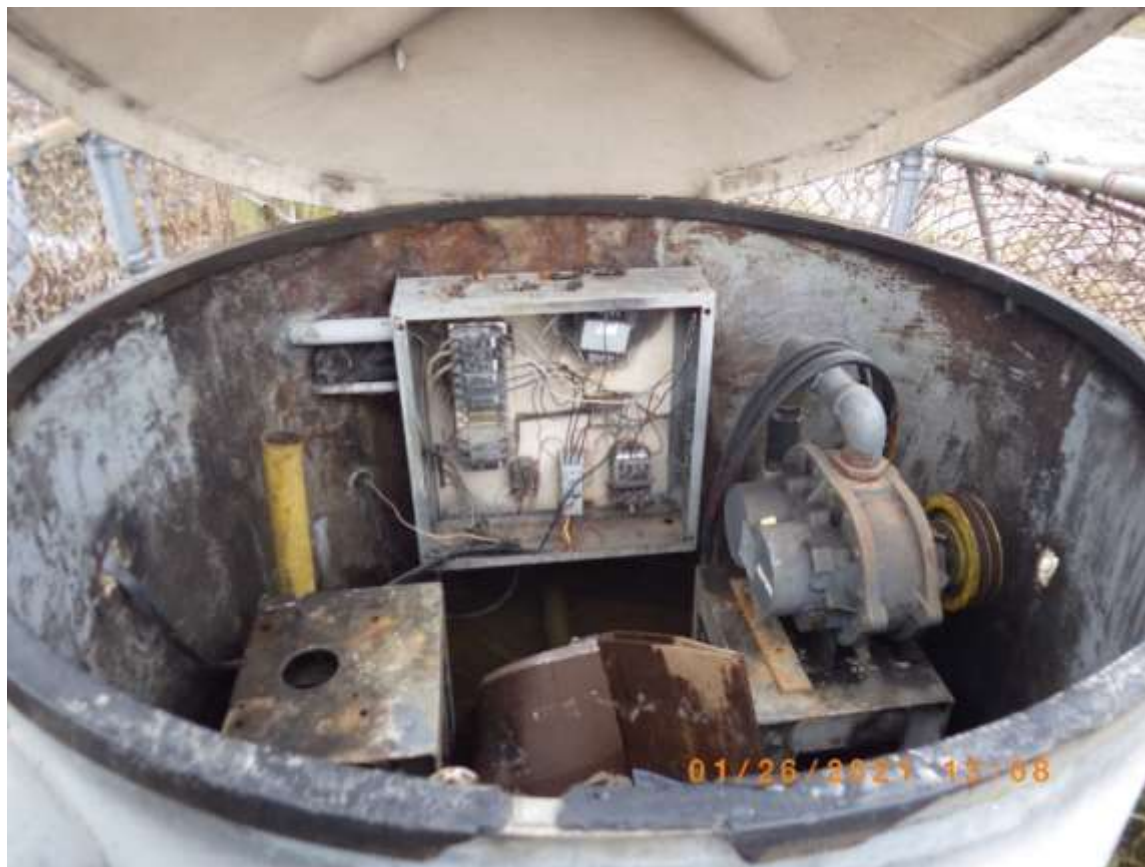
15: COMF0015

Lift Station at N. 82 St. and Bluff: At 13:00, I met up with IEPA inspectors at Lift Station 11 on N. 82 St. and Bluff (photograph COMF0006). According to Mr. Stitely, this is the last lift station prior to entering the East St. Louis sewer system in this area. He added that the lift station had a history of operations and maintenance issues and was operated manually by District staff until recently. Mr. Stitely lifted the lift station's cover and observed an uncovered electrical panel, indicative of poor maintenance (photograph COMF0015).

Description: Lift station #11. Returned to lift station with IEPA inspectors. Note lack of maintenance, no cover on electrical panel.

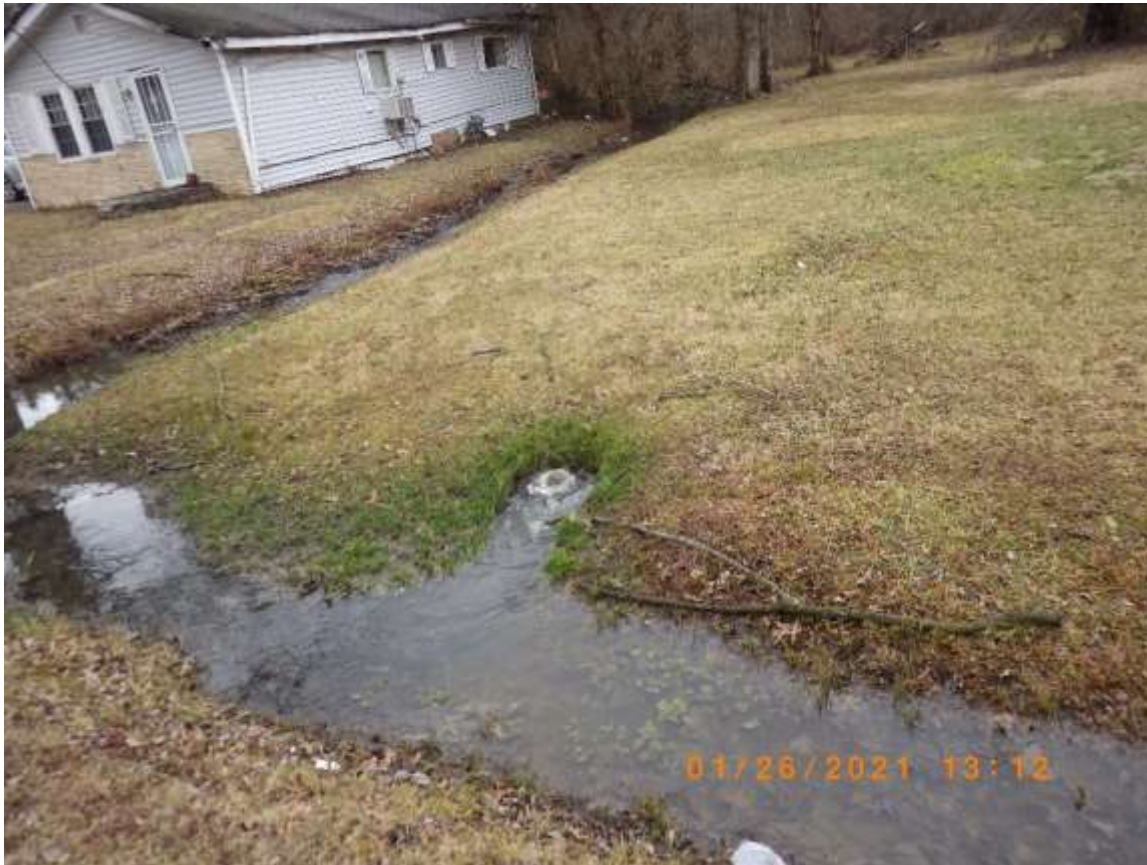
16: COMF0017

I then met the IEPA inspectors at the SSO I observed earlier in the morning in front of 219 N. 82nd St. Raw sewage was still flowing from the relief point into the ditch (photograph COMF0017; and video COMF0018). Mr. Stitely confirmed that the sewage flowed into the yard behind the residence and through the twin culverts under N. 80th St. then discharging to Canal #1.

Description: [Returned to location with IEPA inspectors] Observed sewage flowing from cleanout in front yard of home. Noted toilet paper and strong sewage odor.

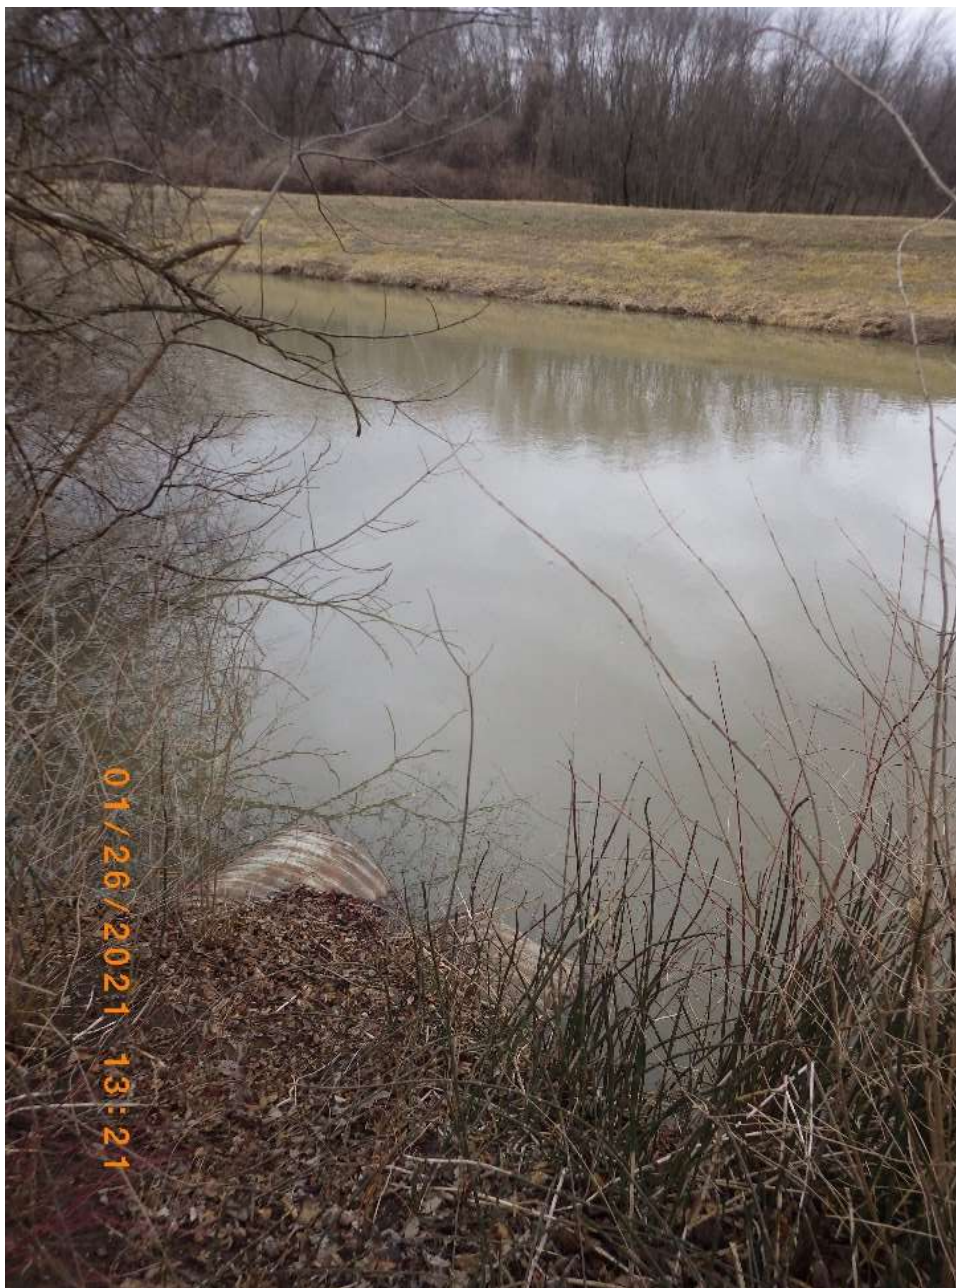
17: COMF0020

We then drove around the corner to the culverts under N. 80th St. Mr. Stitely explained that the culverts may be too low at the outlet to Canal #1 (photograph COMF0020) which may create opportunity for back flow, under high water conditions, towards the Ping-pong area, including the N. 80th and N. 82nd St. neighborhood.

Description: Culvert outlets draining "Ping-Pong" area between N 82nd and N 80th Sts. to Canal #1.

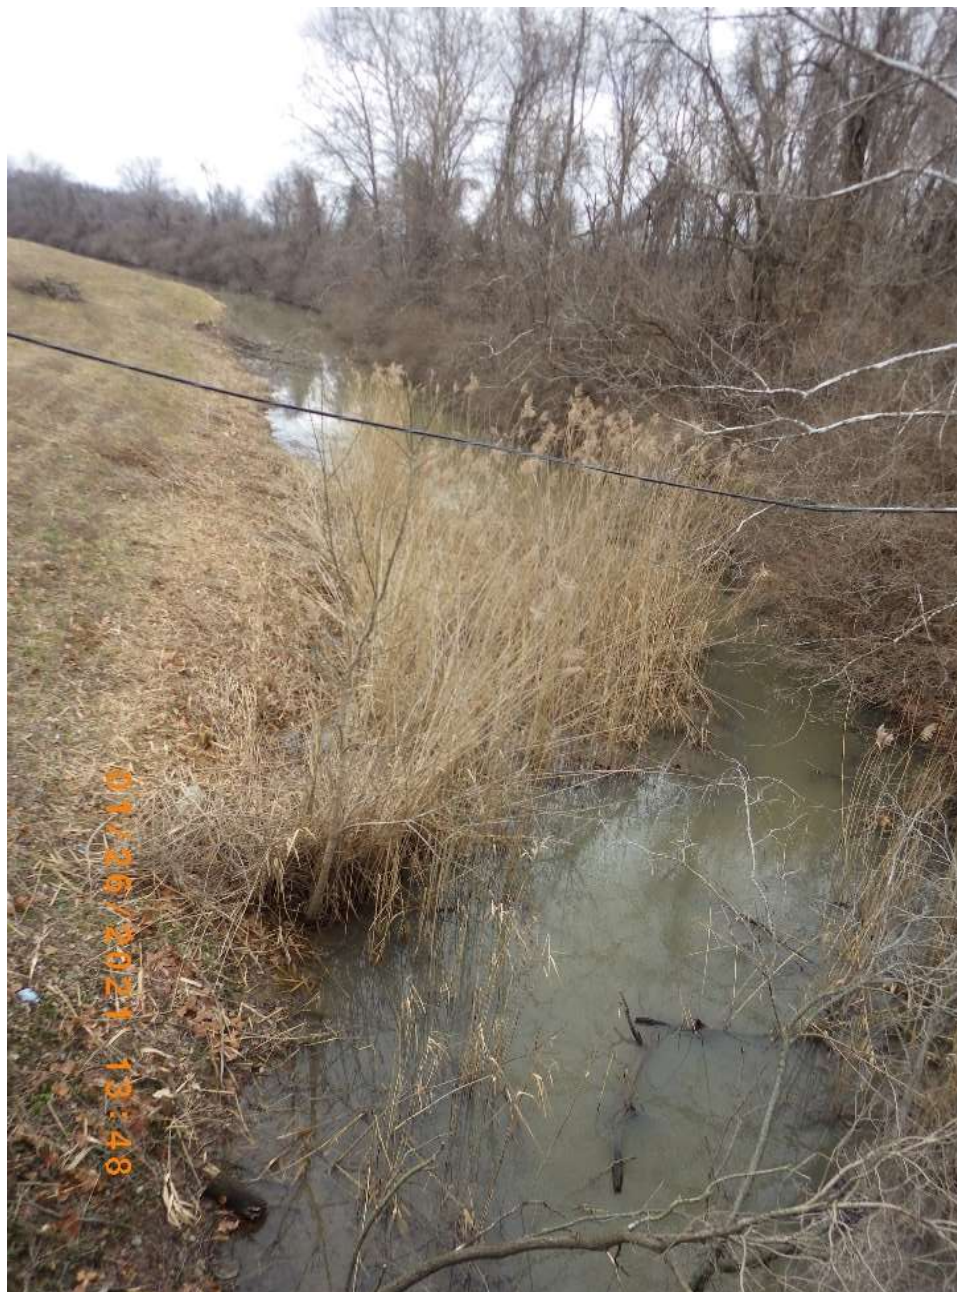
18: COMF0021

Description: View north from Lake Dr. overpass of Canal #1 area downstream of “Ping-pong area” culverts.

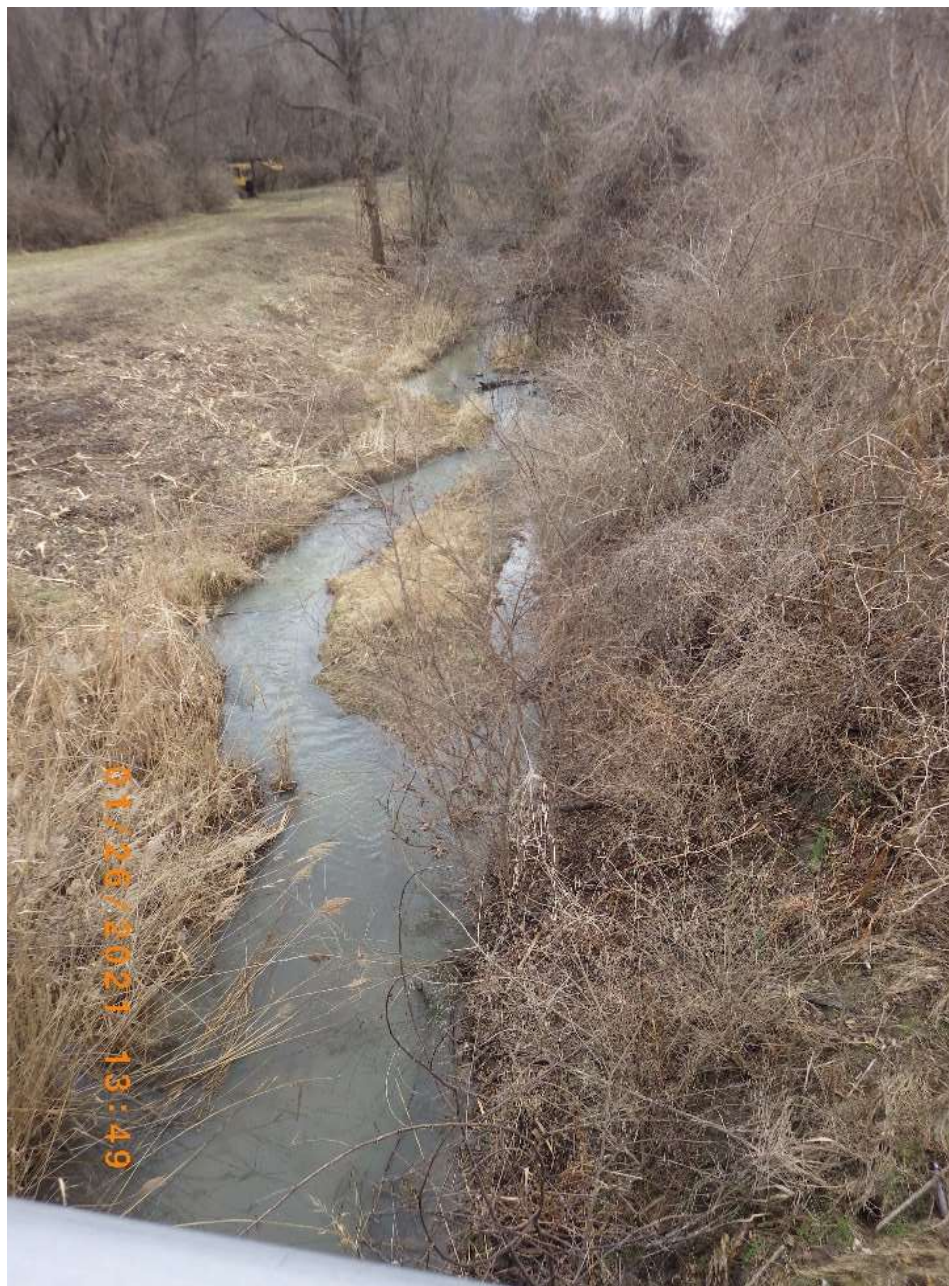
19: COMF0022

Description: View south from Lake Dr. overpass of Canal #1 area downstream of “Ping-pong area” culverts.

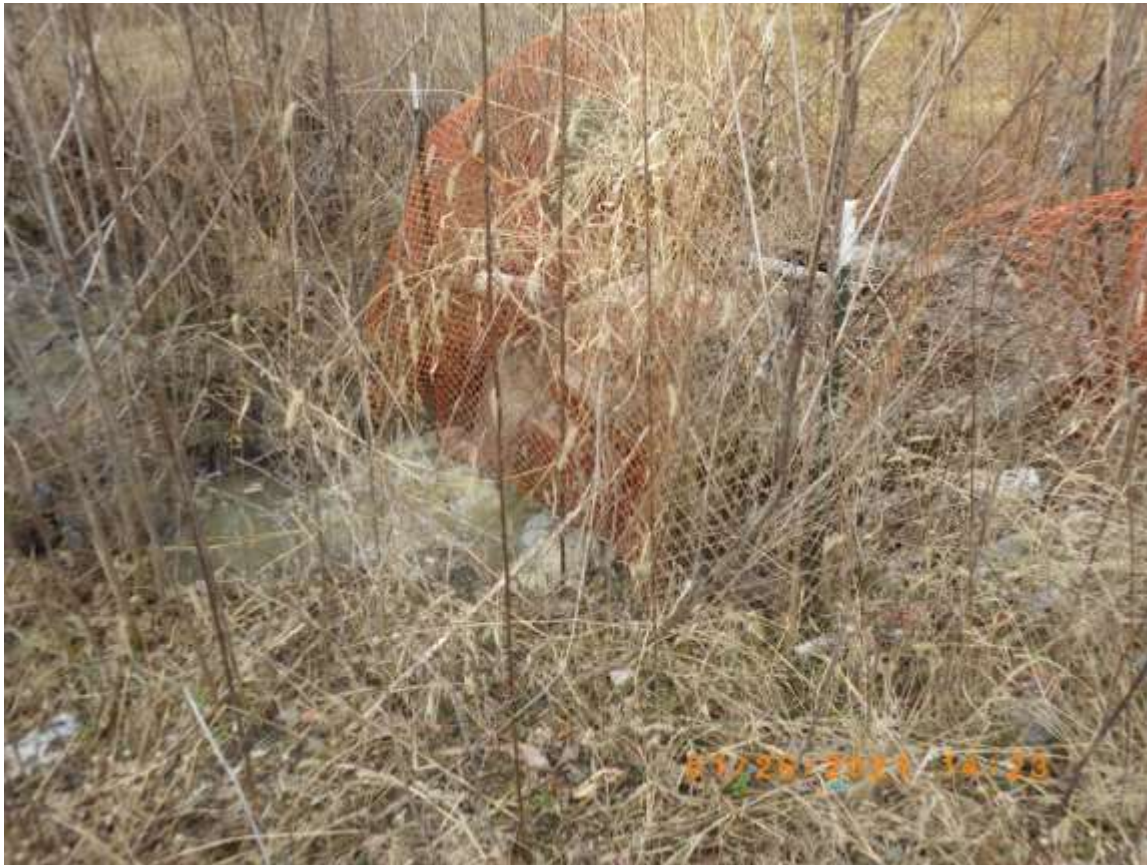
20: COMF0024

The IEPA inspectors departed to respond to a citizen complaint and I continued to Lift Station 22 at Lauralee and Violet. Upon arrival at 14:20, I immediately noticed a strong sewage odor and observed raw sewage overflowing from the lift station (photograph COMF0024). I also captured video of the SSO (video COMF0025). I noted that the manhole cover on the top of the lift station was missing, exposing the lift station to rainwater. A black hose was coming out of the manhole, apparently to facilitate a bypass (photograph COMF0027 and video COMF0026). I noted that the level of sewage in the lift station was just below the lip of the manhole. I did not have access to the field receiving the sewage overflow. As a result, I could not verify the downstream path or impacts of the ongoing sewage overflow.

Description: Lift station 22. Lift station was overflowing. Noted strong sewage odor.

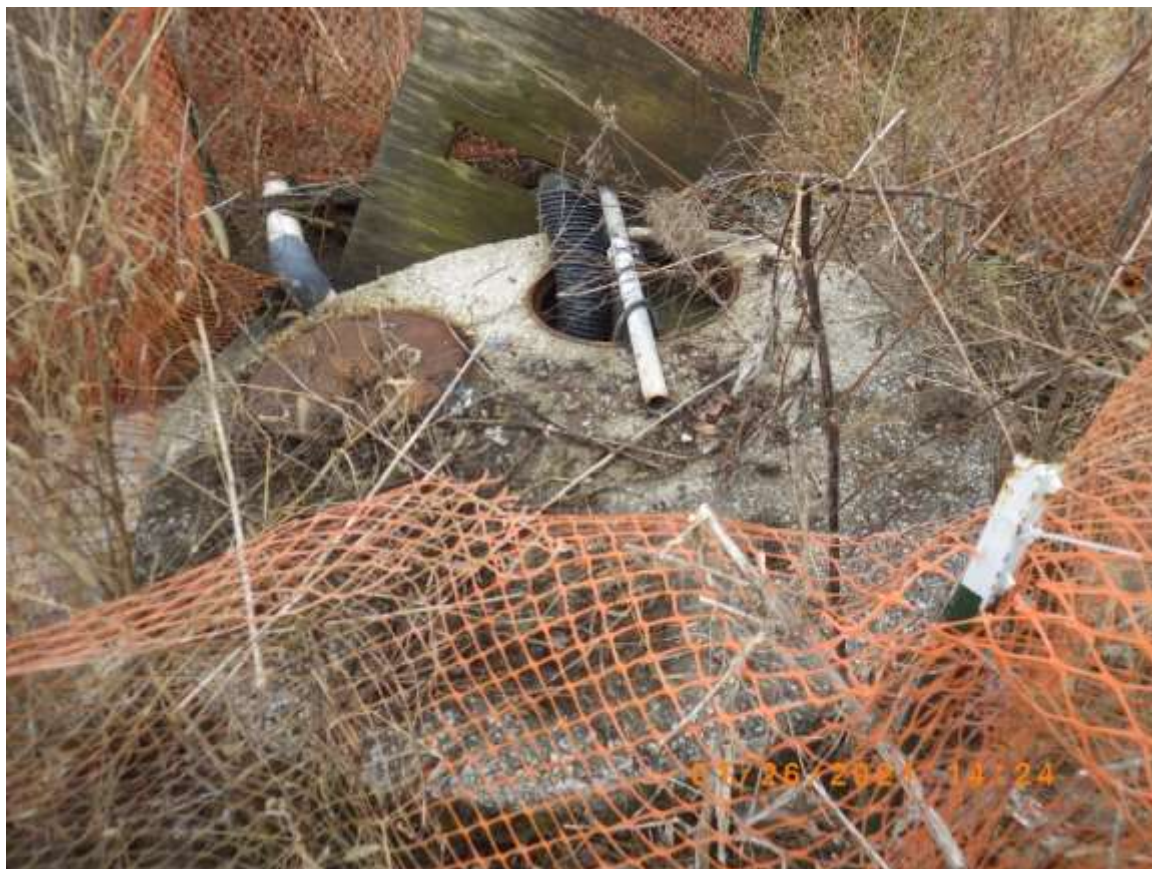
21: COMF0027

Description: Lift station 22. View of top of list station with uncovered manhole. Note black hose and level of sewage just below lip of the manhole.
