## Region 6 Compliance Assurance and Enforcement Division

### INSPECTION REPORT

| Company Name: | <b>Southwestern Electric Power Company</b> | | |
| Facility Name: | <b>Lieberman Power Plant</b> | | |

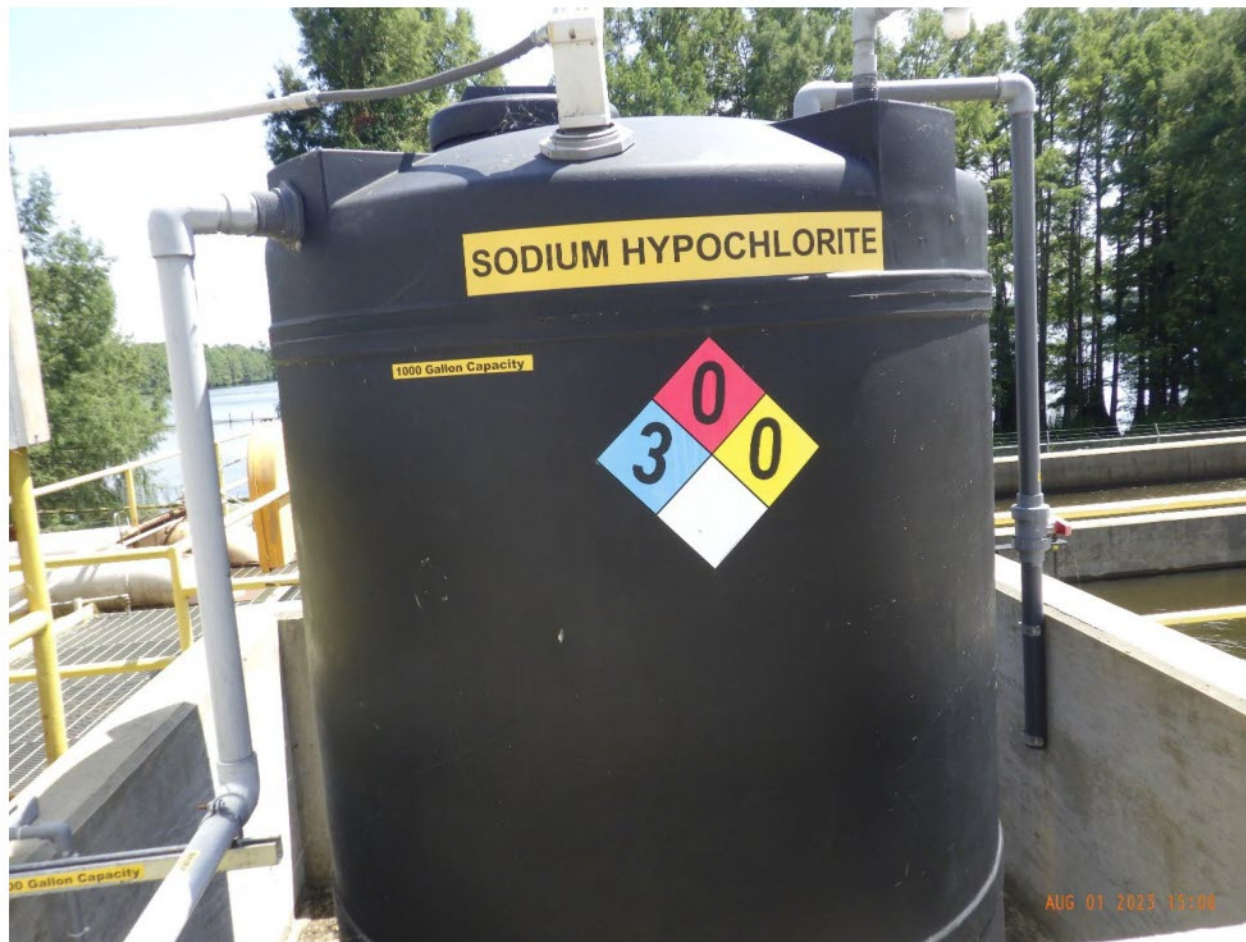
Facility apply Sodium hypochlorite (bleach) to control and inhibit marine growth that could foul the condenser, piping, heat exchangers, and other equipment where the circulating water flow. I inspected the enclosing chemical process and found a leak on the pipe that formed part sodium hypochlorite's control system. I observed corrosion formation on pipe and areas that got in contact with sodium hypochlorite. This acid could produce irritations and burns on people. Also, it could cause carcinogenic effects on water. (See Photo Nos. 8 – 10 in Appendix 1).

Photograph File Name: R0010335.JPG  
Date of Photograph: 08/01/2023  
Latitude and Longitude: 32.704233, -93.961383  
Orientation: SE  
Map Datum: WGS-84  
Time of Photo: 3:08 PM  
Photographer: Jack Arias  
Description:

This image shows the sodium hypochlorite tank that form part of the bleaching system to control and inhibit marine growth that could foul the condenser, piping, heat exchangers, and other equipment.

Facility needs to fix the leak and later provide information and pictures that demonstrate the corrective action.

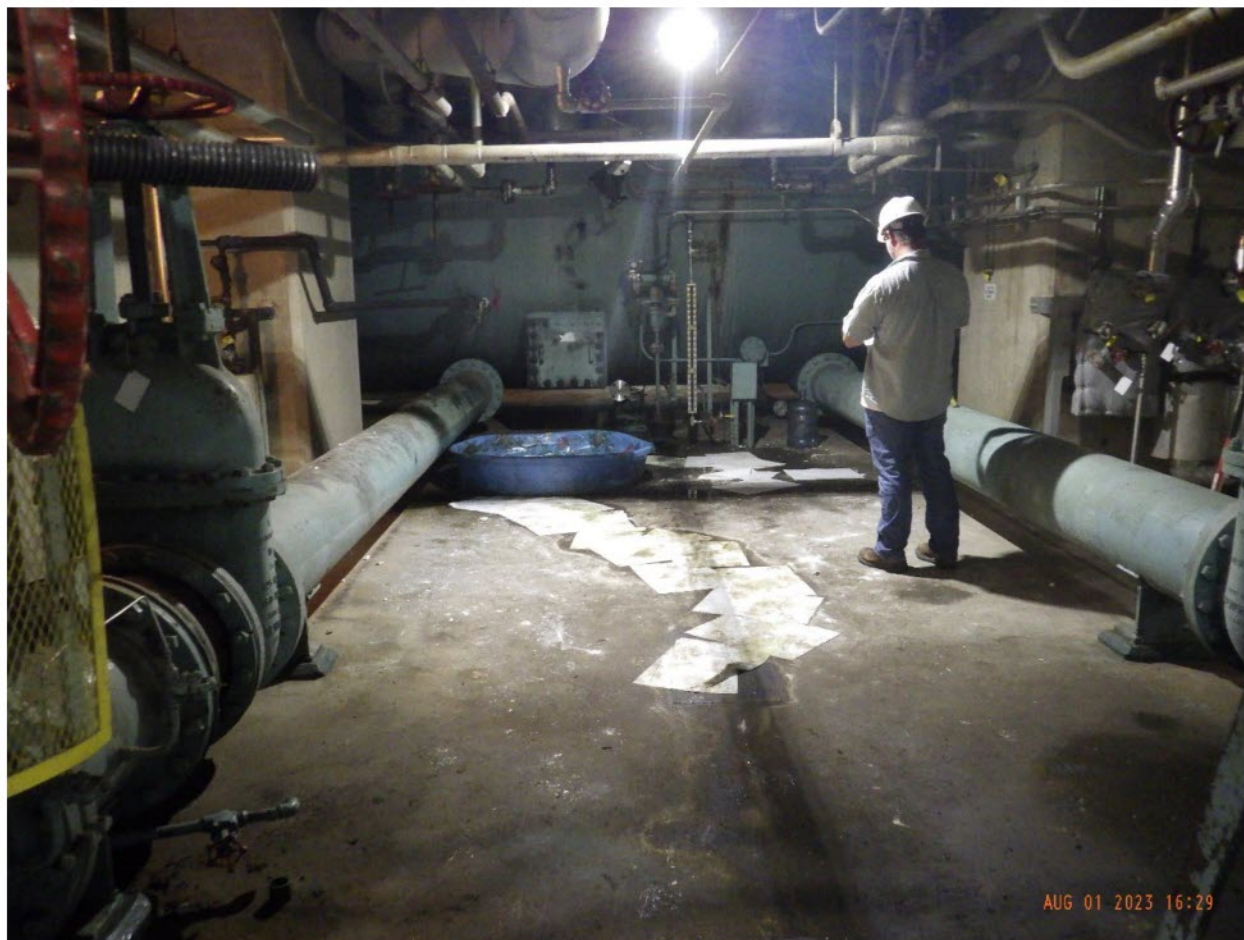
Photograph File Name: R0010390.JPG  
Date of Photograph: 08/01/2023  
Latitude and Longitude: 32.704363, -93.960933  
Orientation: S  
Map Datum: WGS-84  
Time of Photo: 4:29 PM  
Photographer: Jack Arias  
Description: This image shows a minor oil spill near the condenser cooling operation pipes.

6. Facility needs to fix the oil leak and later provide information and pictures that demonstrate the corrective action (requirement prescribed in section B, proper operation and maintenance, part 6 on page 51 of 64).

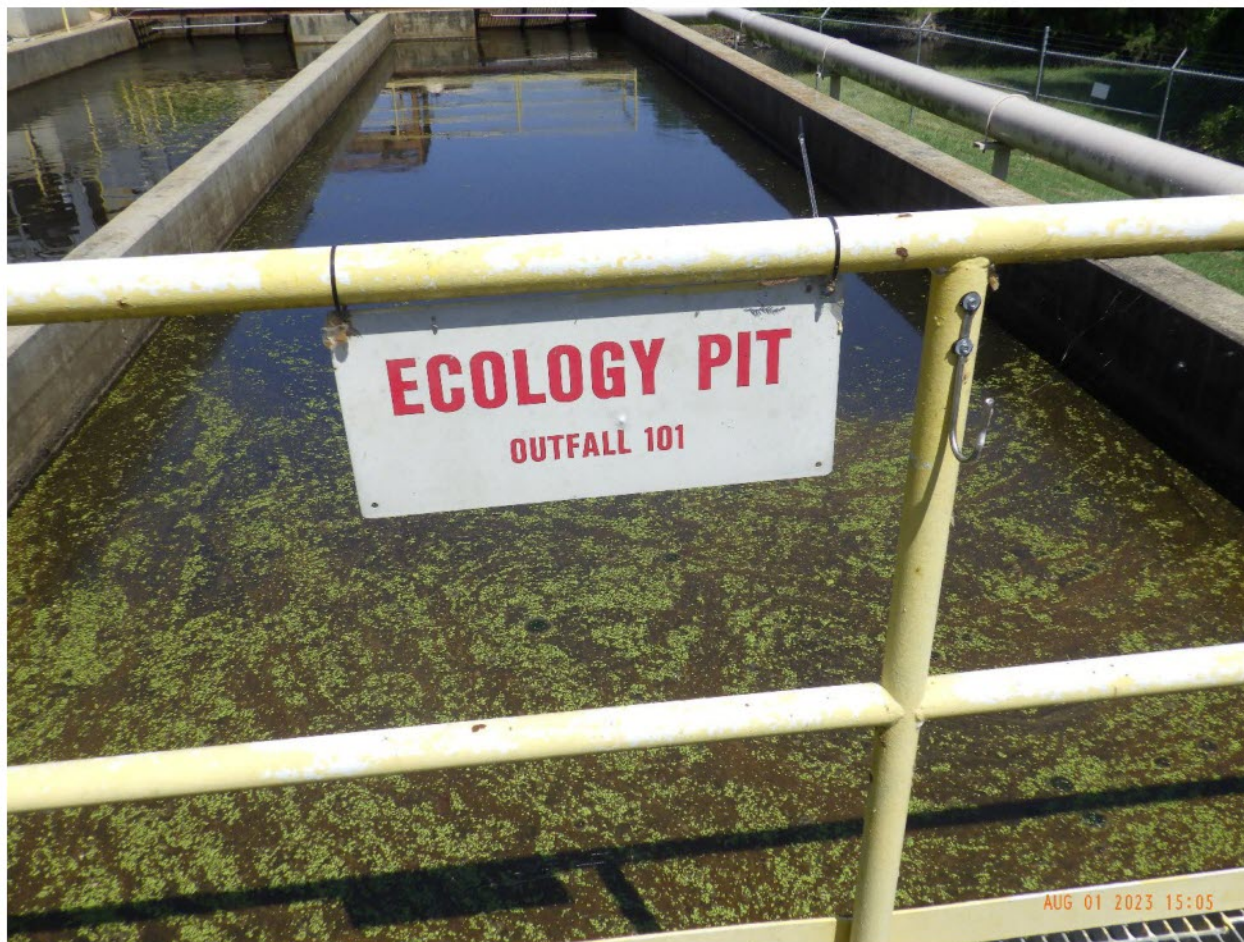
The facility uses the ecology pit as monitor location where wastewater is discharged and monitored by outfall 101 that checked pH, settling of solids, and oil water separation. This is completed before wastewater goes to the seal well and eventually to outfall 001. I observed some vegetation and algae formation on the wastewater surface on the ecology pit. Also, I observed sediments accumulation inside the ecology's pit structure. These formations and sediment accumulation could impact the integrity of the system and the monitoring activities of pH, settling and accumulation of solids, oil/water separation, and removal of sediments (See Photo Nos. 23 – 24 in Appendix 1).

Photograph File Name: R0010331.JPG  
Date of Photograph: 08/01/2023  
Latitude and Longitude: 32.704143, -93.961603  
Orientation: E  
Map Datum: WGS-84  
Time of Photo: 3:05 PM  
Photographer: Jack Arias  
Description: This image shows sediments accumulation, vegetation and algae formation on the wastewater surface on the ecology pit.

Facility needs to provide specific information about the annual integrity inspection and maintenance of the ecology pit. Also, facility needs to correct the algae/vegetation formations, flow wastewater diagram and update information in the permit.

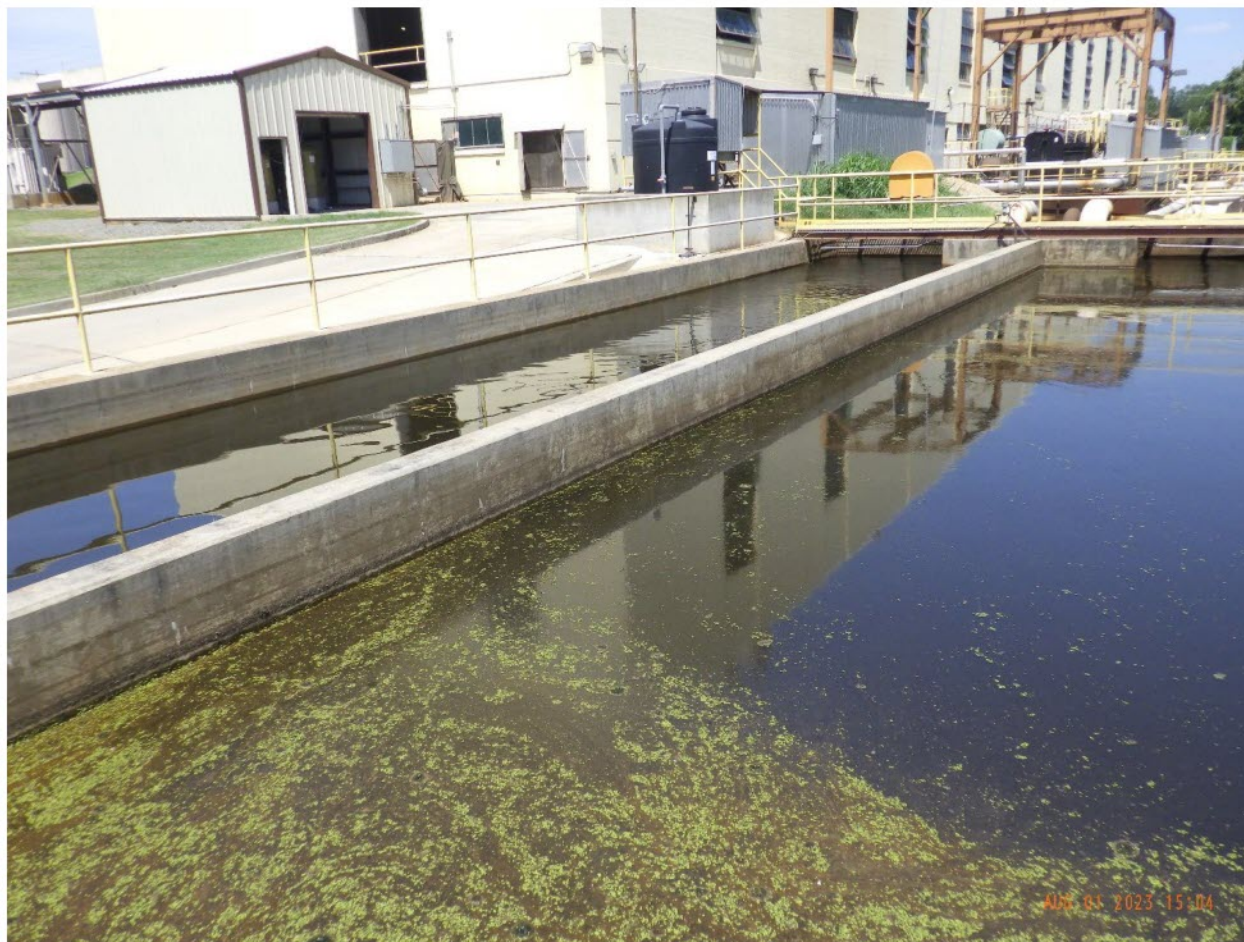
Photograph File Name: R0010328.JPG  
Date of Photograph: 08/01/2022  
Latitude and Longitude: 32.704143, -93.961603  
Orientation: E  
Map Datum: WGS-84  
Time of Photo: 3:04 PM  
Photographer: Jack Arias  
Description: This image shows sediments accumulation, vegetation, and algae formation on the wastewater surface on the ecology pit.

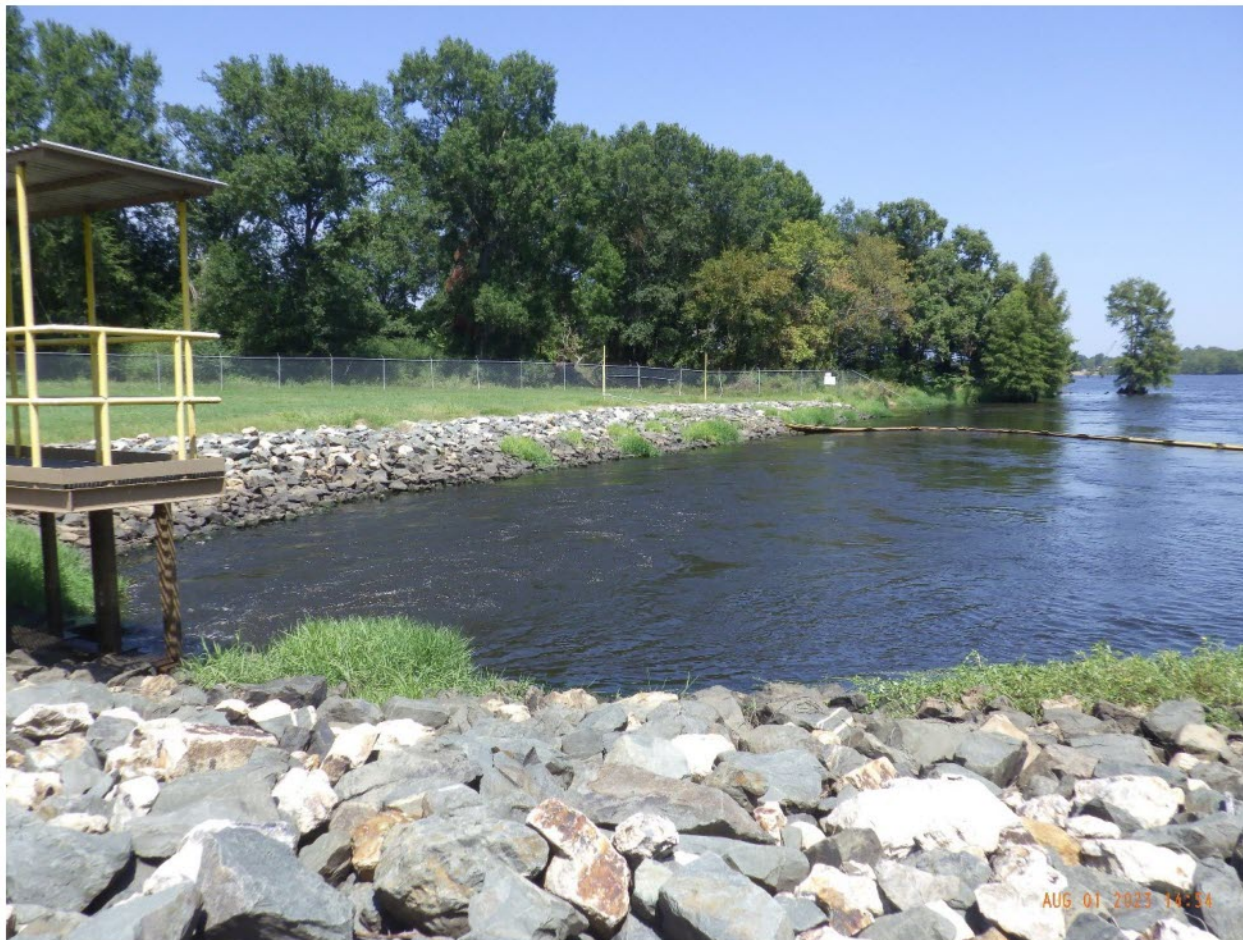
I observed that the sampling location for outfall 001 was not established properly in the permit. The sampling location is not representative. This sampling location should be where there is an effluent discharge where no receiving water is available and prior to mixing with other waters such as Cado Lake. According to the effluent limitations and monitoring requirements RLP 2 Outfall 001 on the permit, cooling wastewater should be monitored and determined low volume wastewater from the internal outfall 101 before discharge to outfall 001 (See Photo No. 1 in Appendix 2). Therefore, the wastewater samples should be taken from an effluent discharge location where no receiving water is available and prior to mixing with other waters such as Cado Lake. The wastewater is mixing with Caddo lake waters and potentially the sampling location is not representative. Also, unit #3 Boiler blowdown, unit #2 boiler blowdown, and unit #2 hydrogen cooler wastewater are not monitored or analyzed prior to outfall 001. These unit's wastewater could alter and impact the analysis and sampling results from the biomonitoring activities and chemical specific limit from outfall 001 (See Photo Nos. 29 – 31 in Appendix 1).

Photograph File Name: R0010325.JPG  
Date of Photograph: 08/01/2023  
Latitude and Longitude: 32.7043226, -93.9582014  
Orientation: SW  
Map Datum: WGS-84  
Time of Photo: 2:54 PM  
Photographer: Jack Arias  
Description: This image shows outfall 001 and sampling location for outfall 001. Receiving water is available and mixing with other water from Cado Lake.

Facility needs to provide detail information about the sampling methodology at outfall 101 and outfall 001. Also, facility needs to develop a plan (for unit #3 Boiler blowdown, unit #2 boiler blowdown, and unit #2 hydrogen cooler) that will identify a new sampling location for outfall 001 and monitor potential contamination and low volume of wastewater from non-contact cooling water from boiler blowdowns and cooler process before discharge to outfall 001 and prior to mixing with other waters such as Cado Lake. Also, this information must be updated in the permit.

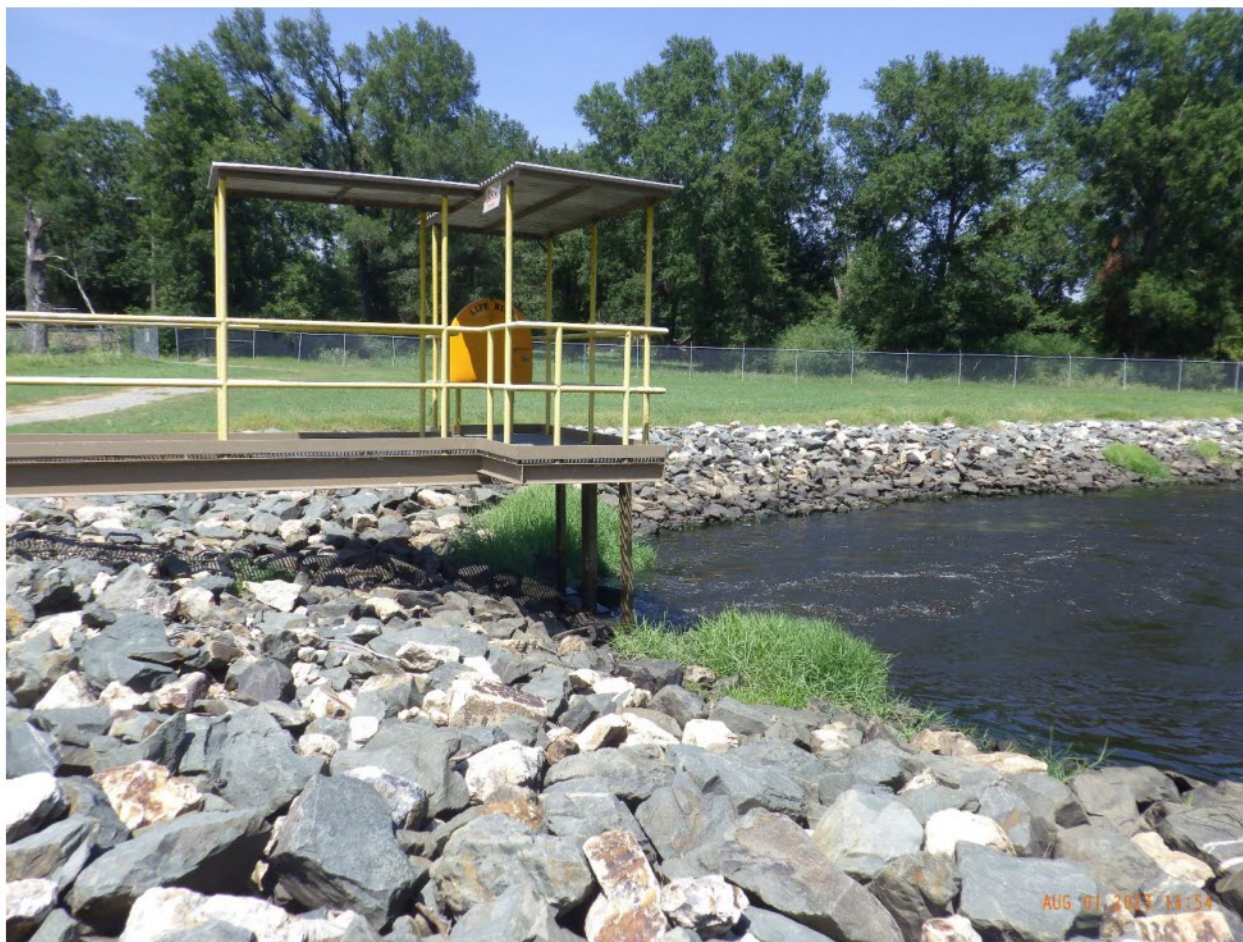
Photograph File Name: R0010324.JPG  
Date of Photograph: 08/01/2023  
Latitude and Longitude: 32.7043226, -93.9582014  
Orientation: SW  
Map Datum: WGS-84  
Time of Photo: 2:54 PM  
Photographer: Jack Arias  
Description: This image shows an approximation to outfall 001 and sampling location for outfall 001.

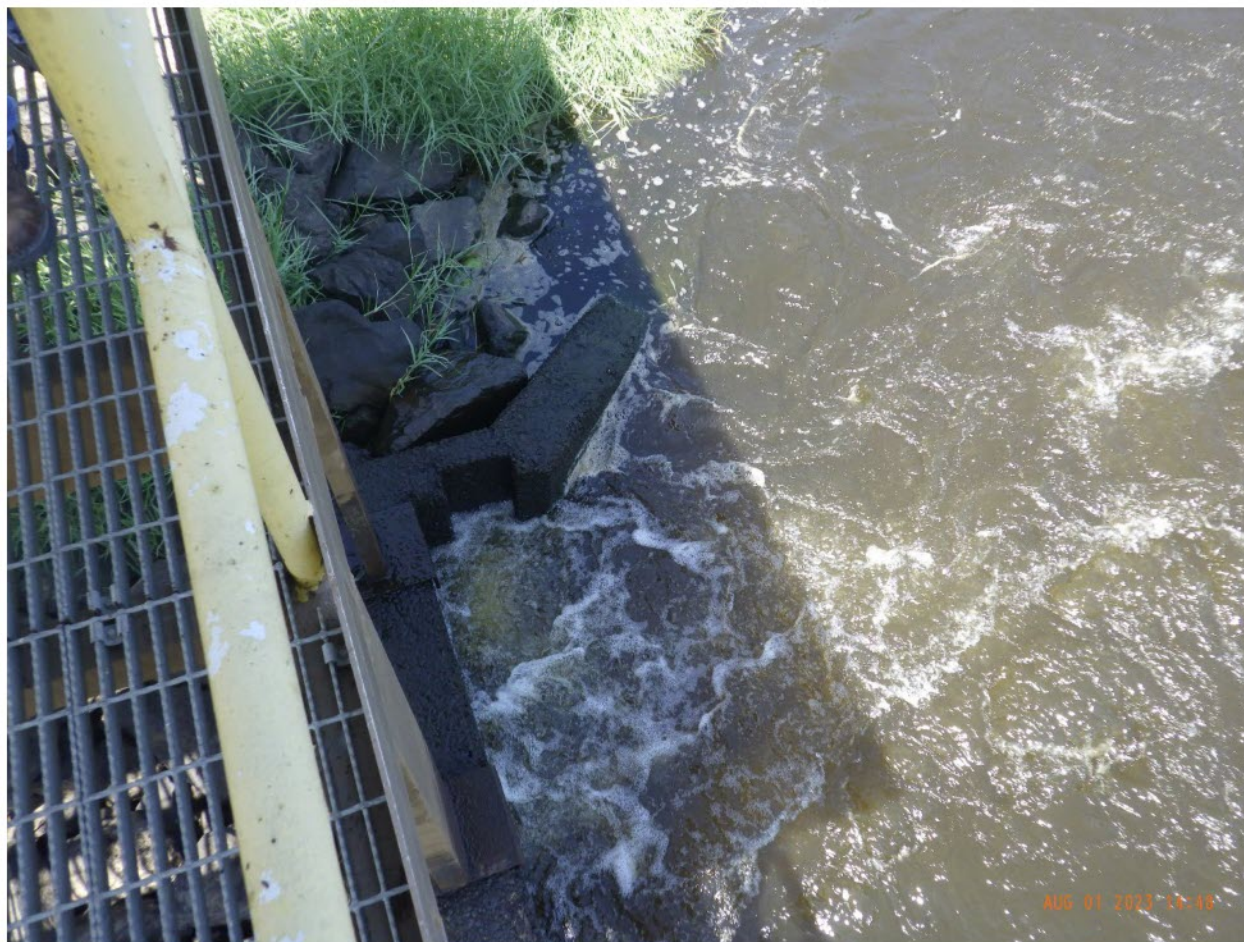
Photograph File Name: R0010320.JPG  
Date of Photograph: 08/01/2023  
Latitude and Longitud: 32.7043226, -93.9582014  
Orientation: SW  
Map Datum: WGS-84  
Time of Photo: 2:48 PM  
Photographer: Jack Arias  
Description: This image shows an approximation of sampling location for outfall 001.

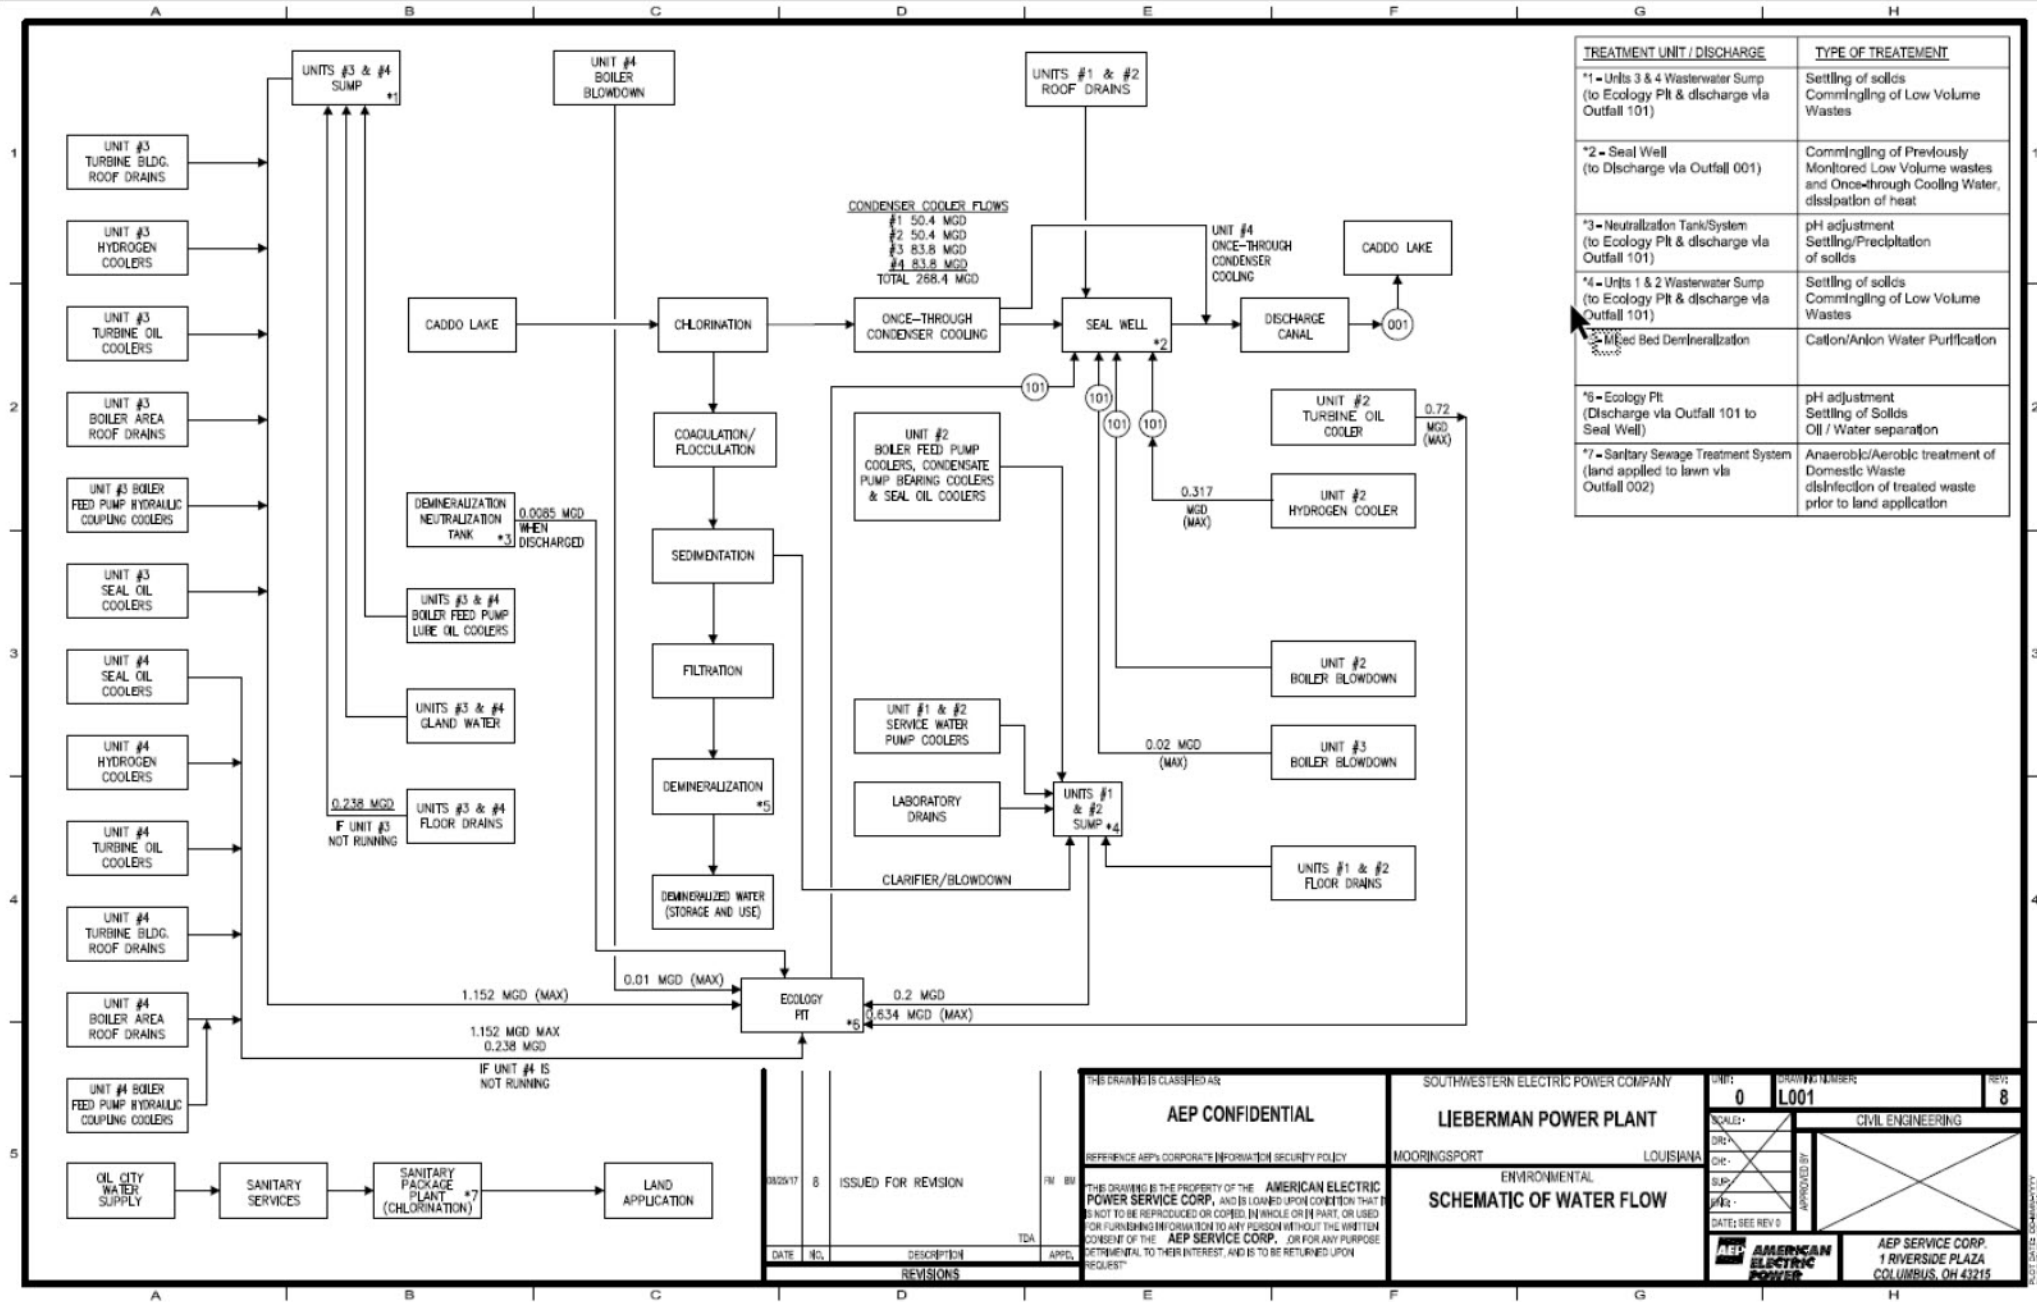
## Storm Water Site Plan

Also, I found that the outfall 101 sampling location on the facility's flow wastewater diagram is incorrect. (See Photo No. 1 in Appendix 2).

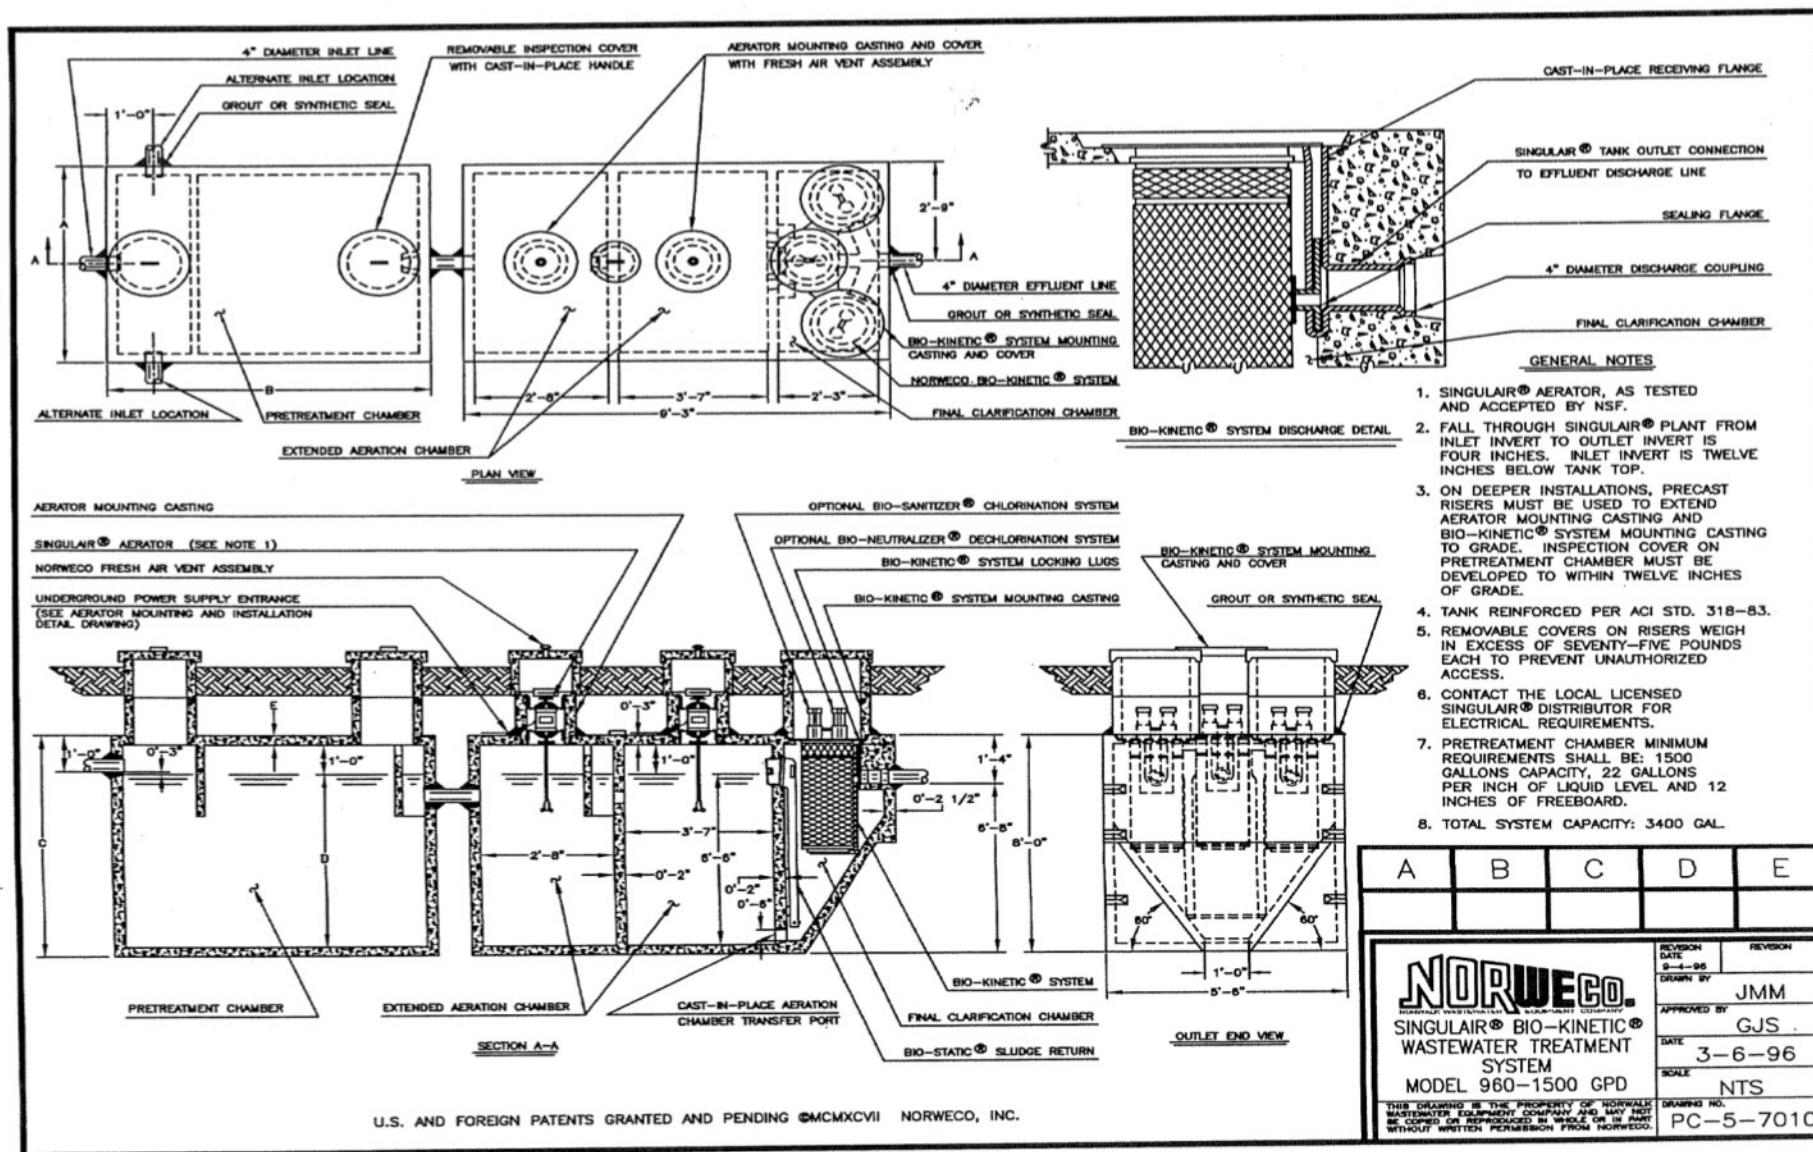
# Photo No. 2 Sanitary Wastewater Treatment System

A spray irrigation system was installed at the facility to land apply treated sanitary wastewater. The permit does not authorize the discharge or treated sanitary wastewater. At the time of the inspection sanitary system was covered with grass and debris, and a spray sprinkle was not working properly. Maintenance could avoid potential discharges of untreated sanitary wastewater into caddo Lake (See Photo No. 2 in

Appendix 2). Facility needs to provide a copy of the of the inspection report from JDW construction INC that agrees to inspect the facility sanitary system two times a year. We need a copy of inspection report for February 2023 and August 2023. Also, facility needs to provide a picture the corrective action to fix the spray sprinkle (See Photo Nos. 32 – 34 in Appendix 1).

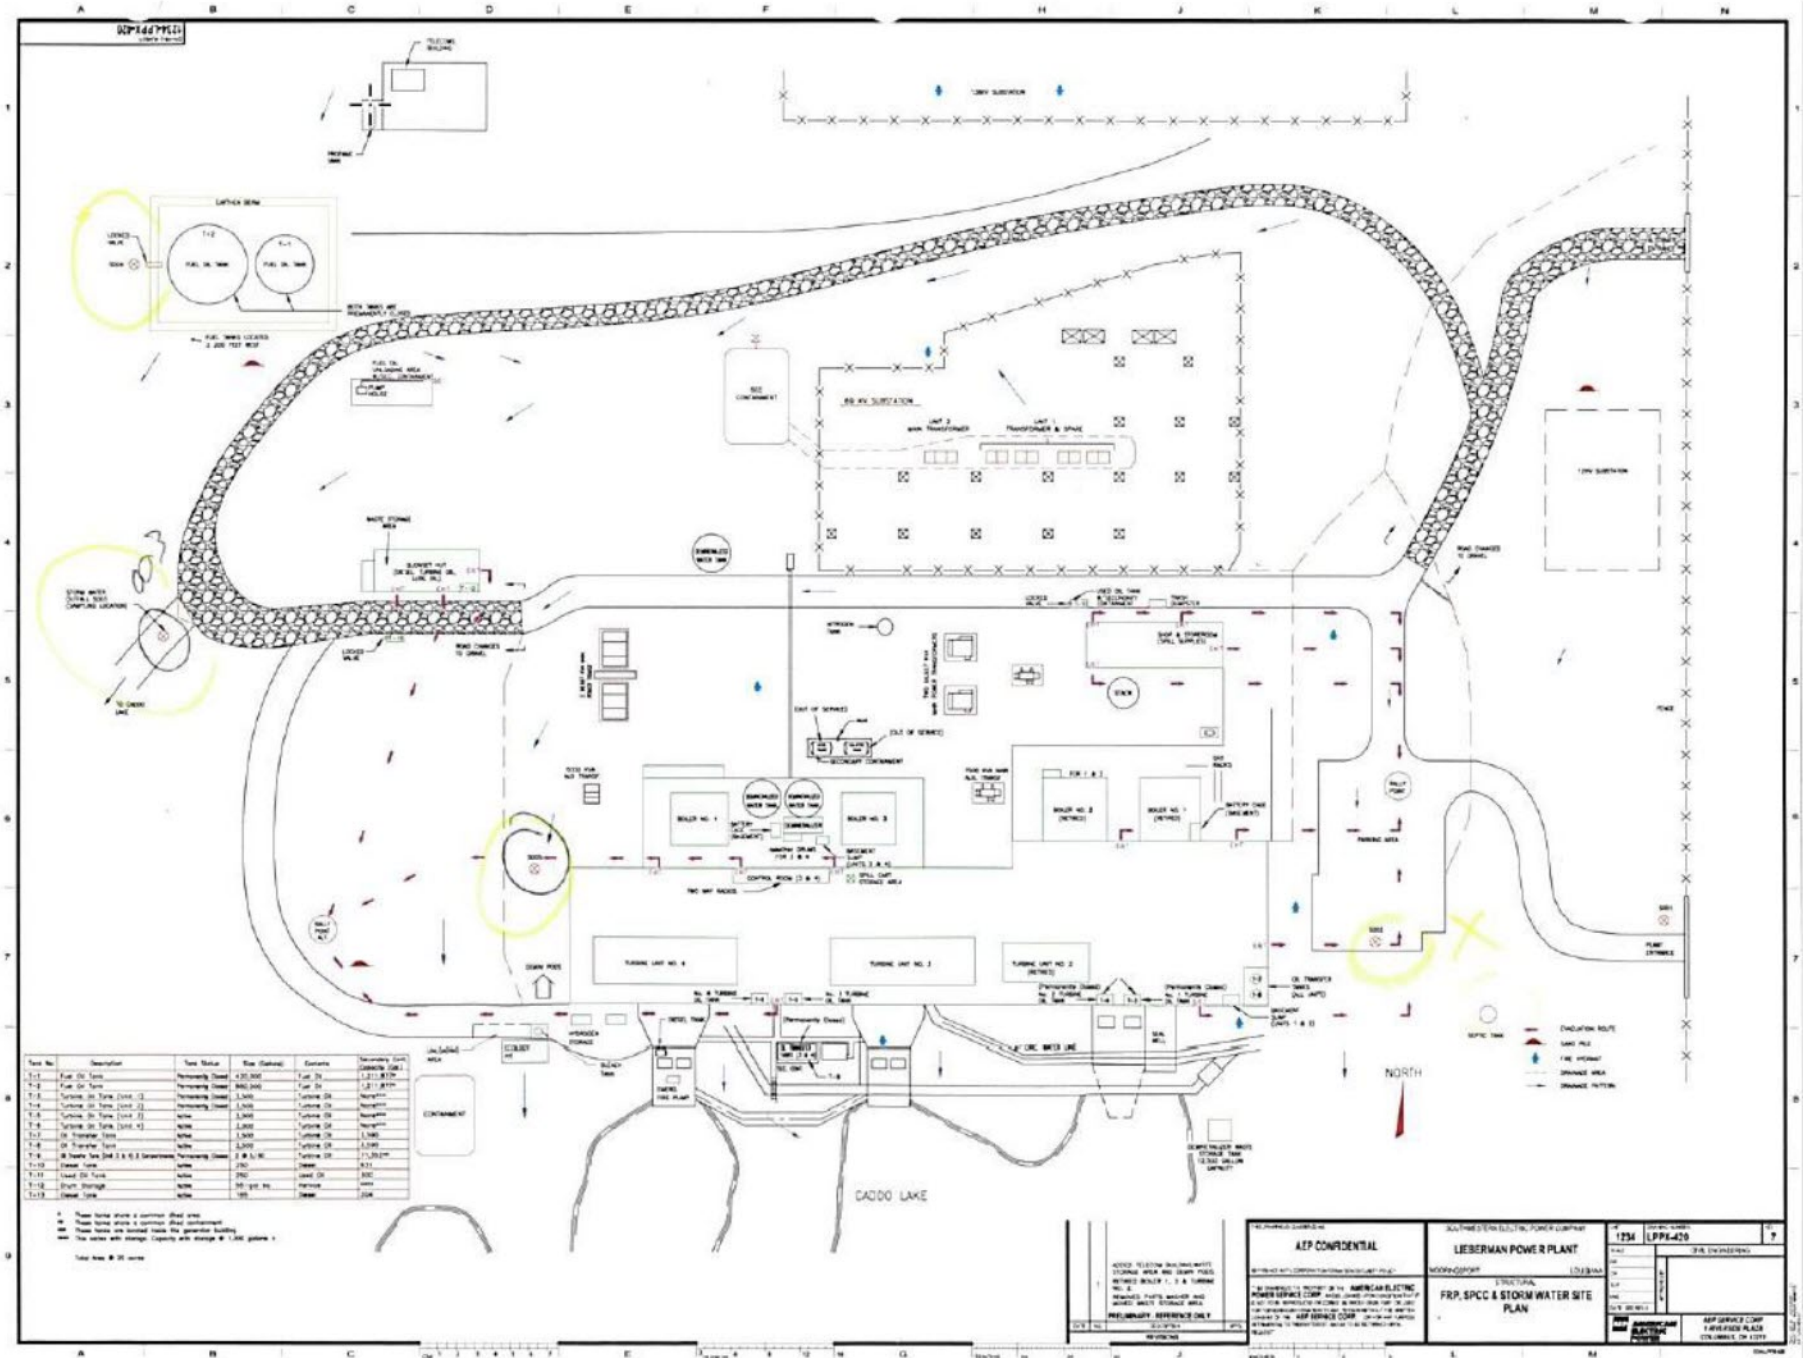
# Photo No.3 Storm Water Site Plan

Stormwater discharges were covered under multisector general permit (LAR05N078) until September 6, 2016. After 2016, the facility should incorporate stormwater discharges into this permit. Also, I observed that Outfall 002 is not active, but the information and diagram are not update in the FRP, SPCC, and storm water plan in the permit. So, facility needs to update and provide a detail information and diagrams of inactivity and the stormwater discharges into this permit according to other conditions section J of the permit (See Photo No. 3 in Appendix 2).

17. Facility needs to update and provide a detail information and diagrams of inactivity and the stormwater discharges into this permit according to other conditions section J of the permit (requirement prescribed in Section J, Storm Water Discharges on page 24 of 64).
