**CLEAN AIR ACT (CAA) § 112(r)(1) AND EMERGENCY PLANNING,  
COMMUNITY RIGHT-TO-KNOW ACT (EPCRA) § 312  
INSPECTION REPORT**

**Pitman Farms Salina Processing Plant  
Salina, Utah**

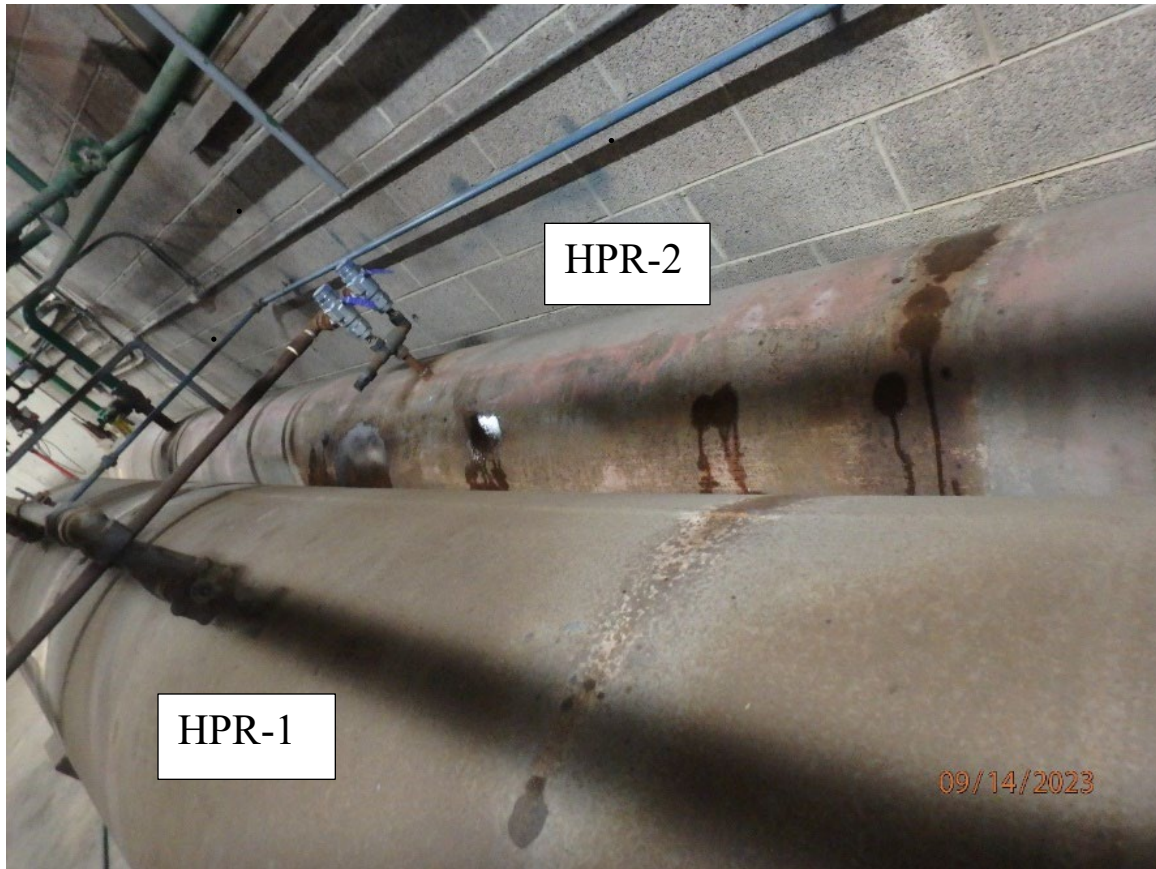
- 16. Copies of the annual inspections for the High-Pressure Receivers (HPR-1 and HPR-2) were requested for 2021, 2022, and 2023. The 3 annual checklists for HPR-2 indicates the nameplate is not legible and complete. The 2021-2023 annual checklists for both high-pressure receivers indicate “slight visible corrosion” even though the receivers have not had any protective coating (i.e. paint) applied since the 2017 inspection and corrosion was observed.**

**Photo 1. HPR-1 and HPR-2 corrosion**

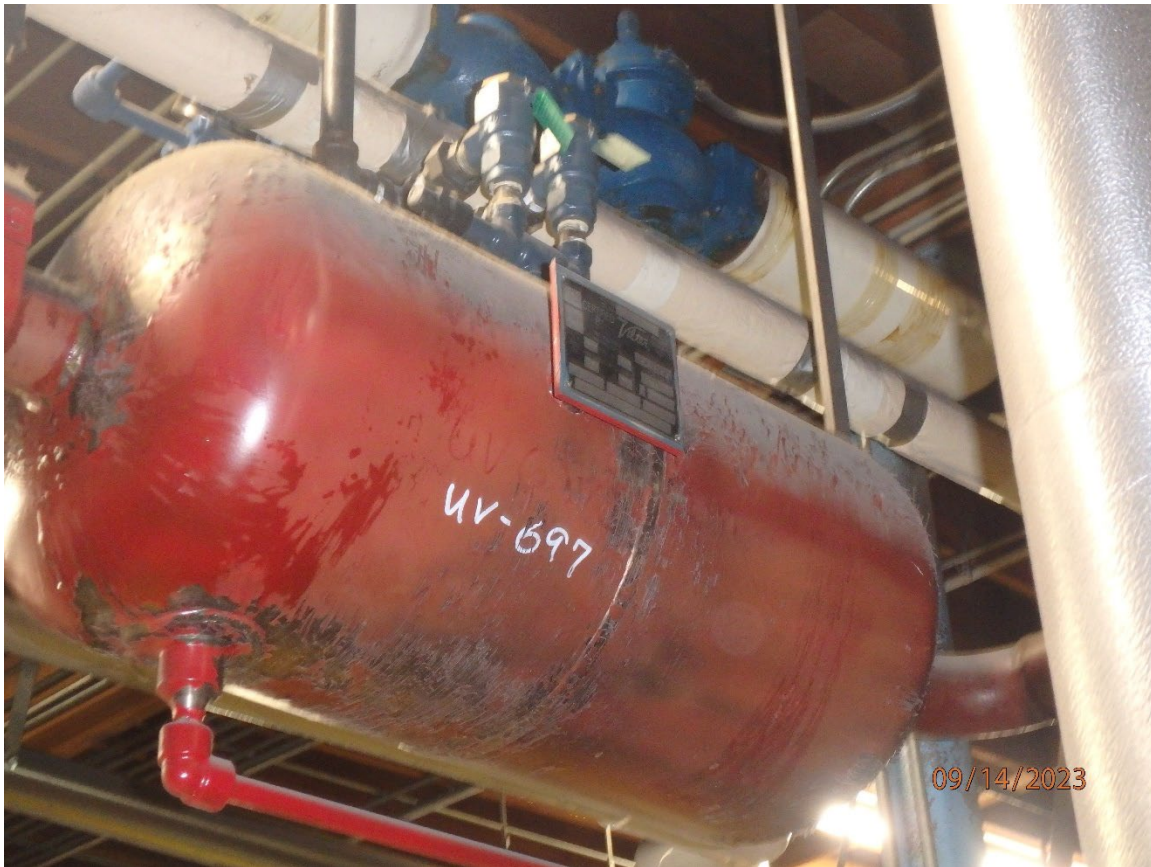
- 18. The facility provided checklists for the annual inspections for pressure vessels UV-697 (CV-6) and UV-691 (CV-3) for 2021, 2022, and 2023. All checklists had “no visible corrosion” checked for item j. Vessel condition. The 2023 inspections for these pressure vessels were conducted on 8/24/2023, which was 3 weeks prior to this EPA inspection. Visible corrosion of these pressure vessels was observed during the 9/14/2023 inspection. (See Photos 2 and 3.)**

**Photo 2. UV-697 visible corrosion**

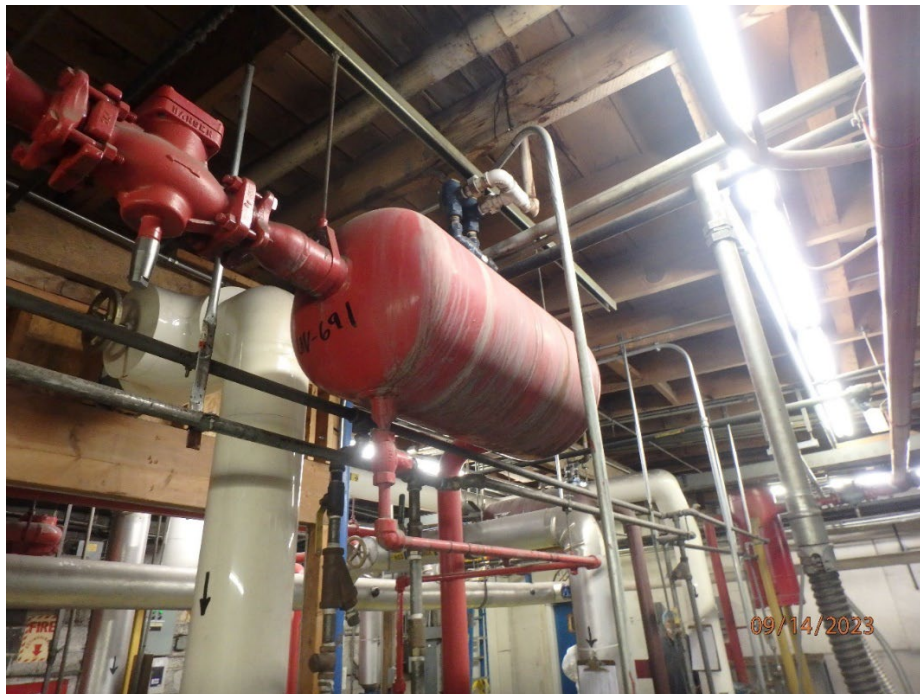
**Photo 3. UV-691 visible corrosion**
