## NPDES Inspection Report – Wastewater

| National Database Information | |
|---|---|
| Inspection Date: July 13, 2022 | Inspection Type: CEI - Wastewater Treatment Facility |

| Facility Location Information (Name/Location/ Mailing Address) | |
|---|---|
| Site/Facility Name & Location:<br>Little Eagle Community Lagoon (Also known as<br>Running Antelope)<br>S1 T8N R27E<br>Fort Yates, North Dakota 58538 | Mail Report to:<br>Randez Bailey<br><a href="mailto:rbailey@standingrock.org">rbailey@standingrock.org</a><br>Leon Spotted Bull<br><a href="mailto:leon.spottedbull@standingrock.org">leon.spottedbull@standingrock.org</a> |

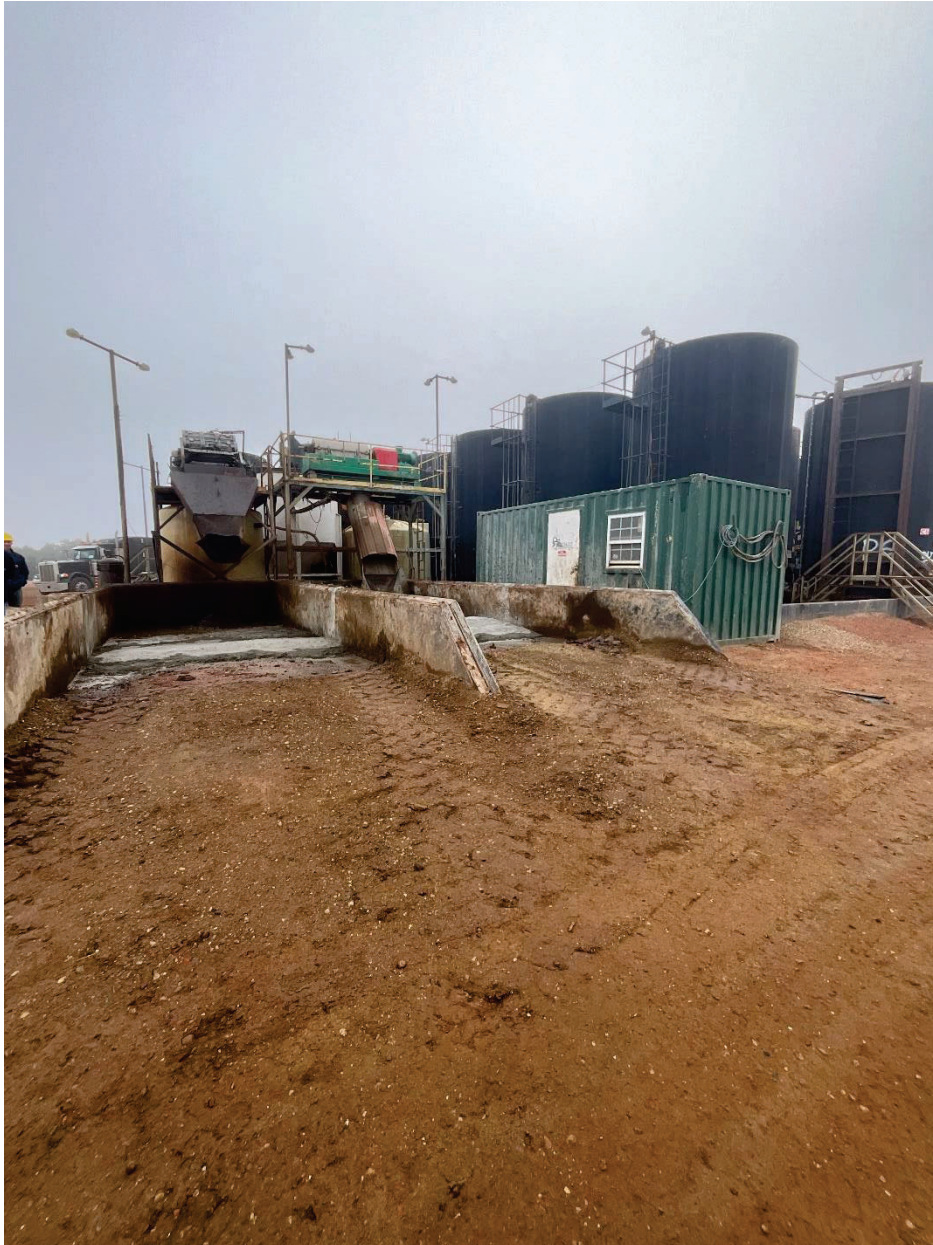
Photo 1: IMG\_0239.jpg, 9/17/2024, 9:56 a.m. – photo of shaker bins located near the northwest corner of the facility next to the centrifuge.

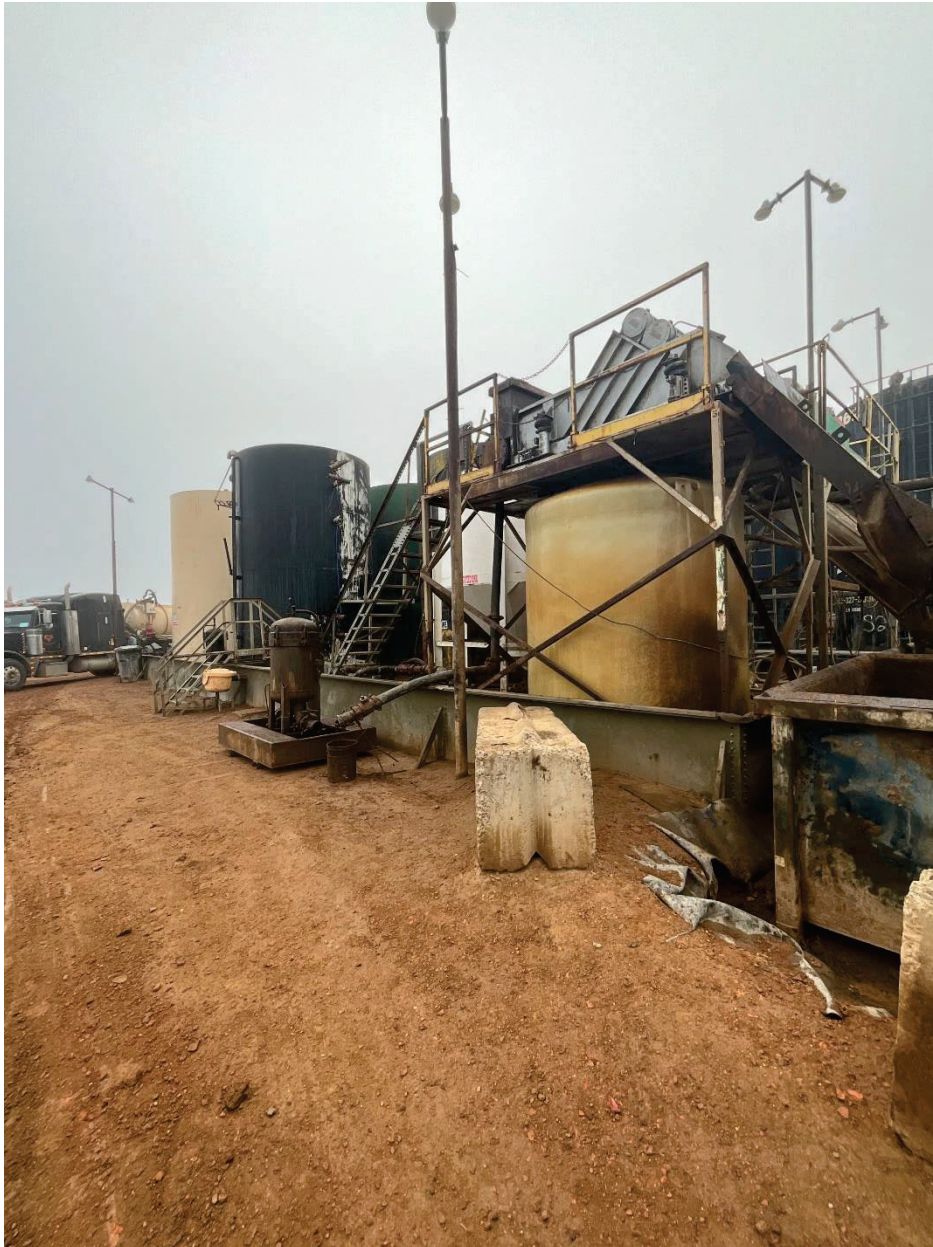
Photo 5: IMG\_0243.jpg, 9/17/2024, 9:57 a.m. – photo of the centrifuge, with the shaker bins shown in photo 1 visible at right.

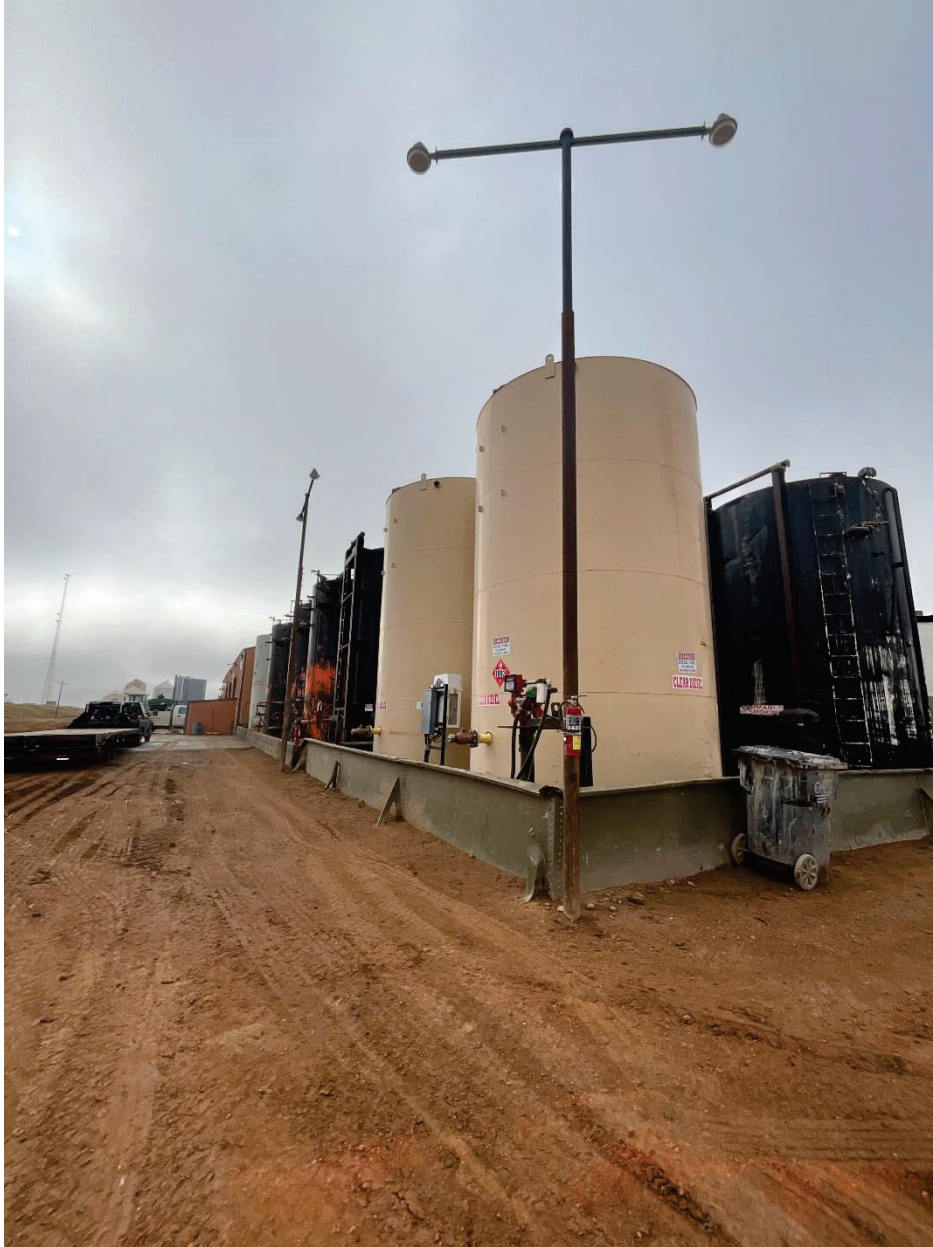
Photo 8: IMG\_0246.jpg, 9/17/2024, 11:39 a.m. – photo of the tank storage battery, taken facing south/southwest. A filter sock collection bin is visible in photo toward the right outside of the tank area secondary containment.

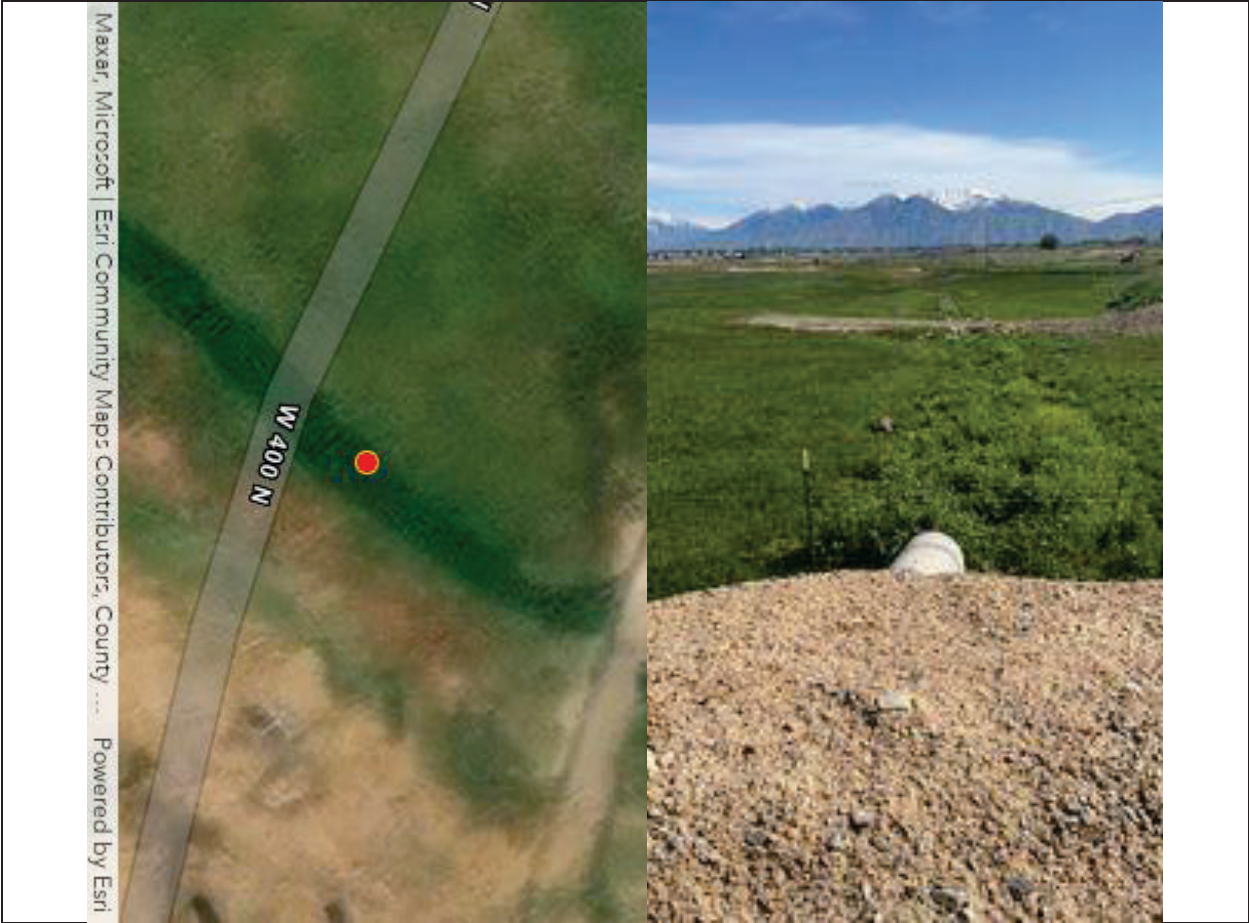
| | | <b>Photo #:</b> 1 | | IMG_20240502_100500 | |

| <b>Comments</b> | | Berm in foreground with a culvert installed that was not in the original permit. | | | |

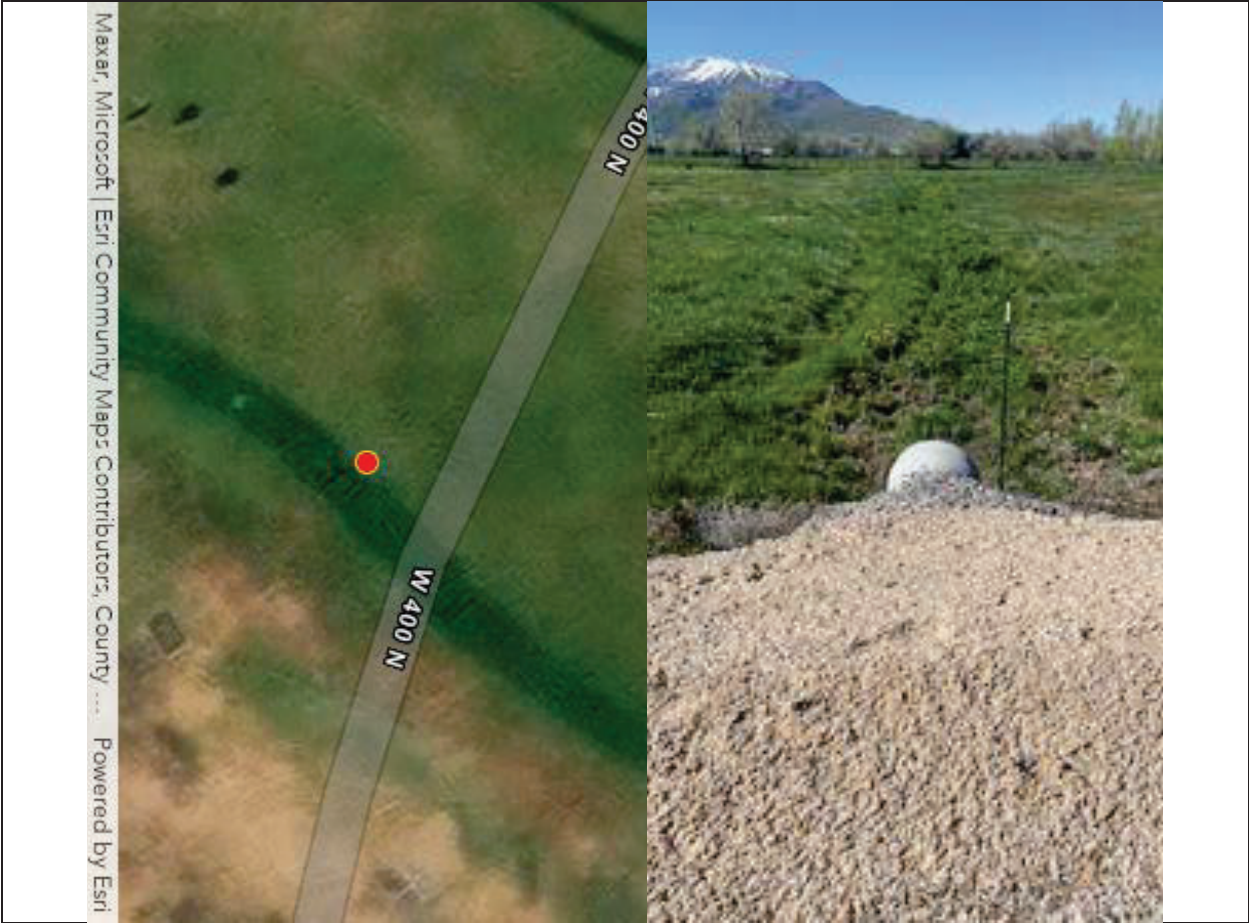
| <b>Photo #:</b> 2 | | IMG_20240502_100500 | |

| <b>Comments</b> | Southern portion of the berm and culvert identified in photograph 1. | | |

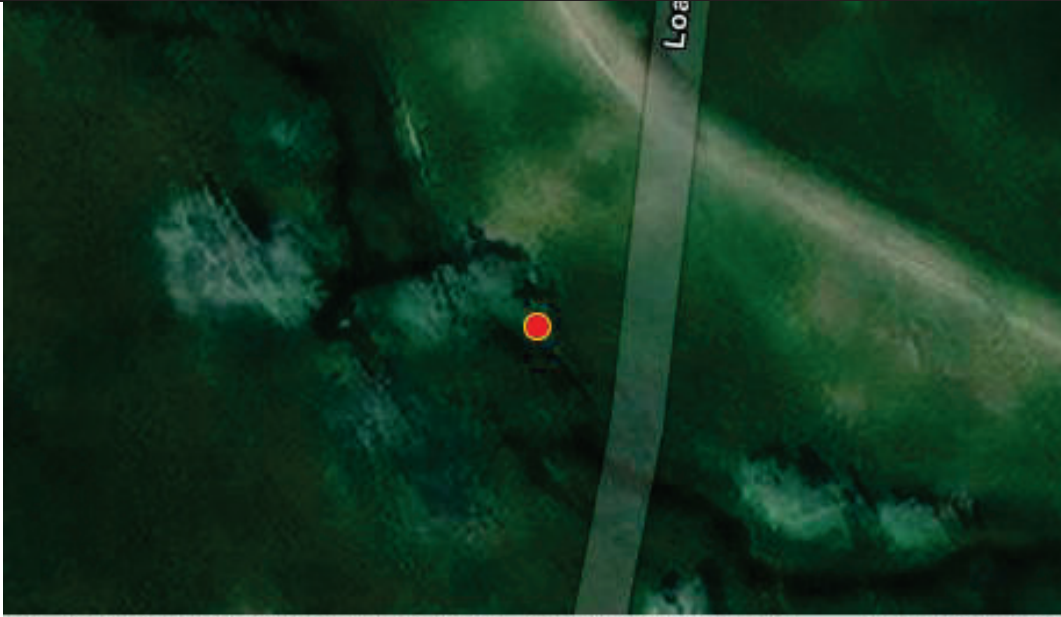
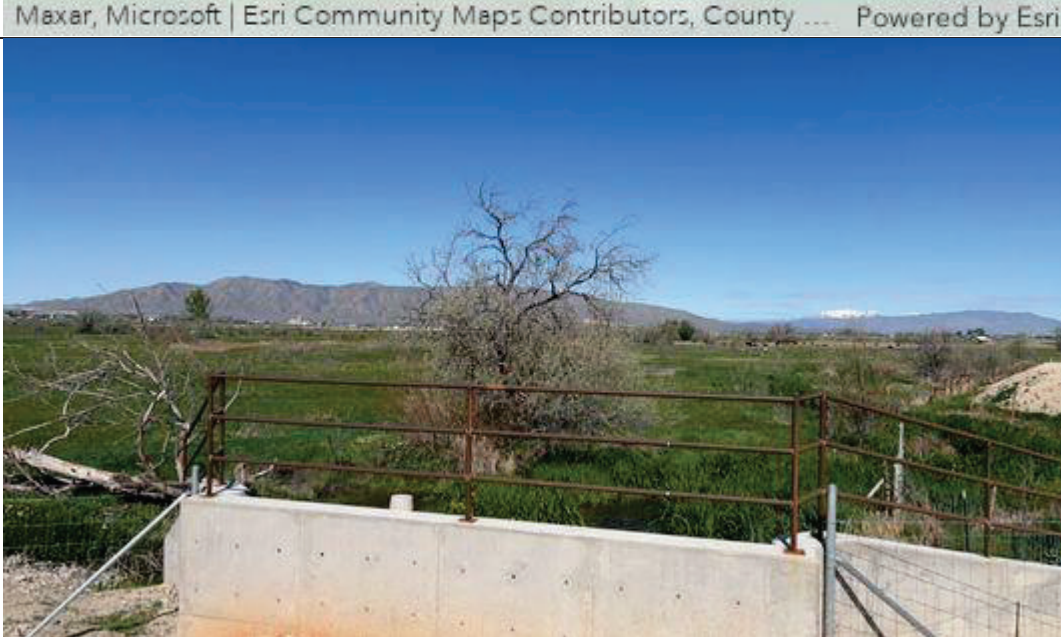
| <b>Photo #:</b> 3 | | IMG_20240502_100500 | |

| <b>Comments</b> | Approximate 16ft Box culvert on Beer Creek. | | |

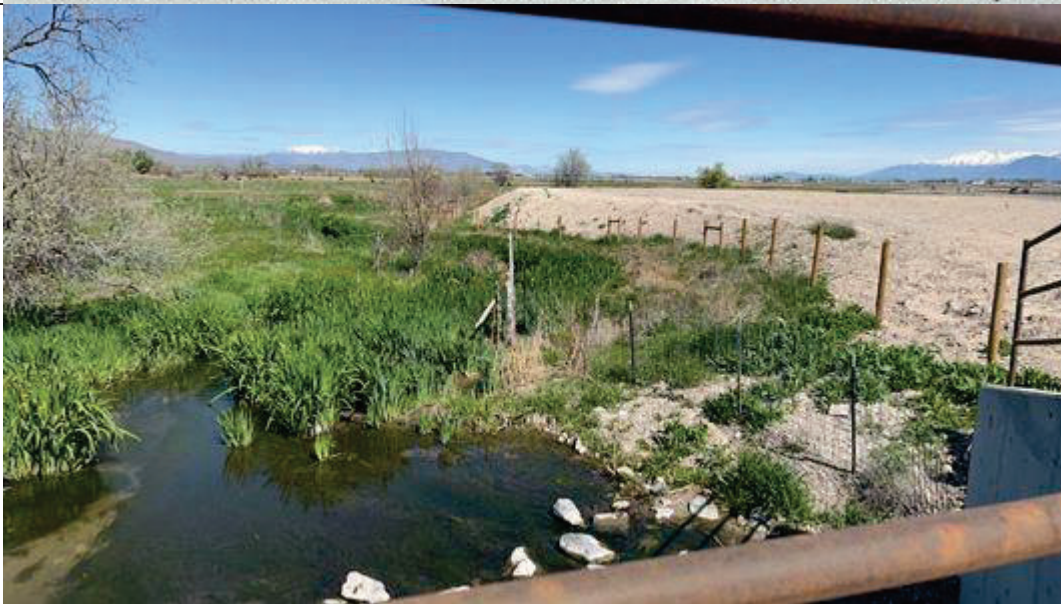
| <b>Photo #: 4</b> | | IMG_20240502_100500 | |

| <b>Comments</b> | Spoil pad that has spilled into the riparian and wetland area along Beer Creek. The fence was installed to keep cattle and people out. | | |

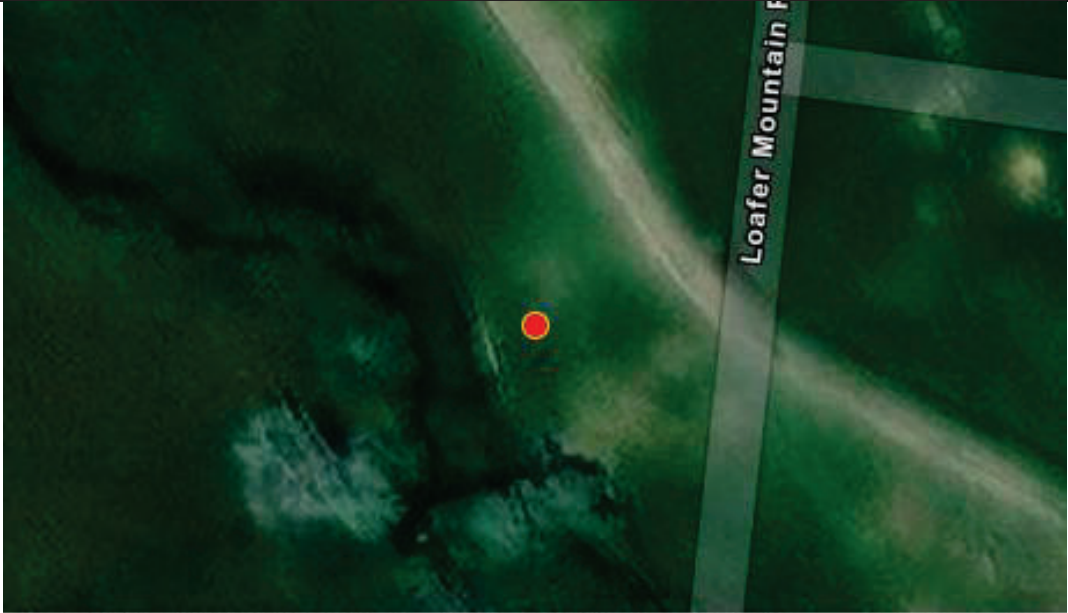
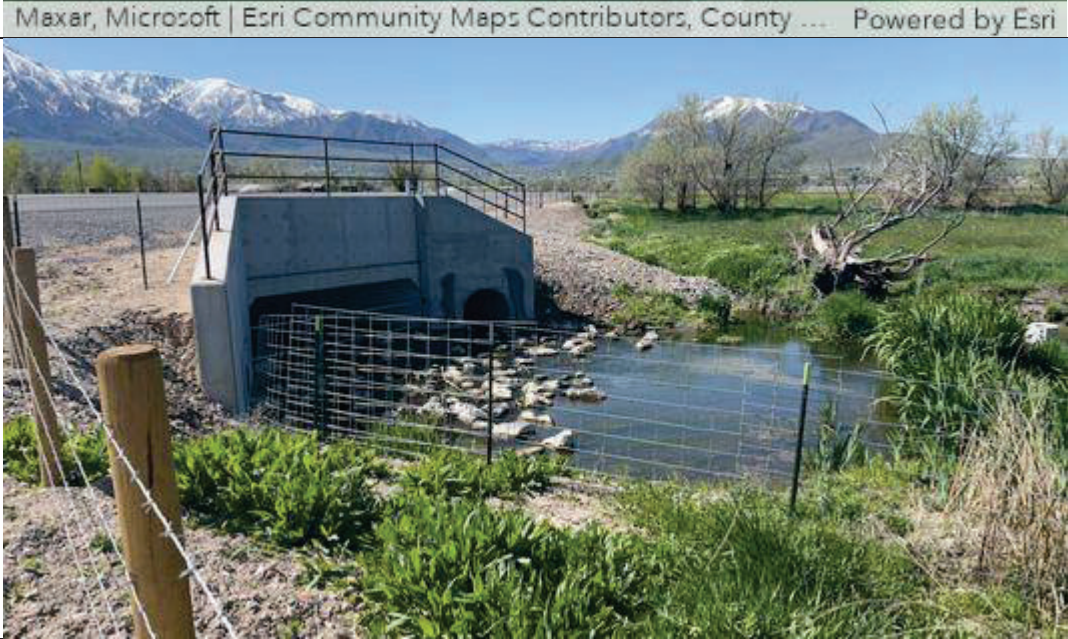
| <b>Comments</b> | Approximate 4ft x 10ft box culvert intentionally built below grade along Beer Creek. The culvert is approximately 10ft from bank to bank and was originally designed to be 10ft x 3ft but was extended to 4ft. The culvert installed on the side functions as a storm drain. | | |

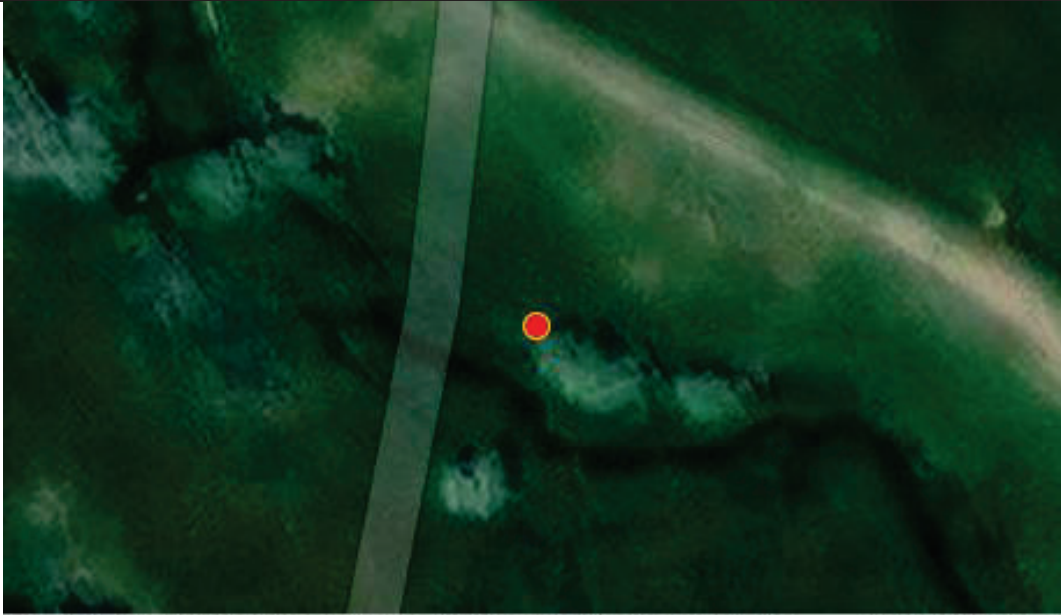
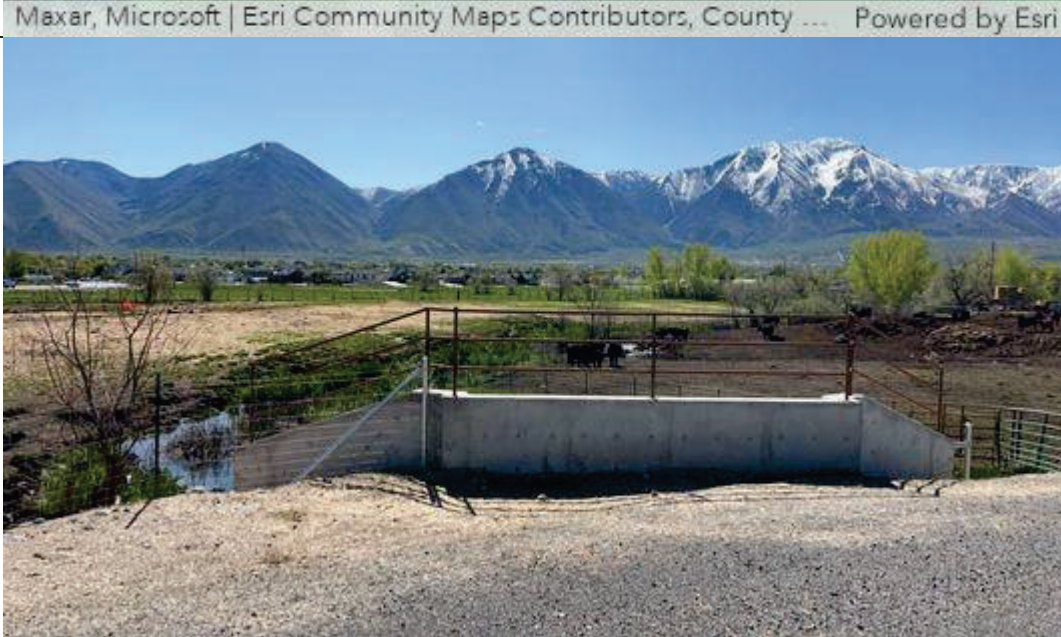
| <b>Photo #:</b> 6 | | IMG_20240502_100500 | |

| <b>Comments</b> | Striking east over the boxed culvert identified in photograph 5. | | |

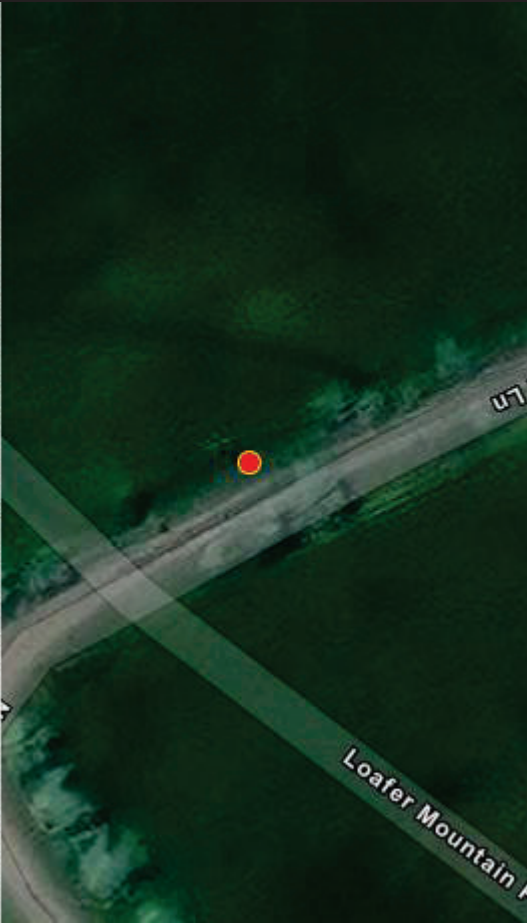
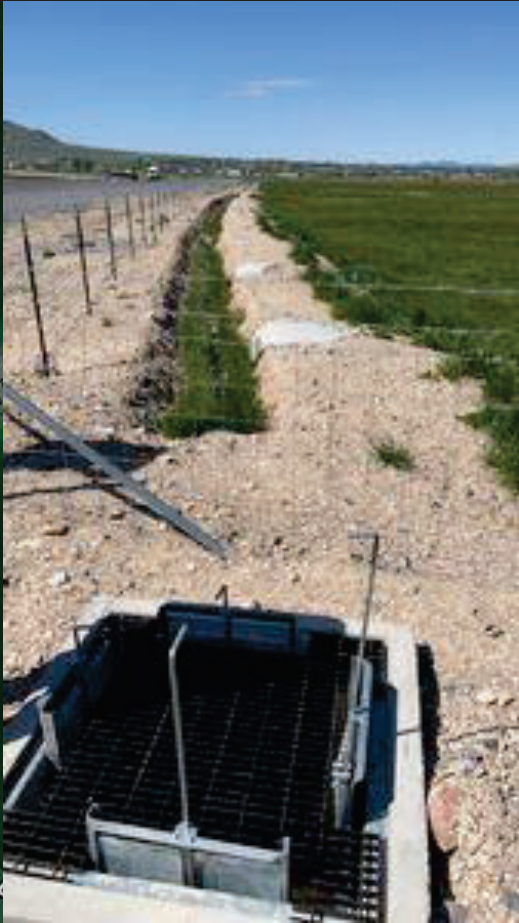
| <b>Comments</b> | In 2023, to appease a landowner, irrigation ditches were constructed along the roadway. Impacts occurred in Spring of 2023; the pre-construction notice and nationwide permit application was submitted in August 2023. | | |

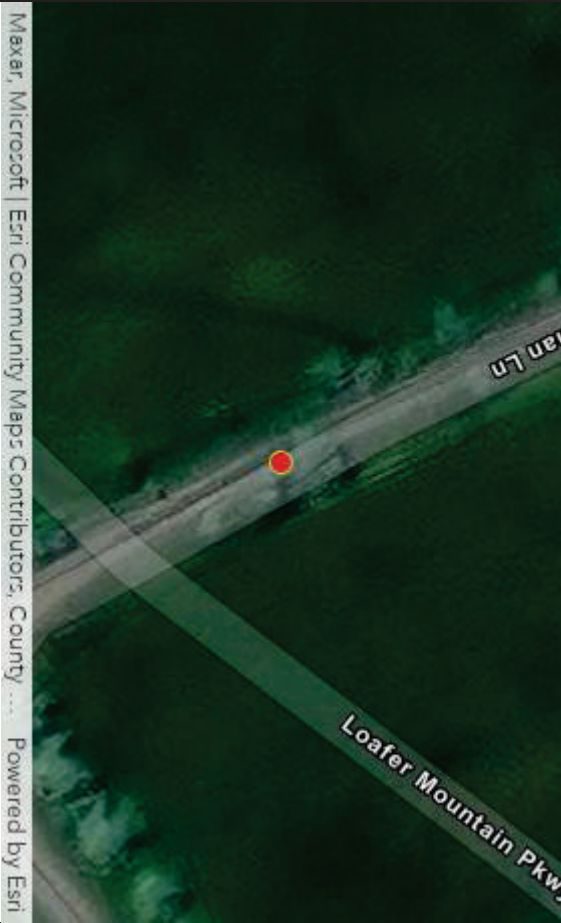
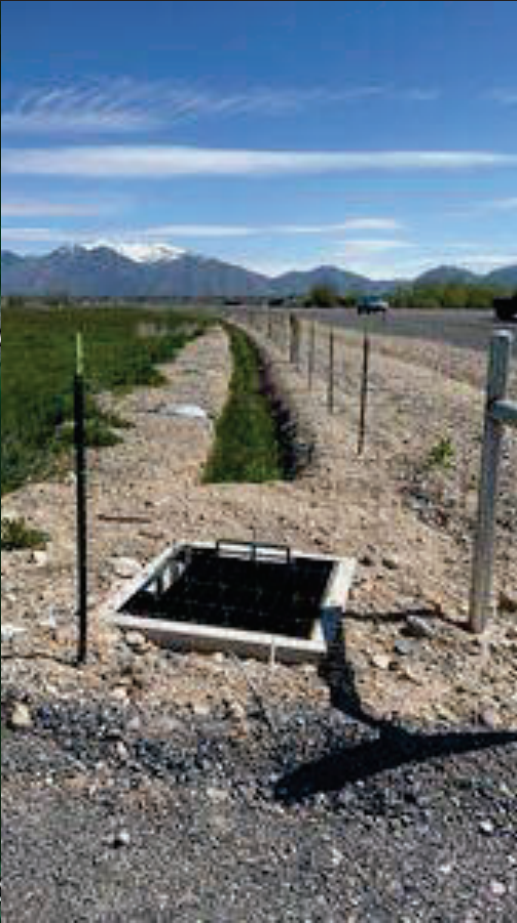
| <b>Comments</b> | In 2023, to appease a landowner, irrigation ditches were constructed along the roadway. Impacts occurred in Spring of 2023; the pre-construction notice and nationwide permit application was submitted in August 2023. | | |

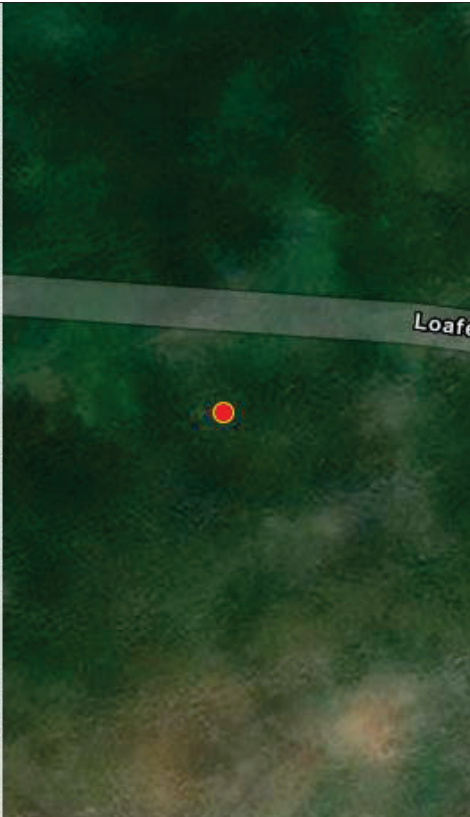
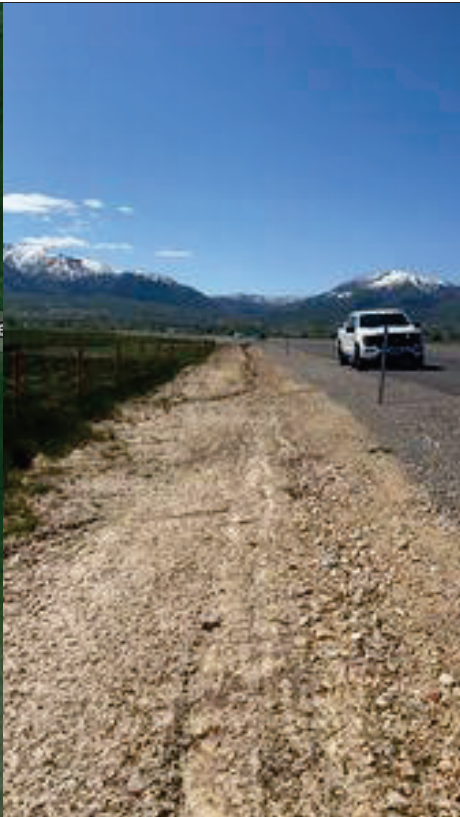
| Comments | The individual permit required retaining walls within wetland crossing areas to reduce the width to 64 feet. However, the completed roadway width did not incorporate retaining walls and fill slopes were constructed instead, in excess of 64 feet. | | |

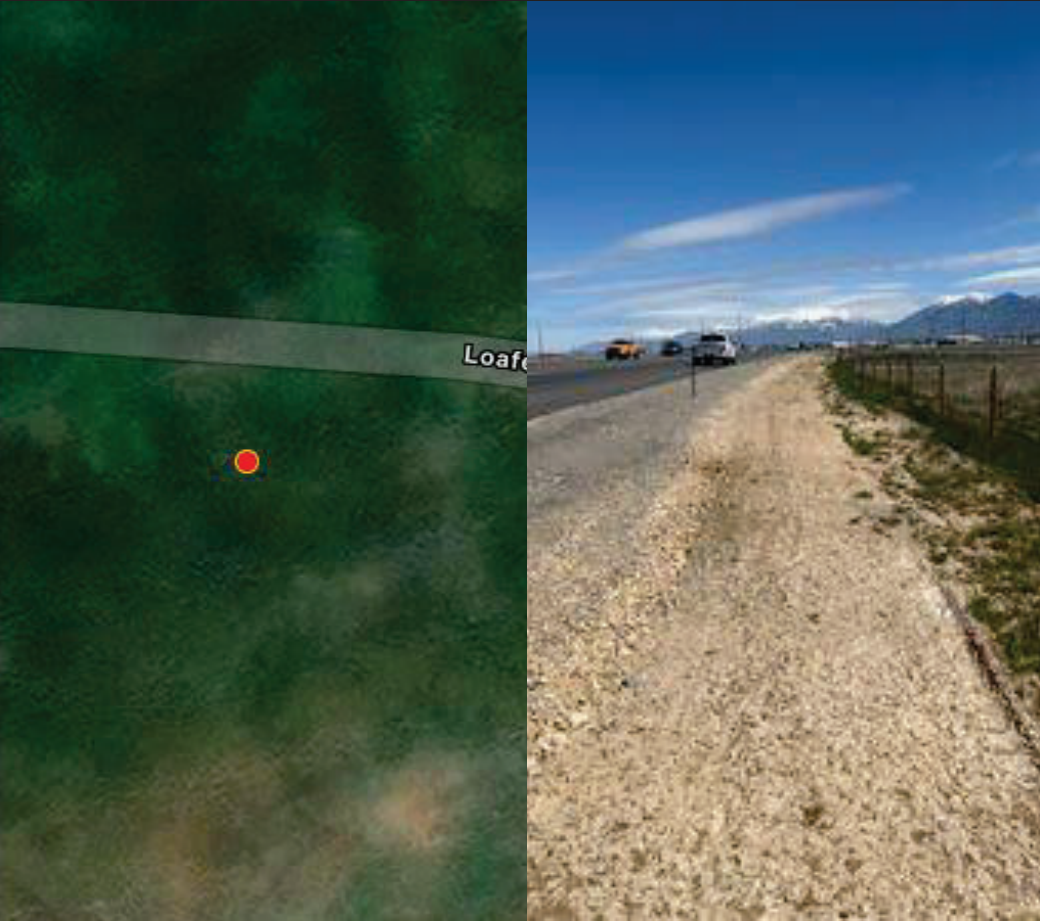
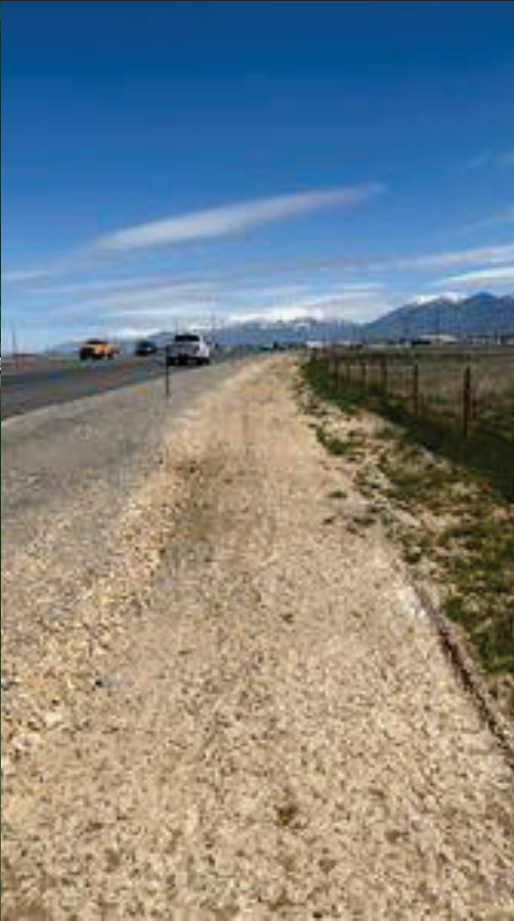
| Comments | Same as photograph 11 but striking north. | | |

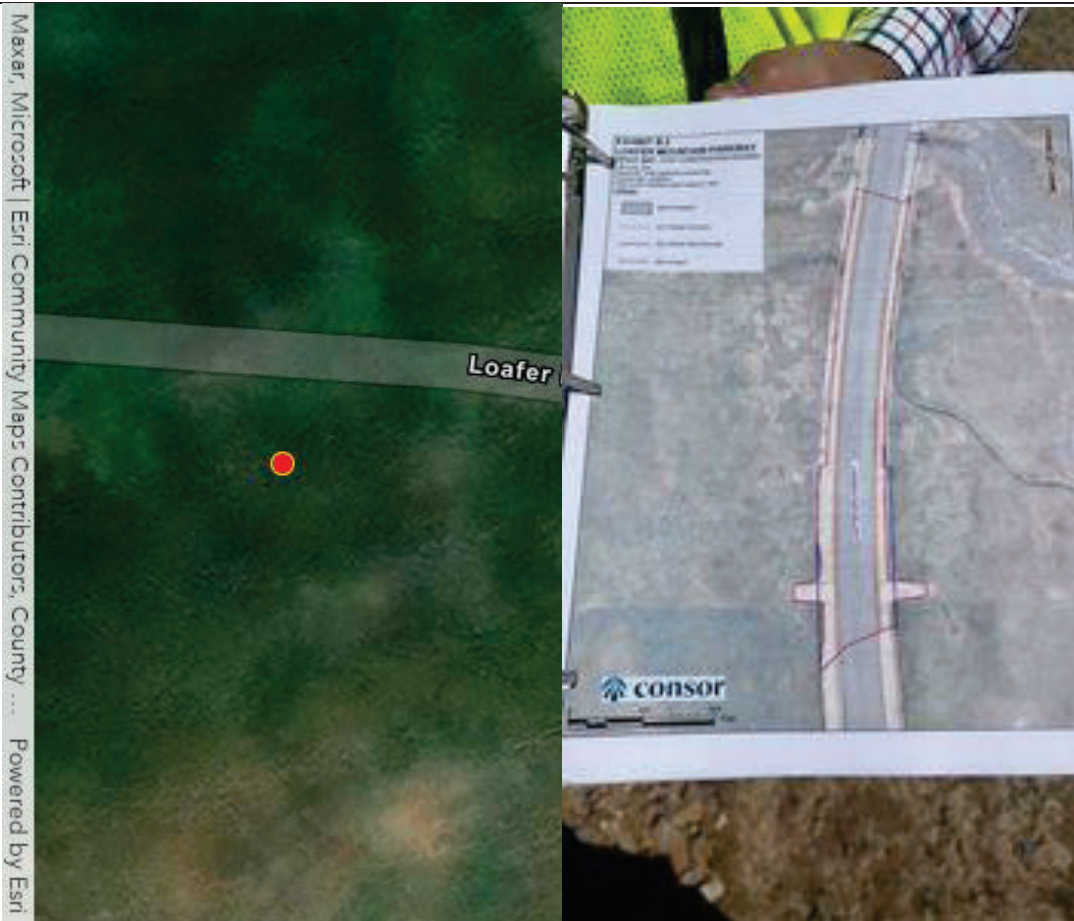
| Comments | 2023 as built design. The orange line is the retaining wall, the red line is the fill slopes, which is what was constructed in place of the retaining wall. The approximate distance is 86ft from fence to fence. | | |

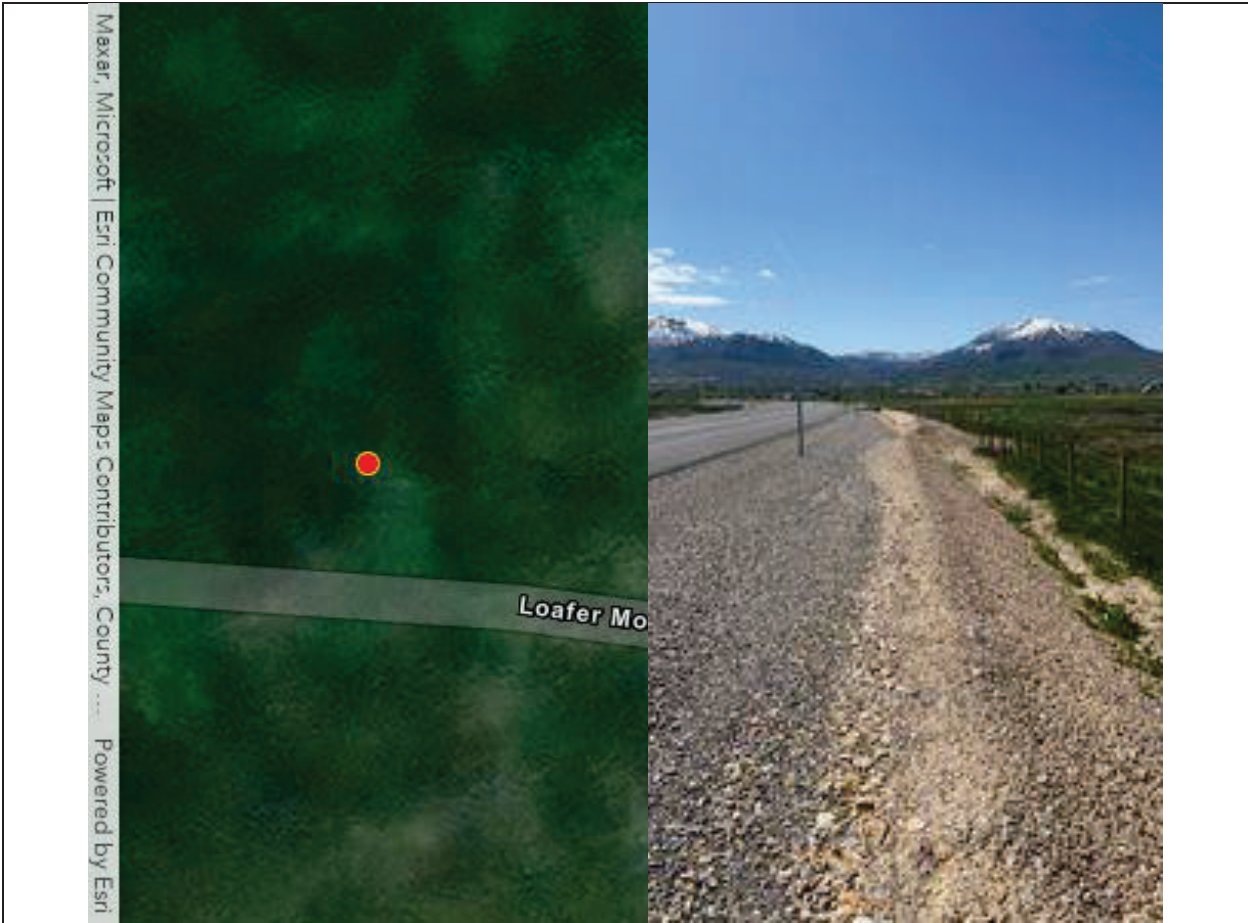
| Comments | | Constructed 3:1 fill slopes. | | | | | |
