**CHEMOURS CHAMBERS WORKS  
CLEAN WATER ACT (CWA)  
INSPECTION AND SAMPLING**

**Deepwater,  
New Jersey**

**Report Date: September 6, 2019 (Revised 4/13/2023)**

**Inspection and Sampling Activities: July 9 – 11, 2019**

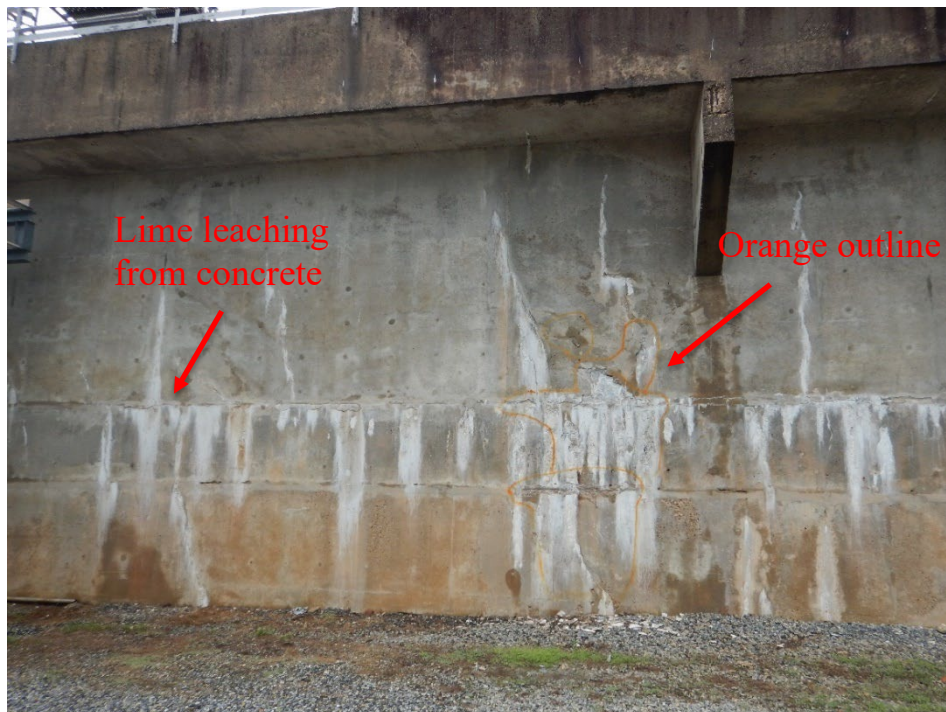
The Inspection and Sampling Team observed structural issues along the exterior concrete wall of the clarifier tanks. Specifically, there were cracks, crumbling, and lime leaching from the exterior concrete wall of the clarifiers (refer to Photograph 4, Photograph 5, and Photograph 6). The Inspection and Sampling Team observed orange outlines along the exterior wall of the clarifiers. The facility representatives explained that the orange lines were from an integrity assessment of the clarifiers performed by a contractor and that the

**Photograph 4.** Cracks and lime (white substance) leaching from the exterior of the WTP clarifier. Note orange outline from previous integrity assessment by outside vendor.

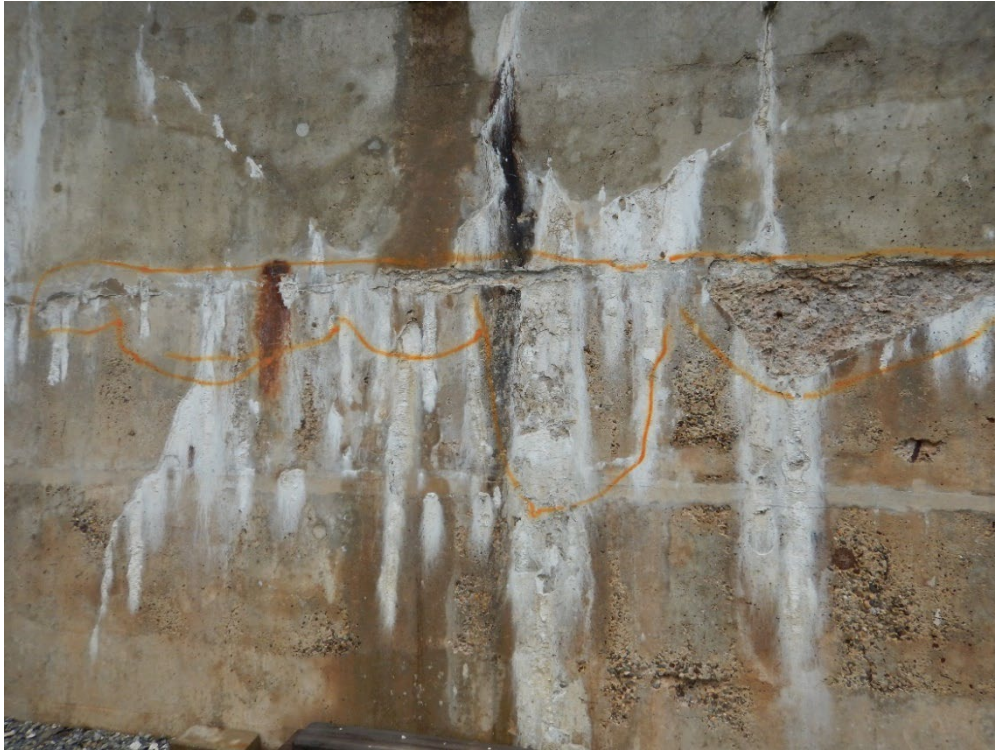
**Photograph 5.** Cracks, crumbling, and lime (white substance) leaching from the exterior of the WTP clarifier. Note orange outline from previous integrity assessment by outside vendor.

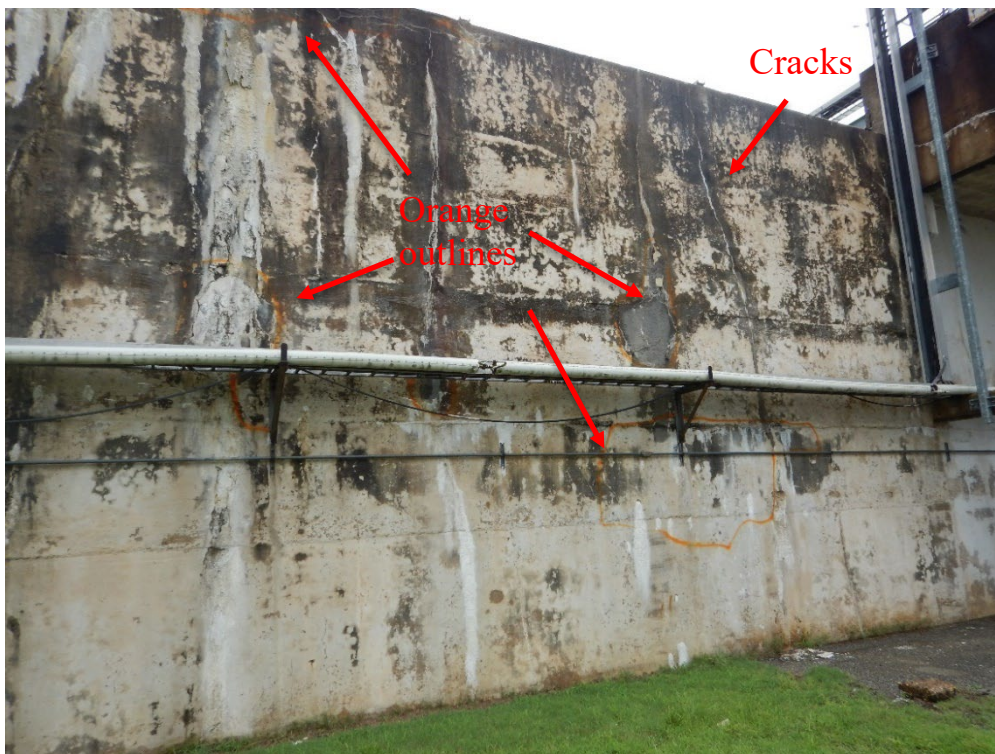
**Photograph 6.** Cracks on the side of the WTP clarifier. Note orange outline from previous integrity assessment by outside vendor.

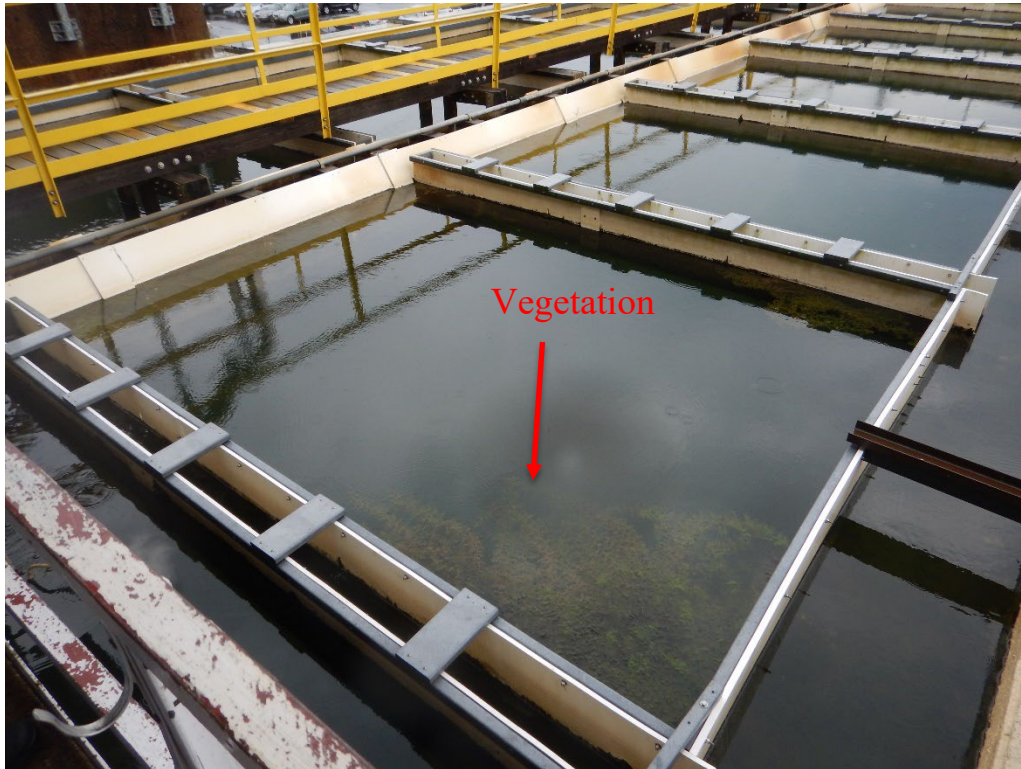
The Inspection and Sampling Team also observed vegetation in one of the clarifiers and in the proceeding chemical mix chamber (refer to Photograph 7 and Photograph 8). Additionally, the Inspection and Sampling Team observed corrosion in the piping conveying treated water from the sand filters to the diversion box (refer to Photograph 9).

**Photograph 7.** Vegetation growth in a WTP clarifier.

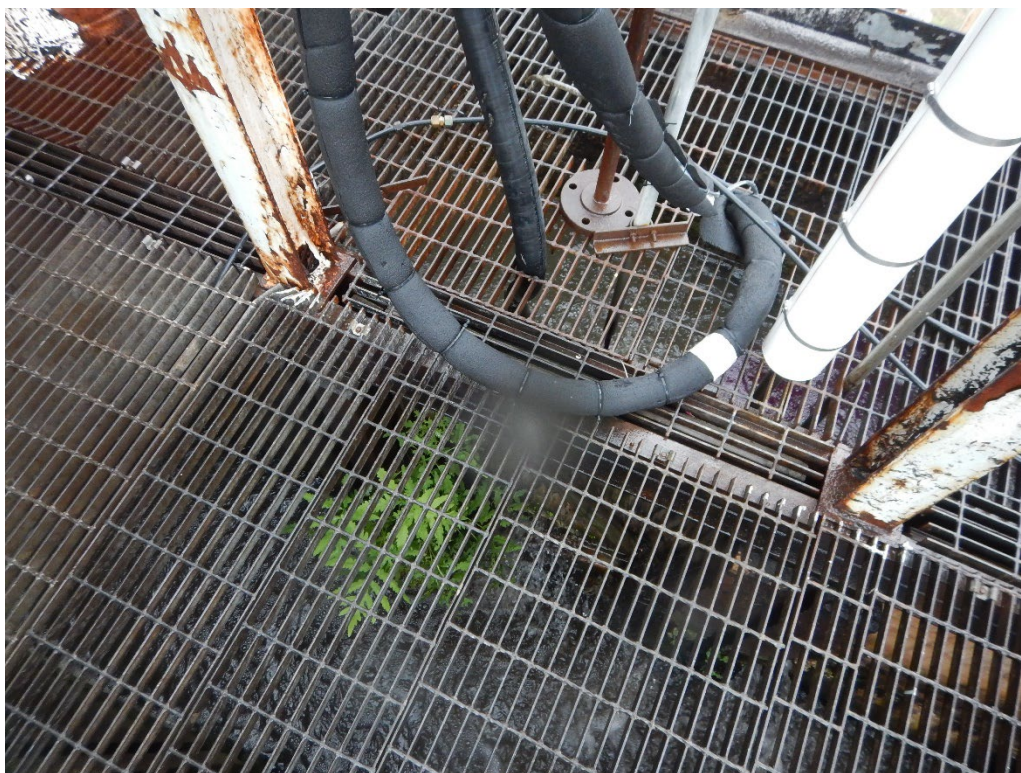
**Photograph 8.** Vegetation in the WTP chemical mix chamber prior to the clarifier.

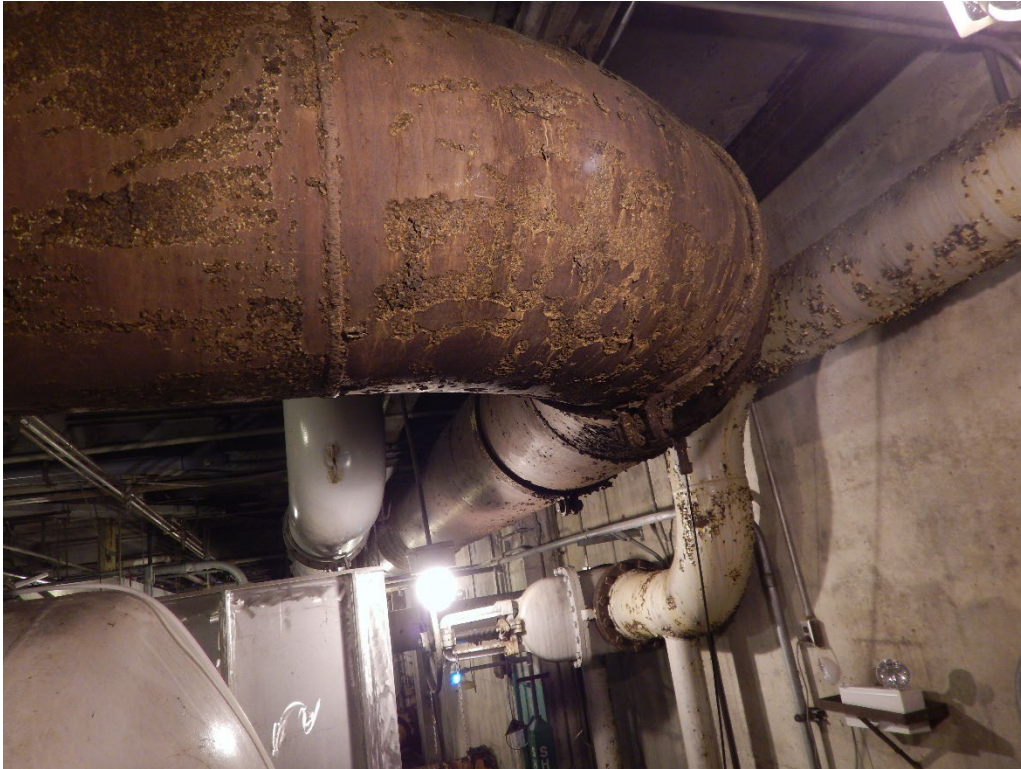
**Photograph 9.** Corrosion on piping in the WTP conveying treated water from the sand filters to the diversion box.

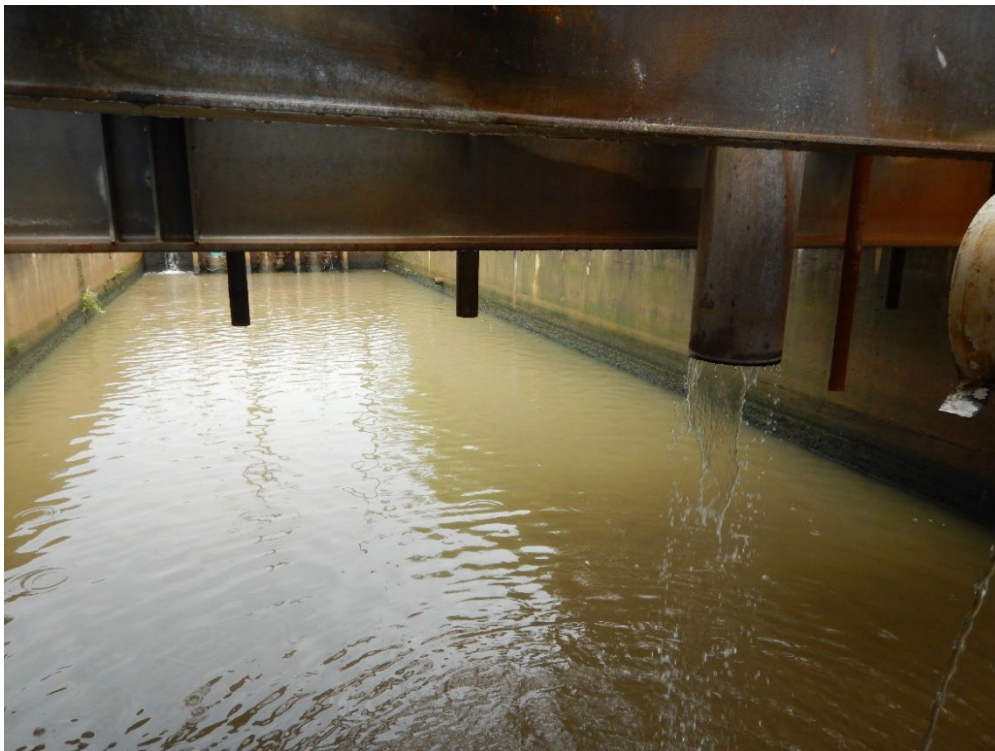
**Photograph 10.** Sanitary service water bleeding from the sanitary service line distribution pumps into A Basin (which is routed to the WWTP).

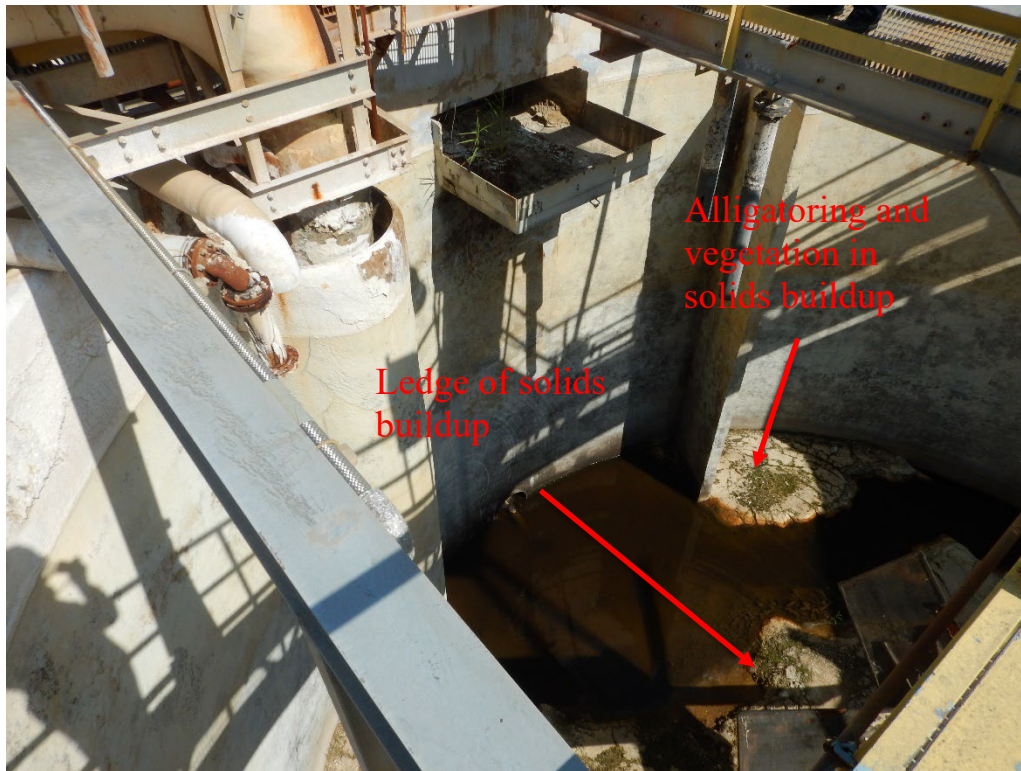
**Photograph 13.** Alligatoring and vegetation on bottom of the neutralizer NE-41 at the WWTP.

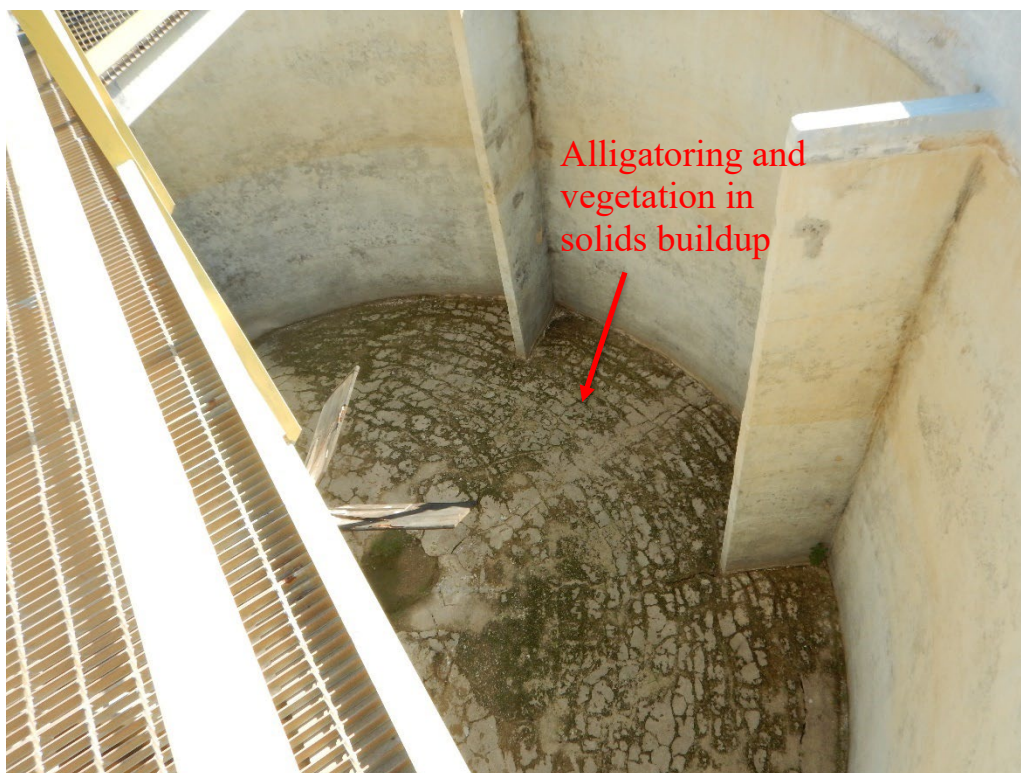
**Photograph 14.** Alligatoring along bottom of the neutralizer NE-41 at the WWTP.

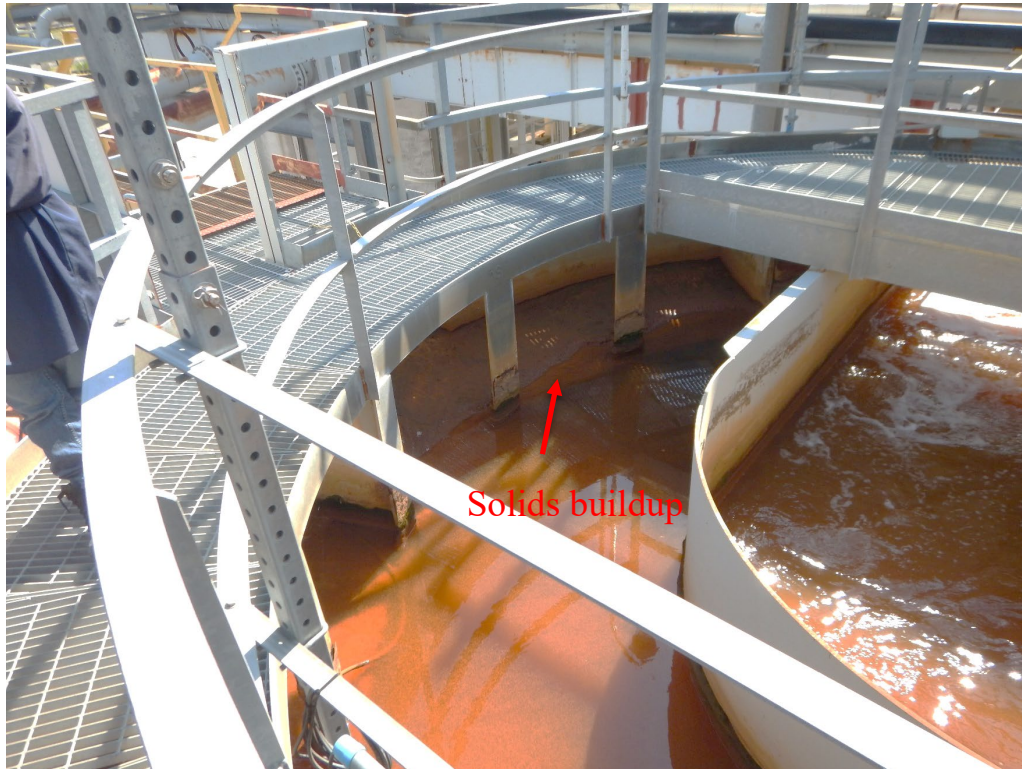
**Photograph 15.** Solids buildup along outer wall of the flow splitter at the WWTP.

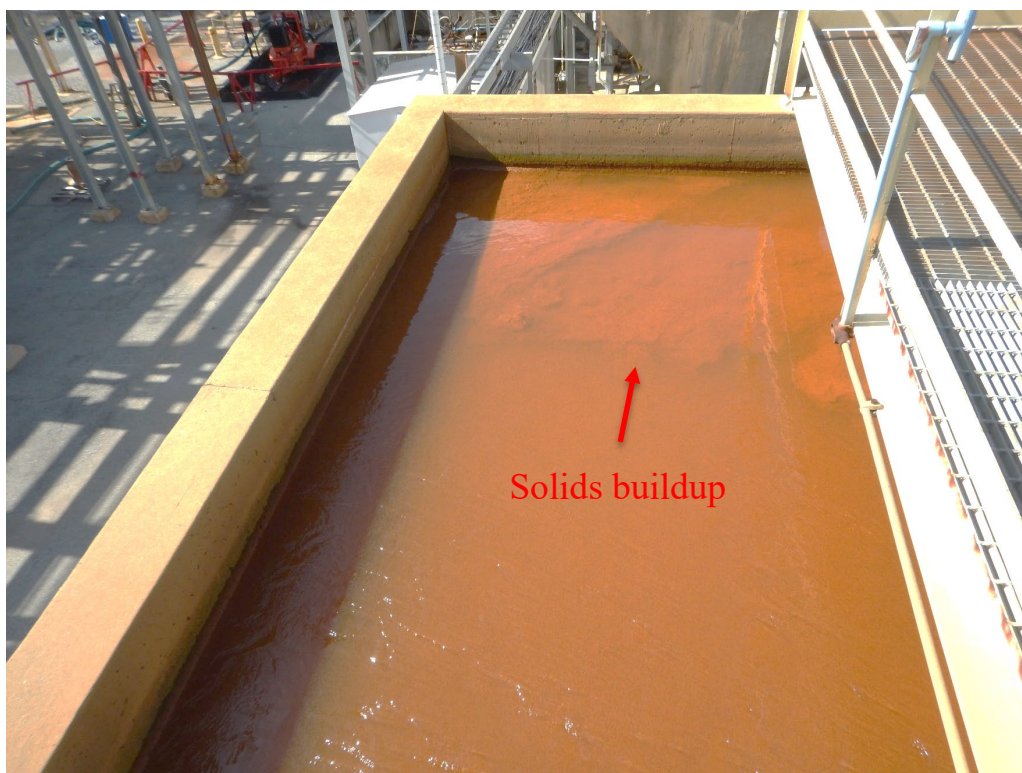
**Photograph 16.** Solids buildup in the flocculator FL-62 at the WWTP.

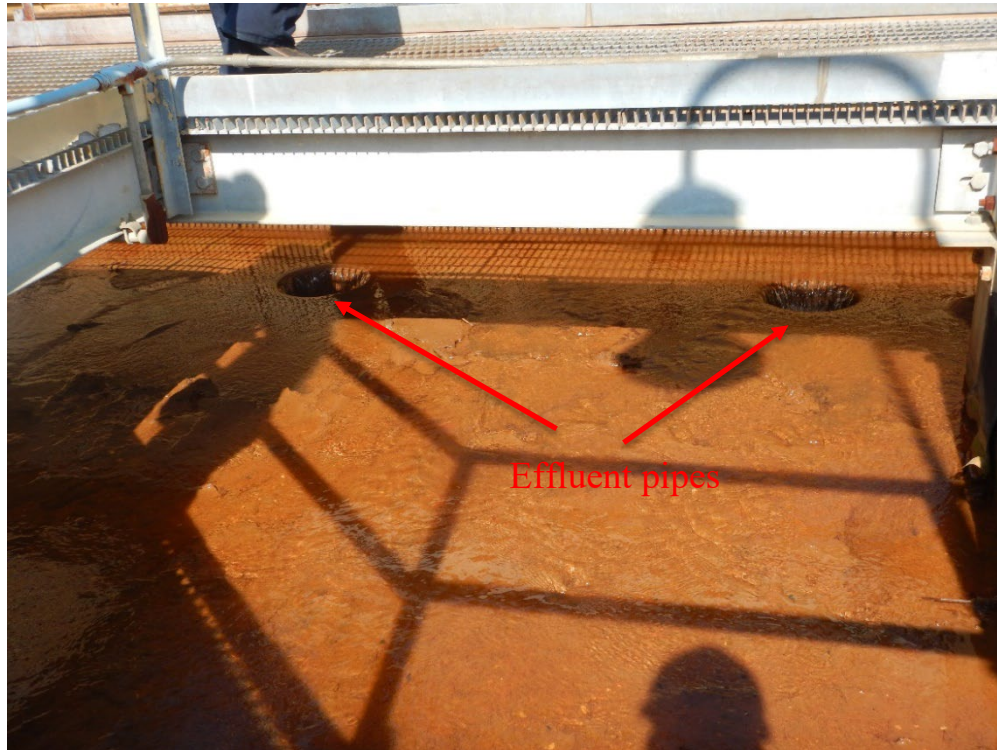
**Photograph 17.** Solids buildup in the flocculator FL-62, reaching the top of the effluent pipes at the WWTP.

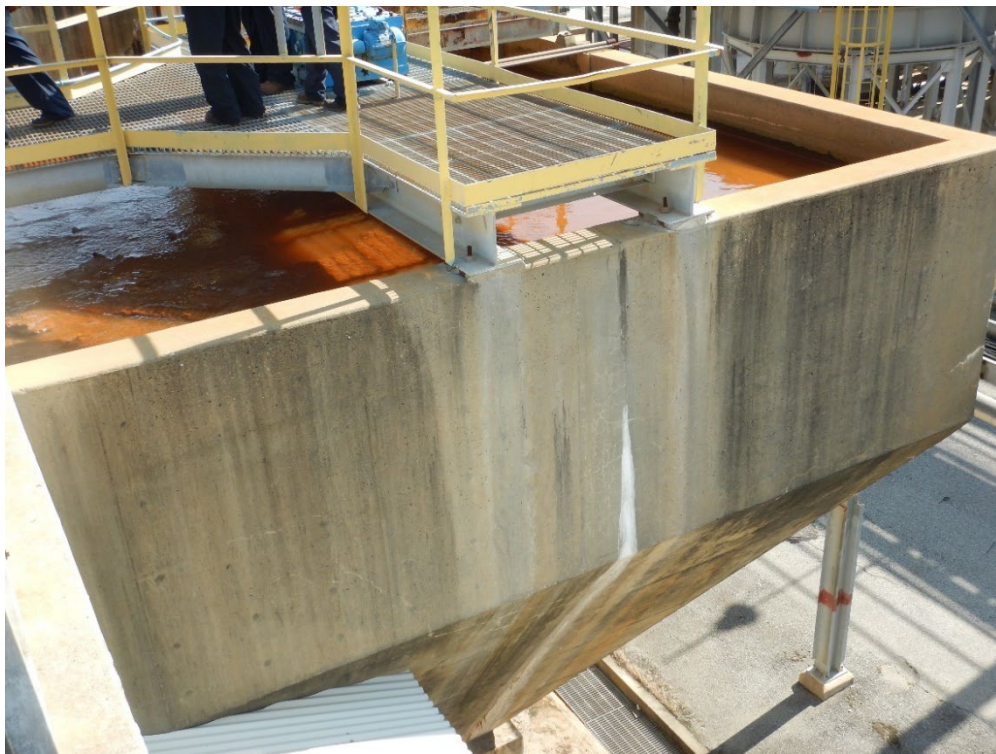
**Photograph 18.** Side view of flocculator FL-62, showing depth of solids deposition, at the WWTP.

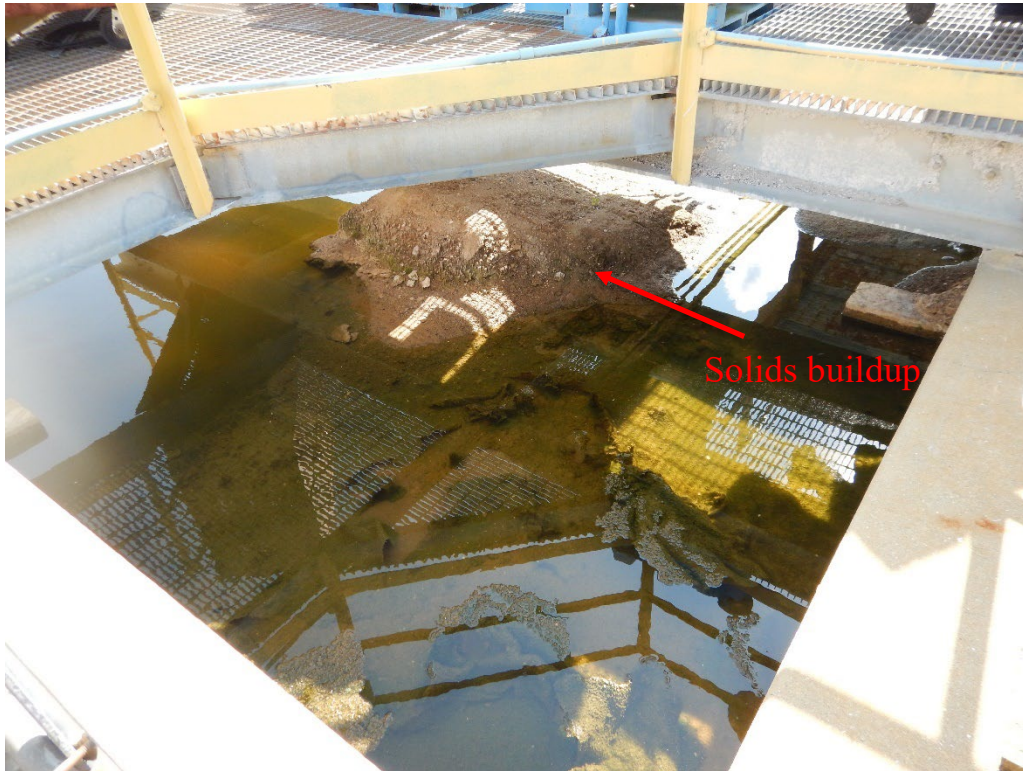
**Photograph 19.** Solids buildup in a flocculator at the WWTP not being used at the time of the inspection.

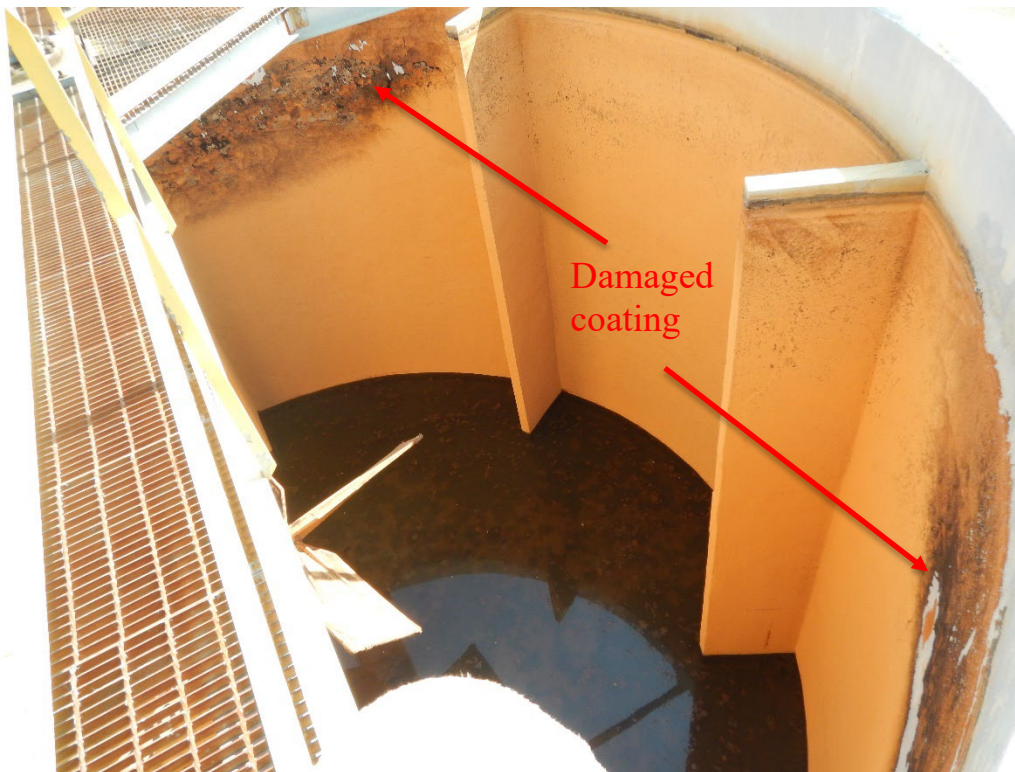
- Damaged coating along the side of the neutralizer NE-43 (not in use during the inspection) (refer to Photograph 20).
- Large cracks in the walls of the flocculators (refer to Photograph 21 and Photograph 22).
- Rusty support structures:
  - Flow splitter GT-161, which receives flow from the aerators in secondary treatment (refer to Photograph 23 and Photograph 24).
  - Secondary clarifier CF-161 (not in use during the inspection) (refer to Photograph 25).
- Damaged floating roof on surge tank TS-501, including broken expansion valves. This tank was out of service at the time of the inspection and the facility was conducting repairs, with an estimated completion date of summer 2020.

**Photograph 20.** Damaged coating on the interior of neutralizer NE-43 at the WWTP.

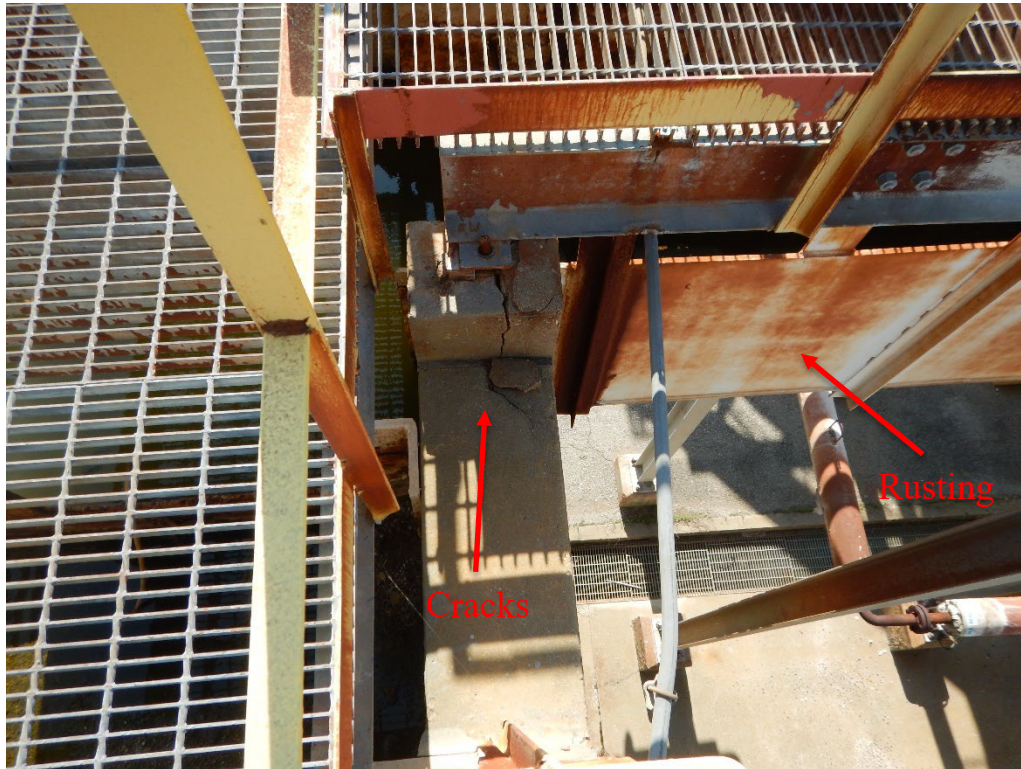
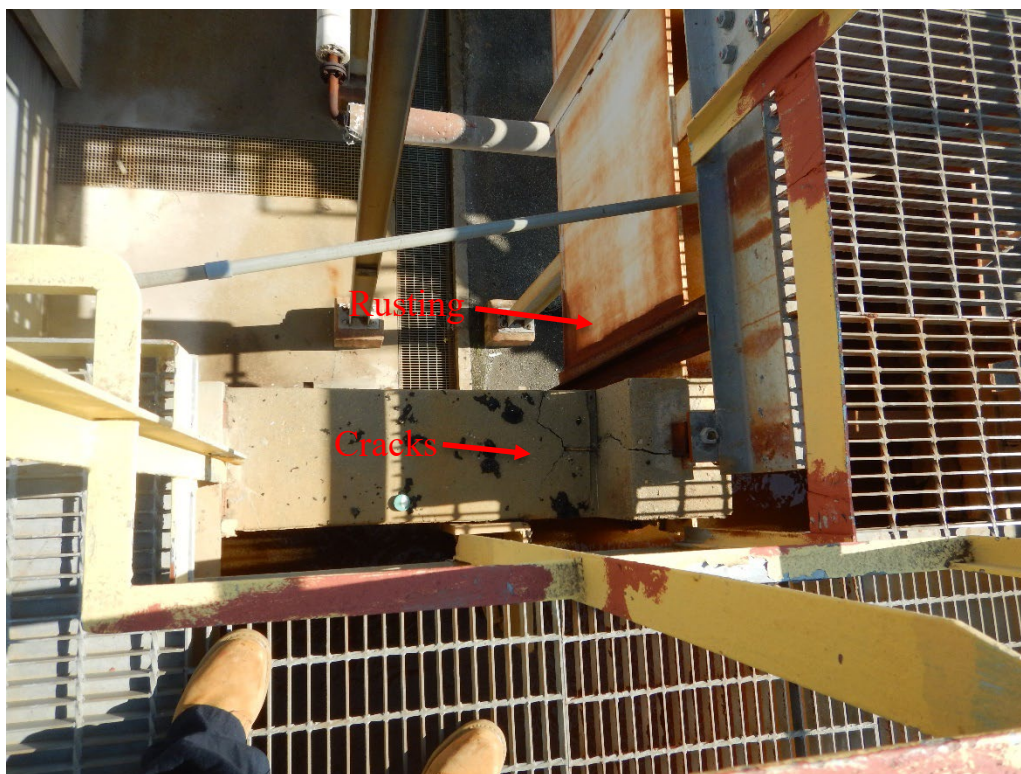
**Photograph 21.** Cracks in the wall of the flocculator FL-62 and rusting of the support structures at the WWTP.

**Photograph 22.** Cracks in the wall of the flocculator FL-62 and rusting of the support structures at the WWTP.

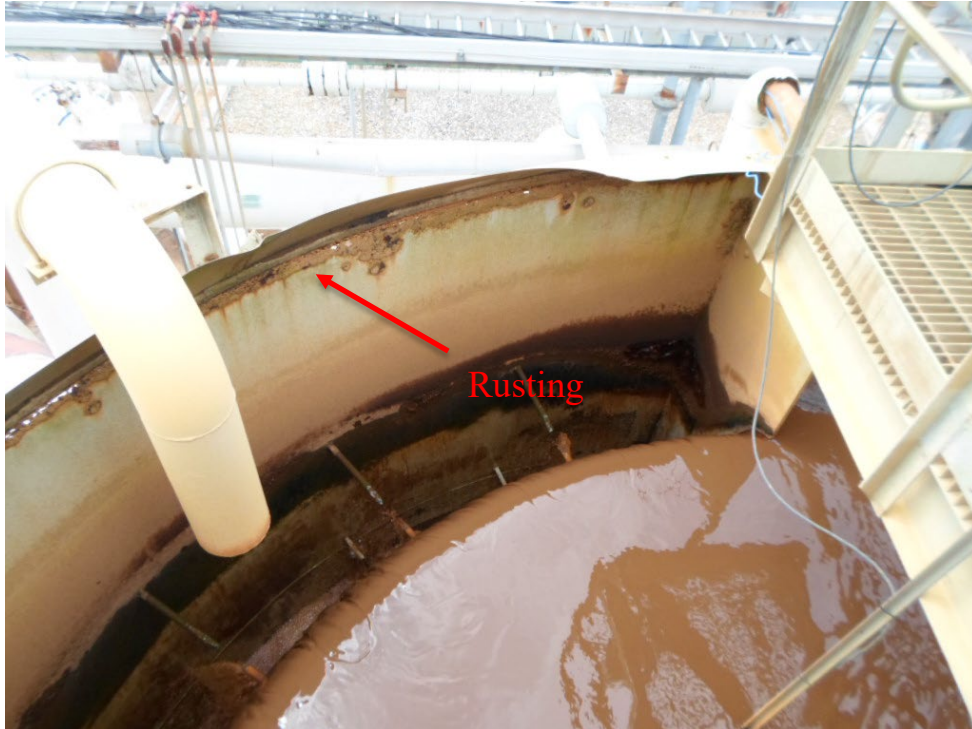
**Photograph 23.** Flow splitter GT 161 receiving flow from the WWTP's secondary treatment aerators. The structural supports between the exterior wall and internal flow receiver had failed at multiple locations due to rust.

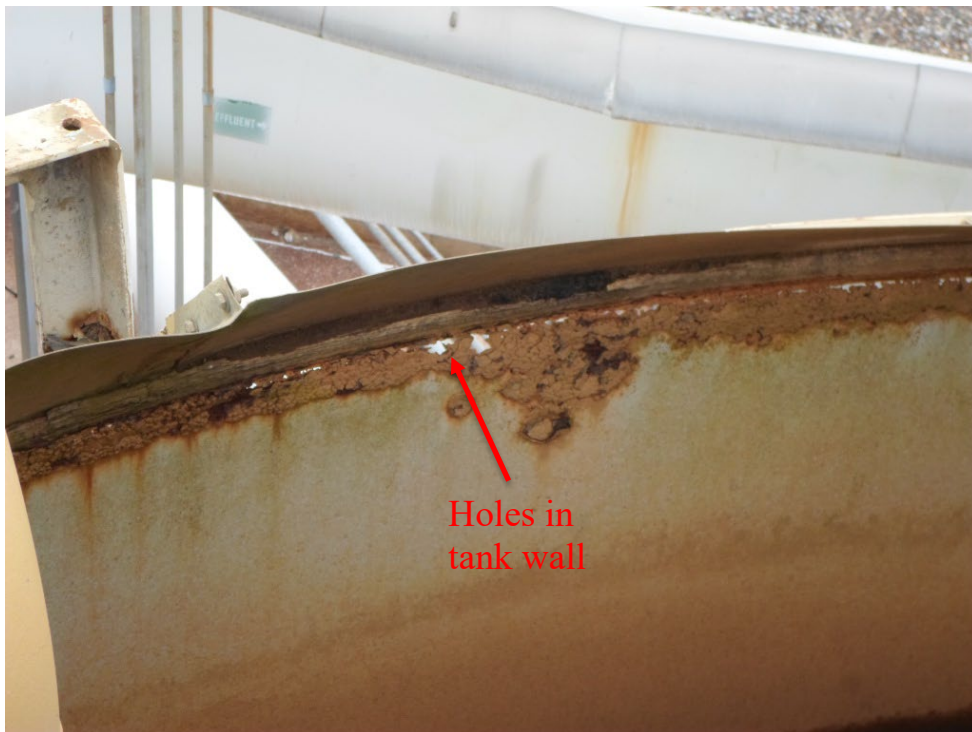
**Photograph 24.** View of the upper exterior tank wall on flow splitter GT-161 at the WWTP. The wall has rusted through in areas creating holes in the tank wall.

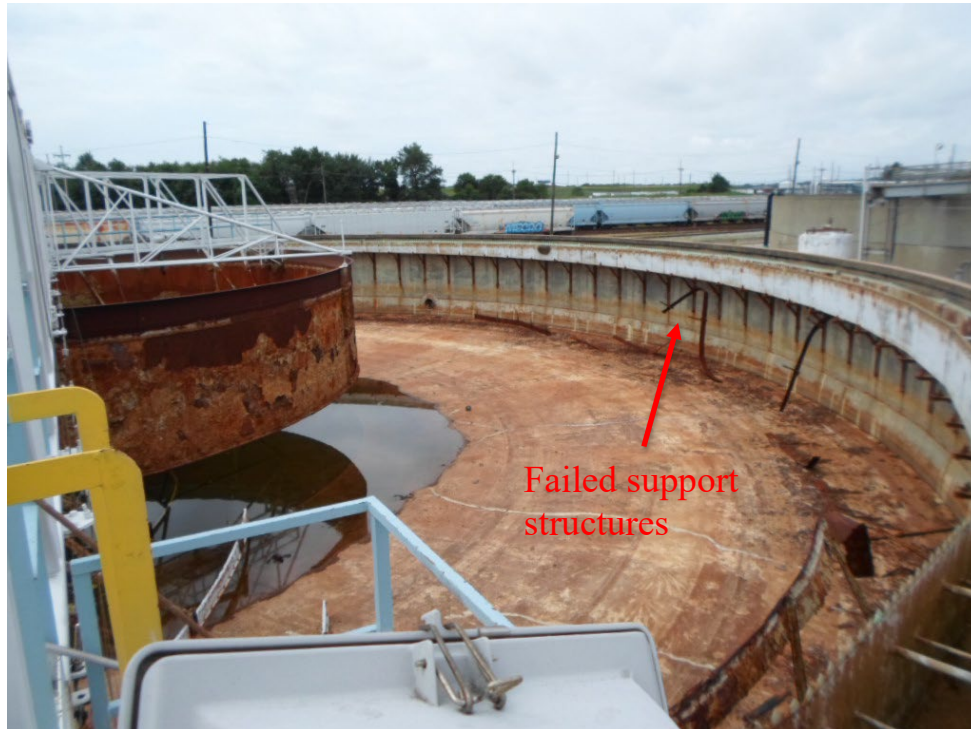
**Photograph 25.** Secondary clarifier CF-161 at the WWTP, which was out of service at the time of the inspection. The structure supports under the effluent trough had failed and were laying on the bottom of the clarifier and hanging from the trough.

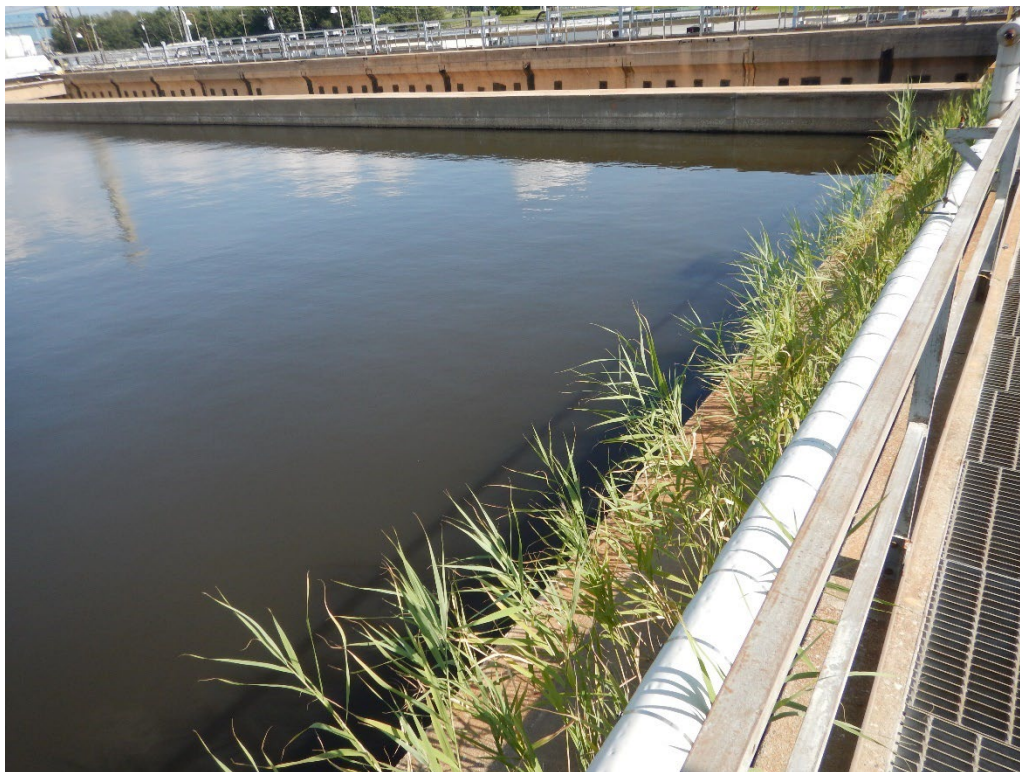
**Photograph 26.** Vegetation along the primary clarifier CF-63 at the WWTP.

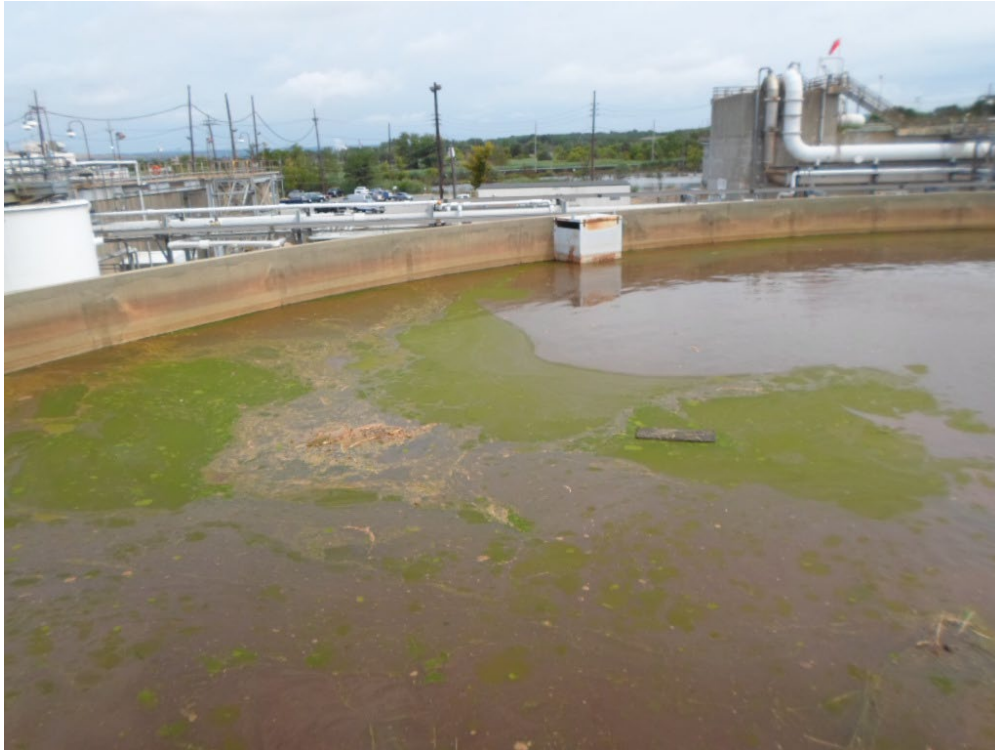
**Photograph 27.** Secondary treatment aerator AE-153 at the WWTP, with floating debris and vegetation along the surface of the tank.

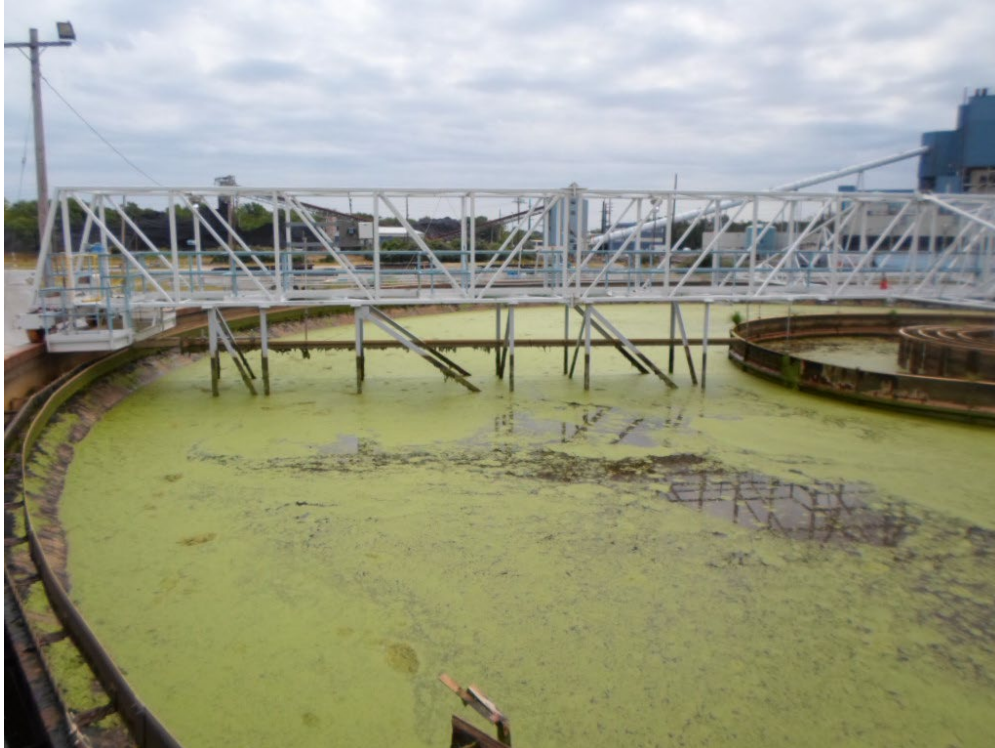
**Photograph 28.** Secondary clarifier CF-162 at the WWTP, covered with duck weed. Note the clarifier had just started receiving flow from the secondary aeration tanks at the time the photograph was taken.

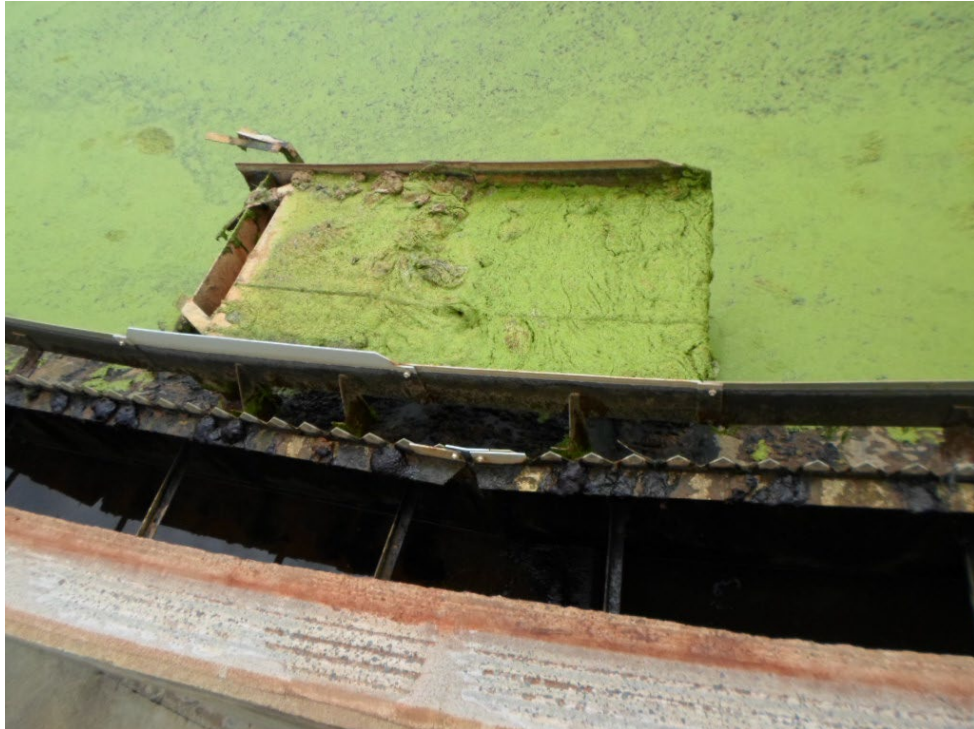
**Photograph 29.** Alternate view of the duck weed in secondary clarifier CF-162 at the WWTP. The water level was approximately two feet below the weir plate and scum beach due to operational redirection of flows earlier in the day.

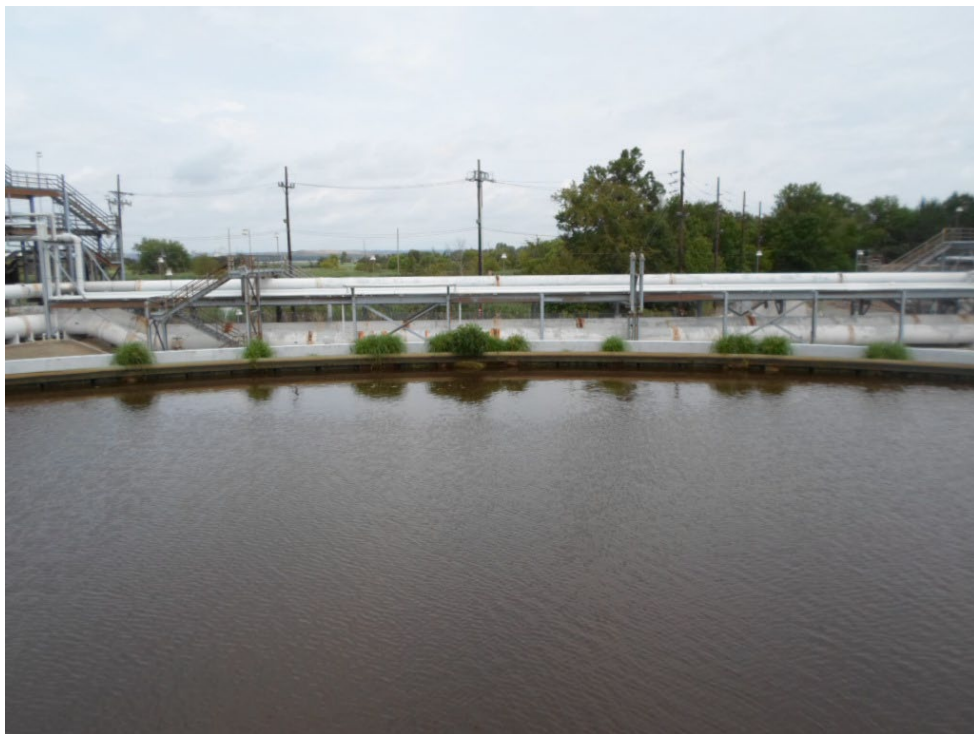
**Photograph 30.** Vegetation in the effluent trough in multiple locations around secondary clarifier-CF 163 at the WWTP. The process wastewater level was below the weir plate and slowly rising.

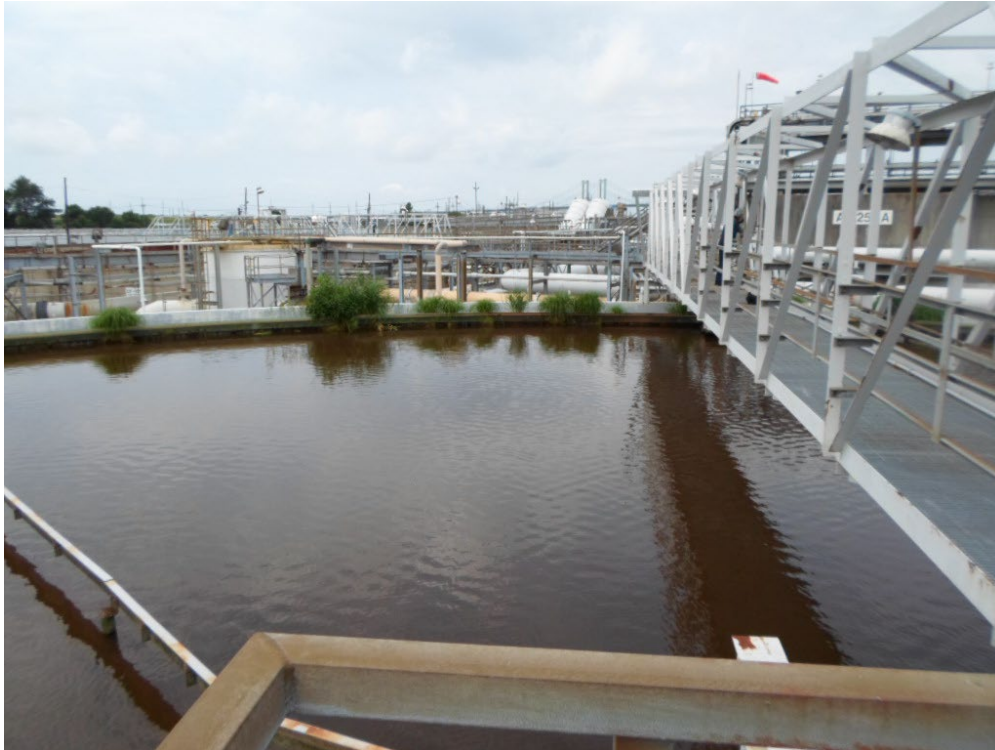
**Photograph 31.** Alternate view of vegetation in the effluent trough in multiple locations around secondary clarifier-CF 163 at the WWTP. Some vegetation was over four feet high.

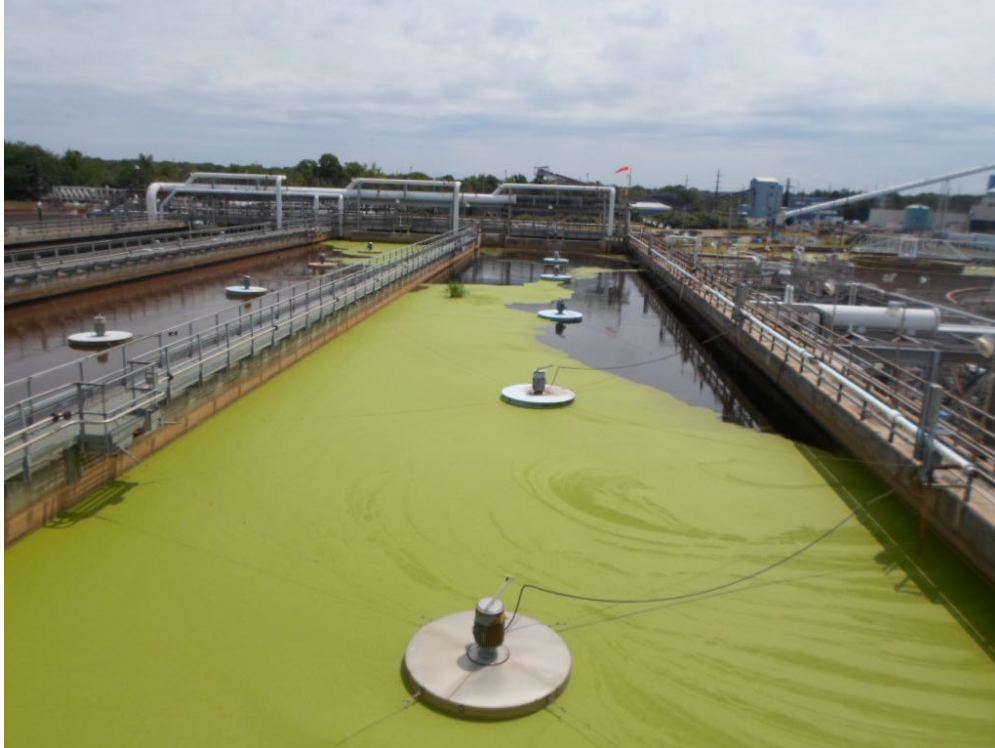
**Photograph 32.** Duck weed covering approximately 50% of Cell A of tertiary aerator AE-251, which was out of service, at the WWTP.

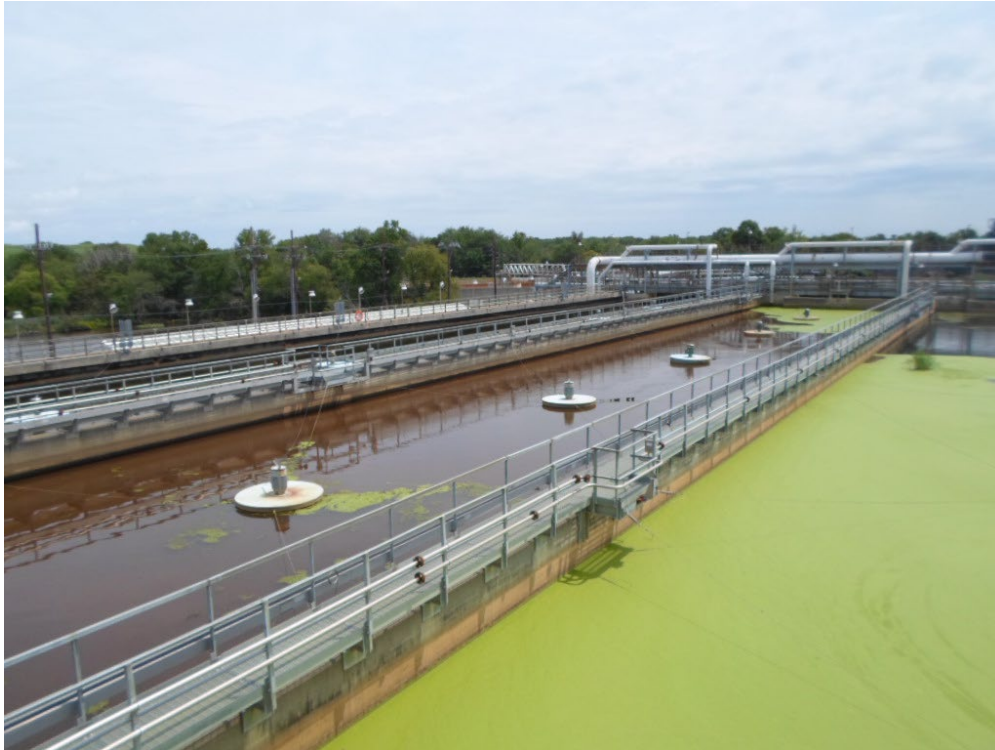
**Photograph 33.** Duck weed covering approximately 10% of Cell B (center of image) of tertiary aerator AE-251 at the WWTP.
