**CHEMOURS CHAMBERS WORKS  
CLEAN WATER ACT (CWA)  
INSPECTION AND SAMPLING**

**Deepwater,  
New Jersey**

**Report Date: September 6, 2019 (Revised 4/13/2023)**

**Inspection and Sampling Activities: July 9 – 11, 2019**

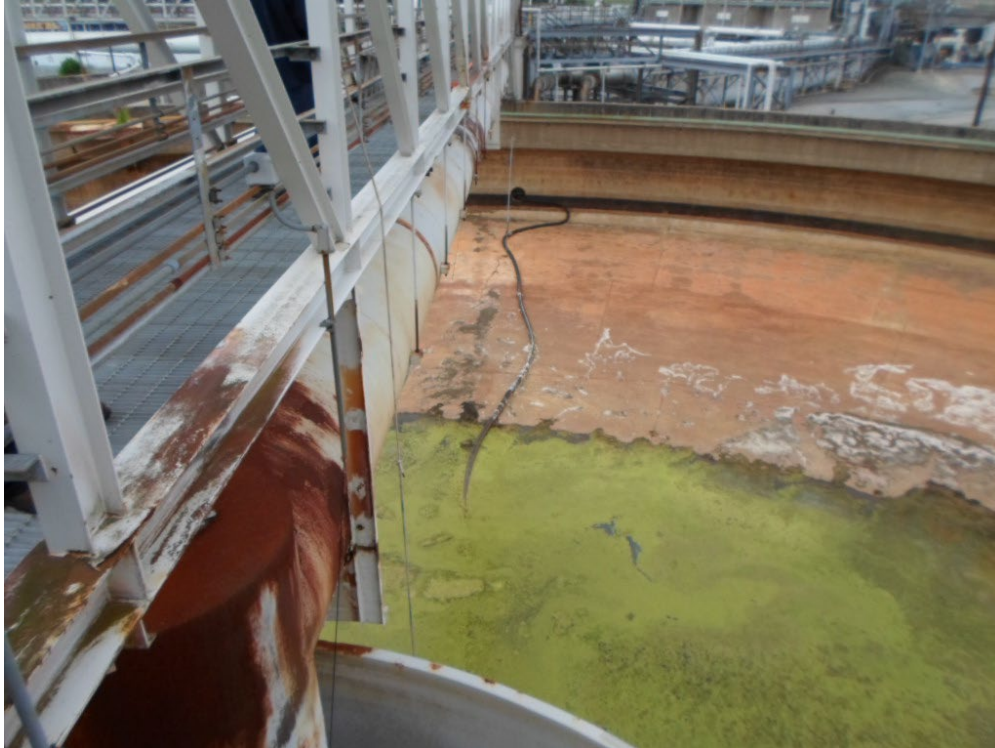
**Photograph 34.** Vegetation in tertiary clarifier CF-261 at the WWTP. Note CF-261 was out of service and being pumped down with a hose and a Godwin trailered pump.

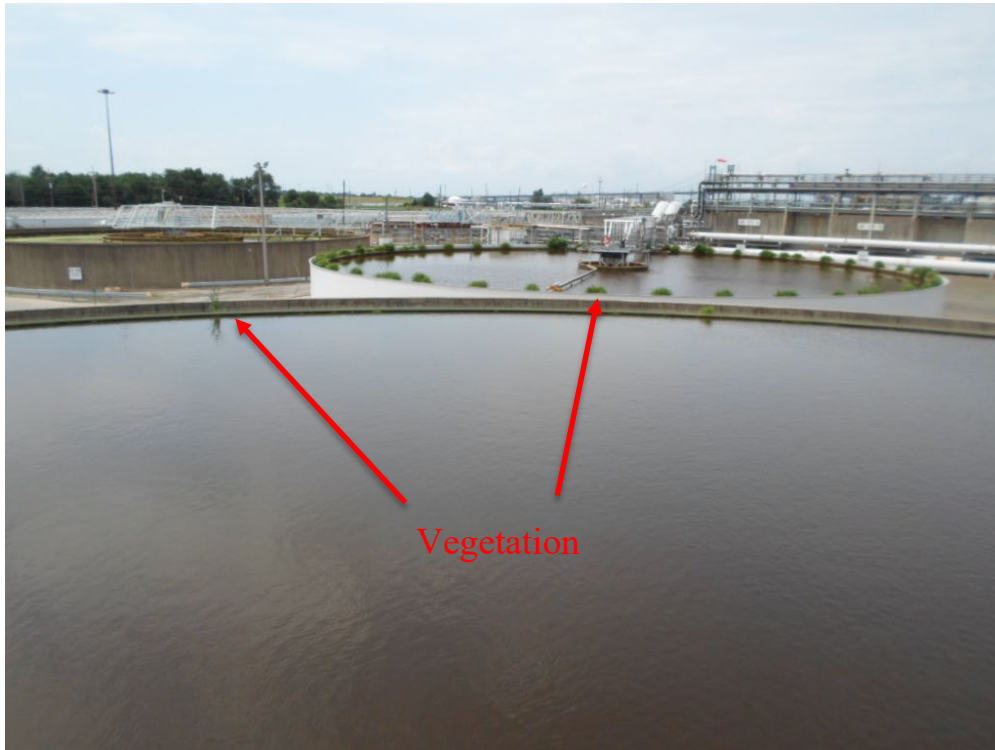
**Photograph 35.** Vegetation in the effluent trough in multiple locations around tertiary clarifier CF-262 (foreground) and secondary clarifier CF-163 (background) at the WWTP.

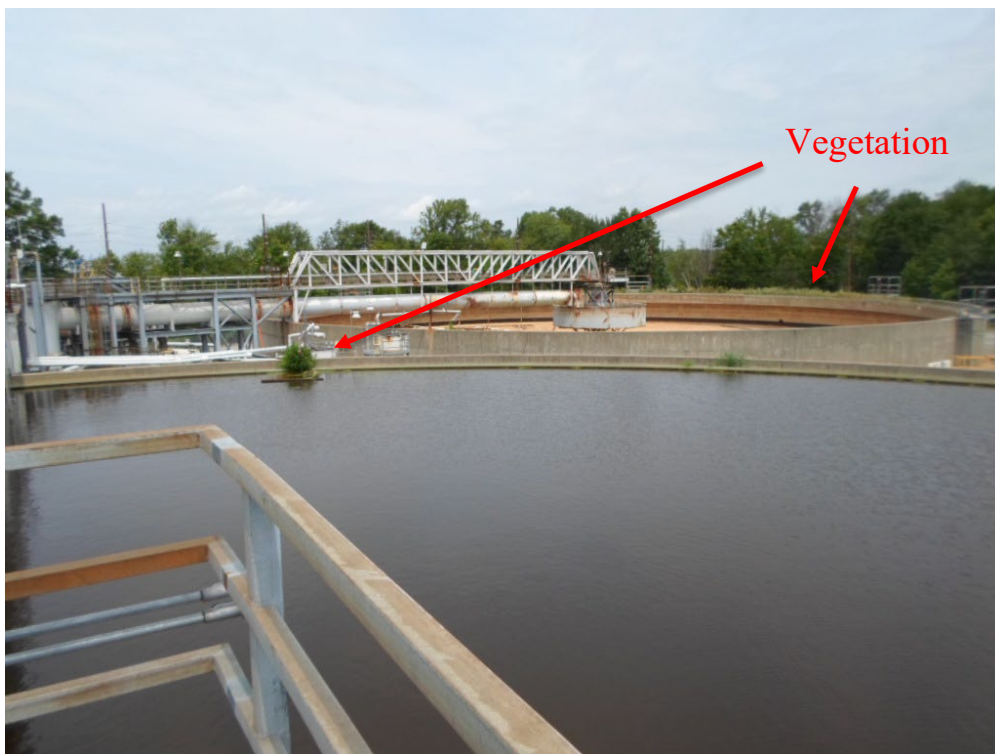
**Photograph 36.** Vegetation in the effluent trough of tertiary clarifier CF-262 (foreground) and tertiary clarifier CF-261 (background - out of service and empty) at the WWTP.

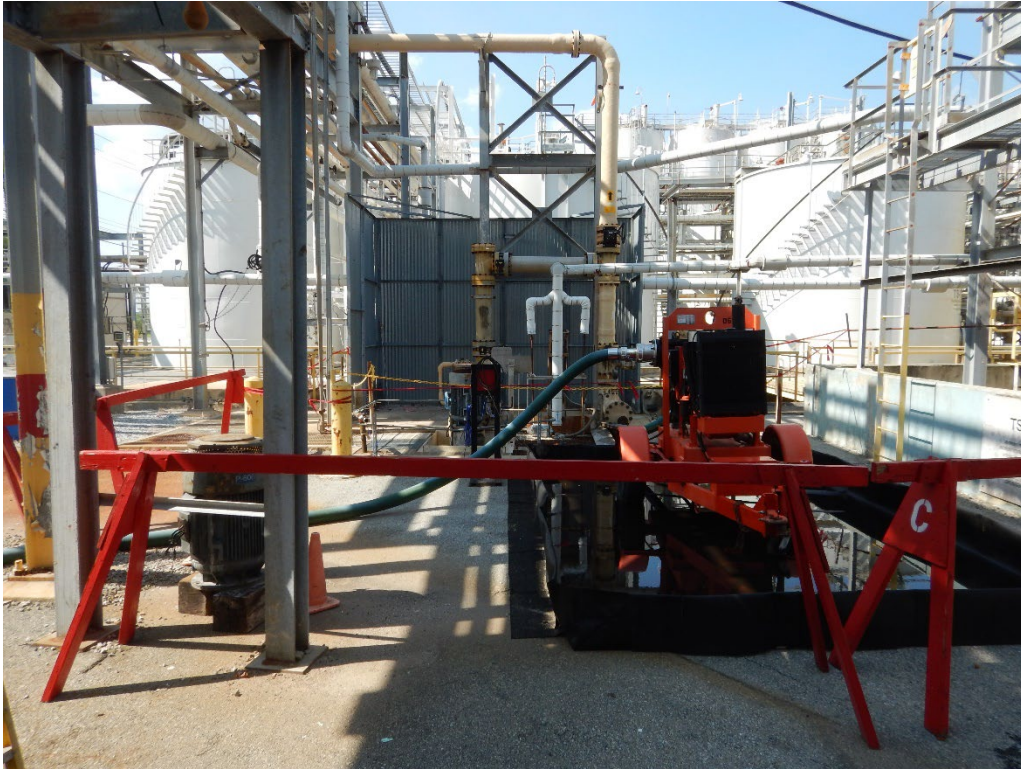
- A temporary pump being used to replace a broken pump (P606), which conveys wastewater to the neutralizers (refer to Photograph 37). Facility representatives indicated that pump P606 broke approximately three weeks prior to the inspection. The Inspection and Sampling Team asked about work orders for this

pump, which the facility provided as part of a follow-up documentation request. The work orders include an order to inspect an expansion joint with a start date of June 10, 2019, followed by screen cleaning with a start date of June 12, 2019, expansion joint replacement with a start date of June 28, 2019, and a work order to rebuild and install with a start date of July 17, 2019.

**Photograph 37.** Temporary pump being used to replace a broken pump used to transport water into the neutralizers at the WWTP.

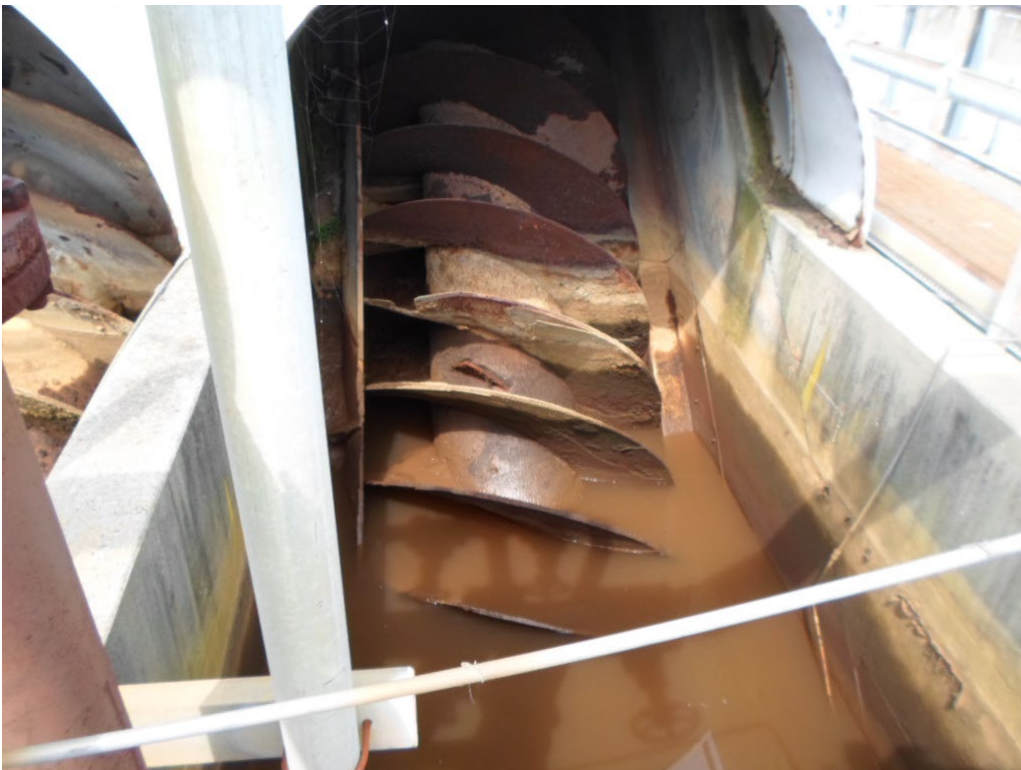
- Two decommissioned return activated sludge (RAS) screw pumps (refer to Photograph 38) that the facility replaced by a different pump (refer to Photograph 39).

**Photograph 38.** Decommissioned return activated sludge screw pumps at the WWTP.

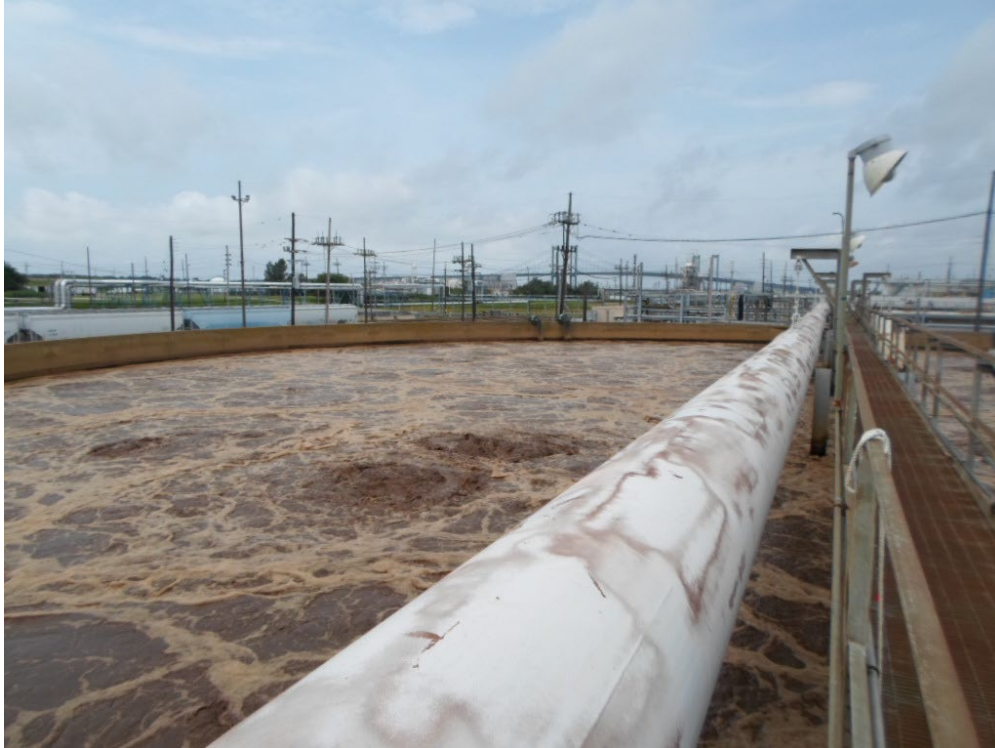
- Leaking equipment.
- Excessive air flow in areas of biological aeration basin AE-152 actively used for secondary treatment (refer to Photograph 40). Facility representatives indicated that there was broken piping in the air distribution system contributing to the excessive air flow. The excessive air flow was evident by the higher than average dissolved oxygen (DO) concentrations in the water in AE-152 on the monthly process control data reviewed by the Inspection and Sampling Team.

**Photograph 40.** Secondary treatment aerator AE-152 at the WWTP. Note some areas had excessive air flow.
