**UNITED STATES ENVIRONMENTAL PROTECTION AGENCY**  
**REGION III**  
**Four Penn Center**  
**1600 John F. Kennedy Boulevard**  
**Philadelphia, Pennsylvania 19103-2852**

**Report Title:** Clean Water Act, Section 404 Inspection Report for Hadensville - Fife Road Site  
**Inspection Date(s):** 03/24/2023  
**Start Time:** 9:00 am **End Time:** 10:30 am  
**Regulatory Program(s):** Inspections authorized pursuant to Clean Water Act, Sections 308 and 404 (33 U.S.C. §§ 1318 and 1344)  
**Site Name:** Boyd Farm, LLC  
**Site Location:** Approximately Hadensville – Fife Road  
Sandy Hook, Virginia 23063  
**Latitude:** 37.8009 N **Longitude:** -78.0261 W  
**County/Parish:** Goochland  
**Site Owner:** Boyd Farm, LLC and Frazier T. Boyd, III  
**Mailing Address:** 3009 River Road West  
Goochland, Virginia 23063  
**Unique Project #:** 3E23WW037A

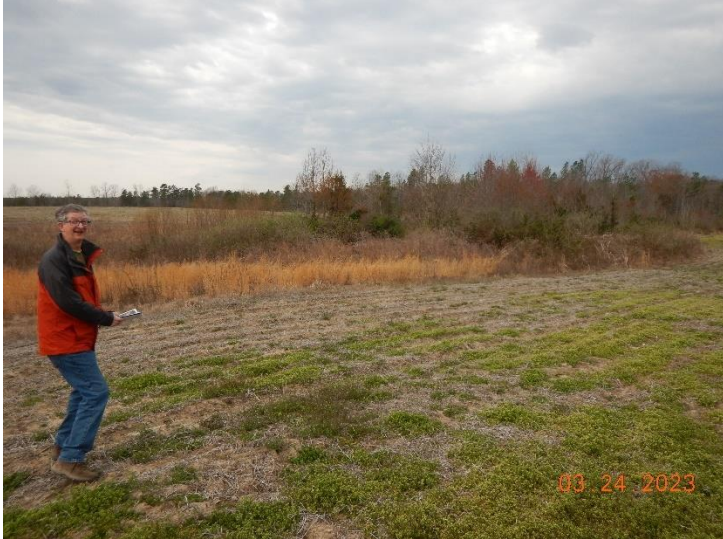
The inspection walkthrough began at Area 1, located in the central portion of the Site on the western side (See **Attachment 1 – Site Map**). Area 1 was observed from the east at the edge of the field (see **Attachment 2 – Photographic Log**; DSCN4580). The EPA inspector and Mr. Kerr walked from the east into the wetland area. Locations where silt fence had been removed by cutting it off at ground level were observed (DSCN4581). Intact sediment control sock was observed (DSCN4583 and DSCN4584). Based on visual observations, vegetative coverage of the herbaceous stratum appeared to be near 100%. A diverse herbaceous vegetative community was observed including *Juncus effusus*, *Scirpus cyperinus*, and *Andropogon virginicus*. Living, planted woody stems were observed within the wetland area (DSCN4582). No estimate of percentage of surviving woody stems was made by the EPA inspector but many of the woody stems either had buds or were beginning to leaf-out. *Salix nigra* and *Sambucus nigra* were observed. Areas of surface saturation and the groundwater monitoring well were observed in the wetland area (DSCN4583 and DSCN4585).

| | <p>Photo ID: DSCN4580<br/>Date: March 24, 2023<br/>Photo Taken By: Katelyn Almeter</p> <p>Notes: overview of Area 1; facing west</p> |

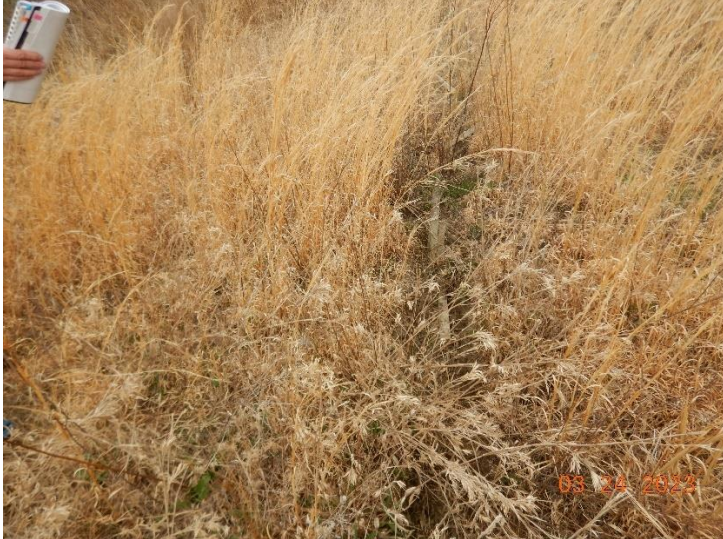
| | <p>Photo ID: DSCN4581<br/>Date: March 24, 2023<br/>Photo Taken By: Katelyn Almeter</p> <p>Notes: silt fence cut at ground level around Area 1</p> |

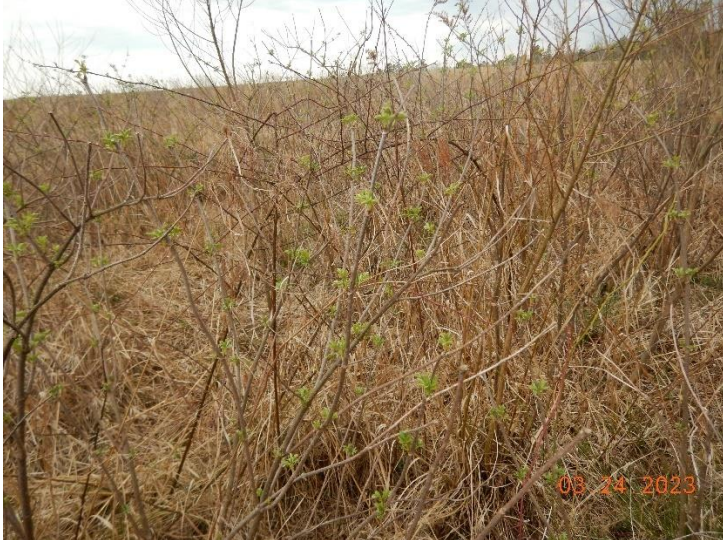
| | <p>Photo ID: DSCN4582<br/>Date: March 24, 2023<br/>Photo Taken By: Katelyn Almeter</p> <p>Notes: buds and leaves on woody stems in Area 1</p> |

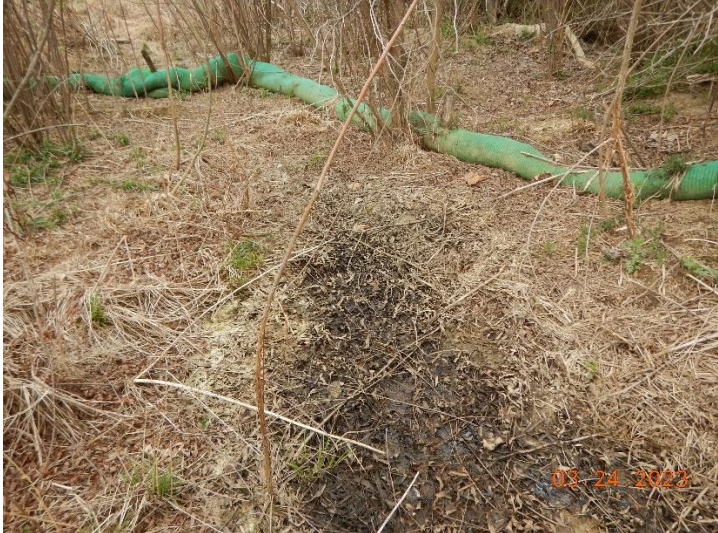
| | <p>Photo ID: DSCN4583<br/>Date: March 24, 2023<br/>Photo Taken By: Katelyn Almeter</p> <p>Notes: surface saturation and<br/>sediment control sock in Area 1</p> |

- The wetland areas appeared to be functioning as expected. The coverage and diversity of the vegetation observed was satisfactory and appeared to be well-established.
- A few of the sediment control socks in Area 1 appeared to be intact. The EPA Inspector asked for those sediment control socks be cut and the mulch dispersed to naturalize those areas as a voluntary measure.
- A few locations with *Typha* sp. were observed in Area 2 and Area 3. They appeared to be present at a coverage below the corrective action threshold, but invasive species control measures may want to be considered to minimized growth and spread.

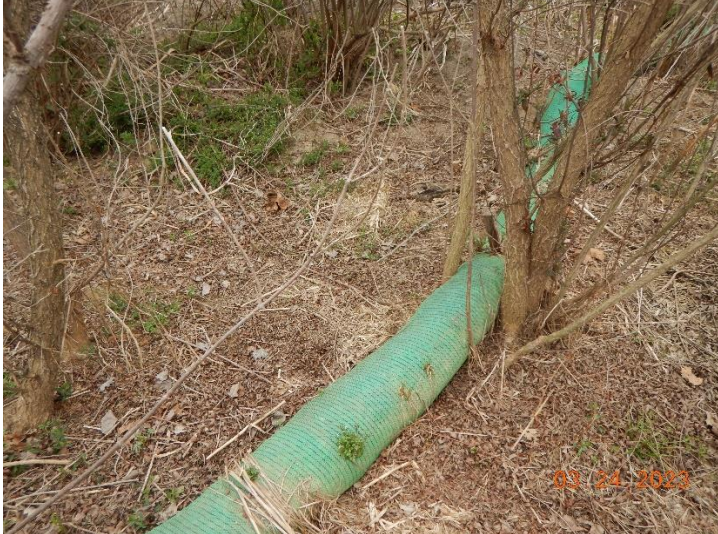
| | <p>Photo ID: DSCN4584<br/>Date: March 24, 2023<br/>Photo Taken By: Katelyn Almeter</p> <p>Notes: sediment control sock in<br/>Area 1</p> |

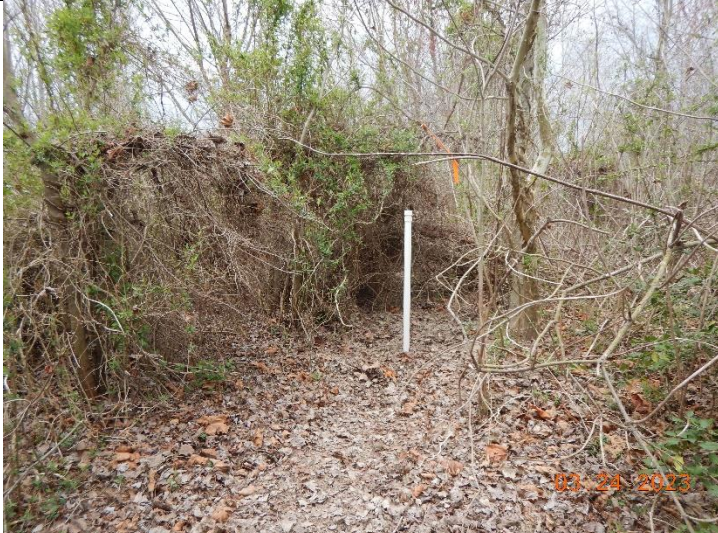
| | <p>Photo ID: DSCN4585<br/>Date: March 24, 2023<br/>Photo Taken By: Katelyn Almeter</p> <p>Notes: control groundwater<br/>monitoring well at Area 1</p> |

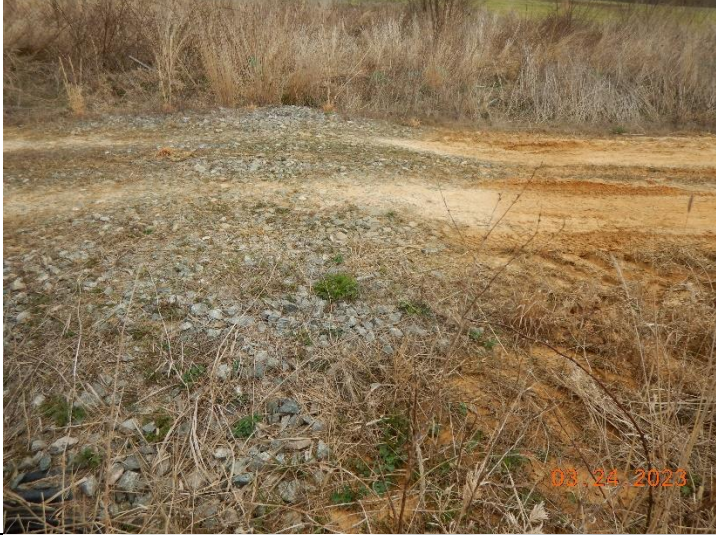
| A photograph showing a dirt road crossing a field of dry, brown grass and gravel. The date '03.24.2023' is visible in the bottom right corner of the photo. | <p>Photo ID: DSCN4586<br/>Date: March 24, 2023<br/>Photo Taken By: Katelyn Almeter</p> <p>Notes: road crossing to the east of Area 1; looking east</p> |

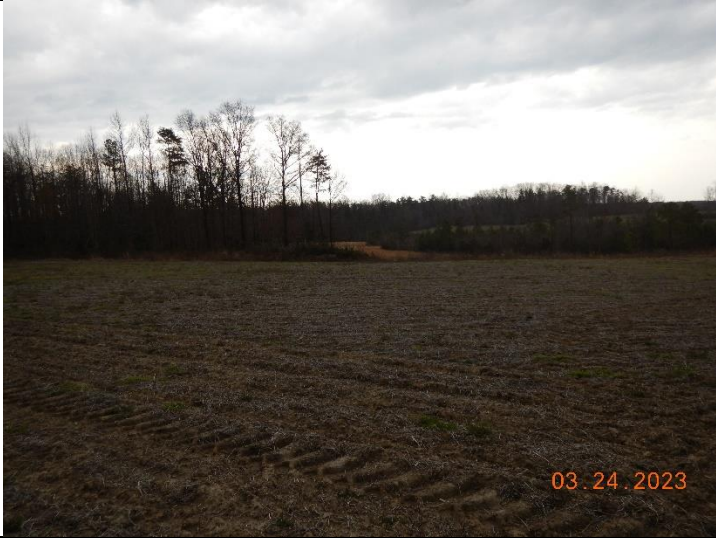
The inspection walkthrough moved to Area 2, located to the north on the eastern side of the Site (DSCN4587). Areas of saturation to the ground surface were observed within the wetland area. Locations where the sediment control sock had been removed and the mulch dispersed were observed (DSCN4588). Vegetative coverage and diversity were consistent with Area 1 (DSCN4589). However, *Typha* sp. was also present (DSCN4593). Crayfish burrows were observed in the wetland area (DSCN4591 and DSCN4592). Using a pit that was still open from previous monitoring events the water table was measured and found to be present at approximately 11 inches (DSCN4594).

| A wide-angle photograph of a large, flat, open field with dry grass. In the background, there is a line of bare trees under a cloudy sky. The date '03.24.2023' is visible in the bottom right corner of the photo. | <p>Photo ID: DSCN4587<br/>Date: March 24, 2023<br/>Photo Taken By: Katelyn Almeter</p> <p>Notes: overview of Area 2; looking south</p> |

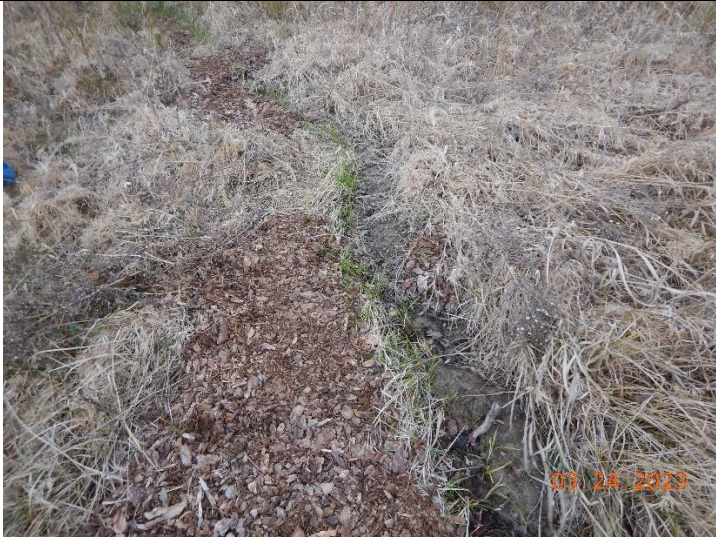
| A close-up photograph of a field with dry, brown grass and a path of mulch. The date '03.24.2023' is visible in the bottom right corner of the photo. | <p>Photo ID: DSCN4588<br/>Date: March 24, 2023<br/>Photo Taken By: Katelyn Almeter</p> <p>Notes: mulch from sediment control sock</p> |

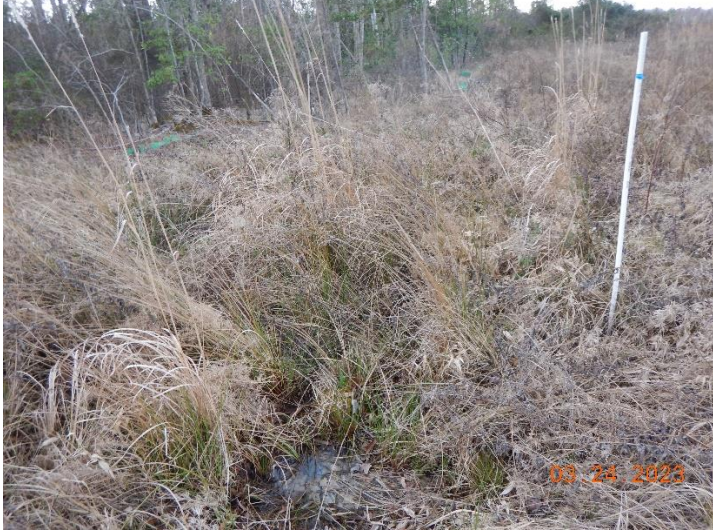
| | <p>Photo ID: DSCN4589<br/>Date: March 24, 2023<br/>Photo Taken By: Katelyn Almeter</p> <p>Notes: overview of Area 2 near a photo monitoring point</p> |

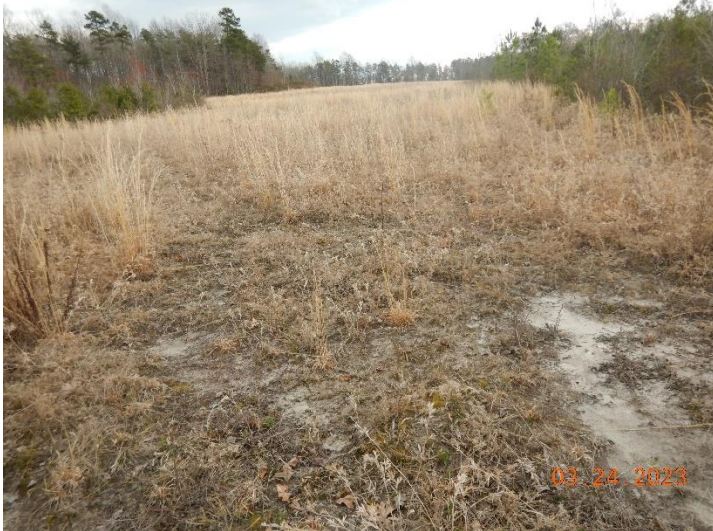
| | <p>Photo ID: DSCN4590<br/>Date: March 24, 2023<br/>Photo Taken By: Katelyn Almeter</p> <p>Notes: eastern side of Area 2</p> |

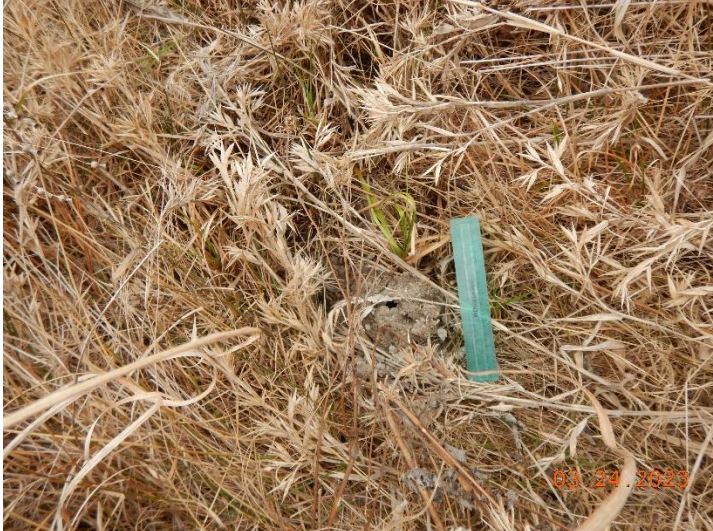
| | <p>Photo ID: DSCN4591<br/>Date: March 24, 2023<br/>Photo Taken By: Katelyn Almeter</p> <p>Notes: crayfish burrow in Area 2</p> |

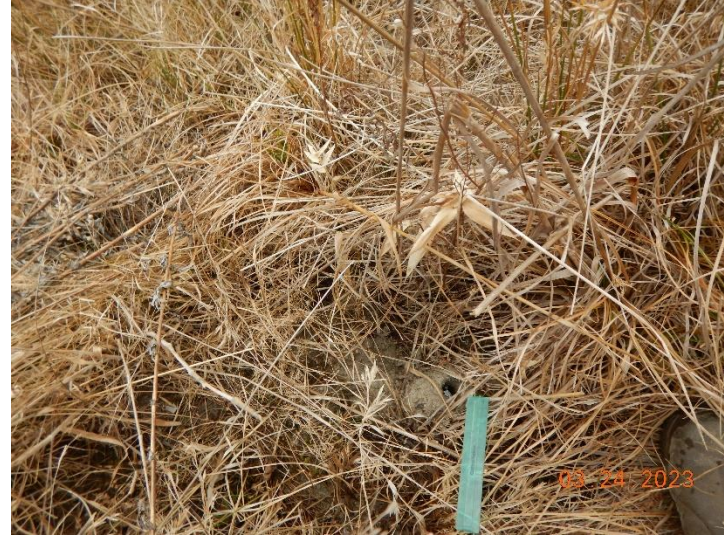
| | <p>Photo ID: DSCN4592<br/>Date: March 24, 2023<br/>Photo Taken By: Katelyn Almeter</p> <p>Notes: crayfish burrow in Area 2</p> |

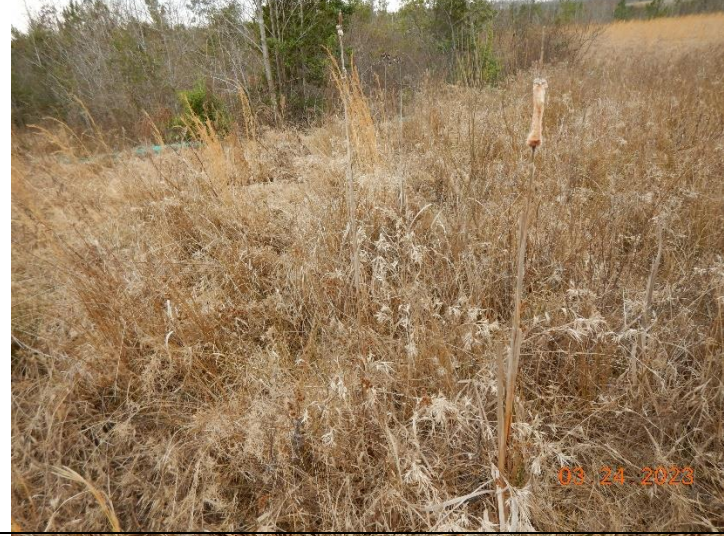
| | <p>Photo ID: DSCN4593<br/>Date: March 24, 2023<br/>Photo Taken By: Katelyn Almeter</p> <p>Notes: <i>Typha</i> sp. in Area 2</p> |

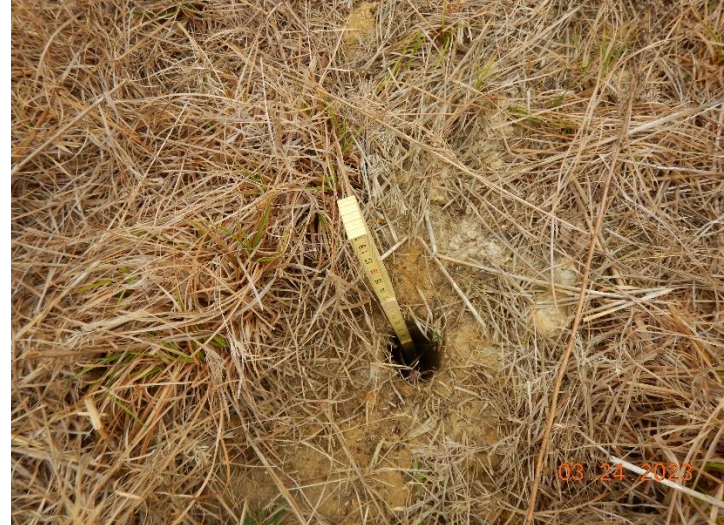
| | <p>Photo ID: DSCN4594<br/>Date: March 24, 2023<br/>Photo Taken By: Katelyn Almeter</p> <p>Notes: open pit where water table presence was observed and measured in Area 2</p> |

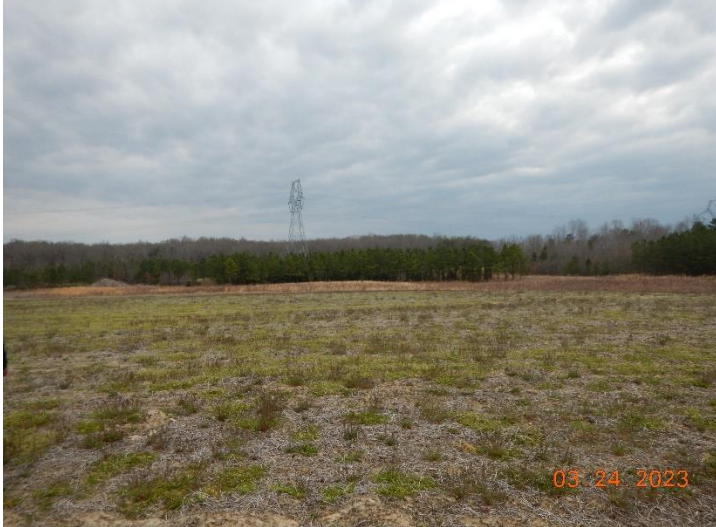
The Inspection walkthrough moved to Area 3, located to the north of Area 2 and near the overhead powerline right of way (DSCN4595). Vegetative coverage and diversity were consistent with Area 2, including the presence of *Typha* sp. (DSCN4599). Using a pit that was still open from previous monitoring events the water table was measured and found to be present at approximately 6 inches (DSCN4596).

| <p>03.24.2023</p> | <p>Photo ID: DSCN4595<br/>Date: March 24, 2023<br/>Photo Taken By: Katelyn Almeter</p> <p>Notes: overview of area 3; facing northwest</p> |

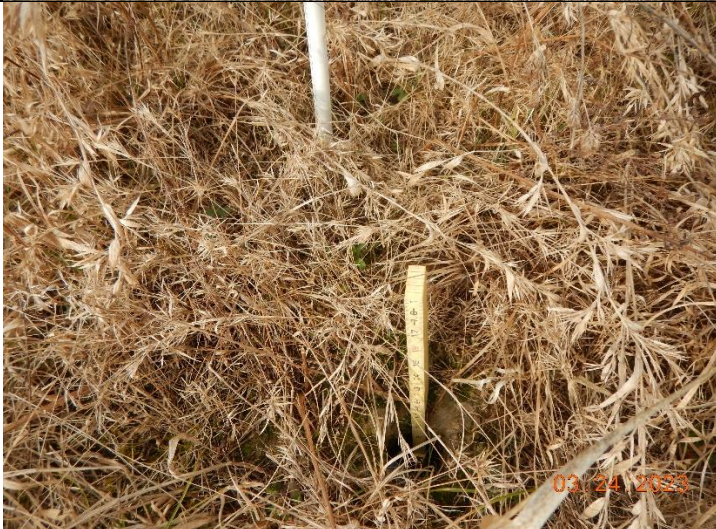
| <p>03.24.2023</p> | <p>Photo ID: DSCN4596<br/>Date: March 24, 2023<br/>Photo Taken By: Katelyn Almeter</p> <p>Notes: open pit where water table presence was observed and measured in Area 3</p> |

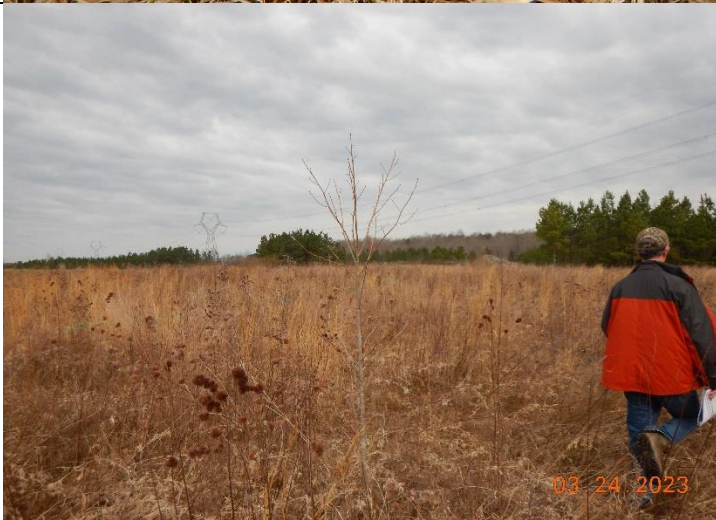
| <p>03.24.2023</p> | <p>Photo ID: DSCN4597<br/>Date: March 24, 2023<br/>Photo Taken By: Katelyn Almeter</p> <p>Notes: near Area 3; looking west</p> |

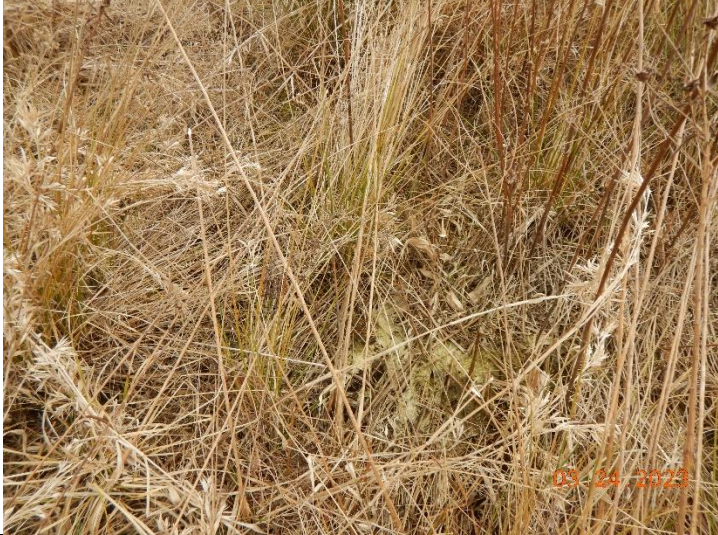
| | <p>Photo ID: DSCN4598<br/>Date: March 24, 2023<br/>Photo Taken By: Katelyn Almeter</p> <p>Notes: vegetation in Area 3</p> |

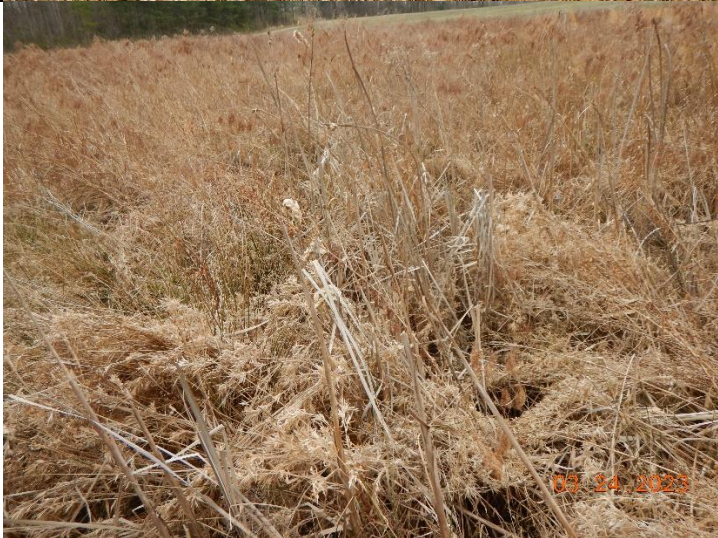
| | <p>Photo ID: DSCN4599<br/>Date: March 24, 2023<br/>Photo Taken By: Katelyn Almeter</p> <p>Notes: <i>Typha</i> sp. in Area 3</p> |

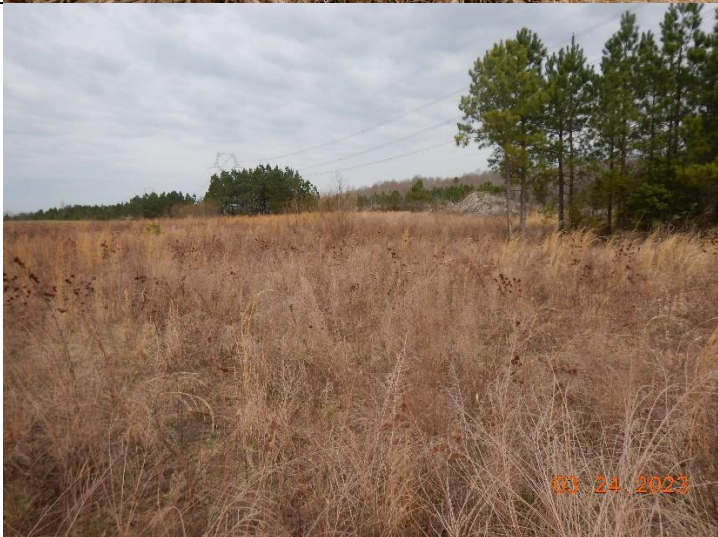
| | <p>Photo ID: DSCN4600<br/>Date: March 24, 2023<br/>Photo Taken By: Katelyn Almeter</p> <p>Notes: overview near edge of Area 3; facing northwest</p> |
