## Region 6 - Enforcement & Compliance Assurance Division

### INSPECTION REPORT

| Company Name: | <b>JTWROS OIL AND GAS</b> | |
| Facility Name: | <b>Edwards Lease</b> | |

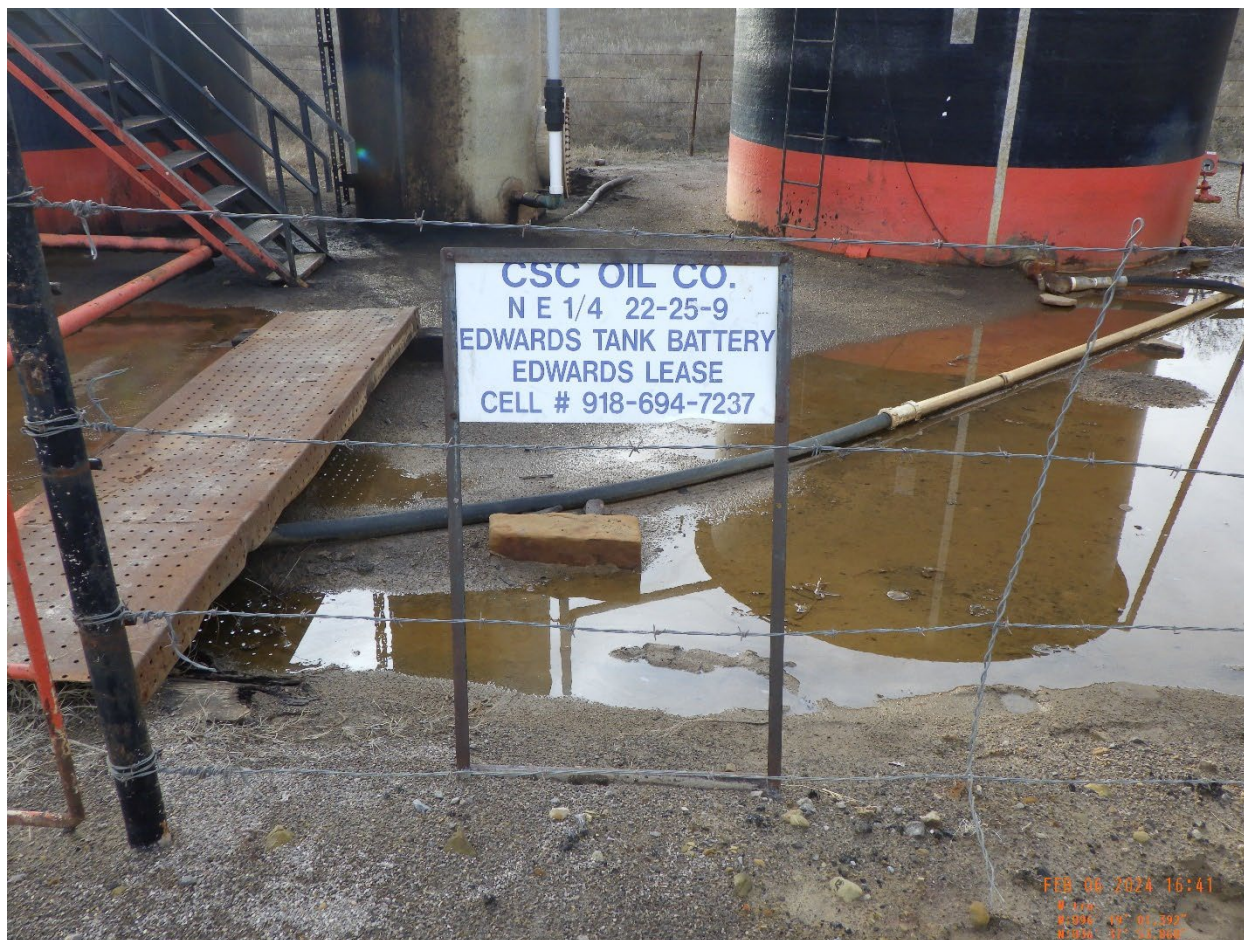
Photo No. 1

I observed the JTWROS OIL AND GAS (dba. CSC OIL CO), Edwards Lease Tank Battery facility sign. See Appendix 1 (photo log) photo No. 1. For additional GPS location information and photo metadata, see the attached photo log.

**Description:** This was the JTWROS OIL AND GAS (dba. CSC OIL CO.) Edwards lease facility sign showing the lease name and operator's phone number.

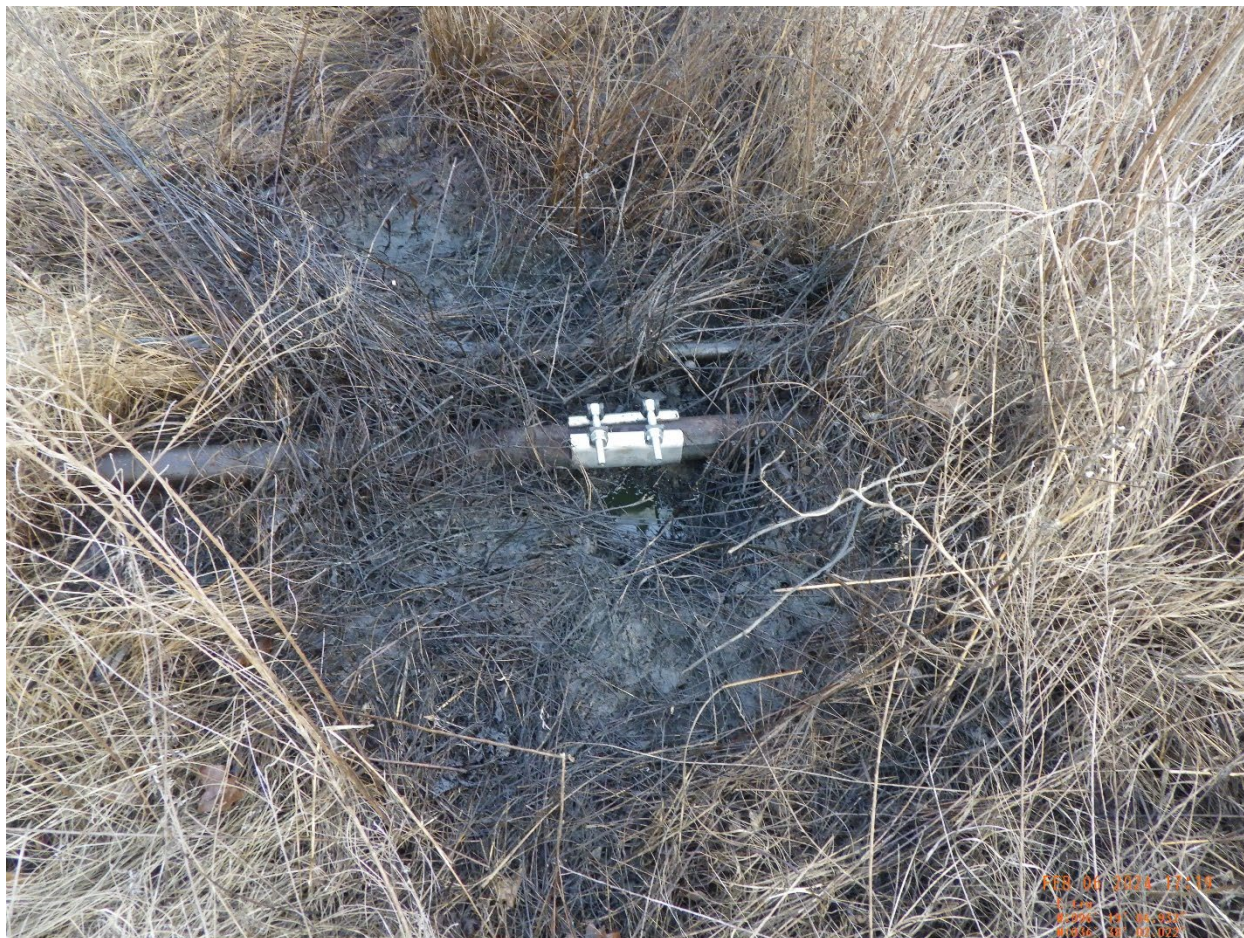
Photo No. 2

I observed the release point of the spill (GPS 36.633831, -96.318018). At the time of the inspection, the lease operator had installed a temporary repair claim on the leaking flowline to prevent additional fluids from being released. At the same location, I observed pooled oil, oil-stained soil, vegetation and the overland flowpath which traveled in a general east and northeast direction. See photos No. 2 and 3.

**Description:** This was a temporary repair clamp on the 2" steel line which had been installed by the operator to prevent additional oil/produced water from spilling to the soil. This was the release point of the spill.

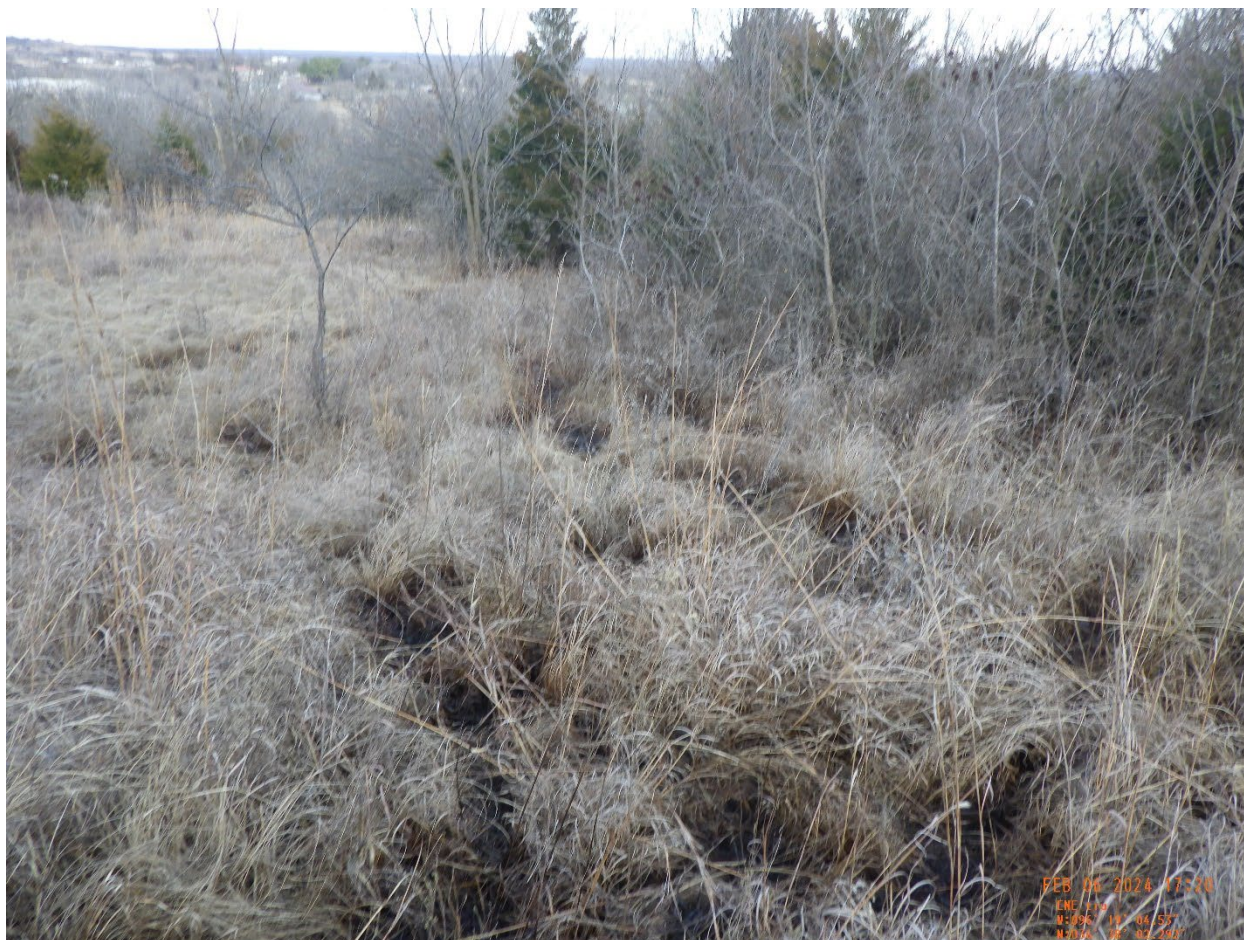
Photo No. 3

**Description:** This was a photo taken from the release point with a view to the ENE showing the overland flowpath which travelled in a general northeast direction, downhill, eventually spilling into an unnamed tributary of Quapaw Creek.

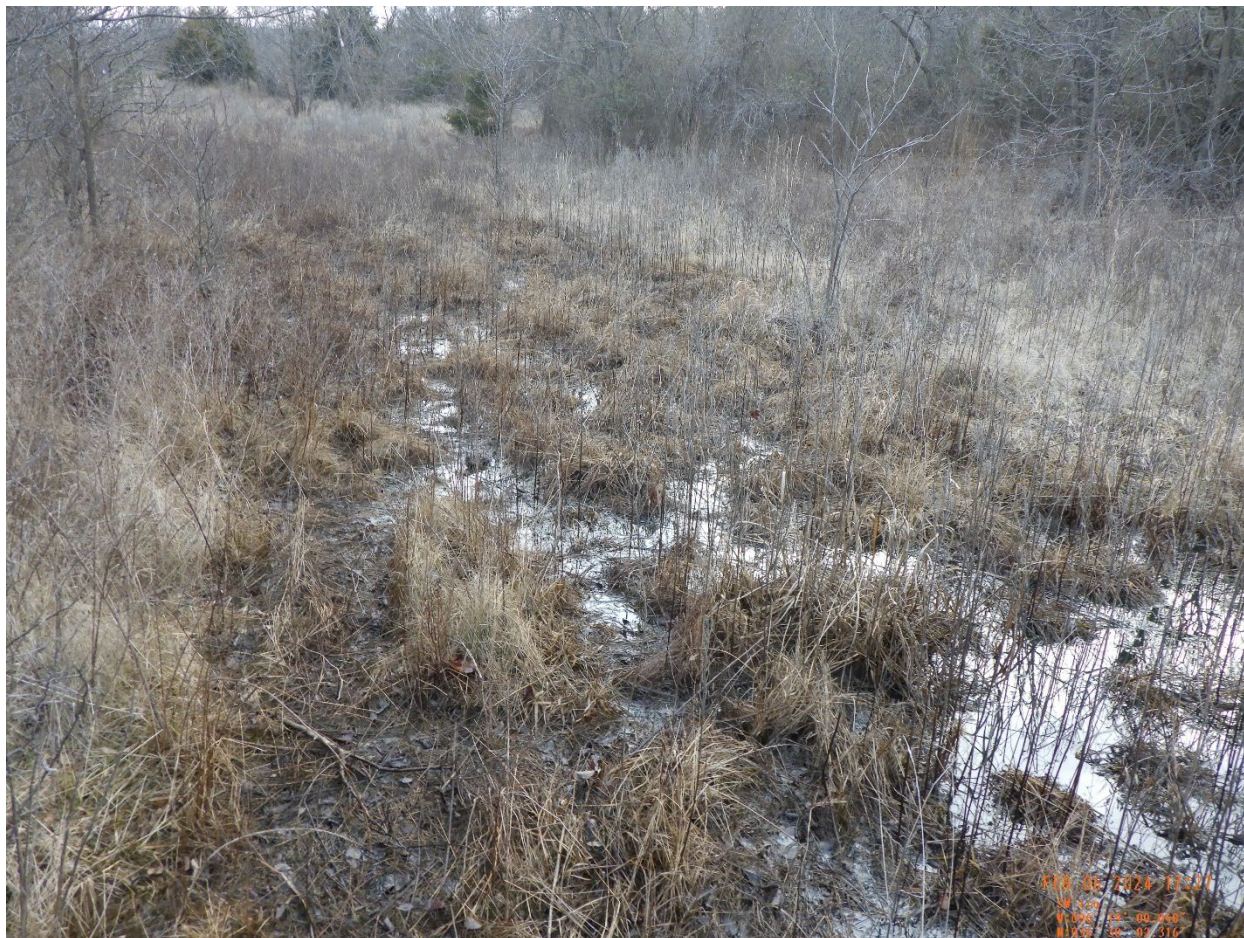
Photo No. 4

At the base of the hill, I observed a drainage feature with a significant amount of pooled oil. The pooled oil ranged in width between 10 feet and 15 feet. There was no defined bed or bank features associated with the drainage feature. There was no change in vegetation type along the drainage. See photos No. 4 and 5.

**Description:** This was a view looking southwest along the flowpath of pooled crude oil along the bottom of the hill below the release point of the spill. All the fluid in the photo is crude oil. At the time of the inspection, vacuum trucks were working in the area to remove the oil. This was a drainage feature but had no defined bed or bank features.

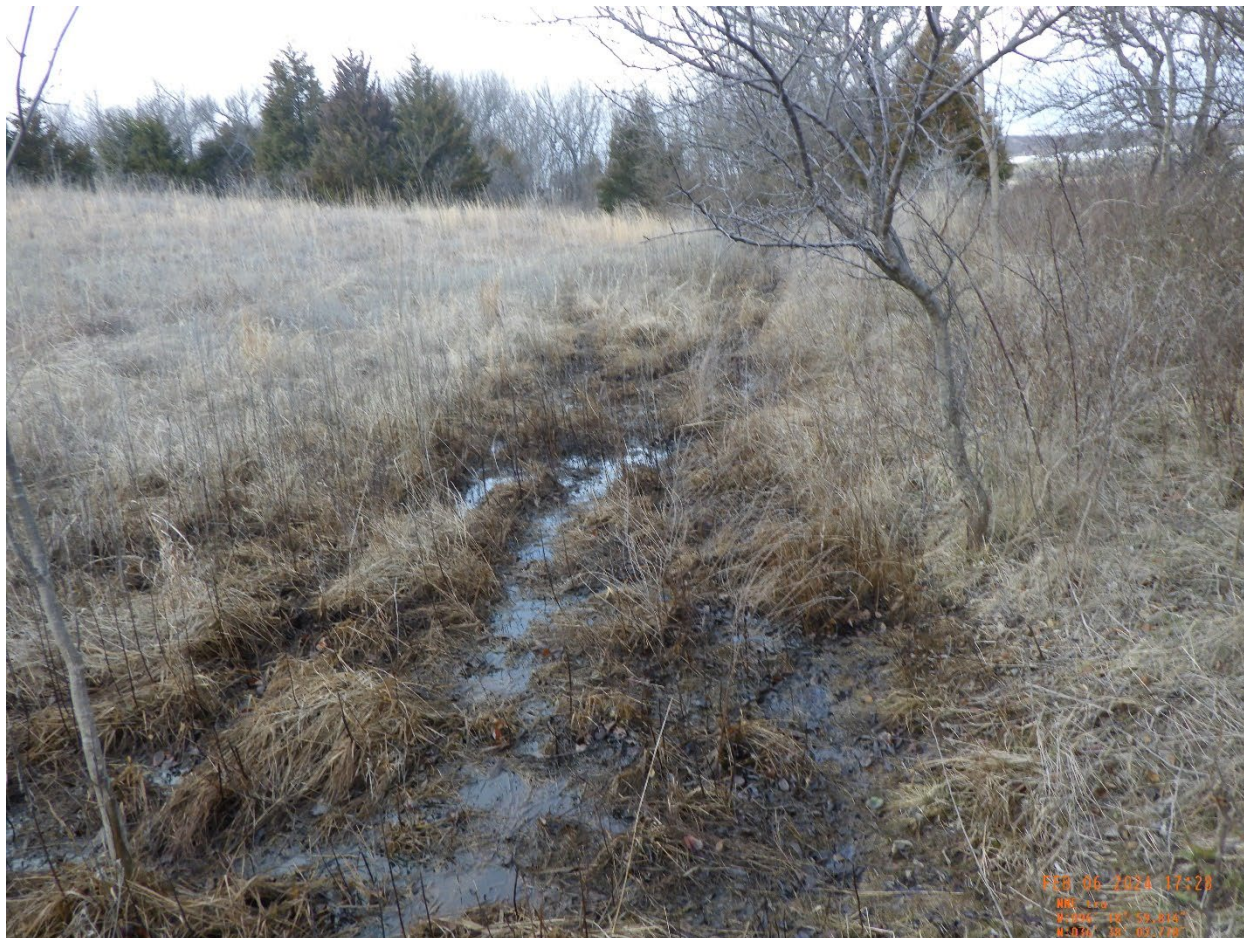
Photo No. 5

**Description:** This was a photo taken from the same location as photo No. 4 with a view to the northeast. All fluid in the photo is crude oil but oil staining, which was elevated on the vegetation showed the level of spilled fluids in the area had been reduced. The flowpath in this area ranged from 10 feet to 15 feet in width.

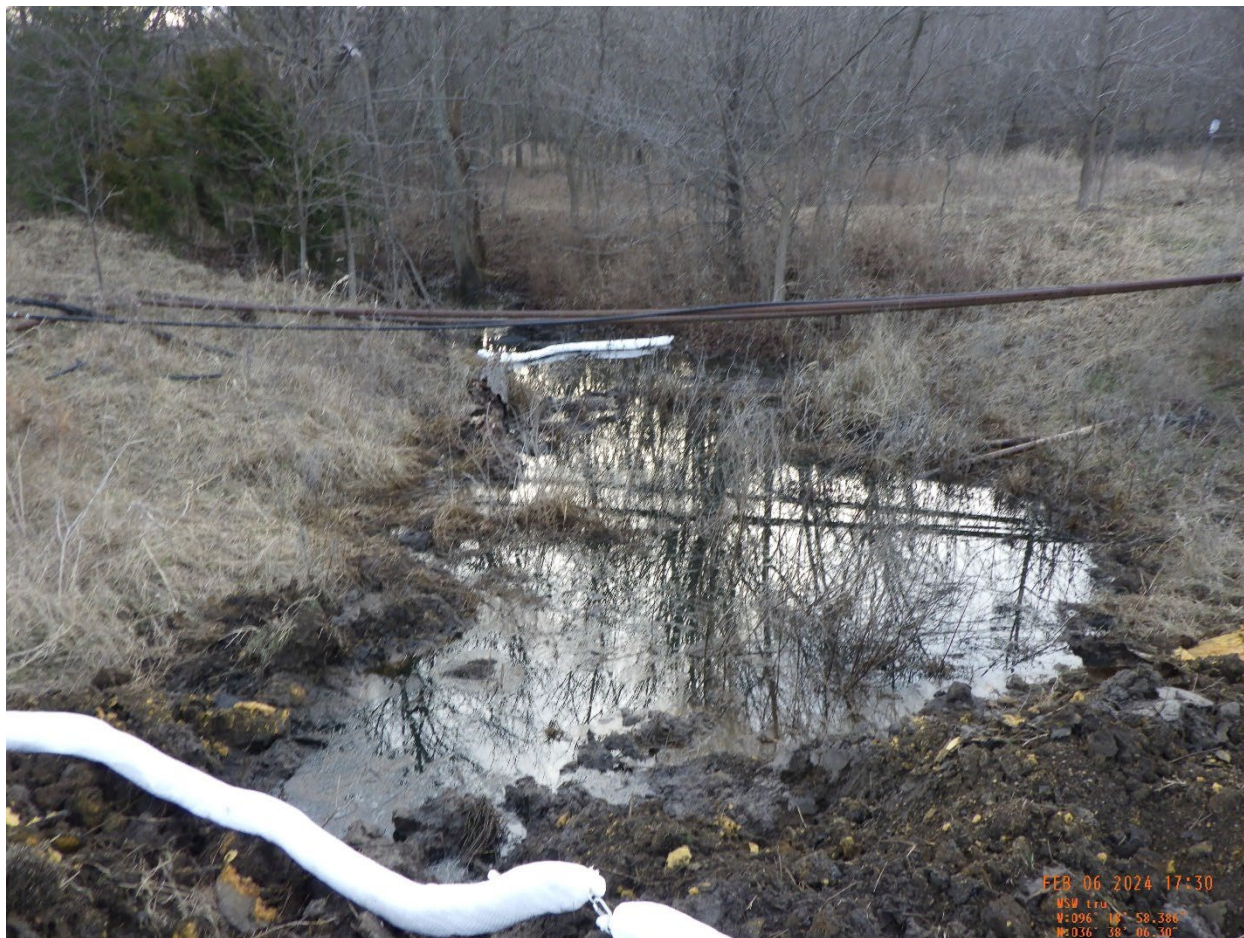
Photo No. 6

I observed the point of entry (POE) (GPS 36.635083, -96.316214) into an unnamed tributary of Quapaw Creek. At the same location, I observed a temporary containment dam and oil absorbent booms which had been installed by the operator to prevent downstream migration of spill impacts. See photos No. 6 and 7 for upstream and downstream views of the impacted tributary.

**Description:** This was a temporary containment dam and absorbent booms which had been installed by the operator to prevent further downstream migration of oil and produced water. The pool of fluid in the photo was covered in crude oil. This was the pool where the drainage feature from photos 4 and 5 entered the unnamed tributary of Quapaw Creek. This was the Point of Entry (POE).

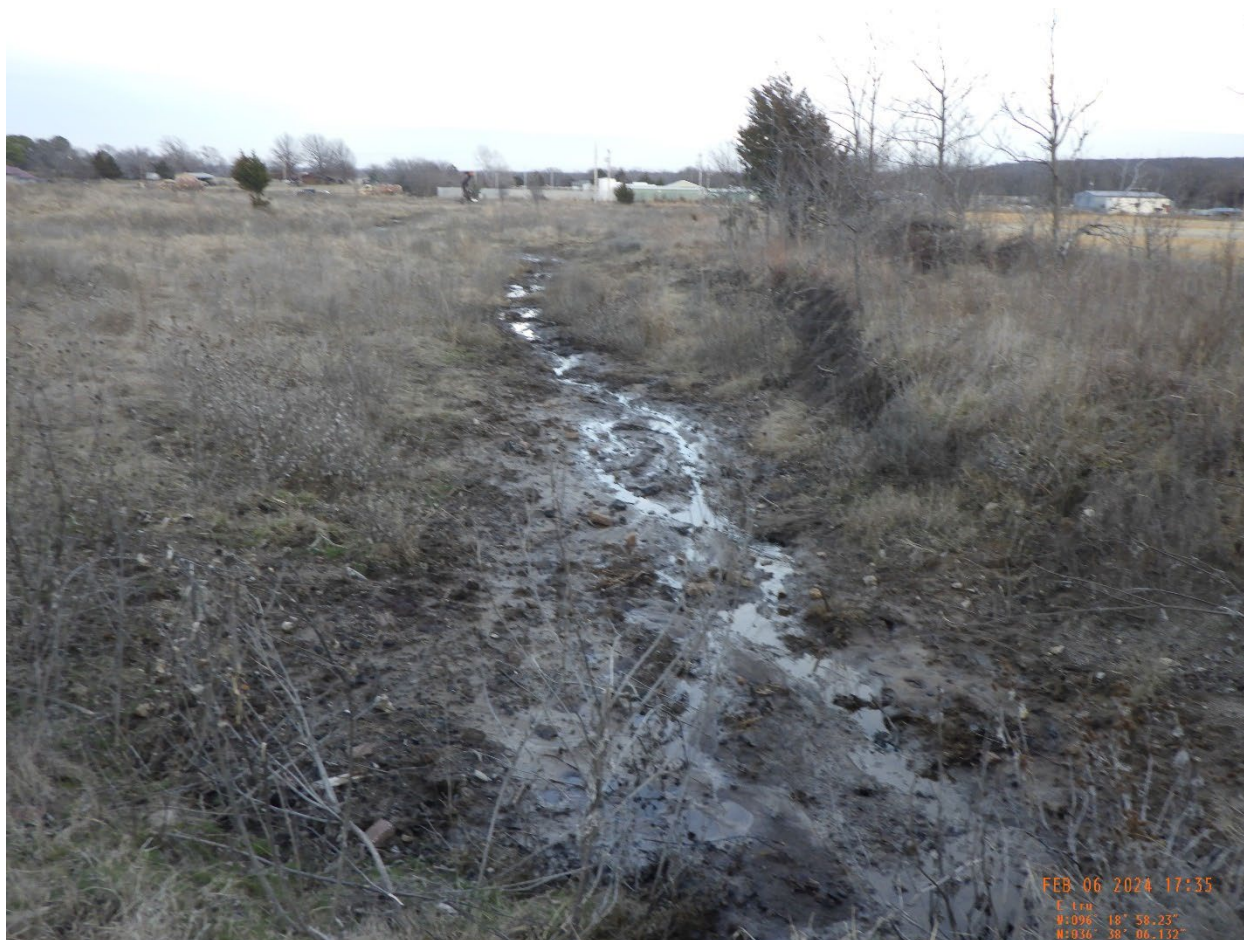
Photo No. 7

**Description:** This was a photo taken from the same temporary containment dam from photo No. 6. This photo had a view to the east showing the impacted, unnamed tributary of Quapaw Creek.

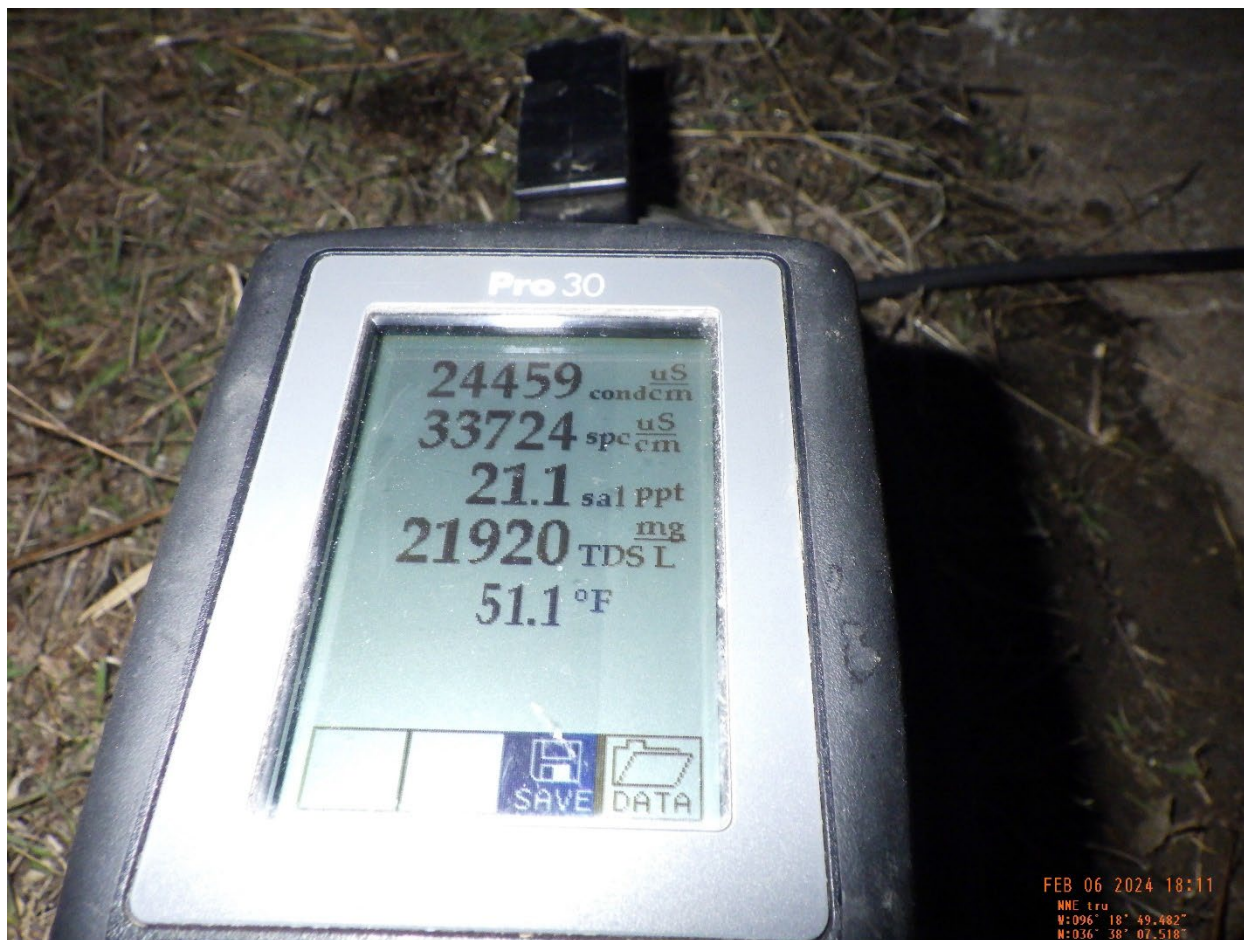
Photo No. 8

Continuing downstream, I observed an elevated total dissolved solids (TDS) field reading of 21920 mg/L. This was the highest TDS reading observed during the inspection. This was observed in a pool of water which had been emptied one time by a vacuum truck as part of the ongoing cleanup activities. This was the first location the YSI Pro 30 conductivity probe could be deployed without risk of contaminating the sampling probe. At this same location, I observed “sphag sorb” (an industrial oil absorbent) which had been applied to the impacted tributary to tie up loose oil. See photos No. 8 and 9.

**Description:** This was an elevated total dissolved solids (TDS) field reading of 21920 mg/L which was taken downstream along the main channel of the impacted tributary. This was taken in a pool of water which had already been emptied once by a vacuum truck, which removed much of the oil, allowing the YSI meter probe to be deployed without the risk of oil contamination.

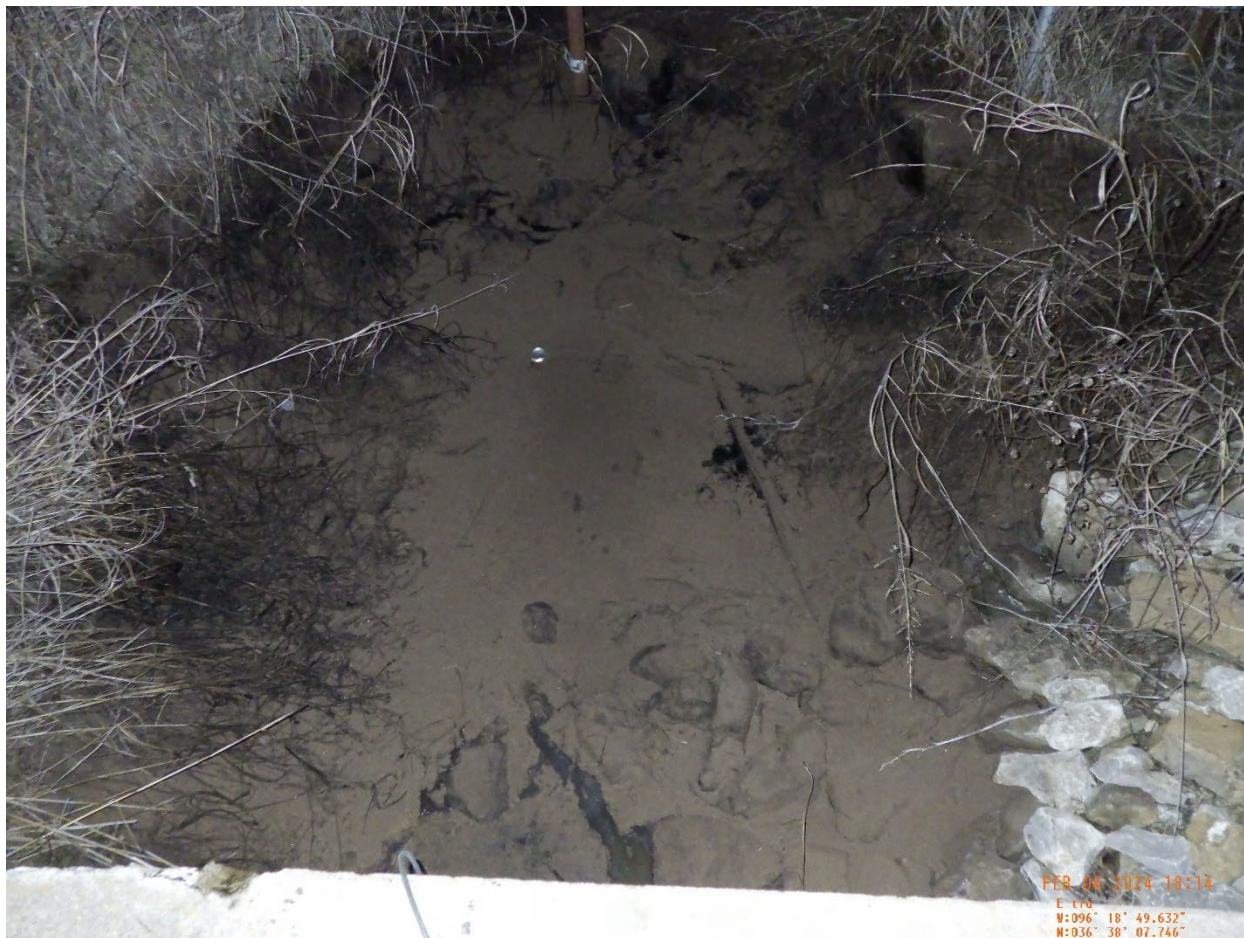
Photo No. 9

**Description:** This was the pool along the main channel of the impacted tributary where the TDS field reading from photo No. 8 was observed. This pool had been emptied by a vacuum truck as part of the ongoing cleanup effort. The pool was covered in "sphag sorb," an industrial oil absorbent, at the time of the inspection.

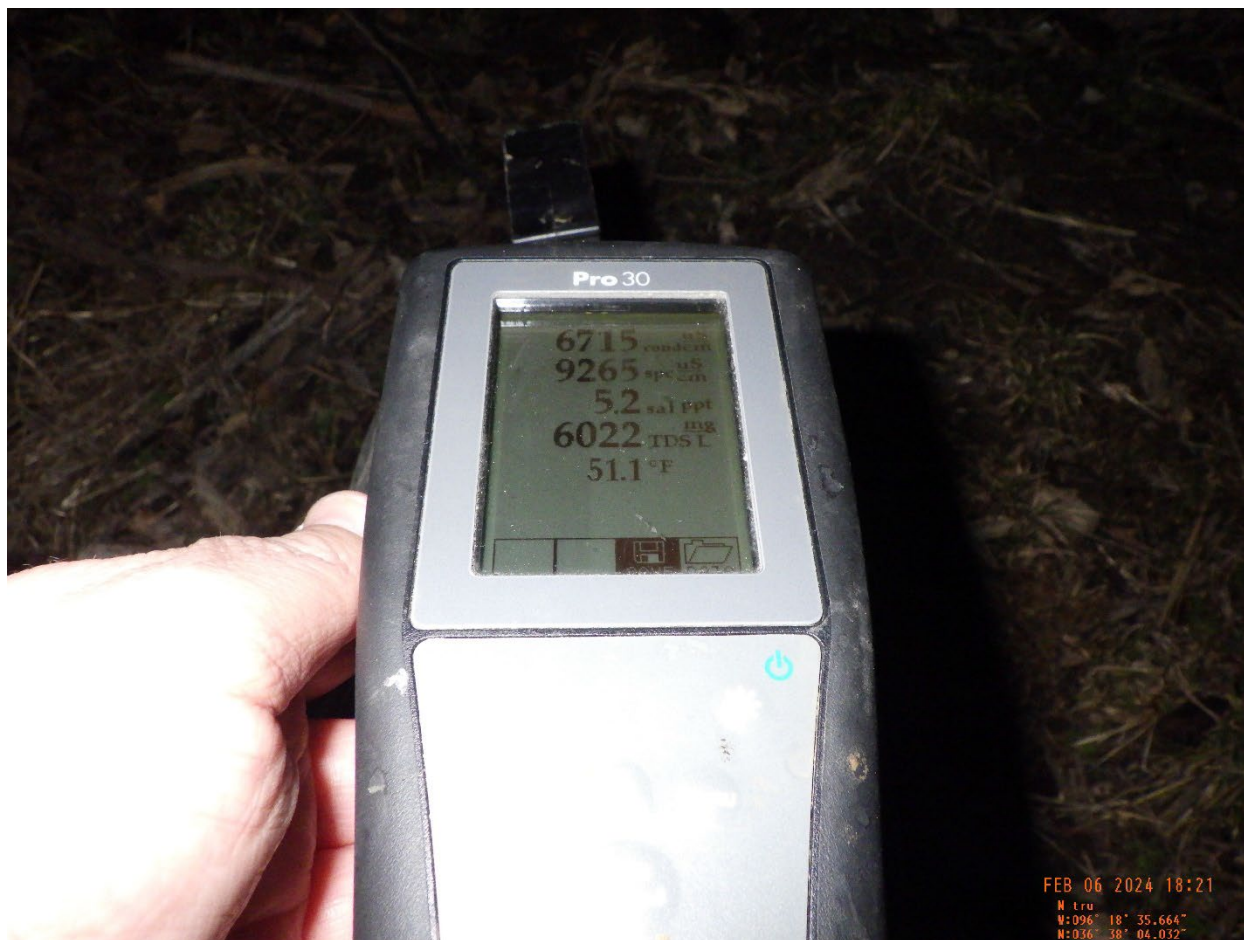
Photo No. 10

I observed the lowermost temporary containment dam, the end of spill impacts, and an elevated TDS field reading of 6022 mg/L. These observations were all made at the same location. At this location, the impacted tributary spilled into and out of a small stock pond. The containment dam was properly placed and was preventing spill impacts from migrating downstream at the time of the inspection. See photos No. 10, 11 and 12.

**Description:** This was an elevated TDS field reading of 6022 mg/L taken at the lowermost temporary containment dam.

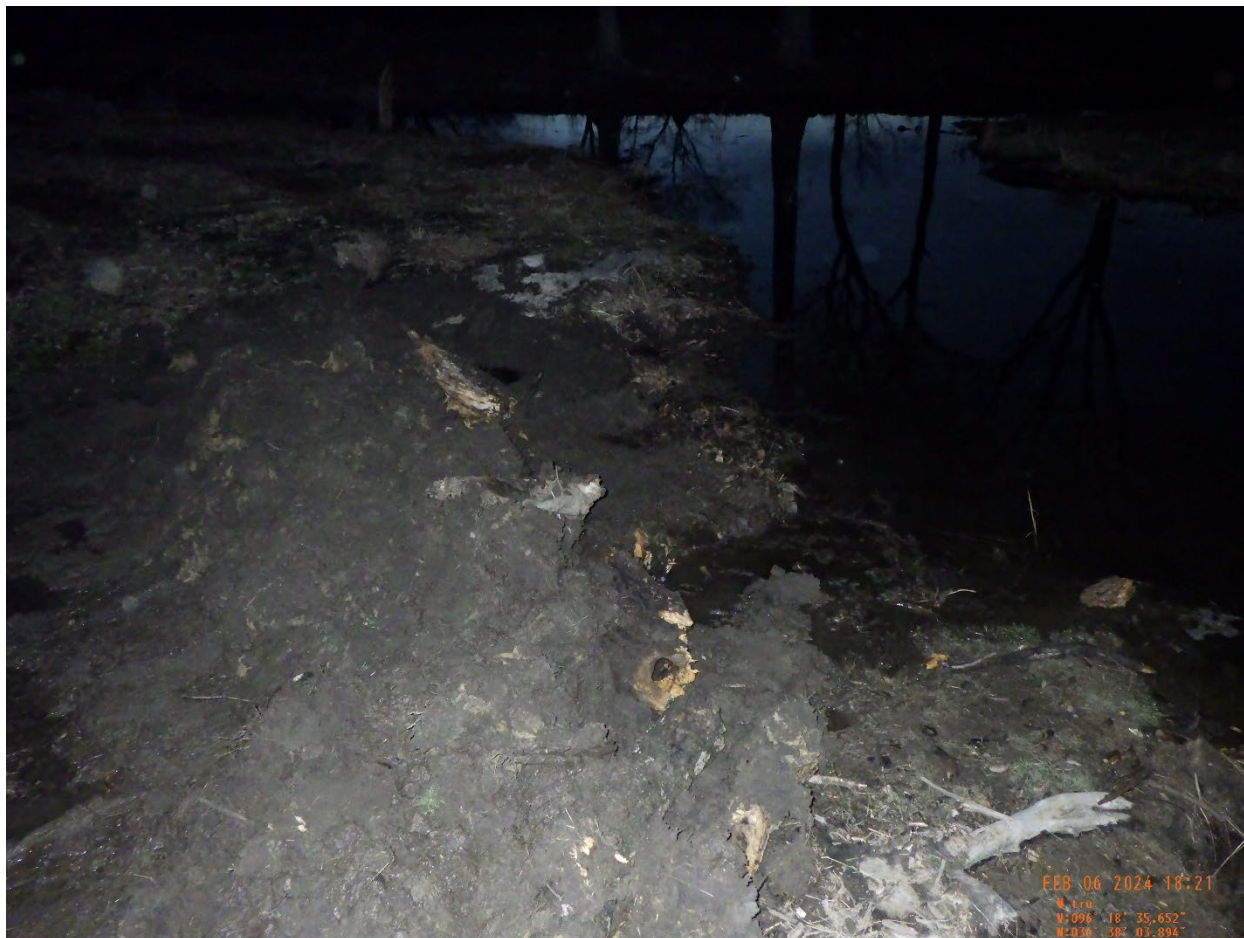
Photo No. 11

**Description:** This was the lowermost containment dam. The dam was placed where the impacted tributary spilled into and out of a small stock pond. The stock pond had captured the elevated TDS waters. This dam was properly placed and was preventing downstream migration of elevated TDS waters.

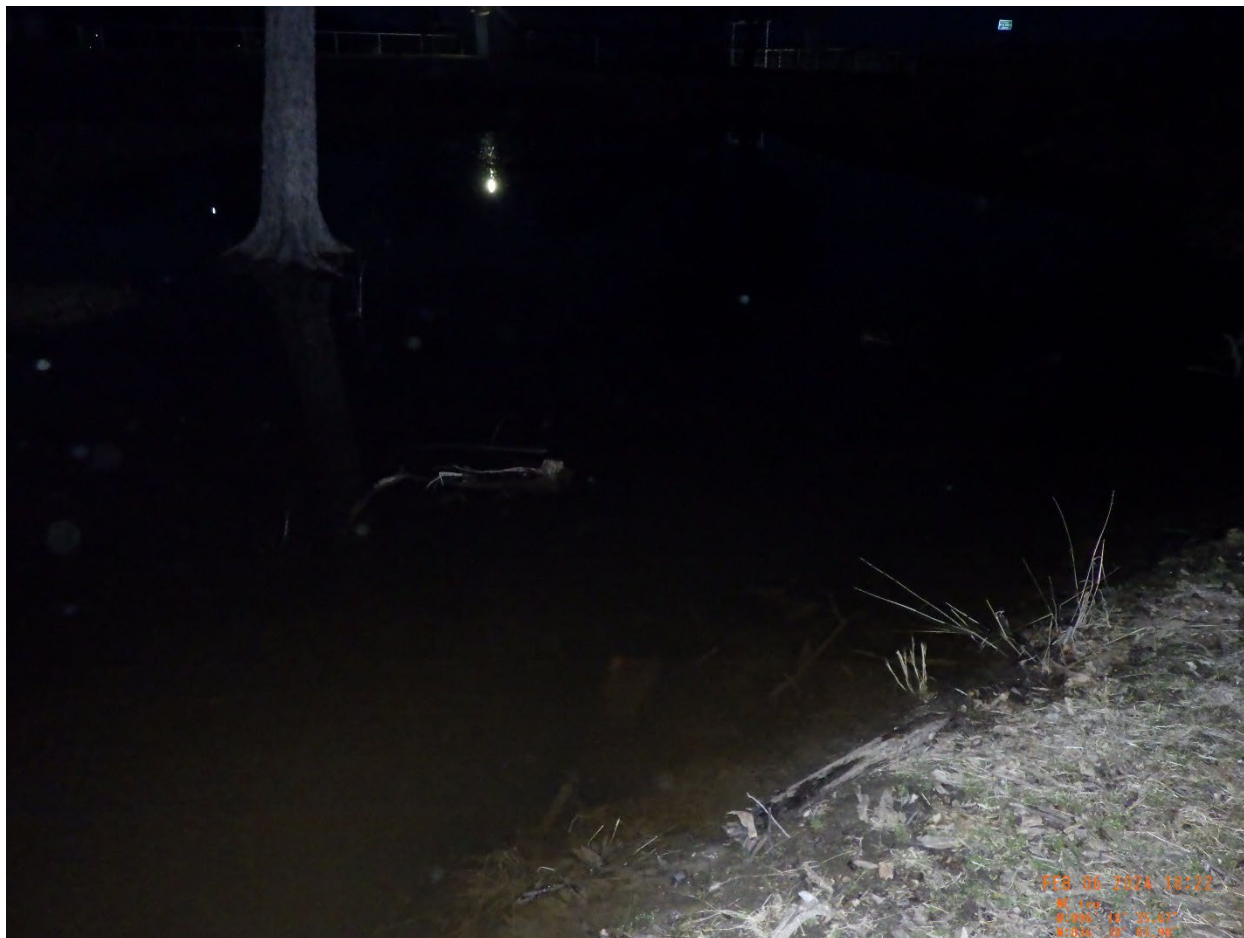
Photo No. 12

**Description:** This was the stock pond which was impacted by the spill. At the time of the inspection, this was the end of the observed spill impacts. The containment dam placed at this location was effectively restricting downstream migration of impacted waters.

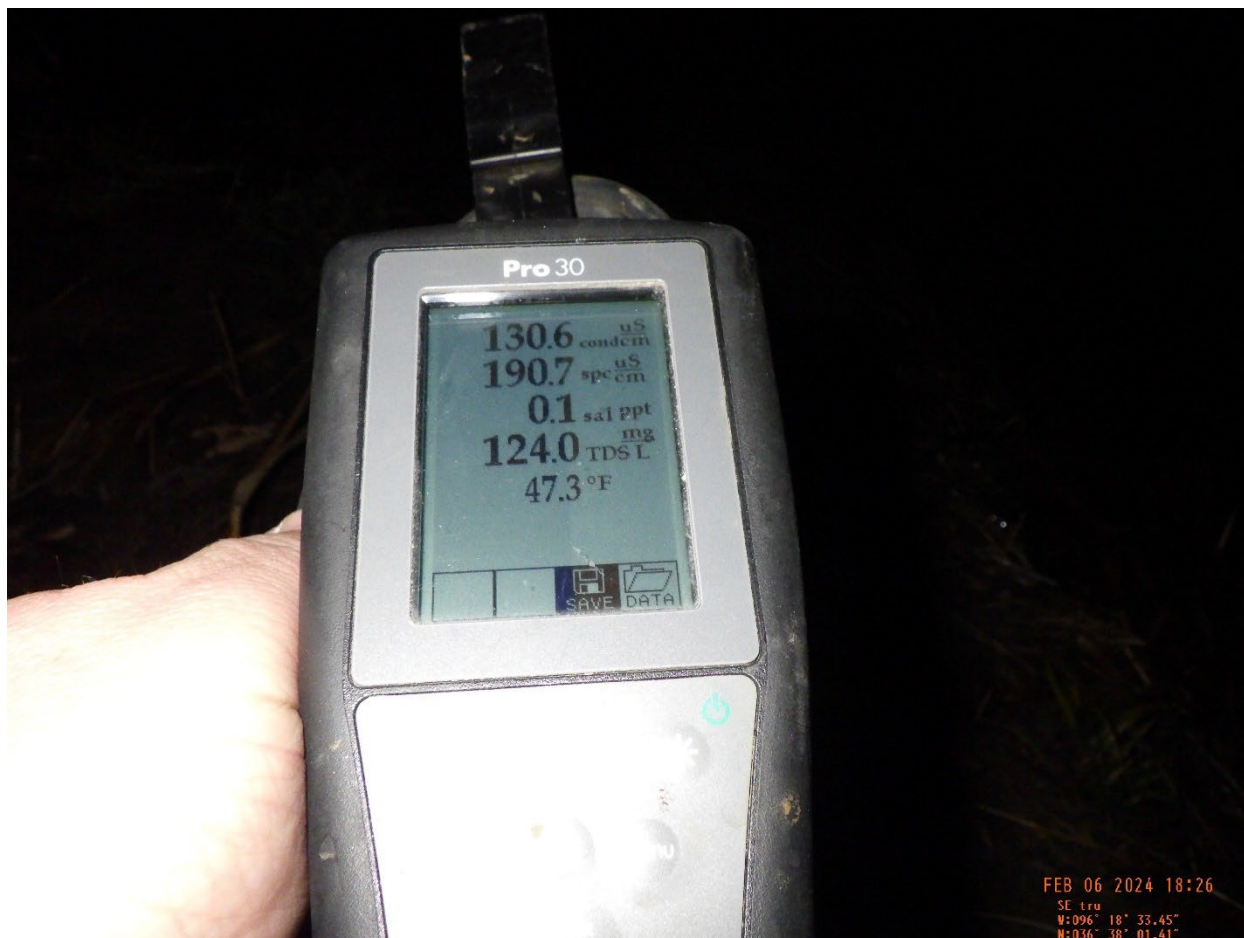
Photo No. 13

Approximately 400 feet downstream from the lowermost containment dam, I observed the POE of the impacted tributary into Quapaw Creek. I observed a TDS field reading of 124 mg/L at this location, which indicated there was no impact to Quapaw Creek at the time of the inspection. This TDS reading should be used when establishing “background” TDS levels for the area. See photos No. 13 and 14.

**Description:** This was a TDS field reading of 124 mg/L taken at the confluence of the impacted tributary and Quapaw Creek. This location was approximately 400 feet downstream from the lowermost containment dam. At the time of the inspection, there was no observable impact to Quapaw Creek. This TDS reading should be used when assessing the “background” TDS level in the area.

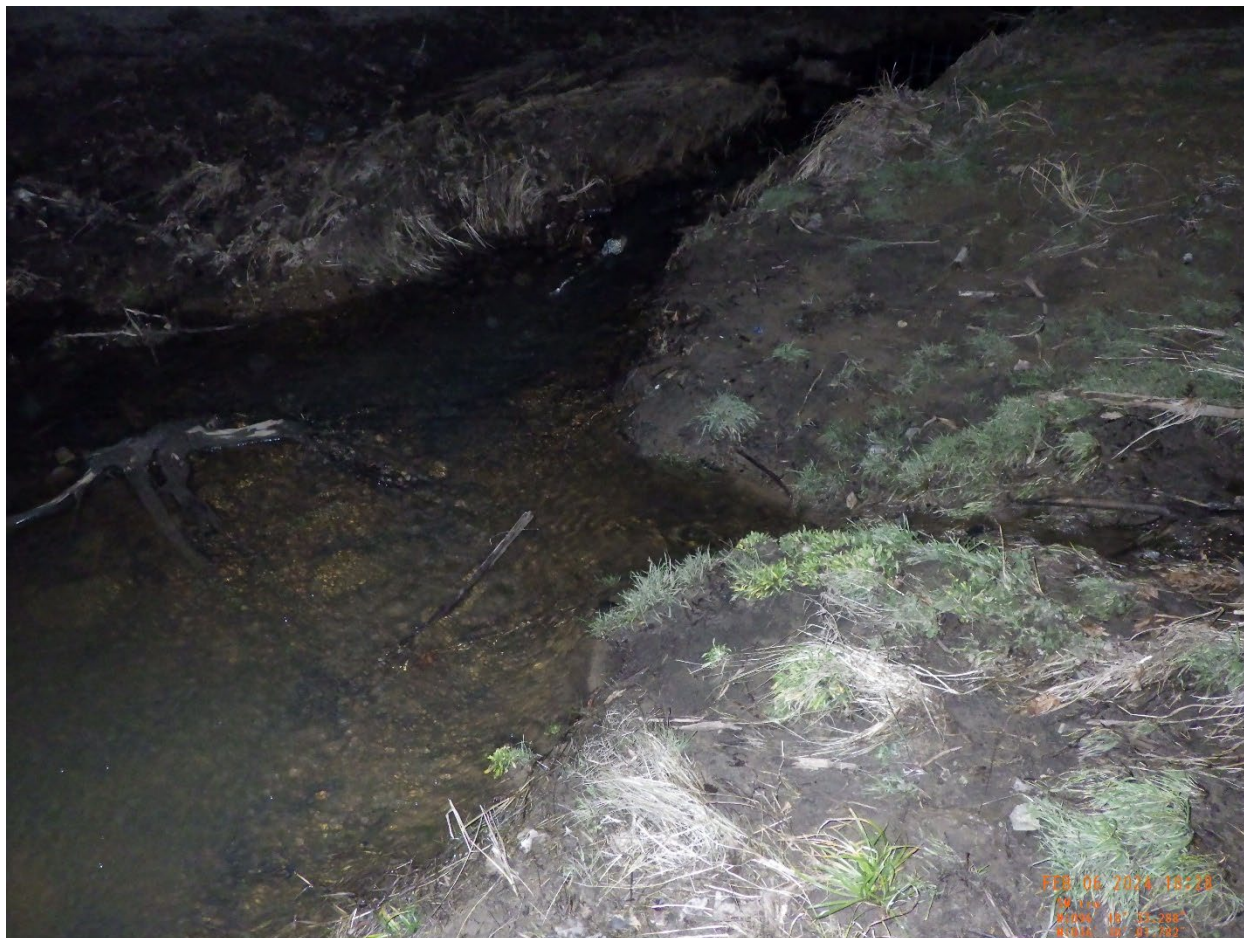
Photo No. 14

I observed no additional spill impacts downstream from the location of photo No. 14.

**Description:** This was the confluence of the impacted tributary (entering from the right side of the photo) and Quapaw Creek (entering from the top side of the photo). At the time of the inspection, the temporary containment dam which had been placed approximately 400 feet upstream was preventing impact to Quapaw Creek.
