**REGION 3**

**Report Title:** Clean Water Act, Section 404 Inspection Report for Preston Hoopes Site  
**Inspection Date(s):** 08/8/2024  
**Start Time:** 11:09 **End Time:** 13:10  
**Regulatory Program(s):** Inspections authorized pursuant to Clean Water Act, Sections 308 and 404 (33 U.S.C. §§ 1318 and 1344)  
**Site Name:** Preston Hoopes  
**Site Location:** Intersection of Loucks Mill Road and T536  
Ulysses Township, Pennsylvania 16948  
**Latitude:** 41.892121 **Longitude:** -77.743672  
**County/Parish:** Potter County  
**Site Owner(s):** Preston Hoopes  
**Mailing Address:** 1002 Empson Road  
Ulysses, Pennsylvania 16948

**DSB-ID #:** ECAD-5531

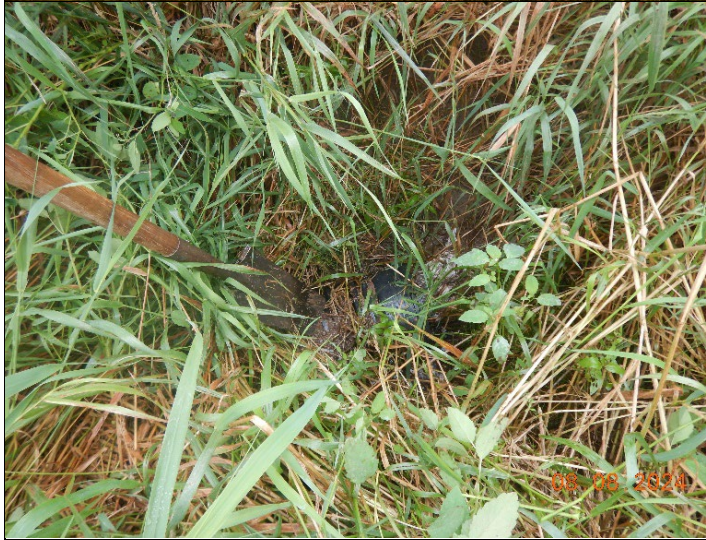
Hoopes Property  
Date: 8 August 2024  
Photo ID: DSCN5556.JPG  
Photo taken by: Laura Mathew

Following opening conference, the inspection began upstream in the Genessee River at the southern end of the recently installed, 10-inch drainpipe. The area was densely vegetated with herbaceous vegetation and water was observed flowing into the drainpipe (Attachment 3 – Photographic Log; DSCN5556 and DSCN5557). The area to the east has been mowed. Ecotune stated that wheat had been farmed in the area to the east of the Genessee River but is currently just mowed to maintain it. Ecotune also stated that when Mr. Hoopes installed the 10-inch drainpipe into the Genessee River, he side-casted material and spread it around.

Notes: Upstream end of the 10-inch drainpipe installed in the Genessee River.

- Removal of the 10-inch drainpipe from the Genessee River;
- Potentially install in-stream features in the Genessee River for erosion control;
- Removal of all 4-inch drainpipes located within the identified wetlands;
- Daylight 4-inch drainpipes outside the wetland boundary; and
- Disturbed areas will be allowed to naturally revegetate.

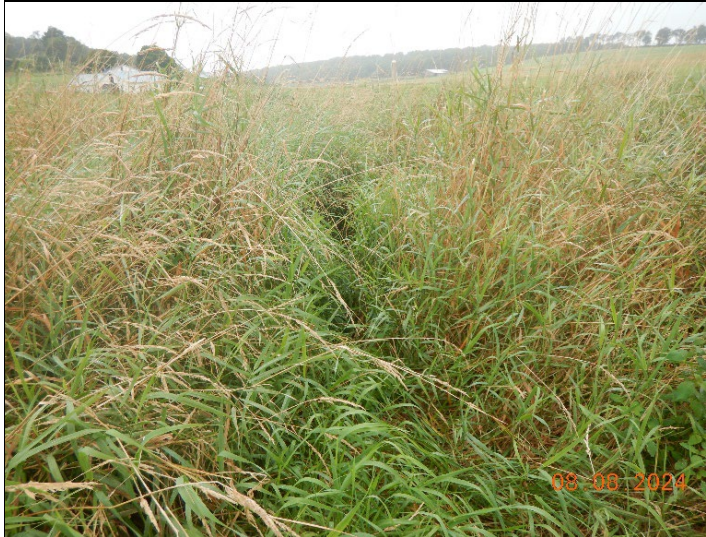
Hoopes Property  
Date: 8 August 2024  
Photo ID: DSCN5557.JPG  
Photo taken by: Laura Mathew

Notes: Downstream view of the flowpath of the 10-inch drainpipe.

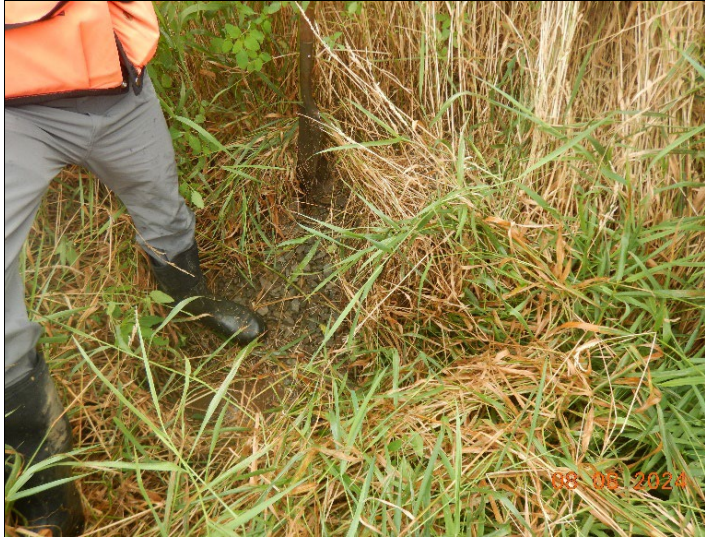
Hoopes Property  
Date: 8 August 2024  
Photo ID: DSCN5558.JPG  
Photo taken by: Laura Mathew

The inspection continued downstream. The location of one of the 4-inch drainpipes was identified, the area was vegetated with herbaceous vegetation and fill material was observed on the ground surface (DSCN5558). Moving further downstream, the inspector observed vehicle tracks in the area east of the Genessee River with standing water present, and an unused 4-inch and 10-inch drain discarded in vegetation near the Genessee River (DSCN5559, DSCN5562, and DSCN5563).

Notes: View of the surface above a drain tile that had been installed.

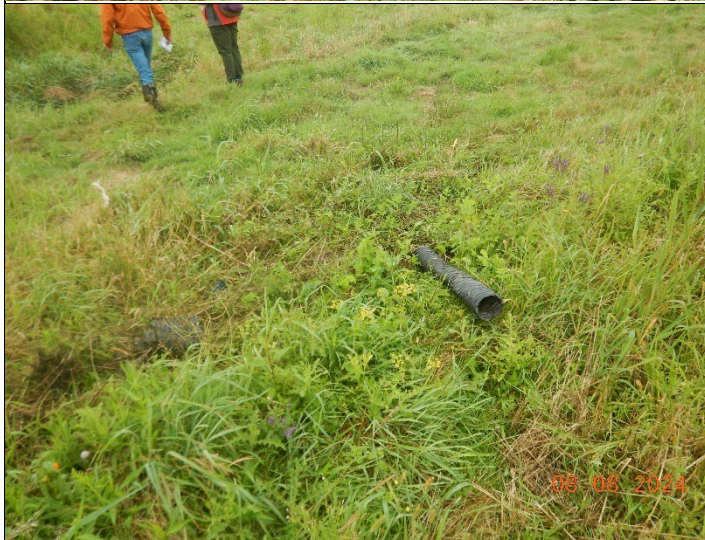
Hoopes Property  
Date: 8 August 2024  
Photo ID: DSCN5559.JPG  
Photo taken by: Laura Mathew

Notes: Debris observed in the field during the walkthrough.

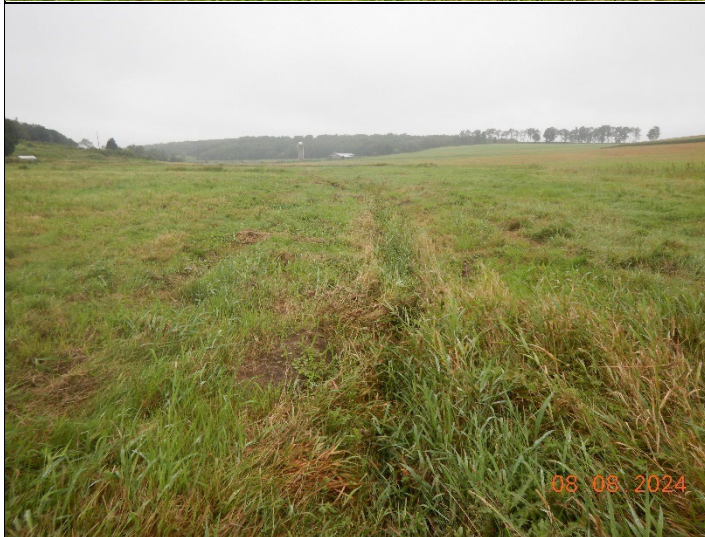
Hoopes Property  
Date: 8 August 2024  
Photo ID: DSCN5560.JPG  
Photo taken by: Laura Mathew

Notes: North facing view of the Genessee River with an installed 10-inch drainpipe.

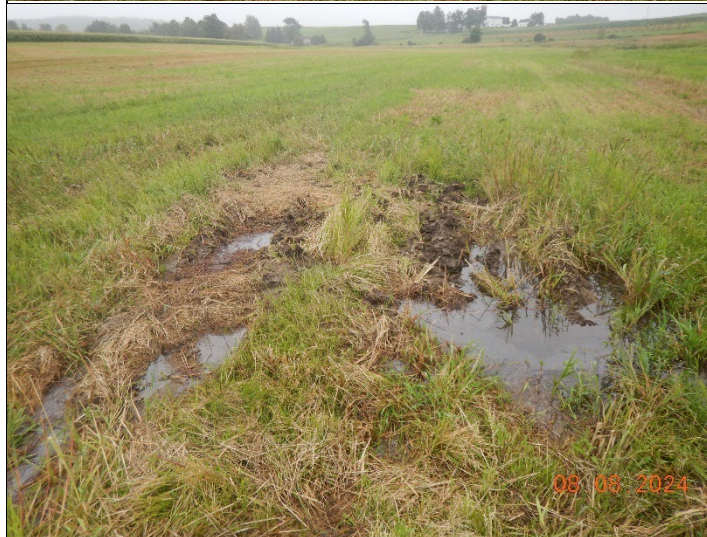
Hoopes Property  
Date: 8 August 2024  
Photo ID: DSCN5562.JPG  
Photo taken by: Laura Mathew

Notes: Surface water noted on east side of the Genessee River.

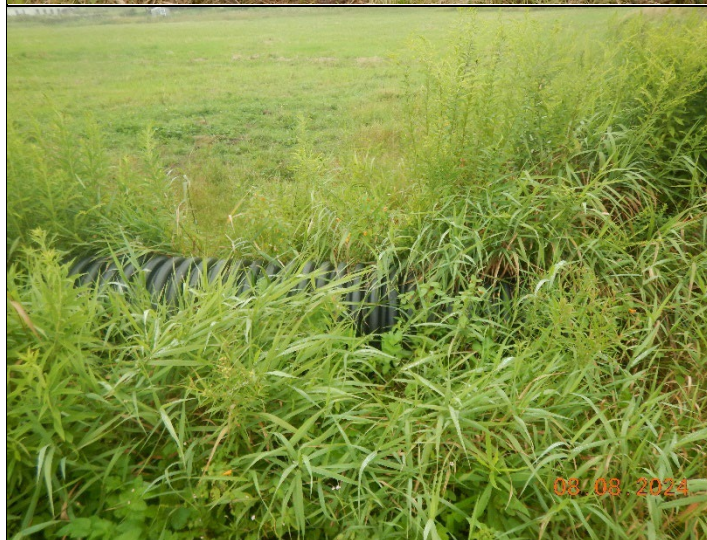
Hoopes Property  
Date: 8 August 2024  
Photo ID: DSCN5563.JPG  
Photo taken by: Laura Mathew

Notes: Unused drain observed in the vegetation during walkthrough.

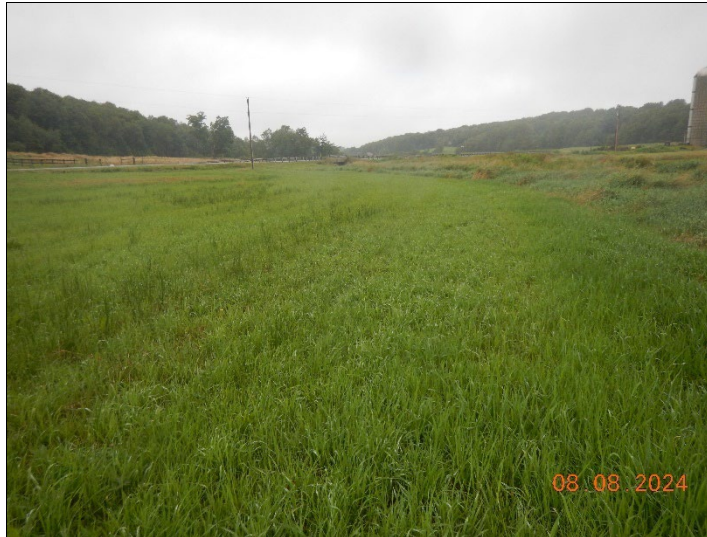
Hoopes Property  
Date: 8 August 2024  
Photo ID: DSCN5567.JPG  
Photo taken by: Laura Mathew

The inspection continued to the north along the Genessee River to the Hoopes property (Attachment 1 – Site Map). A mowed field was noted to the west between the Genessee River and Loucks Mill Road (DSCN5567). The inspection walkthrough continued to a location of a possible drainageway based on pre-inspection review of aerial imagery of the Site. The area was within a slight depression and a variety of grasses were observed, including crabgrass. A soil boring (SB-01) was conducted at 41.8925171, -77.7447140 within the slight depression (Attachment 2 – Soil Boring Locations). The soil boring contained dense roots near the surface and was characterized as: [0-7 inches] 100% 7.5YR 3/2; [7-12 inches] 95% 7.5YR 4/1 silty loam with 5% 7.5YR 4/6 redoximorphic features (DSCN5569). The soil profile met the technical definition of a hydric soil (Indicator F3). The soil was saturated, and evidence of mixing in the soil profile was observed. The area had 100% vegetation cover that consisted primarily of grass.

Notes: North-facing view of area between Genessee River and Loucks Mill Road.

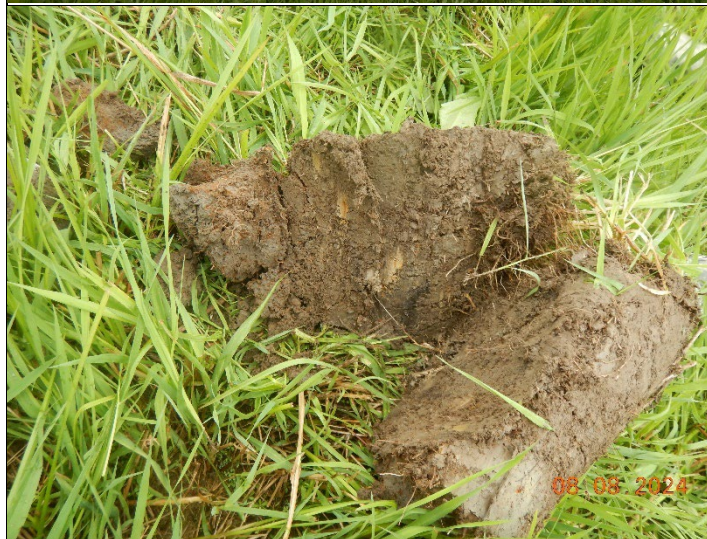
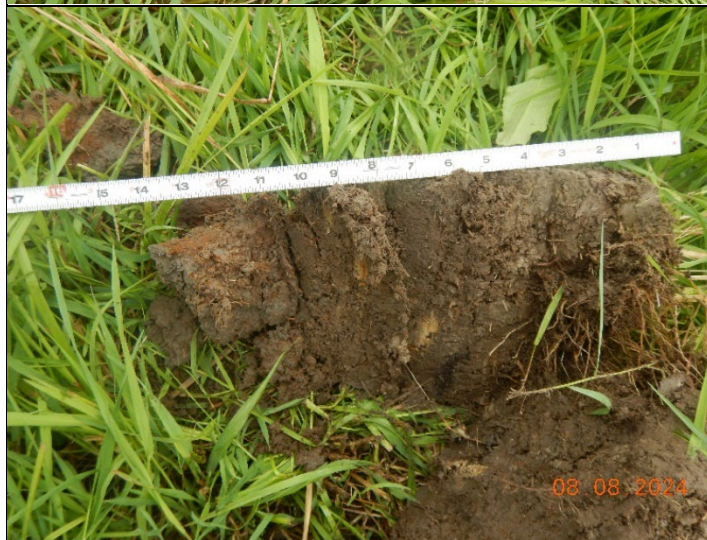
Notes: View of Soil Boring #1.

Notes: Another view of Soil Boring #1.

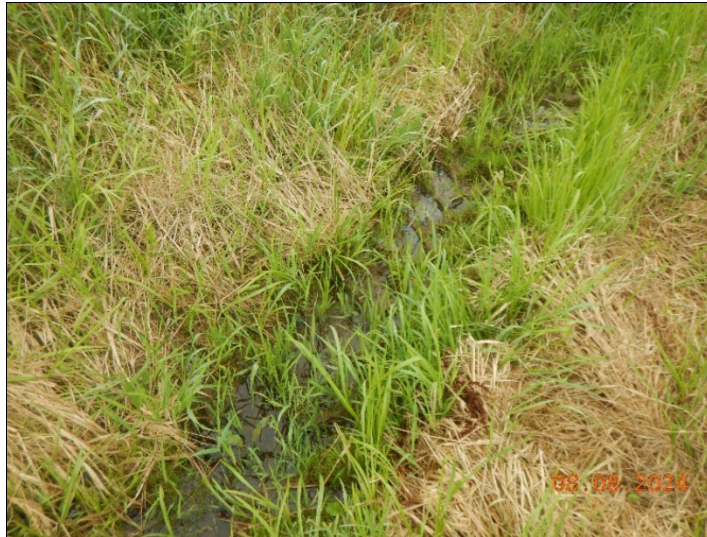
Hoopes Property  
Date: 8 August 2024  
Photo ID: DSCN5570.JPG  
Photo taken by: Laura Mathew

The inspection moved to the south and vehicle depressions were observed in the field. Surface water was present in the vehicle depressions at the time of the inspection (DSCN5570 and DSCN5571). A culvert under Loucks Mill Road was observed with water flowing to the Site (DSCN5572). Ecotune stated this culvert had recently been installed, replacing an older culvert.

Notes: Vehicle depression with surface water present.

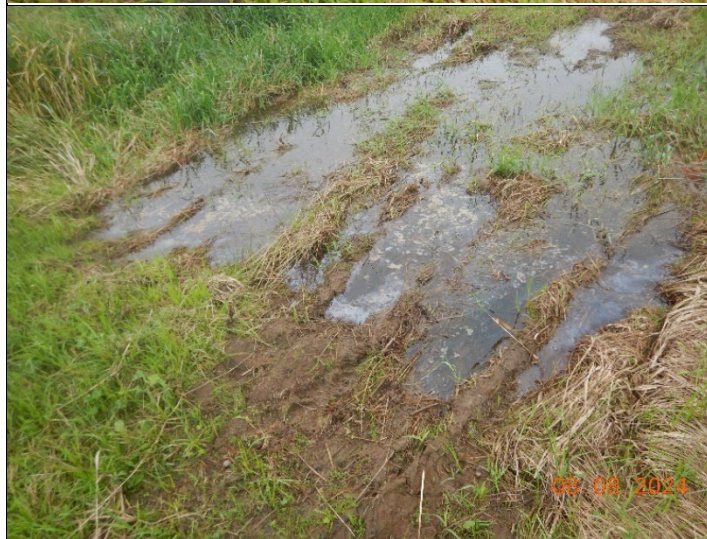
Hoopes Property  
Date: 8 August 2024  
Photo ID: DSCN5571.JPG  
Photo taken by: Laura Mathew

Notes: Vehicle depressions with surface water present.

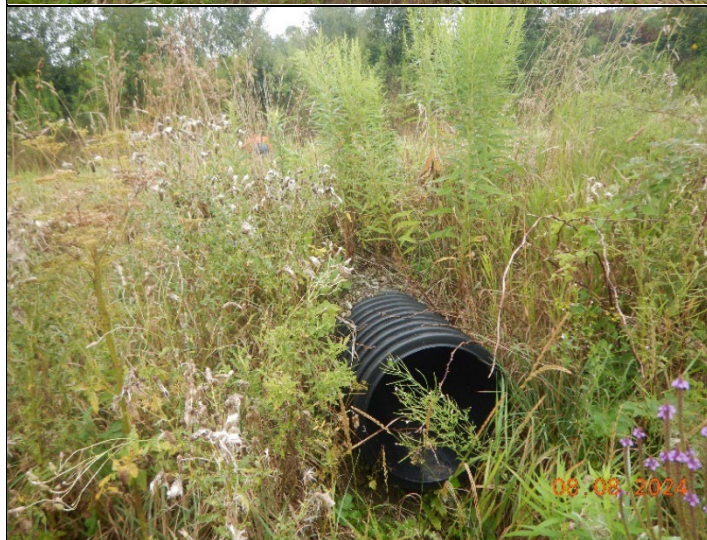
Hoopes Property  
Date: 8 August 2024  
Photo ID: DSCN5572.JPG  
Photo taken by: Laura Mathew

Notes: Outfall of stormwater drain under Loucks Mill Road.

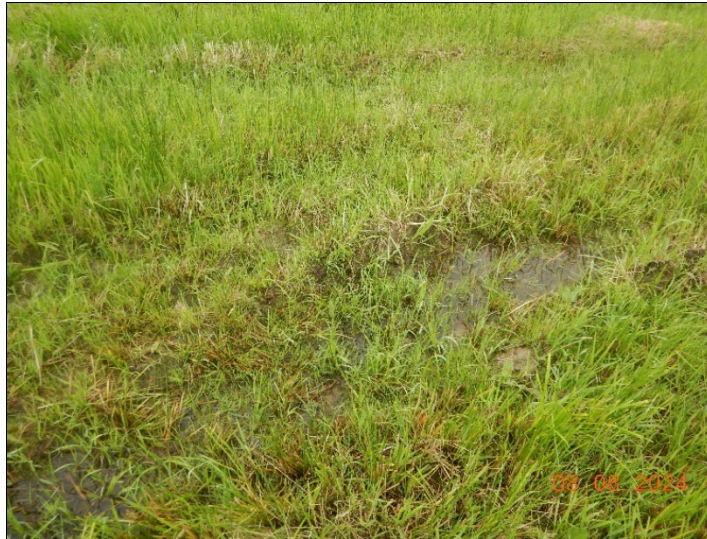
Hoopes Property  
Date: 8 August 2024  
Photo ID: DSCN5576.JPG  
Photo taken by: Laura Mathew

(Attachment 2) and was characterized as: [0-4 inches] 100% 7.5YR 3/2 silty loam; [4-12 inches] 60% 2.5YR 4/1 silty loam with 40% 7.5YR 4/6 redoximorphic features (DSCN5577). The soil profile met the technical definition of a hydric soil (Indicator F3). The soil was saturated and surface water was observed nearby (DSCN5576). The area had approximately 85% vegetation cover that was comprised of grass.

Notes: Standing surface water near location of Soil Boring #2.

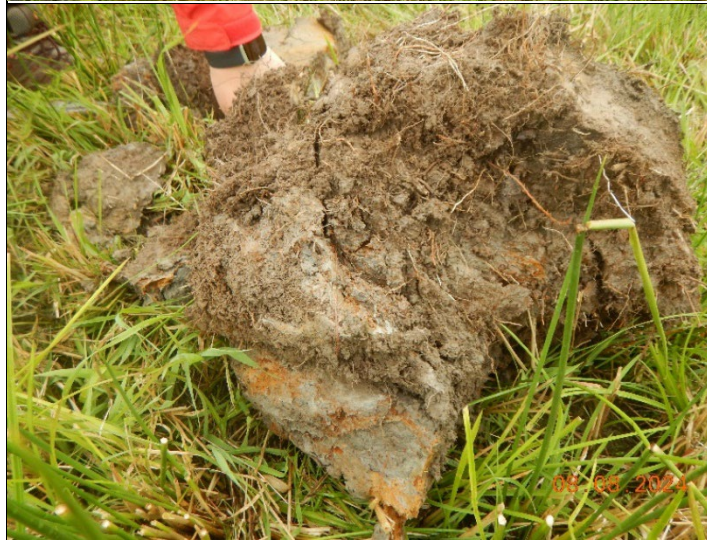
Hoopes Property  
Date: 8 August 2024  
Photo ID: DSCN5577.JPG  
Photo taken by: Laura Mathew

Notes: View of Soil Boring #2.

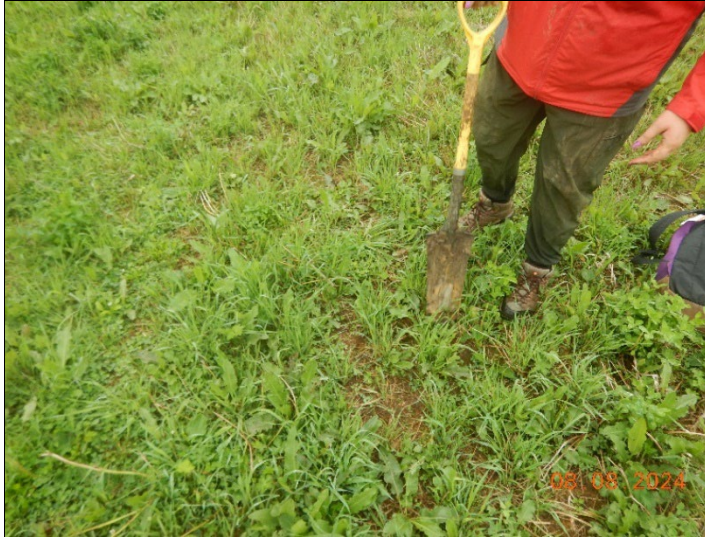
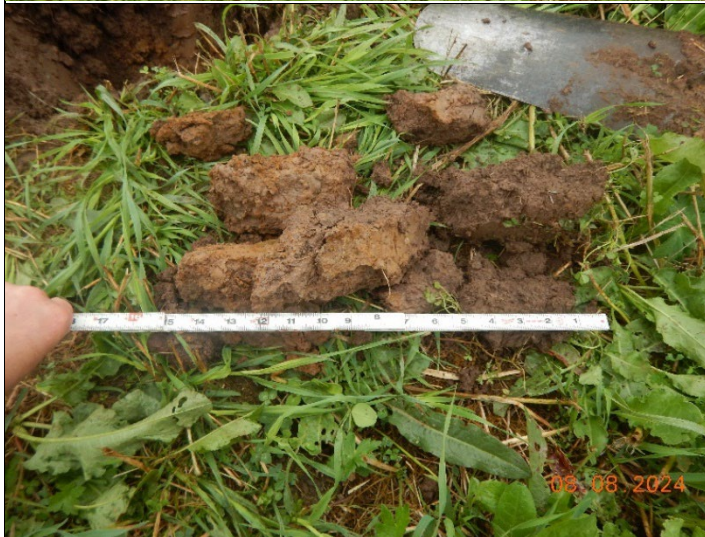
A third soil boring (SB-03) was conducted in the mowed area at approximately 41.8919129, - 77.7445052 in an area upgradient from SB-02 (Attachment 2). The soil boring was characterized as: [0-8 inches] mixed matrix with 90% 7.5YR 4/2 and 10% 7.5YR 5/2 silty loam; [8-14 inches] 60% 7.5YR 5/3 silty loam with 40% 7.5YR 5/8 redoximorphic features (DSCN5580). No hydrology was observed, approximately 80% of the area was vegetated with herbaceous vegetation including grass, clover, and docks.

Notes: Location of Soil Boring #3.

Notes: View of Soil Boring #3.

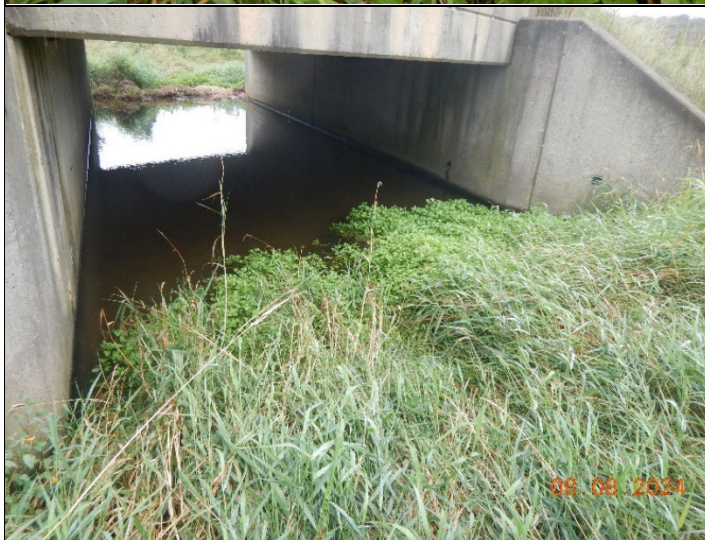
Hoopes Property  
Date: 8 August 2024  
Photo ID: DSCN5581.JPG  
Photo taken by: Laura Mathew

The inspection moved along the Genessee River to the culvert under Loucks Mill Road (DSCN5581). The downstream end of the 10-inch drainpipe was observed, water was flowing out of the drainpipe and through the culvert. Indicators of an Ordinary High Water Mark were observed downstream of the culvert including a change in the plant community along the bank and the bed and bank of the Genessee River were stable and well vegetated (DSCN5582 to DSCN5586). Water was flowing in the river at the time of the inspection at an approximate depth of 7 inches (DSCN5587).

Notes: Downstream view of the Genessee River flowing into culvert under Loucks Mill Road.

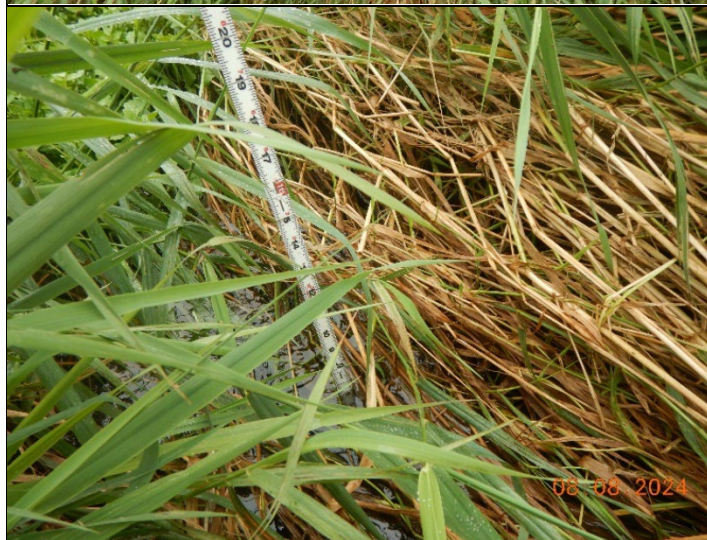
Hoopes Property  
Date: 8 August 2024  
Photo ID: DSCN5587.JPG  
Photo taken by: Laura Mathew

Notes: Depth of the Genessee River downstream of the culvert.
