## Clean Water Act Section 404: Site Visit/Case Development

| Inspector Name(s) | Chelsey Sherwood | Time In | 10:50 AM | Start Date | February 28, 2024 | | |
| Site Name | Greenwood 950, LLC-Springridge-Texas Line Road | | | | | | |

| Inspection Purpose | Initial site visit | | |

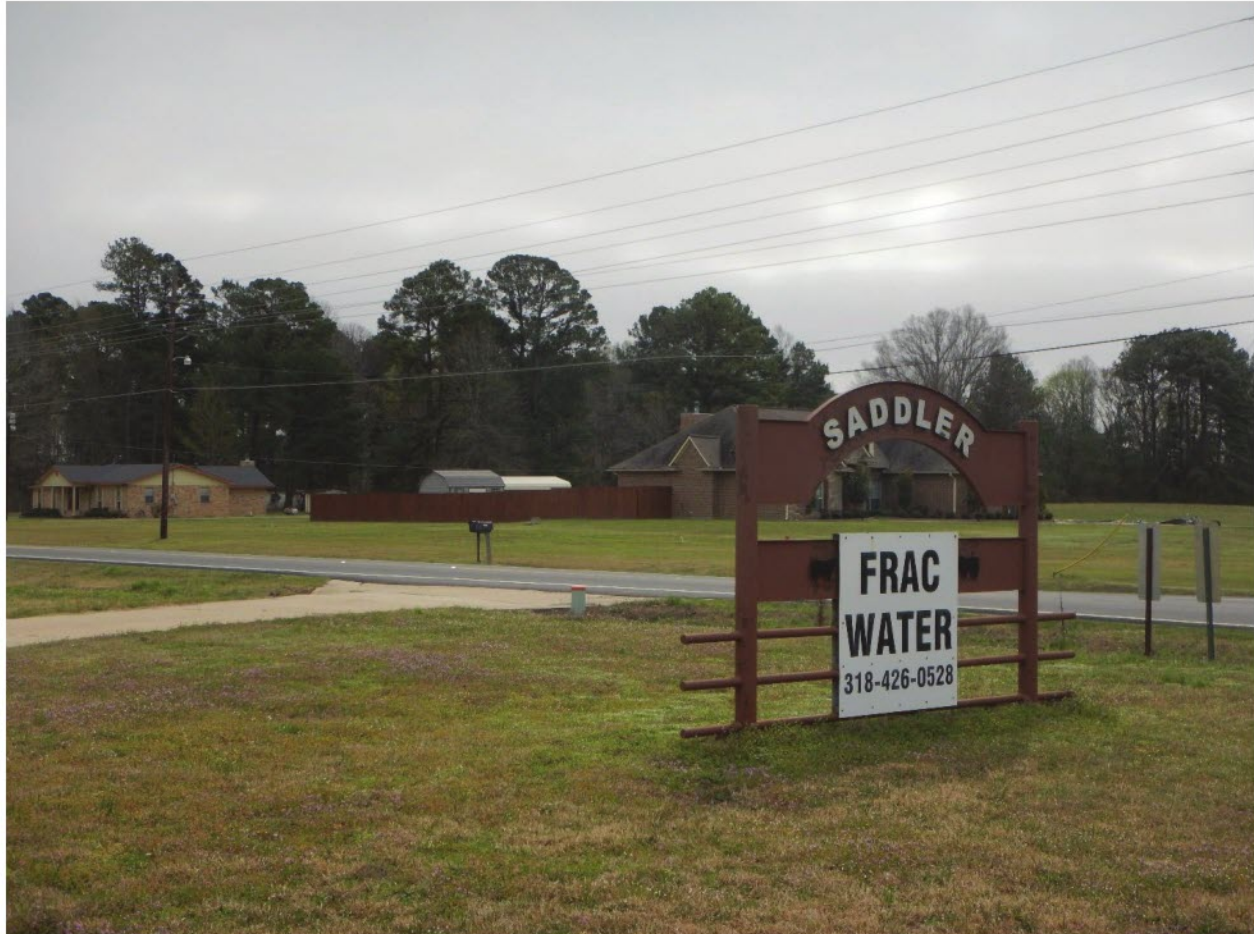
Photo No. 1

| There is a sign for selling frac water as you enter the property (see photo 1). | | | |

| Photo File Name | Date and Time of Photo | Photographer | Description |
|---|---|---|---|
| DSCN6334.JPG | 02/28/2024, 10:53 AM | Chelsey Sherwood | Showing Frac Water for sale sign at entrance of site. Picture taken facing south. |

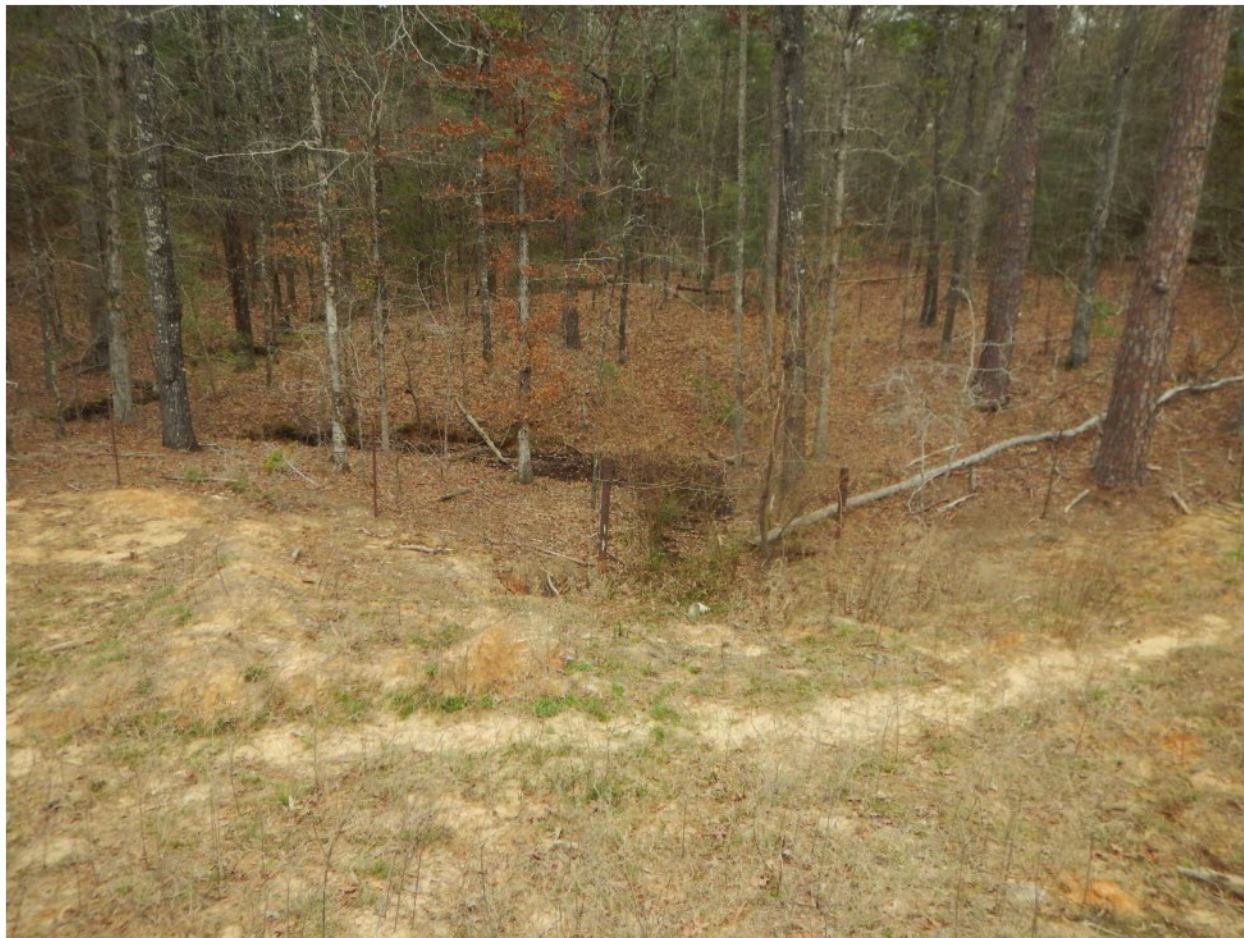
Photo No. 2

| Photo File Name | Date and Time of Photo | Photographer | Description |
|---|---|---|---|
| DSCN6335.JPG | 02/28/2024, 11:12 AM | Chelsey Sherwood | Showing stream from on top of spillway that was built. Picture taken facing downstream, north. |

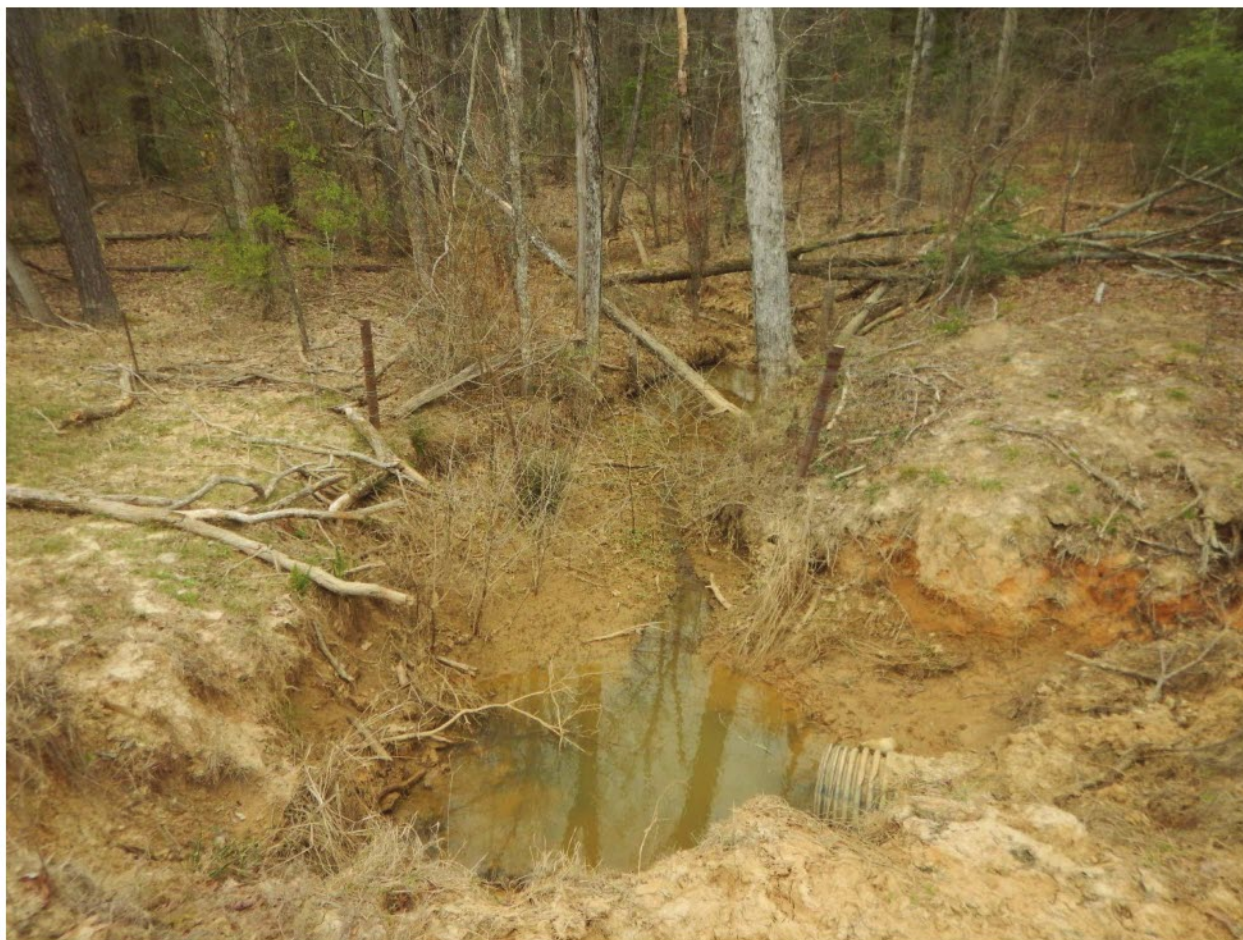
Photo No. 3

| Photo File Name | Date and Time of Photo | Photographer | Description |
|---|---|---|---|
| DSCN6336.JPG | 02/28/2024, 11:17 AM | Chelsey Sherwood | Showing stream from on top of spillway that was built. Note the excessive sedimentation in stream bed and eroding bank. Picture taken facing downstream, north. |

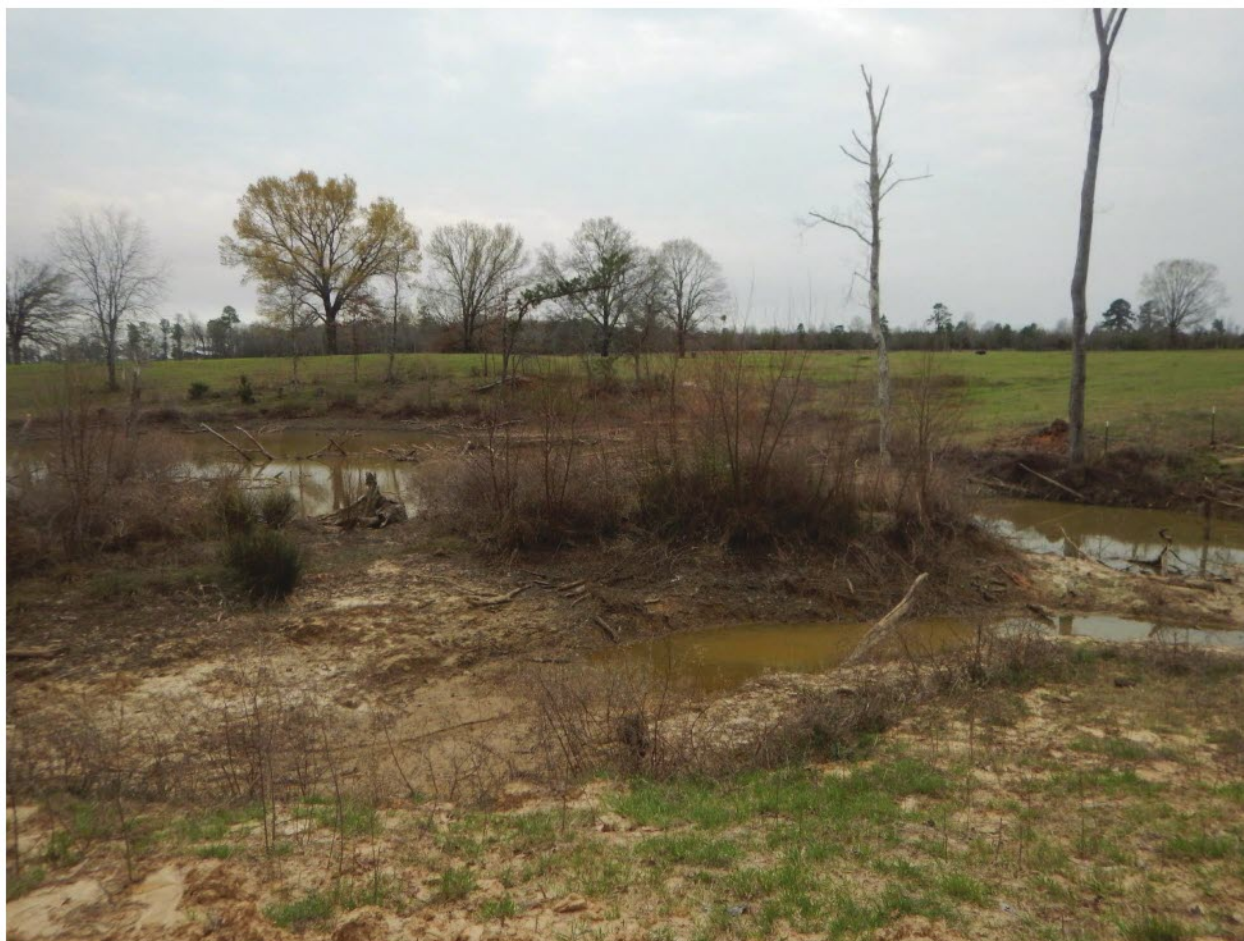
Photo No. 4

| Photo File Name | Date and Time of Photo | Photographer | Description |
|---|---|---|---|
| DSCN6337.JPG | 02/28/2024, 11:19 AM | Chelsey Sherwood | Showing where original stream channel was located but has now been filled and dammed up creating a lake. Note the excessive sedimentation. Picture taken facing upstream, south. |

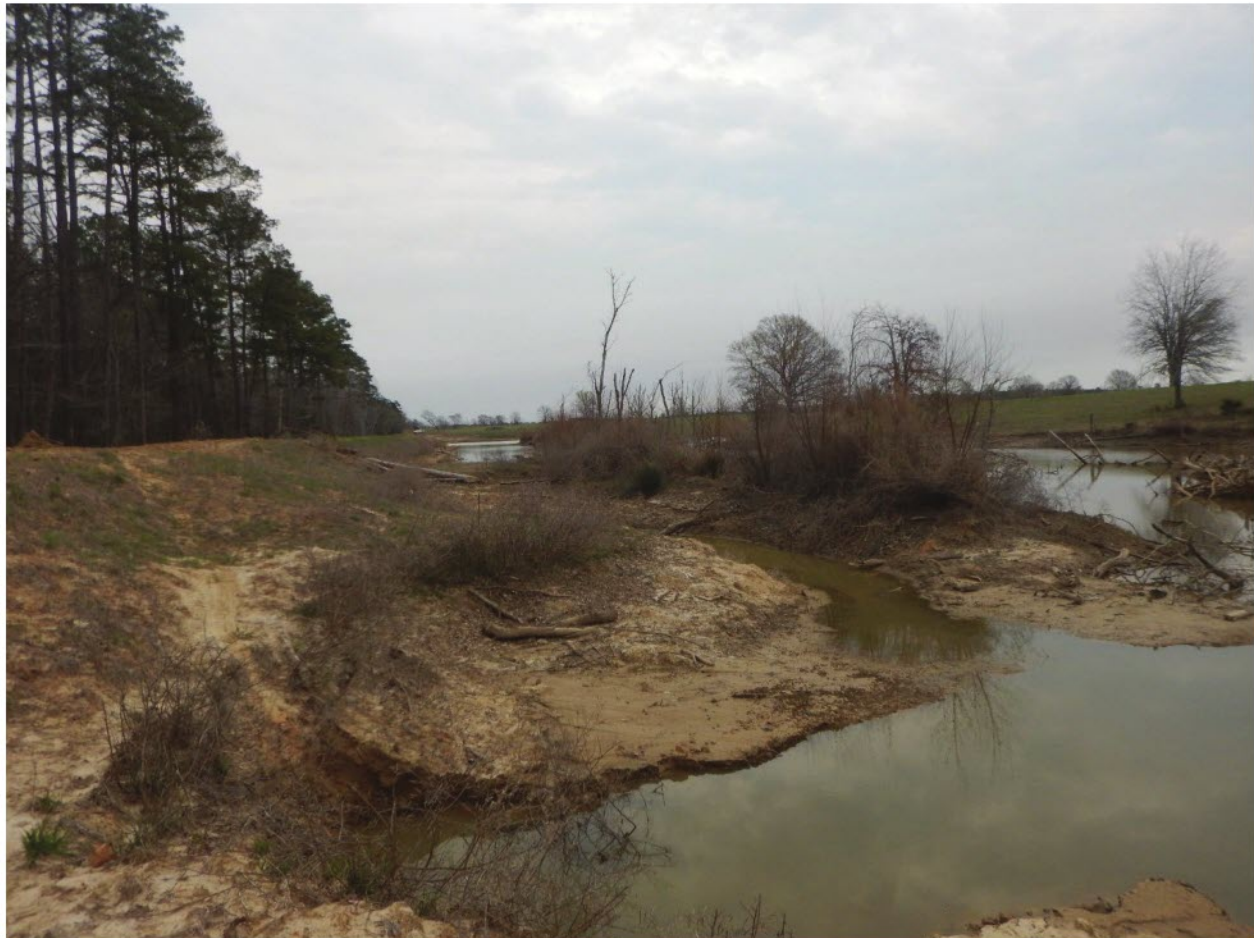
Photo No. 5

| Photo File Name | Date and Time of Photo | Photographer | Description |
|---|---|---|---|
| DSCN6338.JPG | 02/28/2024, 11:21 AM | Chelsey Sherwood | Showing where original stream channel was located but has now been filled and dammed up creating a lake. Note the excessive sedimentation. Picture taken facing east. |

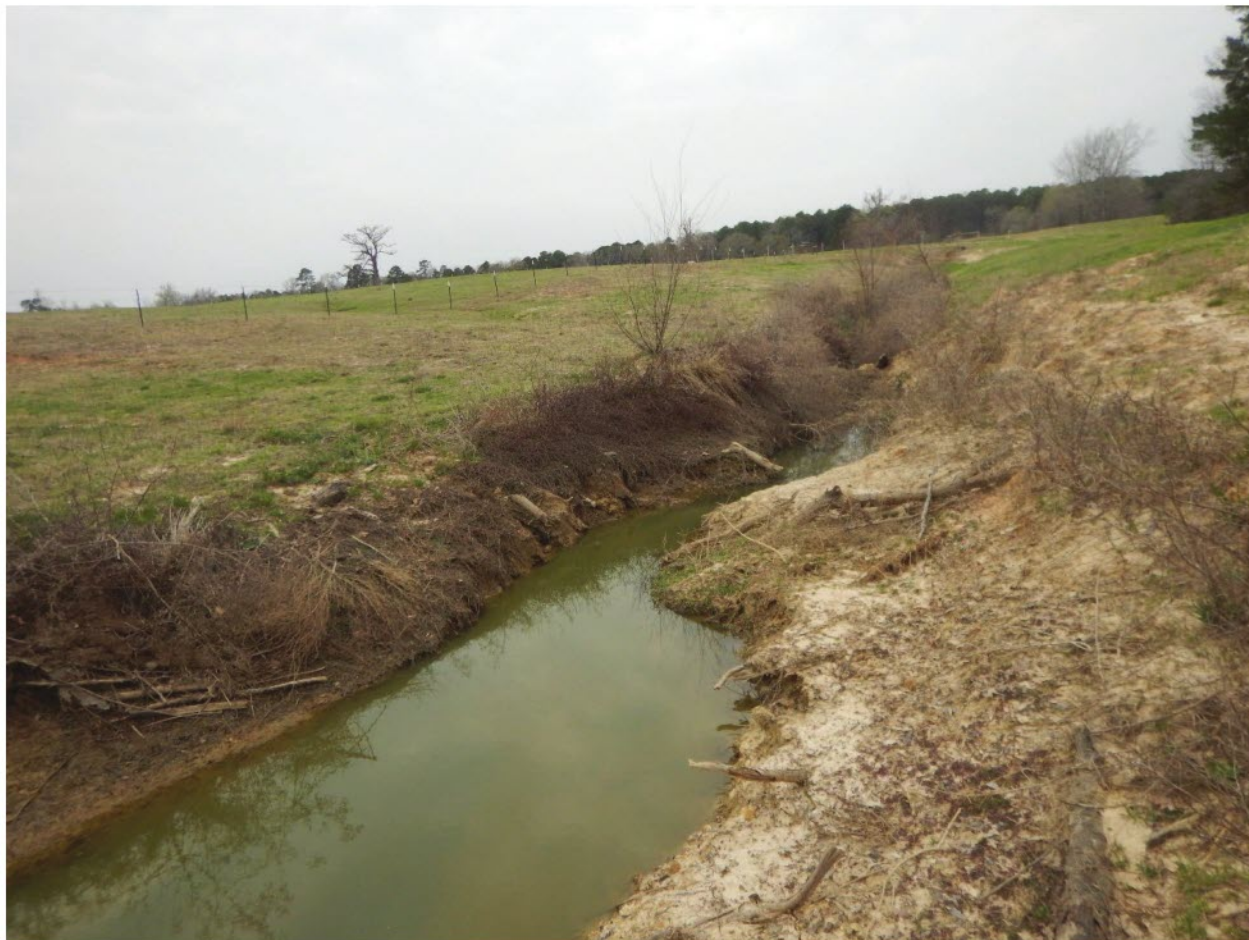
Photo No. 6

| Photo File Name | Date and Time of Photo | Photographer | Description |
|---|---|---|---|
| DSCN6339.JPG | 02/28/2024, 11:24 AM | Chelsey Sherwood | Showing where original stream channel was located and spillway to the right. Picture taken facing west. |

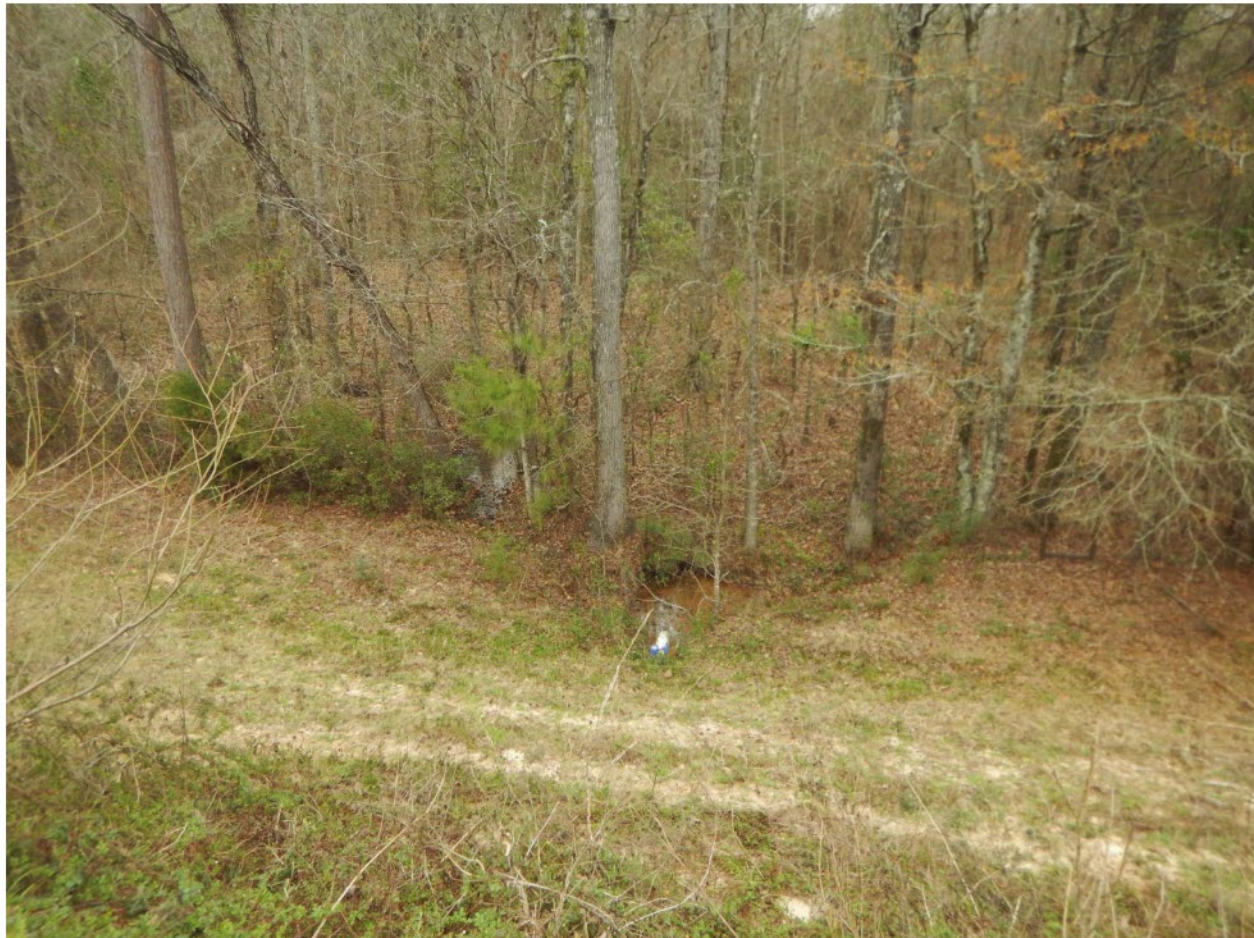
Photo No. 7

| Photo File Name | Date and Time of Photo | Photographer | Description |
|---|---|---|---|
| DSCN6340.JPG | 02/28/2024, 11:29 AM | Chelsey Sherwood | Showing where stream channel exits lake. Note a pipe and gate installed to control water level in lake. Picture taken facing downstream, east. |

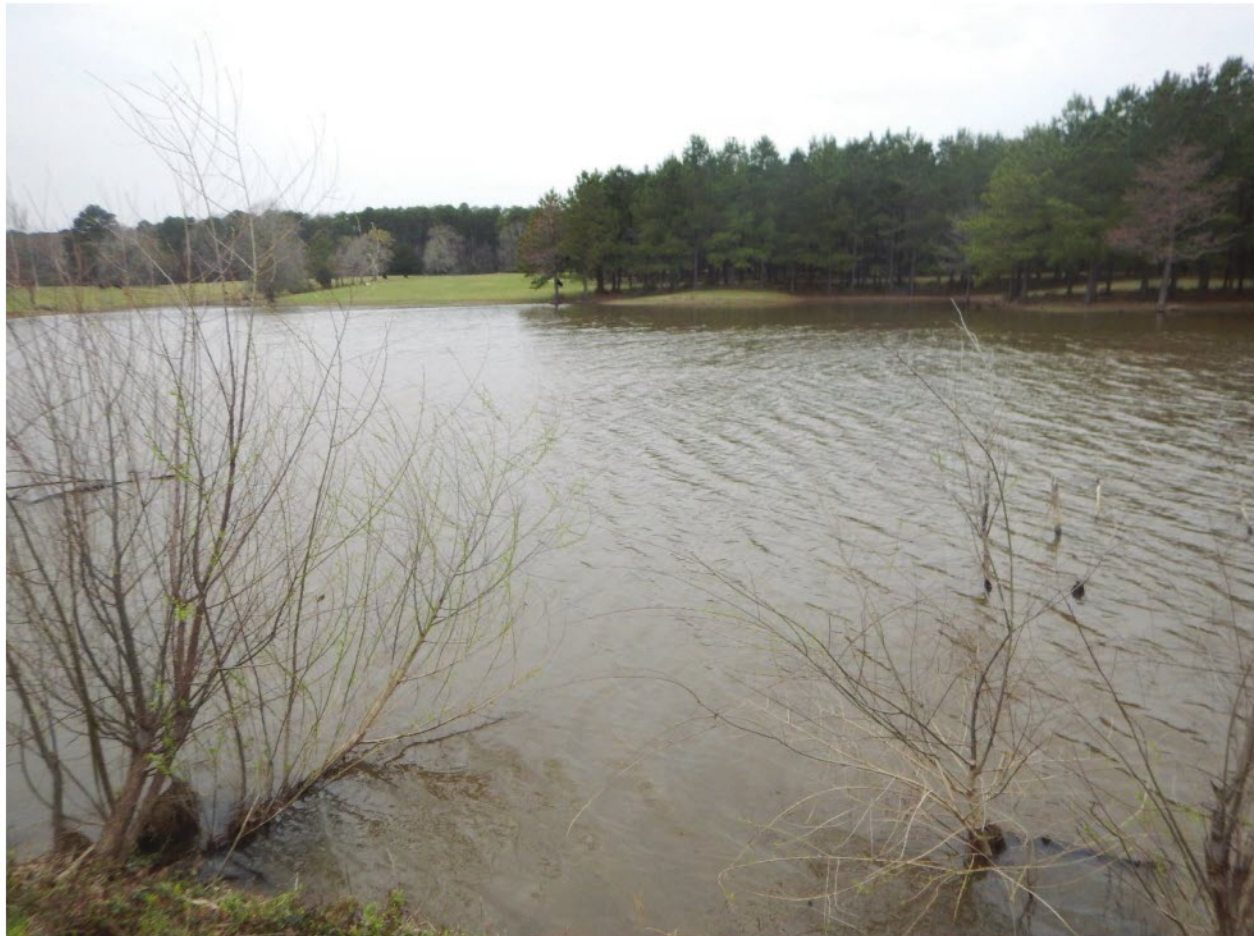
Photo No. 8

| Photo File Name | Date and Time of Photo | Photographer | Description |
|---|---|---|---|
| DSCN6341.JPG | 02/28/2024, 11:29 AM | Chelsey Sherwood | Showing lake that was raised approximately 2 feet around 2021. Note a pipe and gate installed to control water. Picture taken facing west. |

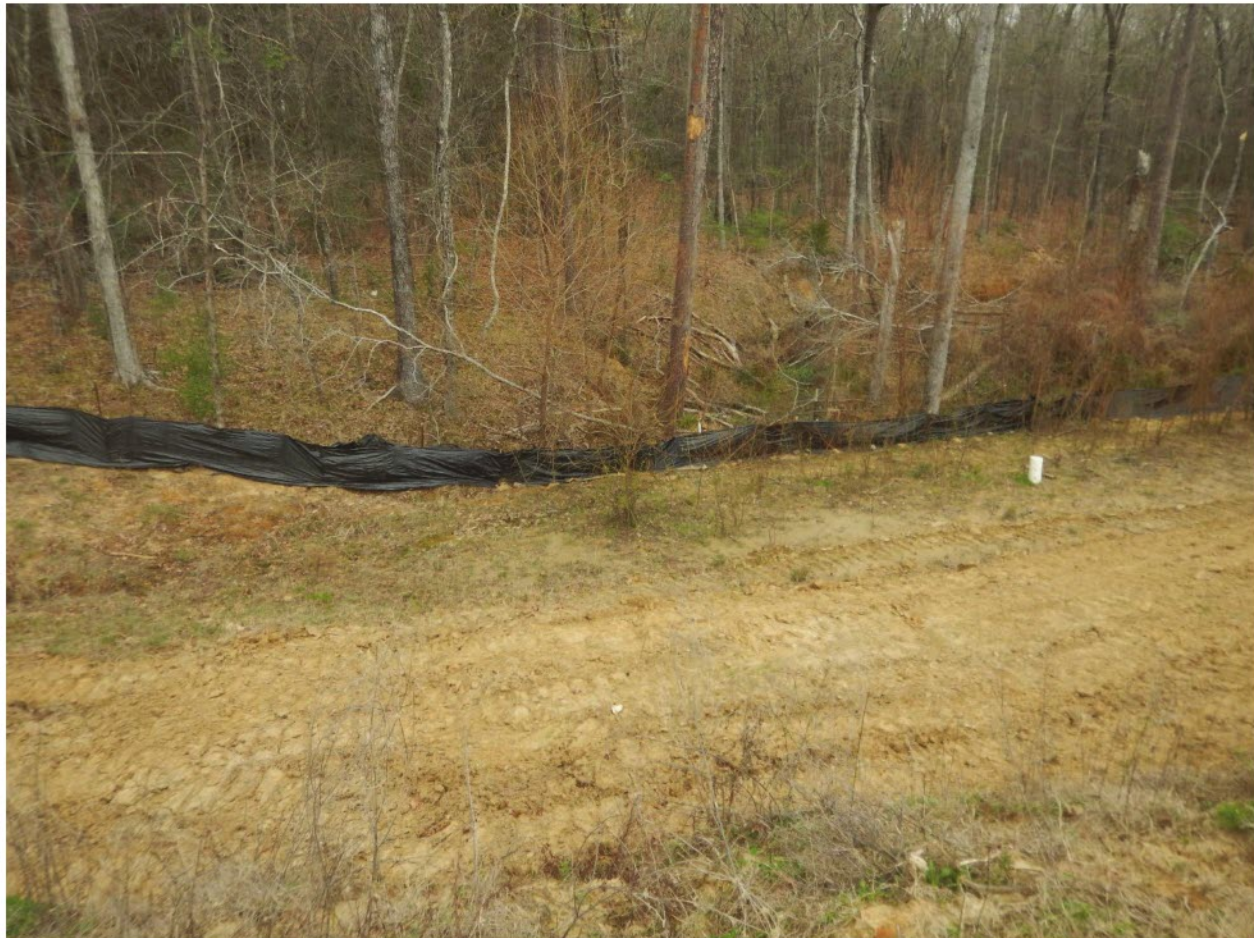
Photo No. 9

| Photo File Name | Date and Time of Photo | Photographer | Description |
|---|---|---|---|
| DSCN6342.JPG | 02/28/2024, 11:41 AM | Chelsey Sherwood | Showing where original stream channel was located but has now been filled and the connection severed by the spillway. Picture taken facing north, downstream. |

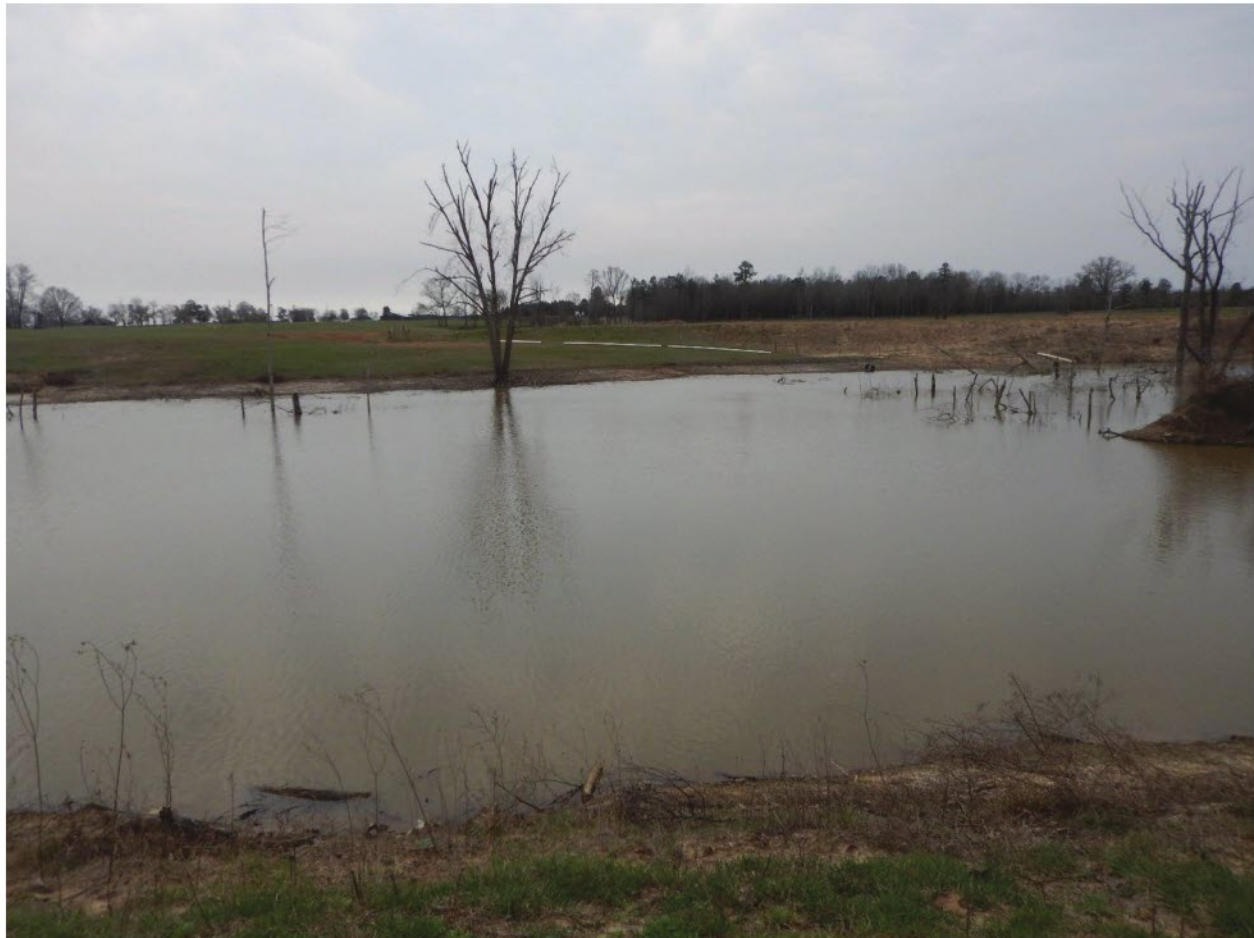
Photo No. 10

| Photo File Name | Date and Time of Photo | Photographer | Description |
|---|---|---|---|
| DSCN6343.JPG | 02/28/2024, 11:43 AM | Chelsey Sherwood | Showing where original stream channel was located upstream from photo 9. Note: no culvert here and everything flows to a catch box now. Picture taken facing south, upstream. |

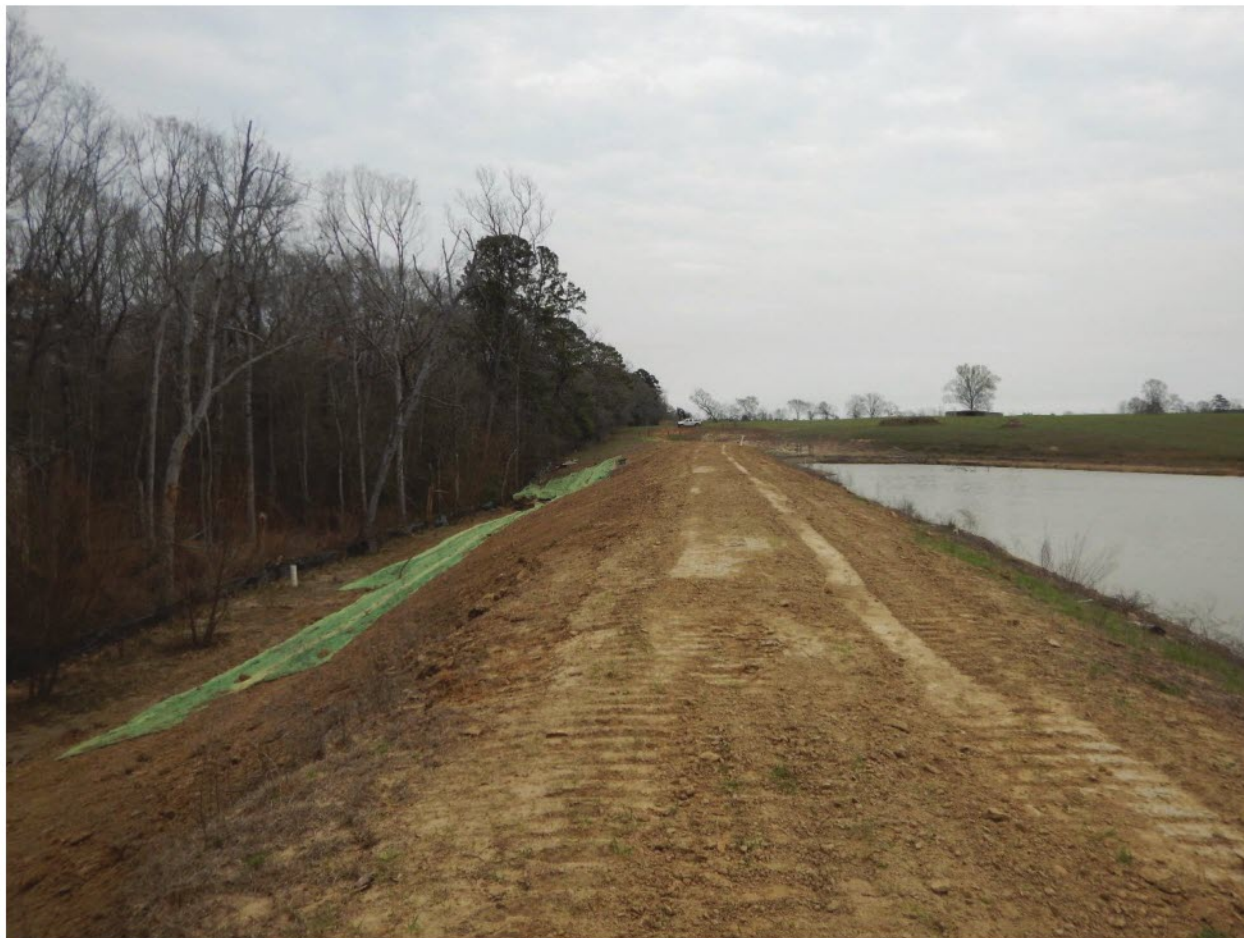
Photo No. 11

| Photo File Name | Date and Time of Photo | Photographer | Description |
|---|---|---|---|
| DSCN6344.JPG | 02/28/2024, 11:43 AM | Chelsey Sherwood | Showing spillway that was built that has filled and dammed the stream to create a lake. Picture taken facing east. |

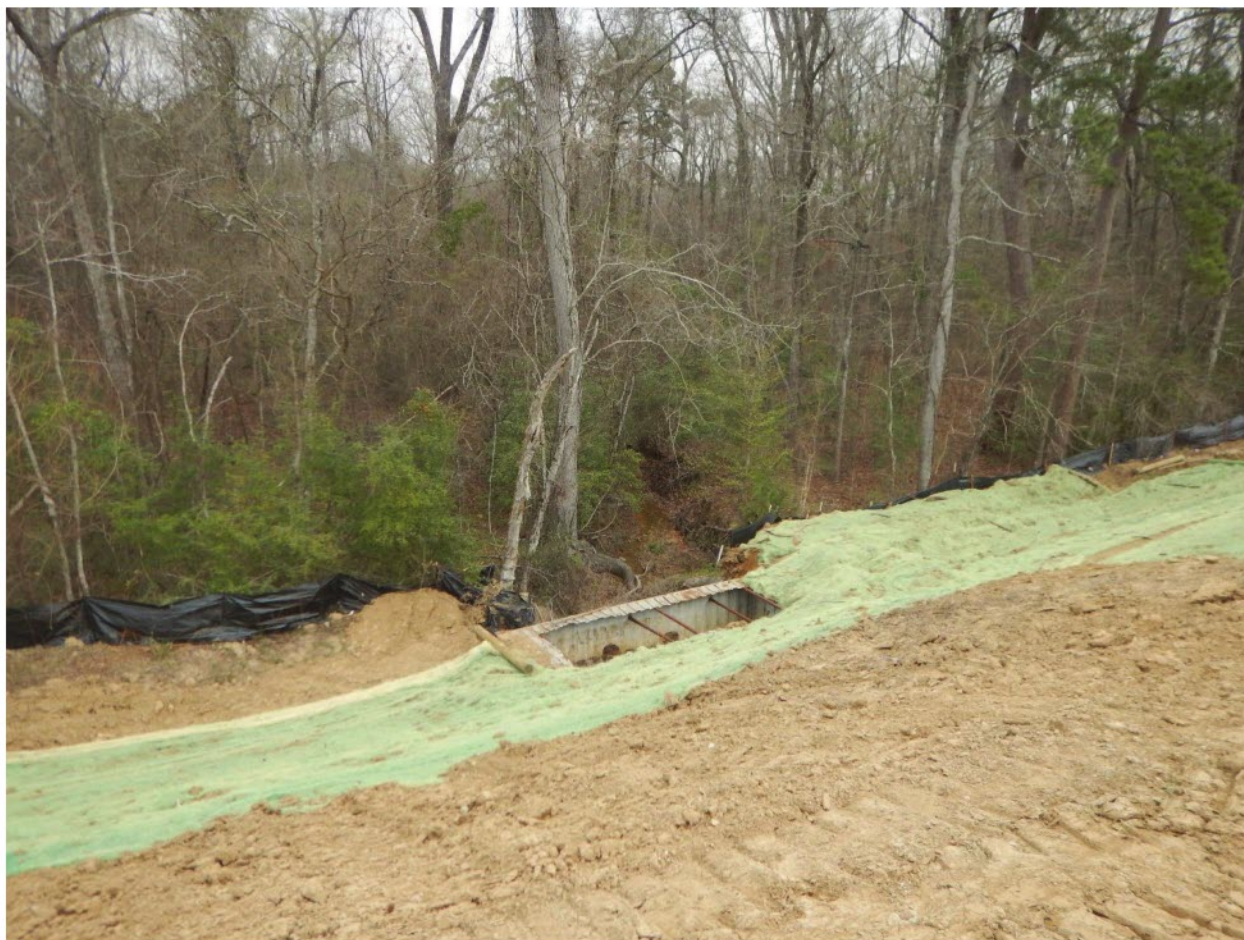
Photo No. 12

| Photo File Name | Date and Time of Photo | Photographer | Description |
|---|---|---|---|
| DSCN6345.JPG | 02/28/2024, 11:45 AM | Chelsey Sherwood | Showing the catch box that all water upstream has been diverted to now. Note observed lots of sedimentation and silt fences need to be maintained. Picture taken facing north, downstream. |

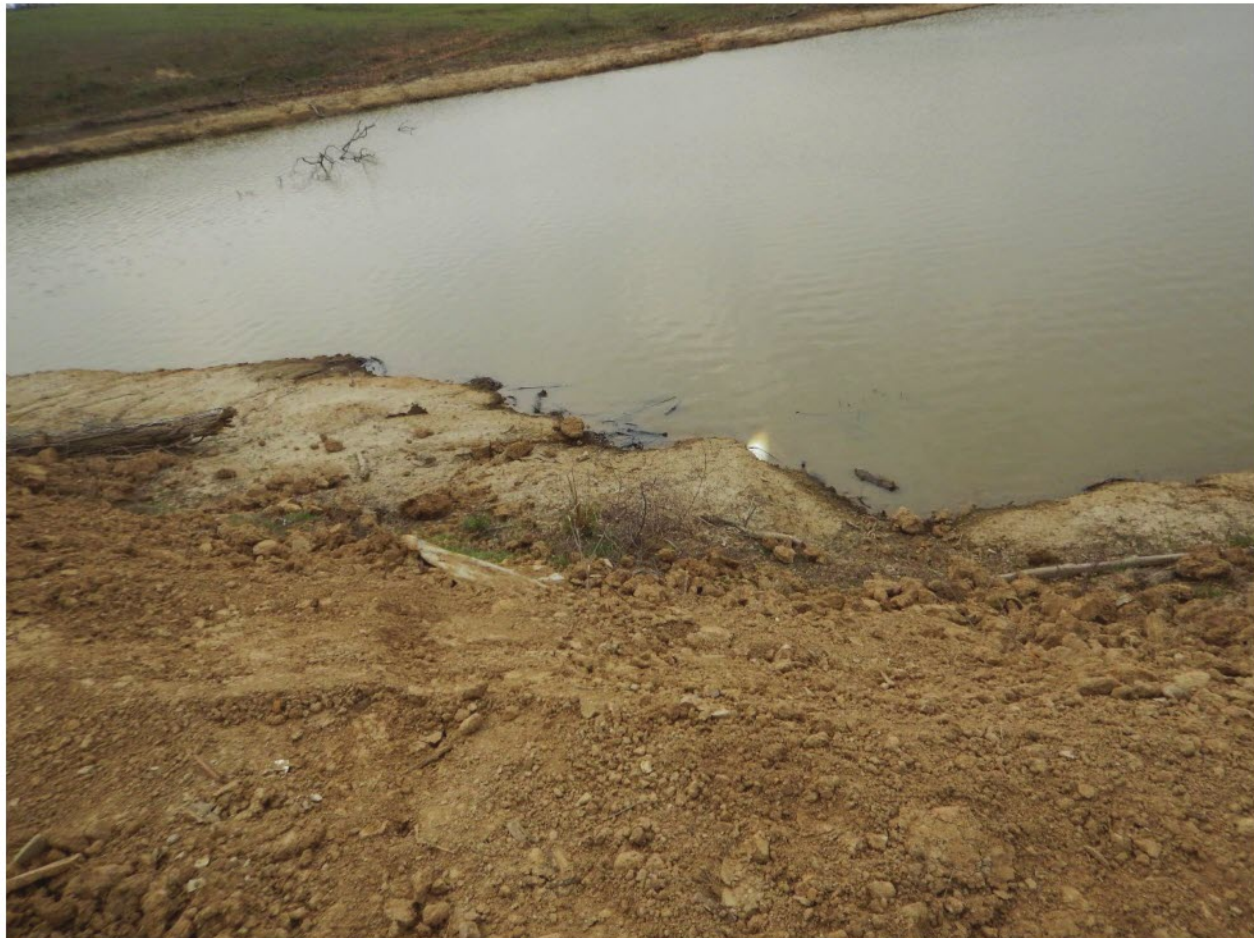
Photo No. 13

| Photo File Name | Date and Time of Photo | Photographer | Description |
|---|---|---|---|
| DSCN6346.JPG | 02/28/2024, 11:45 AM | Chelsey Sherwood | Showing pipes that direct water to catch box from photo 12. Note the lake has been dug out and original stream channel is gone. Picture taken facing south, upstream. |

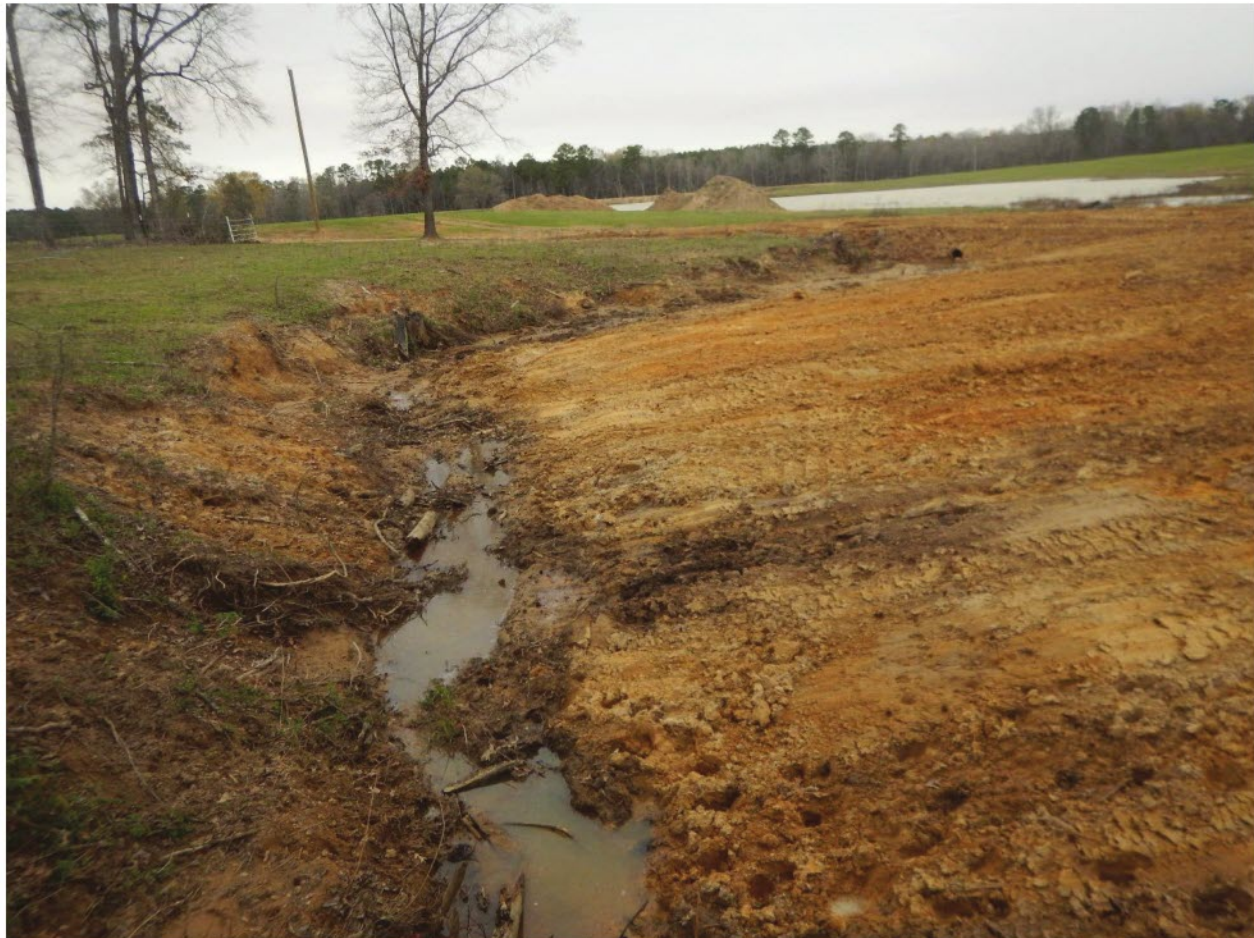
Photo No. 14

| Photo File Name | Date and Time of Photo | Photographer | Description |
|---|---|---|---|
| DSCN6347.JPG | 02/28/2024, 11:56 AM | Chelsey Sherwood | Showing fill material pushed into stream and river right streambank demolished. Note spoil piles in background. Picture taken facing north, downstream. |

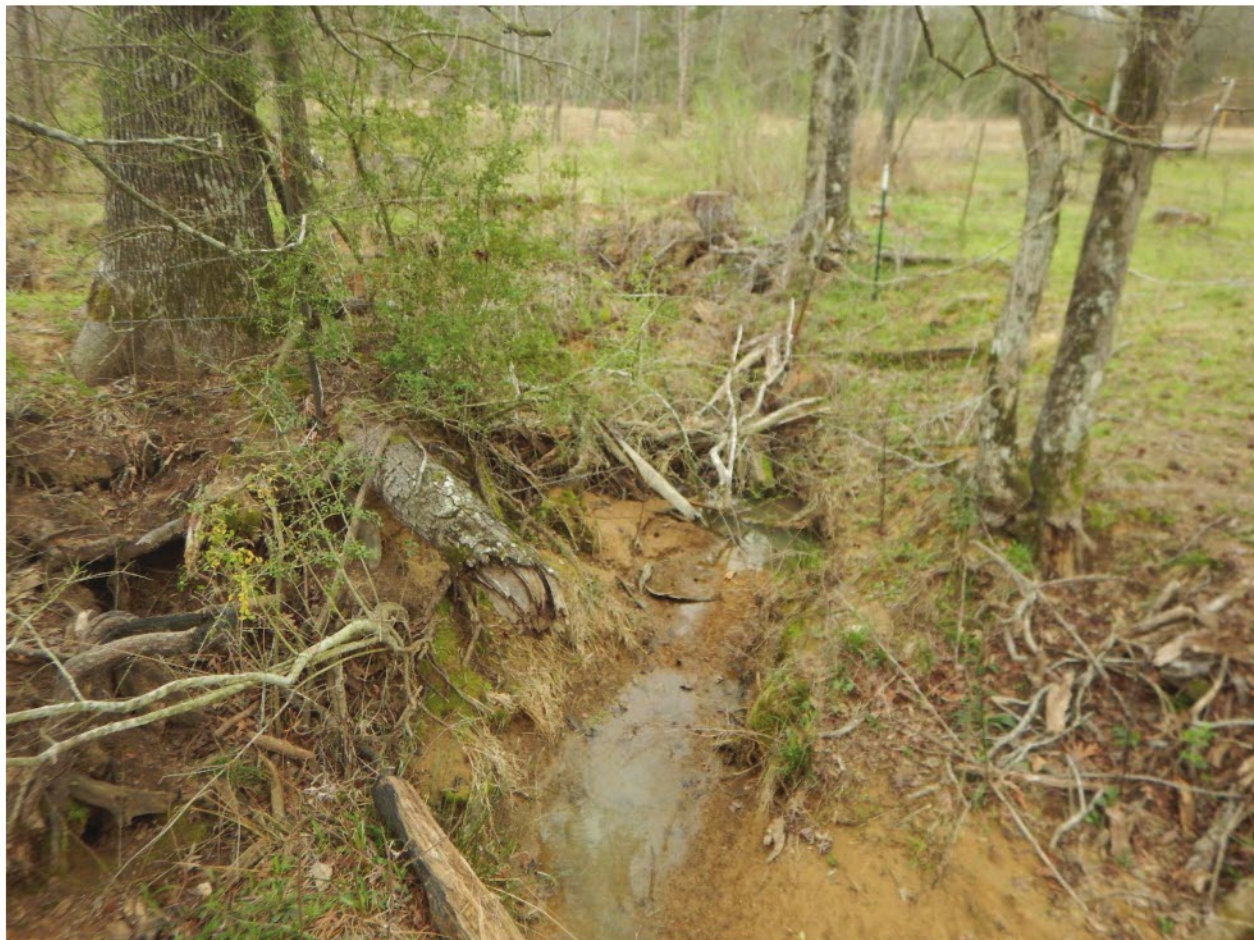
Photo No. 15

| Photo File Name | Date and Time of Photo | Photographer | Description |
|---|---|---|---|
| DSCN6348.JPG | 02/28/2024, 11:56 AM | Chelsey Sherwood | Showing stream upstream from work in photo 14. Picture taken facing south, upstream. |

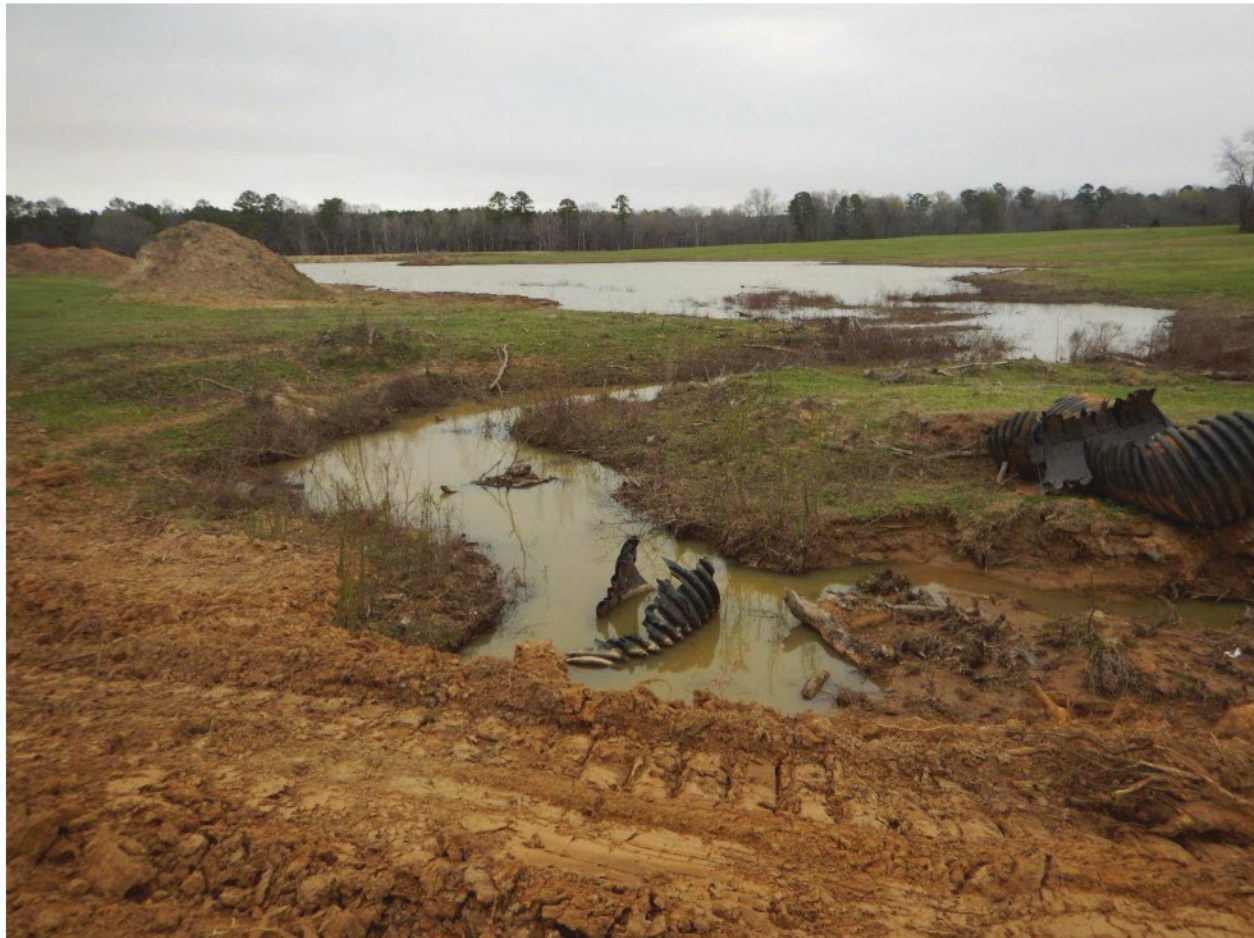
Photo No. 16

| Photo File Name | Date and Time of Photo | Photographer | Description |
|---|---|---|---|
| DSCN6349.JPG | 02/28/2024, 11:59 AM | Chelsey Sherwood | Showing fill material in stream to create a road crossing. Picture taken facing north, downstream. |

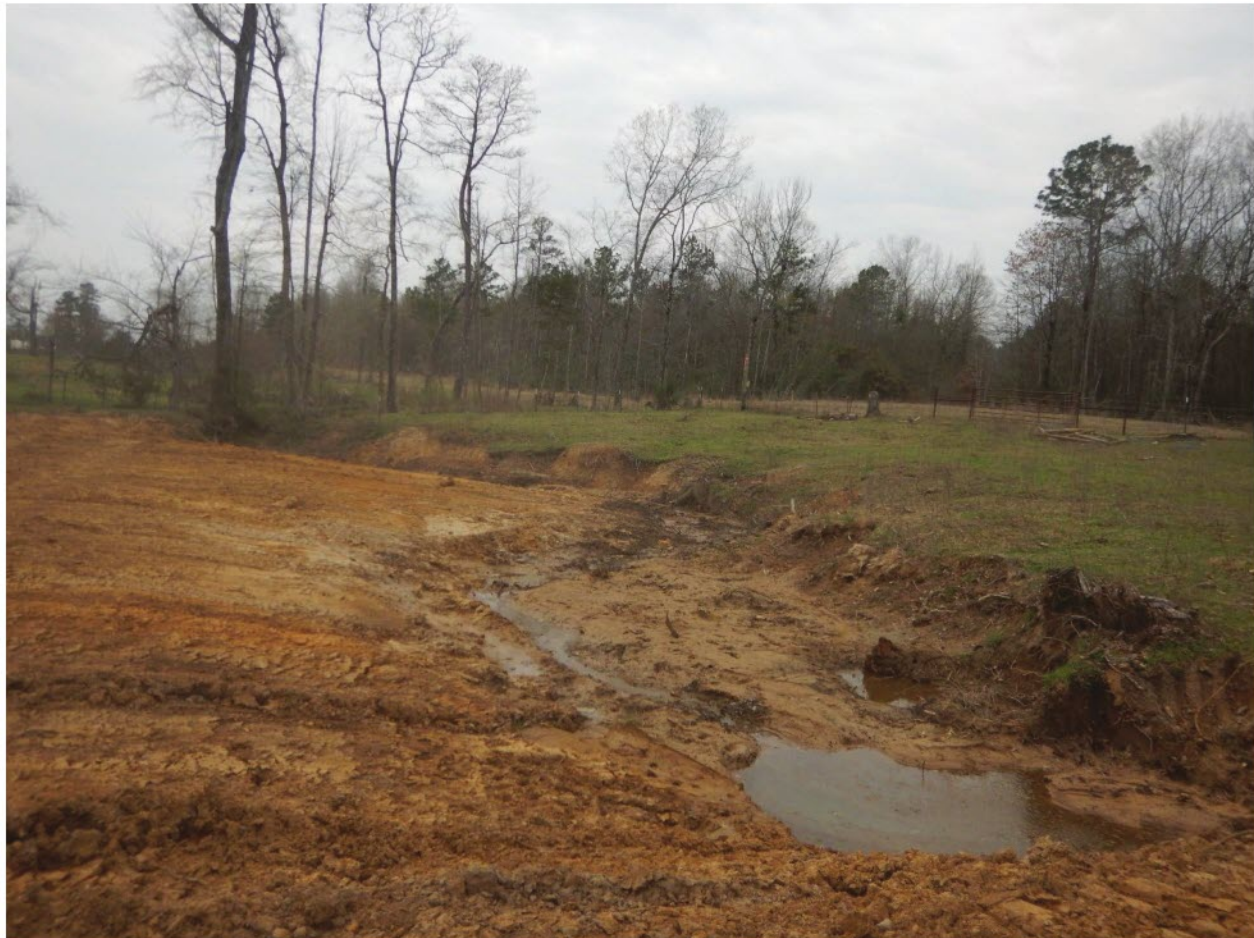
Photo No. 17

| Photo File Name | Date and Time of Photo | Photographer | Description |
|---|---|---|---|
| DSCN6350.JPG | 02/28/2024, 12:12 PM | Chelsey Sherwood | Showing stream bank demolished and fill material pushed into stream impeding flow. Picture taken facing south, upstream. |
