**Region 6 - Enforcement & Compliance Assurance Division**  
**INSPECTION REPORT**

| Inspection Date(s): | 02/01/2024 | |
| Company Name: | <b>Parsage Oil Company, LLC</b> | |
| Facility Name: | <b>Candy Creek Lease</b> | |

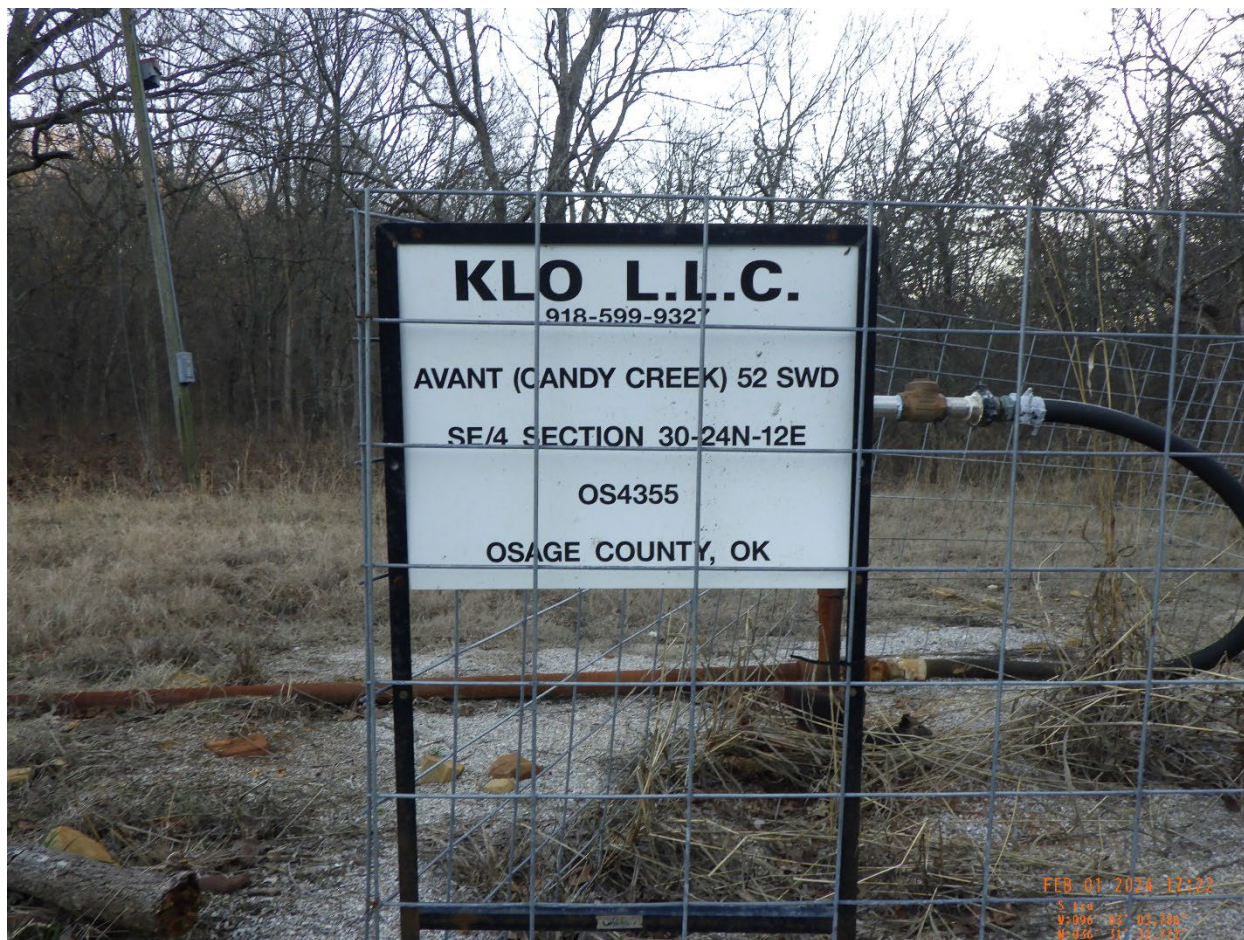
Photo No. 1

I observed the 52 SWD well which was connected to the leaking flowline. See photo No. 1 of Appendix 1 (photo log) which is attached to this report. For additional GPS location information and photo metadata, see the attached photo log.

**Description:** This was the disposal well connected to the end of the leaking injection line. The operator, lease name and phone number were inaccurate at the time of the inspection. The well was operated by Parsage Oil Company, LLC and the lease name was Candy Creek Lease.

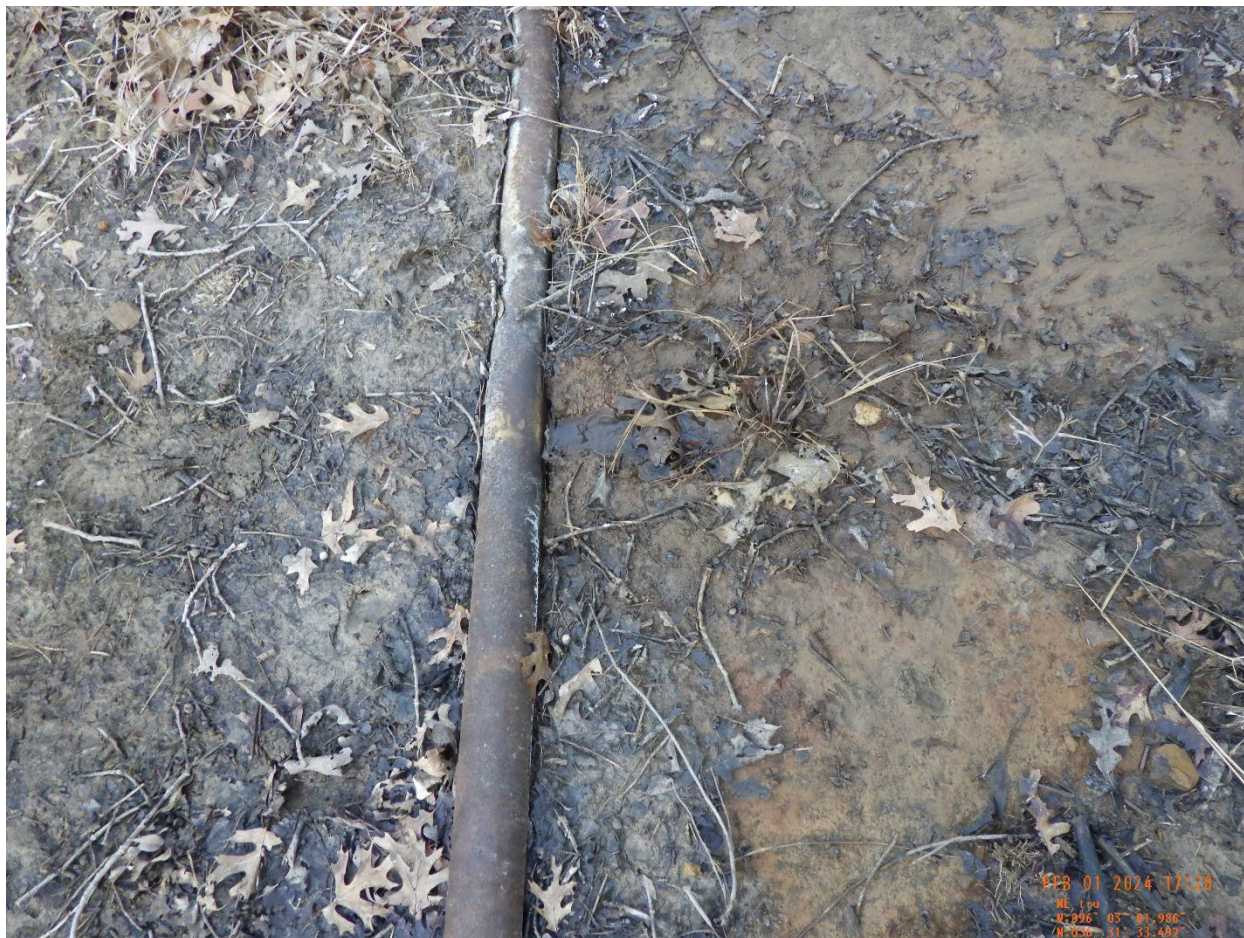
Photo No. 2

I observed release point 1, (36.52597, -96.050552), which was a hole in the side of the 2 3/8" steel injection line. I observed oil staining and produced water-soaked soil, leaves and vegetation in the area immediately surrounding the release point. See photo No. 2.

**Description:** This was the release point located furthest south, which was closest to the disposal well. The hole was located on the right side of the steel pipe, centered in the picture frame. Fluid from this leak migrated north along the lease road (approximately 75 feet) before entering into the unnamed tributary of Candy Creek.

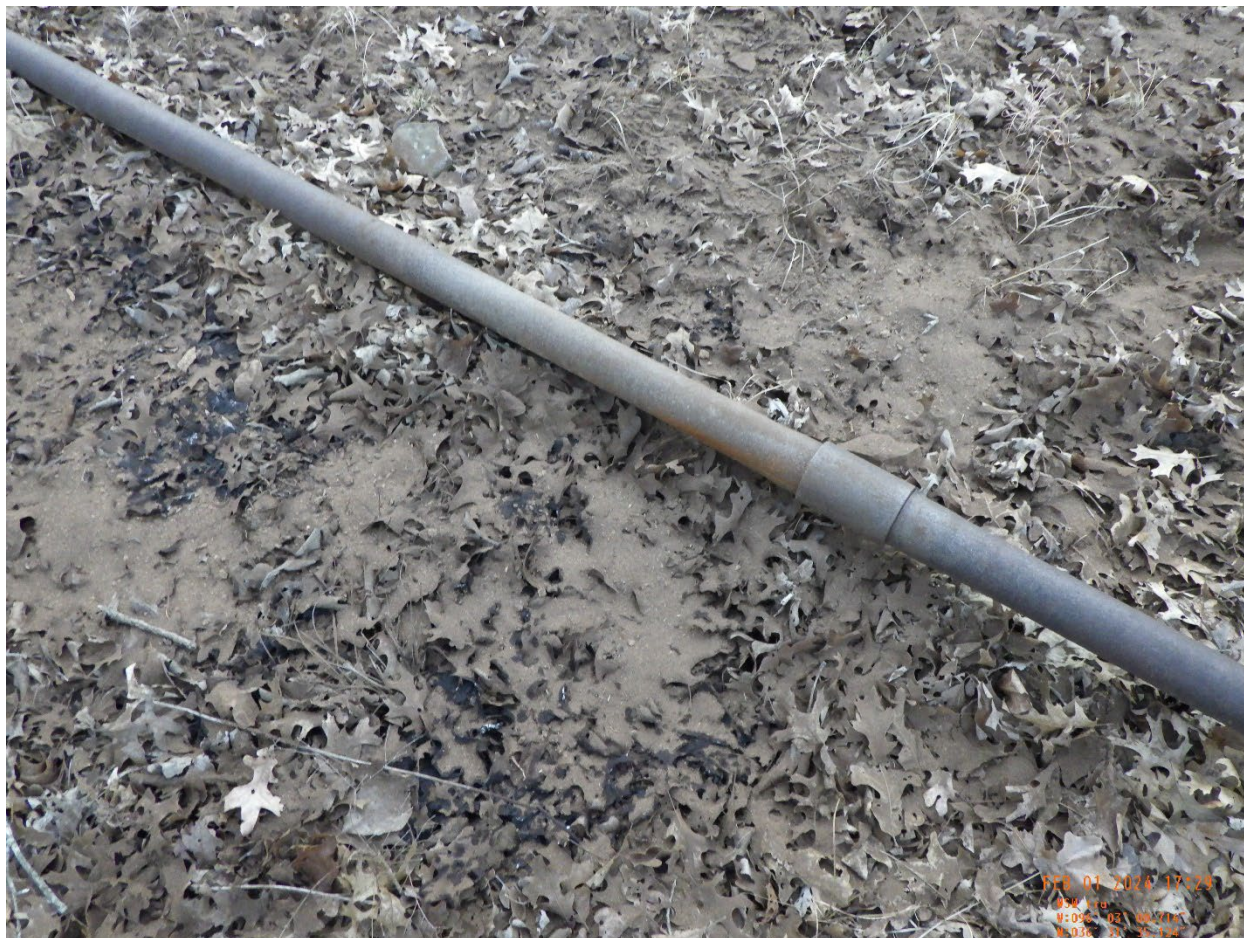
Photo No. 3

I observed release point 2, (36.526423, -96.050198), which was a hole located on the bottom of the 2 3/8" steel injection line. I observed oil and produced water-stained leaves and vegetation in the area immediately surrounding the release point. I also observed "sphag sorb" and industrial oil absorbent which had been applied to capture the spilled oil. See photo No. 3.

**Description:** This was the location of the second leak on the same injection line. The hole was located on the underneath side of the line, 6"-8" to the left of the pipe collar. Fluid from this hole migrated south along the lease road, approximately 75 feet before entering the unnamed tributary of Candy Creek.

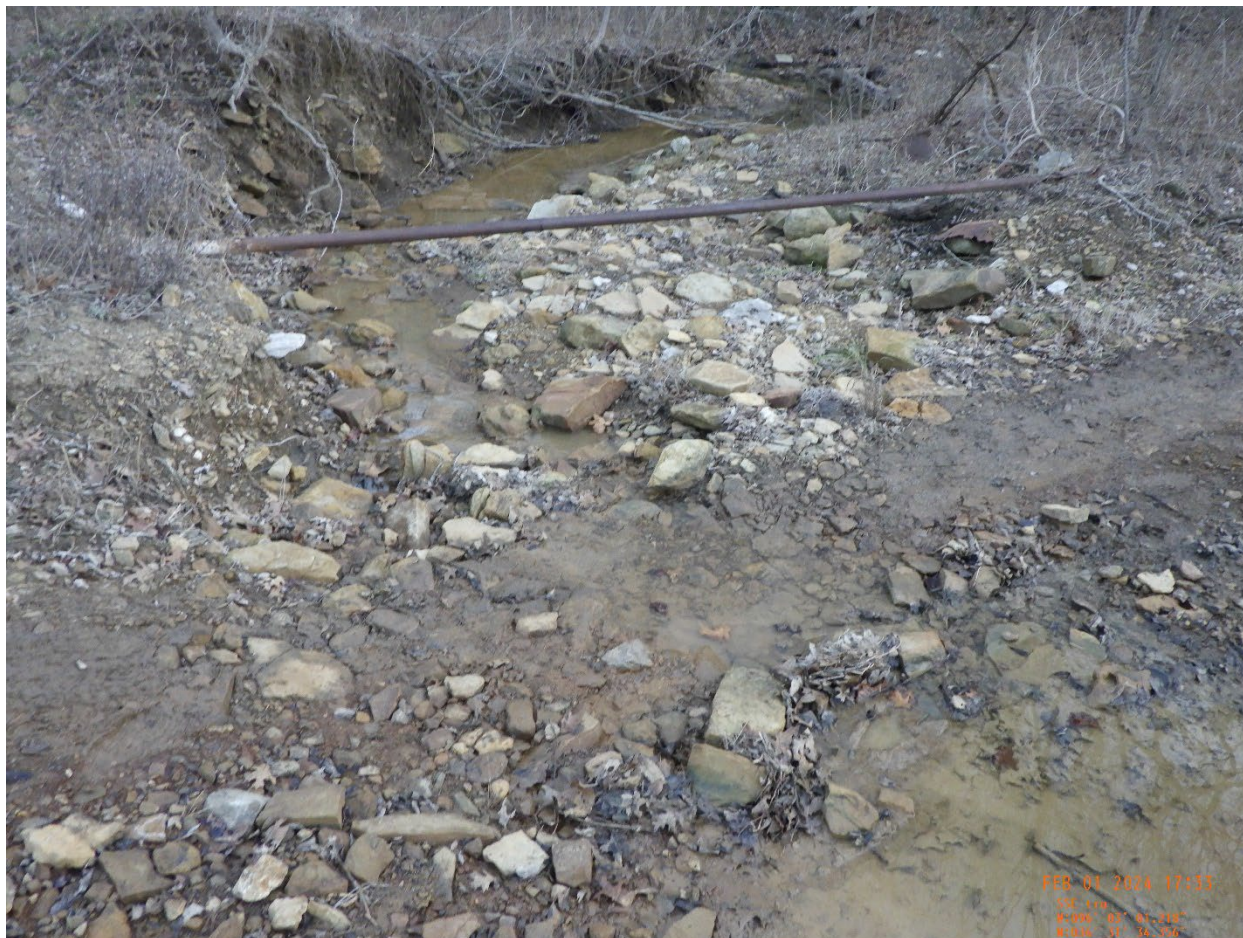
Photo No. 5

I observed the flowpath down the lease road, and the point of entry (POE) into an unnamed tributary of Candy Creek. At this same location I observed an elevated total dissolved solids (TDS) field reading of 2348 mg/L. Both leaks followed the same gravel lease road, one flowpath from the south and one flowpath from the north to the same POE. Photos No. 4 and 5 show the elevated TDS field reading and POE into the tributary. (POE 36.526138, -96.050360)

**Description:** This was an elevated total dissolved solids (TDS) field reading of 2348 mg/L observed at the point of entry (POE), where both spills entered into the unnamed tributary of Candy Creek.

**Description:** This was the POE where both flow paths entered the unnamed tributary of Candy Creek. This photo was taken while standing on the lease road with a view to the southeast/downstream.

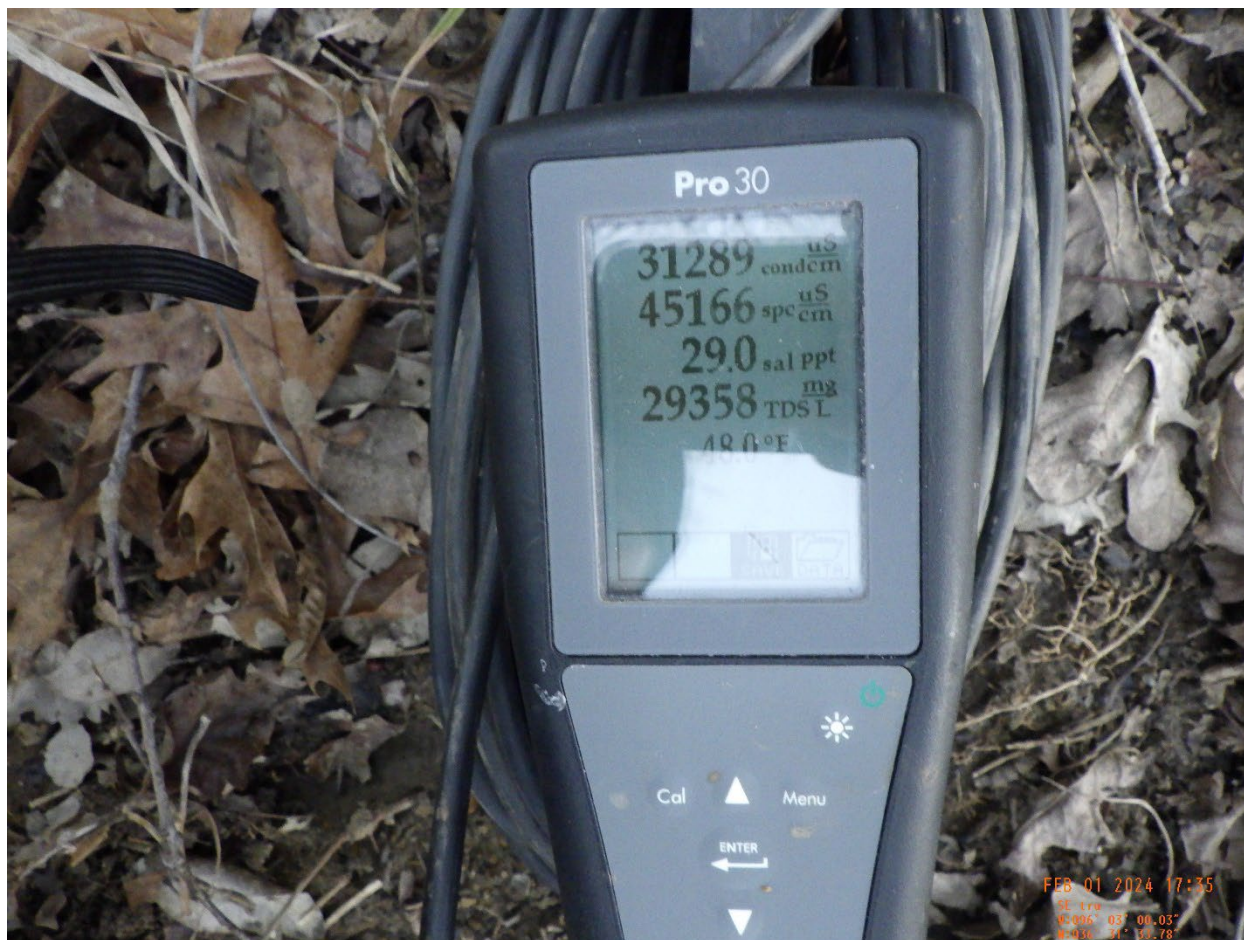
Photo No. 6

Continuing downstream along the impacted tributary, I observed an elevated TDS field reading of 29358 mg/L. This was the highest TDS reading observed during the inspection. See photo No. 6.

**Description:** This was an elevated TDS field reading of 29358 mg/L, observed in the main channel of the impacted tributary, downstream from the POE. This was the highest TDS level observed during the inspection. This was located approximately 100 feet downstream from the POE.

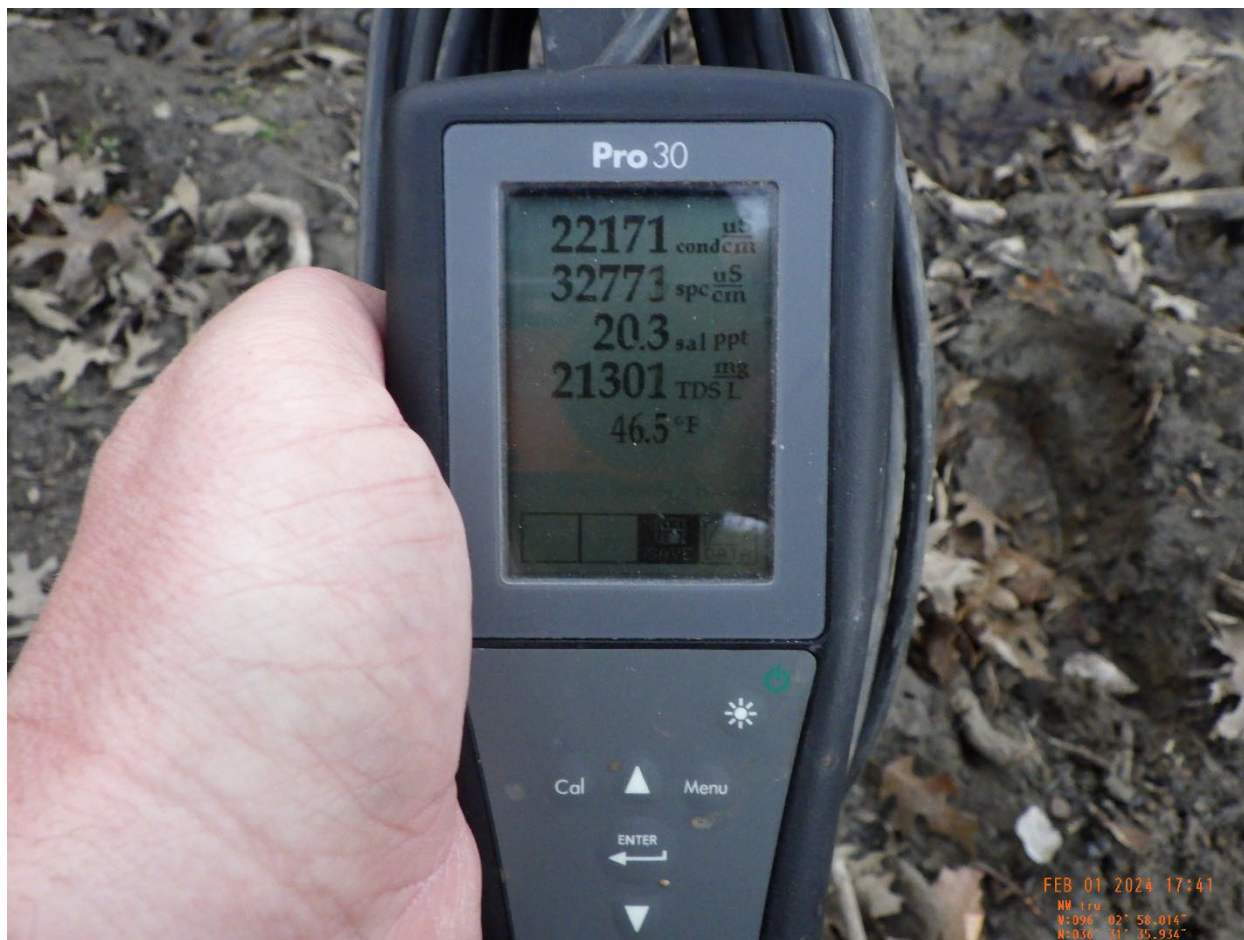
Photo No. 7

At the mouth of the unnamed tributary, I observed an elevated TDS field reading of 21301 mg/L TDS. This reading was observed where the impacted tributary flowed into a secondary channel of Candy Creek. See photos No. 7 and 8.

**Description:** This was an elevated TDS field reading of 21301 mg/L taken at the confluence of the unnamed tributary and a side channel of Candy Creek.

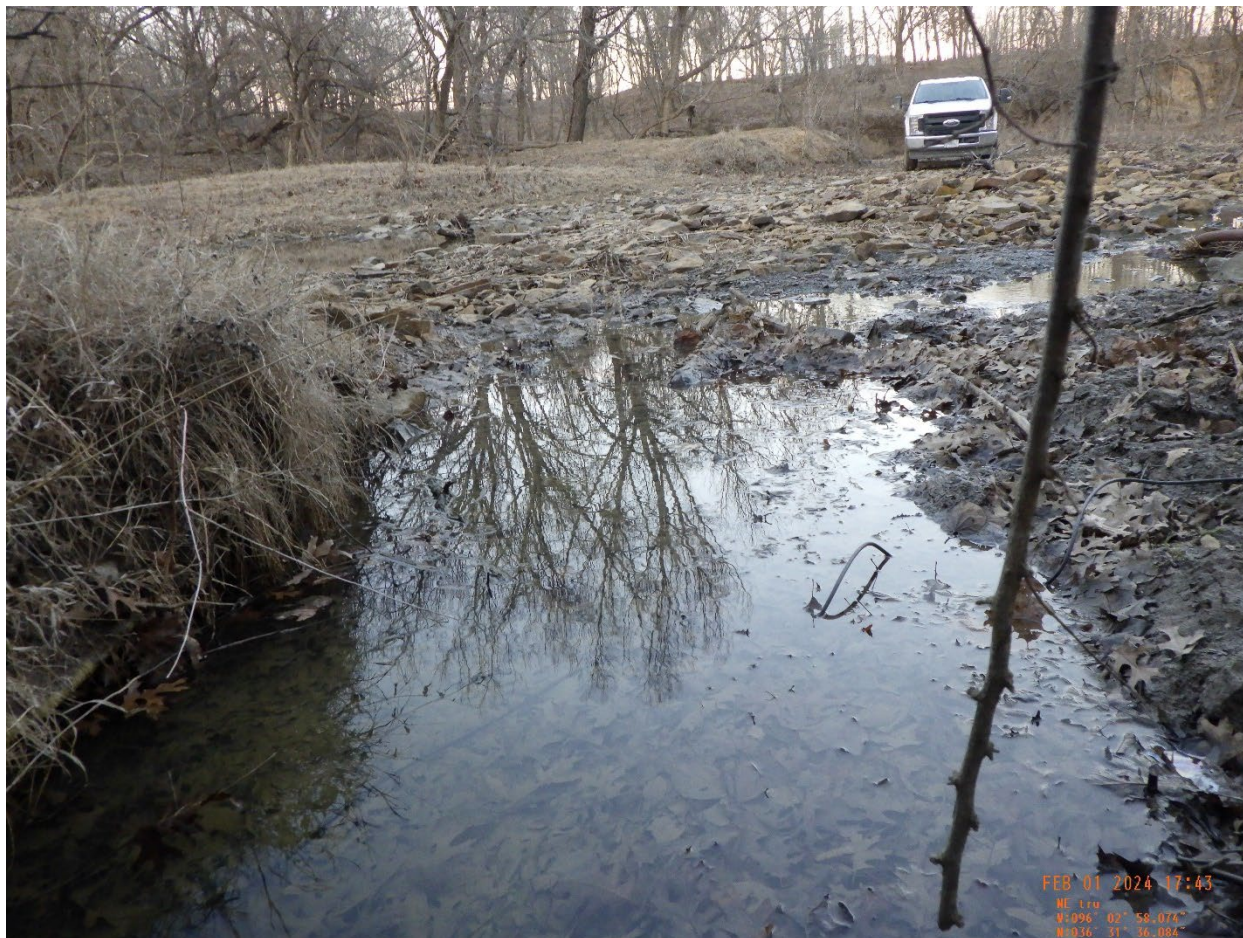
Photo No. 8

**Description:** This was the location where the TDS field reading from photo No. 7 was observed. This was the mouth of the unnamed tributary as it flowed into the secondary channel of Candy Creek.

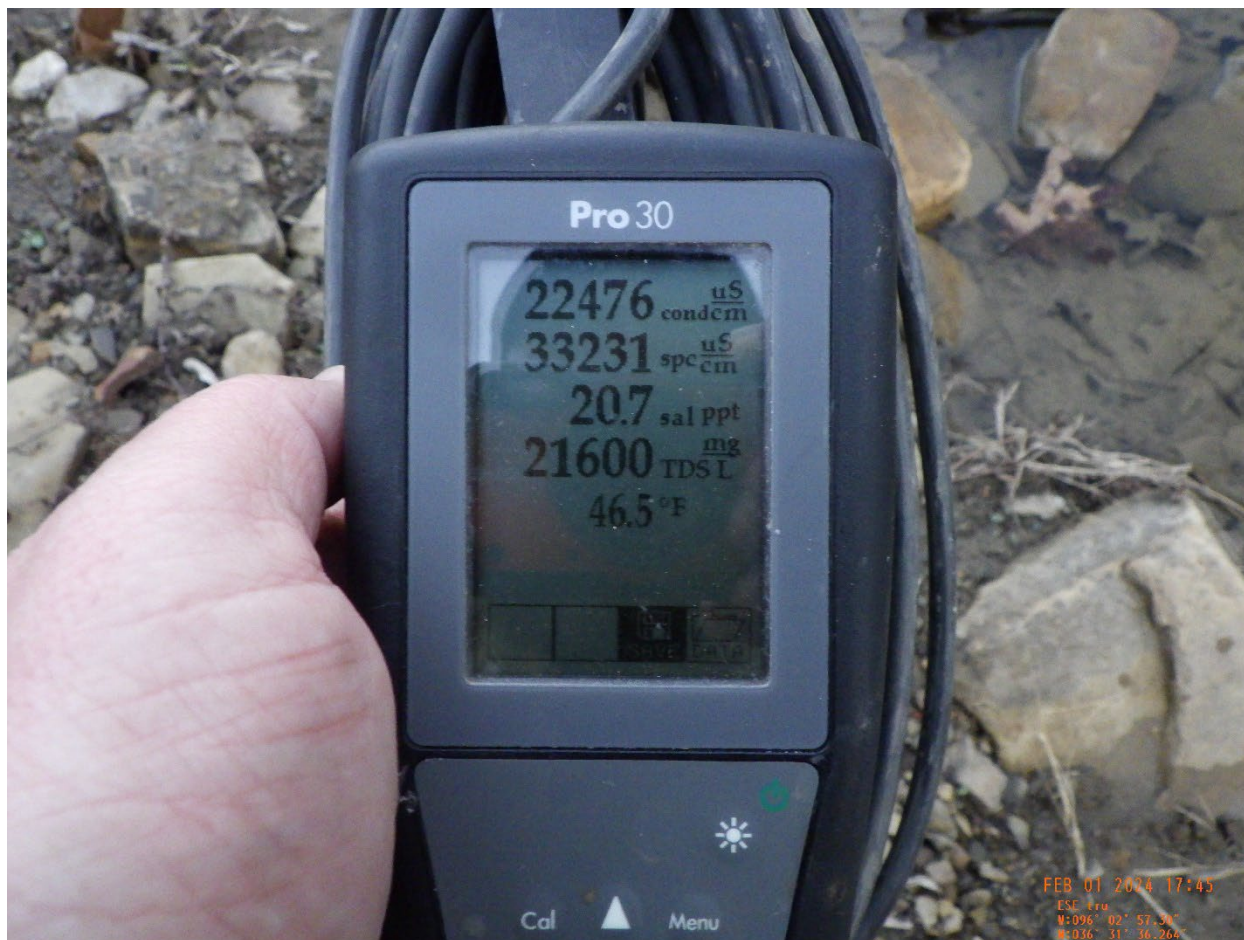
Photo No. 9

Working downstream along the secondary channel of Candy Creek, I observed an elevated TDS field reading of 21600 mg/L. At this same location I observed 2 small dead fish approximately 1.5" in length. See photos No. 9 and 10.

**Description:** This was an elevated TDS field reading of 21600 observed in the secondary channel of Candy Creek. At the time of the inspection this channel was flowing and connected to the main channel of Candy Creek. I observed 2 small dead fish floating at this location, approximately 1.5" in length.

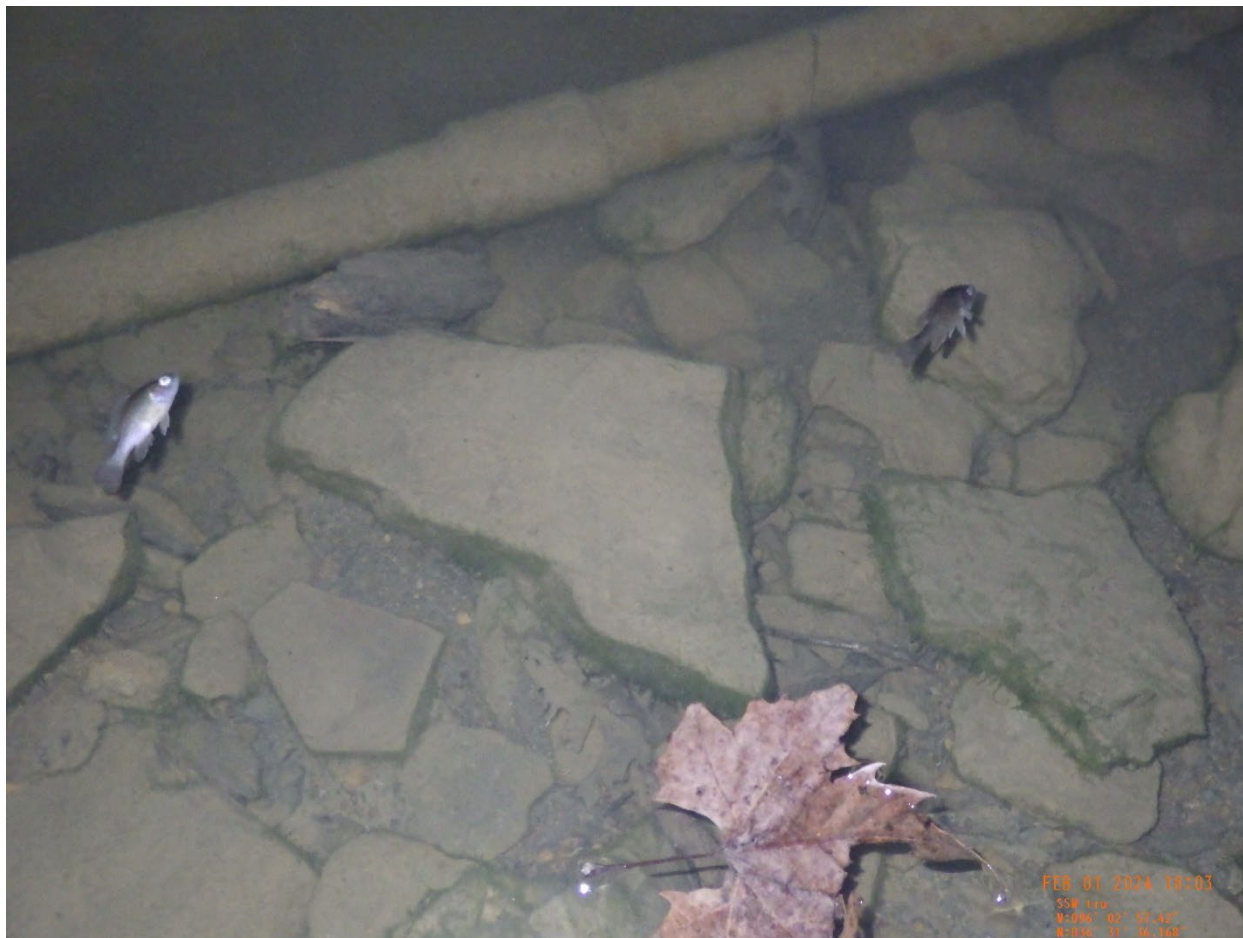
Photo No. 10

**Description:** This was the 2 small dead fish which were located at the same location as photo No. 9. The fish were approximately 1.5" in length.

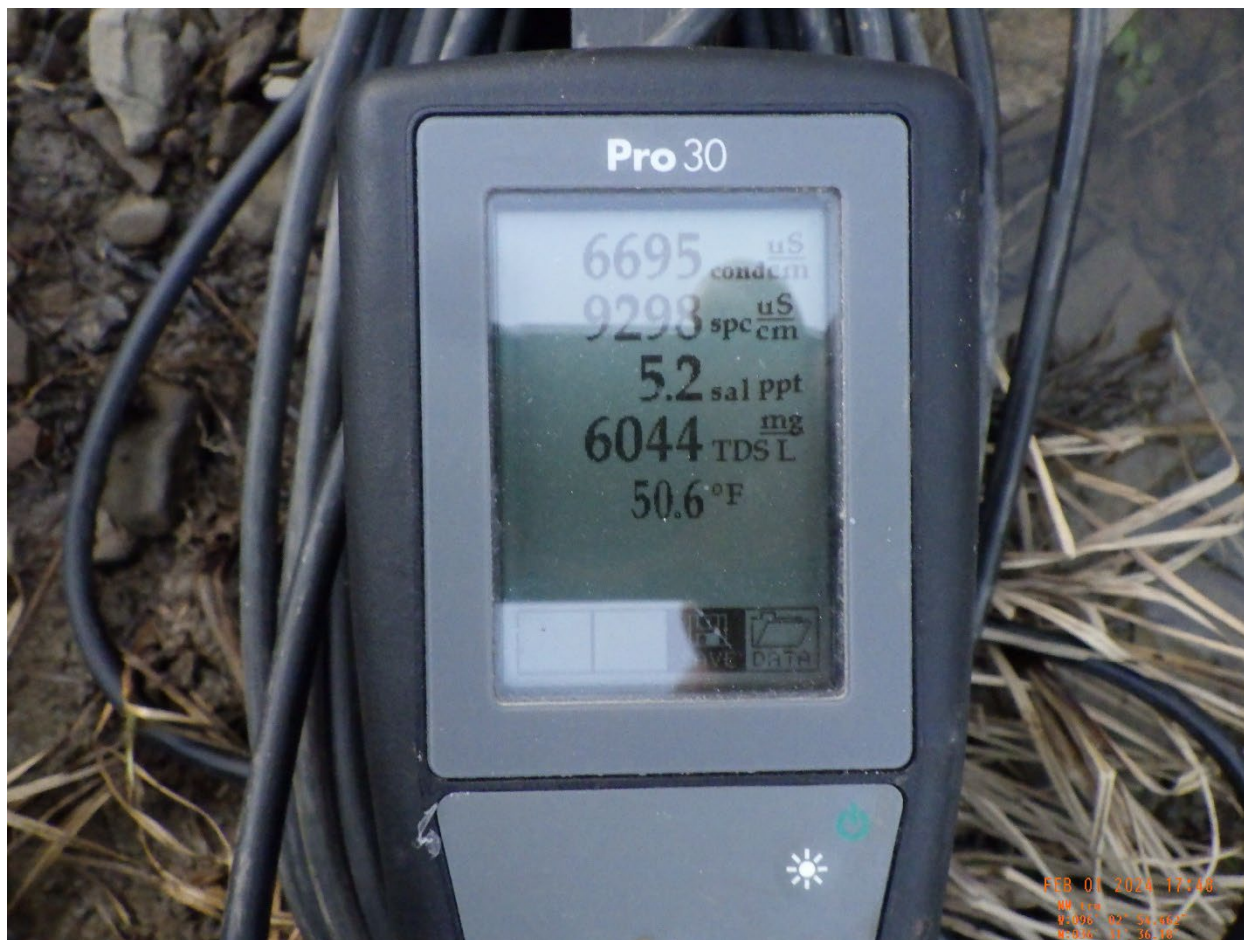
Photo No. 11

I observed an elevated TDS field reading of 6044 mg/L where the secondary channel of Candy Creek flowed into the primary channel of Candy Creek. See photos No. 11 and 12.

**Description:** This was an elevated TDS field reading of 6044 mg/L taken at the point where the secondary channel of Candy Creek flowed into the primary channel of Candy Creek. This reading was observed in a significant pool of water along the main channel of Candy Creek. See photo No. 12.

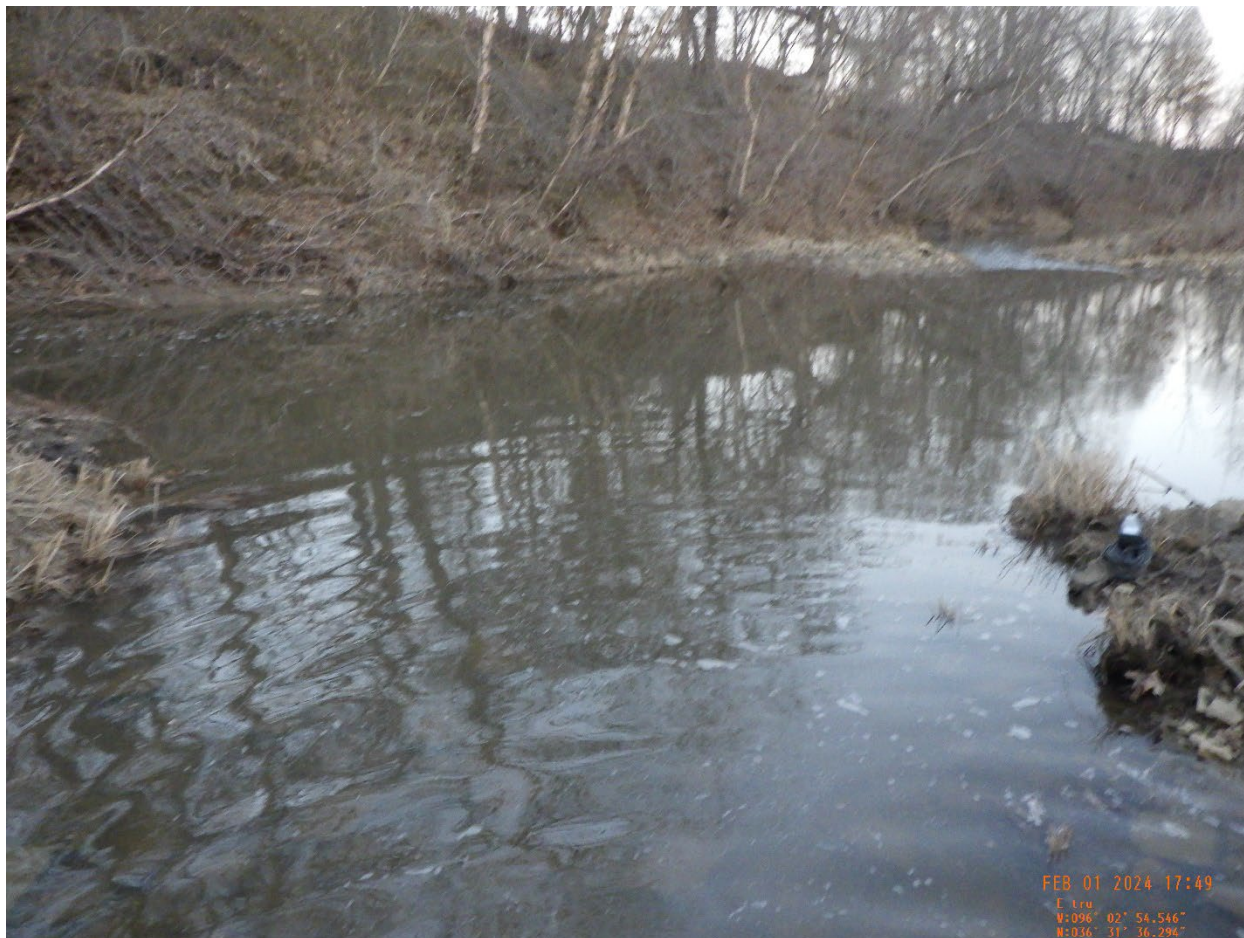
Photo No. 12

**Description:** This was the location where the elevated TDS field reading from photo No. 11 was taken. This photo is taken with a view to the east/downstream along the primary channel of Candy Creek.

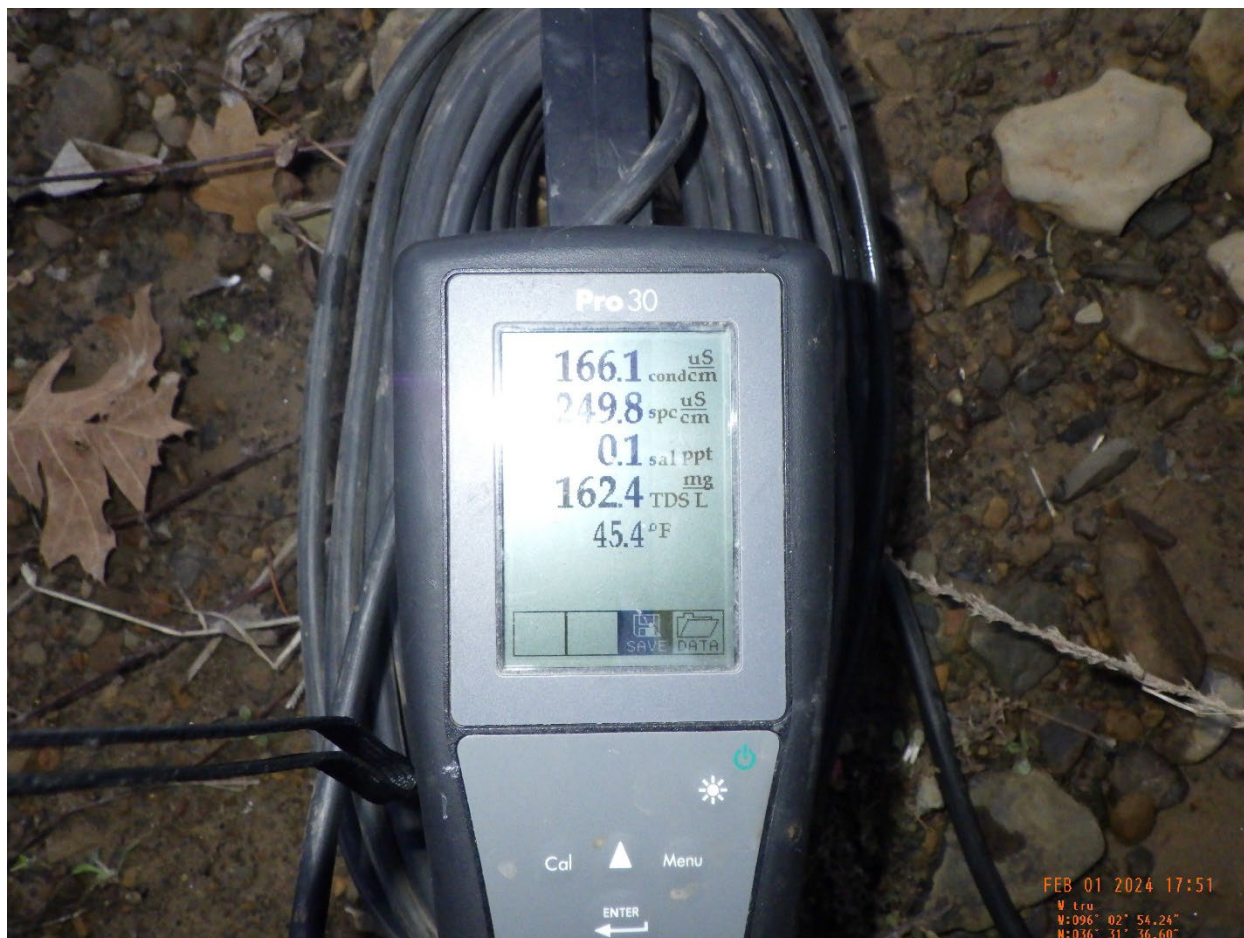
Photo No. 13

I observed a "background" TDS field reading of 162.4 mg/L in the main channel of Candy Creek. See photo No. 13 and 14.

**Description:** This was a TDS field reading of 162.4 mg/L taken in the main channel of Candy Creek, west/upstream from the impacted section of Candy Creek. This reading should be used when establishing background TDS levels for the area.

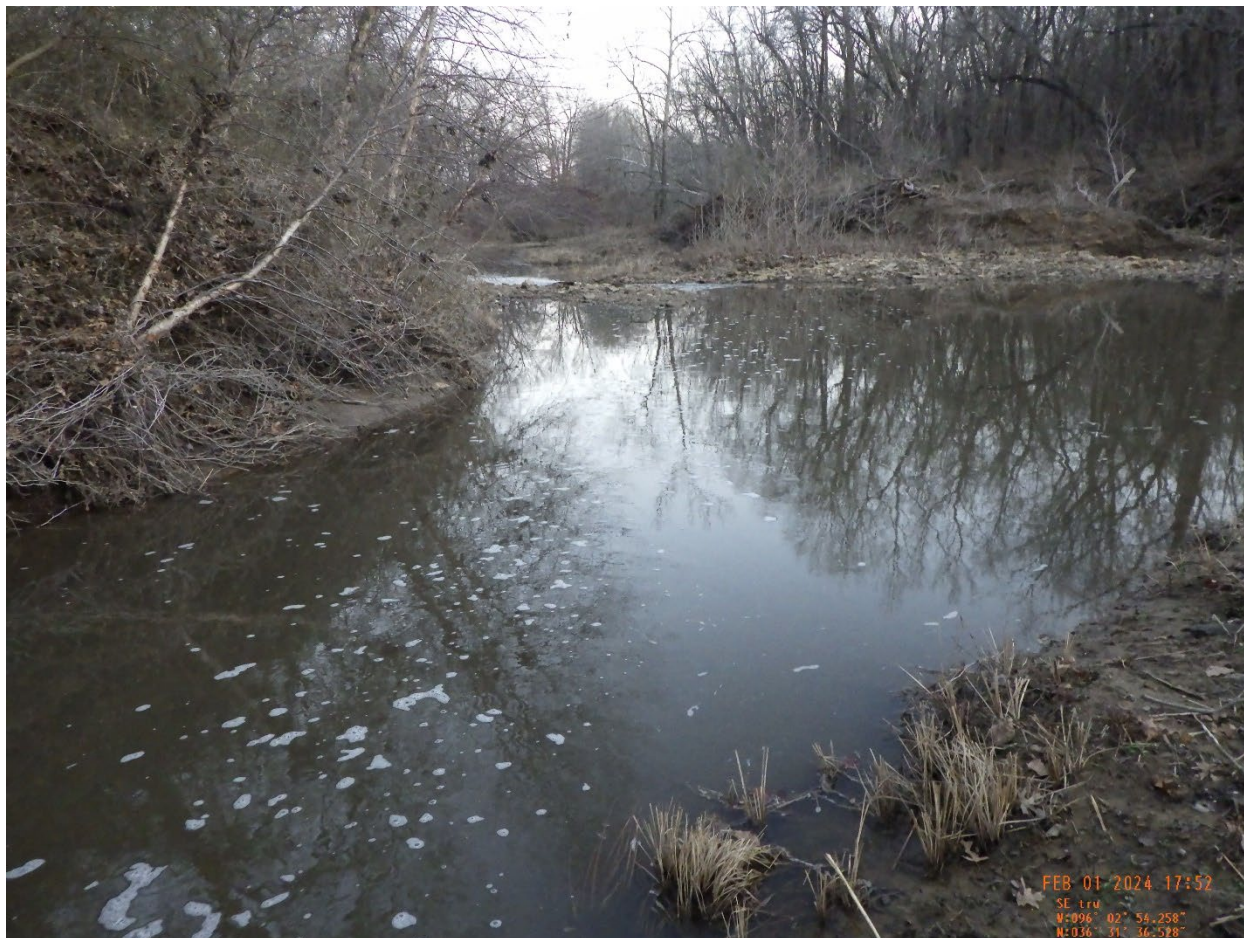
Photo No. 14

**Description:** This photo was taken at the same location as the “background” TDS observation from photo No. 13. This photo was taken while standing on the south edge of the main channel of Candy Creek with a view to the southeast. This photo was taken upstream from the point where the secondary channel carrying elevated TDS waters from the spill enters the primary channel of Candy Creek. The impacted channel enters from the right-hand side of this photo.

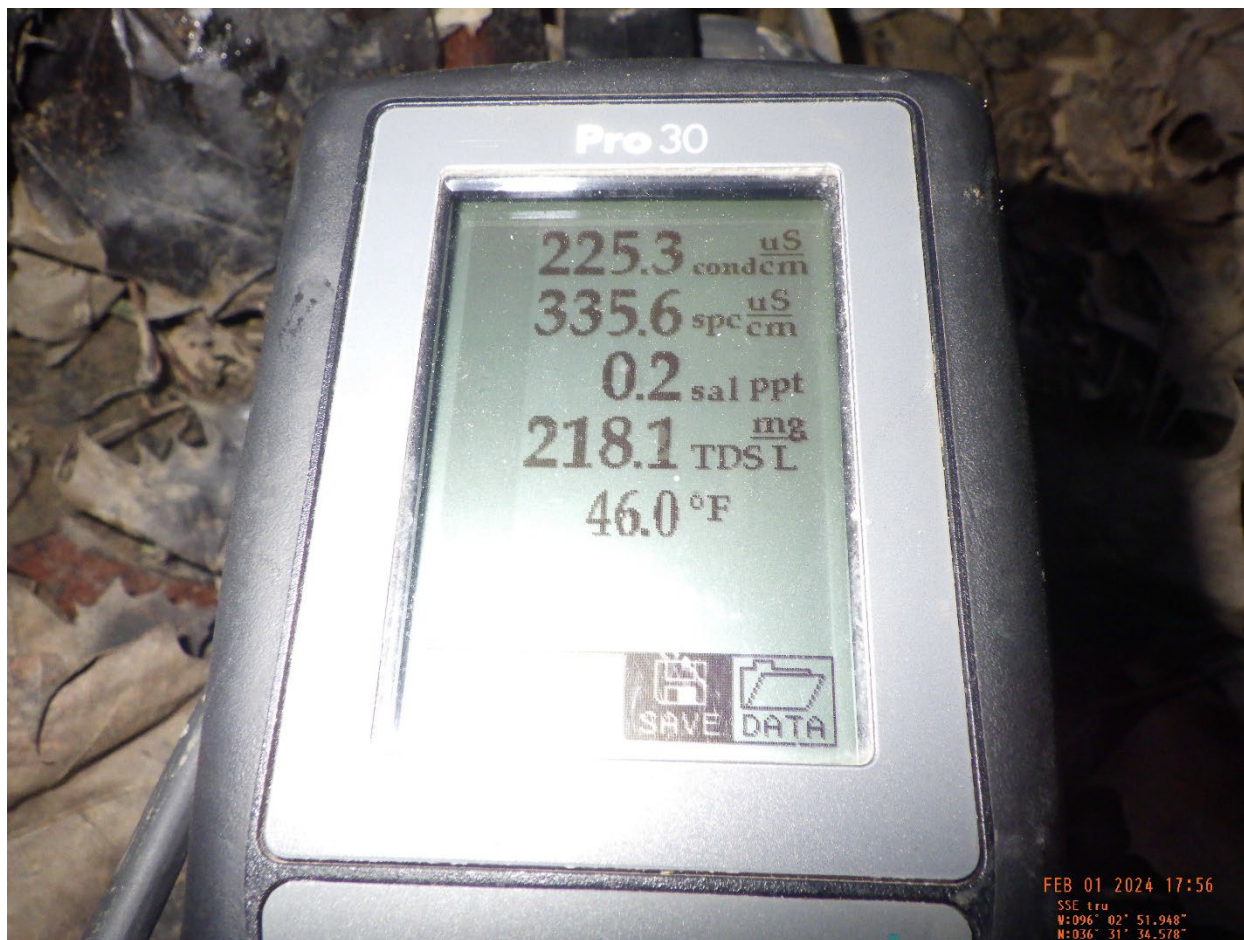
Photo No. 15

Approximately 200 feet downstream along the main channel of Candy Creek, I observed a TDS field reading of 218.1 mg/L. See photos No. 15 and 16.

**Description:** This was a TDS field reading of 218.1 mg/L taken approximately 200 feet downstream along the primary channel of Candy Creek. At the time of the inspection there was significant in-stream flow along Candy Creek due to recent rainfall.

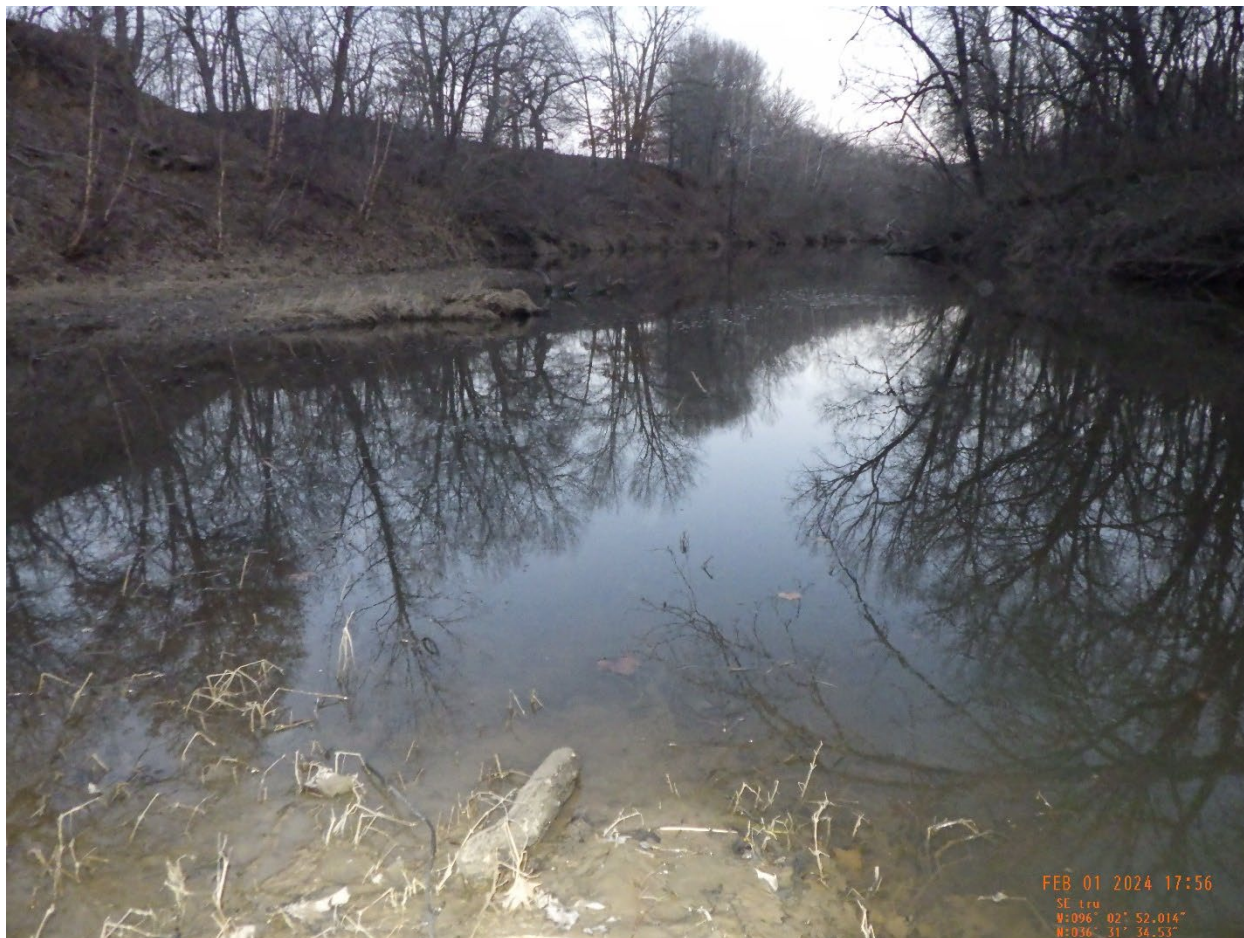
Photo No. 16

I observed no additional spill impacts downstream from the location of photo No. 16.

**Description:** This was the location of the TDS reading from photo No. 16. This was a view looking east along the main channel of Candy Creek.
