**Region 6 - Enforcement & Compliance Assurance Division**  
**INSPECTION REPORT**

| Inspection Date(s): | 06/28/2023 | |
| Regulatory Program(s) | AWIA/SDWA | |
| Facility Name: | <b>Salem Water Users Association</b> | |

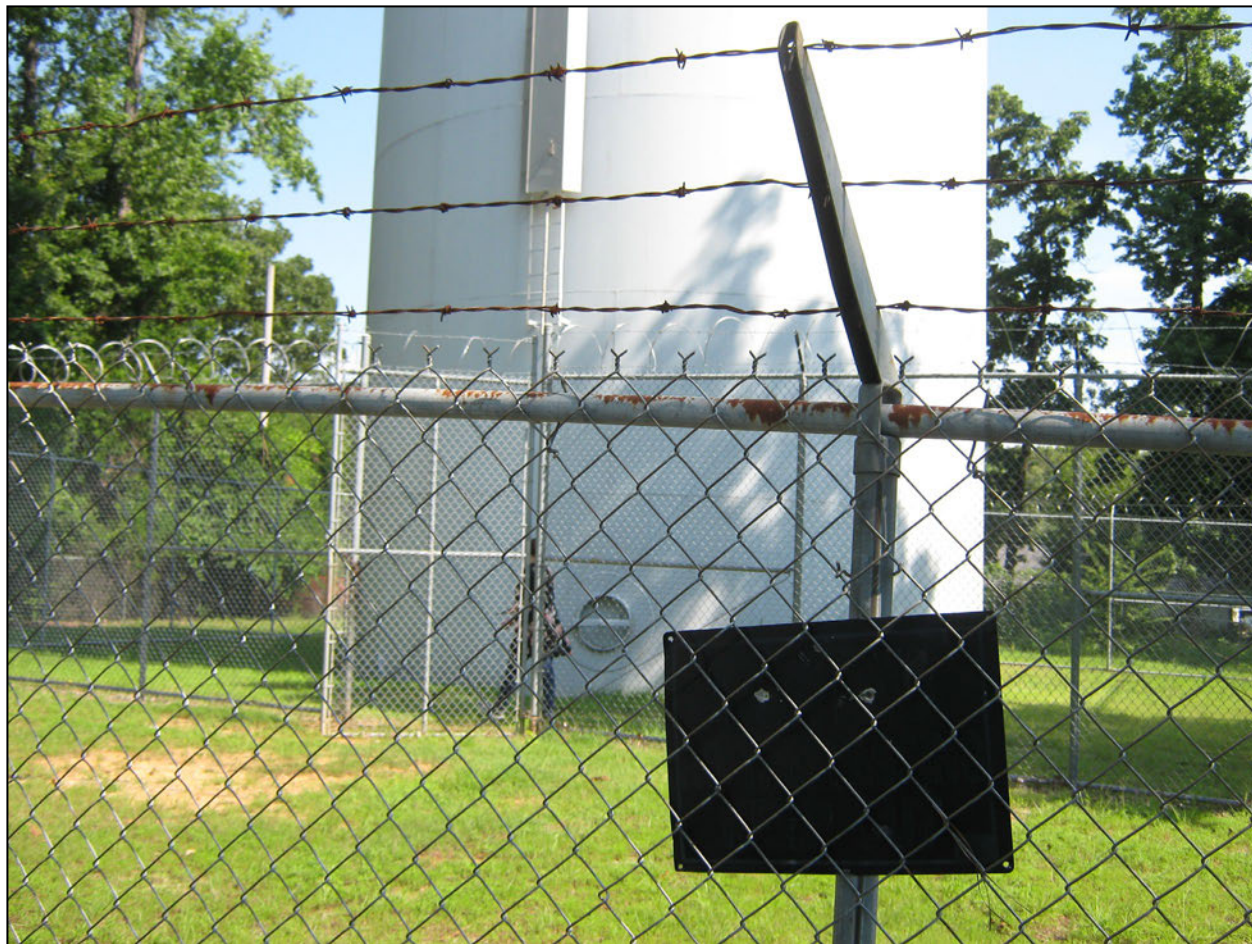
Photo No. 1

The Longhills Tank was inspected first (refer to [Appendix 2, Photograph 1](#)). The access to the tank was a driveway that was a few hundred feet beyond a locked gate. The tank is a 500,000-gallon standpipe that was surrounded by two locked perimeter fences. The outer fence is 6 feet high and equipped with barbed wire. The inner fence is 10 feet high and equipped with razor wire (refer to [Appendix 2, Photograph 1](#)). An older “No Trespassing” warning sign was not legible (refer to [Appendix 2, Photograph 1](#)). A sign reading “In Case of Emergency” contained emergency contact phone numbers. The bottom rungs were removed from the tank’s access ladder to approximately 14 feet, and the ladder was equipped with a locked security shield (refer to [Appendix 2, Photograph 2](#)). An overflow pipe extended from the approximate overflow level of the tank. It was downturned and appeared to be screened, however, the screen size and condition could not be evaluated from ground level (refer to [Appendix 2, Photographs 3 and 4](#)).

**Photograph 1. Longhills Tank** View of the double-fence system with the innermost fence equipped with razor wire and access ladder modified to above ground level. The “No Trespassing” signage was unreadable.

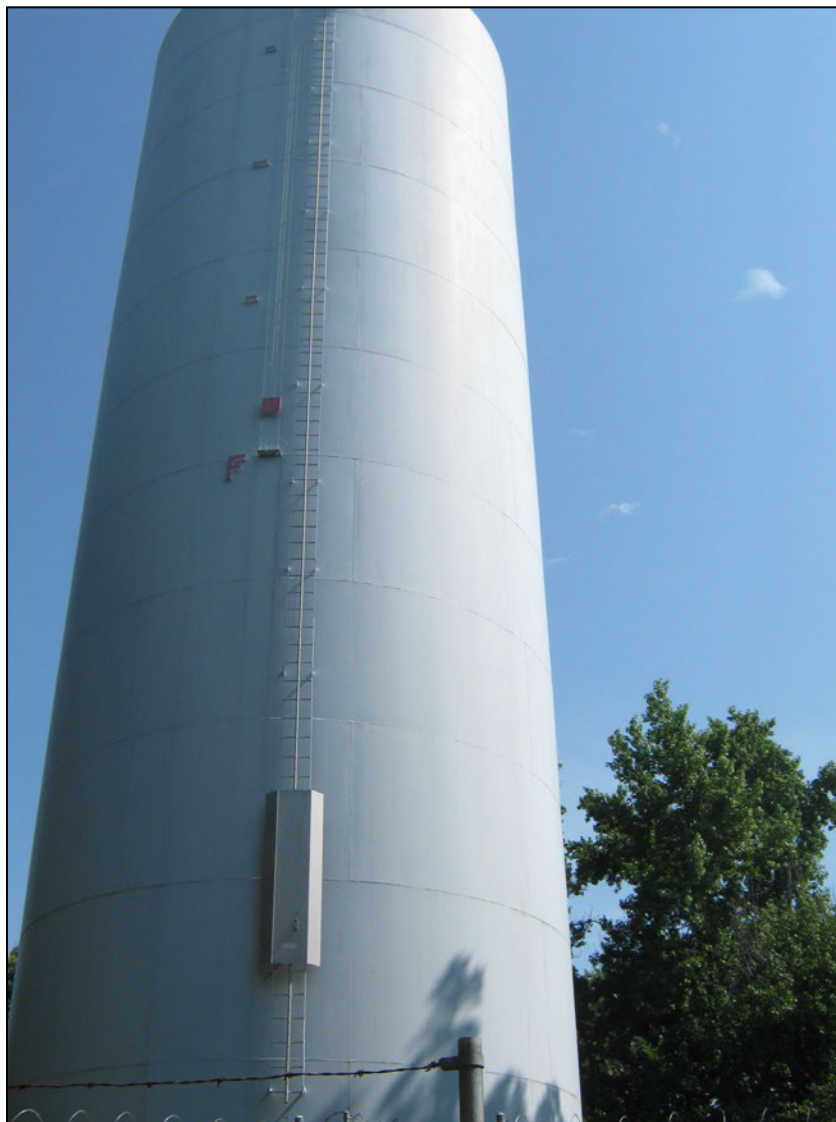
Photo No. 2

**Photograph 2. Longhills Tank** View of the Longhills Tank access ladder that was cut above ground level and shielded with a ladder guard.

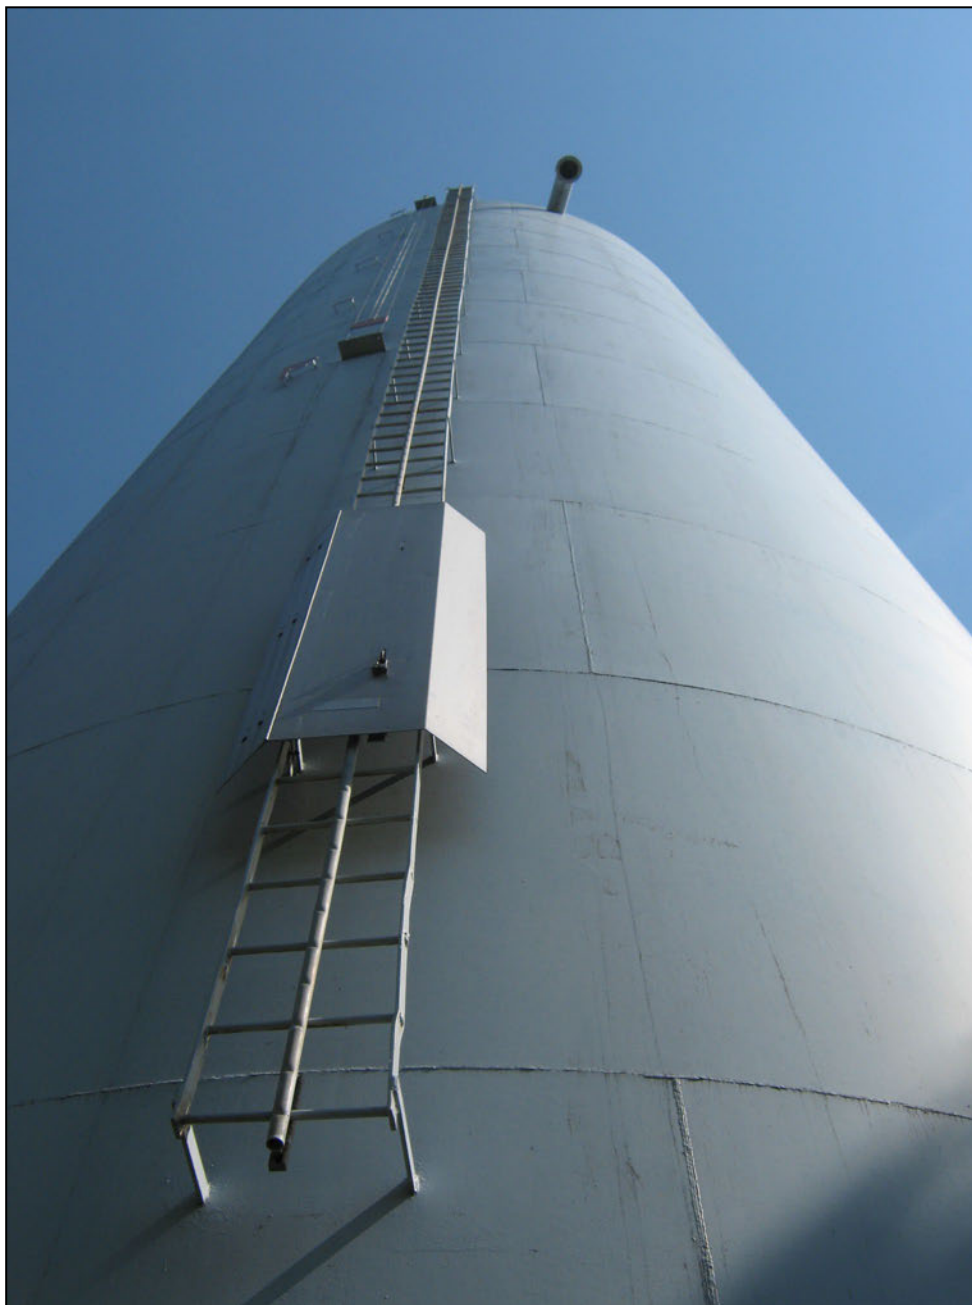
Photo No. 3

**Photograph 3. Longhills Tank** Alternate view of the Longhills Tank access ladder that was cut above ground level and shielded with a ladder guard. Also, visible in this image is the overflow that was downturned but did not extend to ground level. The overflow did not allow for evaluation for adequate screening.

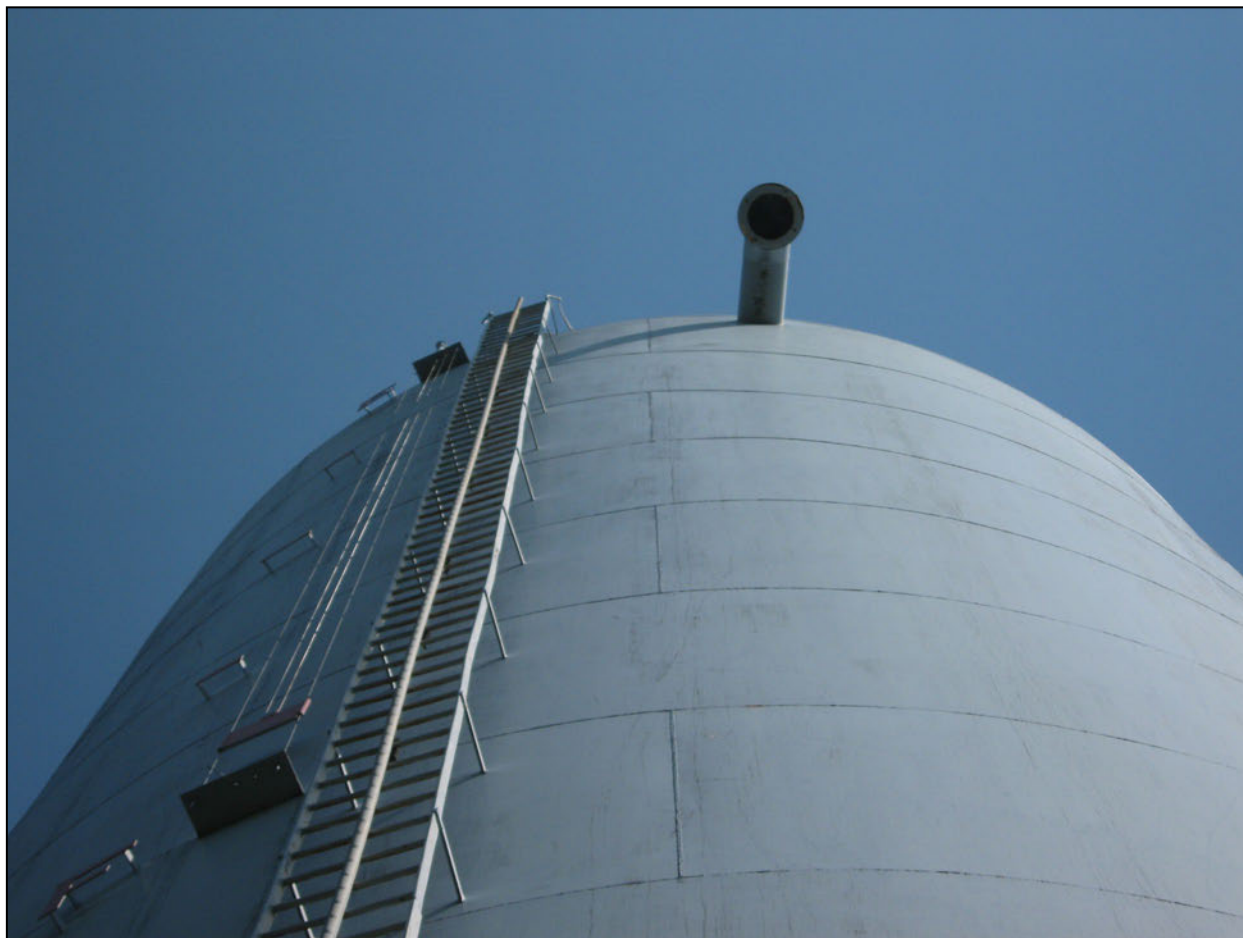
Photo No. 4

**Photograph 4. Longhills Tank** Alternate view of the Longhills Tank overflow. The overflow was downturned but did not extend to ground level. The overflow did not allow for evaluation for adequate screening.

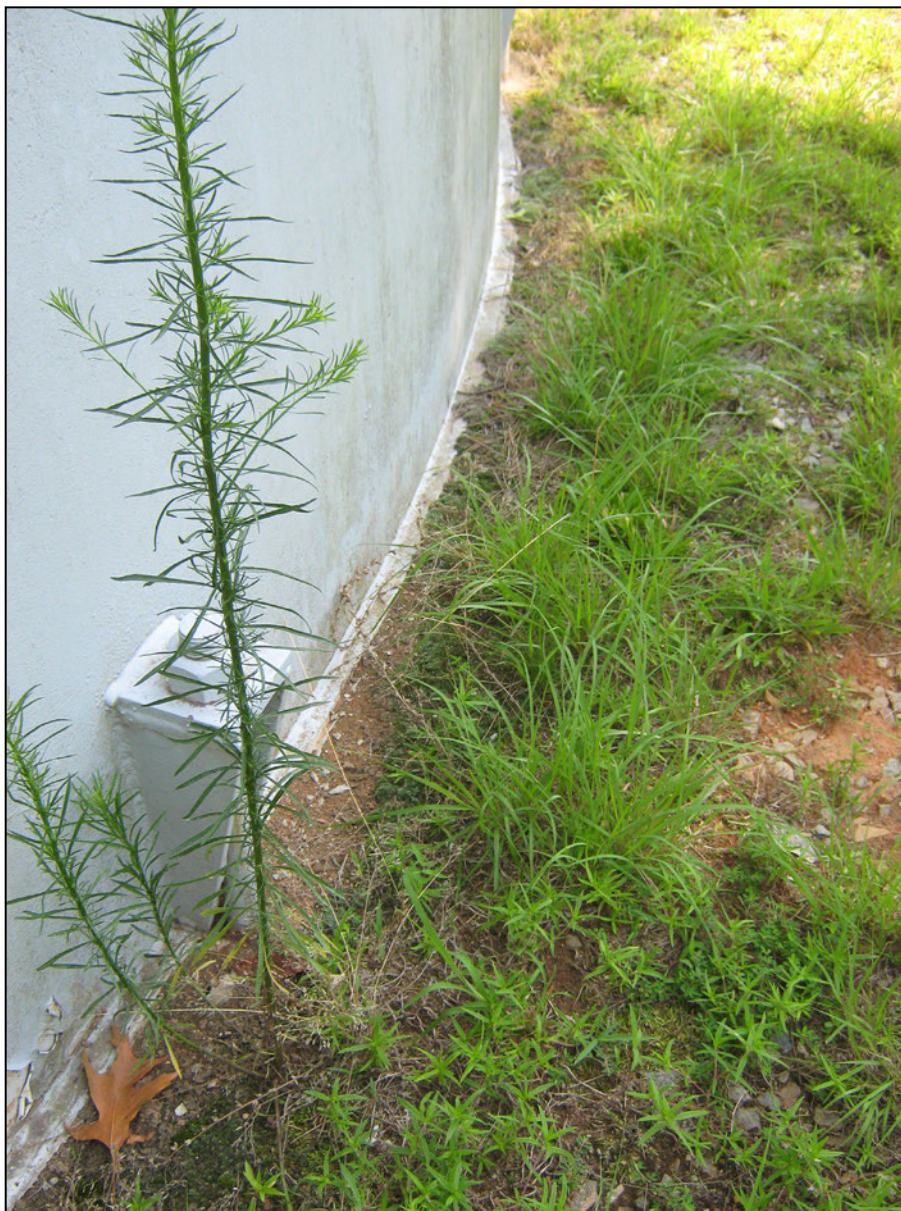
Photo No. 5

**Observation 15.** The base of the Longhills Tank had soil coverage above the concrete foundation and against the metal base of the tank and metal sidewall for about one half of the circumference (refer to [Appendix 2, Photograph 7](#)). The entire concrete foundation was flush to the ground on the remainder of the circumference, limiting drainage away from the base (refer to [Appendix 2, Photograph 5](#)).

**Observation 18.** The EPA Inspector observed apparent seepage from the Longhills Tank at one 2-foot section (rear right) and one 4-foot section (front left) as referenced from the entrance gate (refer to [Appendix 2, Photographs 5 and 6](#)).

**Photograph 5. Longhills Tank** View of the concrete base of the Longhills Tank. The base was flush to ground level which allows water and sediment to come in contact with the metal tank base. The area was wet, indicating tank seepage from the base.

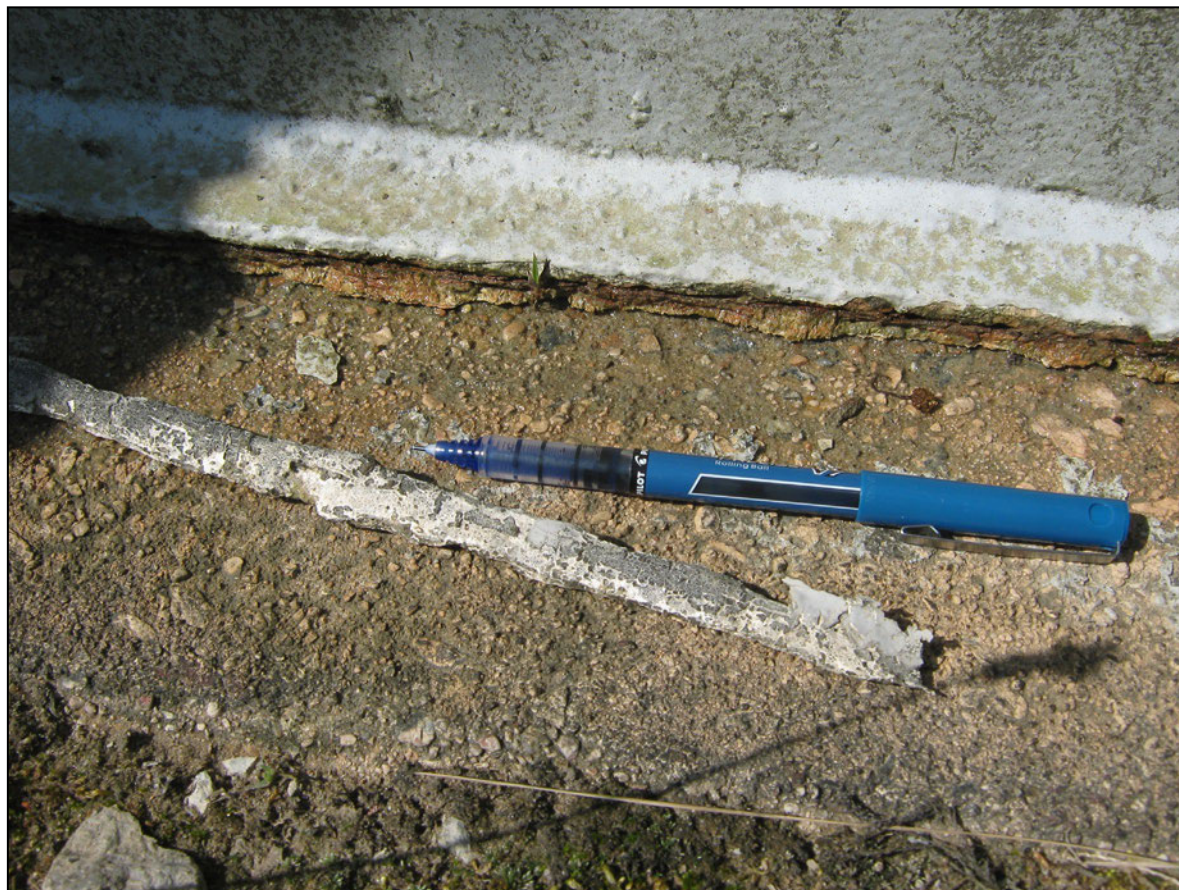
Photo No. 6

**Observation 16.** The junction of the concrete base and metal bottom of the Longhills Tank is a blend of grout and caulking. The grout and caulking were loose or missing around the circumference (refer to [Appendix 2, Photograph 6](#)).

**Photograph 6. Longhills Tank** View of the grout and caulking seal at the base of the Longhills Tank that was weathered, peeling away, and cracked.

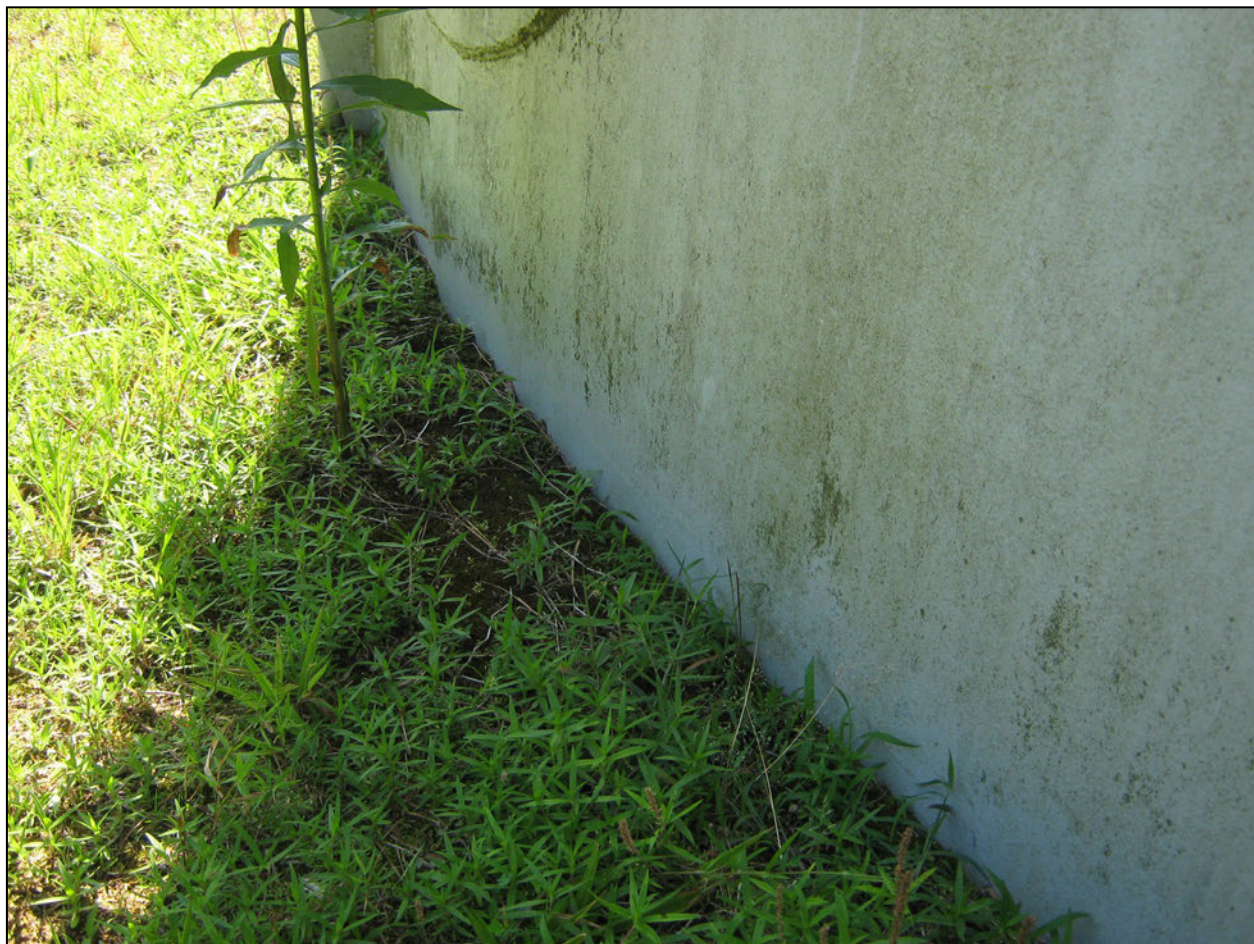
Photo No. 7

**Photograph 7. Longhills Tank** View of the concrete base of the Longhills Tank that was covered with soil above the base seal and to the sidewall of the tank.

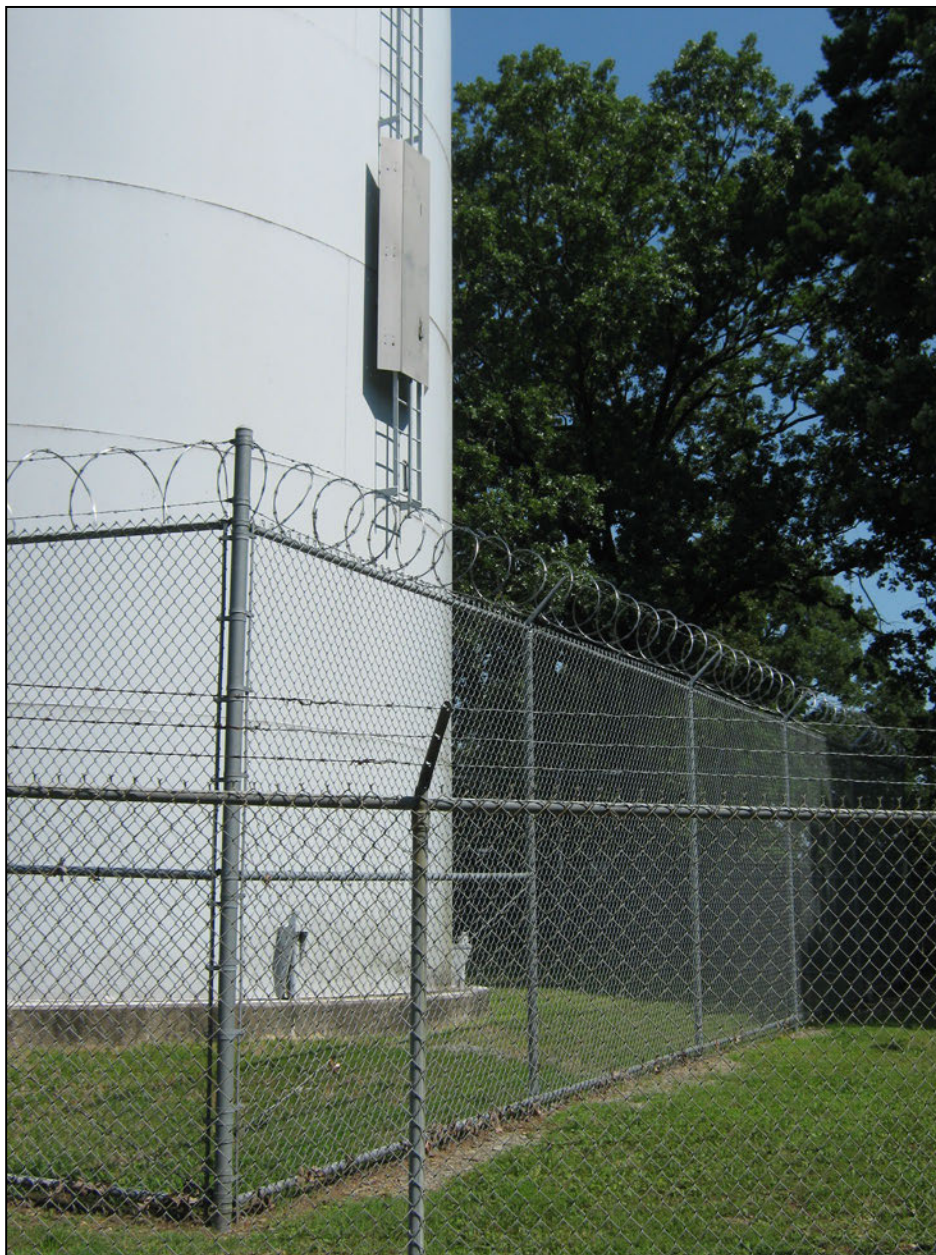
Photo No. 8

The Mulberry / Salem Tank was inspected second (refer to [Appendix 2, Photograph 8](#)). The tank is a 500,000-gallon standpipe that was surrounded by two locked perimeter fences. The outer fence is 6 feet high and equipped with barbed wire. The inner fence is 10 feet high and equipped with razor wire (refer to [Appendix 2, Photograph 8](#)). A sign reading "In Case of Emergency" contained emergency contact phone numbers (refer to [Appendix 2, Photograph 9](#)) but did not have "No Trespassing" warning signage. The bottom rungs were removed from the tank's access ladder to approximately 14 feet and was equipped with a locked security shield (refer to [Appendix 2, Photograph 8](#)). An overflow pipe extended from the approximate overflow level of the tank. It was downturned and appeared to be screened; however, the screen size and condition could not be evaluated from ground level (refer to [Appendix 2, Photograph 10](#)). The System representative said that there were no alarms or video surveillance tied to the tank. A tank level sensor was tied to SCADA for remote tank level observation. The seal between the metal tank base and the concrete foundation that was visible was weathered, cracked, and had numerous gaps as wide as 1/4 inch throughout (refer to [Appendix 2, Photograph 11](#)). Tank water appeared to be seeping from three areas of the tank base located on the right half of the tank from the entrance gate. The seepage was not in enough volume to collect a sample to test for chlorine that would more confidently identify the tank water as the source. System representatives stated that the tank was professionally inspected within the year prior to the inspection, but it was unclear if the inspection provided a quality view, and therefore a thorough assessment of the tank floor.

**Photograph 8. Mulberry/Salem Tank** View of the double-fence system with the innermost fence equipped with razor wire and access ladder modified to above ground level.

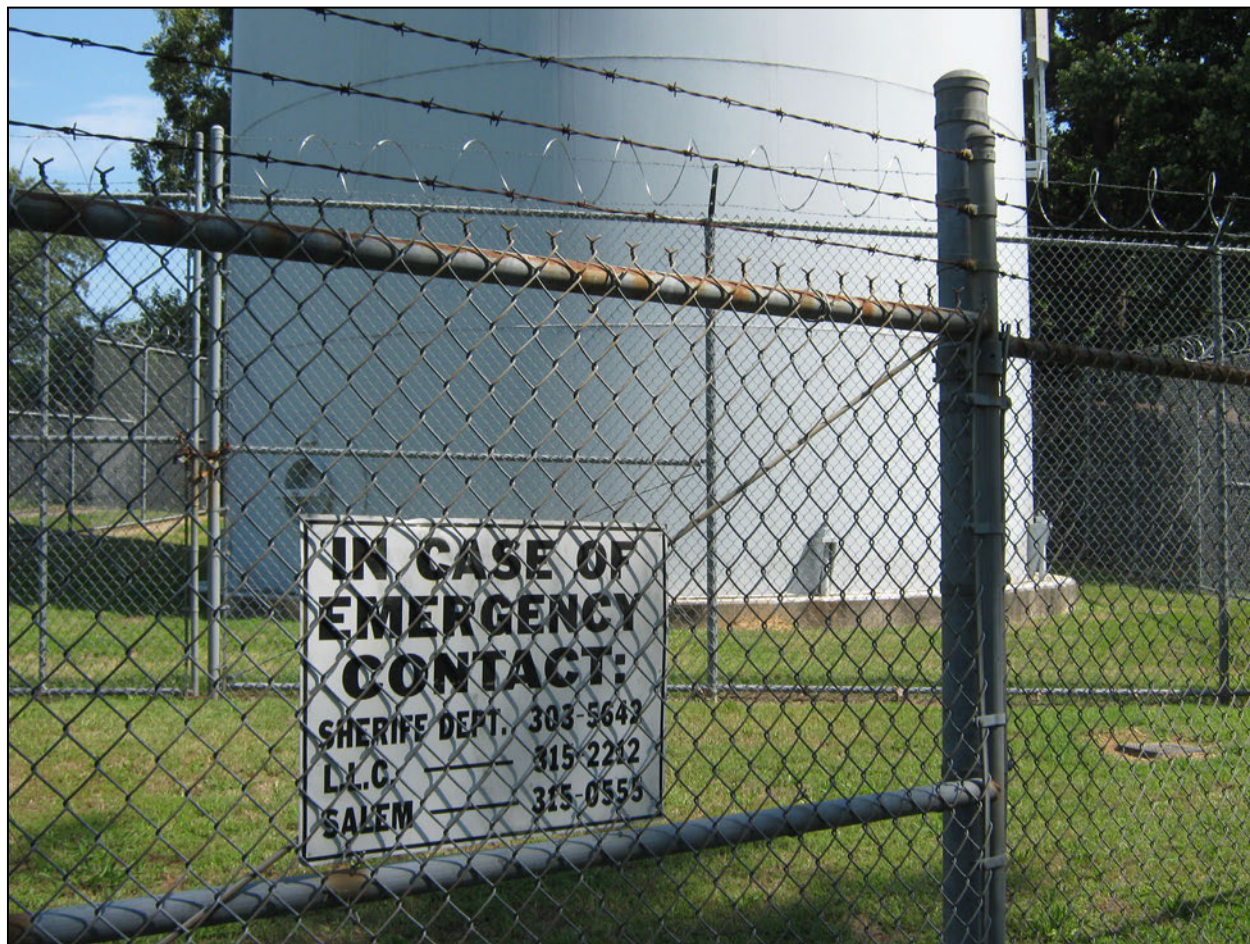
Photo No. 9

**Photograph 9. Mulberry/Salem Tank** View of an emergency contact sign that was prominently attached to the outer fence at the Mulberry/Salem Tank. A “No Trespassing” sign was not present.

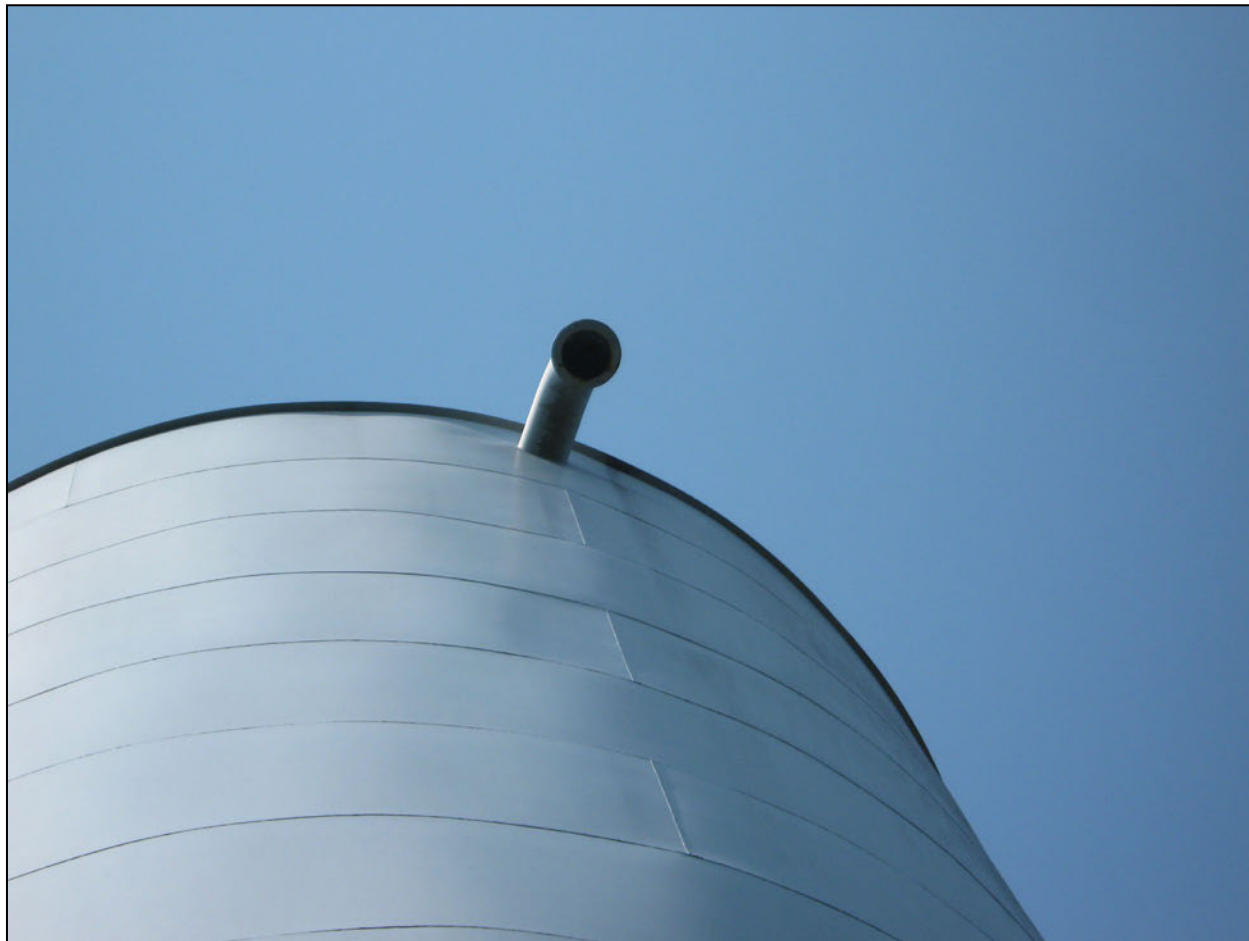
Photo No. 10

**Observation 22.** The Mulberry / Salem Tank overflow was downturned at the top of the tank and appeared to be at least rough screened, but evaluation for fine mesh could not be made. The overflow did not come to a ground-level standard (refer to Appendix 2, Photograph 10).

**Photograph 10. Mulberry/Salem Tank** View of the overflow of the Mulberry/Salem Tank that was downturned but did not extend to ground level. The overflow did not allow for evaluation for adequate screening.

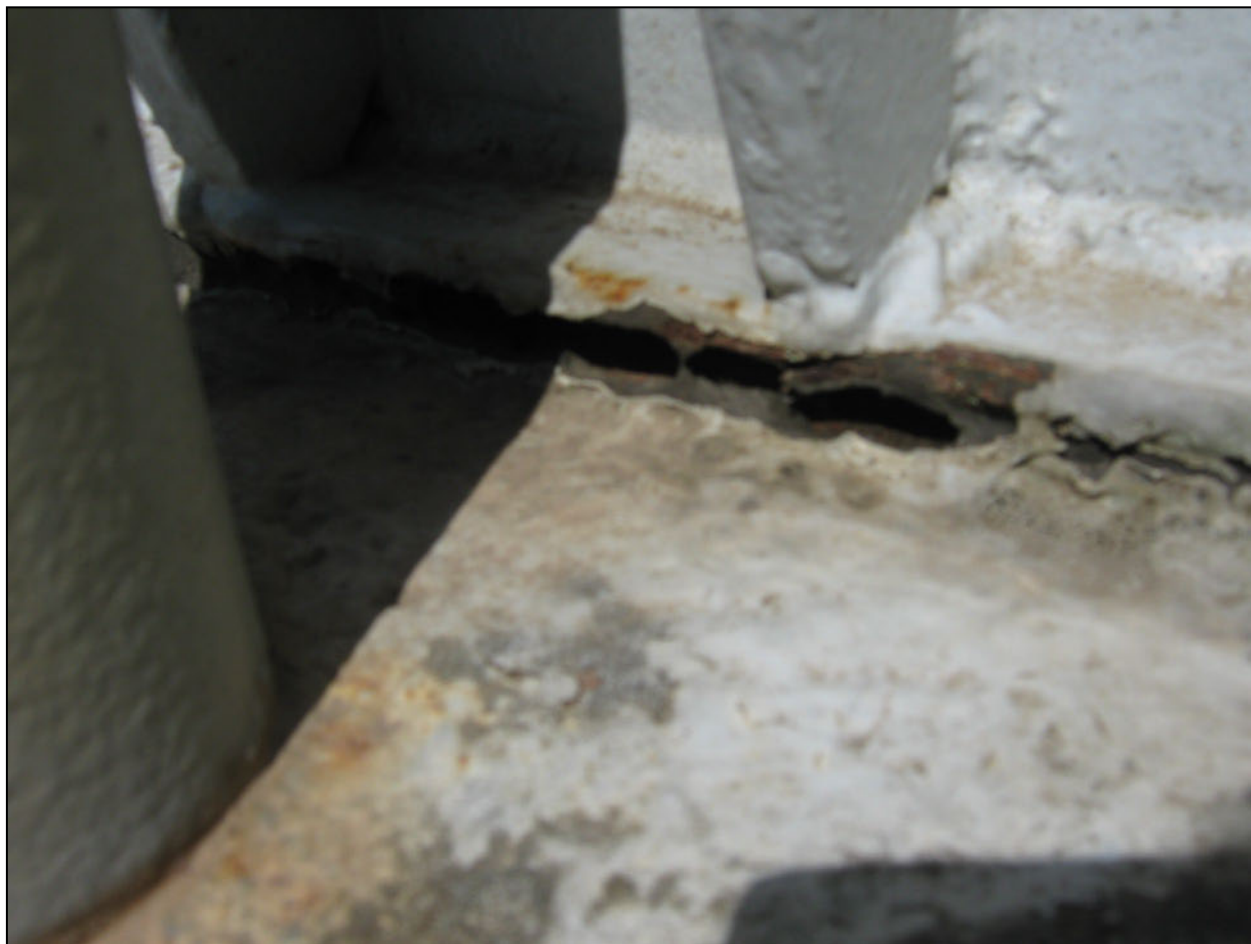
**Observation 17.** The junction of the concrete base and metal bottom of the Mulberry / Salem Tank is a blend of grout and caulking. The grout and caulking were loose or missing around the circumference. In some areas, a 1/4-inch gap exists which allows stormwater under the floor of the tank (refer to [Appendix 2, Photograph 11](#)).

**Photograph 11. Mulberry/Salem Tank** View of a gap greater than  $\frac{1}{4}$  inch between the metal tank base and the concrete foundation of the Mulberry/Salem Tank.

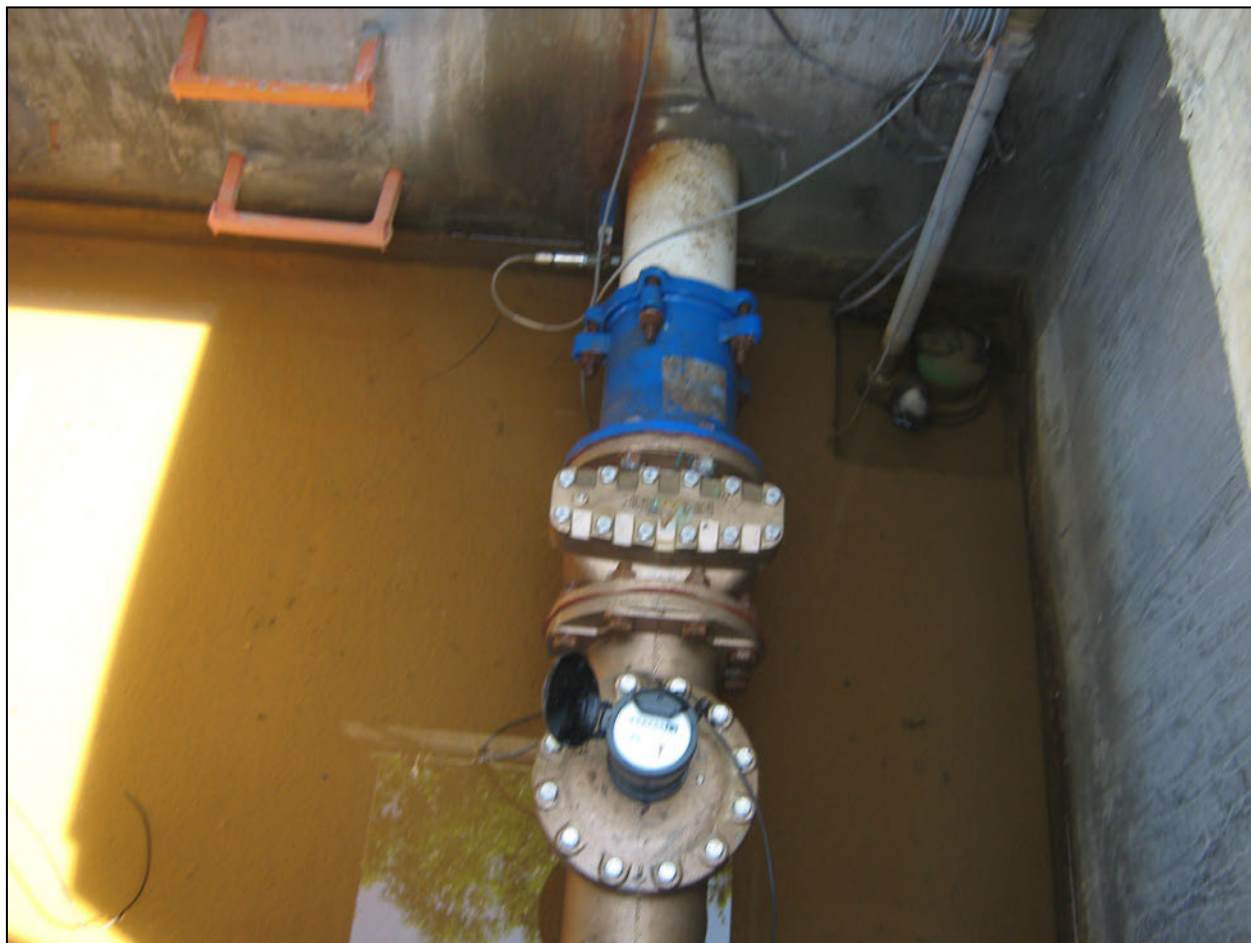
The Sparks Master Meter was observed (refer to [Appendix 2, Photograph 12](#)). System representatives stated that the master meter infrastructure is owned and operated by CAW. The meter was below-grade in a meter vault, and downstream of the meter was a control valve in a separate vault. The vaults were locked and located within the same perimeter security fencing as the Sparks Chlorination Booster Station. There was approximately one foot of standing water in each vault which was beneath the meter and the control valve. The vaults are equipped with automated submersible pumps which appeared to be functional when triggered by a water level just above one foot (refer to [Appendix 2, Photograph 12](#)).

**Photograph 12. Sparks CAW Master Meter** View of light sediment on the pit floor and 1 foot of standing water which was near the submersible pump trigger point to operate.

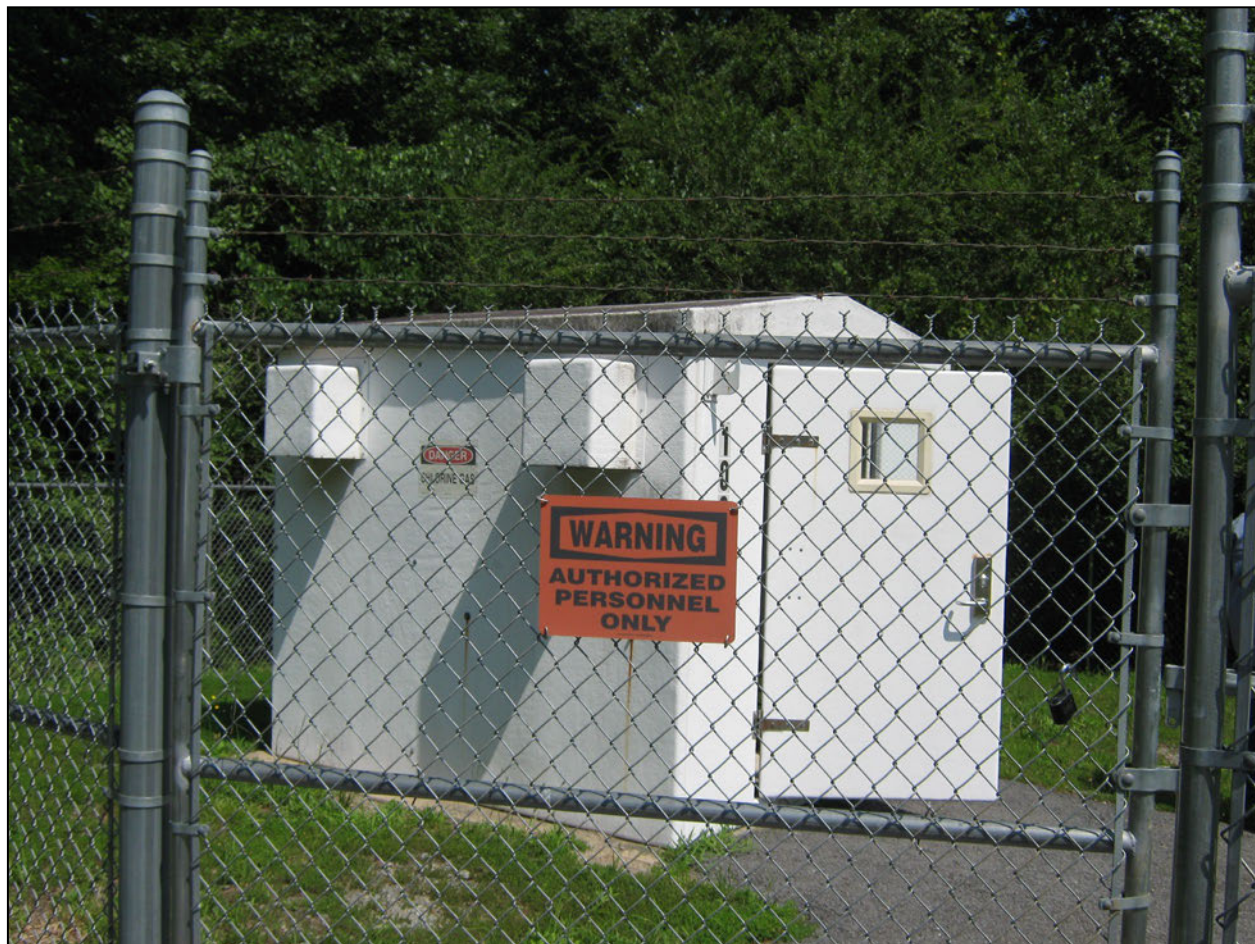
The Sparks Booster Chlorination Station was observed (refer to [Appendix 2, Photograph 13](#)). System representatives stated that this station and the other three stations have very similar designs and are operated and maintained in a similar fashion. The function of the stations is to slightly boost the amount of the purchased water chlorine residual to allow the residual to meet the System's distribution chlorine residual goals at all points of the distribution system. System representatives stated that a failure to boost chlorine levels at the stations would need to be addressed but would not be a high-level emergency due to the chlorine residual levels of the purchased water.

**Observation 7.** The System indicated “no chemicals” on the RRA and did not assess a threat impact on the asset category that addresses the use, storage, or handling of chemicals. During the EPA Inspection, system representatives explained that it does use chemicals in the form of chlorine gas to boost the chlorine residual in the distribution system at several pump stations (refer to [Appendix 2, Photograph 14](#)). The EPA Inspector visited one of the three chlorine booster stations where chlorine gas in 150-pound cylinders is used to increase the chlorine residual in the distribution system (refer to [Appendix 2, Photograph 13](#)).

**Photograph 13. Sparks Chlorine Booster Station** View of the exterior of the chlorine storage and chlorine feed entrance door. A distinct second room had a rear entrance door (not in the photograph view).

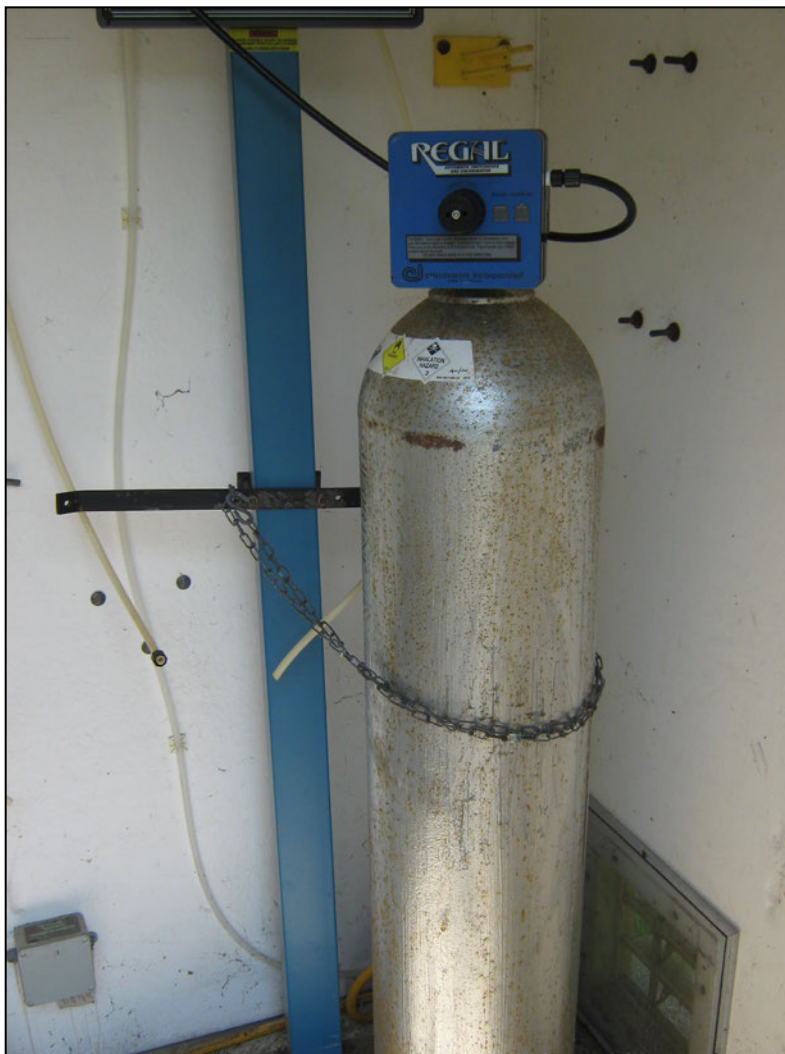
**Observation 24.** The chlorine regulator at the Sparks Chlorine Booster Station was not equipped with a vent (refer to Appendix 2, Photograph 14).

**Photograph 14. Sparks Chlorine Booster Station** View of one (1) 150 lb. chlorine gas cylinder that was in operation on a chlorine scale. The Regal chlorinator did not have a vent plumbed into the unit.

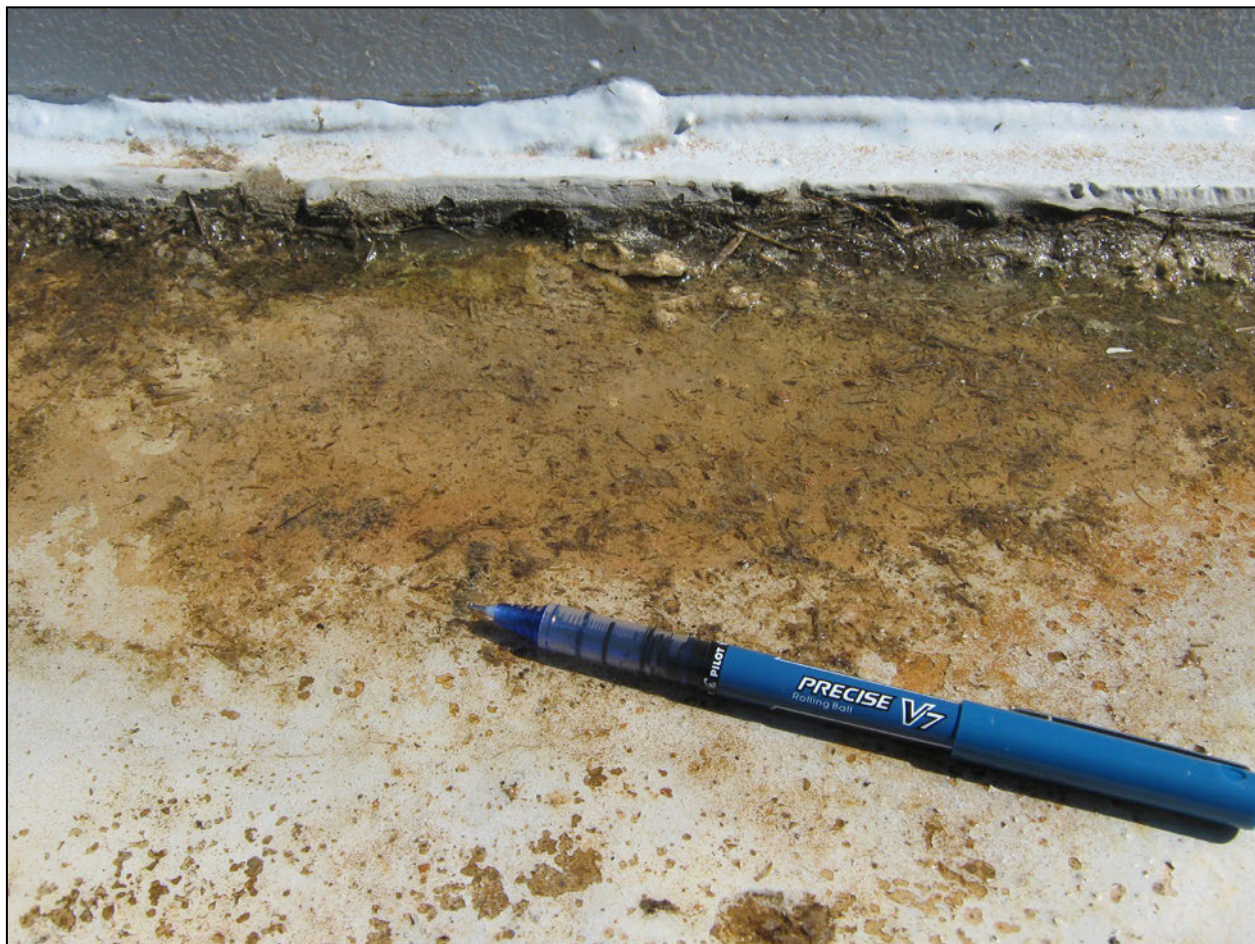
**Observation 19.** The EPA Inspector observed apparent seepage from the Mulberry / Salem Tank at two locations, a 4-foot section (front) and a 6-inch section (front right), as referenced from the gate (refer to [Appendix 2, Photographs 15 and 16](#)).

**Photograph 15. Mulberry/Salem Tank** View of apparent seepage from base of the tank, ponding onto the concrete base at the Mulberry/Salem Tank.

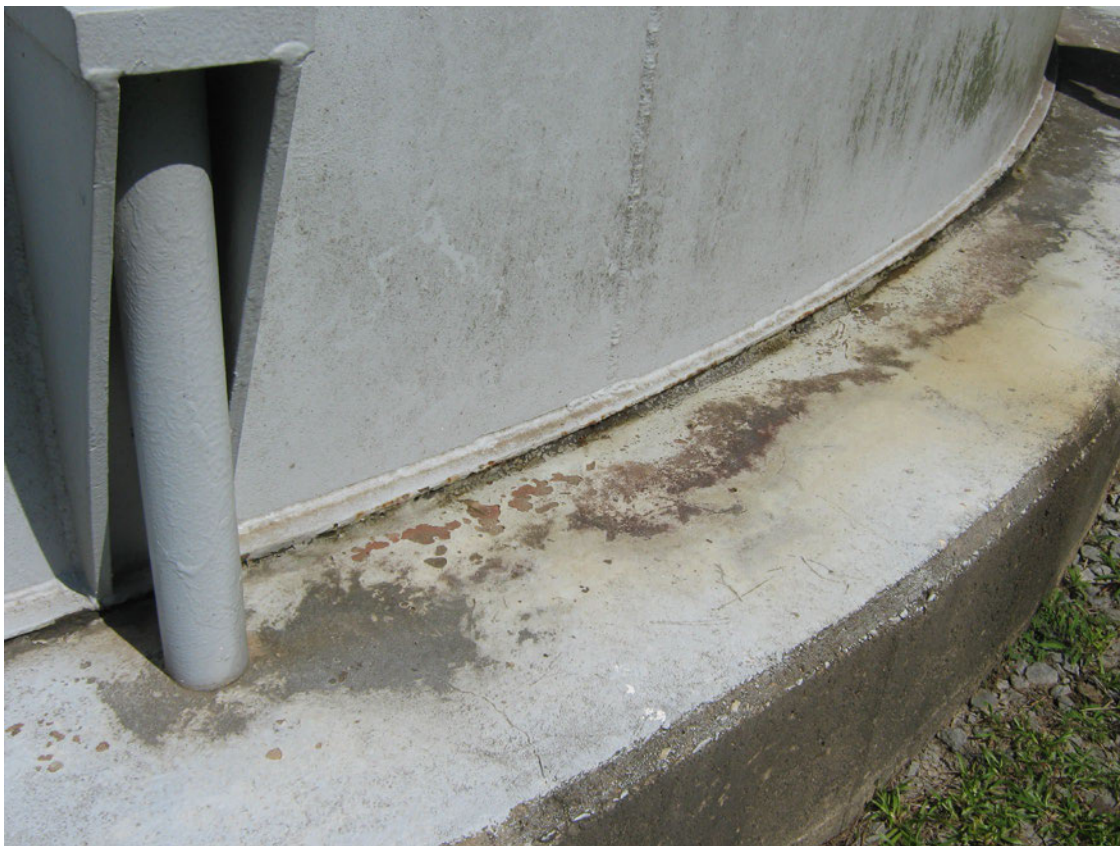
**Photograph 16. Mulberry/Salem Tank** Alternate view of apparent seepage from the base of the tank onto the concrete base at the Mulberry/Salem Tank.

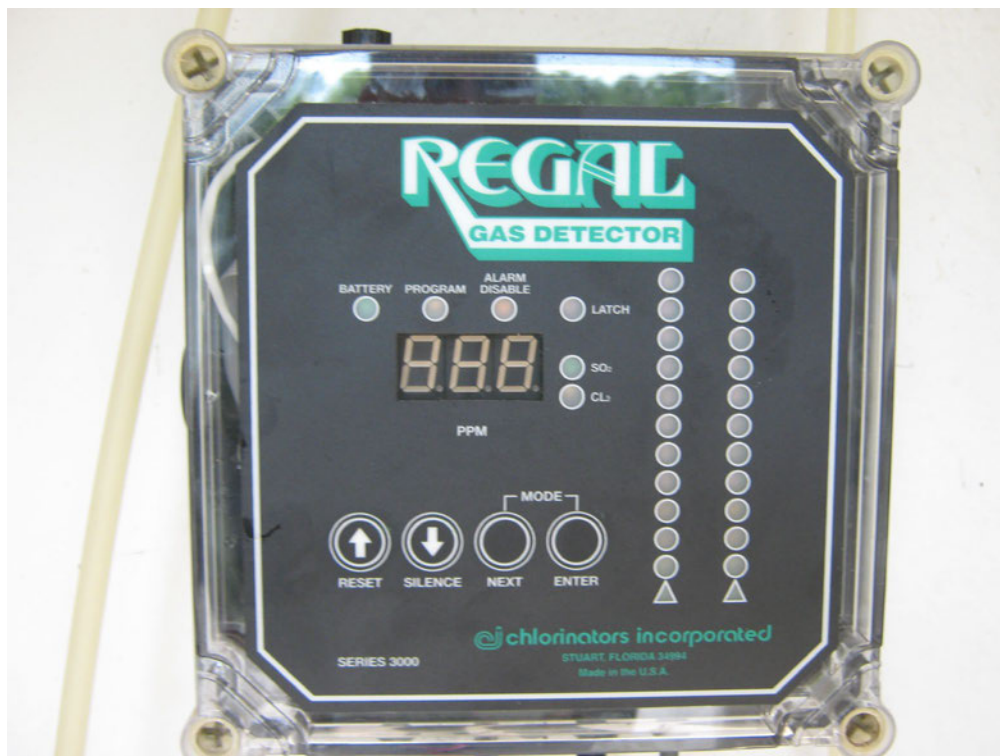
**Observation 23.** The EPA Inspector observed that the chlorine gas detector at the Sparks Chlorine Booster Station was not functioning. System representatives stated that it had failed recently and that a contractor was scheduled to service the detector on 6/29/2023 (refer to Appendix 2, Photograph 17).

**Photograph 17. Sparks Chlorine Booster Station** View of the chlorine gas detector that was not functional at the Sparks Chlorine Booster Station.
