**CWA COMPLIANCE EVALUATION INSPECTION REPORT  
U.S. ENVIRONMENTAL PROTECTION AGENCY, REGION 5**

**Facility:** J&G Storage  
West of the Intersection Wisconsin State Route 47 and Larch Road  
Parcel #10-706-01  
Lac du Flambeau, Wisconsin 54538

**Date of Inspection:** December 14-15, 2023

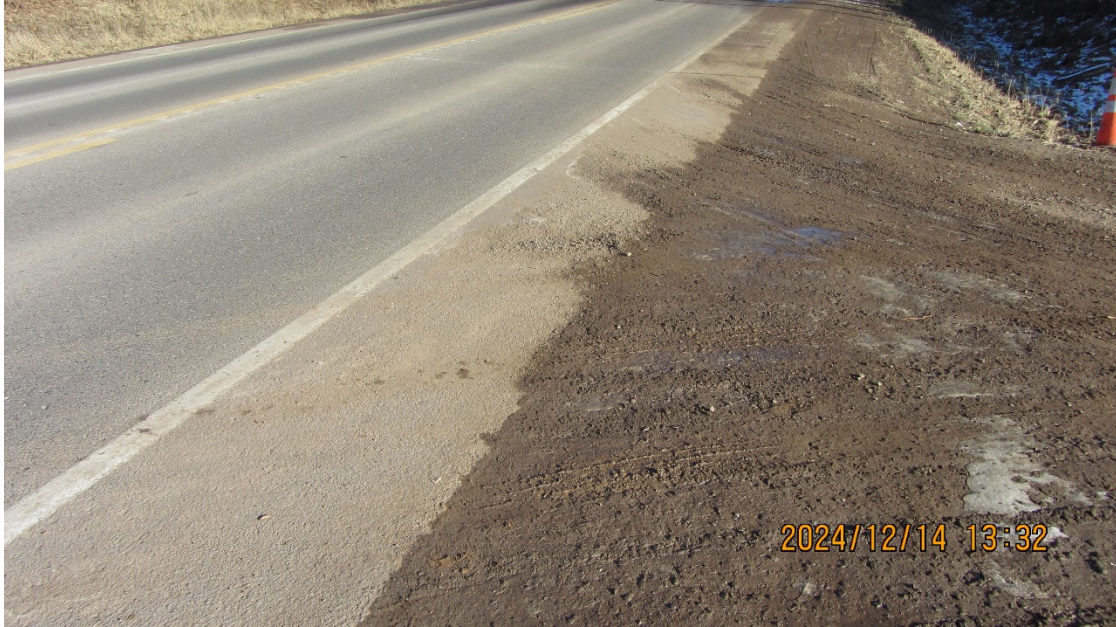
4. IMG\_0842

- EPA observed minimal sediment tracking from the site's entrance (Photograph 4 in Attachment A).
- Photograph 7 in Attachment A shows the upstream culvert and headwall for a small ditch that runs west of the site (referred to above in the Receiving Waters section of this report) and that would likely flow from north to south towards Fence Lake. At the time of this inspection, there was no water flowing through this culvert.

Description: J&G Storage Site - Entrance

4. Site Entrance Tracking Pad: EPA observed during the inspection that there did not appear to be a tracking pad implemented at the site entrance, as indicated by the SWPPP.<sup>2</sup> Although Mr. Fahrner told EPA that the tracking pad had been implemented and then altered by construction equipment leaving the site, EPA did not observe the size of rock (3-inch to 6-inch washed stone) on and around the construction entrance as described in the tracking pad detail in Appendix A of the site's SWPPP.

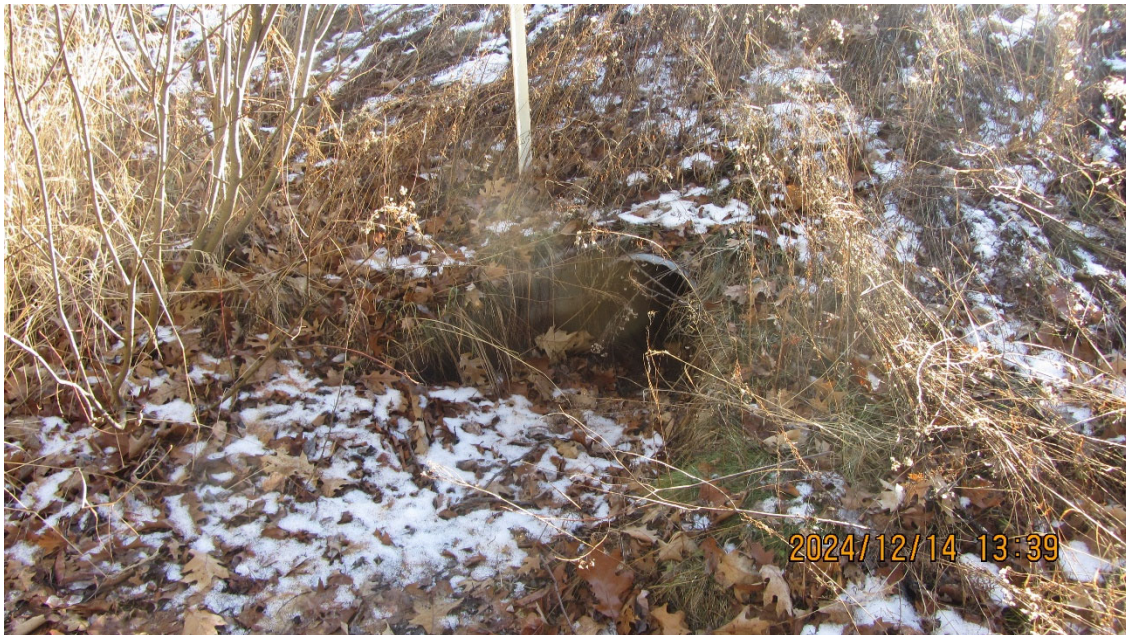
7: IMG\_0845

Description: Culvert Under Route 47 – North of the J&G Storage Site

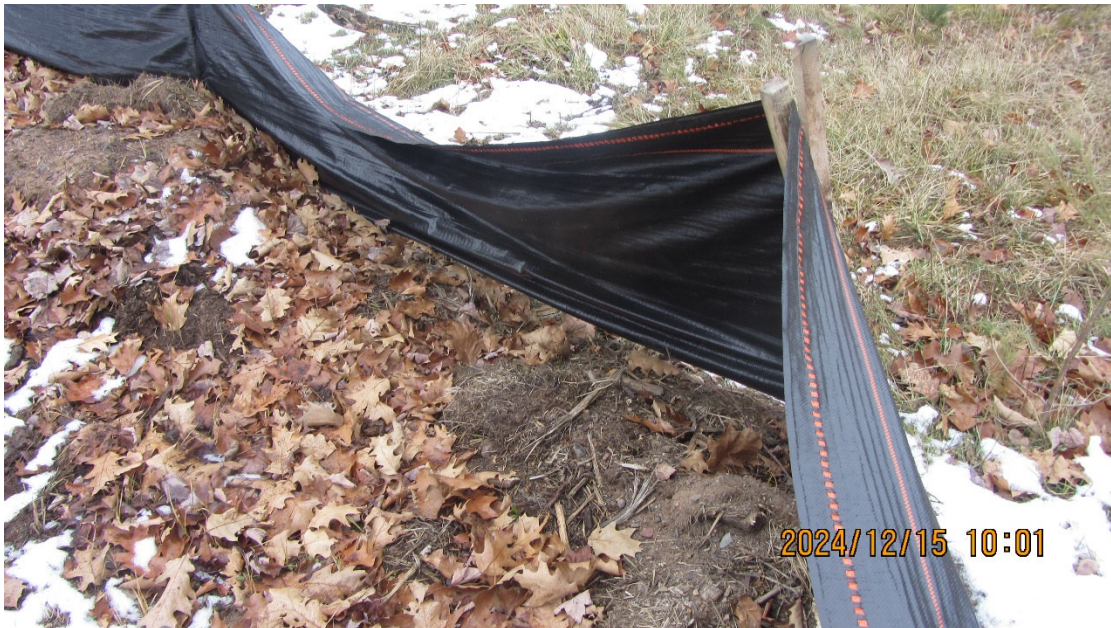
9: IMG\_0847

At approximately 10:00 am, Mr. Middleton, Mr. Jones, Mr. Fahrner, Mr. Guerndt, Mr. Burgess and Mr. Gauthier began a walk-through of the site, starting with the silt fence along Wisconsin State Route 47. Here EPA observed the straw matting that was recently added along Wisconsin State Route 47. Then EPA walked to the northwest corner of the site. At this location, EPA observed some issues with the silt fence along the west side, in terms of either not being properly installed and posts that were broken (Photographs 9, 12, 14, 15, 16, 17, and 19 in Attachment A).

Description: Silt Fence on Northwest Corner of the J&G Storage Site

3. Silt Fence Concerns: During the inspection, EPA observed implementation issues related to the silt fence on the west boundary of the property. These issues included broken posts and silt fence fabric not being trenched in and buried along the bottom. Photographs 9, 12, 13, 14, 15, 16, 19, and 60 in Attachment A show these various silt fence concerns. During a phone call on December 18, 2023, Mr. Guernndt indicated that they were not able to trench in new silt fence due to frozen ground conditions. Instead, Mr. Guernndt told EPA that they would purchase erosion control filter sock and implement that in lieu

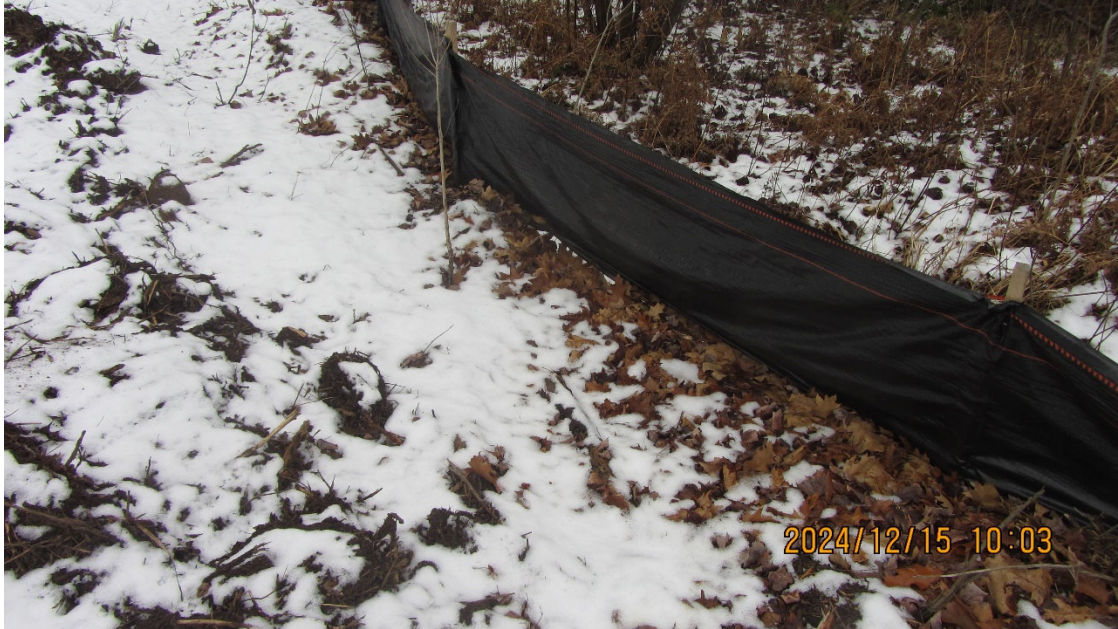
12. IMG\_0850

Description: Silt Fence on West Site of the J&G Storage Site

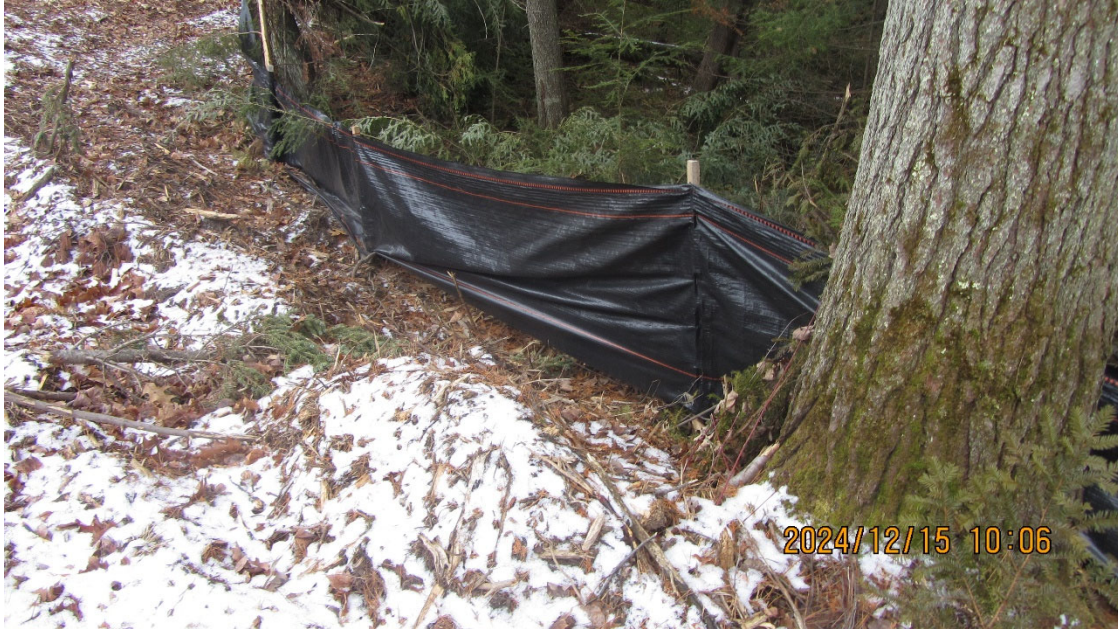
14. IMG\_0852

Description: Zoomed in Silt Fence Issue on West Site of the J&G Storage Site

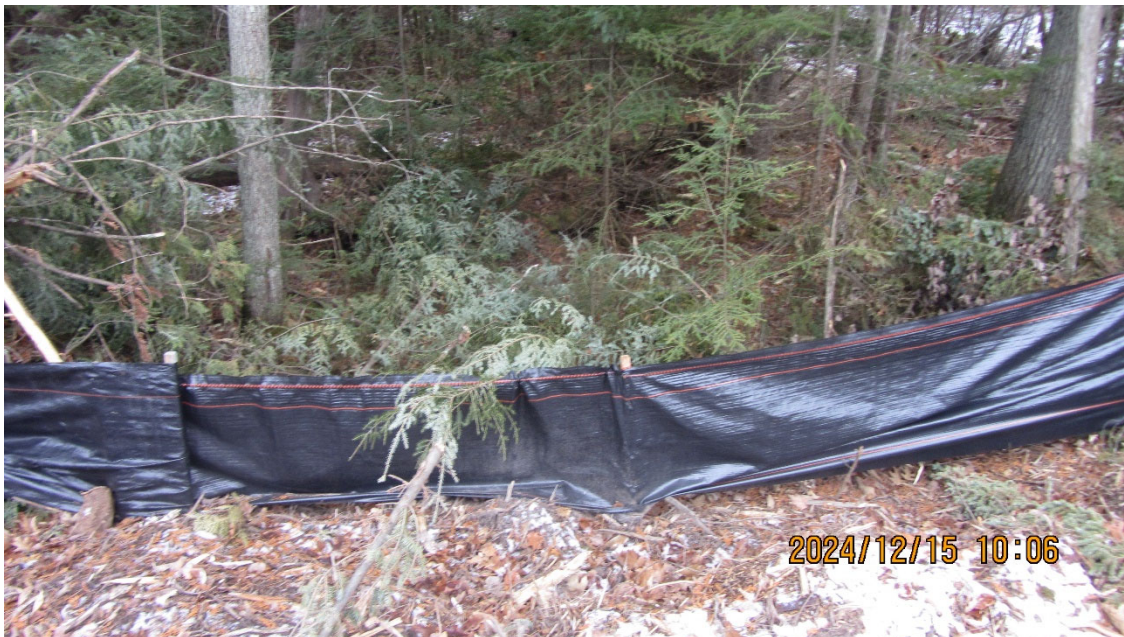
15. IMG\_0853

Desc Description: Silt Fence on Northwest Corner of the J&G Storage Site

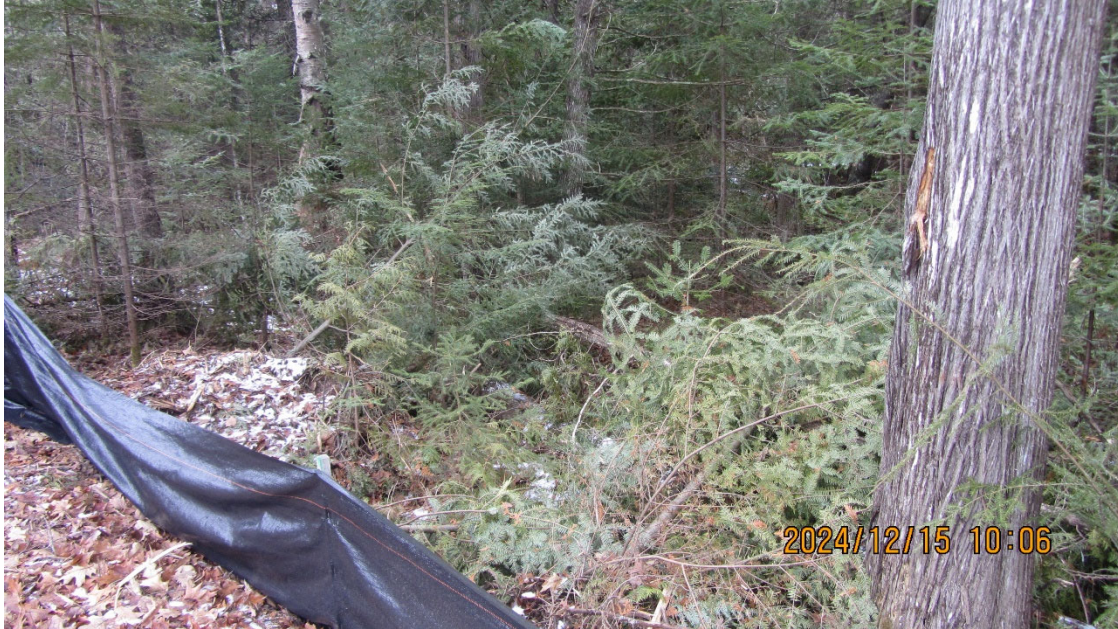
16. IMG\_0854

Description: Silt Fence and Area Beyond on West Side of J&G Storage

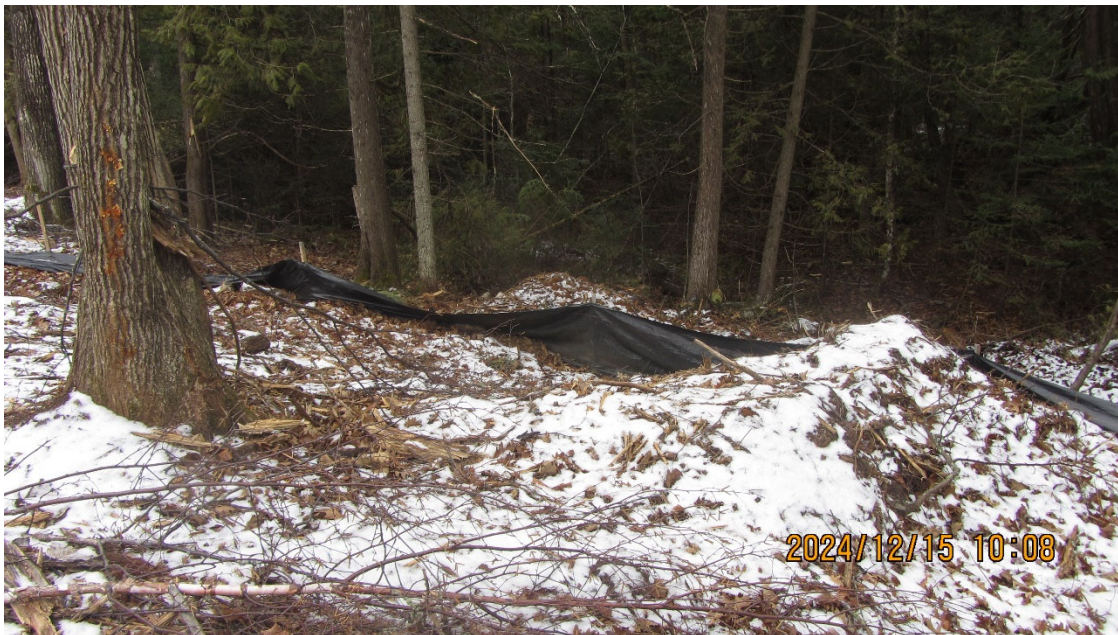
17. IMG\_0855

Description: Silt Fence and Area Beyond on West Side of J&G Storage; Further South than Photograph #16

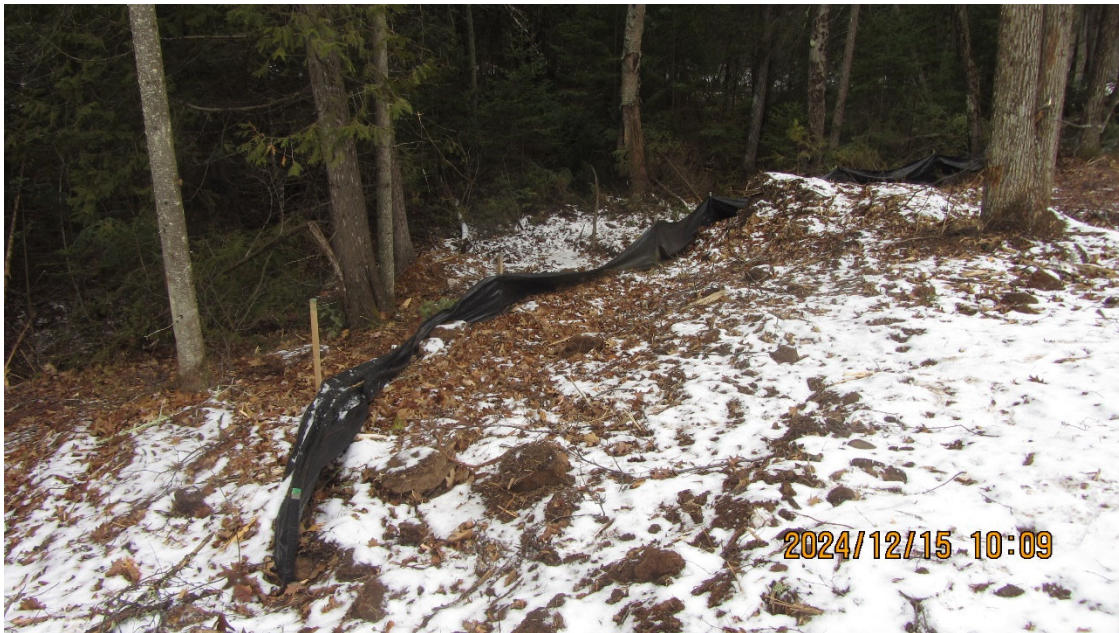
19. IMG\_0857

Description: Southern Section of Silt Fence on West Boundary

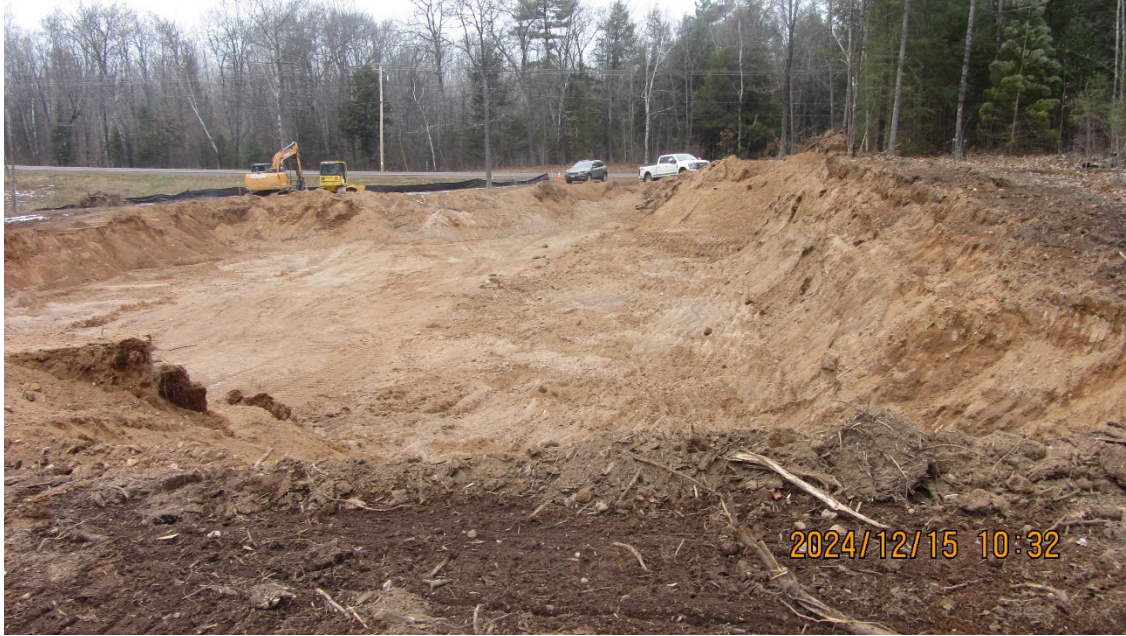
40. IMG\_0878

After EPA observed the southern portion of the site, EPA walked to the excavated area of the site (Photograph 40 in Attachment A). Note that the eastern property line is roughly the same grade as the property with a minimal likelihood of erosion occurring in these areas from the property to offsite areas. EPA then walked back to the southwest corner of the site, walking past the excavator shown in Photograph 41 in Attachment A. EPA continued observations of the southern and western areas of the site, including taking more pictures of these areas. At this time, Mr. Guerndt indicated to EPA that he needed to leave the site to attend to another project within the Town of Lac du Flambeau, but that it was ok for EPA to be there after he left. EPA indicated that they would meet up with Mr. Guerndt at this location to conduct a closing conference inspection. Mr. Guerndt left the site at approximately 10:45 am. Soon after Mr. Guerndt left the site, Mr. Gauthier also left the site.

Description: Excavated Area of J&G Storage Site

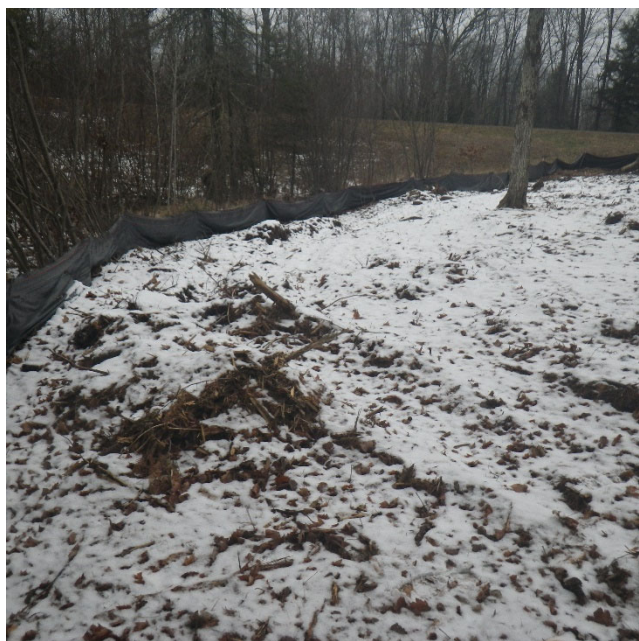
61. IMGP0029

Next, EPA continued to walk on the west property line; taking pictures of this location of the site (Photographs 9-19, 22, 25-27, 35, 46, and 61-63 in Attachment A). EPA continued to observe issues with improper silt fence installation along the west side of the property, as indicated above. Mr. Middleton discussed the silt fence concerns with Mr. Guerndt during this portion of the walk-through; Mr. Guerndt acknowledge the concerns with the silt fence and indicated that the silt fence would be fixed as soon as possible. Soon after this conversation, at approximately 10:20 am, Mr. Fahrner and Mr. Burgess ended their participation in the inspection and left the site.

Description: Silt Fence on West Side of Site
