## Region 6 - Enforcement & Compliance Assurance Division

### INSPECTION REPORT

| Company Name: | <b>Bonds Company Production, LLC</b> | |
| Facility Name: | <b>Curry Lease Tank Battery</b> | |

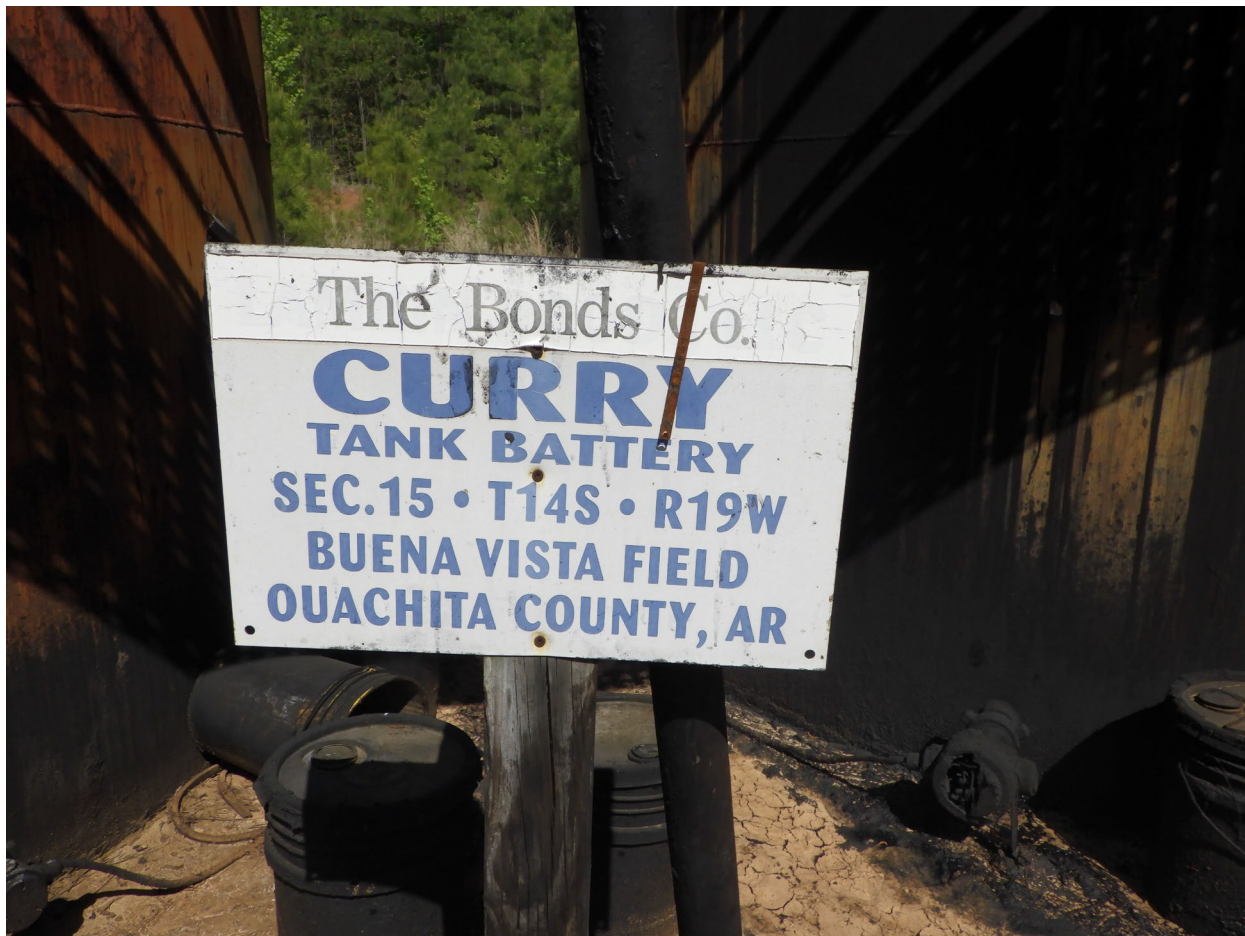
Photo No. 1

I observed the facility signage; see Appendix 1 (Photographs Log), Photos No. 1. For additional GPS location and photo metadata, see Appendix 1.

**Description:** Looking NE, this photo shows the signage at the Bonds Company Production, LLC – Curry Lease Tank Battery ("facility").

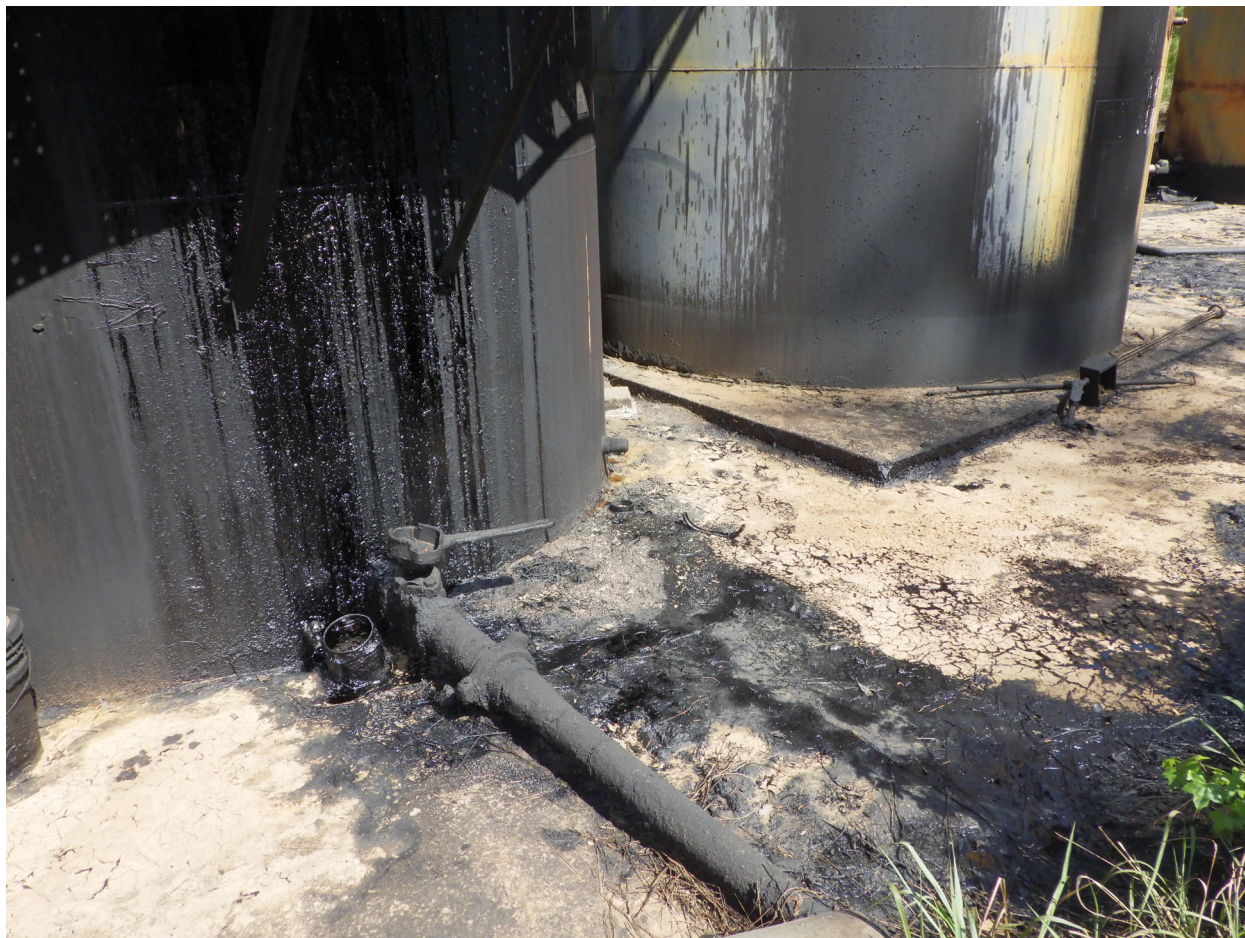
Photo No. 2

I observed an active leak of crude oil inside secondary containment, see Photo No. 2.

- Loose crude oil and saltwater from an SWD pump outside secondary containment (Photo No. 8),
- Loose crude oil inside secondary containment (Photo No. 2), and
- Residual crude oil at the drainpipe for the tank battery (Photo No. 4).

**Description:** Looking ENE, this photo shows loose crude oil inside secondary containment.

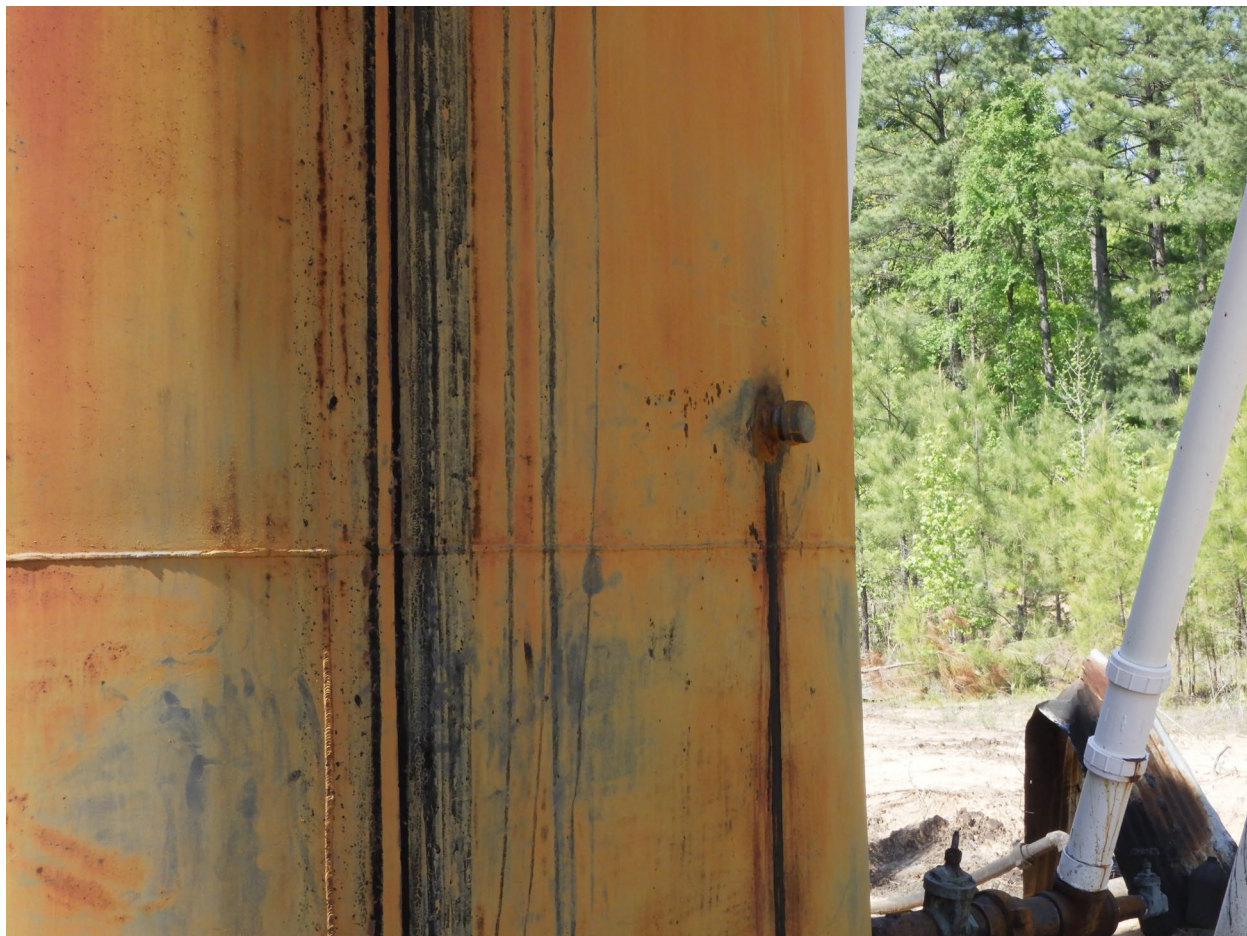
Photo No. 3

I observed the saltwater storage tank that was actively leaking during the 03/05/2025 inspection had been repaired, see Photo No. 3.

**Description:** Looking NNW, this photo shows the saltwater storage tank that was actively leaking during the 03/05/2025 inspection that has been plugged.

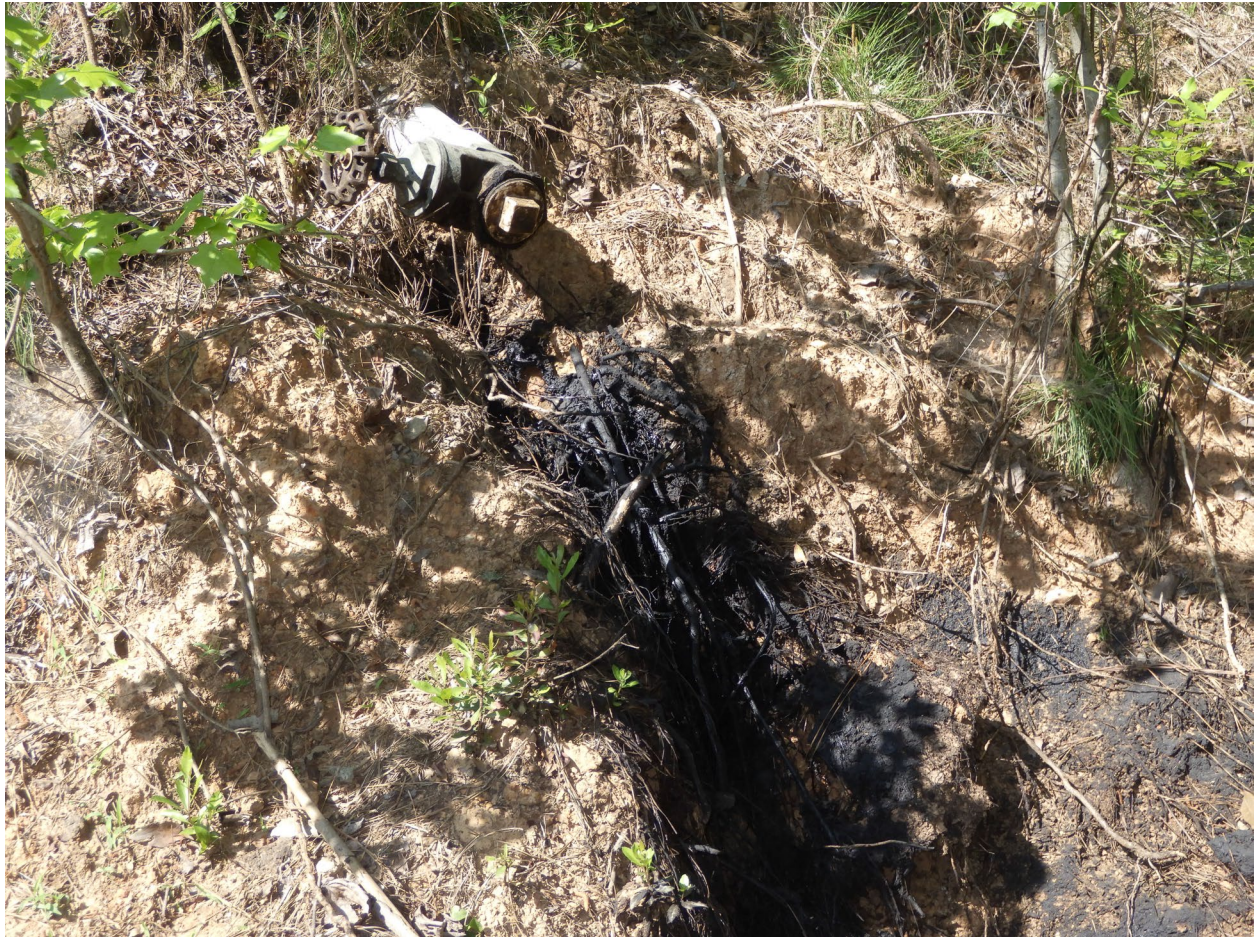
Photo No. 4

I observed the drainpipe that was actively discharging during the 03/05/2025 inspection had been closed and capped, see Photo No. 4.

**Description:** Looking N, this photo shows the drainpipe for secondary containment that was opened and actively discharging during the 03/05/2025 inspection that has been closed and capped.

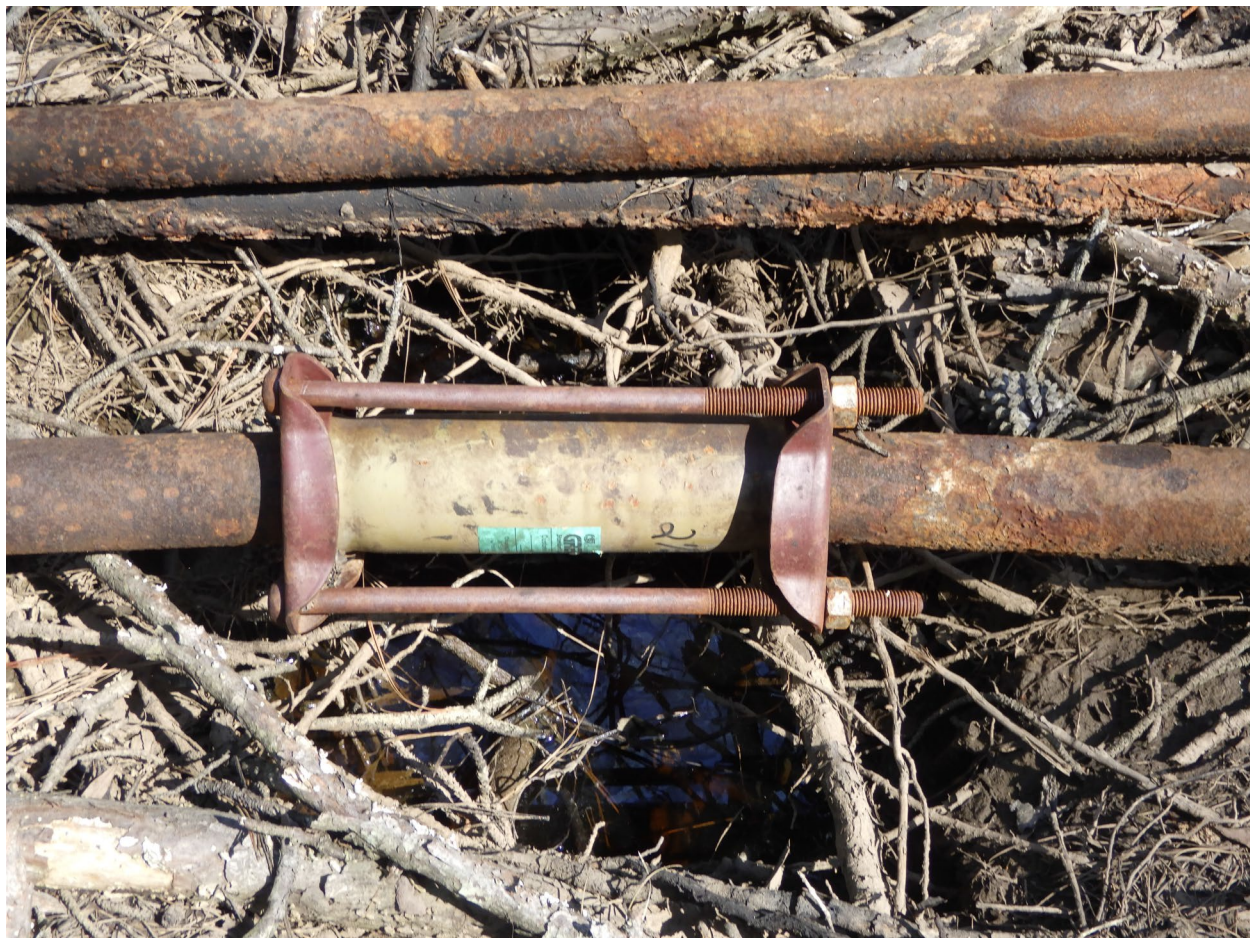
Photo No. 5

I observed the two (2) couplings that were actively leaking during the 03/05/2025 inspection had been repaired, see Photos No. 5 and No. 6.

**Description:** Looking SE, this photo shows one of the metal flowlines that was actively leaking during the 03/05/2025 inspection that has been repaired.

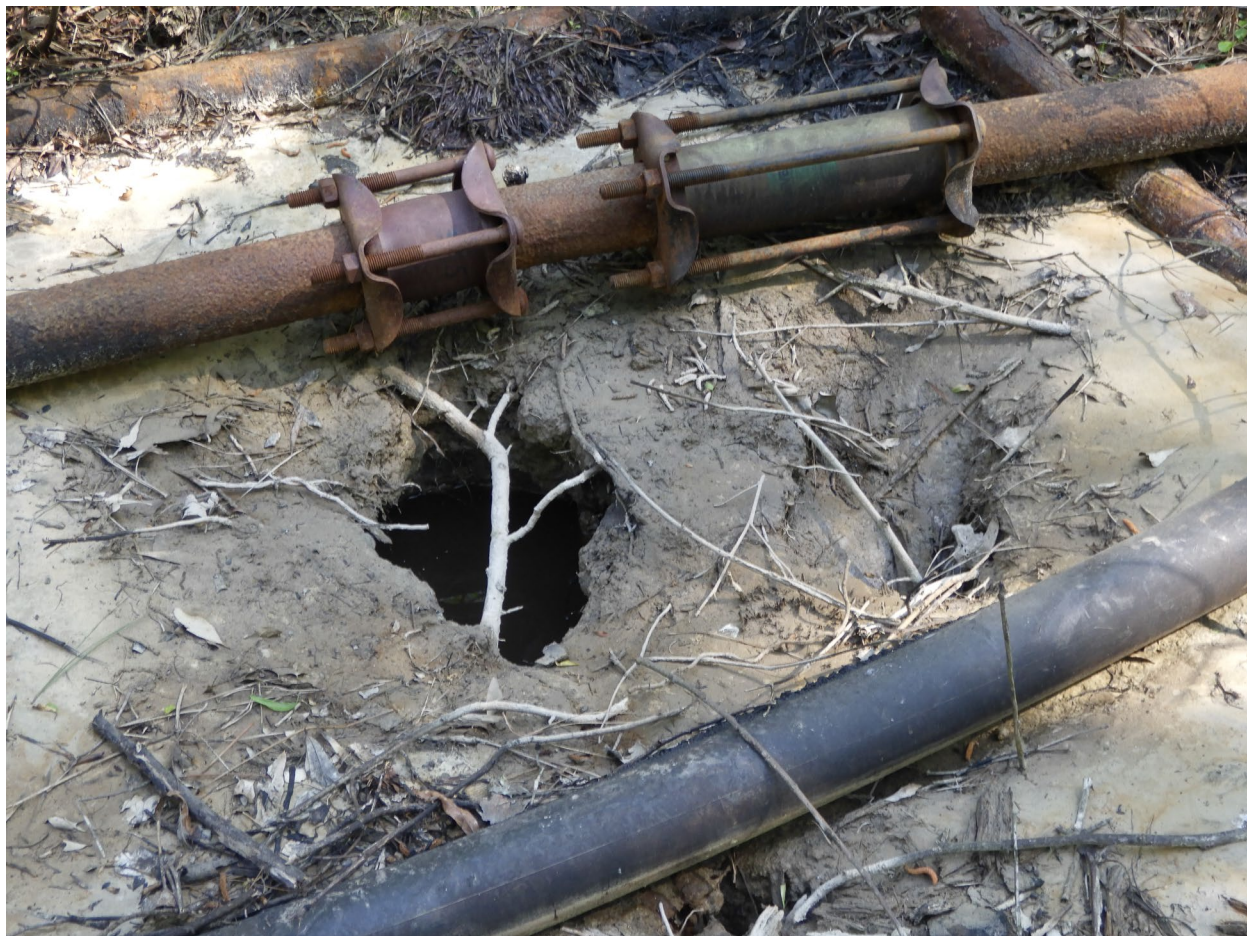
Photo No. 6

**Description:** Looking SSW, this photo shows an additional metal flowline that was actively leaking during the 03/05/2025 inspection that has been repaired.

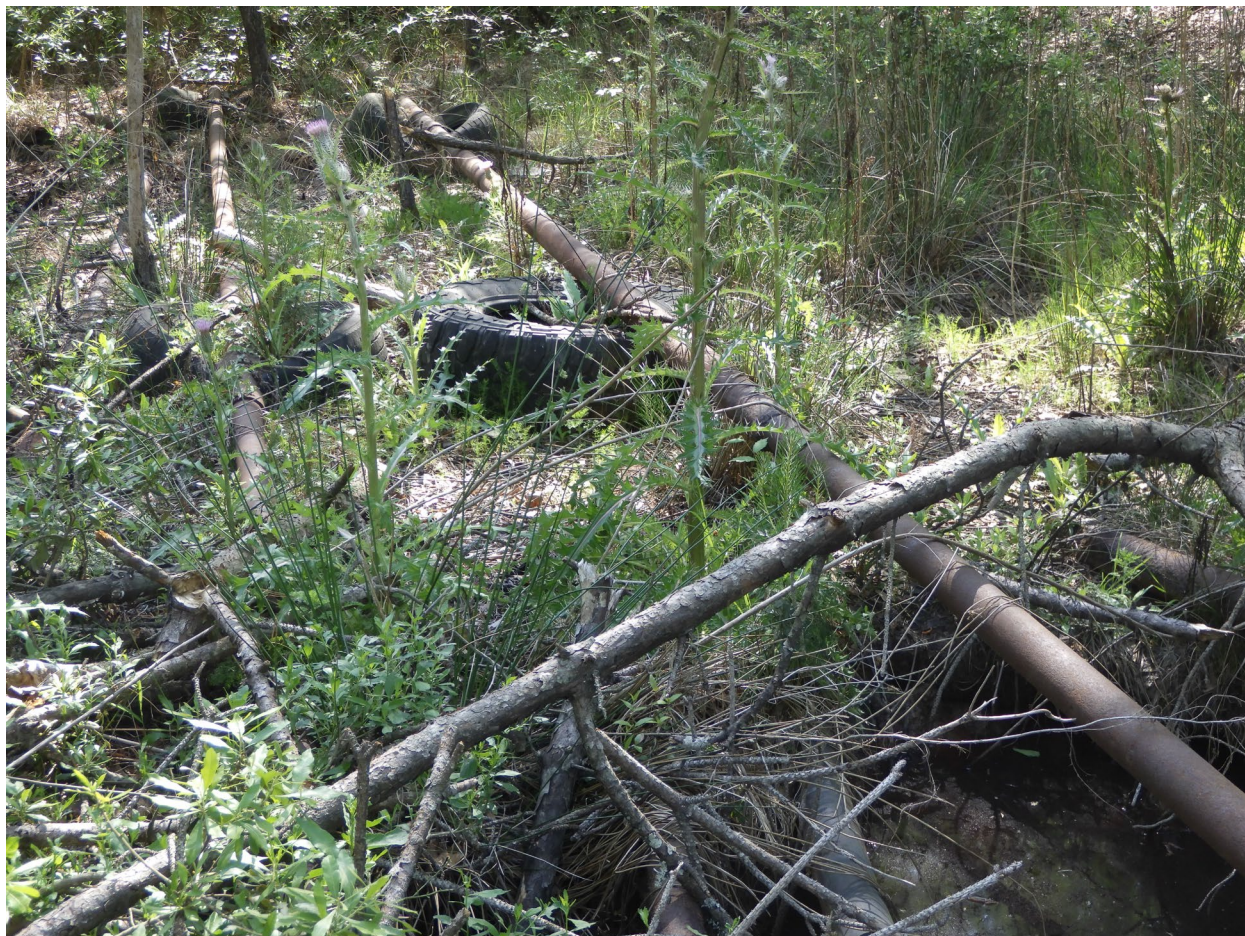
Photo No. 7

I observed the surrounding area and vegetation in the vicinity of the 03/05/2025 saltwater release from the couplings, see Photo No. 7.

**Description:** Looking WNW, this photo shows the area of the 03/05/2025 saltwater release that was dry.

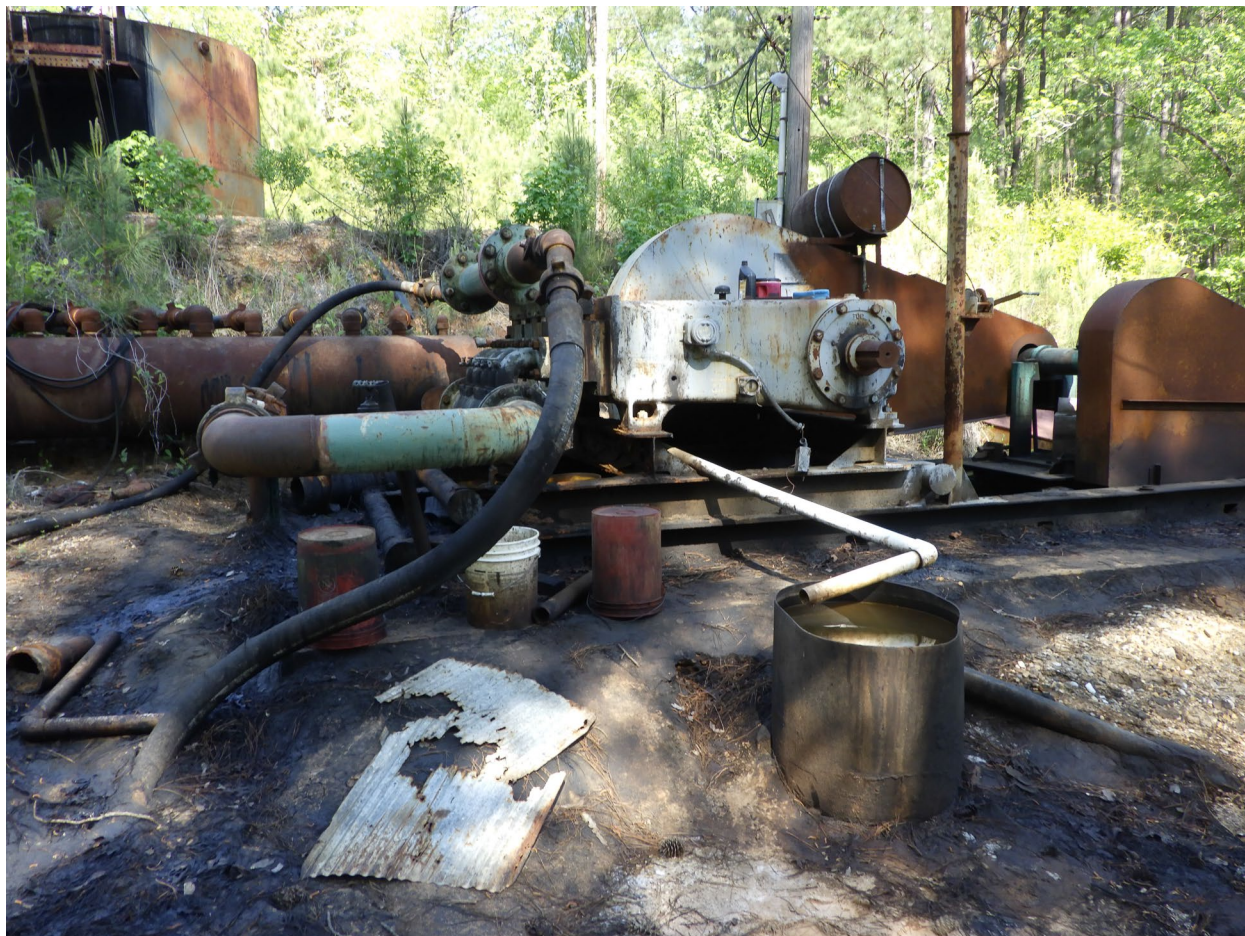
Photo No. 8

I observed the pump for the SWD wells, see Photo No. 8.

**Description:** Looking NE, this photo shows the pump for the saltwater disposal (SWD) injection well with loose crude oil and saltwater outside secondary containment.
