## Region 6 - Enforcement & Compliance Assurance Division

### INSPECTION REPORT

| Company Name: | CapturePoint, LLC | |
| Facility Name: | North Burbank Unit (NBU) 31 Battery | |

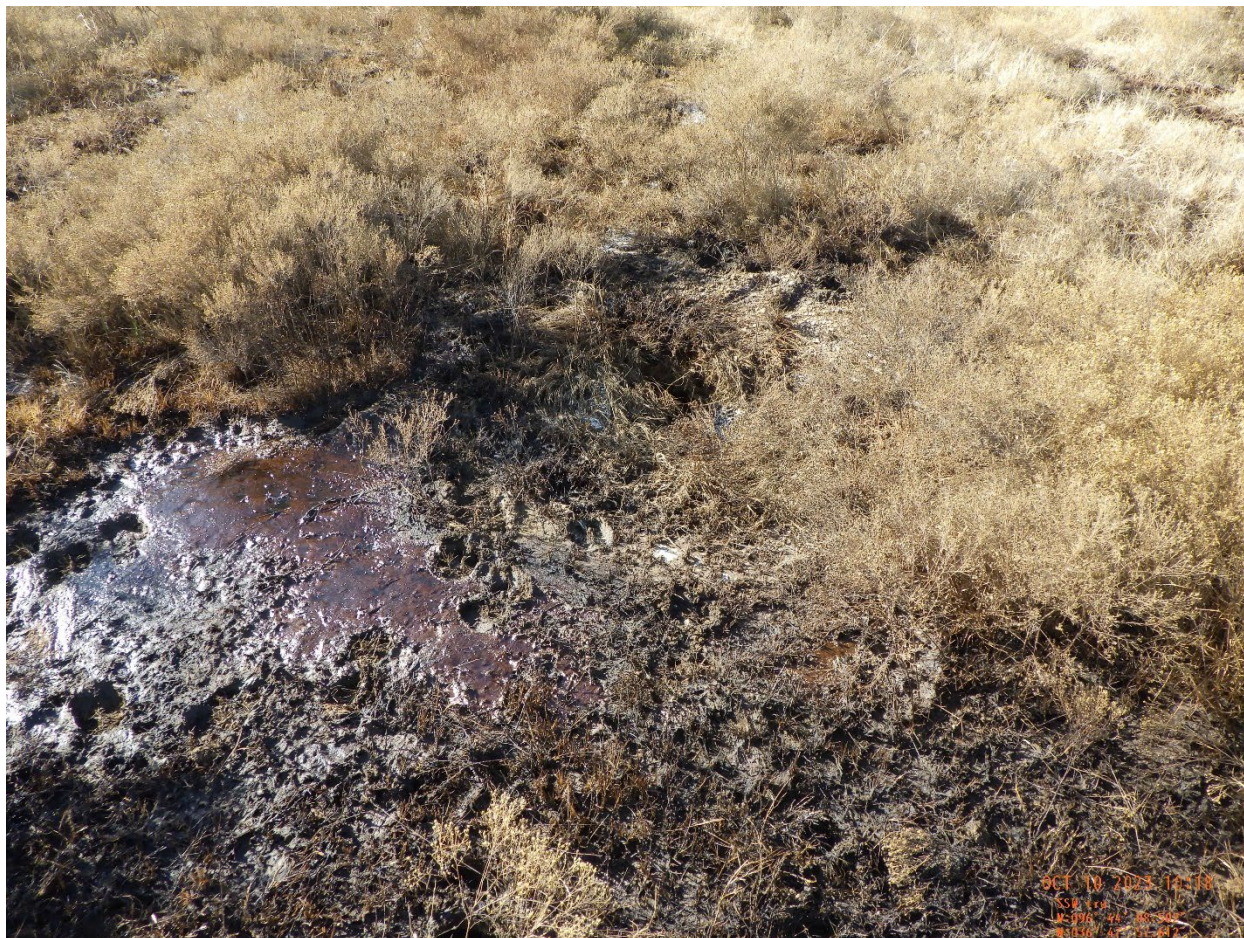
Photo No. 1

I observed the release point of the spill. The injection line was underground, and the operator representative stated the line had been isolated to prevent additional release but had not yet been repaired. I observed crude oil on the soil and vegetation in the area around the release point. I observed damp soil along the flowpath travelling away from the release point but was unable to provide photos due to the heavy vegetation along the flowpath. The release point and visible impacts can be seen in photos No. 1 & 2 of Appendix 1 (photo log) which is attached to this report. GPS and additional metadata for each photo observation can also be found in the photo log.

**Description:** This was the release point. The steel line was underground and had not been repaired at the time of the inspection. Oil was present on the soil and vegetation around the release point.

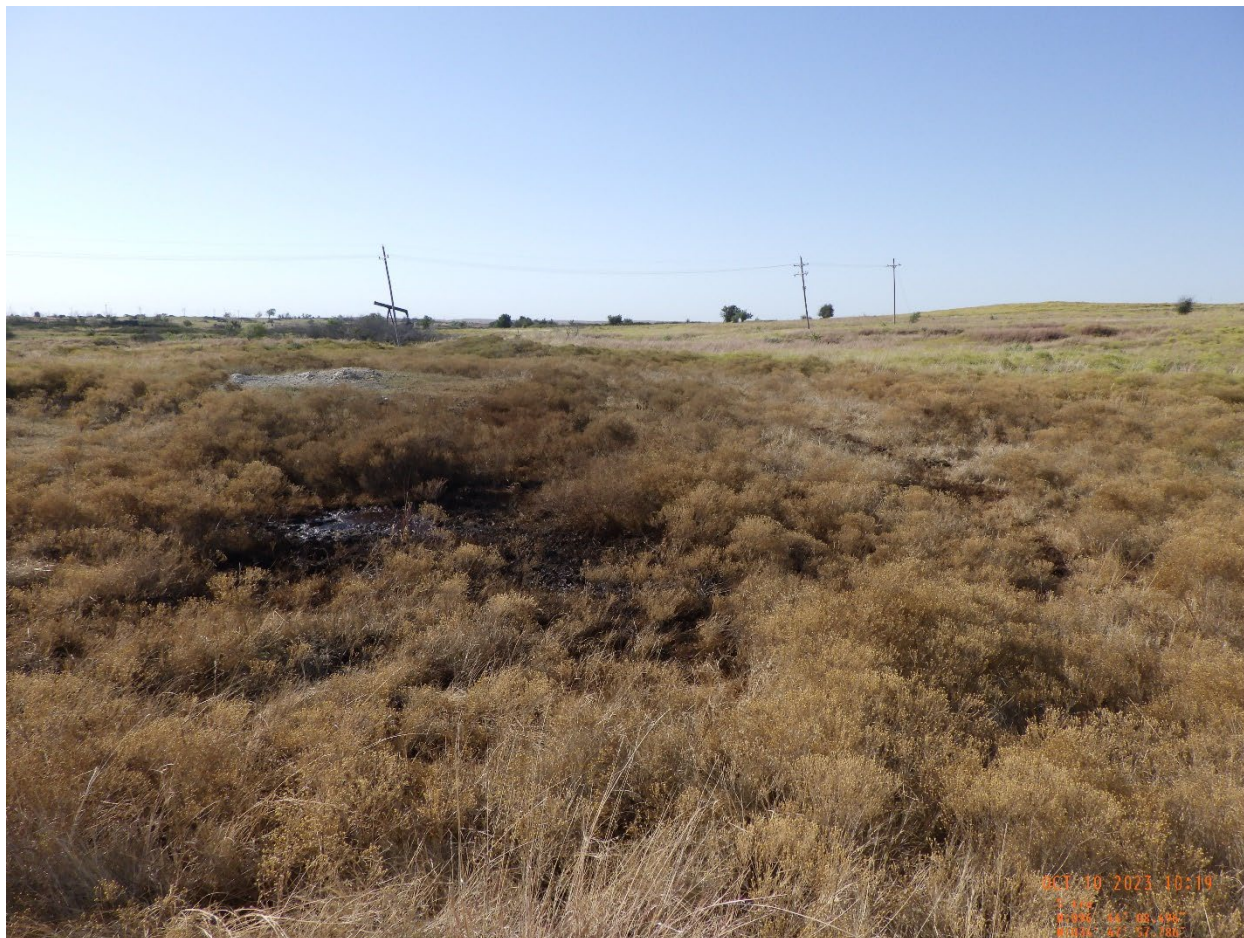
Photo No. 2

**Description:** This was an overview of the release point.

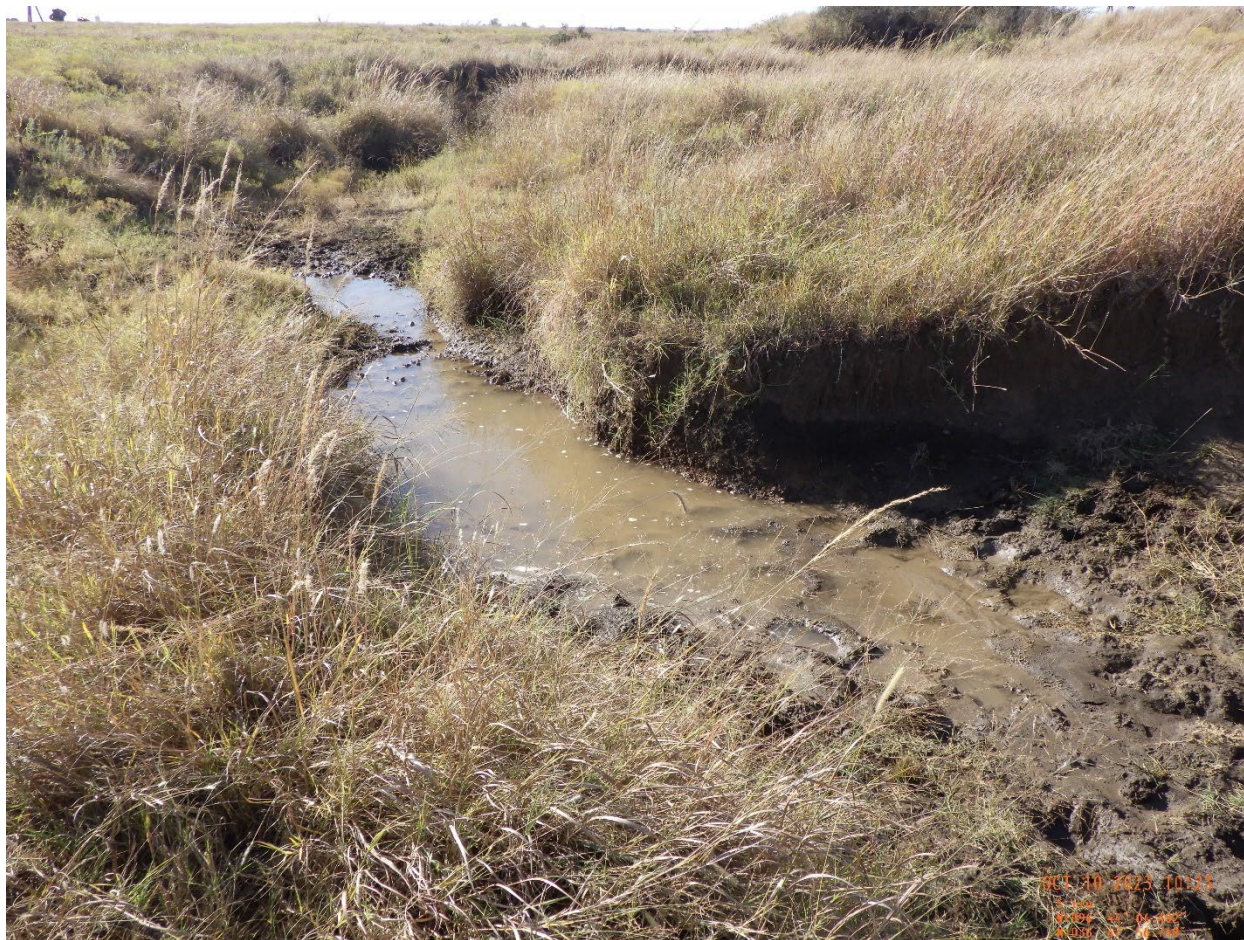
Photo No. 3

I observed the point of entry (POE) into Mud Creek. I also observed an elevated total dissolved solids (TDS) field reading of 14,509 mg/L in the main channel of the impacted creek at the POE. All TDS field readings observed during the inspection were taken with the EPA issued, properly calibrated, YSI Pro 30 conductivity meter. The POE, bed and bank features of the creek and elevated TDS field reading can be seen in photos No. 3 & 4.

**Description:** This was the point of entry (POE) where the spill entered Mud Creek.

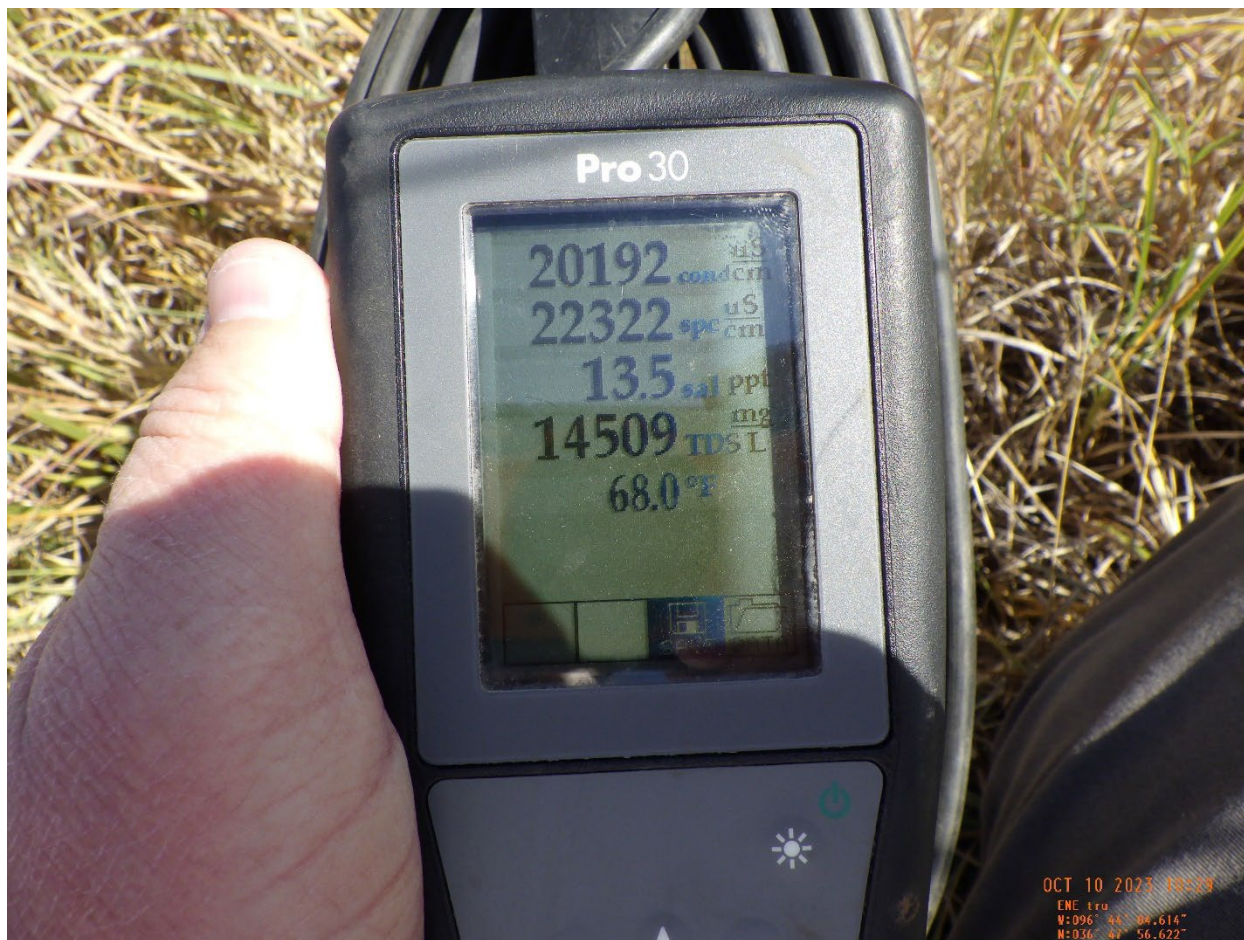
Photo No. 4

**Description:** This was an elevated total dissolved solids (TDS) field reading of 14,509 mg/L observed in the main channel of the impacted creek at the POE.

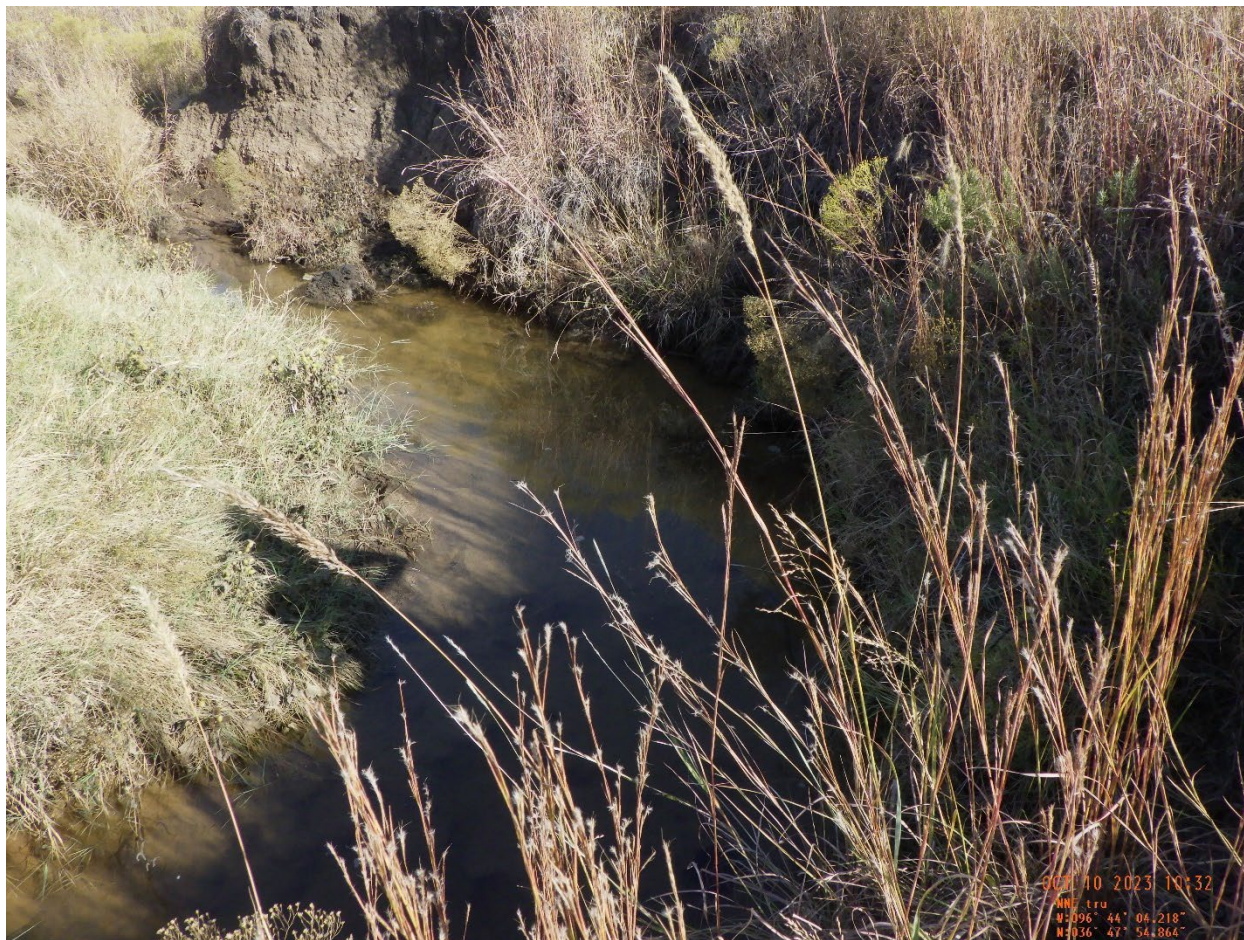
Photo No. 5

Continuing downstream, I observed the bed and bank features of the impacted creek. I also observed an elevated TDS field reading of 66,983 mg/L at the same location. This was the highest TDS field reading observed during the inspection. These observations are documented in photos No. 5 & 6.

**Description:** This was a photo showing the bed and bank features of the impacted creek. The TDS field reading in photo No. 6 was taken at this location.

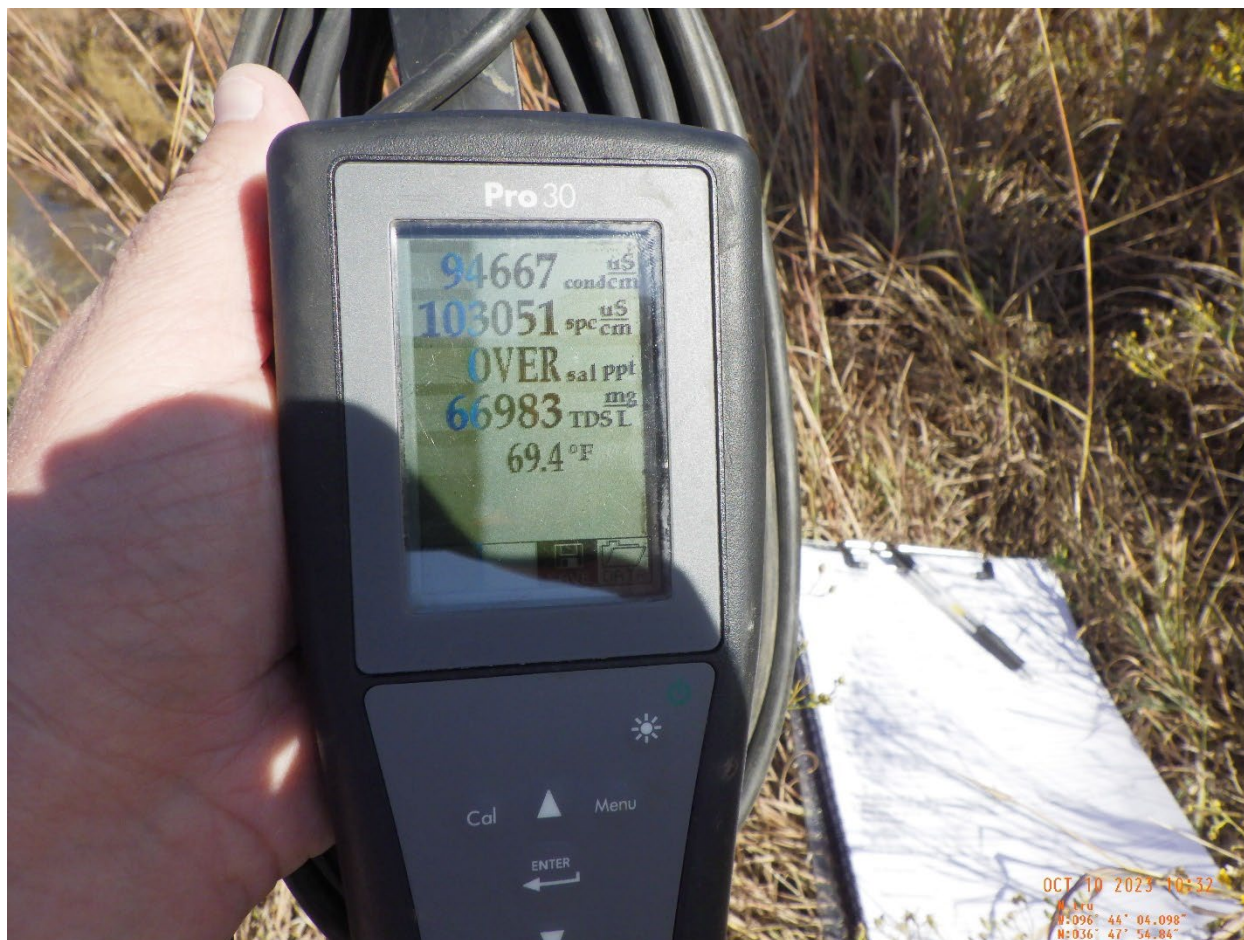
Photo No. 6

**Description:** This was an elevated TDS field reading of 66,983 mg/L taken in the main channel of the impacted creek. This was the highest TDS measurement observed during the inspection.

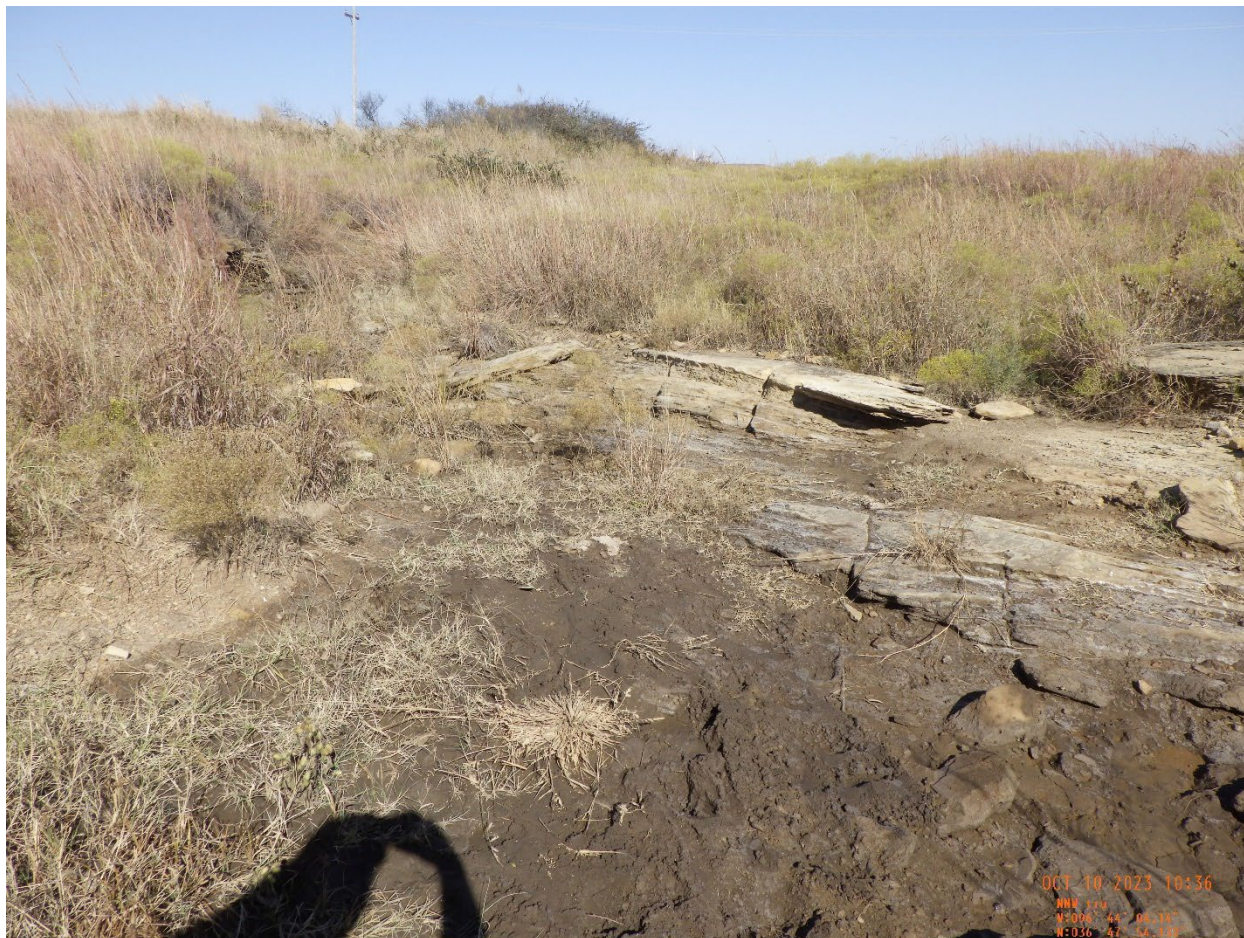
Photo No. 7

Continuing further downstream, I observed additional bed and bank features of the impacted creek. There was no water present in the creek at this location. These observations can be seen in photo No. 7.

**Description:** This was a photo showing the bed and bank features along the impacted creek. There was no water present in the creek bed along this section of the creek.

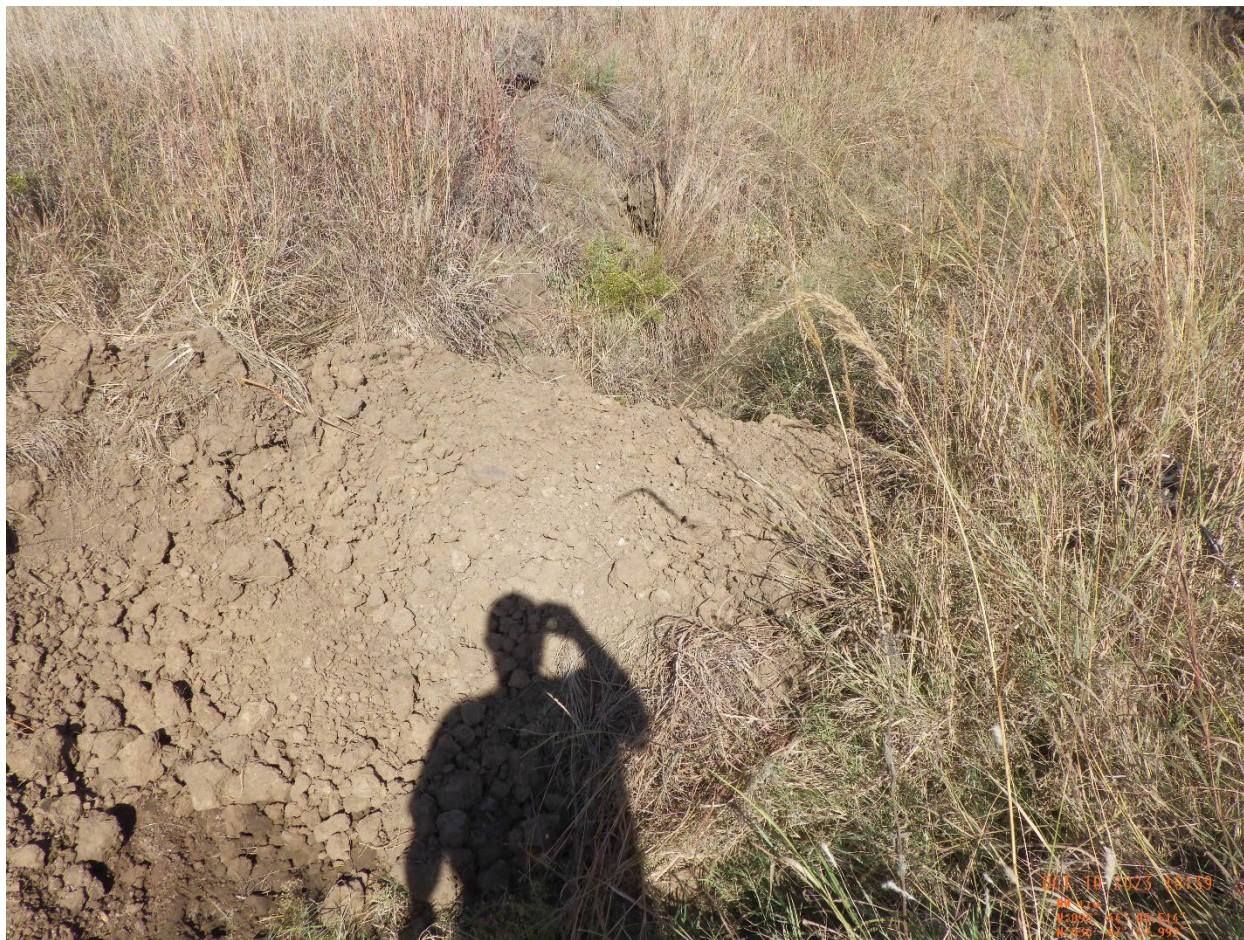
Photo No. 8

I observed the temporary containment dam which had been placed by the operator to prevent further downstream migration of impacted waters. At the time of the inspection, no impacted water had reached the dam, nor had any impacted water migrated past the dam. The temporary containment dam can be seen in photo No. 8.

**Description:** This was a temporary containment dam which had been placed by the operator to prevent downstream migration of contaminated waters. At the time of the inspection, impacted waters had not migrated downstream beyond the dam.
