**Purpose:** City of East St. Louis CSO Inspection

**Facility:** City of East St. Louis, IL

**NPDES Permit:** IL0033472

**Dates of Inspection:** March 31, 2021 – April 1, 2021

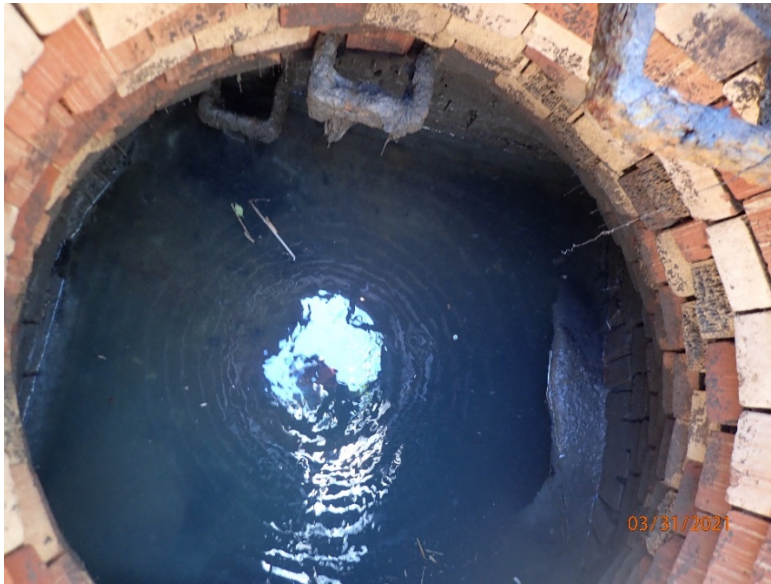
1: P3310004

At 2:00 P.M. the inspection team left the Department of Public Works with City personnel to observe the manholes that are downstream of the City of Centreville. The first manhole observed was on 82<sup>nd</sup> Street, arriving there at 2:19 P.M. This manhole is #15 on the City's sewer maps and is the second manhole downstream of the City of Centreville's system. This manhole was retaining water and while it appeared that there was some flow into and out of the manhole, the level never went down. The water was clear.

Description: Looking down into the manhole that is the second manhole downstream of the flow from Centreville on 82<sup>nd</sup> Street. The manhole had standing water which was clear. There was some flow movement, but the level of the water did not recede.

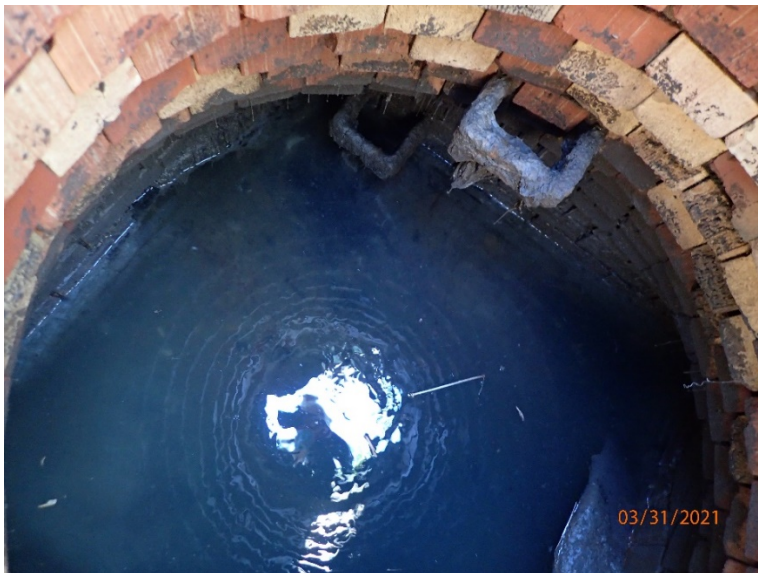
2: P3310005

Description: There was standing water with some flow into and out of manhole #15.

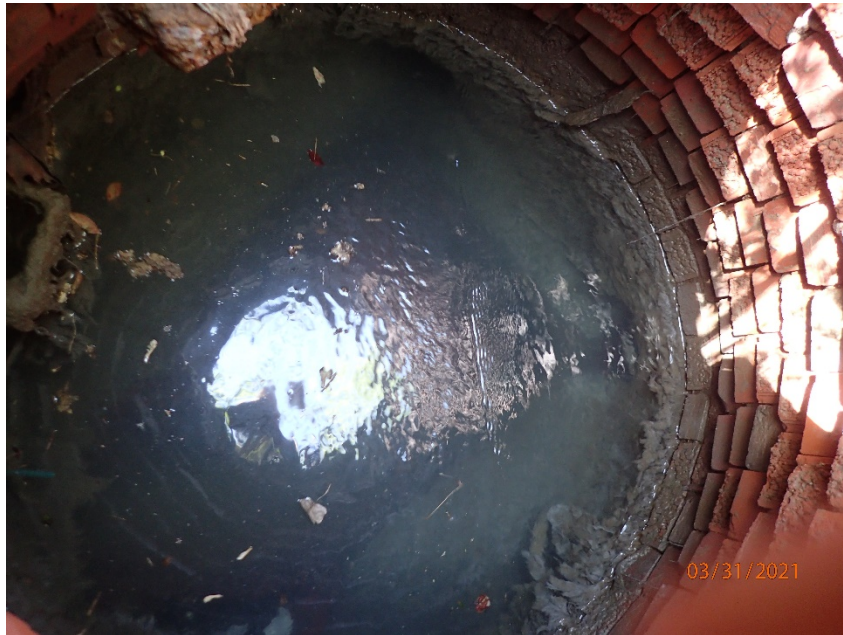
3: P3310007

At 2:30 P.M., EPA observed the first manhole downstream of the City of Centreville's system on 82<sup>nd</sup> Street. Again, the manhole was holding water and the level did not recede.

Description: There was standing water in the first manhole downstream of Centreville in the East St. Louis collection system. There was some flow in and out, but the level of water did not recede.

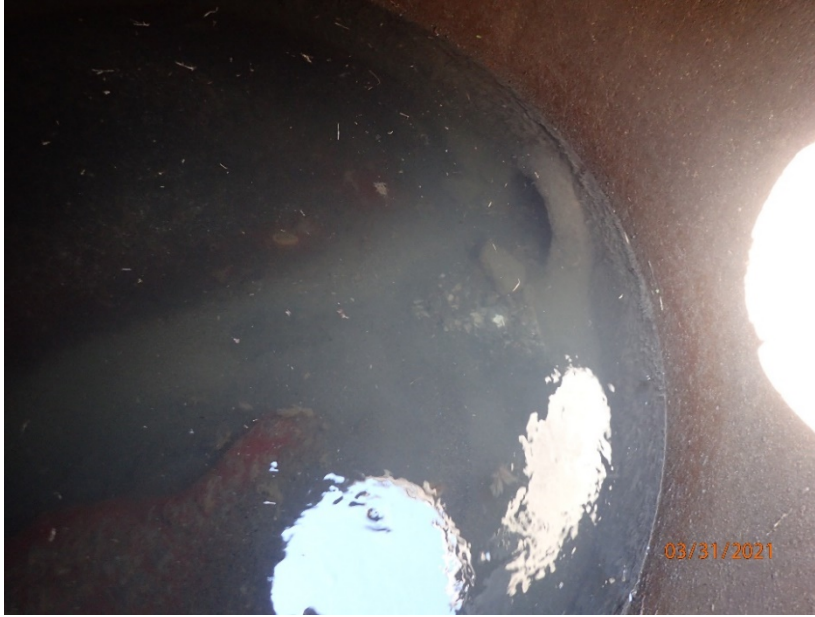
4: P3310008

Mr. Swanson and Mr. Stith then opened the last manhole in the City of Centreville's collection system on 82<sup>nd</sup> Street. This manhole had standing water in it also. IEPA inspector, Mr. Stitely, advised Mr. Swanson and Mr. Stith to continue to open manholes along this sewer line and find one that is not holding water. Mr. Stitely advised them to jet the line upstream of the first manhole that was not holding water to potentially break up any blockage in the sewer line that was preventing water from flowing freely. Mr. Swanson stated that they would try to perform this task the following day.

Description: The last manhole for the Centreville collection system before it flowed into the East St. Louis collection system had standing water in it.

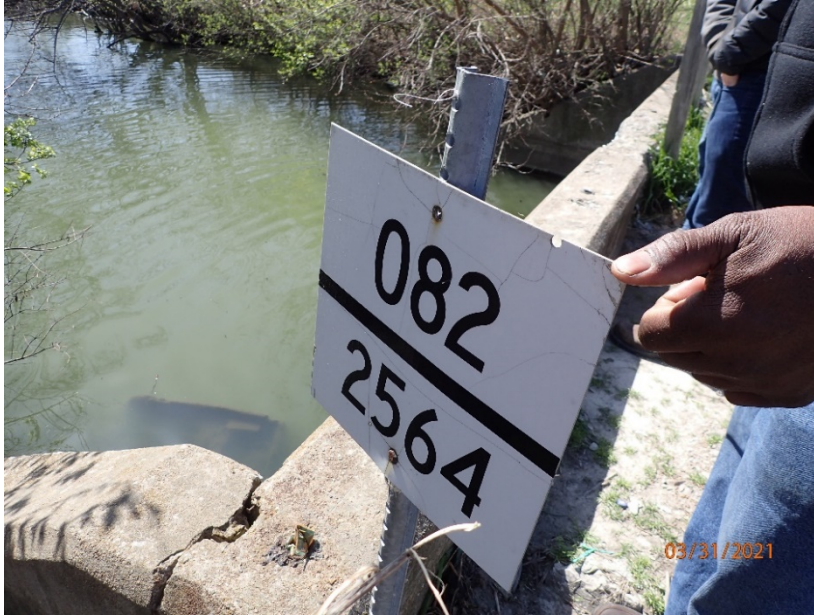
5: P3310009

The EPA inspection team then drove to observe Outfall 003 that discharges into the Frank Holten State Park Lake. Outfall 003 is listed in the Permit as a CSO discharge location at 47<sup>th</sup> Street and Lake Drive and the receiving water is the Frank Holten State Park Lake. There was no signage posted at the discharge location that would let the public know that the three pipes could contain sanitary waste. There were fishing lines and bobs hanging from the vegetation along the banks of the lake which is evidence that people fish off the bridge. The only signage contained some numbers with no description of their meaning.

Description: The sign marking at East St. Louis' Outfall 003, which flows to the Frank Holten State Park Lake.

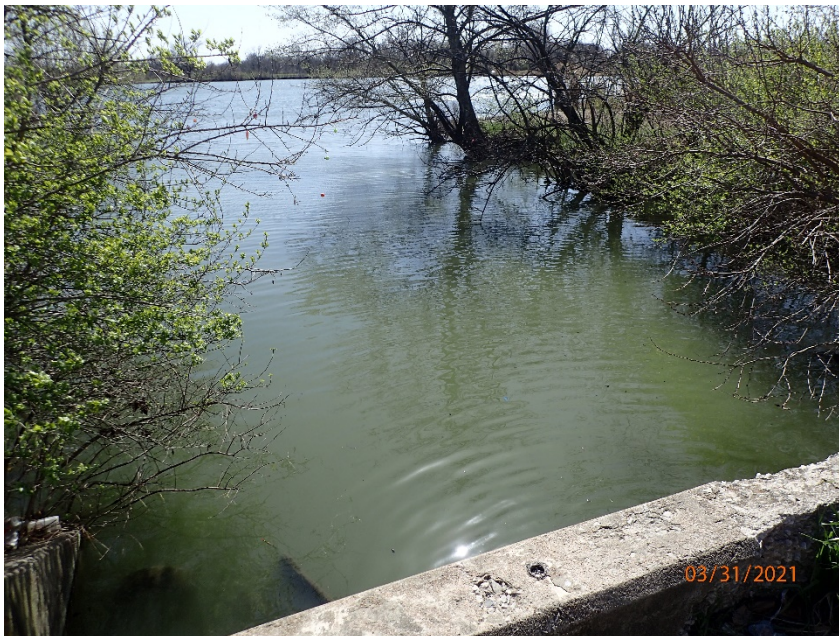
6: P3310010

Description: East St. Louis' Outfall 003 flows into the Frank Holten State Park Lake.

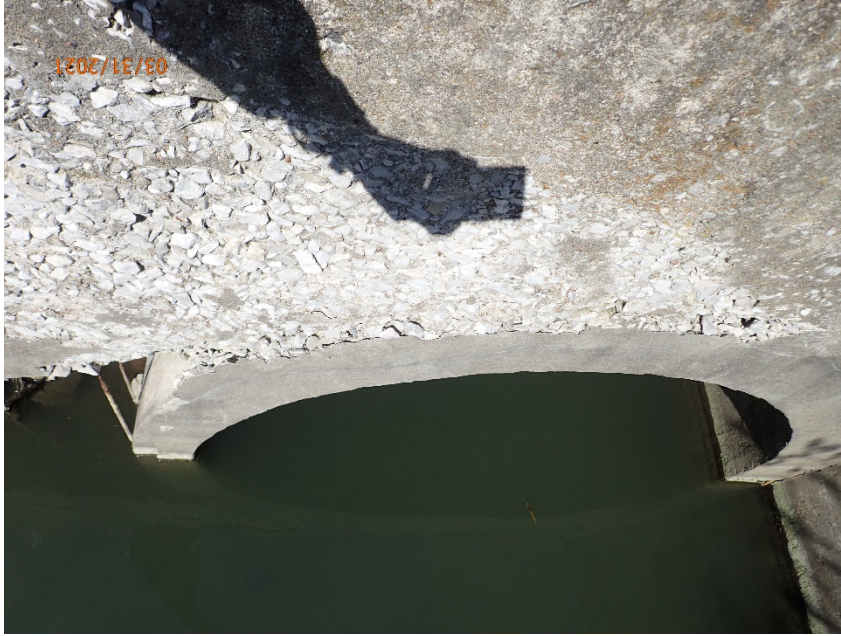
7: P3310011

Description: Looking down at one of the three pipes that make up Outfall 003.

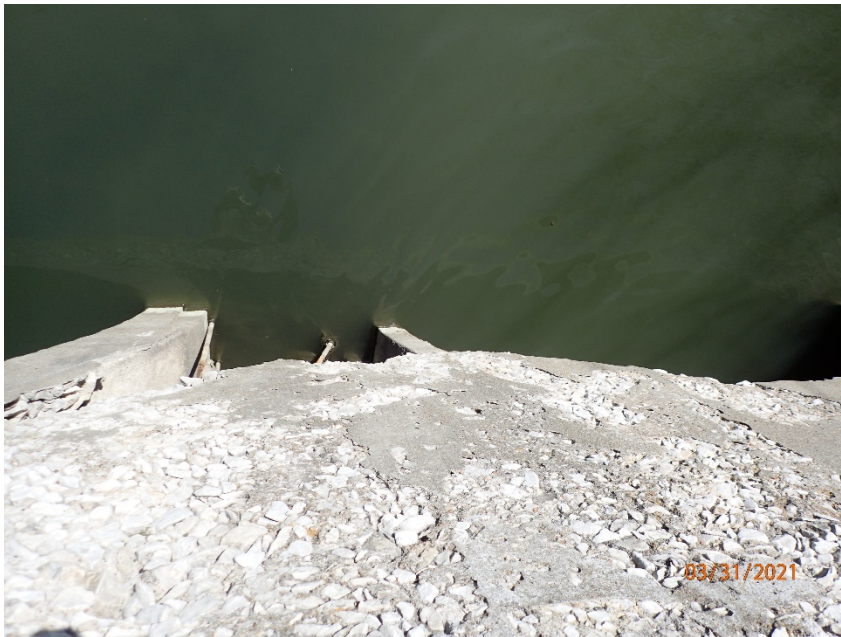
8: P3310012

Description: Looking down at Outfall 003 from above.

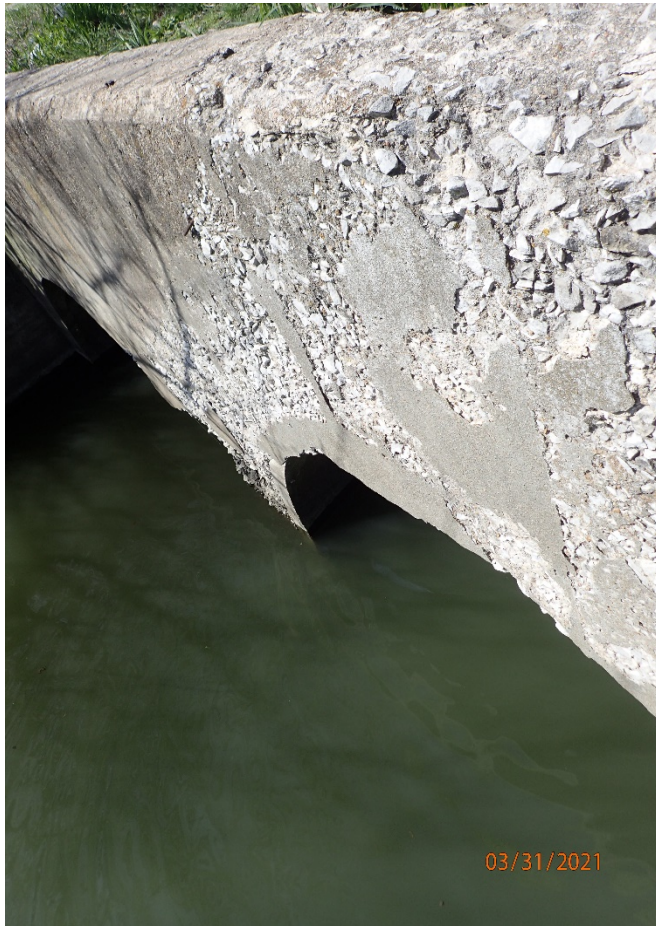
9: P3310013

Description: Looking down at one of the three pipes that make up Outfall 003.

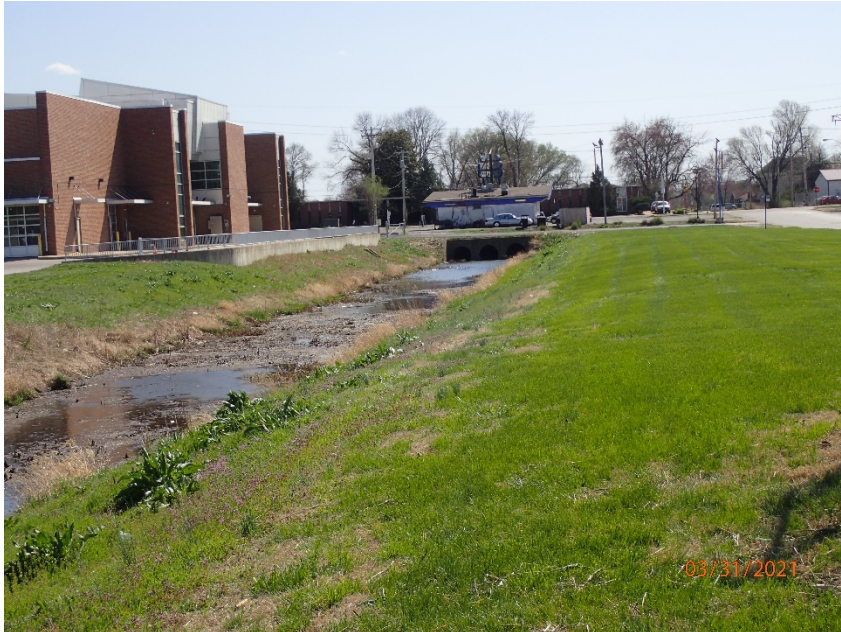
10: P3310014

Description: The ditch next to the pump station on North 47<sup>th</sup> Street north of State Street. Flow from the ditch flows south toward State Street.

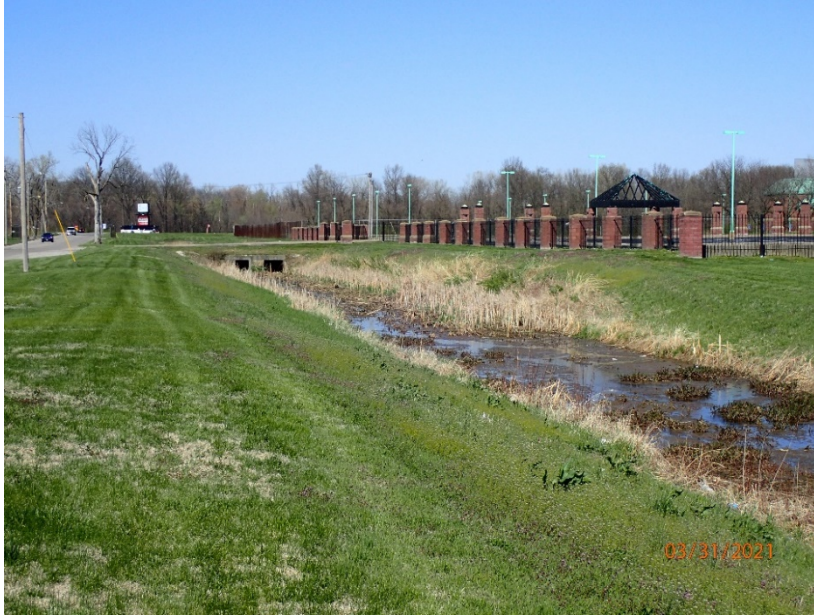
11: P3310015

Description: The ditch next to the pump station on North 47<sup>th</sup> Street north of State Street. Flow from the ditch flows south toward State Street.

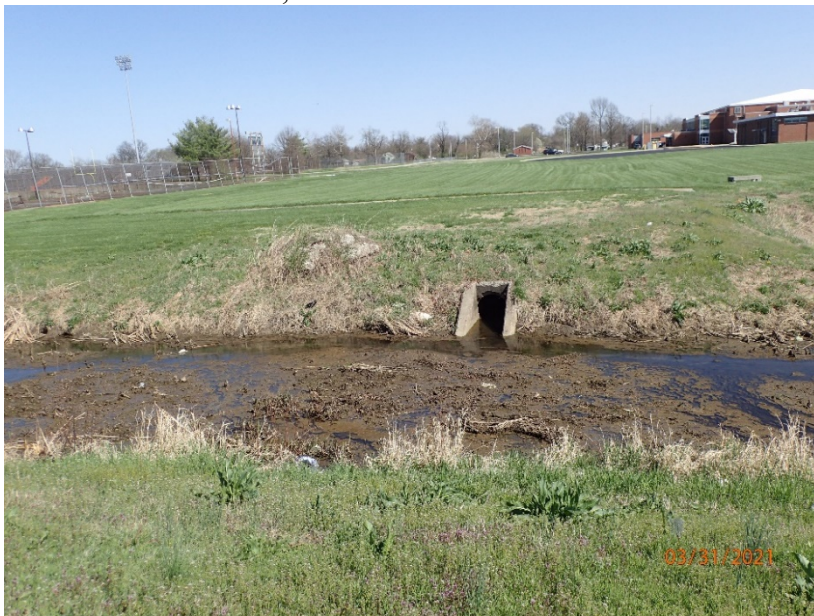
12: P3310016

Description: There are outlets on the east side of the ditch. There was no flow coming from the outlets on the day of the inspection and Mr. Swanson did not know where the flow would originate.

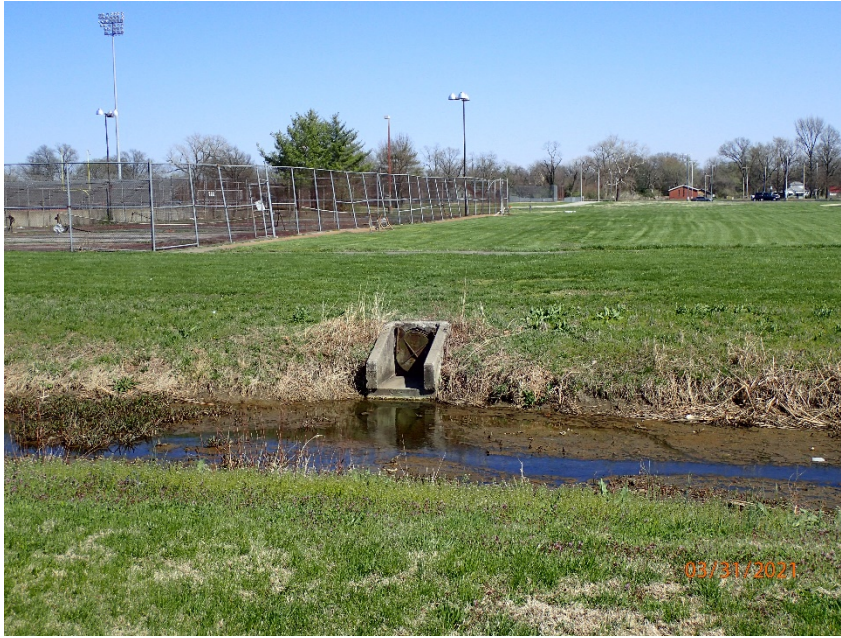
13: P3310017

Description: One of the outlets to the ditch has a backflow cover on the pipe. There was no flow coming from the outlets on the day of the inspection and Mr. Swanson did not know where the flow would originate.

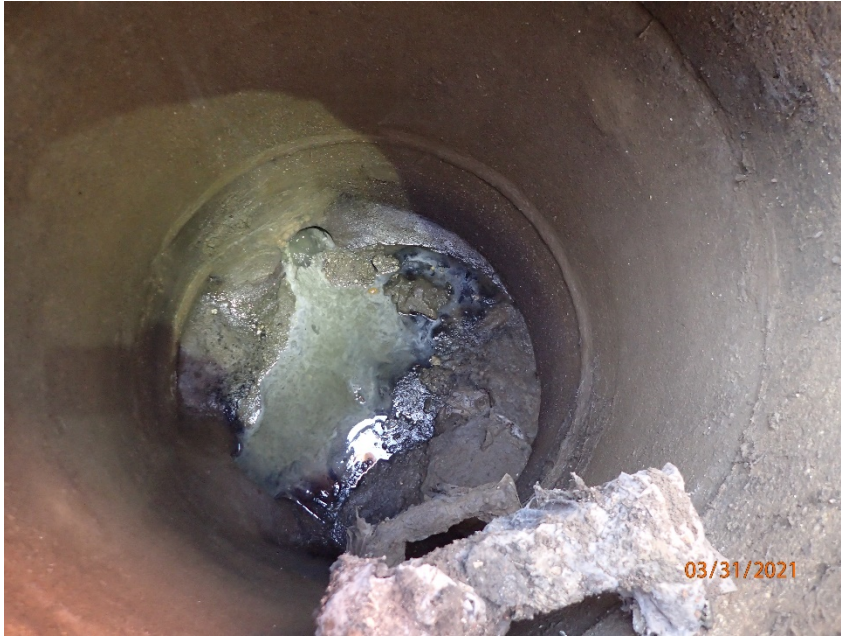
14: P3310018

EPA then continued to the remaining two sewer lines that connect the sanitary waste from the City of Centreville to the collection system in East St. Louis. The first manhole downstream from the City of Centreville along 63<sup>rd</sup> Street was flowing and had very low flow. The water was not clear and contained sanitary waste.

Description: The manhole at 63<sup>rd</sup> Street.

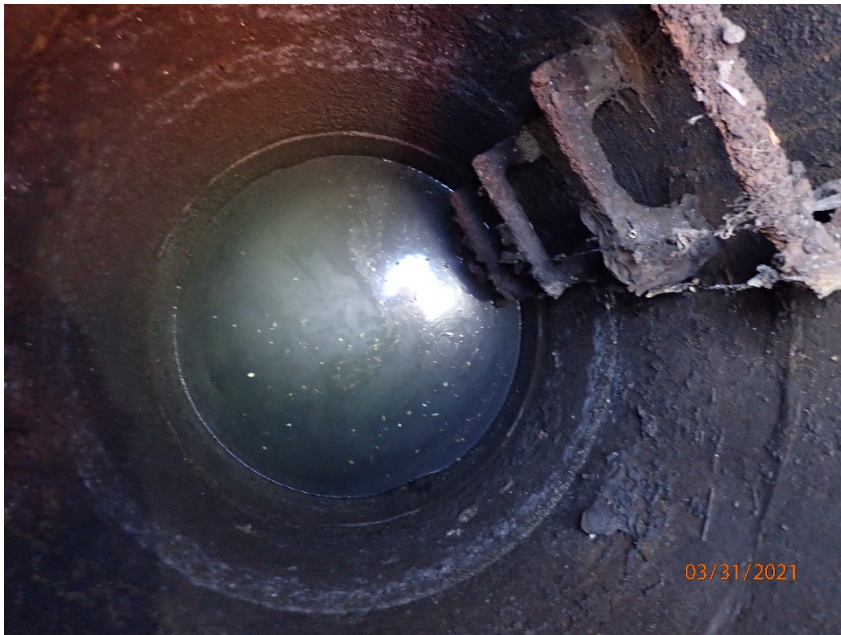
15: P3310019

The first manhole downstream from the City of Centreville along 73<sup>rd</sup> Street had standing water in it, but the water level was low. There did not appear to be any flow coming in or going out.

Description: The manhole at 73<sup>rd</sup> Street.

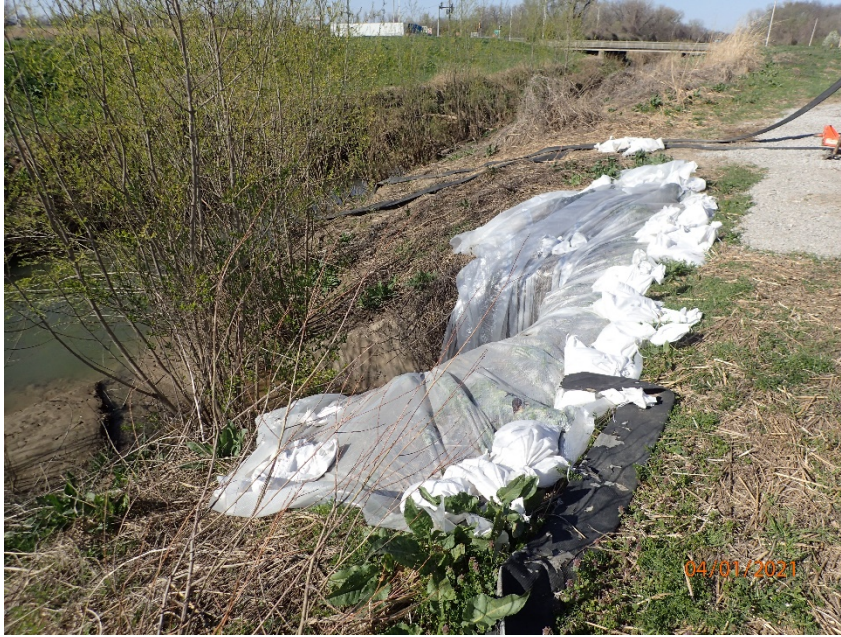
16: P4010023

At 4:30 P.M. on April 1, 2021, the EPA inspectors stopped at the East St. Louis storm water pump station at 68<sup>th</sup> Street and State Street. This pump station was not functioning and was in disrepair. There were no pumps on top of the pump housing in the pump station. There were two

bypass pumps outside the pump station for pumping the storm water from deep wet wells to a waterway that flowed southwest and south to Harding Ditch. Plastic sheeting was being held in place by sandpaper above the outfall pipe. The pump station building was unlocked and open to the public. There was no cover on the deep open wet wells. EPA also observed a deep manhole to the northeast of the building that had no sewer cover. EPA inspectors left the pump station at approximately 4:40 P.M.

Description: Large storm water outfall has been sandbagged and poly lined.

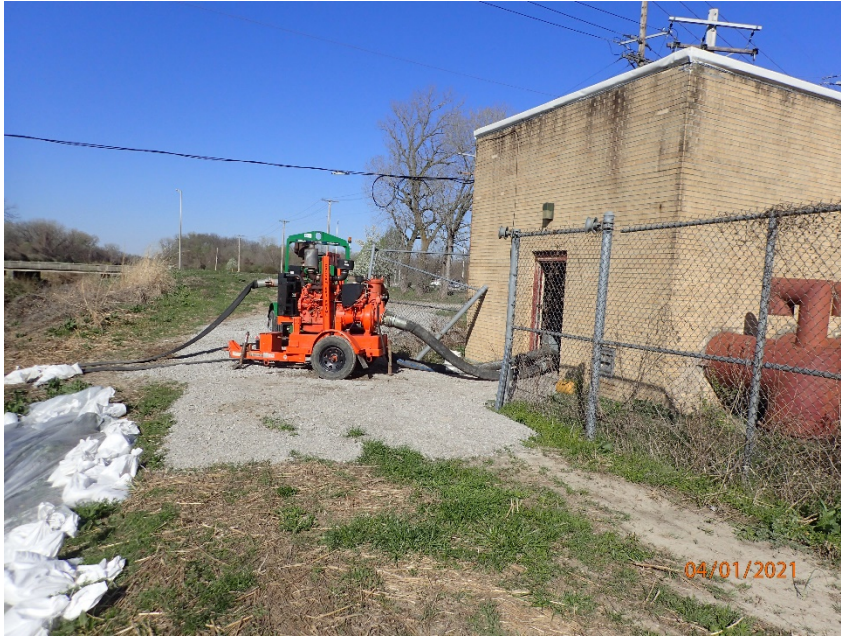
17: P4010024

Description: Storm water pump station is being bypassed.

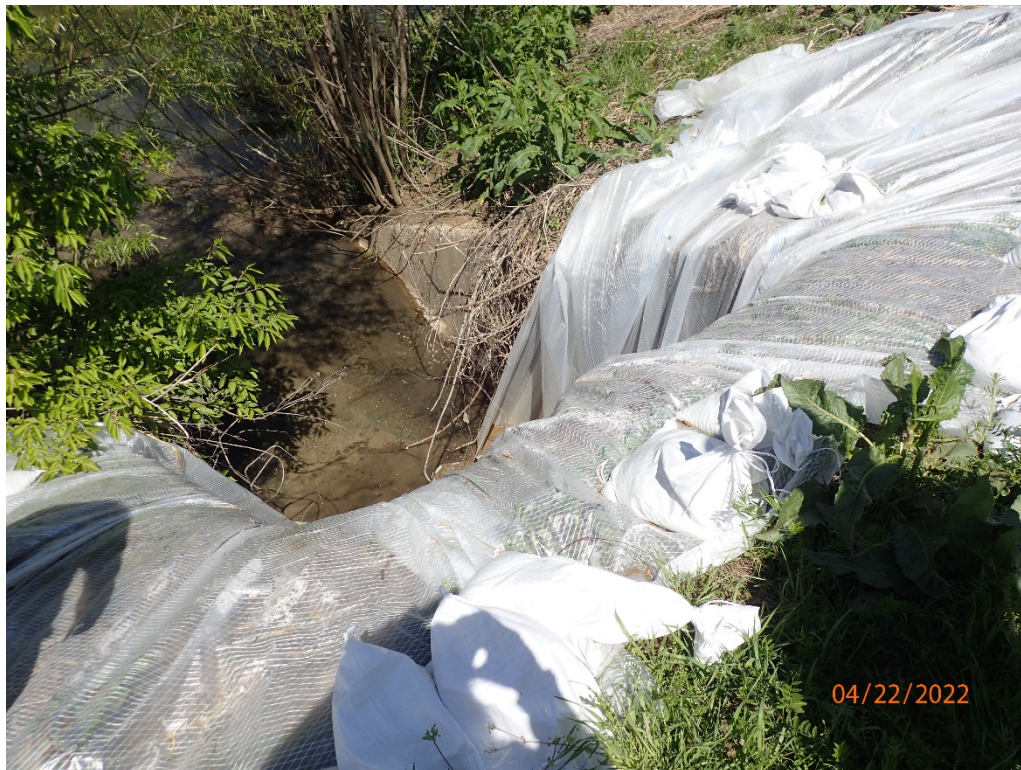
P4220019.JPG

Description: Plastic Sheeting to prevent flow from entering the outlet pipe is held in place by sandbags.

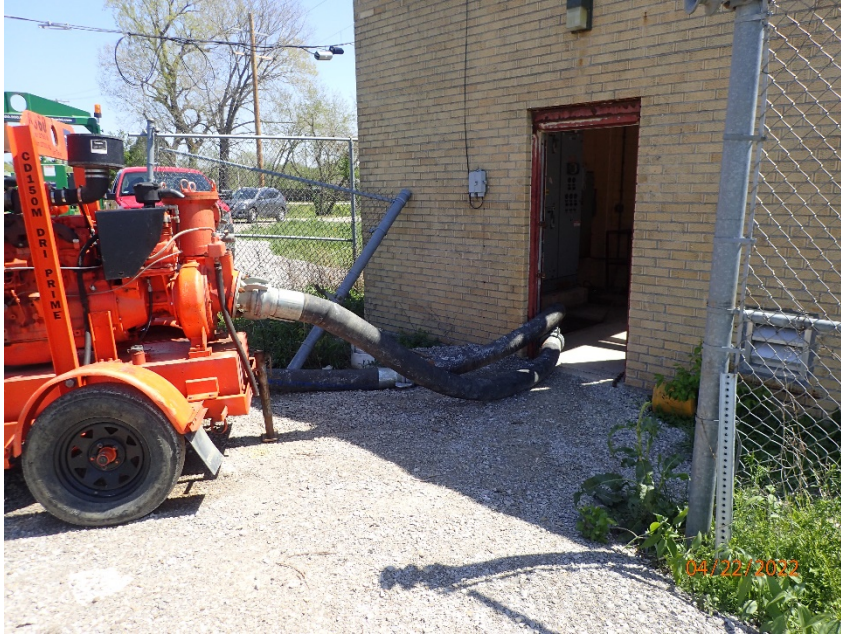
P4220020.JPG

On April 22, 2021, EPA inspectors Joan Rogers, Dean Maraldo, and Ted Flatebo returned to the storm water pump station at 68<sup>th</sup> Street and State Street with Mr. Scott Hillman from the Metro East Sanitary District (MESD). Mr. Hillman explained that MESD installed the plastic sheeting and the sandbags because the flap gate in the outfall pipe was broken and when water levels were high in the waterway, they would back up into the wet well and then overflow into the surrounding neighborhood. The plastic sheeting was to allow water to flow out the outfall, but then it would provide some relief from water flowing back into the pump station. Mr. Hillman stated that Mr. Swanson knew that the gate was not functioning.

Description: Pump station is being bypassed. Gate cannot be closed and pump station door is open.

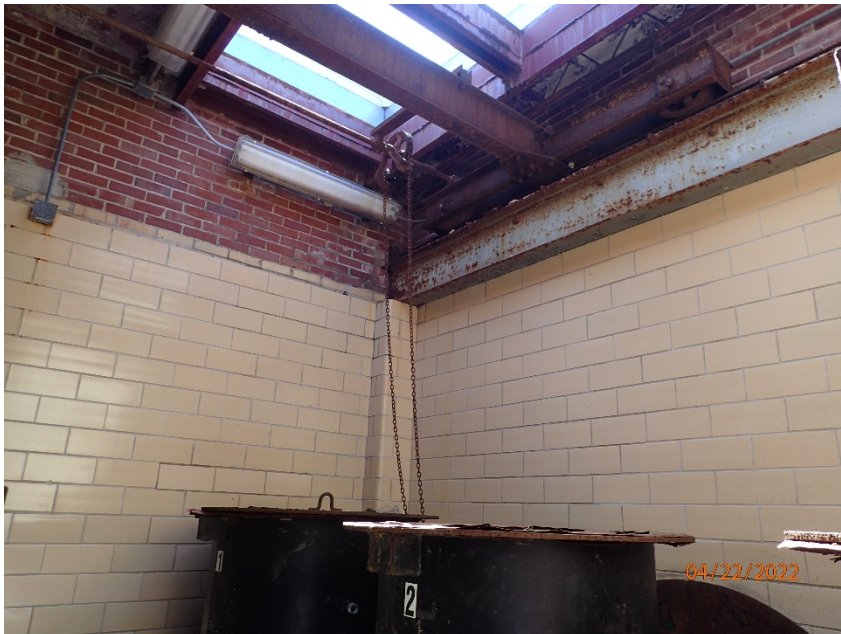
P4220021.JPG

Description: Roof is damaged and open to the elements.

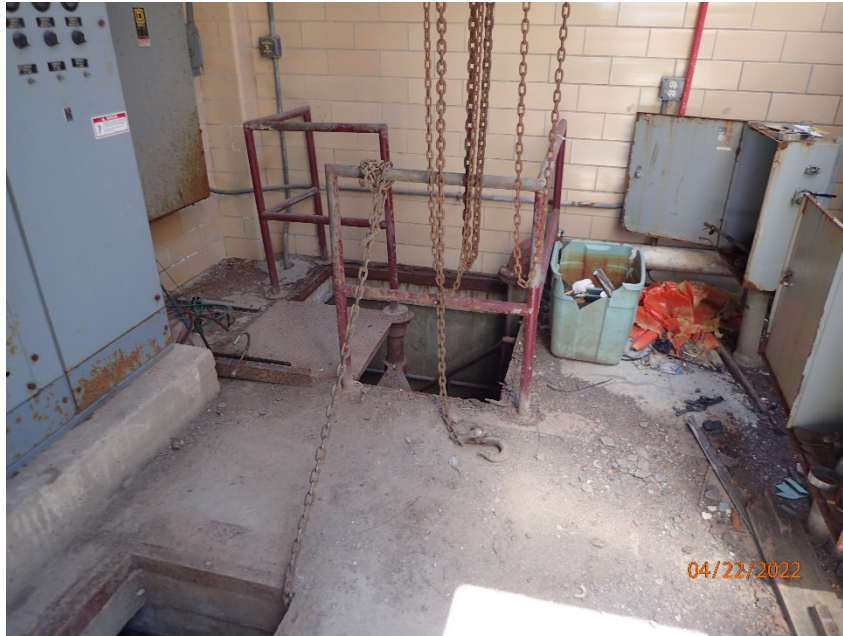
P4220022.JPG

Description: Wet well is open to the public.

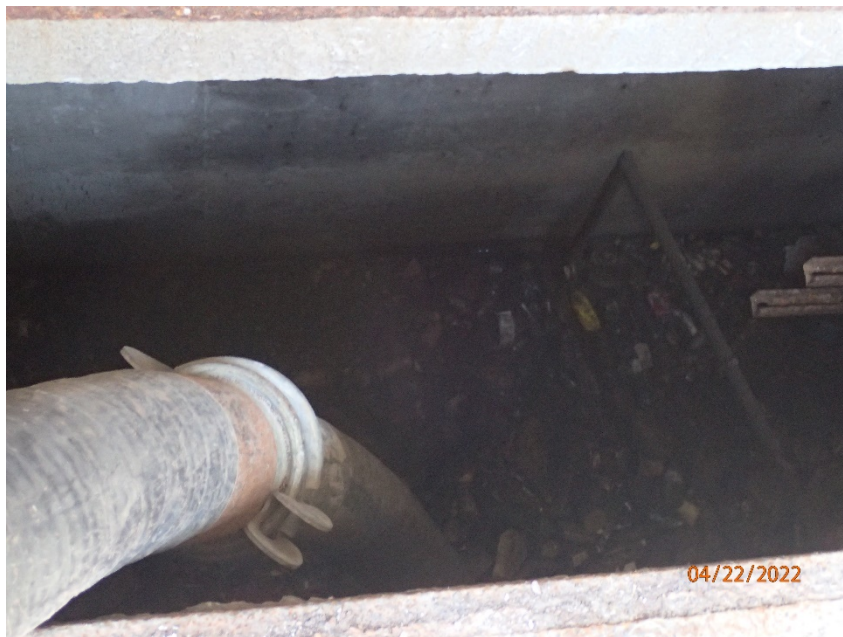
P4220023.JPG

Description: Wet well is not covered and is open to the public.

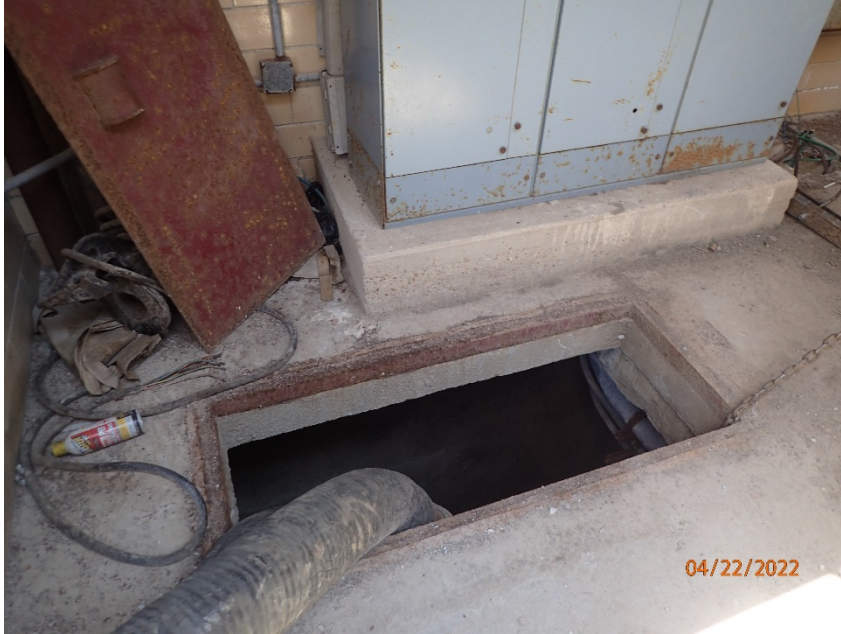
P4220024.JPG

Description: Wet well is not covered and is open to the public.

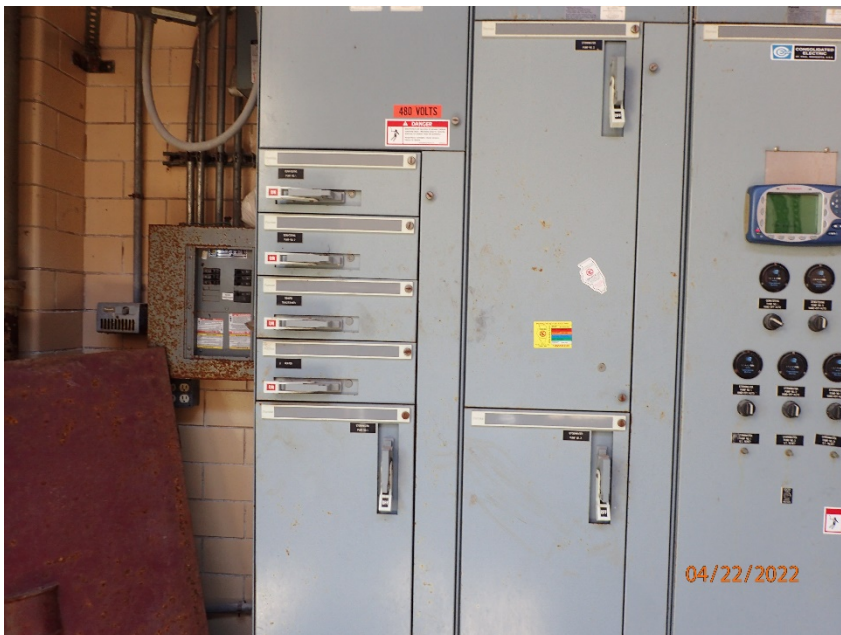
P4220025.JPG

Description: There is still power going to the pump station.

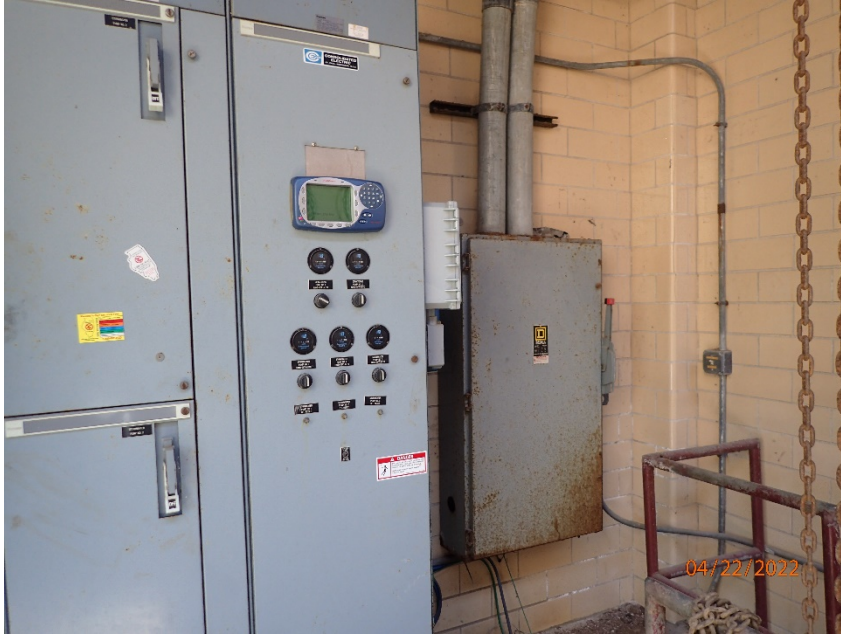
P4220026.JPG

Description: Electric feed is still on.
