**Region 6 - Enforcement & Compliance Assurance Division**  
**INSPECTION REPORT**

| Company Name: | John P Long, Jr | |
| Facility Name: | Tall Chief Lease | |
| Identification/Permit Number: | OKU002211 | |

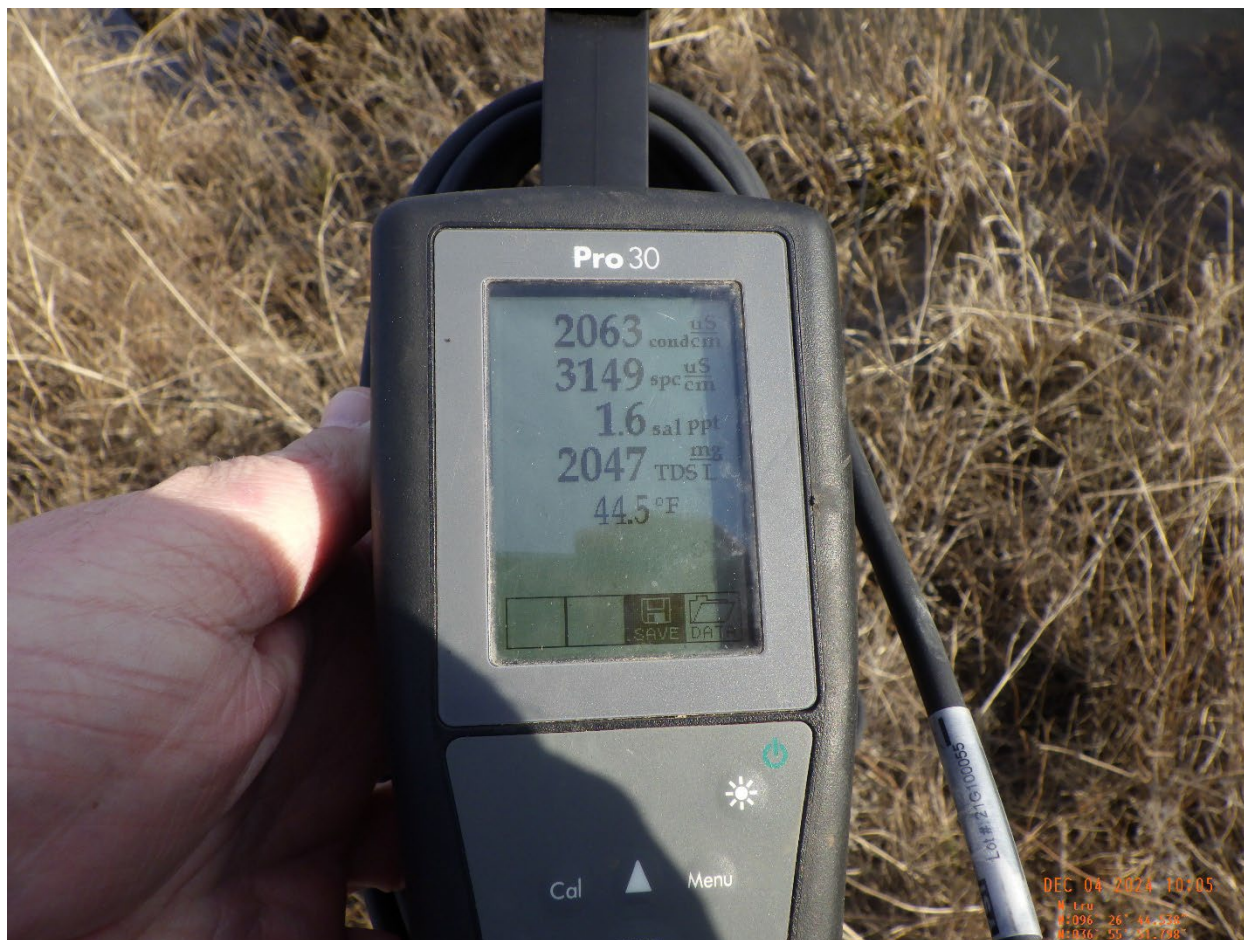
Photo No. 1

I observed a TDS field reading of 2,047 mg/L at the Point of Entry (POE) into the unnamed tributary of Buck Creek. This was significantly improved over the initial spill inspection conducted 11/23/2024. See photo No. 1 of Appendix 1 (photo log). For additional GPS location and photo metadata, see Appendix 1.

**Description:** This was an elevated TDS field reading of 2,047 mg/L observed at the Point of Entry (POE) into the unnamed tributary of Buck Creek. This was a significant improvement from TDS levels observed during the initial inspection.

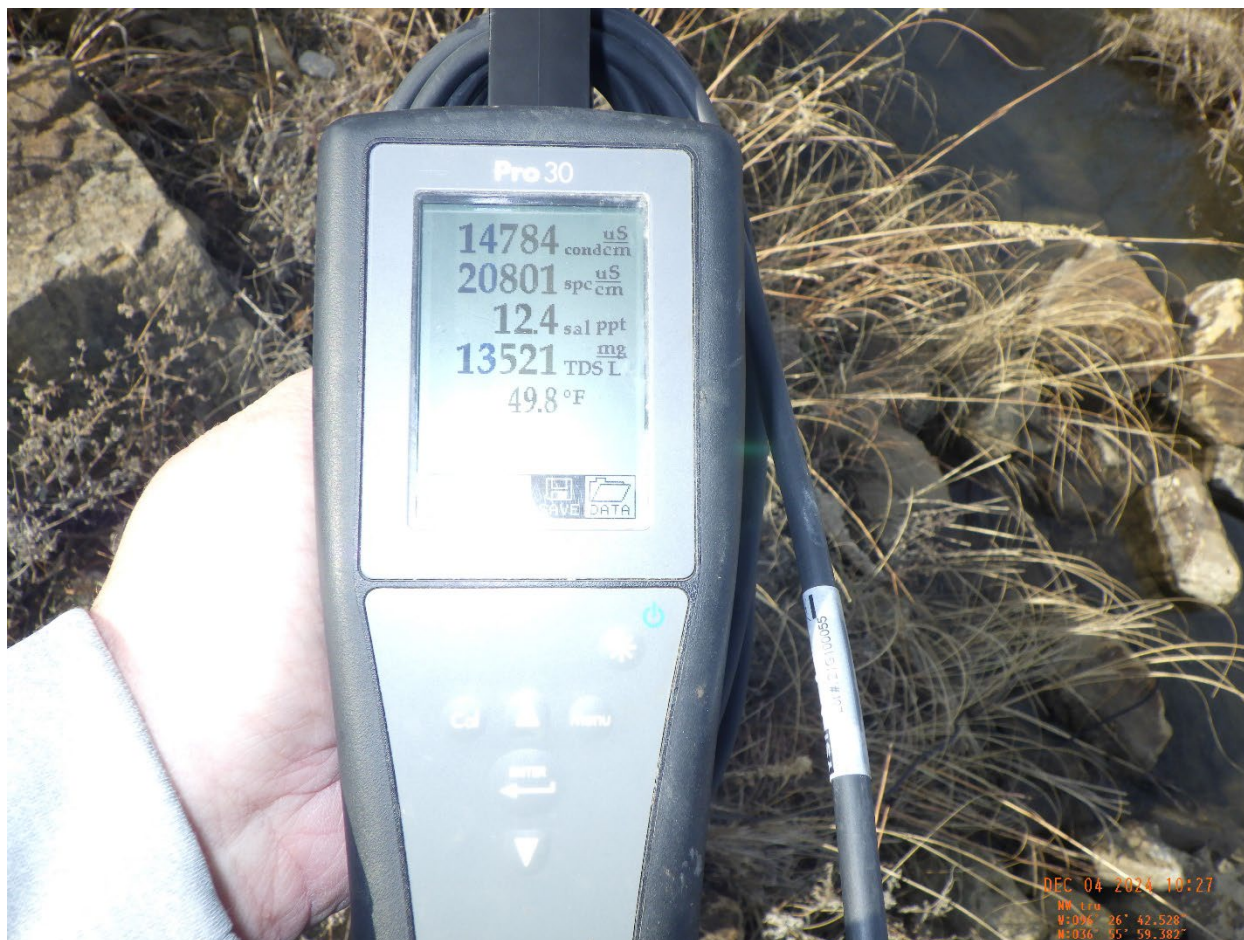
Photo No. 2

Moving downstream, I observed a TDS field reading of 13,521 mg/L. See photo No. 2. This was the highest TDS level observed during the inspection and was the primary area of concern observed during the inspection. The operator representative agreed to immediately remove the impacted water from this location with the vacuum truck that was working to clean up the spill.

**Description:** This was an elevated TDS field reading of 13,521 mg/L observed approximately 250 yards downstream from the POE. This was the highest TDS reading observed during the inspection and was the primary area of concern. This observation was only slightly improved over the initial spill inspection.

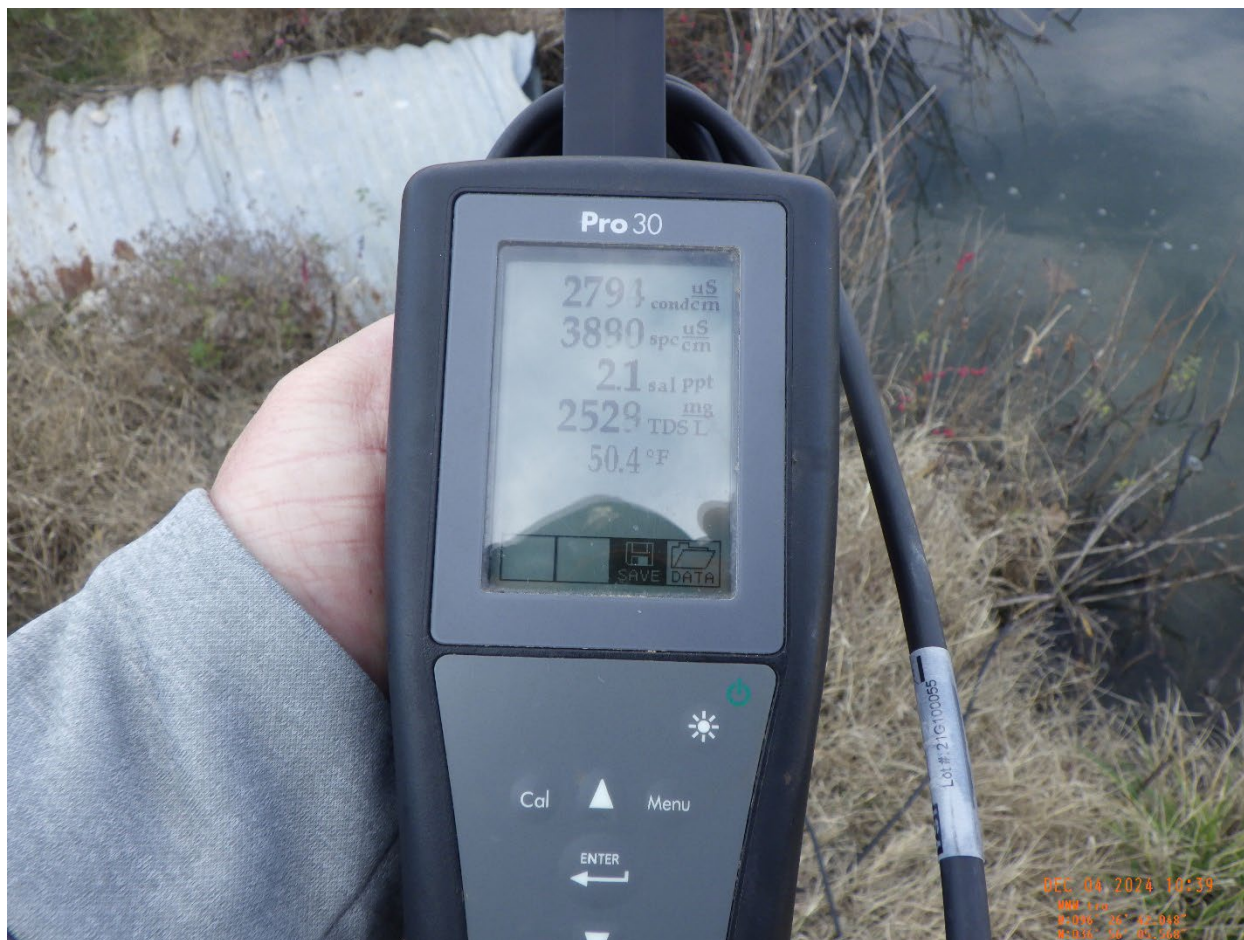
Photo No. 3

At the lowermost road crossing, I observed a TDS field reading of 2,529 mg/L. See photo No. 3. This was the location of the lowermost, temporary containment dam which has been placed after the initial spill inspection. The dam was properly constructed and sufficient to prevent downstream migration of impacted waters.

**Description:** This was an elevated TDS field reading observed downstream from the POE. This observation showed progress had been made through clean-up efforts.

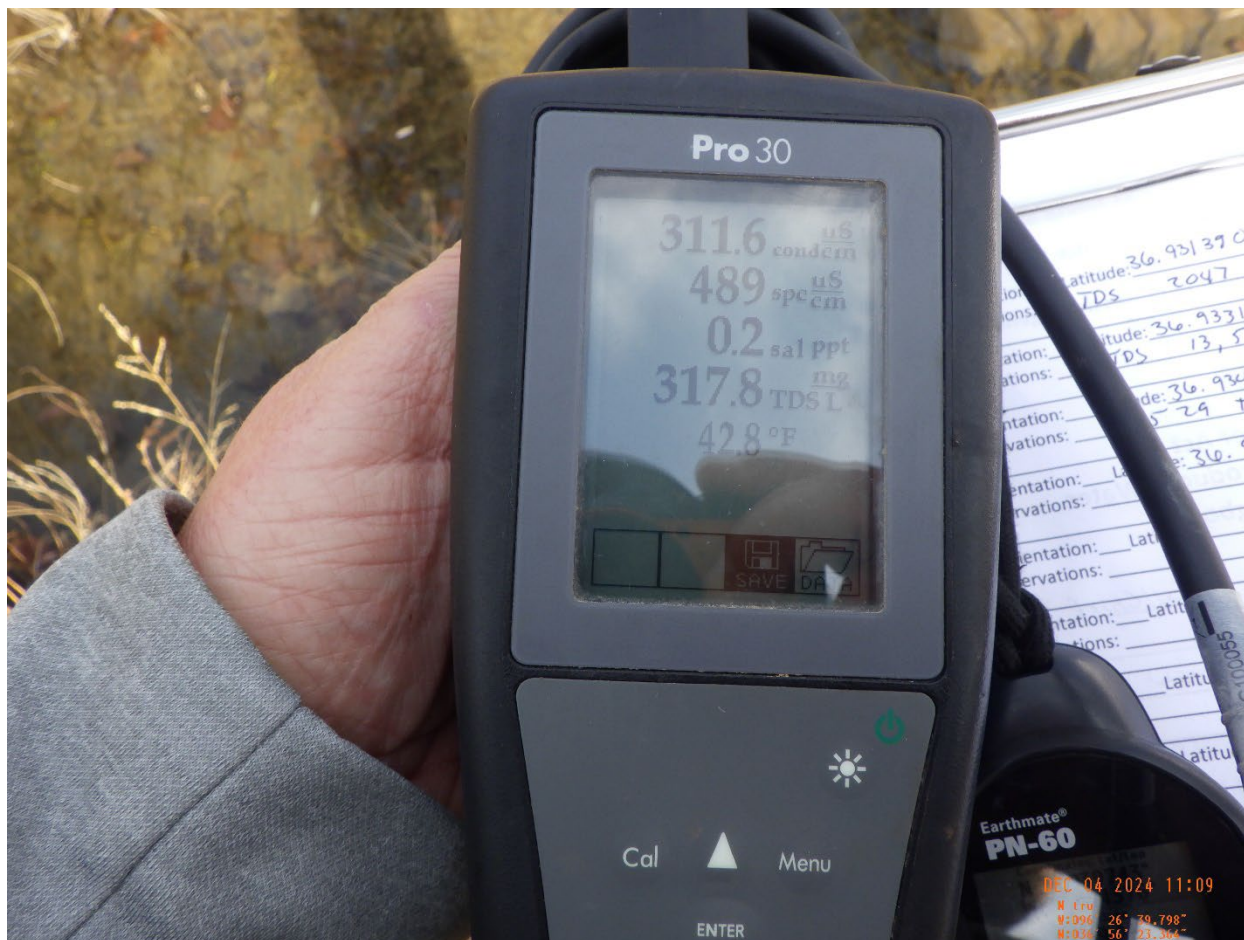
Photo No. 4

I observed a TDS field reading of 371.8 mg/L, see photo No. 4. This was observed at the location where the end of spill impacted were observed during the initial spill inspection. TDS levels at the location had returned to background at the time of the inspection.

**Description:** This was a TDS field reading of 317.8. This TDS reading was observed at the same location where the end of spill impacts was observed during the initial spill inspection.
