**Subj:** Inspection Report  
Clean Water Act

- A. *Facility Name:* North Attleborough WWTF
- B. *Facility Location:* Cedar Rd, North Attleborough, MA 02760
- C. *Facility Contacts:* Gary Farquharson, Chief Operator  
Roland Bombardier, Chief Mechanic
- D. *ID No(s):* MA0101036

- A. *Date(s) of inspection:* November 13, 2024
- B. *Weather Conditions:* Sunny, 50 deg F
- C. *US EPA Representative(s):* David Turin and Elliot Anderson
- D. *State/Local Representative(s):* David Burns and Rick Rondeau, MassDEP
- E. *Federally Enforceable Requirements Covered During the Inspection:*  
CWA Sec 402: NPDES Permit MA0101036 and MSGP Sector T
- F. *Previous Enforcement Actions:* N/A

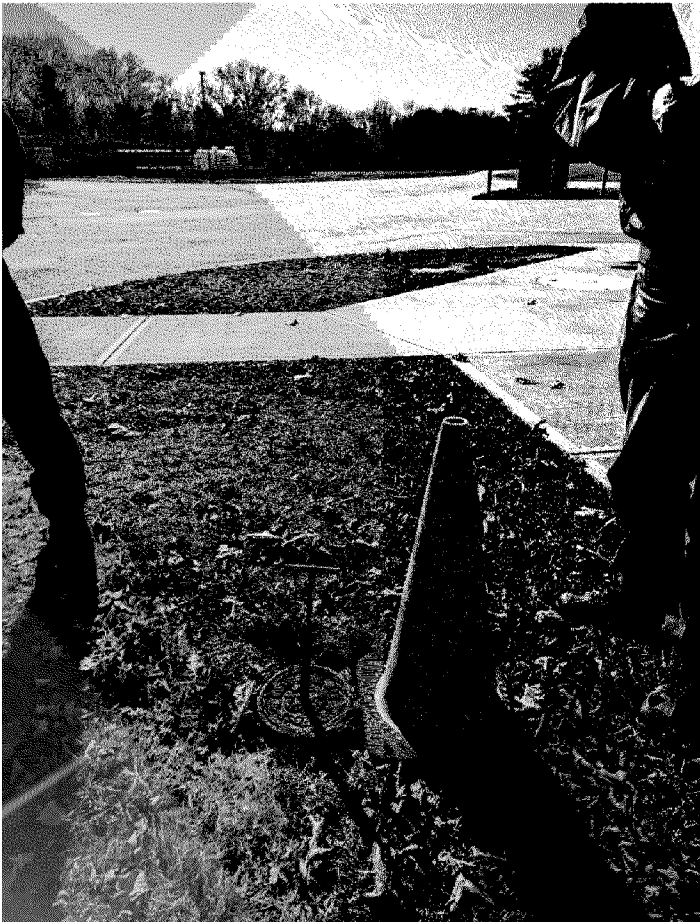
Photo 1 – Stormwater Cutoff Valve

Outside the headworks building, the operators pointed out a valve that cuts off flow from stormwater collection system in the adjacent paved area in the event of spilled material entering the catch basins [see Photo 1]. This system, along with other observations during the inspection document general conformance with the No Exposure Certificate the Town has maintained with EPA under EPA's Multi-Sector General Permit for stormwater.

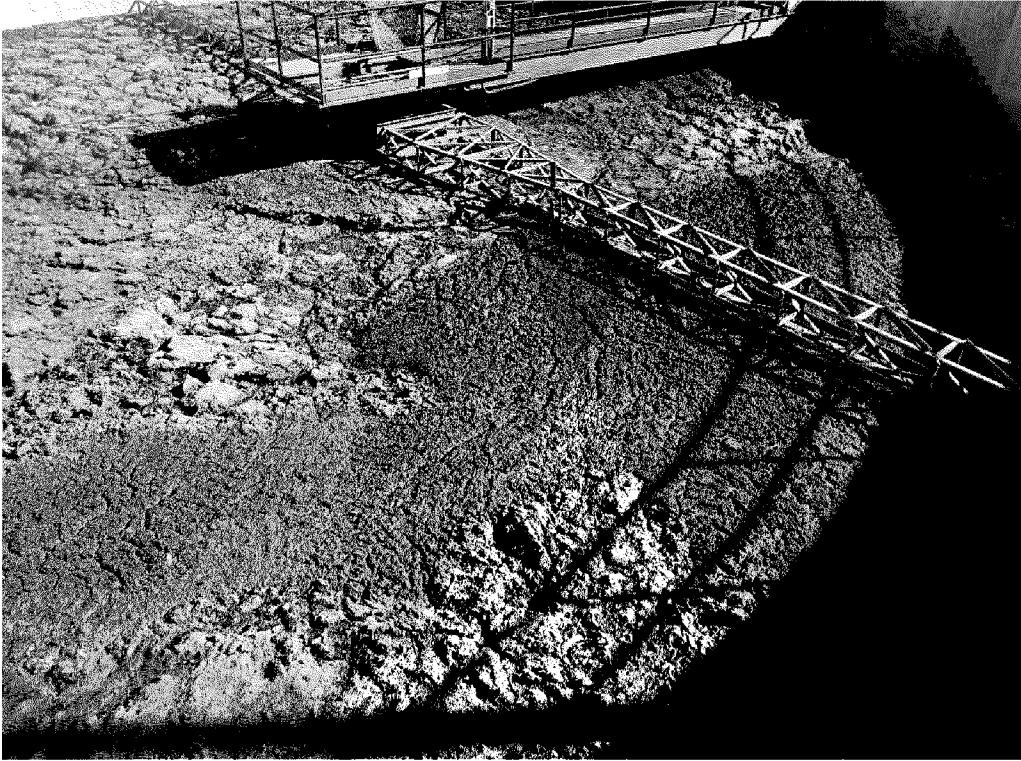
Photo 2 – Primary Tank No. 1

Primary Tank No. 1 is currently off-line and filled with solids [see Photo 2]. We were told that while it needs repairs, it can run, however the solids loading causes issues moving the flow to the secondary tanks without it first going back through the headworks. Primary Tank No. 2 was running with some floc visible on the surface, which was reportedly related to the higher than optimal levels of solids in the system.

During the closing conference, the facility summarized the upgrades and repairs that are planned, including efforts needed to continue to address excess solids in the system, repairs to Primary Tank No. 1, upgrades to the headworks building, and upgrades to the SCADA systems at the pump stations.

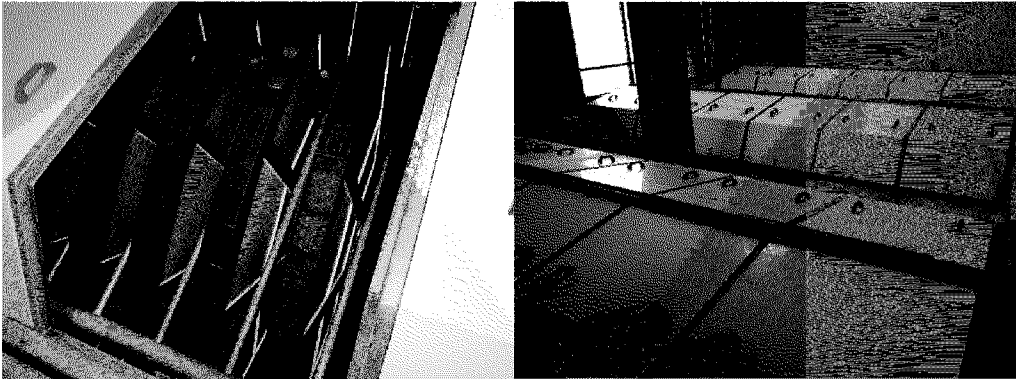
Photos 3 and 4 – Disc Filters

As we walked through the rest of the facility, the operators described challenges at the facility, including a need to work around offline aeration blowers and treatment complications associated with high levels of mixed liquor suspended solids (MLSS) in the aeration tanks. During the summer, the operators described the onerous process of backwashing and cleaning the almost 700 disc filters. It reportedly takes approximately one and a half weeks to complete a cleaning cycle and it needs to be repeated every four weeks to prevent clogging [see Photos 3 and 4].
