**Region 6 Compliance Assurance and Enforcement Division**  
**INSPECTION REPORT**

| Inspection Date(s): | 05/14-16/2018 | | |
| Company Name: | International Paper Company | | |
| Facility Name: | Mansfield Mill | | |

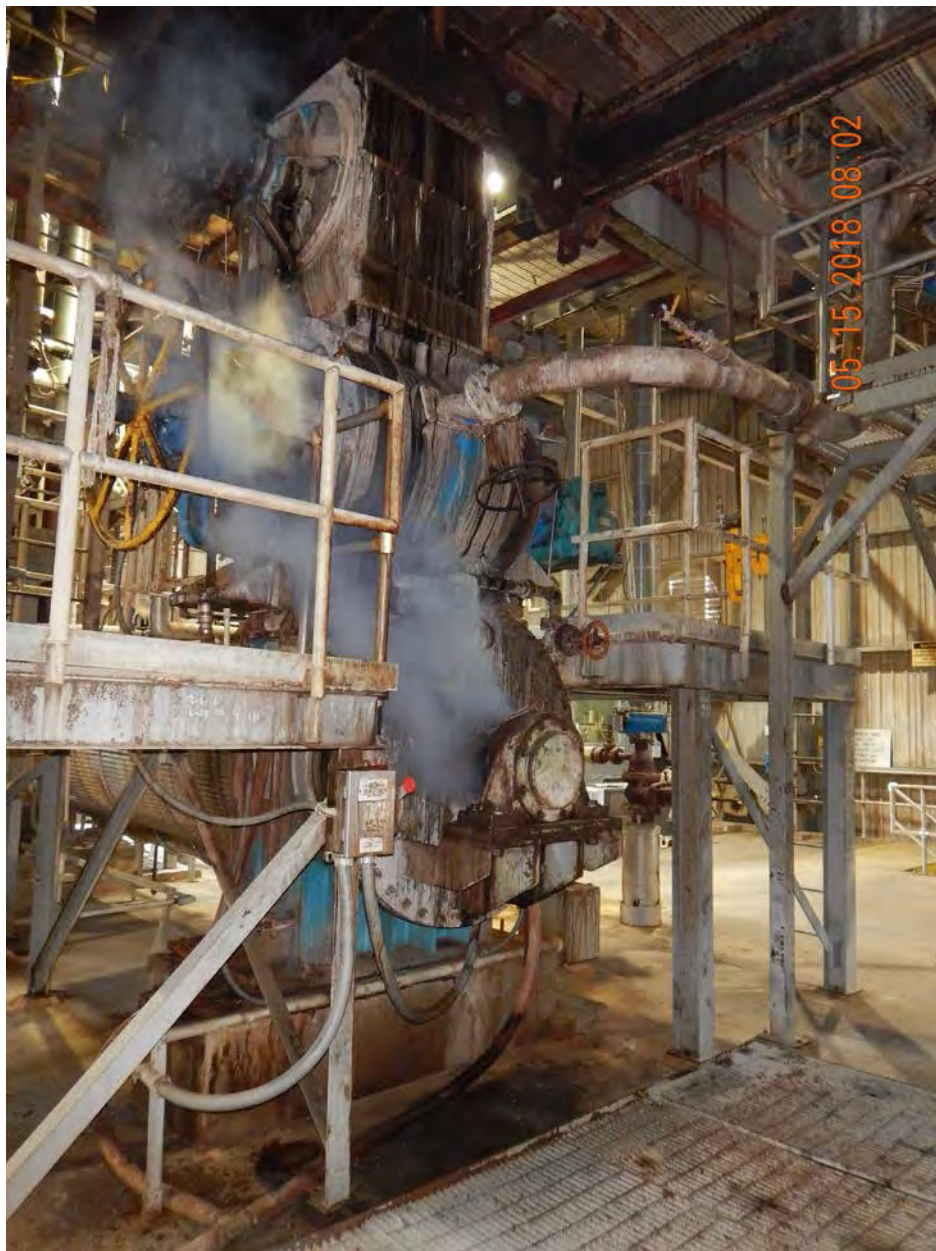
Photo No. 2

- 1) Visible emissions were observed at the steam vessel and low-pressure feeder of the primary line on May 15. All vapors from this part of the pulping process should be routed to the LVHC system. On May 16, Ms. Martin showed us a video of the repaired steam vessel. A work order for the low-pressure feeder was submitted. The inspection team noted that this process equipment may need to be added to the monthly visible LDAR inspections.

Description: We observed visible emissions at the entrance of the primary steaming vessel.

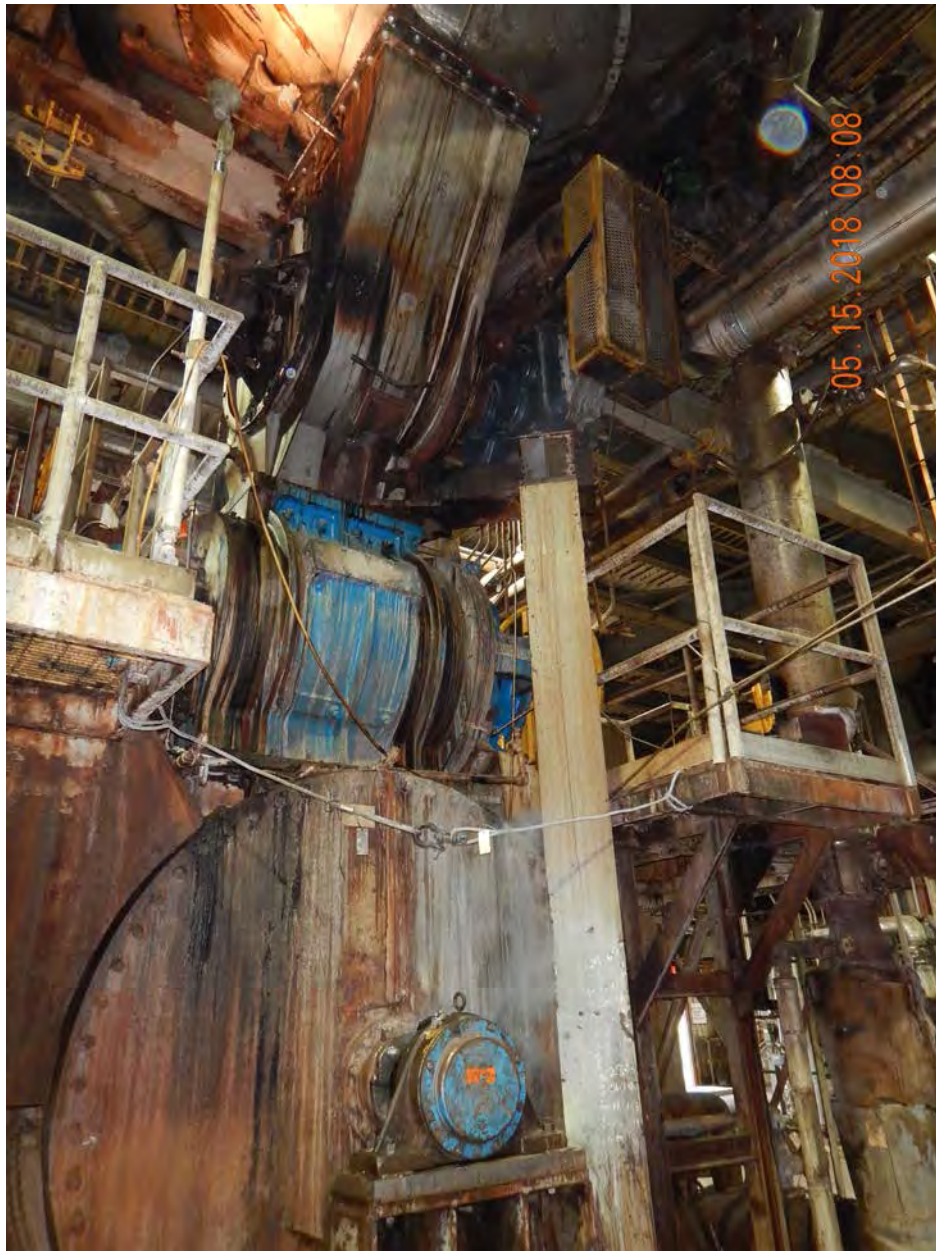
Photo No. 3

Description: Photo of primary line low pressure feeder, visible emissions observed from the top.

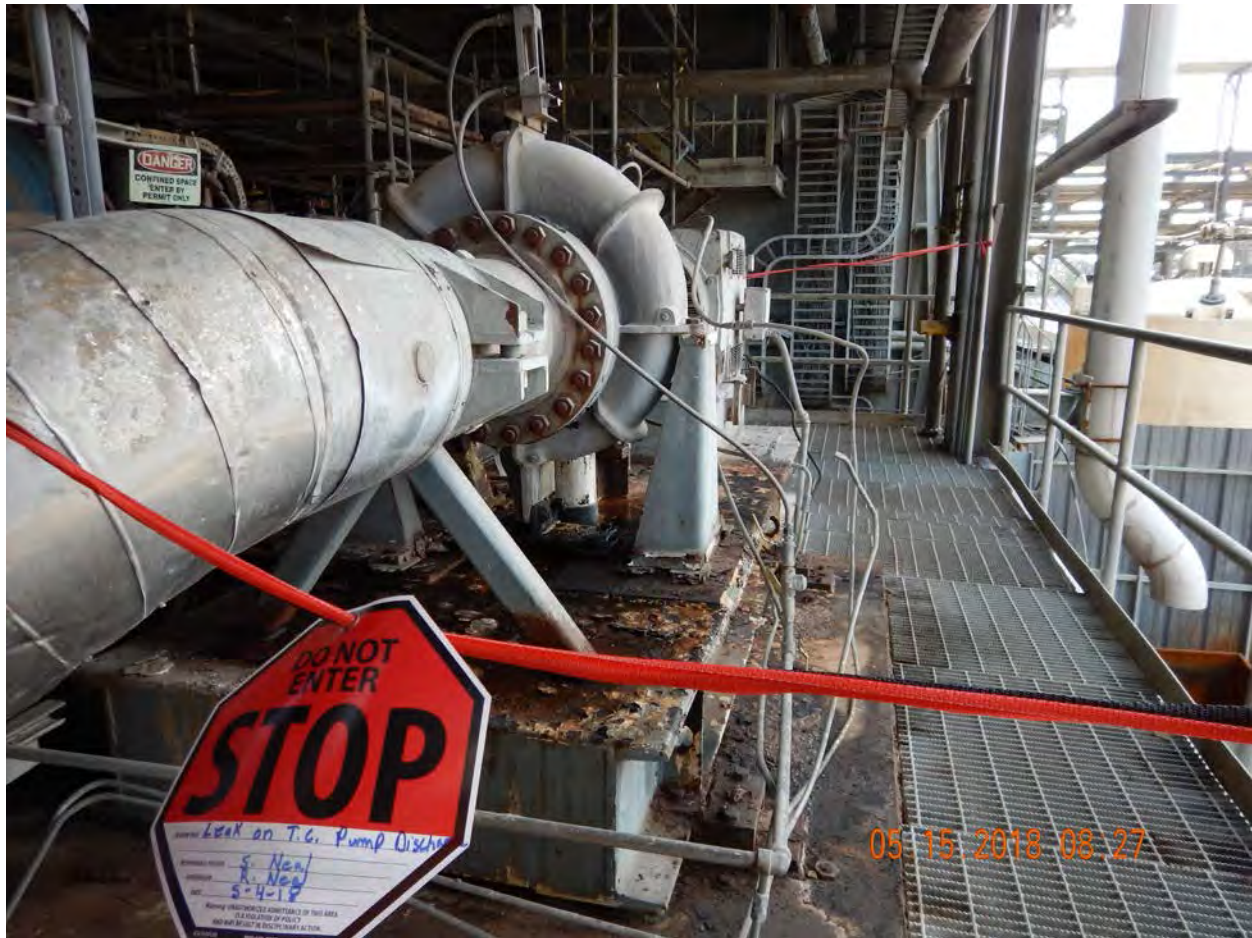
Photo No. 4

Description: Photo of primary line high pressure feeder. Roped off due to previous white liquor leak from pump.

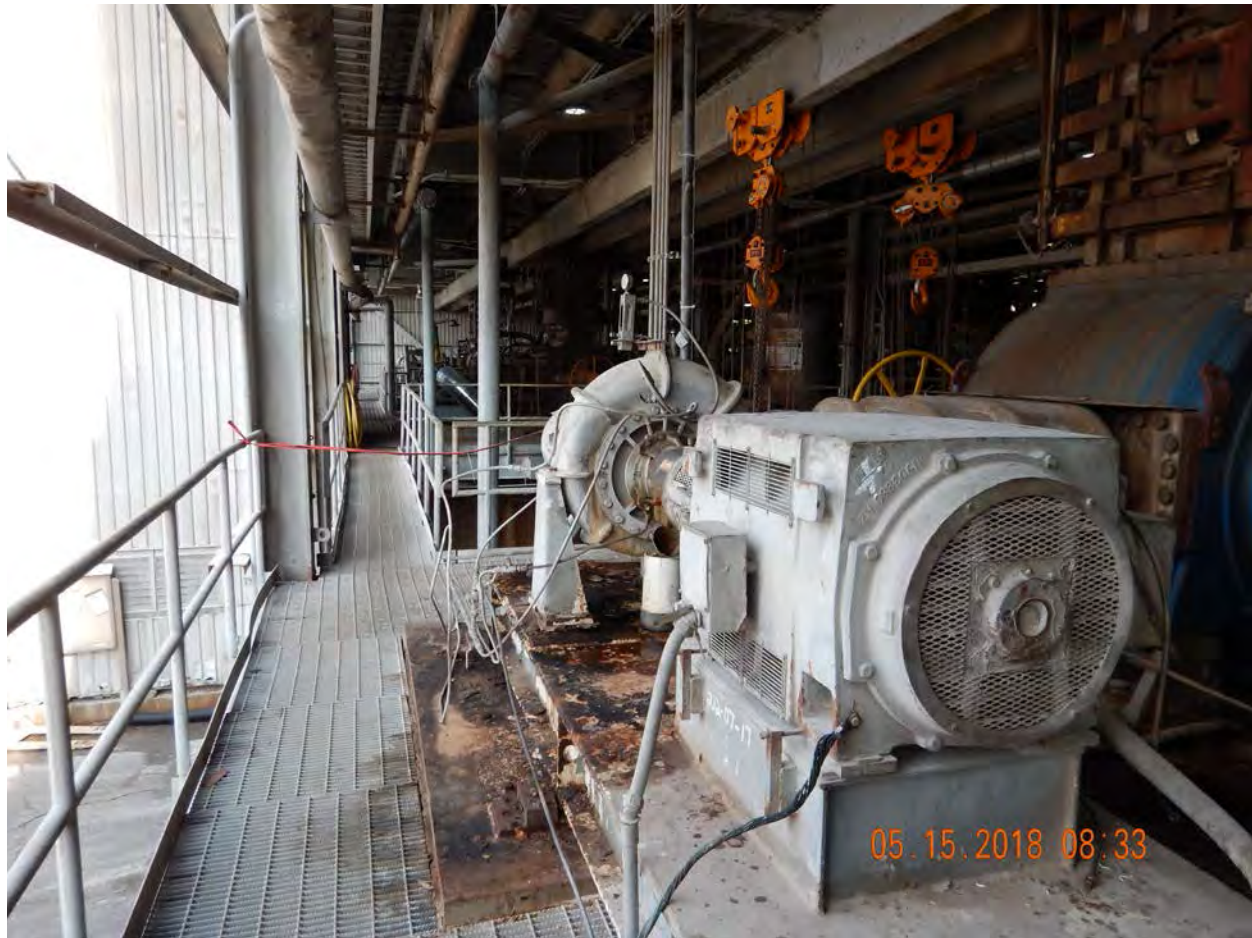
Photo No. 5

Description: Photo of primary line high pressure feeder from the opposite side. Roped off due to previous white liquor leak from pump.

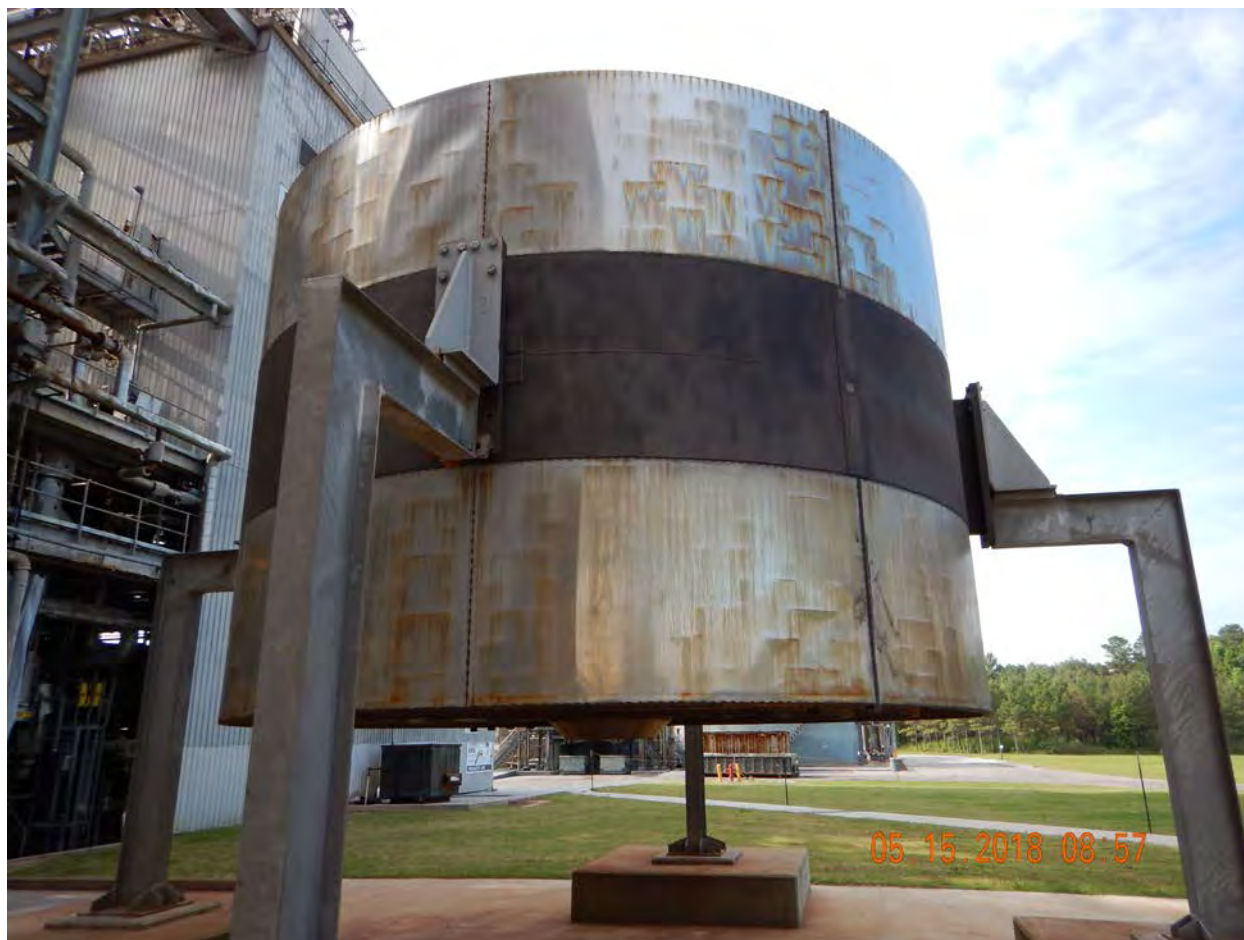
Photo No. 8

Description: Diffusion washer screen removed in 2017.

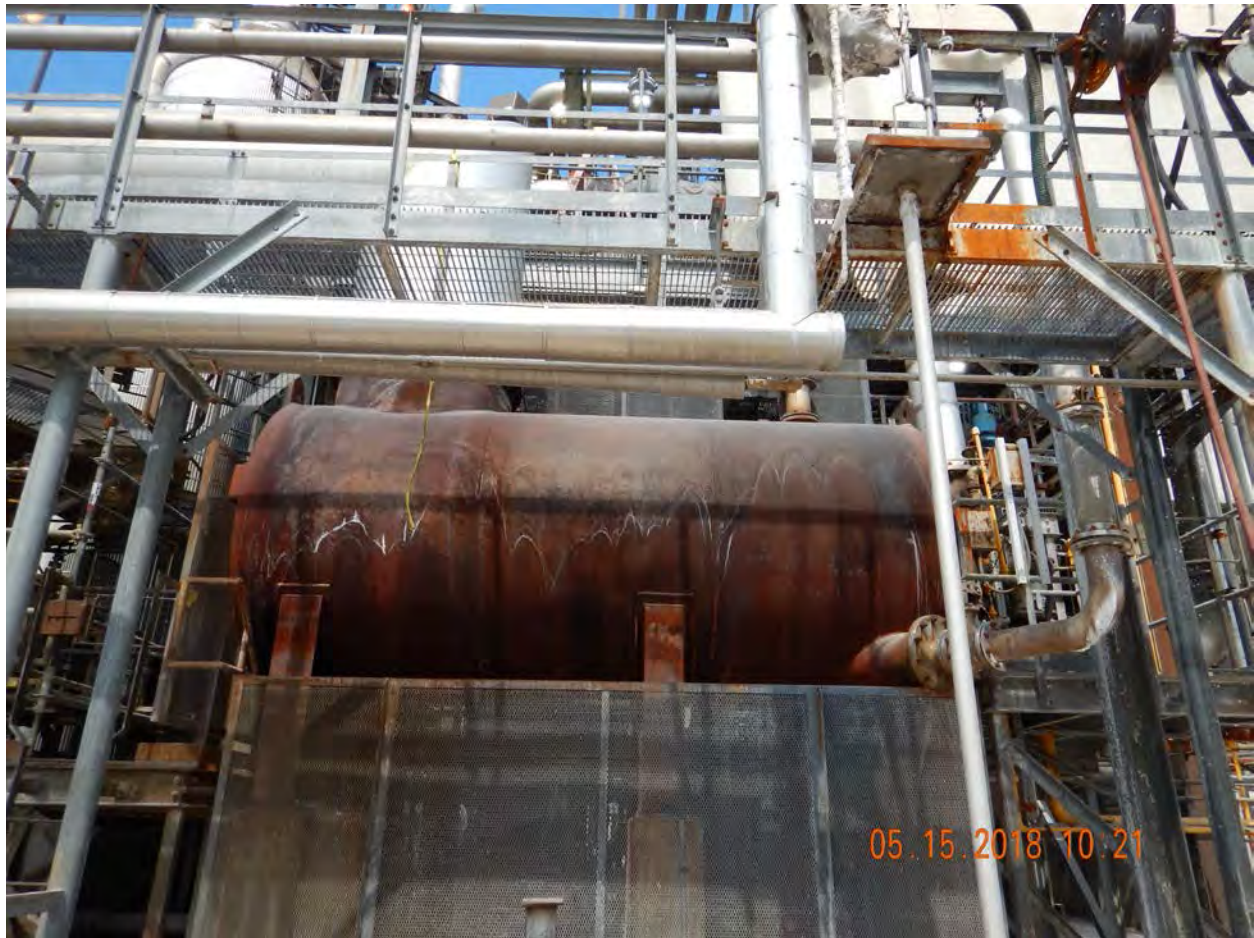
Photo No. 12

incinerator (Photos 12-14). The incinerator is the primary combustion device for both the HVLC and LVHC systems. The lime kiln is the backup combustion device for the LVHC system. The incinerator has a planned outage twice a year, and the HVLC is emitted to the atmosphere.

Description: Close-up view of HVLC/LVHC incinerator.

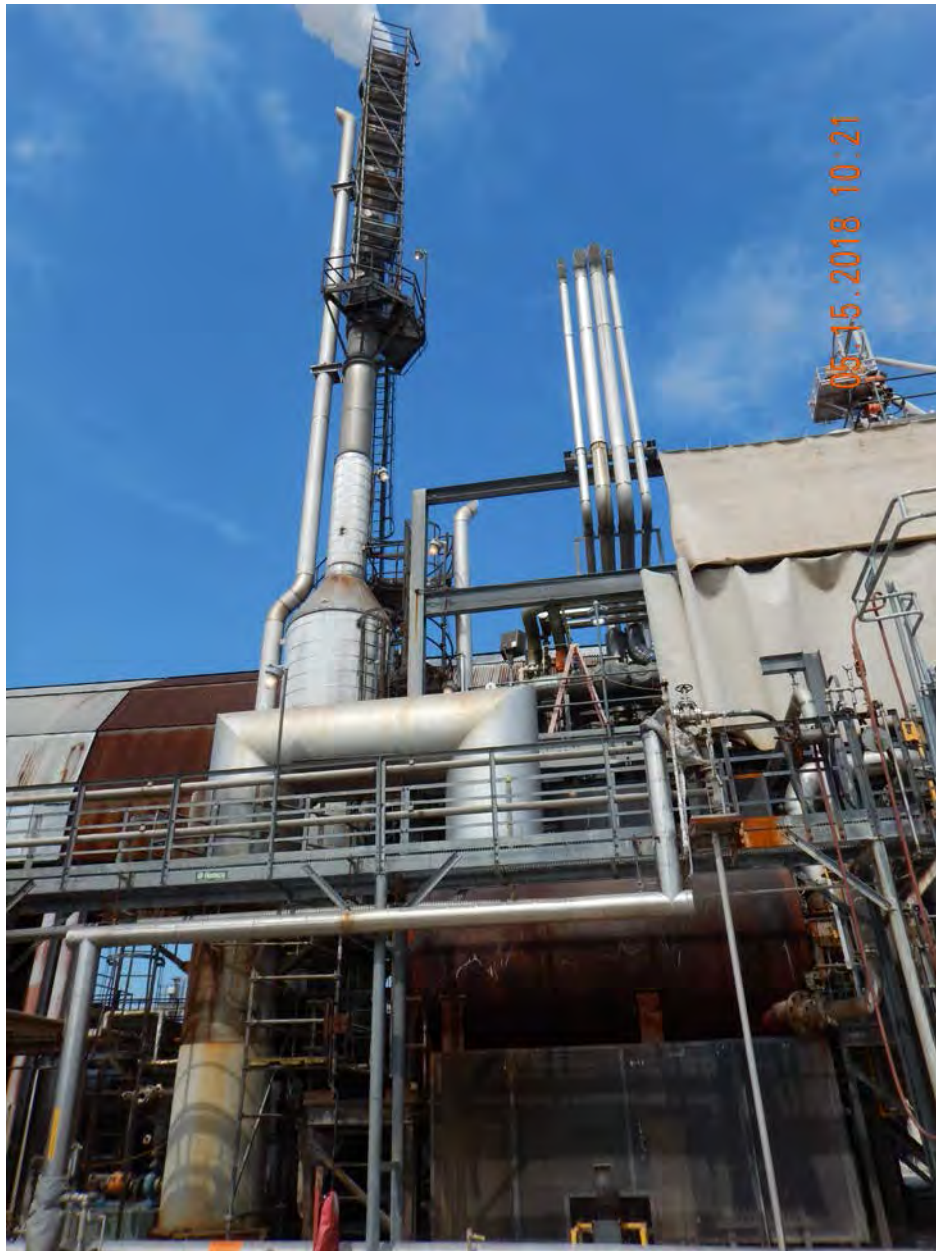
Photo No. 13

Description: Wide view of HVLC/LVHC incinerator.

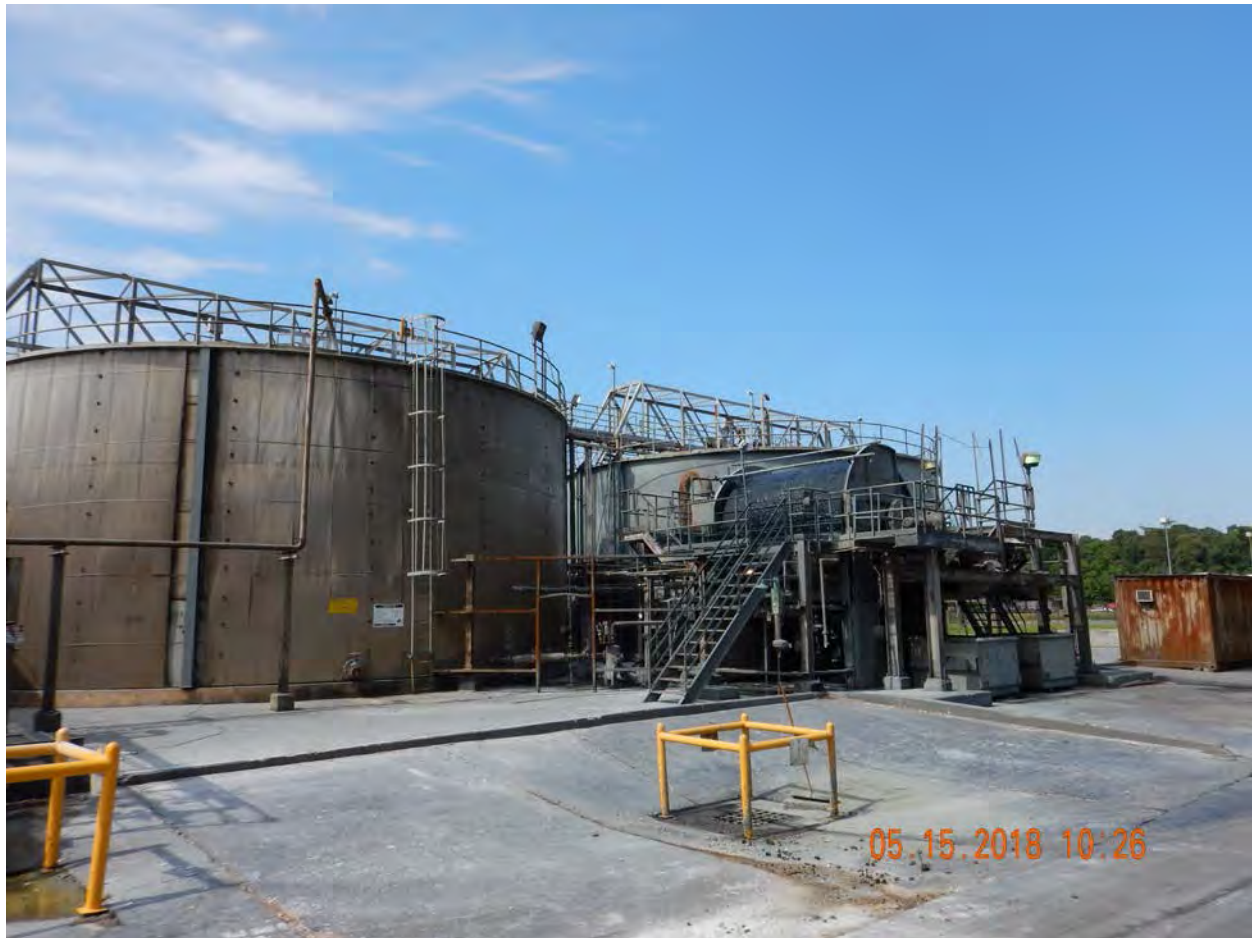
Photo No. 14

Description: Wide view of dregs filter.

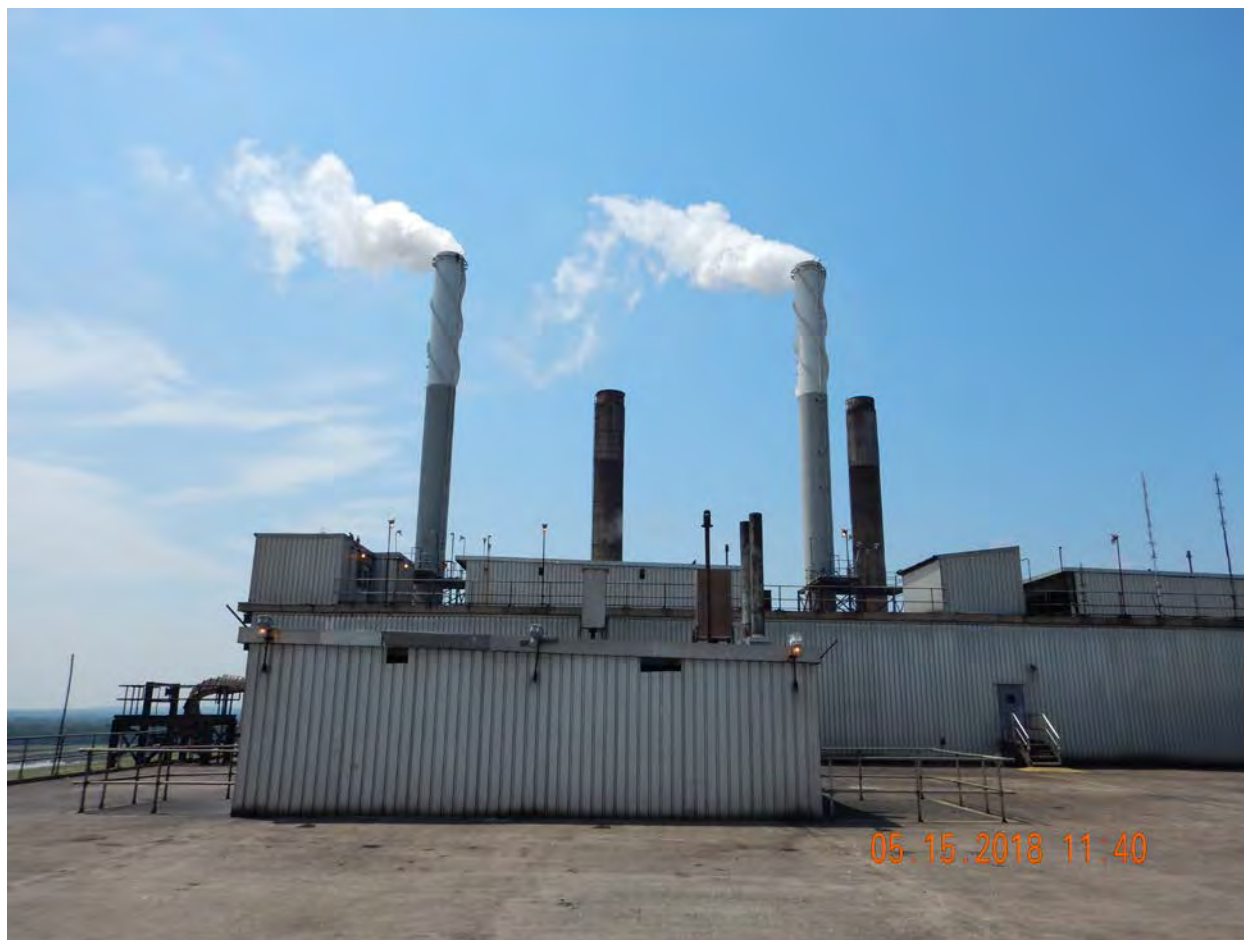
Photo No. 16

5) The inspection team shared that visible emissions from the Recovery Boiler stacks were observed on May 16. An evaluation of all opacity, COMS, and CEMS data will be reviewed after the inspection.

Description: Stacks from smelt dissolving tanks (front) and recovery boilers (back) from powerhouse roof.

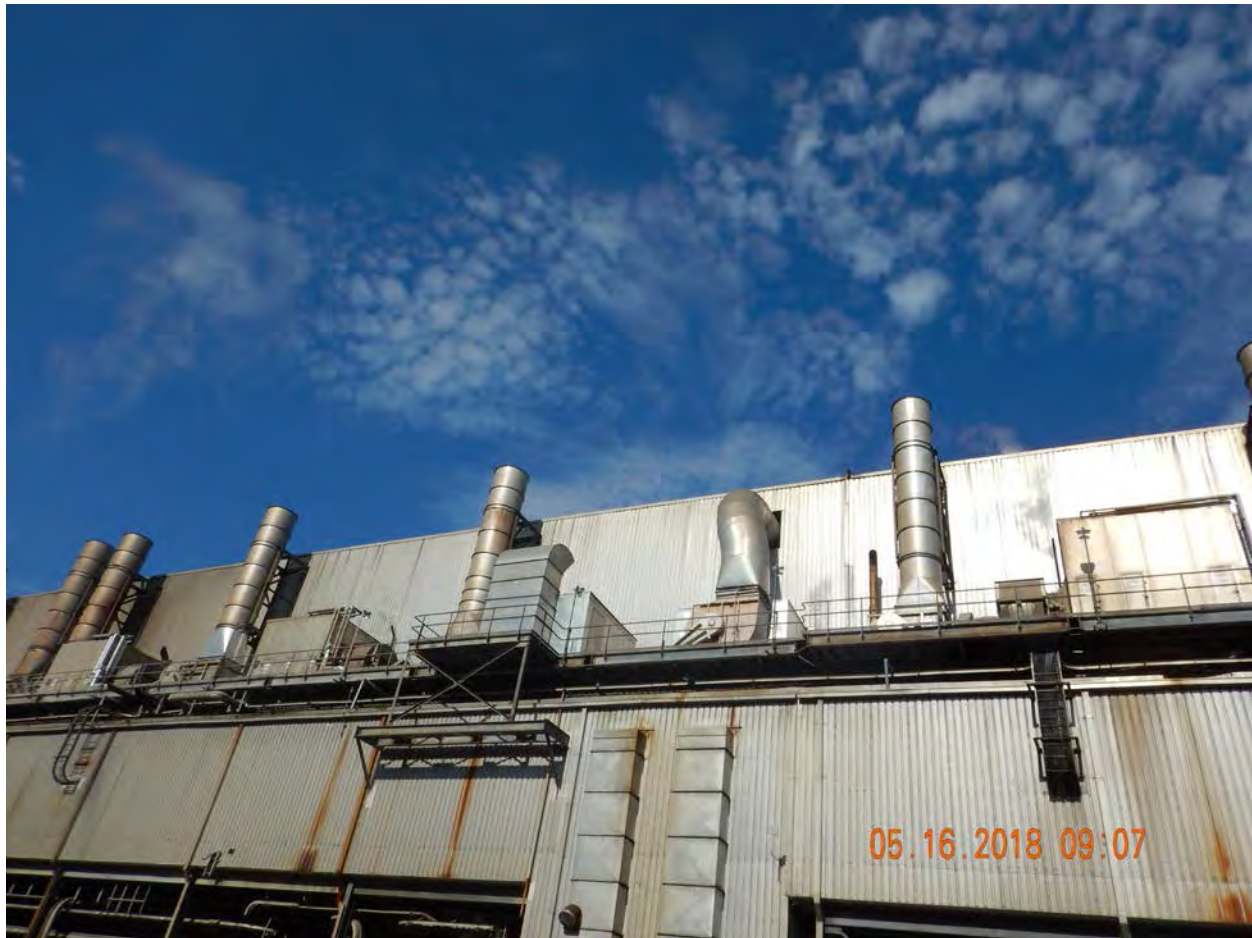
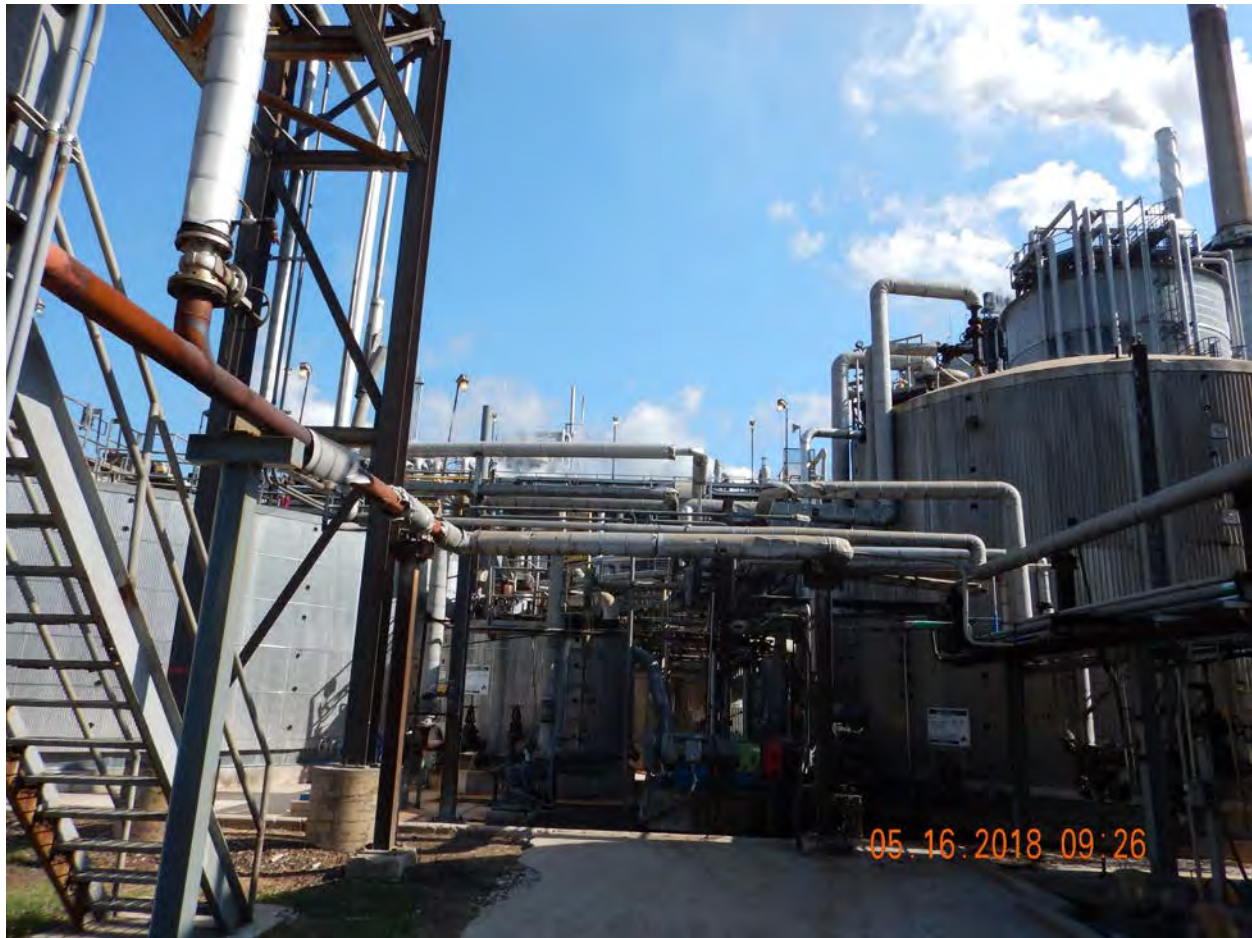
and counted approximately 15 vents on the roof (Photos 21 and 22). We observed dryer vents on the side of the building from the ground, some of which has visible steam (Photo 23). Mr. Cross explained that the dryer vents should be closed when in operation, and repairs are scheduled during the next PM shutdown.
