**Region 6 - Enforcement & Compliance Assurance Division**  
**INSPECTION REPORT**

| Regulatory Program(s) | Clean Water Act – National Pollution Discharge Elimination System (NPDES) – Brine Program | |
| Facility Name: | Unknown (Pipeline Complaint) | |
| (city, state, zip code) | Healdton, Oklahoma | |

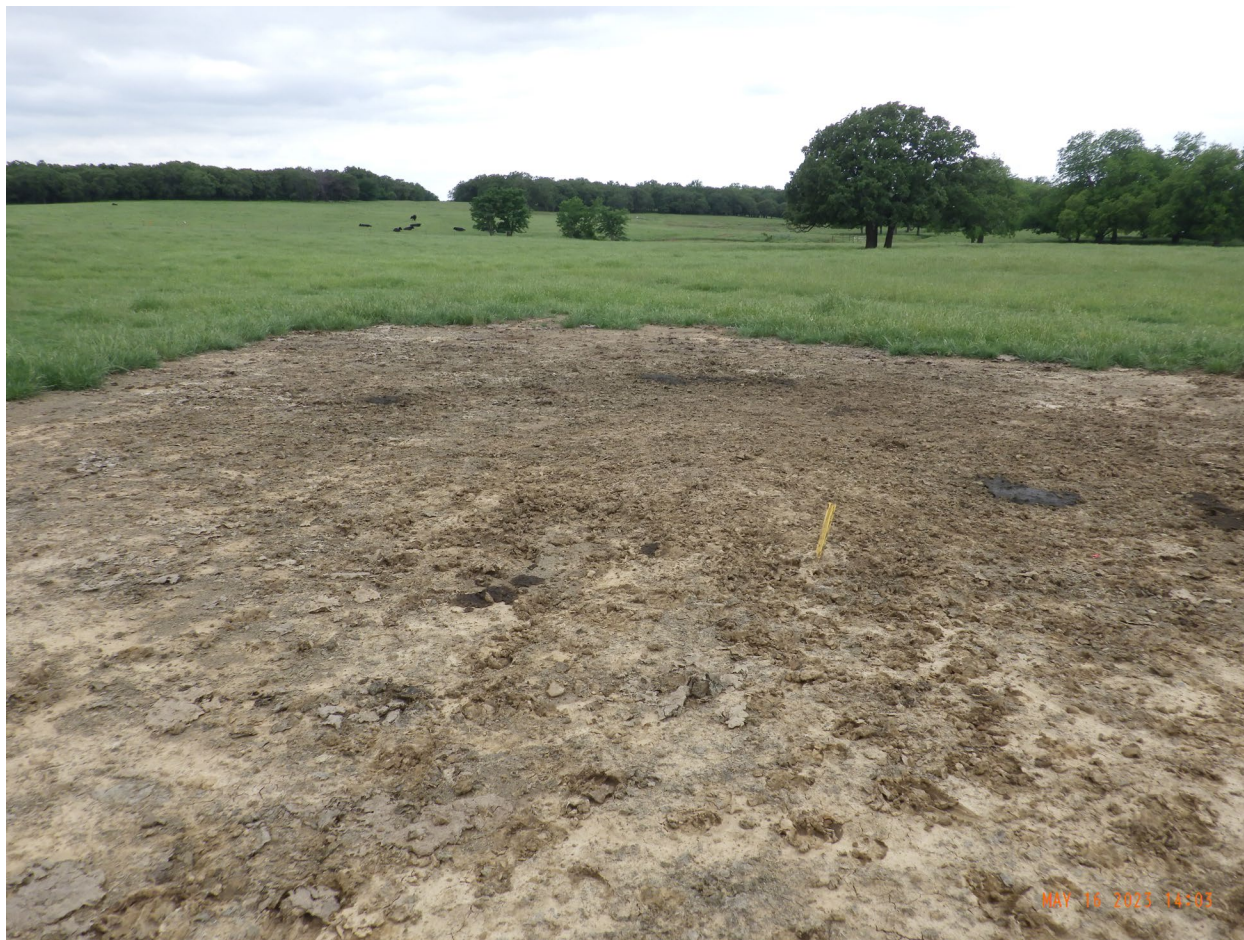
Photo No. 1

At the time of the inspection, the abandoned pipeline was covered up and had been capped by OCC activities to address the potential pipeline leak. The covered location can be seen in **Appendix A**, Photo No. 1.

**Description:** This was a photo of the dug-up pipeline location that was covered back up. According to OCC representatives, this site was a landowner complaint received by OCC. The complainant indicated that surface fluids bubbled up. OCC investigated and concluded that an abandoned pipeline was the source of the fluids that reached the surface.
