# REPORT OF COMPLIANCE EVALUATION INSPECTION

Anderson Farm  
652 West Riverdale Drive  
Nixa, MO 65714  
Christian County

NPDES Permit # MORA20289

November 4, 2024

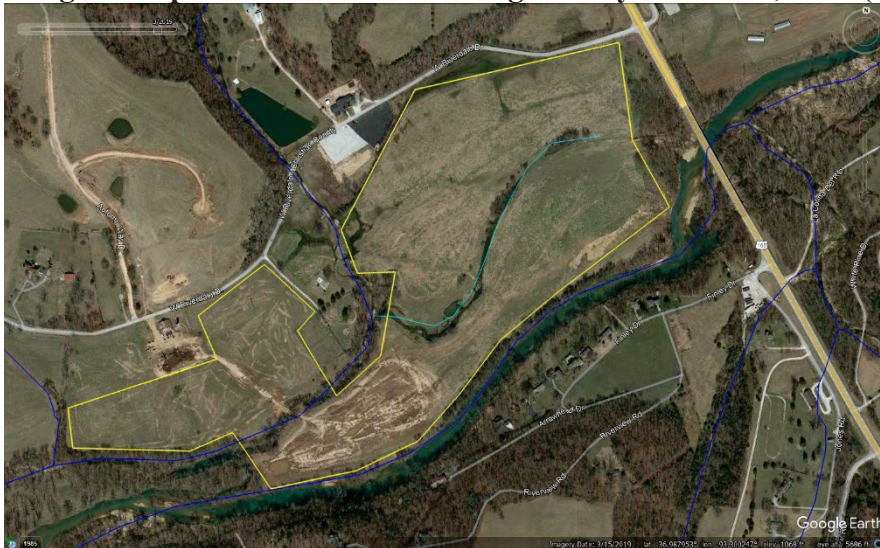
Missouri State Operating Permit MORA12860 was effective September 21, 2019, and expired on February 7, 2022. The permitted area designated by the permittee covers most of Anderson Farm. Image 1 shows land disturbing activity at Anderson Farm in the lower field on March 15, 2019, prior to permit coverage.

**Image 1. Unpermitted land disturbing activity March 15, 2019 (MORA12860 polygon)**

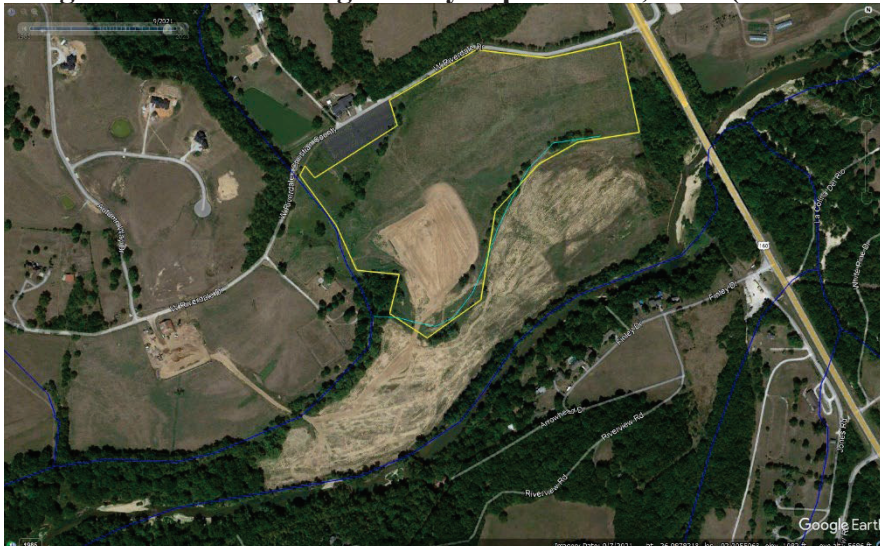
Missouri State Operating Permit MORA20289 was effective February 26, 2022, and expires on February 7, 2027. The permitted area drawn by the permitted indicated activity in the upper field. Image 2 shows land disturbing activity at Anderson Farm in the upper field on September 7, 2021.

**Image 2. Land disturbing activity September 7, 2021 (MORA20289 polygon)**
