## Region 6 - Enforcement & Compliance Assurance Division

### INSPECTION REPORT

| Company Name: | <b>Miranda-Grand Canyon Dairy</b> | |
| Identification/Permit Number: | TX0130923 | |

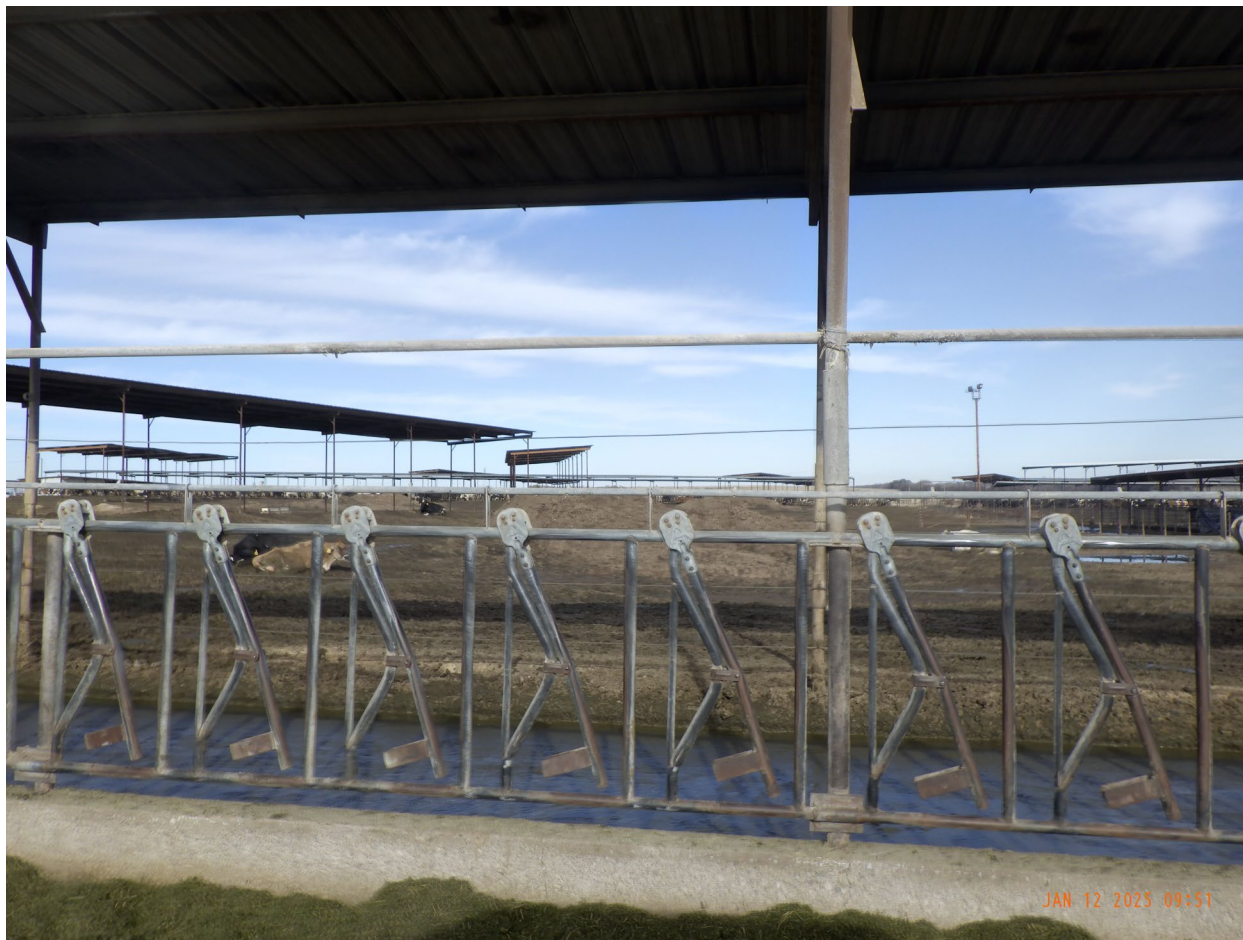
Photo No. 1

Description: Open lot pens with lot scrapings.

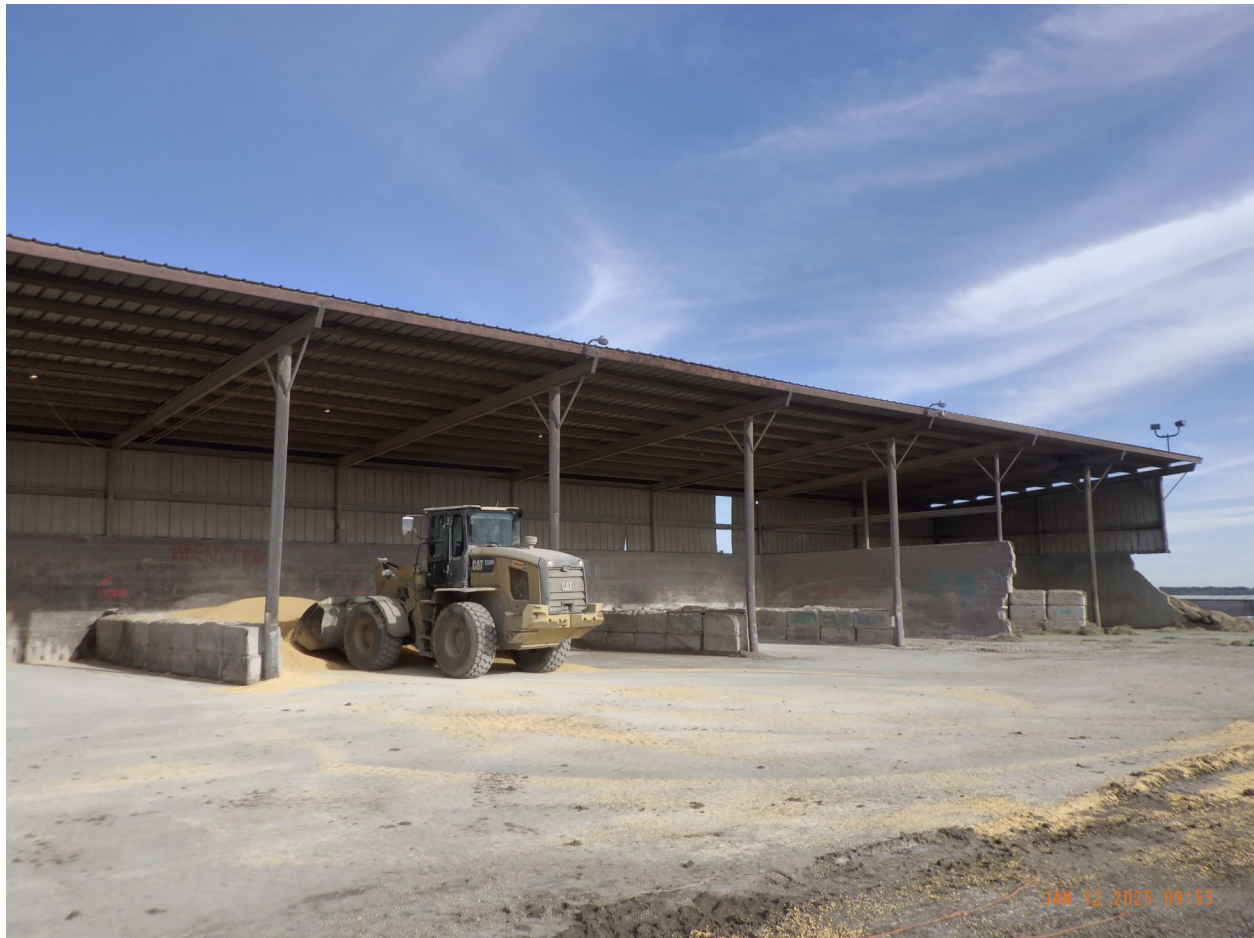
Photo No. 2

Description: Commodities storage under roof.

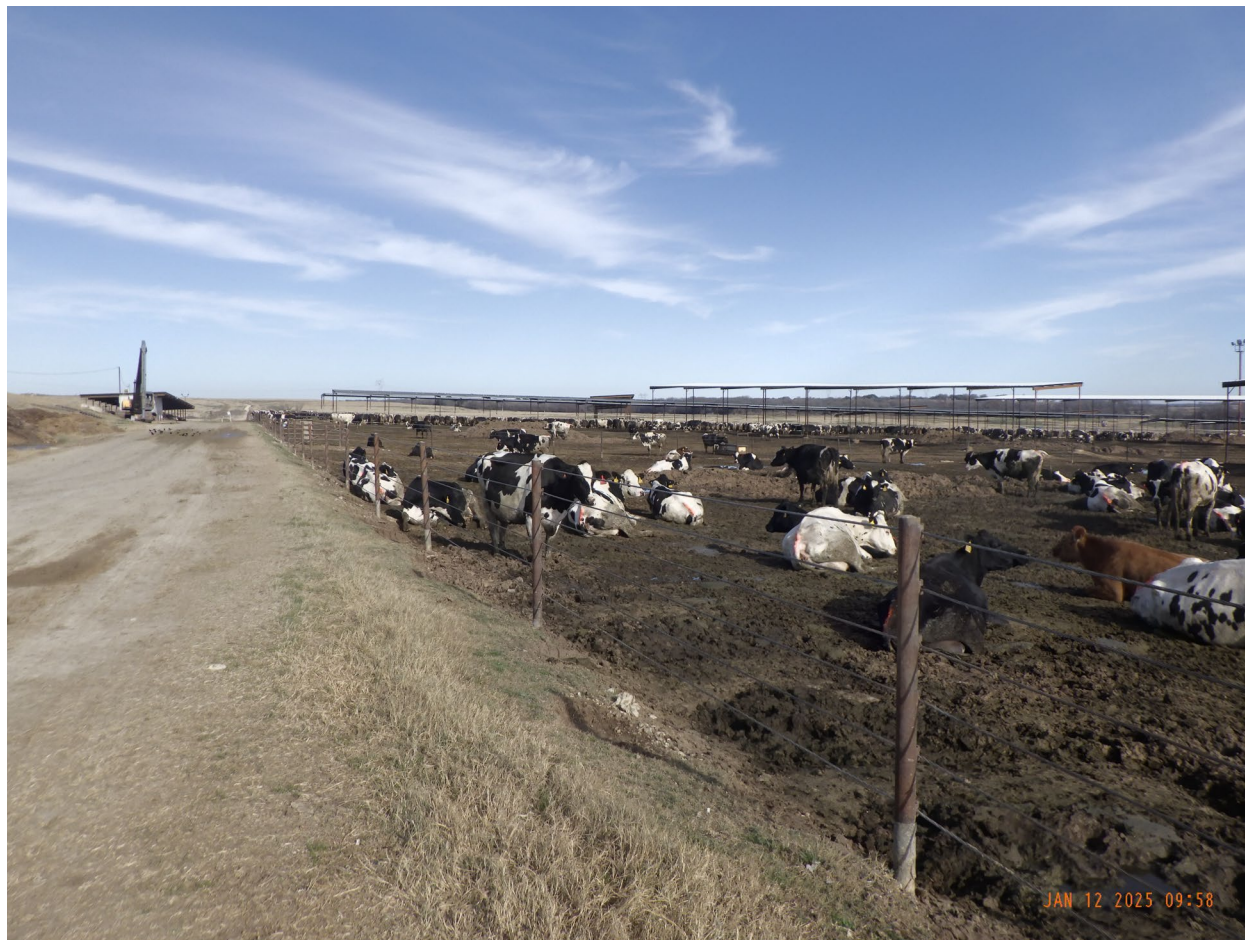
Photo No. 3

Description: Southeastern perimeter of open pens with berm.

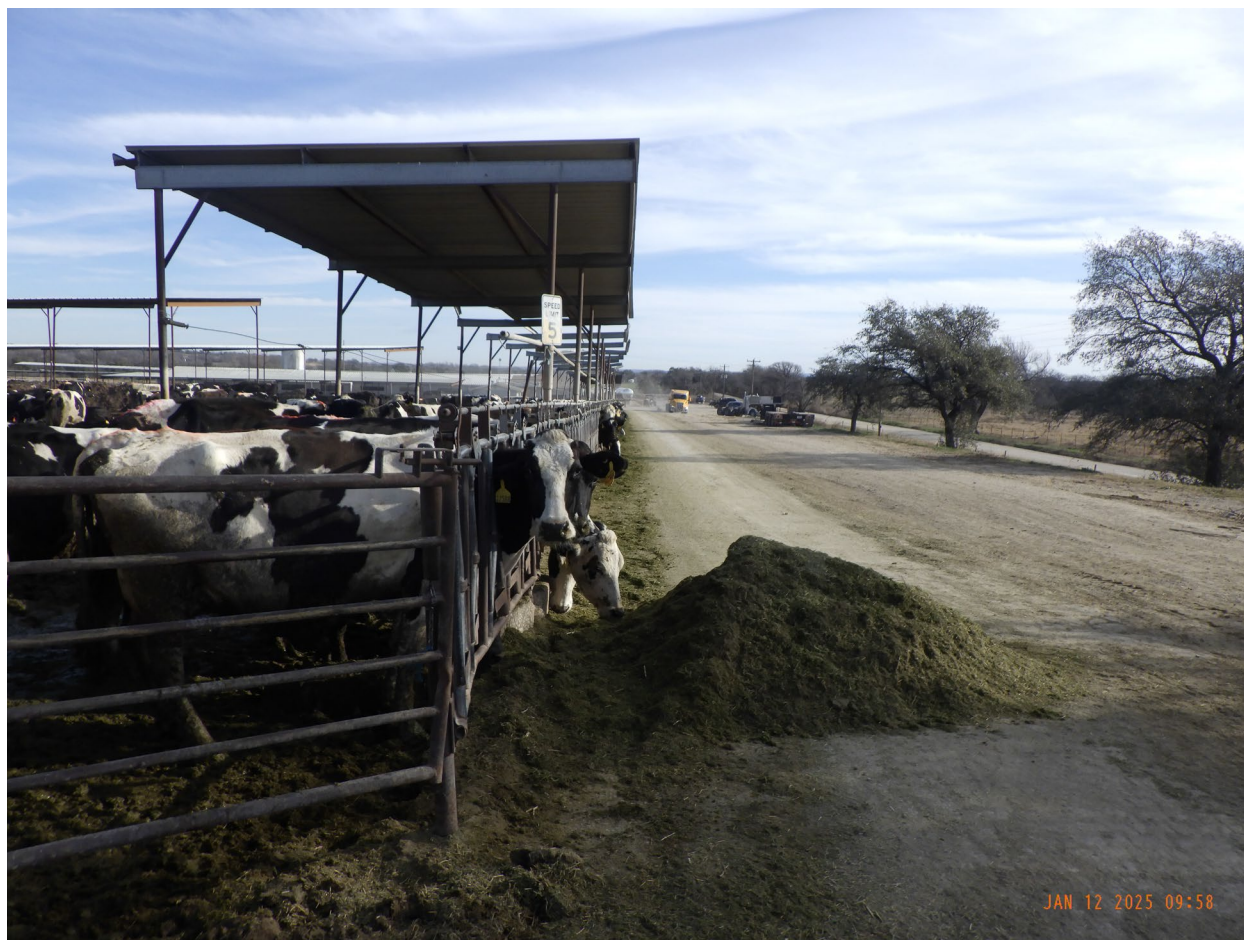
Photo No. 4

Description: Shot of feed lane on southern perimeter of pens.

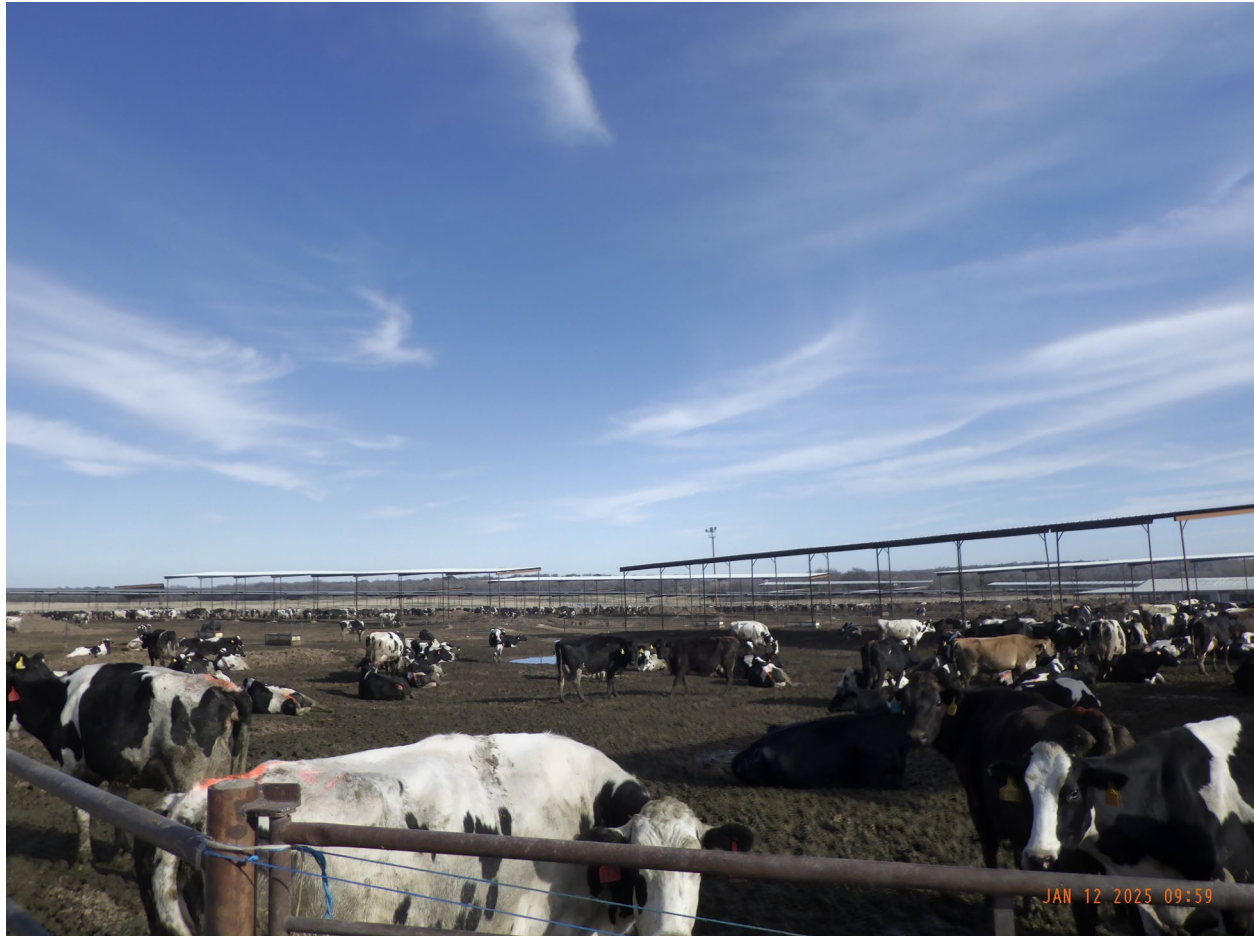
Photo No. 5

Description: Shot of open lot pens showing grading.

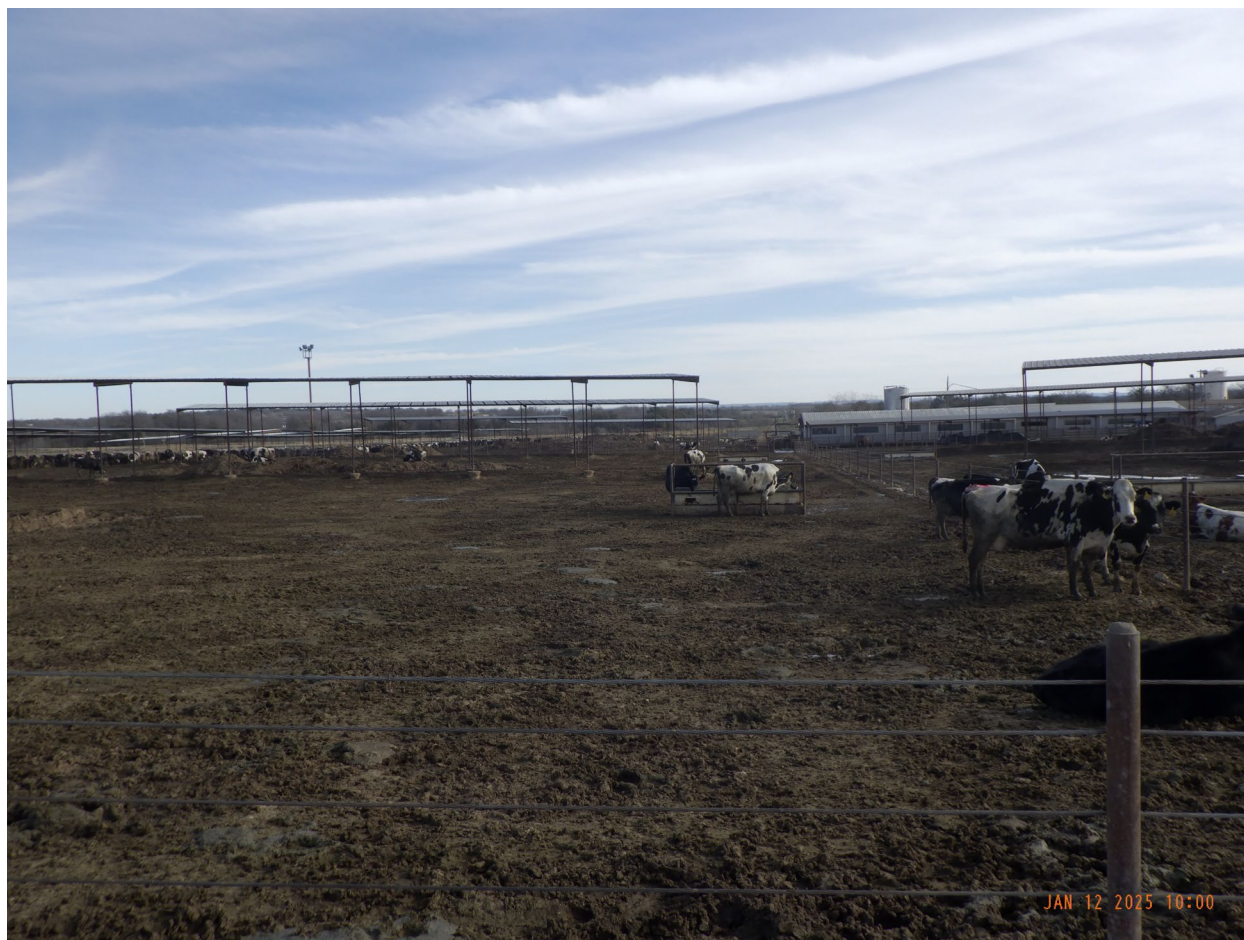
Photo No. 6

Description: Shot of open lot pens showing grading.

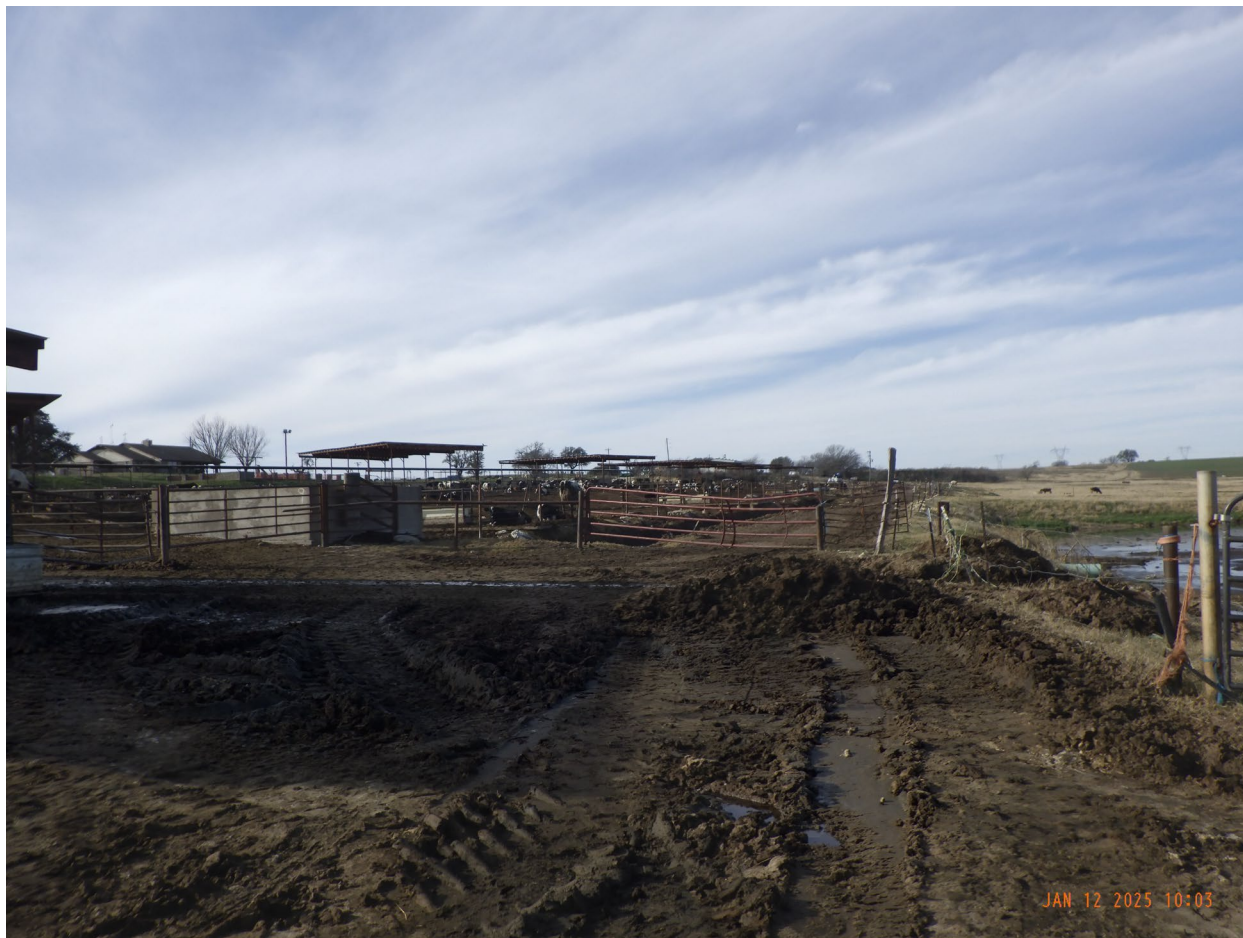
Photo No. 7

Description: Shot of pens draining to settling basins on northern perimeter.

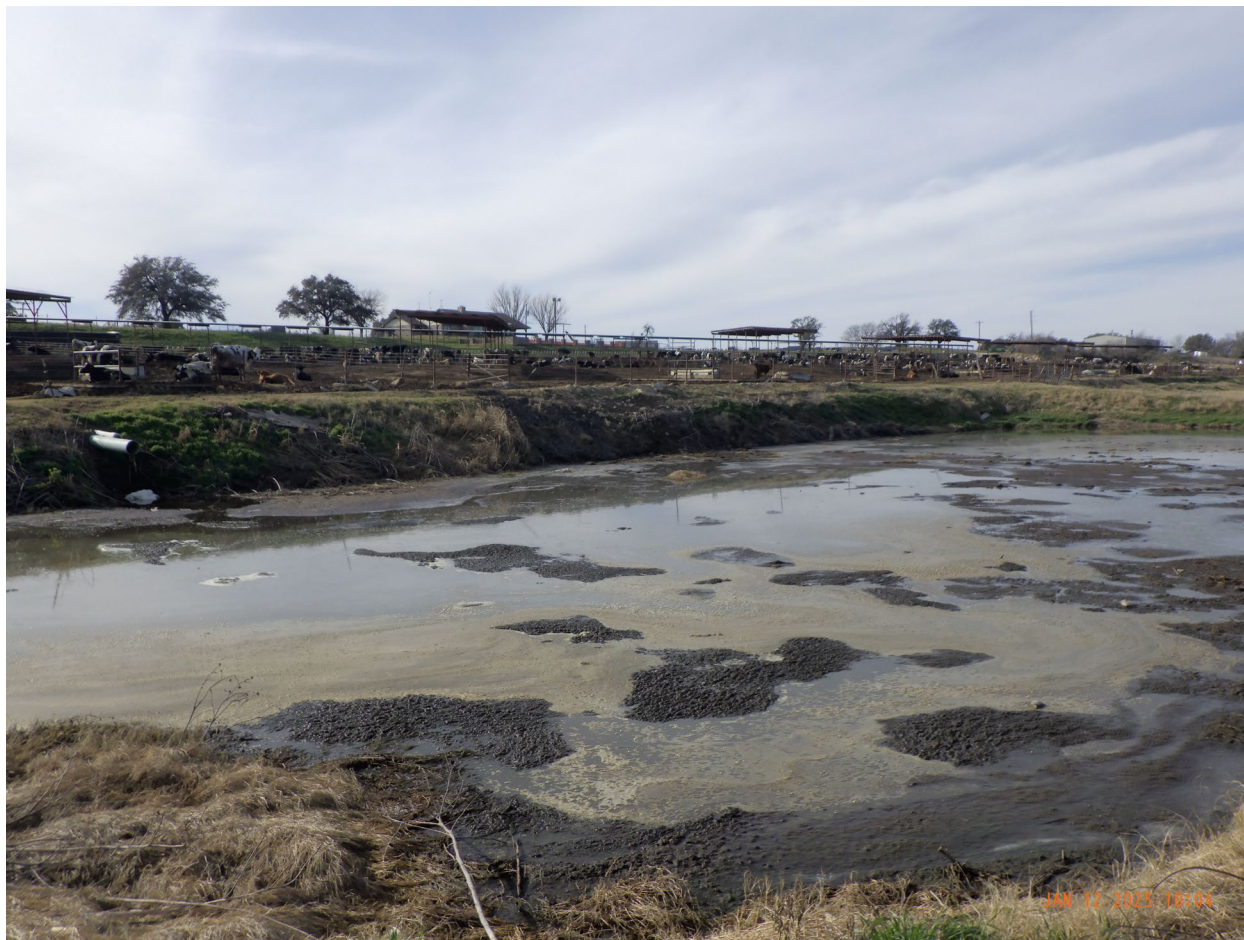
Photo No. 8

Description: Shot of settling basin with pens in background.

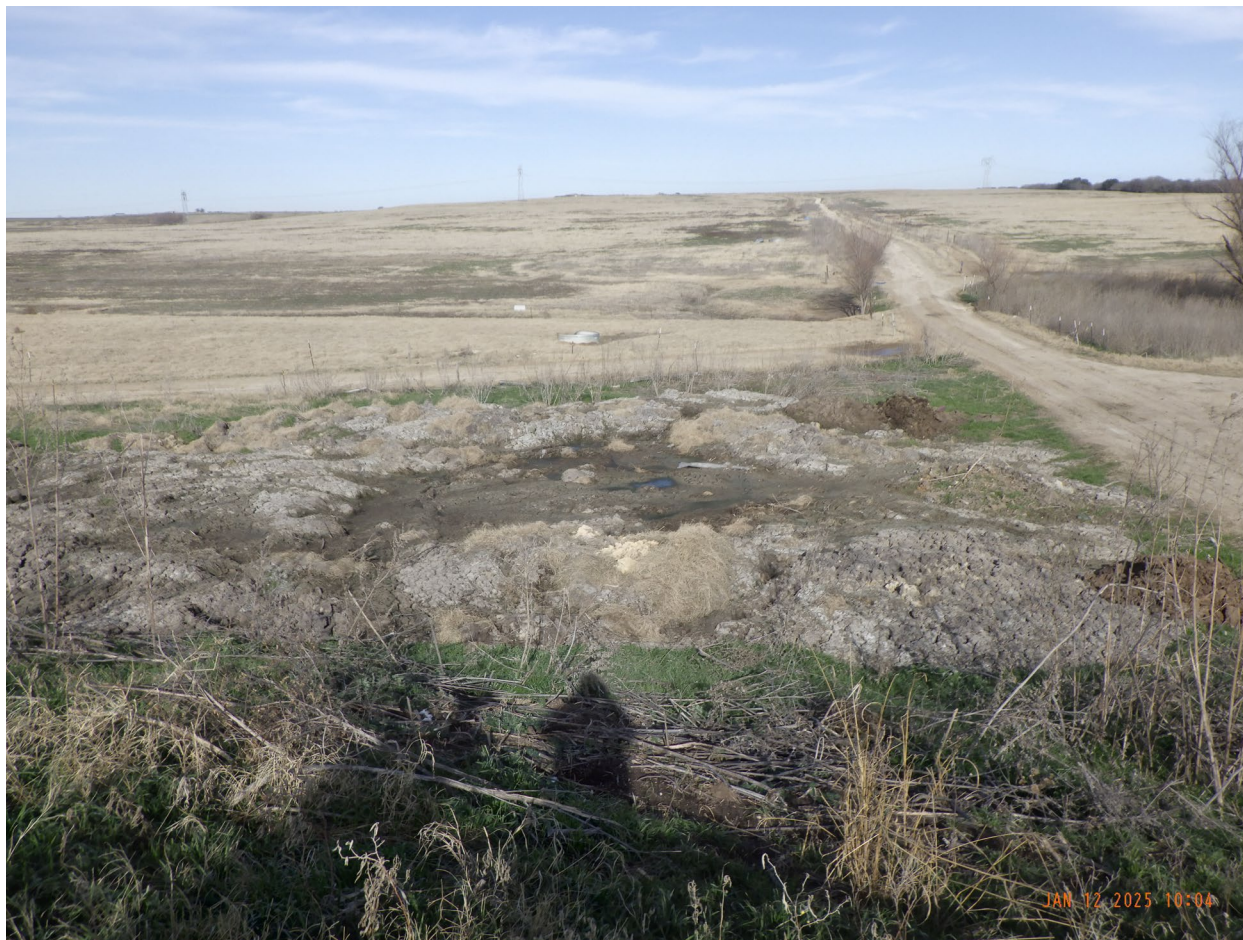
Photo No. 9

Composting is done on site in the field to the north of the pens. Berms were present around the stockpile. However, there was a manure stockpile on site outside the drainage of the RCS and without berms near SB 2 and SB 3 (see Areas of Concern).

2) A manure stockpile was not in the drainage of an RCS or bermed. The TCEQ CAFO general permit Part III.A.9(b) requires that “Manure or sludge stored for more than 30 days must be stored within the drainage area of an RCS or stored in a manner (i.e. storage shed, bermed area, tarp covered area, etc.) that otherwise prevents contaminated stormwater runoff from the storage area.”

Description: Manure stockpile outside drainage of RCS.

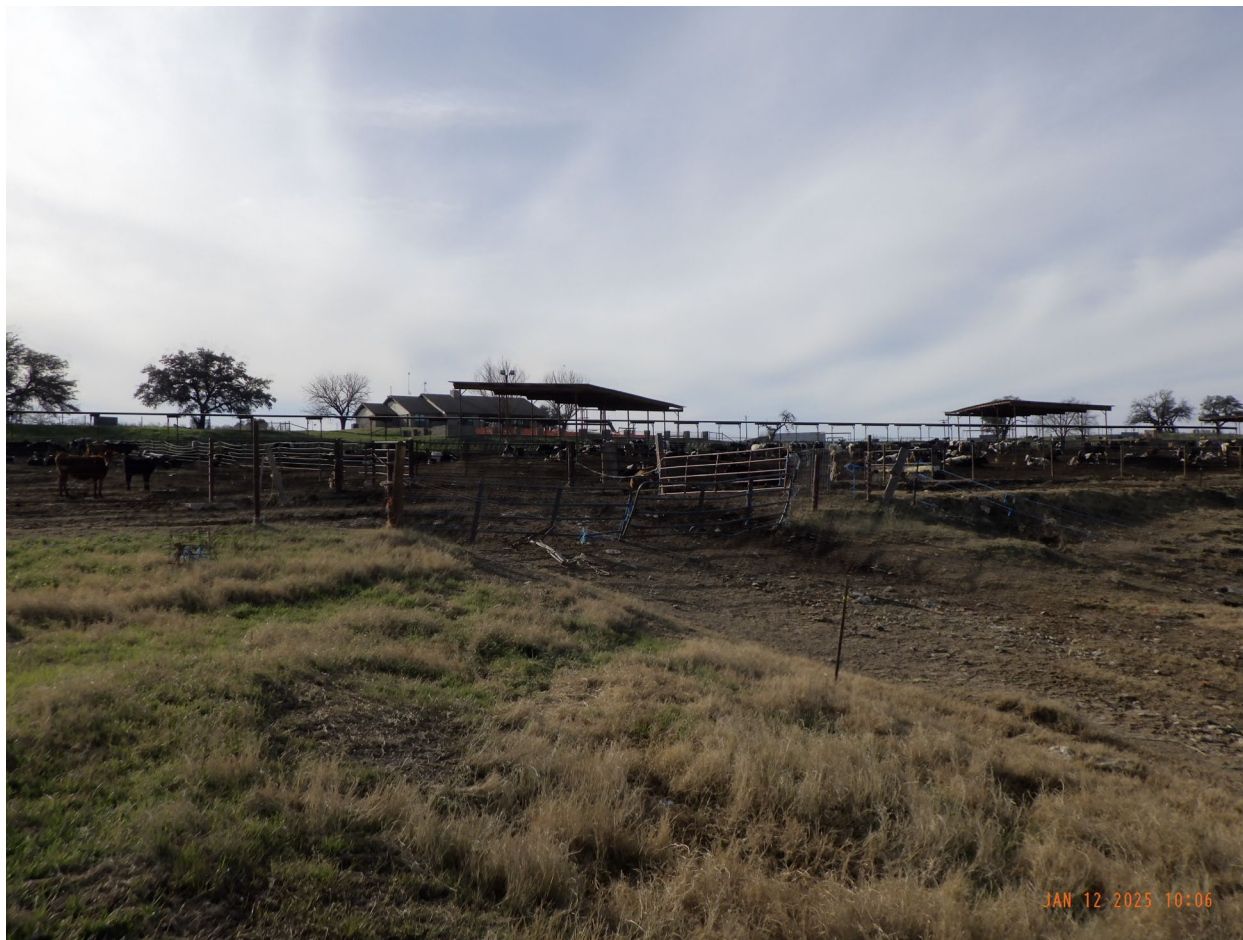
Photo No. 10

1) Two roads leading from the feed lanes on the north side of the property are not adequately bermed to direct runoff coming from pens to the nearby RCSs. The TCEQ CAFO general permit Part III.A.5(a)(4)

requires that “Wastewater must be contained in RCSs properly, designed, constructed, operated, and maintained according to the provisions of this general permit.”

Description: Road without berm at northwestern corner of pens near settling basin. Pens in background.

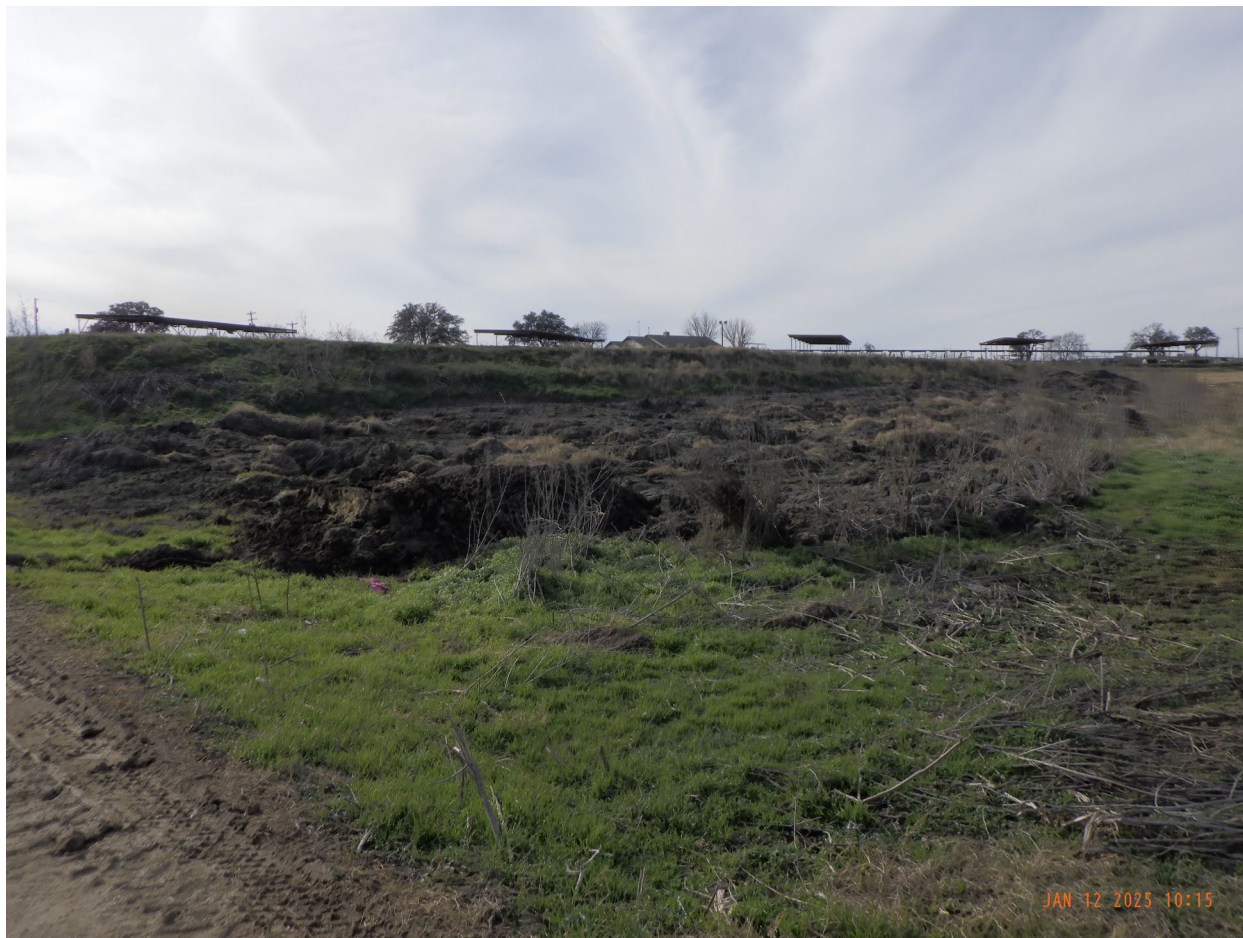
Photo No. 11

Description: Manure stockpile not in the drainage of RCS or bermed.

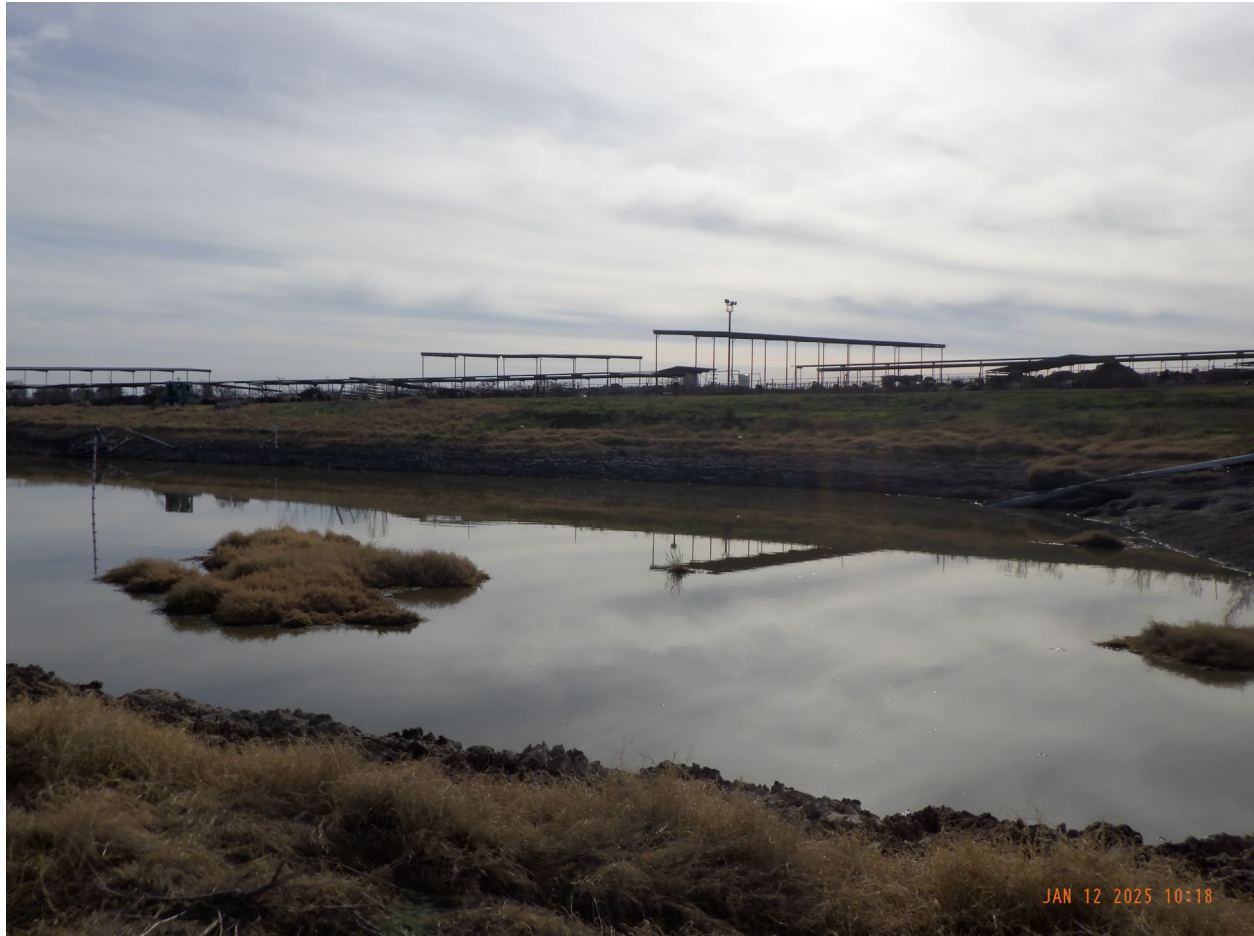
Photo No. 12

Description: RCS 2 with pole marker and pens in background.

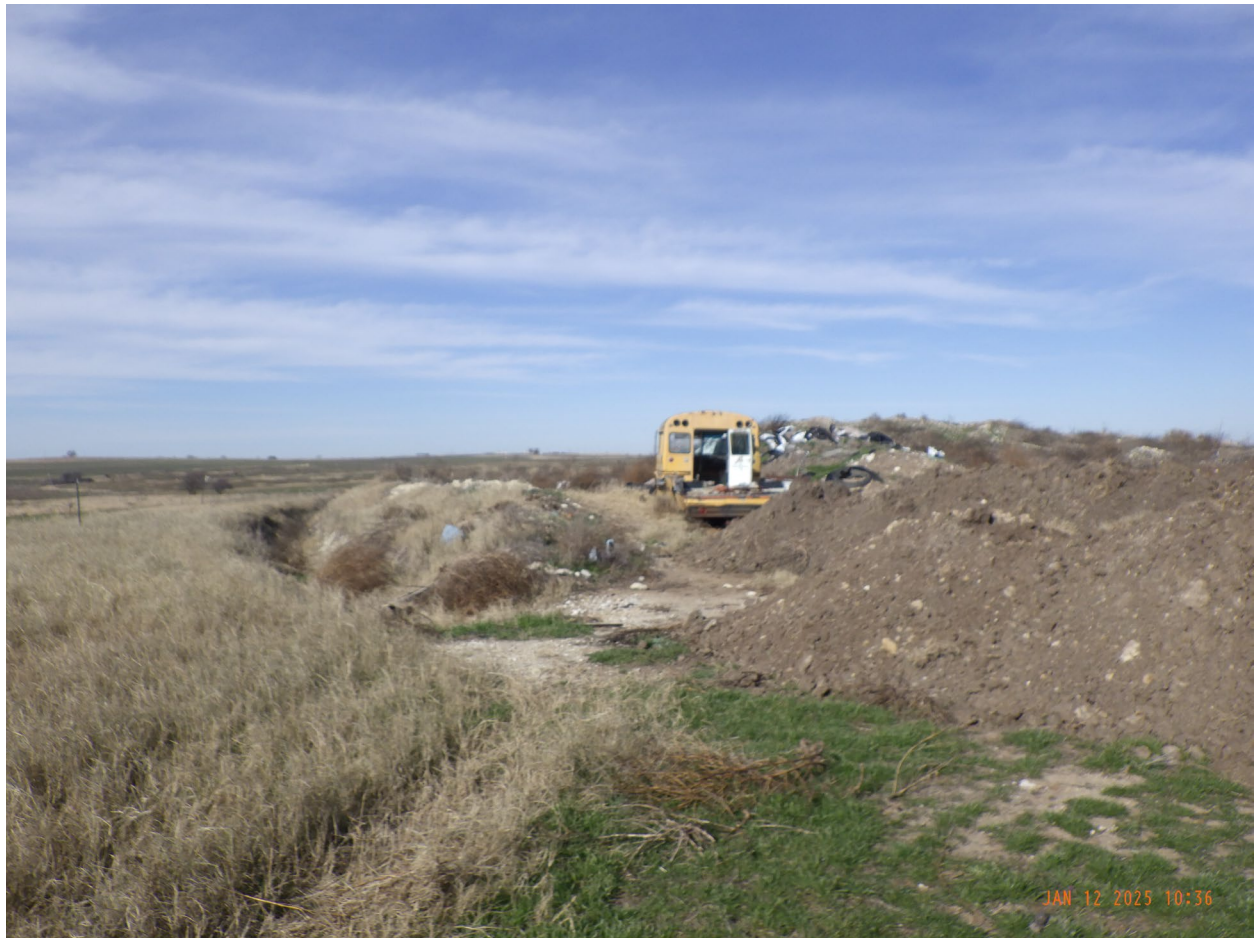
Photo No. 13

Description: Berm surrounding manure stockpile.

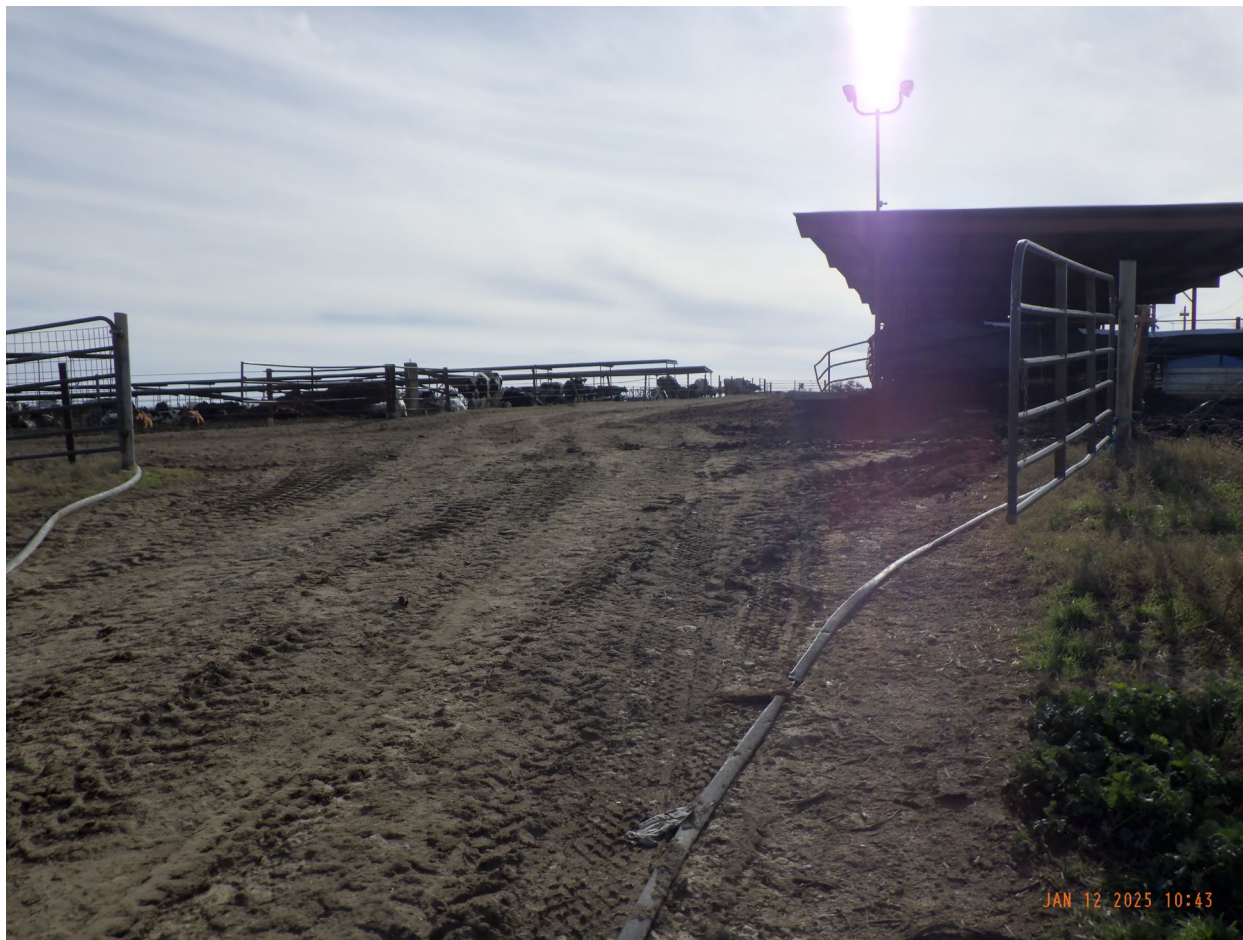
Photo No. 14

Description: Shot of road near RCS 2 and northwestern pens. Lack of berm to direct runoff.

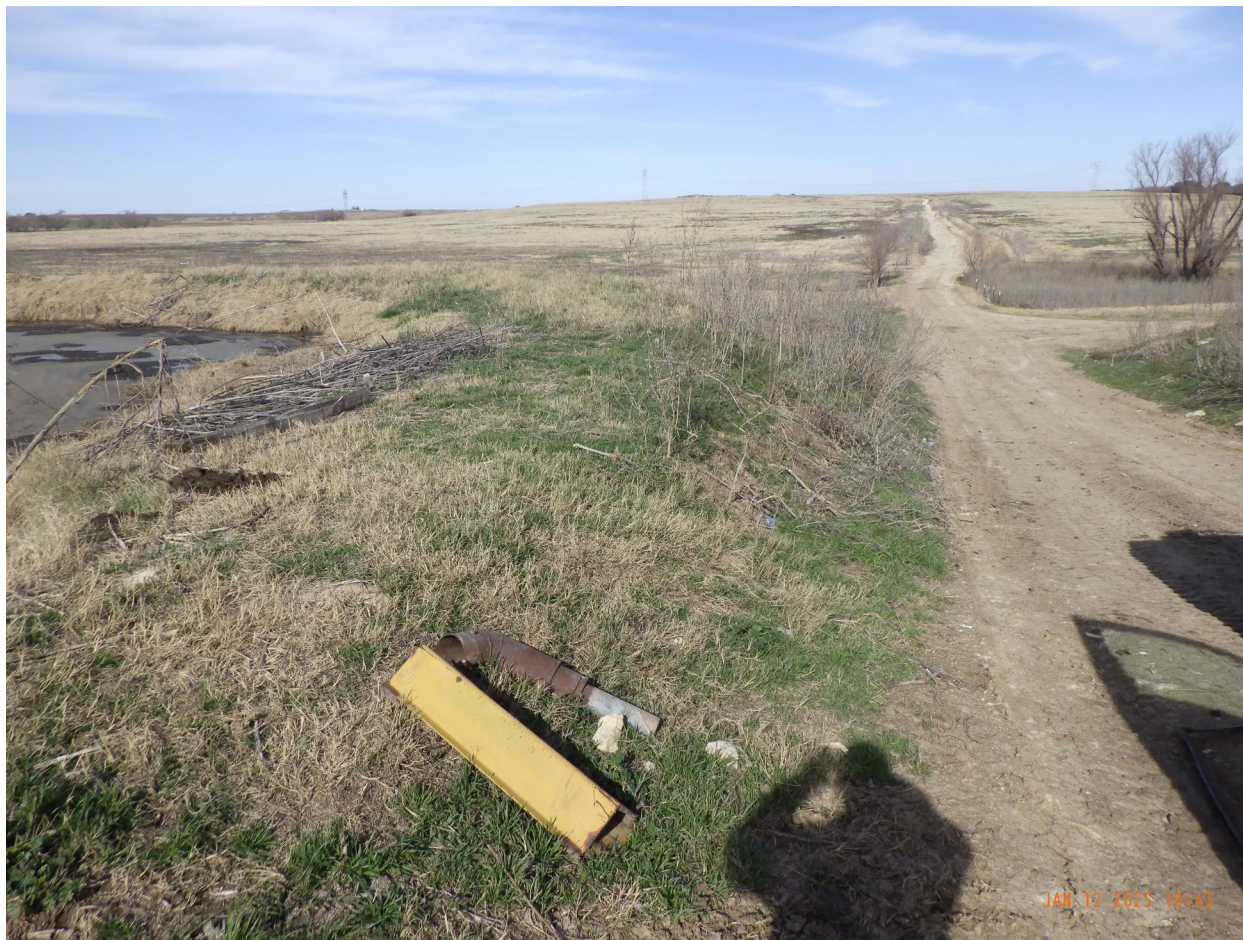
Photo No. 15

Description: Shot of road between settling basins. Lack of berm to direct runoff.

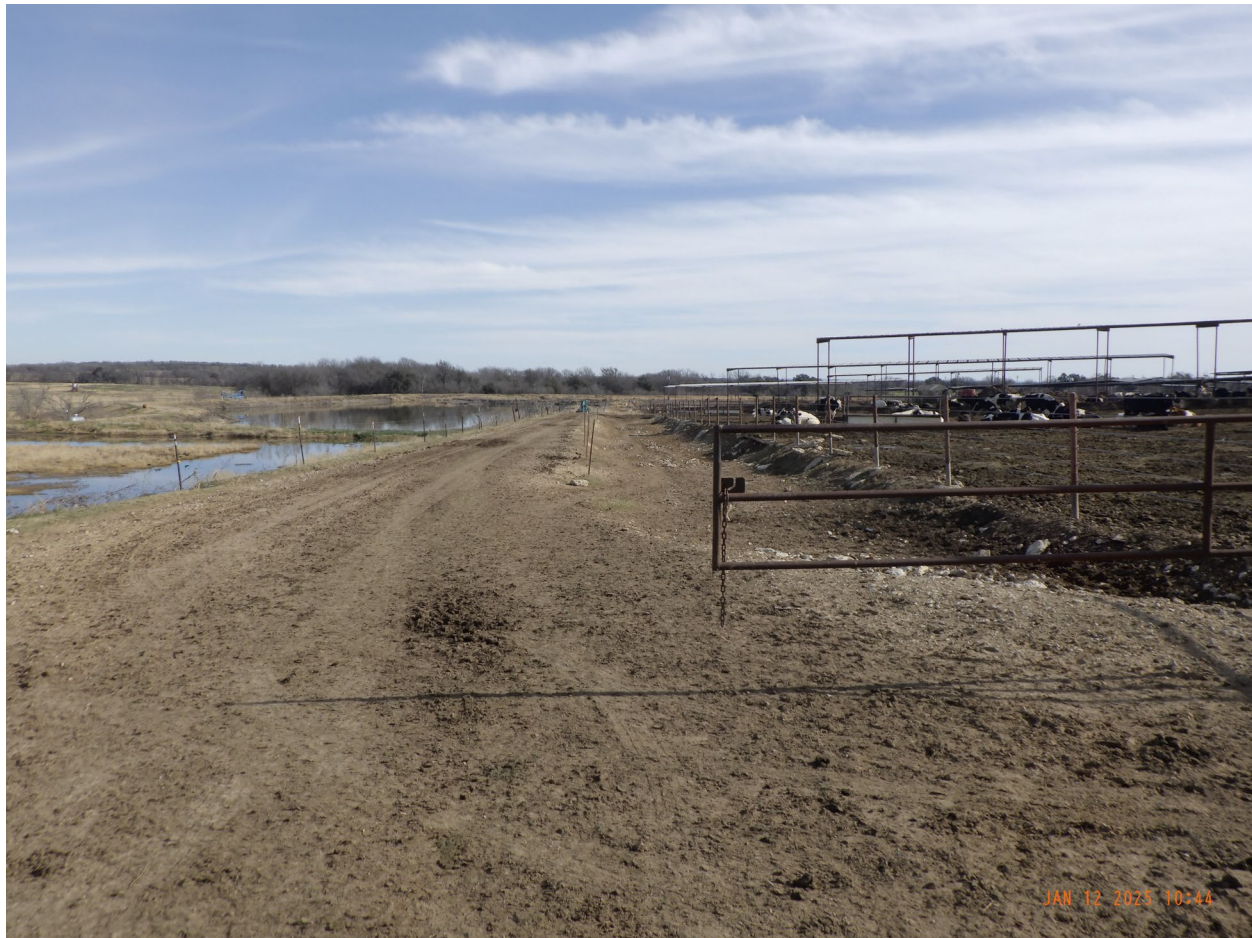
Photo No. 16

Description: Shot of northwestern perimeter of pens with channel leading to RCS 2 and Settling basin 2.

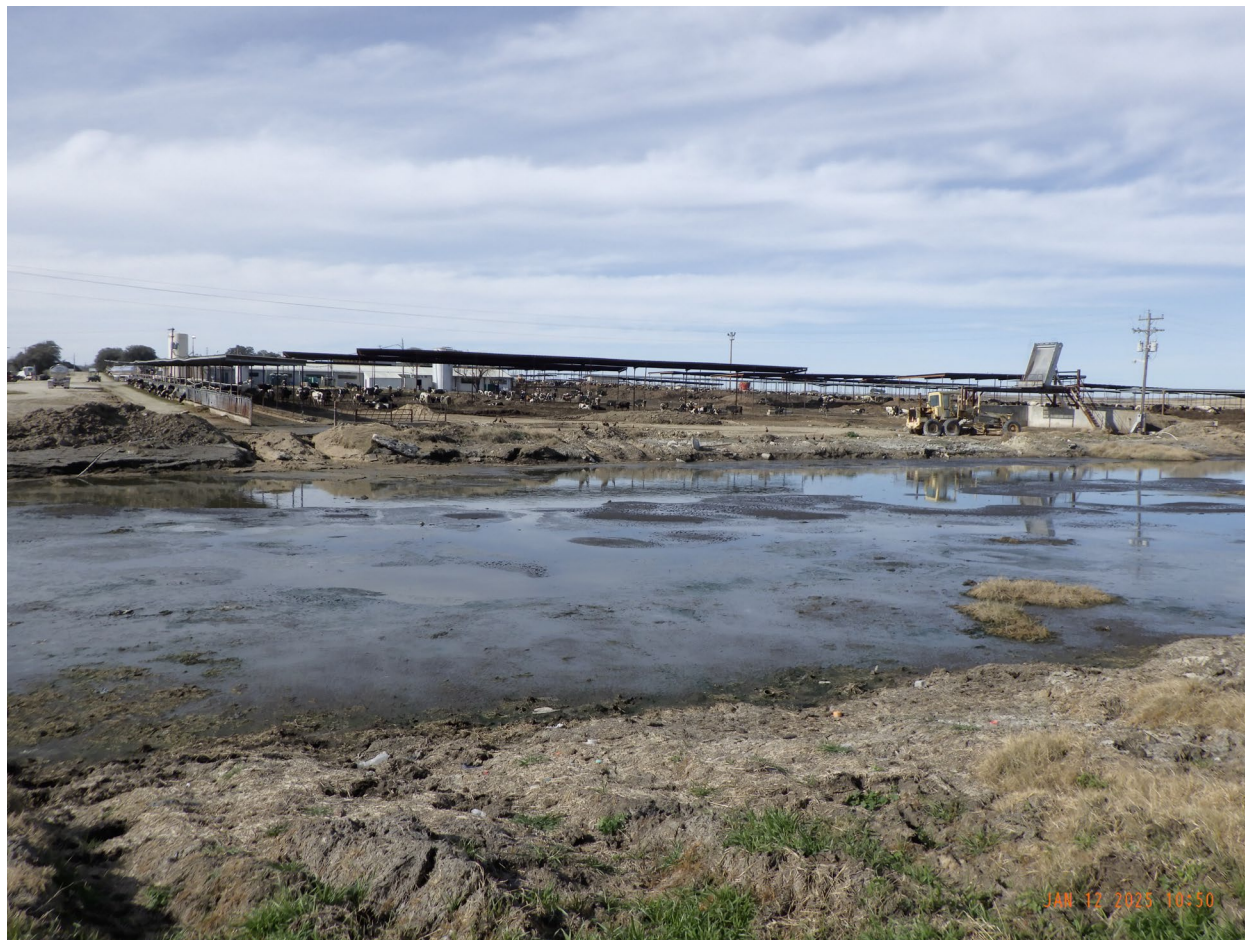
Photo No. 17

Description: Settling basin 1 with pens and manure screen in background.

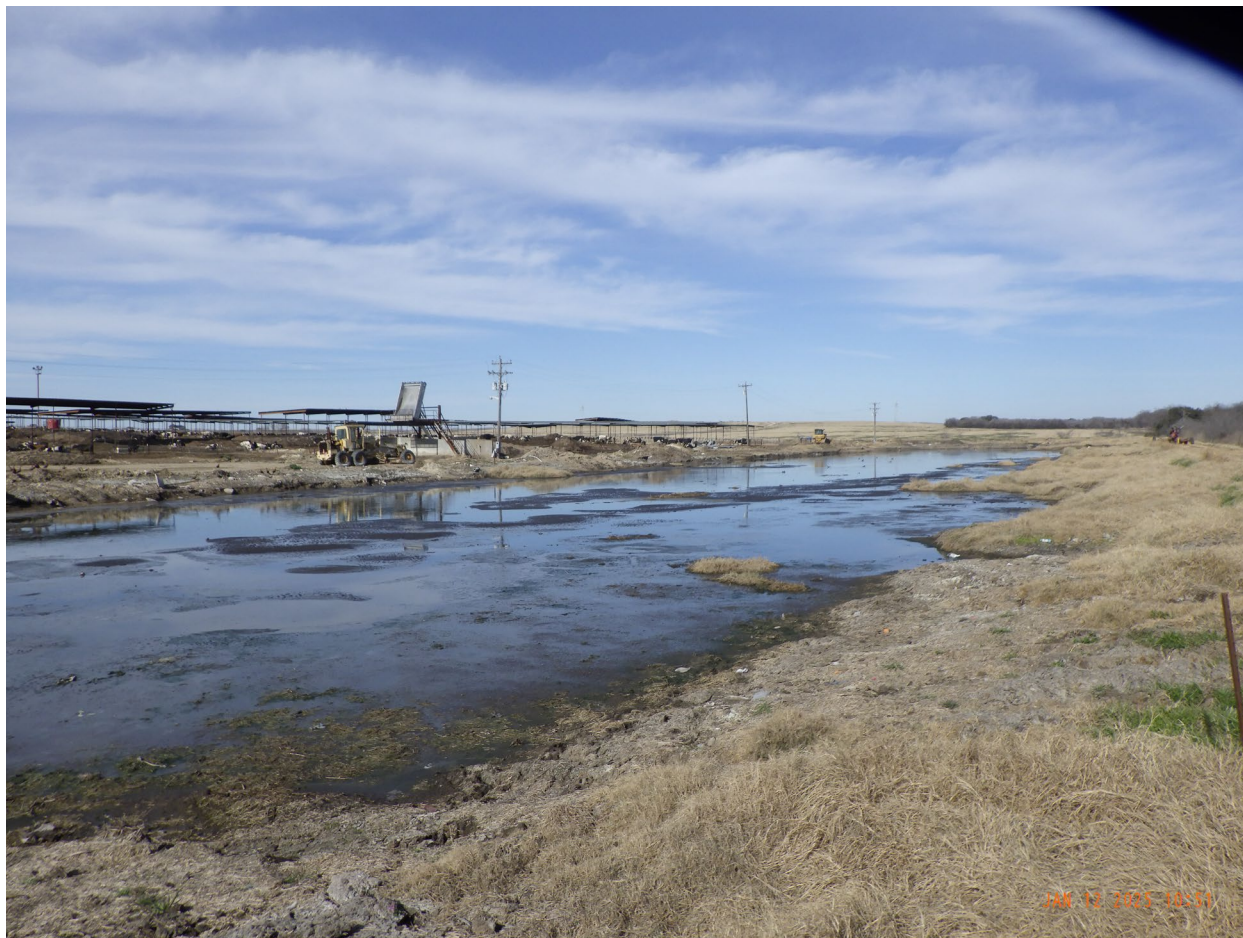
Photo No. 18

Description: Settling basin 1 with manure screen and pens in background.

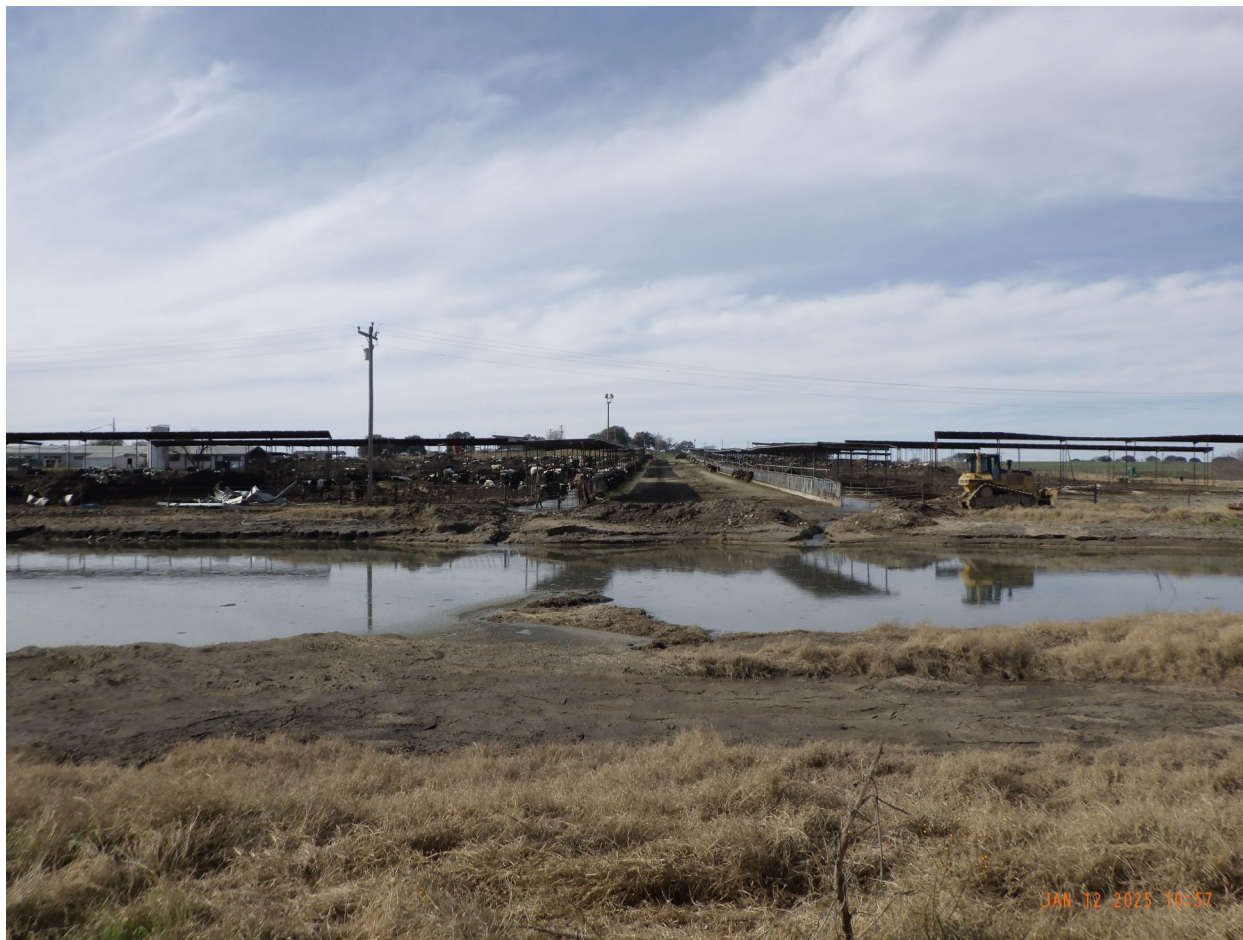
Photo No. 19

Description: Shot of pens and feed lane that drains to settling basin 1 (on left) and RCS 1 (on right).
