## Region 6 - Enforcement & Compliance Assurance Division

### INSPECTION REPORT

| Company Name: | <b>Miranda-Grand Canyon Dairy</b> | |
| Identification/Permit Number: | TX0130923 | |

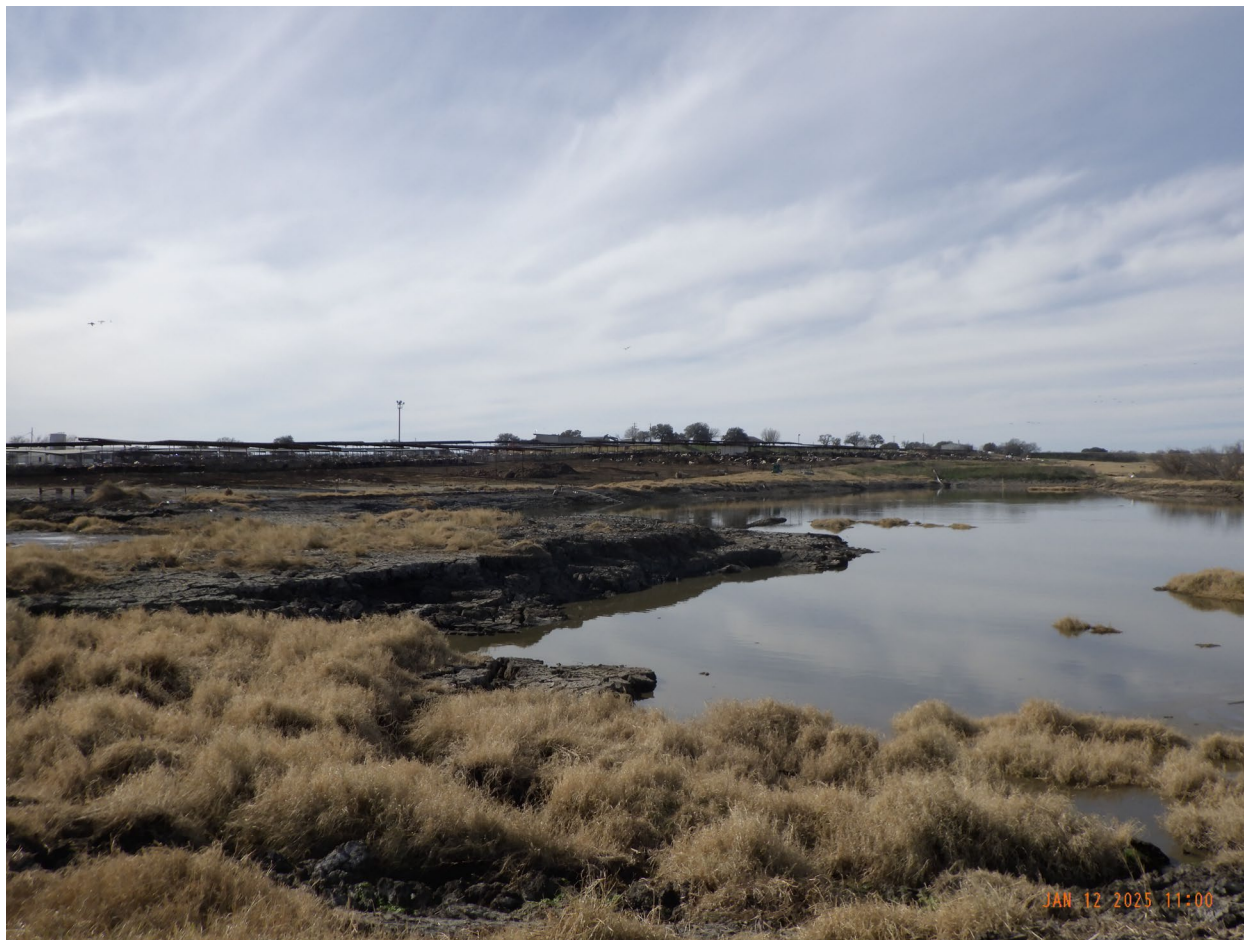
Photo No. 20

Description: Shot of RCS 2 with pens in background and RCS 1 to the left.

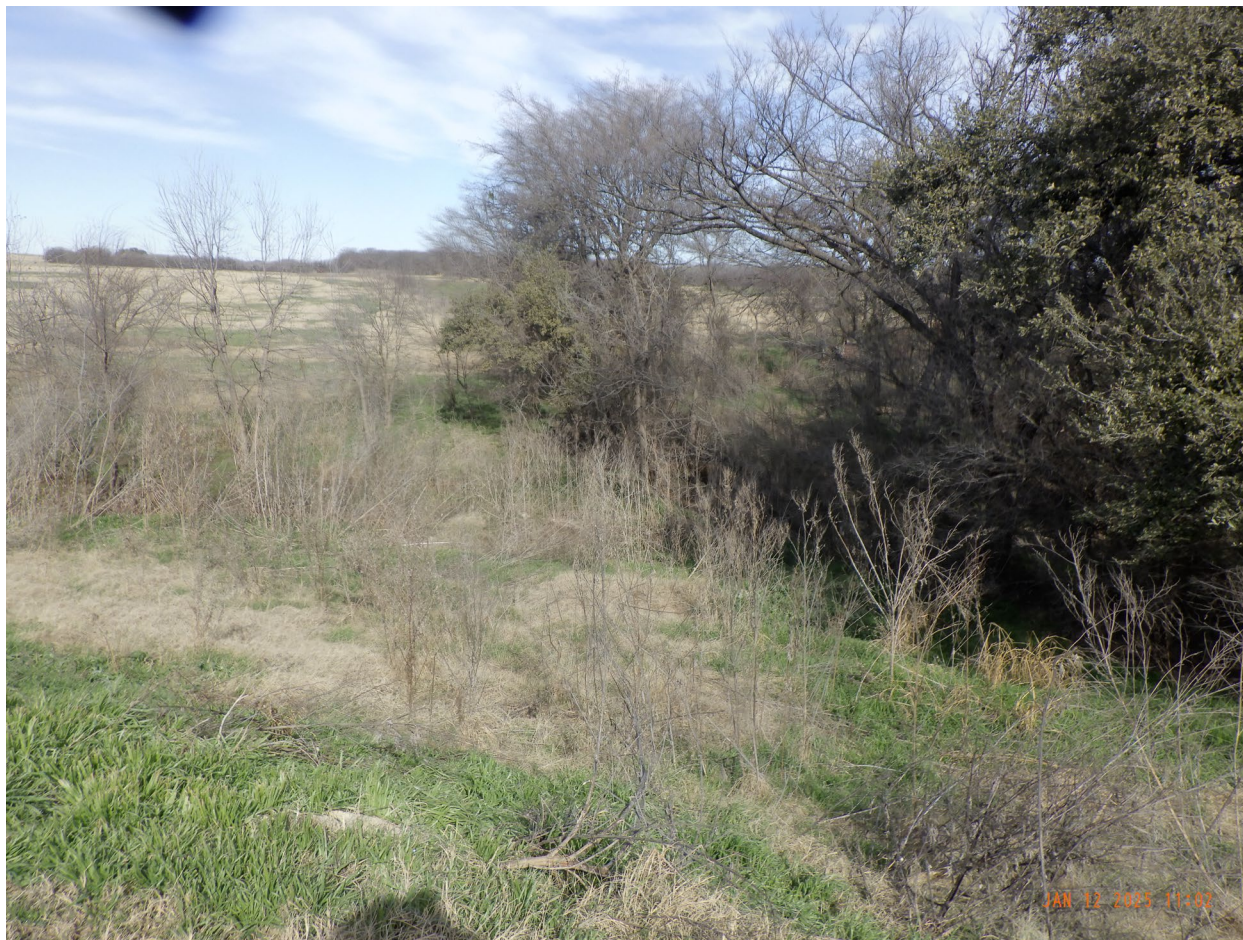
Photo No. 21

Description: Shot of creek behind berm of RCS 2. No evidence of discharge.
