## Compliance Inspection Report for Stormwater Discharges from Construction Activities (CGP)

| <b>Site/Project Name:</b><br>Ashmont Planned Development | | <b>NPDES Tracking Number:</b><br>TNR155437 | | <b>Date Coverage was Issued:</b><br>April 10, 2023 | |
| <b>Name of Permittee (Developer/Operator):</b> Ashmont Developer LLC | | | | | |

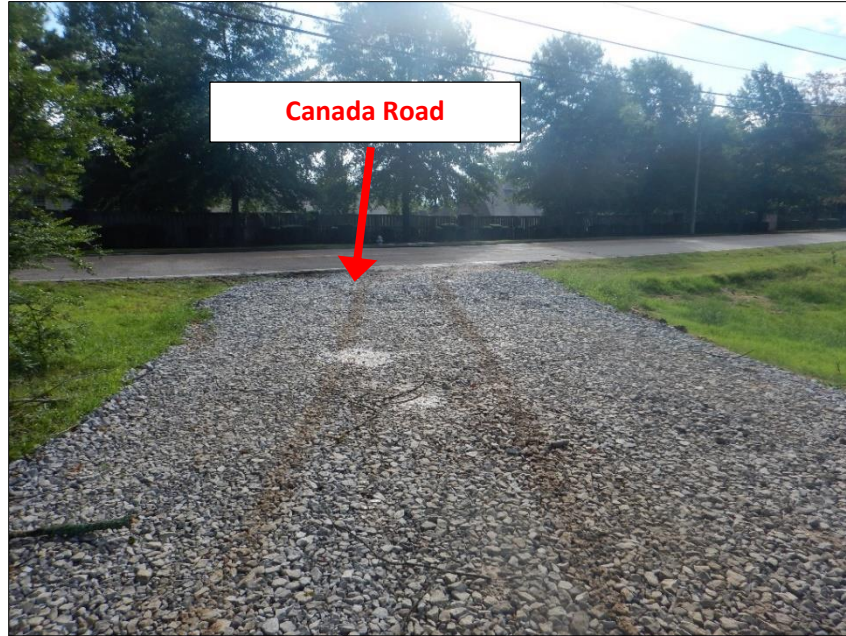
| 5. FIELD EVALUATION & PLAN IMPLEMENTATION | | |
|---|---|---|
| d. Are EPSCs functioning correctly at ingress/egress points such that there is no evidence of track out? | No | The EPA Inspection Team did not observe track out from the Site; however, the EPA Inspection Team observed the Site's rock track-out pad installed at the ingress/egress from Canada Road was not installed to the specification and detail in the Site's ESC plan [Refer to <u>Appendix B, Photograph Log (Photographs 1 through 3)</u> ]. |

Photograph 1. View, facing east, of the stabilized construction entrance/exit off Canada Road.

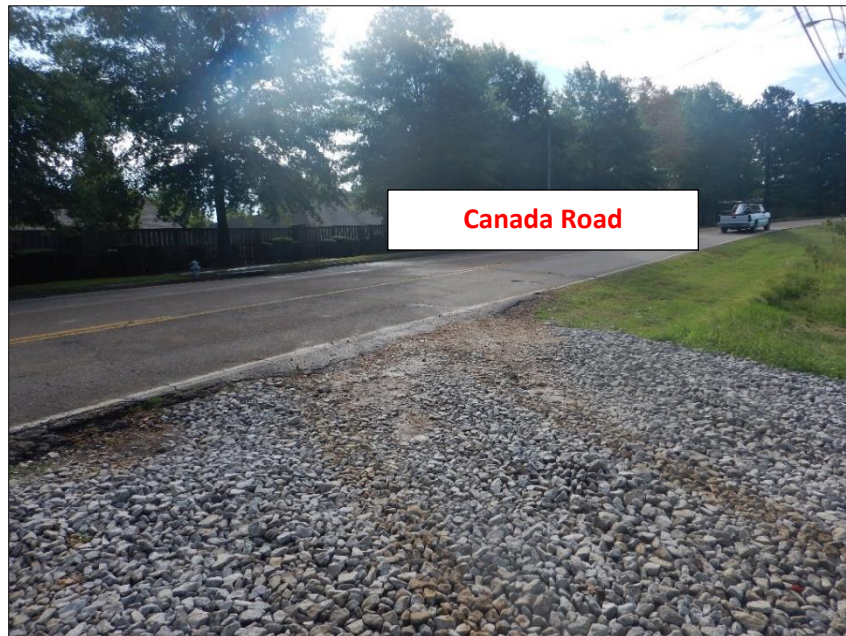
Photograph 2. View, facing southeast, of the stabilized construction entrance/exit off Canada Road. Minor sediment track out was observed. Bare spots were present between the stabilized entrance and Canada Road.

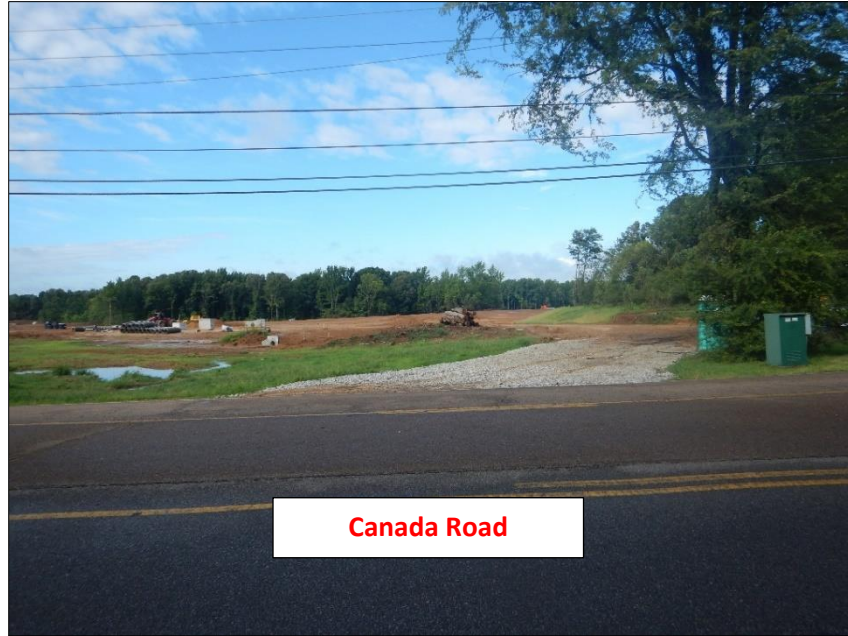
Photograph 3. View, facing west, of the stabilized construction entrance/exit off Canada Road.

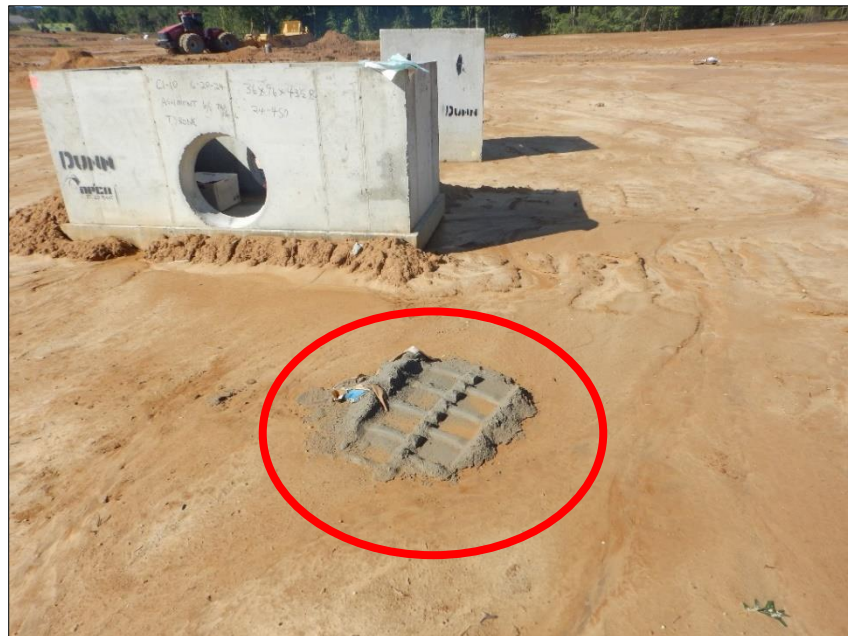
| 5. FIELD EVALUATION & PLAN IMPLEMENTATION | | | |
|---|---|---|---|
| p. Proper Storage & Control of Construction Debris & Chemicals (i.e., sand, litter, paint, solvents, petroleum, & etc.) | No | <p>No storage of chemicals or solvents was observed during the inspection.</p> <p>The EPA Inspection Team observed one (1) hardened concrete bag on the ground surface west of the construction entrance off Canada Road [Refer to <b>Appendix B, Photograph Log (Photograph 4)</b>].</p> | |

Photograph 4. View, facing west, of a hardened bag of concrete mix (red circle) on the ground surface in the northeastern portion of the Site.

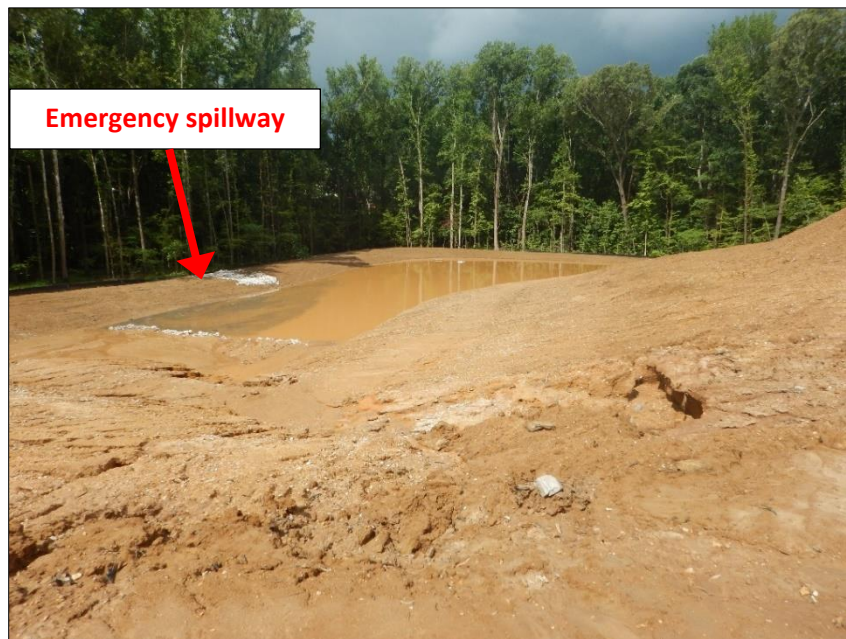
Photograph 6. Downgradient view, facing west, of a permanent sediment basin located in the northwestern portion of the Site. Rill erosion was visible on the unstabilized slopes leading to the basin.

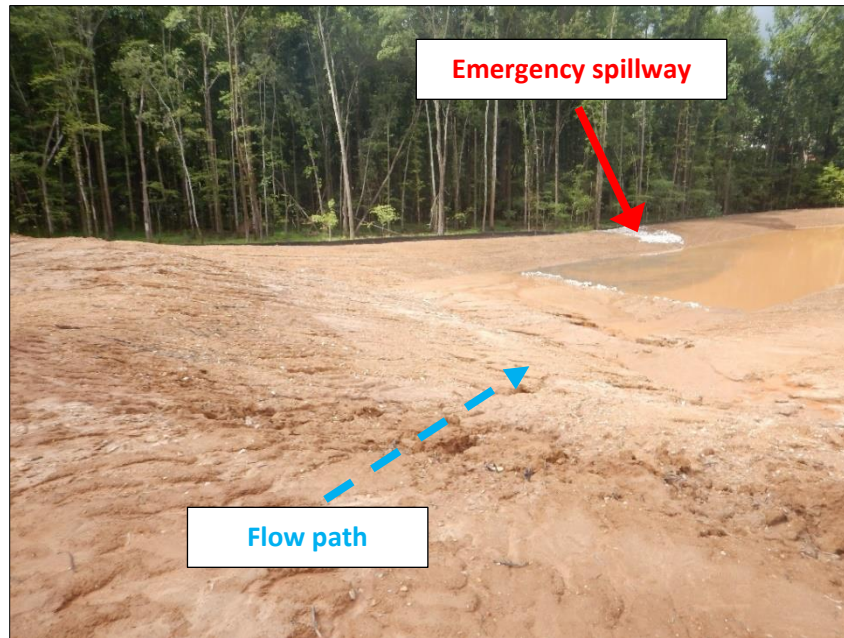
Photograph 7. View, facing west, of the permanent sediment basin in the northwest corner of the Site. Rill erosion was visible on the unstabilized slopes leading to the basin.

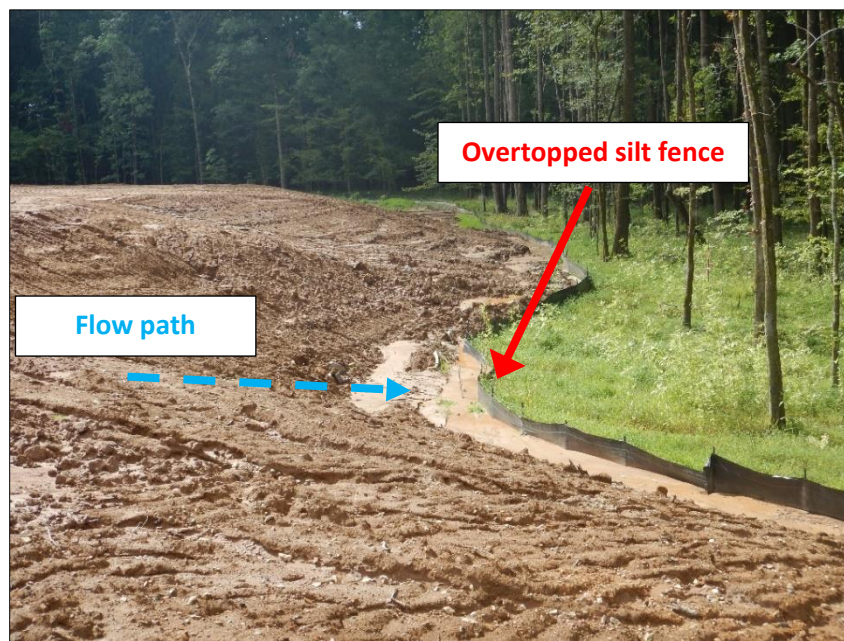
The EPA Inspection Team observed silt fence with sediment accumulation that reduced the capacity of the control by at least 40% [Refer to **Appendix B, Photograph Log (Photographs 8, 12, 13, 14, 16, 17, 19, 20, 24, 25, 28, 35, 40, 48, 52, 61, 62, 64, 66, 67, and 68)**].

The TDEC ESC Handbook silt fence construction specifications state that ponding water depth shall not exceed 1.5 feet, ponding water depths approaching or exceeding 1.5 feet were observed at more than three (3) locations during the inspection (Refer to **Appendix B, Photograph Log (Photographs 8, 12, and 20)**].

Photograph 8. View, facing south, of an unstabilized slope with rill erosion in the northern portion of the Site. The silt fence at the base of the slope had been overtopped by sediment and stormwater.

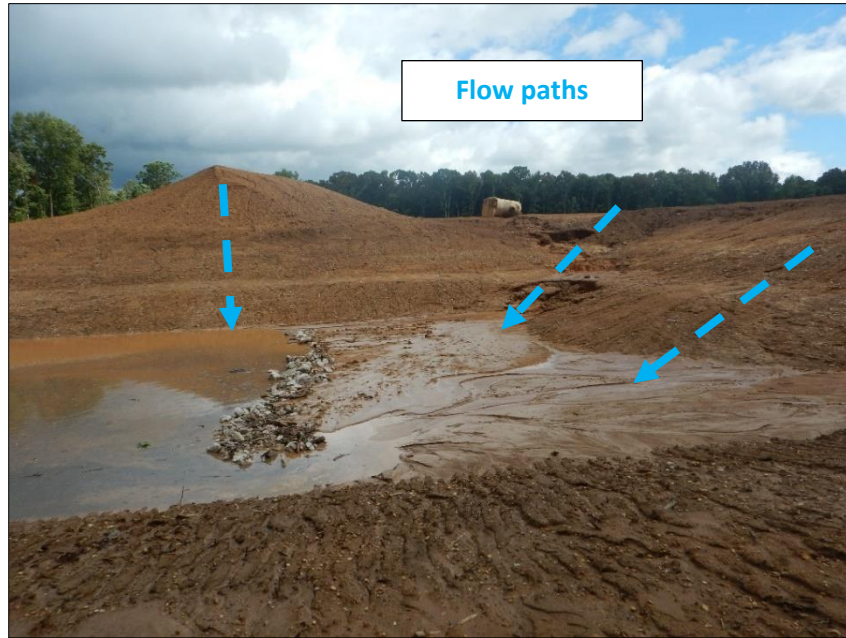
Photograph 9. View, facing north, of the basin shown in Photographs 6 and 7. Rill erosion was visible on the unstabilized slopes leading to the basin.

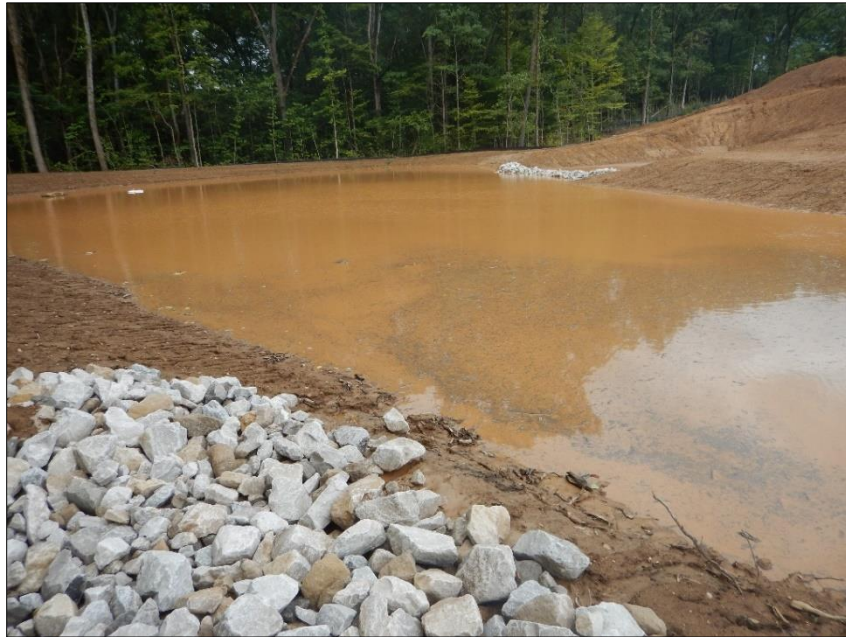
Photograph 10. View, facing northwest, of the sediment basin shown in Photographs 6, 7, and 9. The basin contained sediment-laden water but no discharge occurring at the time of the inspection.

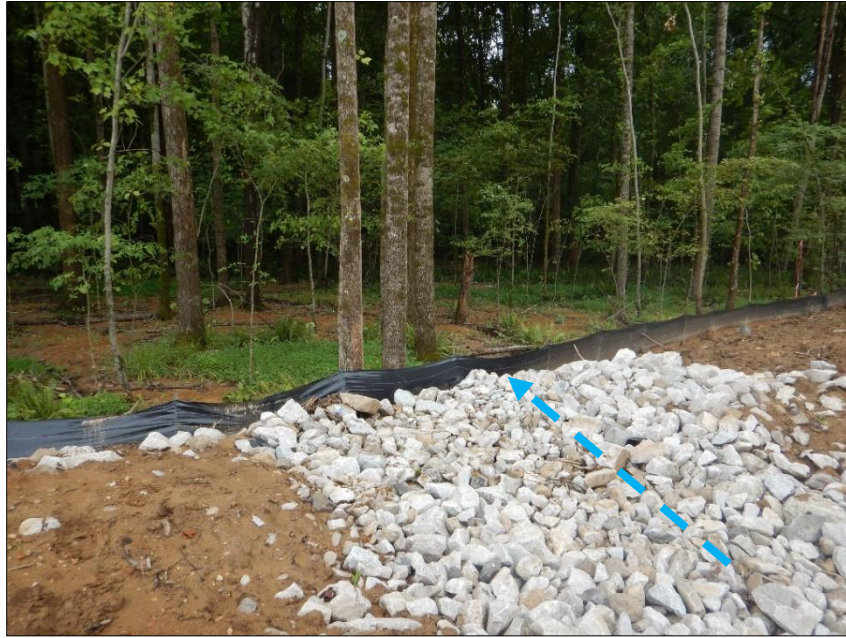
The EPA Inspection Team observed multiple instances where silt fence was installed across areas of concentrated stormwater flow [Refer to **Appendix B, Photograph Log (Photographs 11, 14, 16, 24, 25, 35, 38, 47, 48, 50, 52, 61, 62, 64, 66, 67, and 68)**].

Photograph 11. View, facing west, of the emergency spillway from the sediment basin. Silt fence was installed across the emergency spillway, an area of concentrated flow.

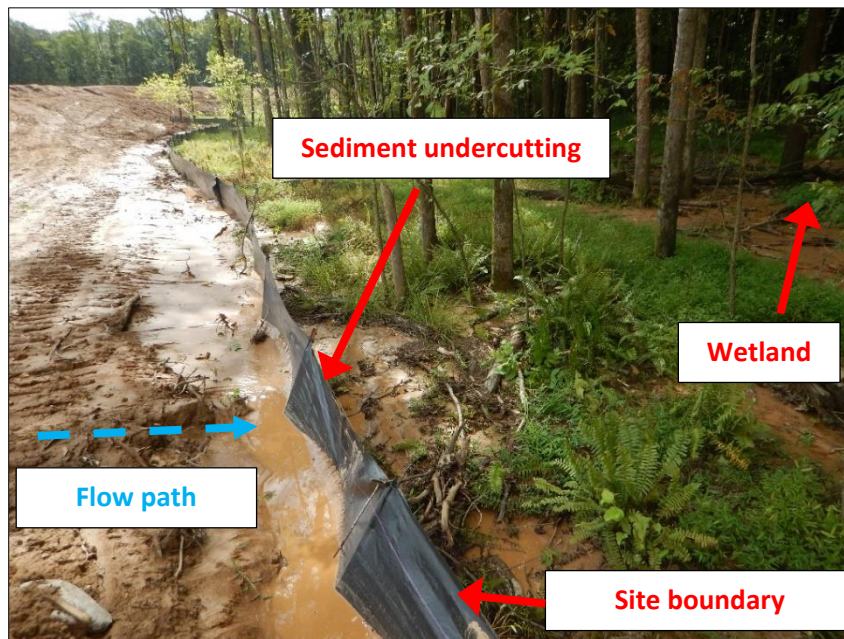
The EPA Inspection Team observed disturbed slopes without temporary or permanent stabilization and rill or gully erosion [Refer to **Appendix B, Photograph Log (Photographs 12, 13, 14, 19, 40, and 48)**]. The EPA Inspection Team, however, did not determine which slopes met the Permit’s definition of steep slopes.

Photograph 12. View, facing south, of turbid water discharged from the Site at the base of a slope in the northwest portion of the Site. The base of the silt fence was not buried, therefore allowing sediment discharges to flow underneath the silt fence and offsite. An identified wetland is located approximately 75 feet west of the silt fence.

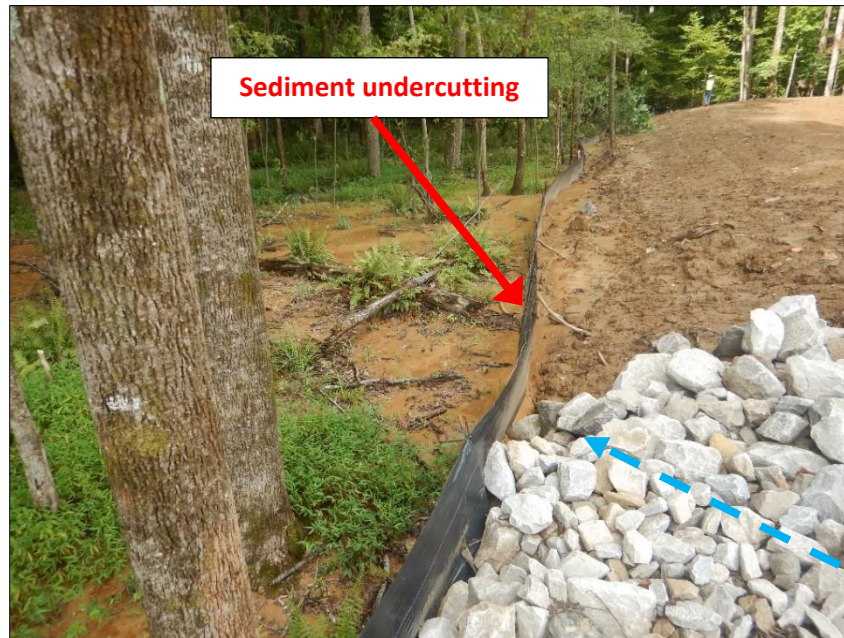
Photograph 13. View, facing north, of a location where the silt fence adjacent to the emergency spillway was incorrectly installed. Upgradient slopes were eroded and not stabilized. The base of the silt fence was not buried, therefore allowing sediment discharges to flow offsite. This area is approximately 75 feet east of an identified wetland area.

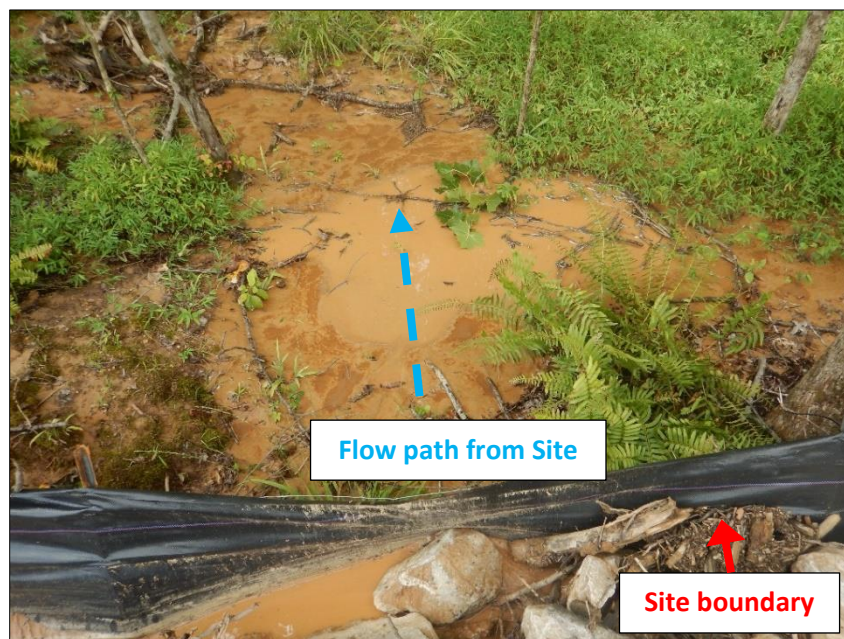
Photograph 14. Closer view of a location where concentrated stormwater flow conveyed sediment under the silt fence (refer also to [Photograph 13](#)) and offsite.

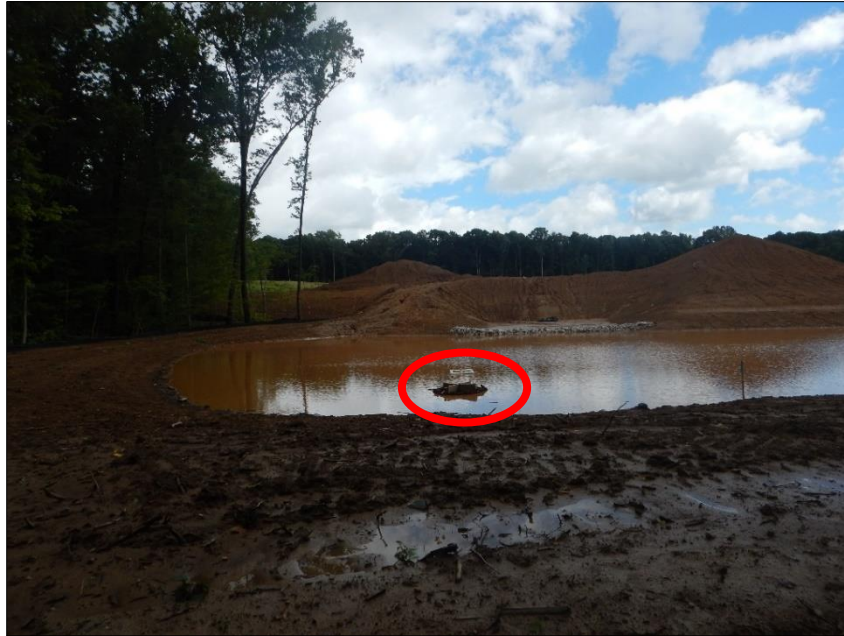
Photograph 15. View, facing east, of the sediment basin shown in Photographs 6, 7, 9, and 10. The riser (circled in red) in the middle of the basin discharges through Outfall #5. The basin contained sediment-laden water but no discharge occurring at the time of the inspection.

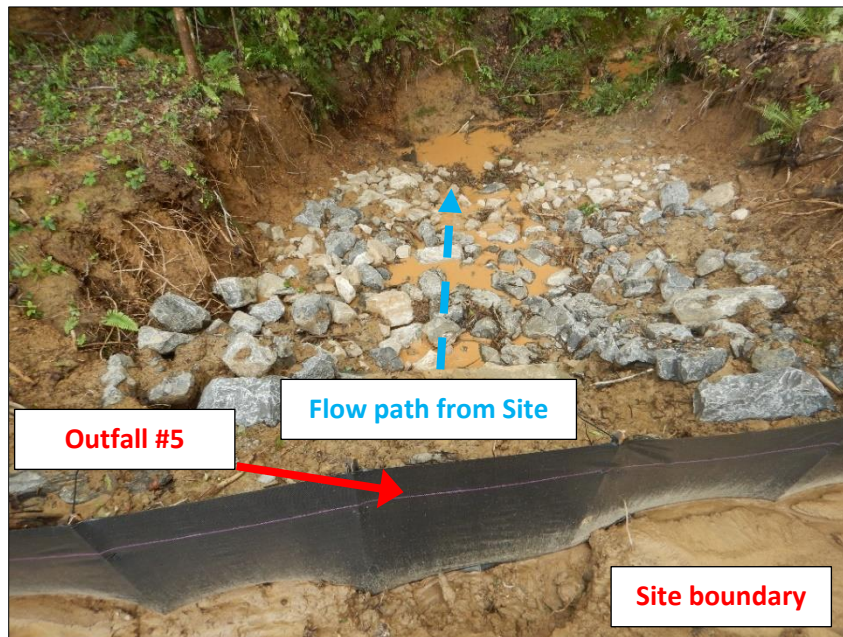
| 5. FIELD EVALUATION & PLAN IMPLEMENTATION | | |
|---|---|---|
| c. Are EPSCs functioning correctly at outfall/discharge points such that there is no objectionable color contrast in the receiving stream, and no other water quality impacts? | No | The EPA Inspection Team observed evidence of turbid water discharging from Outfall #5 towards an adjacent wetland area, an unnamed tributary to Oliver Creek, and Oliver Creek [Refer to <u>Appendix B, Photograph Log (Photograph 16)</u> ]. |

Photograph 16. Downgradient view, facing northwest, of constructed Outfall #5 that leads to Oliver Creek. The water flowing from the site was turbid and contained visible sediment. Silt fence was installed across Outfall #5, an area of concentrated flow.

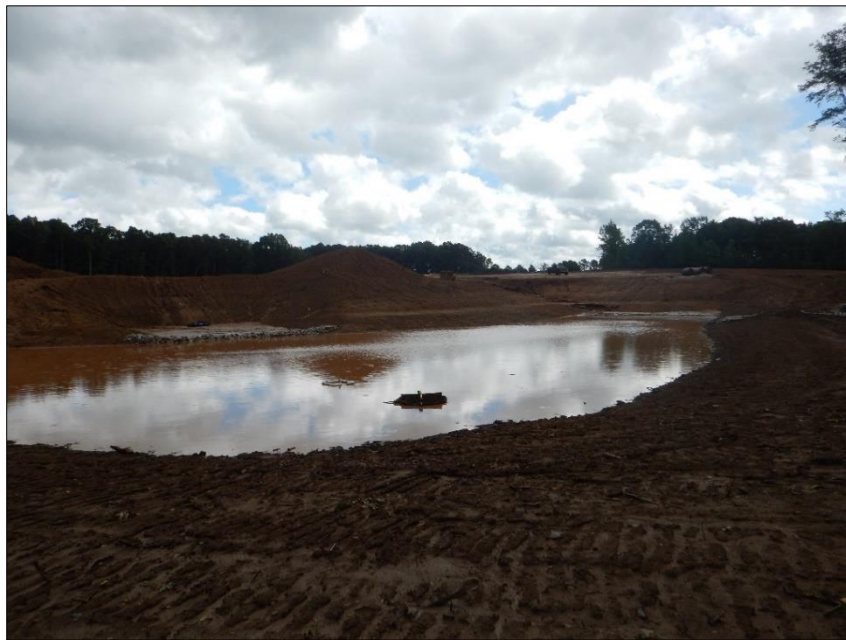
Photograph 18. View, facing east, of the sediment basin shown in [Photographs 6, 7, 9, 10, and 15](#). The basin contained sediment-laden water but no discharge occurring at the time of the inspection.

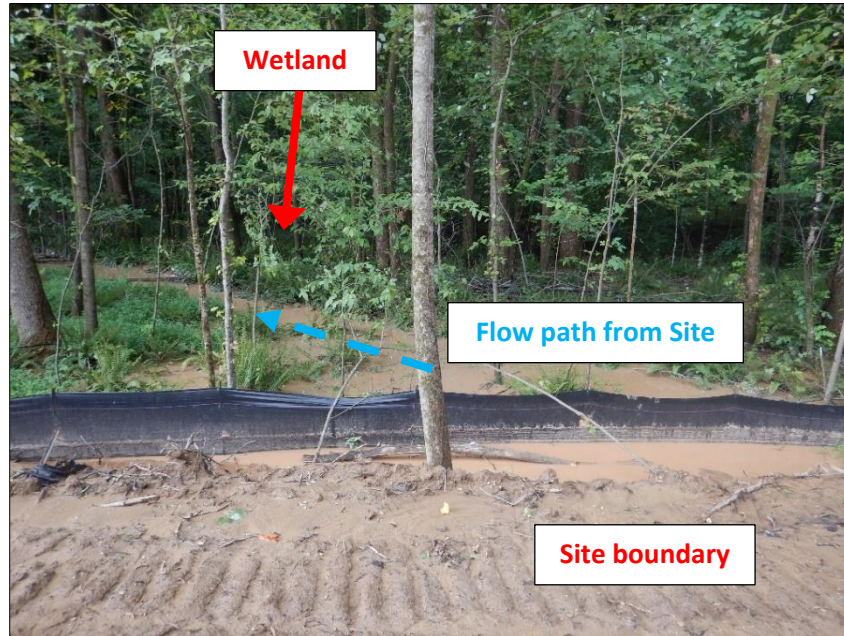
Photograph 19. Downgradient view, facing west, of sediment discharge outside the limits of construction, along the northwestern boundary of the Site. The base of the silt fence was not buried, therefore allowing sediment discharges to flow offsite. Surface roughening was applied in the wrong direction and would increase flow velocity and channelization, not decrease velocity. Stormwater in this portion of the Site flows towards the identified wetland area.

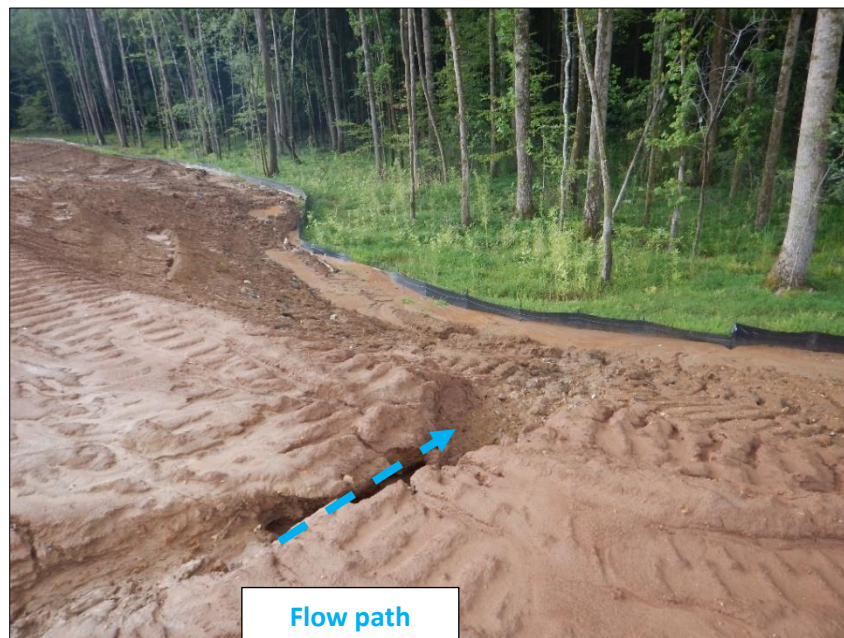
Photograph 20. Downgradient view, facing west, of rill erosion on an unstabilized slope in the northwestern portion of the Site. Sediment had accumulated to more than half the height of the silt fence, on the up gradient side.

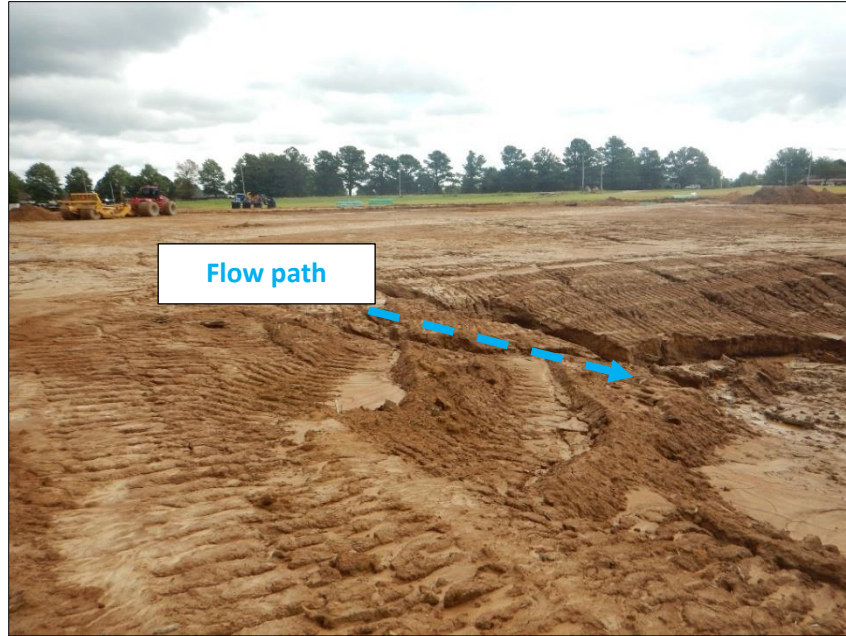
Photograph 21. Upgradient view, facing east, of unstabilized slopes shown in Photograph 20 with rill and gully erosion in the northwestern portion of the Site. Surface roughening was applied in the wrong direction and would increase flow velocity and channelization, not decrease velocity.

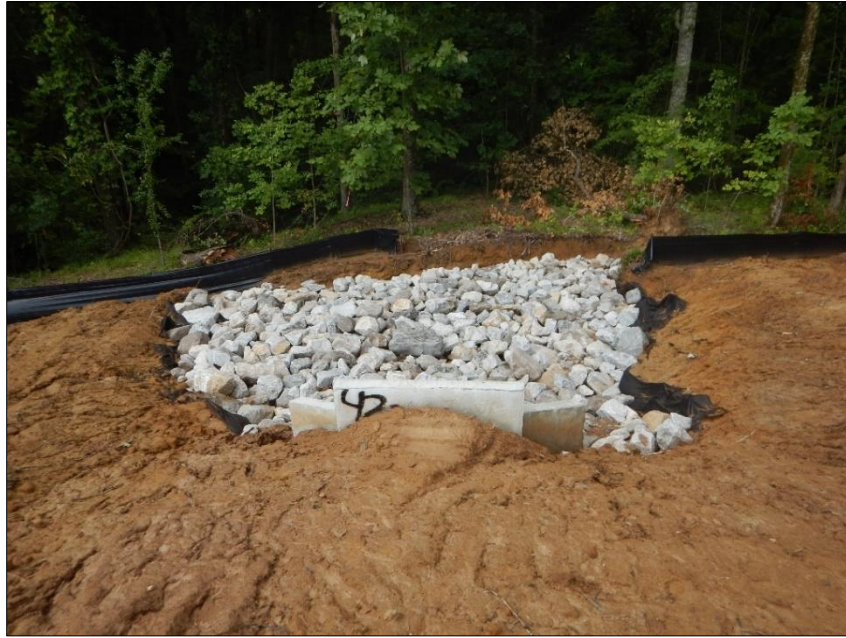
Photograph 23. View, facing west, of constructed Outfall #7 in the western portion of the Site. Slopes around the outfall were unstabilized and eroded.

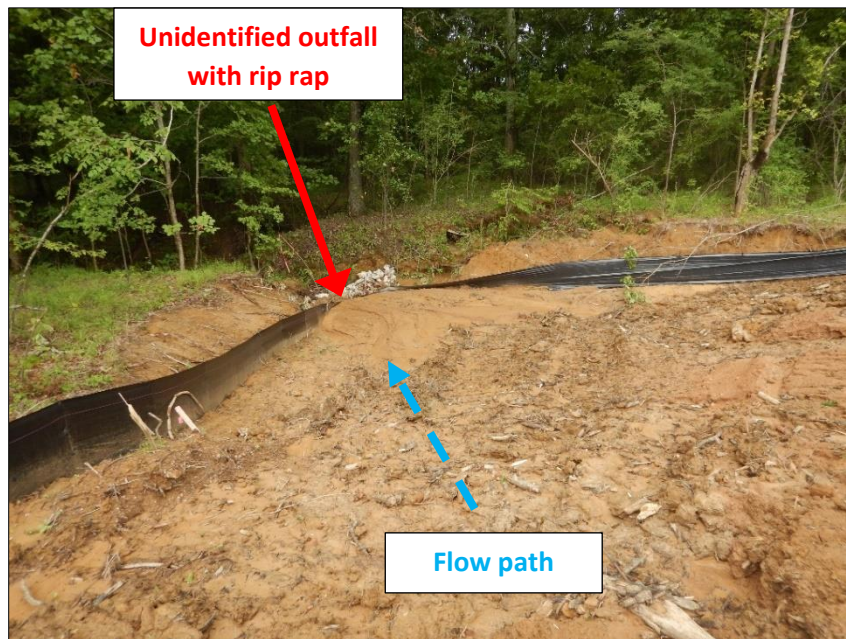
Photograph 24. Downgradient view, facing west, of sediment overwhelming a silt fence approximately 100 feet north of Outfall #7 in the western portion of the Site. Silt fence was installed across this area of concentrated stormwater flow.

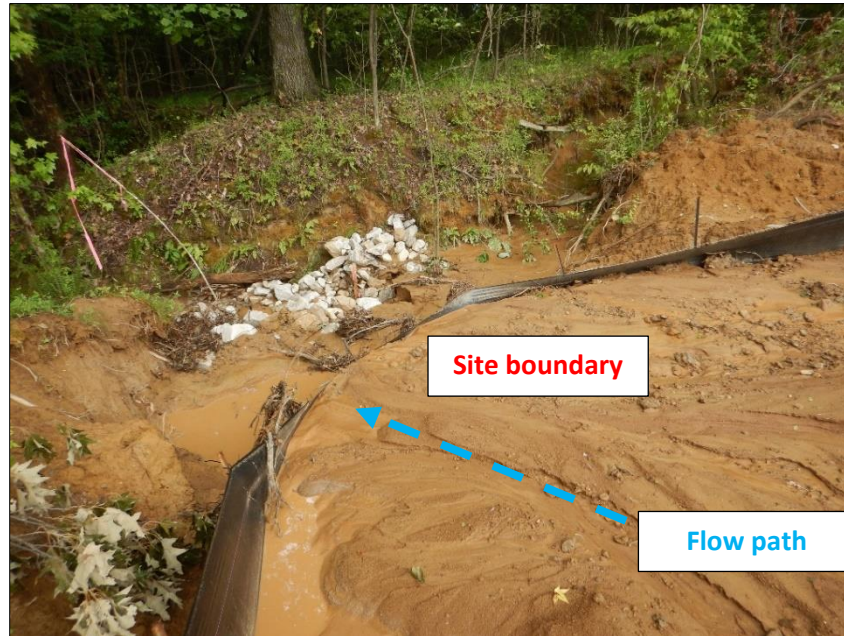
Photograph 25. Closer view of the offsite sediment discharge shown in Photograph 24. Sediment had overtopped silt fence and discharged offsite towards Oliver Creek. Silt fence was installed across this area of concentrated stormwater flow.

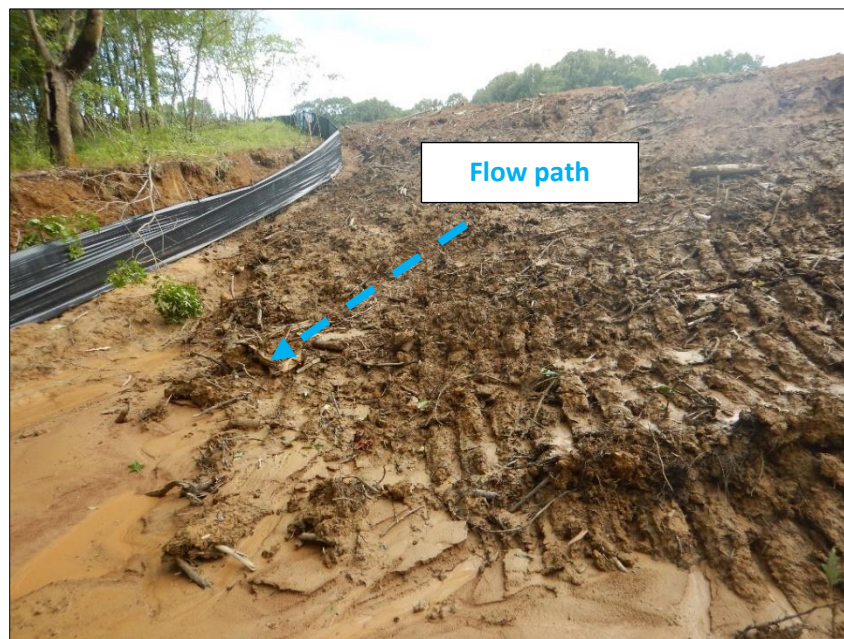
Photograph 26. Upgradient view of an unstabilized slope that leads to the unidentified discharge point shown in Photograph 25. Silt fence was installed along the slope, not along the contour, at this location and no other slope stabilization measures were installed or implemented. The operator had performed earthwork outside the perimeter silt fence.

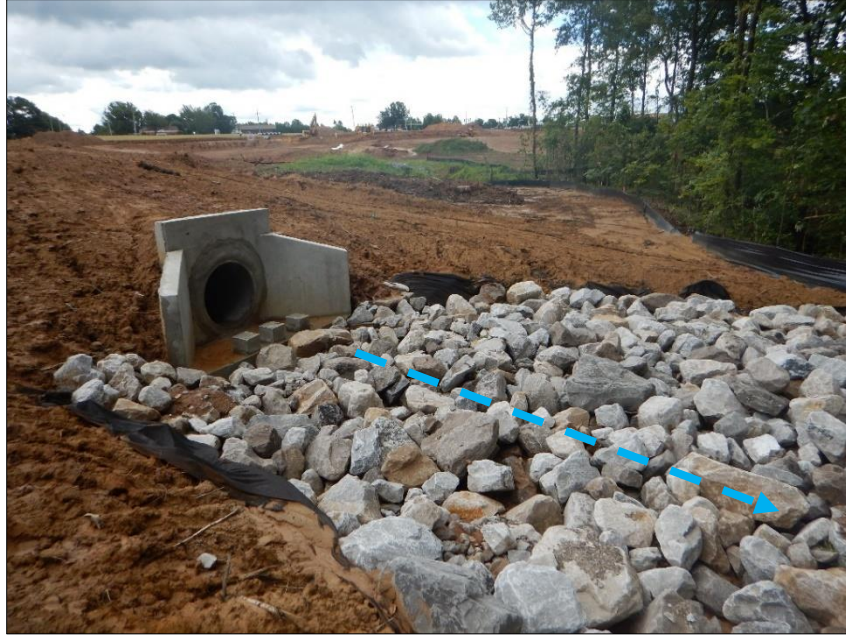
Photograph 27. View, facing south, of Outfall #7. Note the unstabilized slope upgradient of the outfall.

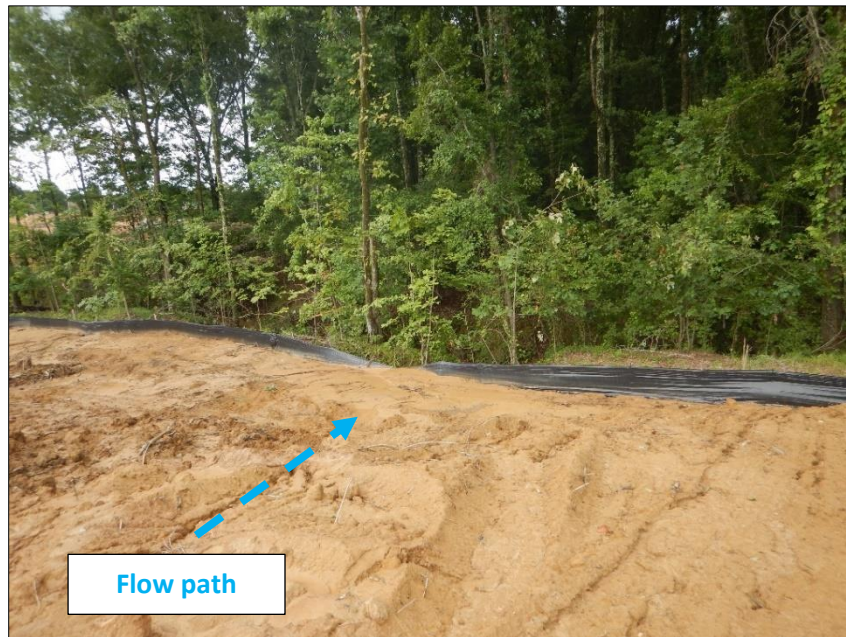
Photograph 28. Downgradient view of an unstabilized and eroded slope in the western portion of the Site. Sediment had overtopped the silt fence and discharged offsite.

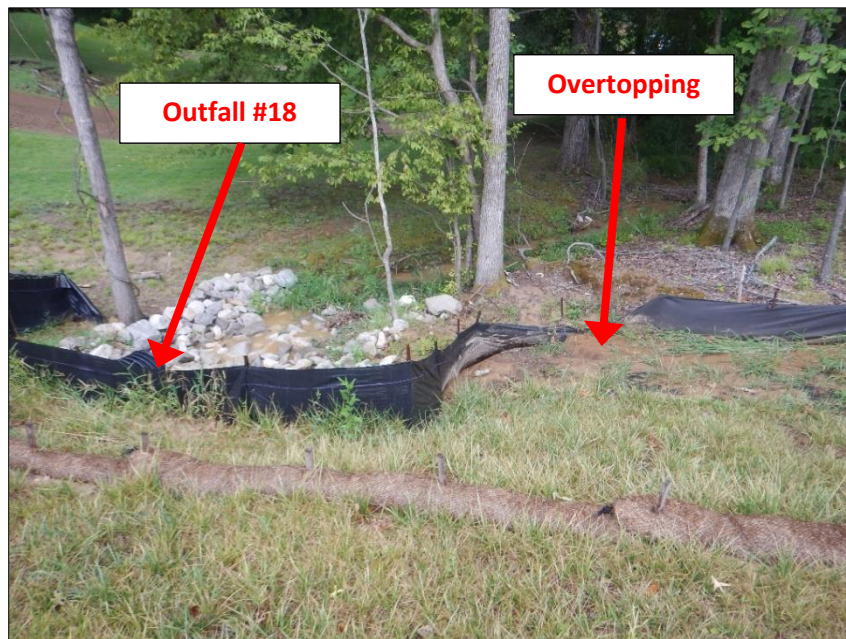
Photograph 30. Downgradient view of Outfall #18 in the southwestern portion of the Site. Vegetative stabilization was not sufficient to prevent sediment from overtopping the silt fence adjacent to the outfall. Sediment was visible downgradient from Outfall #18.

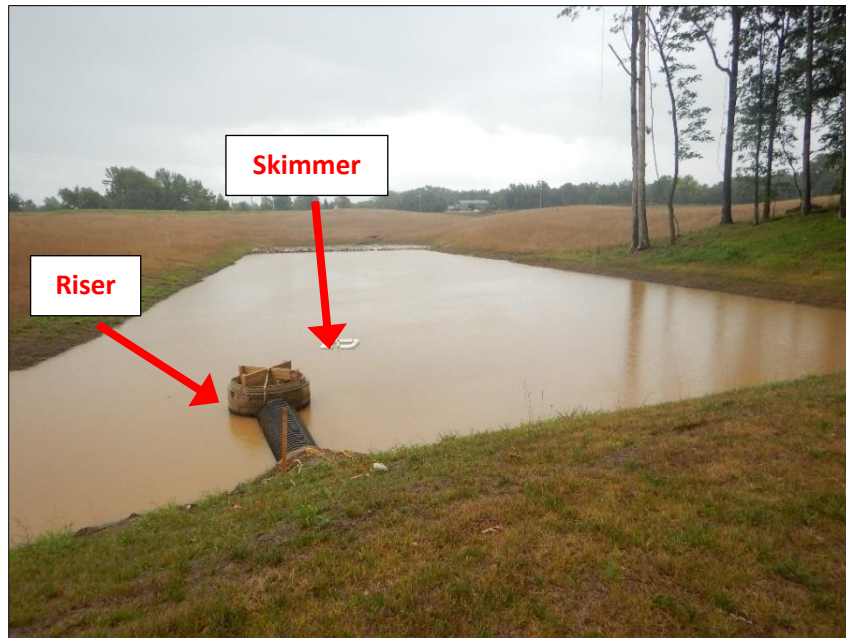
Photograph 31. View, facing east, of a retention basin located upgradient of Outfall #18. The basin contained sediment-laden water; turbid discharge was observed at Outfall #18 (refer to **Photograph 32**).

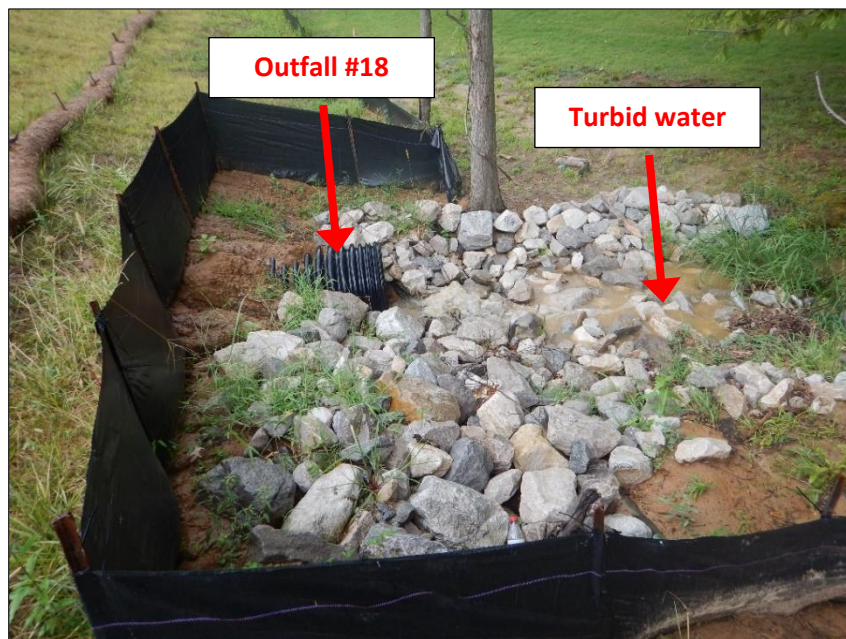
Photograph 32. View facing south, of Outfall #18. The water discharging from the outfall was turbid.

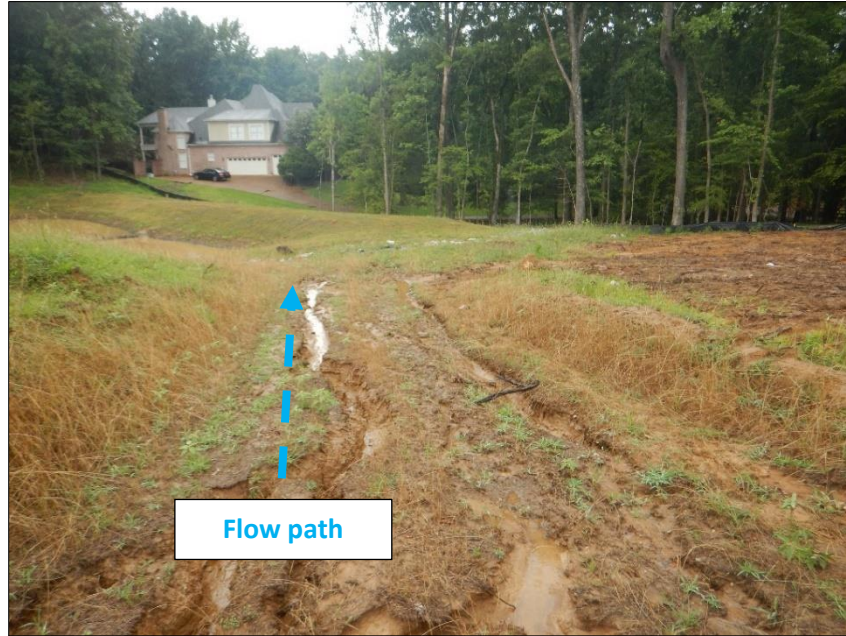
Photograph 33. Downgradient view of the stormwater flow path leading towards Outfall #18. Vegetative stabilization was not sufficient to prevent rill erosion on the slope leading to Outfall #18.

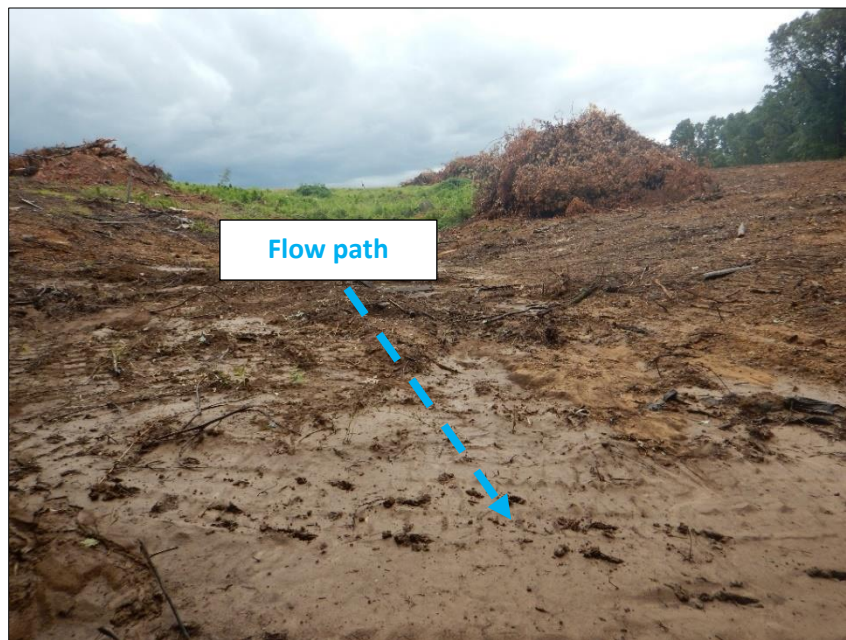
Photograph 34. Upgradient view of an unstabilized slope in the southern portion of the Site.

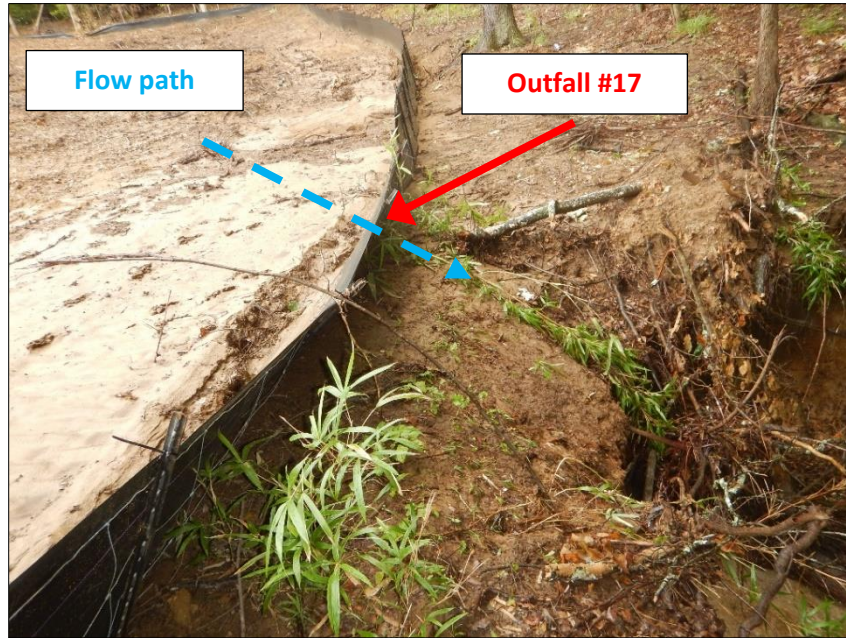
Photograph 35. View, facing west, of Outfall #17 in the center of the Site. A head cut was visible downgradient from Outfall #17. Silt fence was installed across Outfall #17, an area of concentrated flow.

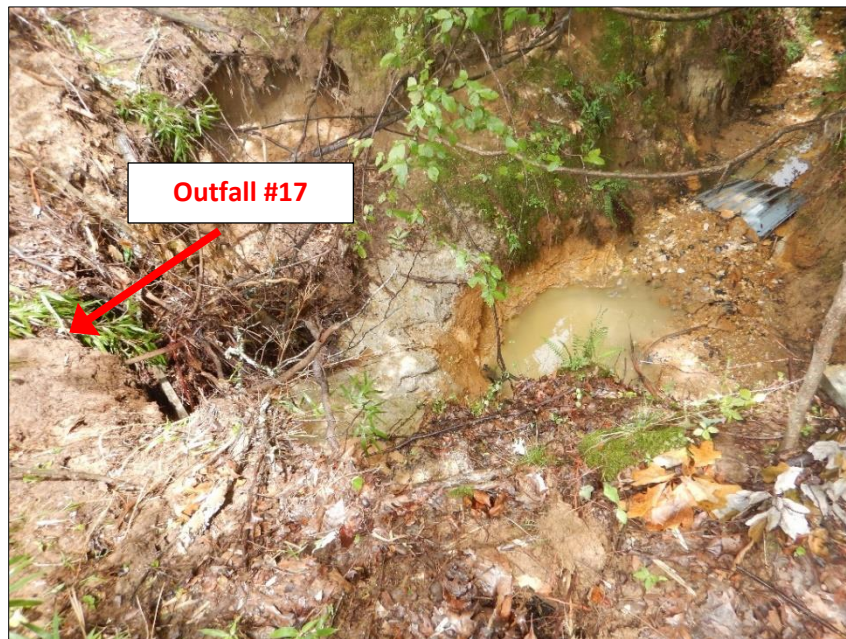
Photograph 36. Closer view of Outfall #17 and the head cut. The water leading to an unnamed tributary of Oliver Creek downgradient of the outfall was turbid.

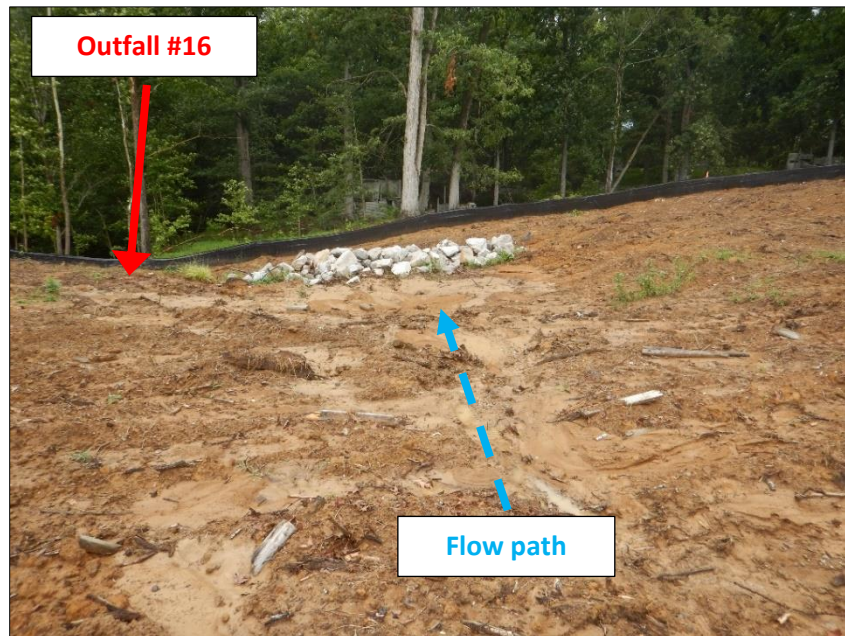
Photograph 38. Downgradient view of the flow path towards Outfall #16 in the center of the Site. Silt fence was installed across the channel downgradient from Outfall #16, an area of concentrated flow.

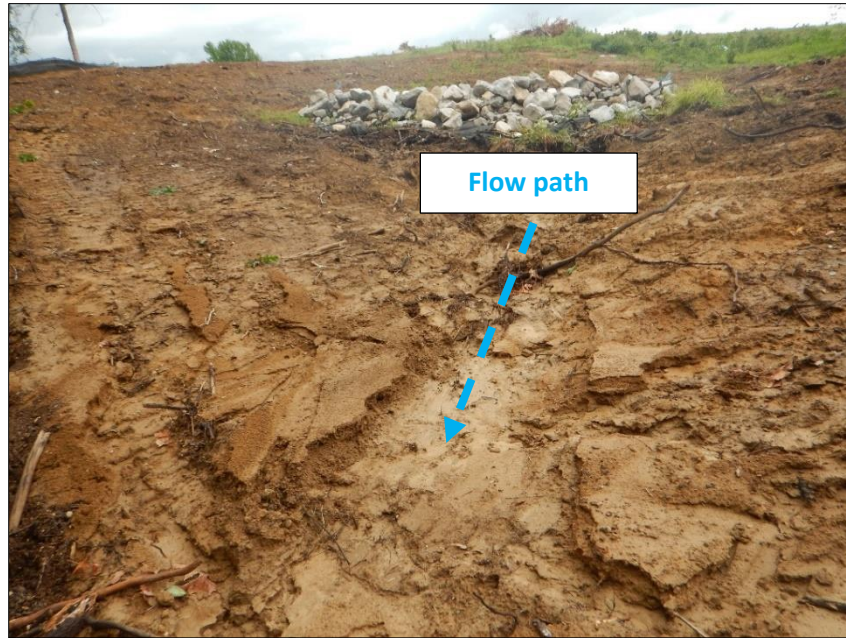
Photograph 39. Upgradient view of the flow path towards Outfall #16. The slopes were unstabilized and eroded. Stormwater and sediment had bypassed and undercut the check dam.

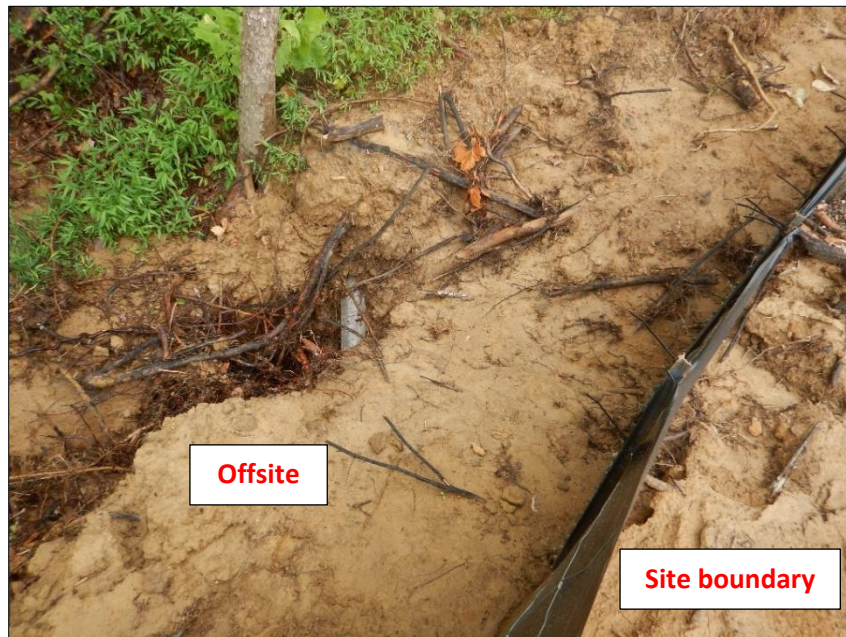
Photograph 40. View of offsite sediment discharge downgradient from Outfall #16. The base of the silt fence was not buried, therefore allowing sediment discharges to flow offsite

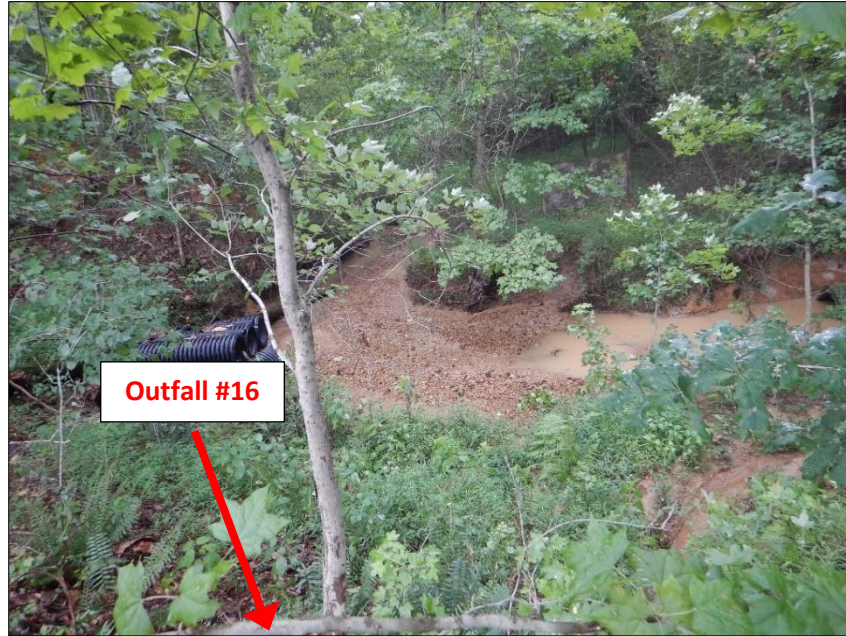
Photograph 41. View of an unnamed tributary to Oliver Creek. The water in the unnamed tributary to Oliver Creek downstream of the Site's Outfall #16 was turbid. The corrugated piping was not installed.

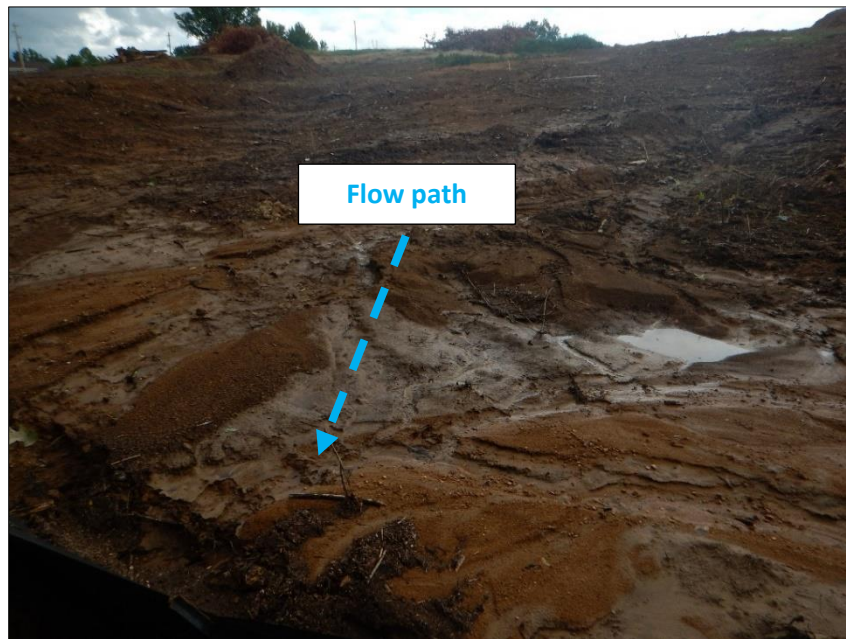
Photograph 42. Upgradient view of an unstabilized and eroded slope in the center of the Site.
