## Compliance Inspection Report for Stormwater Discharges from Construction Activities (CGP)

| <b>Site/Project Name:</b><br>Ashmont Planned Development | | <b>NPDES Tracking Number:</b><br>TNR155437 | | <b>Date Coverage was Issued:</b><br>April 10, 2023 | |
| <b>Name of Permittee (Developer/Operator):</b> Ashmont Developer LLC | | | | | |

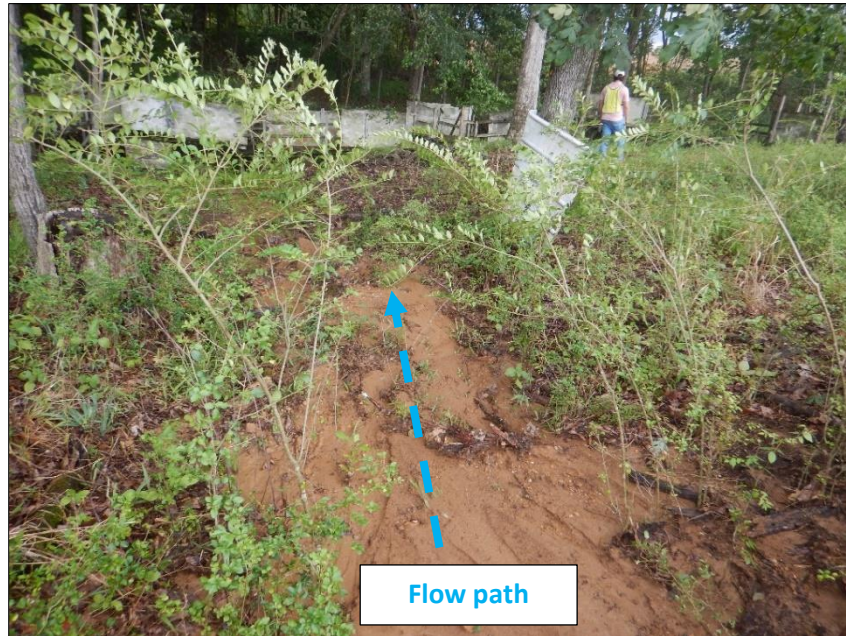
Photograph 43. View of sediment that had discharged offsite in the center of the Site. Note that the area in this picture is entirely offsite.

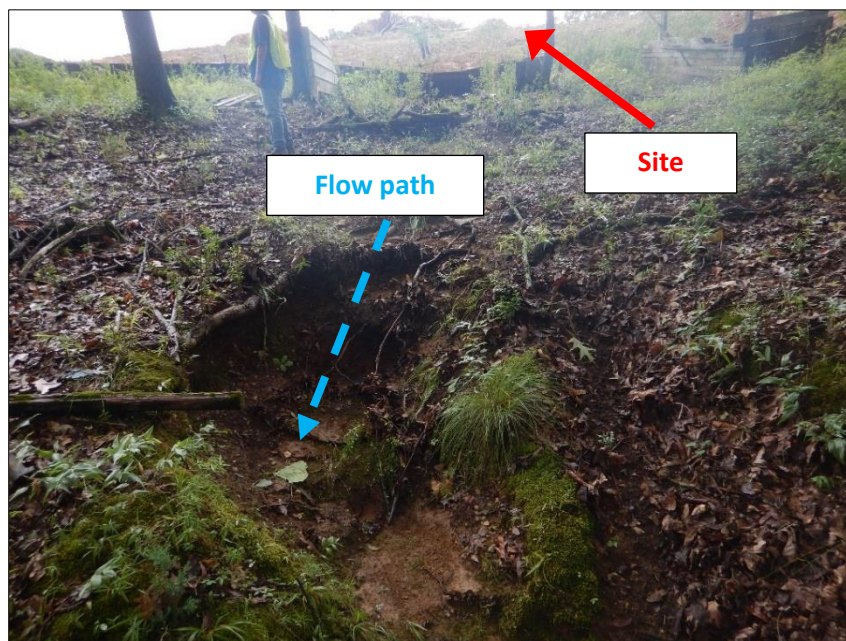
Photograph 44. View, facing south, of a head cut offsite in the middle portion of the Site approximately 100 feet east of Outfall #16.

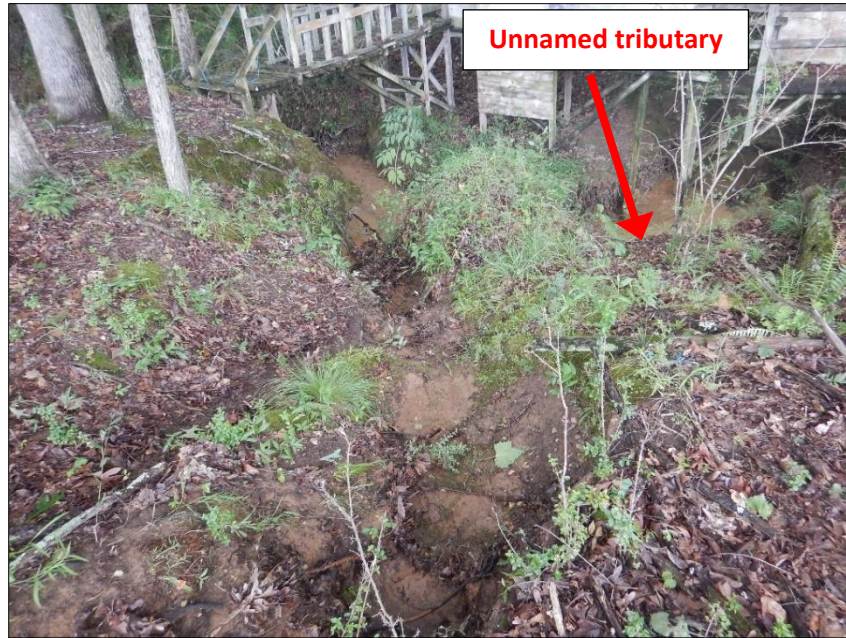
Photograph 45. Downgradient view of the erosion shown in Photograph 44. The unnamed tributary to Oliver Creek runs adjacent to the Site in this location.

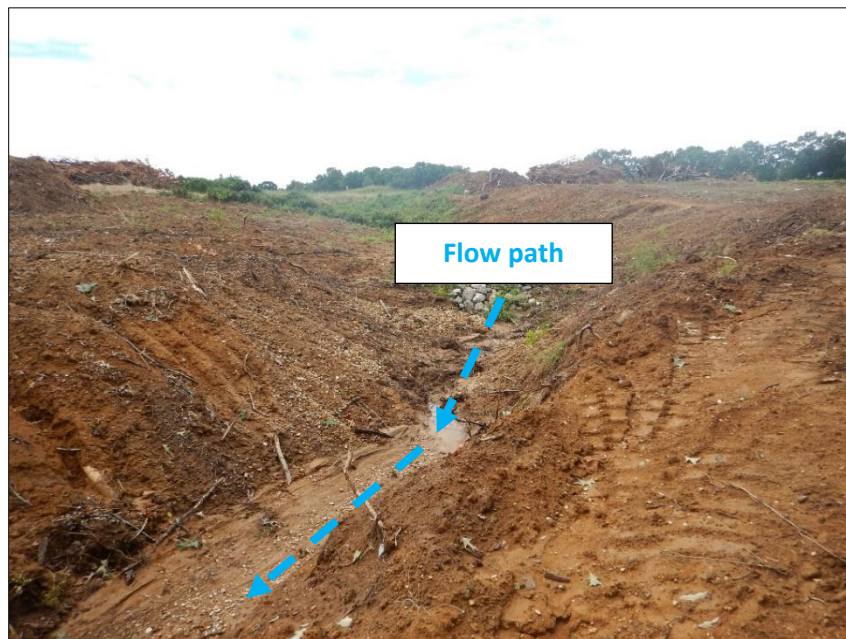
Photograph 46. Upgradient view of a concentrated flow path leading to an unidentified discharge point in the center of the Site. The slopes on either side of the concentrated flow path were unstabilized and eroded.

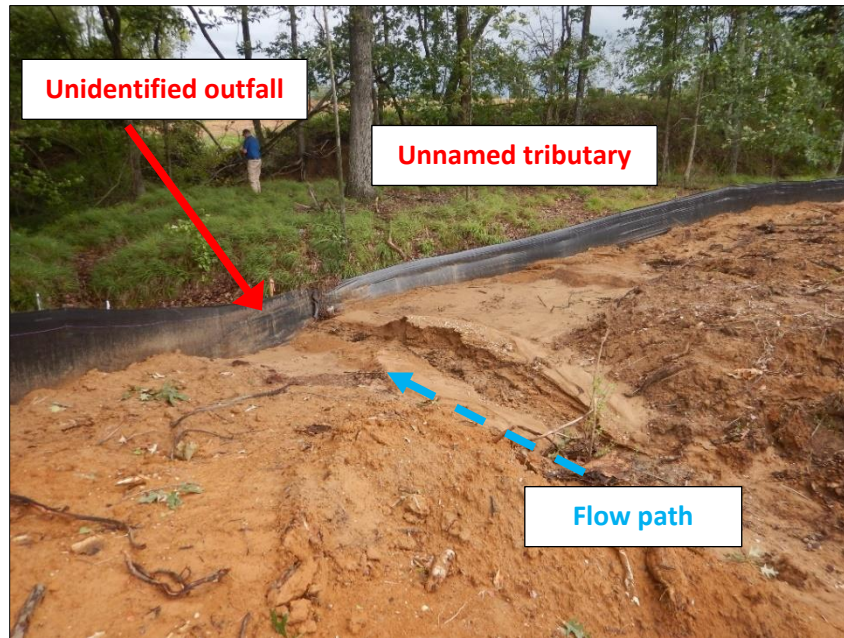
Photograph 47. View, facing north, of a stormwater discharge point in the center of the Site. The silt fence was installed across the discharge point, an area of concentrated flow.

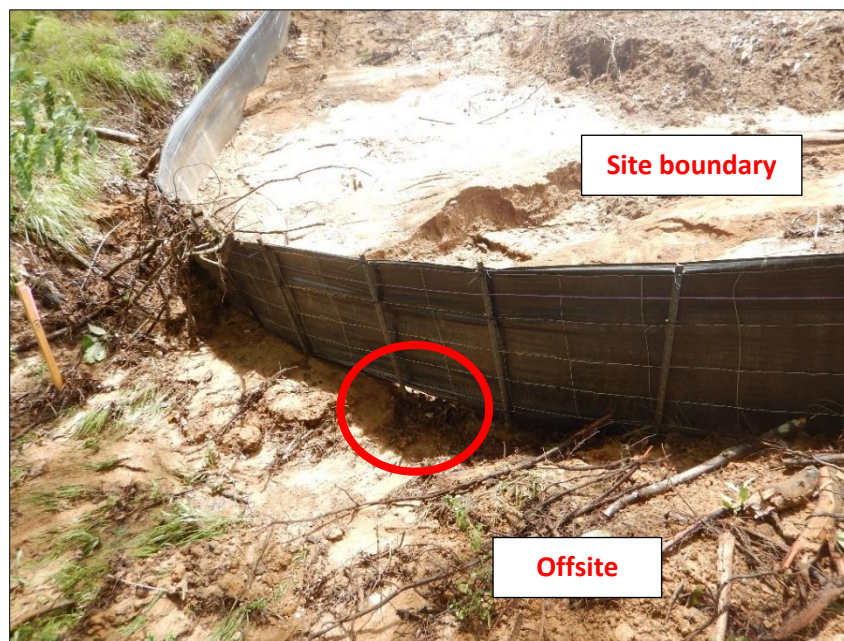
The EPA Inspection Team observed disturbed slopes without temporary or permanent stabilization and rill or gully erosion [Refer to **Appendix B, Photograph Log (Photographs 12, 13, 14, 19, 40, and 48)**]. The EPA Inspection Team, however, did not determine which slopes met the Permit’s definition of steep slopes.

Photograph 48. View, facing east, of the discharge point shown in Photograph 47. The silt fence was not properly buried allowing sediment to undercut the silt fence and discharge offsite (circled in red). The silt fence was installed across the discharge point, an area of concentrated flow.

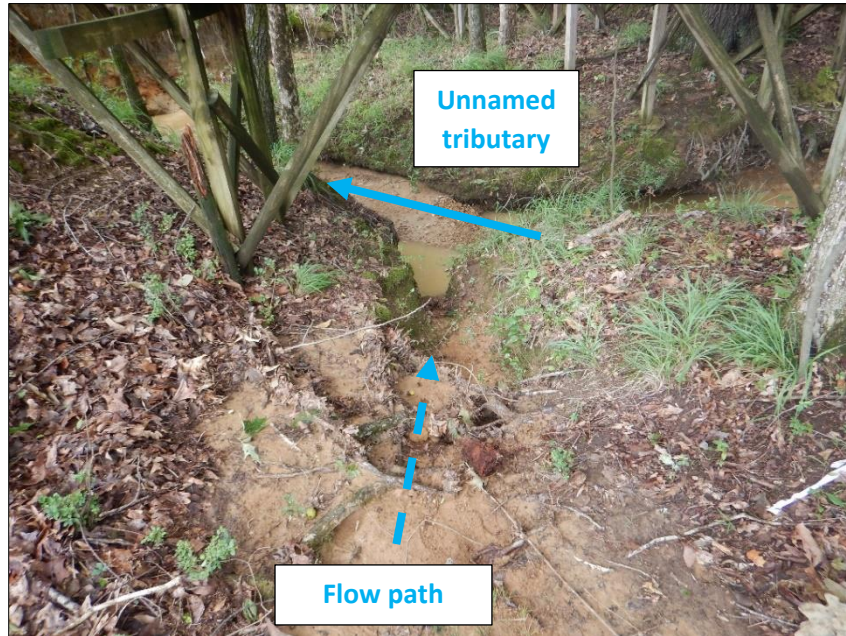
Photograph 49. View of an eroded slope downgradient of the discharge point shown in Photograph 48. The water in the unnamed tributary to Oliver Creek was turbid.

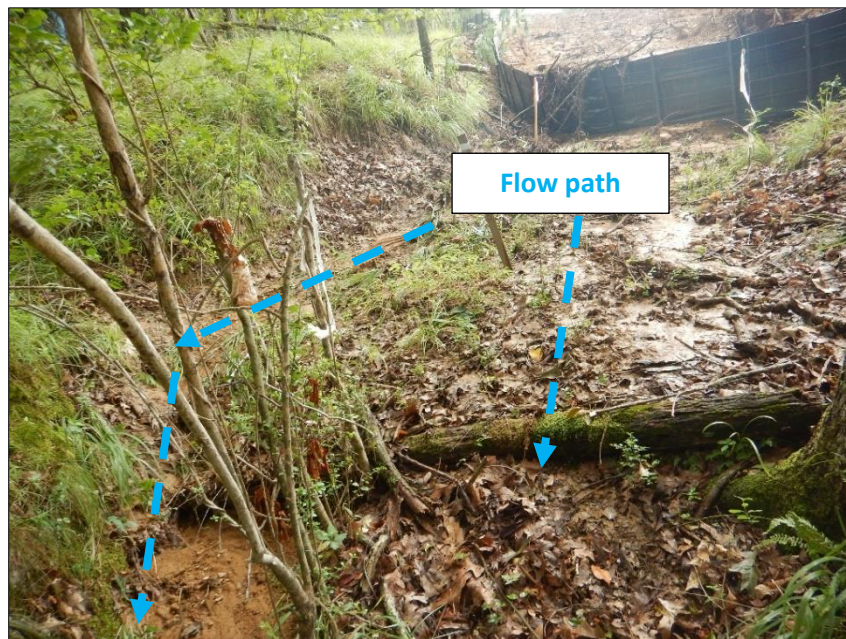
Photograph 50. Upgradient view of the concentrated flow path shown in Photograph 49. The silt fence was installed across the discharge point, an area of concentrated flow.

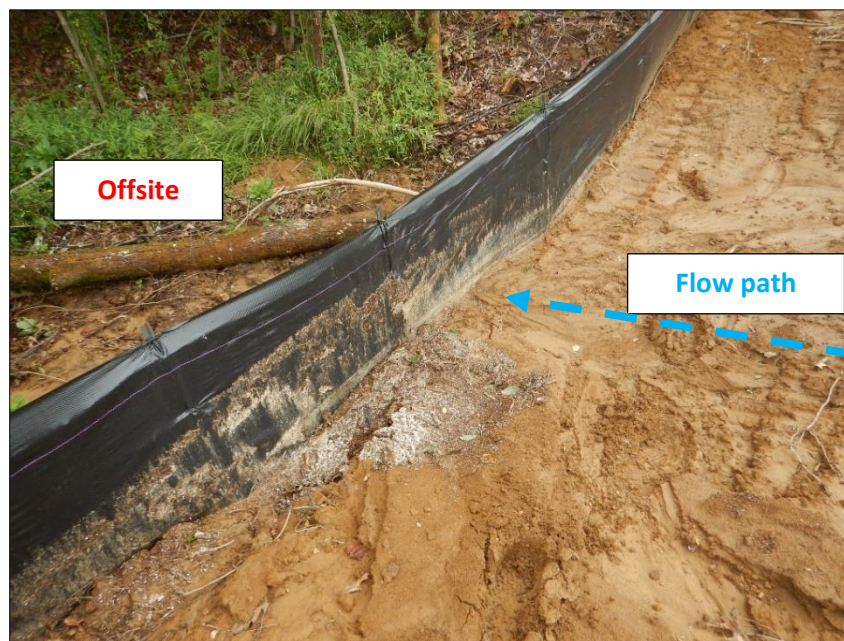
Photograph 52. View, facing east, of another stormwater discharge point in the center of the Site. The silt fence was installed across the discharge point, an area of concentrated flow.

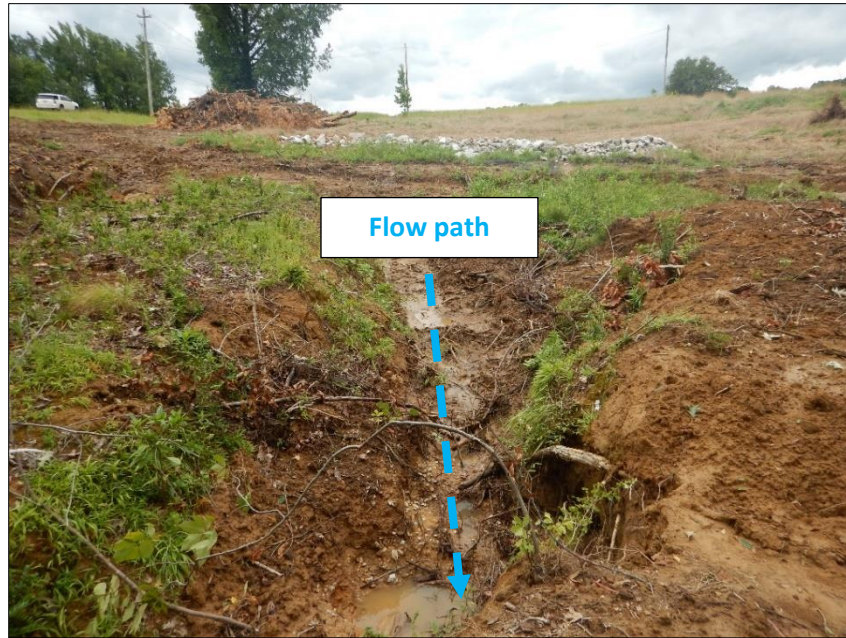
Photograph 53. Upgradient view of gully erosion on an unstabilized slope in the center of the Site. This flow path leads towards an unidentified discharge point shown in [Photograph 55](#).

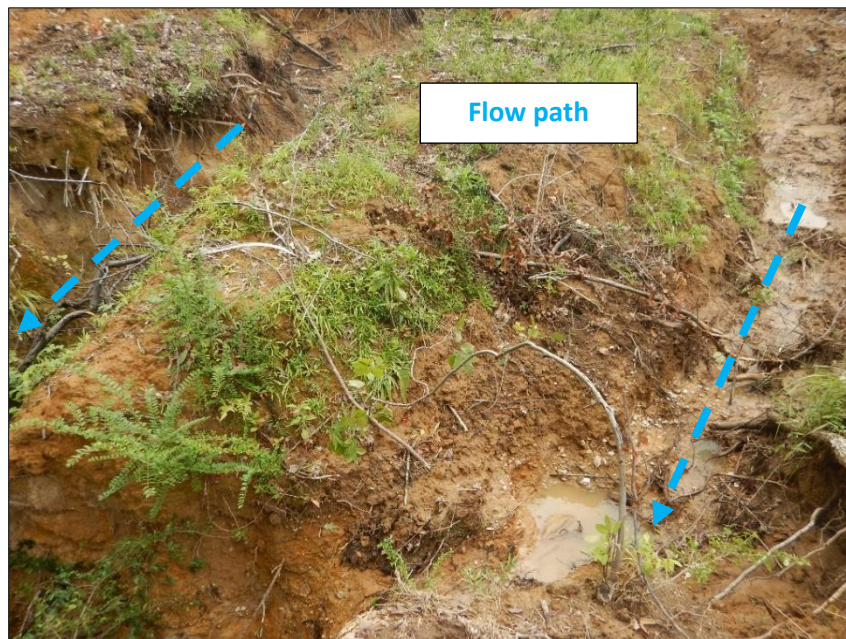
Photograph 54. Closer view of the gully erosion shown in [Photograph 53](#).

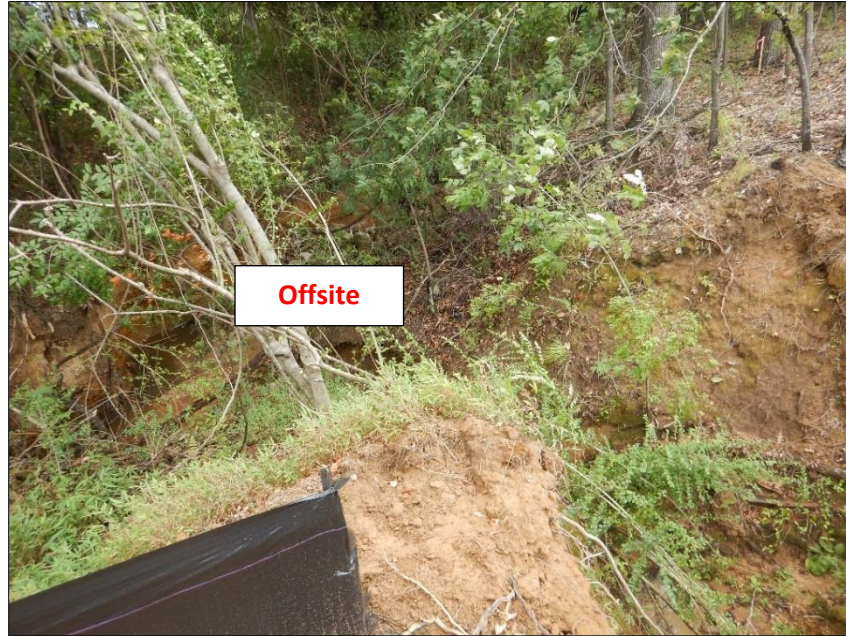
Photograph 55. View, facing northeast, of an unidentified discharge point and head cut in the center of the Site. There was a gap in the silt fence perimeter control in this location.

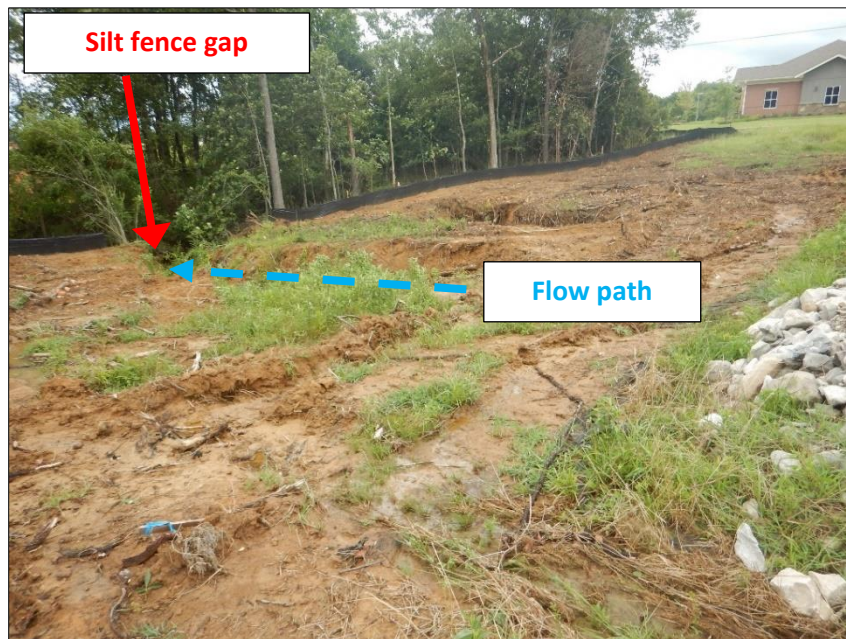
Photograph 56. Downgradient view of the stormwater flow path and gap in the silt fence shown in Photograph 55.

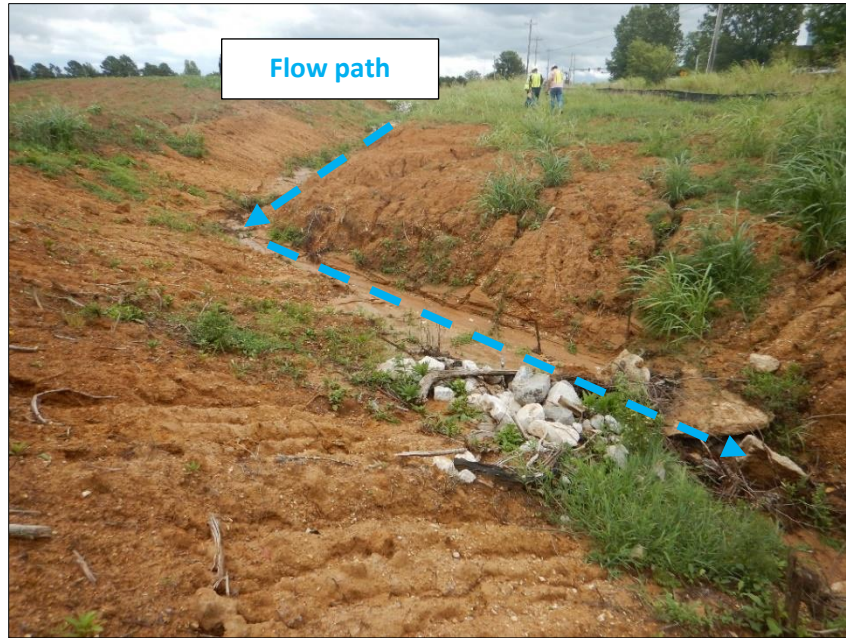
Photograph 57. View, facing northeast of the gully erosion in the center of the Site. The slopes on either side of the gully were unstabilized and eroded.

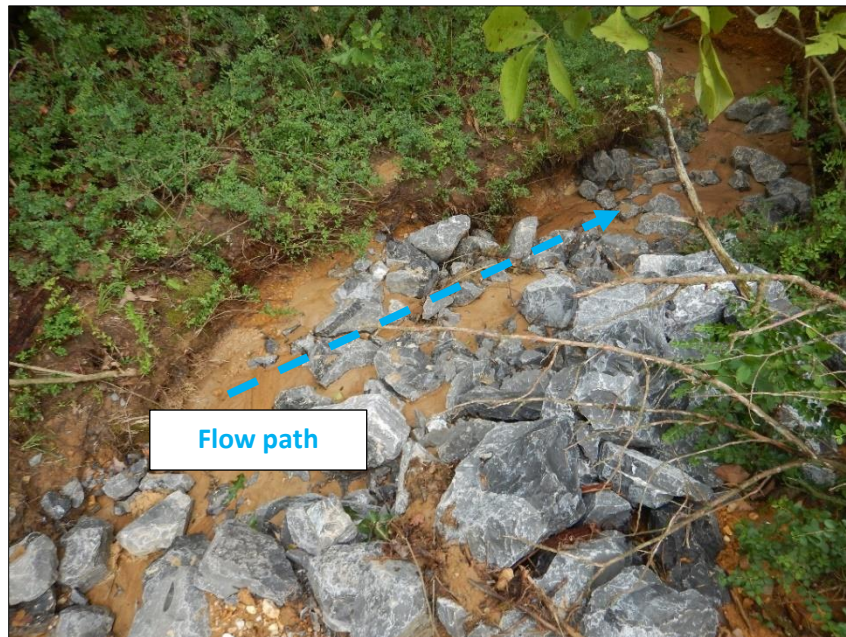
Photograph 60. View of offsite sediment discharge towards the unnamed tributary to Oliver Creek in the center of the Site.

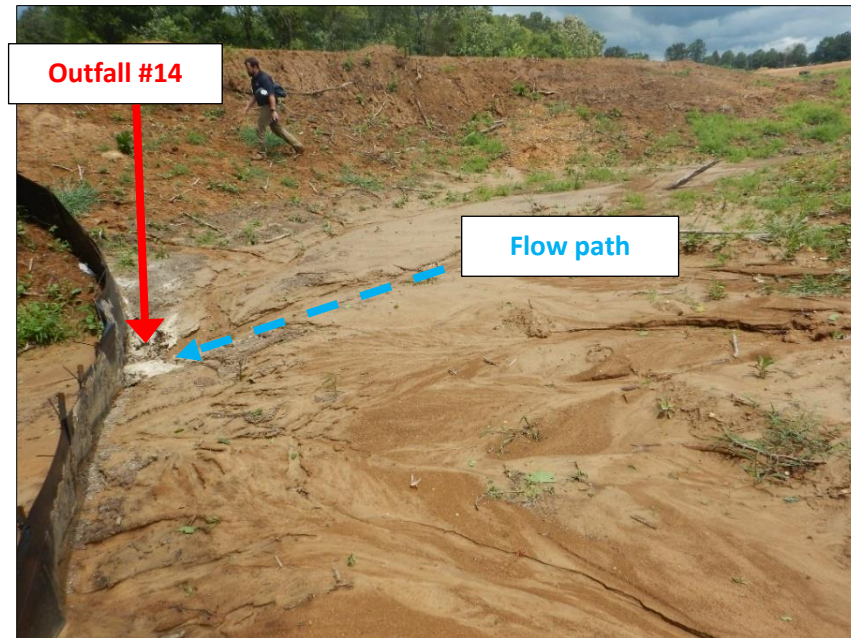
Photograph 61. View, facing northwest, of the stormwater and sediment flow path leading towards Outfall #14 in the center of the Site. The slope was unstabilized and sediment had discharged offsite. The silt fence was installed across the outfall, an area of concentrated flow.

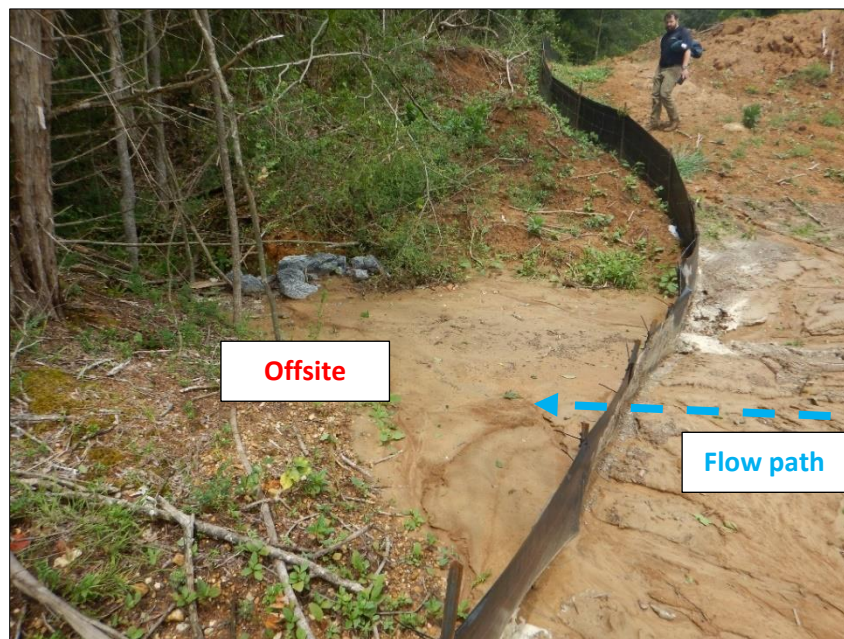
Photograph 62. Additional view of Outfall #14 shown in [Photograph 61](#). Sediment had discharged offsite. The silt fence was installed across the outfall, an area of concentrated flow.

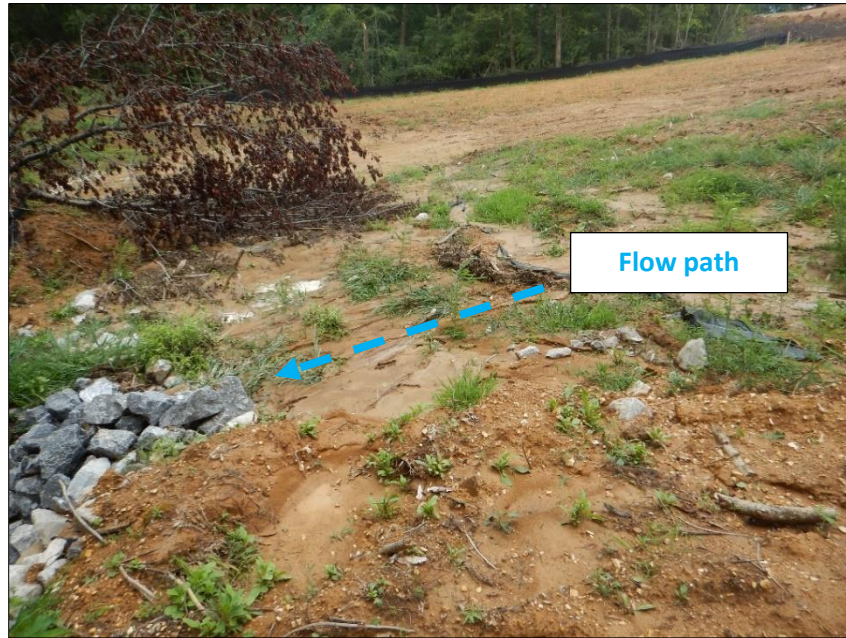
Photograph 63. View, facing northwest, of a stormwater and sediment flow path leading towards an unidentified discharge point in the center of the Site. The slope upgradient from the discharge point was unstabilized.

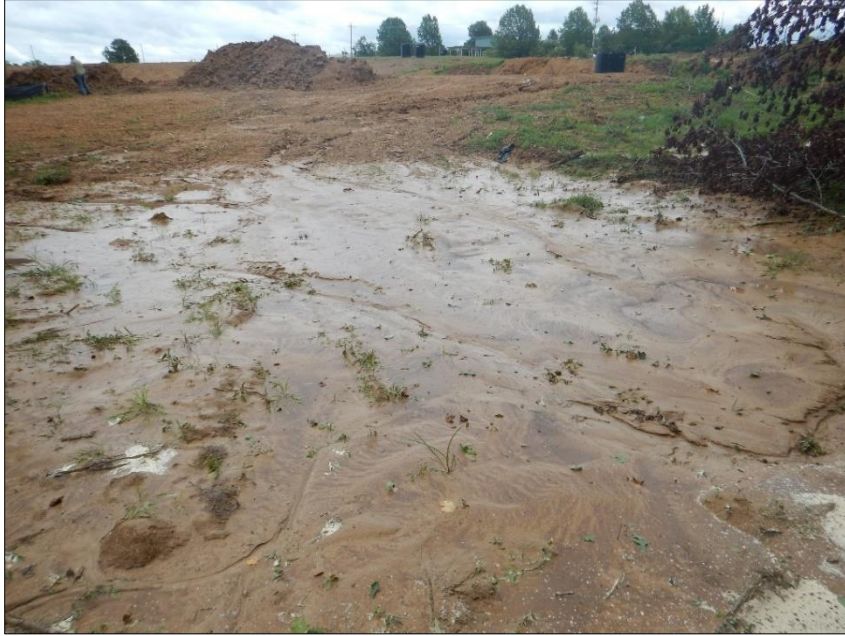
Photograph 65. View, facing northeast, of an unstabilized and eroded slope in the center of the Site.
