**Subj:** Inspection Report Clean Water Act

A. *Facility Name:* Boston Concrete Corporation (the "Facility")  
<https://bostonconcrete.com>

## **V. Site Inspection – October 3<sup>rd</sup>, 2024**

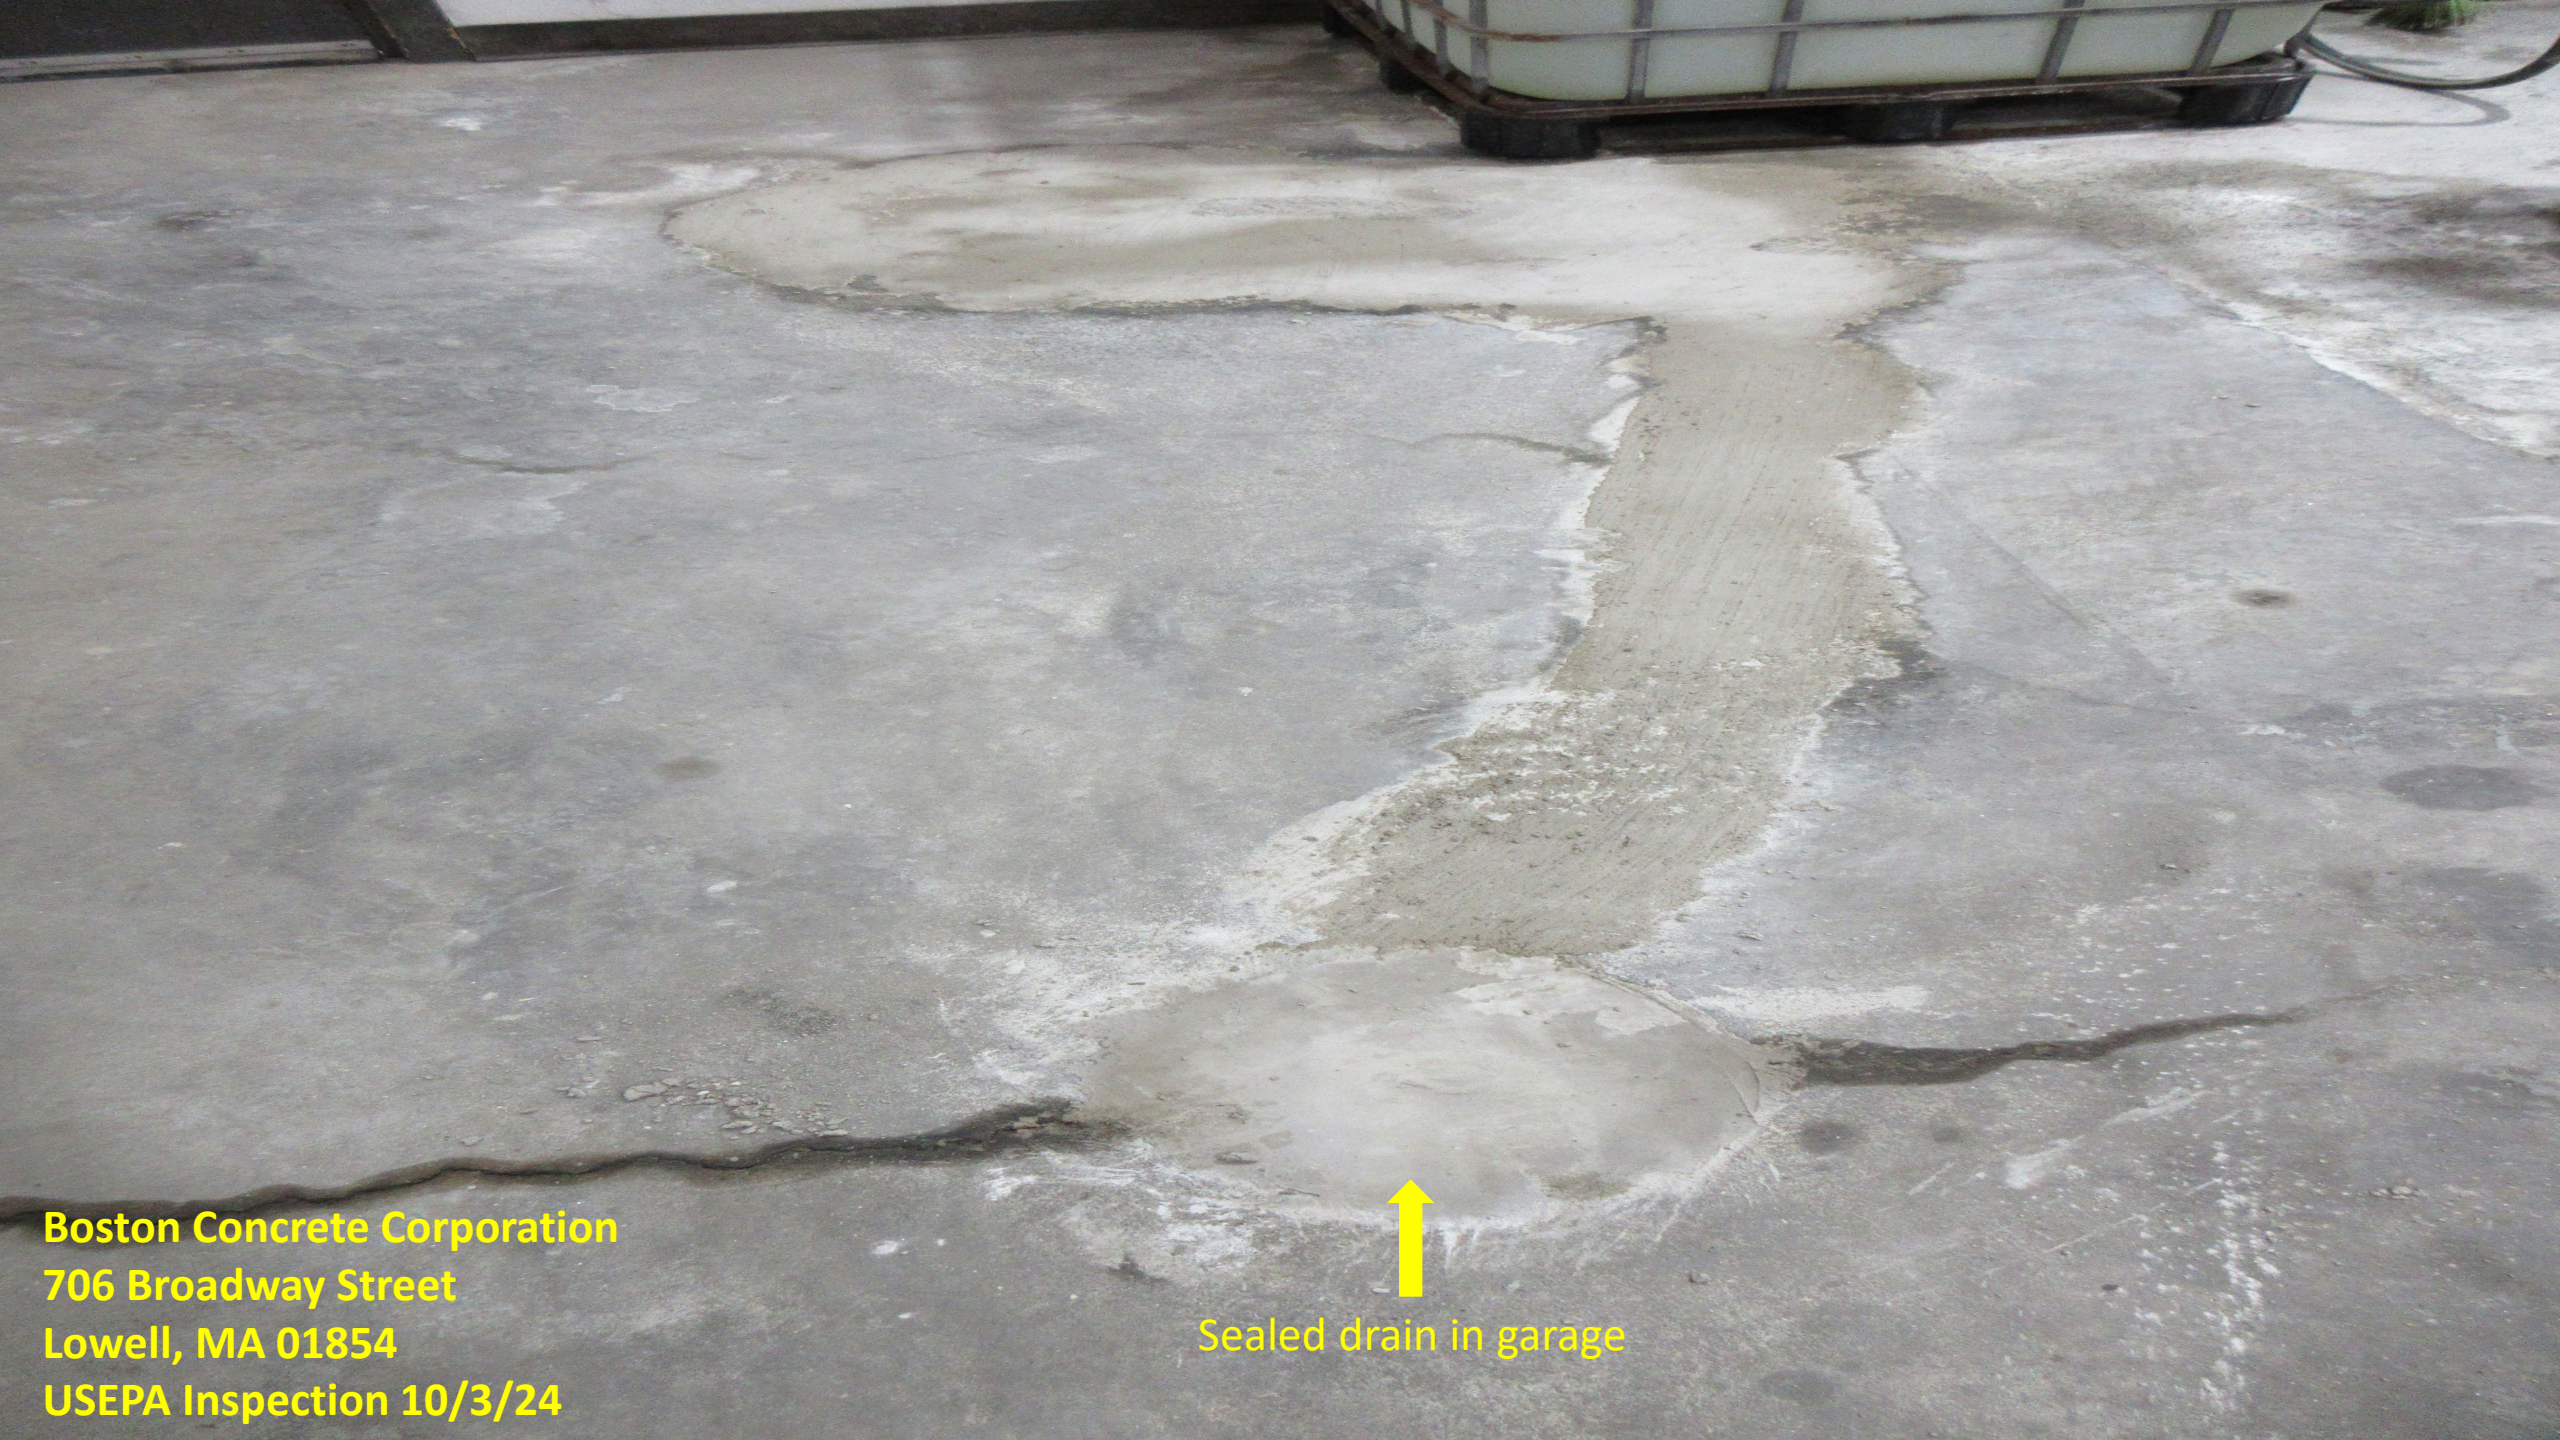
Garage where concrete trucks are stored

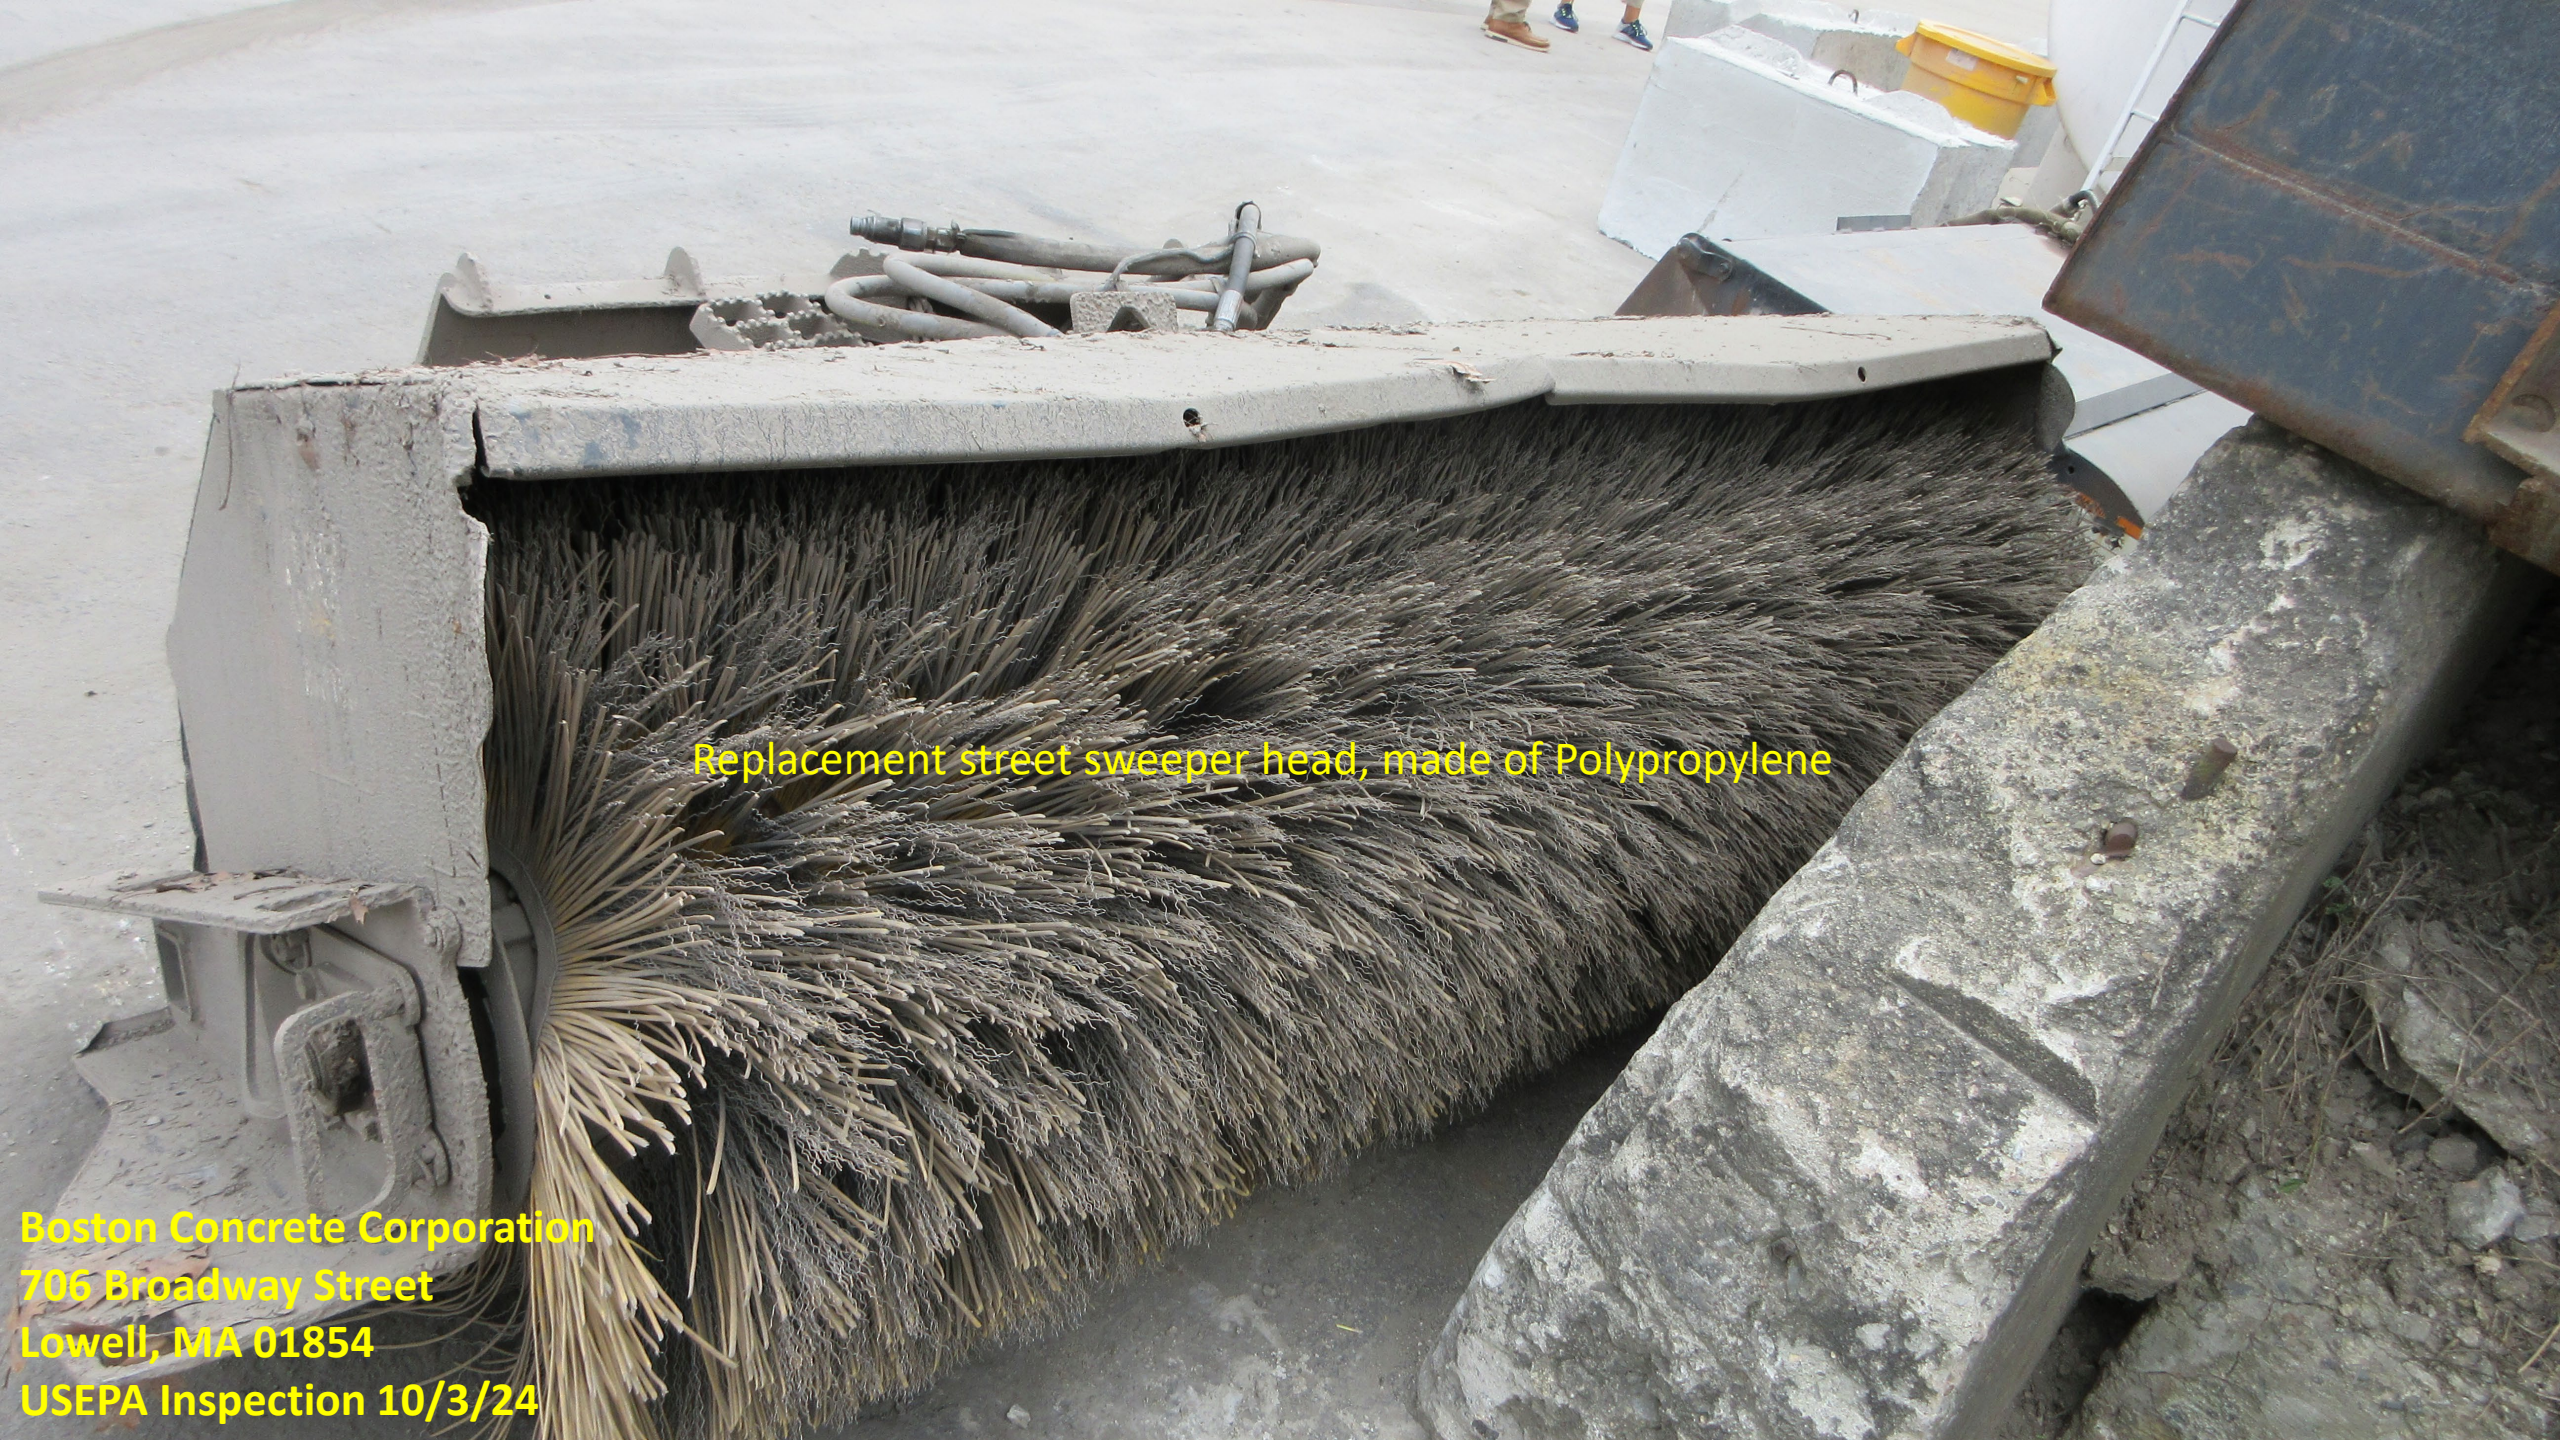
Replacement street sweeper head, made of Polypropylene

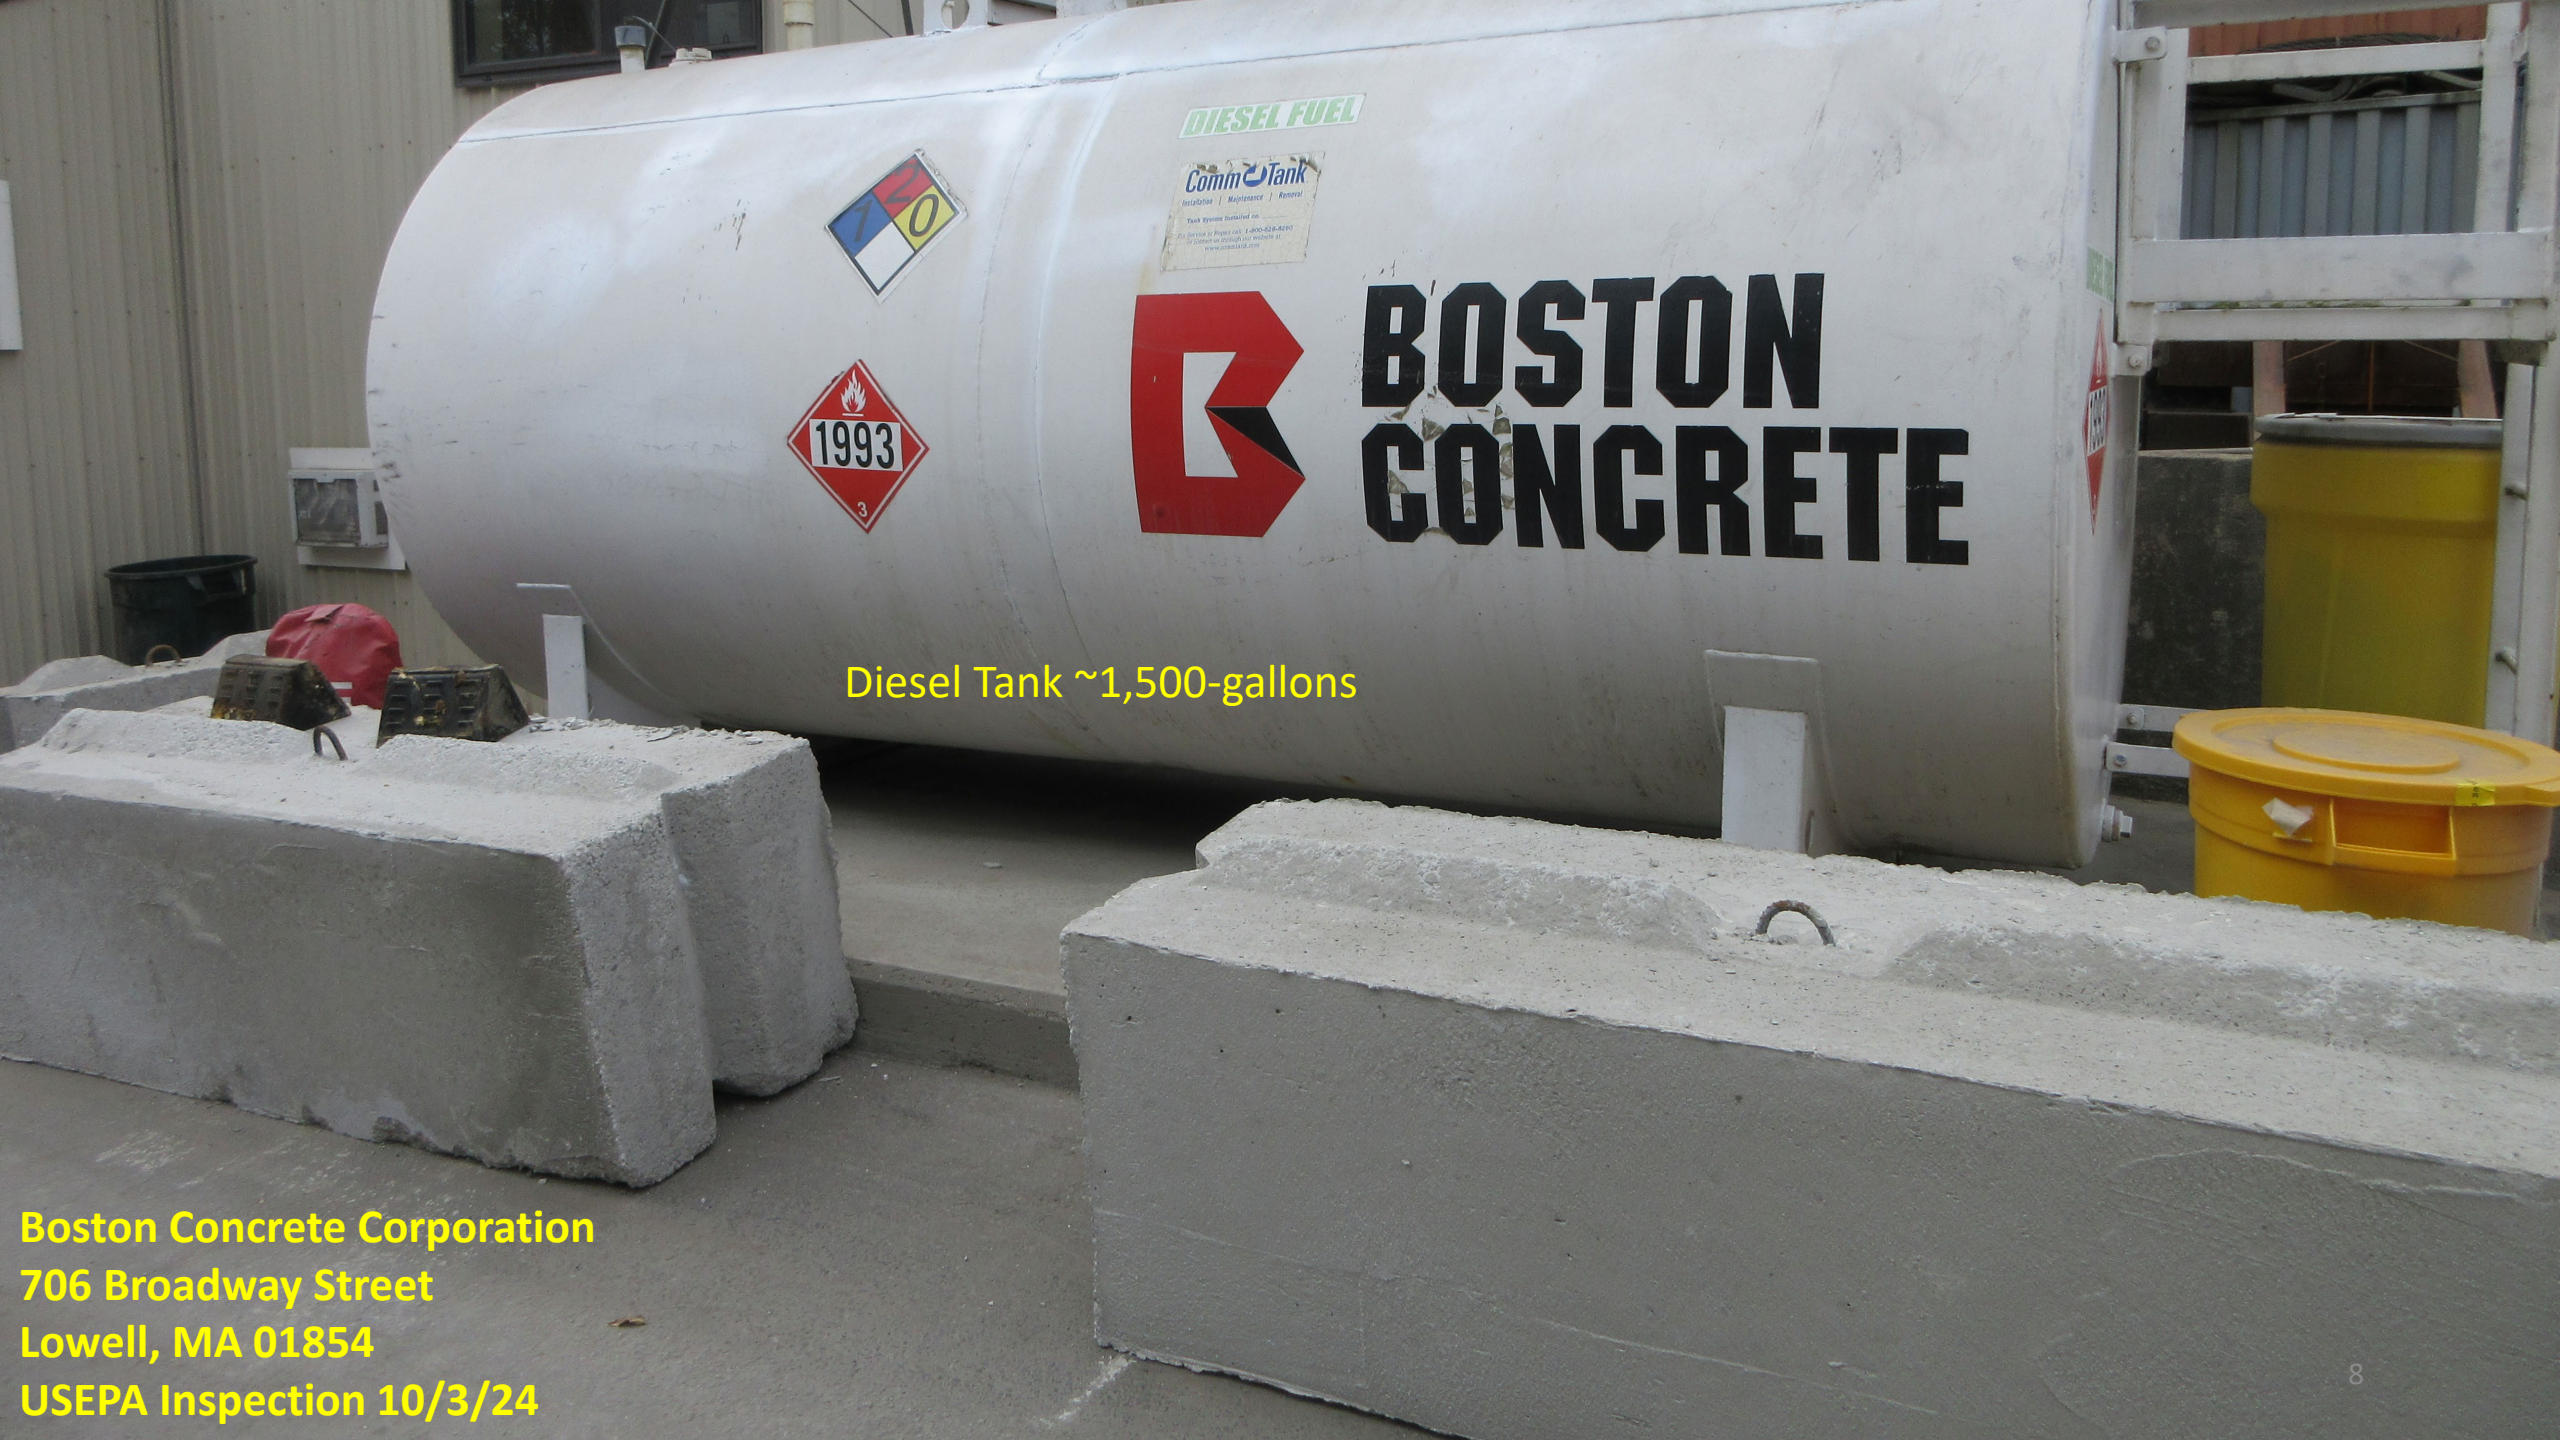
Diesel Tank ~1,500-gallons

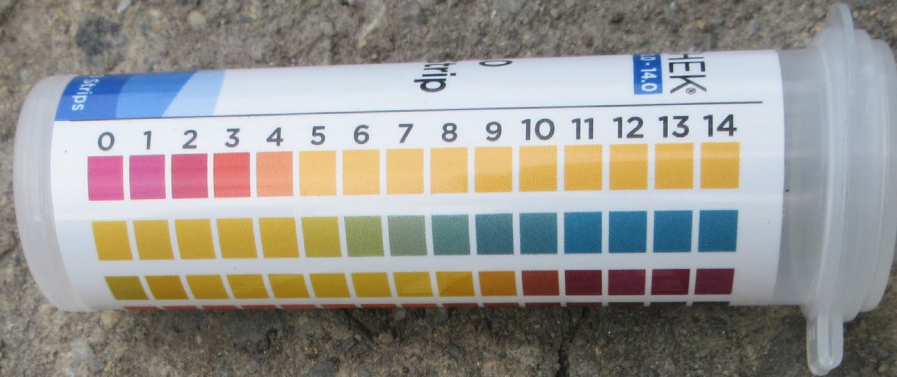
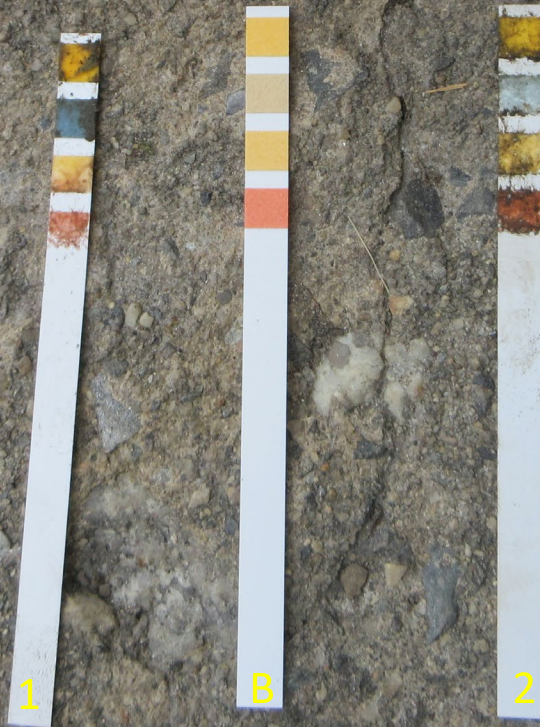
**pH reading for Outfall 002:**

pH strip #1 = 9 S.U

**pH reading from standing water in front of  
Outfall  
002:**

pH strip #2 = 10 S.U

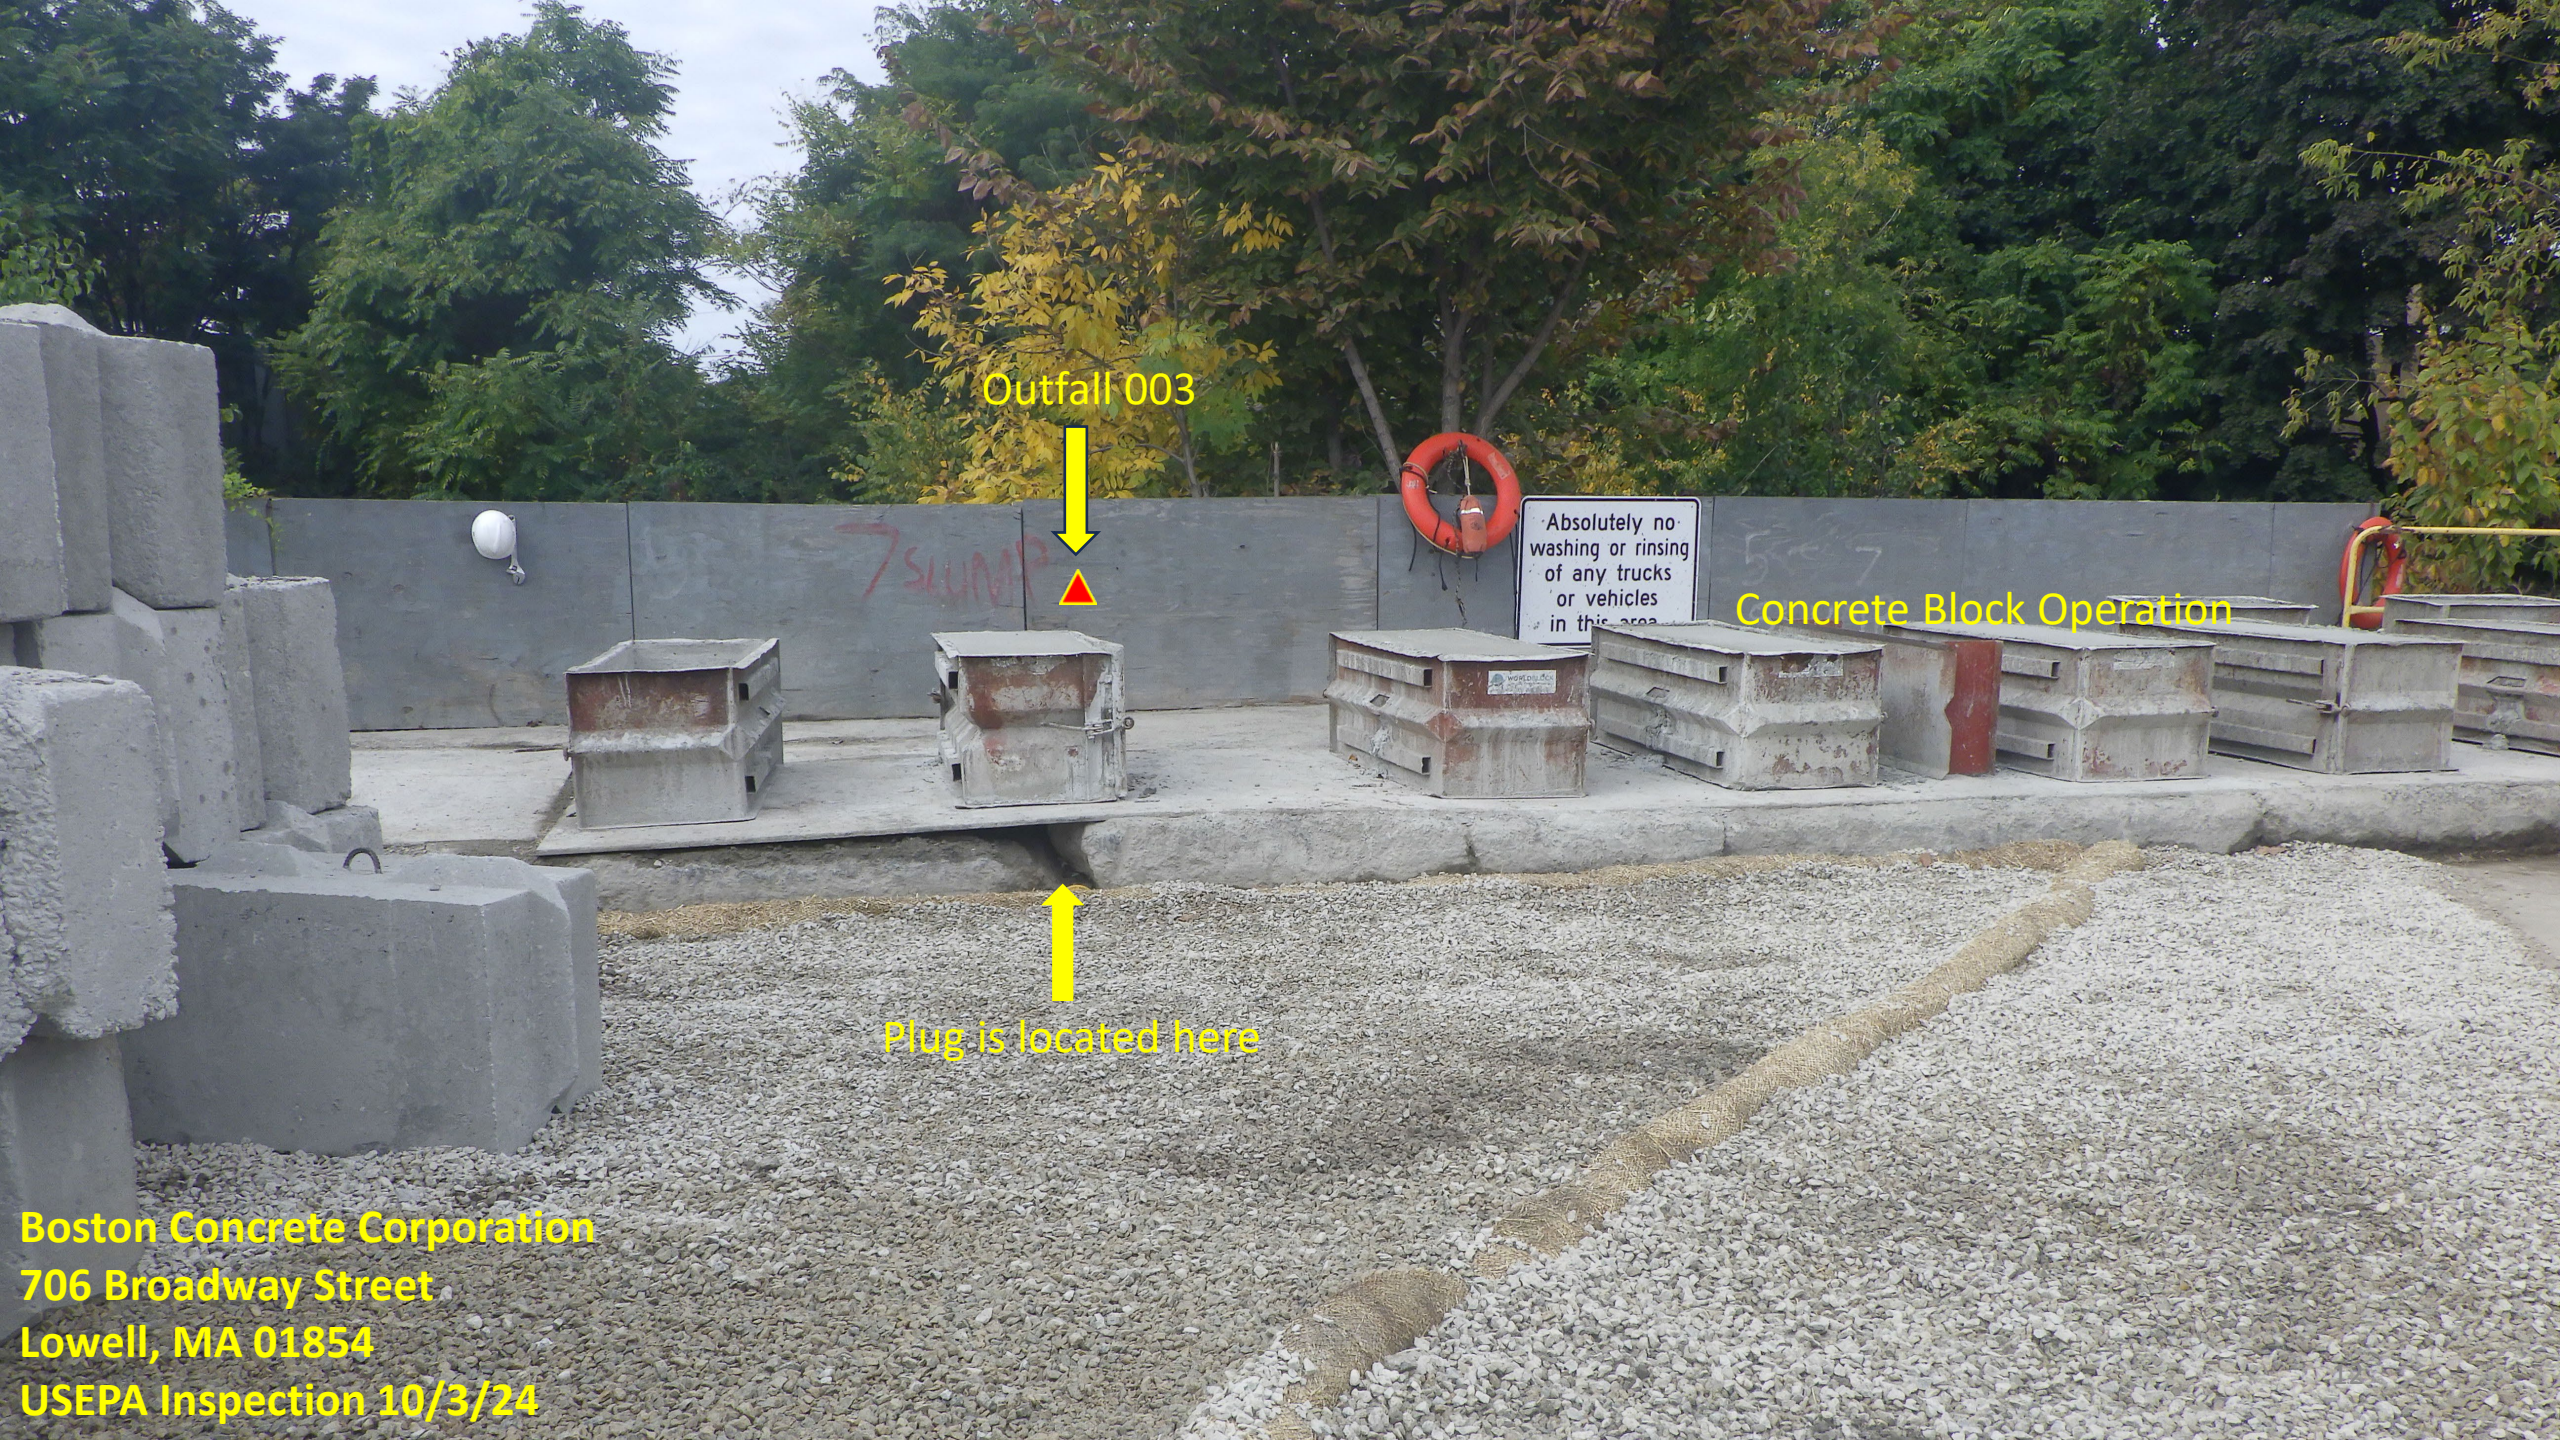
Plug leading to Outfall 003

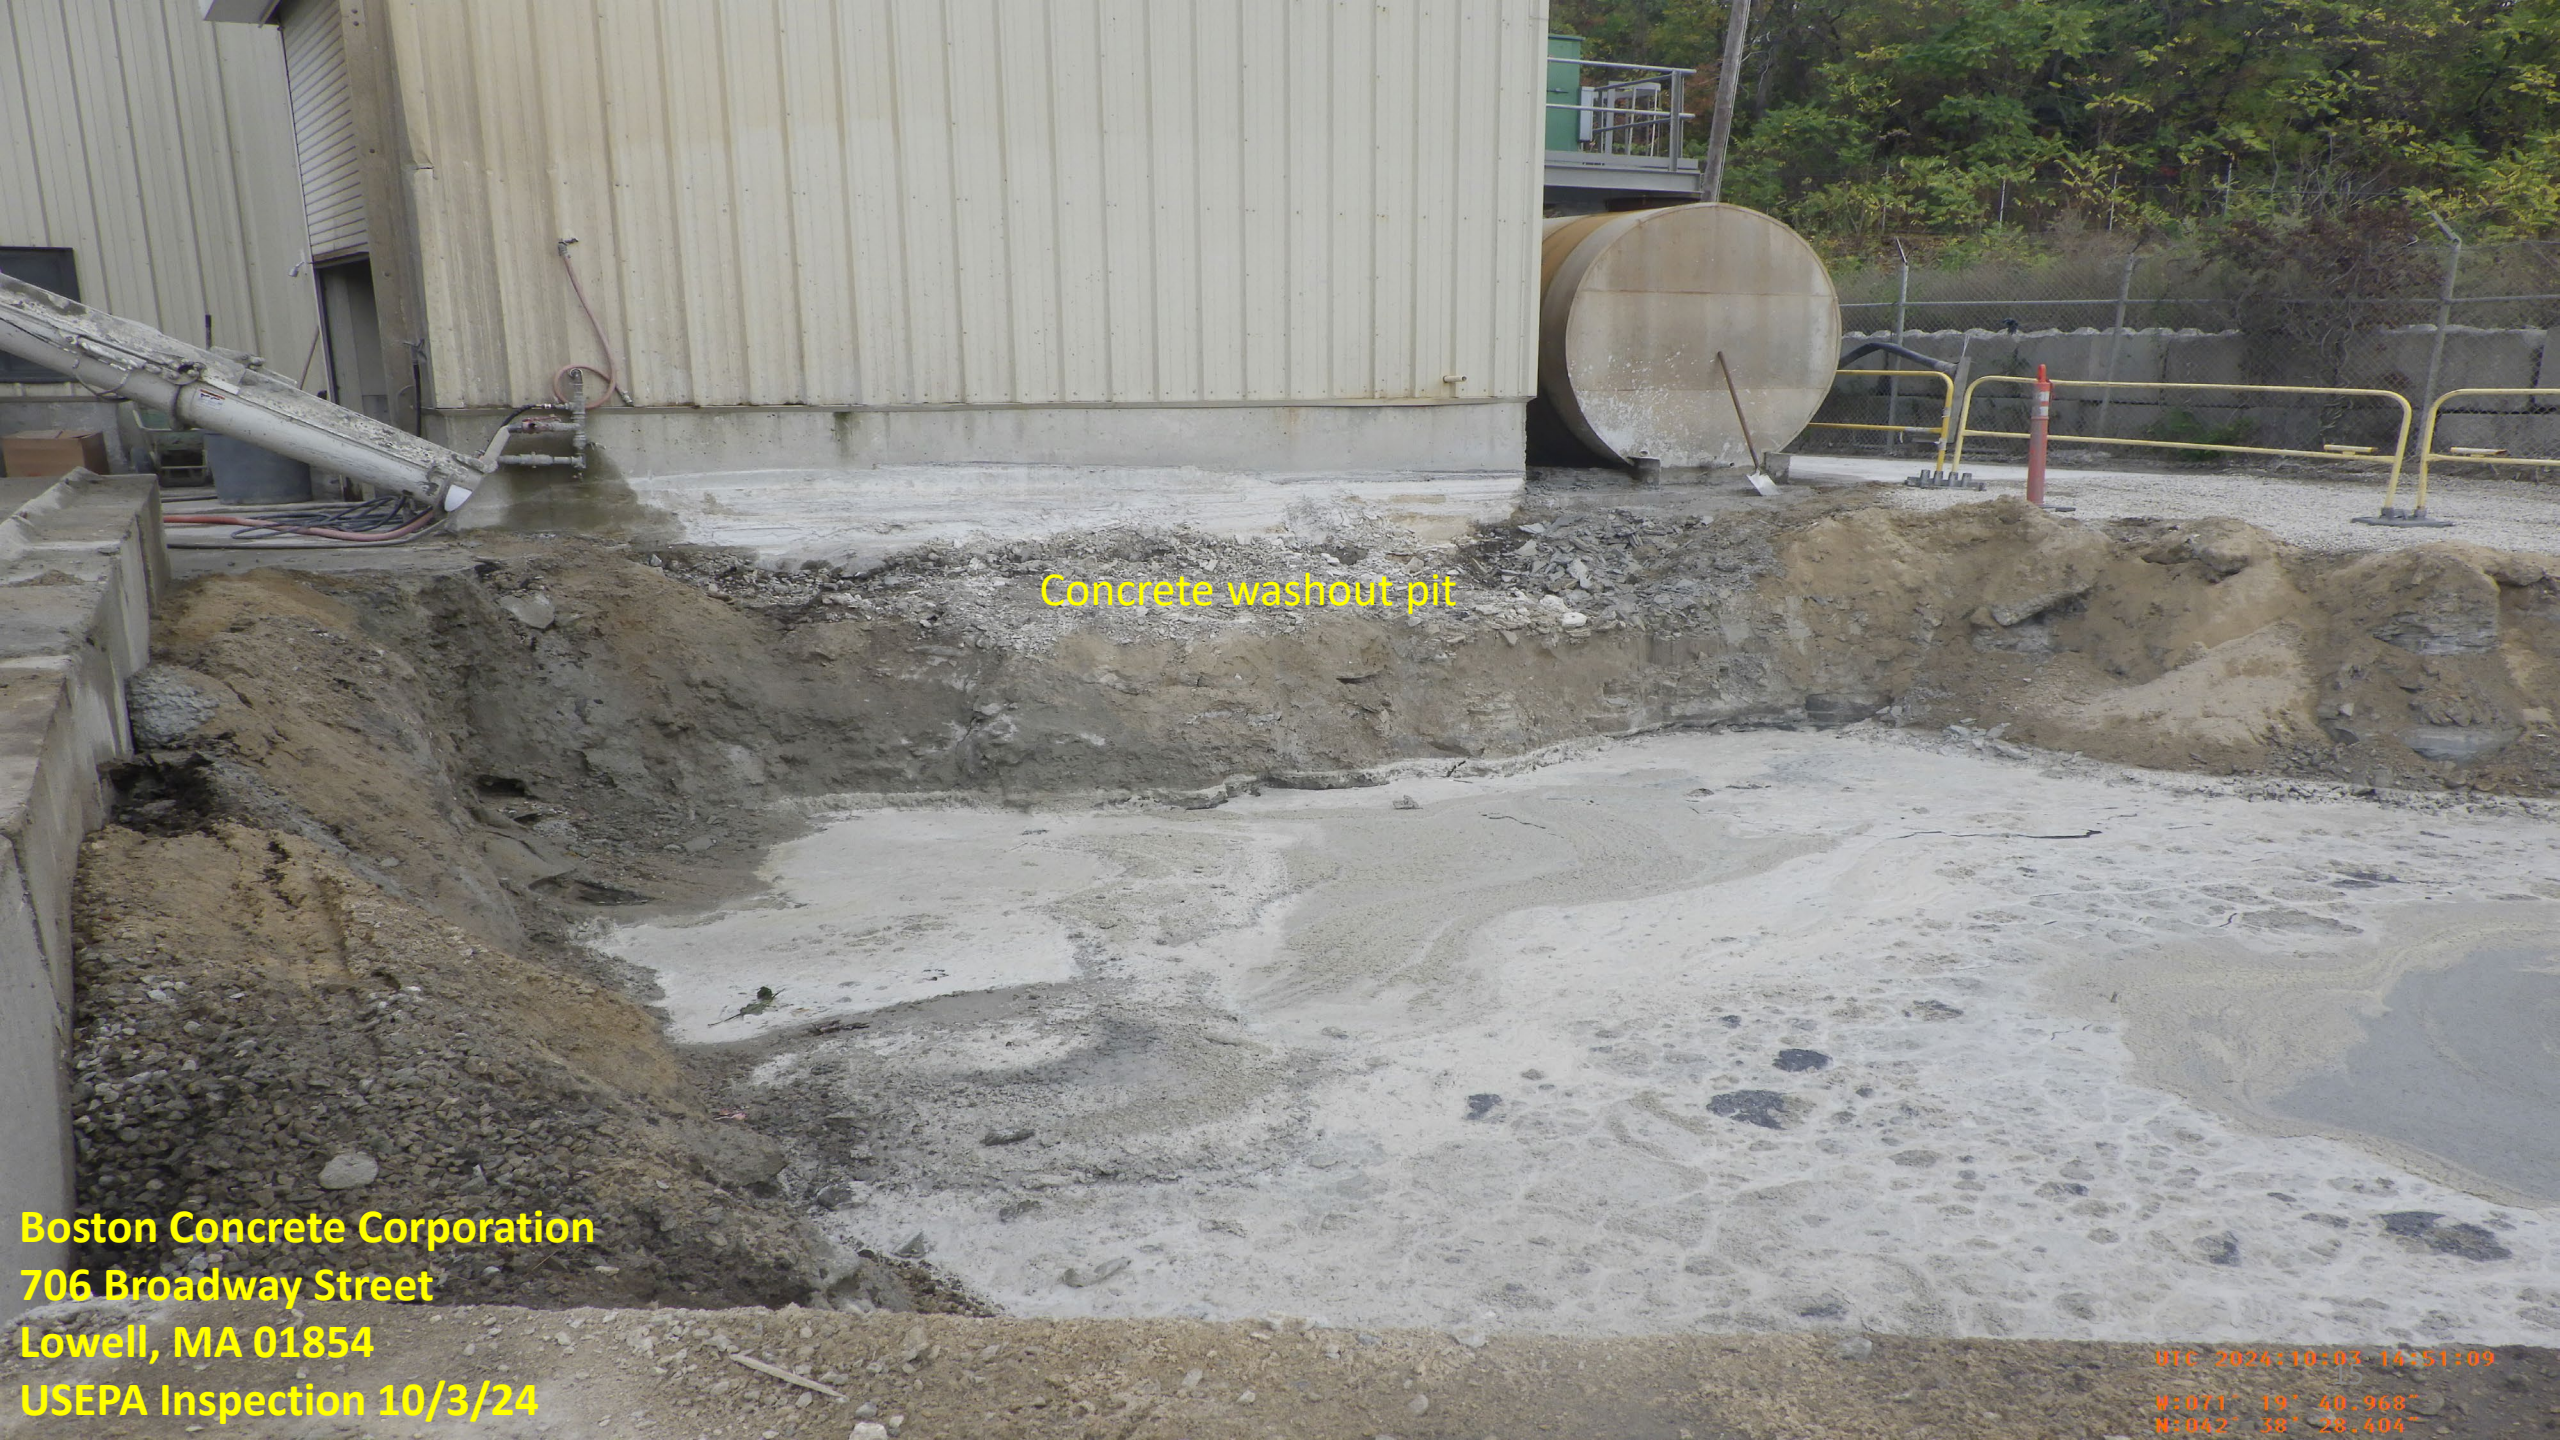
Inspector Canzano asked facility representatives when the liner in the washout pit was last replaced. Ms. Marshall stated that the liner had been replaced two times this year. Inspector Canzano then showed facility representatives 3 google earth images (Attachment C) showing liquid flow path and water staining from certain areas leading to outfall 2. Mr. Ploof explained that some of the staining on the asphalt is from sand delivery and when the sand becomes wet and saturated, the drag out from the sand can cause staining. The dark staining seen on the google earth images was the staining from such events. Inspector Ali asked about the production of colored concrete. Ms. Marshall stated that the company adds coloring, and it is listed as being a biodegradable pigment and operators add color in the concrete mixer truck on arrival to customers. Ms. Marshall informed the inspection team color of concrete doesn't occur on site.

Concrete washout pit

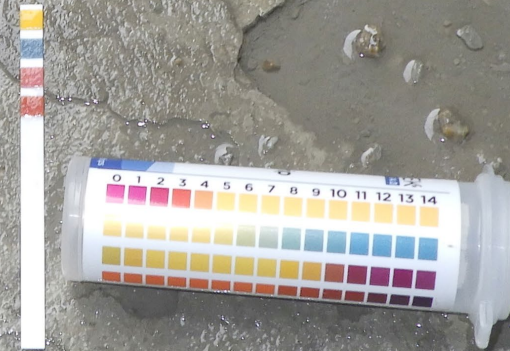
EPA inspectors then walked toward aggregate (dimensional stone and sand) storage pile. Inspector Ali collected a sample for pH using indicator paper of water on the pavement and puddling in front of the aggregate piles and the result was pH 7.0 S.U. As EPA inspectors walked to the concrete truck and chute washout pit located next to the plant. At the washout pit EPA inspectors observe an operator washout out a concrete truck. The processes duration was estimated to lasted for about approximately 10 minutes. Inspector Hatke collected a pH sample using indicator paper of process wastewaters pooling next to the truck washing operation and in front of the washout pit. The pH result was observed to be between 10.0 S.U. and 11.0 S.U. Inspector Canzano informed Ms. Marshall wastewaters from the truck and chute washing operations are process wastewater and should not be commingled with stormwater.

Truck washing operation and in front of the washout pit. The pH result was observed to be between 10.0 S.U. and 11.0 S.U.
