## Region 6 - Enforcement & Compliance Assurance Division

### INSPECTION REPORT

| Company Name: | <b>Novy Oil and Gas Inc.</b> | |
| Facility Name: | <b>Pearsonia</b> | |

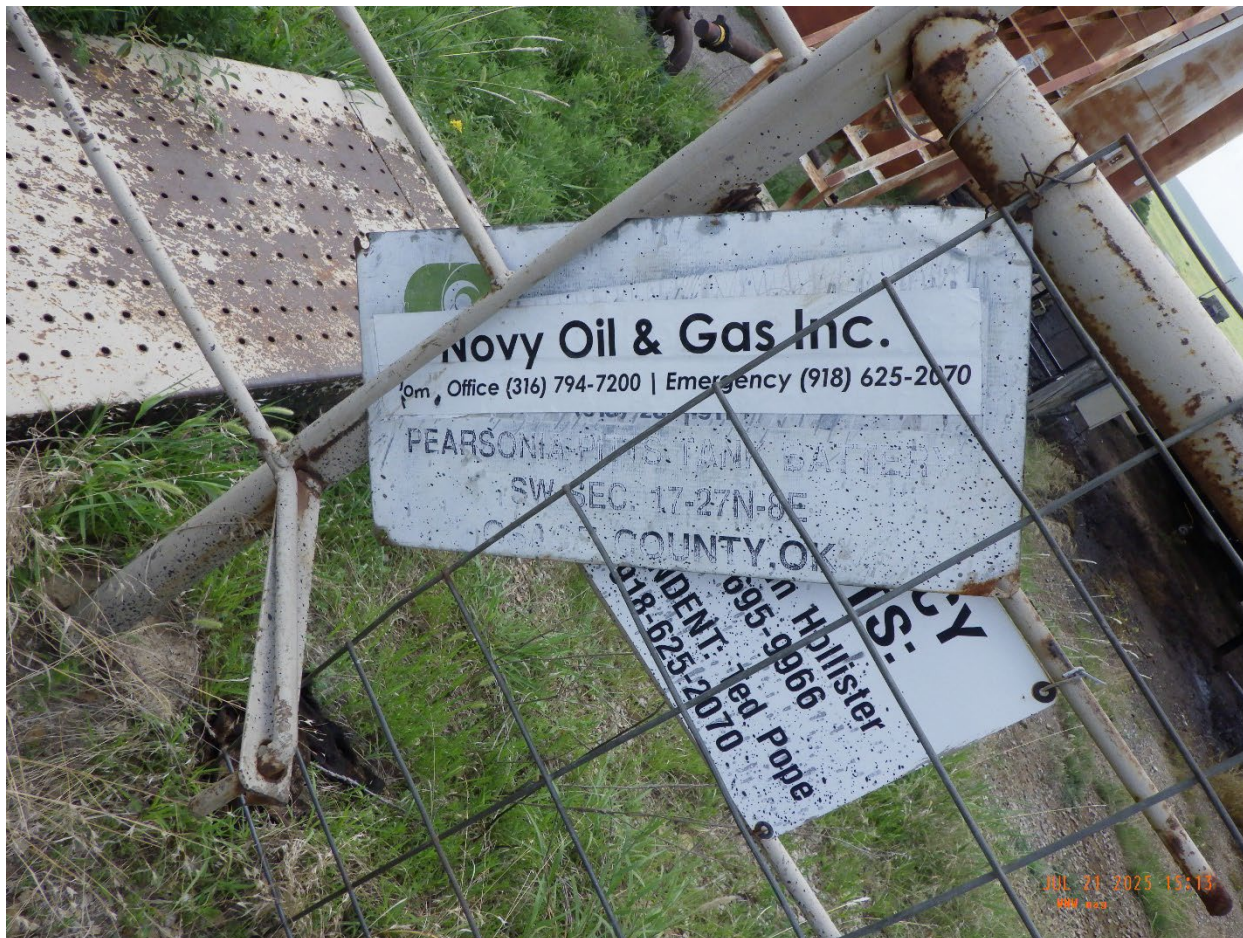
Photo No. 1

I observed the facility sign for the Novy Oil & Gas Inc., Pearsonia Lease tank battery. See photo No. 1. For additional GPS location information and photo metadata, please see Appendix 1 (photo log) attached to this report.

**Description:** This was the facility sign for the Novy Oil & Gas Inc. Pearsonia lease tank battery. This facility was the release point of the spill.

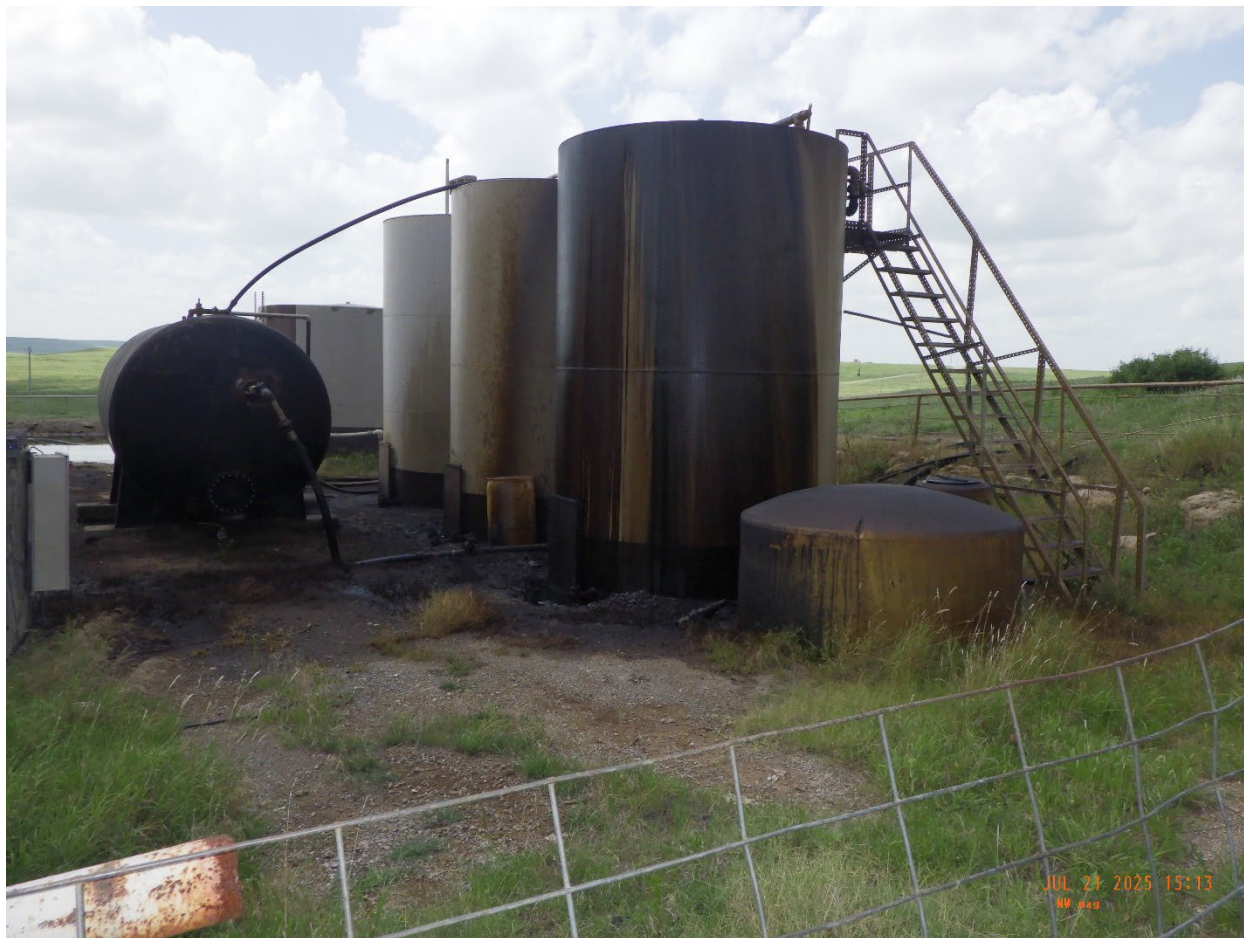
Photo No. 2

I observed the oil tank which overflowed into the secondary containment. At the time of the inspection, the tank was covered in oil. This was the release point of the spill. See photo No. 2.

**Description:** This was the oil tank which overflowed, releasing oil and saltwater onto the floor of the facility.

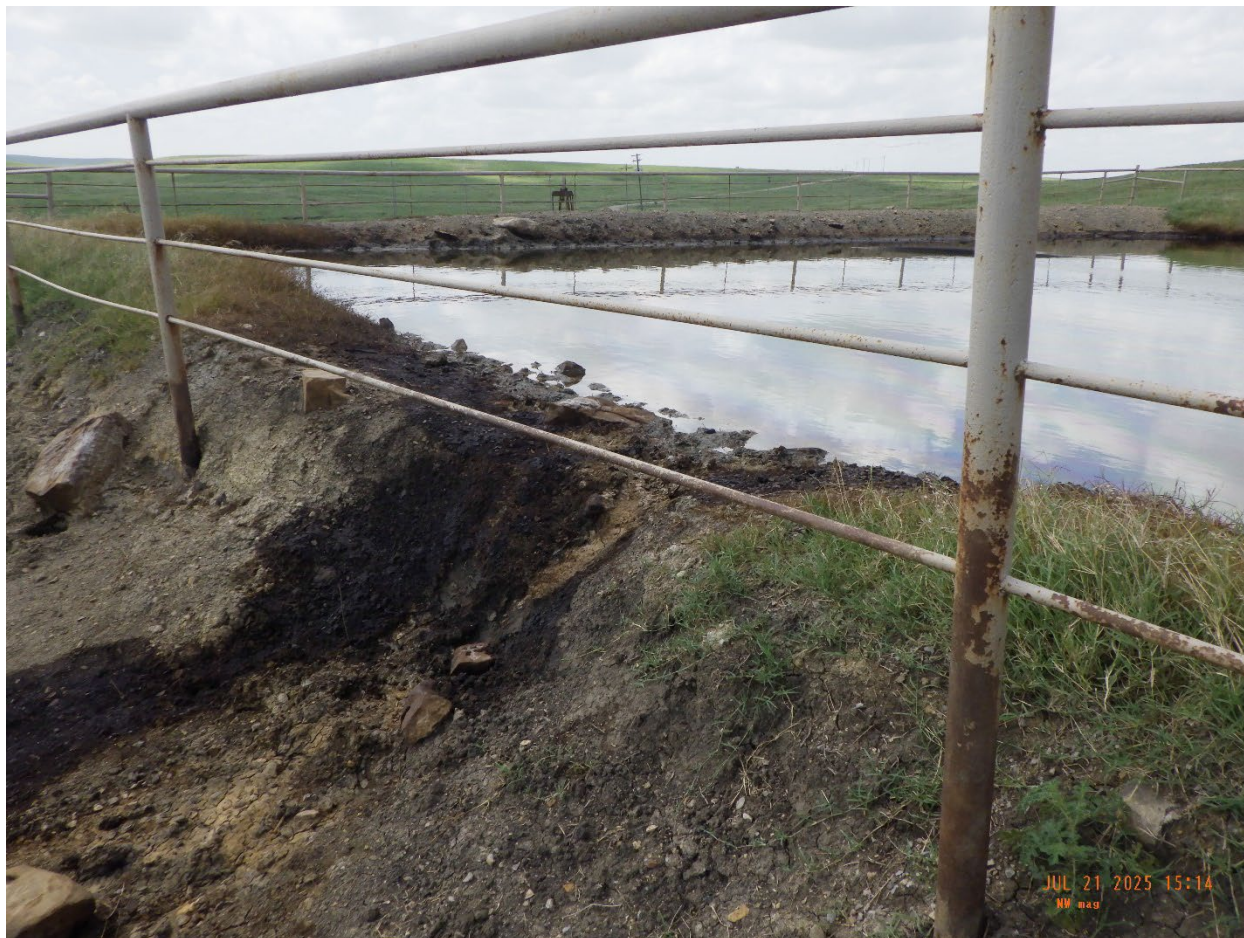
Photo No. 3

I observed a low point in the secondary containment berm along the south edge of the facility. This low section of berm was stained with oil and was the point where spilled fluids overtopped the secondary containment. See photo No. 3.

**Description:** This was a low point in the secondary containment where oil spilled out of the facility.

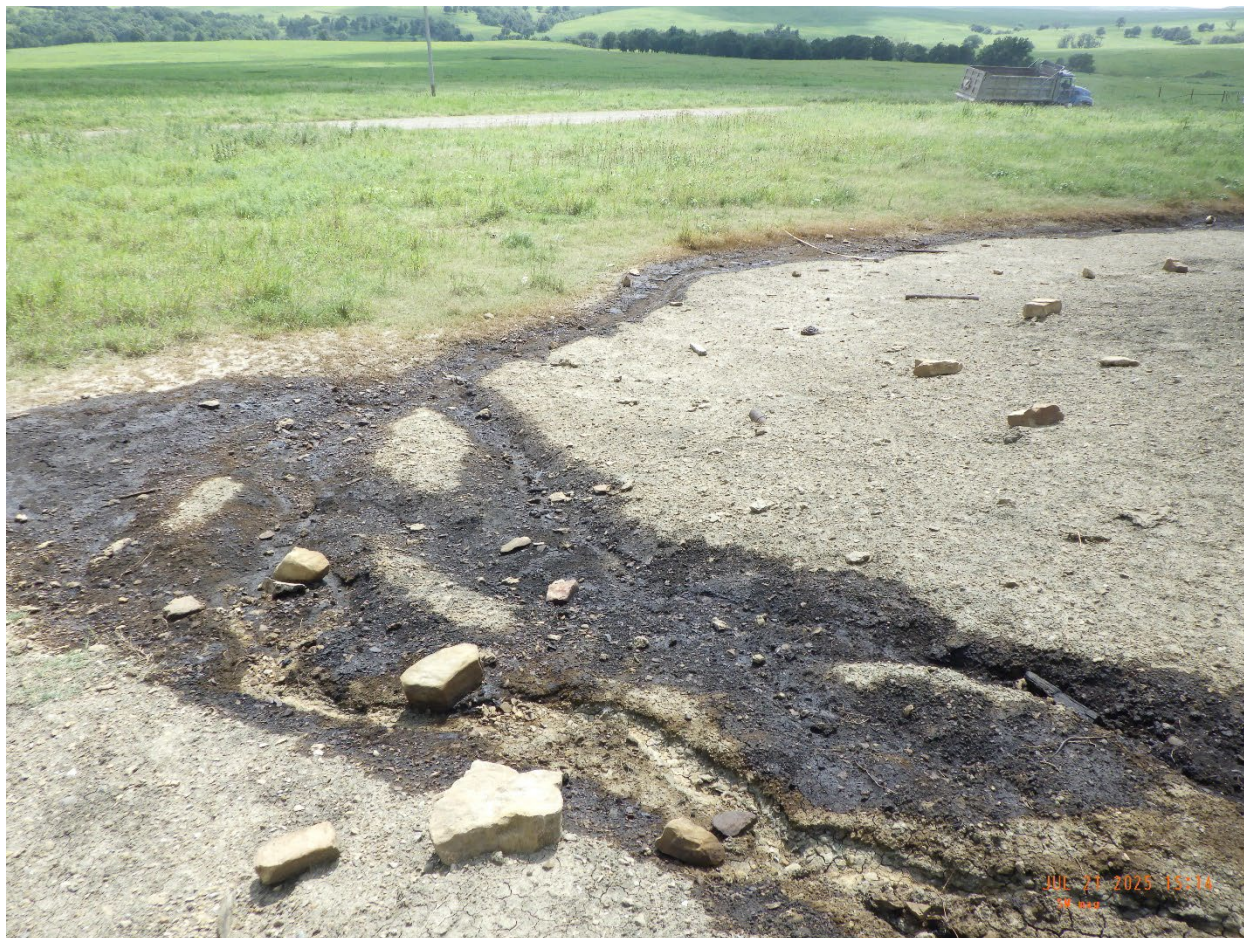
Photo No. 4

I observed the overland flowpath of the spill as it migrated away from the Pearsonia lease tank battery. The area along the flowpath was bare soil with no vegetation, and there was evidence of previous spills or inadequate secondary containment structures. See photo No. 4.

**Description:** This was a view toward the southwest of the overland flowpath as the spill migrated toward a nearby unnamed tributary of North Bird Creek.

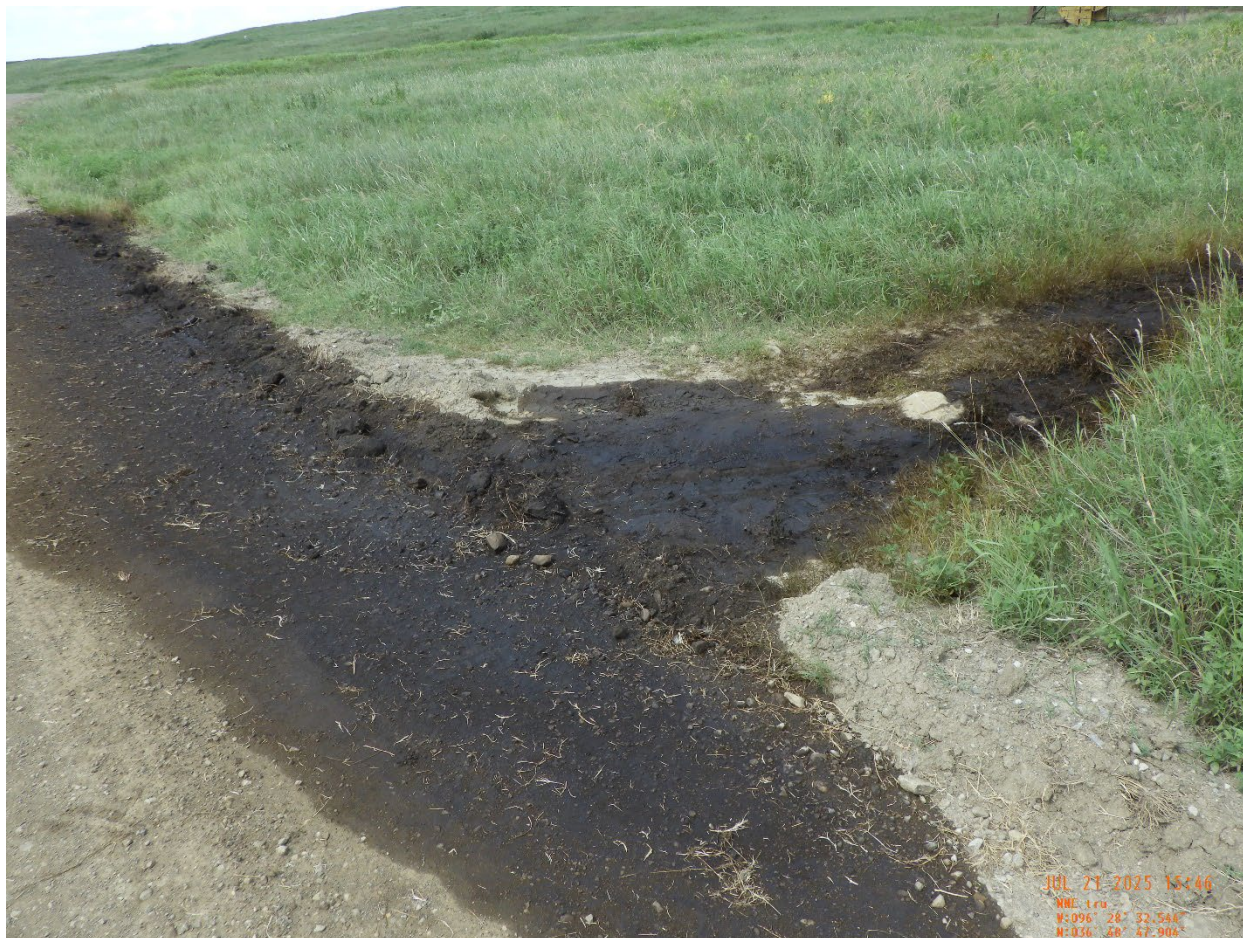
Photo No. 5

I observed oil-stained soil and roadbed along the county road immediately west of the facility. See photo No. 5.

**Description:** This was oil-stained soil and roadbed where the spill crossed the county road, west of the facility.

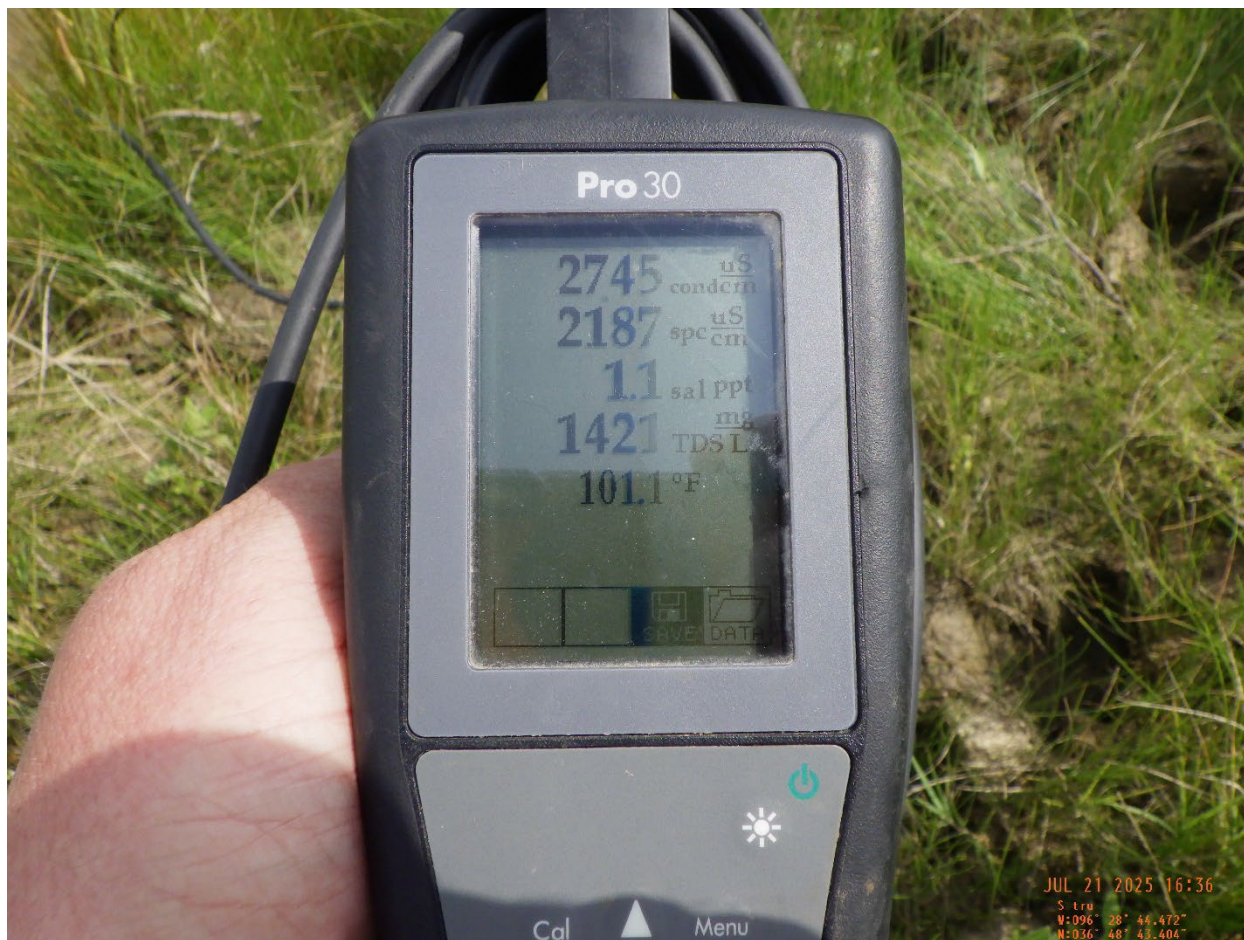
Photo No. 6

I observed a TDS field reading of 1,421 mg/L in the impacted, unnamed tributary of North Bird Creek. This was the highest TDS reading observed during the inspection. At the time of the inspection, cleanup was underway, and this was the first pool of water along the unnamed tributary. At this same location, oil was observed on the water and banks. See photos No. 6 and 7.

**Description:** This was a TDS field reading of 1,421 mg/L in the first pool of water along the impacted, unnamed tributary of North Bird Creek.

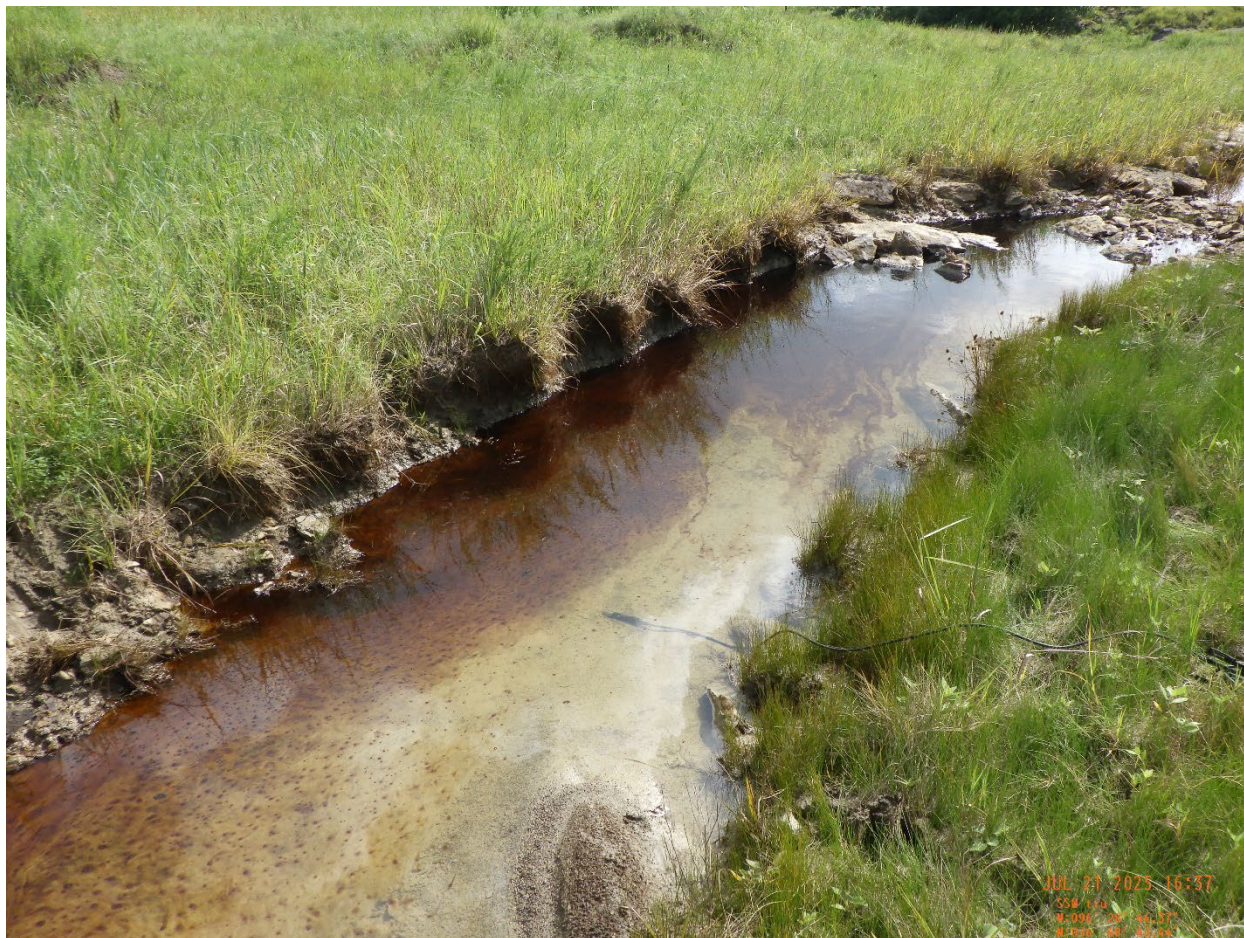
Photo No. 7

**Description:** This was oil floating on the unnamed tributary of North Bird Creek. This is the same location where the TDS field reading from photo No. 6 was observed.

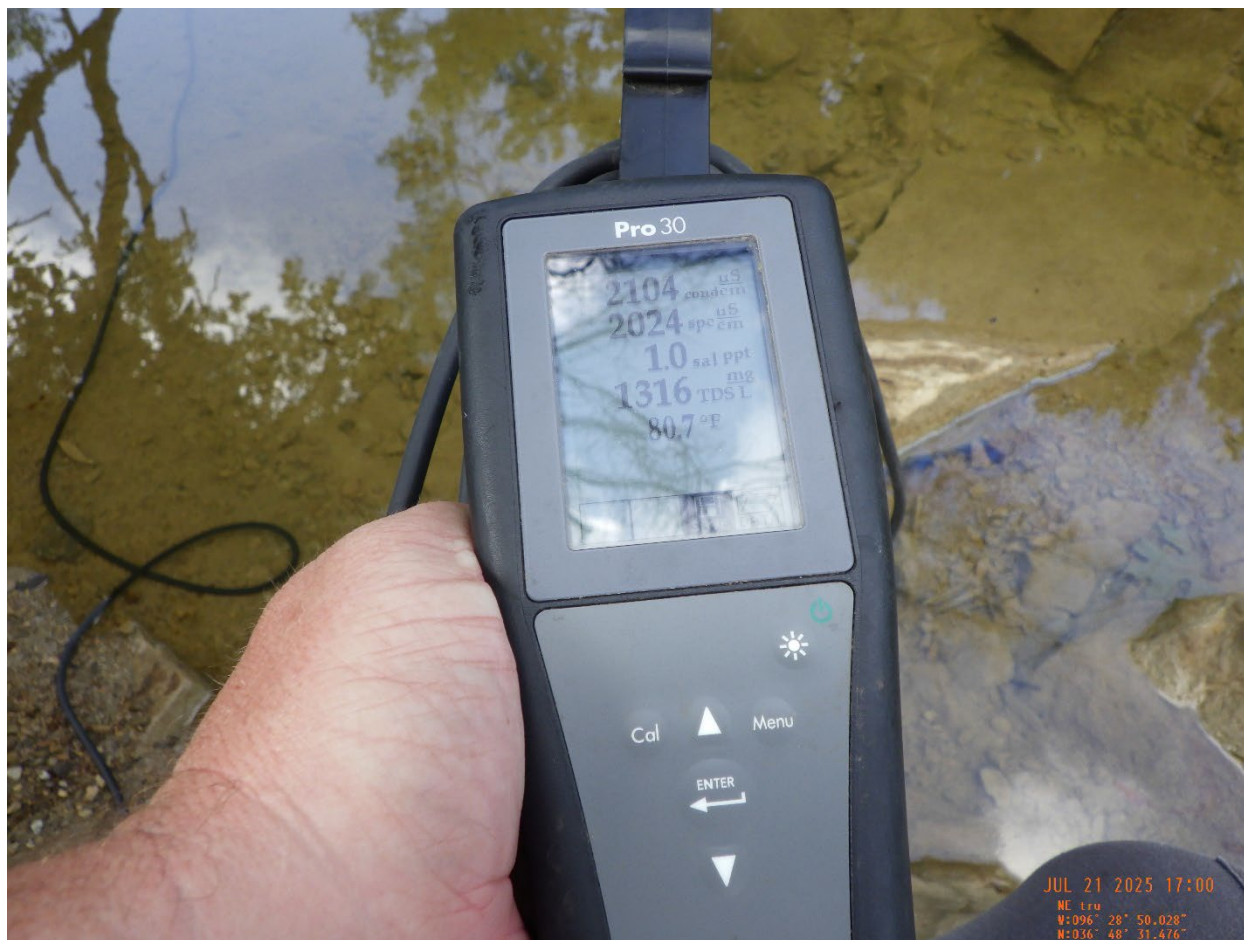
Photo No. 8

Continuing downstream, I observed a TDS field reading of 1316 mg/L. At the same location I observed oil on the surface of the impacted tributary. See photos No. 8 and 9.

**Description:** This was a TDS field reading of 1316 mg/L observed in the impacted tributary of North Bird Creek.

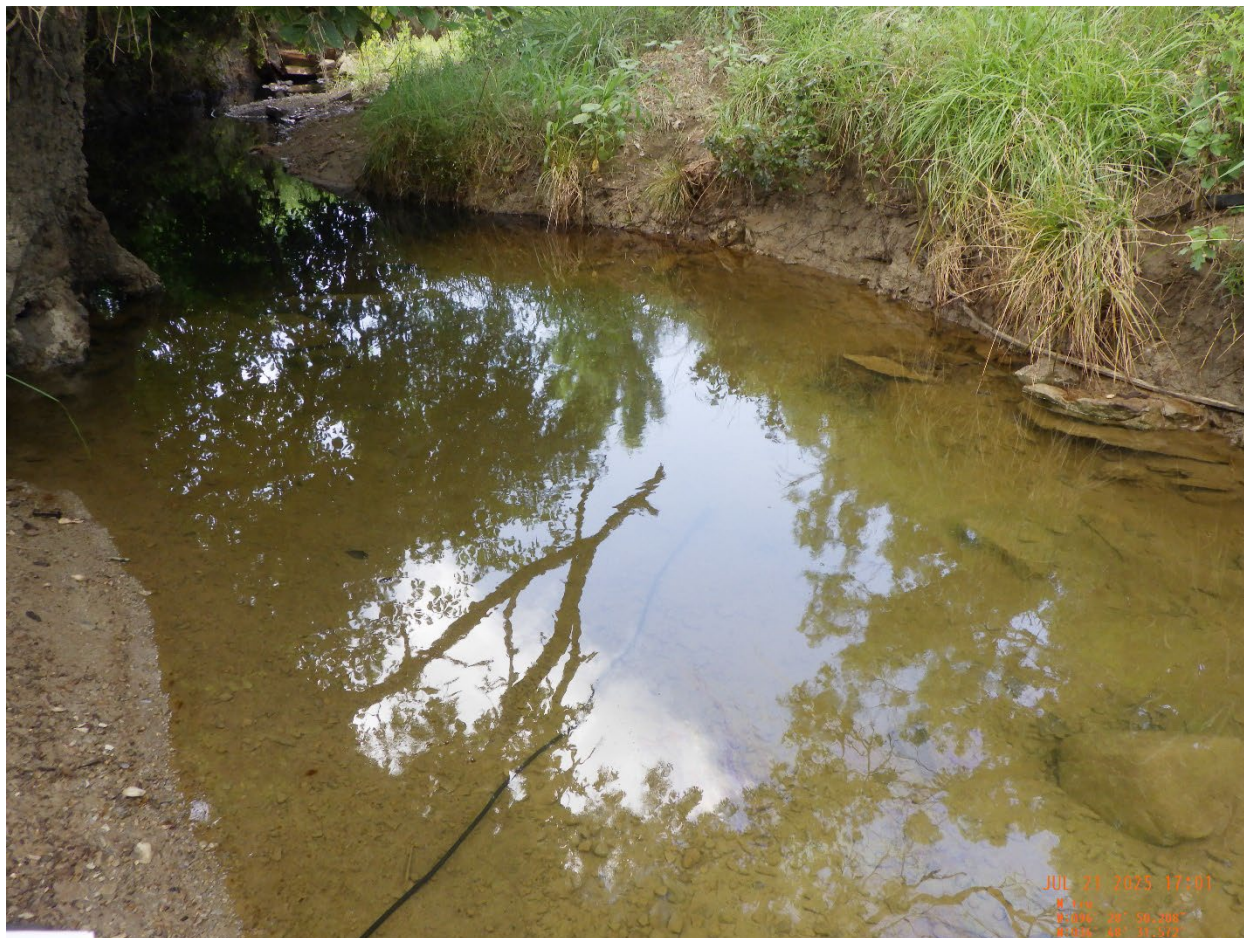
Photo No. 9

**Description:** This was the pool where the TDS reading from photo No. 8 was observed. Oil was present on the water in the top left portion of the photo.

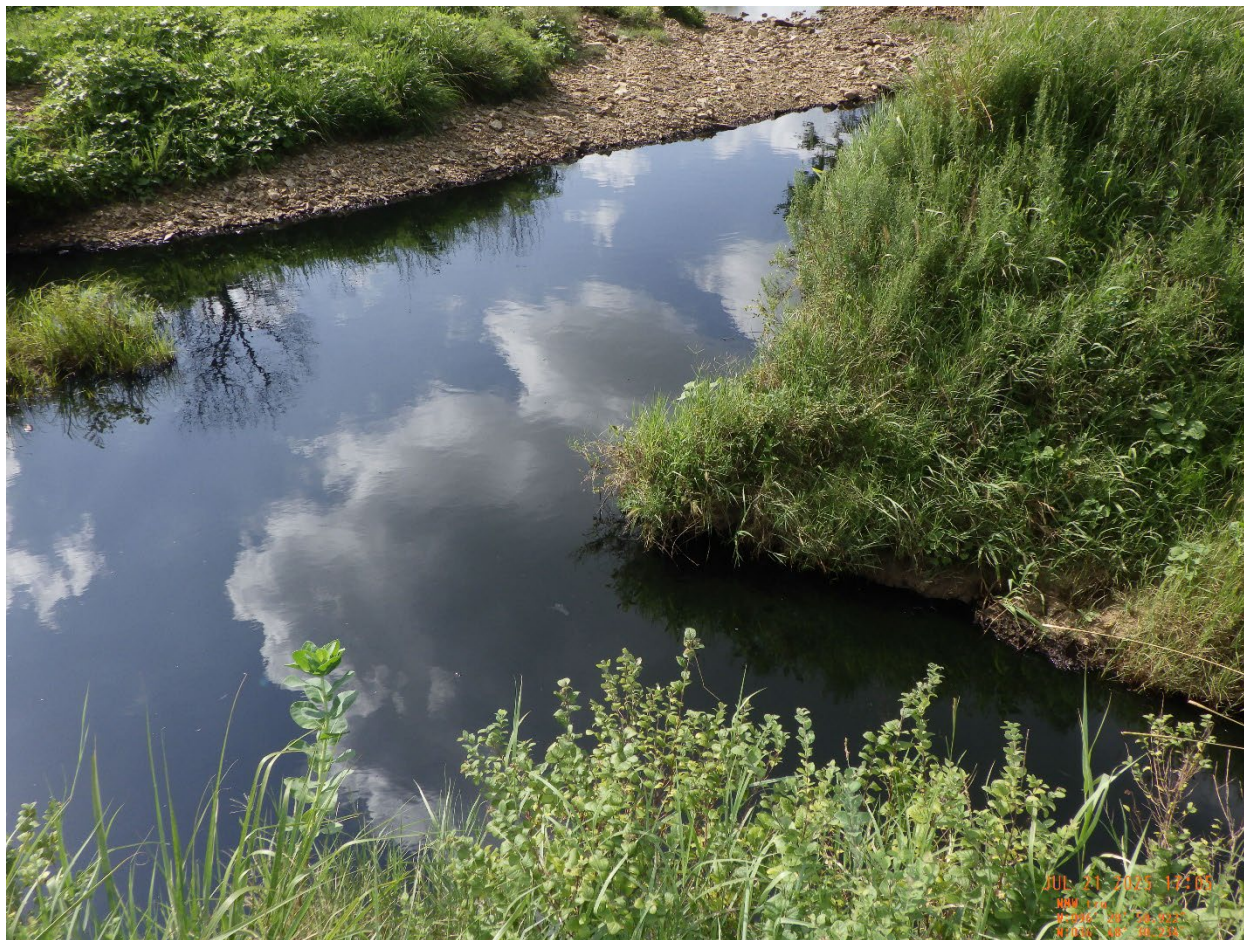
Photo No. 10

I observed the confluence of the impacted tributary and North Bird Creek. Significant oil was present on the unnamed tributary and North Bird Creek. See photo's No. 10, 11, 12 and 13.

**Description:** This was the confluence of the unnamed tributary and North Bird Creek. This was the point of entry (POE) into North Bird Creek. The unnamed tributary enters the photo from the lower right corner. The unnamed tributary and North Bird Creek had a significant amount of oil floating on the surface at this location.

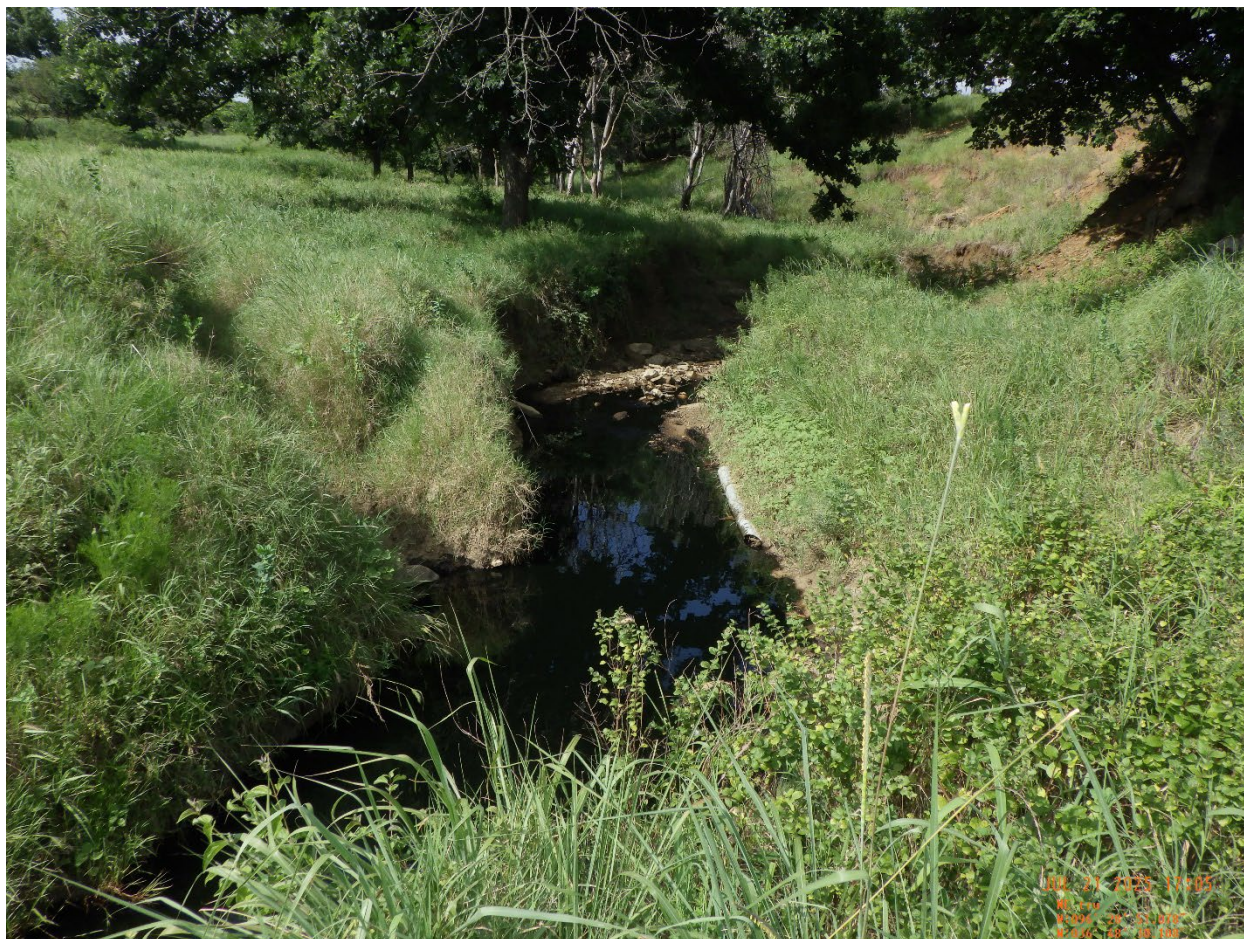
Photo No. 11

**Description:** This was a view from the confluence of North Bird Creek and the unnamed tributary with a view toward the northeast, looking back upstream along the unnamed tributary.

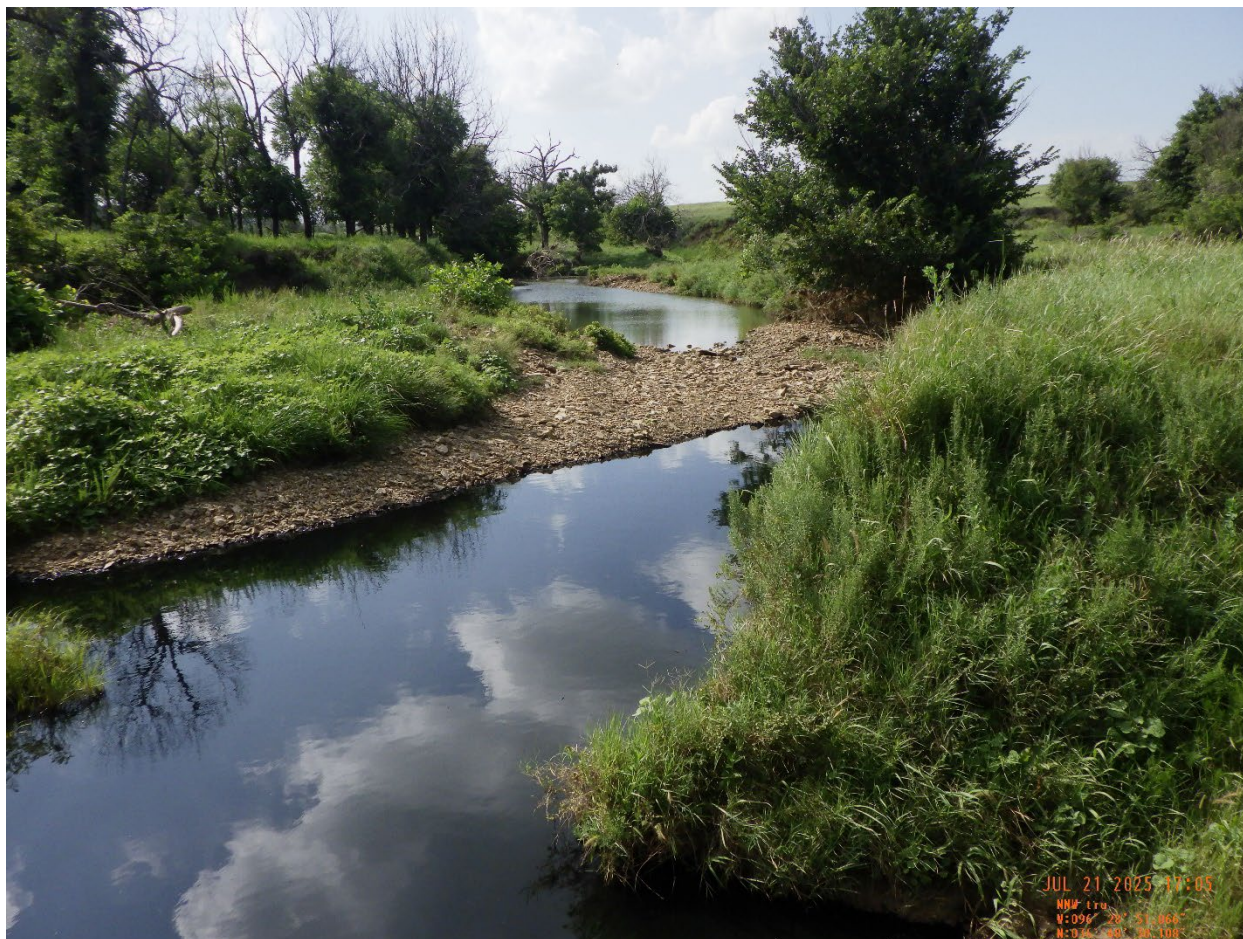
Photo No. 12

**Description:** This was a view from the confluence of North Bird Creek and the unnamed tributary with a view toward the northwest along North Bird Creek. The gravel bar prevented oil from being pushed further upstream by the south wind.

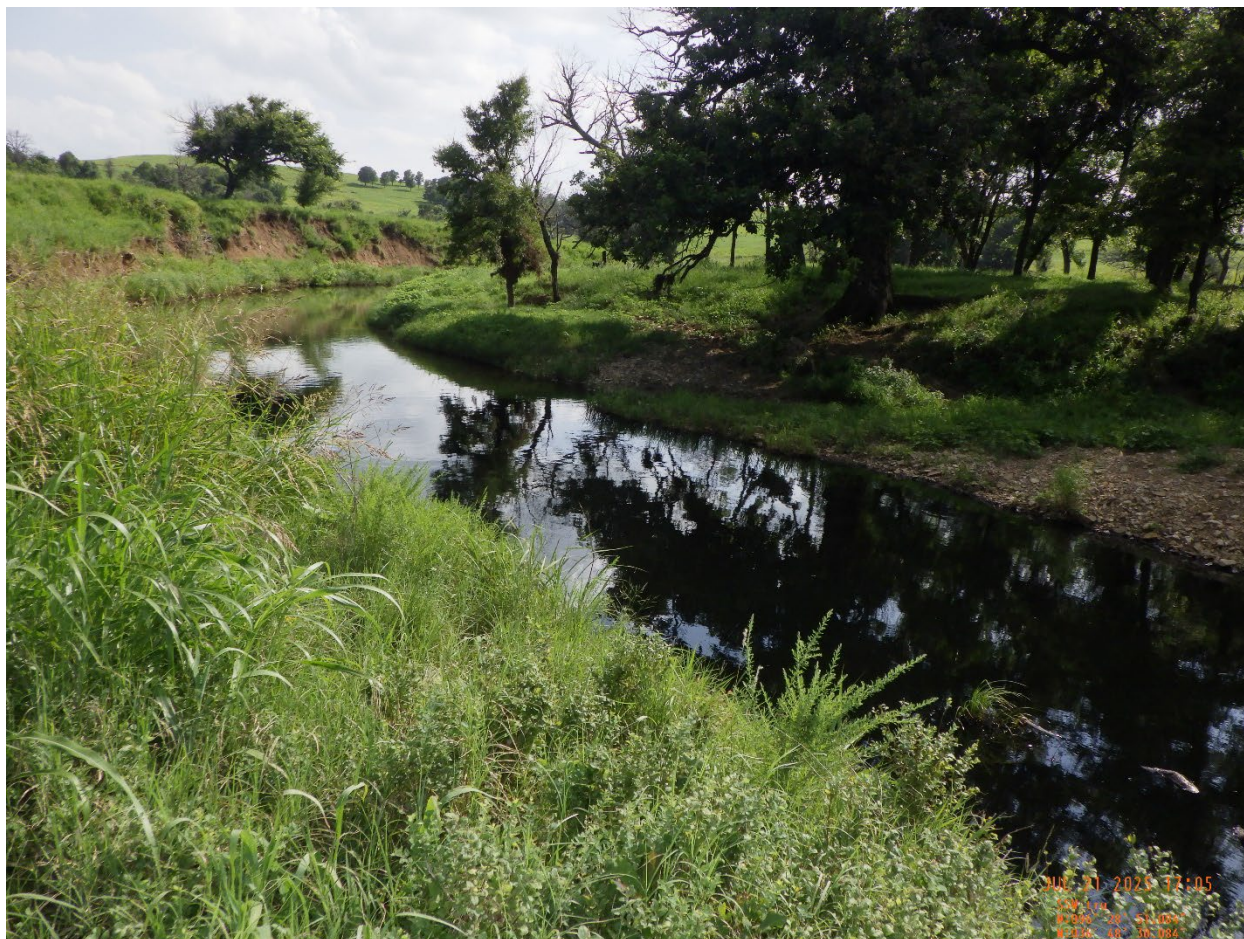
Photo No. 13

**Description:** This was a view from the confluence of North Bird Creek and the unnamed tributary with a view toward the southwest along North Bird Creek. There was significant oil on the surface of North Bird Creek.

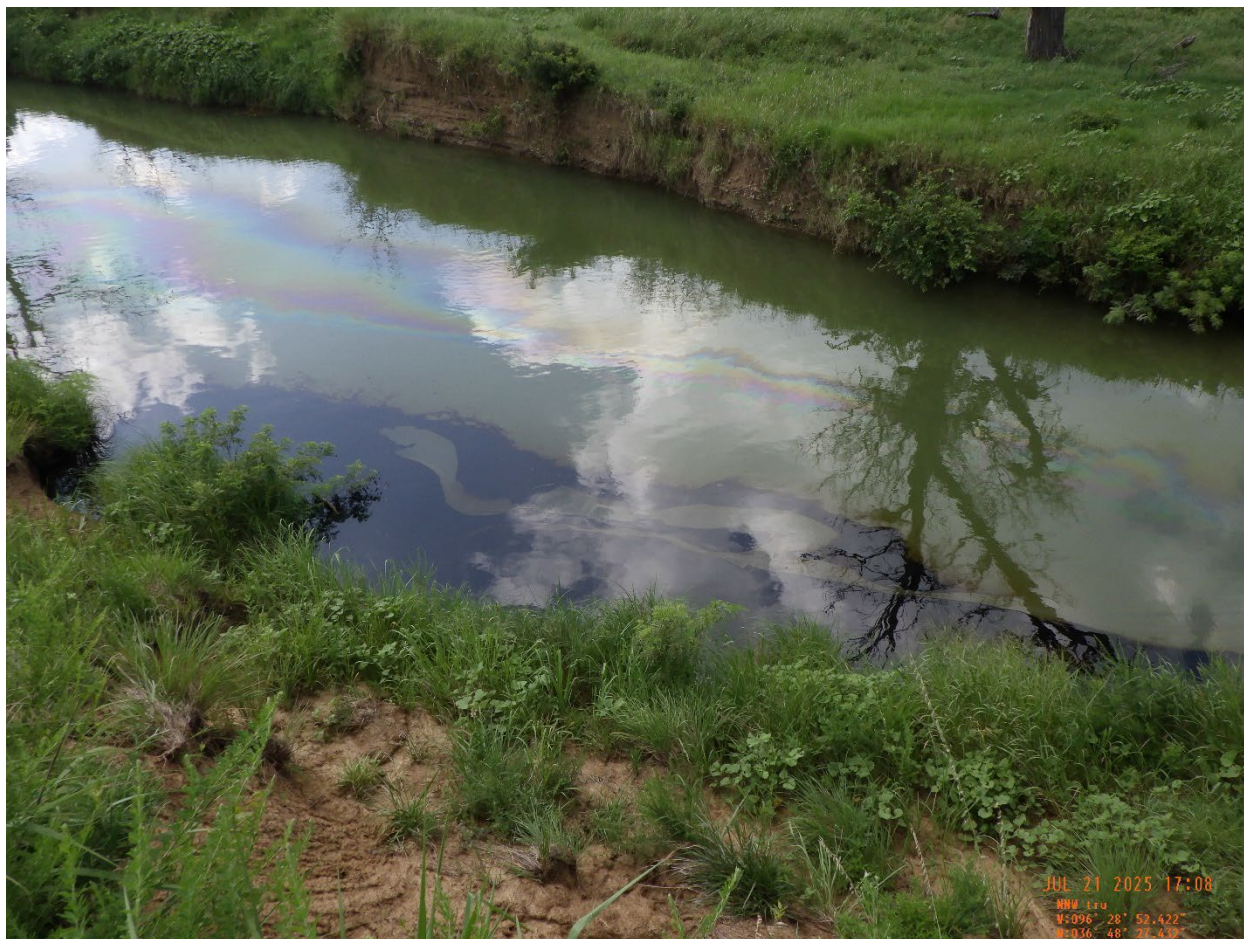
Photo No. 14

Continuing downstream along North Bird Creek, I observed oil and sheen on the water. See photo No. 14.

**Description:** This was a view of oil and sheen present on North Bird Creek downstream from the POE.

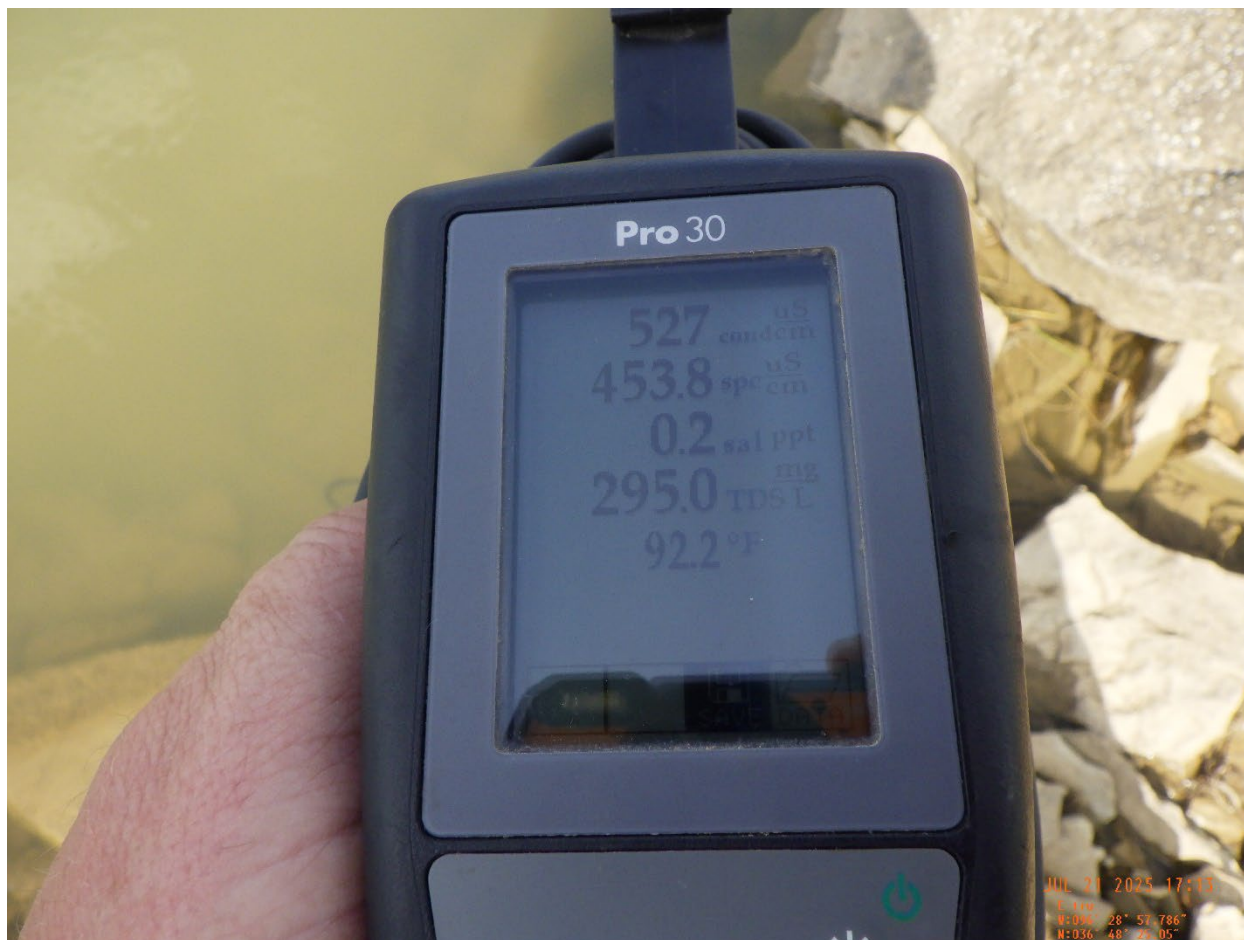
Photo No. 15

At the lowermost containment area along North Bird Creek, I observed a TDS field reading of 295 mg/L. At this same location, I observed round bales of hay which had been placed in North Bird Creek by the operator to prevent downstream migration of the oil. At the time of the inspection, there was no oil present at the hay bales, and there was no spill impacts observed downstream beyond this point. See photos No. 15, 16 and 17.

**Description:** This was a TDS field reading of 295mg/L. This was the highest reading observed in North Bird Creek.

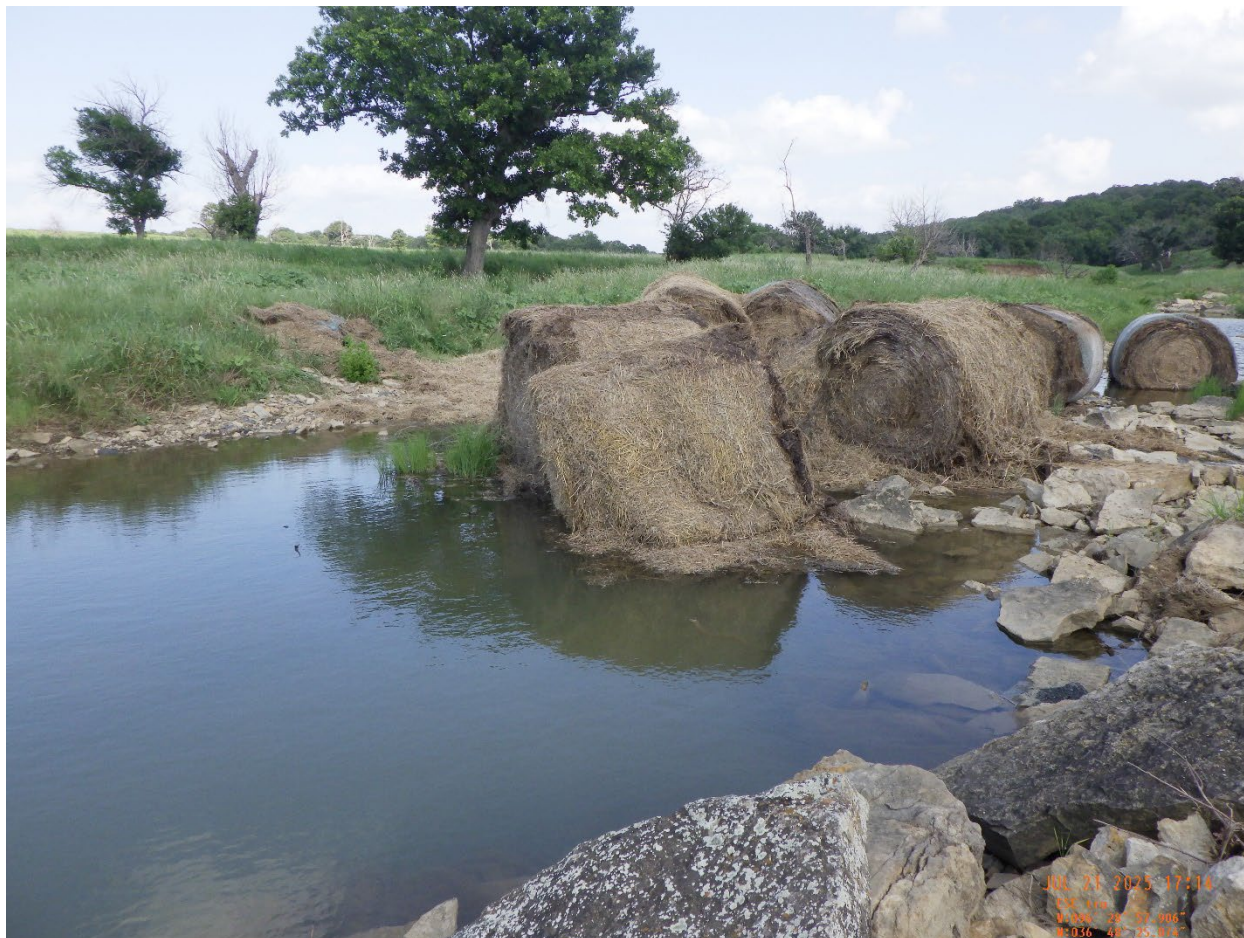
Photo No. 16

**Description:** This was hay bales placed in North Bird Creek by the operator to prevent downstream migration of oil. At the time of the inspection, the hay bales were preventing downstream migration of oil.

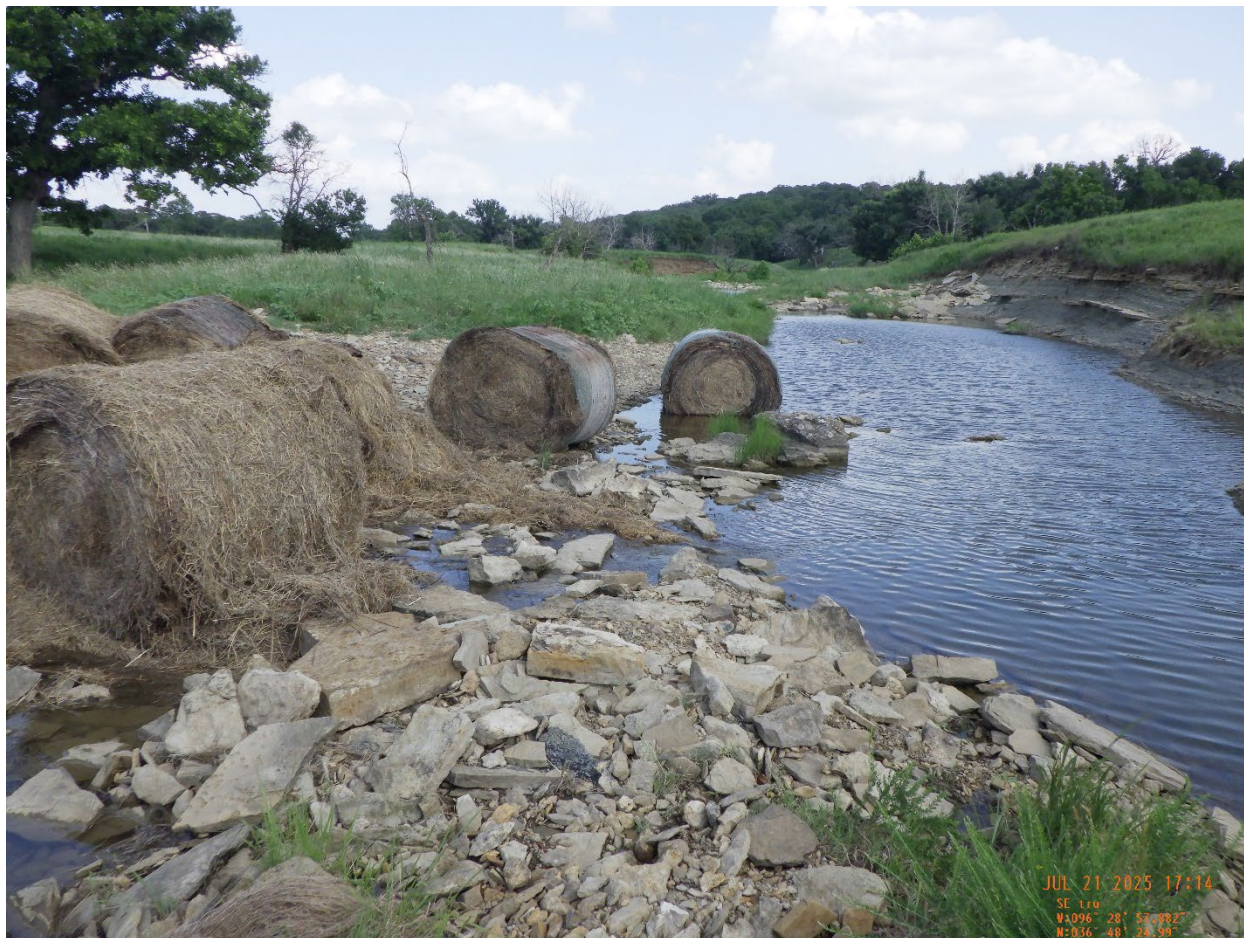
Photo No. 17

**Description:** This was a view downstream from the hay bales/containment area. There was no oil or spill impacts observed downstream from this location.

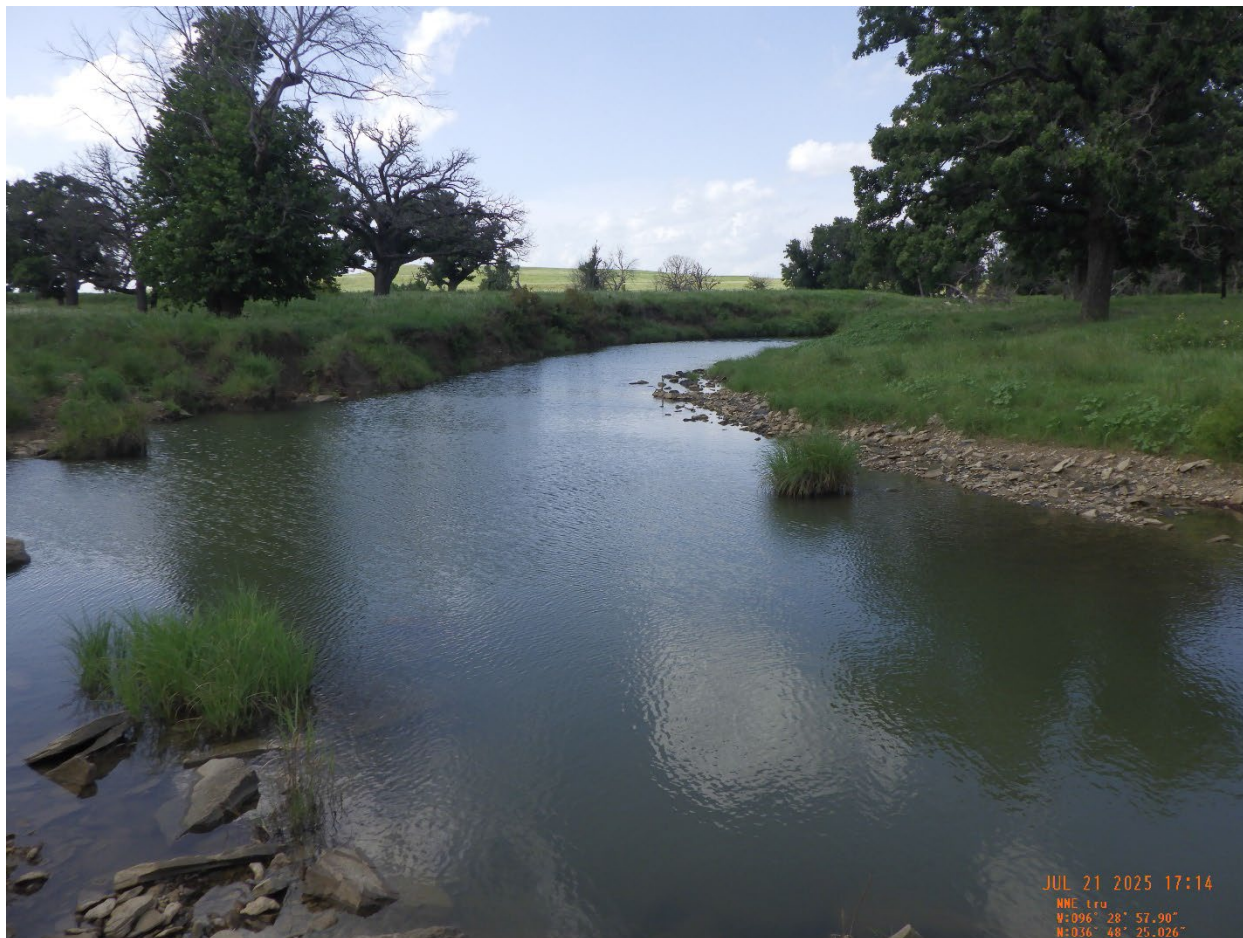
Photo No. 18

From the lowermost containment area, with a view toward the northeast, I observed the bed and bank features of North Bird Creek. At the time of the inspection, south winds were preventing oil from migrating to this location. See photo No. 18.

**Description:** This was a view from the hay bales/containment area looking upstream. At the time of the inspection the south wind was pushing oil up the creek, there was no oil present at this location at the time of the inspection.
